# GLASS SANDS CLOSURE PLAN SIBELCO AUSTRALIA, MINJERRIBAH

2419A

OCT 2024

GEO-ENG

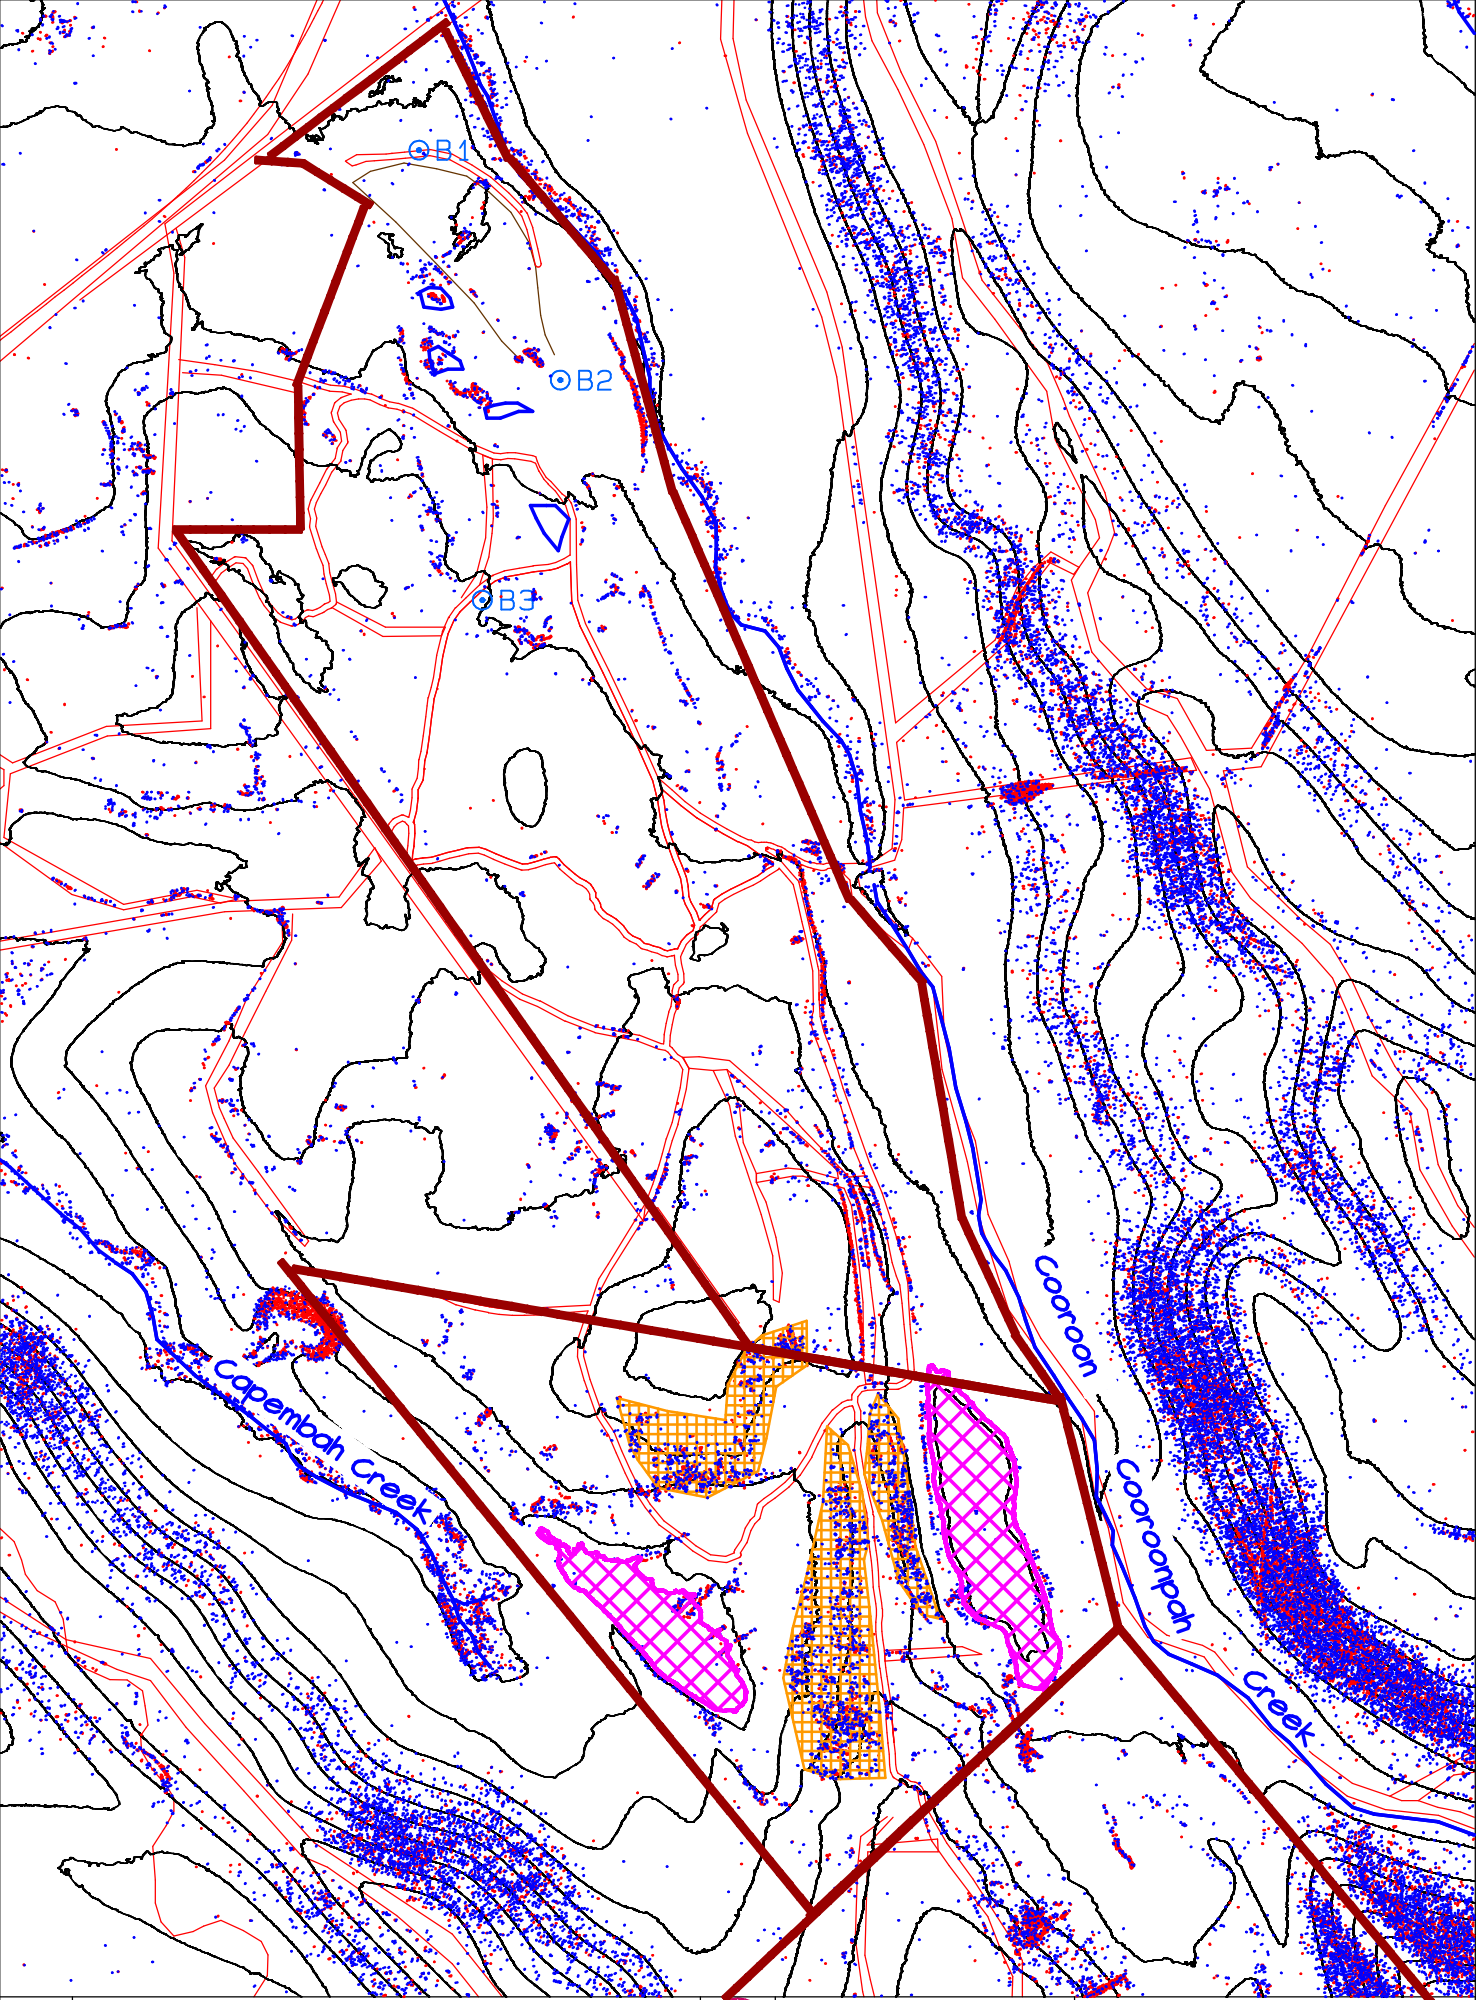
For sand slopes, overall slope failures tend to be shallow planar failures (non-circular). The Factor of Safety (FOS) can be determined by comparing the slope angle to the residual angle of friction for the sand. The dune sand generally has an internal friction angle in the range of 32° to 36° and an in-situ density of 1.6 t/m<sup>3</sup>.<sup>7</sup> Conservatively using the lower internal friction angle value of 32°, a slope of 25° would have a FOS of 1.34. The target FOS for stable sand slopes is greater than or equal to 1.3, based on well-accepted industry standards, and site experience. As shown in Figure 3 nearby undisturbed dune sand slopes have areas steeper than 25° and show no mass stability issues. Similar outcomes would be expected where any small areas with slopes steeper than 25° occur in the rehabilitation.

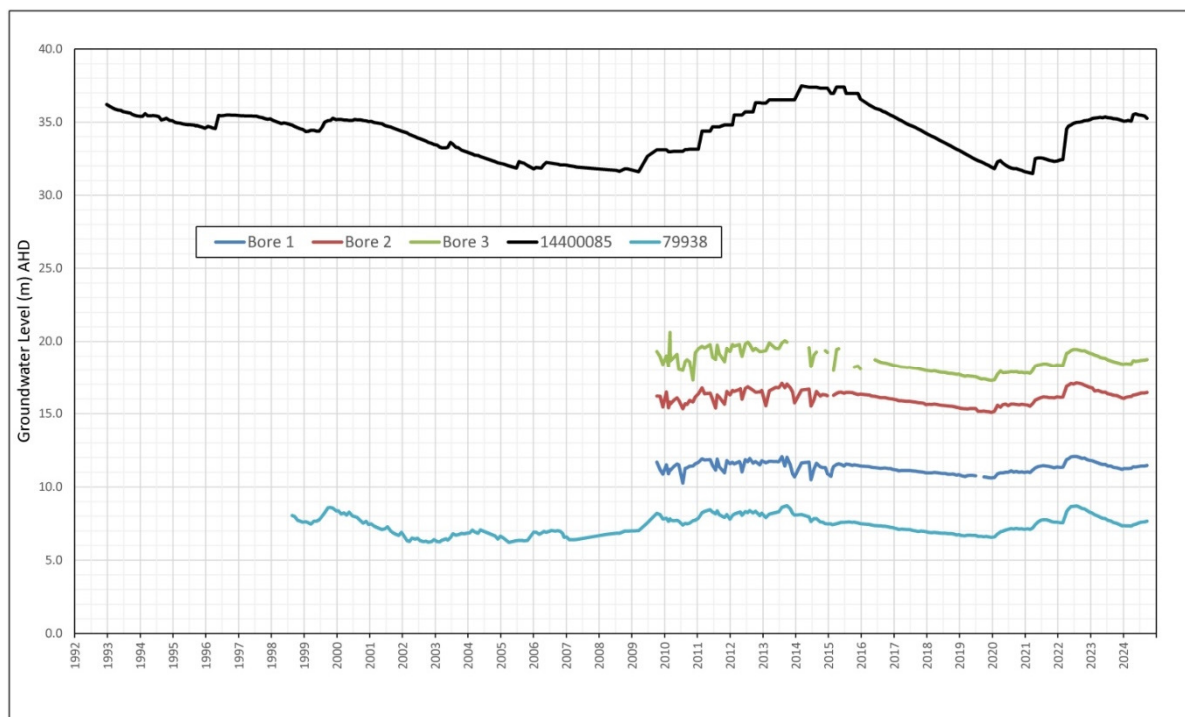
**Figure 4 Groundwater Monitoring Levels**

Water supply bores B1-B3 are located at the northwestern end of ML1124. Water level monitoring records are available from 2009 (Figure 4). Bore pumping ceased in 2015, as is evident by the smoother hydrograph after this date. As most of the water used for pumping and washing of the sand was returned to the aquifer via infiltration, the bore pumping would

not have had a significant long-term impact on the groundwater table level. This is confirmed by comparing the groundwater monitoring levels before and after 2015 for the bores to the nearby monitoring bore 79938.

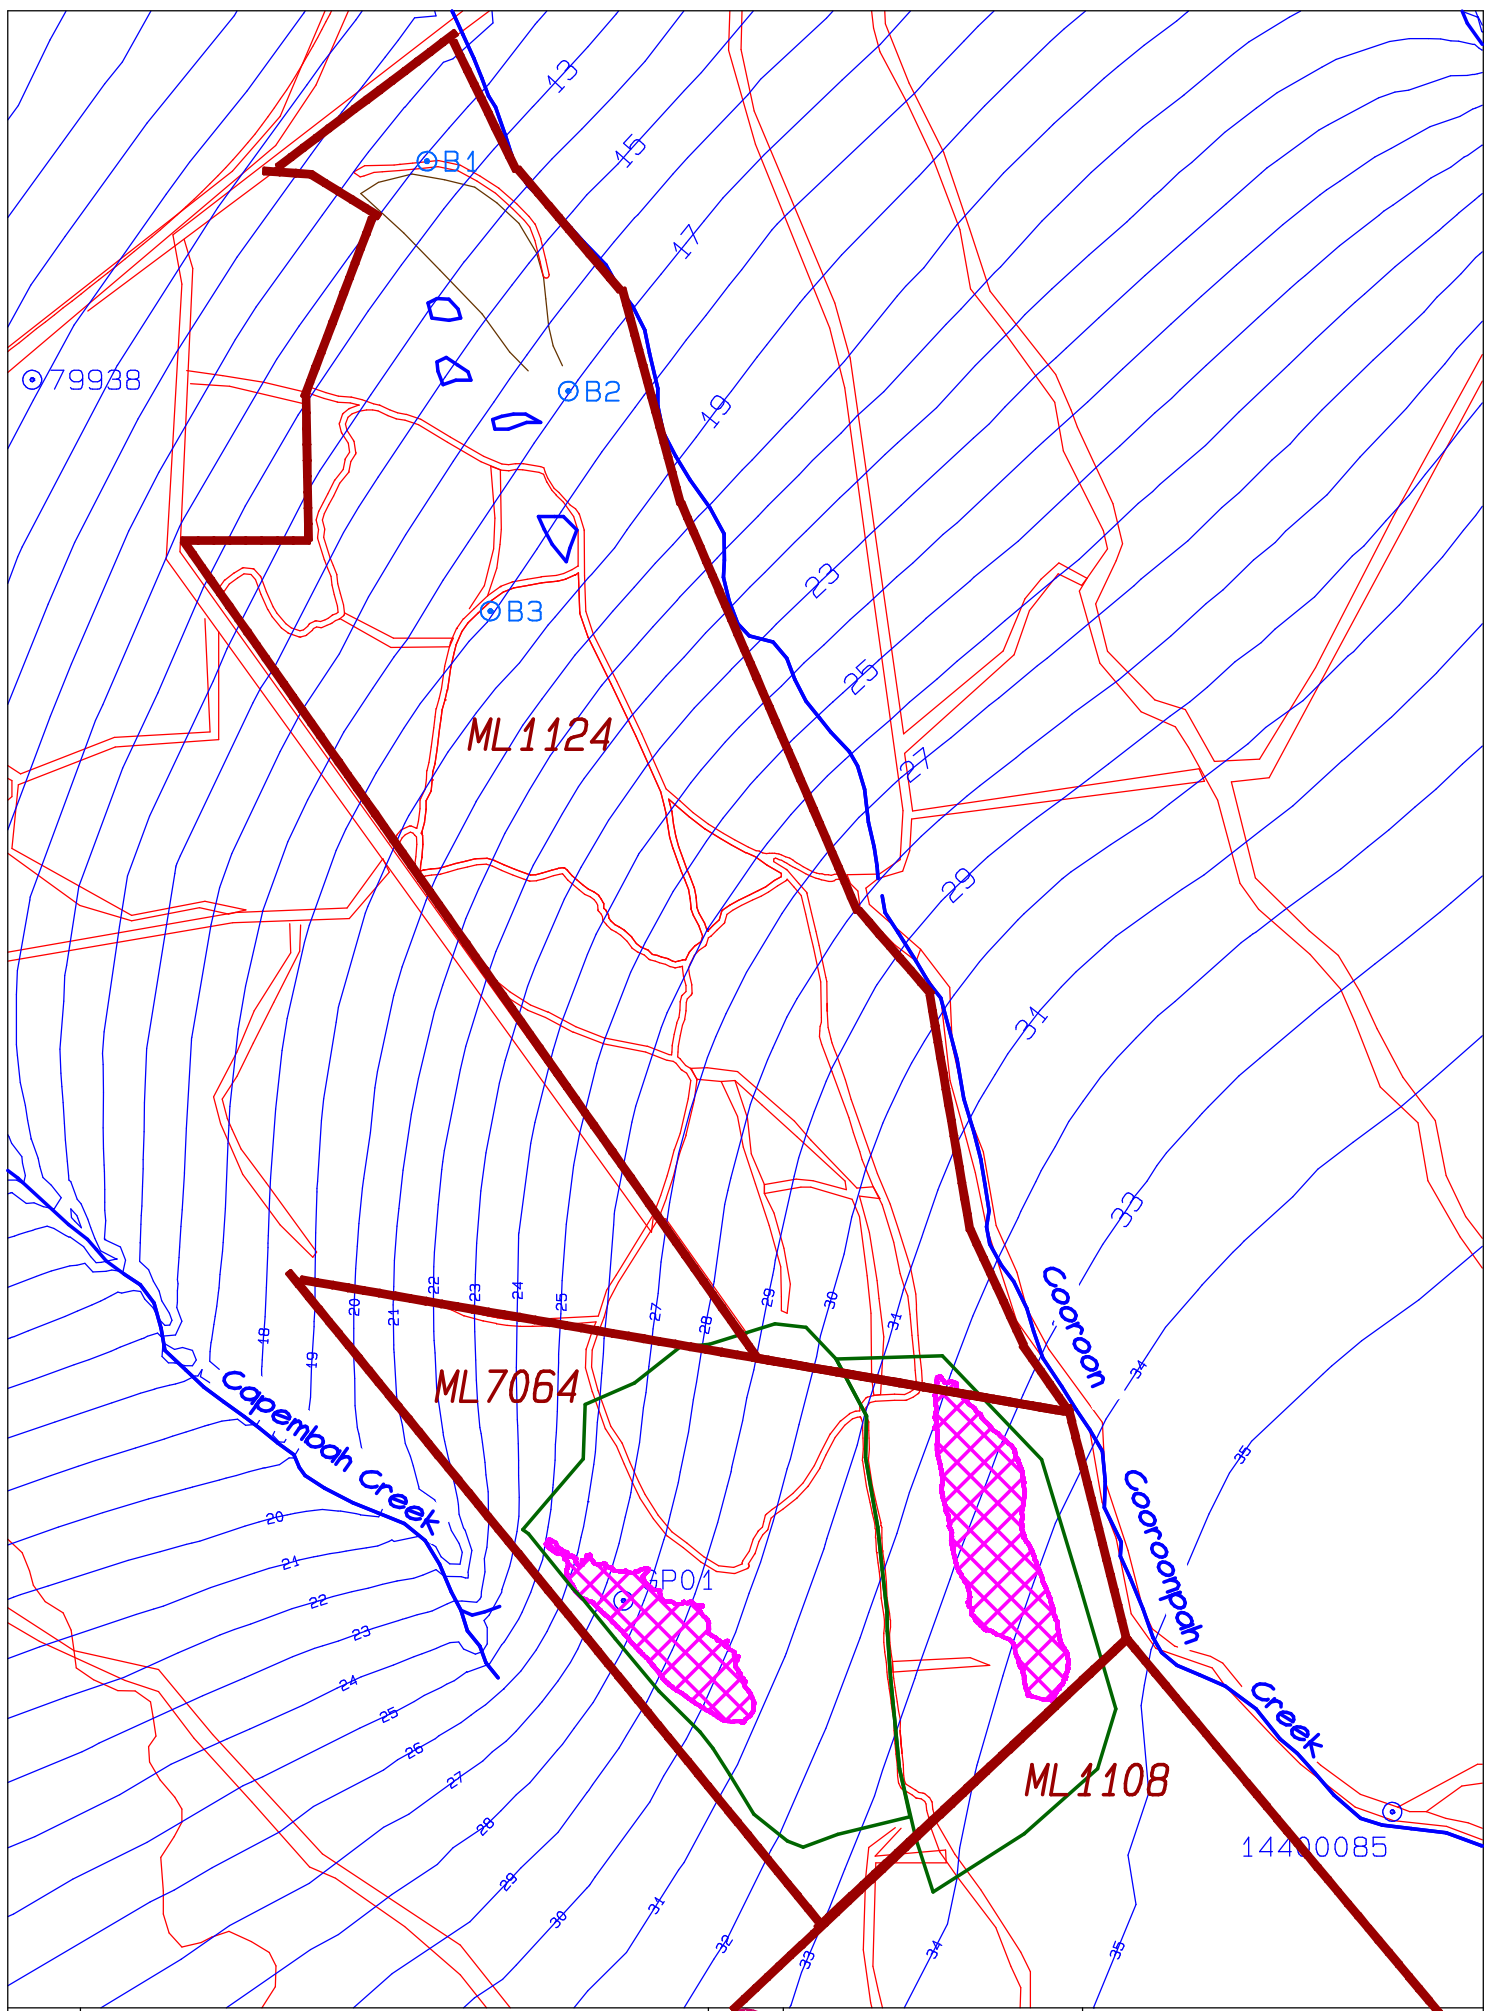
The Sibelco Groundwater Model<sup>9</sup> was refined with more accurate topography, especially to reflect the creeks near to Glass Sands. Estimated groundwater contours from the model for a near average groundwater table are shown in Figure 5. The model estimates the groundwater table to be within eight meters of the local ground level at the two voids (Table 1).

A standpipe piezometer (GP01) was installed within the western void to investigate the groundwater levels (Figure 5). The piezometer was installed to a depth of 3.3 m and intersected water at 2.8 m (approximately 32.3 mAHD), about 1.7 m below the nearby perched pond level. This confirms that the ponded water is not a window lake of the groundwater table. The water level in the piezometer is higher than the expected groundwater table level of about 27.5mAHD<sup>10</sup>, and may reflect a second, lower perching layer.

The local groundwater gradient flows to the west (Figure 5), with an estimated average gradient of about 1V:80H, steepening near to Capembah Creek. The estimated throughflow rate across the site is about 40 L/s.

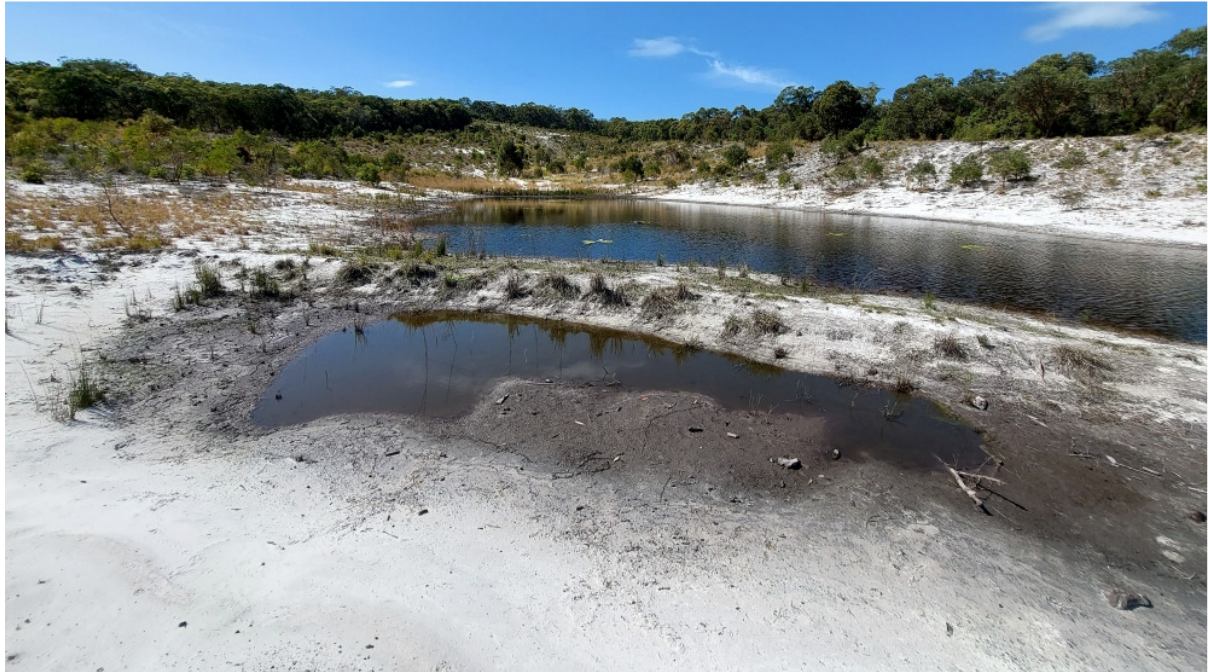
PHOTO 1 WESTERN VOID

The direct catchments of the void areas are 21.8 ha on the west and 15.5 ha on the east (Figure 5). Surface runoff appears to be higher than usual due to shallow cemented sand layers that limit infiltration. During the site visit of 21/10/24 about 20 mm of surface water was noted at the eastern void. The depth of water in the western void pond was about 0.5 m (Photo 1–Appendix A).

Ponding of water at the western void is evident in Google Earth photographs since the locality was mined in 2017. It is expected that the ponding would fully evaporate during extended dry periods, given its shallow depth. Hand auger drilling near the water body indicated a water holding perching layer of dark sand within 1 m of the surface. As discussed in Section 2.2, there may be multiple perching layers beneath this area. The historic photos also indicate significant past rainfall-runoff erosion from the slope to the east. The area is being colonized by aquatic plants and is expected to develop into an intermittent wetland.

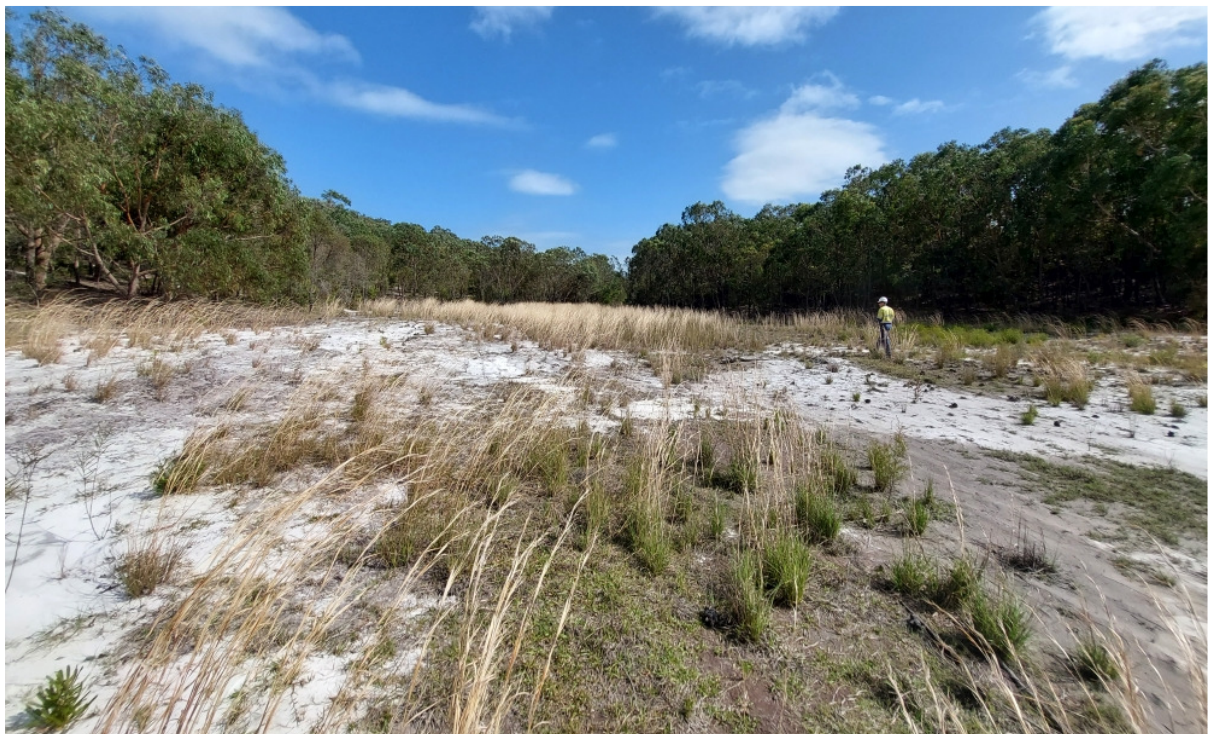
PHOTO 2 EASTERN VOID

The eastern void had about 20 mm of water at the lowest point, and is not expected to host surface water for long periods of time, due to the high evaporation rate (Photo 2–Appendix A).

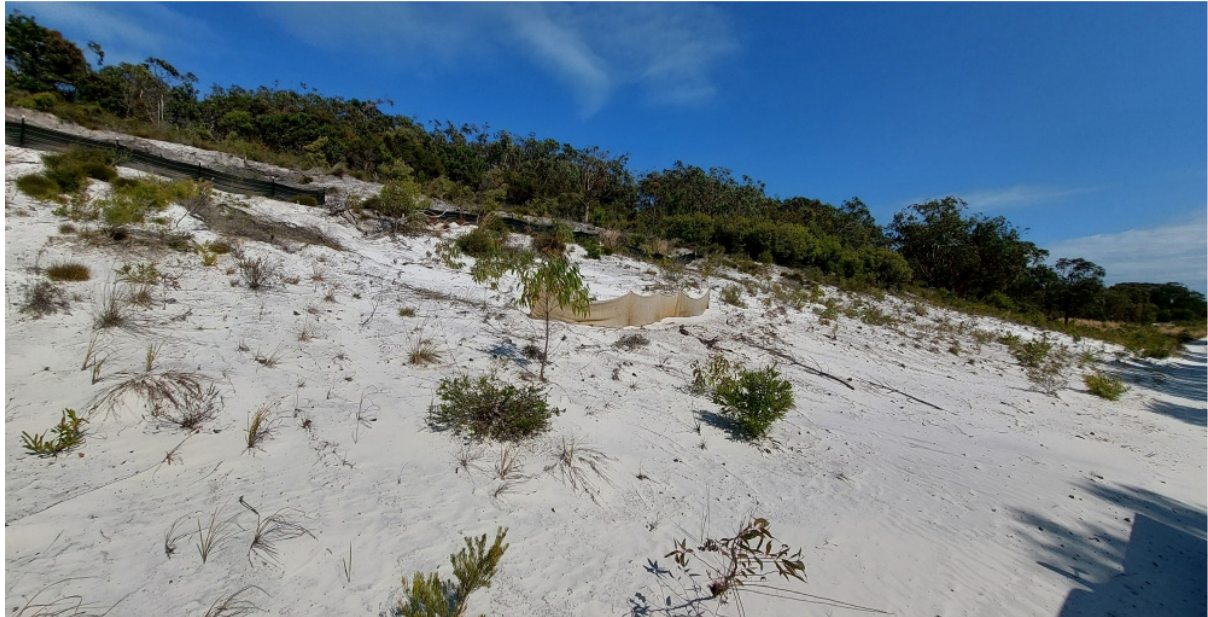
PHOTO 3 EROSION ZONE 1

Erosion Zone 1 has been recontoured to a slope angle of about 18°, re-vegetated and protected with fencing. Ongoing maintenance would be required until the vegetation cover has developed (Photo 3–Appendix A).

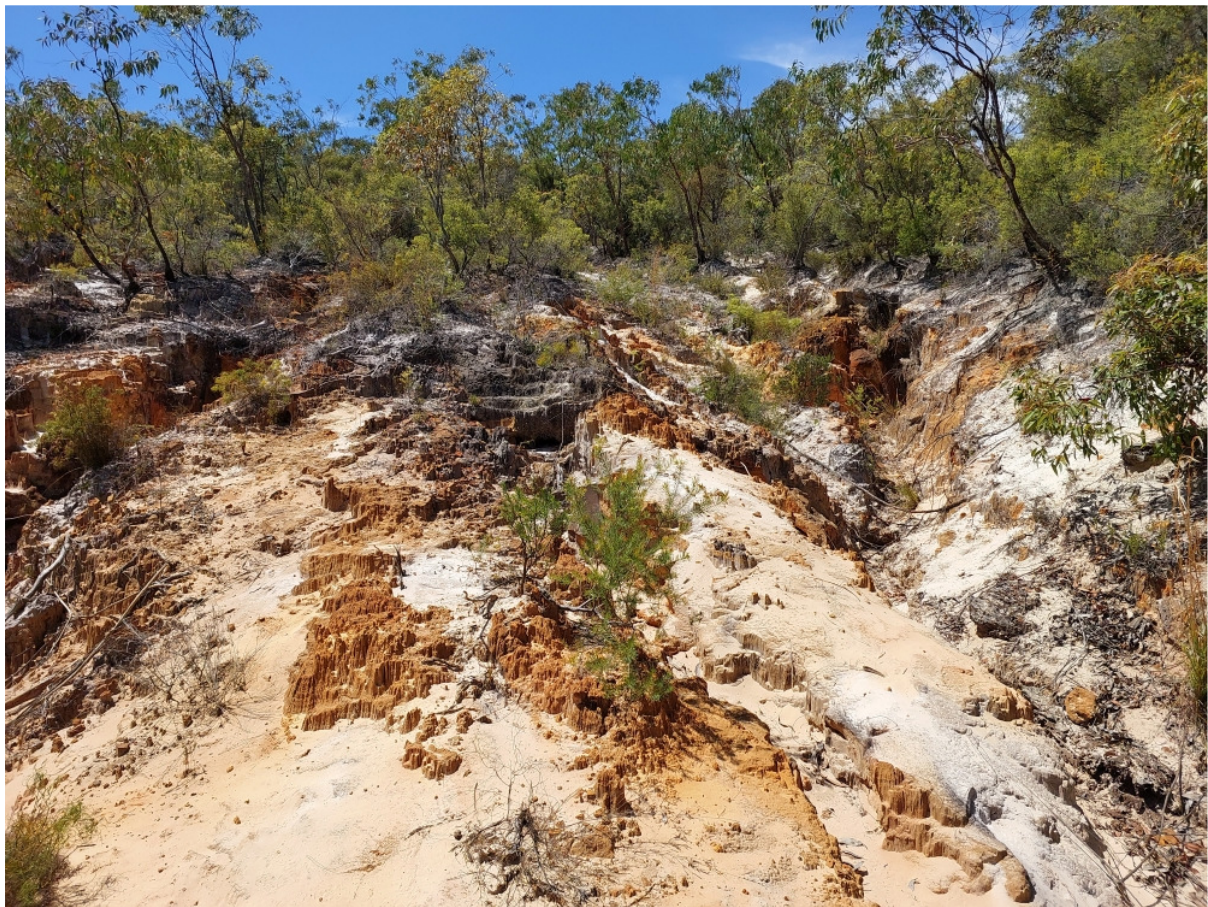
PHOTO 4 EROSION ZONE 2

Erosion Zone 2 has many deep erosion gullies down to the cemented sand layer, which is limiting infiltration (Photo 4–Appendix A). Ripping of the cemented sand would improve the ground condition, but would destroy the thick vegetation cover. It is recommended to backfill the erosion gullies with hay bales and brush cutting to trap run-off and prevent sand erosion

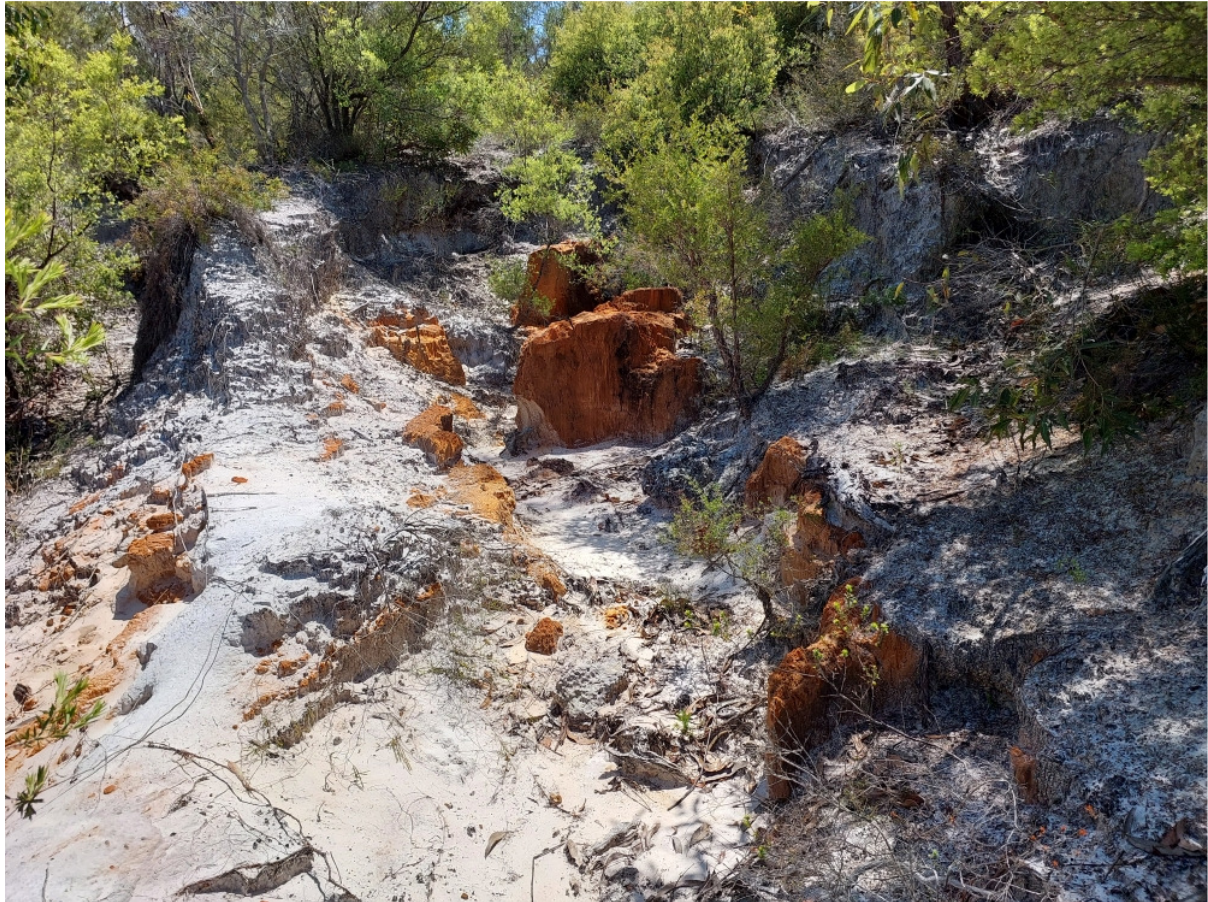
PHOTO 5 EROSION ZONE 3

Erosion Zone 3 is similar to Zone 2, but has sparser vegetation (Photo 5–Appendix A). This area could also be treated with hay bales, brush cutting and mulching to encourage better vegetation growth.

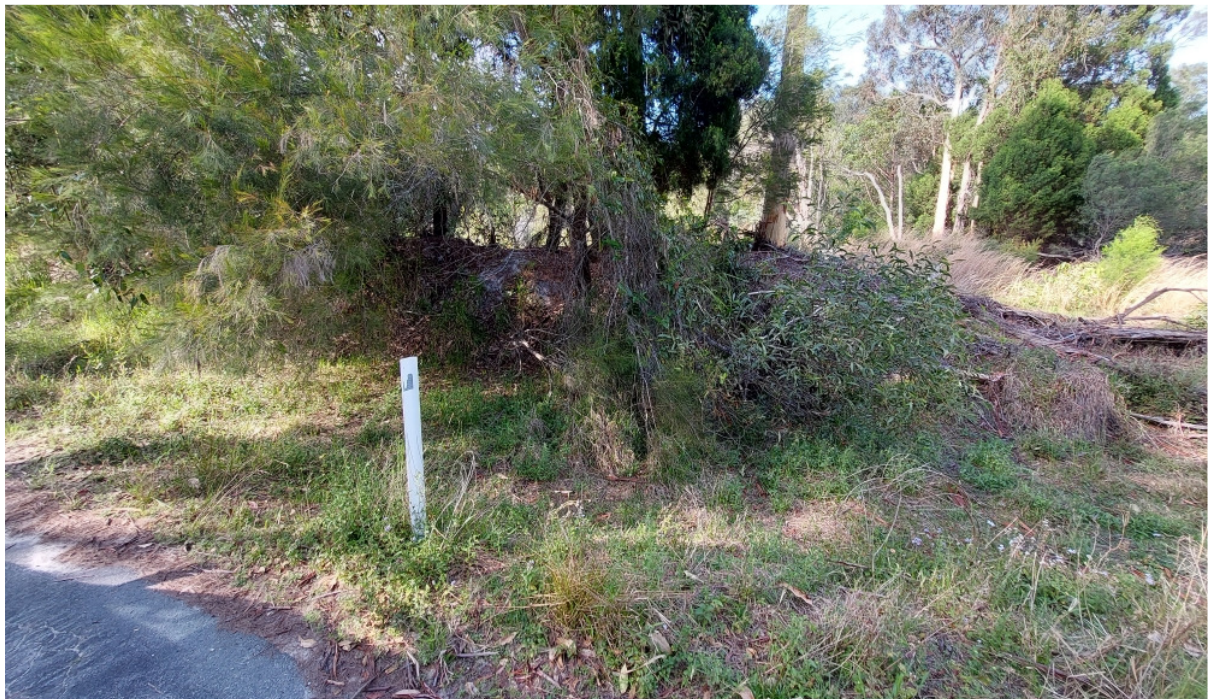
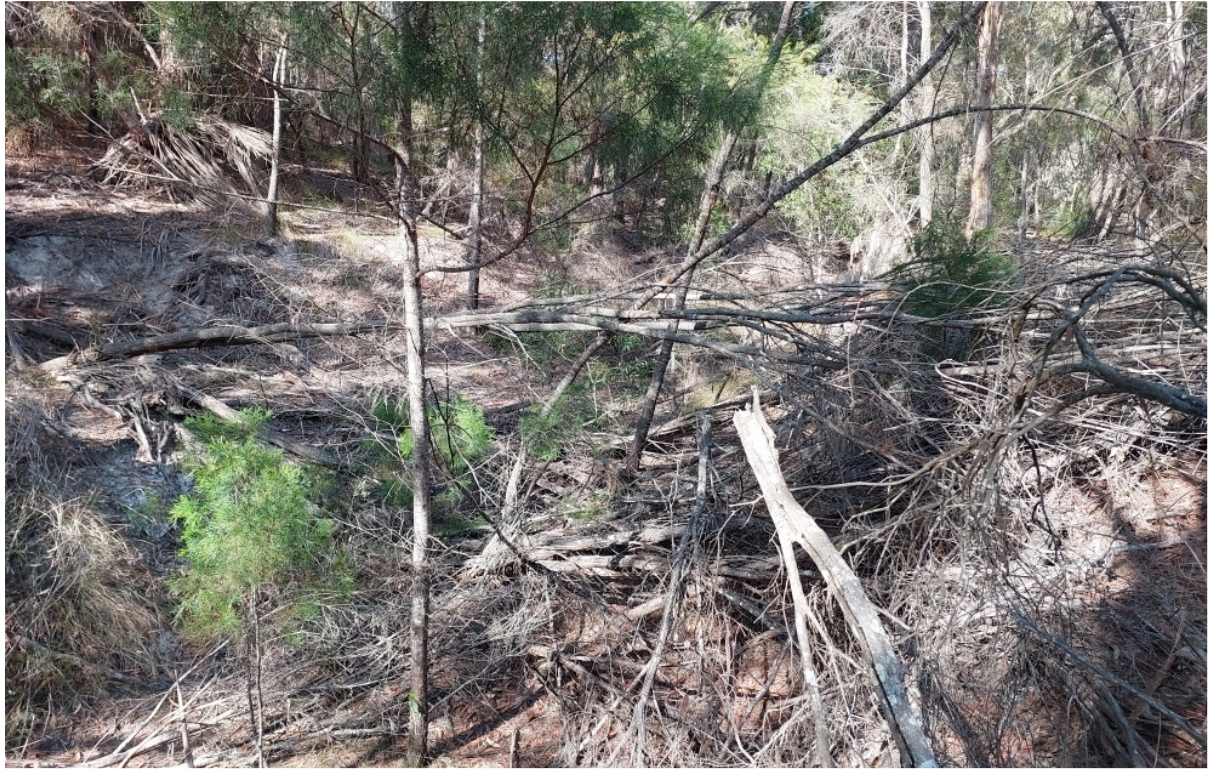
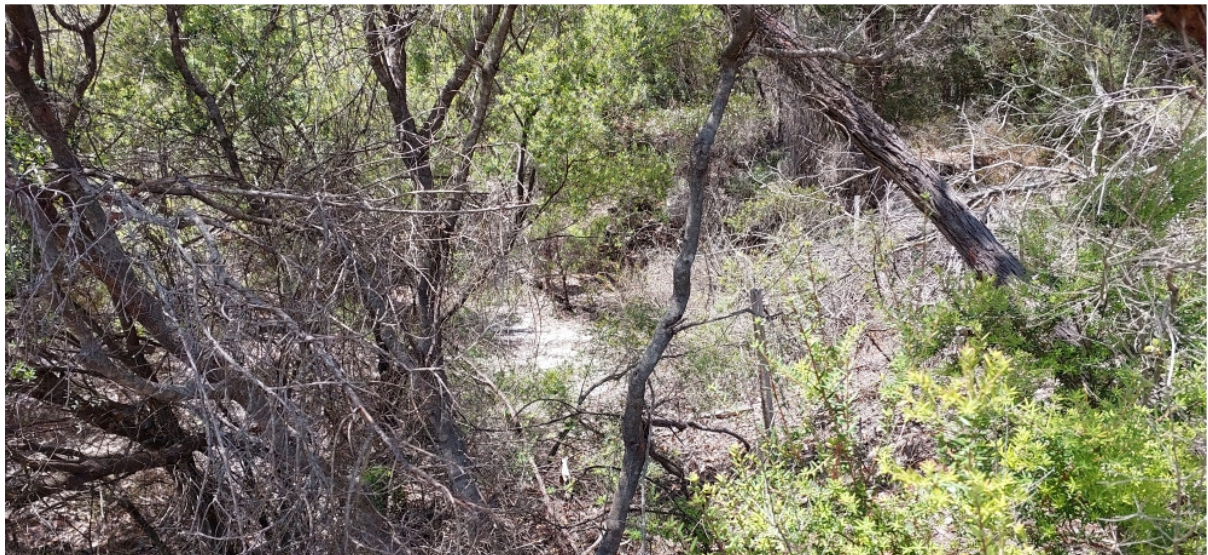
Other smaller areas of steep slopes across both mining leases were found to be stable with good vegetation growth and ground cover (Photos 6 to 8–Appendix A).
