# Notice

### Environmental Protection Order

The EPO is issued in respect to the activities at the Mt Allison Mining Project on land described as Lot 8 on Plan CL40381, situated at Mining Leases (MLs) 80135 and ML80137 (the premises).

**RE: Compliance inspection, ML80135, ML80136, ML80137, ML80138, ML80139, EPSL00294513, 19 August 2019**

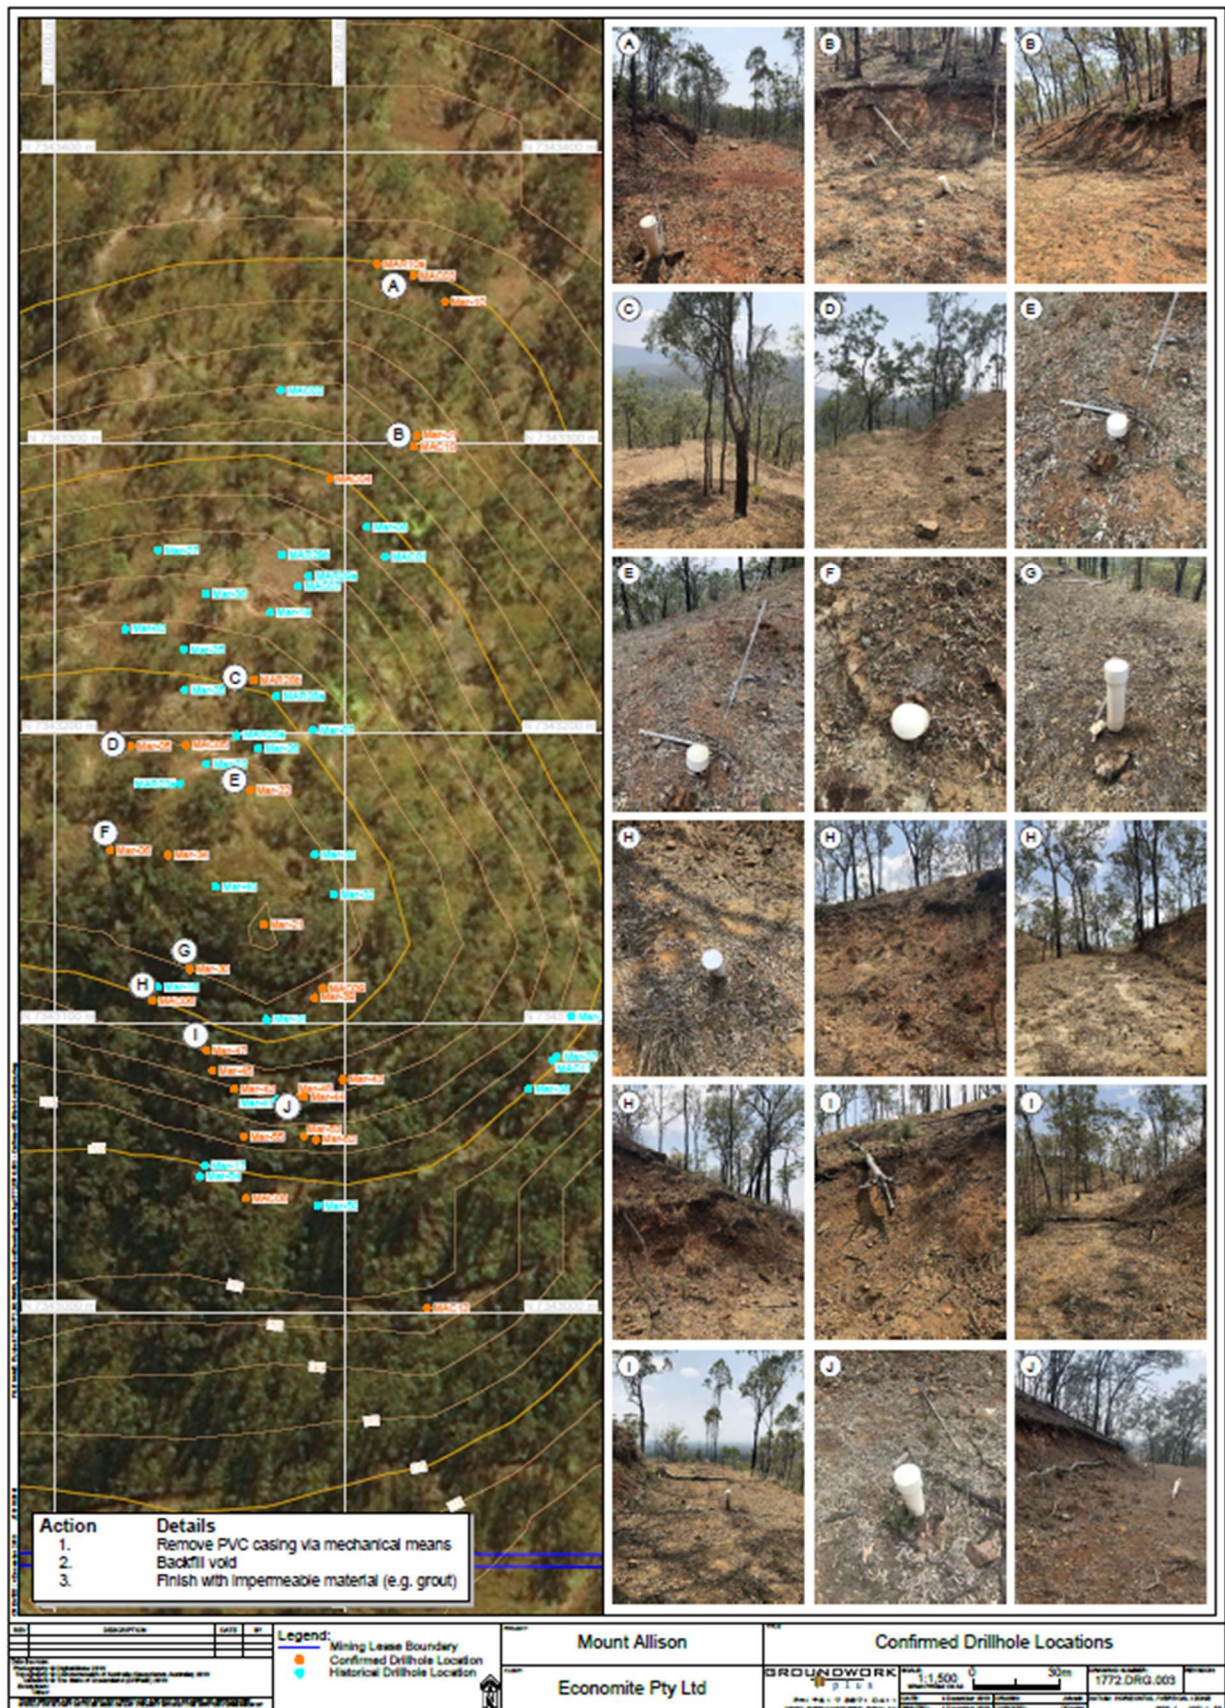
The location of the 2008 bulk sampling test pit and the 2009 drill holes are illustrated in the attached figures Drawing No. 1772.DRG.003 – Confirmed Drill Hole Locations.

As detailed in Table 1, approximately 60 diamond drill holes were progressed in 2009. Approximately 31 bore locations were positively identified, each with remnants of bore infrastructure remaining. Typically, these were white PVC casing extending between 200 mm to 600 mm above ground, either angular or straight (depending on the desired drill core angle). It is very likely that not all of the 60 originally drilled bores were finished with these white PVC casing as a number of drill holes that were visited did not have any permanent remnants present. Refer to Drawing No. 1772.DRG.003 – Confirmed Drill Hole Locations for the locations of these casings and photographs to show the condition of a selection of these bores during the inspection.

It is recommended that each of the white PVC casings is removed to below the ground level and the resultant drill void backfilled with material.

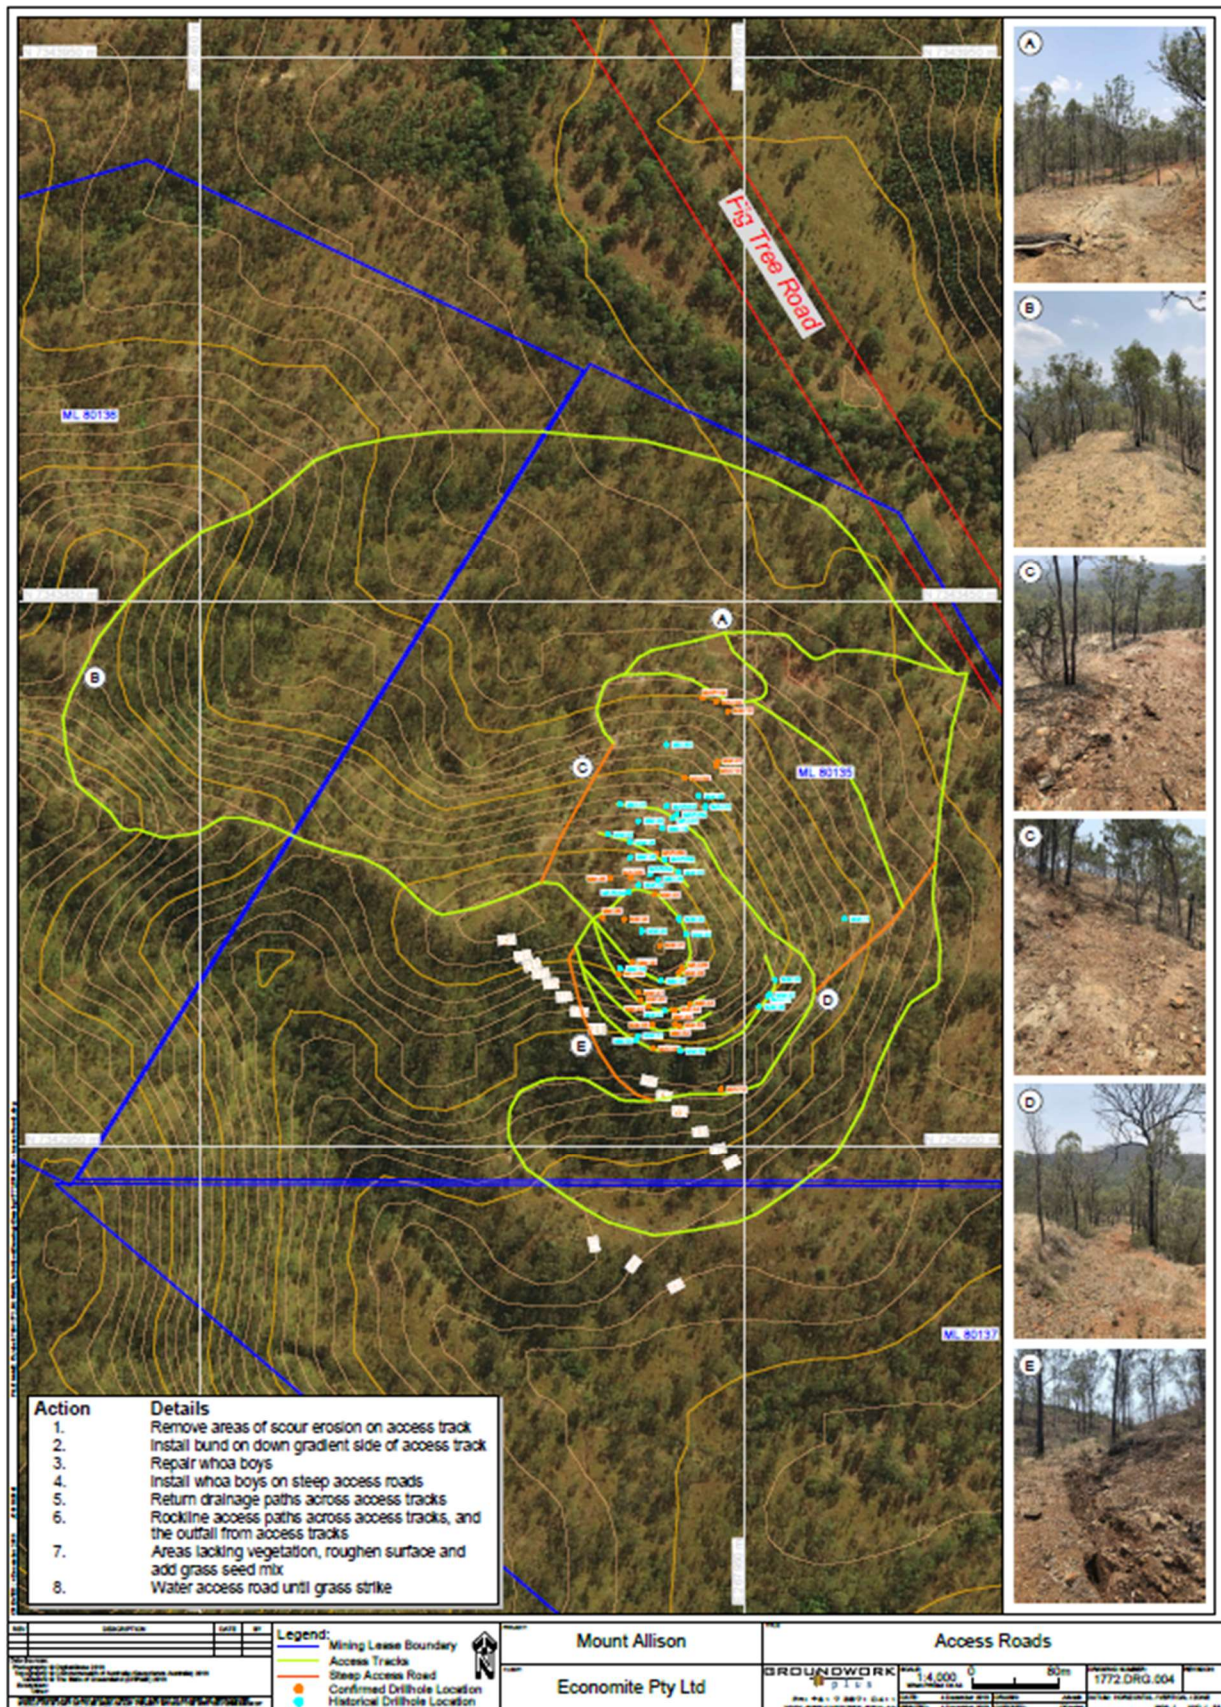
Refer to Drawing No. 1772.DRG.004 – Access Roads for the locations of access tracks that were attended to as part of the inspection. These access tracks were presumably formed during the drilling program.

These access tracks were the subject of the previous assessment in 2014 (refer **Section 6**), which resulted in recommendations for some improvements such as drainage and erosion control. Since that time, significant high intensity rainfall events have occurred which has resulted in some erosion and scouring. On 21 November 2019, some portions of the access tracks were observed to be in a fair condition, stable and with some grass cover present; however, these are interspersed with areas that require improvements.

There are three distinct areas of the existing access roads that require erosion and sediment control implementation, these are shown on **Drawing No. 1772.DRG.003 – Access Roads**. These areas are to be reprofiled, with drainage controls installed, and seeded to promote grass growth. There are local areas within the access tracks that will benefit from some reprofiling and drainage improvements, these will be identified and actioned during the rehabilitation works.

Flow diversion banks are recommended to be installed at the downstream end of the higher gradient access roads, with stormwater directed towards a dedicated drainage outlet.

The benefit of using flow diversion banks is that they can be placed on dispersive soils without cutting into the substrate<sup>2</sup>, minimising the potential for generating additional erosion and scour. To mitigate high flow velocities adjacent to the banks, check dams should also be formed to slow runoff flows.

The site has the benefit of rock being present both in stockpile at the ore body test site, and other locations, and the local geology of the site means that rock is close to the surface. It is recommended that major overland drainage features, that transect roads, are rock lined to prevent scour erosion during high velocity events.

Final surfaces are to have grass seed applied to promote growth.

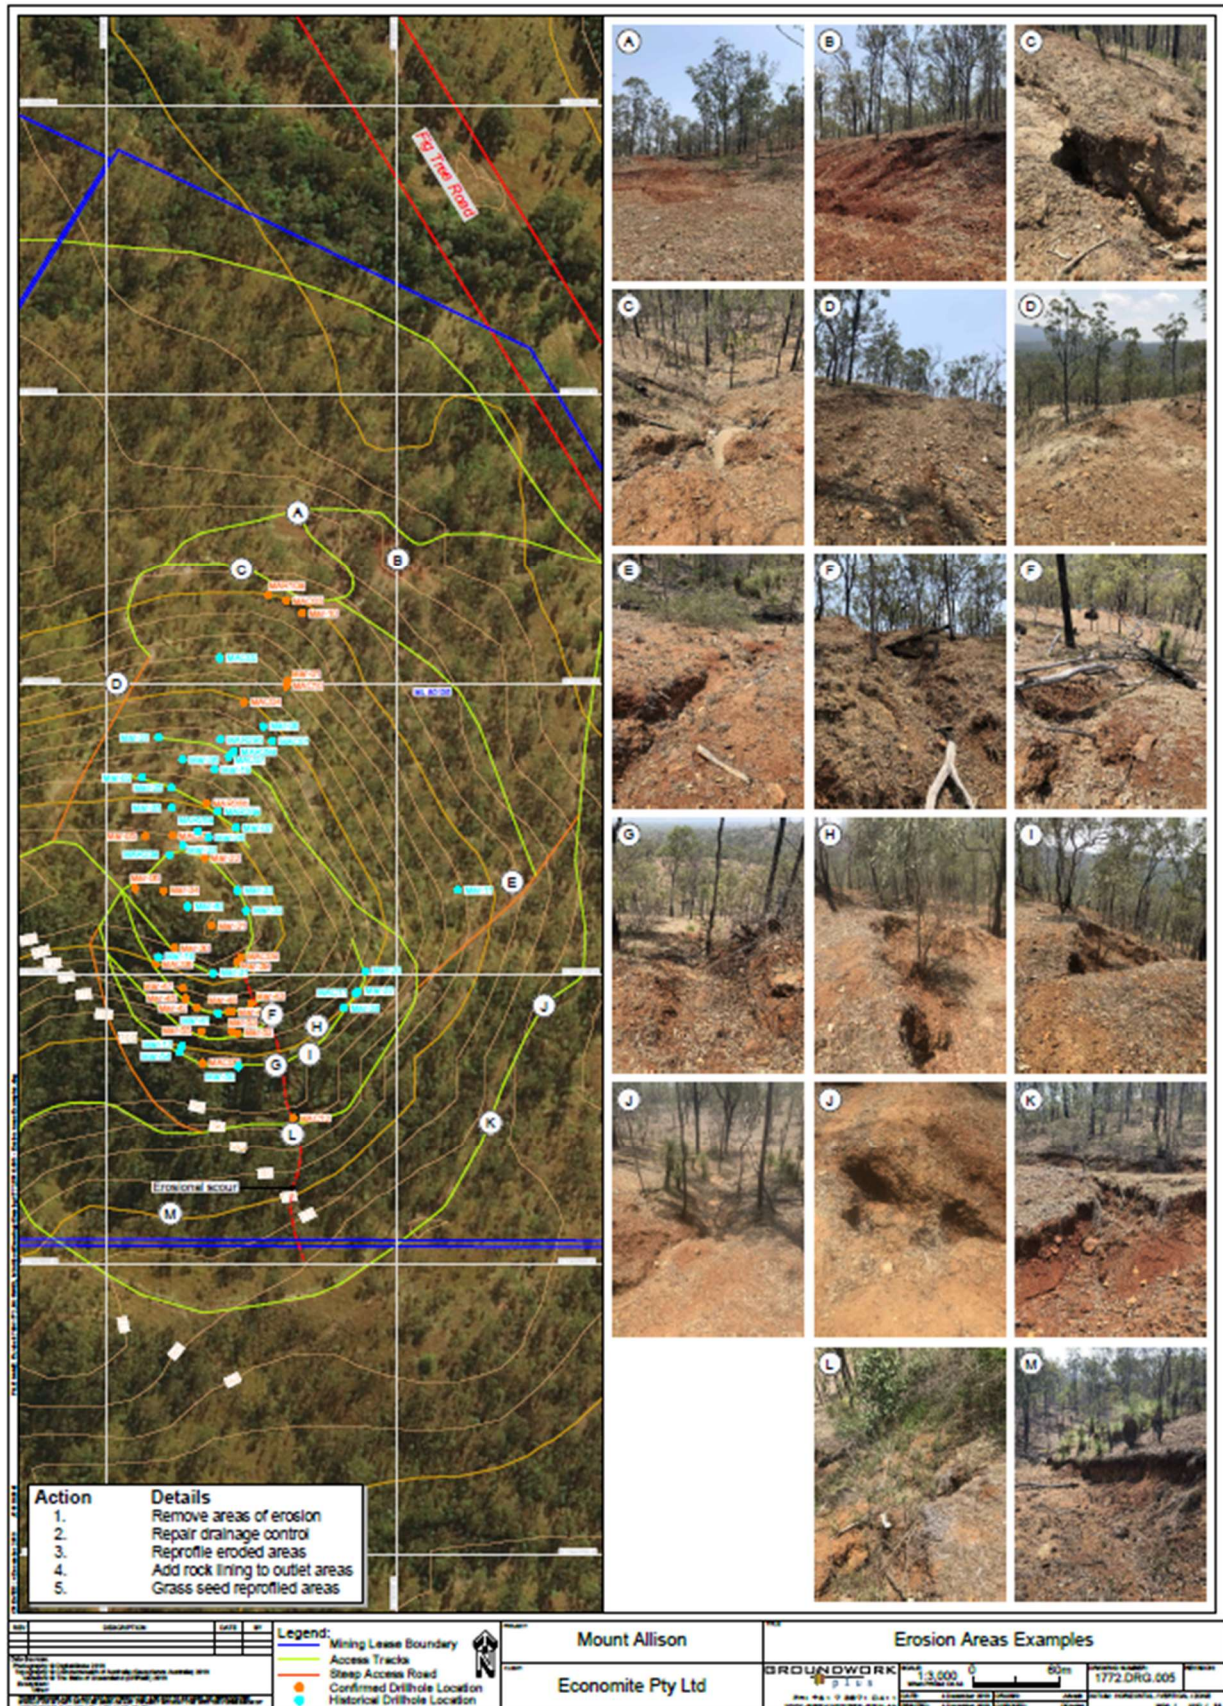
Erosion and scouring have occurred in drainage lines extending downslope from the ridge due to high velocity rainfall events. In addition, some of the formed batters, present as a result of the access track formation, have some erosion present on the exposed faces.

The location and condition of some of these areas of erosion is provided in **Drawing No. 1772.DRG.005 – Erosion Area Examples**.

Similar to the actions required for the access tracks, areas of erosion are to be reprofiled, with the active erosion removed. Local drainage controls are required to slow the velocity of overland flow, and to also provide some protection to the soil.

Within the concentrated drainage paths, rock lining should be added to the concentrated flow paths to provide for a more stabilised surface, particularly at the outlets.

Seeding of any reprofiled areas is also recommended to aid in rehabilitation.

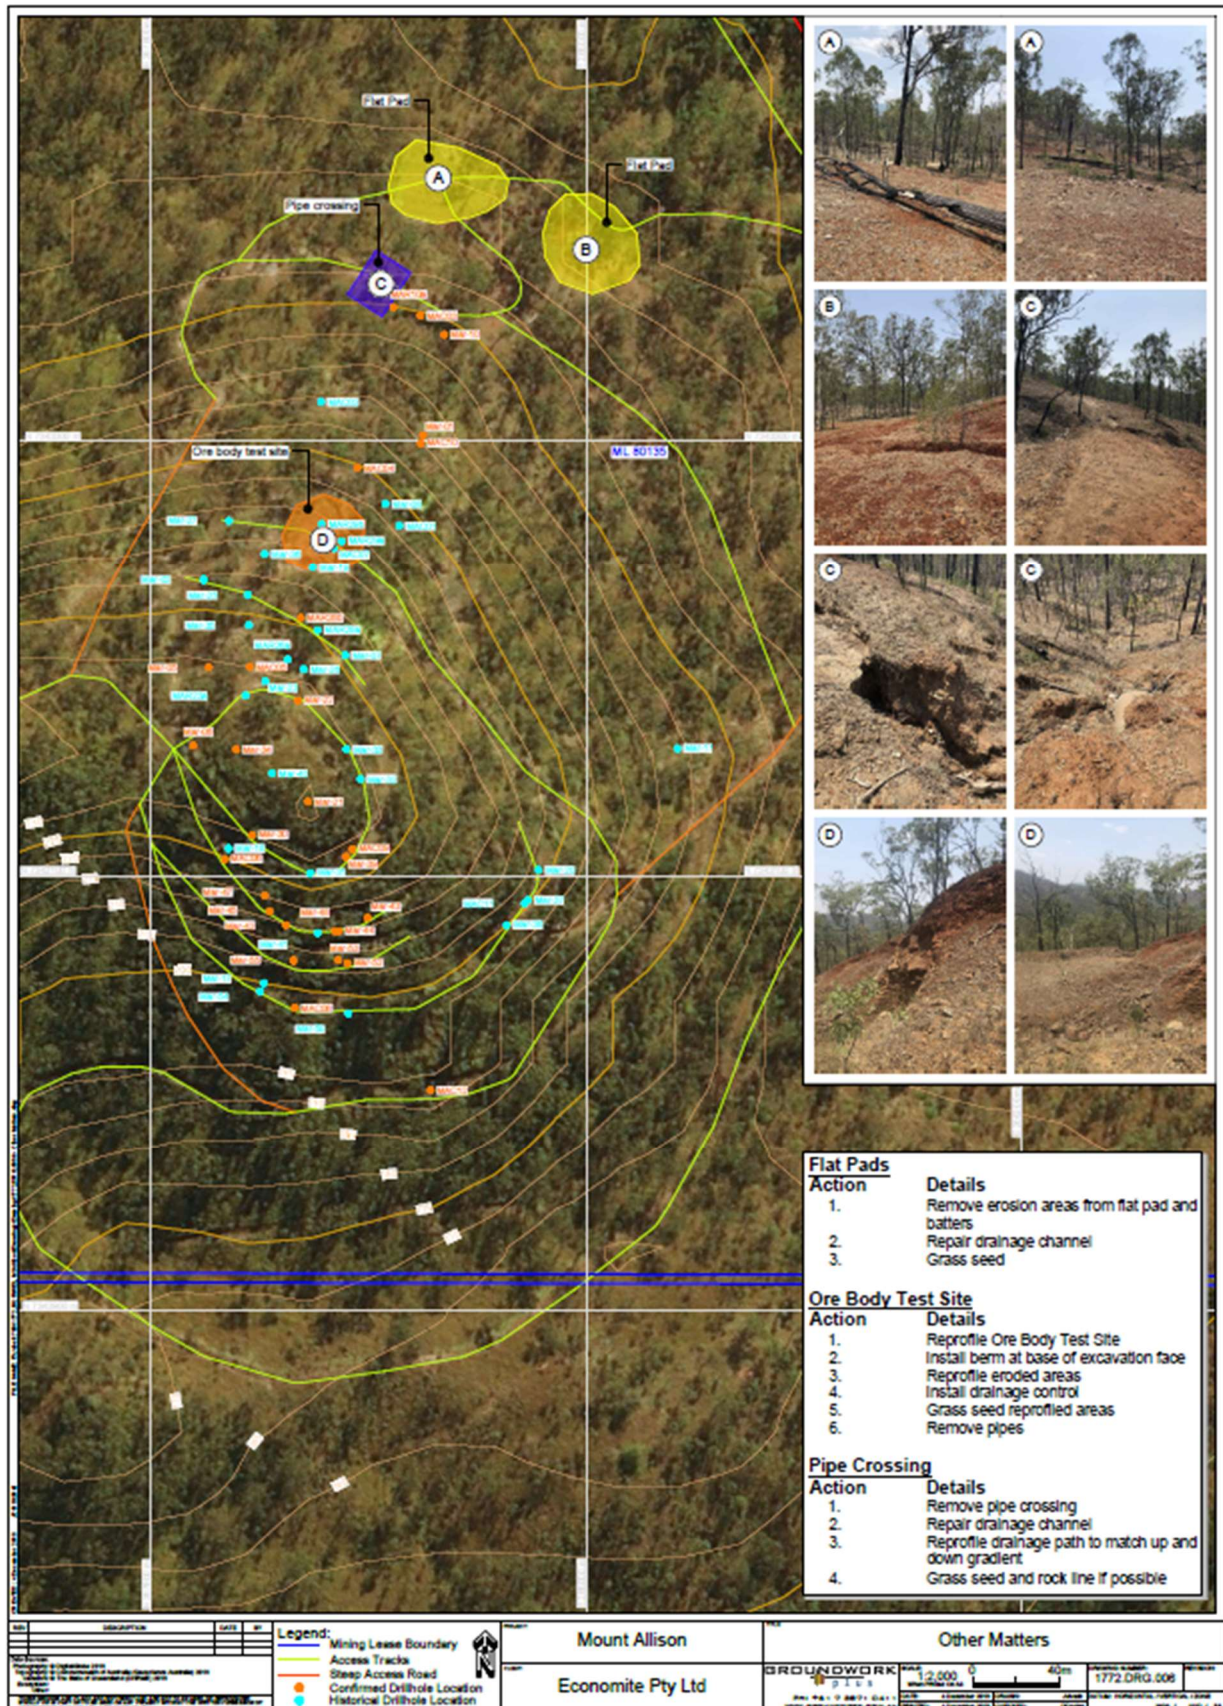
The location and condition of this area is provided in **Drawing No. 1772.DRG.006 – Other Matters**

As part of the exploration and resource evaluation, a small ore body test site was progressed on site. The area includes a small flat pad, with an excavation into the side of the mountain. The exposed material is largely rock. The location and condition of this area is provided in **Drawing No. 1772.DRG.006 – Other Matters**.

As this crossing no longer serves a purpose, and there is erosion present, it is recommended that this structure is removed, and the banks of the drainage path reprofiled to match up and down gradient.
