### Environmental Protection Order

The amended EPO is issued in respect to the activities at the Mt Allison Mining Project on land described as Lot 8 on Plan CL40381, situated at Mining Leases (MLs) 80135 and ML80137 (the premises).

**Annexure 1 – Stage One Report dated 16 December 2019**

**RE: Compliance inspection, ML80135, ML80136, ML80137, ML80138, ML80139, EPSL00294513, 19 August 2019**

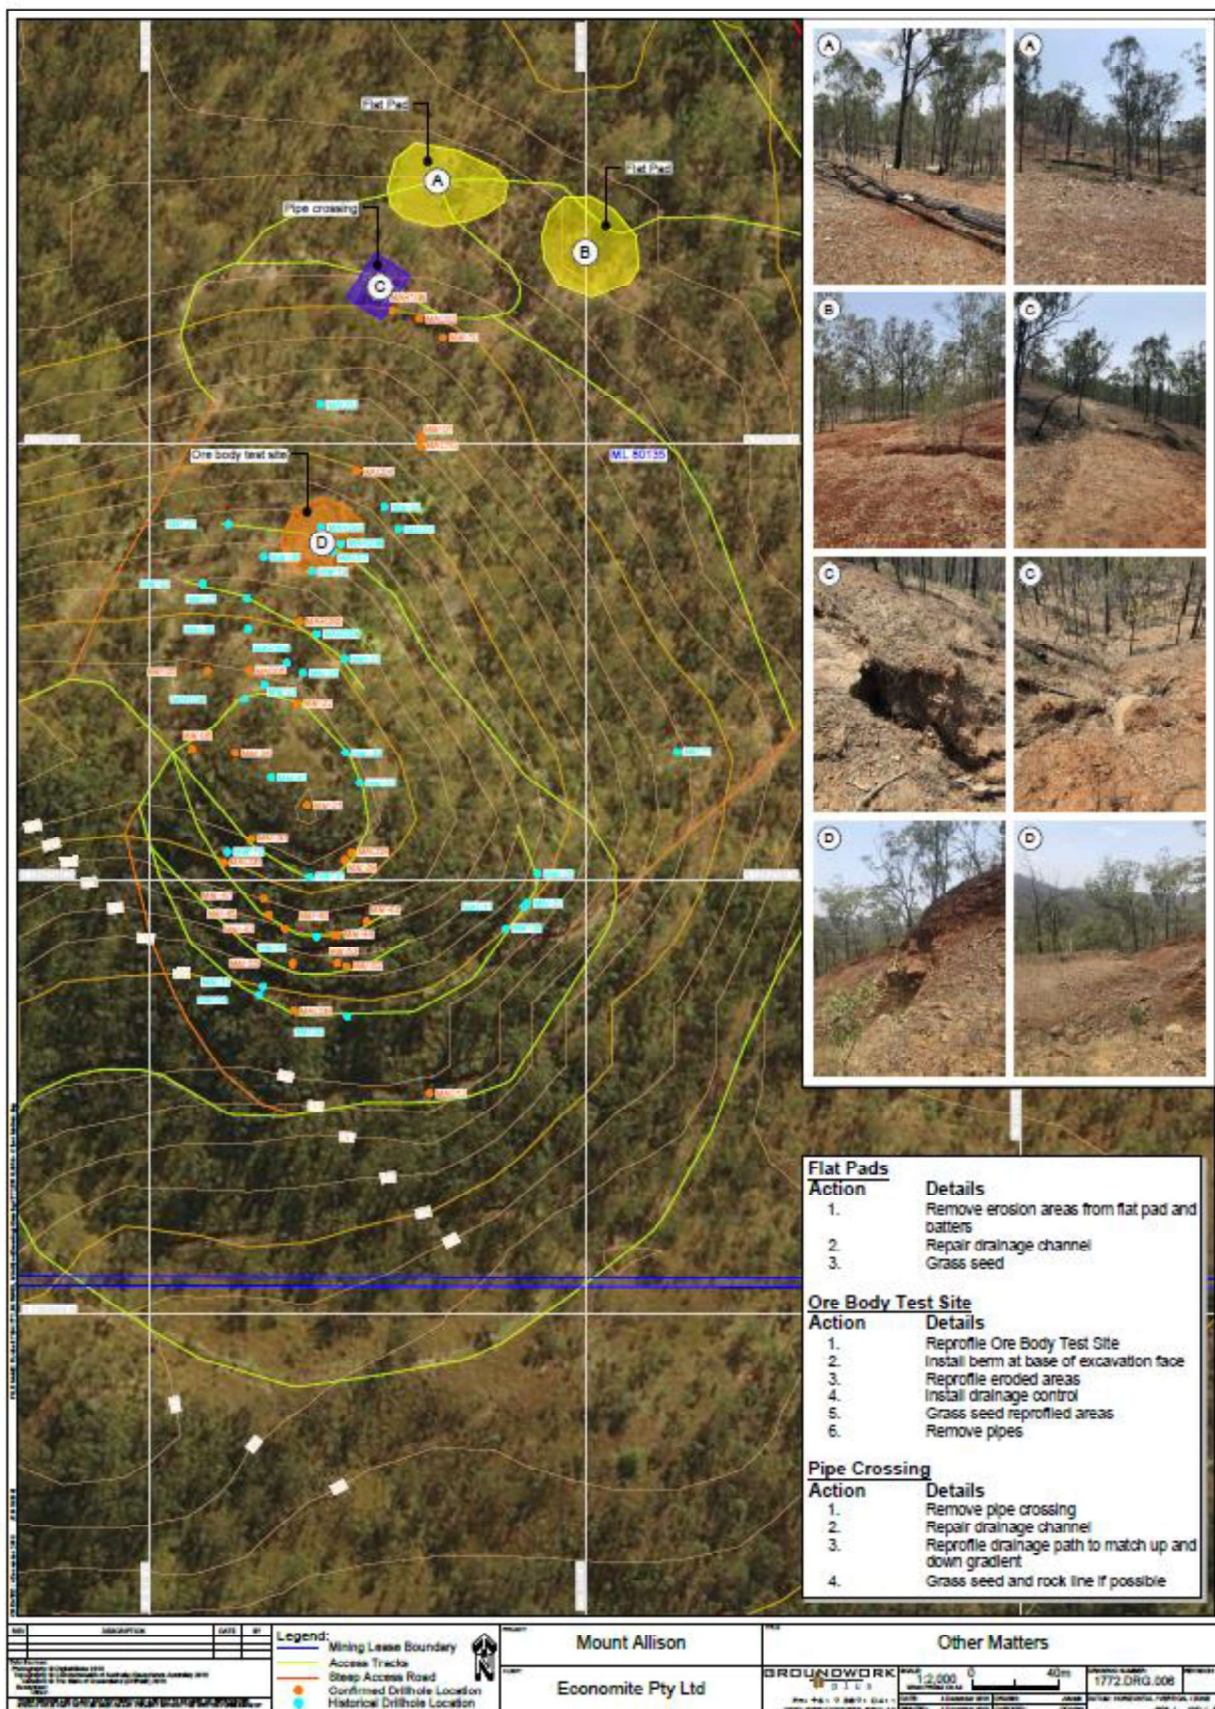
The location and condition of this area is provided in **Drawing No. 1772.DRG.006 – Other Matters**

As part of the exploration and resource evaluation, a small ore body test site was progressed on site. The area includes a small flat pad, with an excavation into the side of the mountain. The exposed material is largely rock. The location and condition of this area is provided in **Drawing No. 1772.DRG.006 – Other Matters**.

As this crossing no longer serves a purpose, and there is erosion present, it is recommended that this structure is removed, and the banks of the drainage path reprofiled to match up and down gradient.
