# Thalanga Copper Mines Pty Ltd

## **Re: Transitional Environment Program (TEP) MAN17020**

In accordance with the commitments made in the above TEP please accept this report on site surface water flows, pit water and TEP investigations at the Highway Reward mine. This report covers the period from 12 June 2014 until 11 December 2014. This period was characterised by extremely low rainfall on site with drought conditions applying. Table 1 shows the monthly rainfall, with 32.69 mm falling over six months.

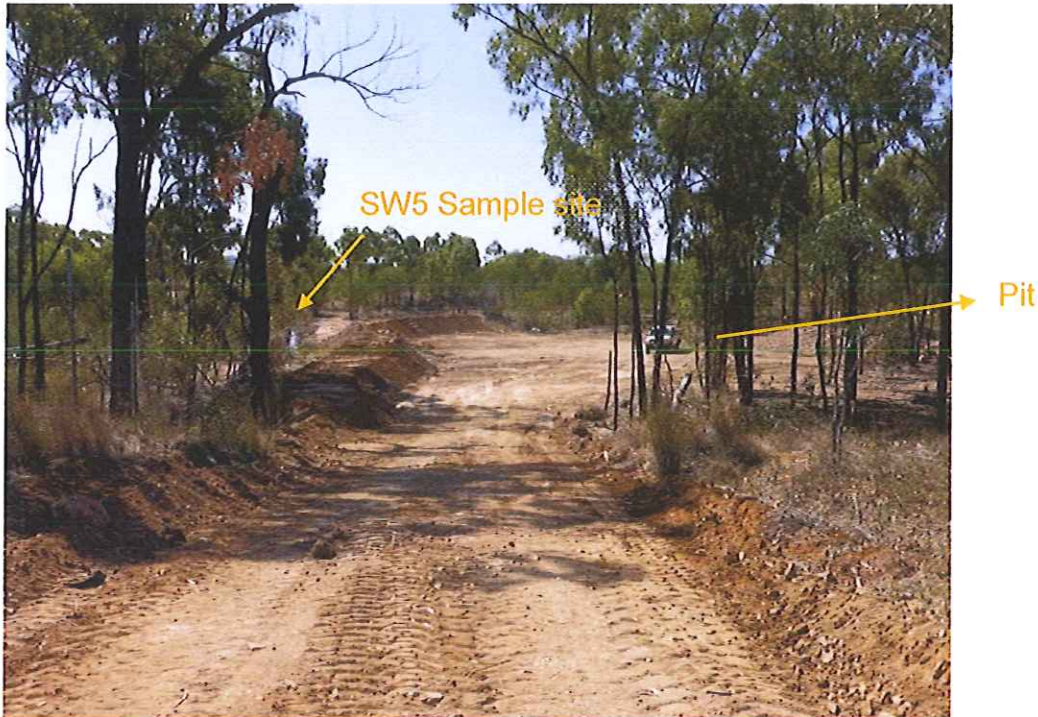
Plate 1      Diversion bund western side of lease

Plate 1 above shows the diversion bund installed to prevent surface water flowing from the mine site to the west of the lease area.

No flow occurred. No samples were taken.

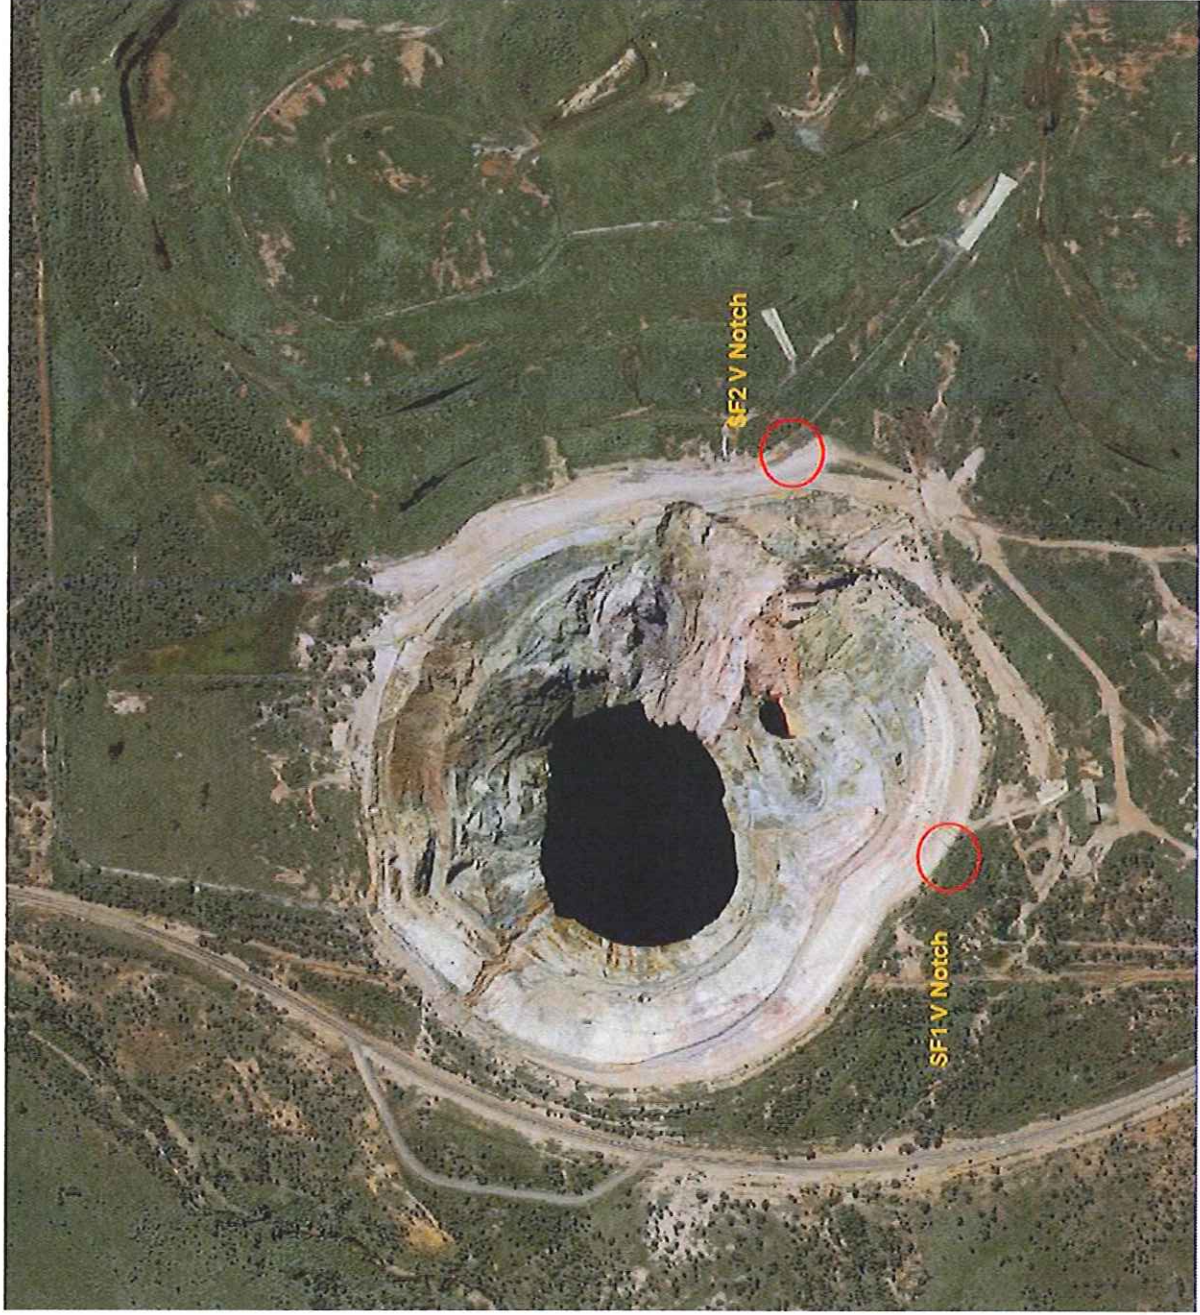
Figure 1 Flow Monitoring Locations Highway Reward

The flow path towards SW6 runs along the western side of the base of the Highway Waste rock dump. Flows along this path were to be measured at SF2 (TEP site 004) and after rainfall, downstream of that at TEP sample sites 003, 002 and 001. These sites are shown in Figure 1 and Figure 2. No flow occurred. No samples were taken.

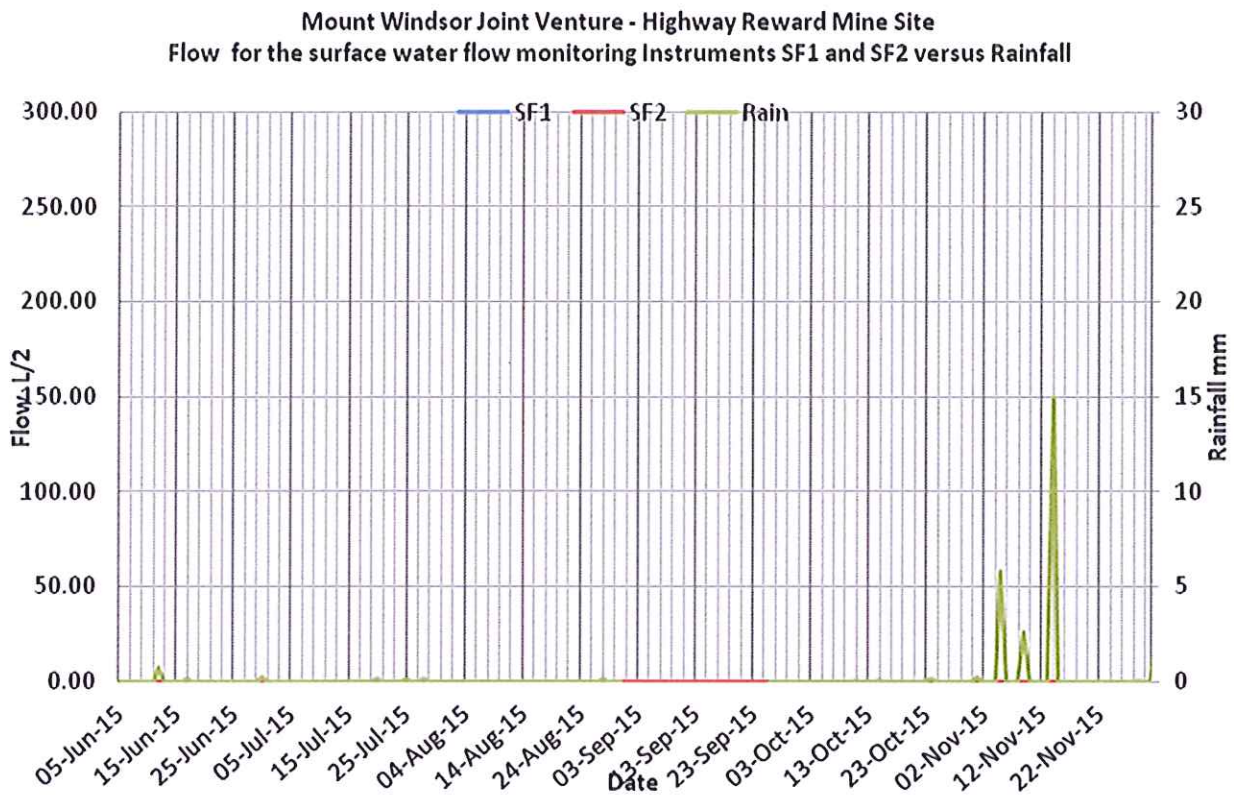
Figure 3 Flows and Rainfall

The pit v notch SF1 has shown no flow into the pit consistent with the lack of rain on site (Figure 3).

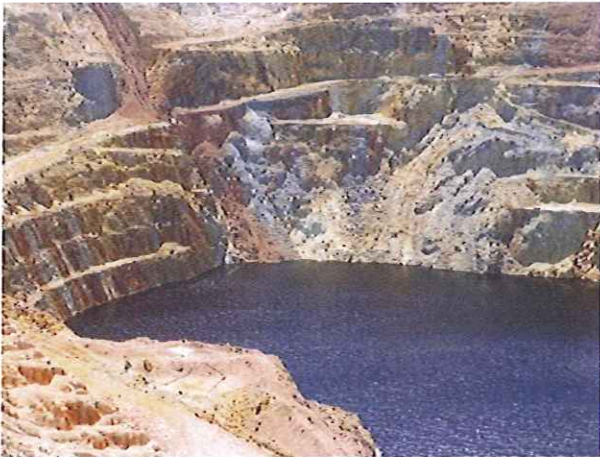
Plate 6 Pit Water Height April 2015

Plate 2 shows the pit water height in September 2011, Plate 3 shows the water level in February 2014, Plate 4 in August 2014 and Plate 5 in October 2014, Plate 6 in April 2015 and Plate 7 in October 2015. An estimated level decrease of 500 mm has occurred in the past six months.
