# Thalanga Copper Mines Pty Ltd

## **Re: Transitional Environment Program (TEP) MAN17020**

In accordance with the commitments made in the TEP please accept this report on the earthworks program recently completed at the Highway Reward mine.

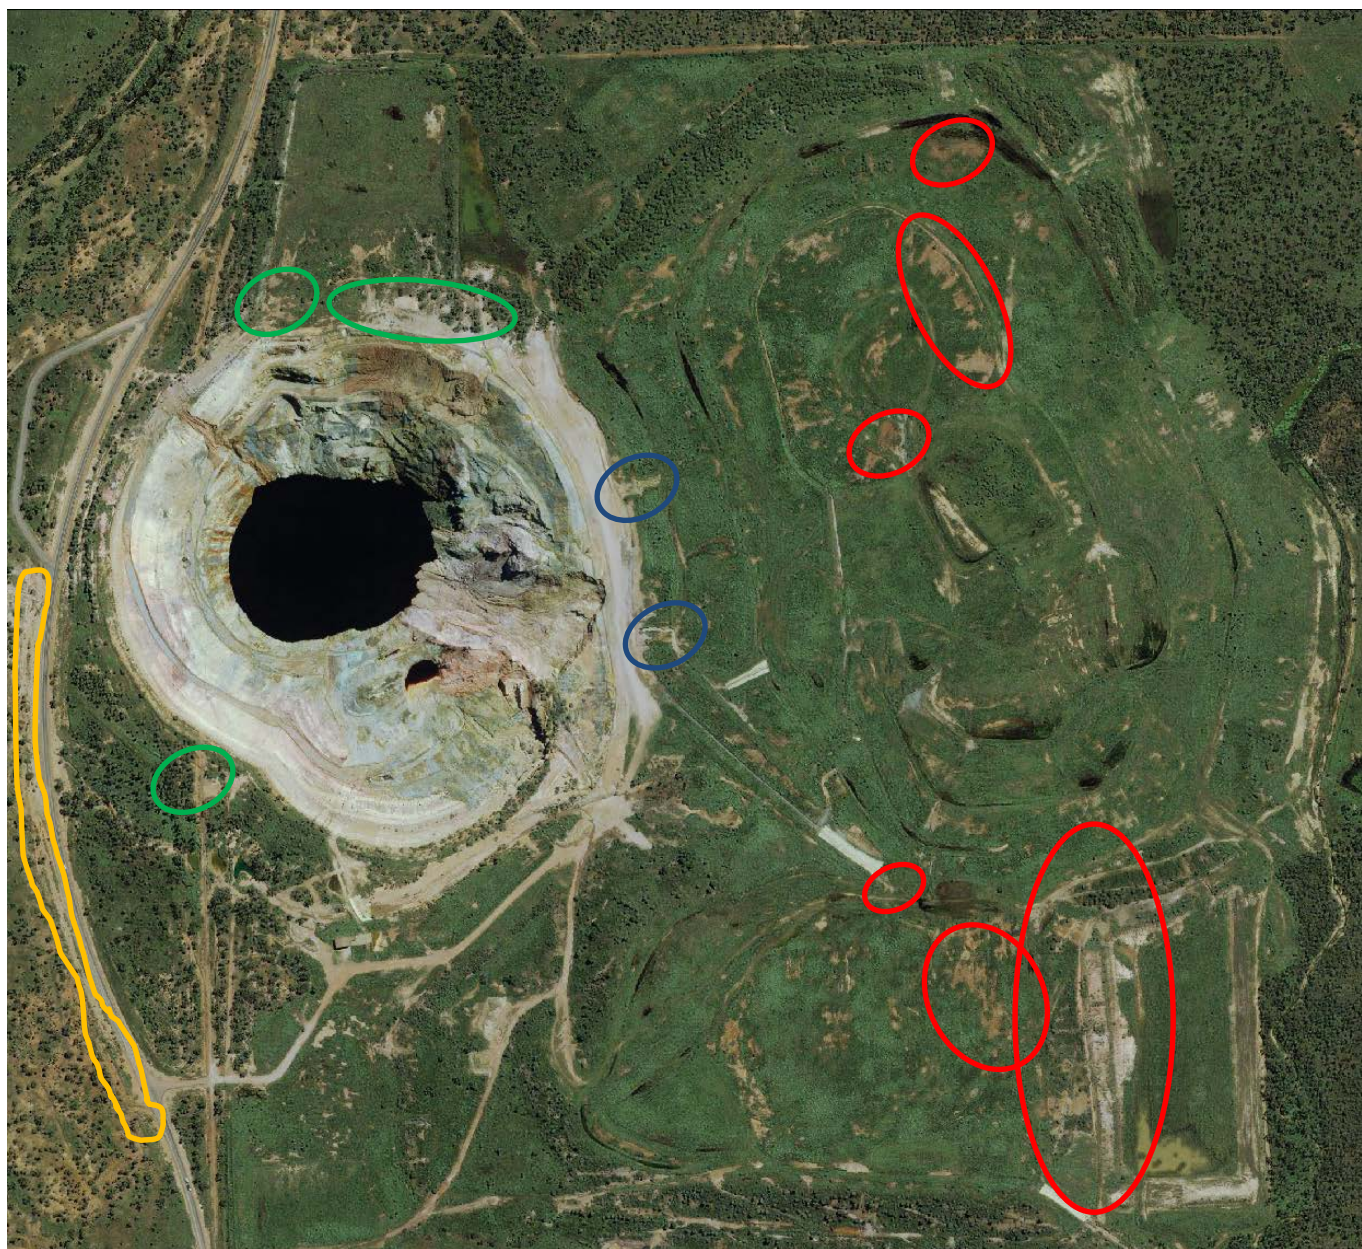
Figure 1      Aerial photo circe 2010.

1. Bare patches on the waste rock dumps. Reddish yellow colouring of surfaces in these patches may have indicated exposed sulphides. These are circled in red in Figure 1.
2. Eroded drop structures which also contained exposed sulphides. These are circled in blue in Figure 1.
3. Remnant areas on the site which contained reddish yellow coloured rocks again indicating the possible exposure of sulphide materials. These are circled in green in Figure 1.
4. Areas on the western side of the Gregory Development Road contained material indicative of sulphides. This appeared to have spilled from haul trucks leaving the site during its operational days. This area is circled in yellow in Figure 1.

Item 1 areas were repaired by covering bare patches with 500 mm compacted clay cap (compacted to at least  $10^{-7}$  m/s permeability) plus 100 mm topsoil over the clay capping. Item 2 areas were repaired by capping exposed sulphides with 500 mm clay as per item 1, removing current scours to the invert of the spillway, supply and installation of scour rock, plus the removal of oversized rocks and reinstatement with 100mm rock compacted in place to reduce flow velocity.

Item 3 areas were capped to the same specifications as Item 1 areas.

Item 4 was remediated by scrapping the roadside to a depth of approximately 100mm and removal of such to the pit (inside the pit drainage perimeter).
