# Thalanga Copper Mines Pty Ltd

## **Re: Transitional Environment Program (TEP) MAN17020**

In accordance with the commitments made in the above TEP please accept this report on the earthworks program recently completed at the Highway Reward mine.

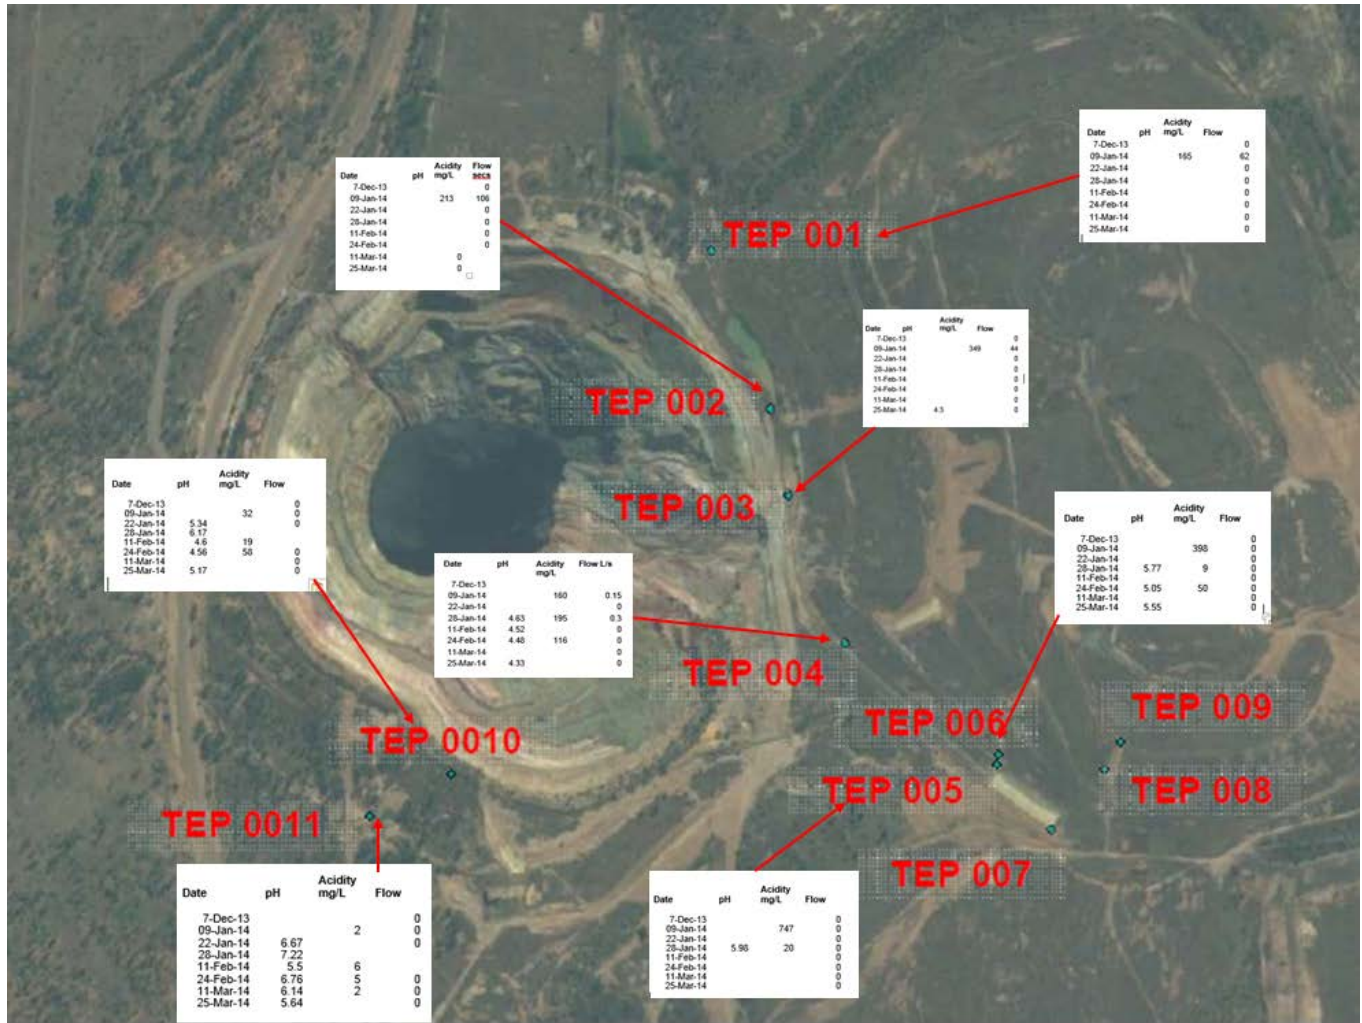
Figure 1      TEP Monitoring 2013

During the first monitoring period for TEP MAN 17020, occasional fluxes of acidity were found moving down the central revetment mattress to the west on the highway waste rock dump. These are shown in Figure 1. Low pH readings were encountered at TEP5 & TEP6 with lower pH at TEP4. To reduce the likelihood of this occurring, capping works were undertaken to the east and north of the revetment mattress where bare patches were visible and potential sulphide exposures could be seen. These areas are circled in red in Figure 2.

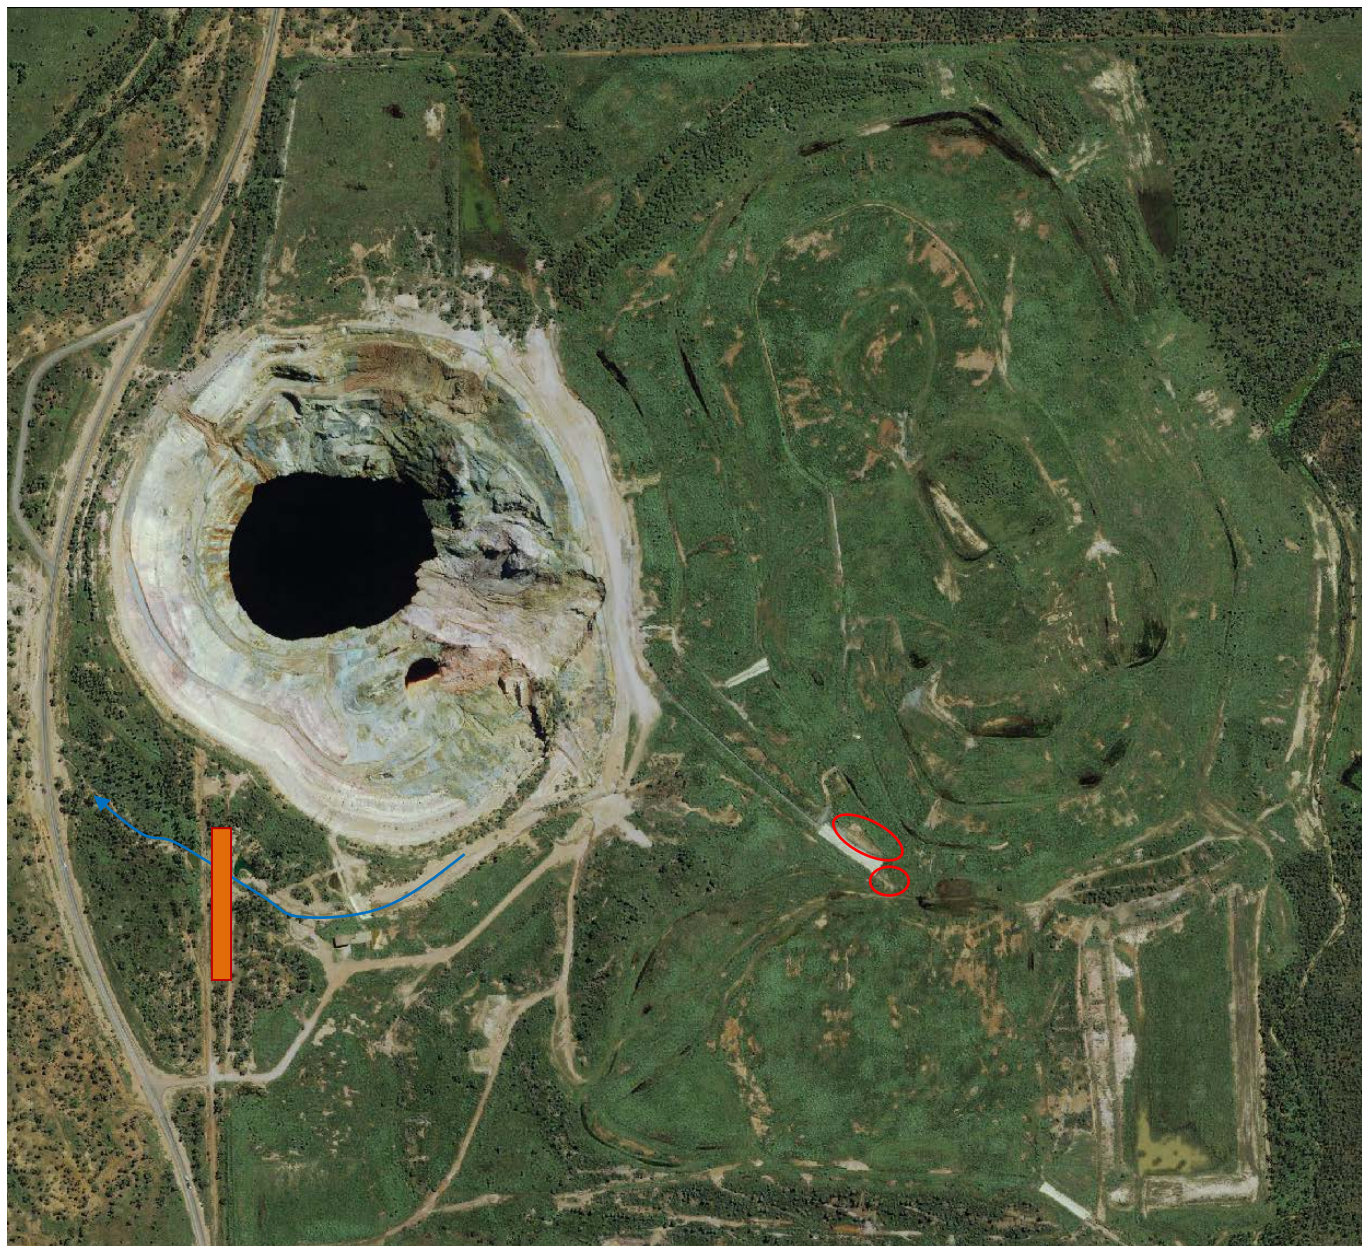
Figure 2      Aerial photo circe 2010.

In addition to this work, further drainage works were undertaken to prevent runoff from leaving the lease to the west along the former creek line as marked in blue in Figure 2. Small diversion cuts were placed on stormwater drainage lines and a bund (Orange line in Figure 2) was placed to the immediate west of the fence line to divert all stormwater drainage from inside the lease in this area into the pit.

The bare areas noted above were repaired by covering bare patches with 500 mm compacted clay cap (compacted to at least  $10^{-7}$  m/s permeability) plus 100 mm topsoil over the clay capping.

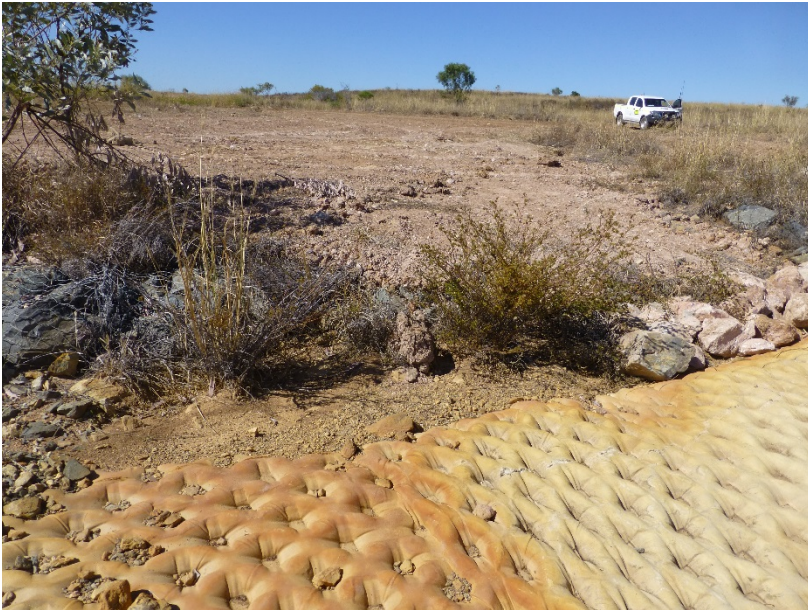
**Plate 1 Above revetment mattress**

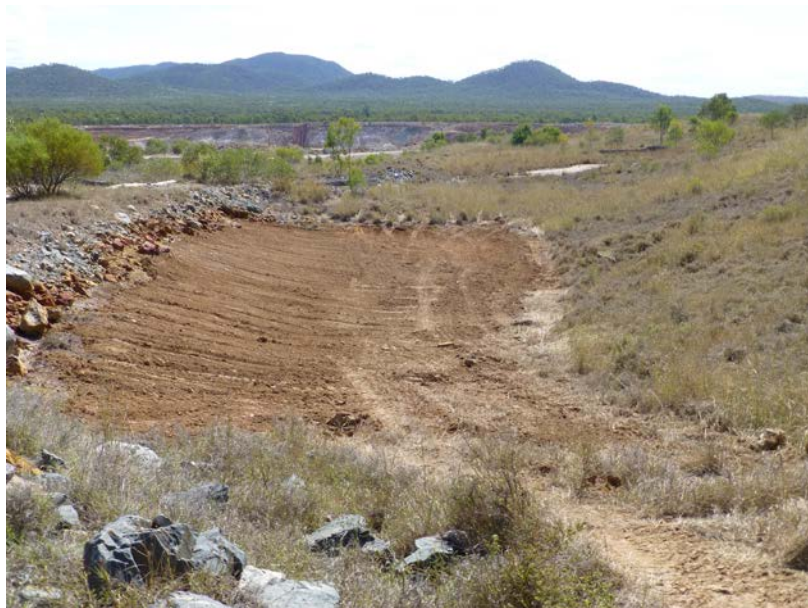
**Plate 2 North of revetment mattress**

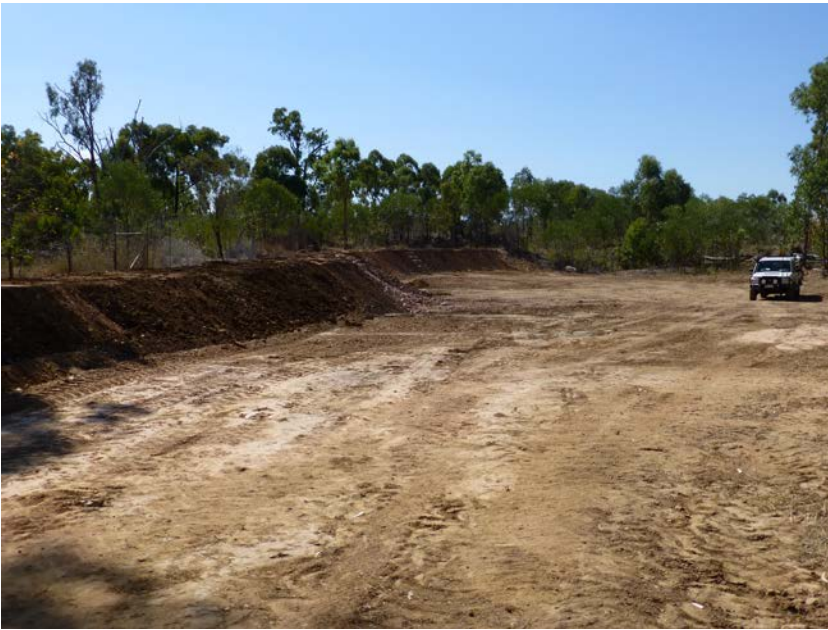
**Plate 3 Diversion bund Western flow path**

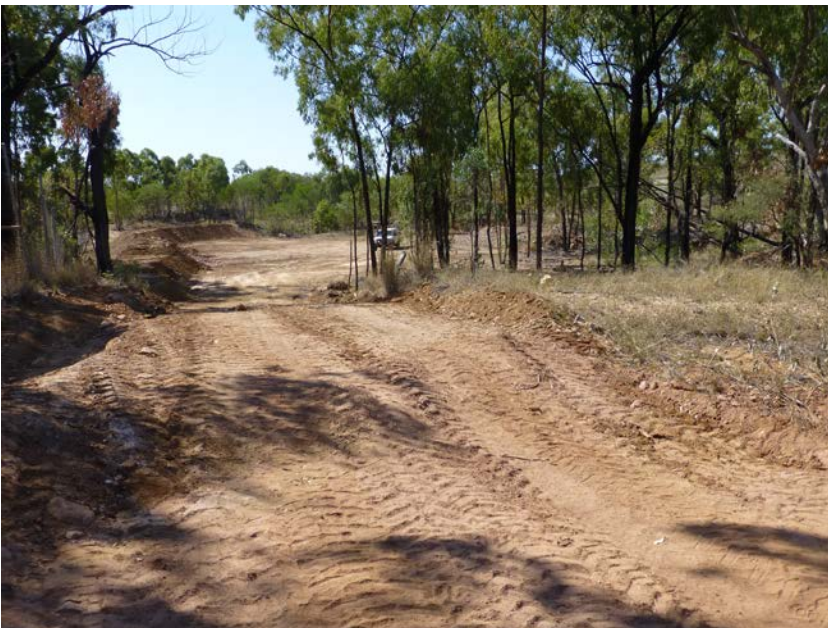
**Plate 4 Diversion bund Western flow path**
