DATE: 1 NOVEMBER 2016

OUR REF: 16\_115

**RE: REPORT ON COMPLETION OF INTERIM EARTHWORKS - TEP MAN17020**

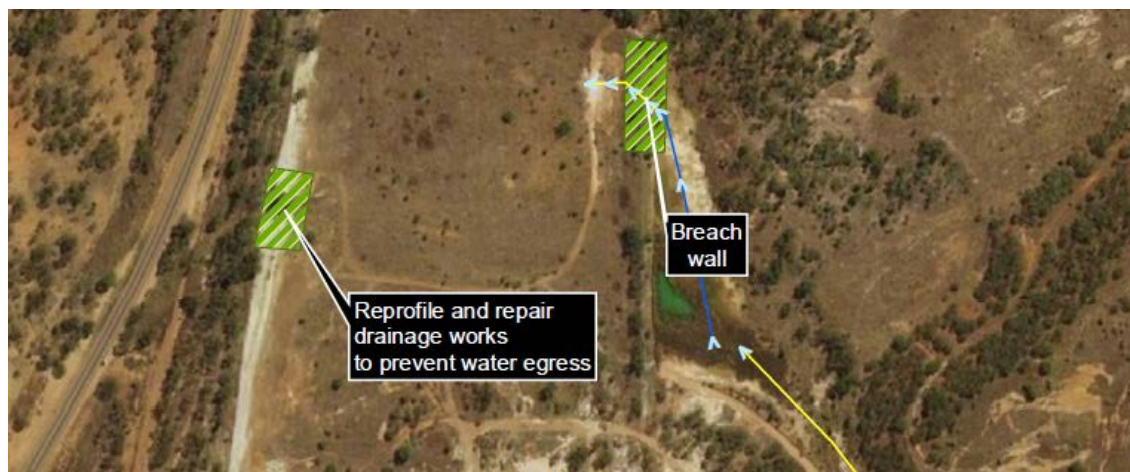
The eastern wall of the historic tailings dam had been previously breached. As part of the interim works, GA Services reinstated the wall to ensure no runoff from the evaporative basin could be released to the receiving environment. Figure 1 shows a conceptual representation of the works completed by 1 November 2016.

Figure 1: Representation of earthworks completed by 1 November 2016.

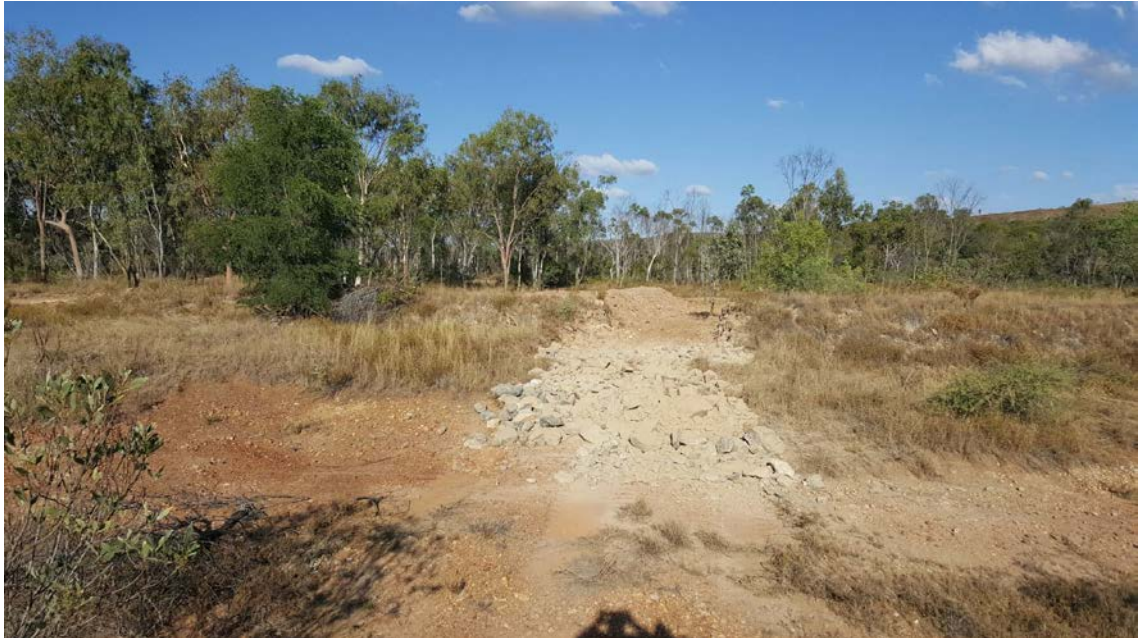
Figure 2: Completion of breach and lime rock armouring from main drainage to historic tailings storage.

As per the letter sent to EHP on 6 October 2016, the earthworks involved the diversion of the main drain to the historic tailings facility, which will act as an interim evaporative basin and which is expected to store and evaporate water for a maximum of 24 months. This was achieved by breaching the historic tailings dam wall and installing a bund to prevent the flow of water off site towards SW6. The location of the breach in the wall was lined with lime rock, which will act as a treatment mechanism to neutralise the pH in water runoff from the site to the interim evaporative basin.

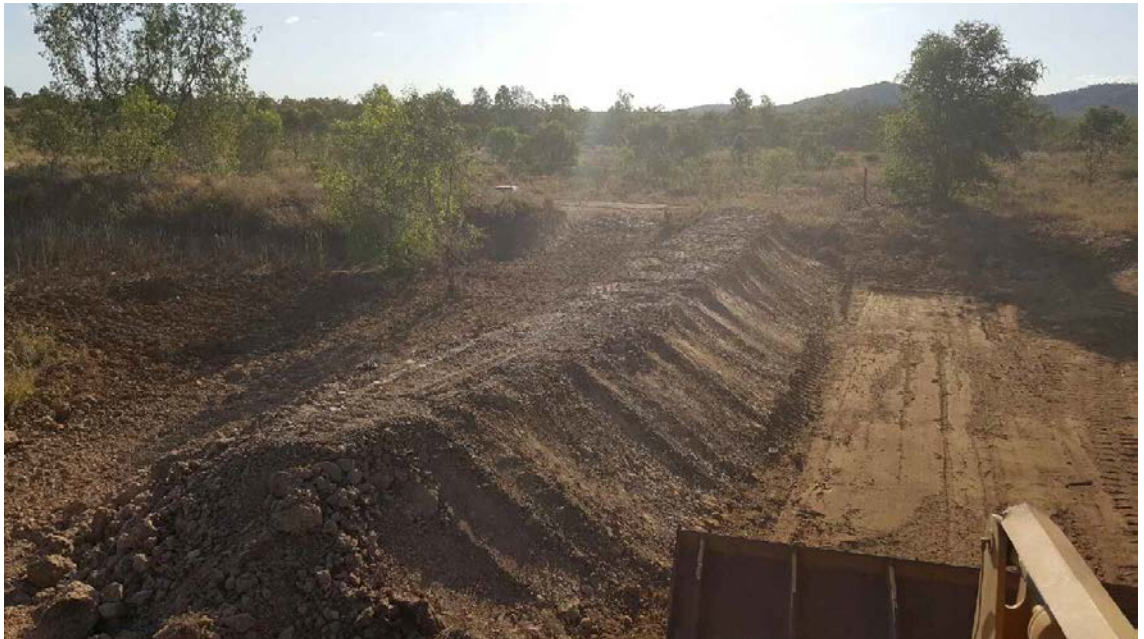
Figure 3: Completion of bund installation to prevent water release offsite towards SW6.

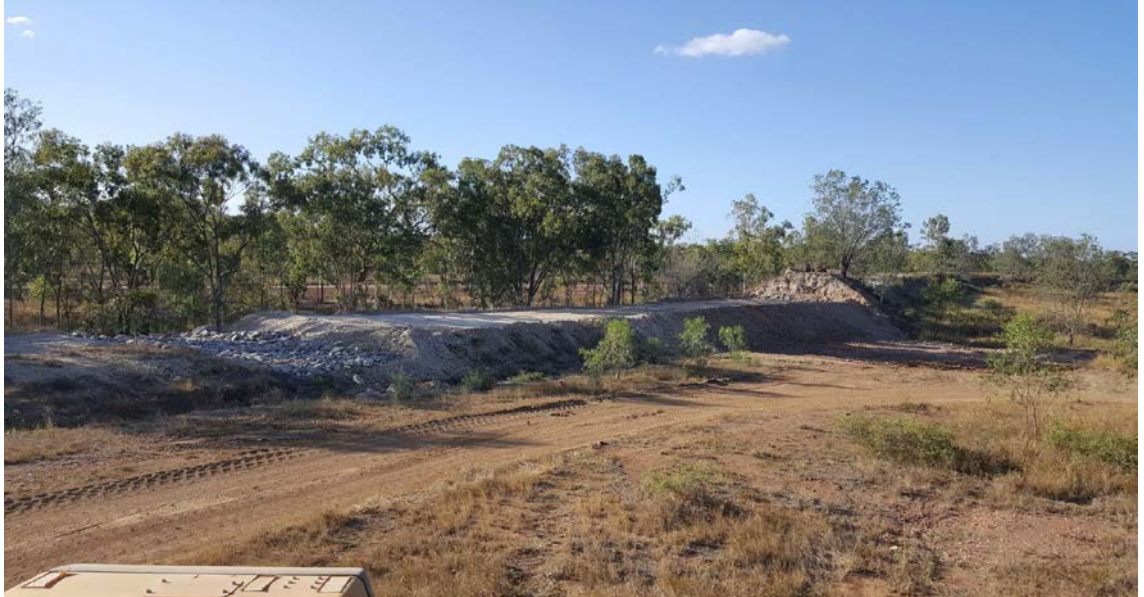
Figure 4: Completion of earthworks to re-instate bund on eastern perimeter of historic tailings storage.

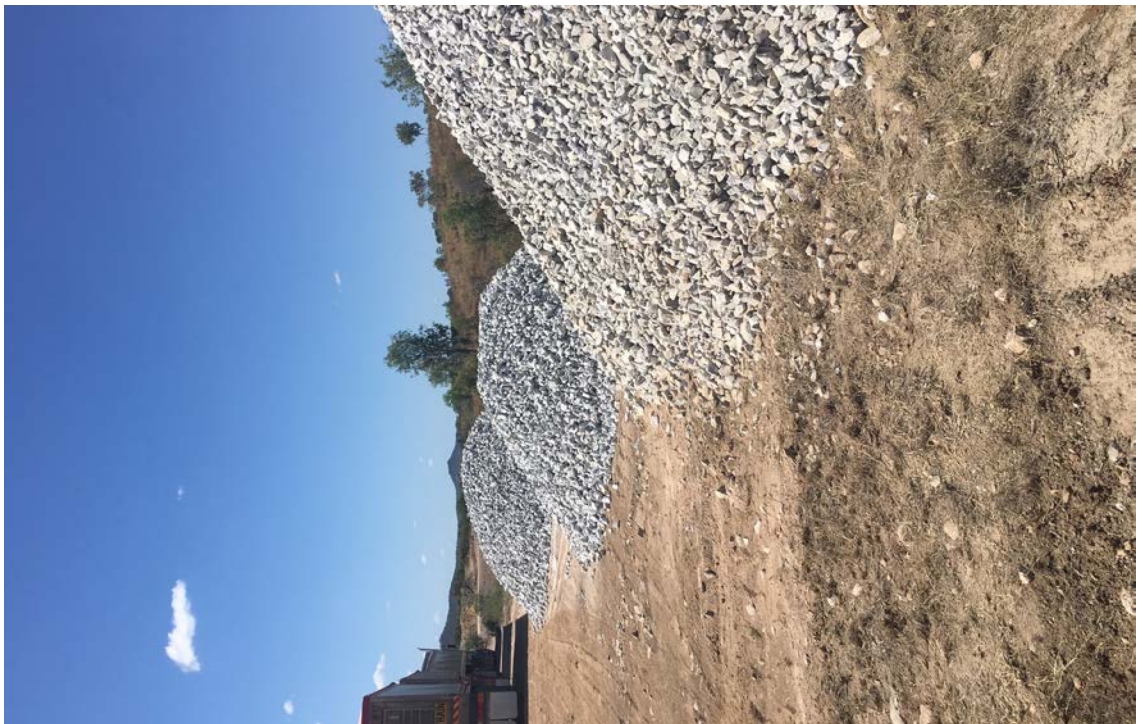
Figure 5: Lime stockpiles on site for use in additional earthworks.
