**RE: HIGHWAY REWARD - TRANSITIONAL ENVIRONMENT PROGRAM - MAN17020 - PERFORMANCE REPORT**

I refer to the amended Transitional Environment Program (TEP) MAN17020 approved by the Department of Environment and Heritage Protection (EHP) and issued to the Mt Windsor Joint Venture partners of Thalanga Copper Mines Pty Ltd (MWJV) on 14 September 2017.

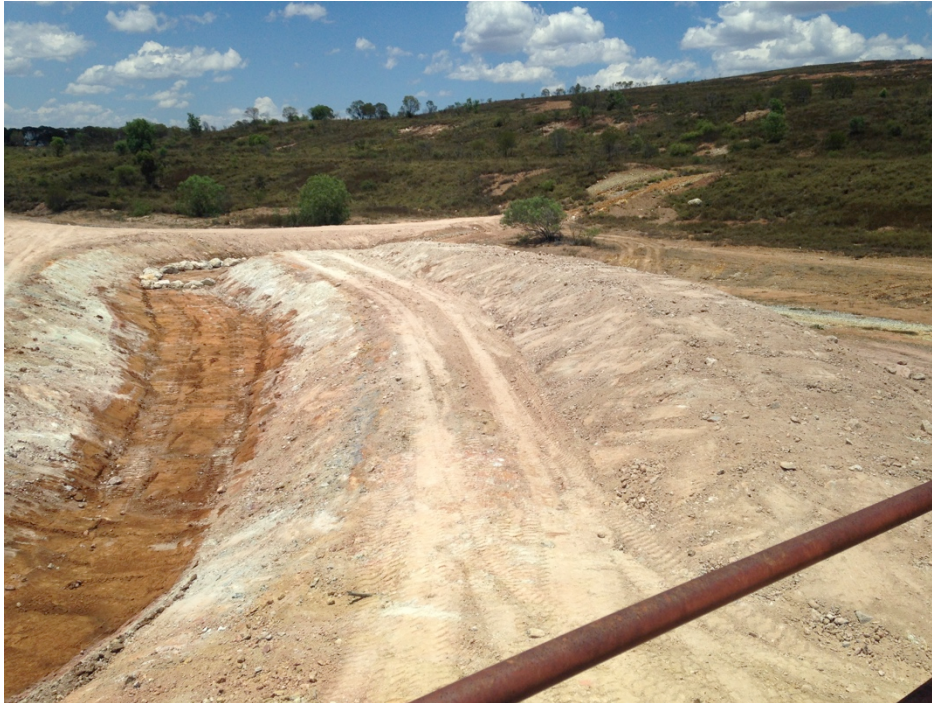
Figure 1: Diversion drain facing towards Highway Waste Rock Dump

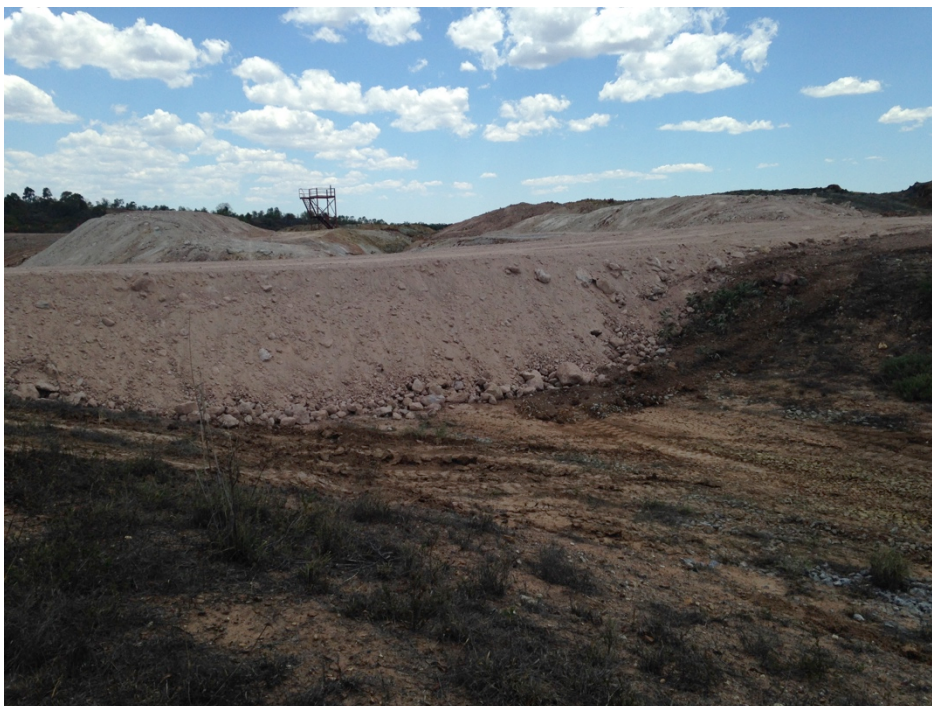
Figure 2: Diversion bund facing towards Highway Reward pit

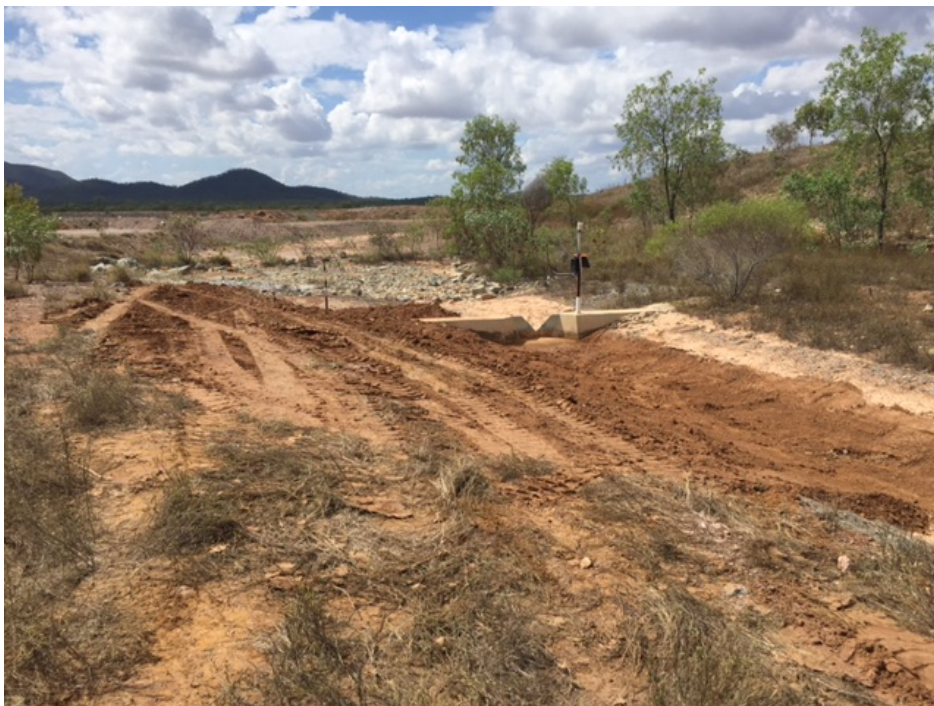
Figure 3: Maintenance of SF2 stream flow gauge

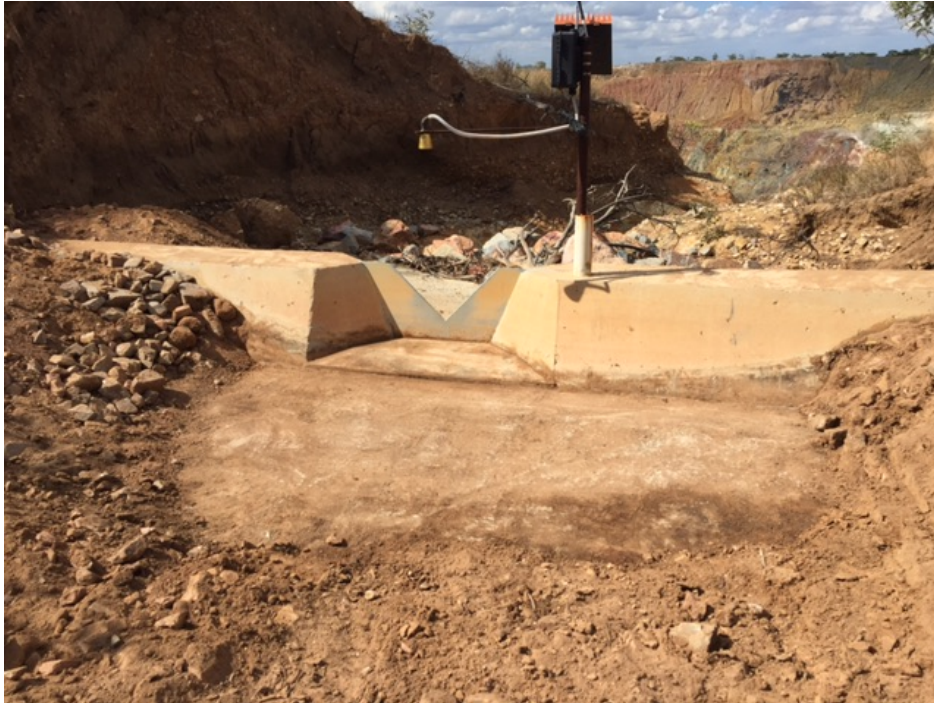
Figure 4: Maintenance of SF1 stream flow gauge

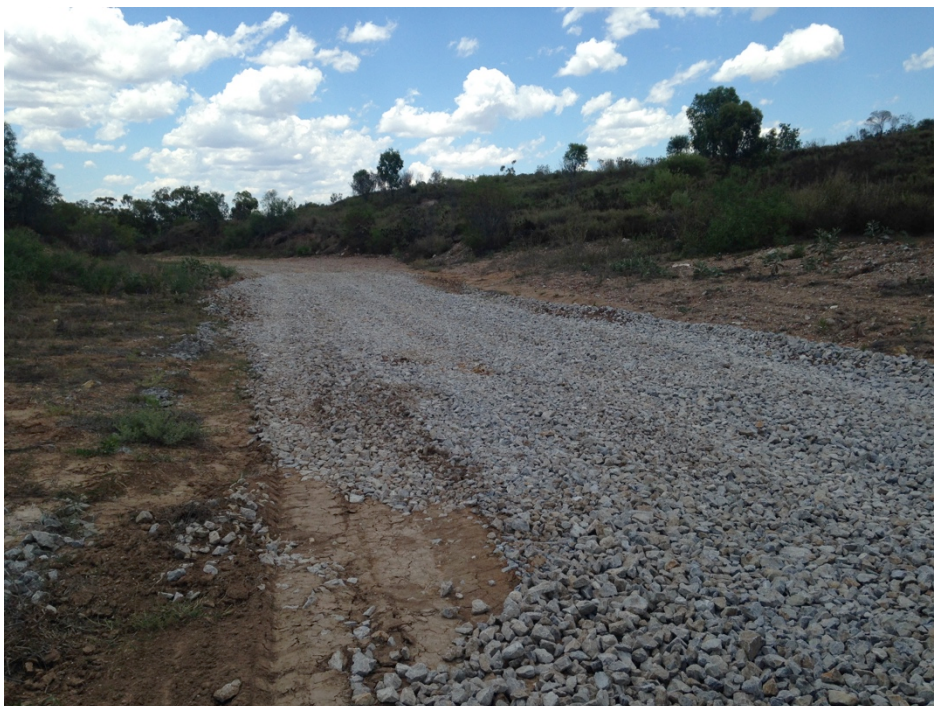
Figure 5: Maintenance of lime rock in main drain

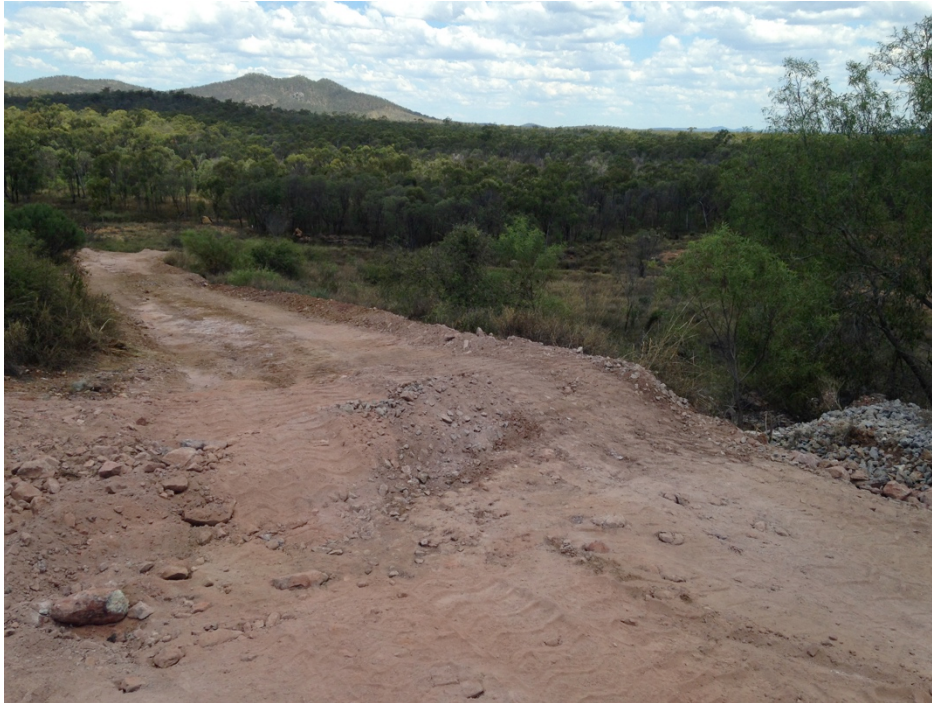
Figure 6: Maintenance of access tracks
