## **Peabody Energy Australia Coal Pty Ltd**

### Construction of the Return Water Dam Decant Structure and Pipeline

April 2014

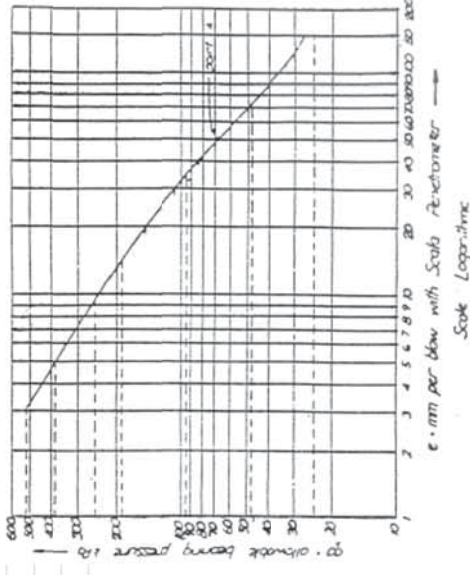
**Figure 4 Summary of the DCP and Allowable Bearing Capacity Ch 112.0 to Ch142.0**

The results indicated a firm uniform base along the length of the trench up until Ch 142.0 approximately 6 m where the outlet works was to be situated. The top 100 mm presented an acceptable bearing capacity of 240 kPa however this gave way to a soft underlying layer below the required 150 kPa bearing capacity.

Chainage 148.5 (end of the pipeline) was inaccessible because of the ponded seepage water and the very soft conditions underfoot. The ramifications of this inaccessibility and the corrective actions taken are discussed in more detail in section 3.3.

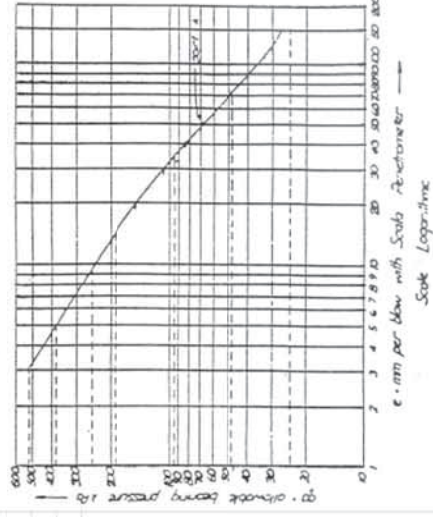
**Figure 5 Summary of the DCP Test and Allowable Bearing Capacity under the Rock-fill Plinth to the Inlet Tank**

The specification required a minimum bearing capacity of 200 kPa to safely support the weight of the decant tank. The initial excavation for the tank foundation was taken down to sandy clay residual soil at level 211.0 m, approximately 1.0 m above the estimated level for the foundation. The DCP test results showed satisfactory bearing capacity at RL 210 m. On this basis the foundation was lowered by 1.0 m. The rock fill plinth was placed and compacted into the foundation with the back of the 40T excavator bucket. The sand capping was then placed and levelled off to the design level of 211.275 m.

Initial testing undertaken when Cathro Bowler was on site, excavation levels were discovered to be still 1.0m above finished level. Testing done to give indicative bearing capacity but ground near front and middle of the plinth toe position had softened up by seepage water standing overnight. Excavation taken down to finish excavation level. Seepage water was contained in sump and removed. The foundation at RFL went to hard clay sand (allowable bearing capacity > 400kPa) and on the strength of the initial testing, and hardening up with increased depth, was accepted as over the required 200kPa.
