**COPPABELLA COAL MINE  
SOUTH ARM DIVERSION SALINE SEEPAGE MONITORING  
REPORT**

March 2017

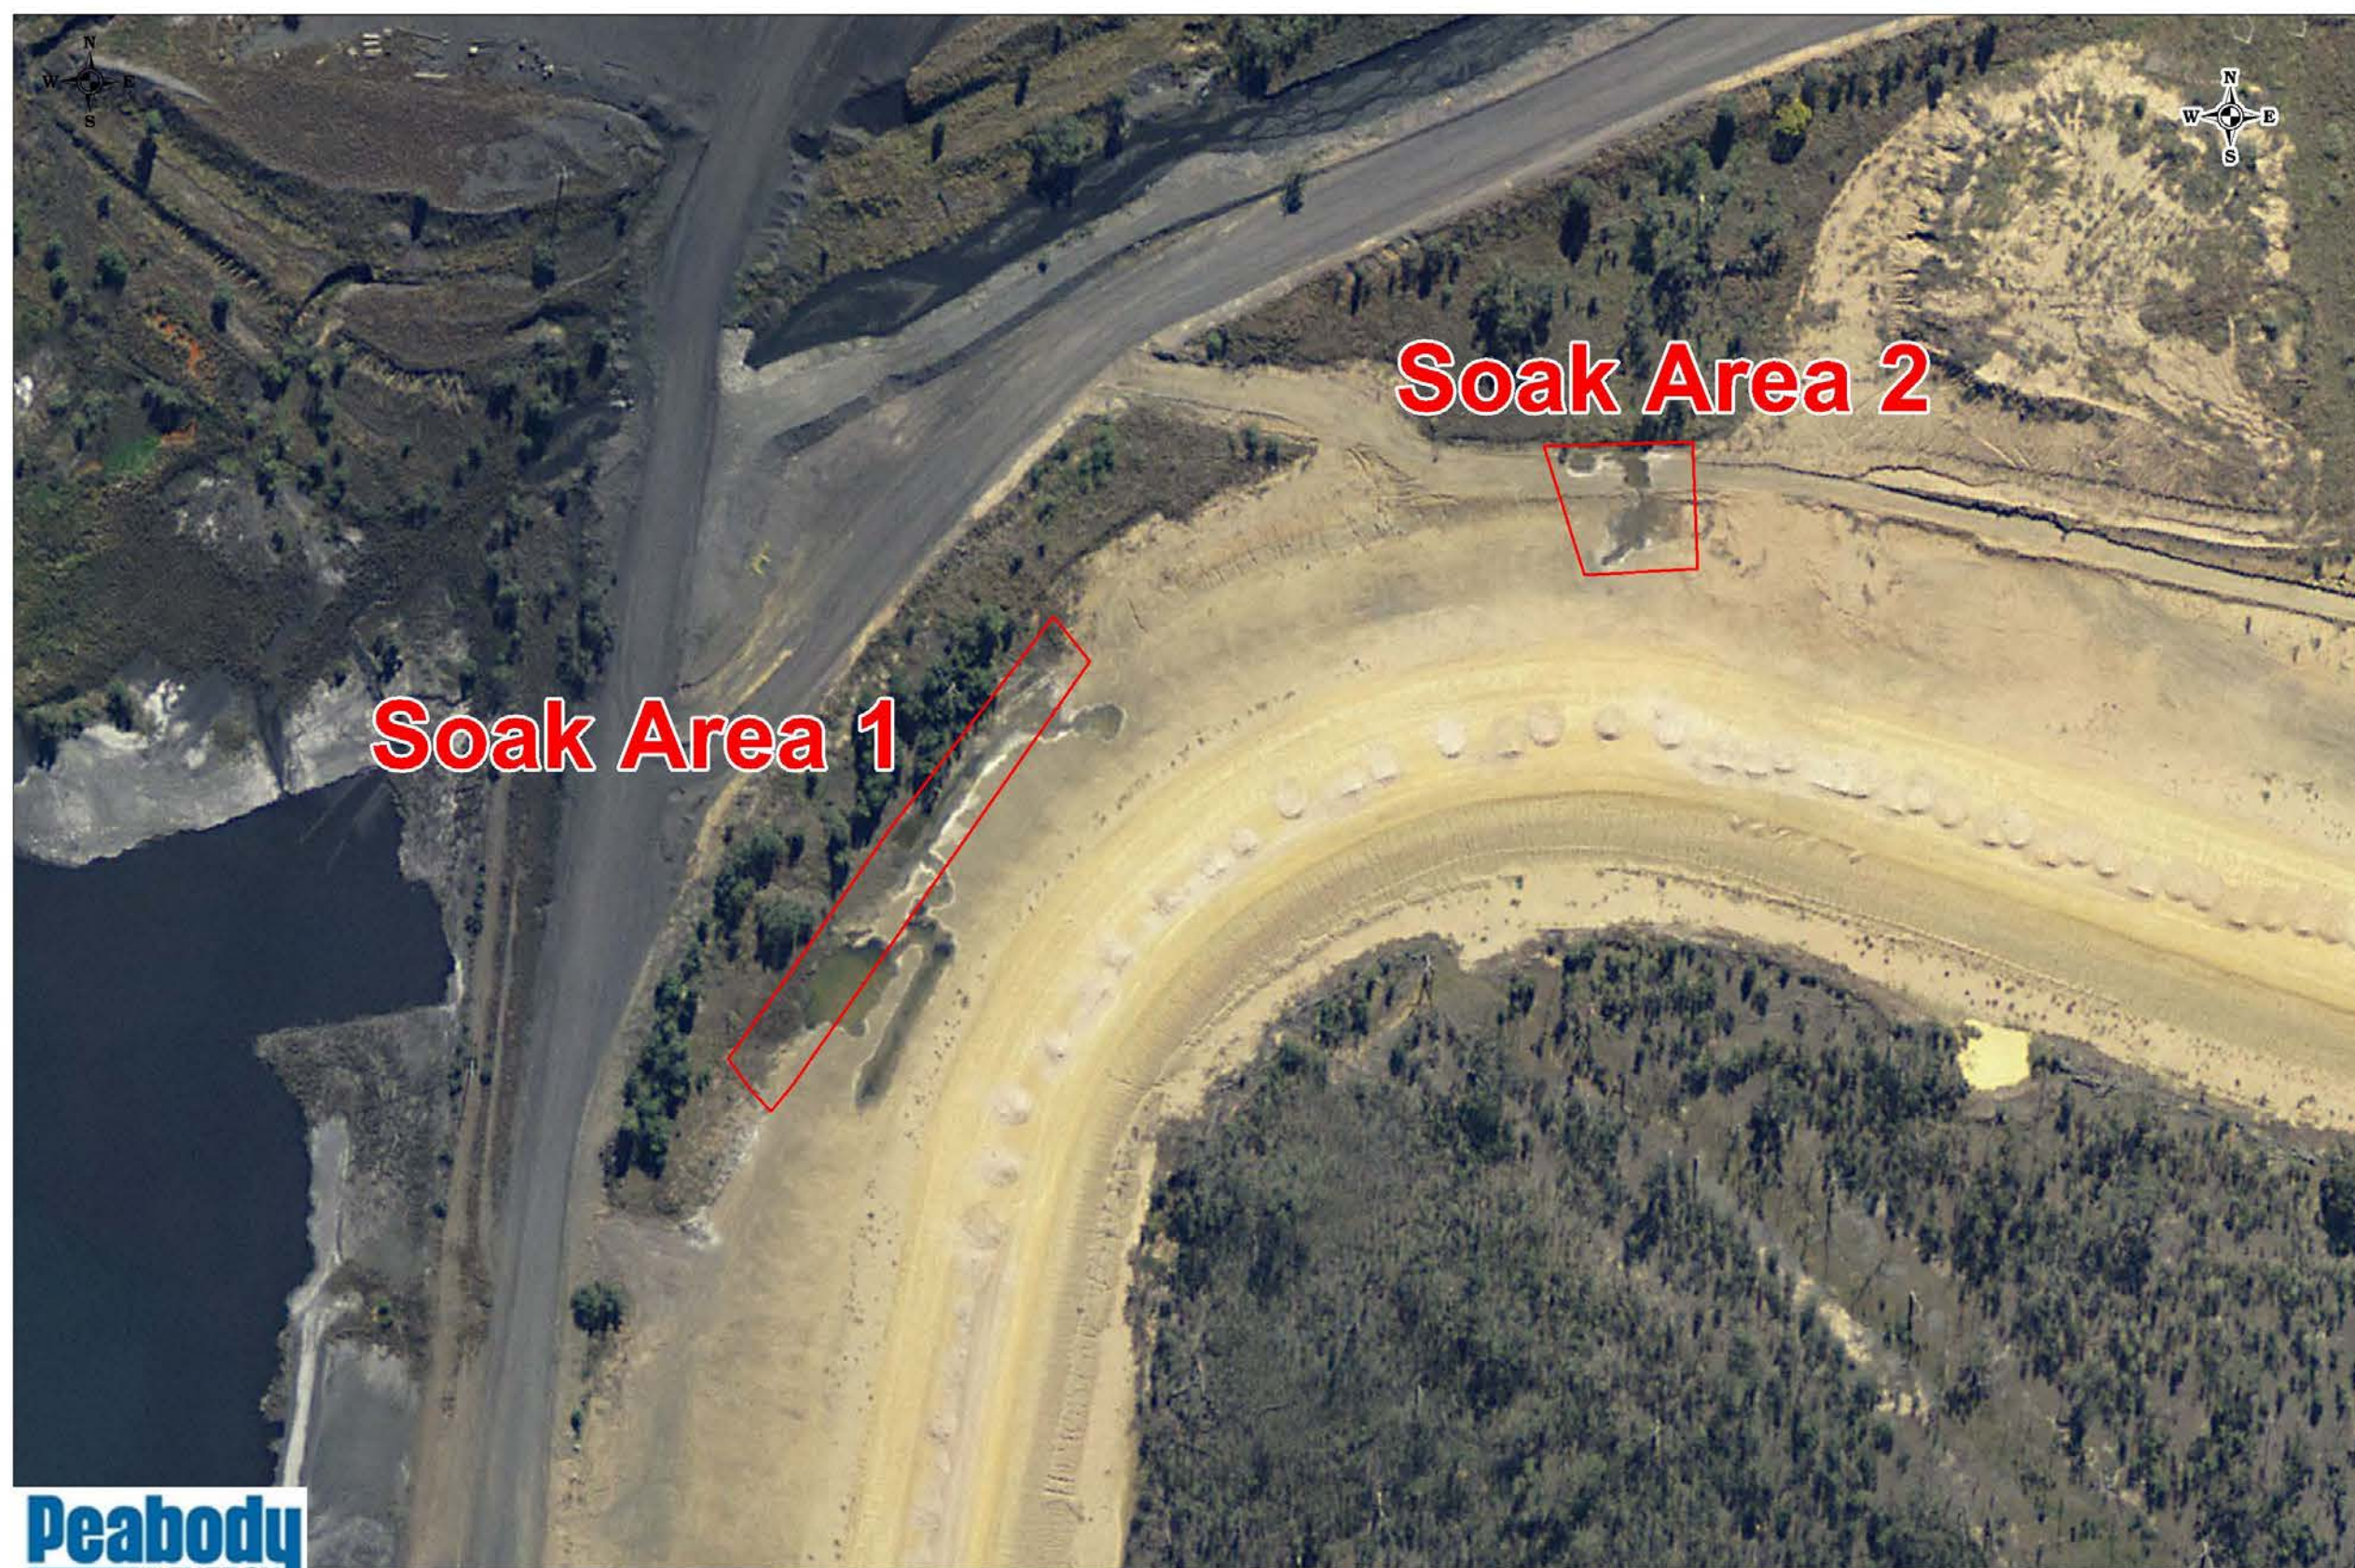
**PER 00087 - South Arm Diversion Revegetation  
Extent of Soak Areas 1 and 2**

During 2013 the visible presence of saline seepage was identified within the SAD (**refer to Appendix A**); as a consequence TEP actions regarding the management of the saline seepage were developed. In order to meet TEP actions #18 and #19, the RP for the SAD was developed and submitted to the Administering Authority. During 2014 the physical remediation works within the SAD commenced, additional works have occurred throughout 2015 and 2016. The key remediation works which have occurred with the SAD regarding saline seepage management are:

The low clay content material of which the current diversion levee banks are constructed of, has been identified as problematic as it is prone to erosion and with the added seepage impact, this has the potential to reduce the structural integrity of the diversion bank. In 2014 to mitigate this erosion impact and to ensure the stability of the diversion banks at the identified soak areas Coppabella Mine undertook; the removal of the unstable material and replacement of this material with component Permian material.

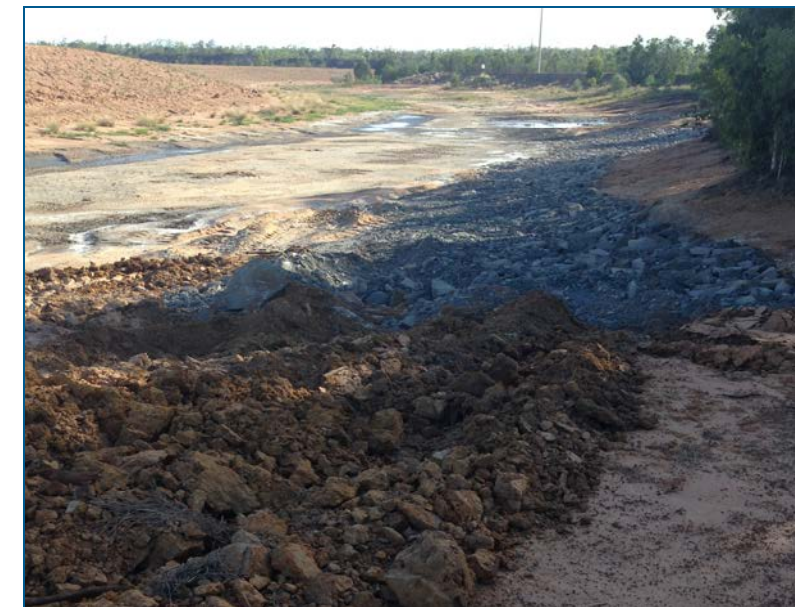
Soak 1 – Photo Point 1 – Dec 14 (post remediation)

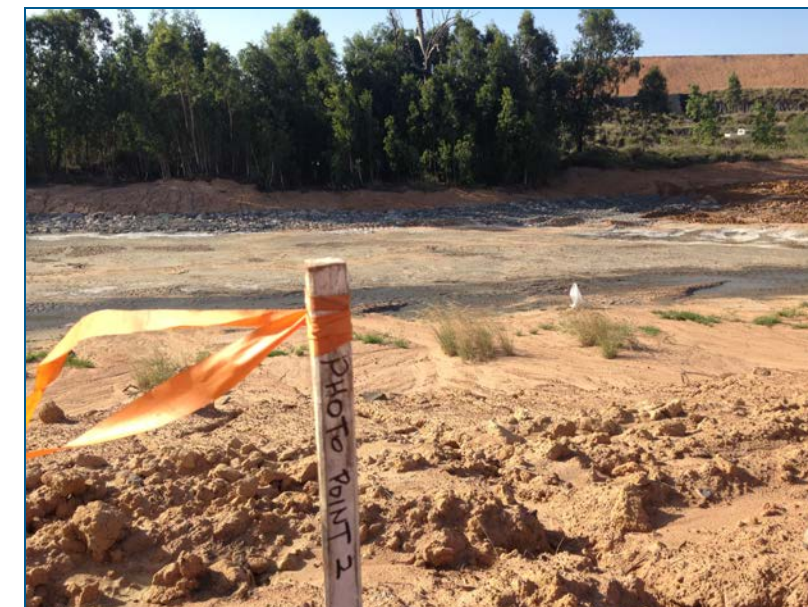
Soak 1 – Photo Point 2 – Dec 2014 (post remediation)

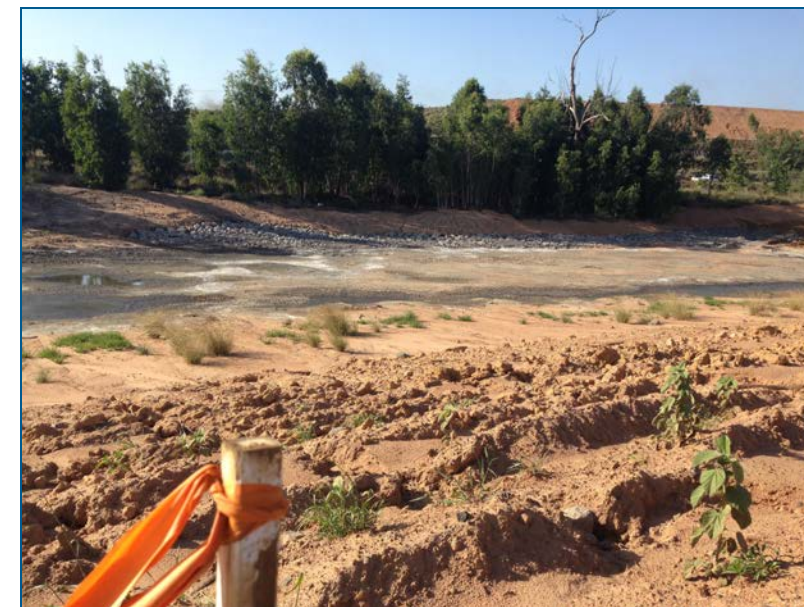
Soak 1 – Photo 3 Point – Dec 14 (post remediation)

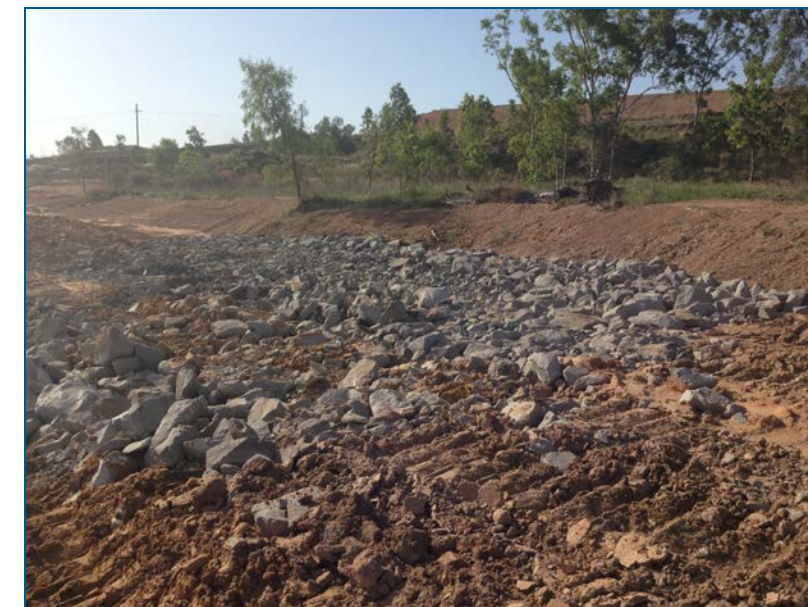
Soak 2 – Photo Point 2 – Dec 14 (post remediation)

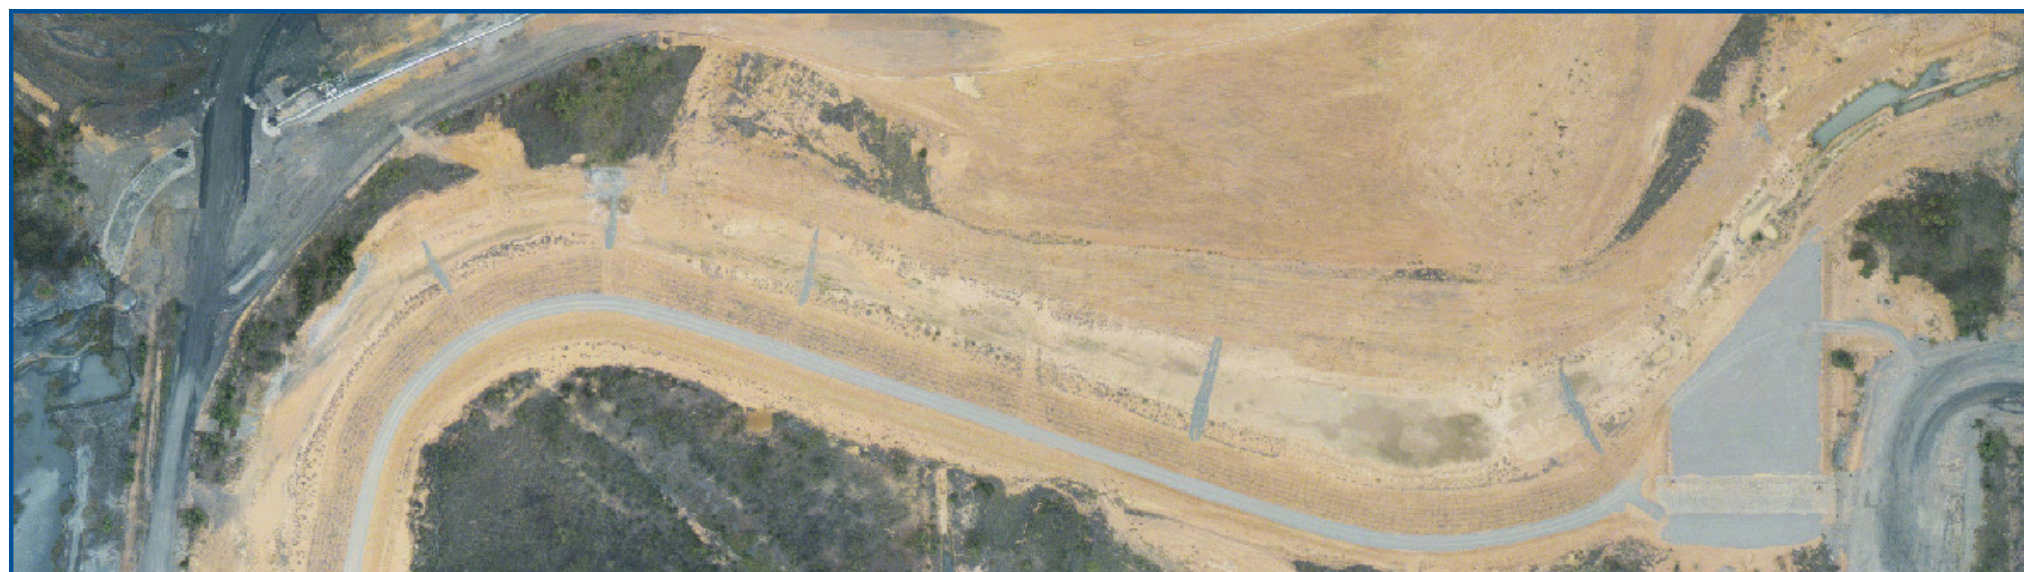
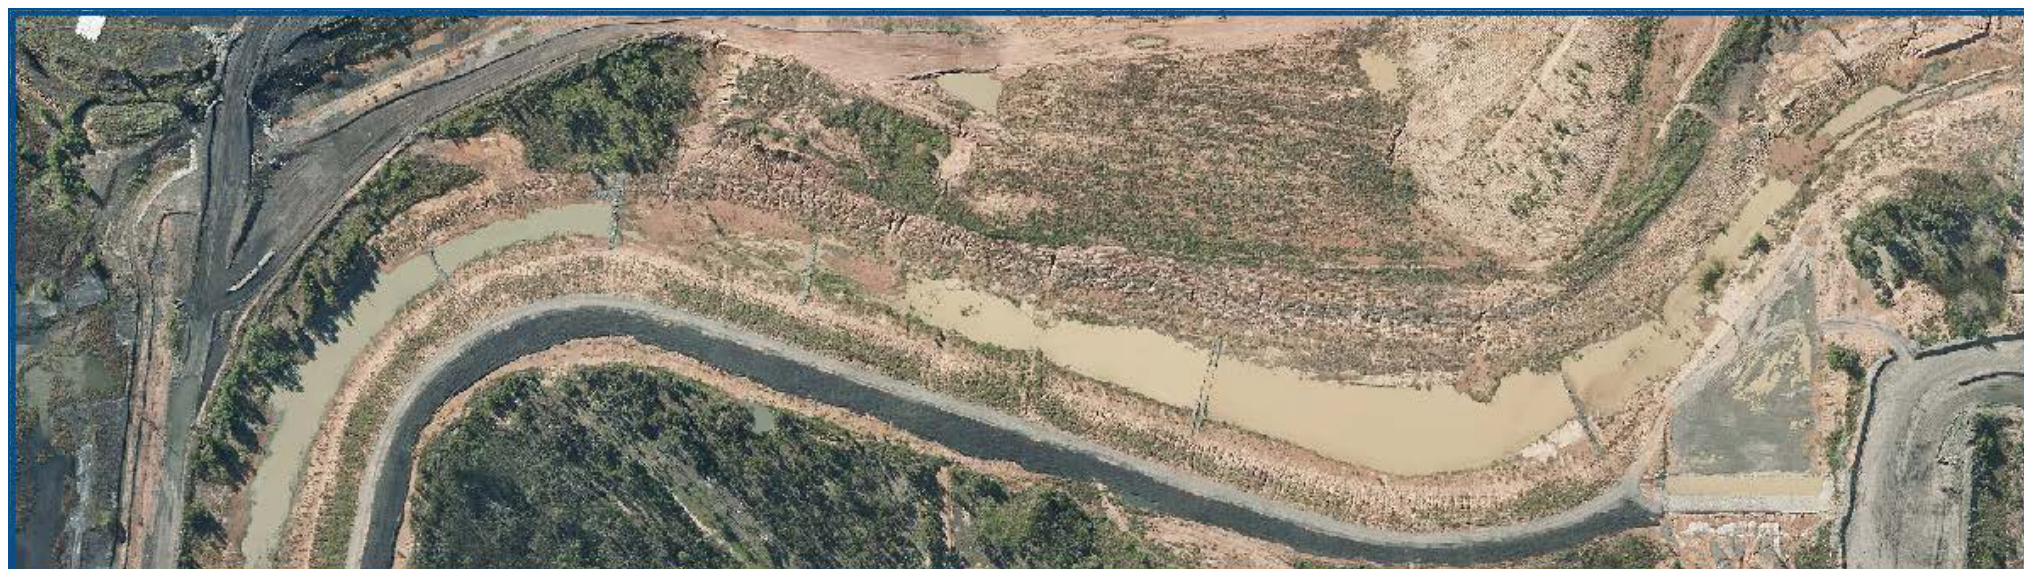
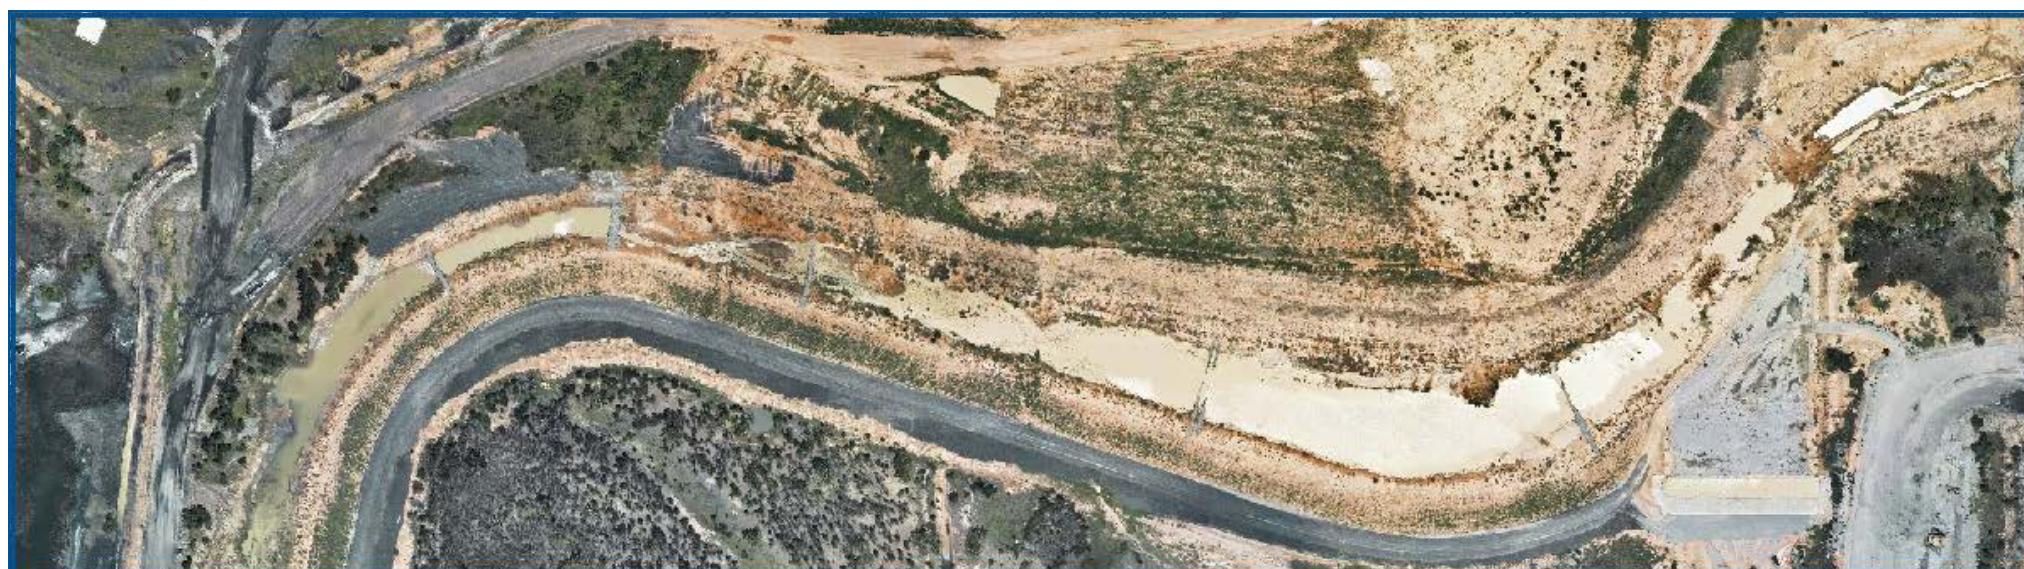
## 8.8 Appendix H: Rock checks

In order to improve the erosion and sediment control within the SAD, several rock checks were installed at regular intervals. To date the rock checks have made a visible improvement with regards to erosion and sediment control. However the most positive impacts rock checks have had within the SAD are; improved vegetation growth within the diversion bed and increased wildlife. This has occurred through increased water and sediment retention within the diversion.

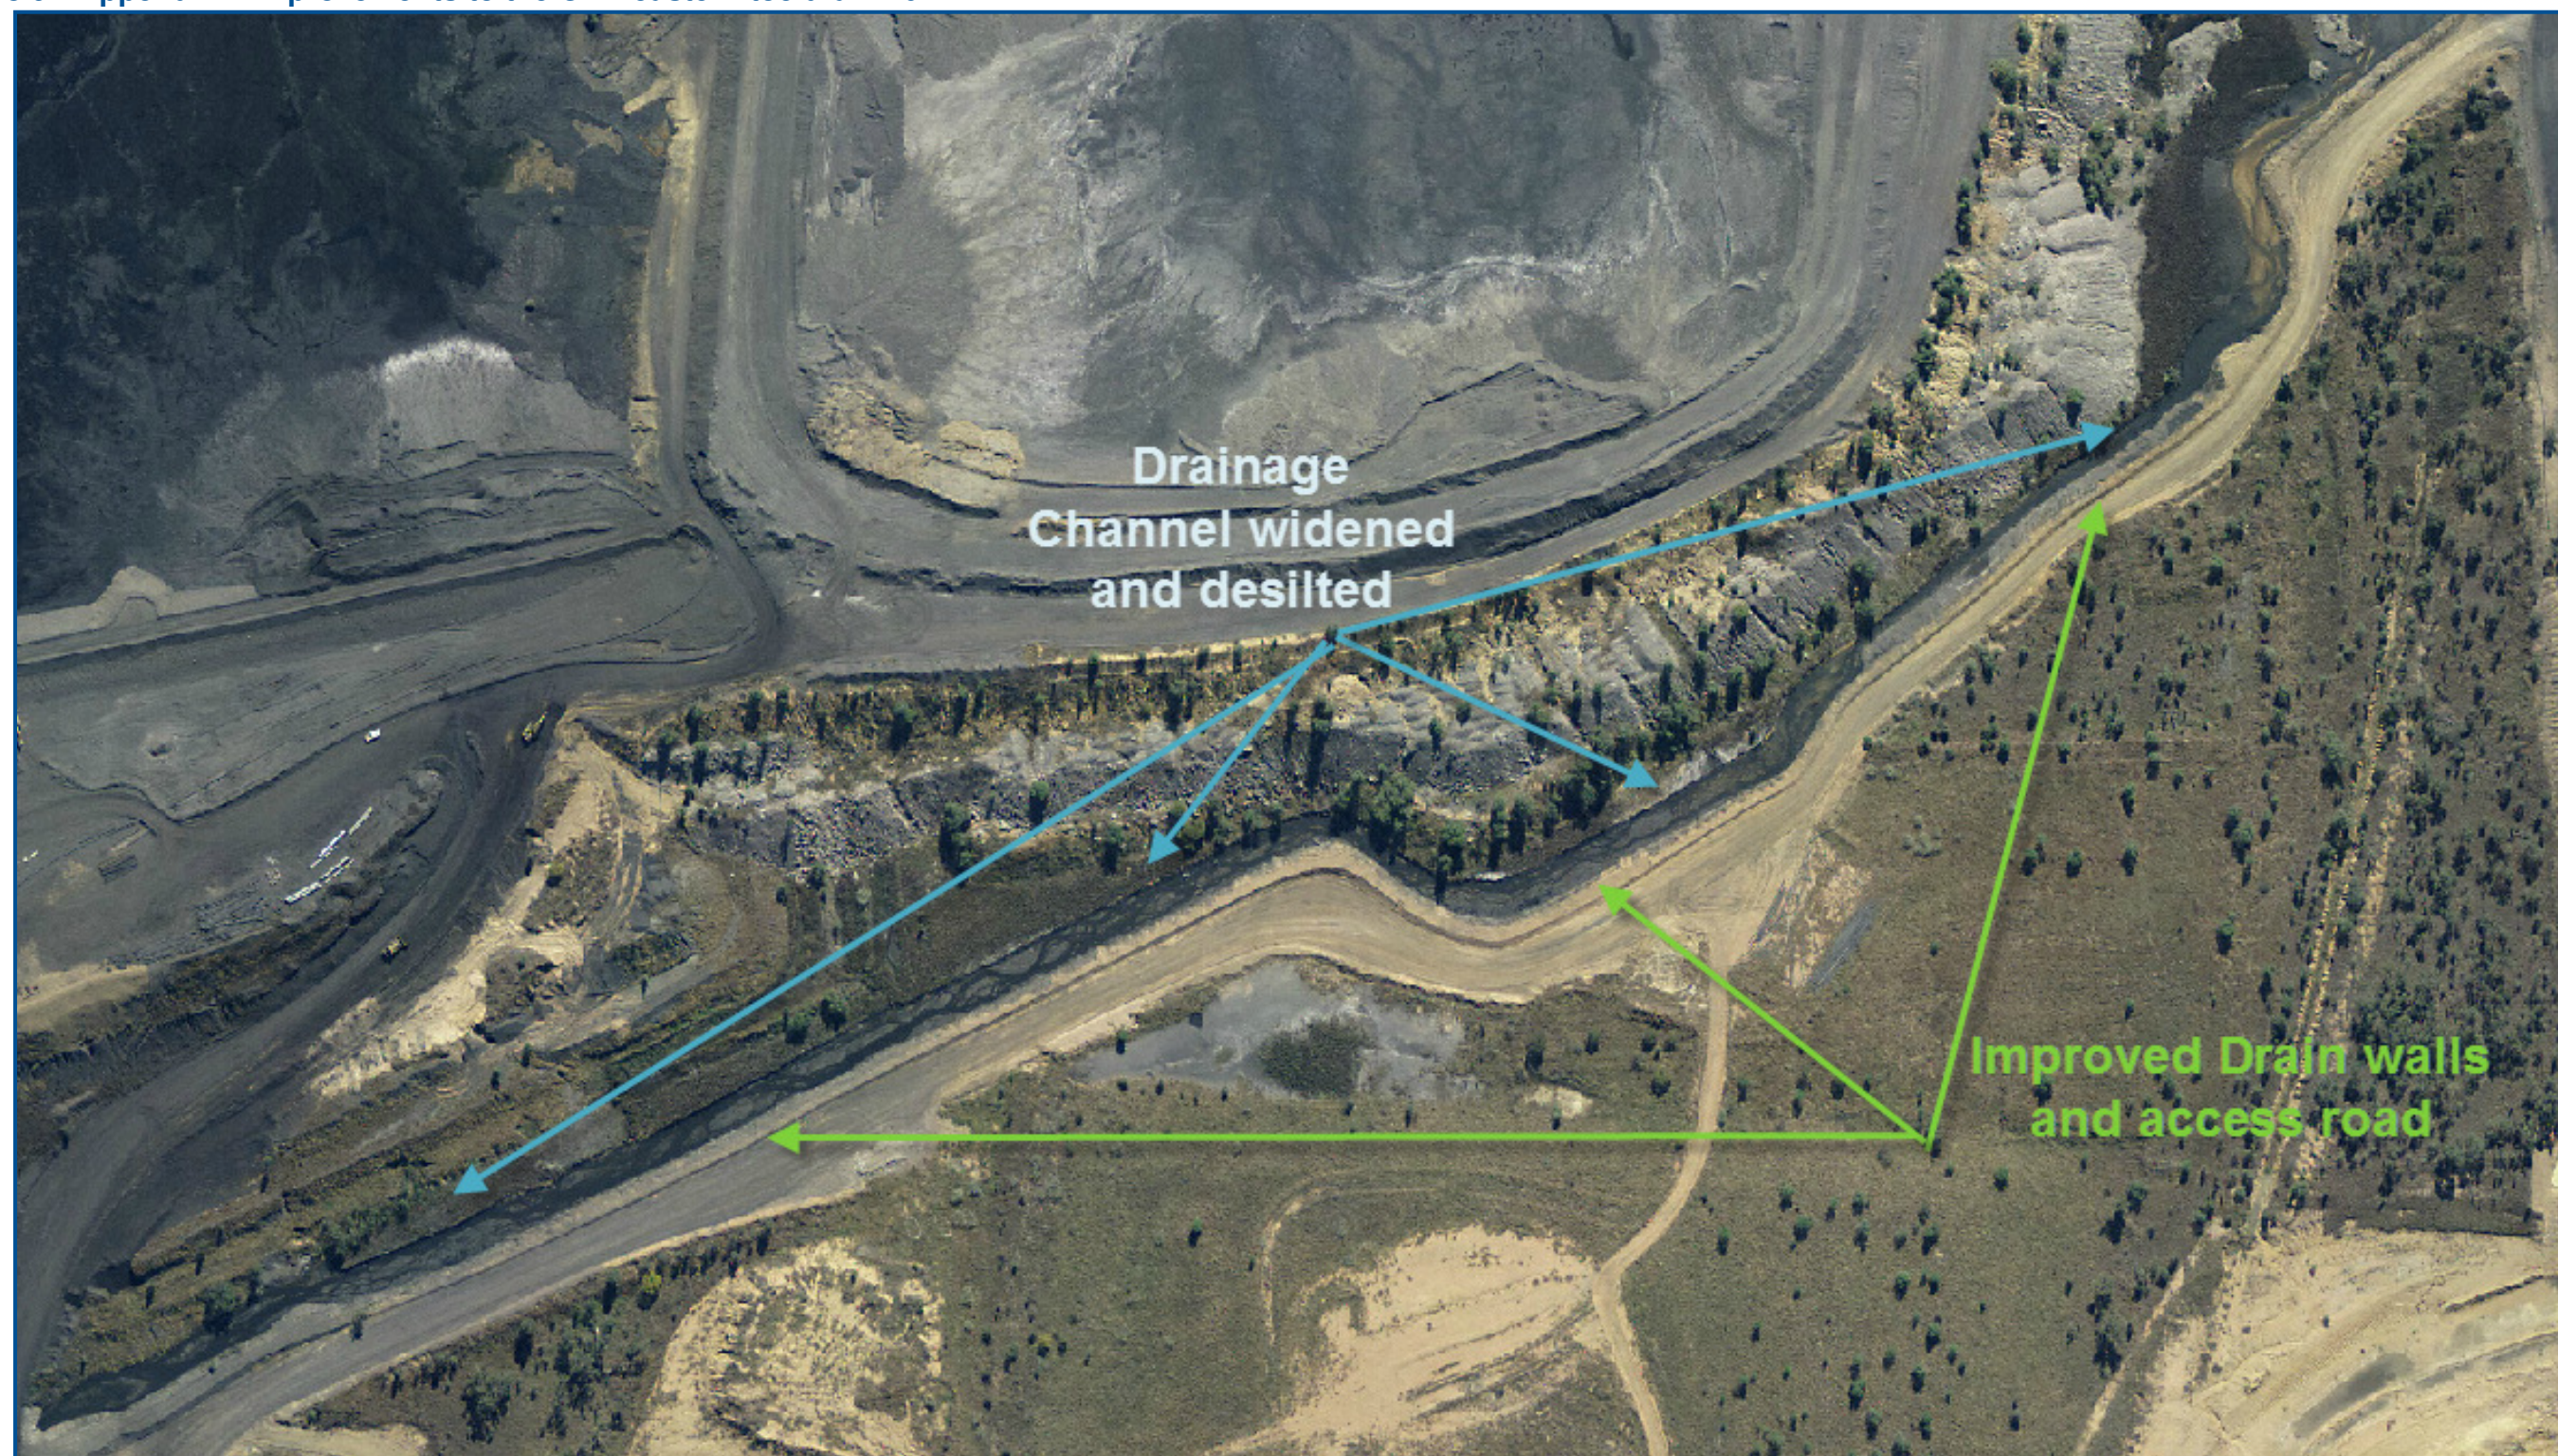
8.9 Appendix I: Improvements to the CDA eastern toe drain 2014

The existing toe drain for the CDA was full of vegetation and sediment which was slowing the speed of the water traveling in the drain, subsequently allowing it to seep into the surround areas (i.e. the diversion).

During 2014 the eastern toe drain had vegetation and sediment removed and in 2015 a new drainage channel was established. Maintaining the drainage channel has enabled water to flow freely rather than ponding is has likely lead to the reduction of saline seepage. Refer to **Appendix I** for a map of the improvements made to the eastern toe drain. Refer to **Appendix J** for a map depicting the new eastern toe drain.
