**COPPABELLA COAL MINE**

**CHPP AREA – IMPLEMENTATION REPORT**

EROSION AND SEDIMENT CONTROL IMPLEMENTATION AND MONITORING PLAN  
December 2015

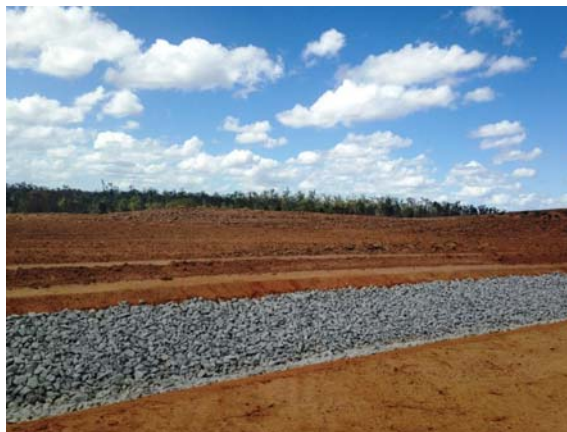
- The topsoil stockpile area to the North of the new C0-Disposal has been Ripped and Seed as per Figure 2 below.

Figure 2 – Co-Disposal Topsoil stock pile Ripped and Seed

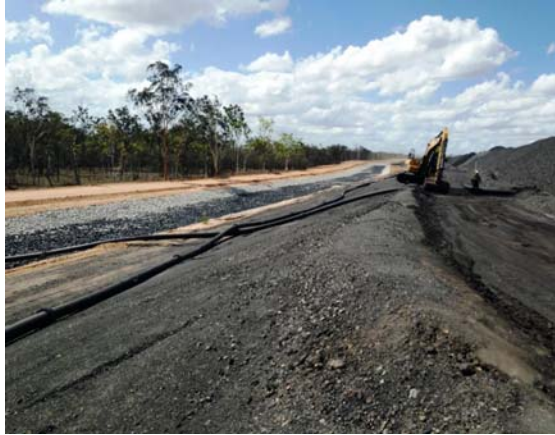
- The construction of the Co-disposal Extension project also installed a long term drainage structure, the Western toe drain. This drain separates the worked water catchment from the ESCP catchment.

*Figure 3 – Western Toe Drain*

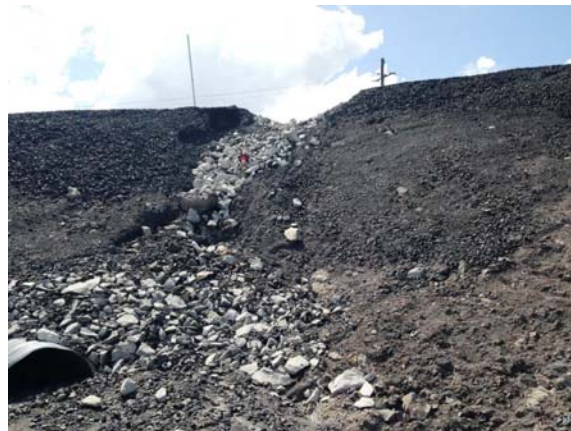
- A series of Woo Boys have been installed on the CDA access ramp, directing worked water into the Eastern Toe Drain, as seen in Figure 5 below.

Figure 5 – Woo Boy entry into Eastern Toe Drain

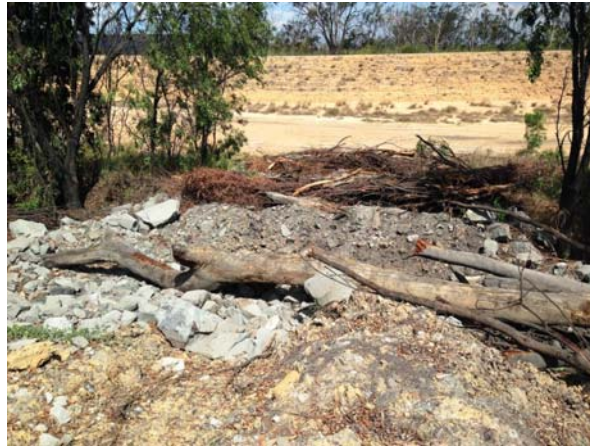
- A small sediment sump and spine drain was installed to the East of the Worked Water dam, however this was not effective in trapping the sediment.
- The installation of a sediment fence and fallen vegetation filters has now been installed as per Figure 6 below.

*Figure 5 – Fallen Vegetation Filters.*

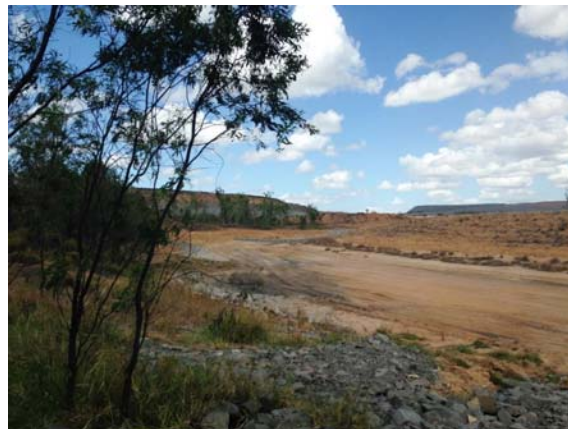
- In addition to the above a series of rock checks have been installed in the south arm diversion to further aid erosion and sediment control until the diversion has sufficient vegetation to replace the structures.

*Figure 6 – Rock Checks in South Arm Diversion.*

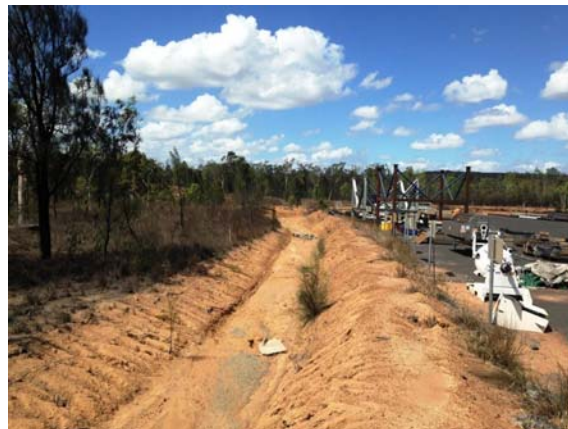
- A drain has been formed along the North Western edge of the catchment with checks installed as per Figure 8.

Figure 8 – NW Clean water Drain.

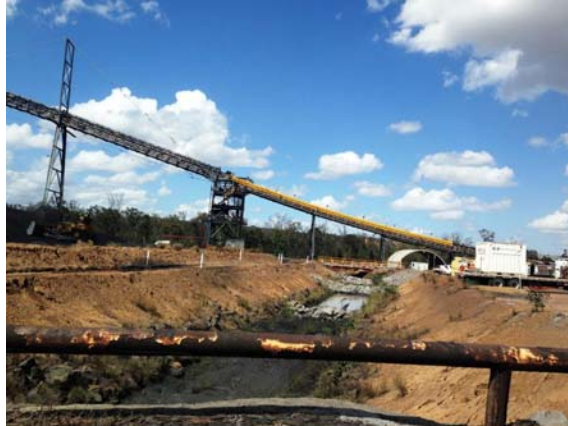
- A Series of rock checks will be installed along the drain lines to slow velocity and trap sediment as illustrated in Figure 9.

*Figure 9 – Clean water drain with rock checks.*
