Teys Australia Beenleigh Pty Ltd

Draft Transitional Environmental Program

Stormwater Management

MILESTONE 1 REPORT

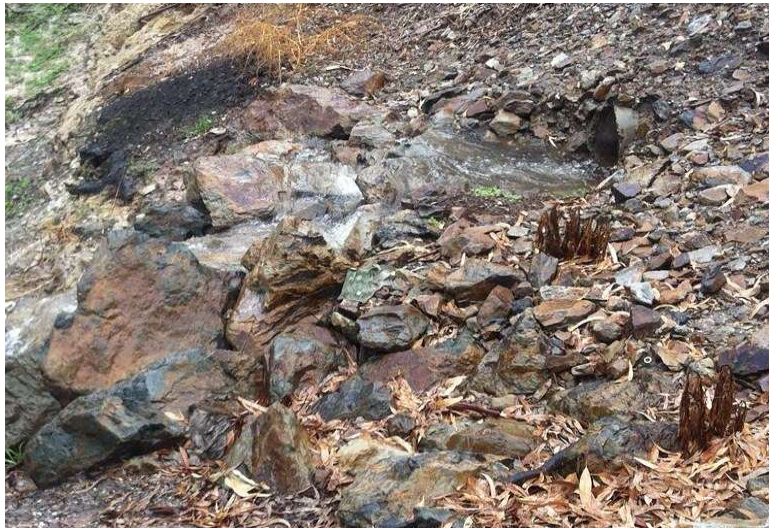
Upon investigation of the stormwater pond during a wet weather event, there was evidence that there was a significant volume of roofed water reporting to the pond as seen in Figure 1. Roofed stormwater could be more appropriately managed by diverting directly to surface waters. By better managing roofed / uncontaminated stormwater run-off and removing it from the stormwater pond, it will significantly reduce the risk of overflowing, as a result of significant rain events (its was expected that this significant flow is coming from roof stormwater on the plant. This was to be investigated in Step 2 of Milestone 1 investigation).

Figure 1 – Significant volume of stormwater entering the contaminated stormwater pond (significant roof stormwater)

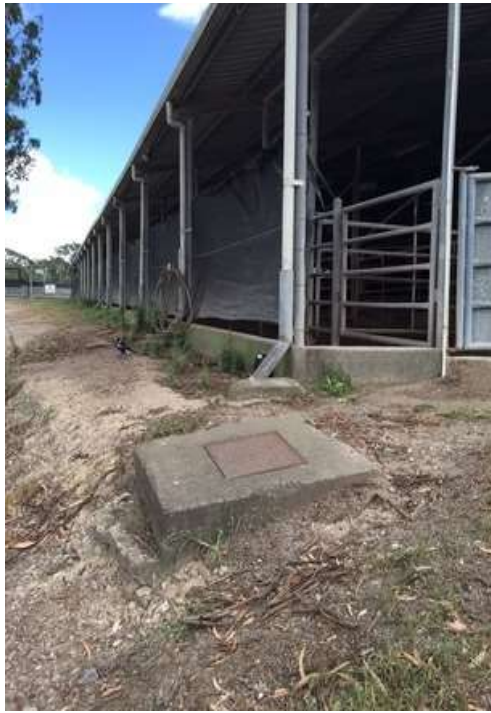
The Roofed Cattle Pens were inspected to determine roof water drainage paths. It was found that the southern side of the roofed pens reported directly to the stormwater pond on its own dedicated pipeline, and the northern side reported to an open drain which later led to the stormwater pond (roof volume calculated below).

Figure 2 – Roofed Stormwater drainage system on southern side of roofed cattle pens

The southern side of the roof pens could be more appropriately managed to reduce volume of roof stormwater reporting to the stormwater pond and therefore coming contaminated with cattle pen run-off. Teys plan to direct this roofed stormwater directly to surface waters once stormwater quality validation is performed.

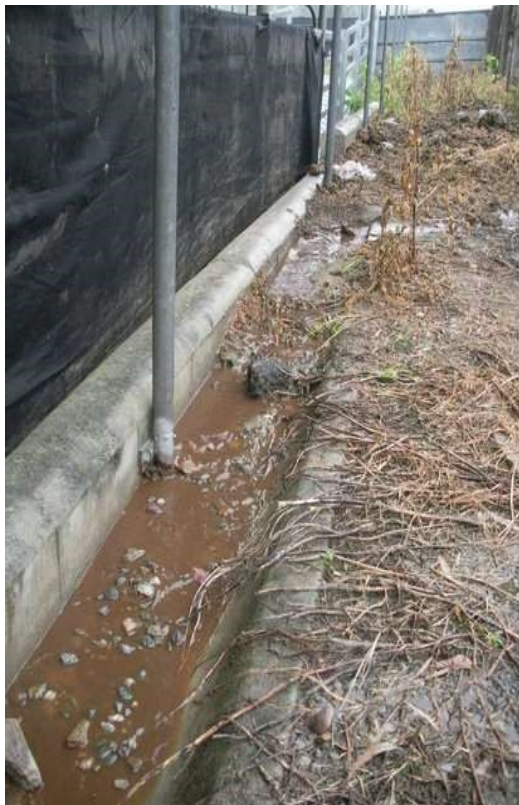
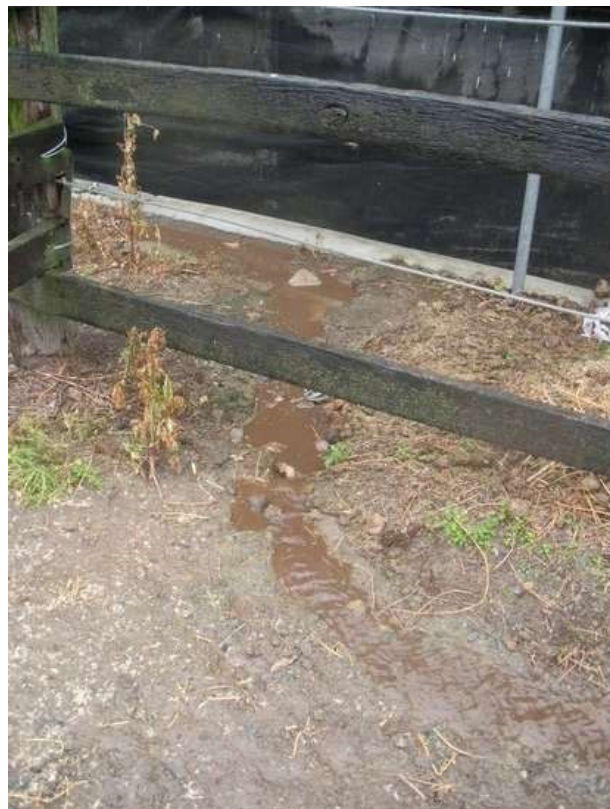
Upon closer investigation of the northern side of the roofed yards, it was found that contaminated water from uncovered cattle holding pens was combining with roof stormwater, resulting in total hydraulic contamination, as seen in Figure 3. To avoid the contamination stormwater, the cattle pen run-off from this area will be directed over the concrete wall and into the wastewater treatment system, as seen in Figure 4.

Figure 3 (left) & 4 (right) – Contaminated run-off from holding pens entering roofed stormwater

drain north side of roofed pens. This contaminated stormwater will be directed through the visible concrete wall and into the site wastewater system to prevent the contamination of roof stormwater.

- Prevent contamination of the roofed stormwater on the northern side of the roofed cattle pens by diverting contaminated flow into the wastewater treatment system located under the roofed holding pens.

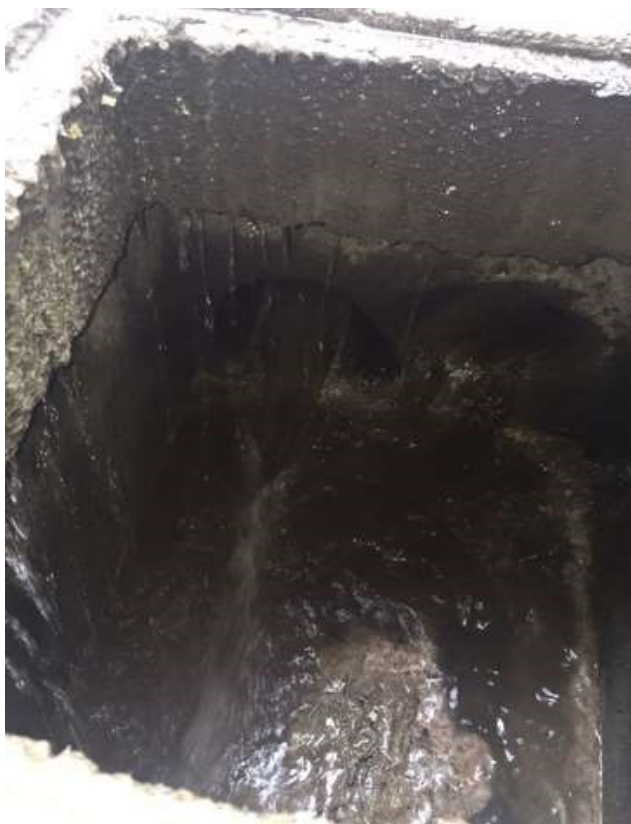
With the significant volume of water discharging into the contaminated stormwater pond, local drain covers were inspected for stormwater flow. It was discovered that there were inflow pipes, into the stormwater drainage system, that were discharging significant volumes into the contaminated stormwater pond, as seen in Figure 5. Further investigation took place in Step 2, to determine what stormwater streams were entering the drainage system to the contaminated stormwater pond.

Figure 5 – Significant volume of stormwater entering stormwater drainage system during rain event. Believed to be from roof stormwater which is to be identified later in the report

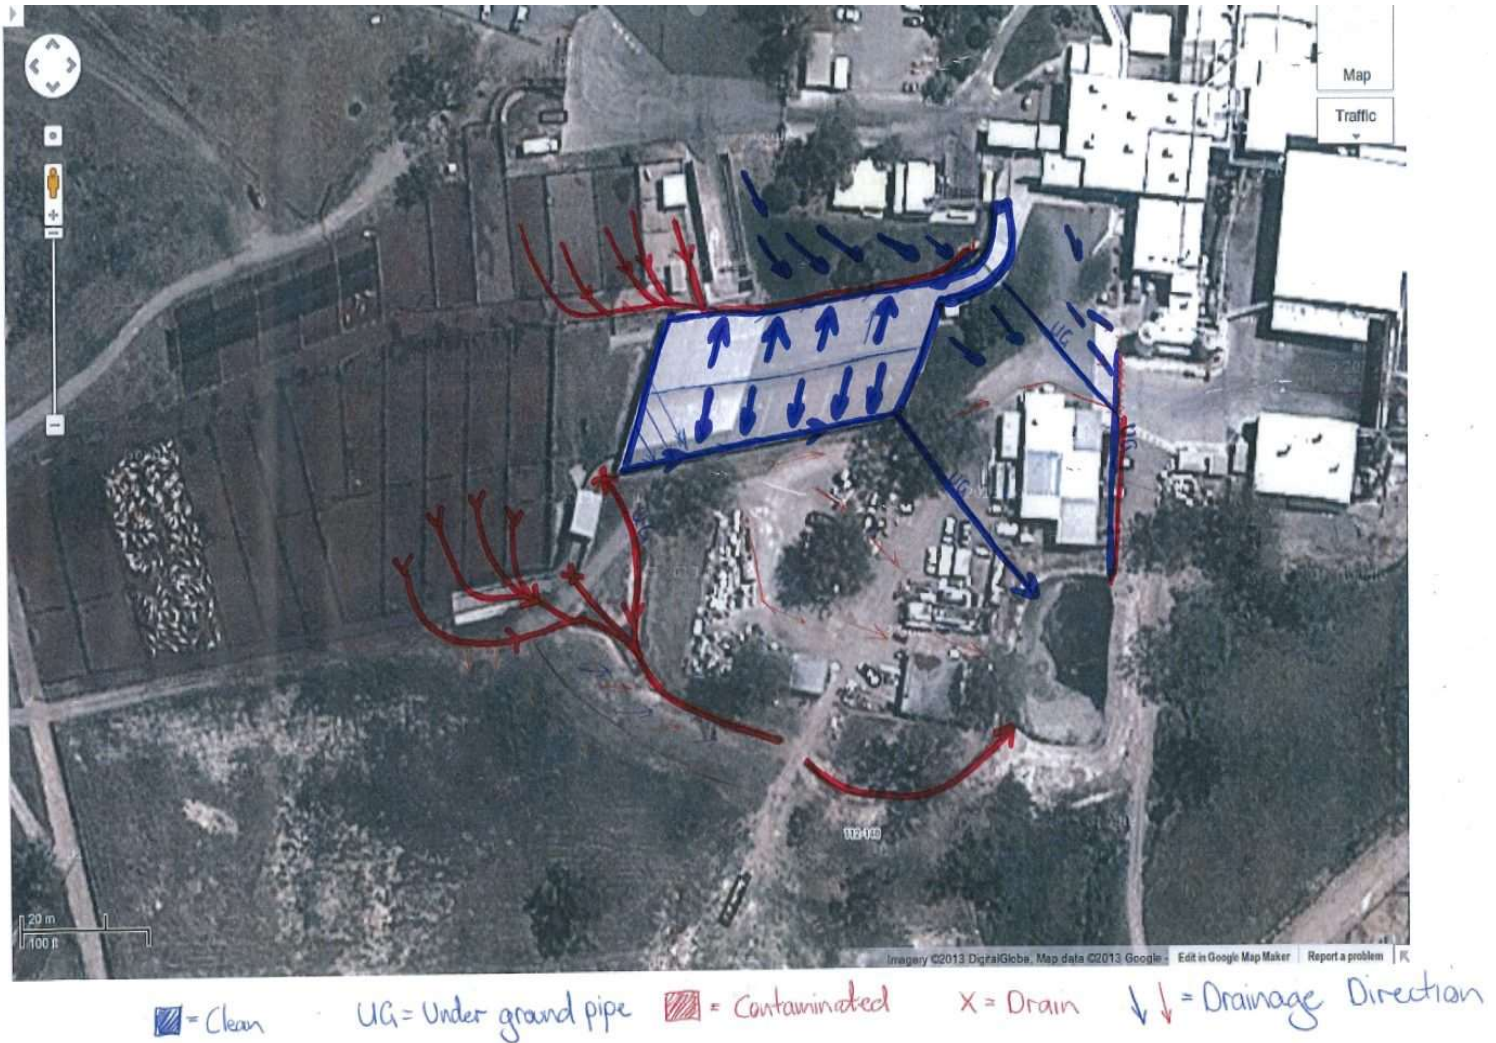
To conclude the wet weather investigation, a stormwater run-off mud map was developed to summarise the findings of the investigation. The drainage map shown in Figure 6, provides a clear guide to the stormwater drainage evidenced in Step 1 of Milestone 1.

Figure 6 – Wet Weather Investigation Mud Map.

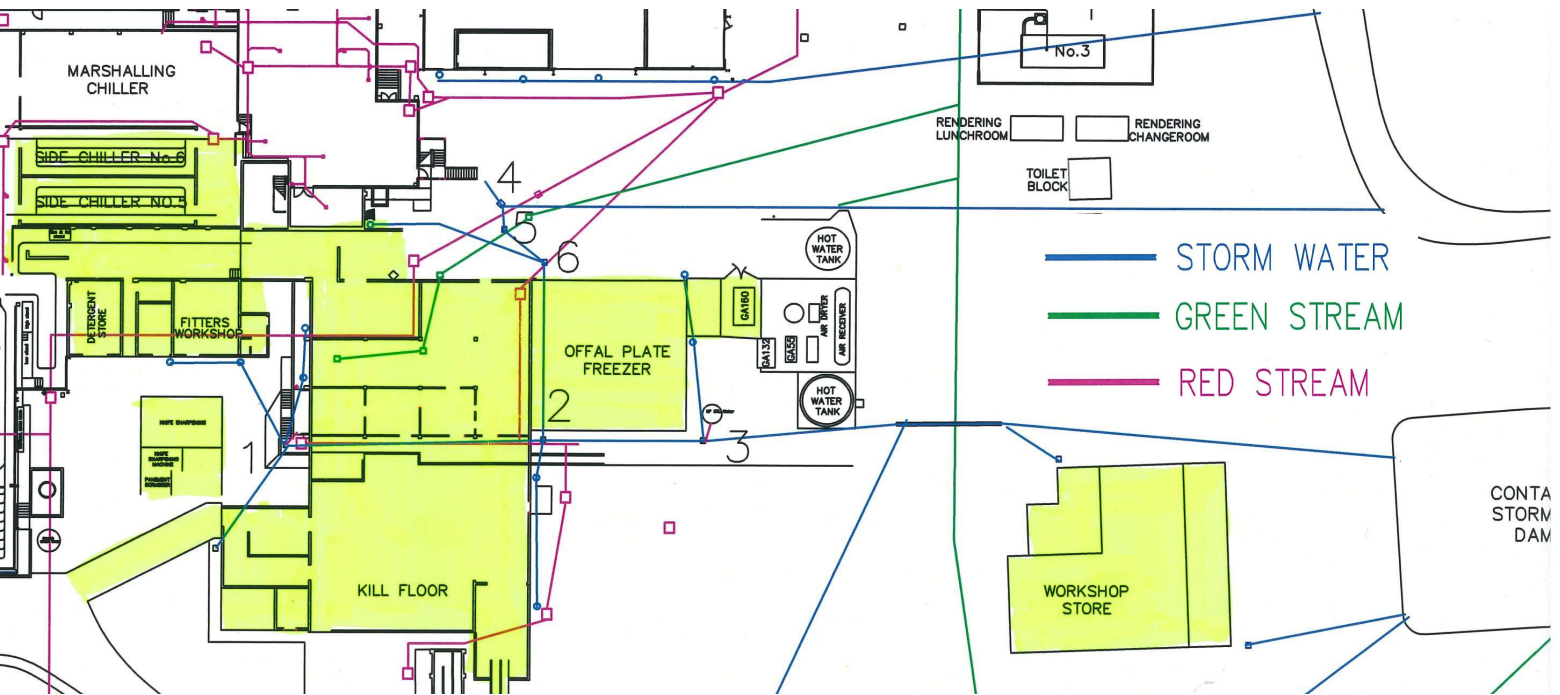
Figure 7 – Dye Tracing Map including drain numbers and highlighted roof areas identifying roofed stormwater draining to contaminated stormwater pond

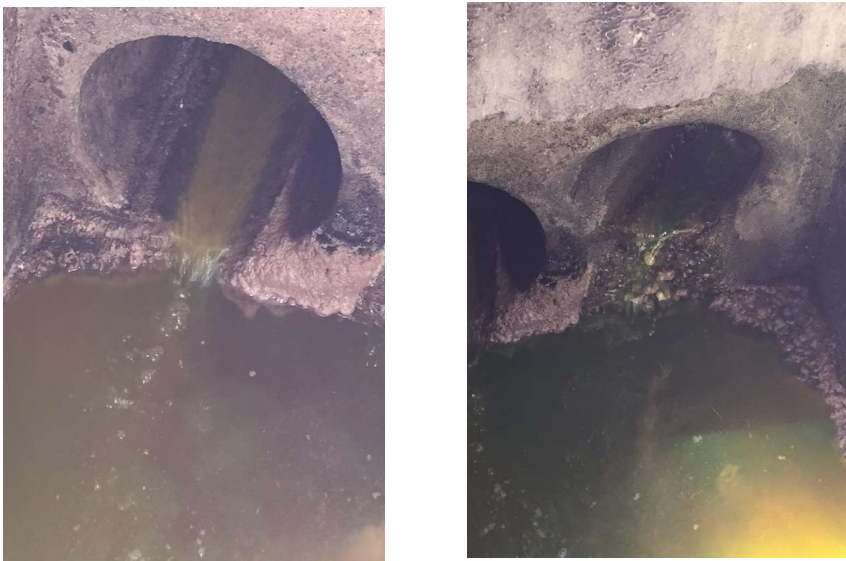
Drain 1 consisted of three entry pipes. Two of the three entry pipes consisted of potentially contaminated hot water that were combining with clean stormwater before draining to the contaminated stormwater pond. The entire contents of drain 1 continued to drain 2.

Figure 8 & 9 – Contaminated Streams entering Drain 1 identified with dye (to be diverted to WWTP)

- Remove contaminated streams from entering drain 1 and 3 and divert to wastewater treatment plant (dates for execution will be provided in later stage of the TEP).

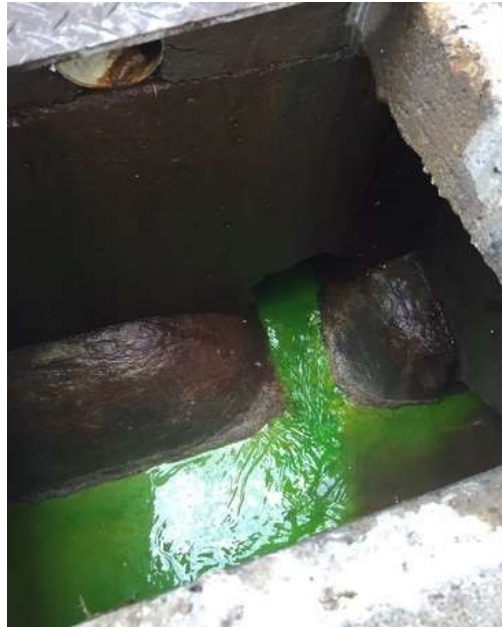
Drain 2 consists of two new entry points, adding to the hydraulic loading of drain 1. One of the entry pipes was identified as the entire stormwater from the Kill Floor roof. The other is coming from two drains from the east (Drains 4 & 5), located between the offal plate freezer and the rendering building. (potential for drains 4 and 5 to be carry some contaminated streams and we are undertaking additional investigations into this.) The hydraulic loading from drains 2, 4 and 5 report to drain 3.

Figure 10 – Roof Stormwater from Kill Floor Roof entering Drain 2.

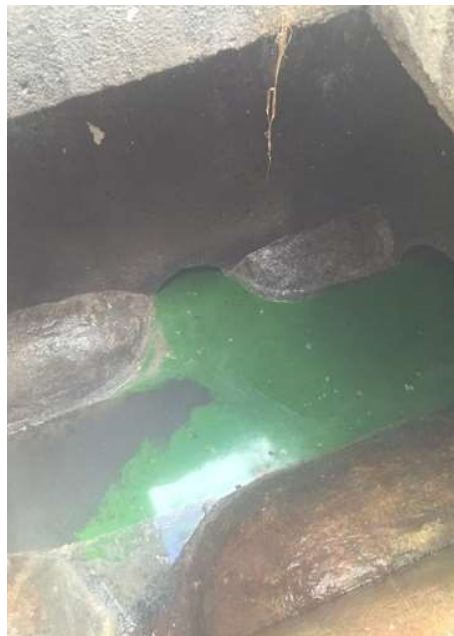
Figure 11 – Tracing Dye entering Drain 2 from Drain 4, 5 and 6.

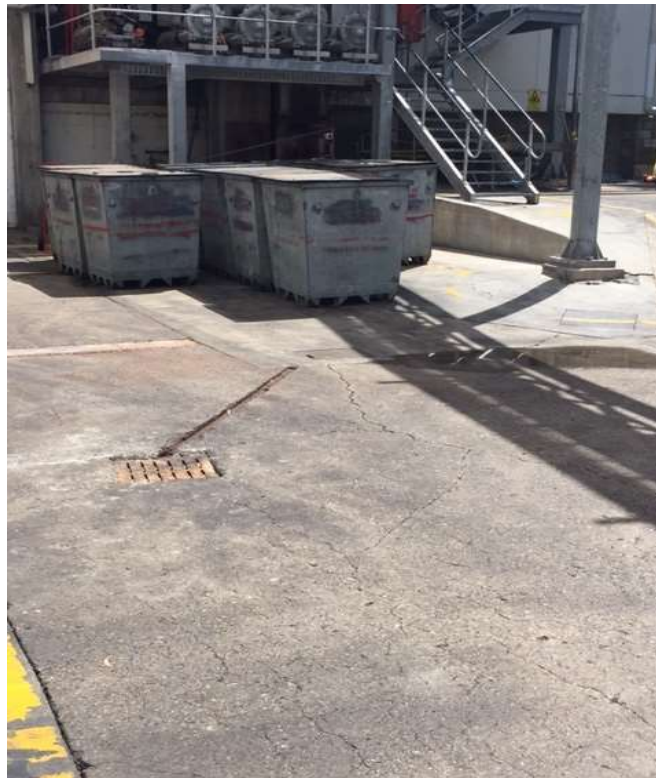
Drain 4 has one entry pipe and two exit pipes. One exit pipe was confirmed as draining directly south to the creek. The other exit pipe drained to a nearby drain (drain 5) and then onwards to drain 2. The entry pipe to drain 4 is expected to be from the roofed area of the Boning Room however the drain was identified as being collapsed. Appropriate works will be undertaken to address.

Drain 5 has two entry pipes and one exit pipe. One of the entry pipes drains directly from Drain 4. The other entry pipe drains directly from a roofed area however the drain has collapsed. All outflow hydraulics from this drain flows directly Drain 6. Teys will plan works to direct this drain into the wastewater treatment system and redirect roof water or remove risk of contamination. Due to the contours in this area, some blood contamination can enter this stream via overland flow (from raw material bin washing).

Drain 6 has one entry pipes and exit pipe. Entry pipes drains directly from Drain 5. All outflow hydraulics from this drain flows directly Drain 6. Teys will plan works to direct this drain into the wastewater treatment system and redirect roof water or remove risk of contamination. Due to the contours in this area, some blood contamination can enter this stream via overland flow (from raw material bin washing). Flow from drain 6 is directed under the Offal Room and into Drain 2 and onward to the stormwater pond.

Figure 12 – Drains 6 (left), 5 (middle), 4 (right) and raw material bin causing potential contamination.

- Divert drains 5 & 6 to wastewater treatment plant or remove risk contamination.
- Repair damaged roof stormwater downpipes.
- Take samples of end of pipe stormwater after contaminated streams are removed.

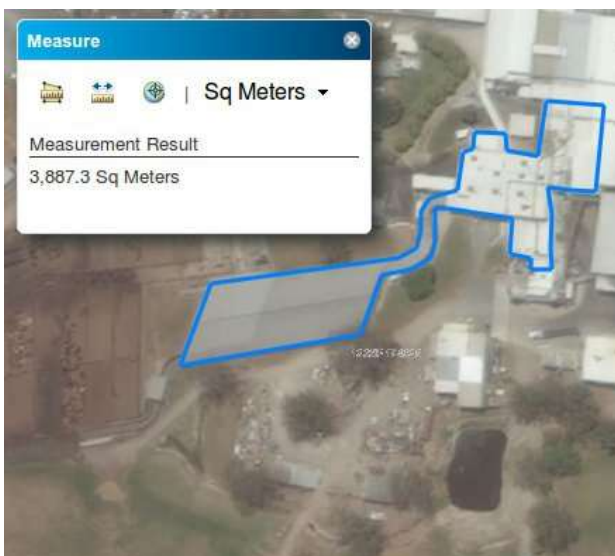
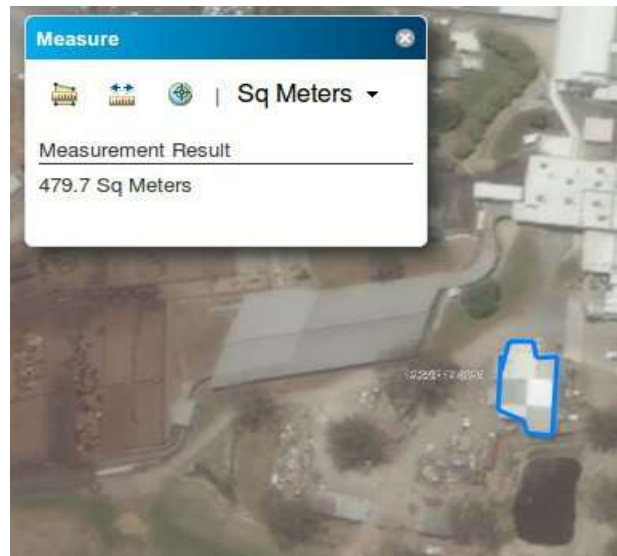
The Dye Tracing and wet weather investigations highlighted that significantly more roofed surface area is draining to the contaminated stormwater pond than previously known. After identifying throughout the investigation, it is estimated that the volume of stormwater from roofed areas would contribute over 1 megalitre of hydraulic loading to the contaminated stormwater pond, in a 1 in 20 year 24 hour storm event (surface area of approximately 4367m² during a 254mm rain event with 1.0 run-off coefficient = 1,109,218 L), as seen in figures 13 and 14.

Figure 13 (left) & 14 (right) – Roof Stormwater Catchment Area using State Planning Policy Tools

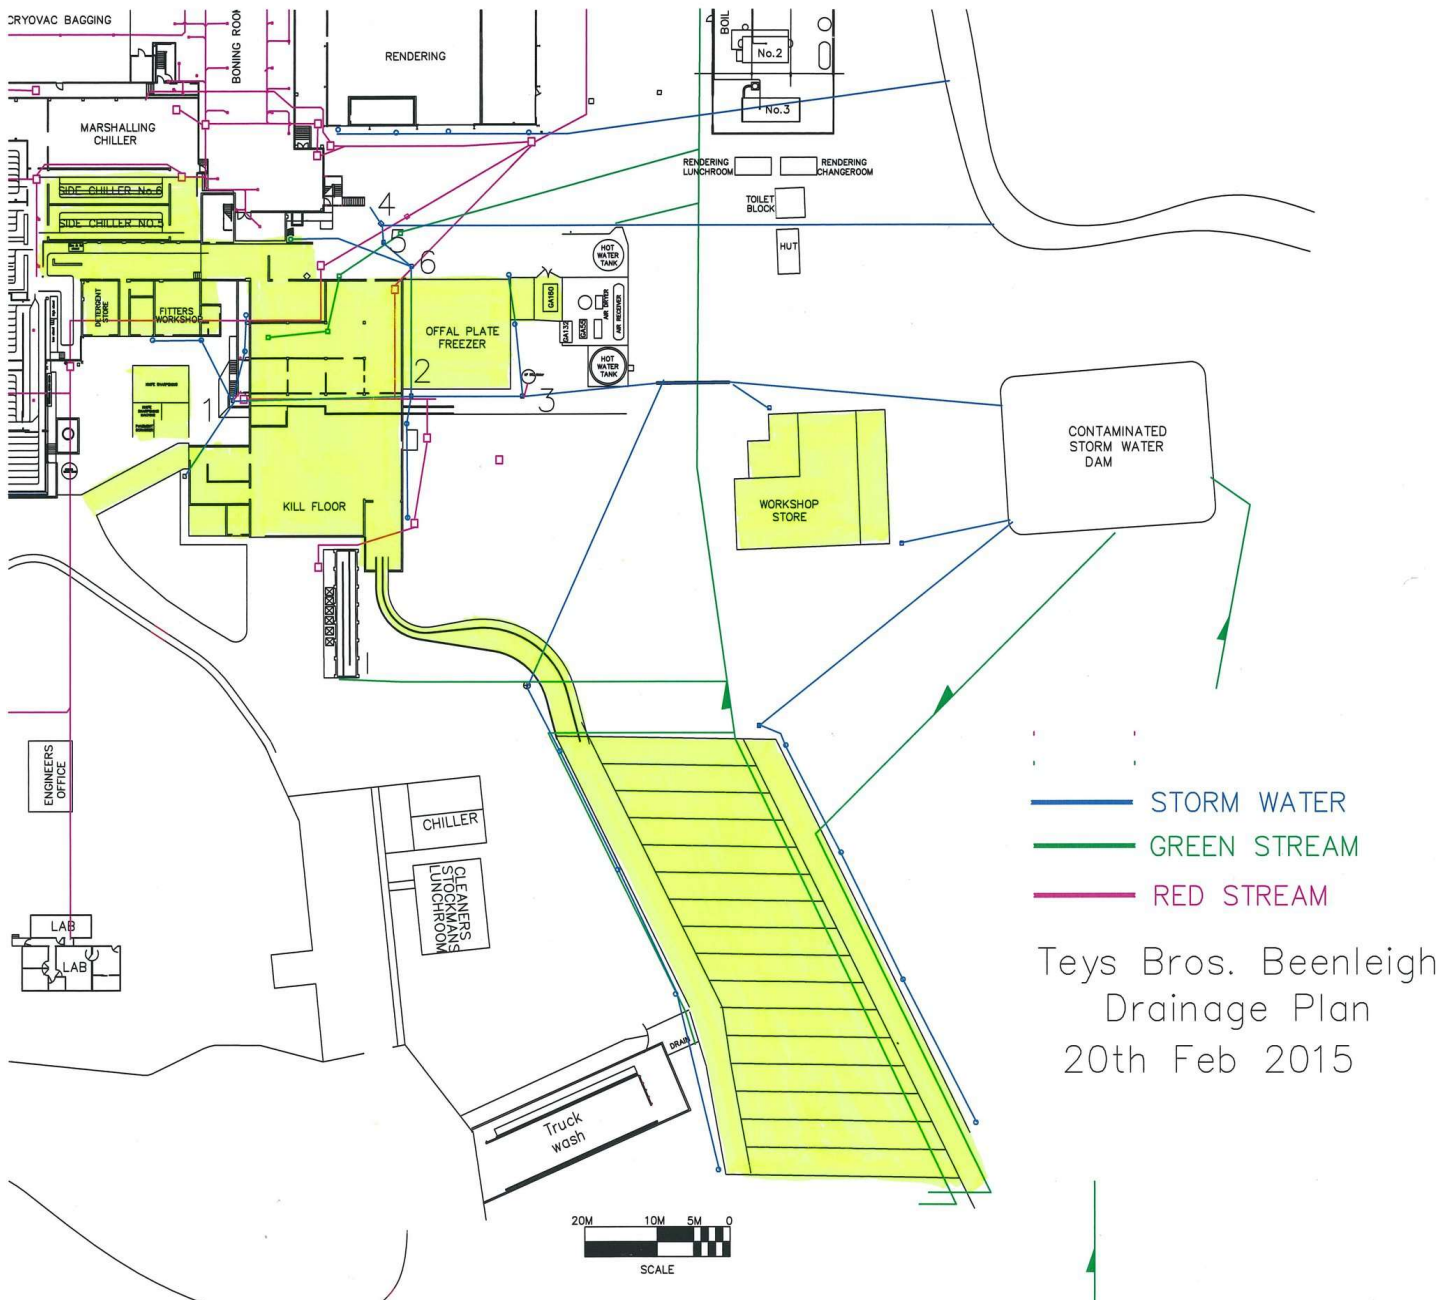
Teys updated the site drainage drawing for inclusion into this TEP milestone 1 report. The updated drawing can be seen below in Figure 15. The highlighted area identifies roofed structures that direct roof stormwater to the contaminated stormwater pond, contributing a significant hydraulic loading.

Figure 15 – Updated Stormwater Drainage Map. Highlighted areas identify roofed structures that direct stormwater to the contaminated stormwater pond.
