# Rehabilitation of the Dawson Dam, Moura, Queensland

for  
WestSide Corporation

10<sup>th</sup> October 2017

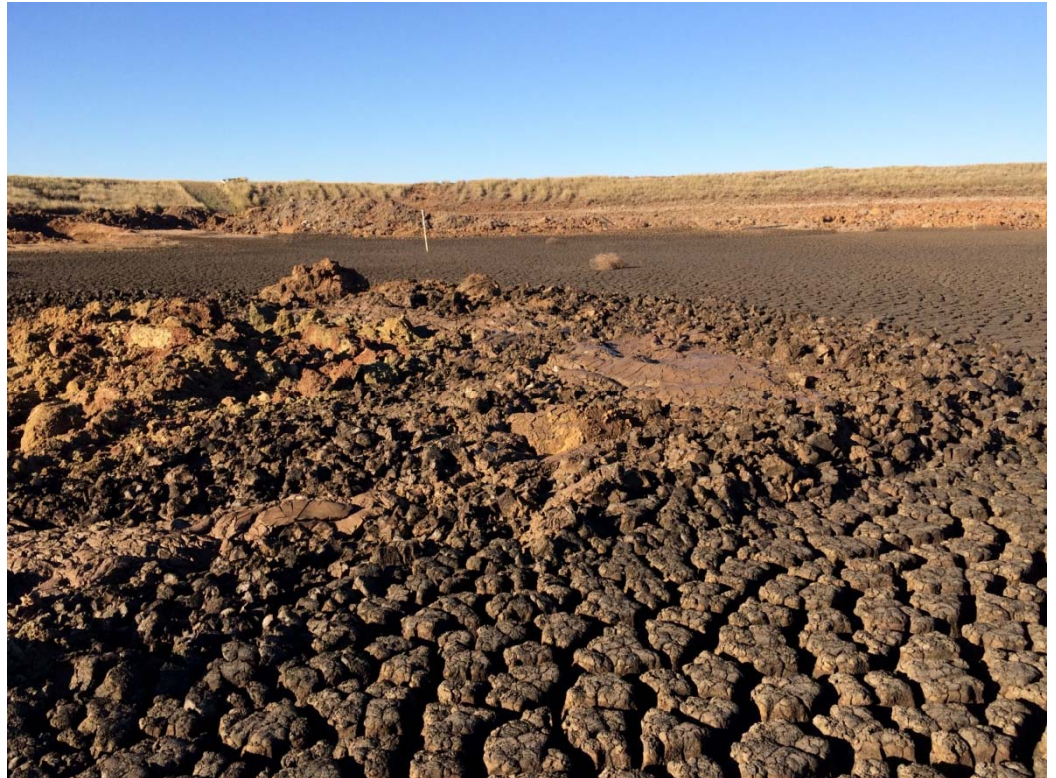
**Figure 2** General views of the Dawson Dam site before rehabilitation started

Before rehabilitation commenced, it was very evident that the clays in the basement material were high swelling and produced large cracks when dried (Figure 2). In addition, the depth of the pits dug for the mix and bury process varied from 2-10m. Consequently, it was decided to leave the site as it is for 12 months to allow for any subsidence to occur, if any. At the end of the resting period, reparations in the surface topography will be made if necessary and mulch will be spread on the surface and cultivated in before pastures species are sown. The 12 month period will also provide time for the gypsum to dissolve and for Ca to displace Na from exchange sites and be washed down the soil profile out of the root zone.

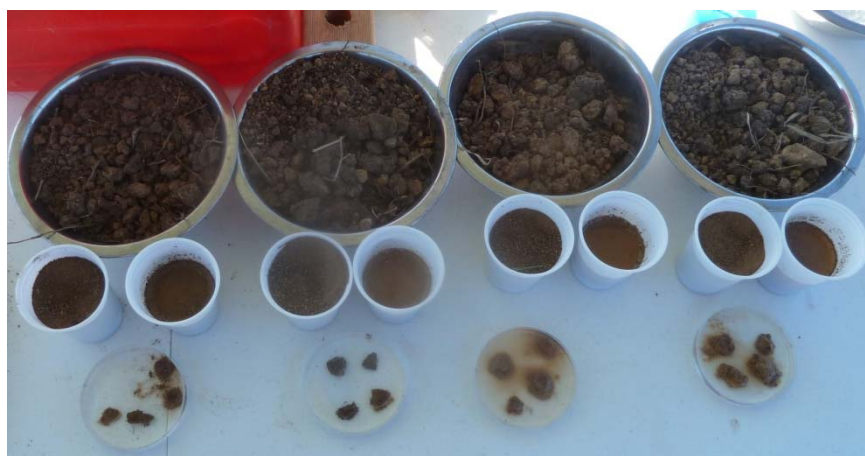
Out of the 52 samples tested, 52% did not disperse (score = 0, Table 7) and another 21% only slightly dispersed (Score = 1, Table 7). The remaining samples had between scores of 2-4. Examples of scores of 0, 2 and 3 are given in Figure 6 for samples 13 and 14.

Figure 6 Slaking and dispersion in dam wall samples 13 and 14

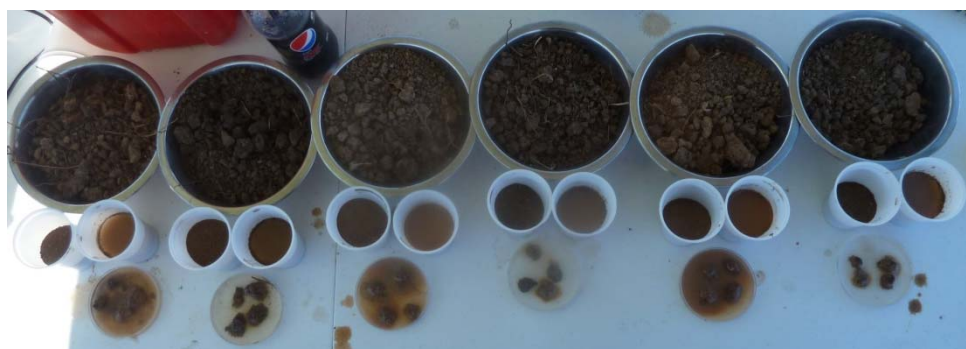
Slaking was quite variable within the 52 samples taken (Table 7). Approximately one third of samples did not slake or there was only slight evidence of it. Slaking in the other samples was evident or very evident. Examples of no slaking (NE), slight evidence (SE) and evident (E) are given in Figure 6 whereas Figure 7 includes an example of very evident (VE) slaking.

Figure 7 shows examples of dispersion with scores of 0, 1 or 4 from samples 15-17.

Figure 7 Slaking and dispersion in dam wall samples 15-17

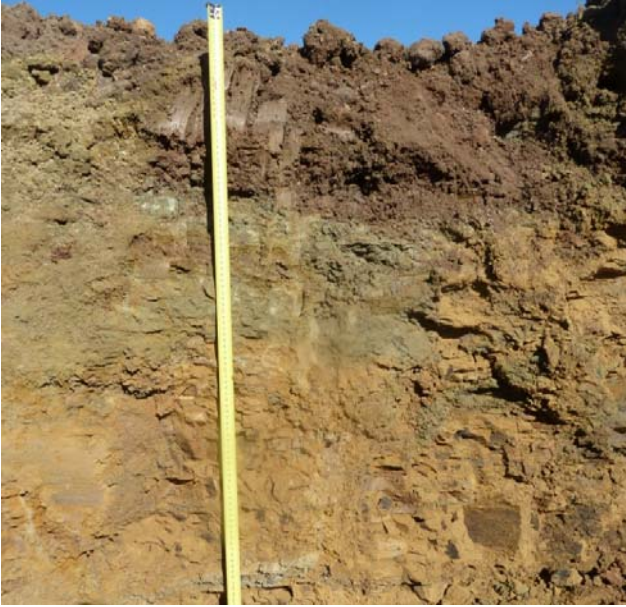
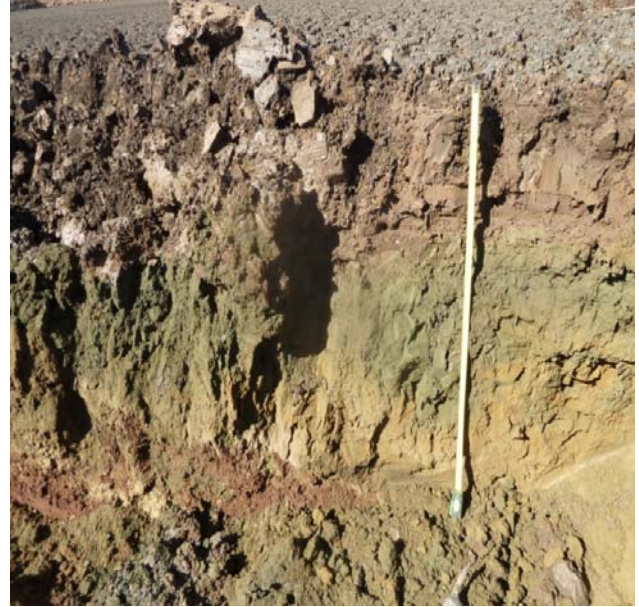
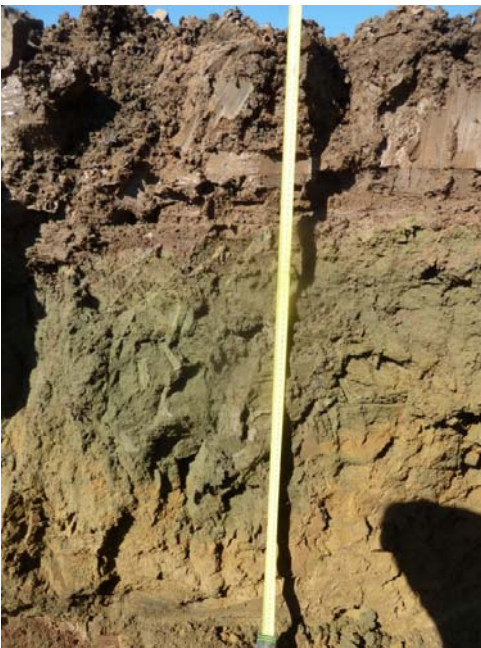
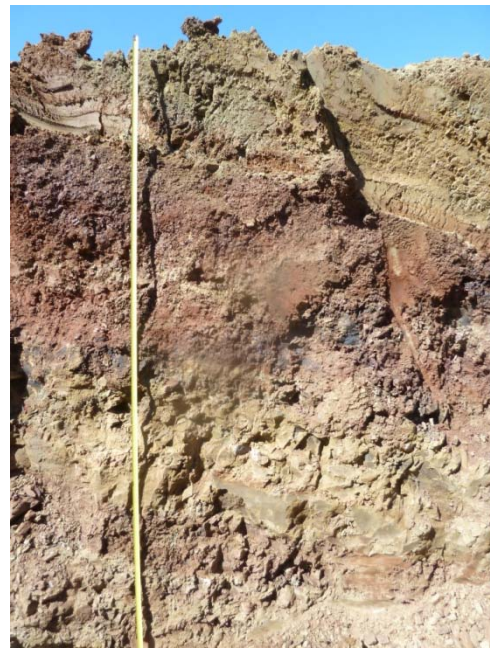
Pits were dug in the dam base and typical examples of the profiles are given in Figure 8. At the surface, there was a layer of red brown sediment that varied in thickness from 30 – 150cm. Below this were mainly clay materials which varied in colour from grey, yellow and red to green (Figure 8).

**Figure 8** Example of materials found in the dam basement

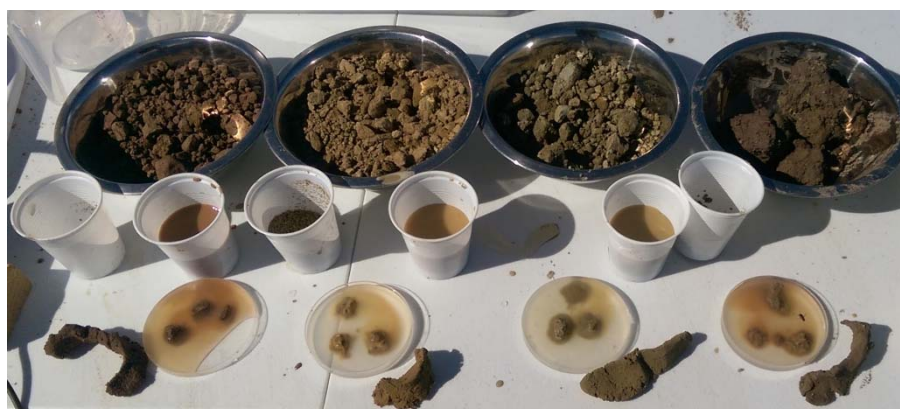
(a) **Site 1:** 0-30, 30-45, 45-100cm and >100cm (left to right in photo)

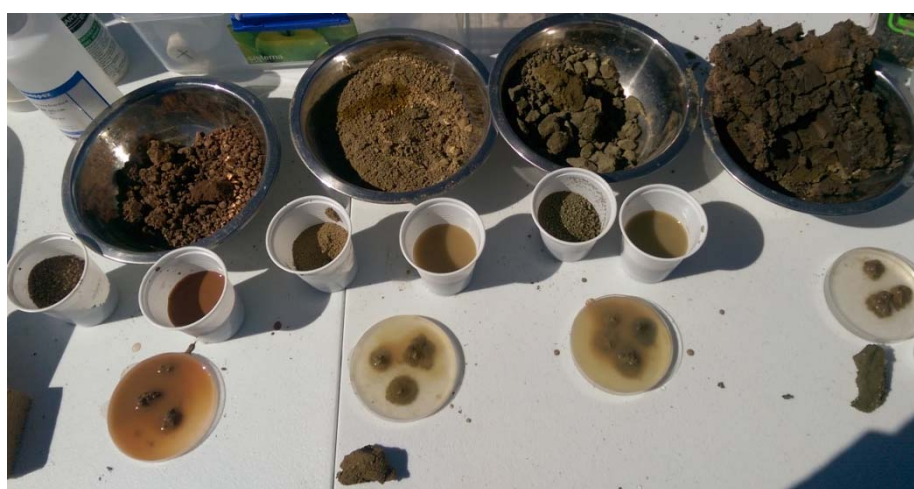
Field analyses indicated that pH values varied from 8.4-9.5 whereas  $EC_e$  would support plant growth except sensitive plants may have difficulty with the salinity of the green clay found at Site 2 (Table 8).

(b) **Site 2:** 0-34, 34-74, 74-120cm and >100cm (left to right in photo)

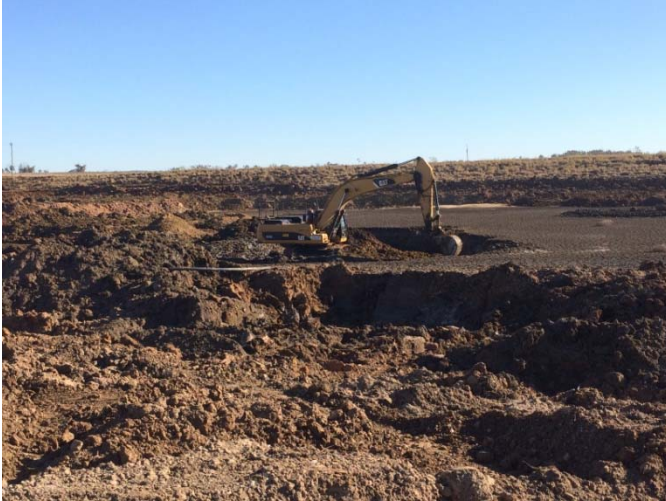
a) A pit being excavated during the mix and bury process

This was undertaken in a stepwise process where a pit was excavated down 3-10m, saline material was added and then the excavated material replaced on top of the saline material and the two materials were mixed together (Figure 12). This process was repeated until all saline material was buried to depths of greater than 1m as required in the rehabilitation plan (Figure 13).

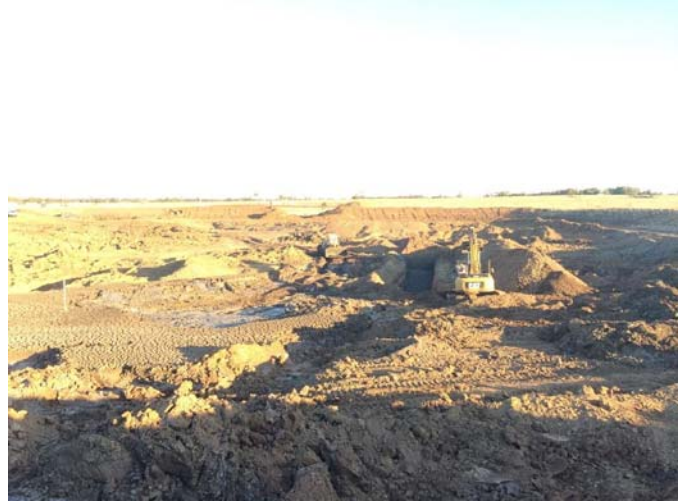
b) Pits and stockpiled material that has been excavated

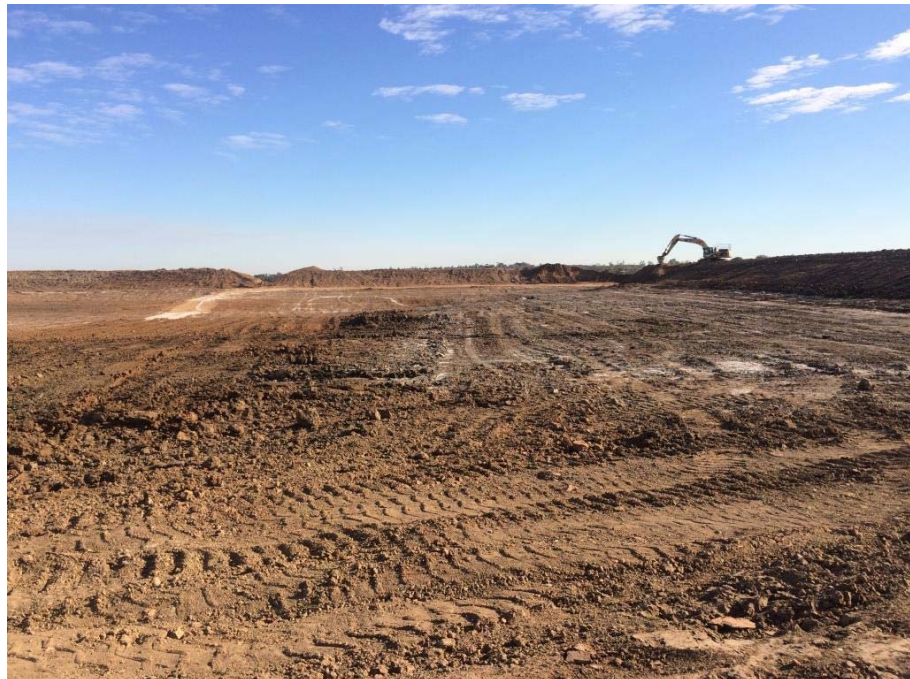
**Figure 13** Reformed basement surface after the mix and bury process was completed

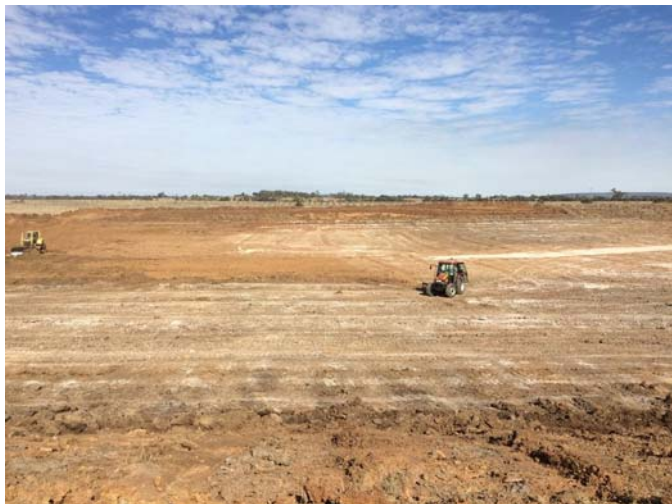
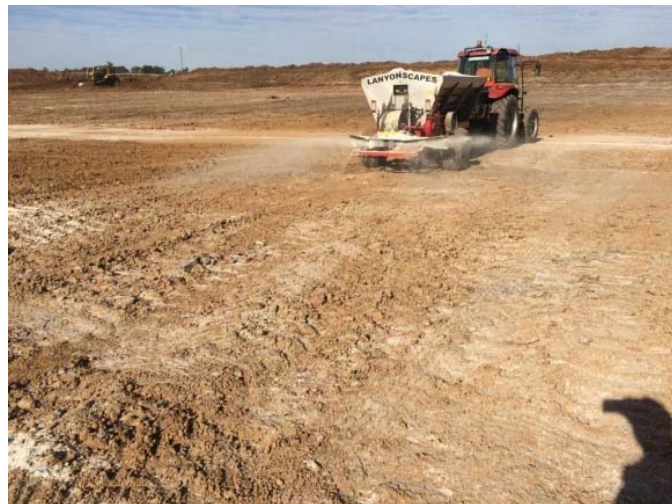
**Figure 14** Spreading gypsum onto the reformed basement layer after completion of the mix and bury process

Gypsum was applied to the surface of the mix and bury layer (Figure 14) and then it was deep ripped to a depth of 1m (Figure 15) before subsoil (~2m deep) was placed over it.

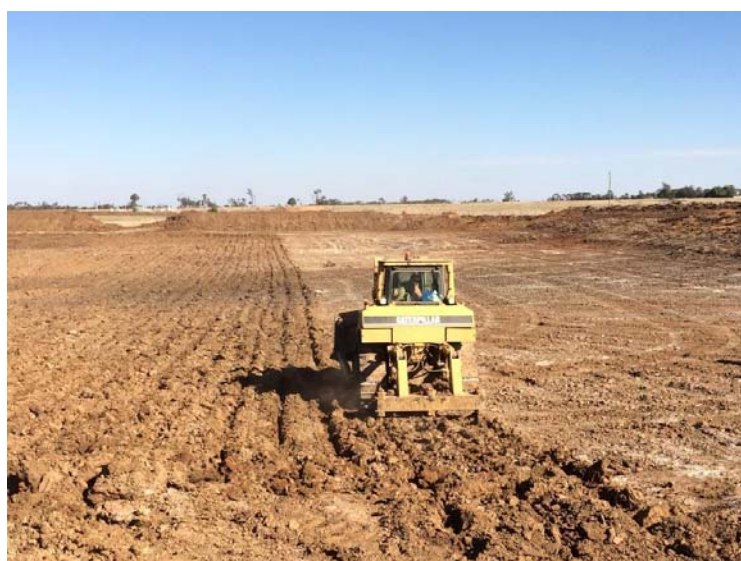
**Figure 15** Ripping the reformed basement layer formed after the mix and bury process

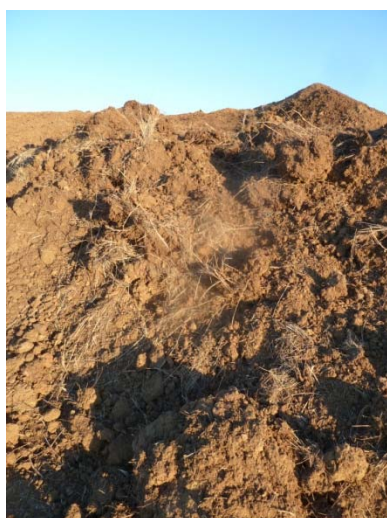
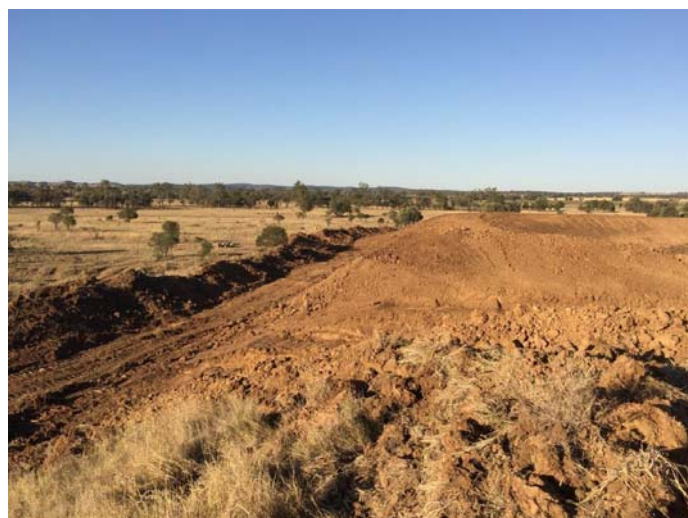
**Figure 16** Topsoil that had been scraped of the outside of the dam walls and stockpiled temporarily

The topsoil on the outer surface of the dam walls was then scraped off into a temporary stockpile (Figure 16).

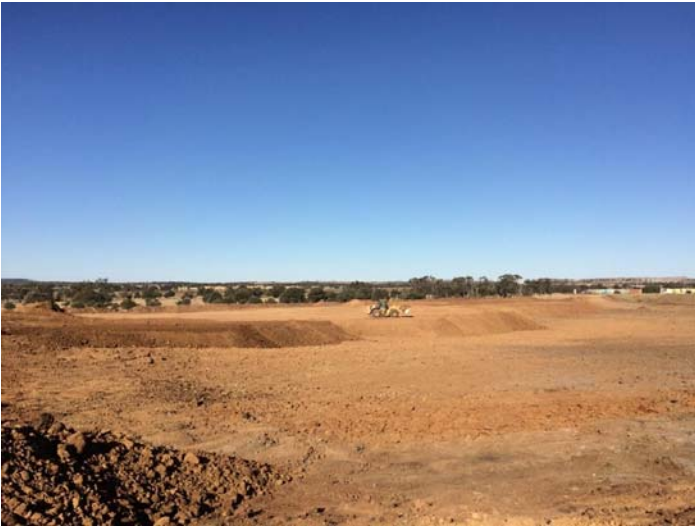
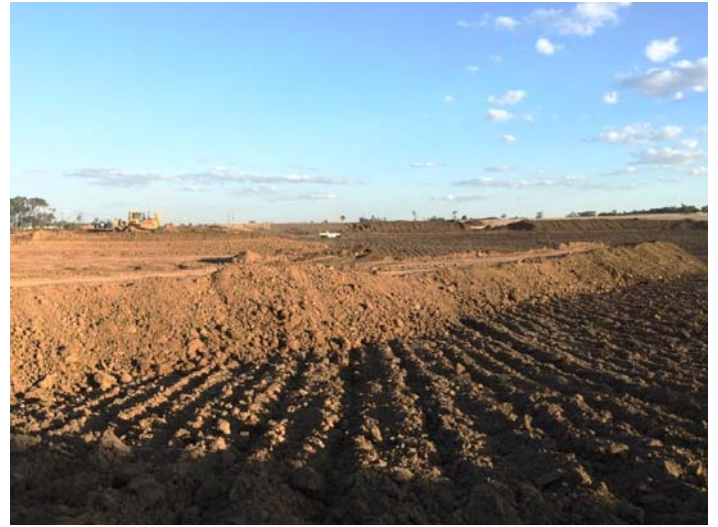
**Figure 17** Spreading the subsoil over the reformed dam basement

The subsoil exposed in the dam walls was then spread over the reformed basement surface (Figure 17) and deep ripped to 1m (Figure 18).

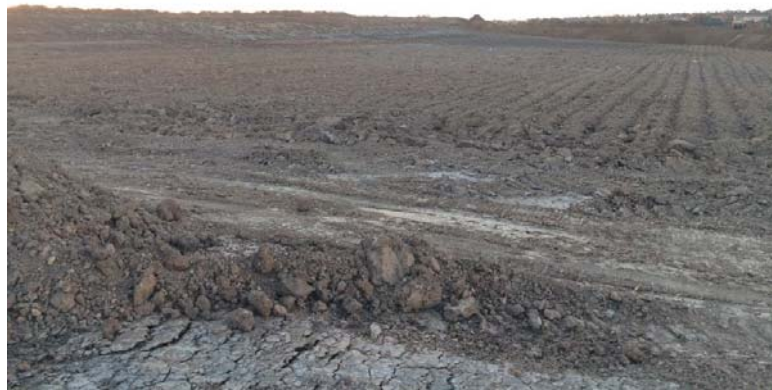
**Figure 18** Deep ripping the subsoil to a depth of 1m

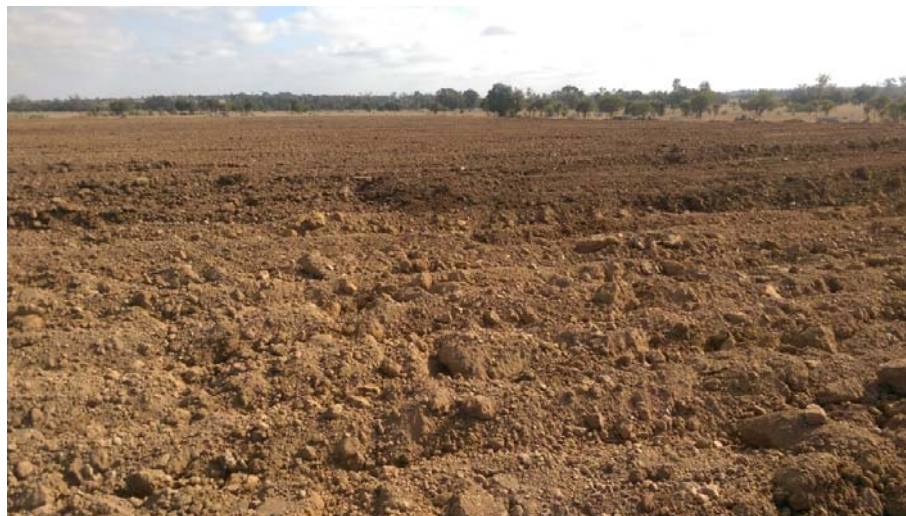
**Figure 19** Spreading the topsoil over the ripped subsoil during rehabilitation of the Dawson dam

Subsequently, topsoil was spread over the subsoil to a depth of ~20cm (Figure 19).

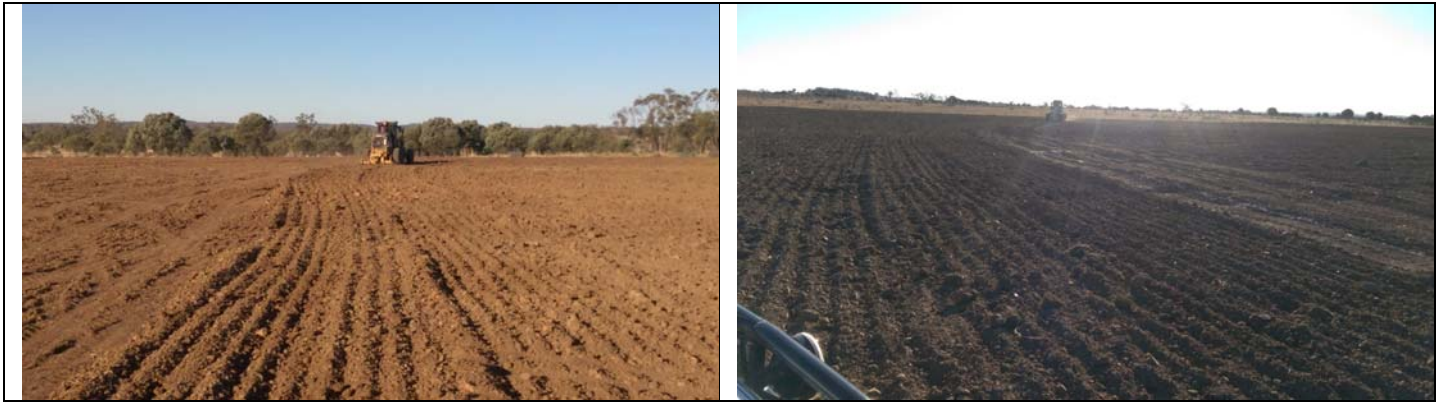
**Figure 20 Cultivating gypsum into the 20cm depth of topsoil**

Gypsum was then applied to the surface and cultivated into the topsoil (Figure 20).

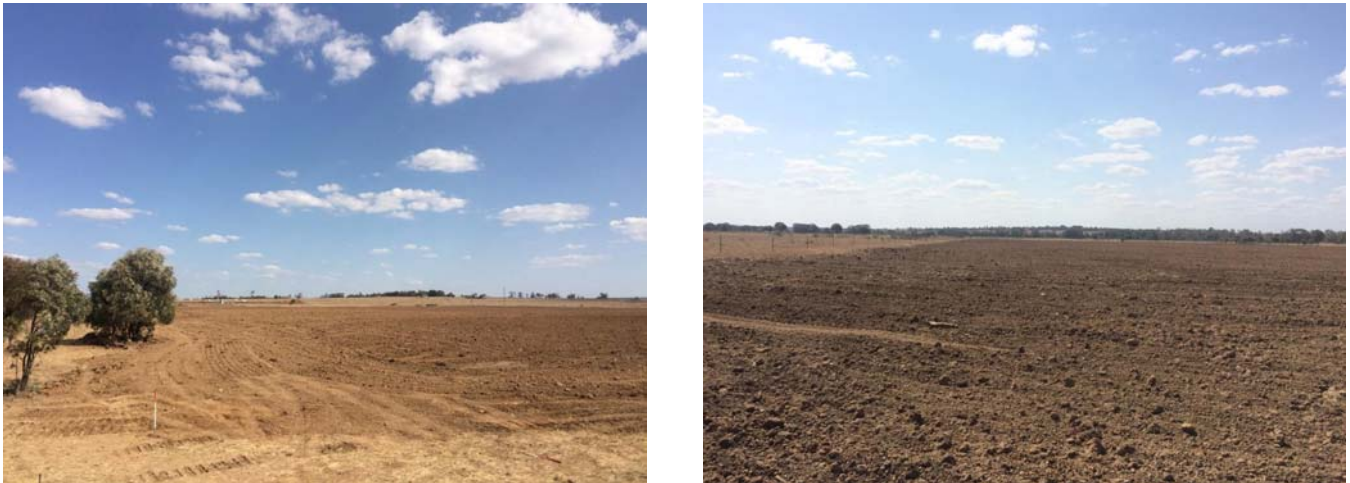
The finished surface after the rehabilitation earthworks were completed is shown in Figure 21, illustrating that the reformation was continuous with the adjacent native land.

**Figure 21 The finished surface after the rehabilitation earthworks were completed**
