Transitional Environmental Program  
Mount Veteran Mill  
October 2014

Report No: MGT14.02.02\_08  
Prepared for: MGT Mining Ltd  
Prepared by: Biotropica Australia Pty Ltd

| Title: | Transitional Environmental Program – Mt Veteran Mill |

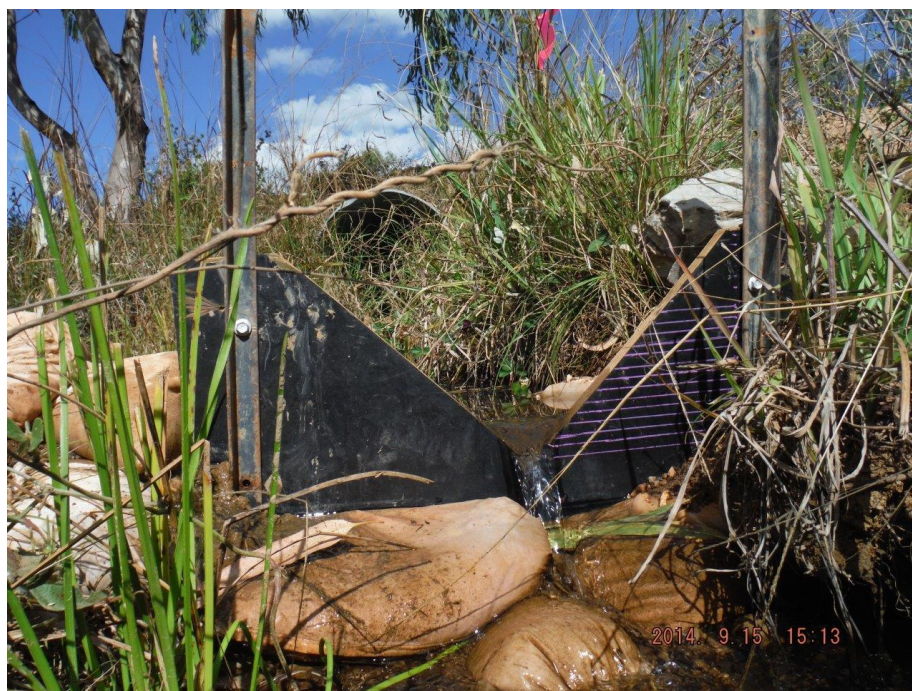
Figure 1: V-notch weir

A v-notch weir was installed at the culvert on the main access road into the site in September 2014. All water that is leaking from the TSF dam wall collects in a small (approximately 0.7ha) low lying area downstream from the TSF (refer Appendix D). The topography of this area channels all water through the culvert under the site access road and into the receiving environment of the diverted Males Gully. As there has been no rainfall on the MGT Mining site since 16<sup>th</sup> August 2014 (BOM, 2014a), it is likely that all flow through the culvert (and v-notch weir) as at September 2014 is a result of seepage from the TSF. Figure 1 shows that the flow through the weir at the culvert as at 15<sup>th</sup> September 2014 is 3.2mm which equates to 0.25L/s or 15L/min.

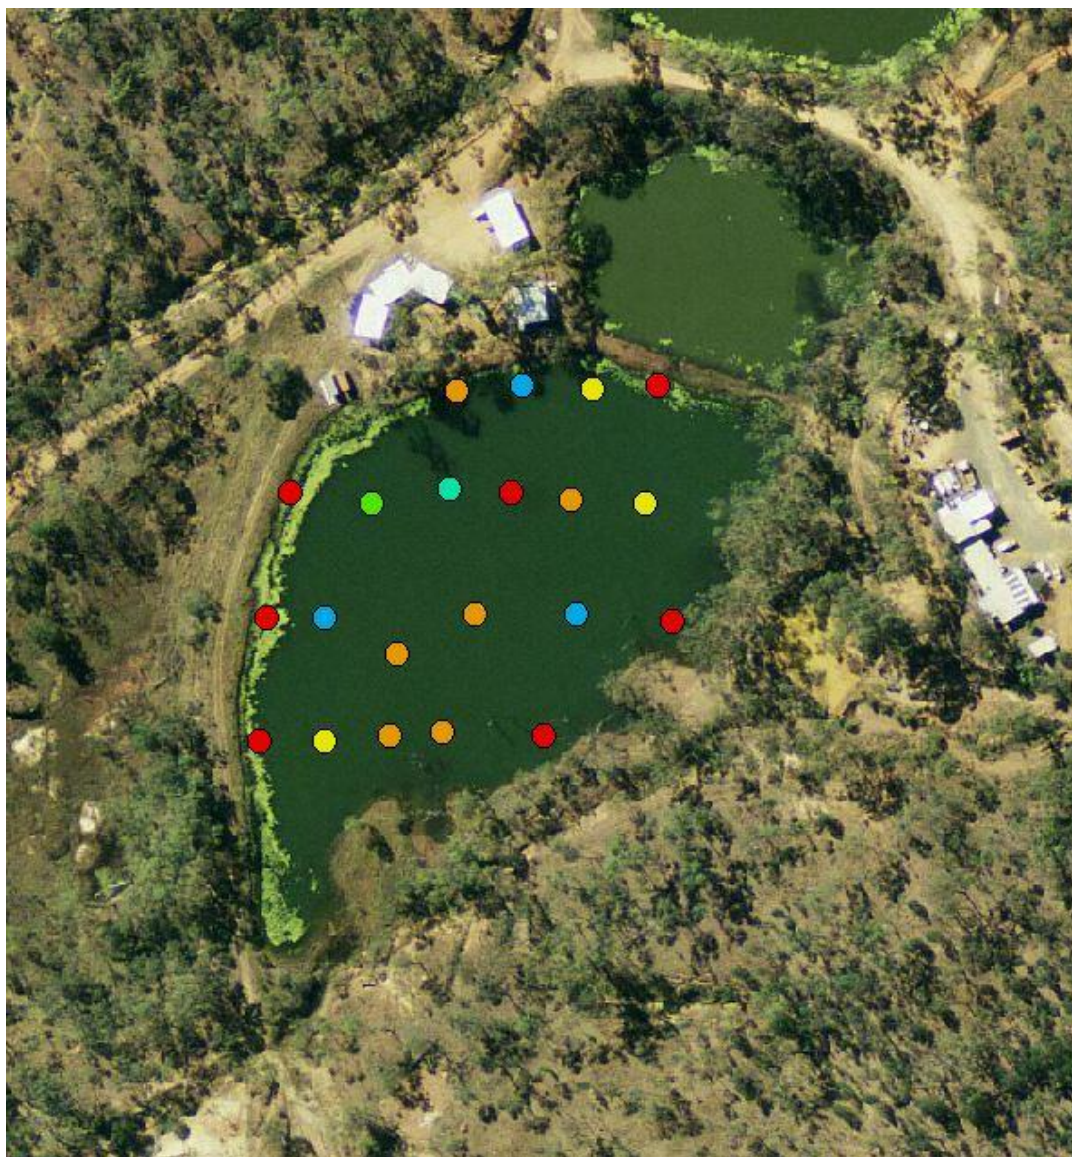
**Figure 2: TSF depth record locations**

The TSF is currently storing approximately 105-110% of its design capacity and there is no freeboard. The water level in the TSF means that the water currently lies approximately half way down the spill way. In the event of a significant rain event, the additional water into the TSF would cause an uncontrolled release. This would lead to the release of non-compliant water to the receiving environment in contravention of the site EA. To prevent such an uncontrolled release from the TSF, it is necessary to reduce the standing water level before the 2014/2015 wet season.

A hazard category assessment of the TSF was undertaken by Fraser Osborn in 2013. It concluded TSF structure is not considered a regulated structure. The dam is therefore not subject to the water level requirements associated with regulated structures. However based on the catchment area (estimated to be 4.2ha), the design storage allowance for the dam requires the dam water level to be lowered 1.29m. For the extreme storage allowance the dam water level needs to be lowered by an additional 0.46m and the freeboard (height from water surface to spillway level) should be a minimum of 0.25m. Altogether there is a requirement to reduce the level of the water in the TSF by approximately 2m (34,400m<sup>3</sup> or 34.4ML).

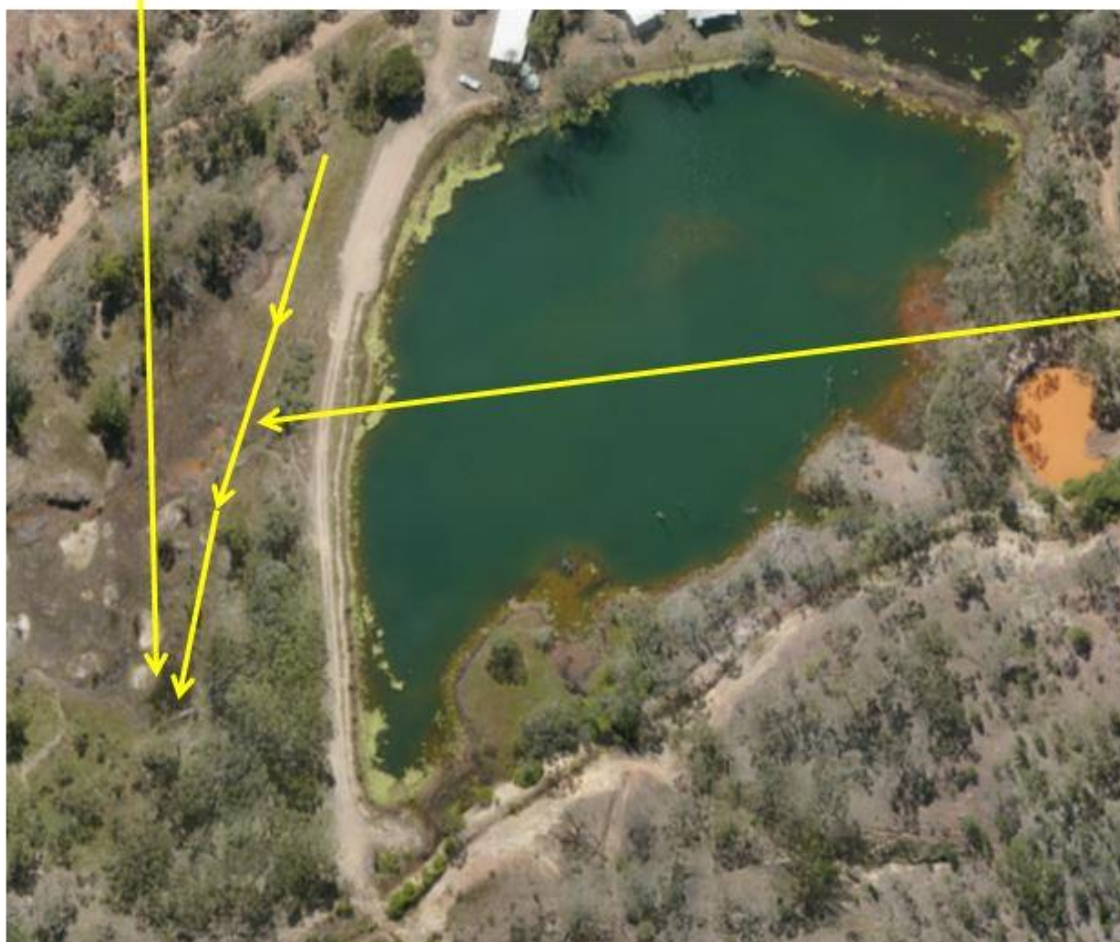
Proposed collection  
point of catch drain for  
transfer back to TSF

Should the sealer fail to stop the seepage from the TSF (as shown by monitoring methods discussed in Section 6), a second and concurrent approach will be undertaken. This will consist of earthworks to construct an earthen catch drain downstream of the seepage point. To ensure that all seepage is captured, whilst minimising the rainwater catchment, the location of this earthen dam wall is as close to the TSF downstream dam wall as is practicable, an indicative location only is shown in Appendix D. The exact location of the catch drain cannot be finalised at this time as the ground is too wet for vehicular access due to the seepage.

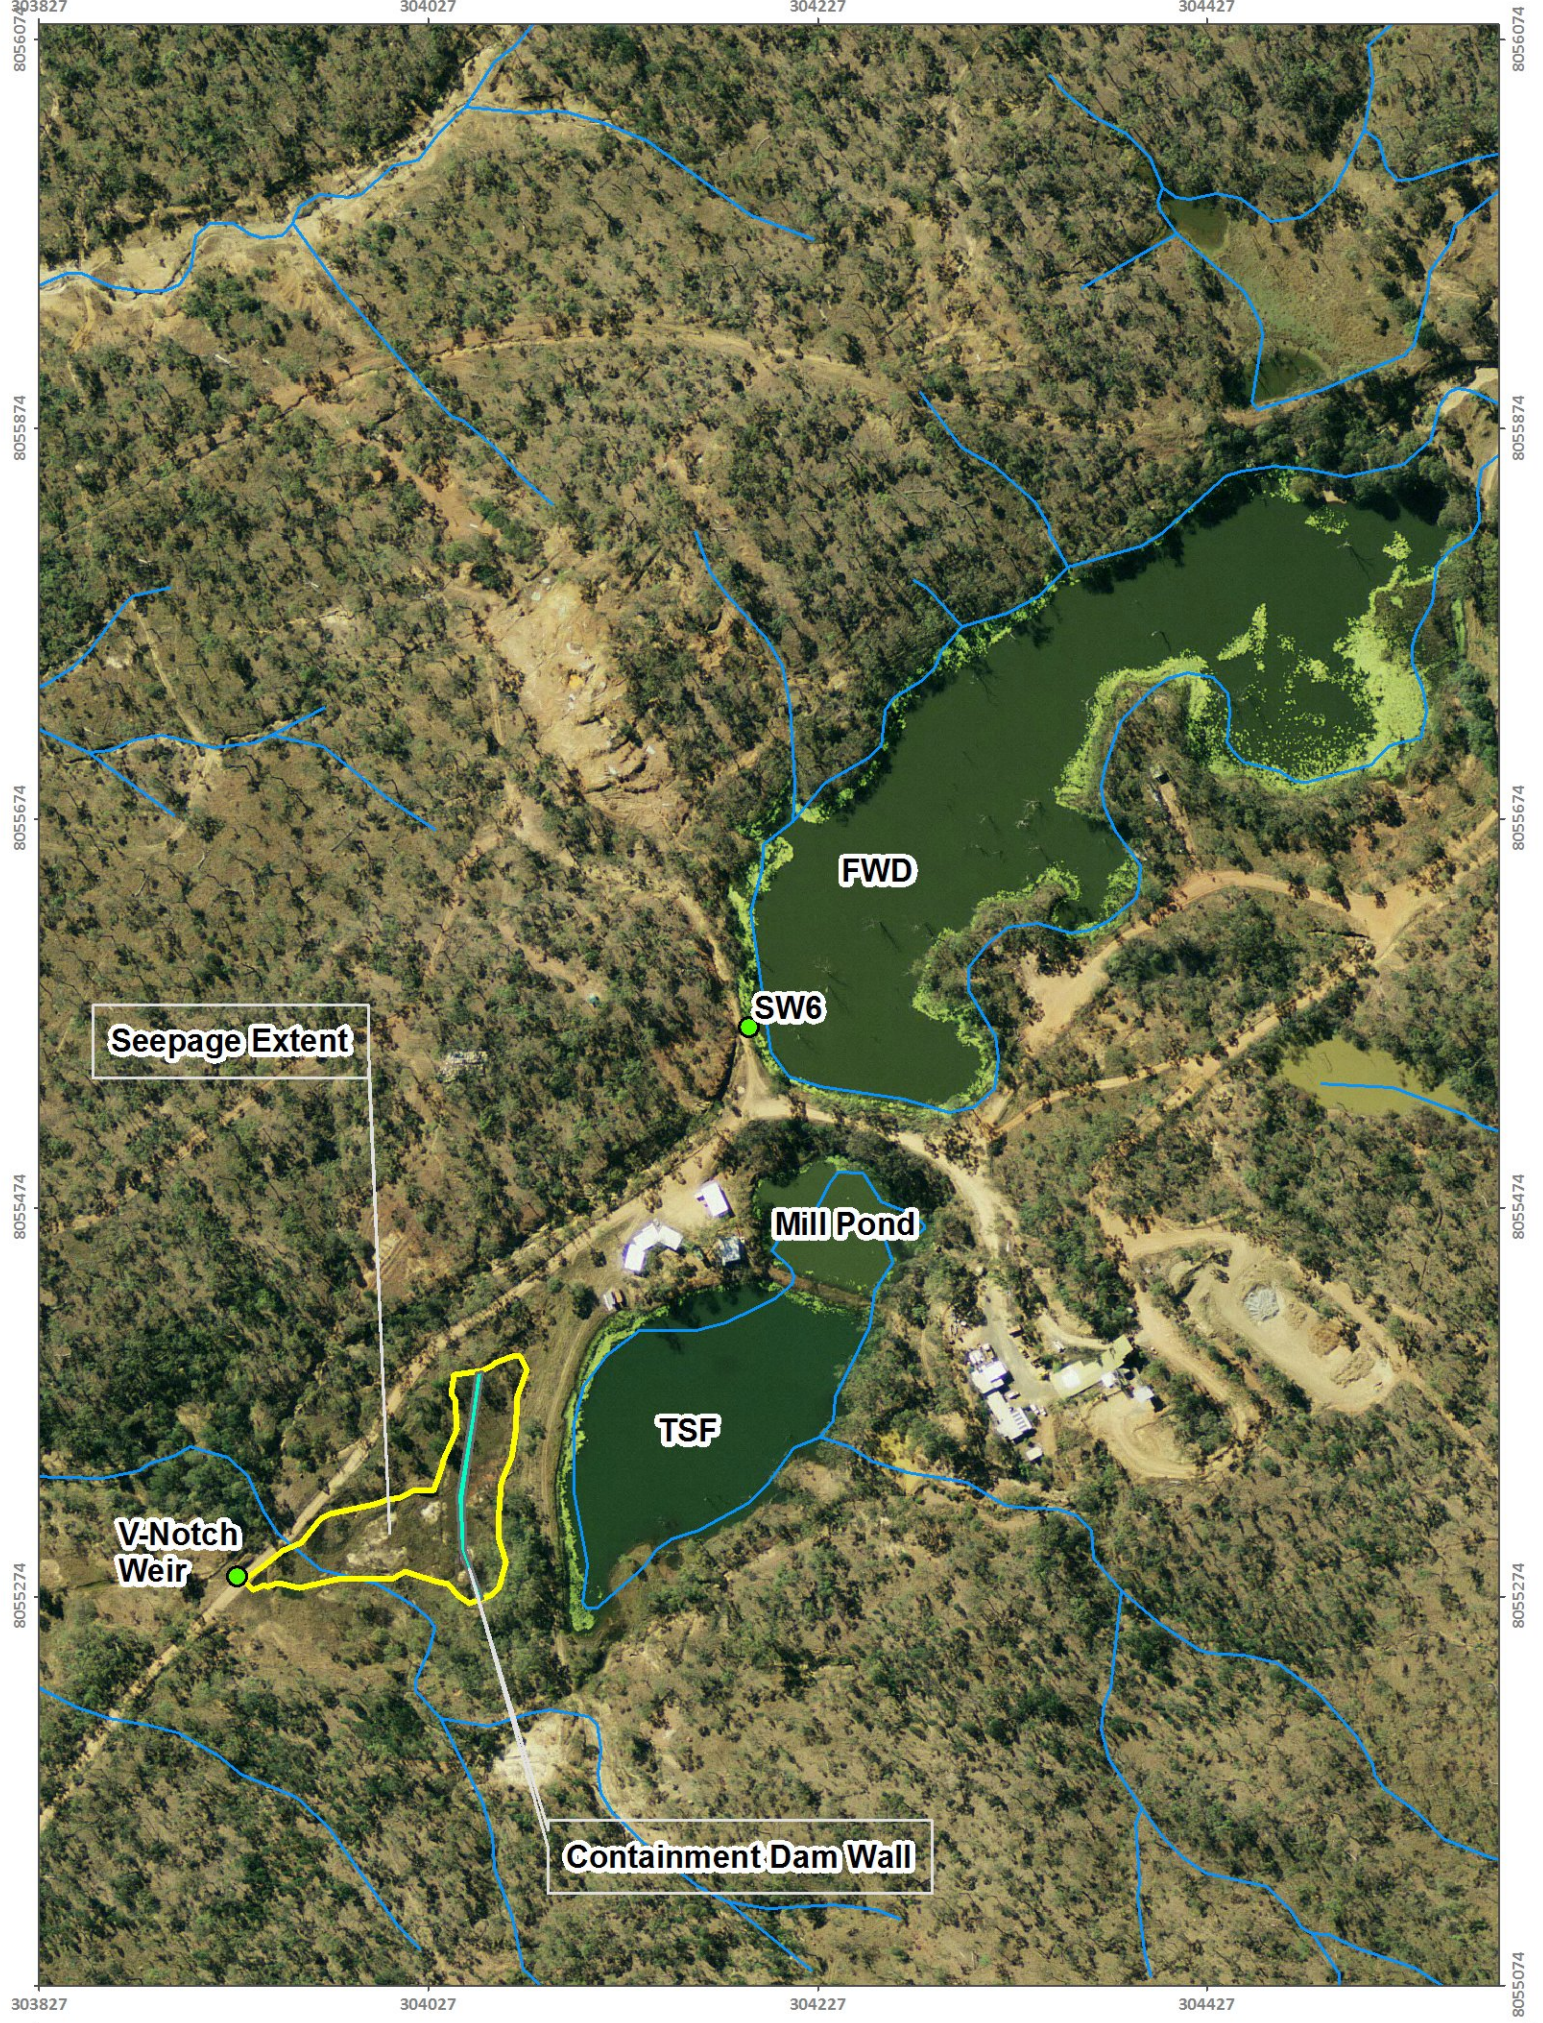
**Summer Hills ML20547 - TEP Locations**

Current  
location  
known as  
SP1
