# Torres Strait Island Regional Council

## Saibai Sewage Treatment Plant

### Part 1: Condition Assessment

Revision B

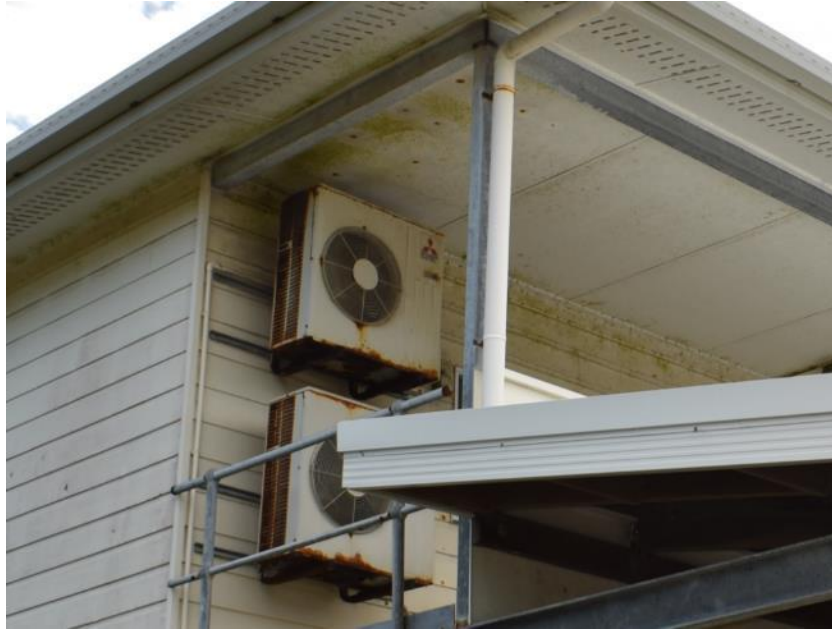
1. The outdoor air-conditioning units and associated supports and frames have corroded and will likely need to be replaced; and
2. Algal growth on the walls and roof.

Figure 4 – Corroded Air-conditioning units & algal growth on roof

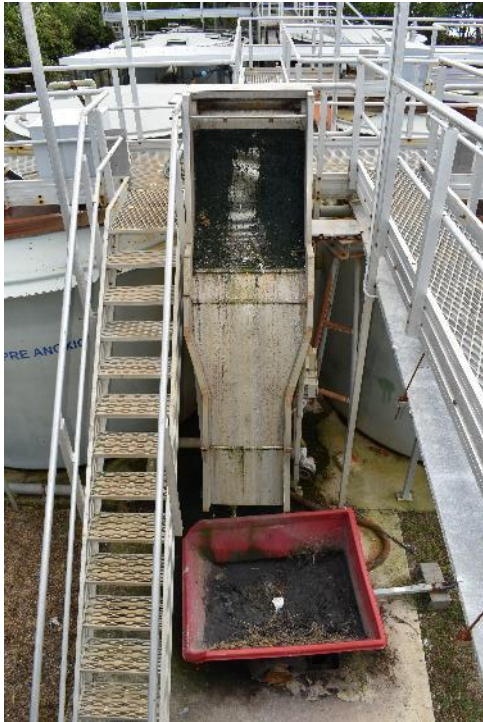
The Static Screen was installed in 2008, the condition of the static screen appeared to have deteriorated significantly since the last assessment (2016). The following issues were identified: -

1. Severe buildup of slime, grit, rags and other putrescible due to lack of maintenance e.g. sprays, cleaning etc. leading to regular overflow of the screen;
2. A section of the STP influent pipeline is in poor condition with severe corrosion on flanges, bolts etc. resulting in leaks and release of raw sewage onto the ground;
3. Leaks were observed on the back and underside of the screening unit due to corrosion around welds and connections;
4. Flowmeter was not in operation and bypass valve actuator was covered in slime/algae preventing the position indication from being read (access to control valves is poor);
5. Screenings collection trailer was damaged (wheels fallen off); and
6. Sump grate was missing.

Figure 5 - Static Screen and Screenings Collection Trailer

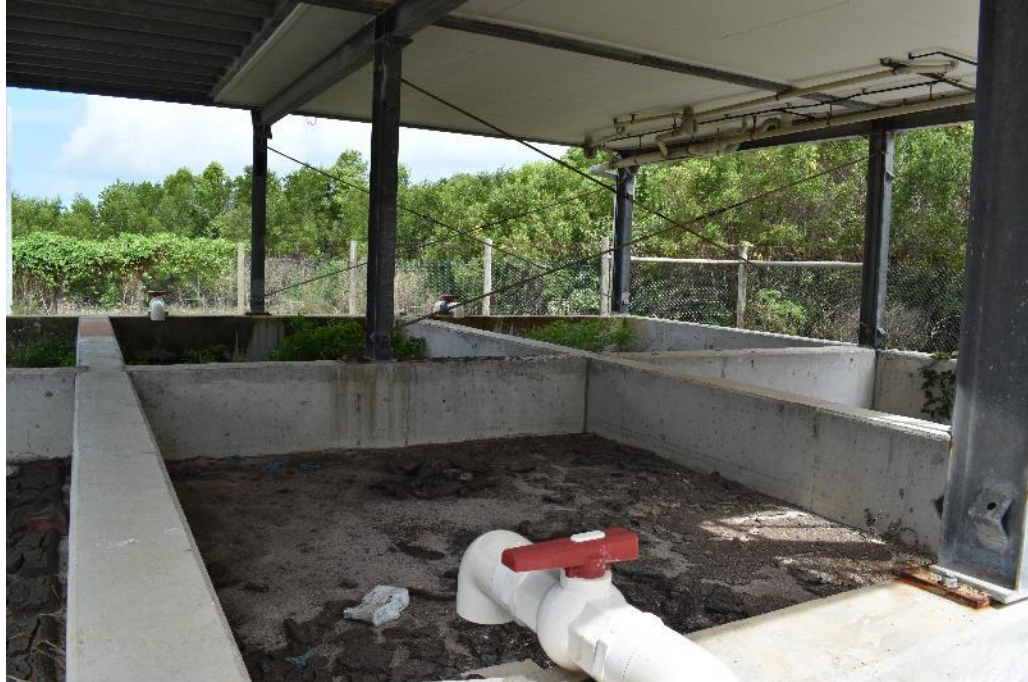
The drying beds and associated pipework and valves were upgraded in 2012 and are in good serviceable condition. Some minor cracking was observed on external the blockwork and some vegetation growth can be seen in the drying beds.

Figure 9 - Drying beds

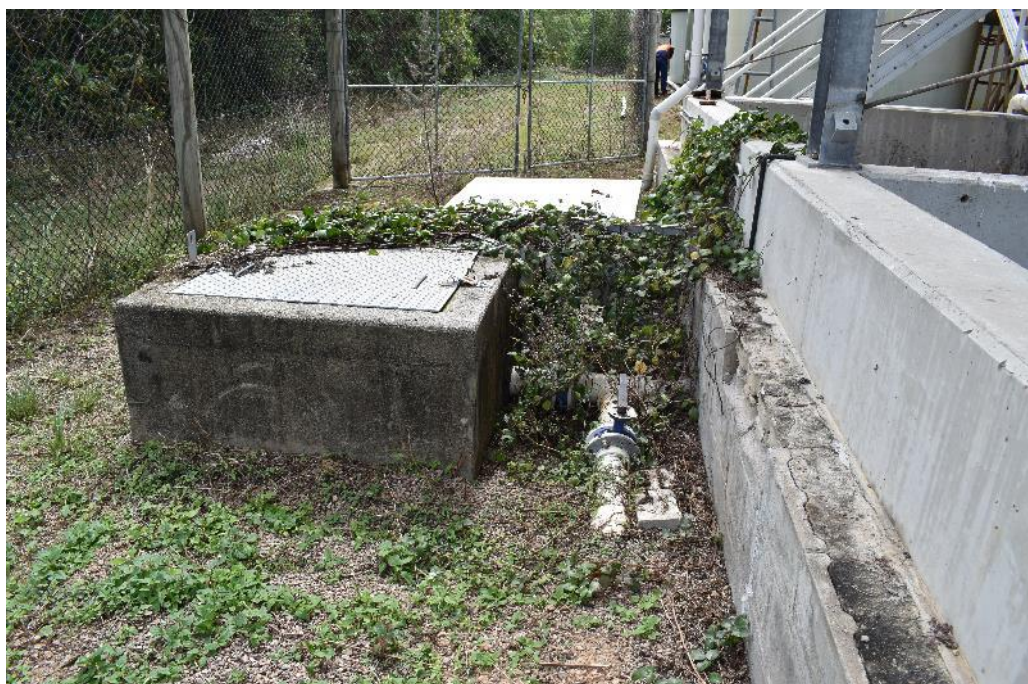
The supernatant pump station well was in good structural condition and some vegetation growth can be seen surrounding the pump station. The submersible supernatant pump was not operating during the site inspection and the level in the well was quite high, possibly indicating that the pump was not operational.

Figure 10 - Supernatant Pump Station

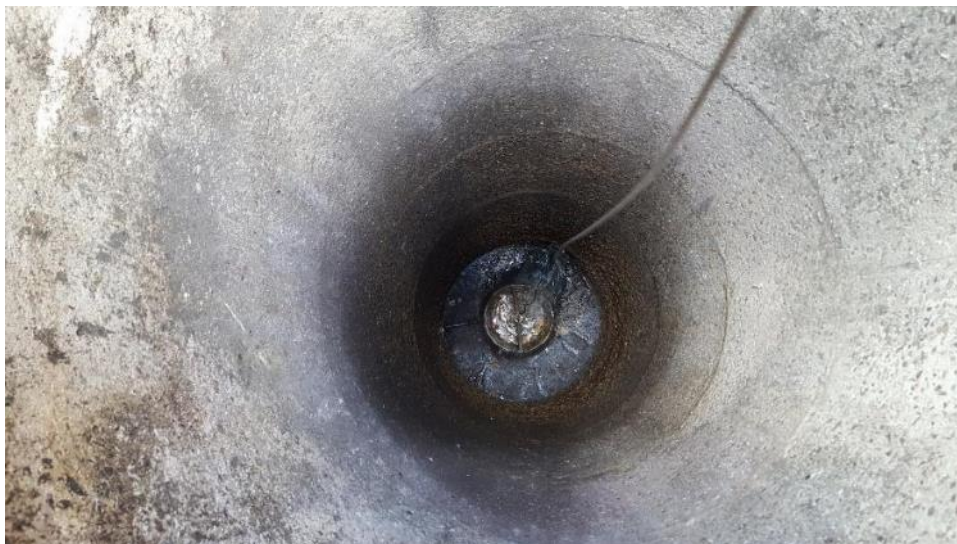
Figure 11 - SPS 1 Screening Manhole (Corrosion near invert)

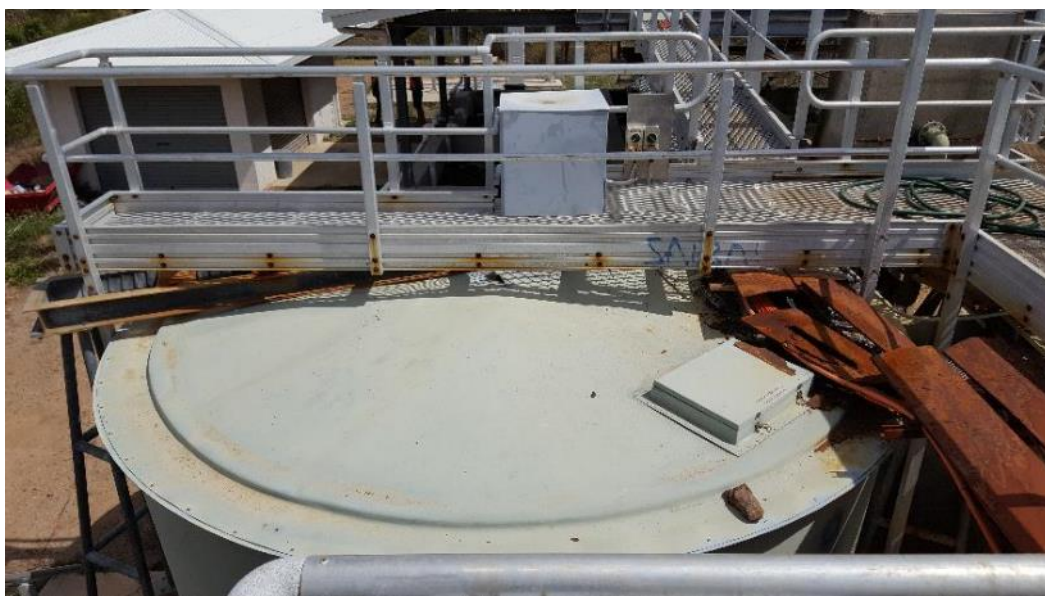
1. Some UV degradation was evident on all fiberglass tanks;
2. A number of patches exist at modified penetrations; and
3. Some tank roofs have collapsed in places.

Figure 16 – Anoxic 1 Tank, corroded cable cable trays, fasteners etc.

| Description | Year Installed/Upgraded | Asset Age (Year) | Typical Asset Life (Years) | Condition/Comments | Estimated Residual Life |
|---|---|---|---|---|---|
| Fibreglass Tanks (Biological Treatment Tanks inc. CCT) | 2001 | 16 | 25 | Average condition, UV degradation, A number of patches exist at modified penetrations. | 9 <sup>1</sup> |

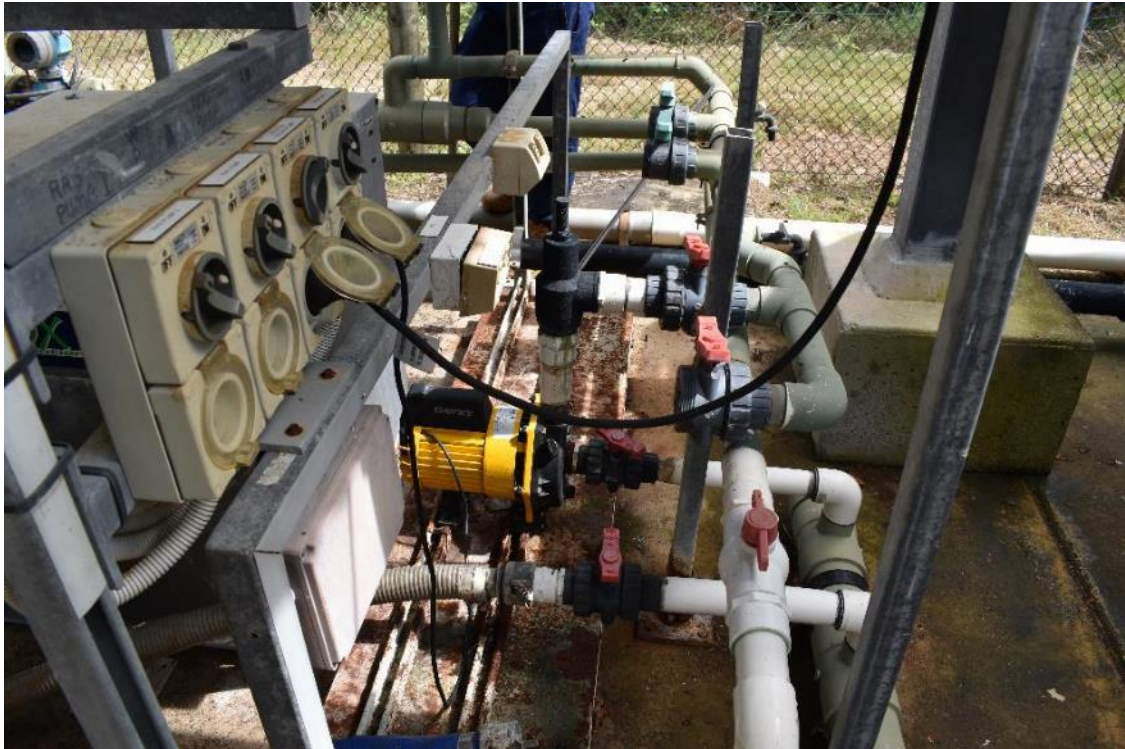
The RAS, WAS and Aerobic Return Pump Station was not operational during the site visit and, there was only a single pump installed (believed to be the RAS). The pump station is located central to the plant and access was poor. The

support frame is corroded and will require replacing in the future. It is noted that the WAS pipeline has become blocked as sludge has dried in the pipeline, this will need to be pigged, rodded or replaced to clear the blockage.

Figure 17 - RAS, WAS & Aerobic Return Pump Station

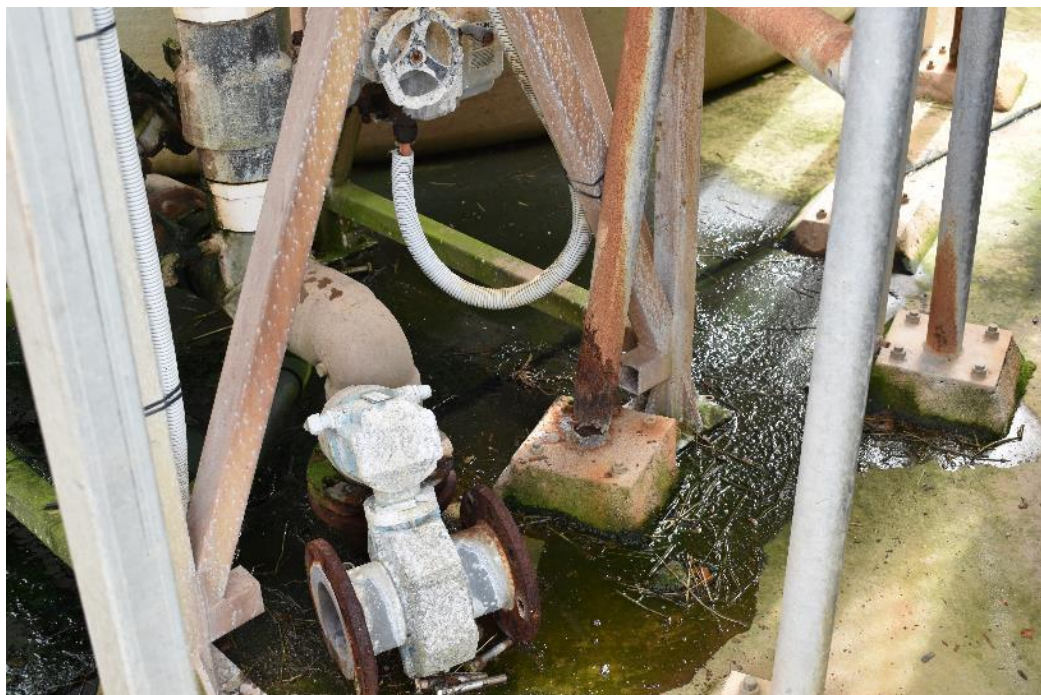
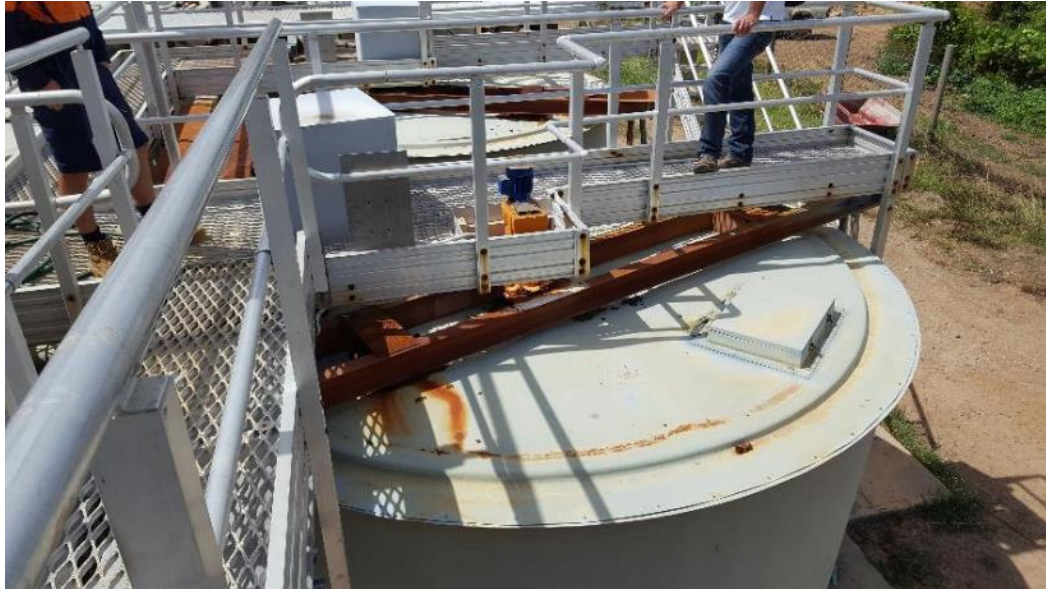
Only one of the anoxic mixers was in service during the site visit (there are 3 anoxic tanks), however, TSIRC confirmed all mixers are operational (power supply to the mixers may have been interrupted during the time of the visit). The mixers support frames are severely corroded and are not in a serviceable condition.

Figure 18 - Corroded mixer supports (typical)

Figure 19 – Corroded Mixer Supports (typical)

| Description | Year Installed/Upgraded | Asset Age (Year) | Typical Asset Life (Years) | Condition/Comments | Estimated Residual Life |
|---|---|---|---|---|---|
| Mixer Support Frames | 2008 | 9 | 20 | Mixer support frames severely corroded. Some support columns had broken. | 0 |

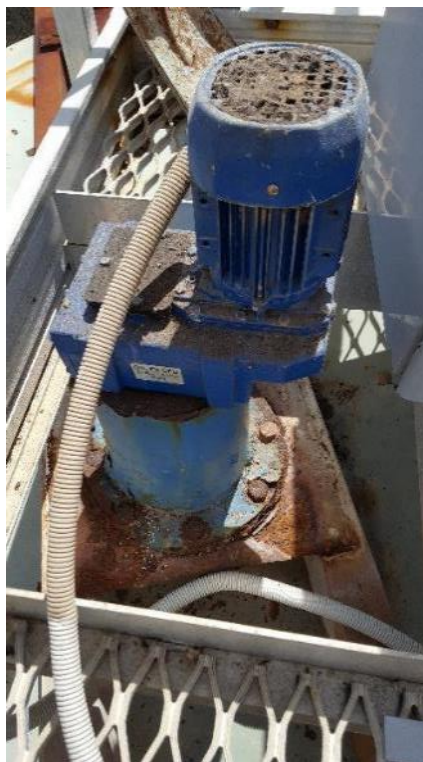
Figure 20 – Corroded Anoxic Tank Mixer (typical)

| Description | Year Installed/Upgraded | Asset Age (Year) | Typical Asset Life (Years) | Condition/Comments | Estimated Residual Life |
|---|---|---|---|---|---|
| Anoxic Tank Mixers | 2008 | 9 | 10 | Mixers corrosion, only one mixer operational at time of site visit. | 1 |

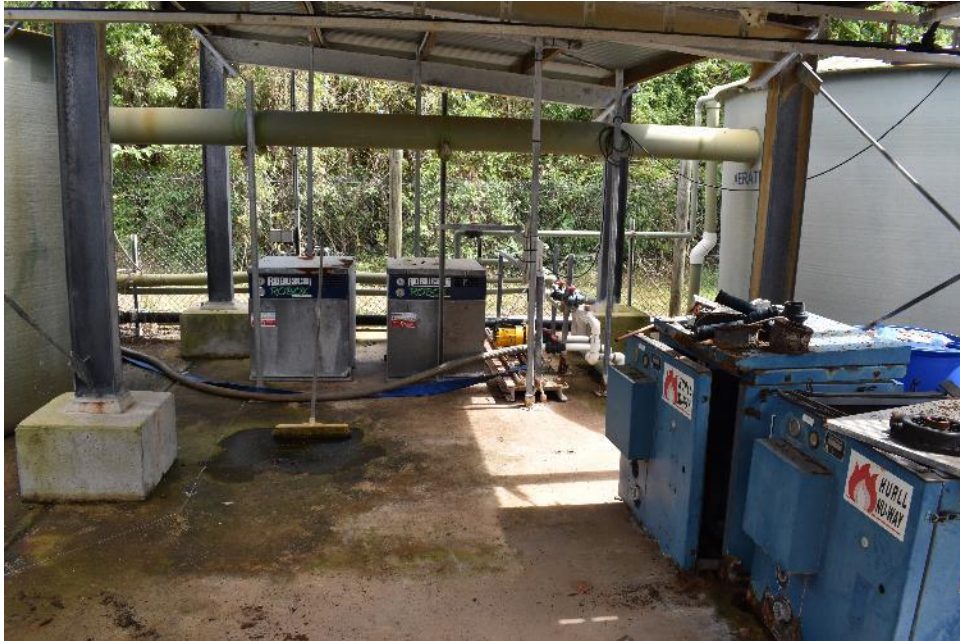
The blowers were not operational during the site visit, these are being replaced with Jet Aerators under a current minor STP improvements project. As the blowers have not been operational in some time, the submerged diffusers within the tanks will be filled with sludge and TSIRC advised that the diffusers have not been routinely replaced and would be approaching the end of their service life.

Figure 21 - Aeration blowers (straight ahead) and old blowers (right) had not been removed from site

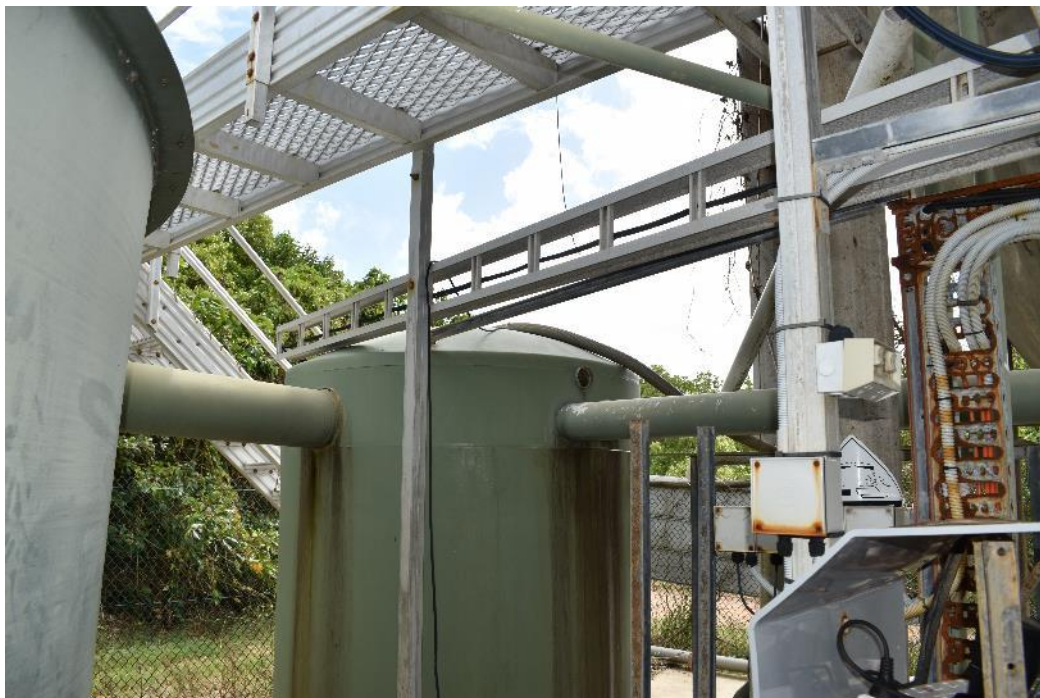
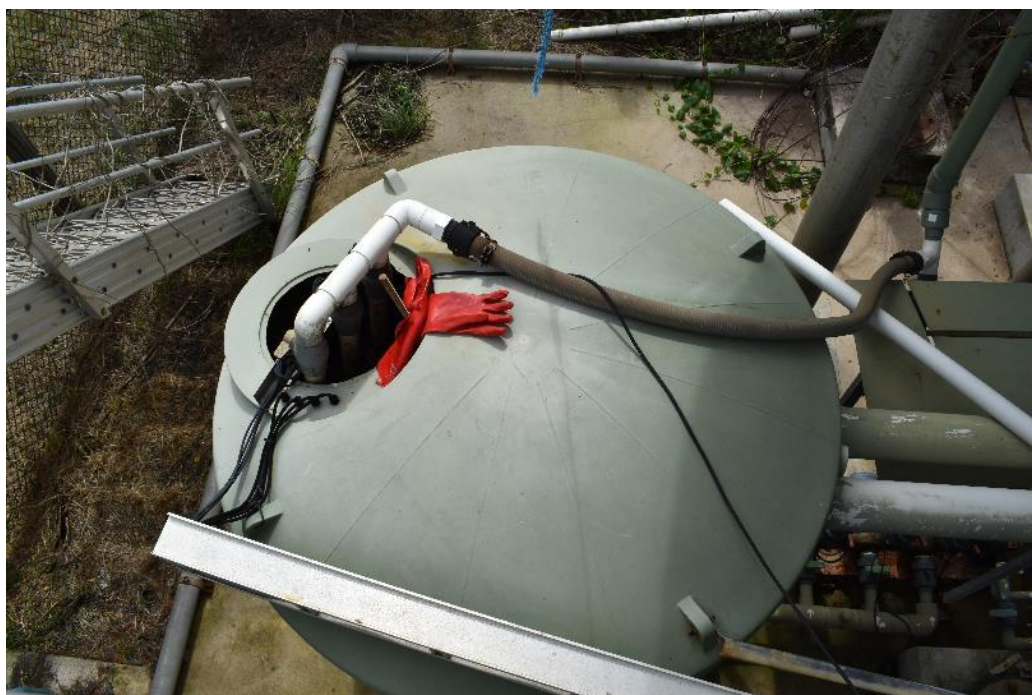
1. Staining can be seen around pipework penetrations indicating leaking;
2. The submersible Clarifier lift pumps were not operational therefore clarifier was being bypassed;
3. The old redundant dry mounted clarifier lift pumps and associated pipework was retained in situ and a flexible hose connection used to connect the new lift pumps into the discharge pipework (Figure 23); and
4. Access to the submersible pumps is poor, a ladder would be required to remove the pumps from the tank if required.

Figure 22 – Clarifier Lift Tank

Figure 23 - Clarifier Lift Pump Station (note: hose connection connecting into existing discharge, old lift pumps retained in situ, see bottom right of photo)

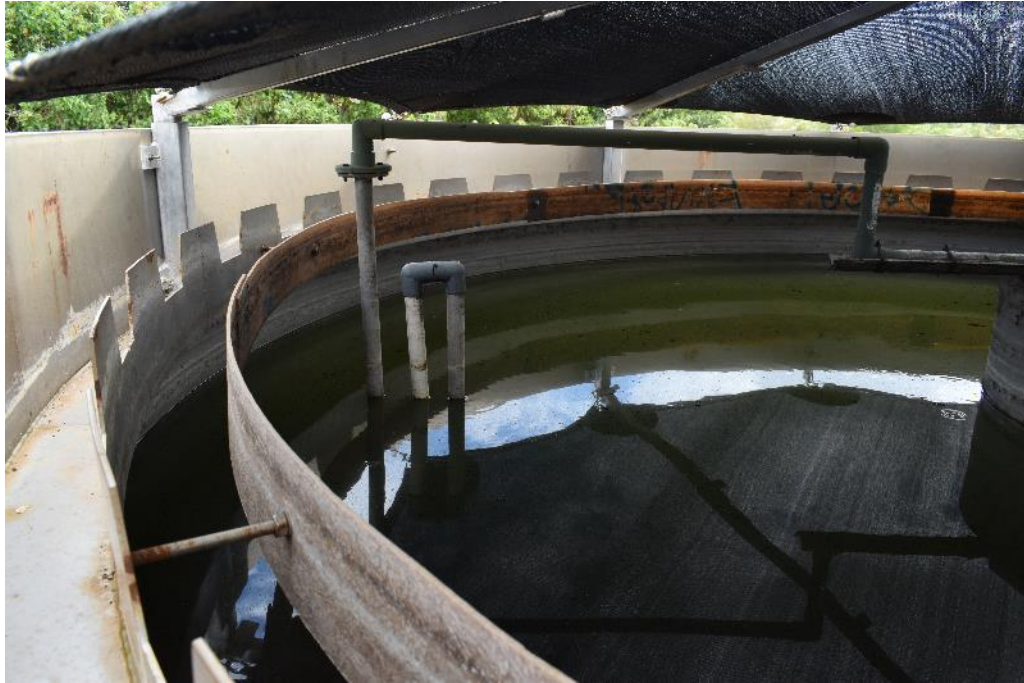
The Stainless-Steel clarifier was installed as part of the 2008 upgrade of the STP. It was evident that the clarifier had not been utilised for some time due to the failure of the Clarifier Lift Pump Station. The overall condition of the clarifier is good, issues identified include: -

Figure 24 – Clarifier with low level water level and stagnant water

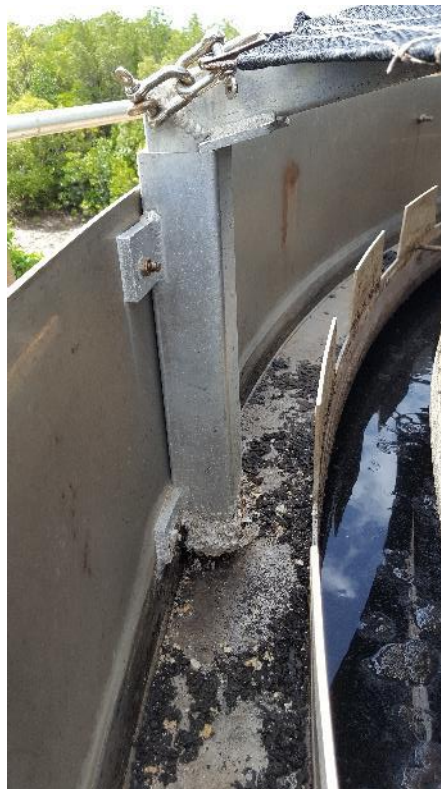
3. Supports for shade sale are corroding due to the lack of dissimilar metal isolation. Aluminum supports have been connected to the stainless-steel clarifier; and
4. Deflection plate for the clarifier sprinkler had fallen off.

Figure 25 - Corrosion of shade structure supports at connection to Clarifier

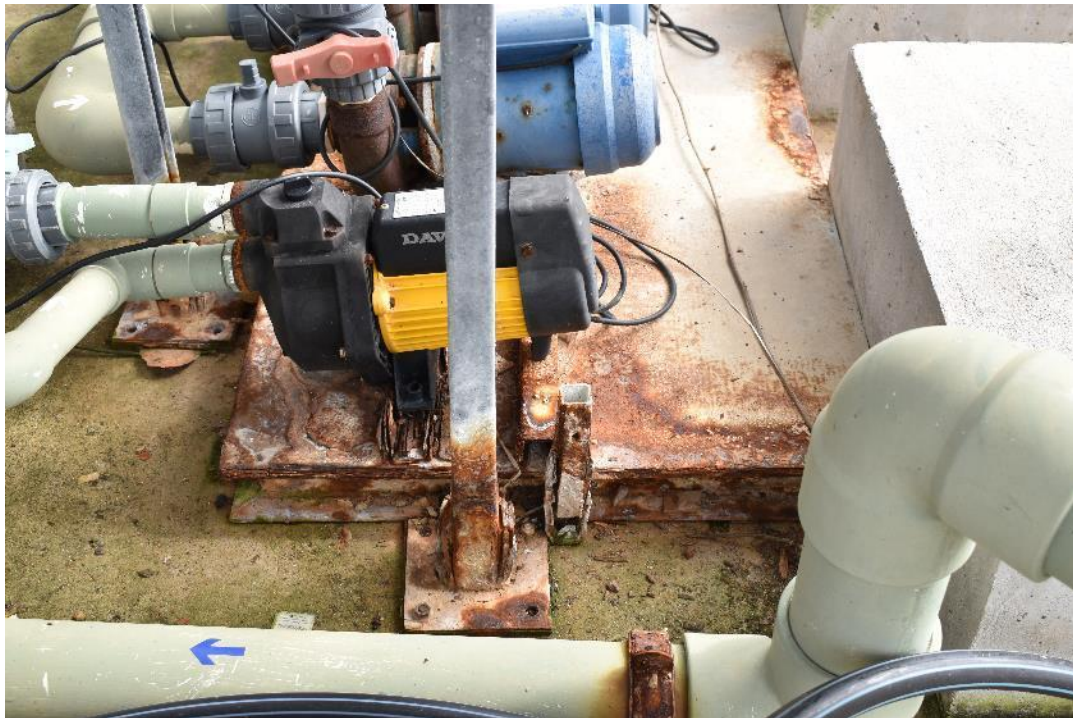
1. Clarifier sprinkler pump was not operational;
2. Sprinkler deflection plate had fallen off; and
3. Clarifier sprinkler pump draws un-clarified effluent from the clarifier, midway up the Clarifier. This is an OH&S risk as the water being used is not clarified therefore solids are being discharged by the way of a sprinkler. The water has not been disinfected and has the potential to cause harm to operators through exposure to, or ingestion of the spray mist.

Figure 26 - Clarifier Sprinkler Pump

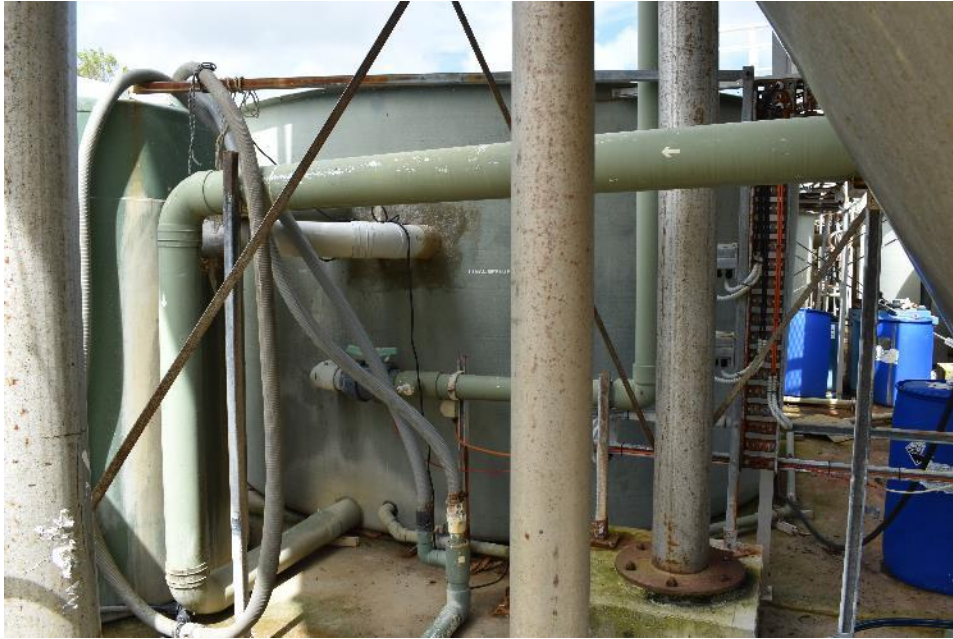
A number of patches have been installed around penetrations on the Chlorine Contact Tank. The integrity of the patch work is unknown, some leaks were evident around patches.

Figure 27 - Chlorine Contact Tank Penetrations

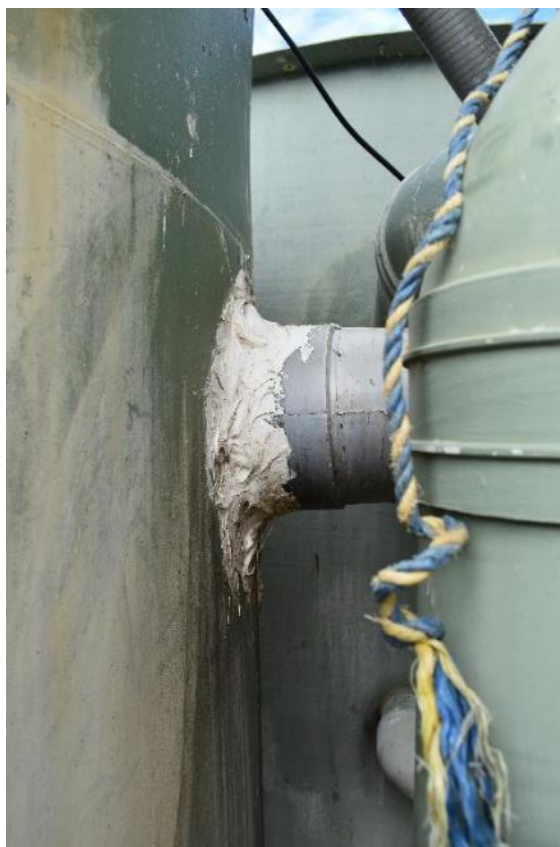
Some leaks were observed on the Final effluent tank, particularly on the incoming line into the tank. See image below.

Figure 28 – Connection into Final Effluent Tank

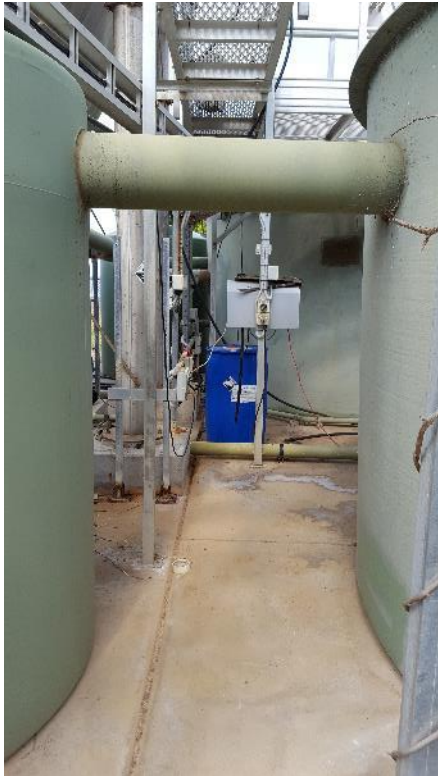
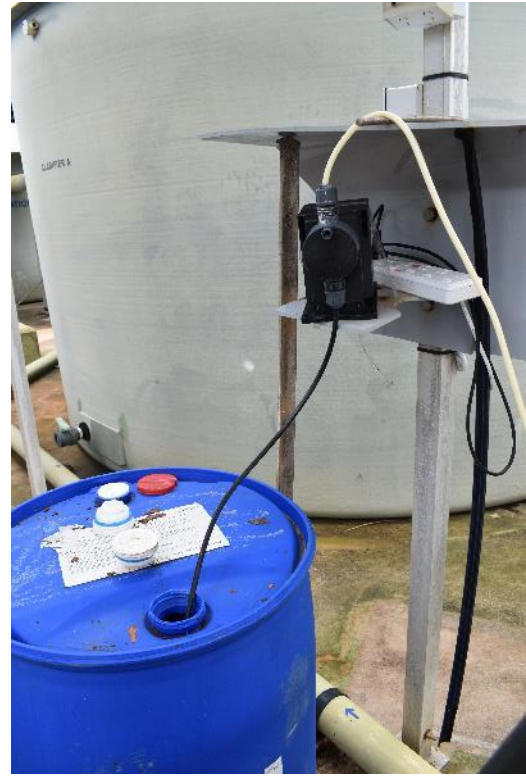
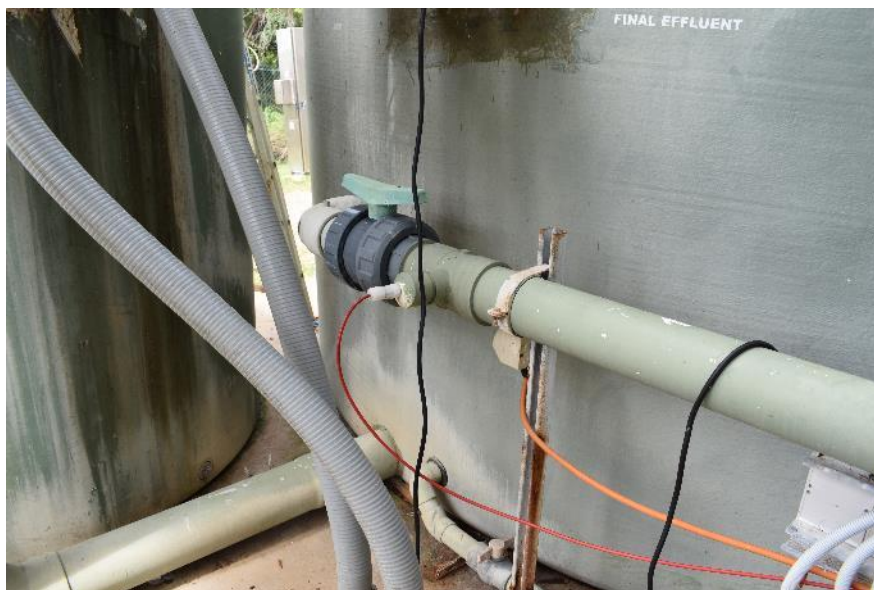
The Sodium Hypochlorite Dosing system does not comply with AS 3780-2008 – The Storage and Handling of Corrosive Substances. A number of OH&S issues have been identified including: -

1. Access to the Sodium Hypochlorite dosing system is poor, operators are required to manually handle the 200L drums;
2. The dosing pump is not properly supported and the support frame has been broken. A steel pole has been placed to support the protection cover;
3. The safety shower is located on the other side of the plant and not within the required distance, and the path from the chlorine dosing system to the safety shower is heavily obstructed; and
4. There is no dedicated bunding or storage for the dosing system.

Figure 29 - Sodium Hypochlorite Dosing System

Figure 30 - Sodium Hypochlorite Dosing System

Figure 31- Sodium Hypochlorite dosing point

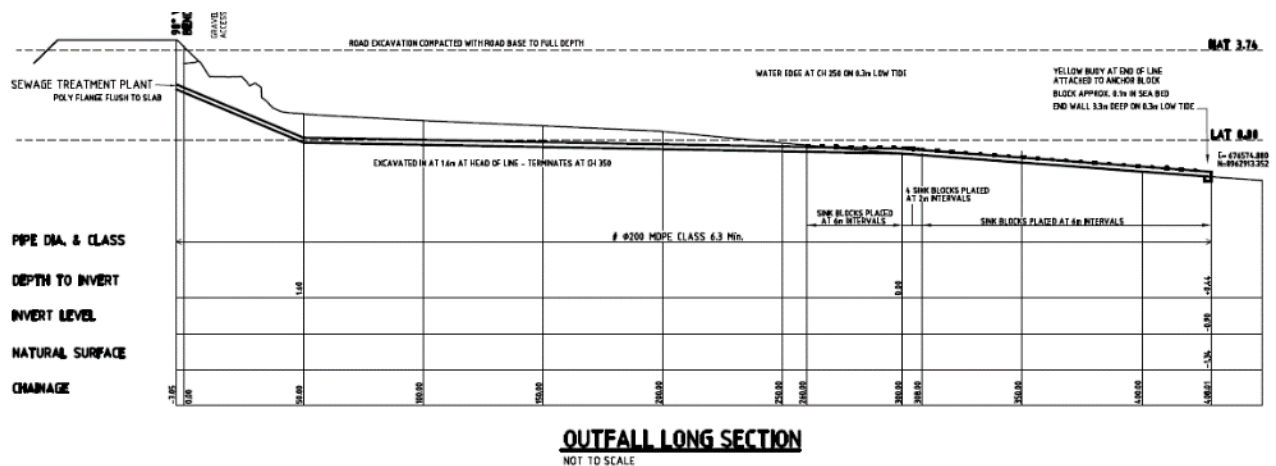
From investigations and the as-constructed drawing of the pipeline (dated 2001), the outfall pipeline has been trenched from chainage 0 to chainage 260 where it breaches (Note: this is from 2001, as this is located around the low tide level, it is likely the surface has changed). Ganden assumes that the pipeline was blocked and has been cutoff between chainage 250 and 400.

Figure 32 - Outfall Pipeline Long Section (From drawing 90014-15 dated 16/08/2001)

As the pipeline has been cut, it has been flagged as a breach of the STP environmental license. TSIRC are required to replace the cut section or replace the entire outfall pipeline. The condition of the existing pipeline is unknown.

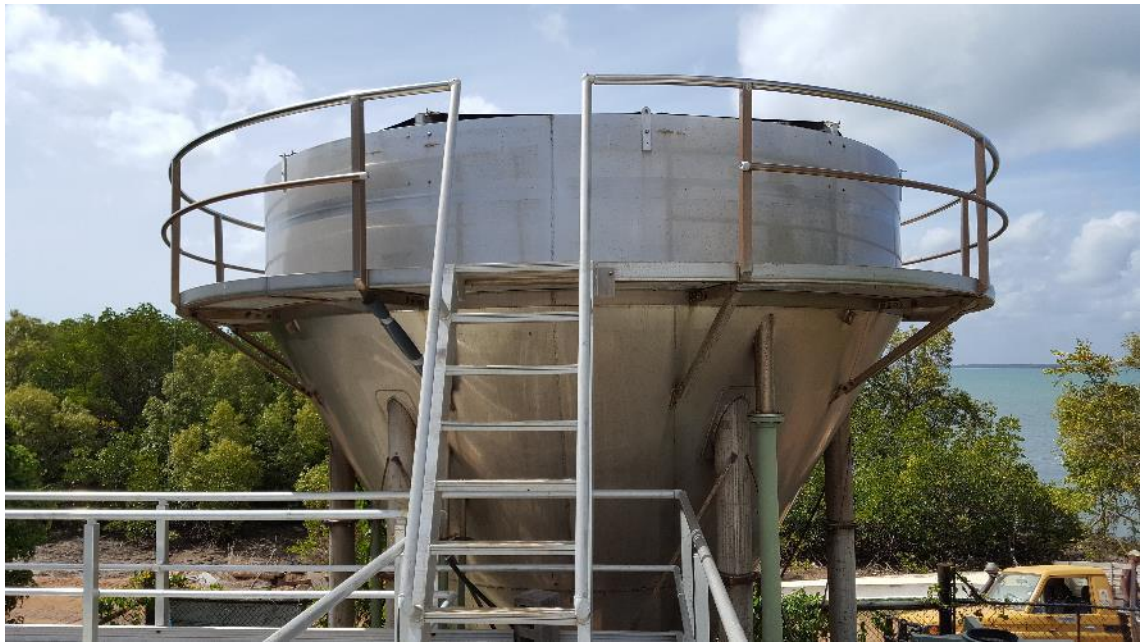
2. Some of the stairs, ladders, walkways and platforms were unstable and do not comply with AS1657-2013 – Fixed Platforms, Walkways, Stairways and Ladders.
3. Structural bolts had corroded (potentially a partial cause of the stability issues); and

Figure 33 – Clarifier (missing handrailing)

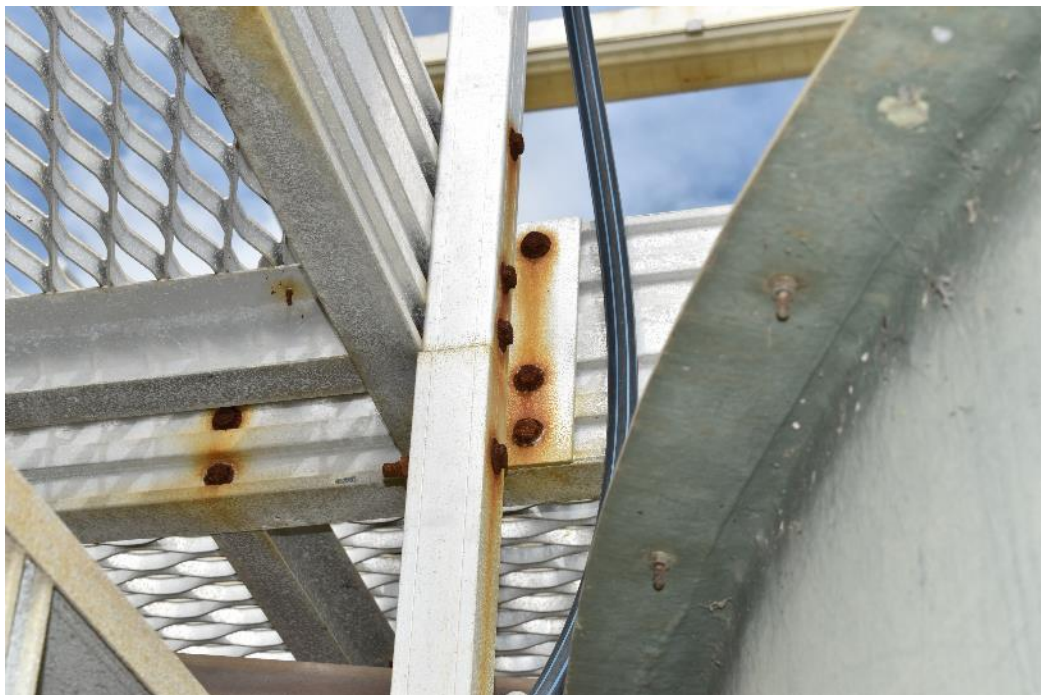
Figure 34 - Corroded Structural Bolts on Platforms

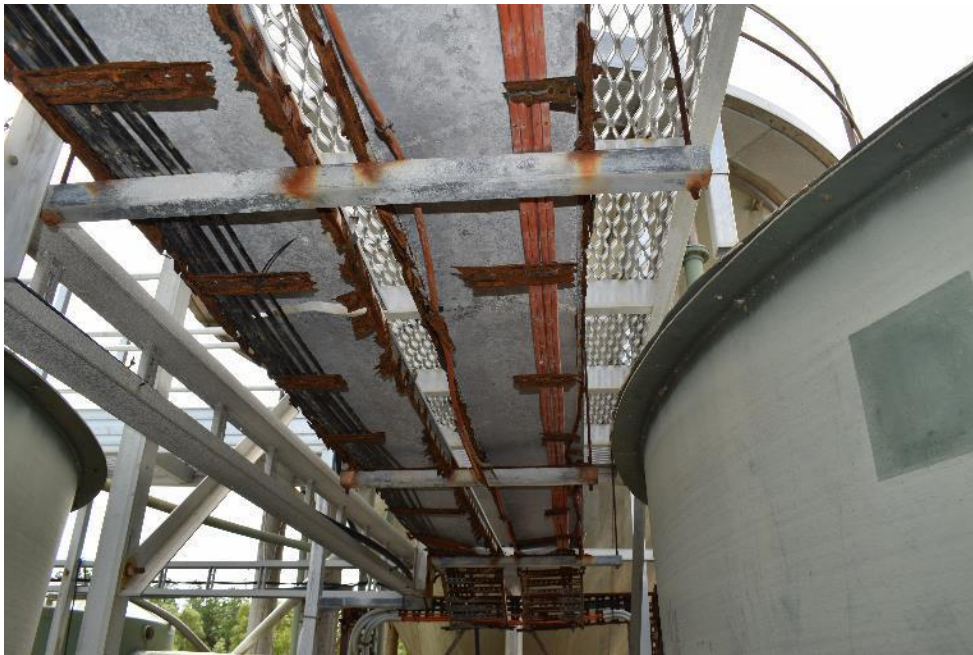
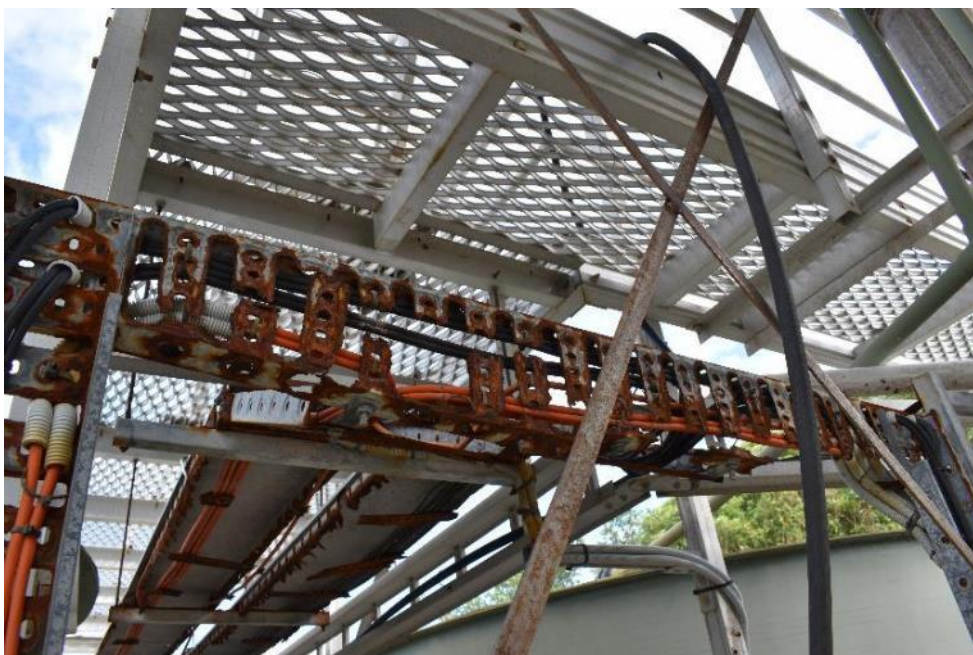
1. All cable trays have suffered from severe corrosion and were falling to pieces. Pieces of the corroded cable trays were witnessed breaking off when the above platforms vibrated. This is an OH&S risk and at any stage under windy conditions (which are common on the island), the corroded cable trays could potentially pierce live electrical cables.
2. Two flowmeters were installed onsite, one on the influent (at the inlet works) and one on the RAS pipeline. Neither flowmeter was operational at the time of the site visit, however, TSIRC have advised that the influent flowmeter is now operational.
  - a. RAS flowmeter – Evidence of surface corrosion and was not operational;
3. Float switches were in poor condition and not operational; and
4. Power points, cables and other electrical fittings were in poor condition.

Figure 35 - Severely Corroded Cable Trays

Figure 36 - Corroded Cable Trays

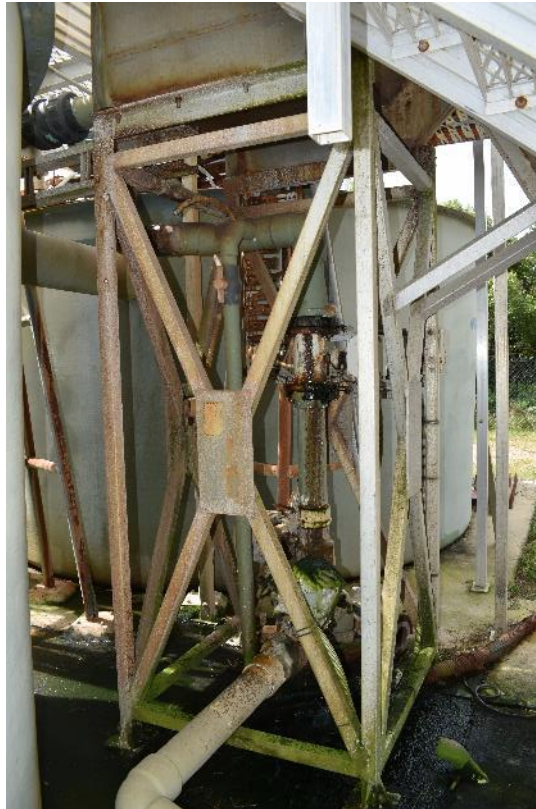
Figure 37 - Influent Flowmeter

| Description | Year Installed/Upgraded | Asset Age (Year) | Typical Asset Life (Years) | Condition/Comments | Estimated Residual Life |
|---|---|---|---|---|---|
| Influent Flow Meter <sup>2</sup> | - | - | 10 | Flanged on connecting pipework corroded. Operational | 10 |

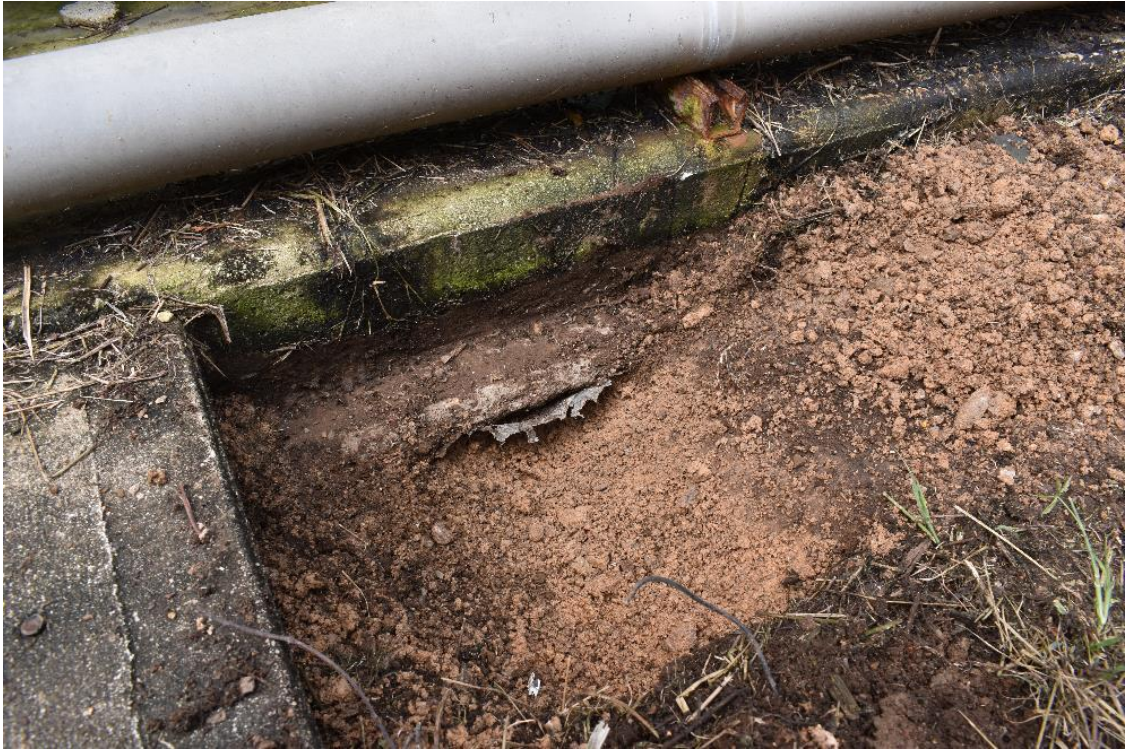
A visual inspection of the concrete slab was undertaken and the slab appeared to be in serviceable condition with minimal damage or corrosion. Excavation adjacent to the slab at one location revealed that is 150mm thick.

Figure 38 - STP Concrete Slab
