# ***Environmental Evaluation Report: March 2016***

for  
**Incitec Pivot Limited**  
***trading as Southern Cross Fertilisers***

## ENVIRONMENTAL REPORT

SITE INSPECTIONS: 8-9 July 2015,  
16 March 2016

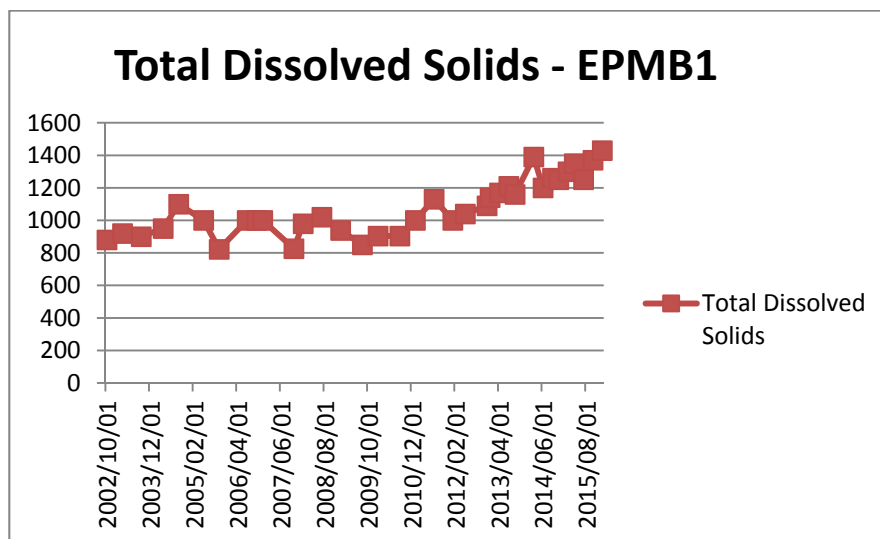
Results attained over the past 5 years reveal no discernible impact trend for chemical contamination within groundwater other than a change in salt concentrations within two bores: Bore GSMB15A, south-east of evaporation pond Cell 3B and Bore EPMB01, east of Cell 1&2. Prominent ions contributing to an increasing TDS trend since 2009 are: calcium, sodium & chloride. An upwards trend appears to have commenced during the year 2009.

Figure E4: TDS (mg/L) trend in Bore EPMB01 (east of Cells 1&2)

Bores EPMB01 and GSMB15A are down hydraulic gradient from Cells 3B and Cells1&2 and are well positioned to evidence impact should GSF water escape the membrane liner and ultimately enter groundwater. Of note is bore GSMB09 which is also down hydraulic gradient of Cell 1&2 but as of yet reveals no discernible impact trend. Should impact be occurring from the GSF, it does not appear to be widespread.

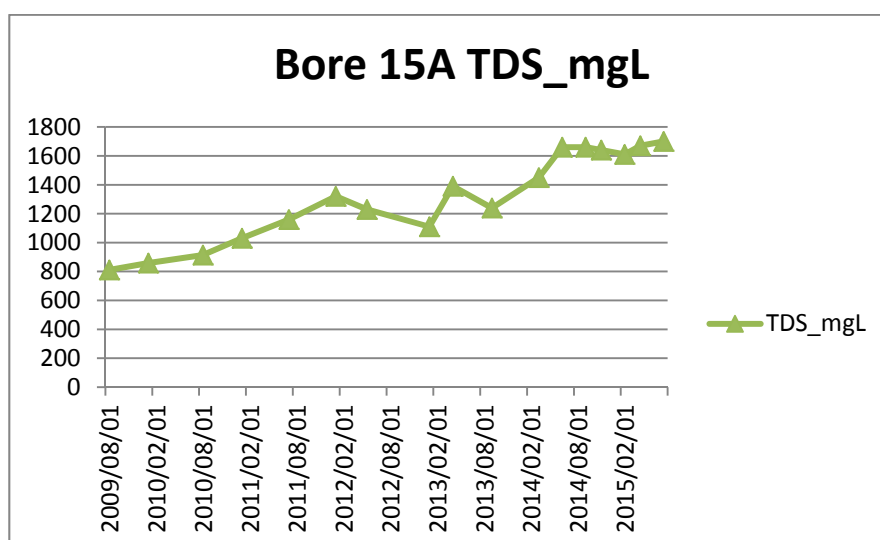
Figure E5: TDS (mg/L) trend in Bore GSMB15A (south-east of Cell 3B)

Increasing trends were noted for TDS concentrations (predominantly a result of increasing calcium, sodium and chloride ions) in bores EPMB1 and GSMB15A (to the south east of cell 3B) and therefore what is likely to be down hydraulic gradient of the cell 1&2 and pond 3B). No other indicators of contamination were noted. Chemical analysis surrounding the GSF has identified no definitive impact above the groundwater's environment value of stock drinking water.

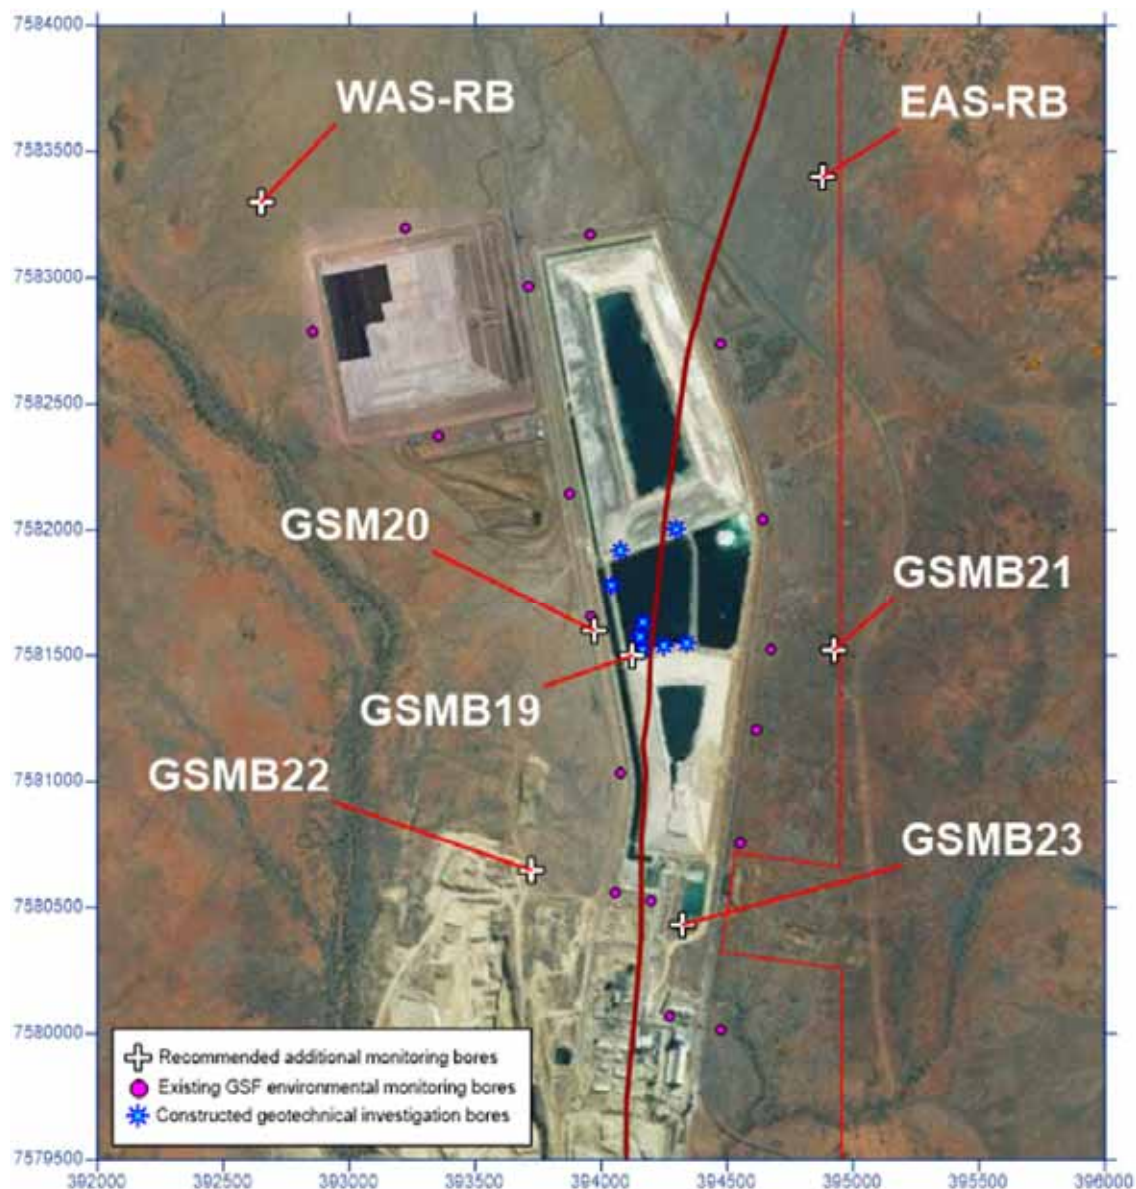
Figure E6 Indicative locations of additional monitoring bores

- Construction of a new bore to the west (GSMB20) adjacent GSMB04 and screen across the upper 5m of the water table so that samples representative of the chemistry of groundwater (bore GSMB04 is over 18m below the water table) are obtained for assessing possible GSF impact.
- Installation of a new bore to east of GSMB15A (e.g. Bore GSMB21) in order to assess water chemistry and obtain hydraulic detail to ascertain whether leakage mounding is occurring, quantify major cation and anion concentrations and use in future base modelling considerations.

- Construction of a new bore (GSMB22) to the southwest of the GSF (between the GSF and the Galah Pit). Flow system analysis indicates that pit dewatering and evaporation of groundwater exposed in deeper parts of the pits and/or just below the pit floor could cause flow towards the pits. Monitoring near the pit would enable more accurate mapping of the water table and movement of potentially contaminated groundwater during both mining and post mining phases.

- Installation of 3x additional bores to the south-west of Cell 3A to permit further evaluation of whether a perched groundwater table exists in this area or whether saturated conditions are sourced from cell and/or localized surge drain leakage.

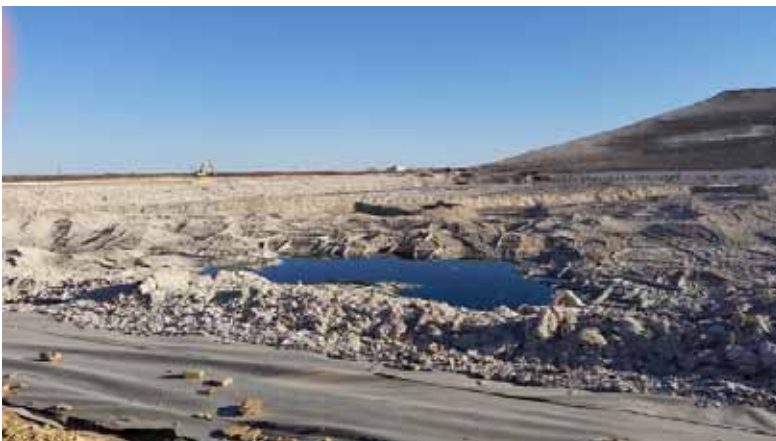
**Image 4: Pond 3A dewatered in preparation for geotechnical investigation**

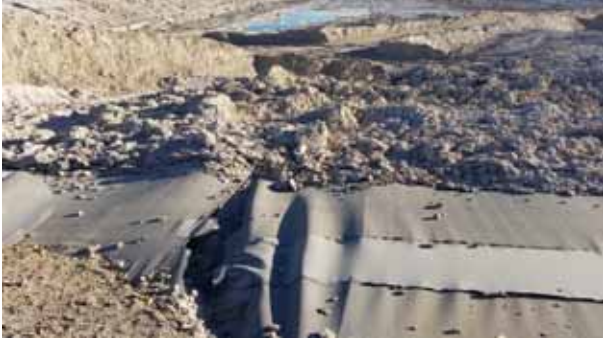
Considerable disruption to the flatness of the liner was noted across the south-east aspect of pond 3A (refer image 6). An investigation program involving soil drilling, and the establishment of a groundwater monitoring bore within the upper horizon to confirm or otherwise the existence of a perched groundwater was initiated. The results of this investigation [AECOM 2016a&b], reveal

variable perch acidic water at various depths both at the north and south ends of the cell, but interesting not to the west between Cell 3A and the surge ditch. This suggests the acid water is variable, localized and possibly sourced from seepage through the Cell 3A liner when it was damaged. Further investigation into the variance in perch water presence is proposed.

Image 6: Liner impairment

Routine integrity inspections of the liner have previously identified tears around the extremities, including on the elevated areas of the outer ditch (refer Image 6). Repairs have been initiated when structural deficiencies have been identified. Deficiencies are noted in daily checks as exemption reporting only. If, during inspections, impairment is not observed, no records are registered.

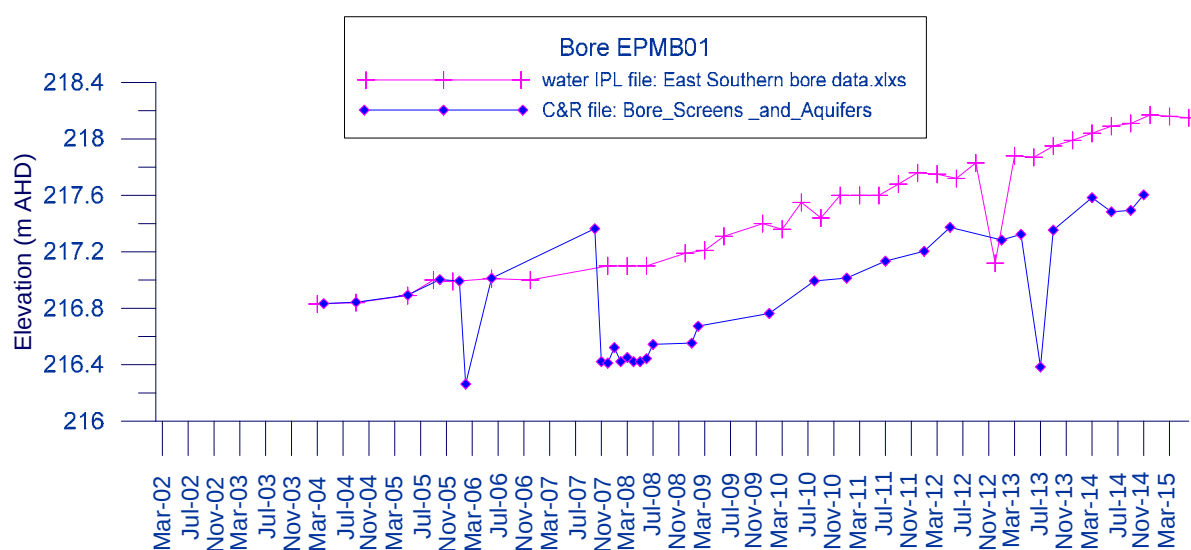
Additionally hydrograph information on file reveals some discrepancies (e.g. refer Figure 12) that require consolidation to facilitate the accuracy of future predictive modelling.

FIGURE 12. Hydrographs for Bore EPMB01 Compiled From Different Datasets

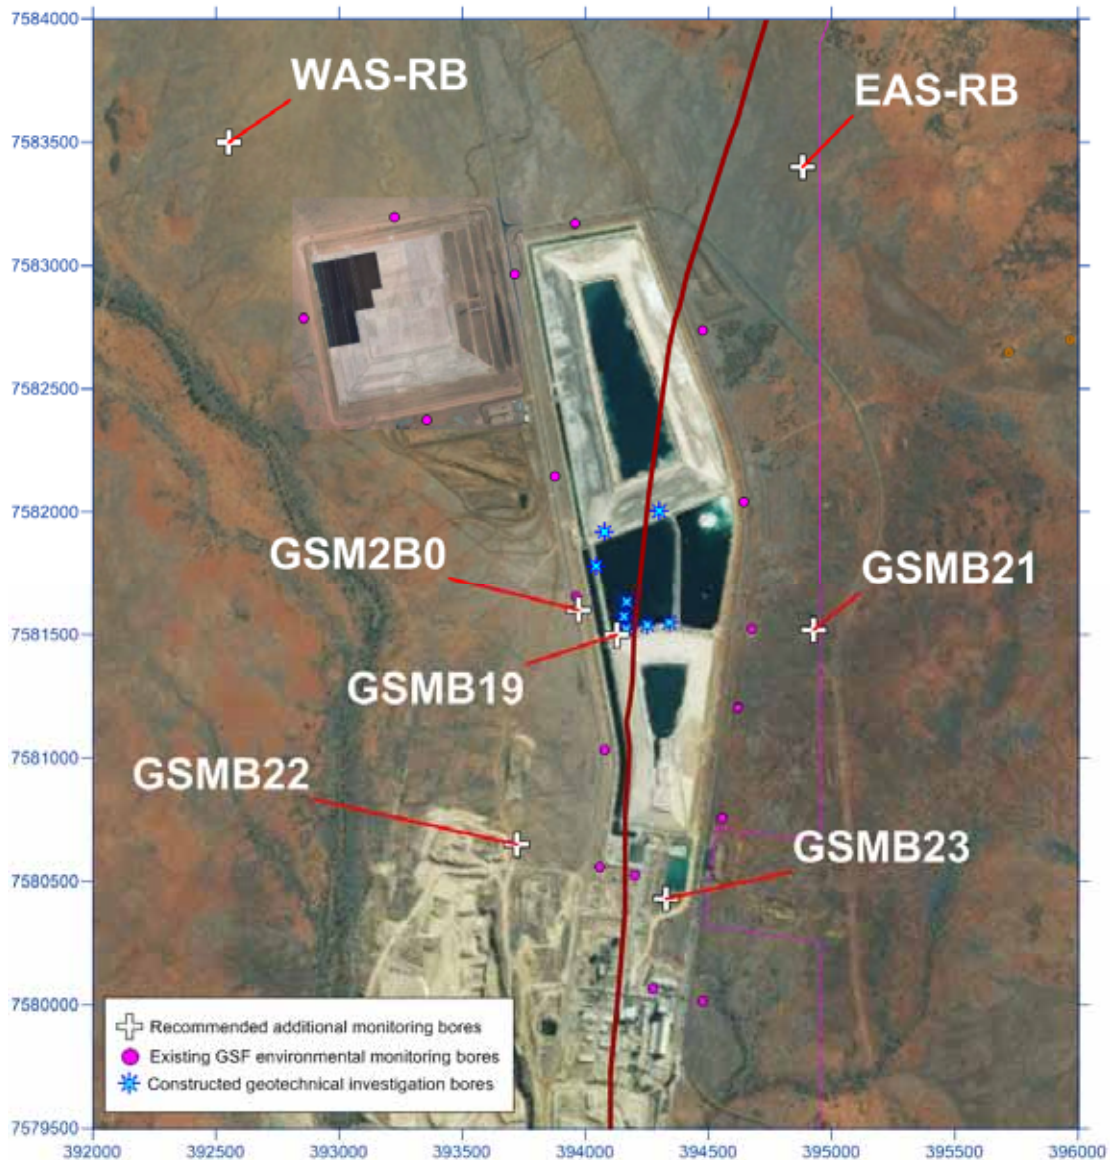
**Figure 14. Indicative locations of new monitoring bores**

Based on our conceptual hydrogeological model and data gap analysis, five(5) new bores are necessary in order to monitor the potential for impact from the GSF on local groundwater and for use in hydrogeological risk assessment. We also support that two new reference bores be established. Tentative locations of the seven(7) new monitoring bores are plotted in Figure 14. The background, objective, site location and constraints are summarized in Appendix 6.

Additional bores south of cell 3A to better gauge the extent of any perch water table, and a trial ‘tangential’ bore to the east of cell 3B, will also be required for risk assessment purposes.
