DWI/ae (G1453.Rosewood)  
4 March 2009

New Hope Coal Australia Pty Ltd  
17 Lowry Street  
IPSWICH QLD 4305

## **RE: NEW OAKLEIGH MINE – NORTH PIT SEEPAGE, TASK 1 DATA REVIEW**

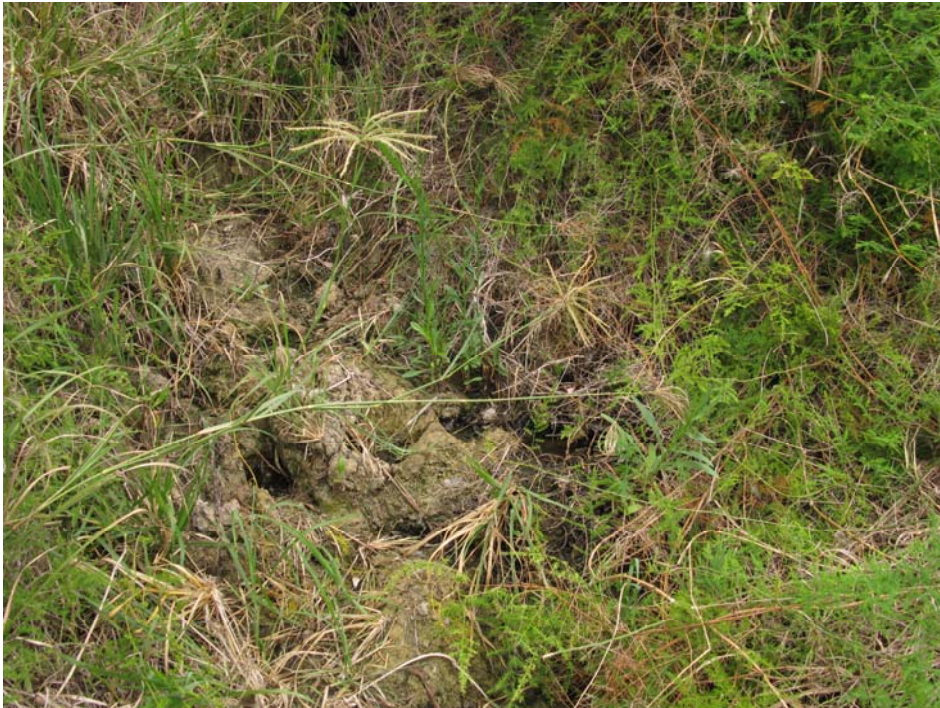
Some rehabilitation of the tailing was completed between 6 to 12 months ago and included partial capping of the desiccated western portion of the tailings area. Around the same time these works were completed, a third seepage breakout was observed within the eastern gully near its confluence with the western gully. All seepage breakout areas are defined by dieback of the grass cover and white dessication salt crystals on the ground surface (refer Figures 1 to 3)

**Figure 1: First seepage area in gully embankment in southern portion of Lot 2; note slight vegetation dieback and white desiccation crystals**

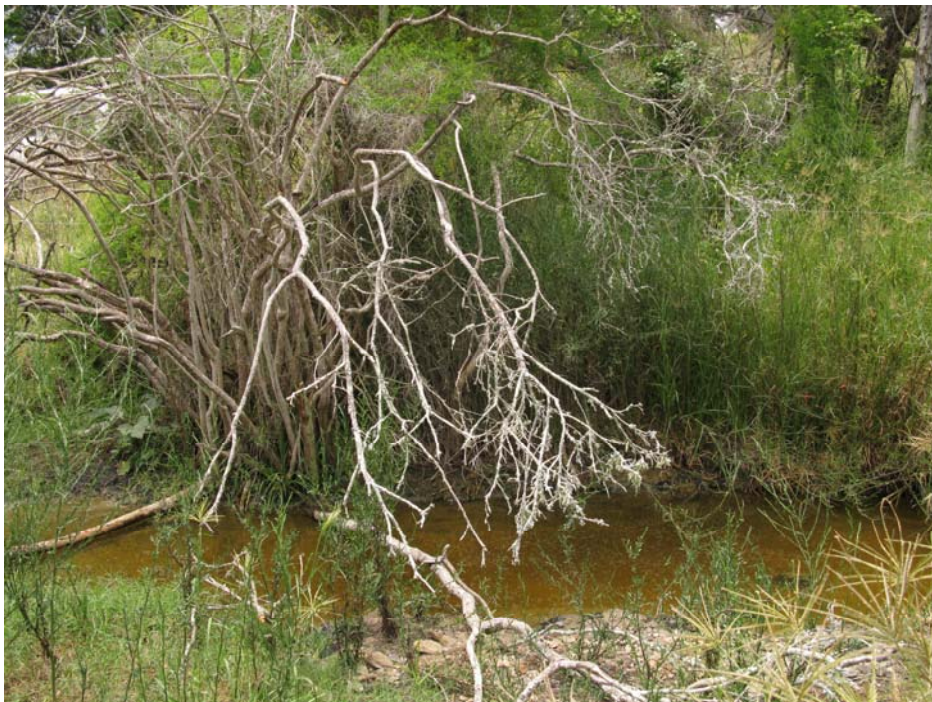
**Figure 2: Second seepage area in Lot 526; note vegetation dieback**

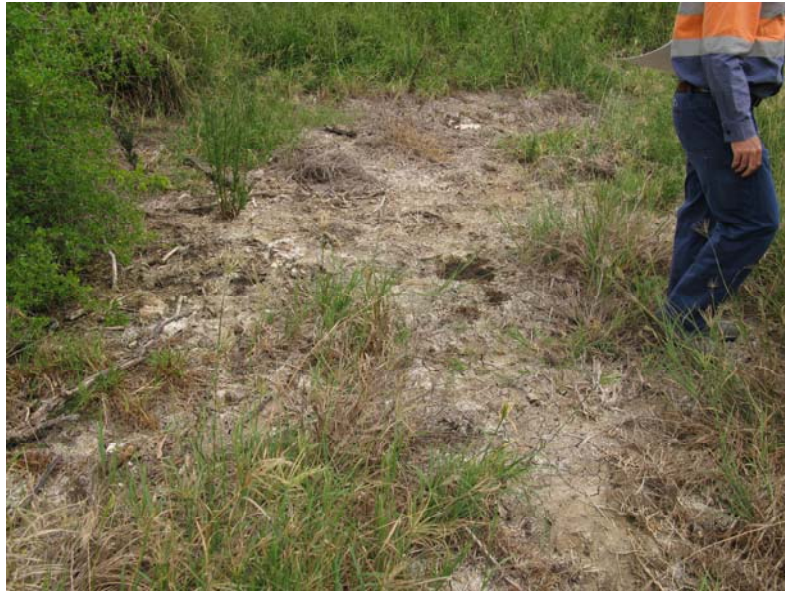
**Figure 3: Third seepage area in Lot 2; note extensive area of white desiccation crystals and vegetation dieback**

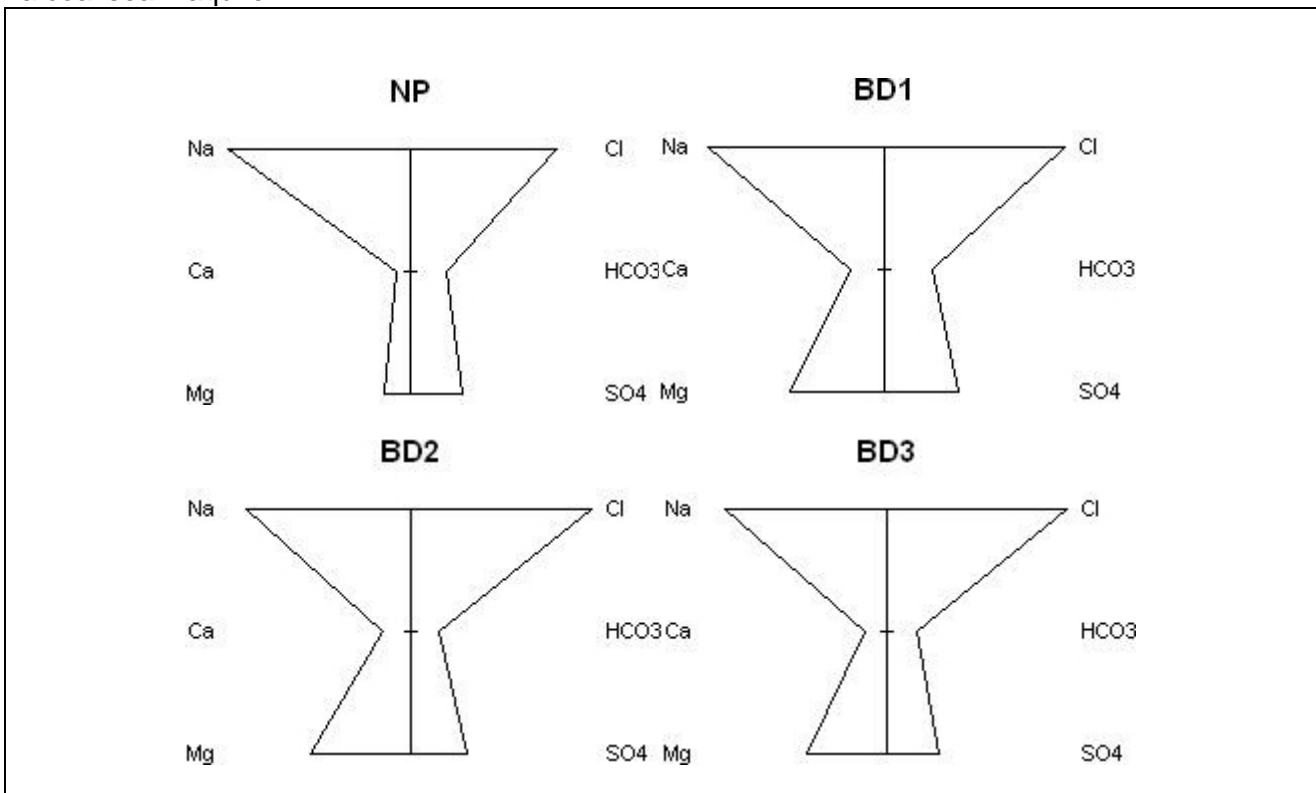
New Hope Coal has sampled surface water within the tailings dam pond (NP) and at three locations (BD1 to BD3) along the Lot 2 property creek alignment to determine the source for the seepage. Stiff diagrams generated from the water quality data are shown in Figure 4 and show a similar water type suggesting the source is either the tailings dam within the pit, or discharge from a coal seam aquifer.

**Figure 4: Stiff Diagram Plots for Tailings Dam and Seepage Waters**

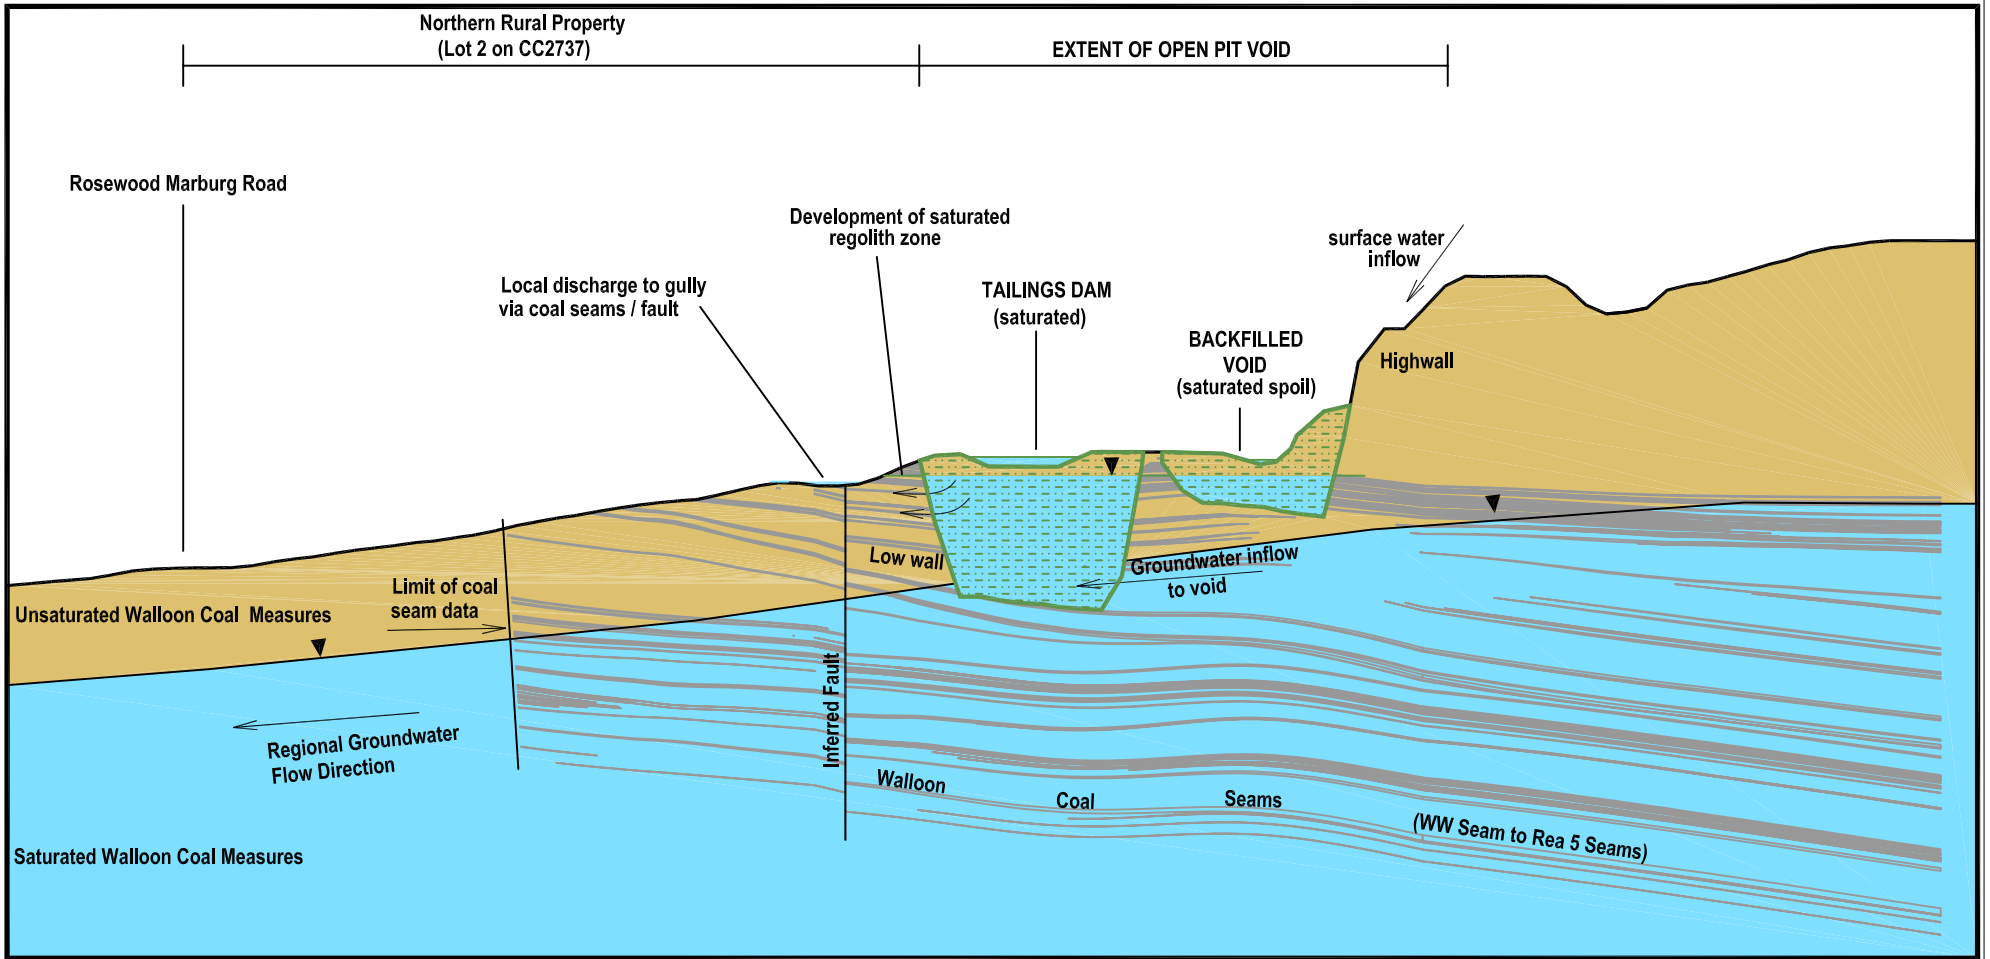
DRAWING No: **3**

The perched aquifer associated with the Oakleigh North Pit spoil and tailings are likely to be fully saturated as indicated by the elevation of the ponded surface water within the mine void. Groundwater recharge to this aquifer would be from a combination of groundwater outflow from the mined coal seams intersected within the pit high wall, and surface water inflows from rain events. The extent of these features is shown conceptually in Drawing No. 3.

Outbreaks on the adjacent properties are considered a result of the development of a seepage front along the down slope portions of the pit low wall, via the following potential seepage pathways:
