ENSHAM RESOURCES PTY LTD

# STAGE 3 GEOTECHNICAL ASSESSMENT

FEBRUARY 2019

Ensham Resources Pty Ltd

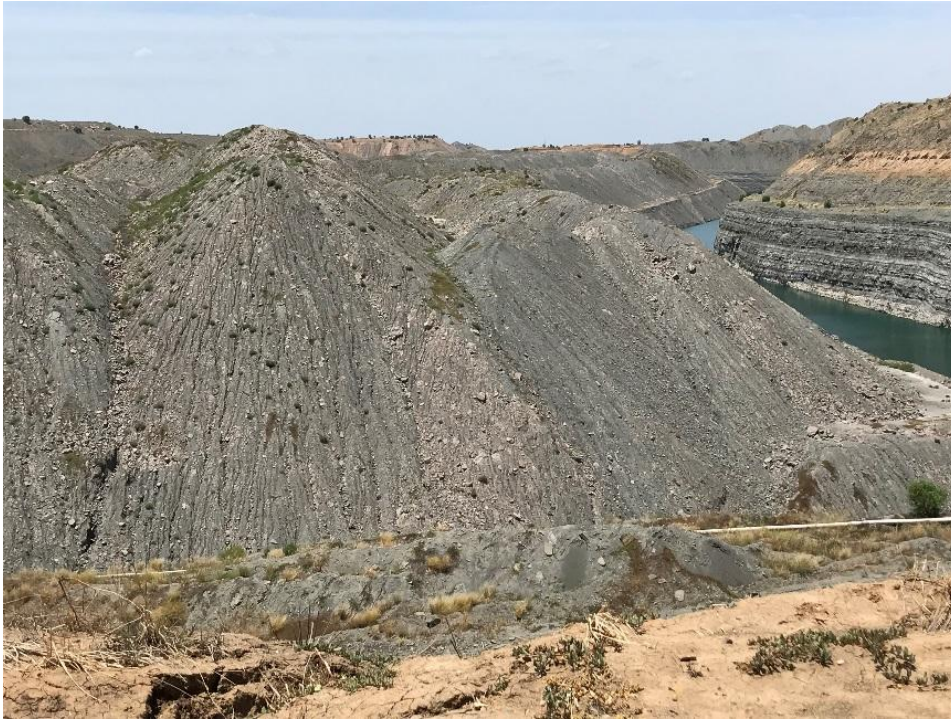
Photo 4-1: Low-wall spoil, mostly Permian materials showing signs of erosion

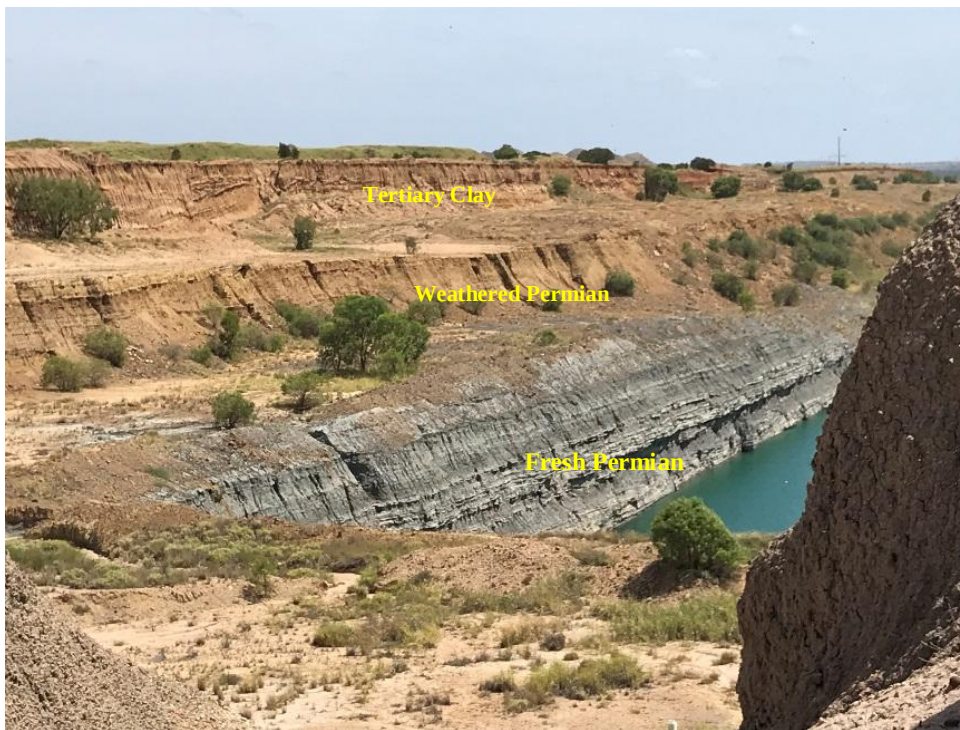
Photo 4-2: B-pit High-wall, fresh Permian, overlain by weathered Permian and weathered Tertiary material

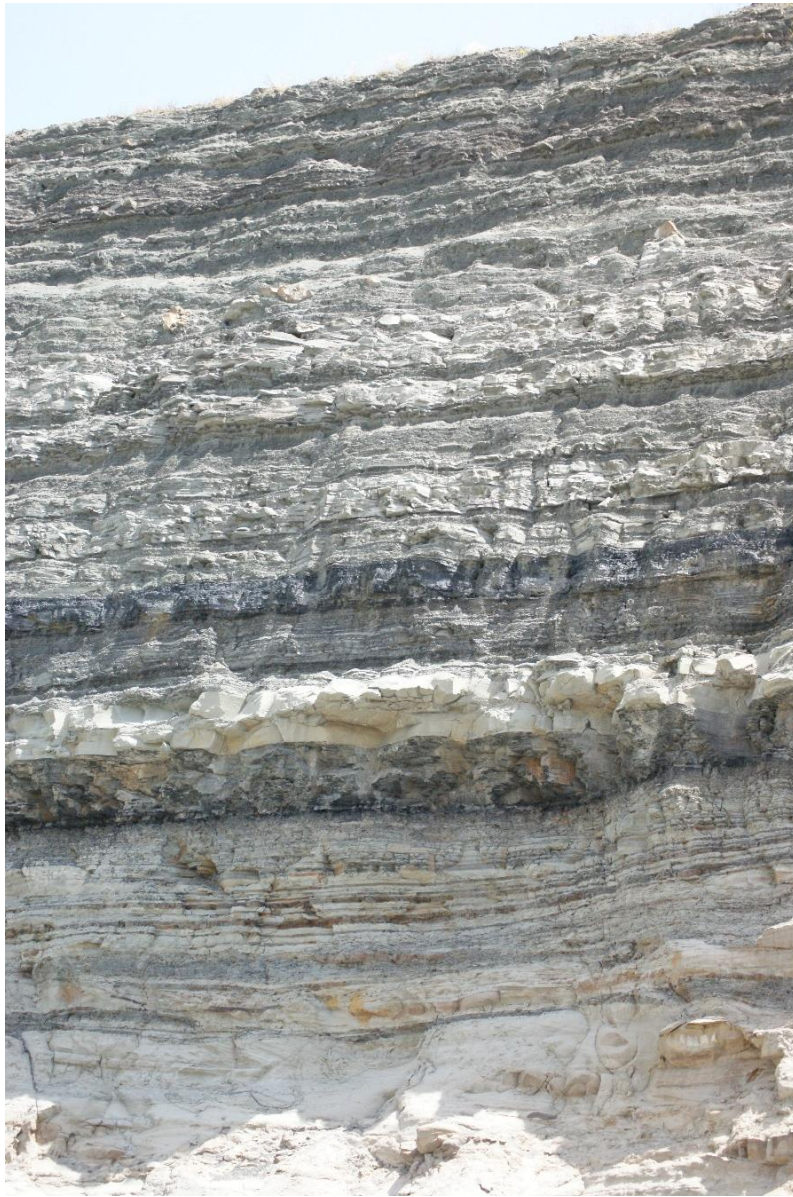
Photo 4-3: B-pit End Wall, exposed Permian material, note breakdown of material and undercutting

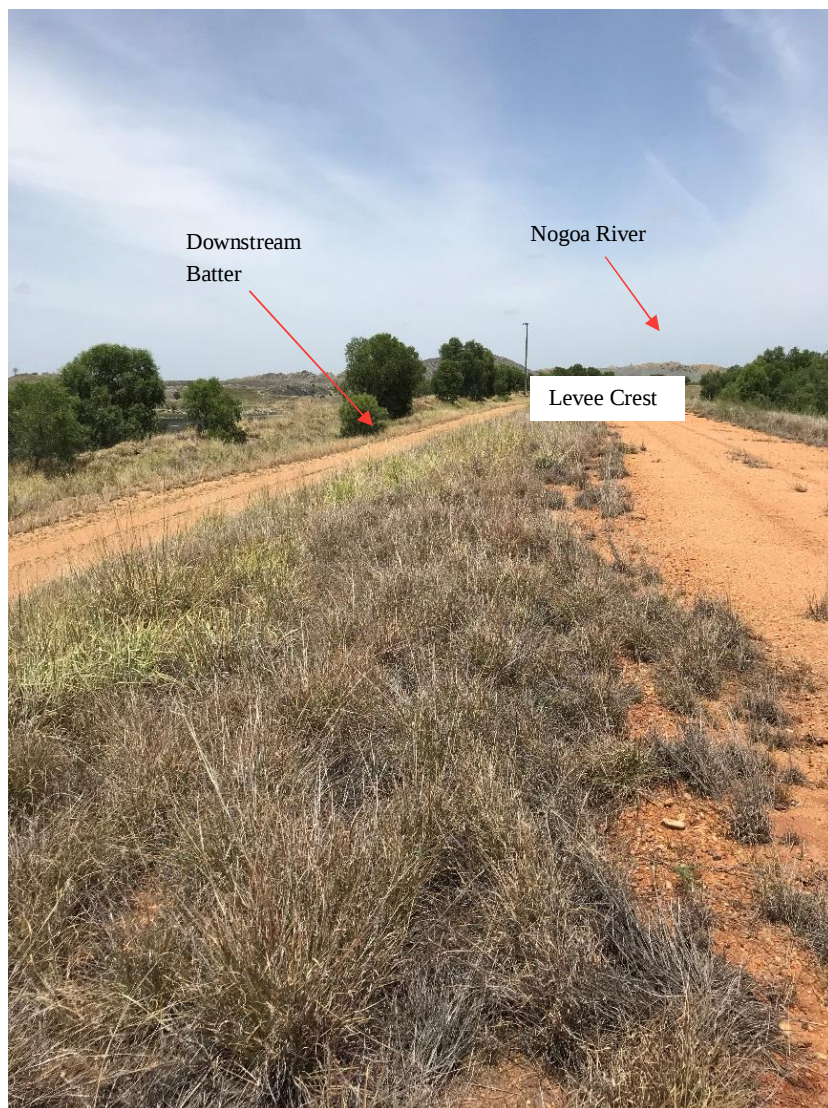
Photo 4-4: Southern Levee (looking west)

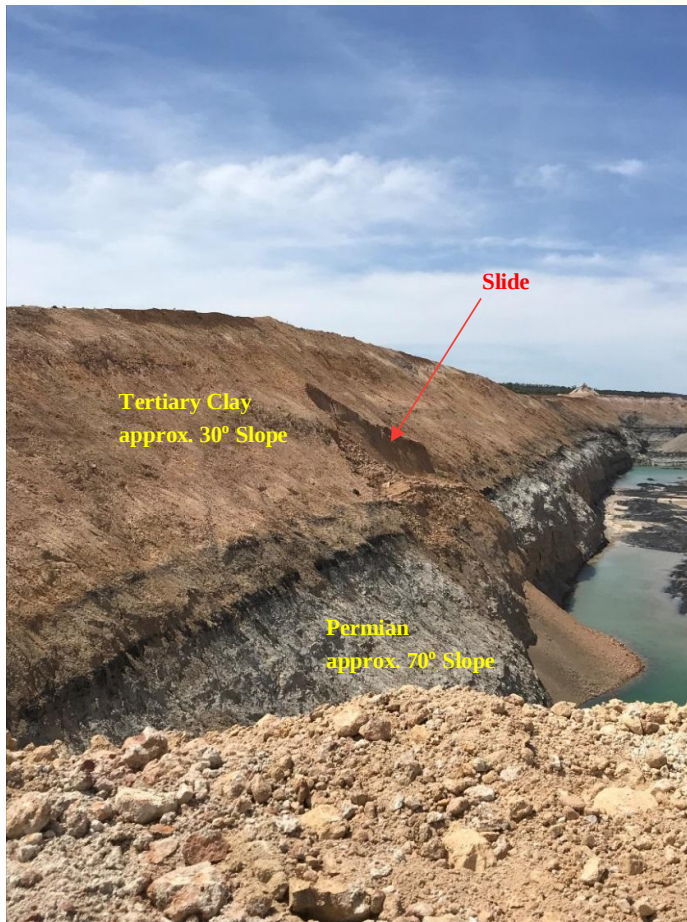
Photo 4-5: Yongala (Y-pit), weathered Permian overlain by weathered Tertiary material, with typical Tertiary failure

Highwall conditions in the Yongala Pit (Y-pit) are substantially different as noted by PSM, 2007 and during the site inspection, as the pit walls consisted of softer Permian materials and/or deeply weathered Tertiary materials. Instability in these materials has been observed during the site inspection in January 2018, and is reflected in the SLOPE/W modelling results. Flatter highwall angles have been utilised in other areas of Y-pit during mining to try and mitigate the risk of instability.

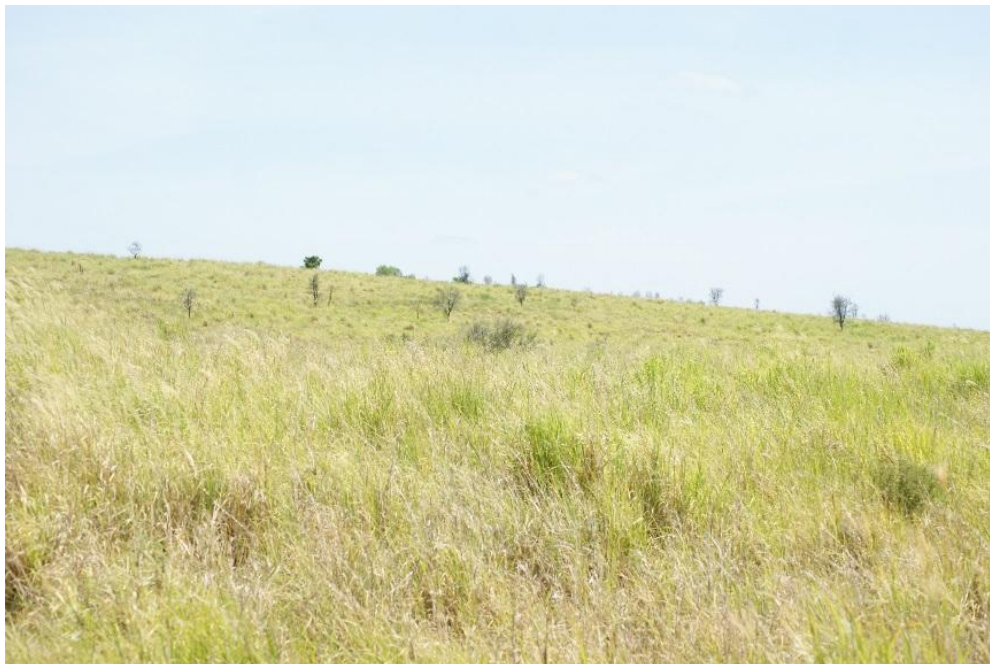
Photo 4-6: Existing rehabilitated slope east of A-pit (approximately 10% slope)

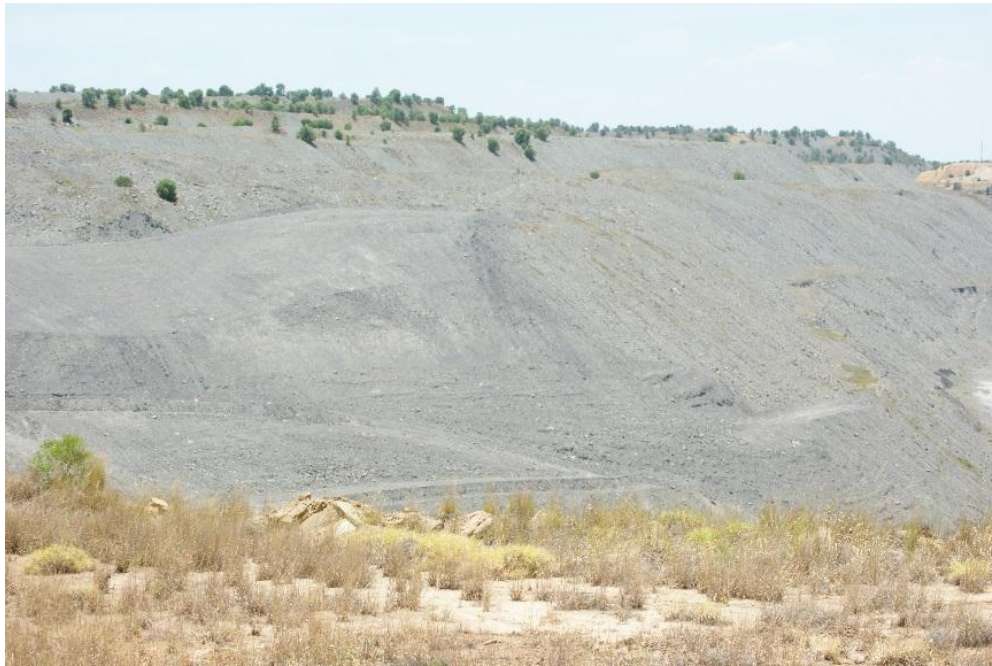
Photo 4-7: Spoil area undergoing rehabilitation

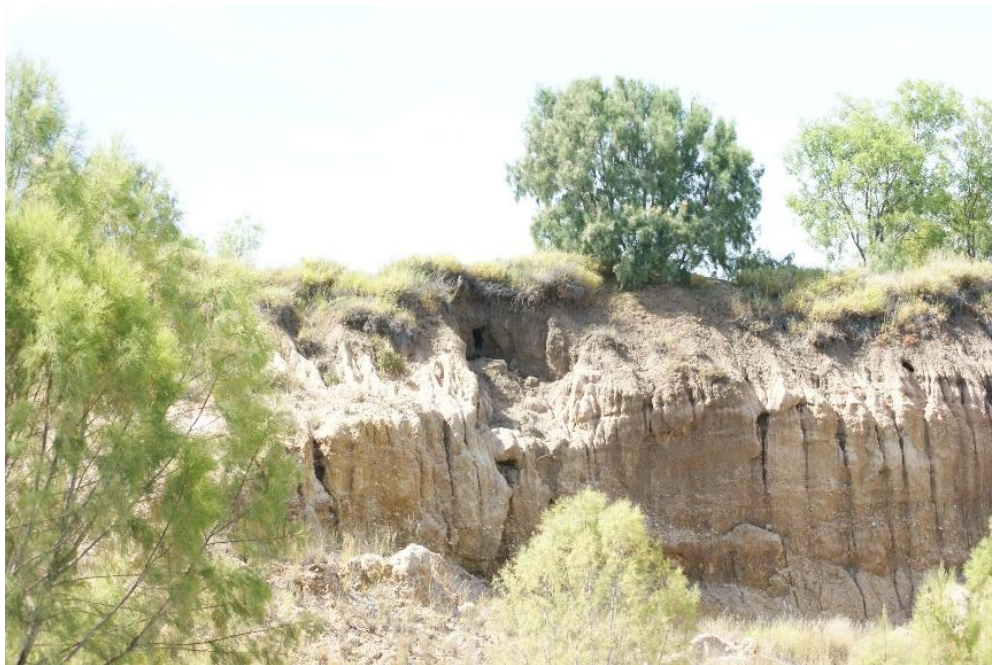
Photo 4-8: Exposed Tertiary soils observed in A-pit

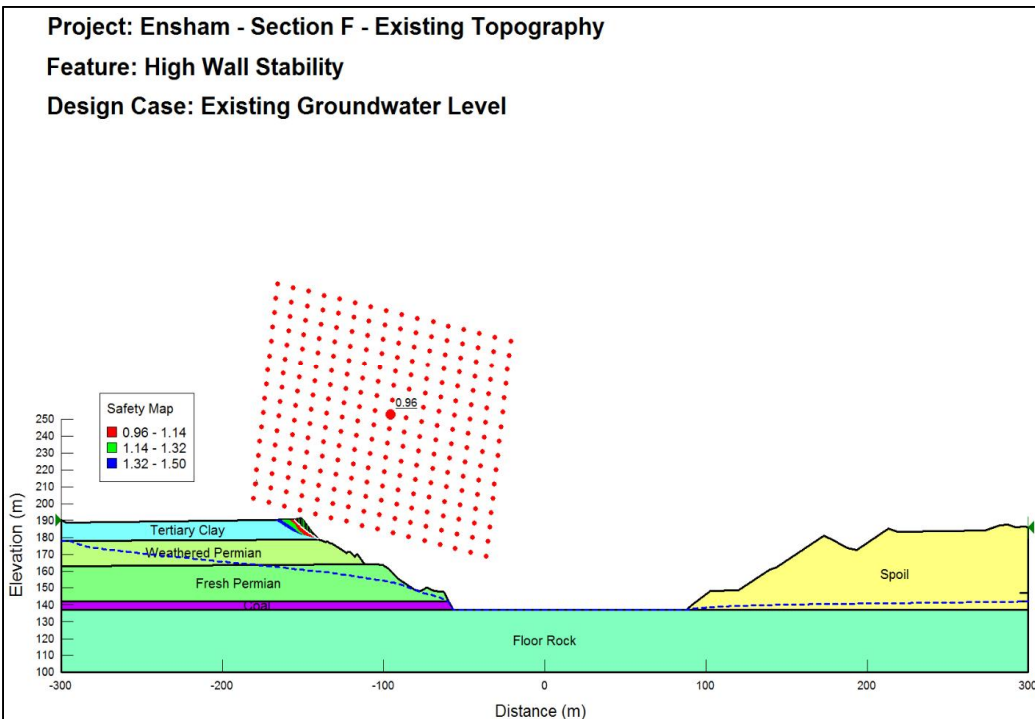
The model results indicate that failures are not expected through the weathered and fresh Permian materials exposed in the pit walls with grades typically encountered in F-pit. The Tertiary clay soils in their current configuration have a FOS of 1 to <1 and are would not be considered stable. The model shows that regrading of these materials would improve their short-term (FOS – 1.3) and long-term stability (FOS – 1.5).

Figure 4-5: SLOPE/W Results for Typical Section F – Current Configuration FOS=0.96

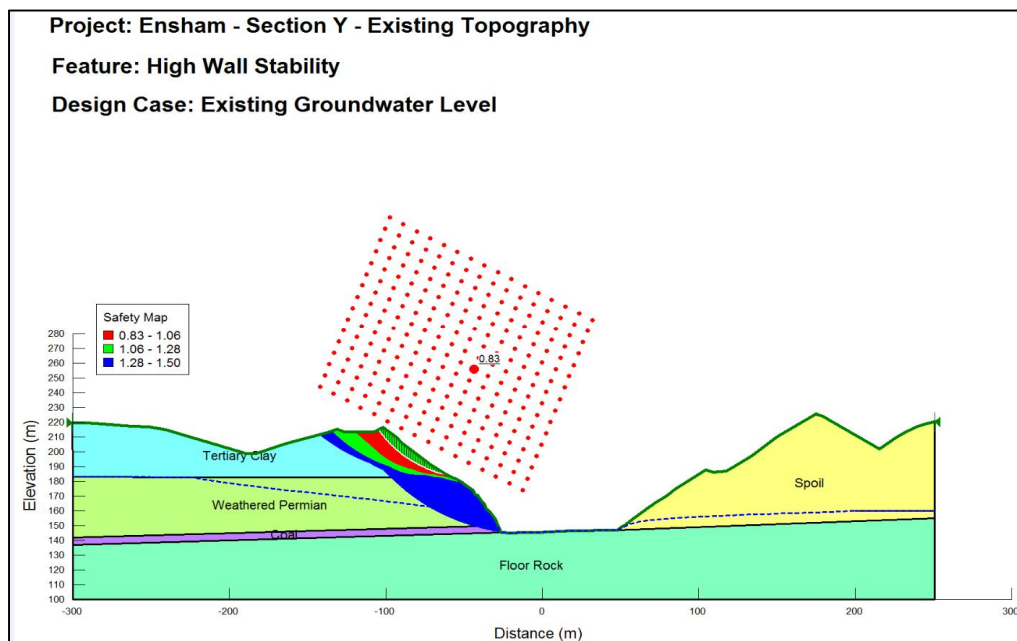
The model results indicate that the weathered Permian materials exposed in the pit walls with grades typically encountered in Y-pit are marginally short-term stable in their current condition with FOS of 1.28. The Tertiary clay soils in their current configuration have a FOS of 1 to <1. The model shows that regrading of Permian and Tertiary materials would improve their short-term and long-term stability.

Figure 4-6: SLOPE/W Results Typical Section Y – Current Configuration FOS=0.83

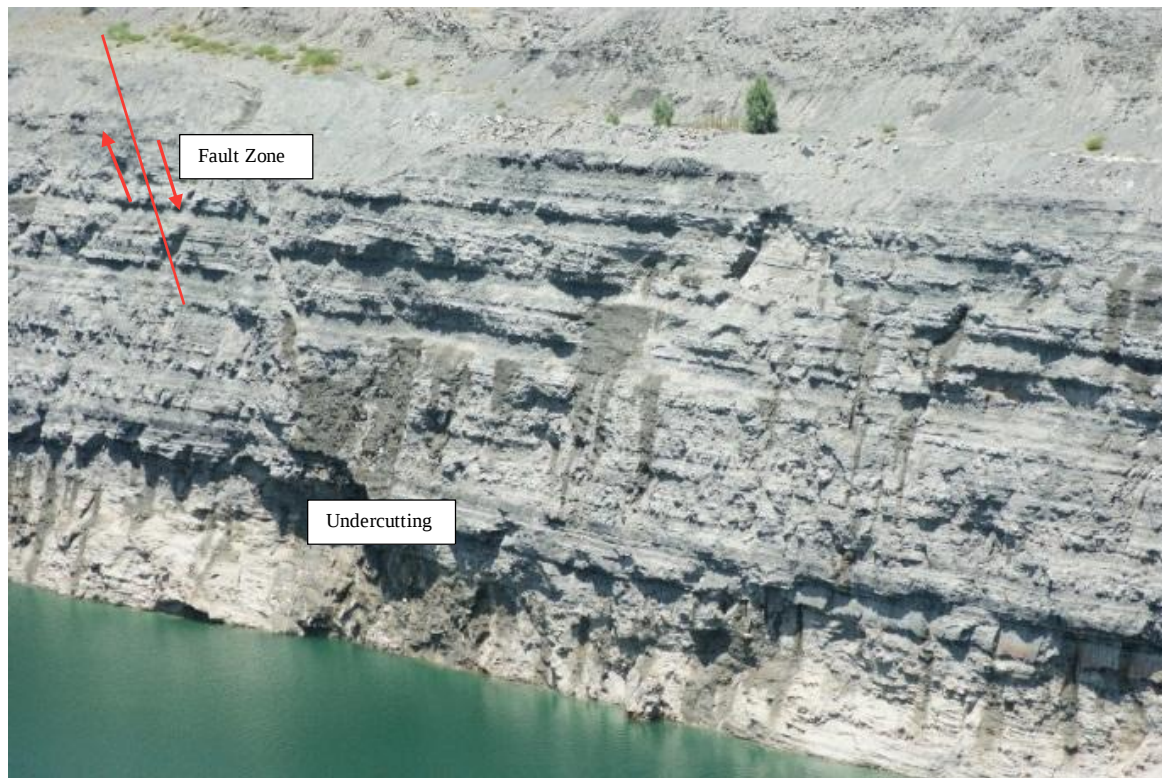
Photo 4-9: Fault in B-pit Highwall

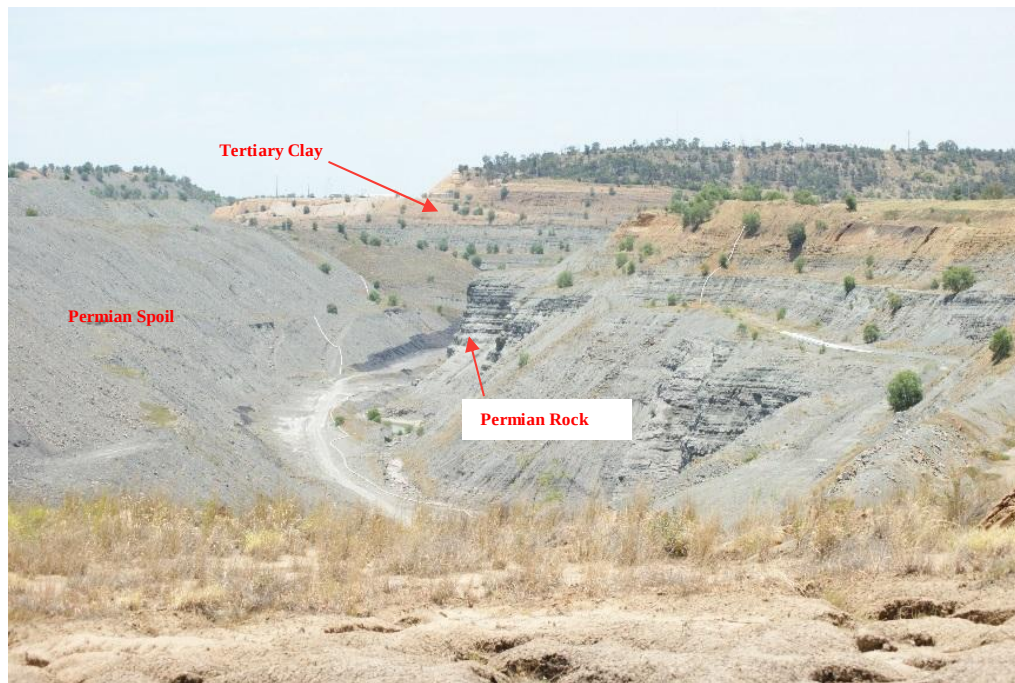
Photo 4-10: Tertiary Clay and Permian Rock exposed at C-pit

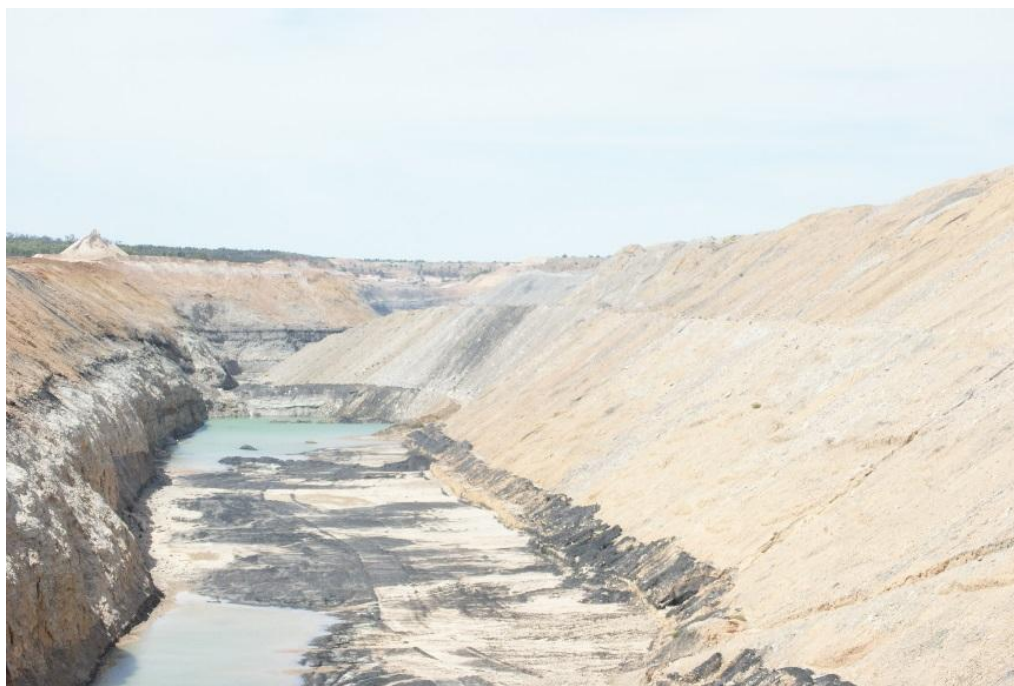
Photo 4-11: Tertiary Spoil Y-pit

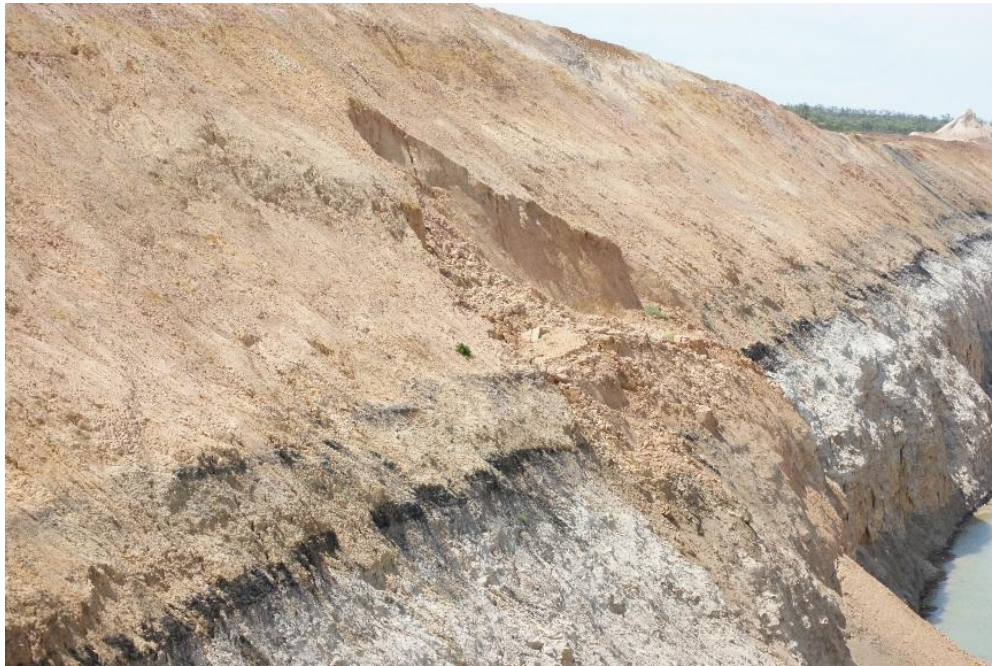
Photo 4-12: Instability in Tertiary Spoil Overlying Weathered Permian Material in Y-pit

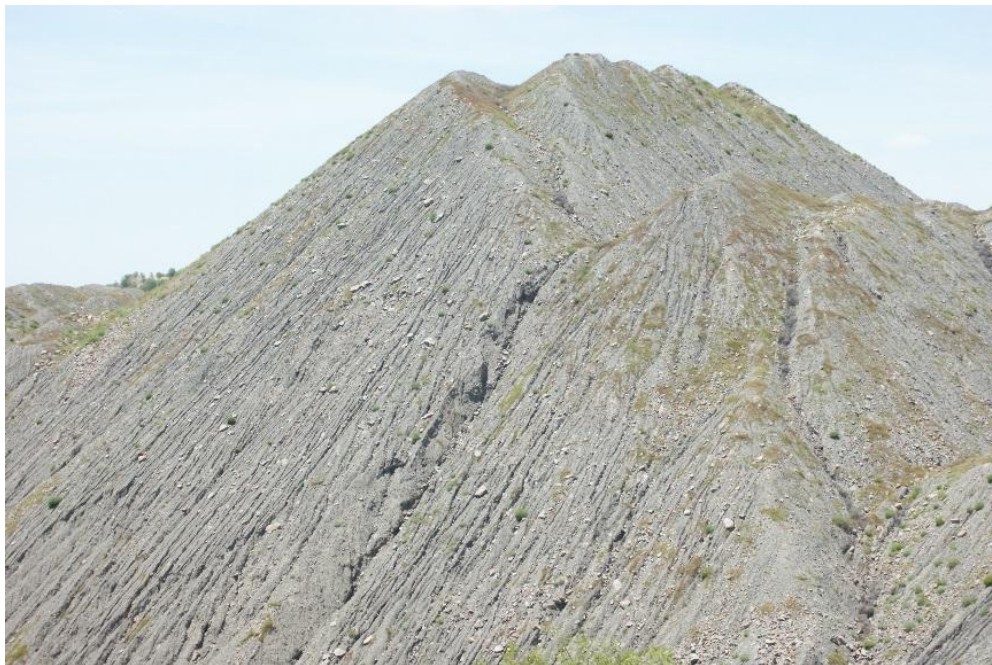
Photo 4-13: Permian Spoil Showing Gulying and Rill Erosion near B-pit

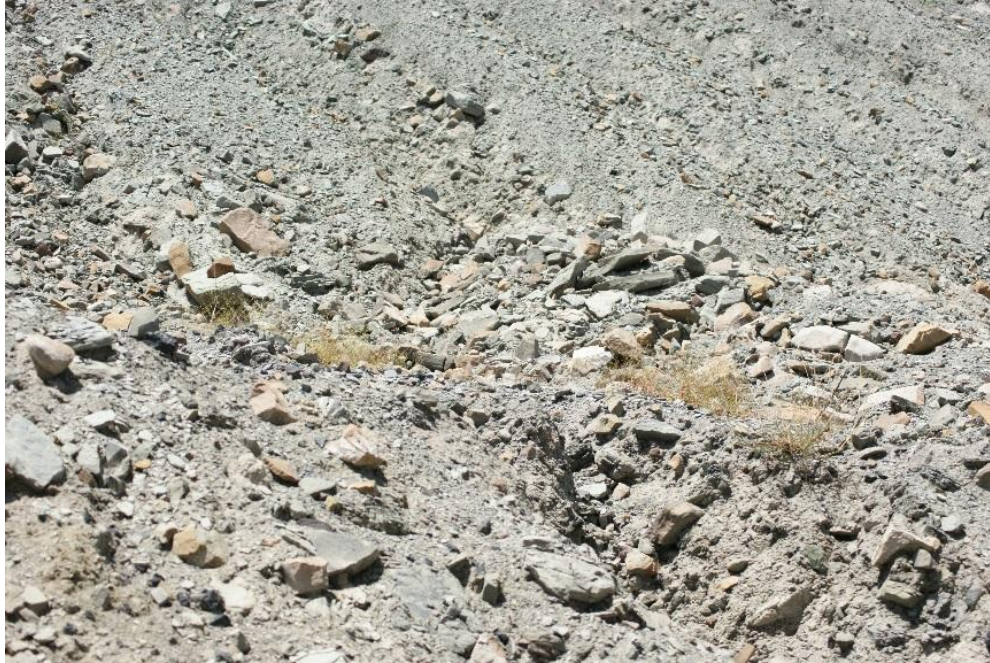
Photo 4-14: Permian Spoil (note degradation)

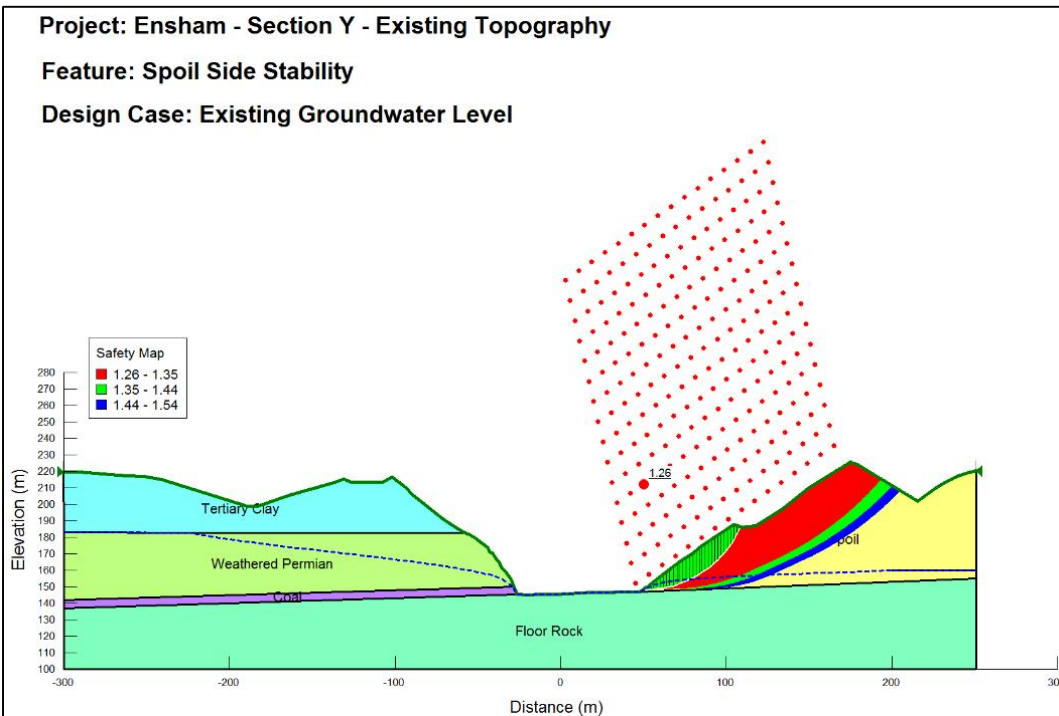
A FOS of 1.5 has been adopted for long-term stability. This value is typically adopted for earth embankments including dams, Fell 2005. The model produced FOS values varying from 1.05 to 1.26 depending on the degree of saturation of the spoil. These FOS values indicate that most spoil piles in their current state (at the angle of repose, with a low groundwater level) would not be considered long-term stable and are marginally stable in the short-term. This is supported by evidence of slips observed during the January site inspection. The modelled output is in Figure 4-18 for unsaturated conditions and Figure 4-19 for a 5m thick saturated zone in the spoil at the bottom of the pile. Regrading of the spoil piles will be required to achieve a landform that would be considered long-term stable.

Figure 4-18: SLOPE/W Results for Typical Unsaturated Spoil Section, FOS=1.26

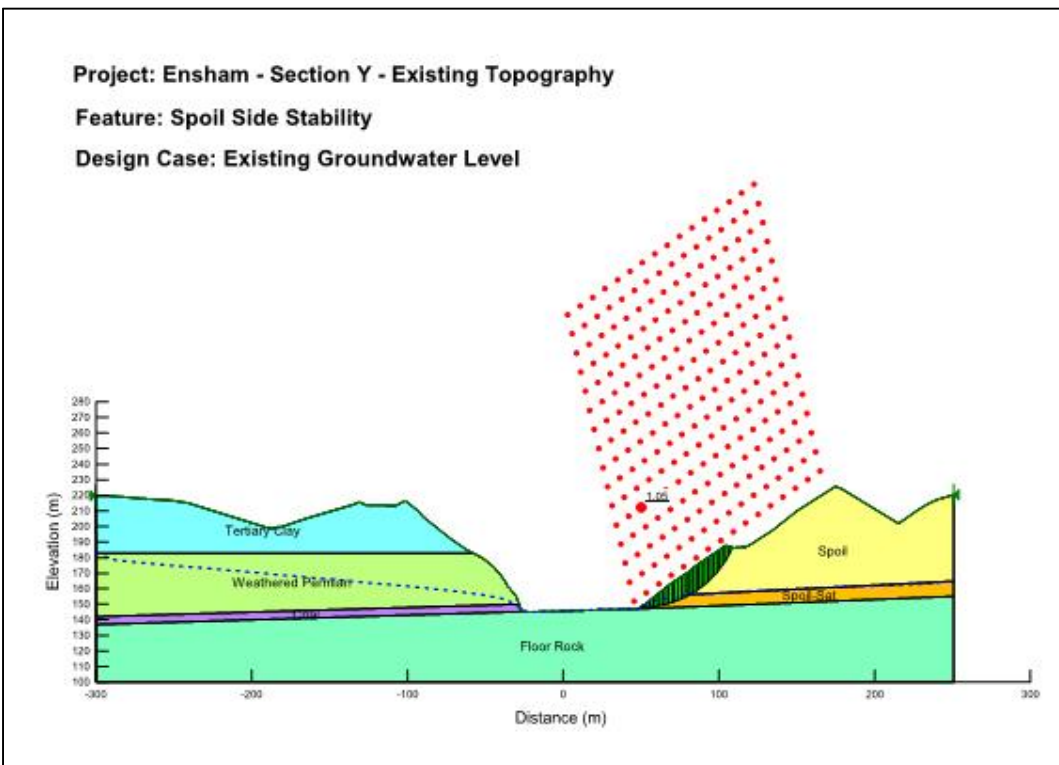
Figure 4-19: SLOPE/W Results for Typical Saturated Spoil Section, FOS=1.05

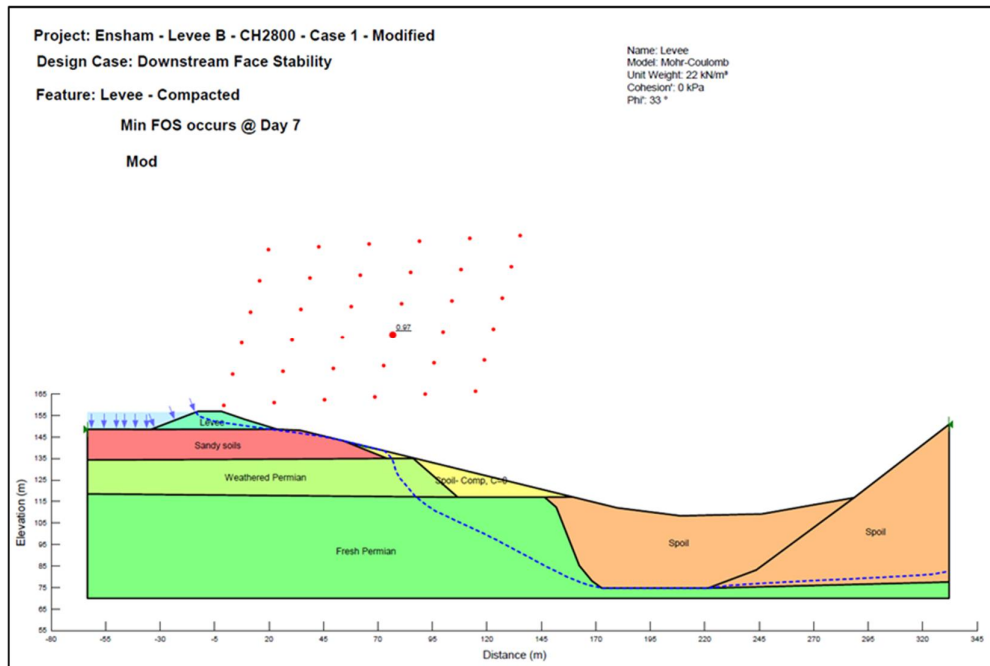
The analysis indicates a FOS of 0.97, with failure occurring in the upper sandy layer with fines. The section assumes a 1V:4H regrade of the endwall into the pit, which has been adopted for Option 2. This slope would be dressed with rock cover to a specified depth, which has not been included in the model, and which would provide some additional resistance to failure. This result demonstrates a sensitivity in stability based on the how the upper clay, sandy, and silty layers are interpreted and modelled, and how effectively the clay upper surface layer seals off the flood plain from interaction with sandier lower layers. An alternative was analysed where a slurry wall cut-off trench is incorporated in the design using the same subsurface layer interpretation. This trench was taken through the upper sand layers into less permeable strata below, and resulted in a FOS of 2.36 (Figure 4-32).

Figure 4-31: SLOPE/W results – Option 2 - B-Pit levee with 25% (1H:4V) regrade into void (alternate subsurface profile sensitivity analysis)

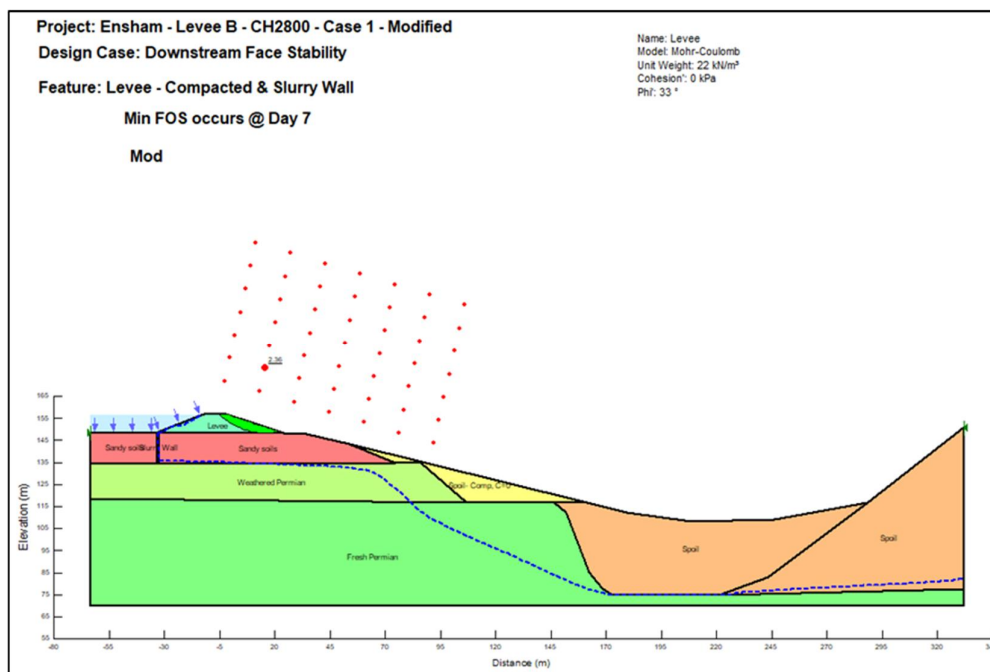
Figure 4-32: SLOPE/W results - Option 2 - B-pit levee with slurry trench - FOS 2.36
