**MILLENNIUM MINE**  
**RESIDUAL VOID SLOPE STABILITY STUDY**

**MILLENNIUM COAL PTY LTD**

**Report No. 170**  
**August 2017**

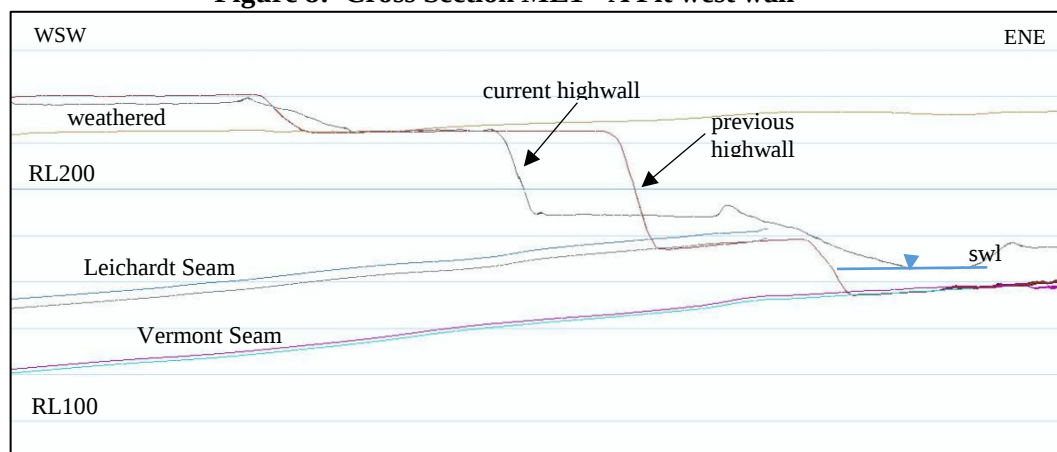
**Figure 8: Cross Section ML1 - A Pit west wall**

Full height final highwall faces will be left along the west and north sides of A Pit. Cross Section ML1 in Figure 8 below shows the current configuration for the west wall, with the partially exposed highwall for the next strip. More strips may be mined but the final configuration should be the same, comprising a 45° upper bench up to 30m high through the weathered zone and a 70° pre-split main overburden bench up to 55m high. Also shown is the predicted long term void water level at RL164.

The highwalls are cut through material that is too strong to permit material failure by shearing and hence will stand indefinitely subject only to weathering degradation. The systematic risk of massive block slippage can also be discounted since the bedding dips back into the wall. However, rock failure conditions can be created by adverse pervasive discontinuities such as fault planes, joint planes or combinations of planes producing block or wedge configurations.

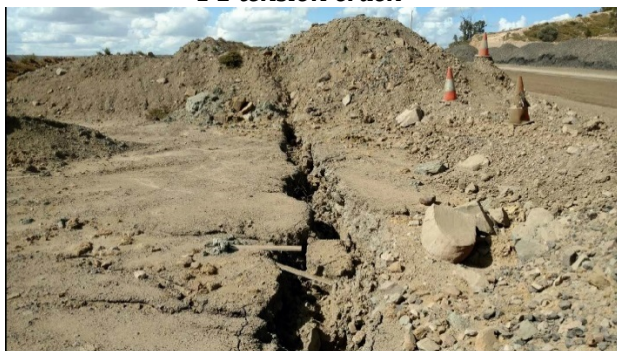
***F1 tension crack***

Two other instances of potential fault-induced instability occur at each end of the west wall, marked as F1 and F2 on Figure 7. F1 appears to be a high angle fault running behind and sub-parallel to the south wall, dipping out of the wall. It has incurred some movement, manifest as a tension crack along the edge of the haul road and slumping of the lower bench. The tension crack enlarged significantly following inflow from cyclone Debbie in March 2017 as shown in the photo below.

Inspection of the face reveals that the movement is due to a slumping collapse of the feather-edging fault intersection with the wall – too much weight on too narrow a base – and that the main section of wall in front of the crack appears to be intact. The feather-edging tension crack is shown in the photo below cutting down across the upper weathered benches. The lower rock batter has incurred slumping collapse.

In terms of remedial action for final void, because the failure is fault controlled it will not extend any further back than the fault itself marked by the tension crack, the recommended action would be to leave as is with a rock bund along the haul road 15m from the tension crack. As the fault trend is moving further away from the wall the potential for mass failure should be reduced and it is unlikely to have any impact on the stability of the next strip endwall.

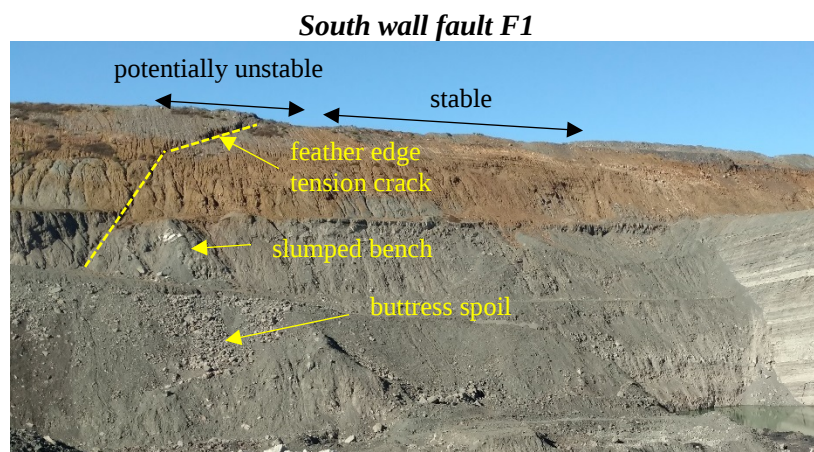
Site Photo IMG\_20170524\_091625948 taken 24/05/2017, looking NE

A spoil buttress has been placed against the wall and this has effectively buttressed the lower bench against any further slumping. The residual risk would be shallow slip failure through the top of the weathered material and haul road spoil at the top.

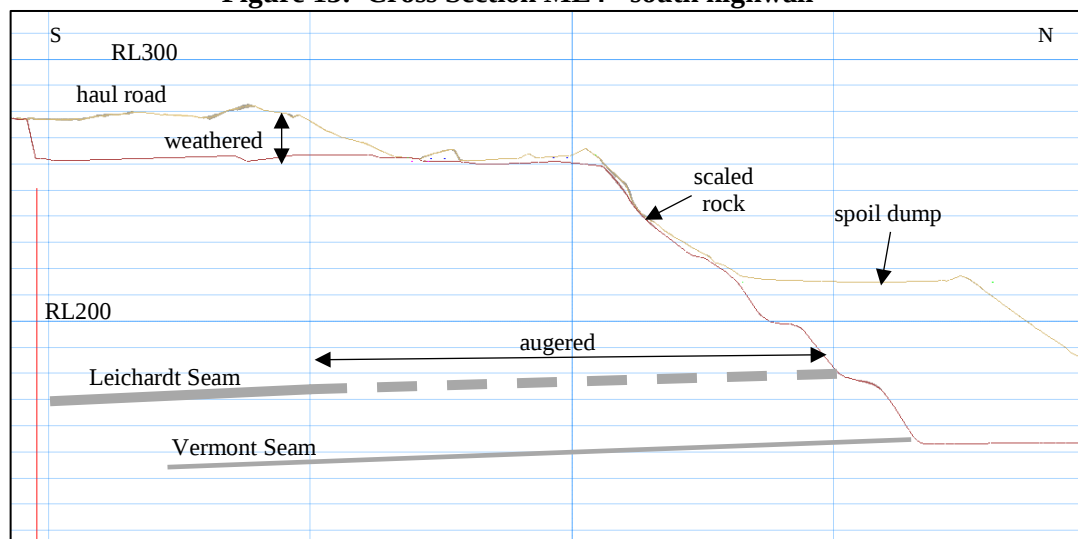
**Figure 13: Cross Section ML4 - south highwall**

Pillar failure at the portal would undermine the highwall and could result in a collapse of the highwall face. Slope failures from this cause tend to be relatively shallow, more of a collapse type slump than a deep seated slope failure, and do not extend far behind the highwall. The use of the higher long term stability FoS value under the highwall should reduce the risk of highwall collapse in isolation, although a widespread collapse of pillars inbye could run forward under the highwall.

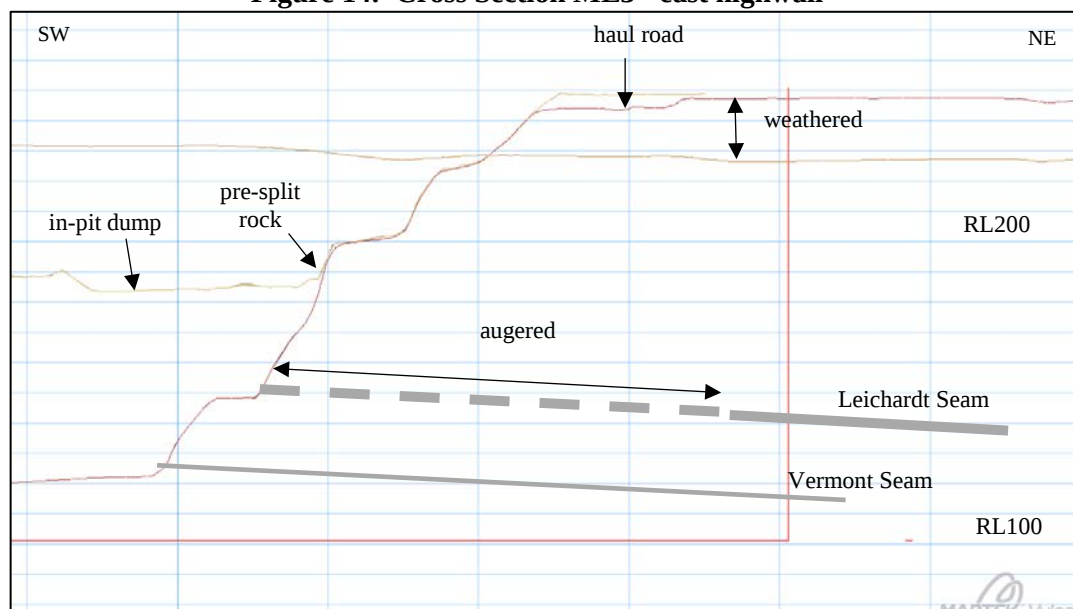
**Figure 14: Cross Section ML3 - east highwall**

A similar case applies to the east wall auger holes, as illustrated in Figure 14 below. The auger holes penetrated some 140m to 155m and passed beneath the haul road but were stopped well short of the New Chum Creek levee. As the pit is already partially backfilled there is no residual risk of face collapse from long term pillar deterioration but a possibility of some small amount of easily remedied subsidence under the haul road if this is to be left as an access road.

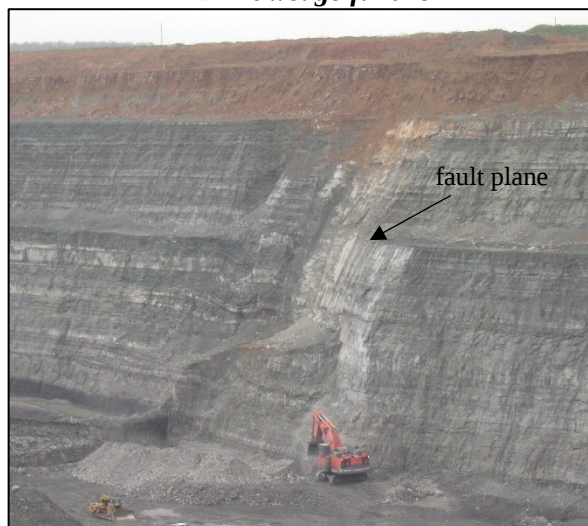
### ***D Pit wedge failure***

A more substantial wedge failure has occurred in D Pit highwall due to a major joint plane intersecting a fault in the face. Material within the wedge has slipped down or been scaled back to the intersecting sliding planes. In terms of long term effect, the zone of instability is confined to within the triangle on the berm formed by the intersecting discontinuities. The failure cannot extend any further back into the highwall in the absence of any other contributing planes and any residual material left suspended will slide down into the void.

The failure has cut back to and slightly undercut the weathered rock bench. This may cause some shallow slumping or erosion in the softer material but would not prejudice the geotechnical stability of the upper benches. No further action would be needed for residual void protection other than the standard exclusion bund at the crest.

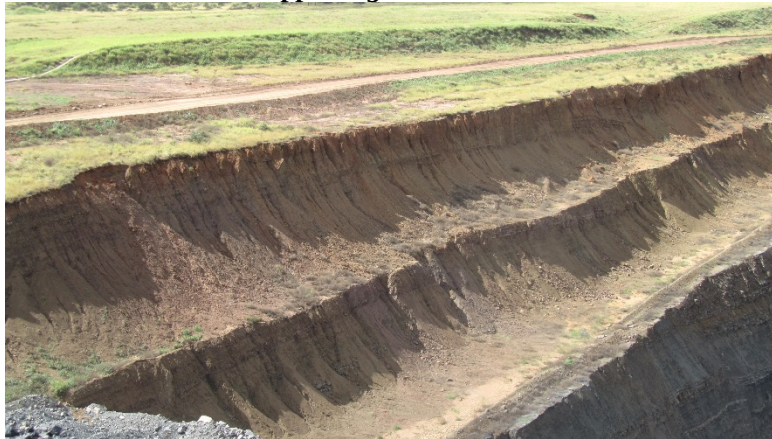
***E Pit upper highwall benches***

The condition of the upper batters is illustrated in the photo below. The batters were 'rough-cut' design and are individually too steep for long term environmental stability and, as a consequence, are gullying from run-off and eroding into lower angle rill slopes.

There is no risk of mass failure but the degradation will continue to eventually create a 35° or so slope. There is adequate room on the rock berm to accommodate rilled material.

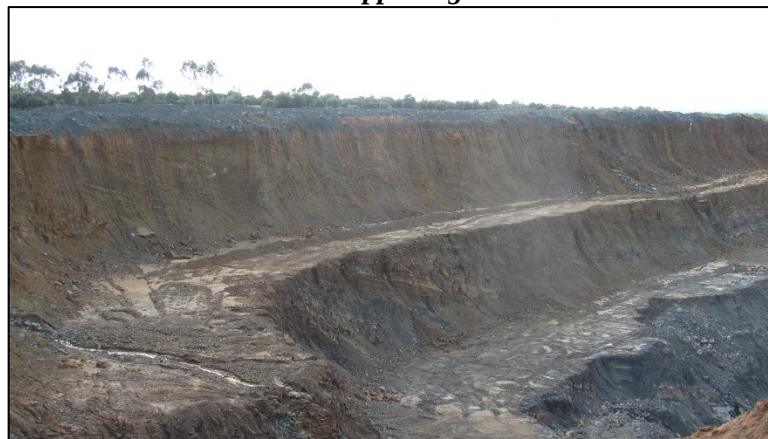
***D North Pit upper highwall benches***

The upper benches at the northern end of D Pit are steeper with a greater proportion of harder material. This is resulting in a different weathering profile whereby the top section is failing by toppling collapse which thus creates and maintains a near-vertical top part, with a smaller rill slope.

The long term implication of this is that the toppling collapse could cause the shape to be retained and allow the crest to be eaten back further over time rather than degrading to a continuous rill slope. One option for remediating this would be to push down the batters to say 28° (typical angle for dozer-push) which would remove the toppling type degradation.

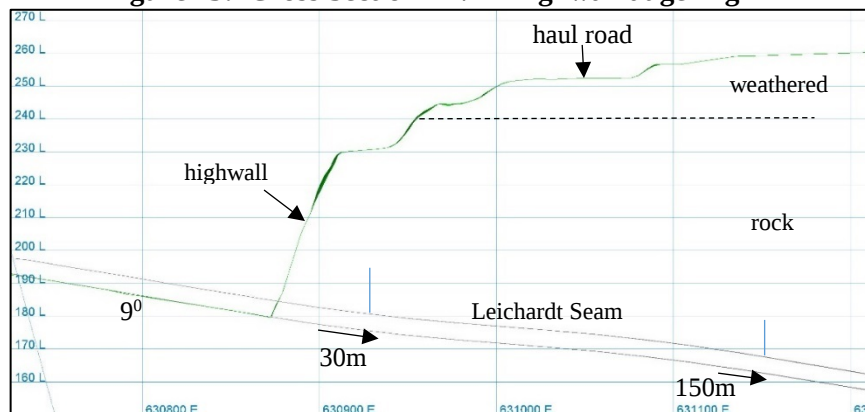
**Figure 23: Cross Section MV2 - highwall augering**

Full penetration of 200m was not achieved due to the presence of an unknown fault running at an angle behind the highwall, penetration depths being between 30m and 150m. Many of the holes would have extended under the haul road along the crest, but stopping a long way short of the perimeter drain and levee, which is approximately 200m back from the crest.
