**MILLENNIUM MINE**  
**RESIDUAL VOID SLOPE STABILITY STUDY**

**MILLENNIUM COAL PTY LTD**

**Report No. 170**  
**August 2017**

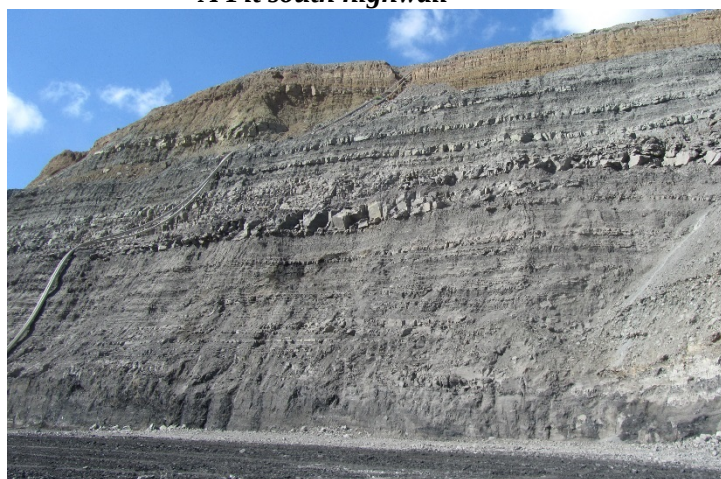
*A Pit south highwall*

In normal conditions the pre-split rock benches are clean and stable. In some cases the walls have not been pre-split but have been scaled to present a reasonably clean face. In either case there will always be a background risk of small blocks becoming detached through weathering and falling out. The Rangal Coal Measures, particularly the finer grained rock, are susceptible to slaking and this allows the softer material to weather out and undercut the harder sandstone blocks. This has no impact on the overall geotechnical stability of the slope but represents a long term weathering effect. The photo below shows a typical scaled highwall bench with undercutting of the harder sandstone bands.

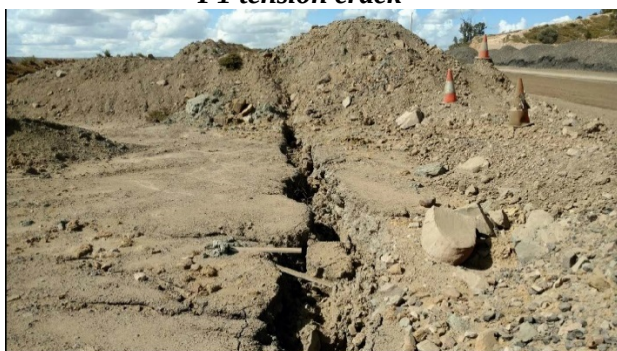
***F1 tension crack***

Two other instances of potential fault-induced instability occur at each end of the west wall, marked as F1 and F2 on Figure 7. F1 appears to be a high angle fault running behind and sub-parallel to the south wall, dipping out of the wall. It has incurred some movement, manifest as a tension crack along the edge of the haul road and slumping of the lower bench. The tension crack enlarged significantly following inflow from cyclone Debbie in March 2017 as shown in the photo below.

In terms of remedial action for final void, because the failure is fault controlled it will not extend any further back than the fault itself marked by the tension crack, the recommended action would be to leave as is with a rock bund along the haul road 15m from the tension crack. As the fault trend is moving further away from the wall the potential for mass failure should be reduced and it is unlikely to have any impact on the stability of the next strip endwall.

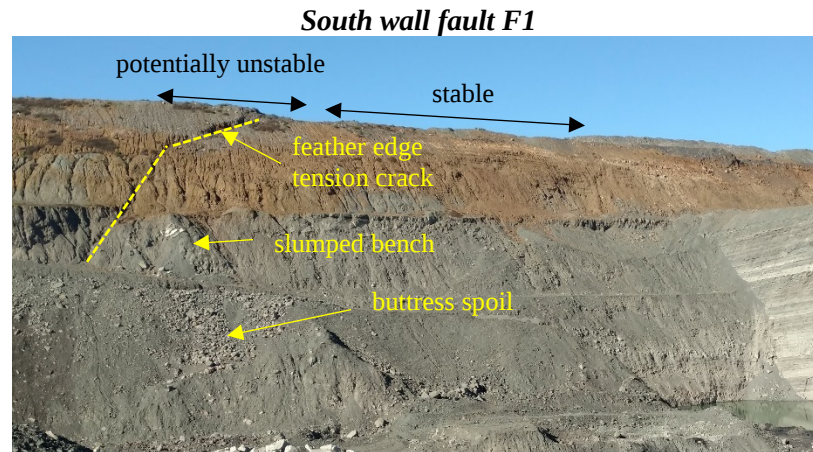
Site Photo IMG\_20170524\_091625948 taken 24/05/2017, looking NE

Inspection of the face reveals that the movement is due to a slumping collapse of the feather-edging fault intersection with the wall – too much weight on too narrow a base – and that the main section of wall in front of the crack appears to be intact. The feather-edging tension crack is shown in the photo below cutting down across the upper weathered benches. The lower rock batter has incurred slumping collapse.

A spoil buttress has been placed against the wall and this has effectively buttressed the lower bench against any further slumping. The residual risk would be shallow slip failure through the top of the weathered material and haul road spoil at the top.

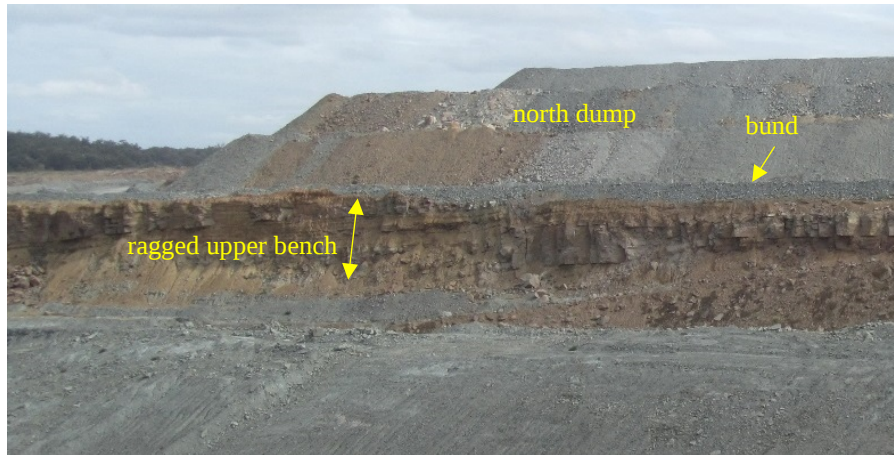
### ***B Pit north wall***

In this instance a band of strong sandstone has prevented the formation of the normal 45° batter and although there is no risk of mass failure, there is a likelihood of large blocks weathering out. Any rockfall will report to the void and will in any case be contained on the wide rock berm.

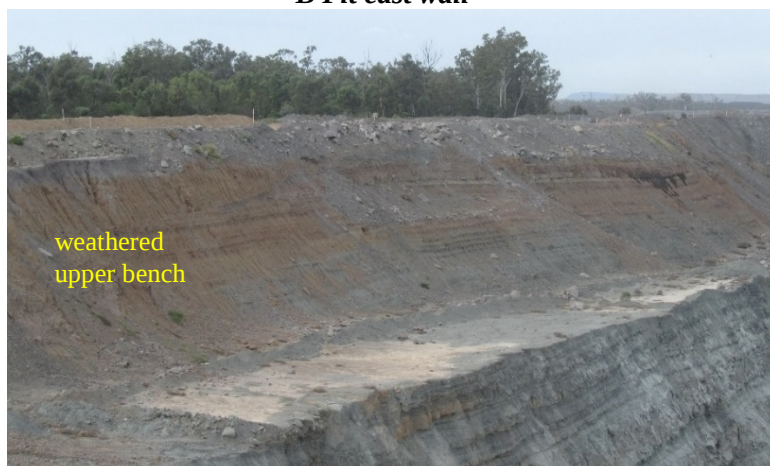
### ***B Pit east wall***

From experience to date and the current condition of the walls, it can be concluded that the highwall design is appropriate for producing a stable final wall, except for those areas where faults are present behind and parallel to the face as discussed above.

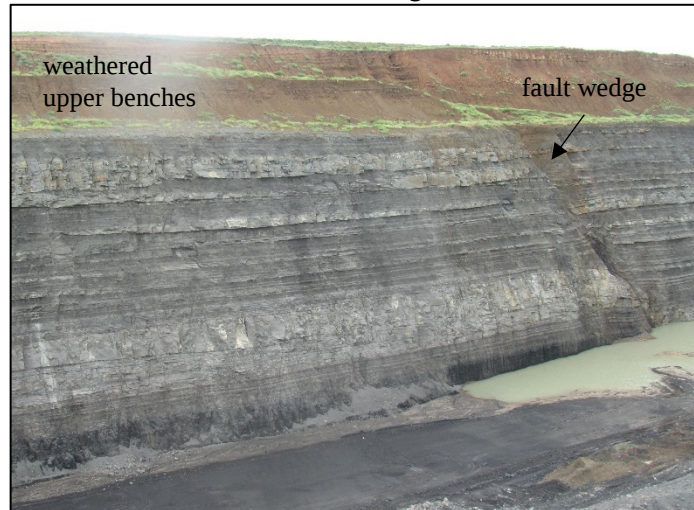
### ***E Pit north highwall***

The highwall slopes are formed in moderately strong back-dipping bedded rock and are inherently stable for the most part. The walls are intersected by a number of large high angle faults but these have tended to be perpendicular to the face and thus do not create a potential for mass failure. In some cases there has been some spalling or shallow slumping to create a vee-shaped notch down the wall but this is a very local feature confined to the fault intersection and does not prejudice the stability of the rest of the face.

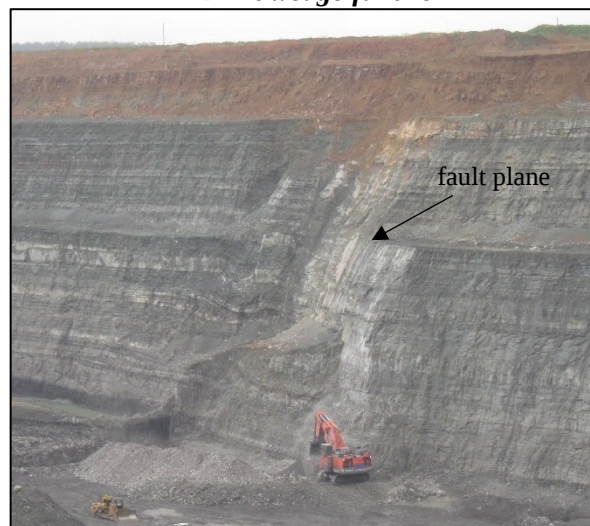
### ***D Pit wedge failure***

A more substantial wedge failure has occurred in D Pit highwall due to a major joint plane intersecting a fault in the face. Material within the wedge has slipped down or been scaled back to the intersecting sliding planes. In terms of long term effect, the zone of instability is confined to within the triangle on the berm formed by the intersecting discontinuities. The failure cannot extend any further back into the highwall in the absence of any other contributing planes and any residual material left suspended will slide down into the void.

The failure has cut back to and slightly undercut the weathered rock bench. This may cause some shallow slumping or erosion in the softer material but would not prejudice the geotechnical stability of the upper benches. No further action would be needed for residual void protection other than the standard exclusion bund at the crest.

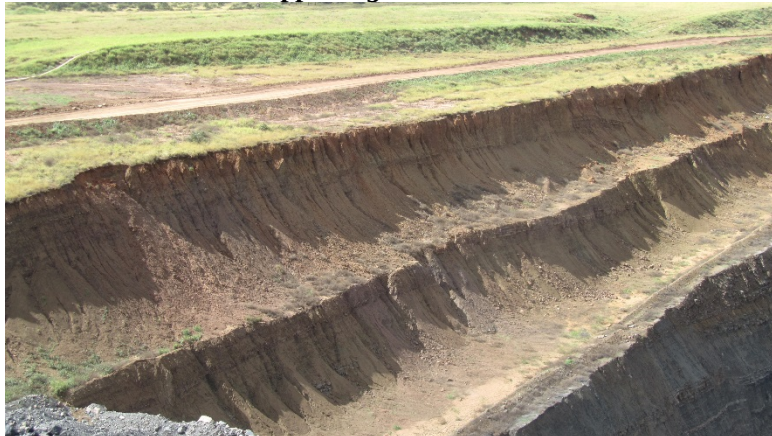
***E Pit upper highwall benches***

The condition of the upper batters is illustrated in the photo below. The batters were 'rough-cut' design and are individually too steep for long term environmental stability and, as a consequence, are gullying from run-off and eroding into lower angle rill slopes.

There is no risk of mass failure but the degradation will continue to eventually create a 35° or so slope. There is adequate room on the rock berm to accommodate rilled material.

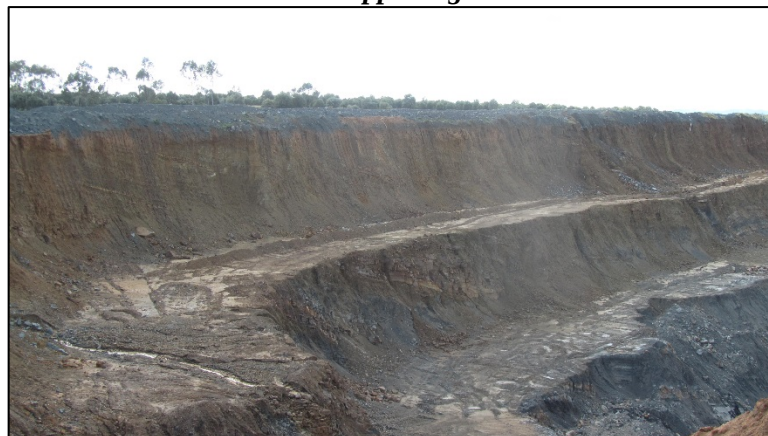
***D North Pit upper highwall benches***

The upper benches at the northern end of D Pit are steeper with a greater proportion of harder material. This is resulting in a different weathering profile whereby the top section is failing by toppling collapse which thus creates and maintains a near-vertical top part, with a smaller rill slope.

The long term implication of this is that the toppling collapse could cause the shape to be retained and allow the crest to be eaten back further over time rather than degrading to a continuous rill slope. One option for remediating this would be to push down the batters to say 28° (typical angle for dozer-push) which would remove the toppling type degradation.

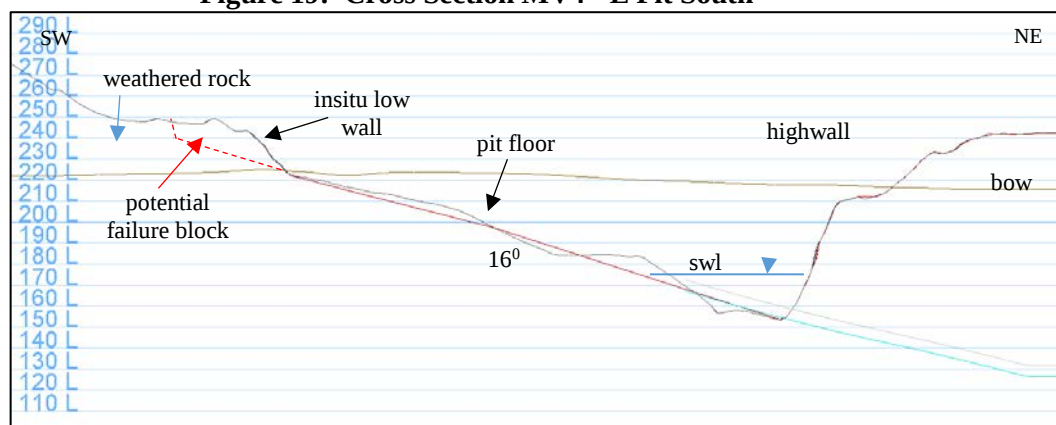
**Figure 19: Cross Section MV4 - E Pit South**

In this case however an insitu low wall has been cut down to the base of weathering, which leaves a residual risk of low wall failure due to slippage along the relict coal horizon extending up through the weathered zone. The potential failure configuration is shown above. The FoS is obviously more than 1.00 but as the dip angle is at least as much as the expected friction angle on the relict slip plane, the FoS can be presumed to be close to 1.00. This means there will be a high probability of failure in the insitu low wall at some stage, as consequence of softening of the shear strength and increased pore pressure from ingress of water, particularly during storm events.

In terms of long term exposure, the low wall would not have an acceptable margin of stability and failure can be expected. This condition could be alleviated by pushing down the low wall bench in front of the out-of-pit dump to match the pit floor. Alternatively it could be left to fail as any displaced material would migrate down the pit floor towards the highwall and would be contained within the void.

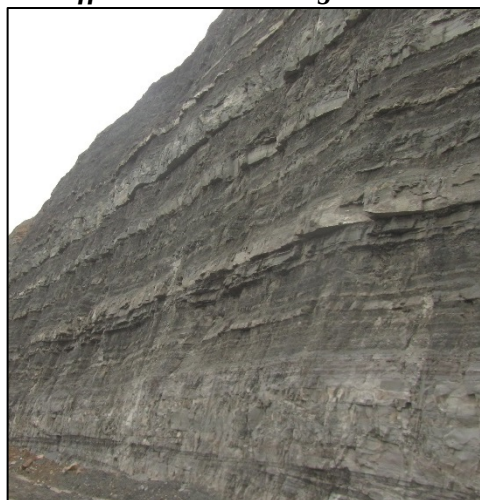
### *Differential weathering – E Pit*

The Permian Rangal coal measures are prone to slaking, in particular the siltstone, which slakes and falls as fines continuously from the highwall. This action undercuts the harder more durable sandstone beds and leads to ongoing rockfall. Observations of highwalls at Burton Mine suggest a degradation rate of 40mm to 50mm per year on the highwall, equivalent to 1m after 20 years.
