# Progressive Rehabilitation and Closure Plan

## WARWICK LIMESTONE MINE

**WARWICK LIMESTONE MINE –  
PROGRESSIVE REHABILITATION AND  
CLOSURE PLAN**

29 SEPTEMBER 2023

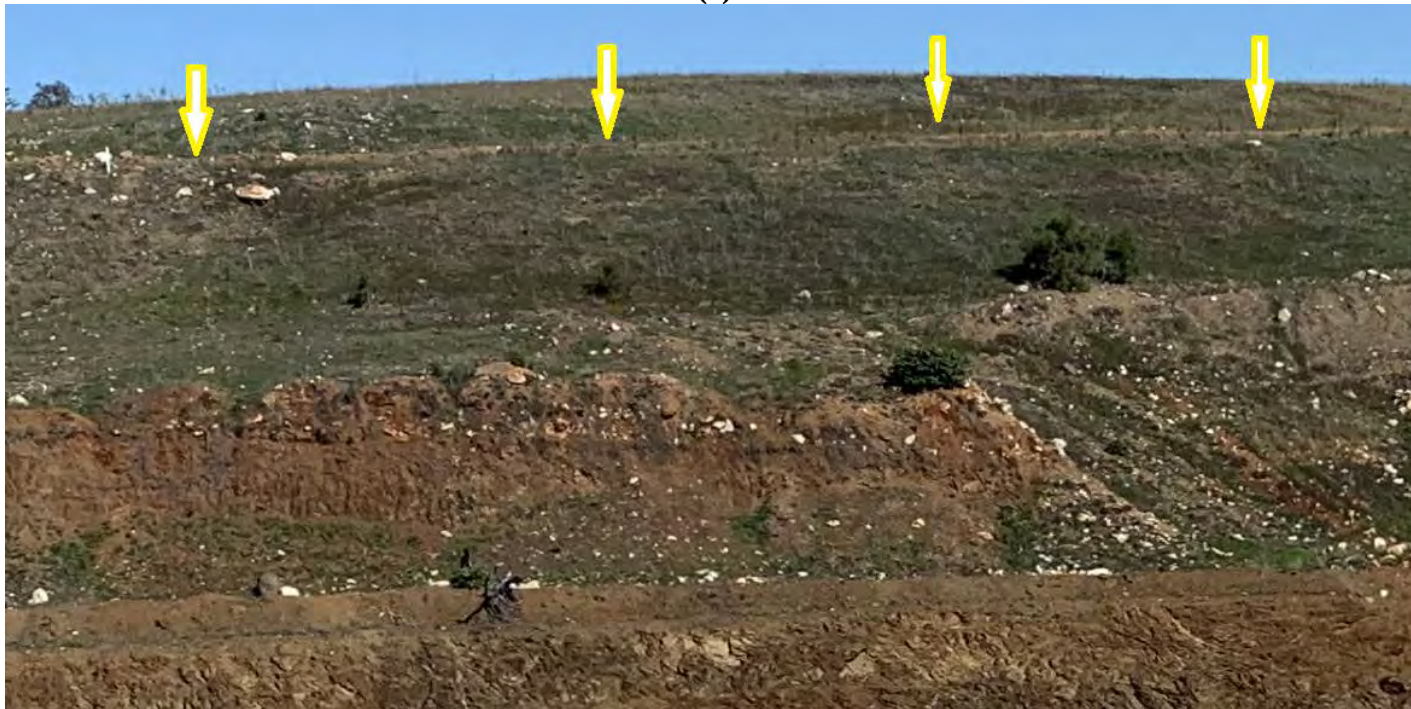
**Figure 5.** WRD 1 to the west of the East-West pit. The dump to remain in-situ. (b) The bund along the crest is inadequate as an abandonment barrier. It is to be replaced with an abandonment bund (Section 7.3.2). The bund is to tie into the bund encircling the pit at the east and west ends of the dump.

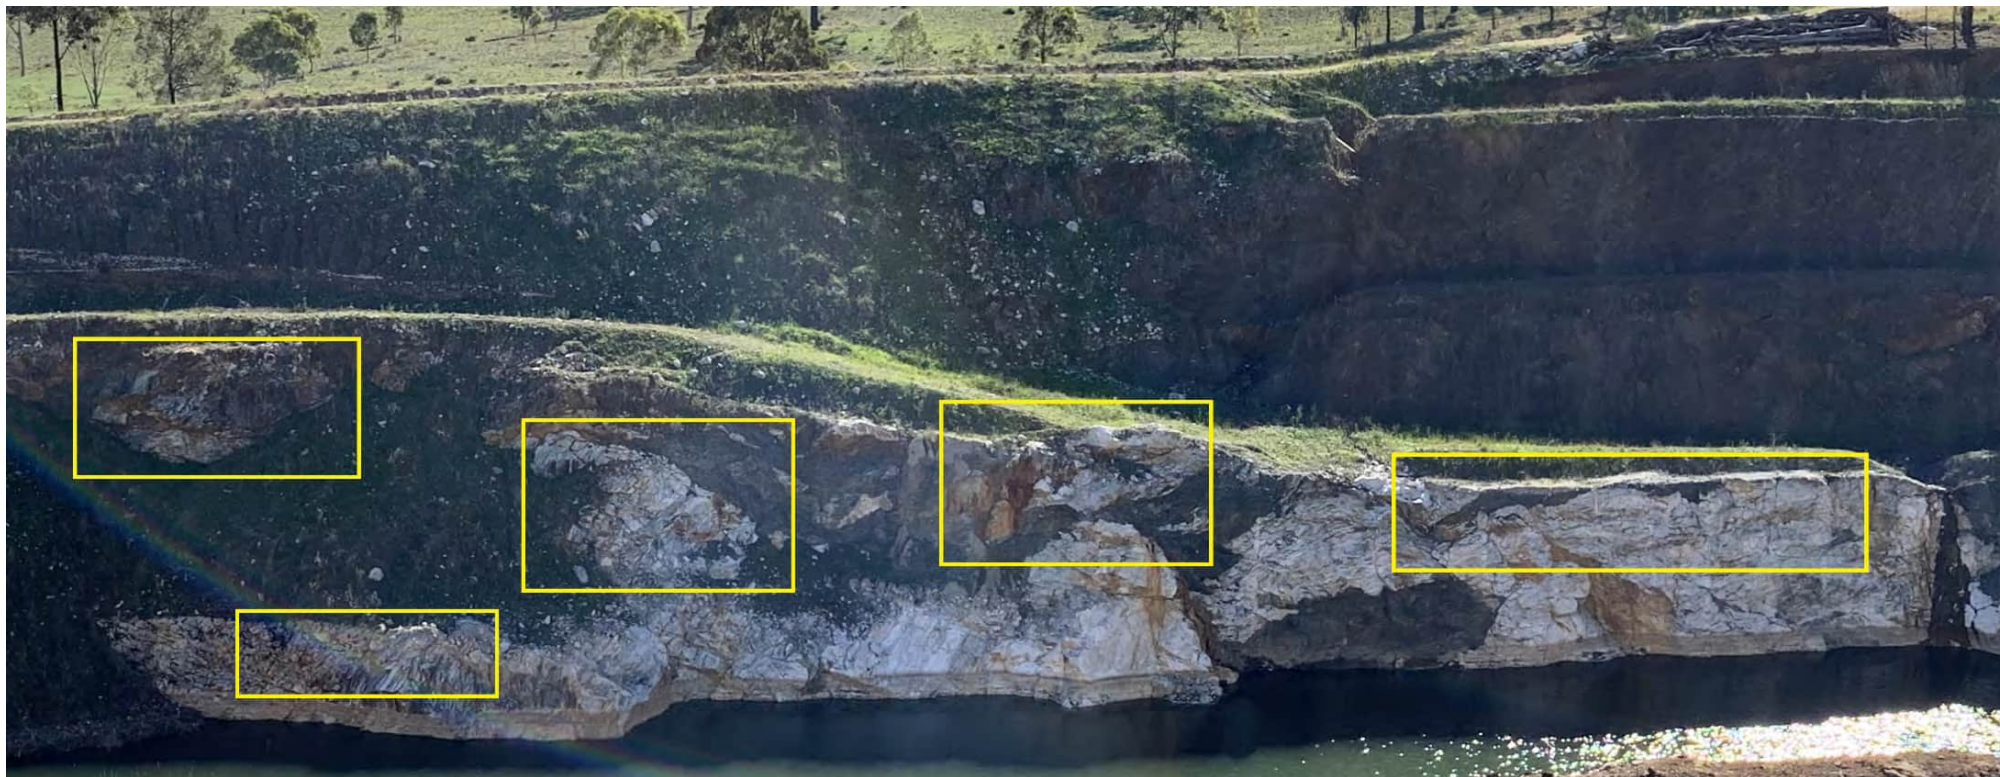
**Figure 23.** Loose and overhanging rocks (highlighted) on the batters of the north wall at the west end of the East-West pit.

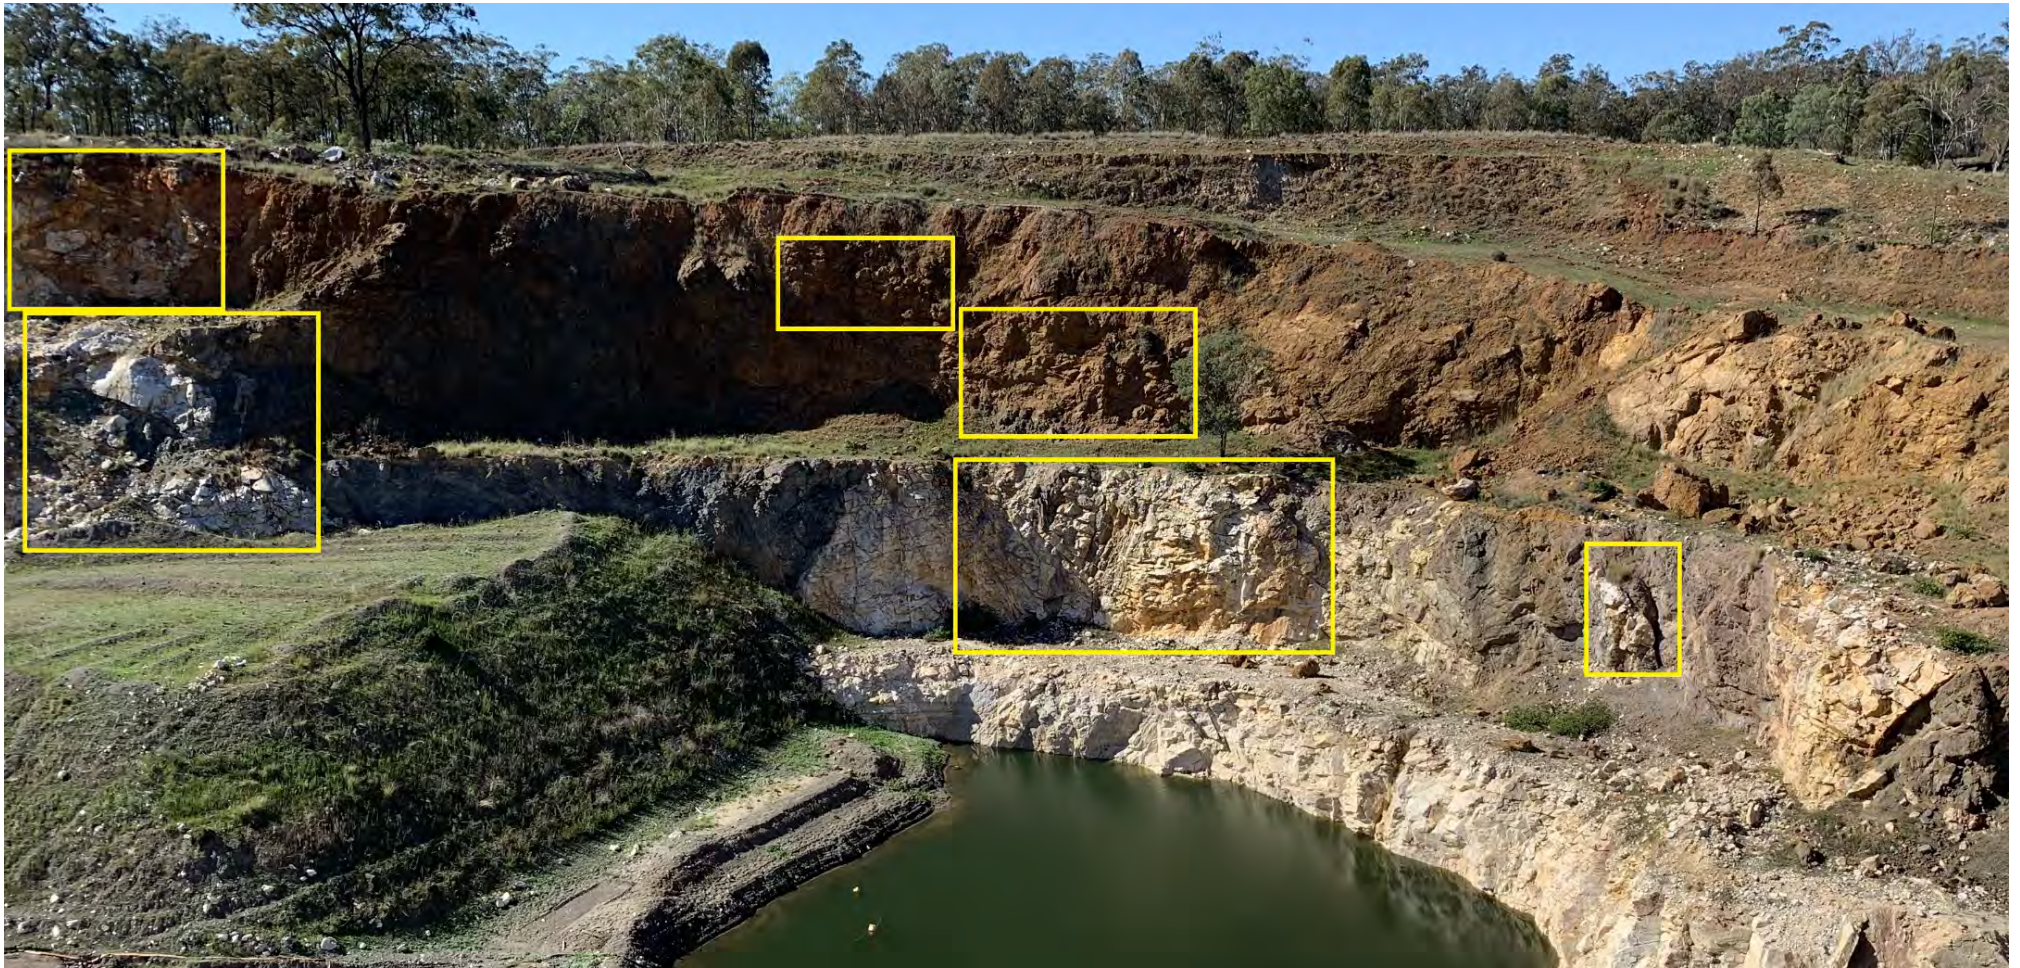
**Figure 24.** Scree filled berms, loose rocks on batters and overhanging rocks (highlighted) on the northeast wall at the east end of the East-West pit.

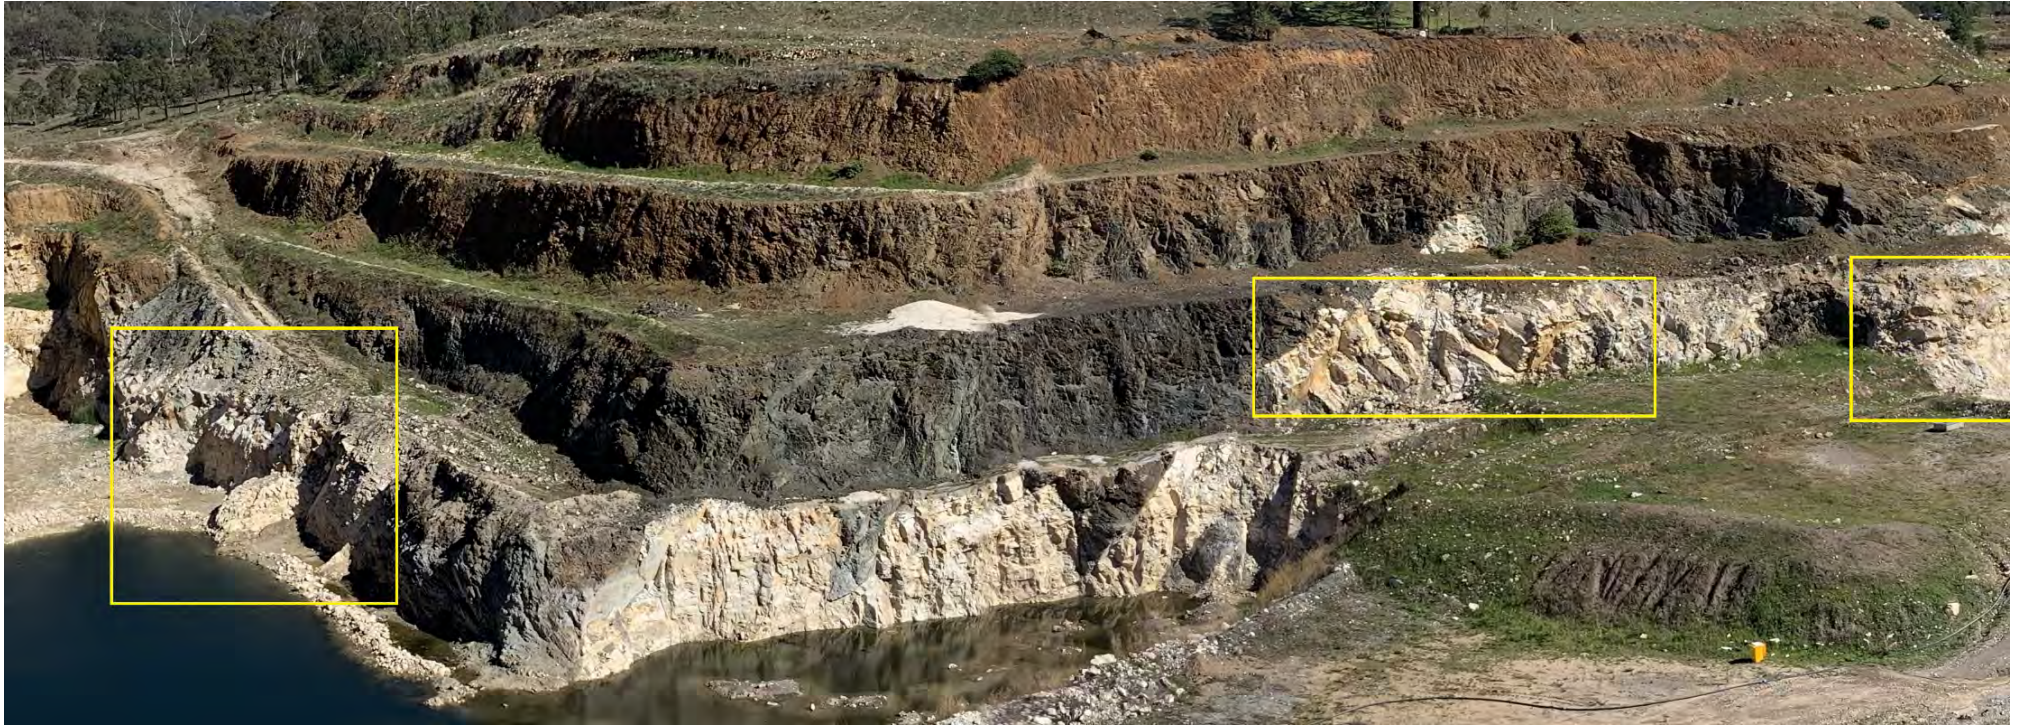
**Figure 25.** Loss of widths of some sections of some berms, loose rocks on batters (highlighted) on the southwest wall at the east end of the East-West pit.

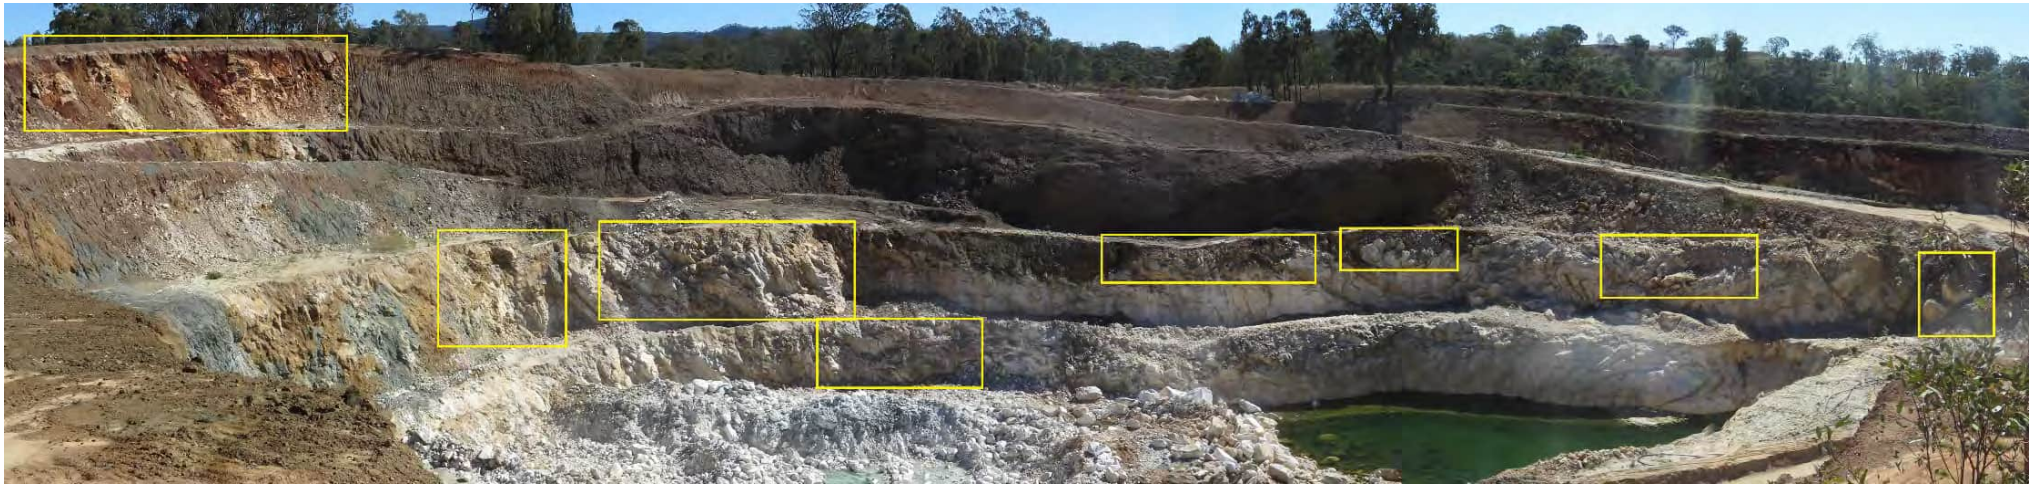
**Figure 26.** Loss of widths on some berms and scree filled sections of berms, loose rocks on batters and overhanging rocks (highlighted) on the north wall of the Phoenix pit.

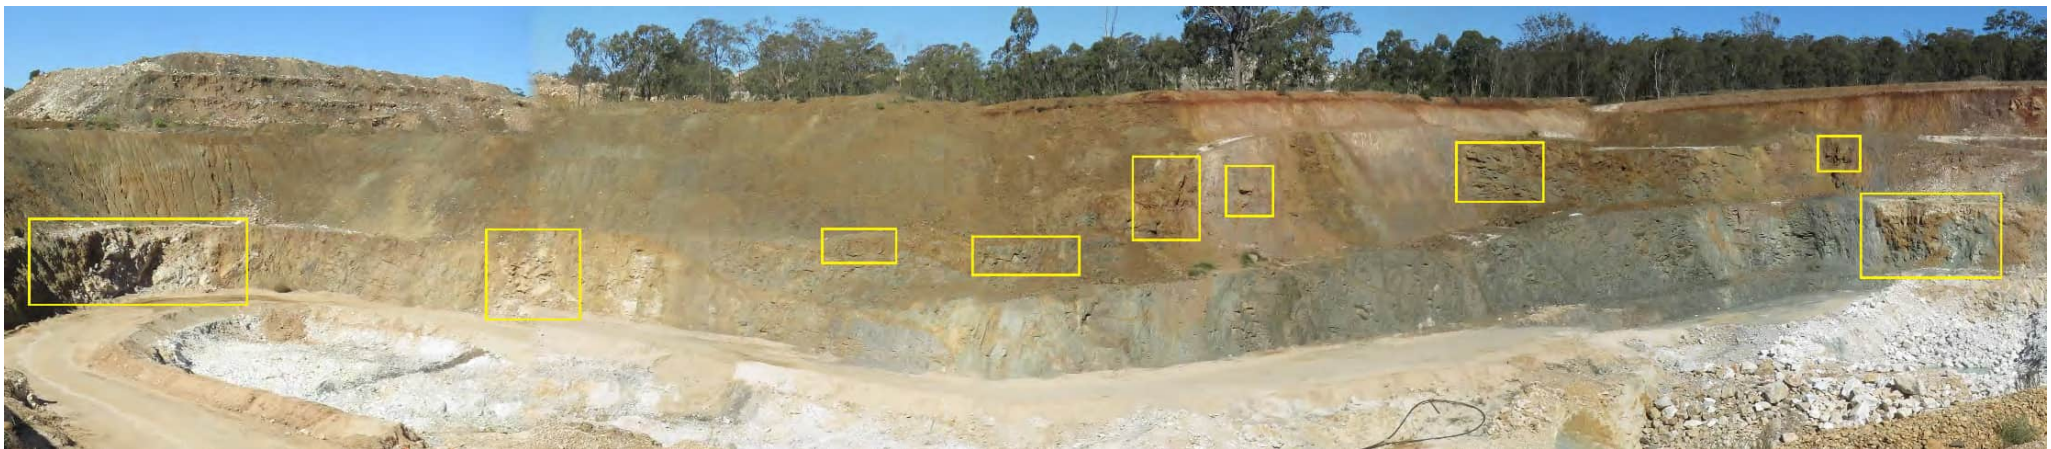
**Figure 27.** Loose rocks on the batters and overhanging rocks (highlighted) on the south wall of the Phoenix pit.

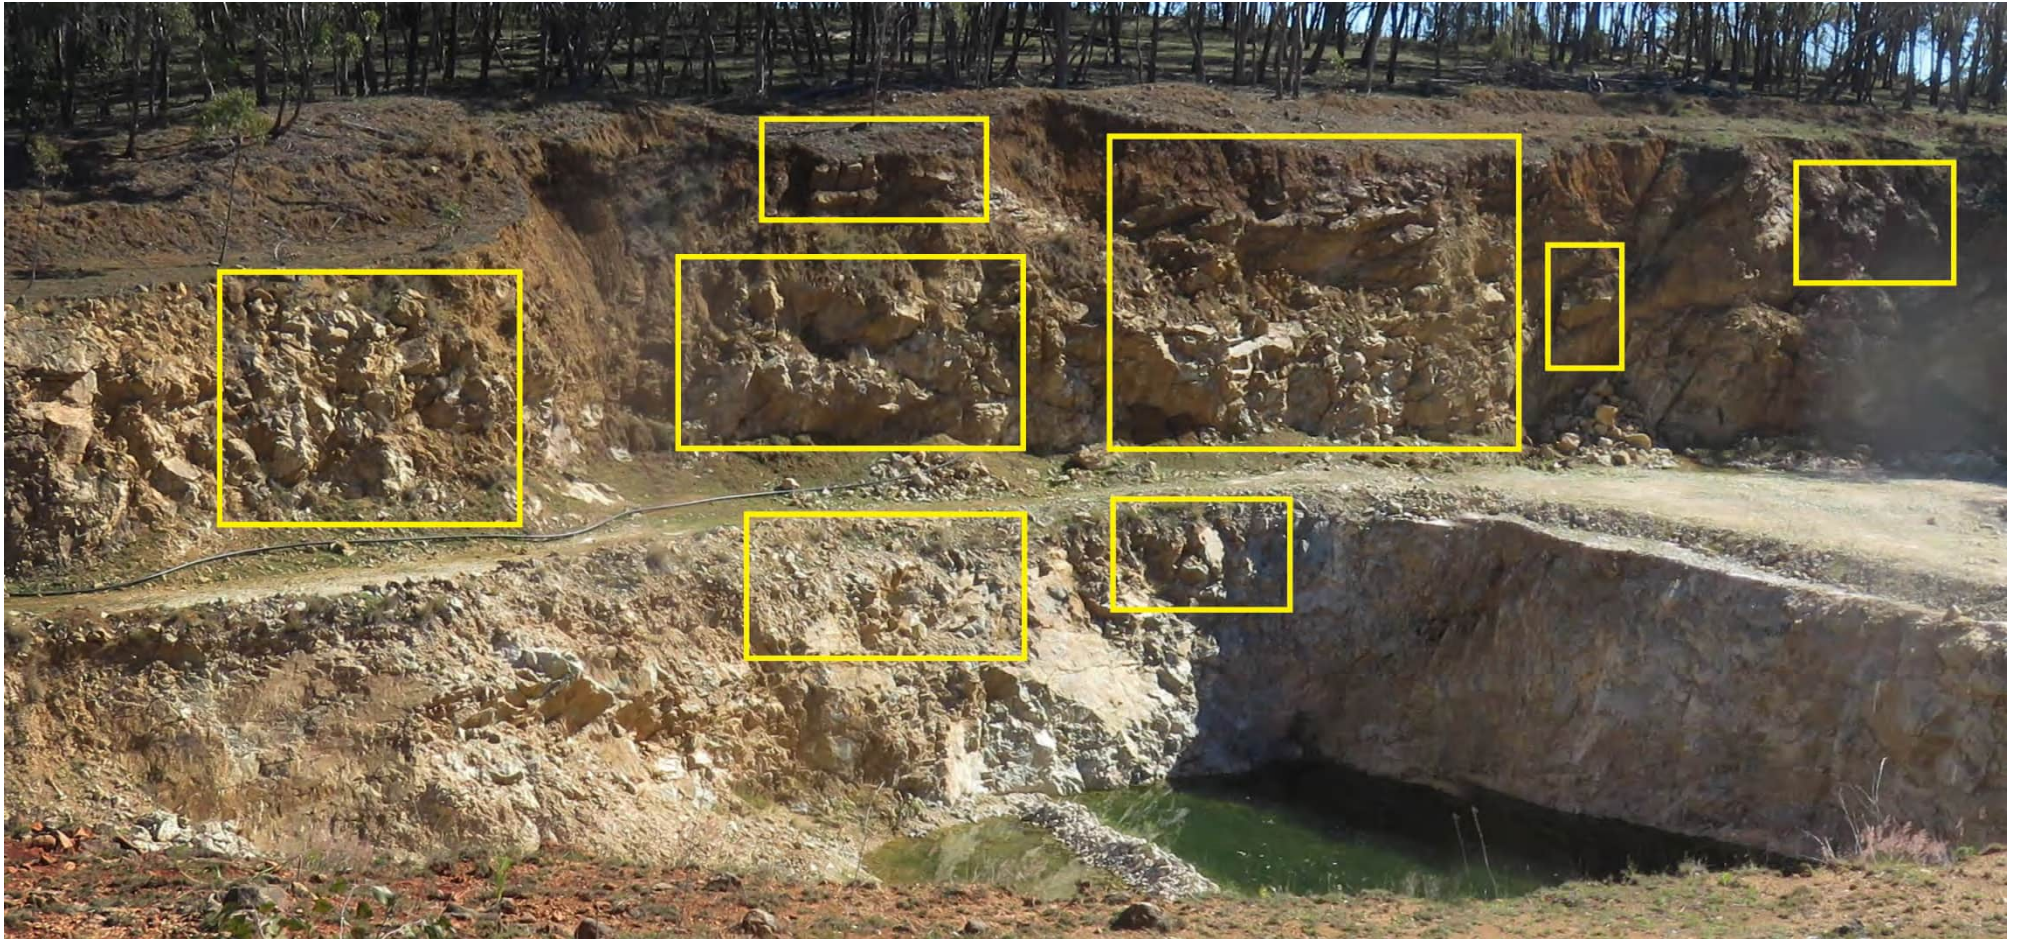
**Figure 28.** Loose rocks on the batters and overhanging and toppling rocks (highlighted) and scree on the berms on the west wall of the Aspinal pit.

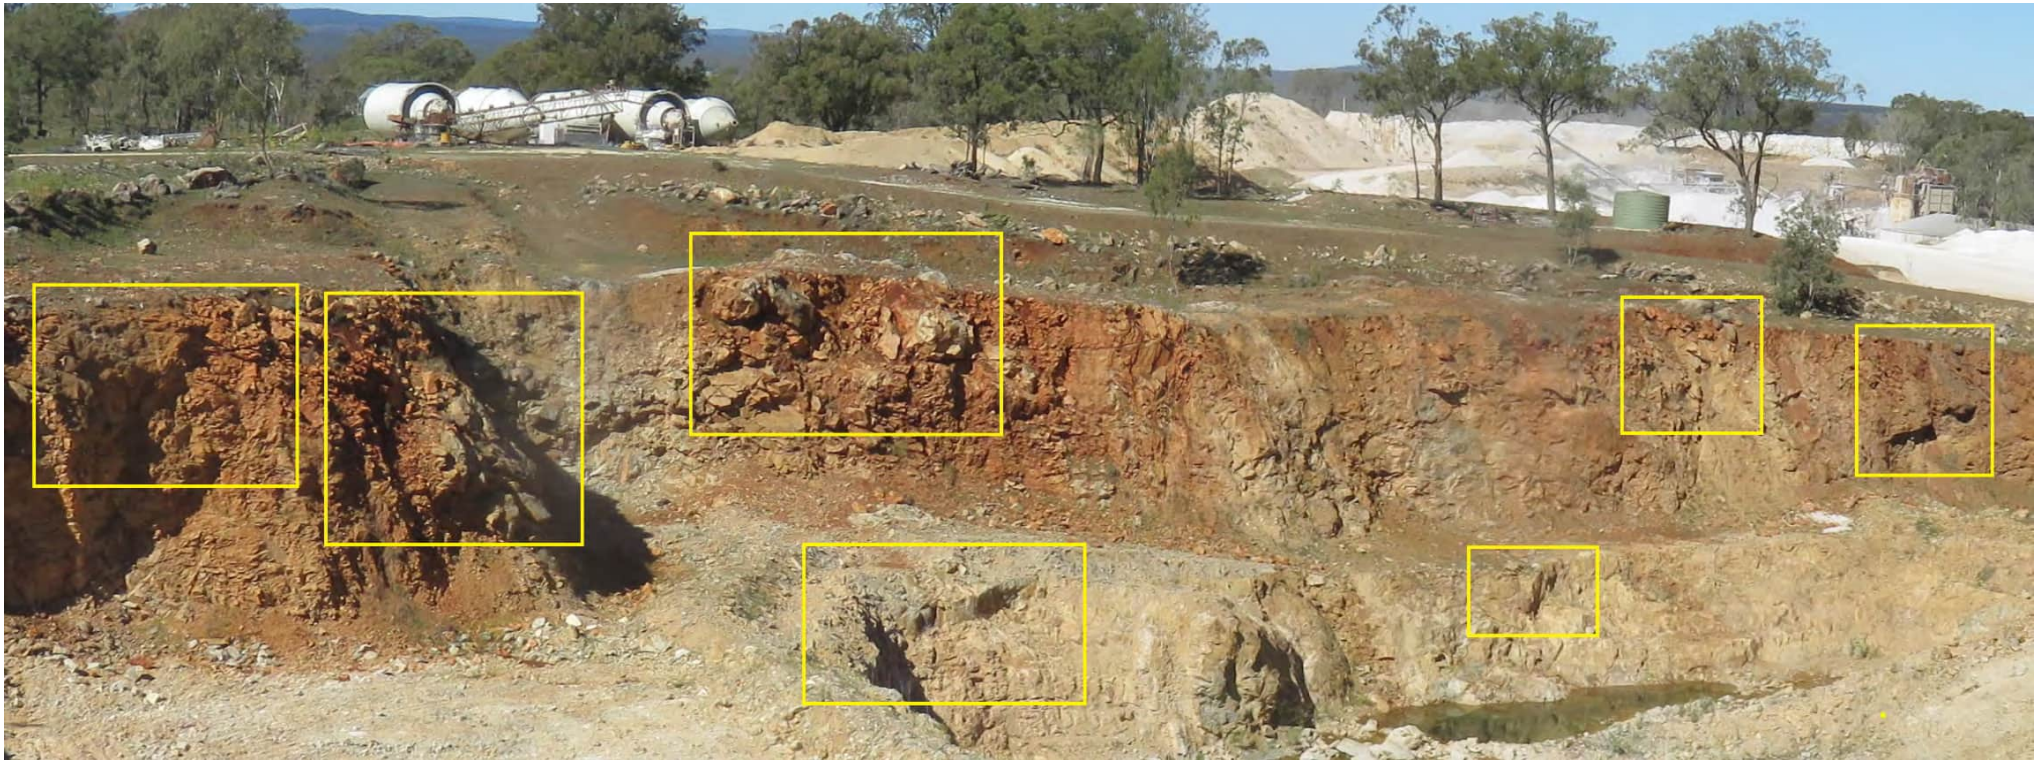
**Figure 29.** Loose rocks on the batters and overhanging rocks (highlighted) and loss of berm widths and scree on the berms on the east wall of the Aspal pit.

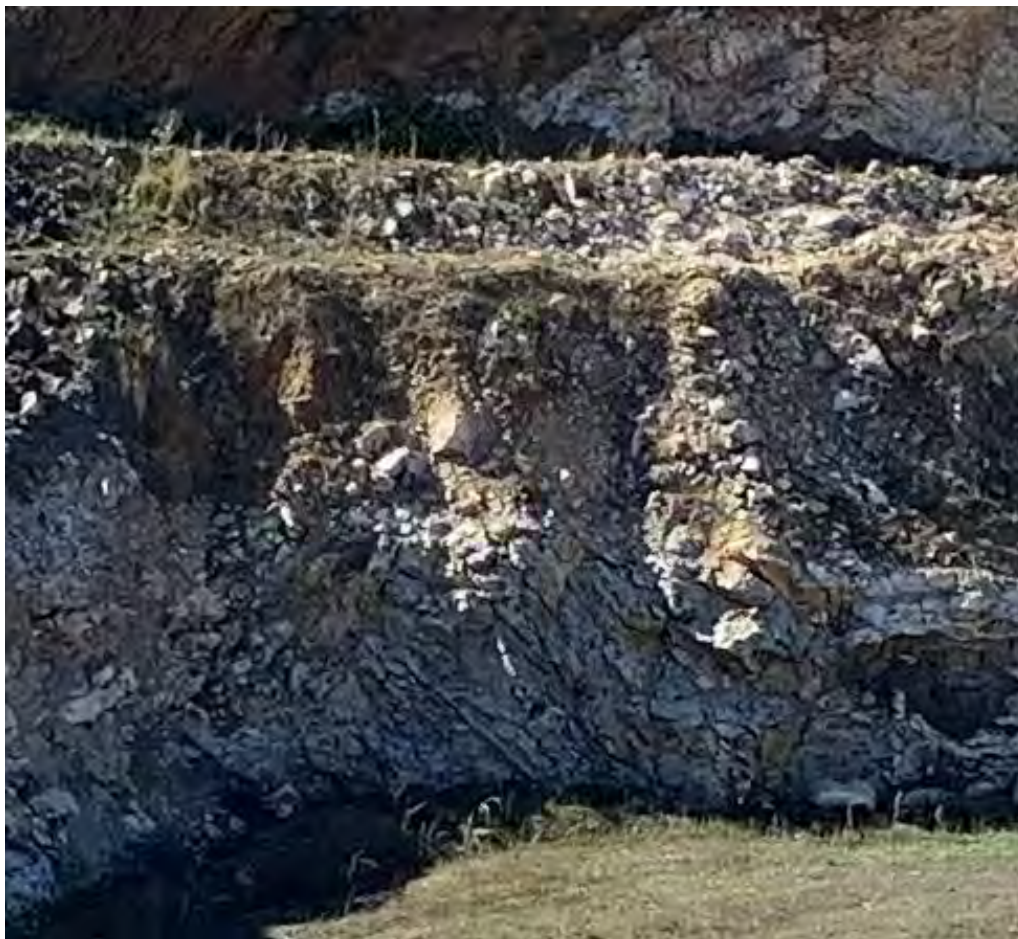
**Figure 30.** Sawtooth profile on the lower batter of the north wall of the east pit in the East-West pit due to multiple wedges sliding.

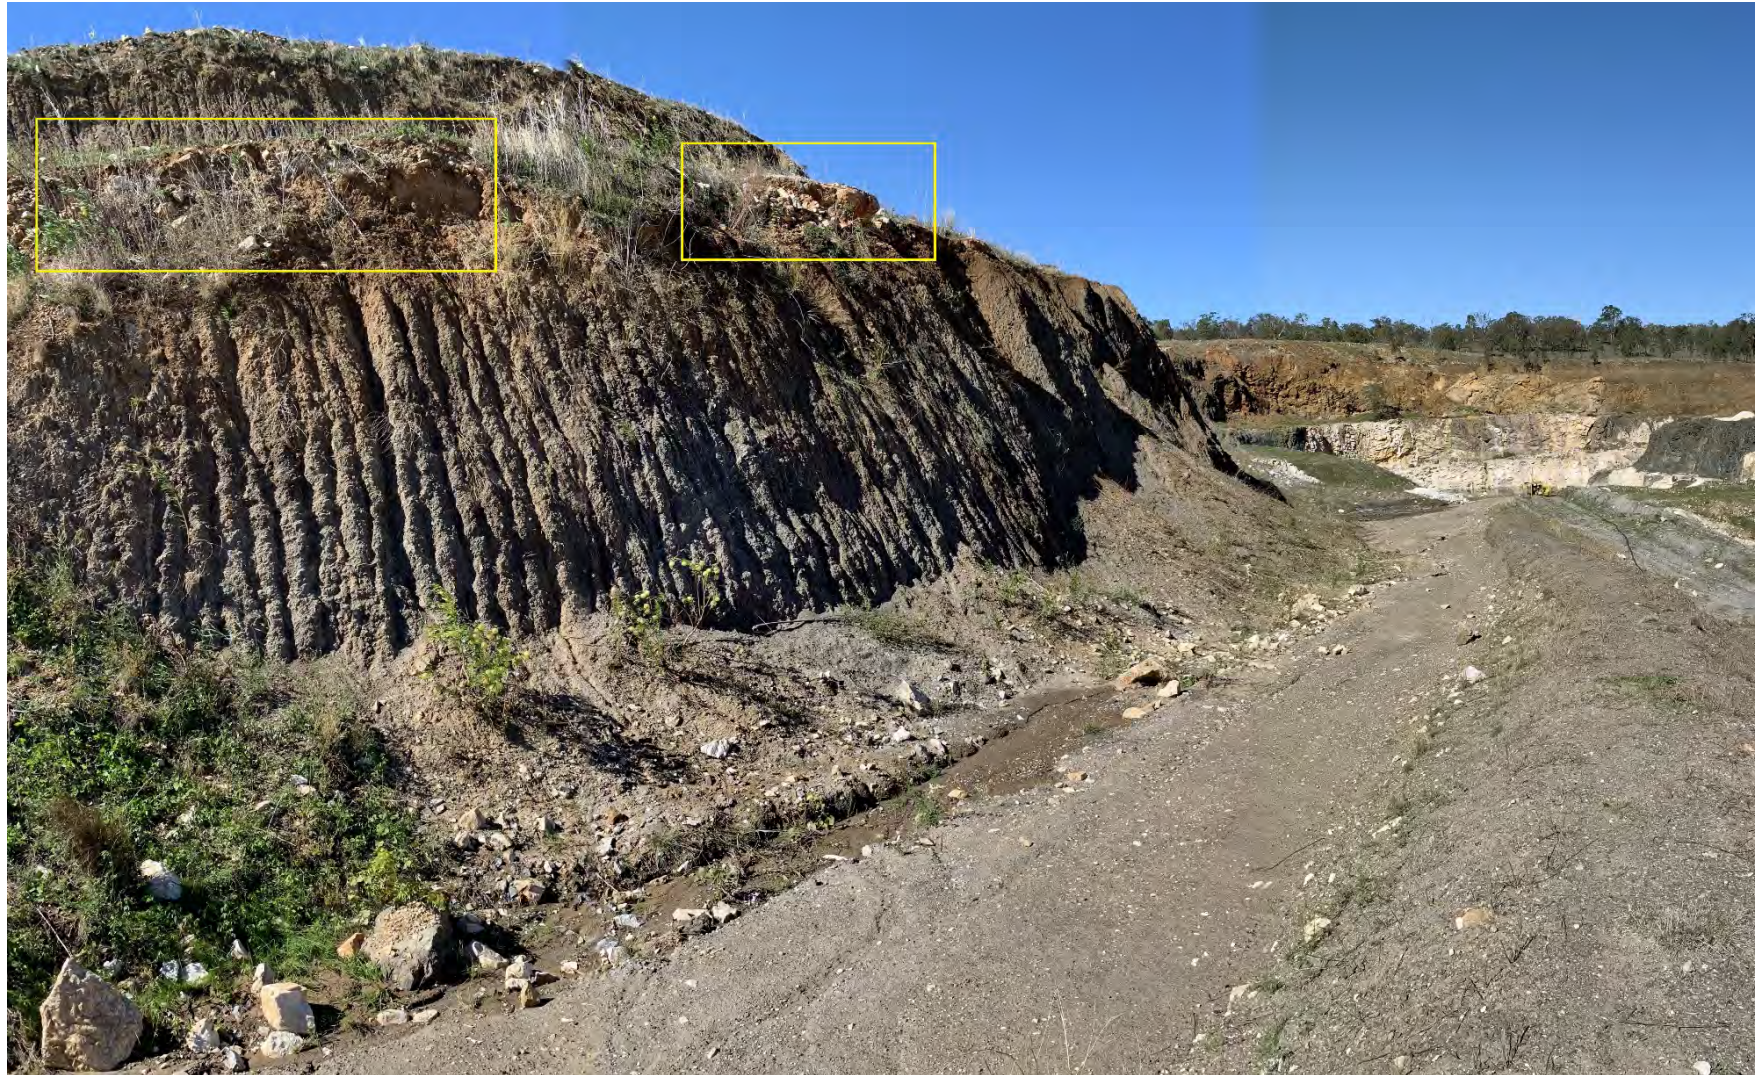
**Figure 32.** Loose rocks (highlighted) within soil and weathered siltstones near the crest of the batter adjacent to the central ramp in the East-West pit are currently hazards for users of the ramp. Batter should be draped in rockfall mesh, debris removed from the toe and drainage installed across and down the ramp. Flows of water from the overlying 550-mRL berm are not be modified with berm and batter drain and crest bunds.

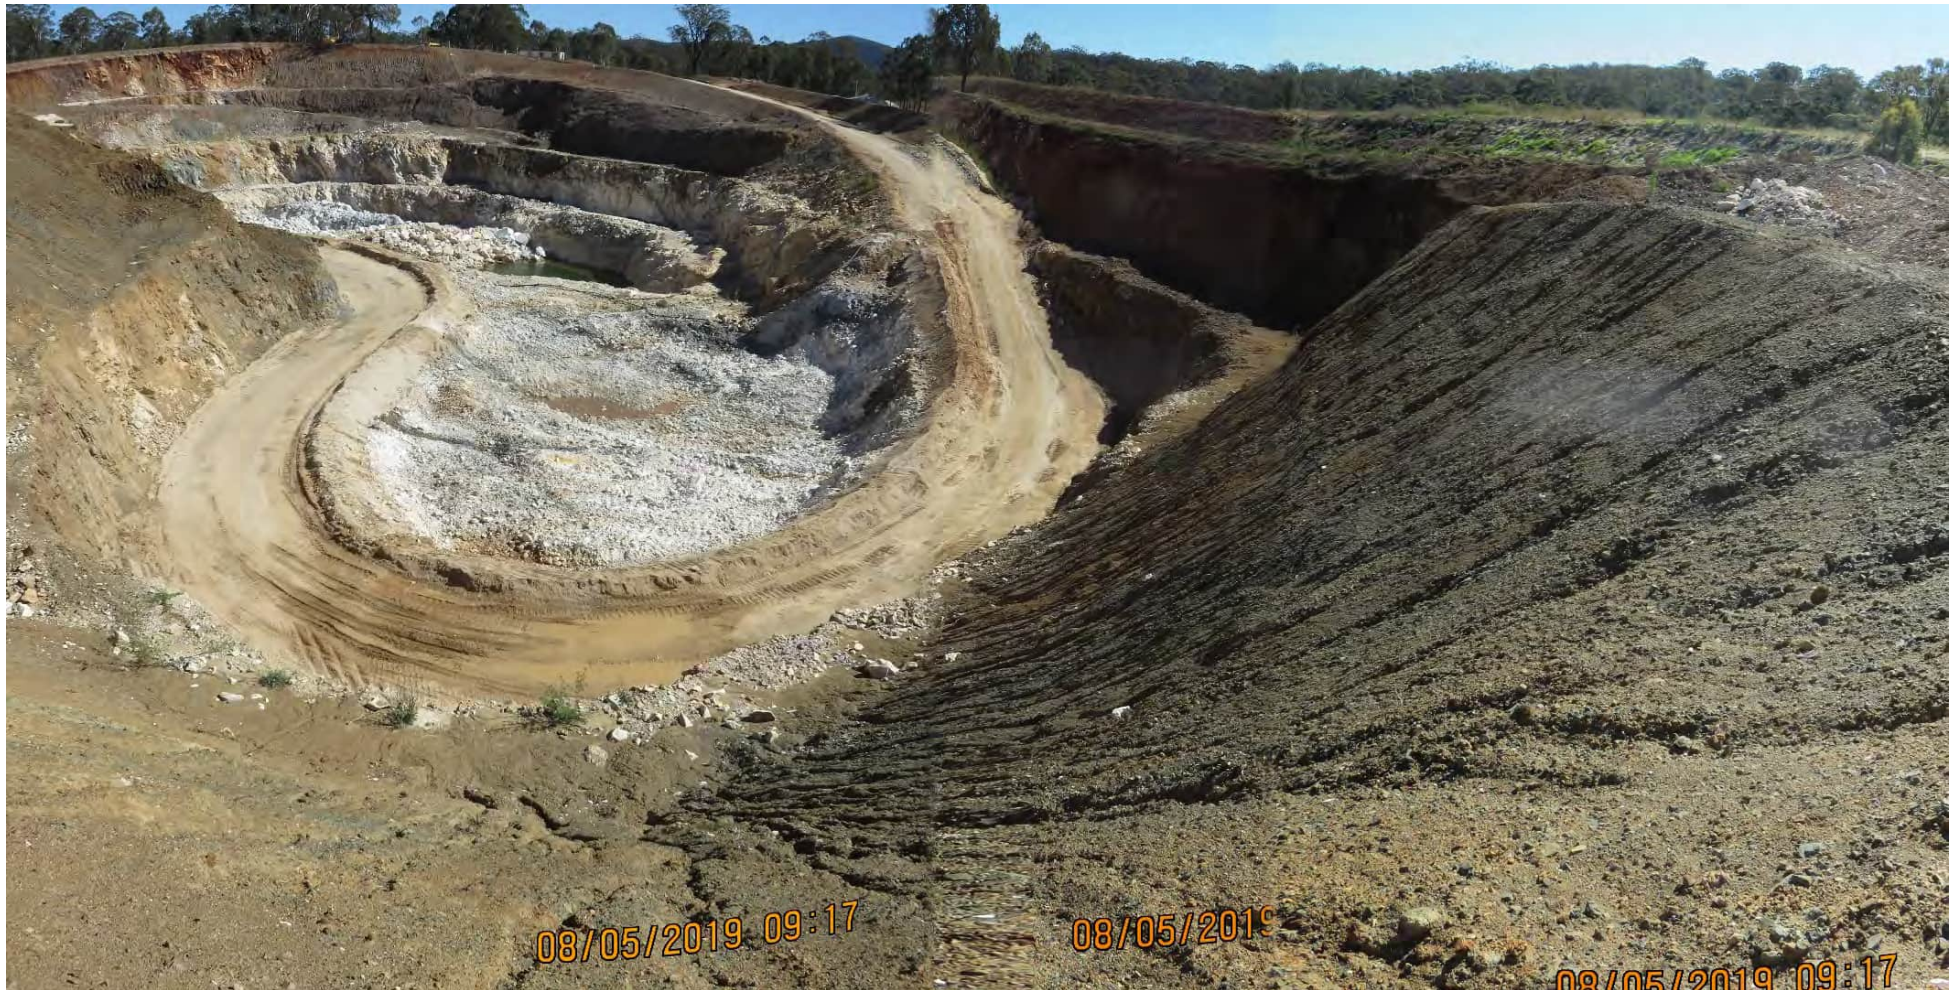
**Figure 33.** Erosion on the batters adjacent to the main ramp in the Phoenix pit. If not controlled will increase the likelihood for instabilities.  
Batter is to be hydroseeded

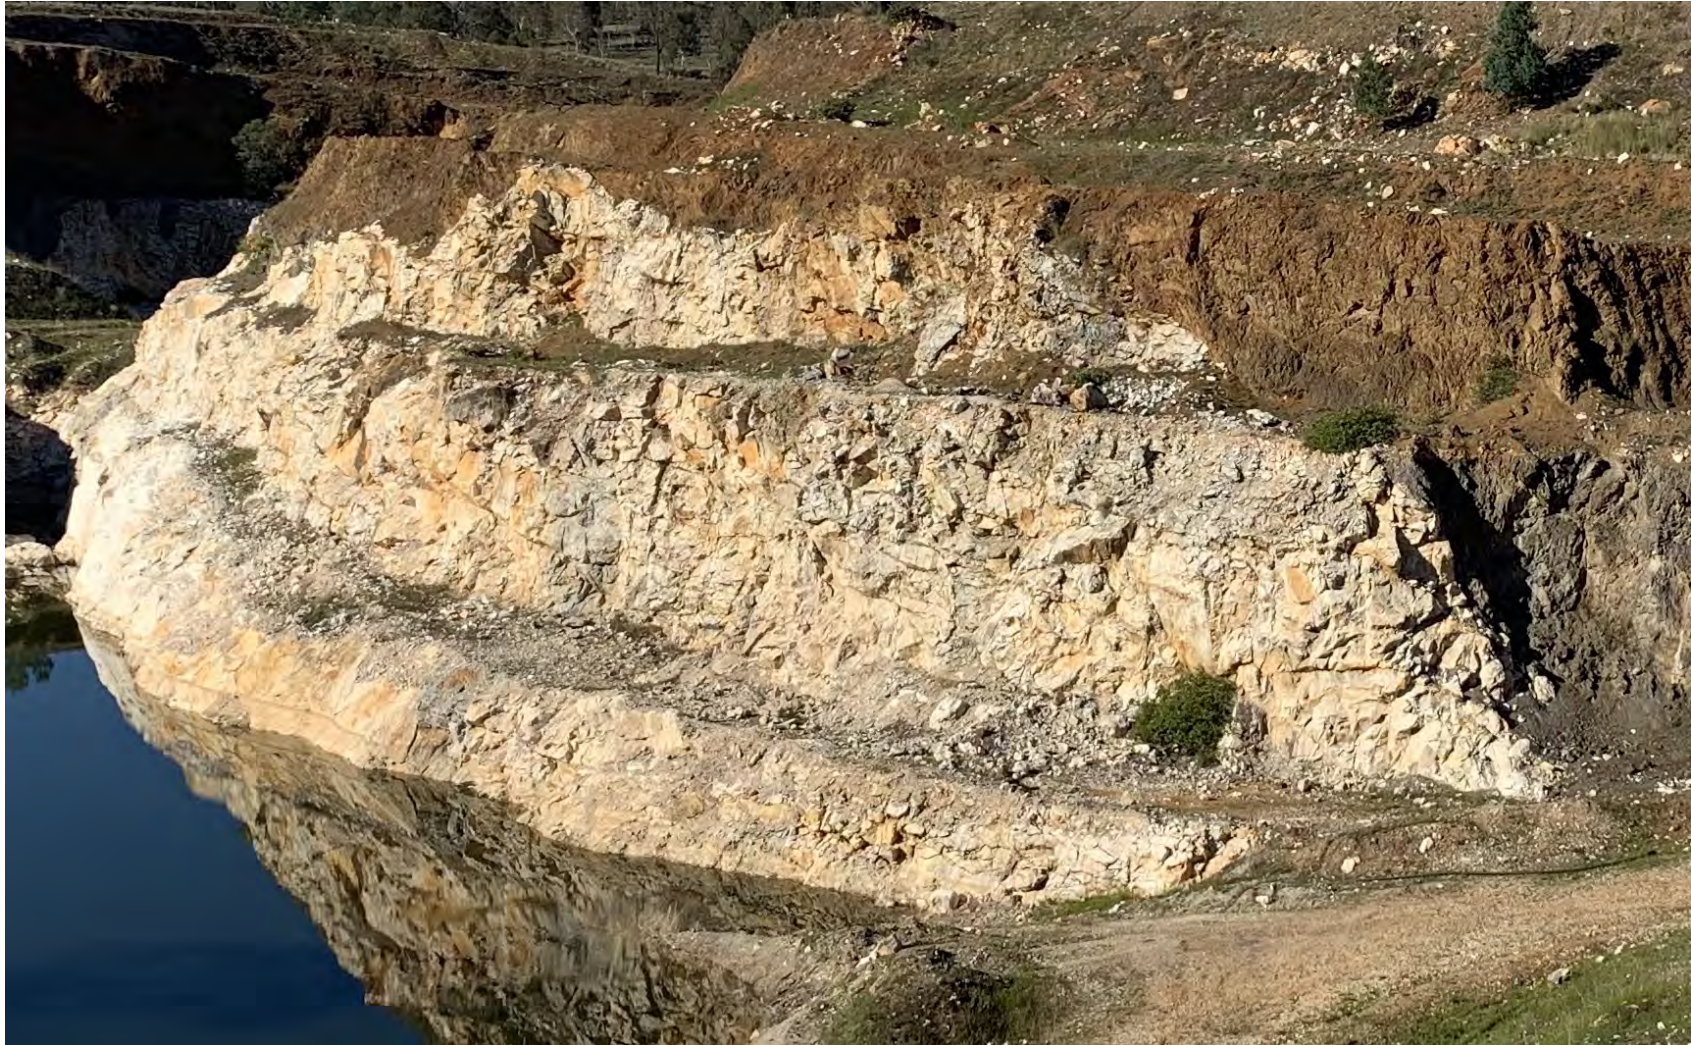
**Figure 34.** Loss of widths of most sections of the berms and scree filled berms, loose rocks on batters and overhanging rocks on the south wall at the west end of East-West pit. If the adjacent western ramp is to be retained, the height and continuity of the current toe bund are to be increased. Otherwise the ramp will be removed.

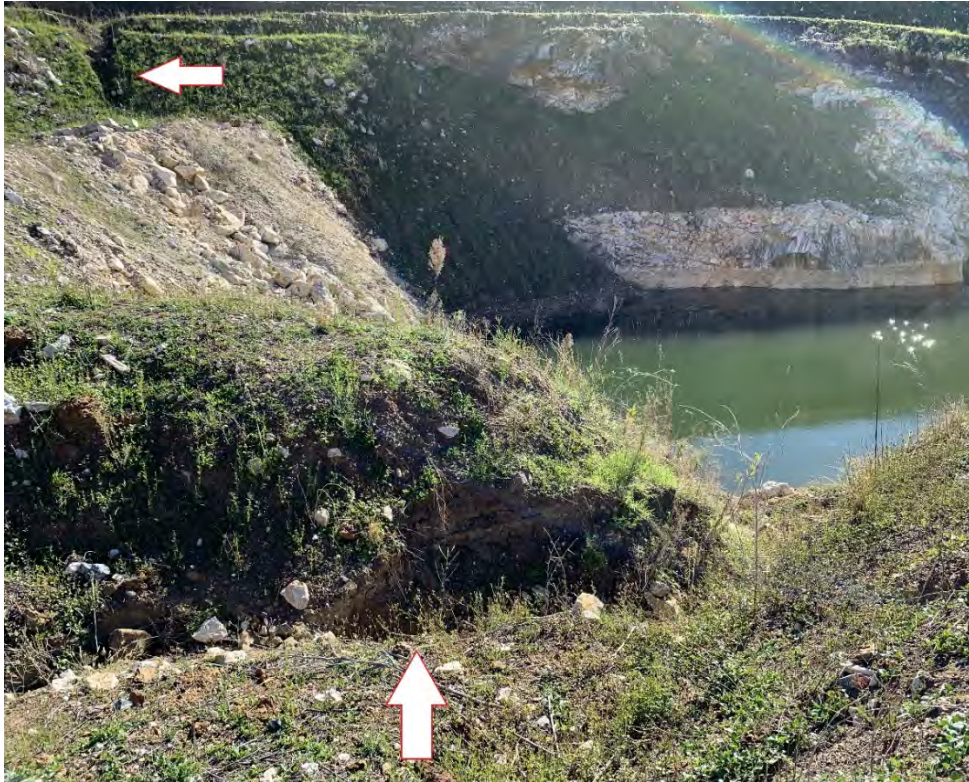
**Figure 35.** Two deep gullies cut in the haul-road and ramp at the west end of the East-West pit by water shedding off the ramp require remediation.

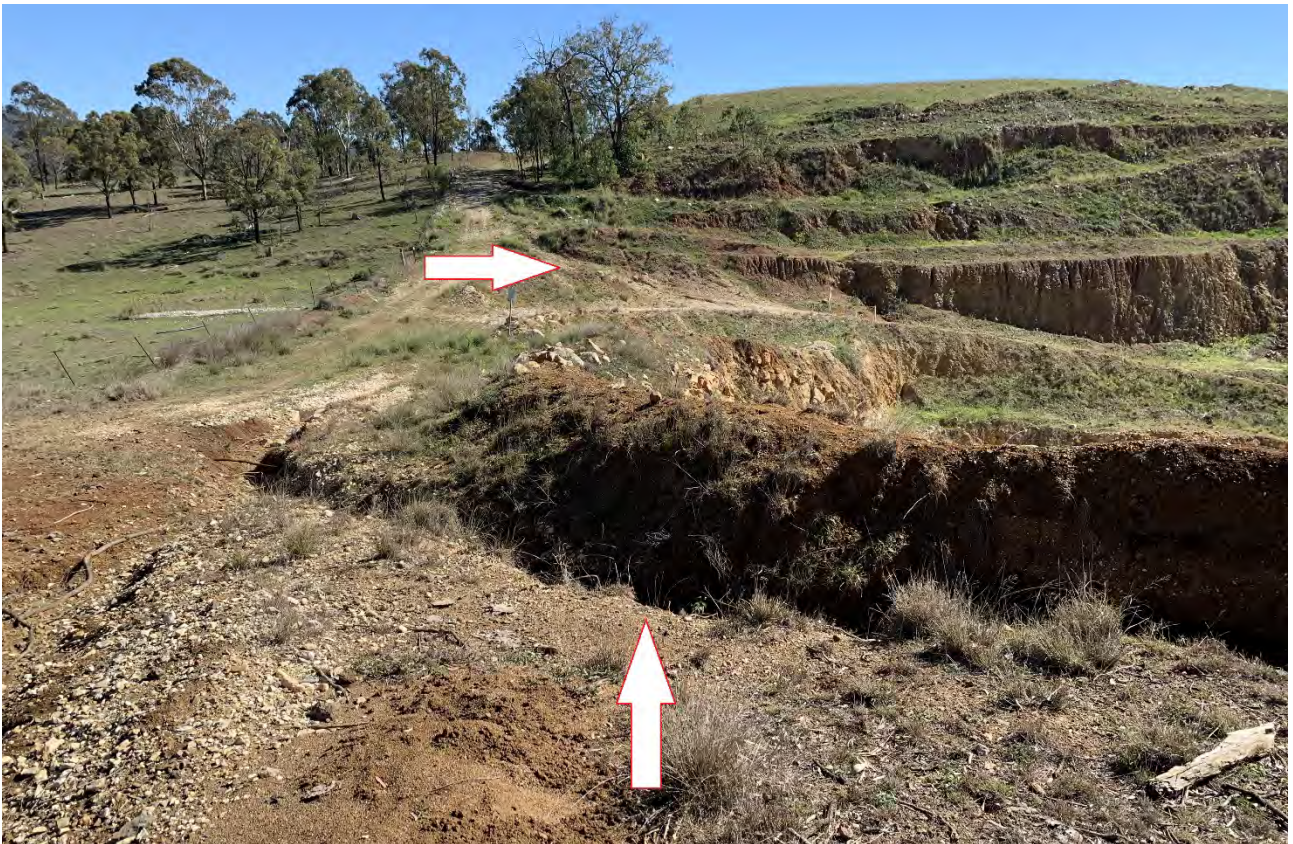
**Figure 38.** 2 x deep gullies cut by water shedding off the haul-road along the east end of the East-West pit requires repair. Haul-road to be graded to shed water to the east and ripped.

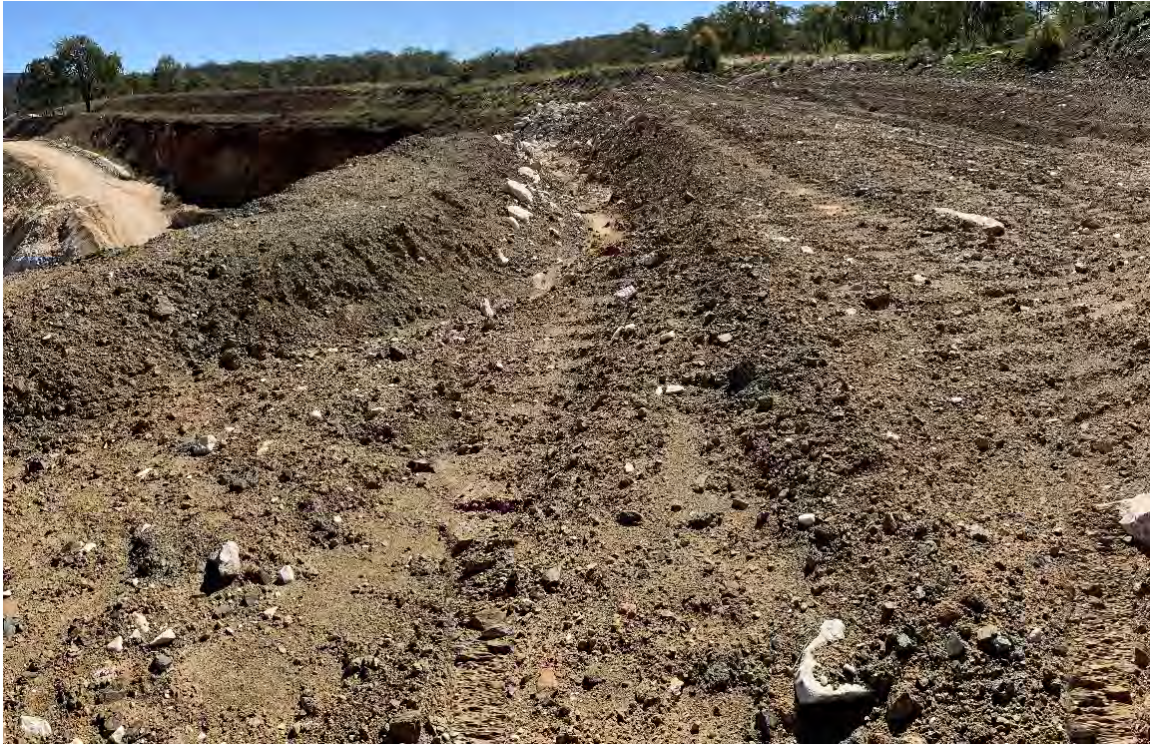
**Figure 39.** The haul-road along the east end of the Phoenix pit is to be graded to shed water to the east, removed by ripping and hydroseeded.

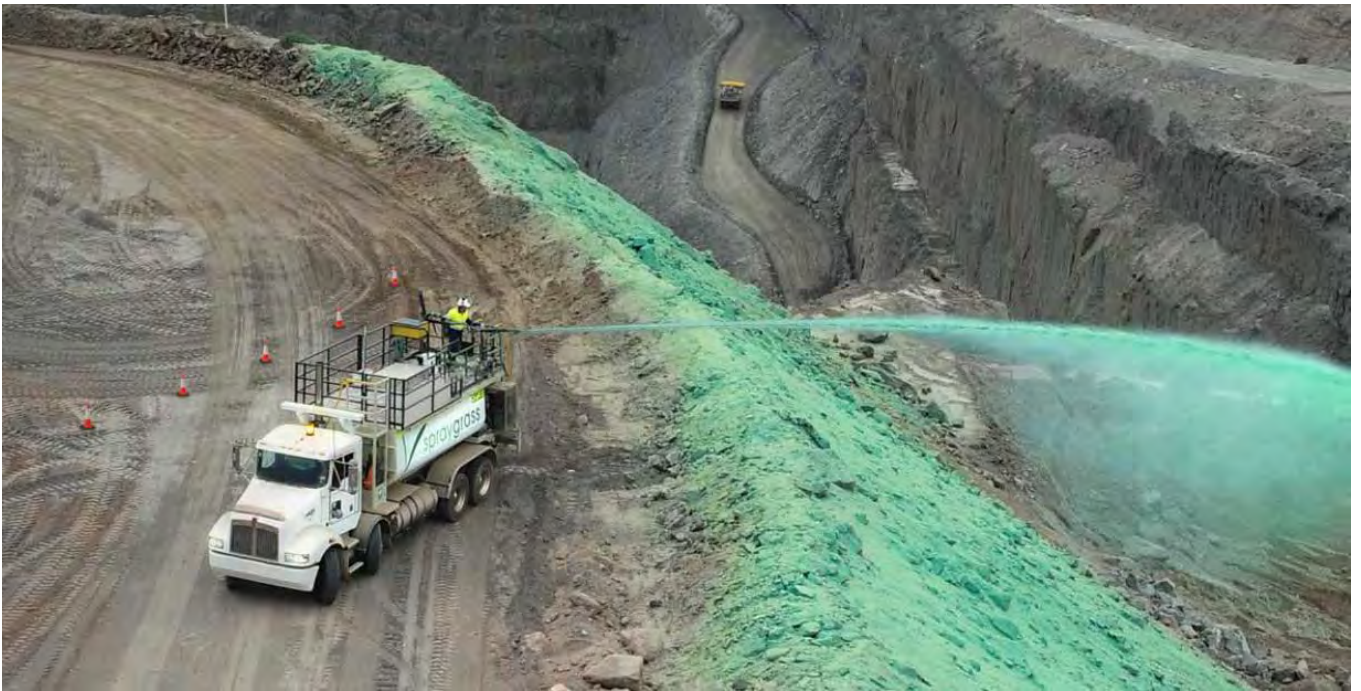
**Figure 55.** Hydroseeding, and desirably hydromulching, are recommended for the batter adjacent to the main ramp along the east wall of the Phoenix pit and for spraying topsoil on WRD 2.
