# Progressive Rehabilitation and Closure Plan

## WARWICK LIMESTONE MINE

**WARWICK LIMESTONE MINE –  
PROGRESSIVE REHABILITATION AND  
CLOSURE PLAN**

29 SEPTEMBER 2023

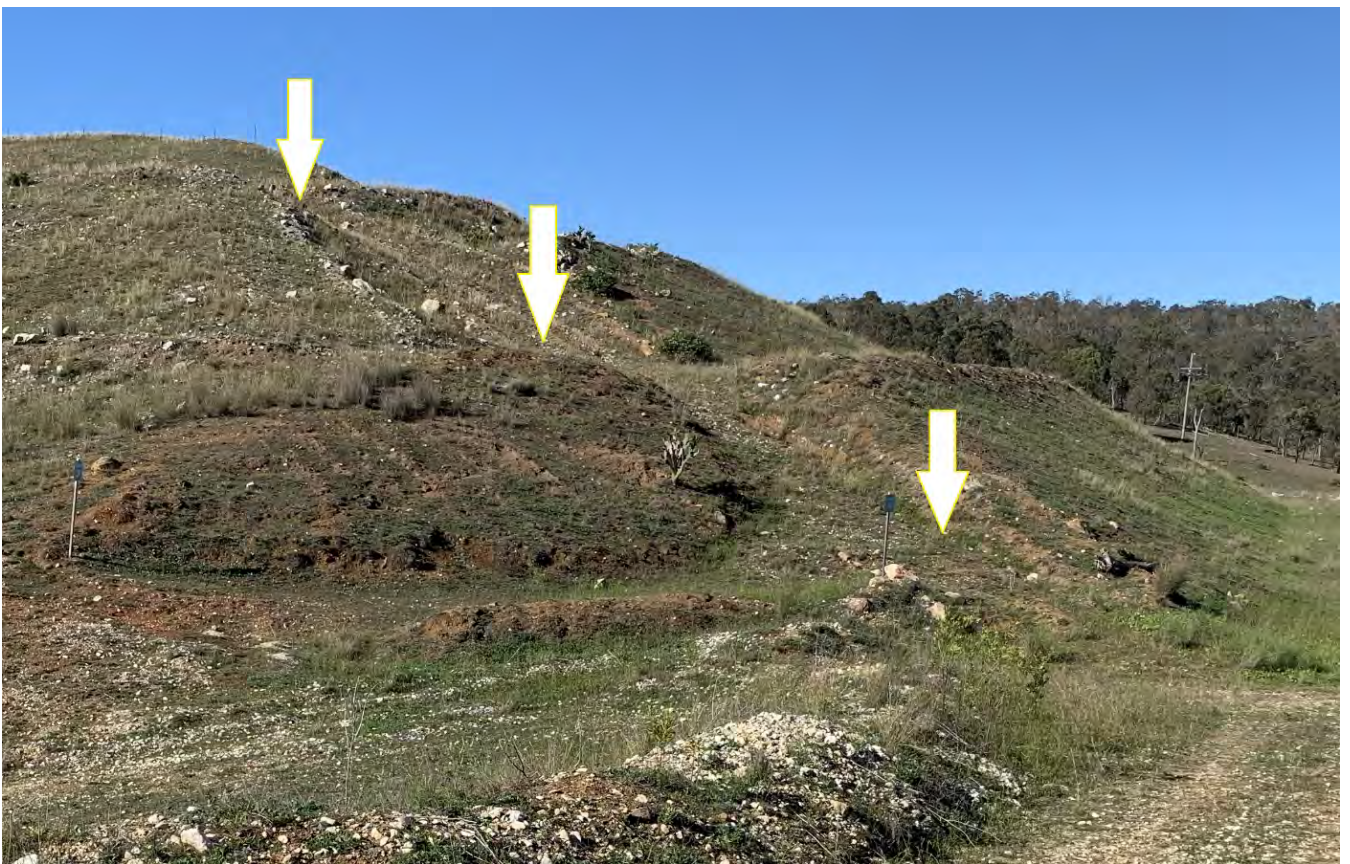
**Figure 56.** The ramp at the west end of WRD 1 on the south wall of the East-West pit is to be removed by ripping after an abandonment bund has been being installed along the north crest of the dump.

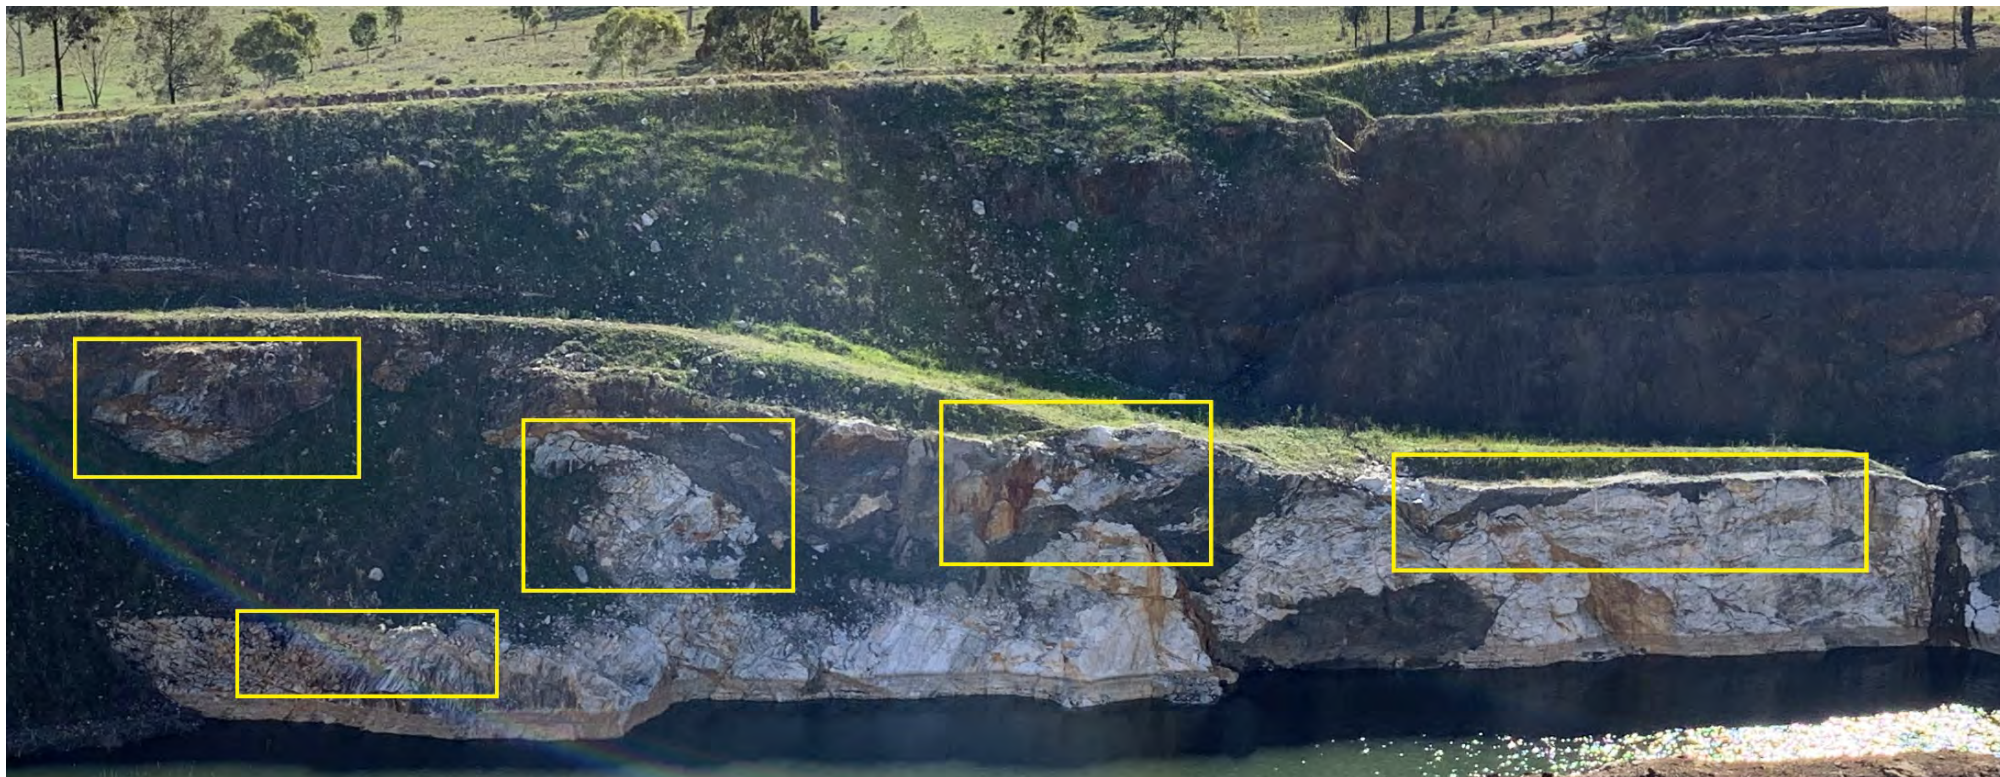
**Figure 23.** Loose and overhanging rocks (highlighted) on the batters of the north wall at the west end of the East-West pit.

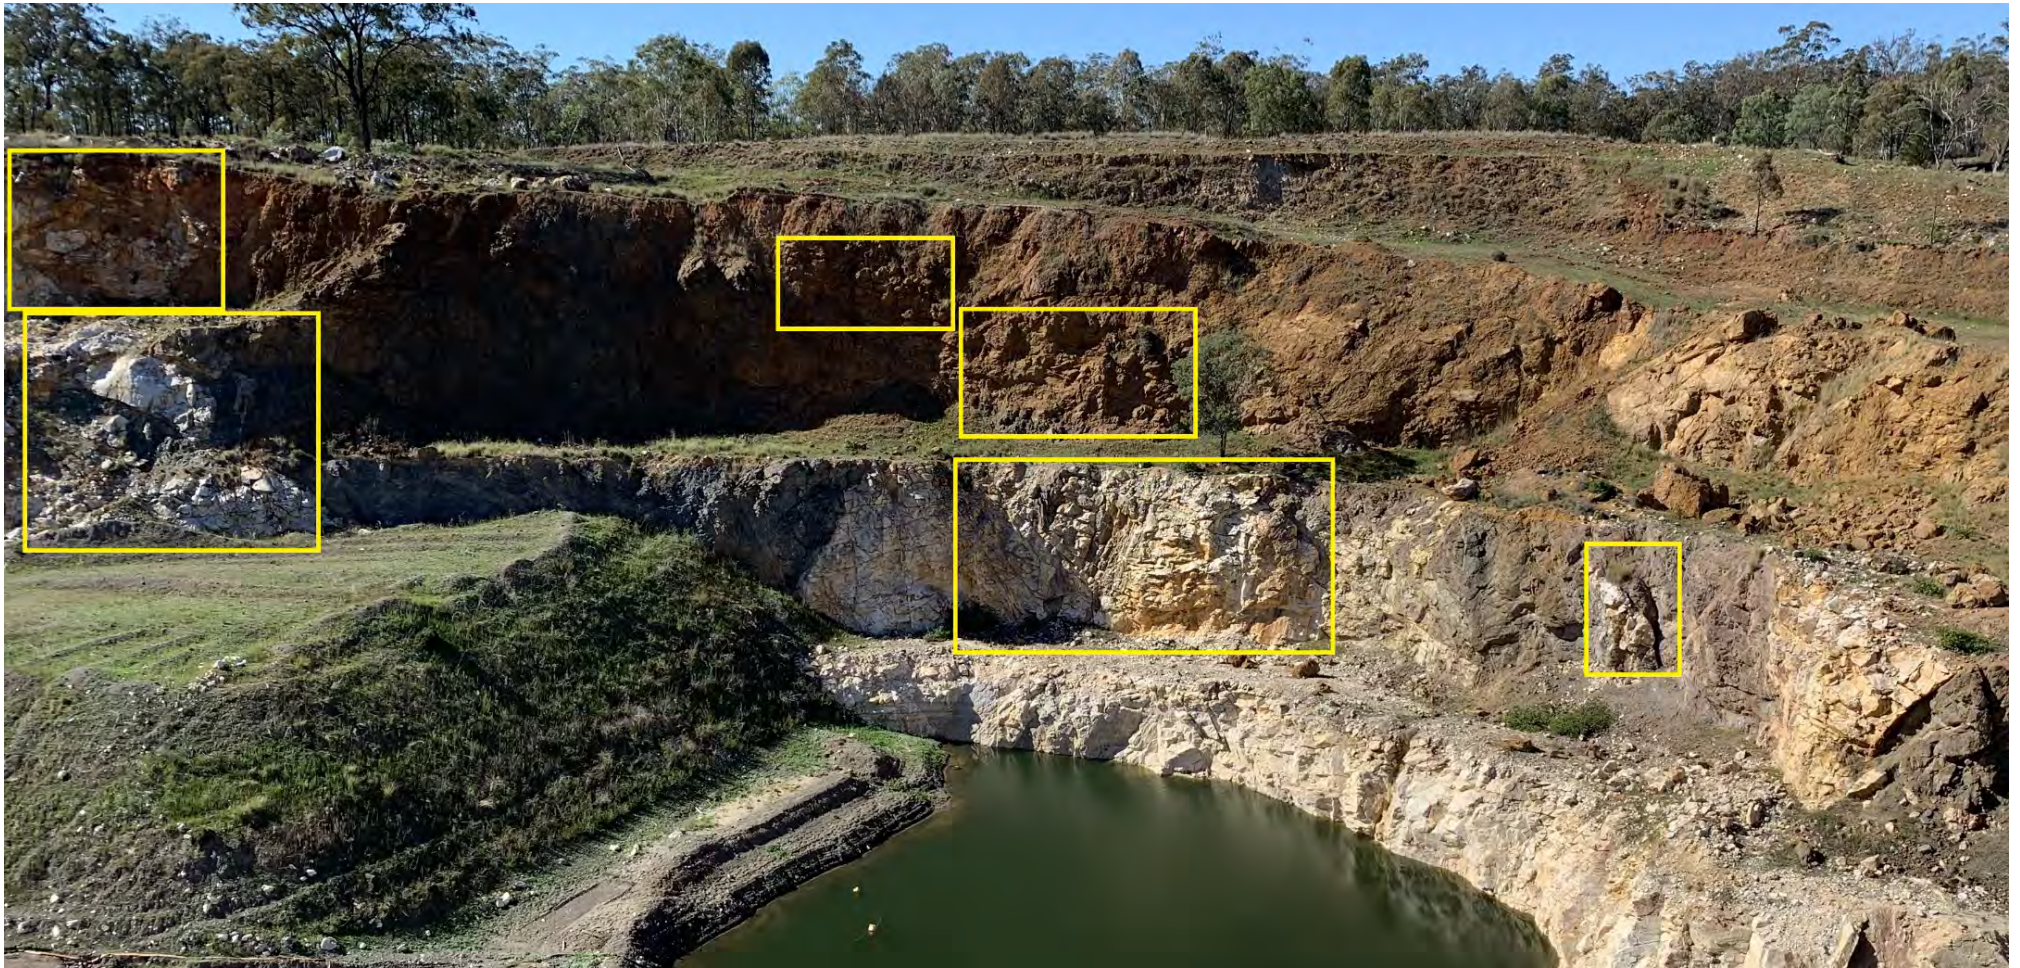
**Figure 24.** Scree filled berms, loose rocks on batters and overhanging rocks (highlighted) on the northeast wall at the east end of the East-West pit.

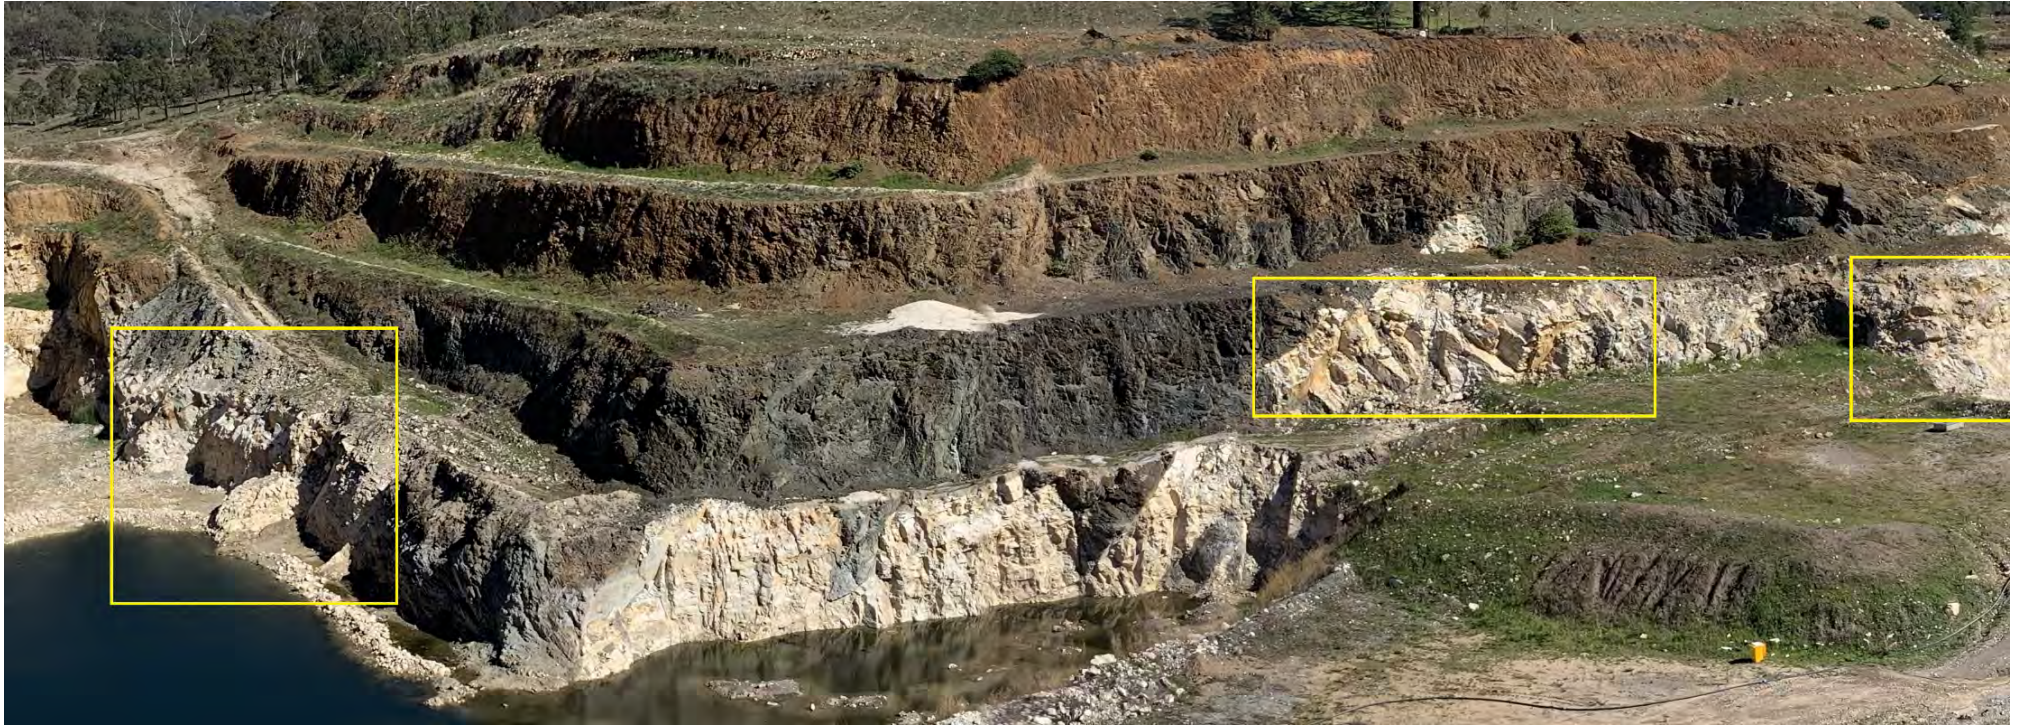
**Figure 25.** Loss of widths of some sections of some berms, loose rocks on batters (highlighted) on the southwest wall at the east end of the East-West pit.

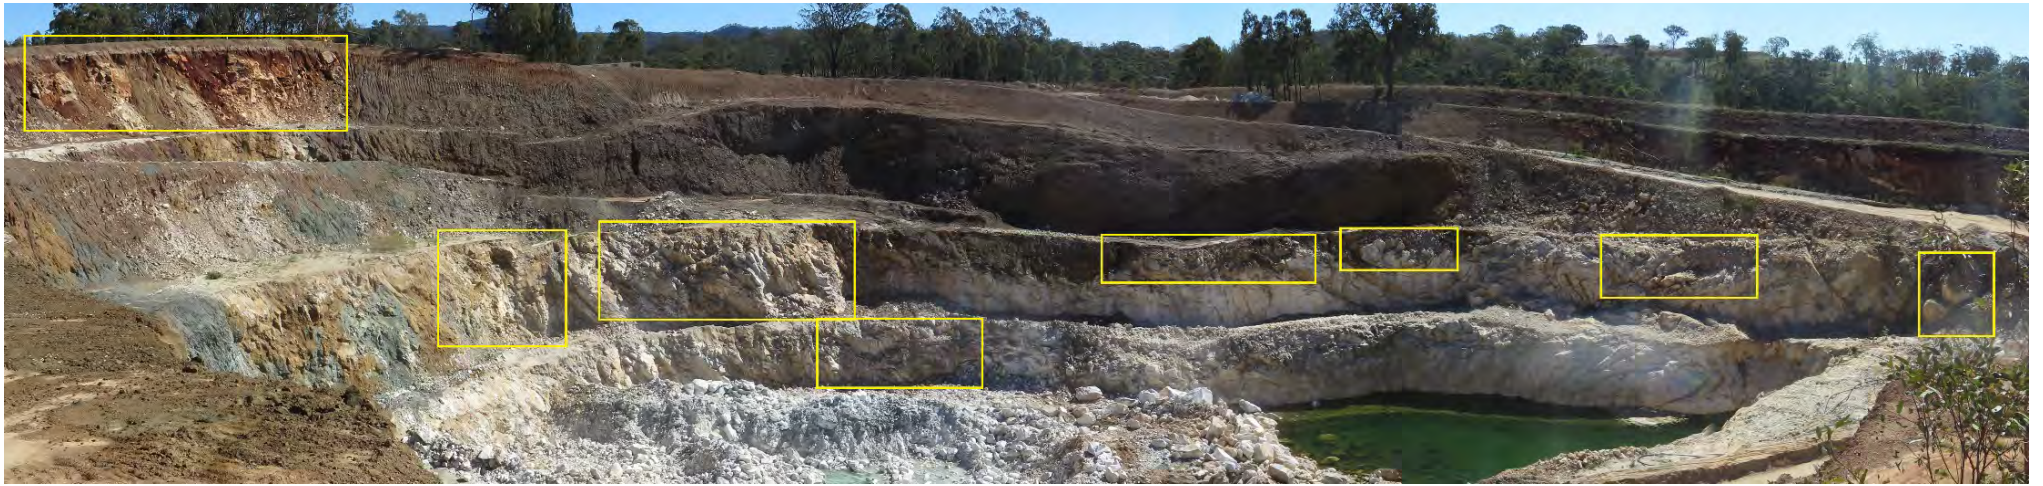
**Figure 26.** Loss of widths on some berms and scree filled sections of berms, loose rocks on batters and overhanging rocks (highlighted) on the north wall of the Phoenix pit.

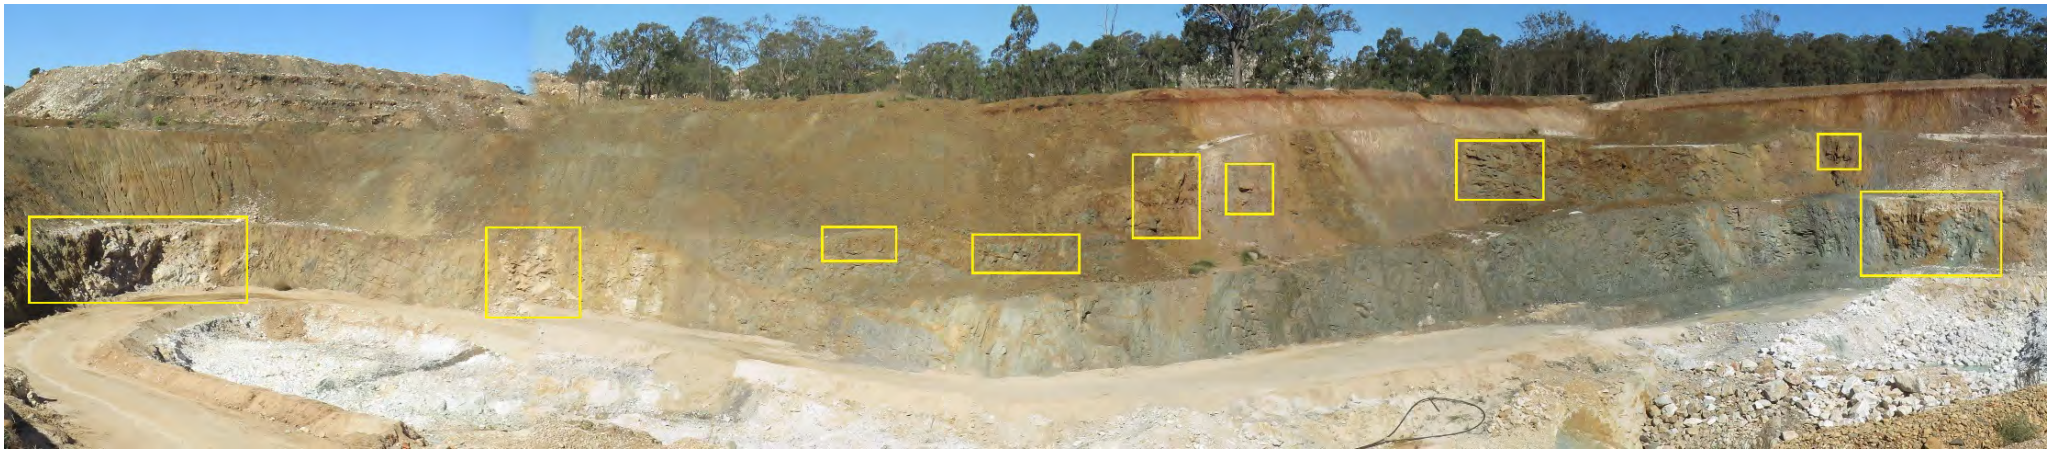
**Figure 27.** Loose rocks on the batters and overhanging rocks (highlighted) on the south wall of the Phoenix pit.

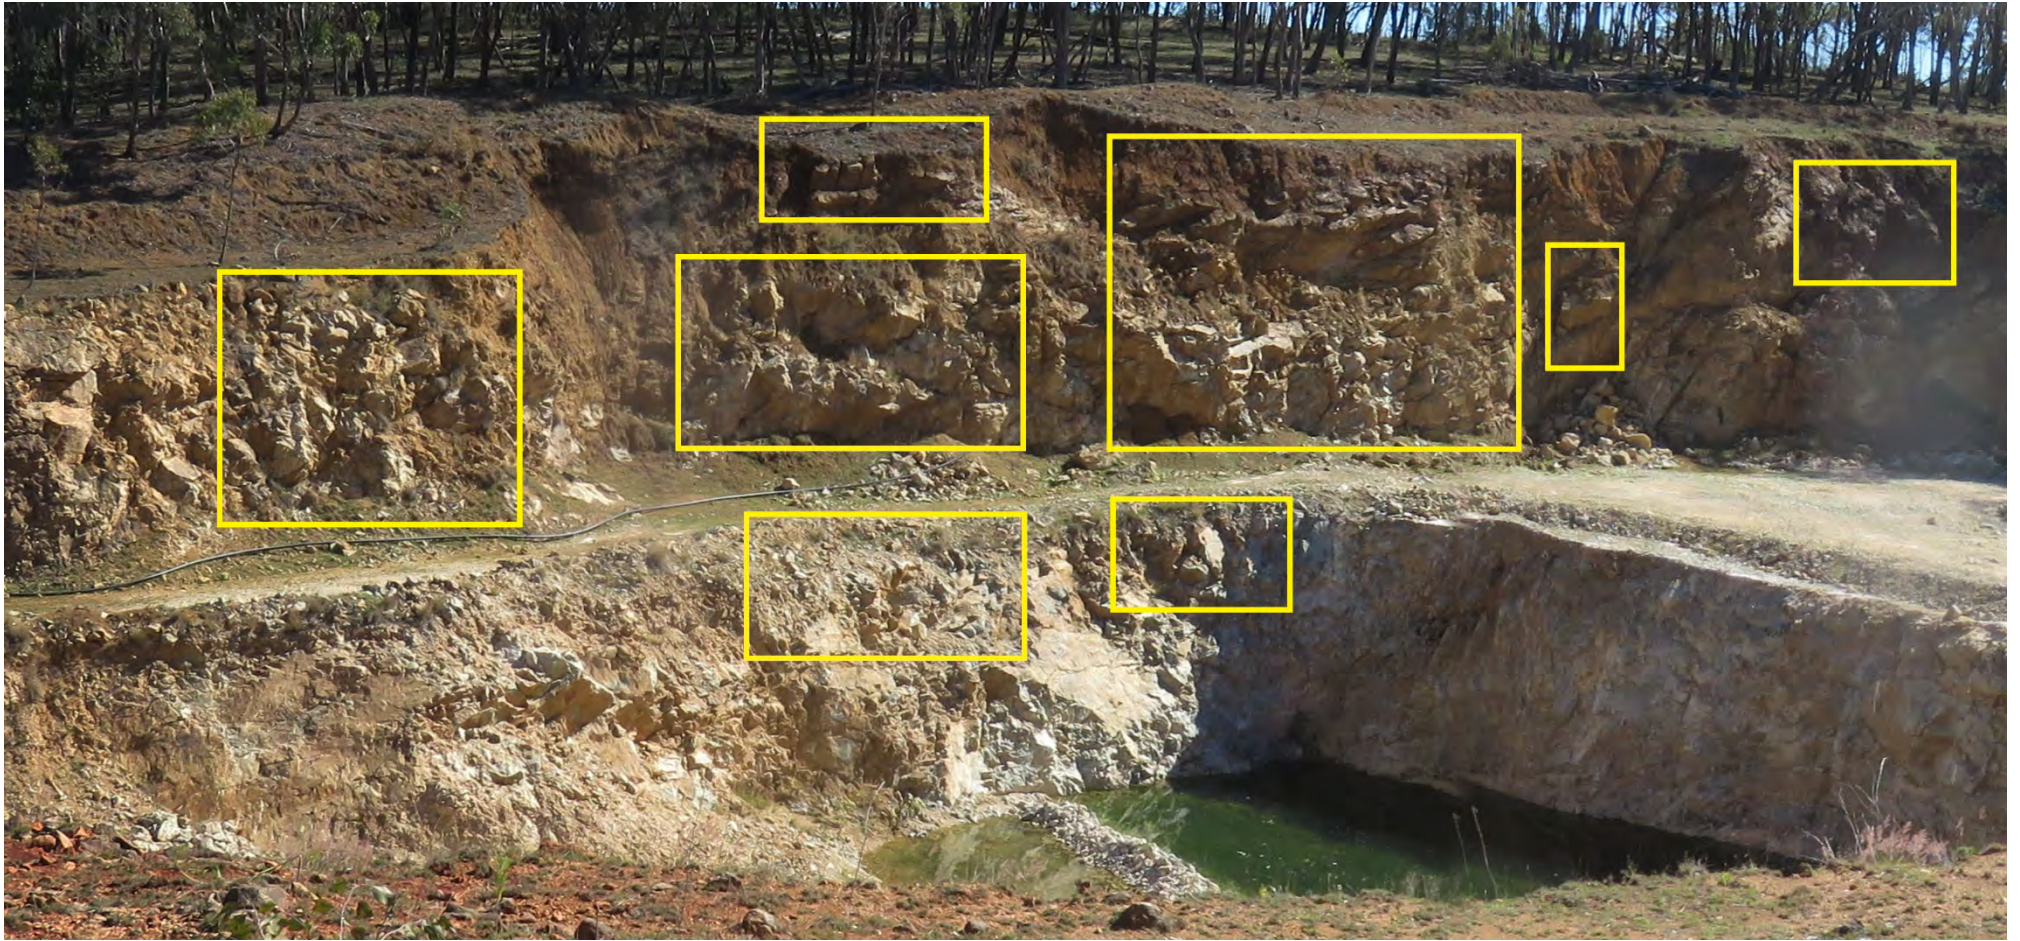
**Figure 28.** Loose rocks on the batters and overhanging and toppling rocks (highlighted) and scree on the berms on the west wall of the Aspinal pit.

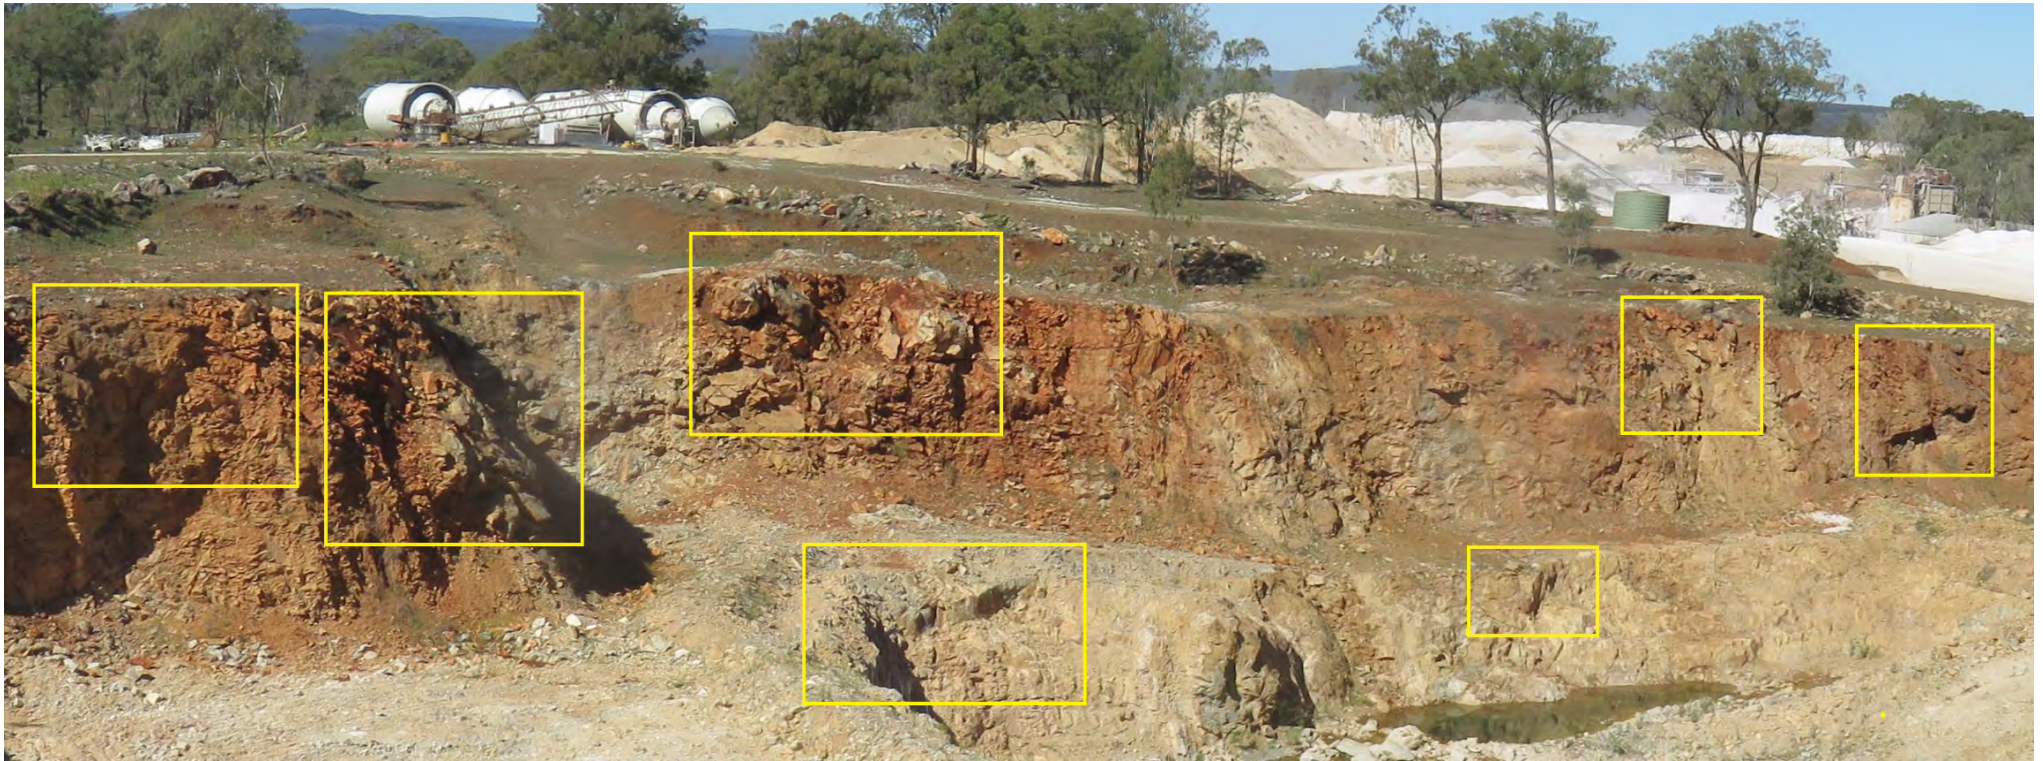
**Figure 29.** Loose rocks on the batters and overhanging rocks (highlighted) and loss of berm widths and scree on the berms on the east wall of the Aspal pit.

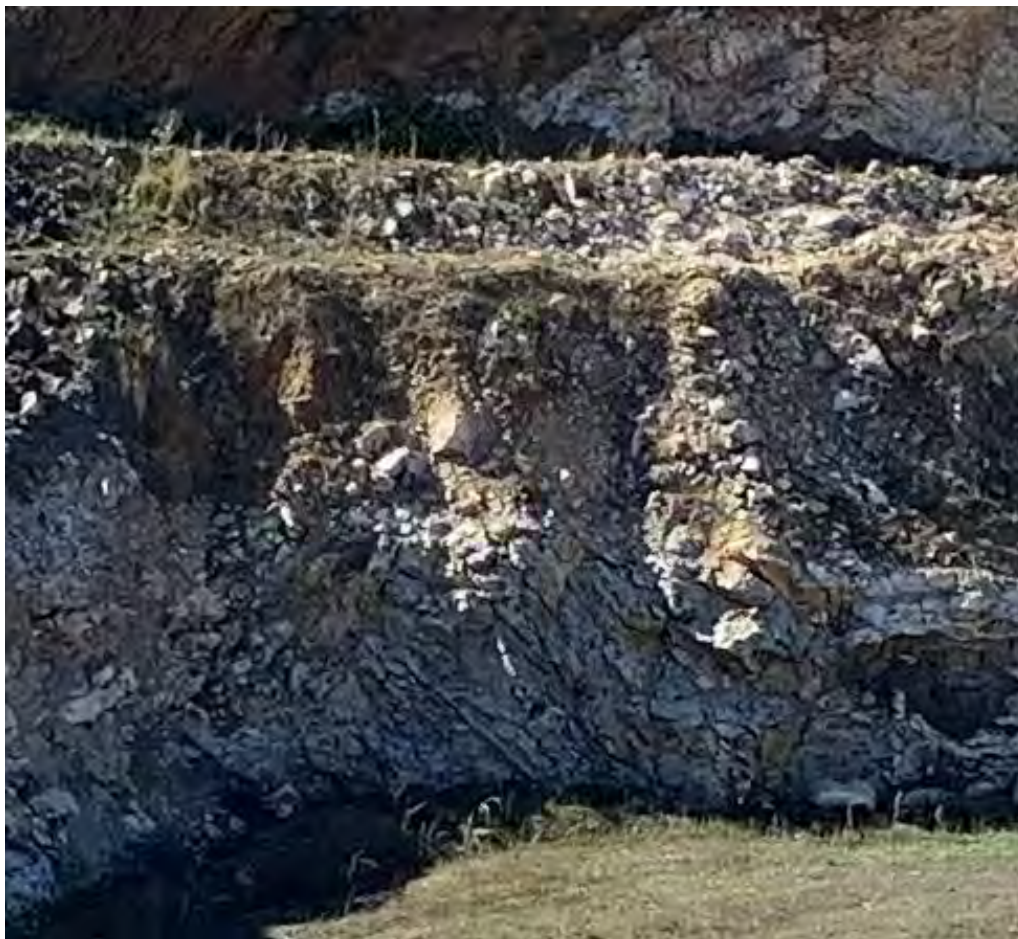
**Figure 30.** Sawtooth profile on the lower batter of the north wall of the east pit in the East-West pit due to multiple wedges sliding.

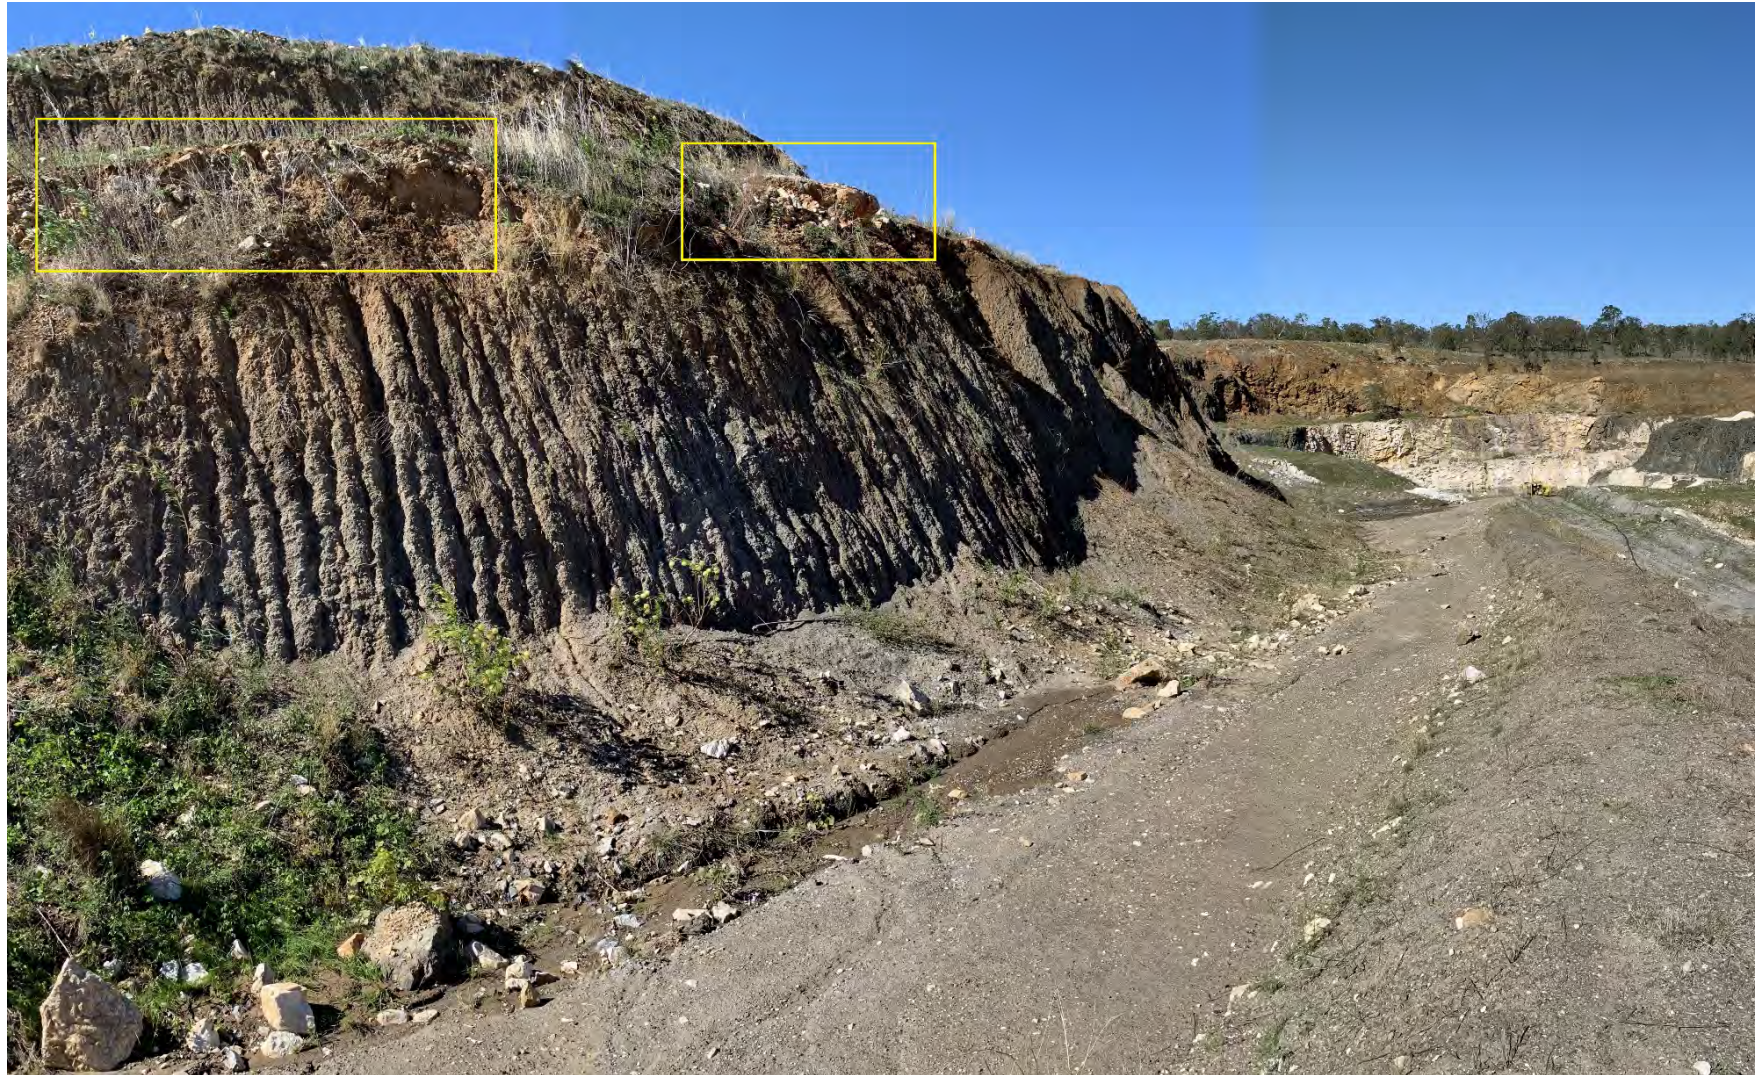
**Figure 32.** Loose rocks (highlighted) within soil and weathered siltstones near the crest of the batter adjacent to the central ramp in the East-West pit are currently hazards for users of the ramp. Batter should be draped in rockfall mesh, debris removed from the toe and drainage installed across and down the ramp. Flows of water from the overlying 550-mRL berm are not be modified with berm and batter drain and crest bunds.

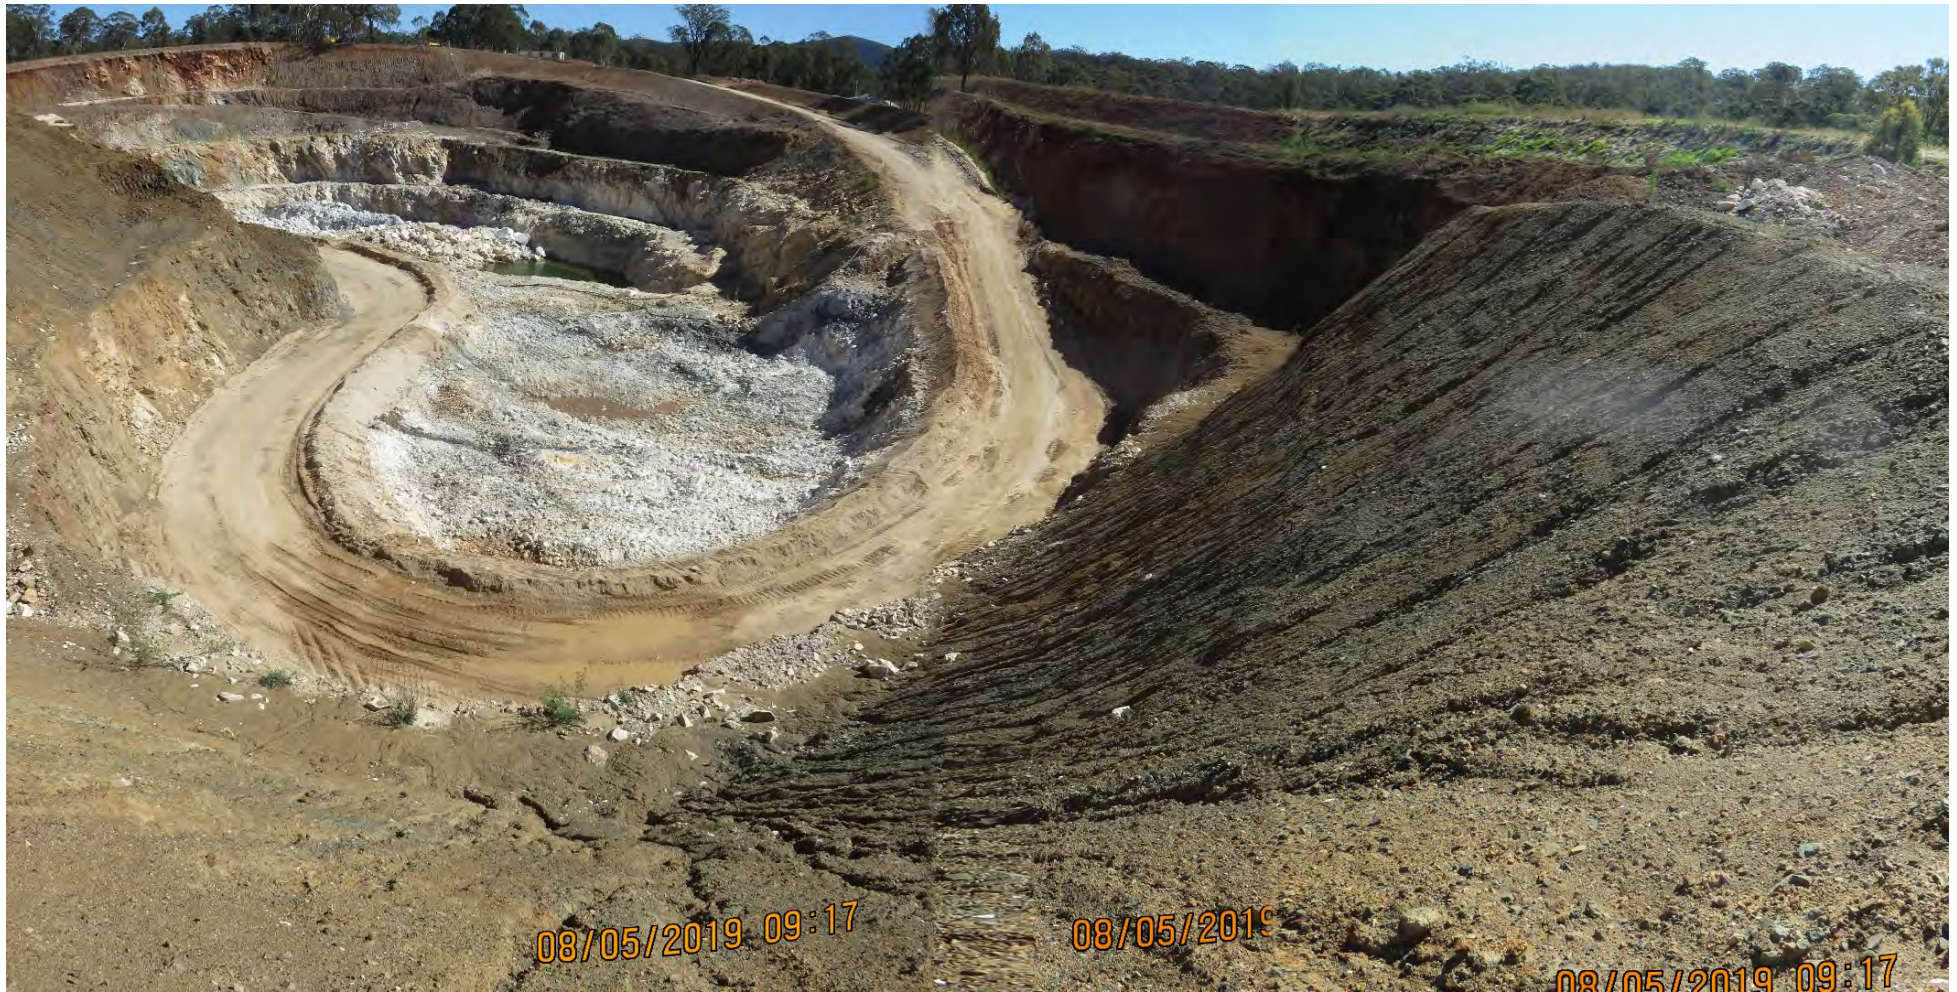
**Figure 33.** Erosion on the batters adjacent to the main ramp in the Phoenix pit. If not controlled will increase the likelihood for instabilities.  
Batter is to be hydroseeded

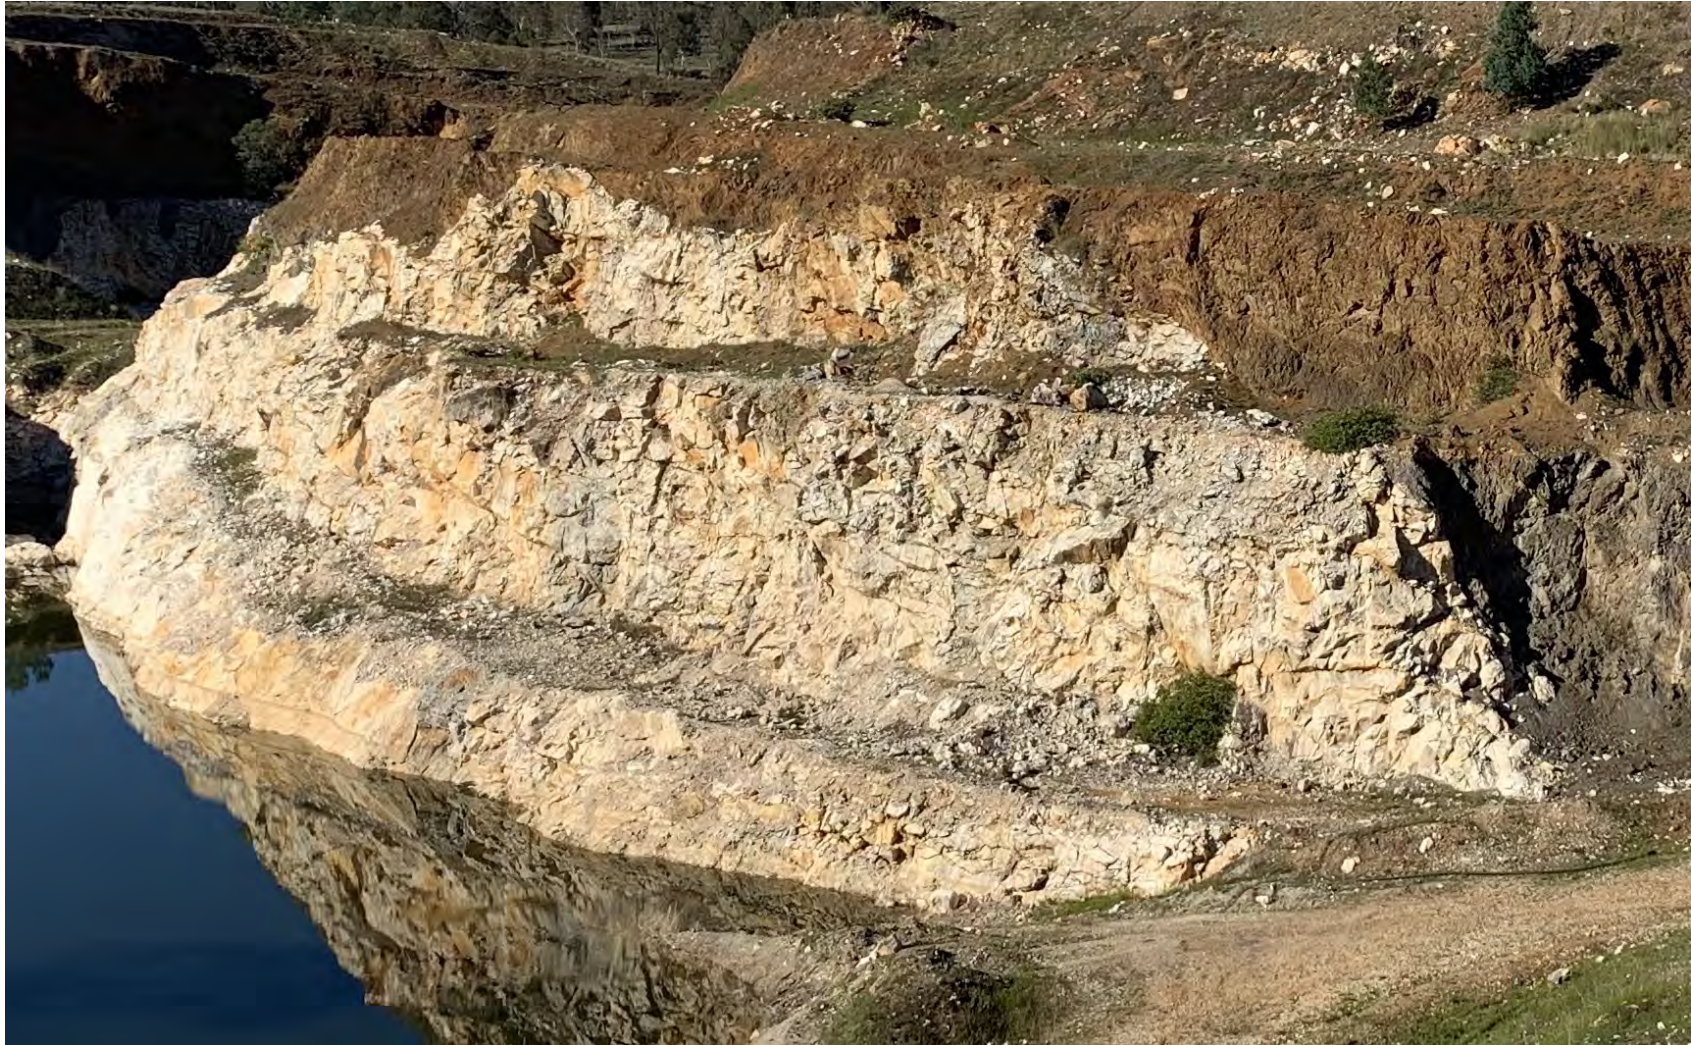
**Figure 34.** Loss of widths of most sections of the berms and scree filled berms, loose rocks on batters and overhanging rocks on the south wall at the west end of East-West pit. If the adjacent western ramp is to be retained, the height and continuity of the current toe bund are to be increased. Otherwise the ramp will be removed.

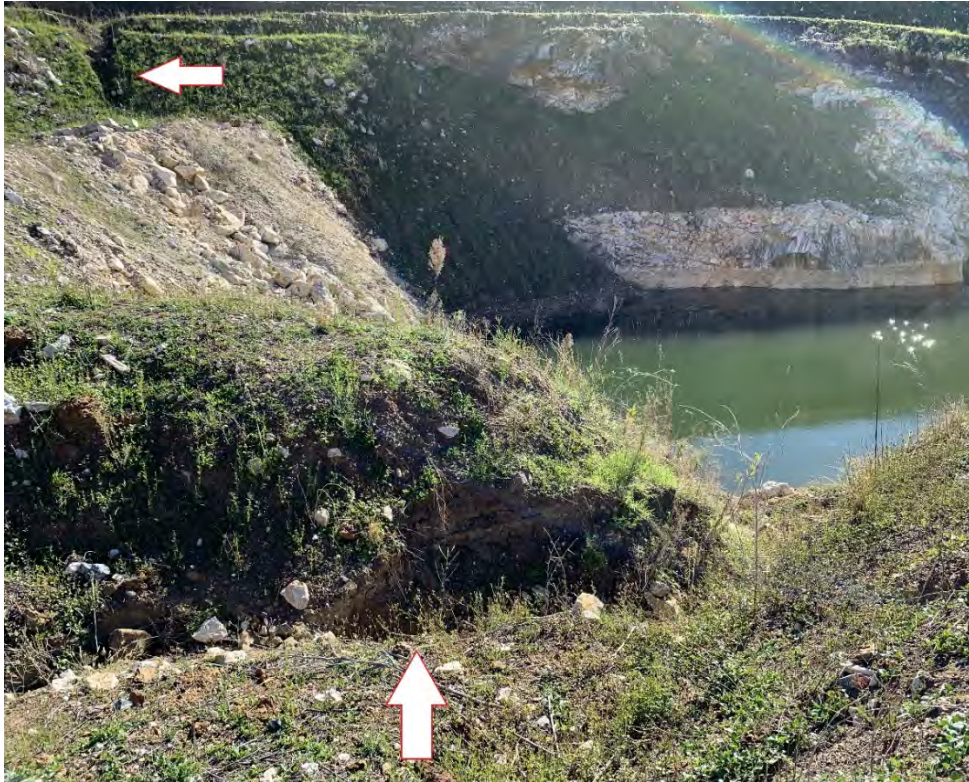
**Figure 35.** Two deep gullies cut in the haul-road and ramp at the west end of the East-West pit by water shedding off the ramp require remediation.

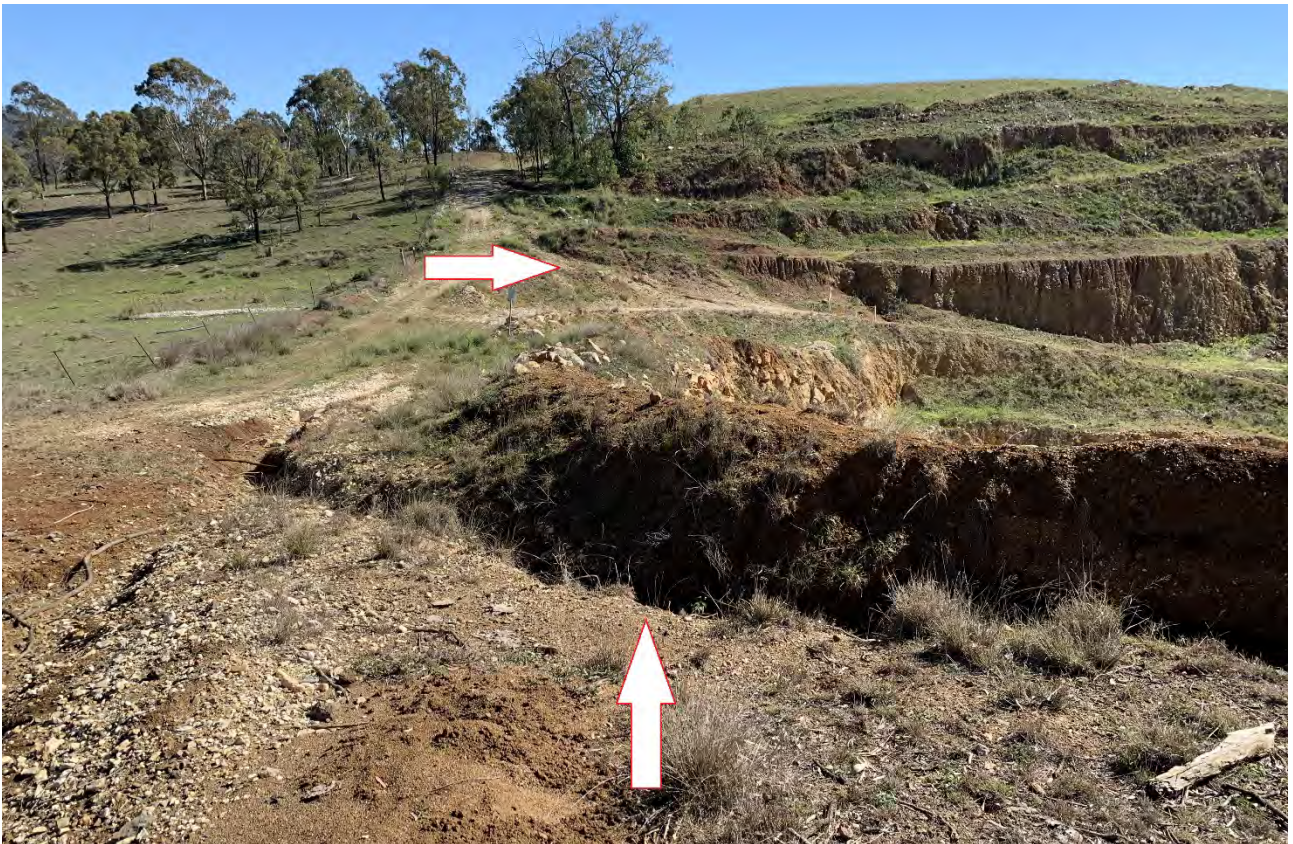
**Figure 38.** 2 x deep gullies cut by water shedding off the haul-road along the east end of the East-West pit requires repair. Haul-road to be graded to shed water to the east and ripped.

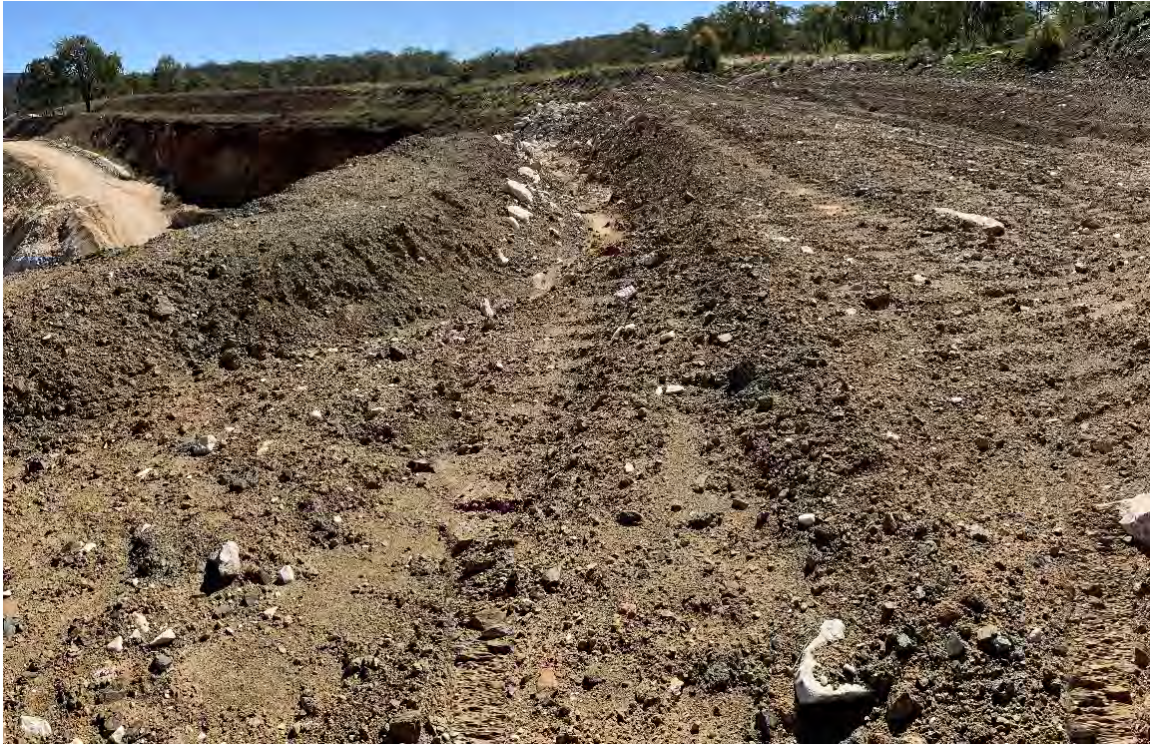
**Figure 39.** The haul-road along the east end of the Phoenix pit is to be graded to shed water to the east, removed by ripping and hydroseeded.

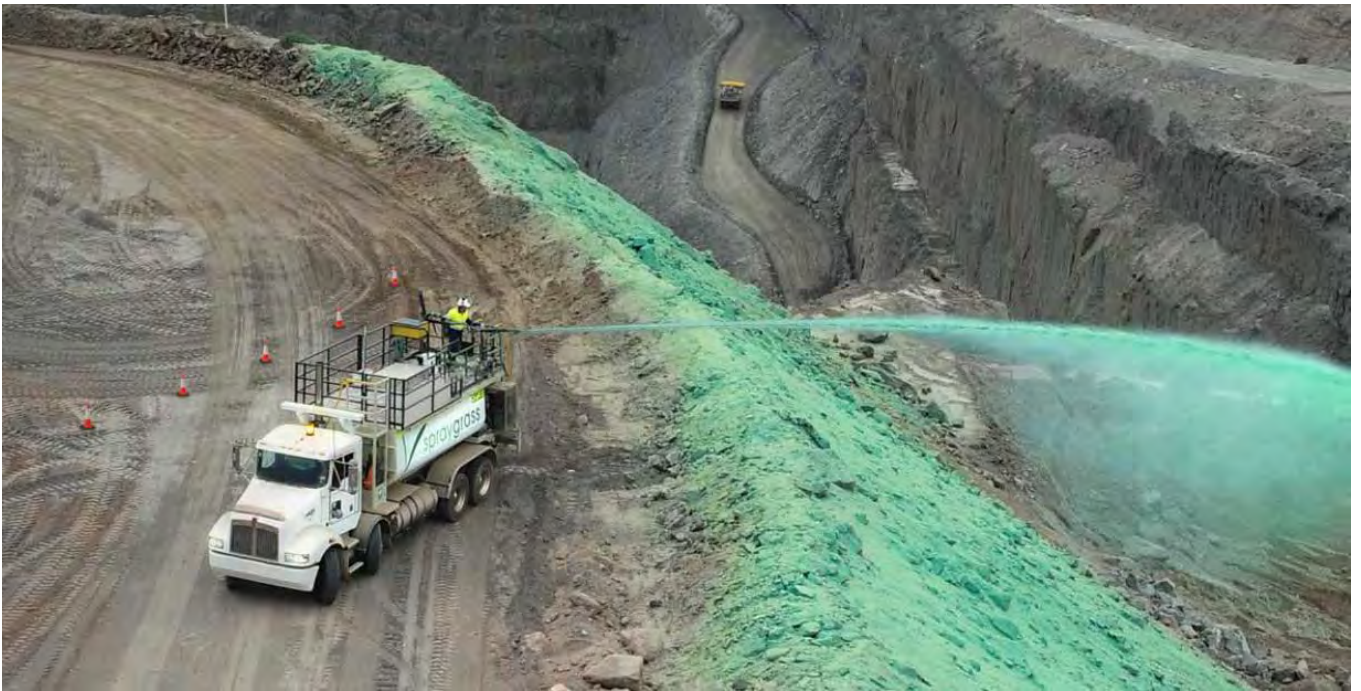
**Figure 55.** Hydroseeding, and desirably hydromulching, are recommended for the batter adjacent to the main ramp along the east wall of the Phoenix pit and for spraying topsoil on WRD 2.
