# Progressive Rehabilitation and Closure Plan

## WARWICK LIMESTONE MINE

**WARWICK LIMESTONE MINE –  
PROGRESSIVE REHABILITATION AND  
CLOSURE PLAN**

29 SEPTEMBER 2023

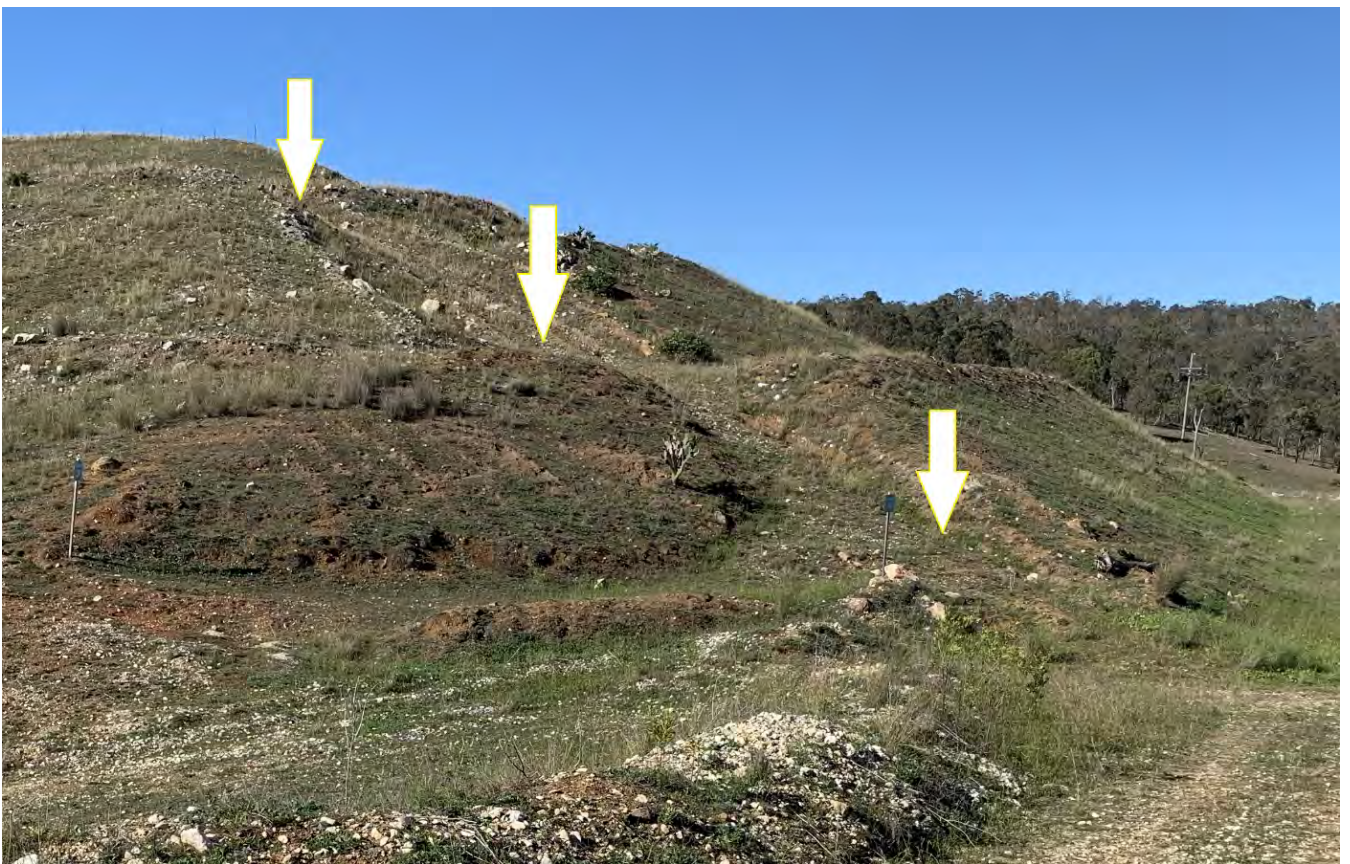
**Figure 56.** The ramp at the west end of WRD 1 on the south wall of the East-West pit is to be removed by ripping after an abandonment bund has been being installed along the north crest of the dump.
