Part 1
Ebenezer Project
Progressive Rehabilitation Closure Plan
Environmental Authority EPML00594013

Mining Lease 4712

18 May 2023

Document ID: PRCPlp1

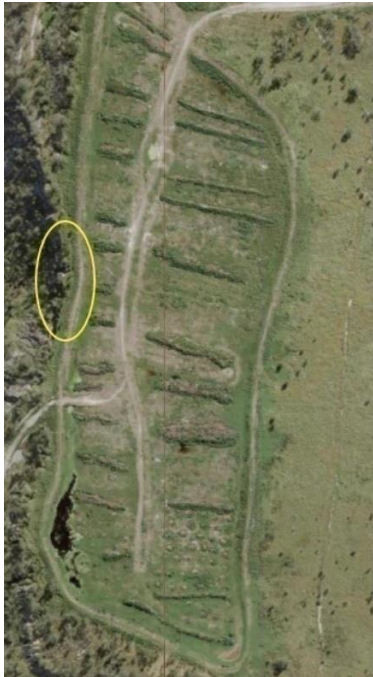
The bund wall located on the western side of the compost will be offset further from the crest of the low-wall due to slippage that occurred early in December 2021. The length of the realignment proposed is 270 m. The location is shown below. **Appendix 2 - Image 12** shows the approximate realignment of the western bund. A 235 m bench will be constructed to stabilise the recent failure. **Appendix 2 - Image 13** shows the slip from the top section of the low-wall batter.

IMAGE 28: LOCATION OF SLIPPAGE ON WESTERN EDGE OF COMPOST PAD

- Realign perimeter bund of compost pad above recent low-wall failure (total length 270m, 5m bottom width, 1m top width and 2.5m high), place topsoil of 0.2m thickness and apply grass seed.
- Extend safety bund 100 m down slope at the southern end of Lanes Eastern Emplacement restricting access to Domain 6.
- Construct bench to stabilise crest (total length 235m).
- Construct stock fence (total length 1.6km).
- Install 3 gates to access Lanes Void Southern Ramp (Domain 3) and IBSD area (Domain 6).

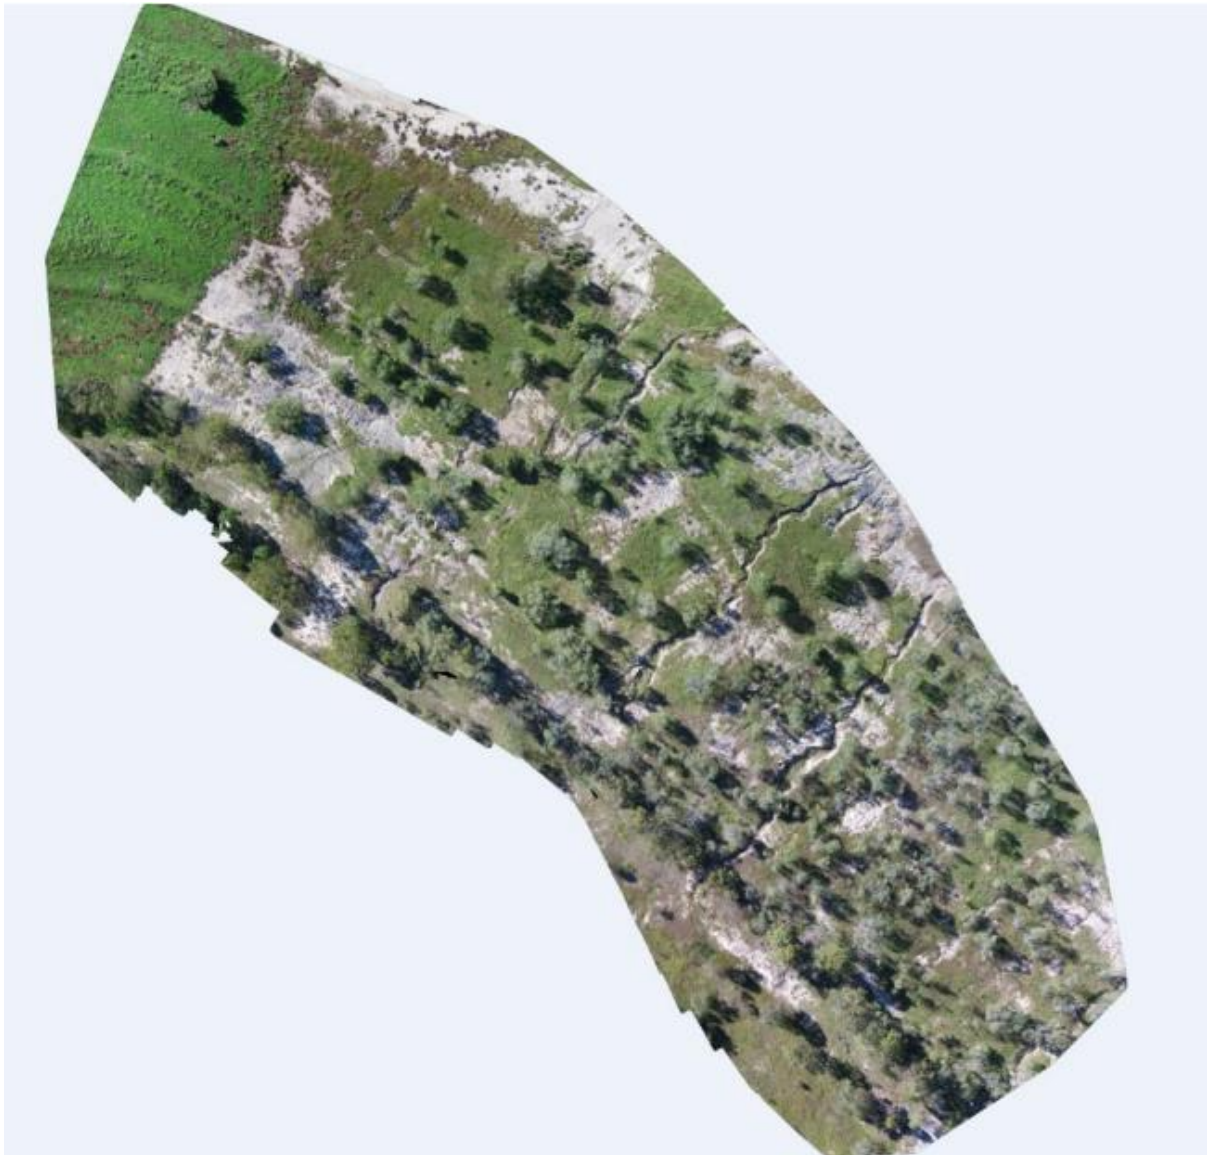
APPENDIX 2 - IMAGE 6: SHEET AND CHANNEL EROSION ON OPD NORTH-EASTERN BATTER SLOPE

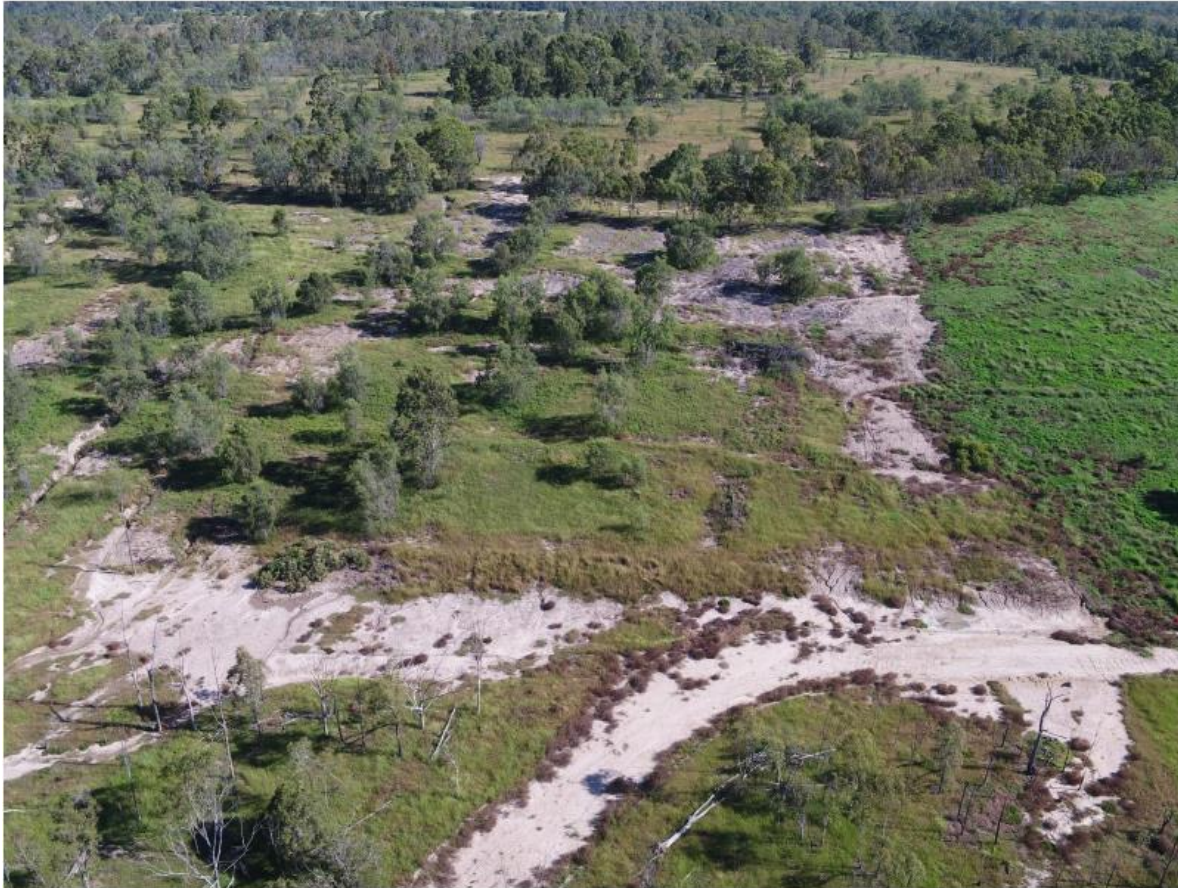
APPENDIX 2 - IMAGE 7: TRANSITION BETWEEN 6 HA AREA OF REPAIRED BATTER SLOPE AND AREA REQUIRING REPAIR

- A new access ramp was constructed to shorten the haulage distance between the compost pad and the Out of Pit Dump (OPD)
- 6 ha of land located at the OPD (Domain 7) were repaired whereby by compost and topsoil were spread across the surface and the contour drain reinstated. Vegetation cover has been achieved (refer to **Appendix 2 - Image 9**).

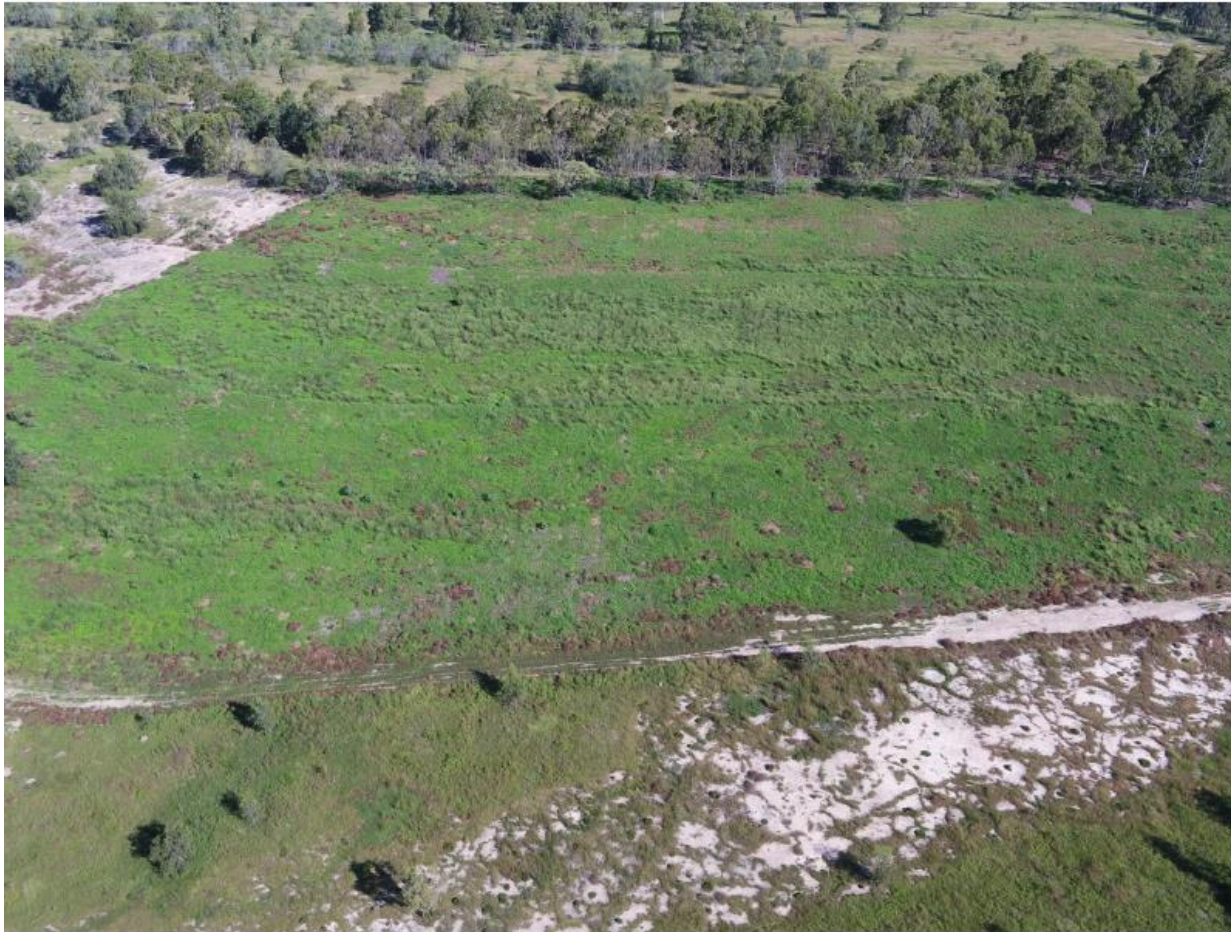
APPENDIX 2 - IMAGE 8: RECENTLY REPAIRED OPD NORTHERN BATTER SLOPE

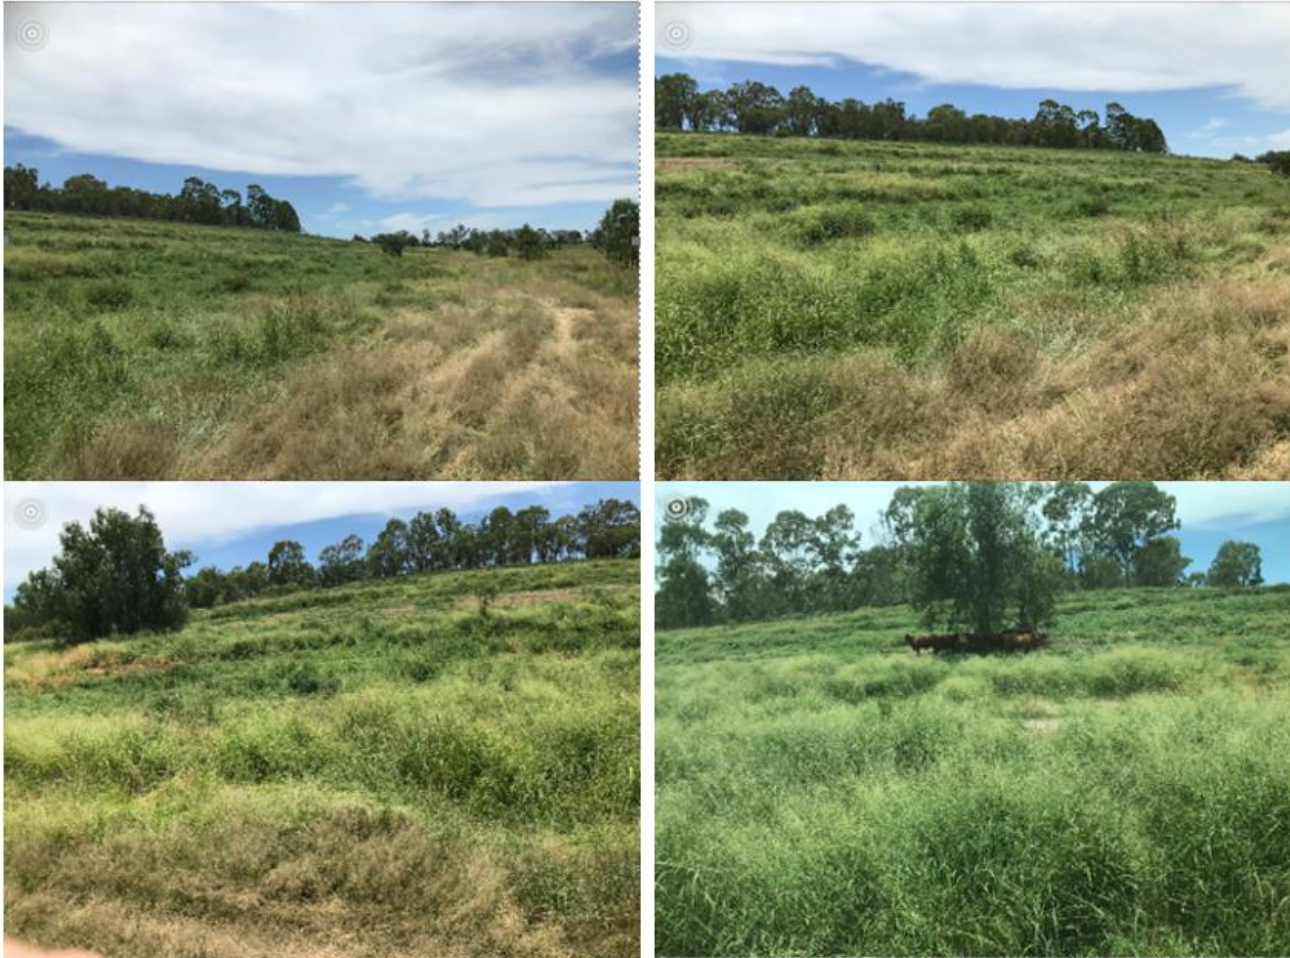
APPENDIX 2 - IMAGE 9: REHABILITATED 6 HA OPD NORTHERN BATTER SLOPE (21/12/2021)

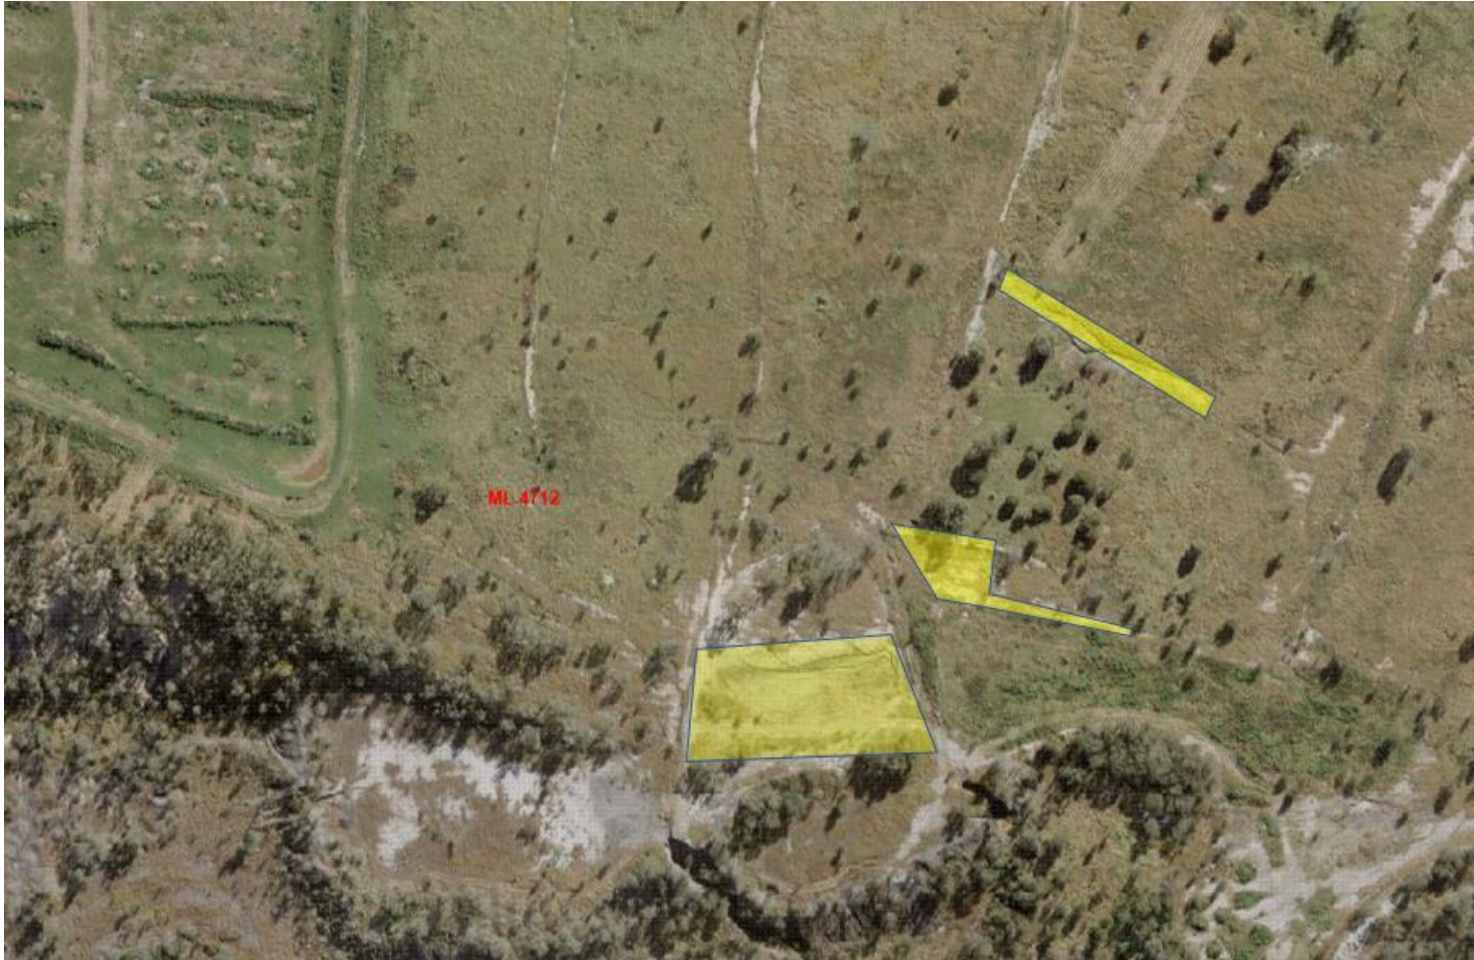
APPENDIX 2 - IMAGE 10: AREAS WITHIN DOMAIN 4 - LANES EASTERN EMPLACEMENT REQUIRING REHABILITATION

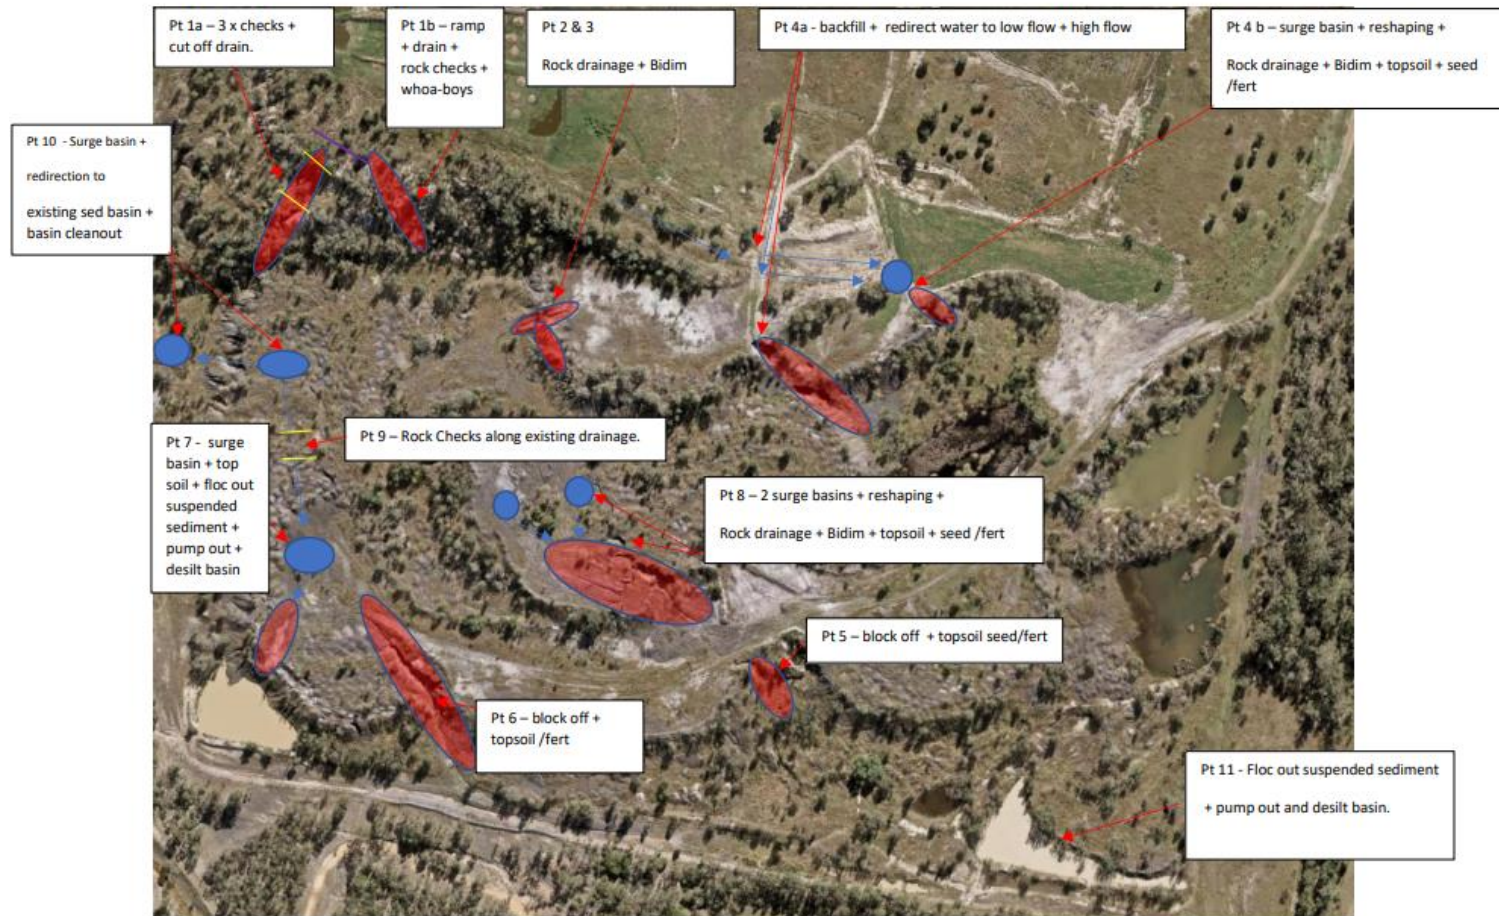
APPENDIX 2 - IMAGE 20: ERODED DRAINAGE CHANNELS WITHIN THE IRONBARK SOUTH AREA AND REQUIREMENTS TO STABILISE

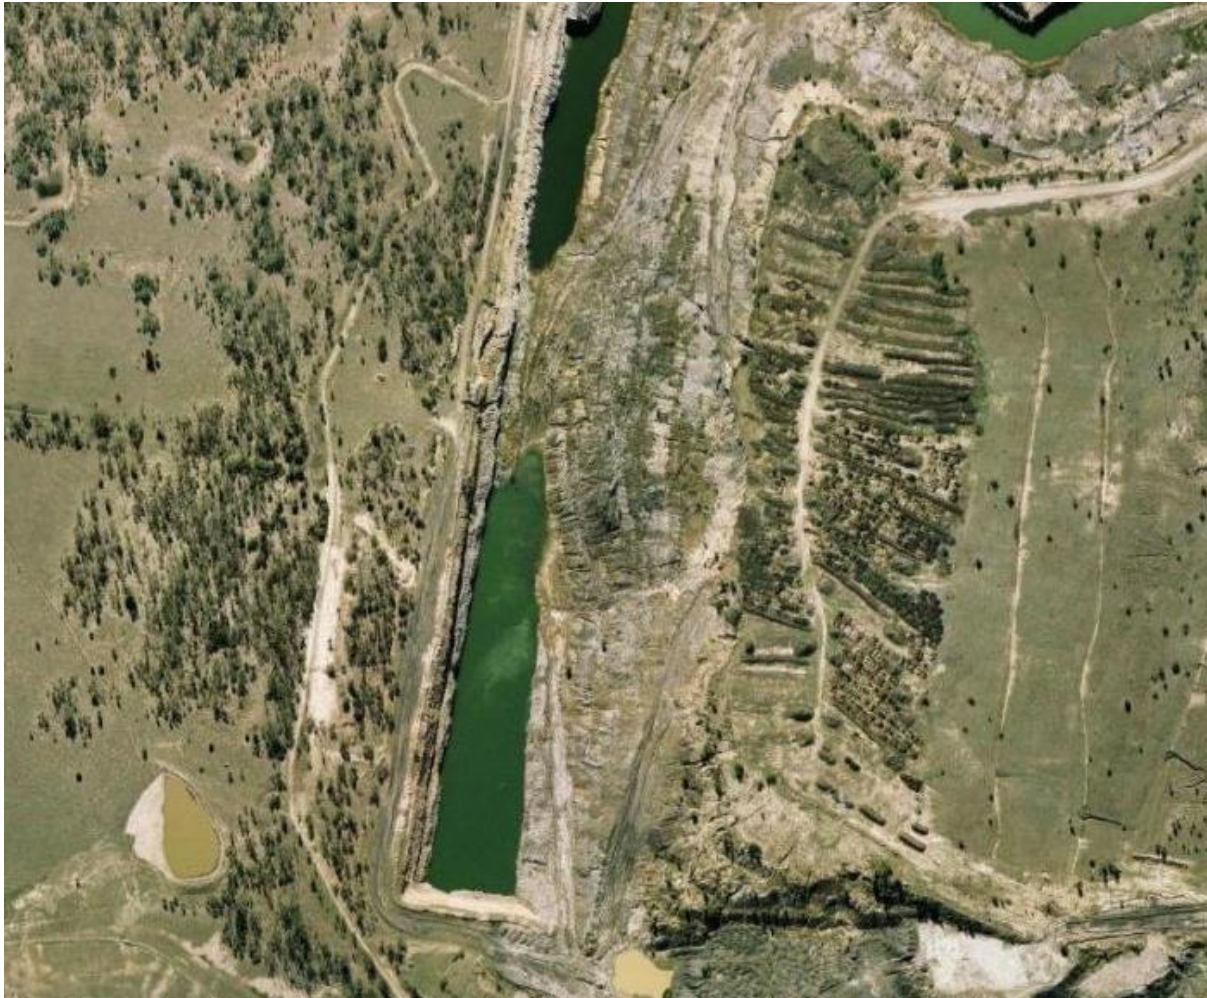
APPENDIX 2 - IMAGE 24: LOW-WALL FAILURE (06/07/2007)

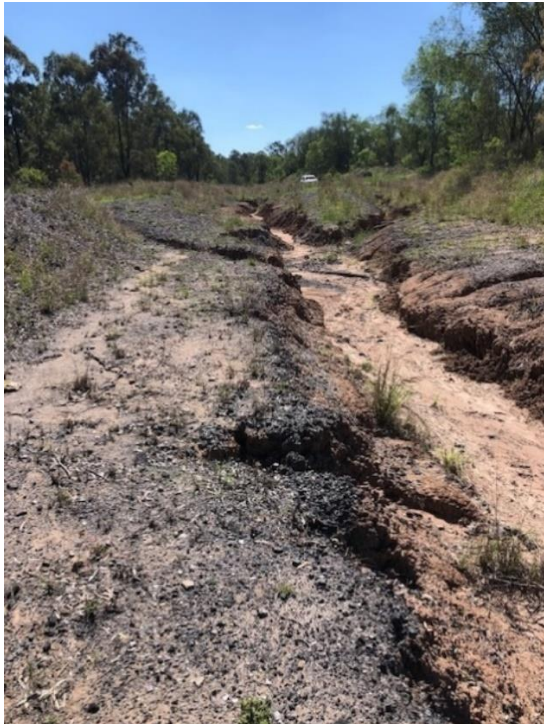
- The southern drain located within the IBSD area (Domain 6) was significantly eroded (refer to **Appendix 2 - Image 25**). It has been repaired via reshaping, installing a number of rock check dams, placing topsoil and spreading grass seed (refer to **Appendix 2 - Image 26**).

APPENDIX 2 - IMAGE 25: SOUTHERN DRAIN IN IBSD AREA BEFORE REHABILITATION, NOVEMBER 2018

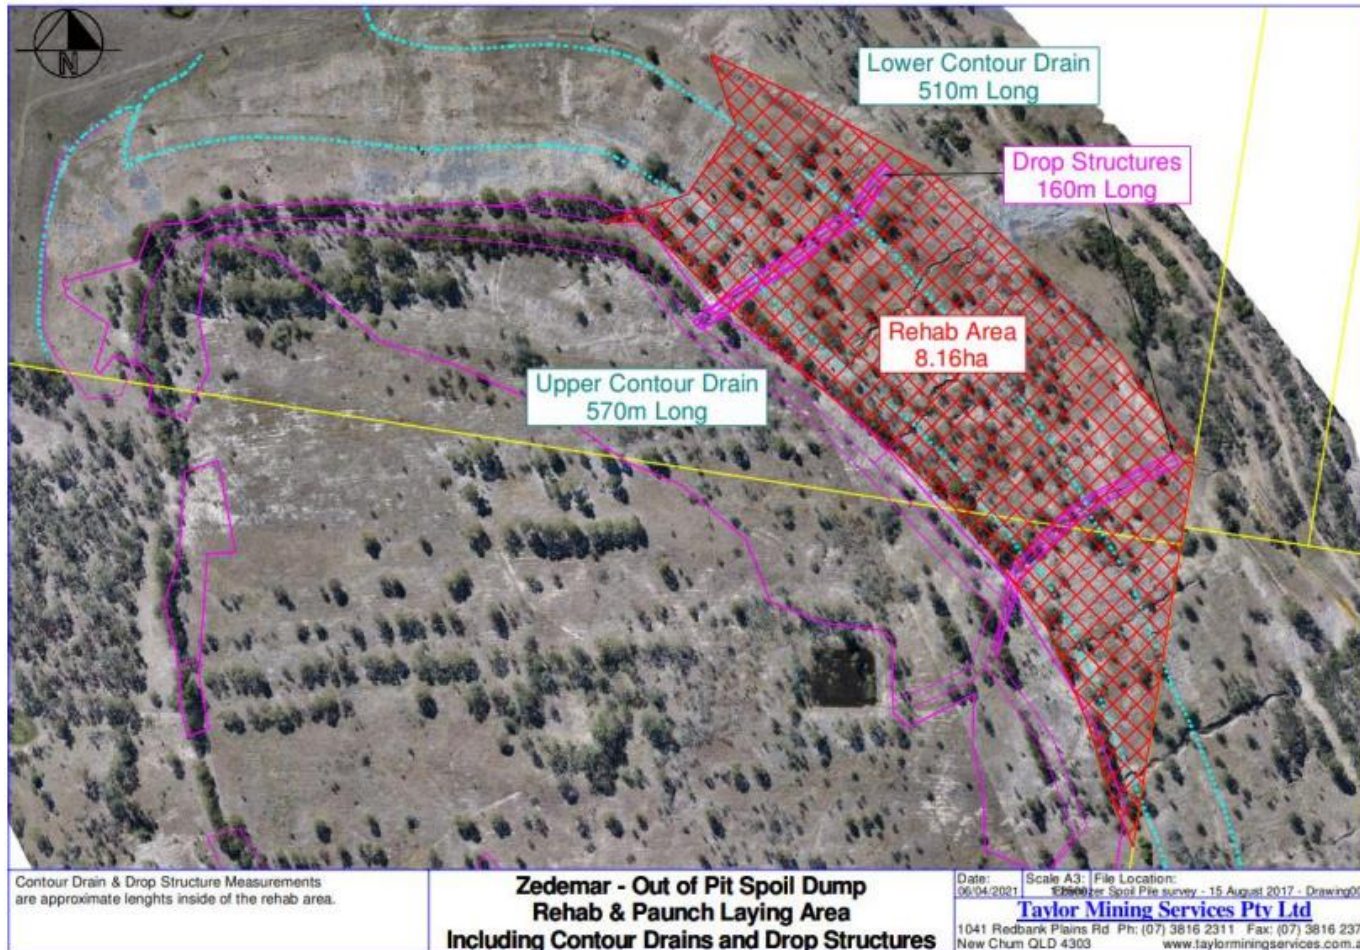
APPENDIX 5 - PLAN 25: 8.16HA AREA ON OPD NORTH-EASTERN BATTER SLOPE REQUIRING REPAIR

- Bulk earthworks to rectify drainage paths and erosion. This includes the addition of deep ripping a further 1.568ha not covered by the JCB Quote #91194 for OPD batter slope repair.
- Spread gypsum over 16.968 ha of ripped surface.
- Spread topsoil over ripped bare ground surfaces to establish vegetation. This includes the addition of spreading topsoil over a further 1.568 ha combined area not covered by JCB quote for OPD batter slope repair.
- Construction of two rock/geofabric lined down chutes to convey stormwater from the top surface of the out of pit dump.
- Repair contour drains.

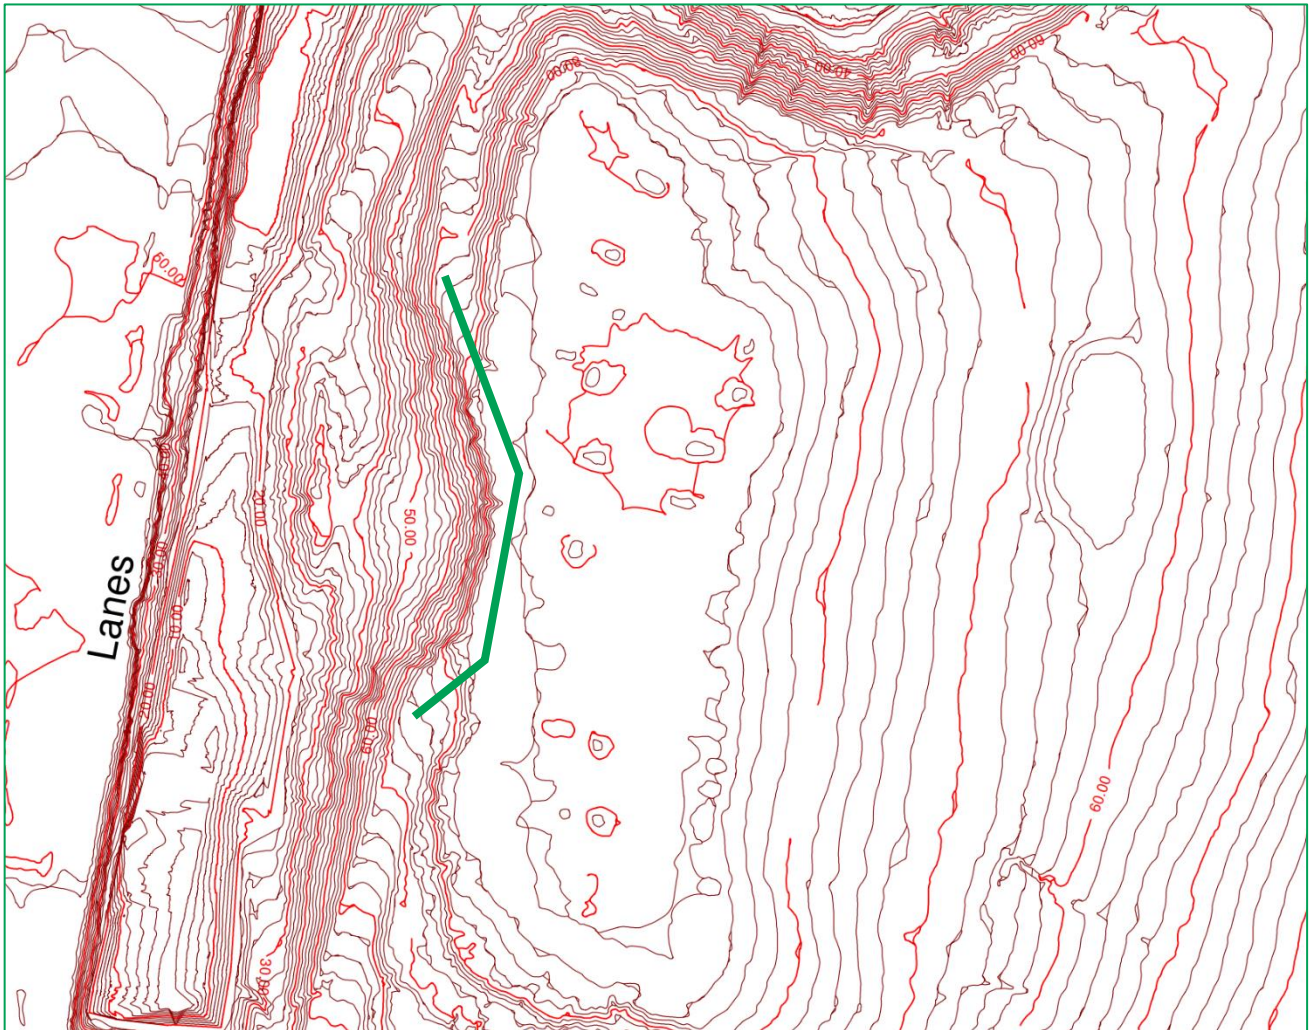
Figure 3: Recommended step slope to be flattened (green line)
