**COPPABELLA COAL MINE**  
**SOUTH ARM DIVERSION REVEGETATION PLAN**

Revegetation of Co-disposal Seepage section in Thirty Mile Creek South Arm Diversion  
December 2014

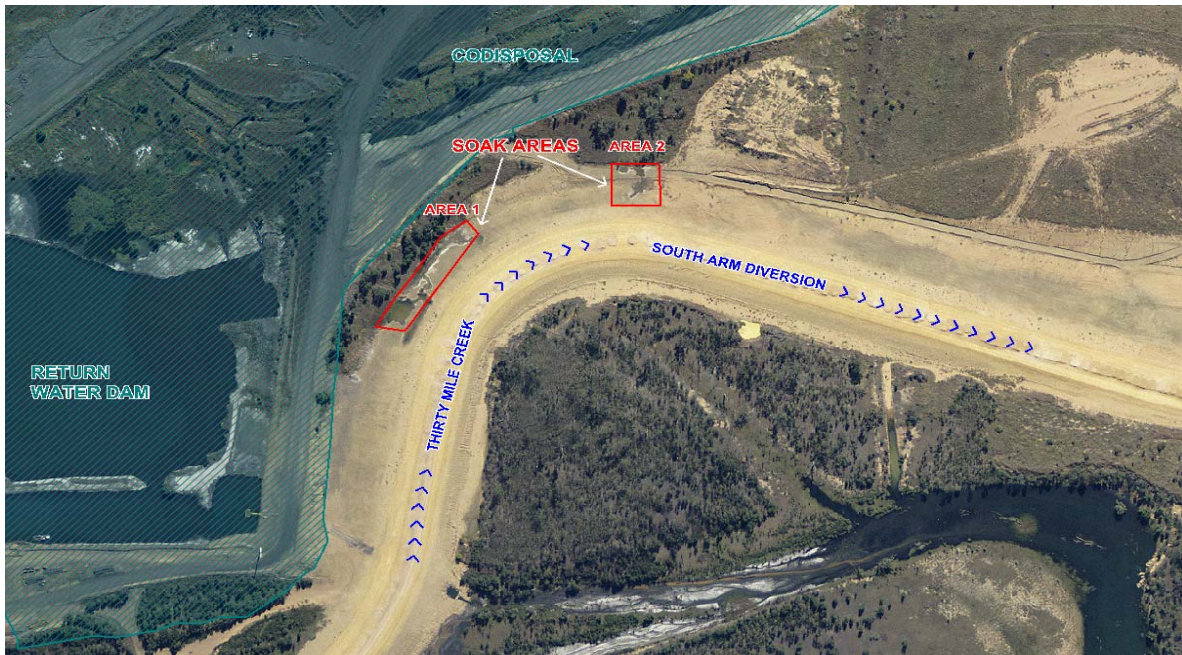
The soak areas identified within the Thirty Mile Creek South Arm Diversion are displayed in Figure 1 (below).

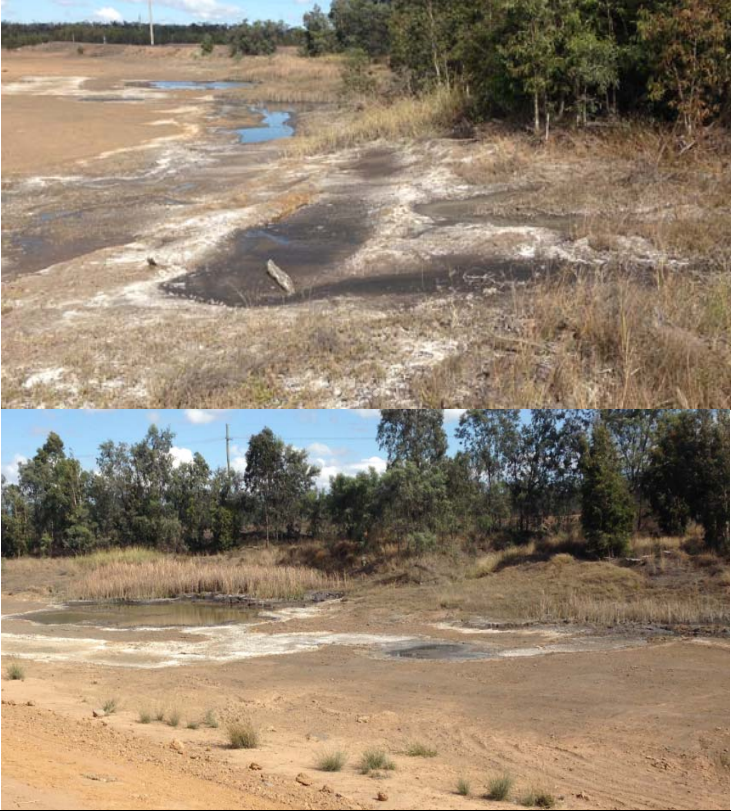
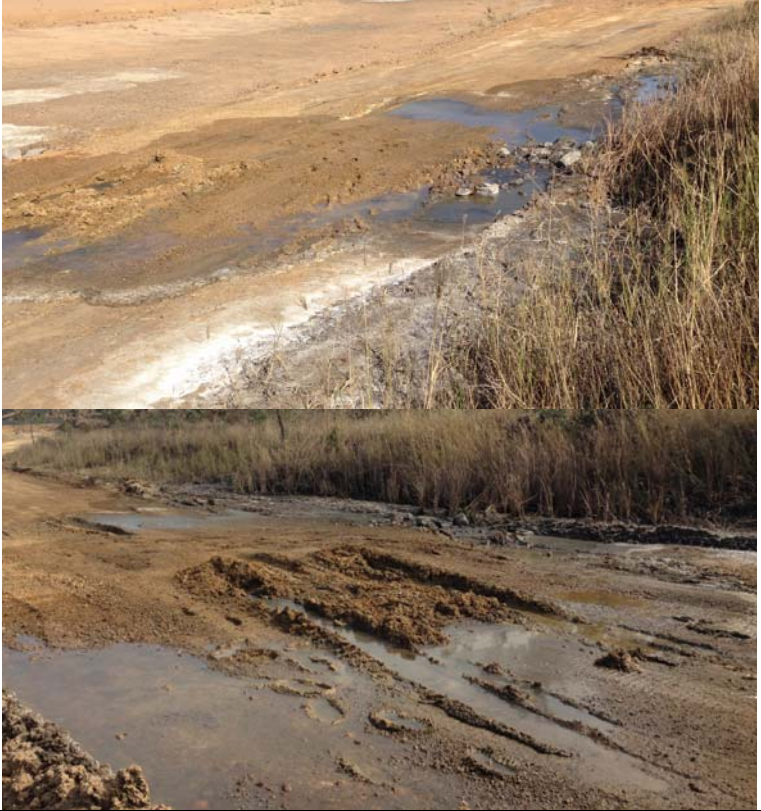
| Soak Areas Prior to Rock Placement | |

The low clay content material of which the current diversion levee banks are constructed of, has been identified as problematic as it is prone to erosion and with the added seepage impact, has the potential reduce the structural integrity of the diversion bank. To mitigate this erosion impact and to ensure the stability of the diversion banks at the identified soak areas, the following action was completed.

1. Removal of a portion of bank at seepage areas to remove unstable material
2. Fill excavated section (rock placement) with competent Permian material

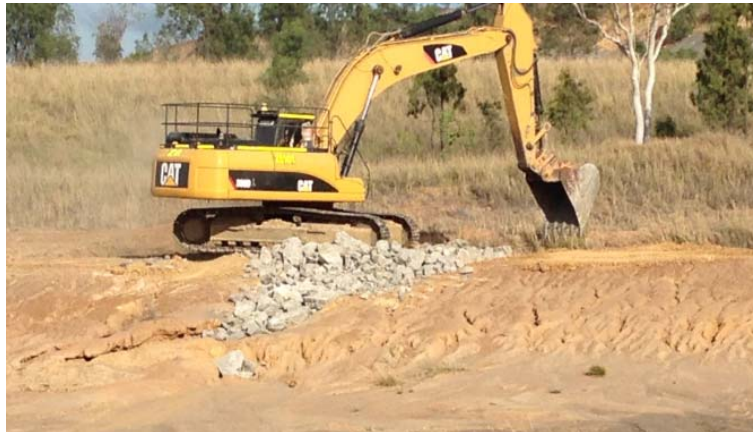
Erosion scours have formed along both diversion levee banks and require remediation to improve sediment control, bank stability and enable topsoiling of levee banks. Specifications for repair grading were:

**Figure 1: Filling of erosion scours with competent Permian material**

1. Grading is to removal all current scouring along banks
2. Material is to be respread over diversion
3. Grading is not to change the prior constructed specifications of the levee banks
4. Where required, competent material may be used to fill erosion scours.

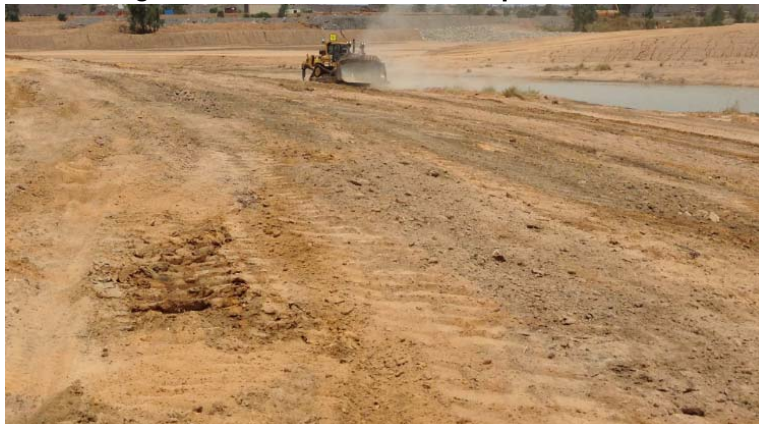
**Figure 2: Removal of Erosion Scours**

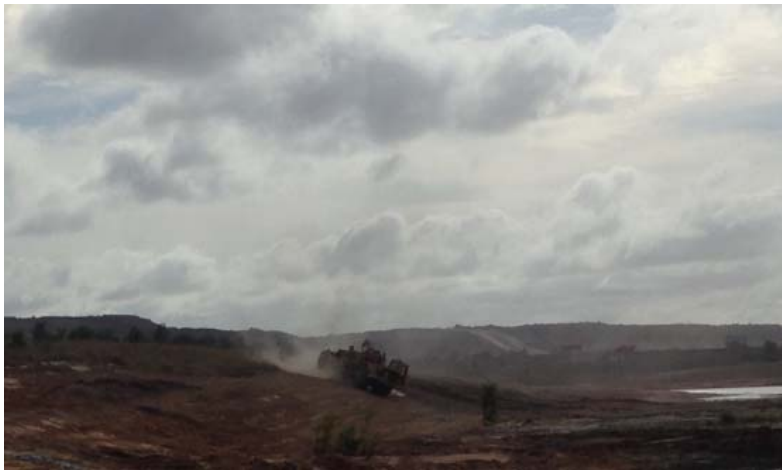
**Figure 3: Scraper conducting topsoiling on Thirty Mile Creek South Arm Diversion banks**

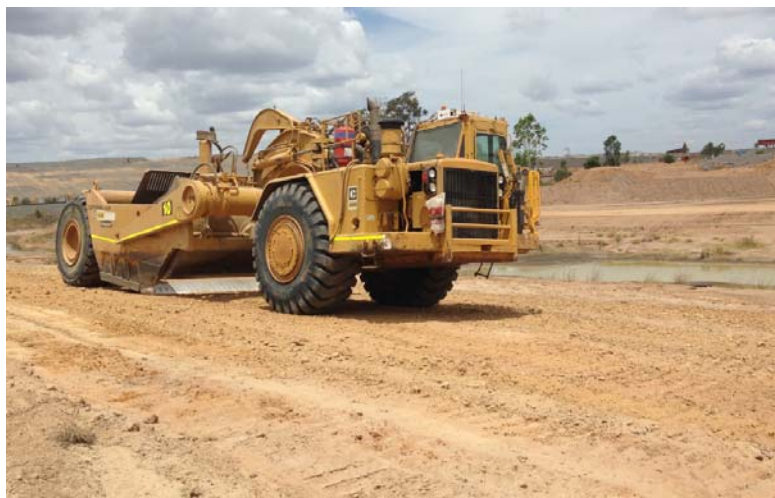
**Figure 4: Scraper conducting topsoiling Thirty Mile Creek South Arm Diversion banks**

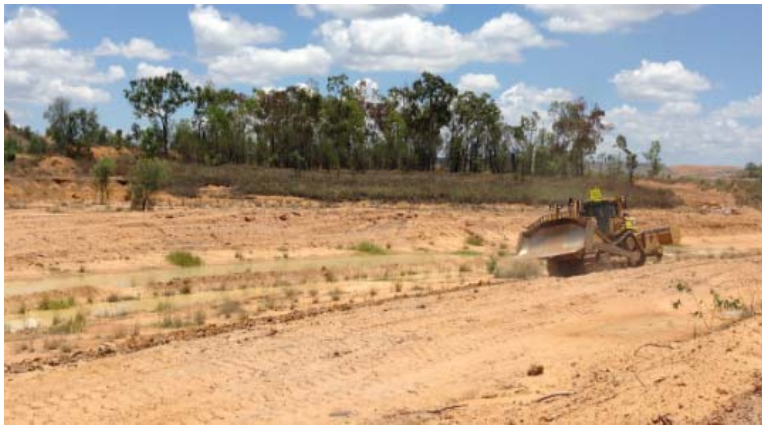
**Figure 5: D8T Dozer with drum seeder undertaking combined ripping and seeding activities**

1. Ripping activities commenced on the upper most section with ripping to occur on the contour
2. Ripping is to be at a depth of 500mm
3. Seed application is at a rate of 20kg/ha.

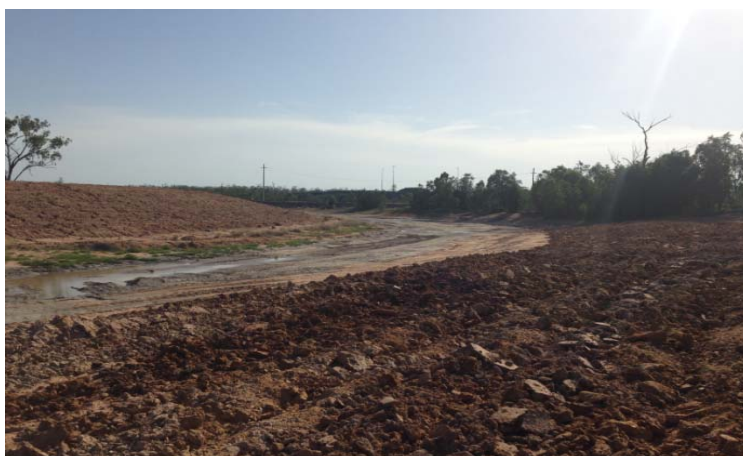
**Figure 6: Ripped and Seeded Thirty Mile Creek South Arm Diversion Banks (upstream)**

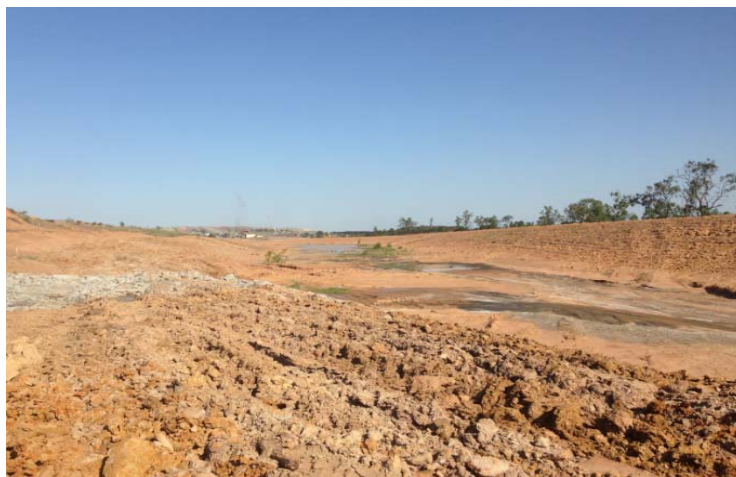
**Figure 7: Ripped and Seeded Thirty Mile Creek South Arm Diversion Bank (downstream)**

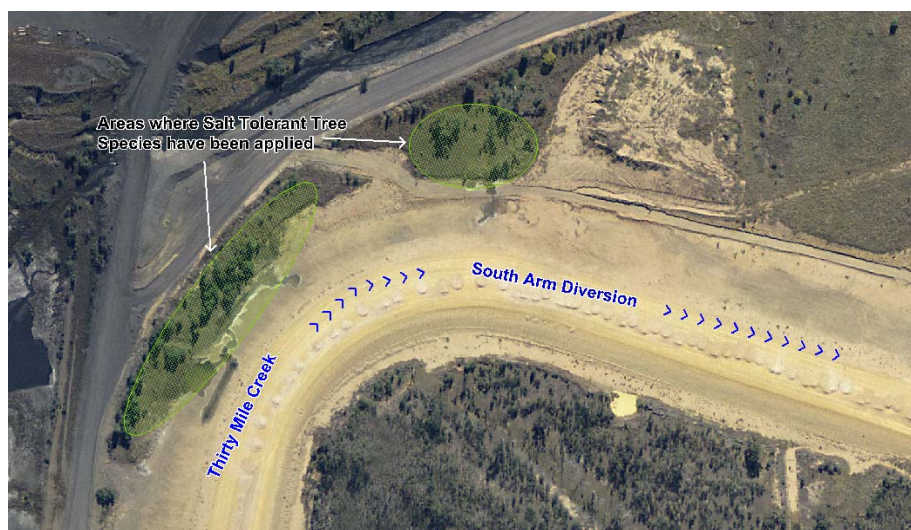
Figure 8: Areas indicating where salt tolerant tree species seed has been applied

In addition to grass seed mix, salt tolerant shrub and tree species have been selected for seeding of the seepage areas present within Thirty Mile Creek South Arm Diversion. The aim of planting shrubs and trees within these areas is to attempt to assist in the control of erosion and reduce water logging and seepage through plant root uptake. Species which have been selected are

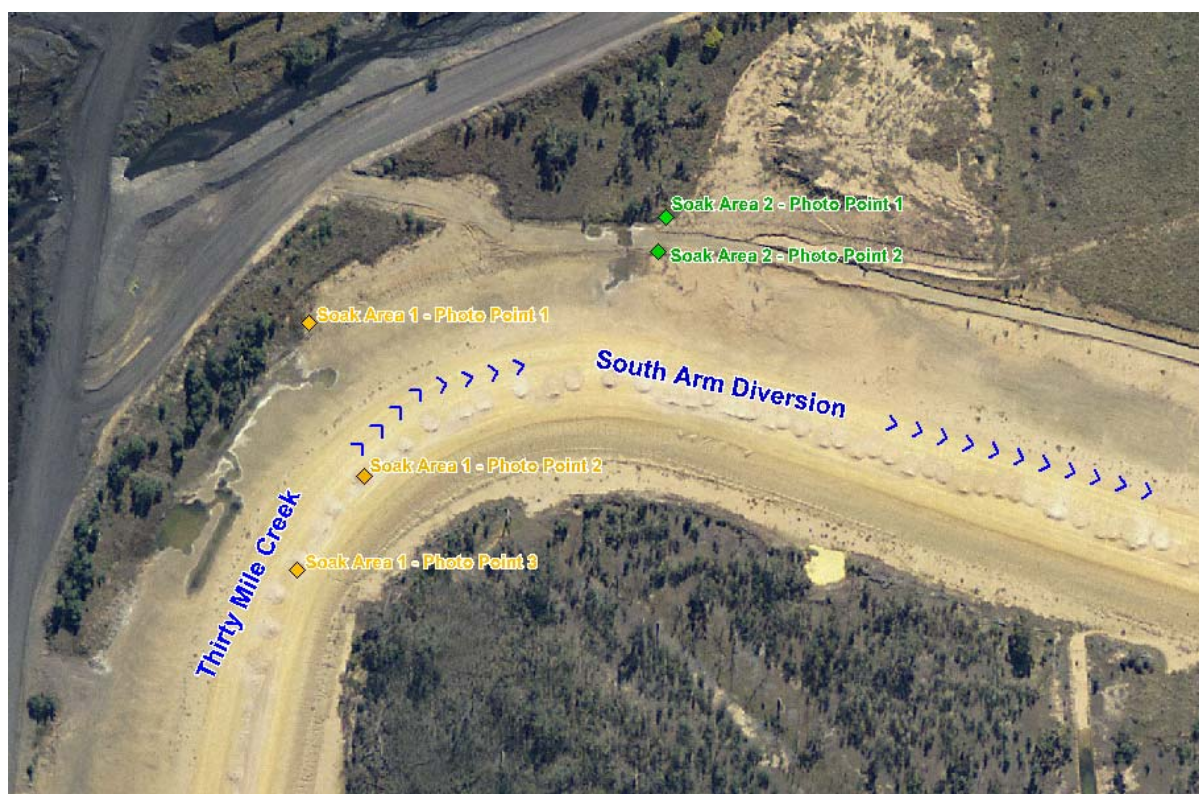
Figure 9: Thirty Mile Creek South Arm Diversion Seepage Photo Monitoring Locations
