LADY LORETTA

## **Z-LLM-HSEC-PLN-Progressive Rehabilitation and Closure Plan**

| Project Name | Lady Loretta Mine |
| Document Title | Z-LLM-HSEC-PLN-Progressive Rehabilitation and Closure Plan |

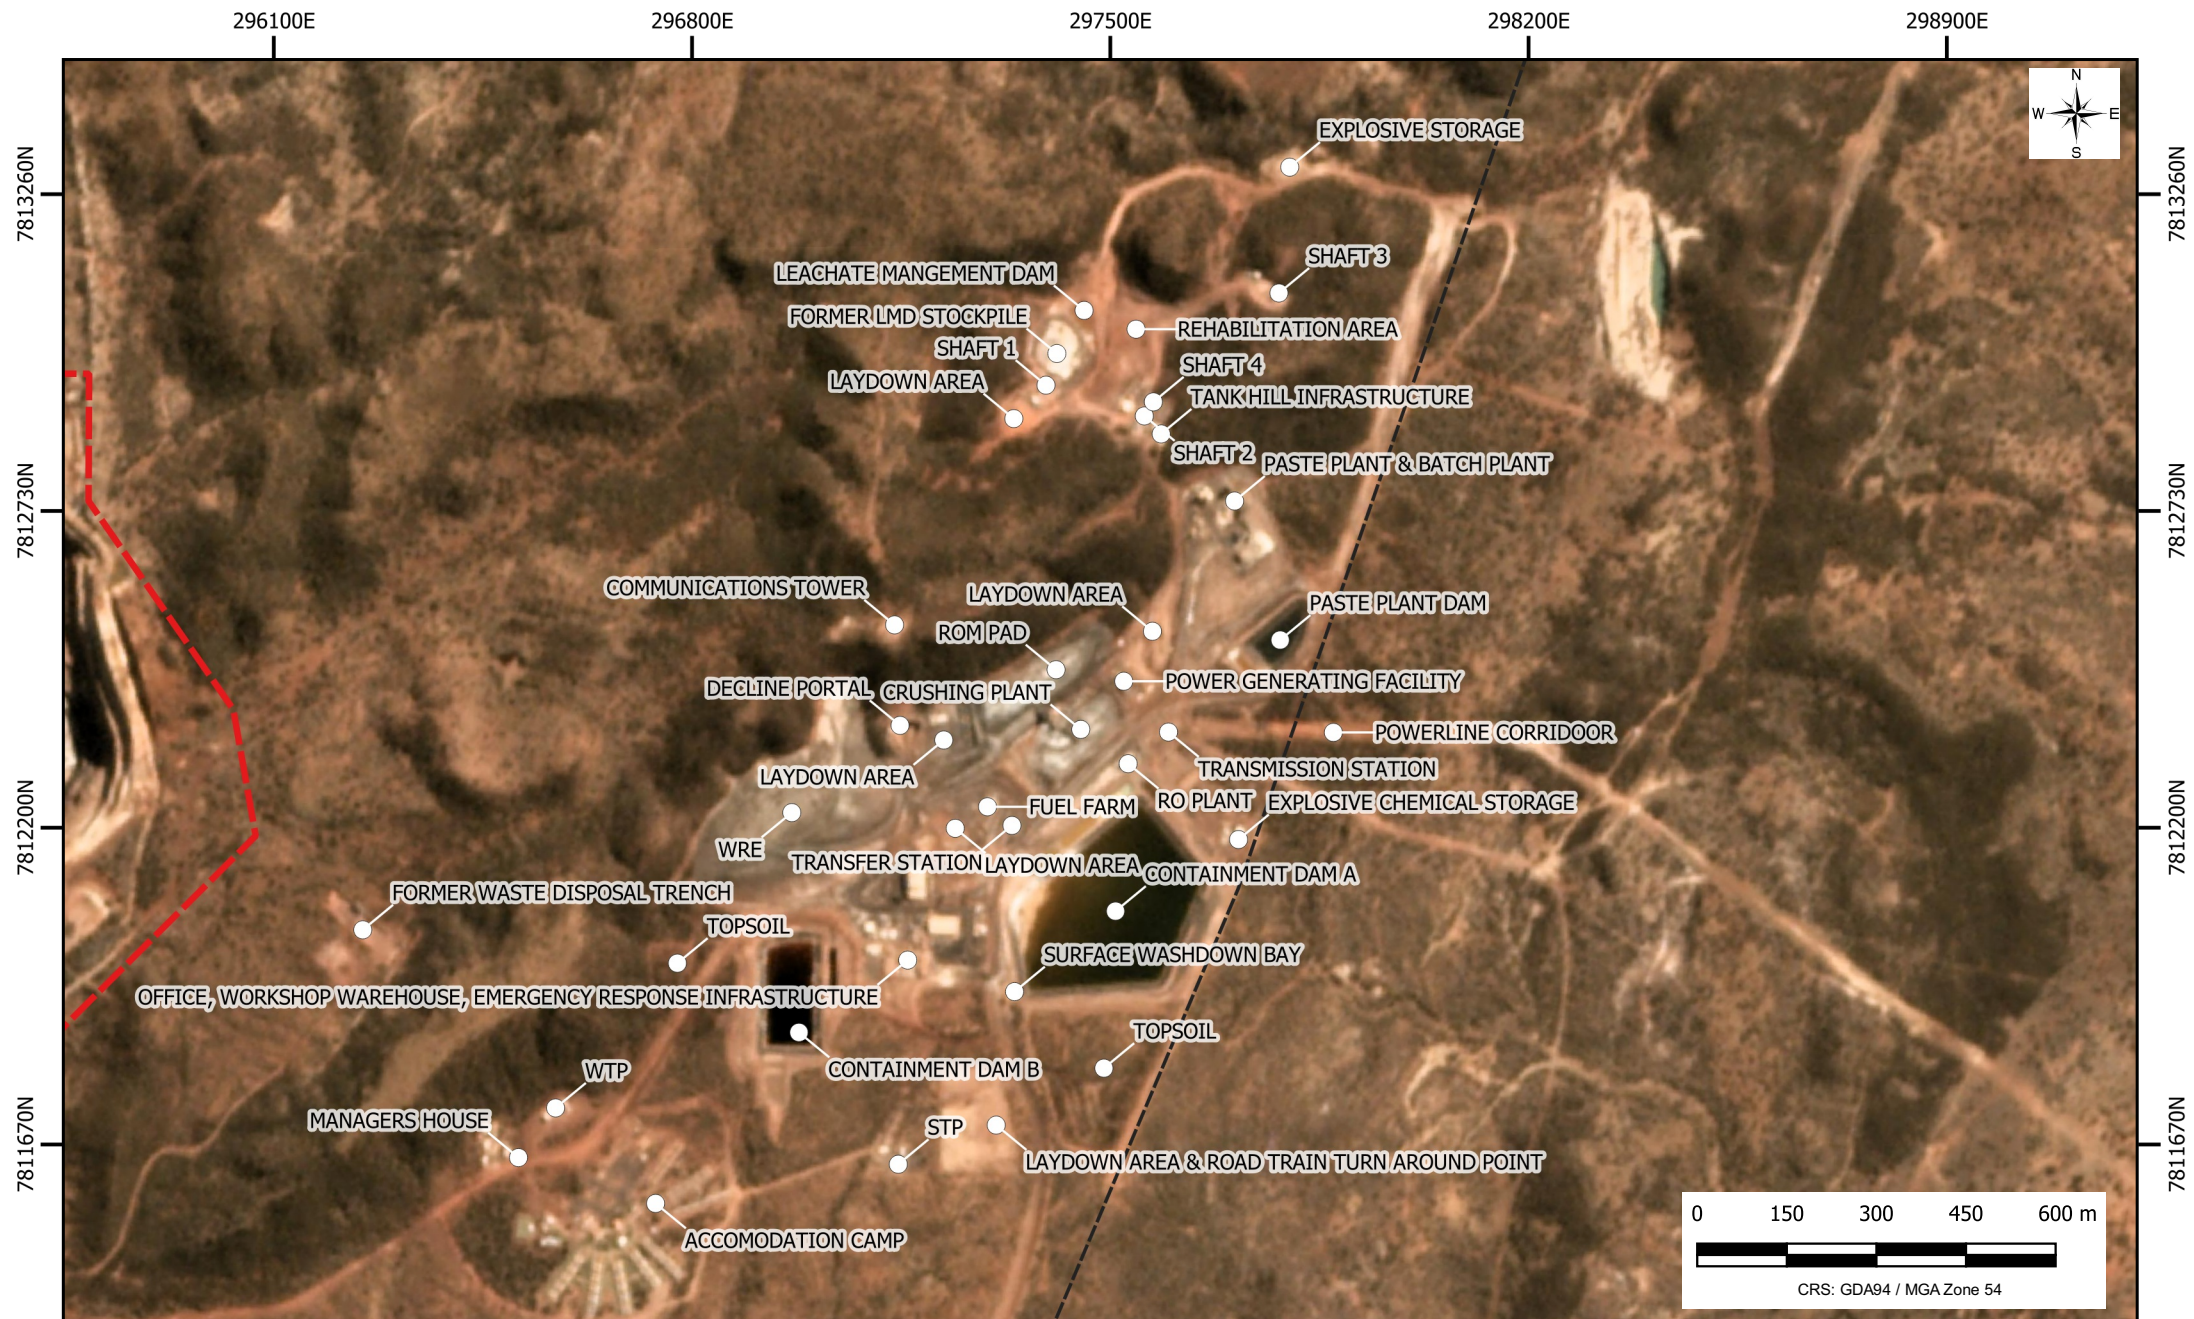
- Explosive chemical storage yard and explosive storage,
- Ventilation equipment,
- Utilities including: fuel farms, power station, transmission station, sewage treatment plant (STP), water treatment plants (WTPs),
- Waste transfer station,
- Laydown areas,
- Communications tower,
- Waste disposal trench,
- Emergency response training ground, and
- Airstrip.

A layout of the Site including the location of major infrastructure is provided in Figure 3.

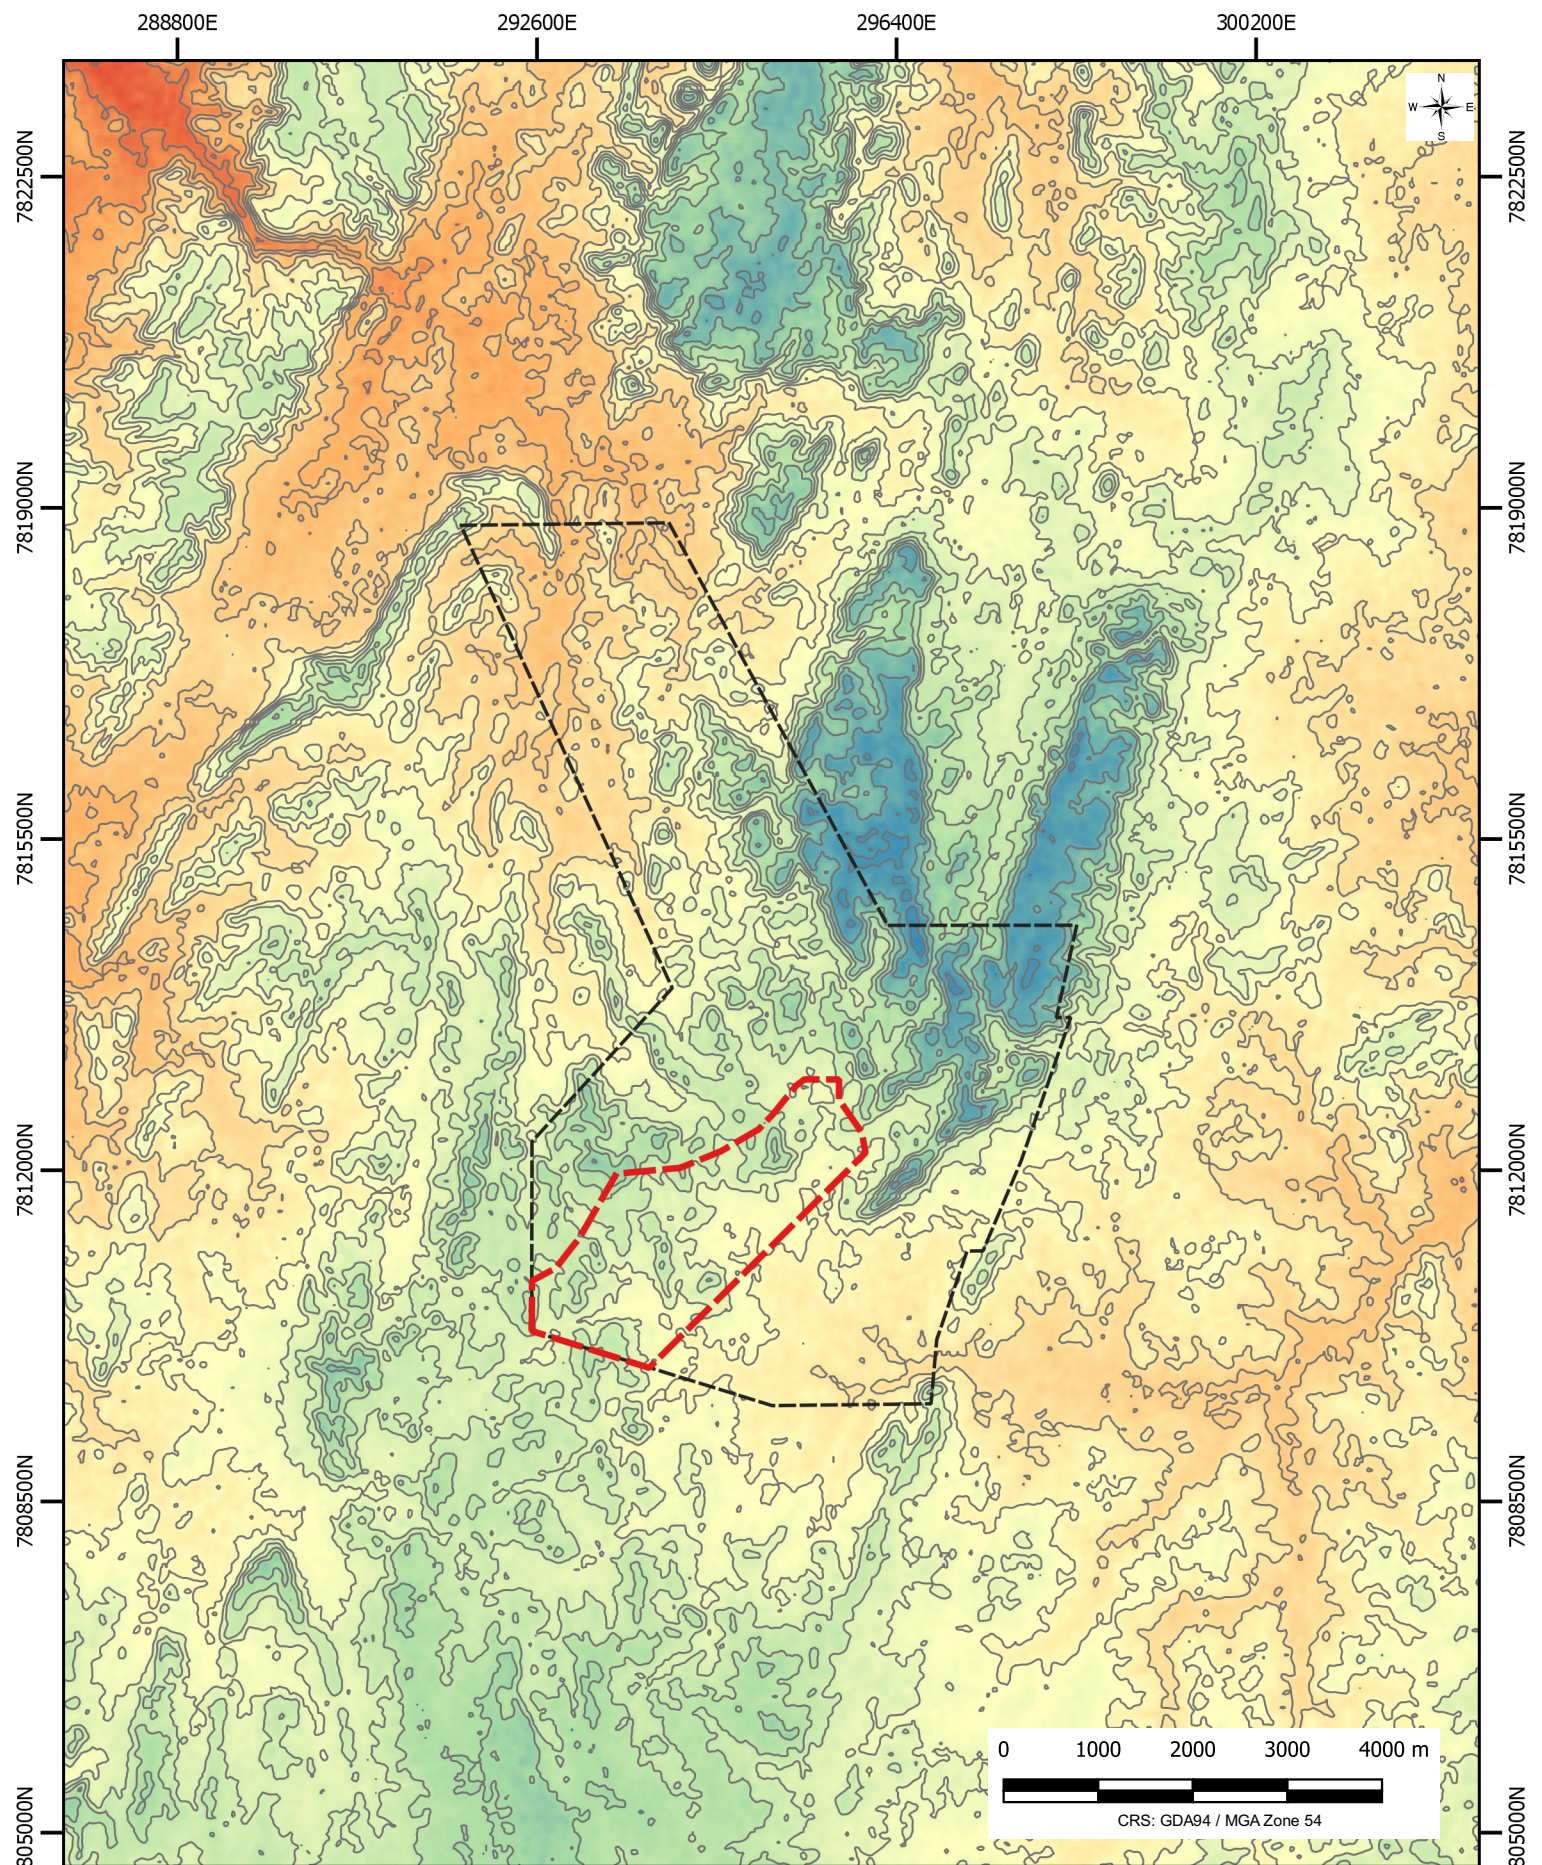
Most of the mine infrastructure is located on the edge of a ridgeline, occupying levels between 325 m and 335 m AHD at typically low gradients, less than 3% slope. The steepest gradients found at LLM are approximately 40% to 50% on the hill slopes of the Big Syncline.

Regional topography is shown in Figure 4.

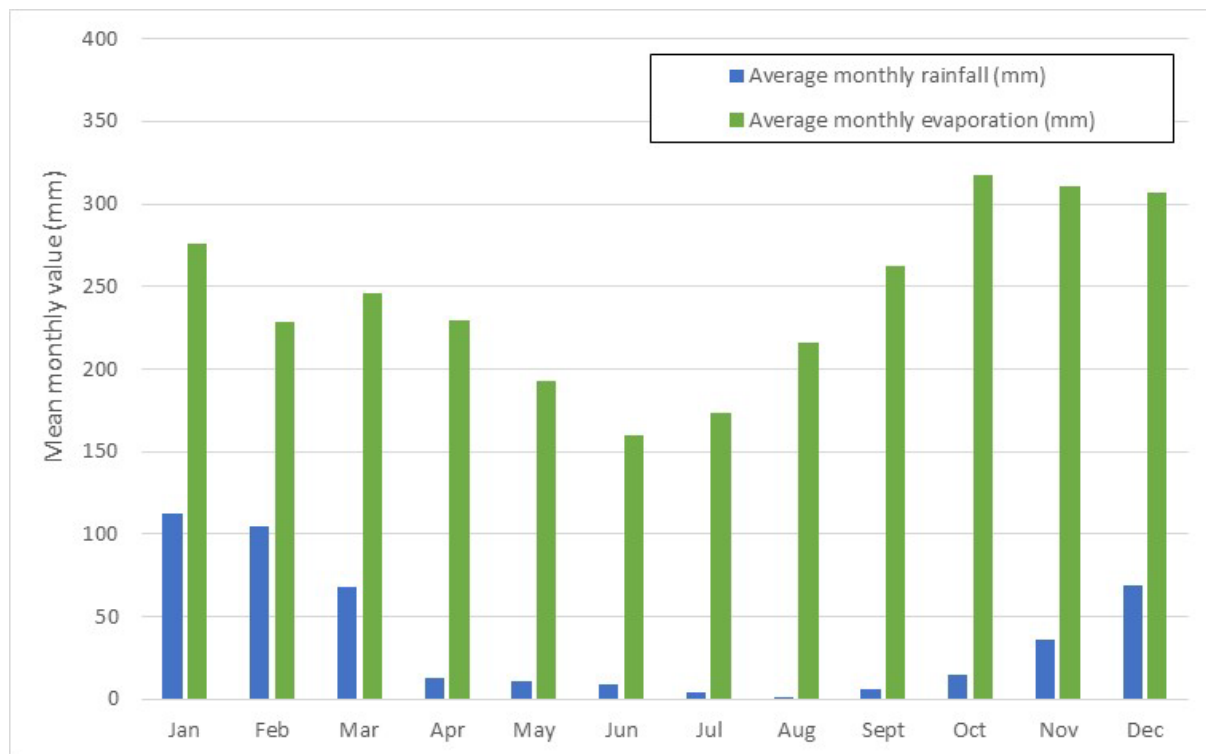
**Figure 5: Climatic Conditions**

The average rainfall and evaporation data are presented in Figure 5.

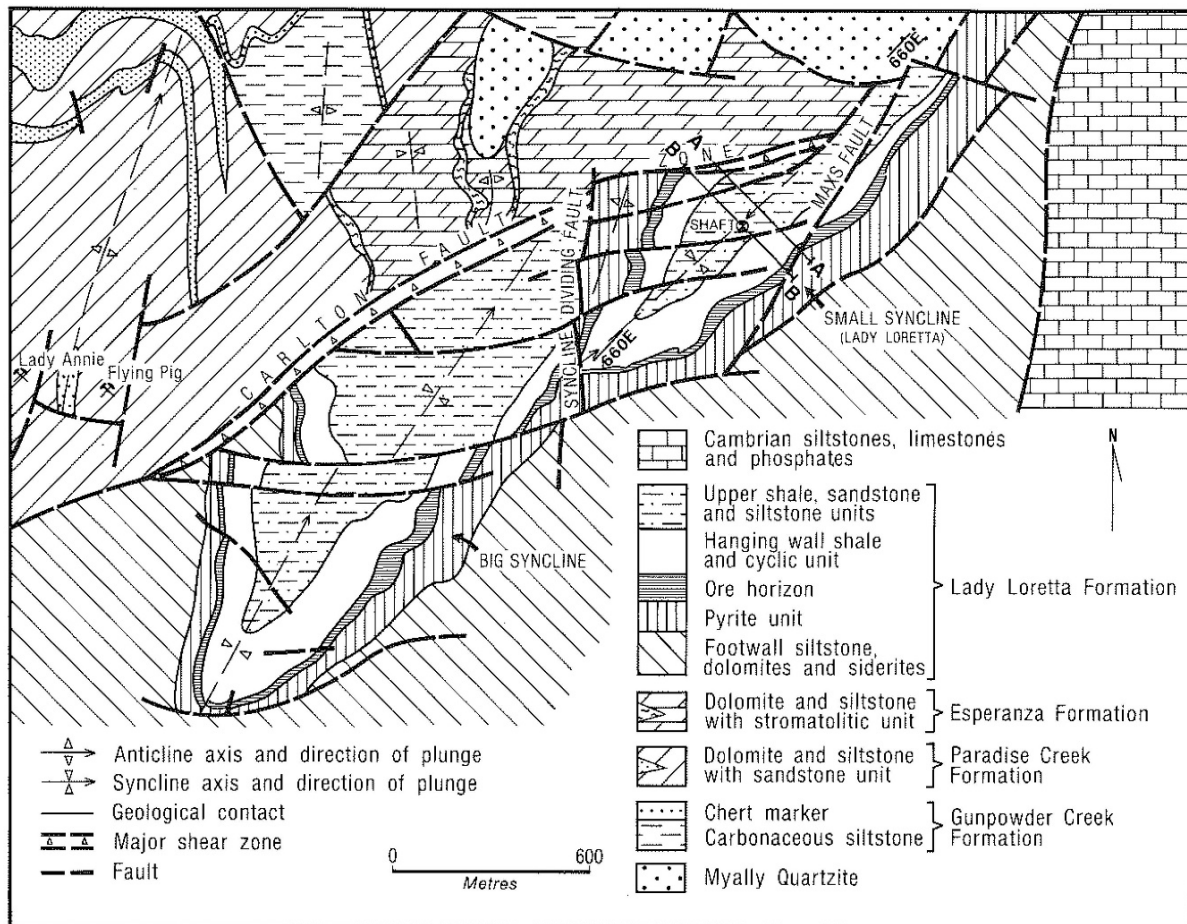
**Figure 6: Plan View Geological Map of the Lady Loretta Deposit and Stratigraphic Column for the Region**

The deposit is hosted within the Palaeoproterozoic Lady Loretta Formation, which is the uppermost outcropping unit of the McNamara Group (Valenta, 2018) within the keel of the Small Syncline, a tight north-east trending fold. The Small Syncline as well as the Big Syncline are heavily faulted with a series of north-east and south trending faults.

Local geology, from Hancock and Purvis (1990), is summarised in Figure 6.

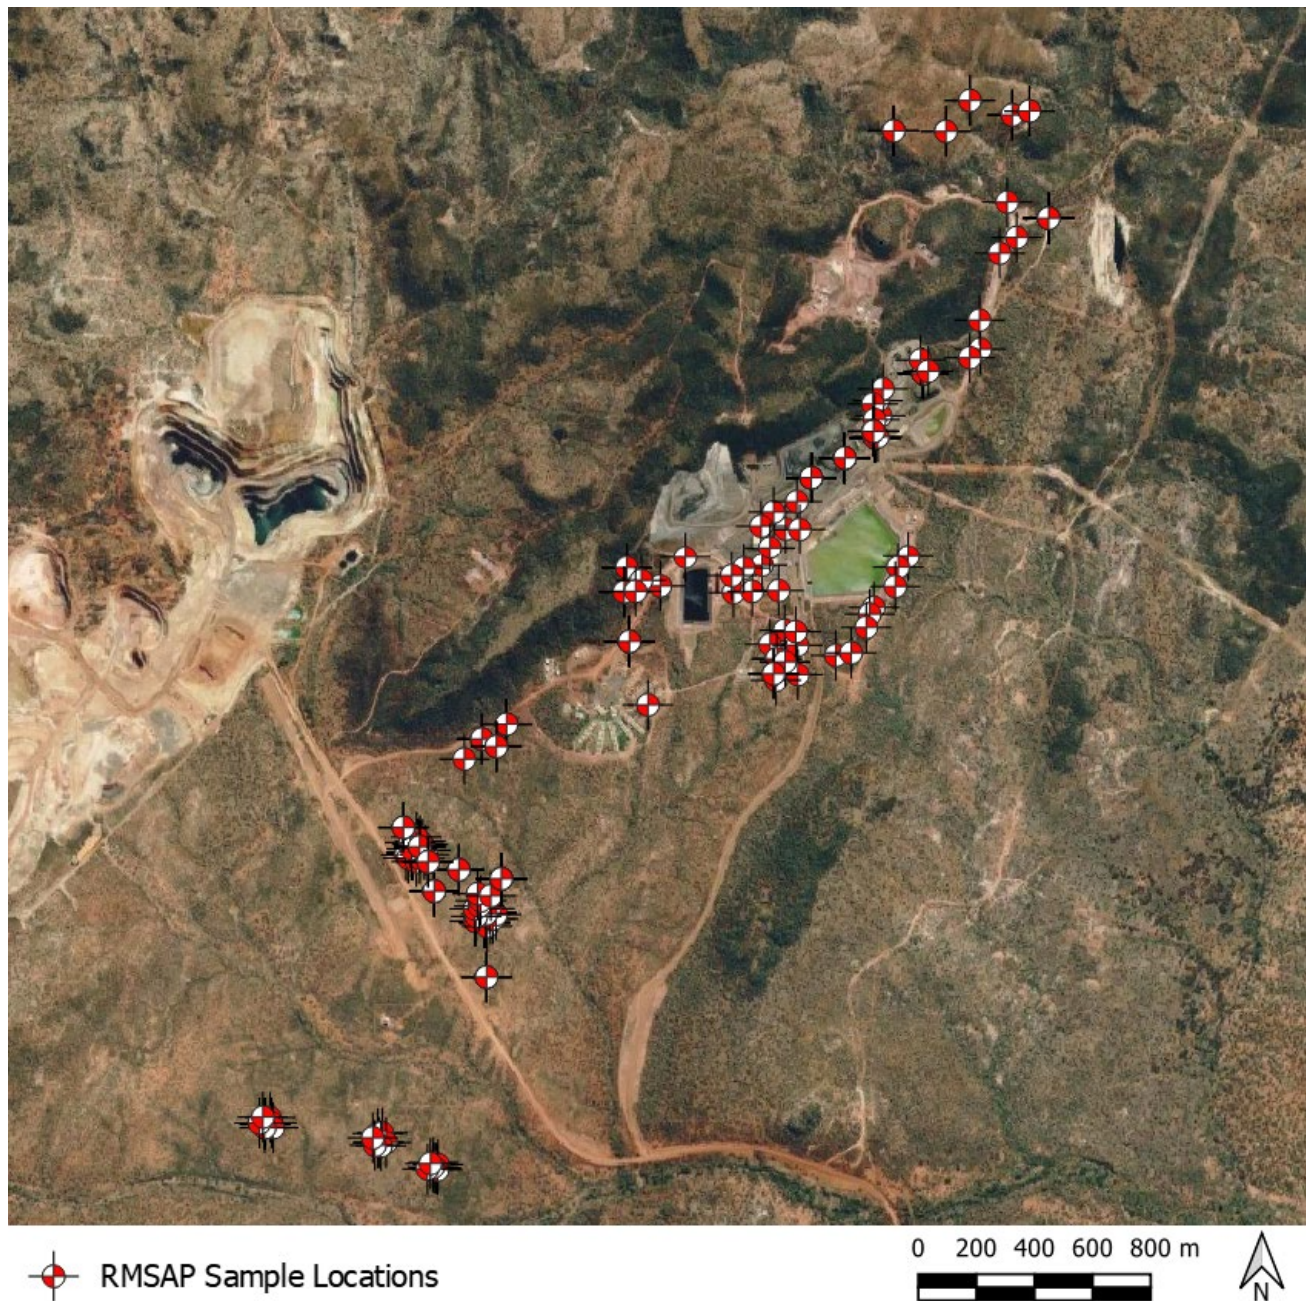
**Figure 7: Soil Sample Locations**

A summary of laboratory test results, which are relevant to erosion stability modelling and general soil characteristics as outlined in RGS (2023) is provided below. The location of test samples taken during 2020 and 2021 is shown in **Figure 7**.

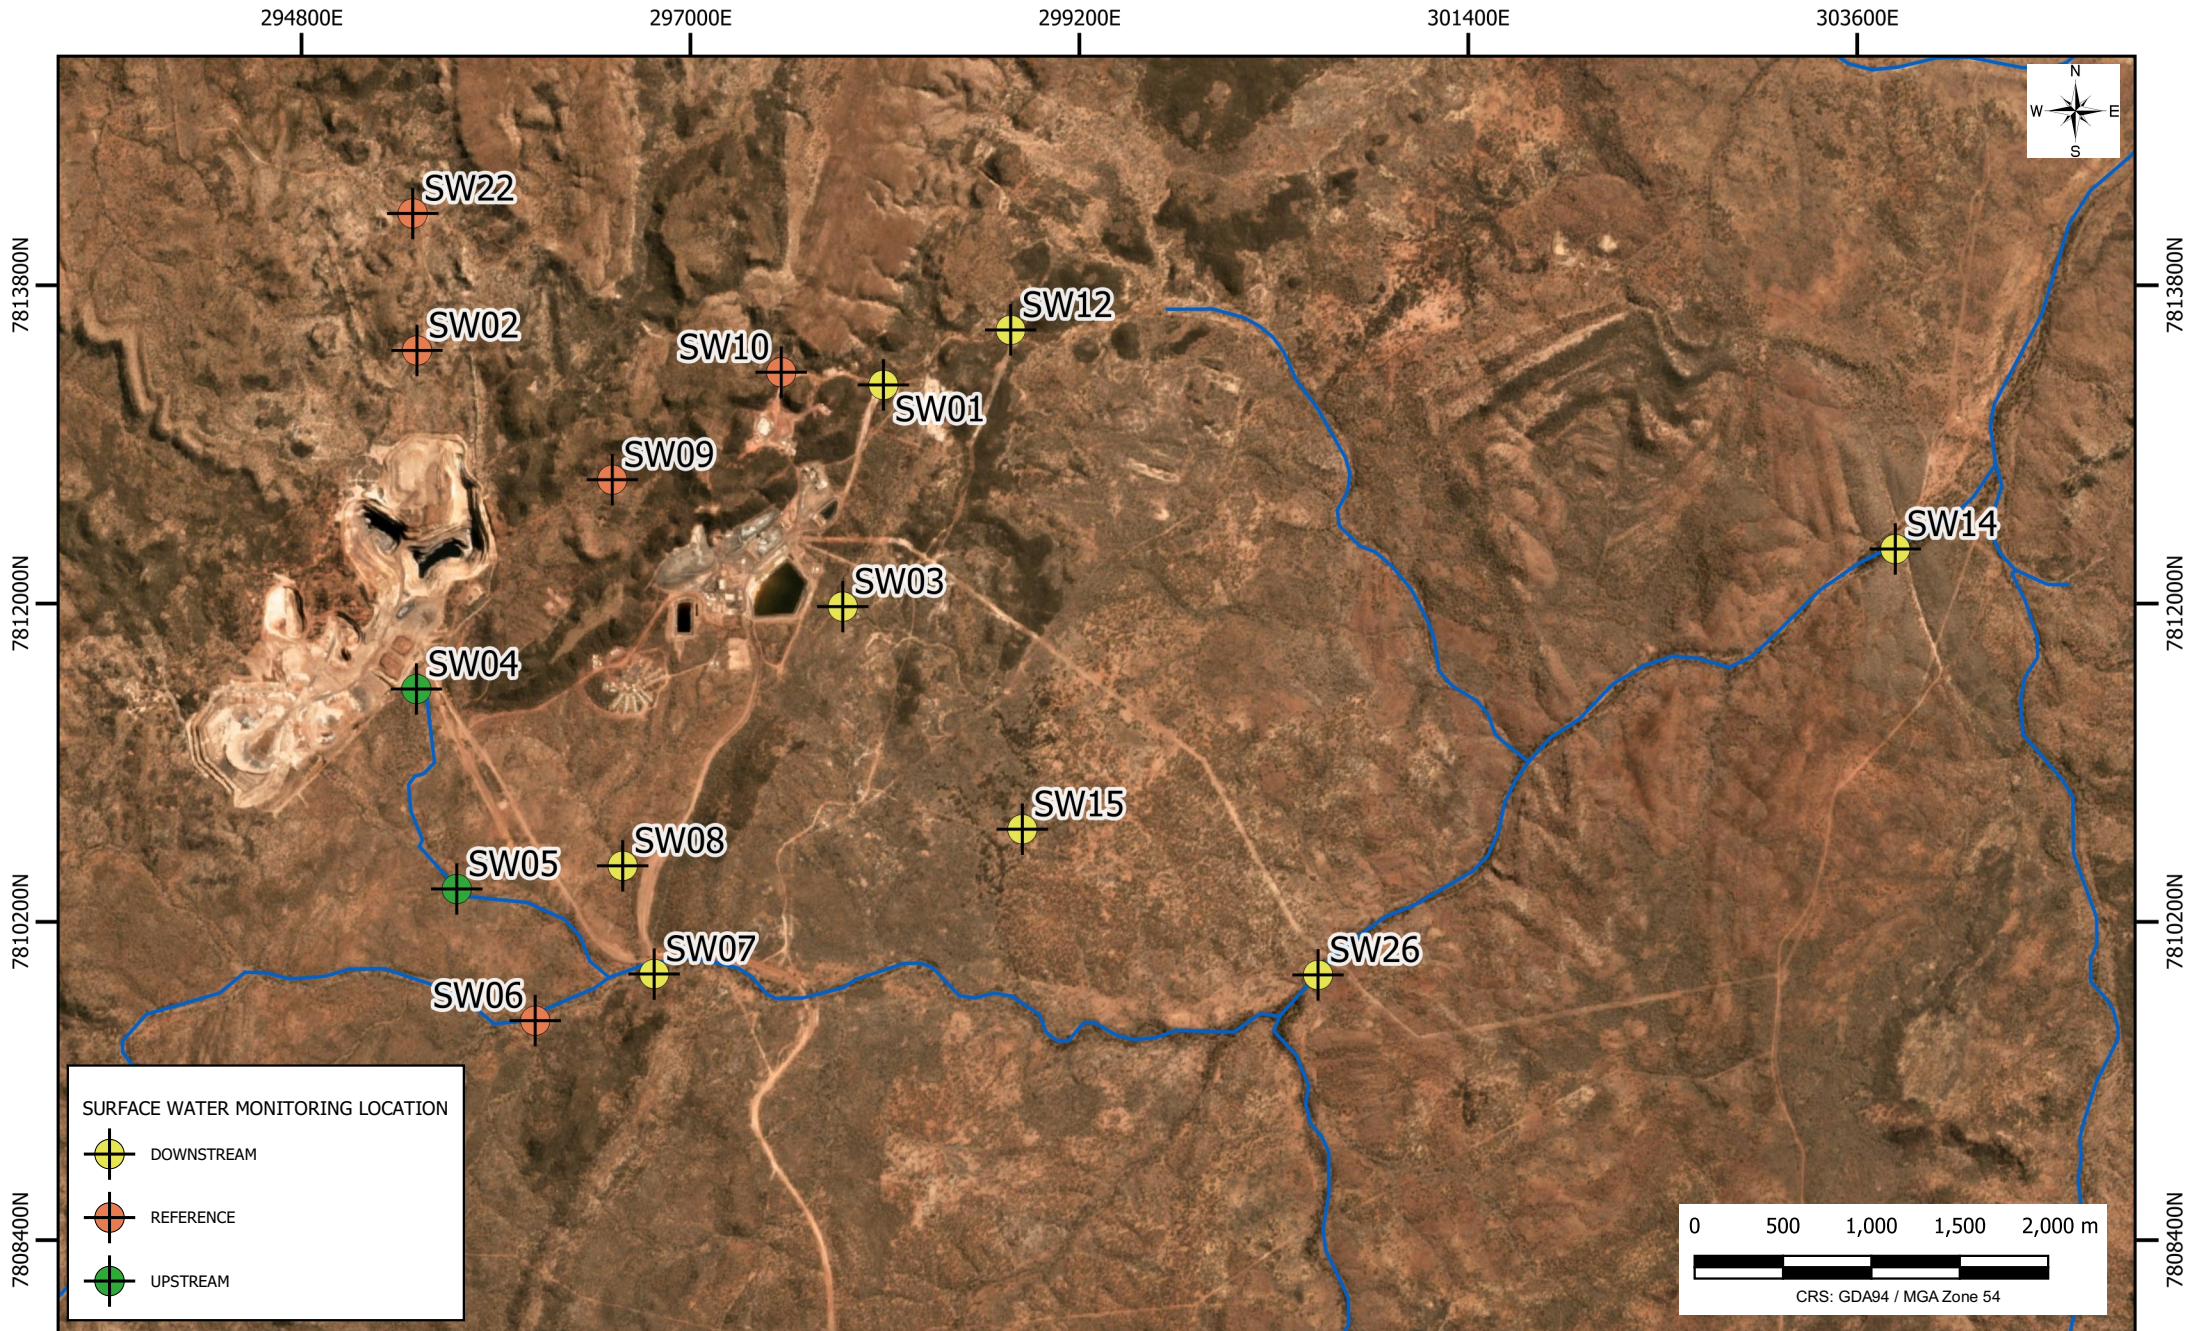
LADY LORETTA MINE  
SURFACE WATER MONITORING

The surface water sampling locations are shown in Figure 8.

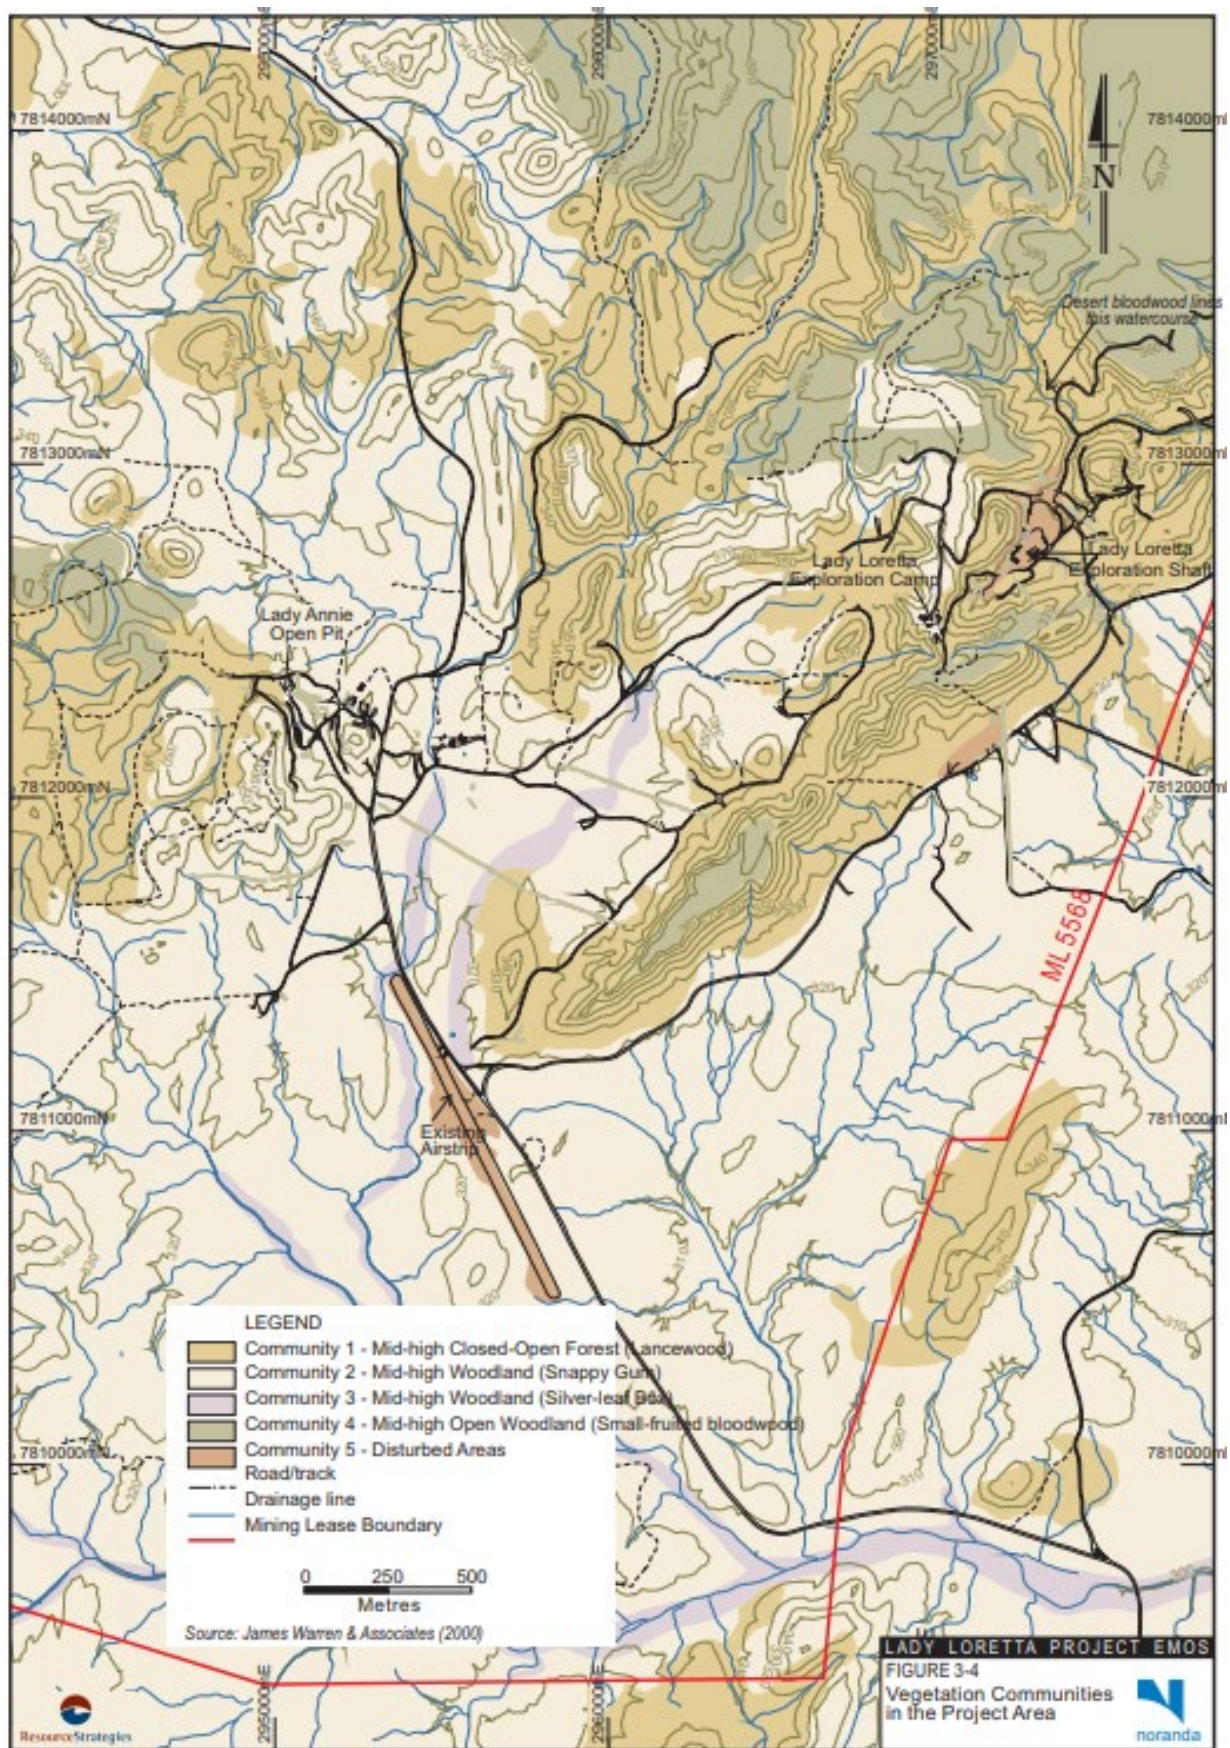
**Figure 10: Pre-disturbance Vegetation Map (from EMOS Noranda Pacific 2000)**

The geology, terrain and vegetation of the Site has been described variously including Section 3 of this PRCP and the EMOS developed by Noranda Pacific in November 2000 to support authorisation of the EA. The EMOS defined four vegetation communities that occur at the Site. The spatial distribution of these communities aligns with the local topography and geology. A plan showing the pre-disturbance vegetation types is presented in Figure 10.

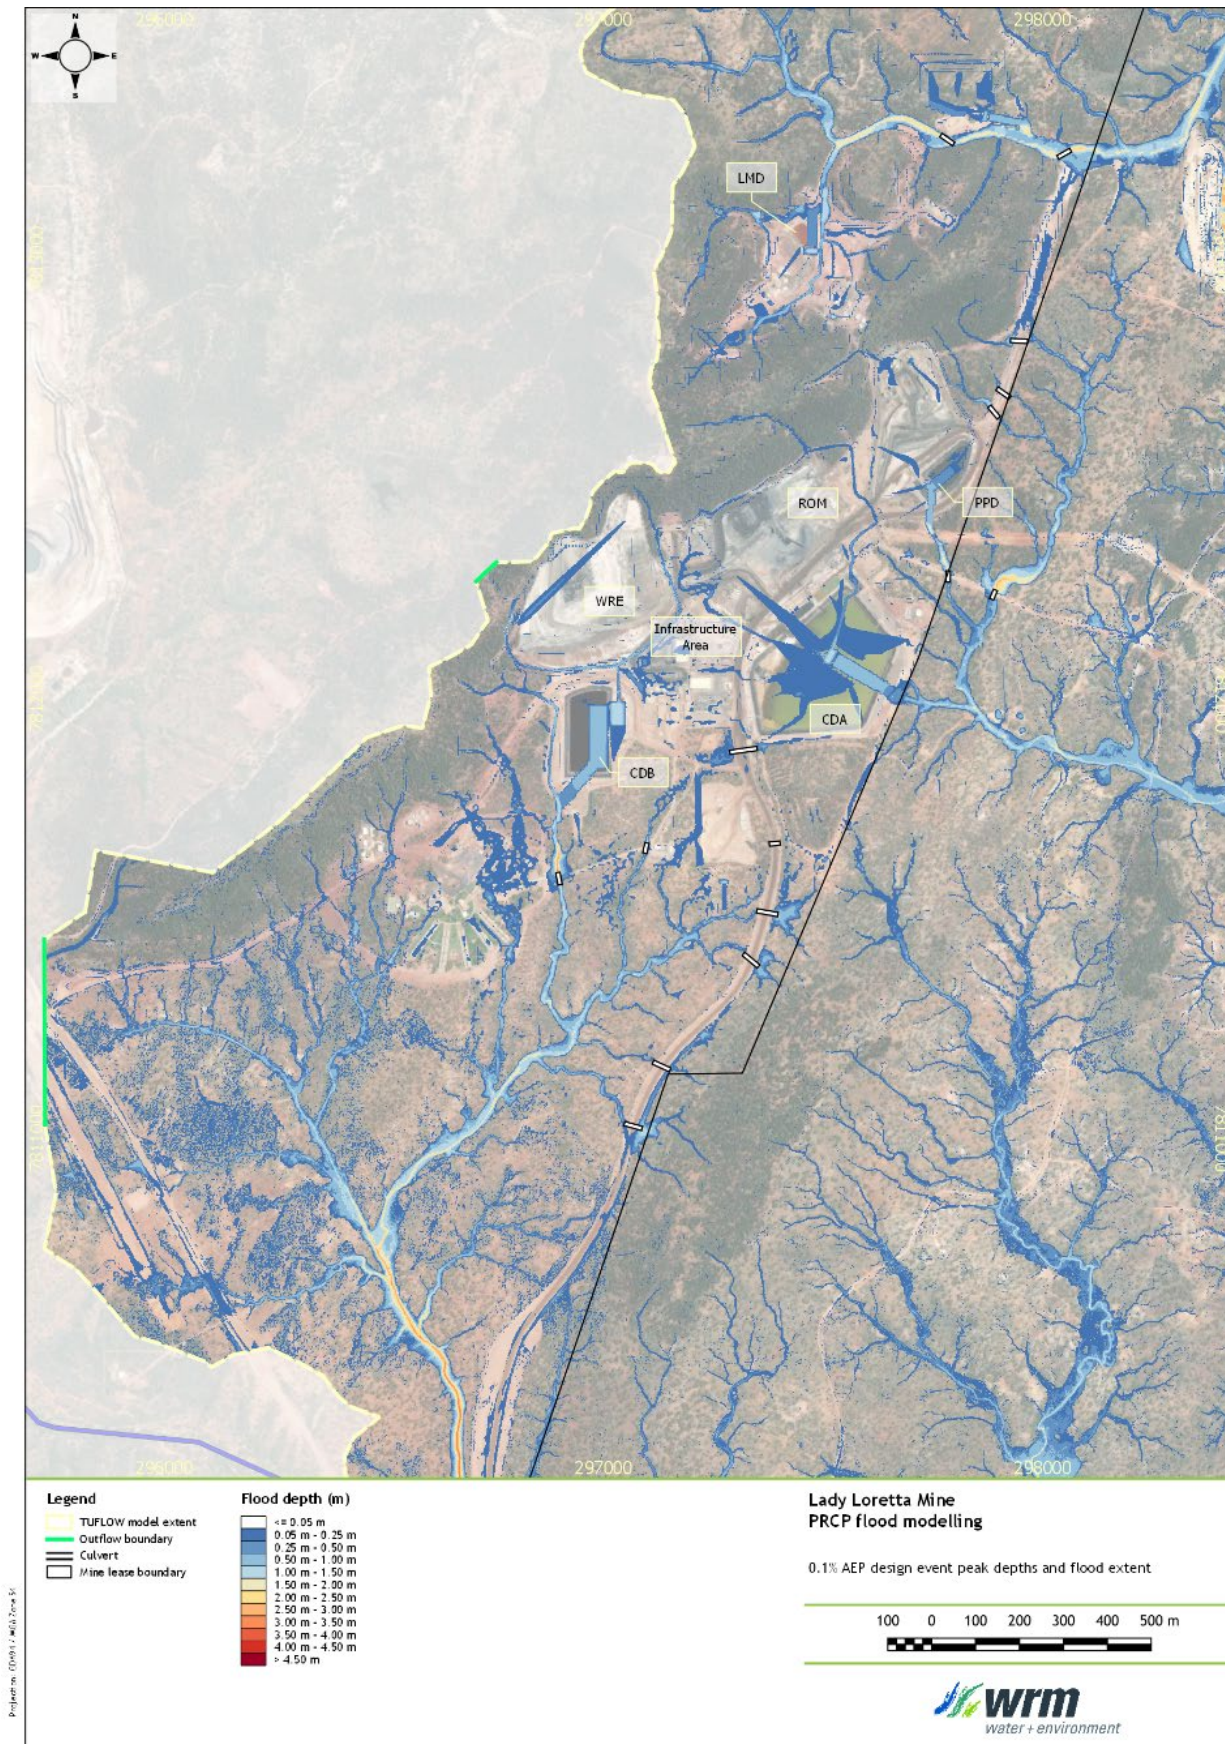
**Figure 13: Flood Inundation Map - 0.1 % AEP Rainfall**

Inundation mapping for the 0.1 % AEP rainfall event is provided in Figure 13. Results of the modelling clearly indicate that:

- the Site will be free draining, and
- under the 0.1 % AEP flood, the major facilities that comprise LLM are above the inundation zone.

Consequently, the risk of floodwaters affecting future rehabilitation areas or inundating final voids is not material.

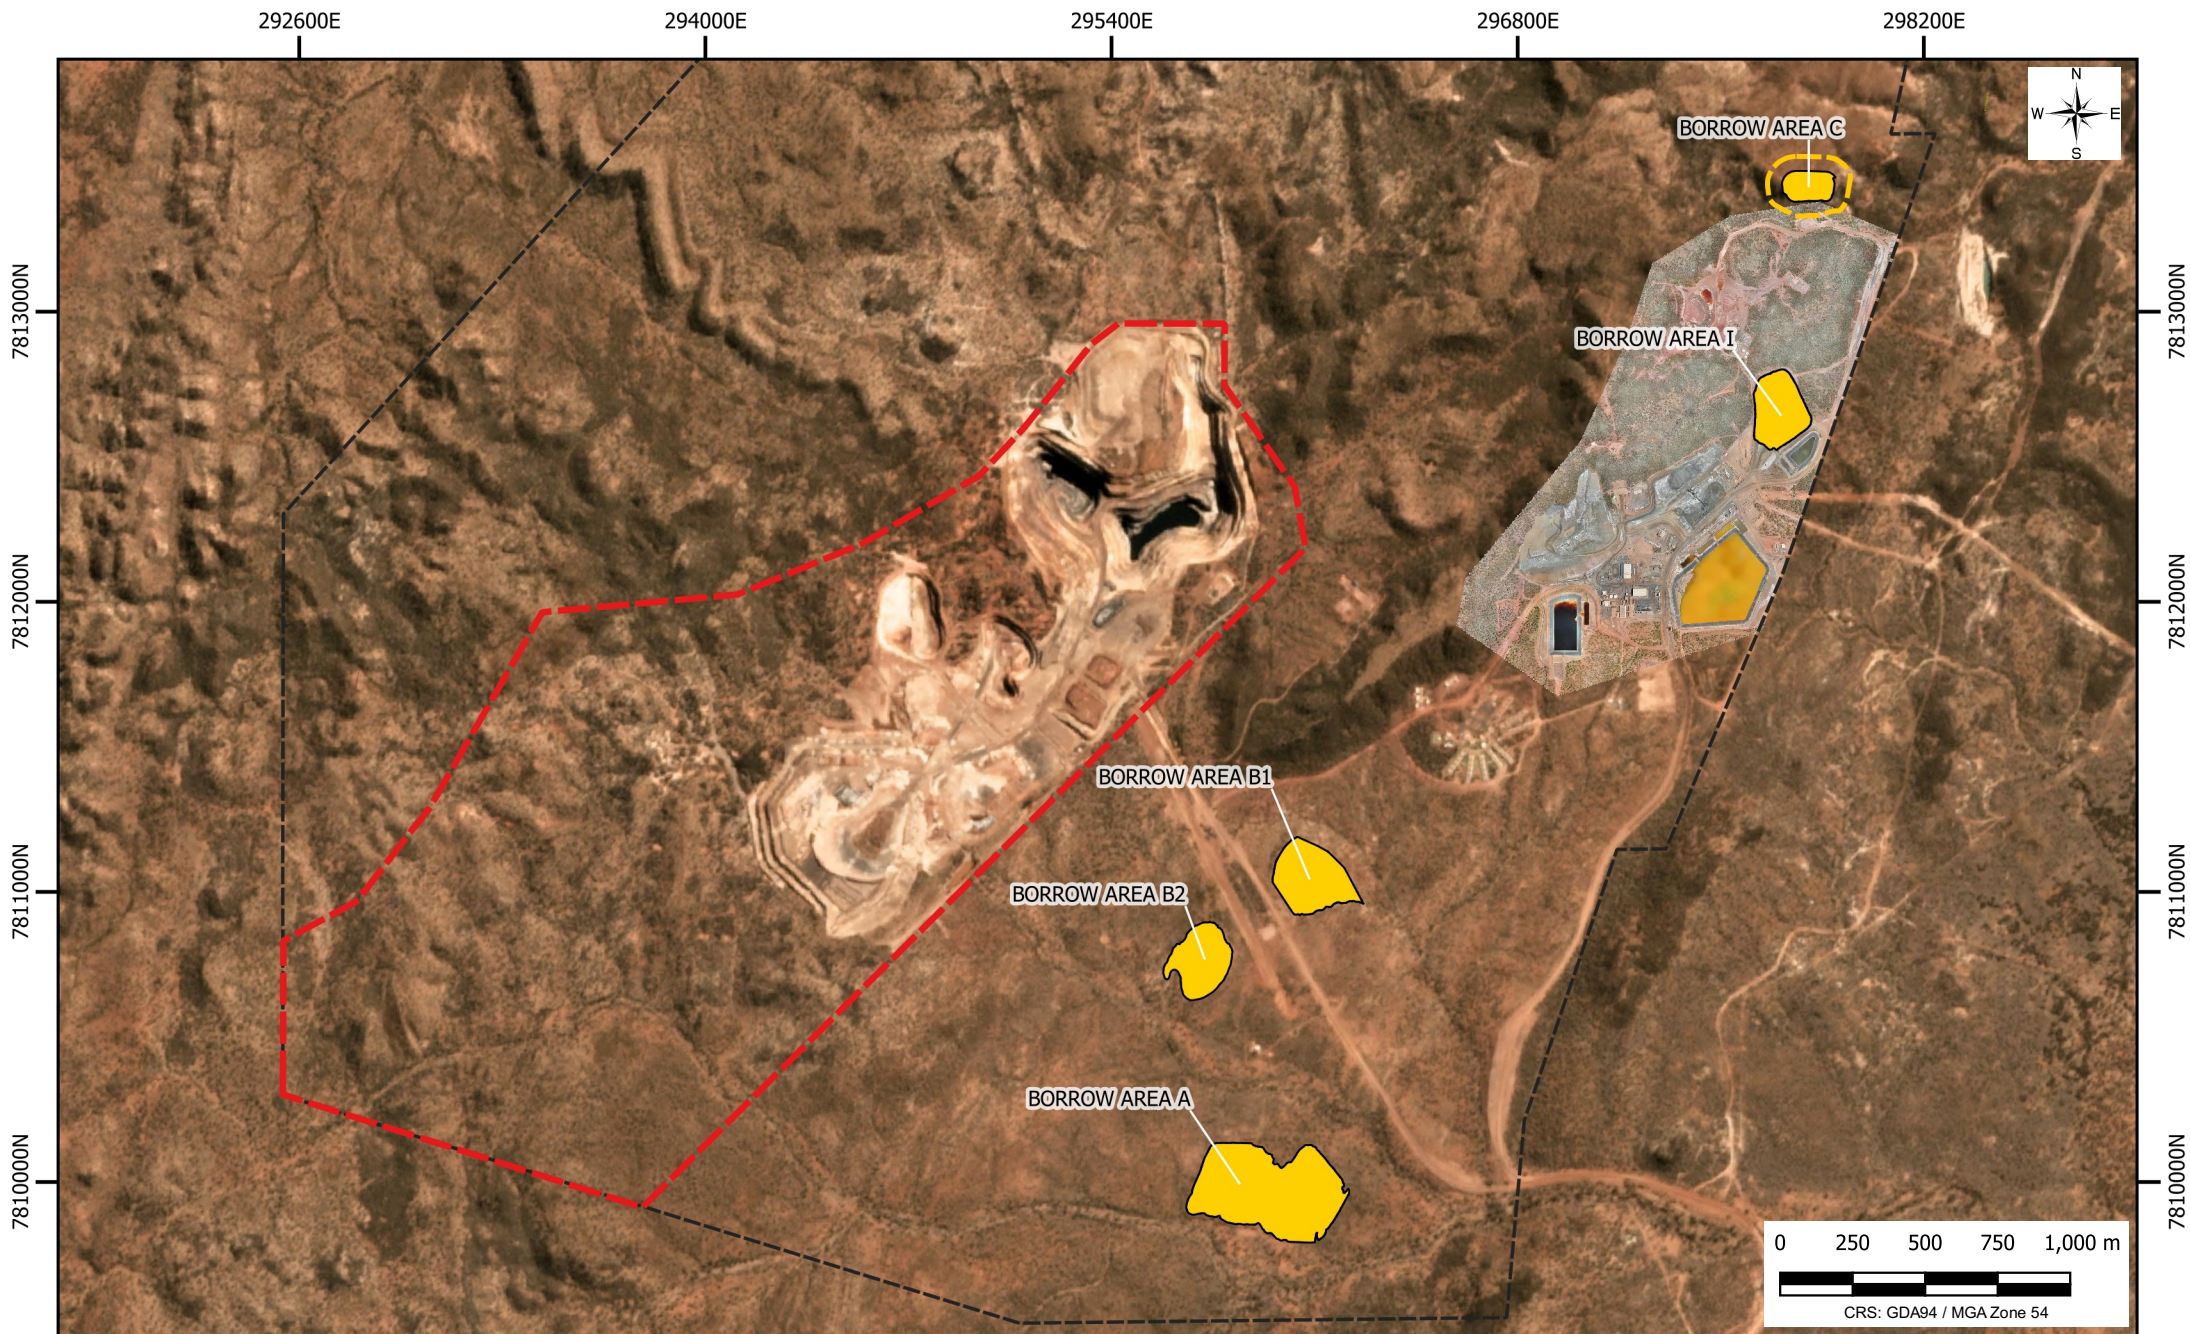
The locations of the optional borrow areas are shown in **Figure 17**.

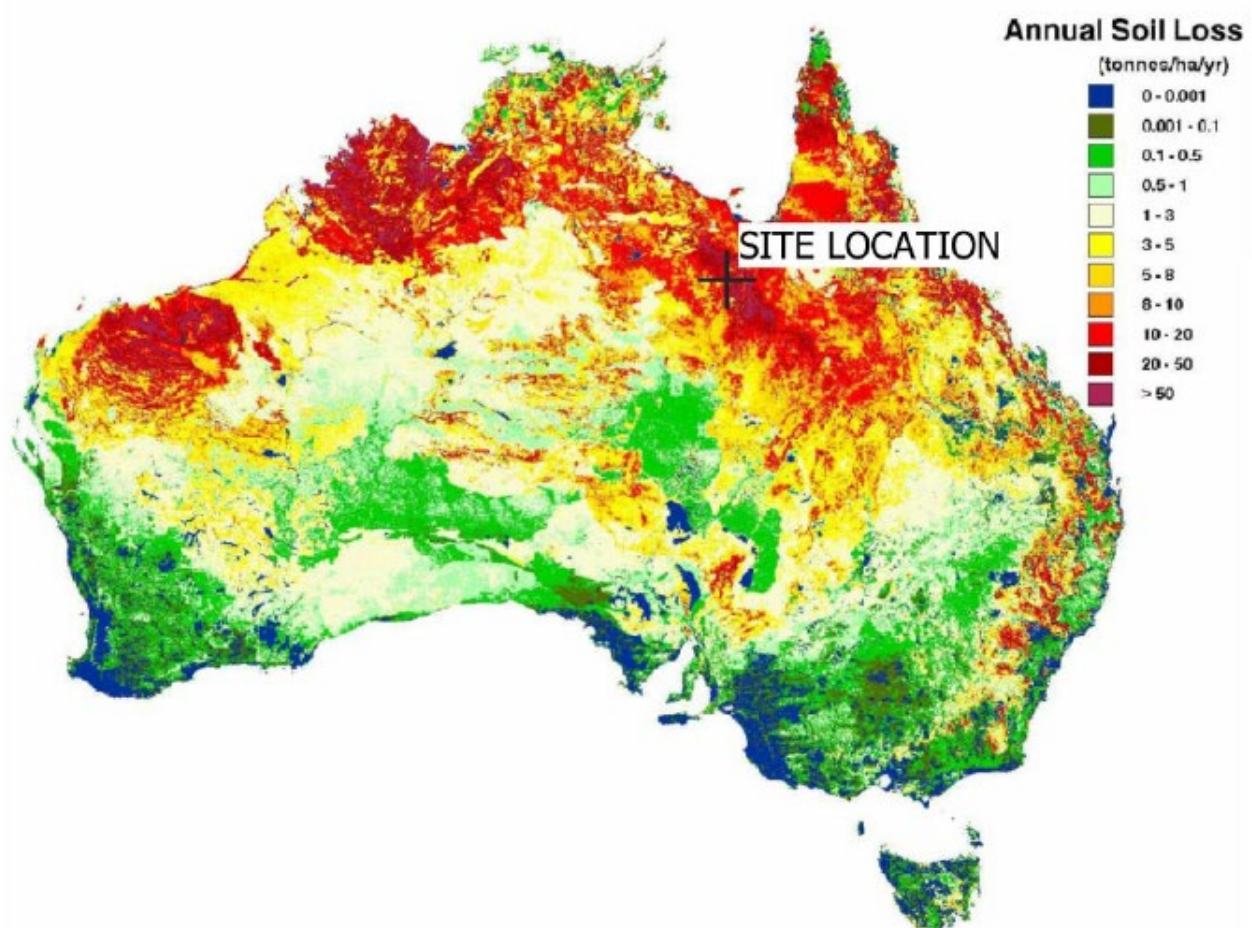
**Figure 18: Australian Soil Loss Rates (Lu, et al, 2001)**

Recognising natural soil loss rates presented by Lu, et. al. (2001), climatic conditions limiting vegetation growth and moderate dispersity of site soils can be found, a maximum annual average erosion loss rate of 30t/ha/yr is deemed appropriate for rehabilitated landforms at LLM and therefore has been adopted as the threshold for drainage controls.

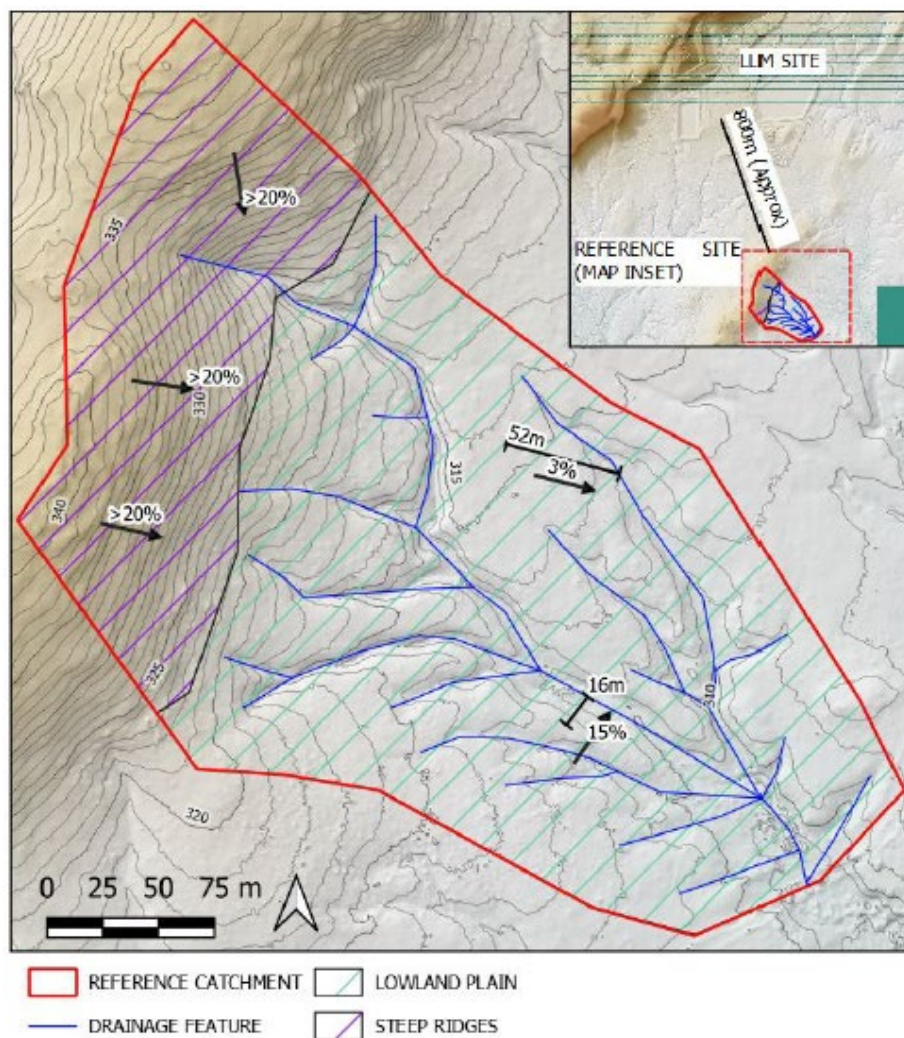
**Figure 19: Reference Site**

To characterise the local natural topography and drainage conditions, an example landform similar in scale to the LLM rehabilitation areas has been mapped. The chosen landform appears to be generally undisturbed by mining or other human activities. The example landform includes both steep ridges and lowland plains. The landform is located approximately 800 m southeast of the site and includes both steep ridges and lowland plains as shown in **Figure 19**.

**Figure 19** shows steep batters only form drainage paths to convey flows from upstream contributing catchments. Whilst within the lowland plain areas, drainage paths are formed with a separation distance of 20 m where surface slopes are steep and a separation distance of 50 m or more where surface slopes are flat.

- Steep, rocky faces are a natural occurrence and are likely to withstand erosion and scouring, provided in-situ materials are comprised of competent rock.
- Lowland plains require drainage features to control conveyance flow volumes and velocities and to confine deposition, erosion and scouring. Without constructed drainage features to reduce the length of overland flow paths, incised gullies will likely form through erosion and scouring, with the severity subject to soil type, vegetation cover, slope and contributing catchment area. During this process the landform is unlikely to be considered stable as there is a risk of undercutting steep batter slopes and scouring which potentially could change the landform and surface hydrology. By defining the locations of drainage features the final landform will be stable at Day One of completion of the rehabilitation.
