LADY LORETTA

## **Z-LLM-HSEC-PLN-Progressive Rehabilitation and Closure Plan**

| Project Name | Lady Loretta Mine |
| Document Title | Z-LLM-HSEC-PLN-Progressive Rehabilitation and Closure Plan |

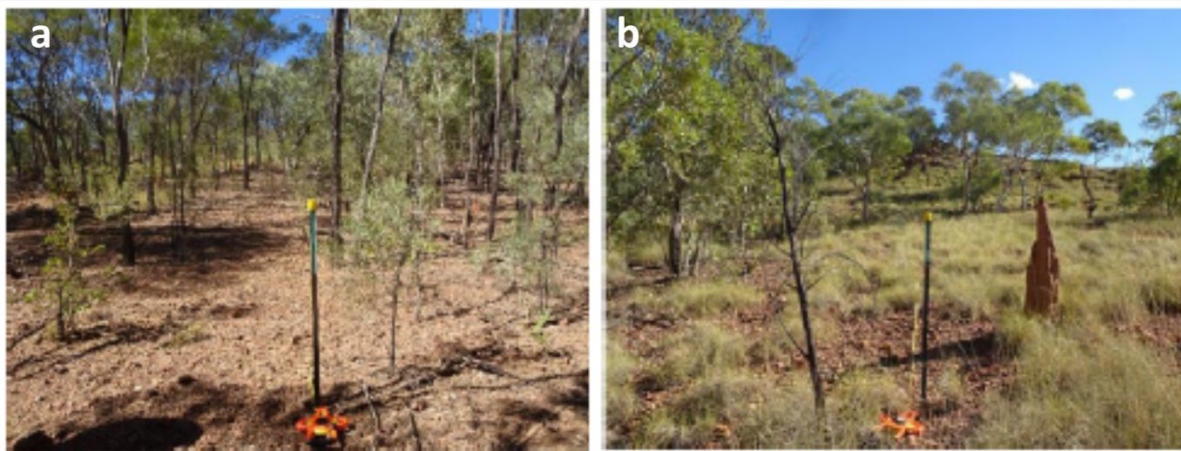
**Figure 20: Native Habitat/Steep Batters (a) and Low Intensity Cattle Grazing/Lowland Plains (b)**

The target vegetative cover is to mimic two vegetation types defined in **Section 3.1.3**, these being steep batters and lowland plains. An example photo of both the steep batters and lowland plains and are shown in **Figure 20**.

| Criteria | Description |
|---|---|
| Vegetative Cover | Refer to example Figure 20<br>Trees on the steep ridges and spinifex on the lowland plain areas |

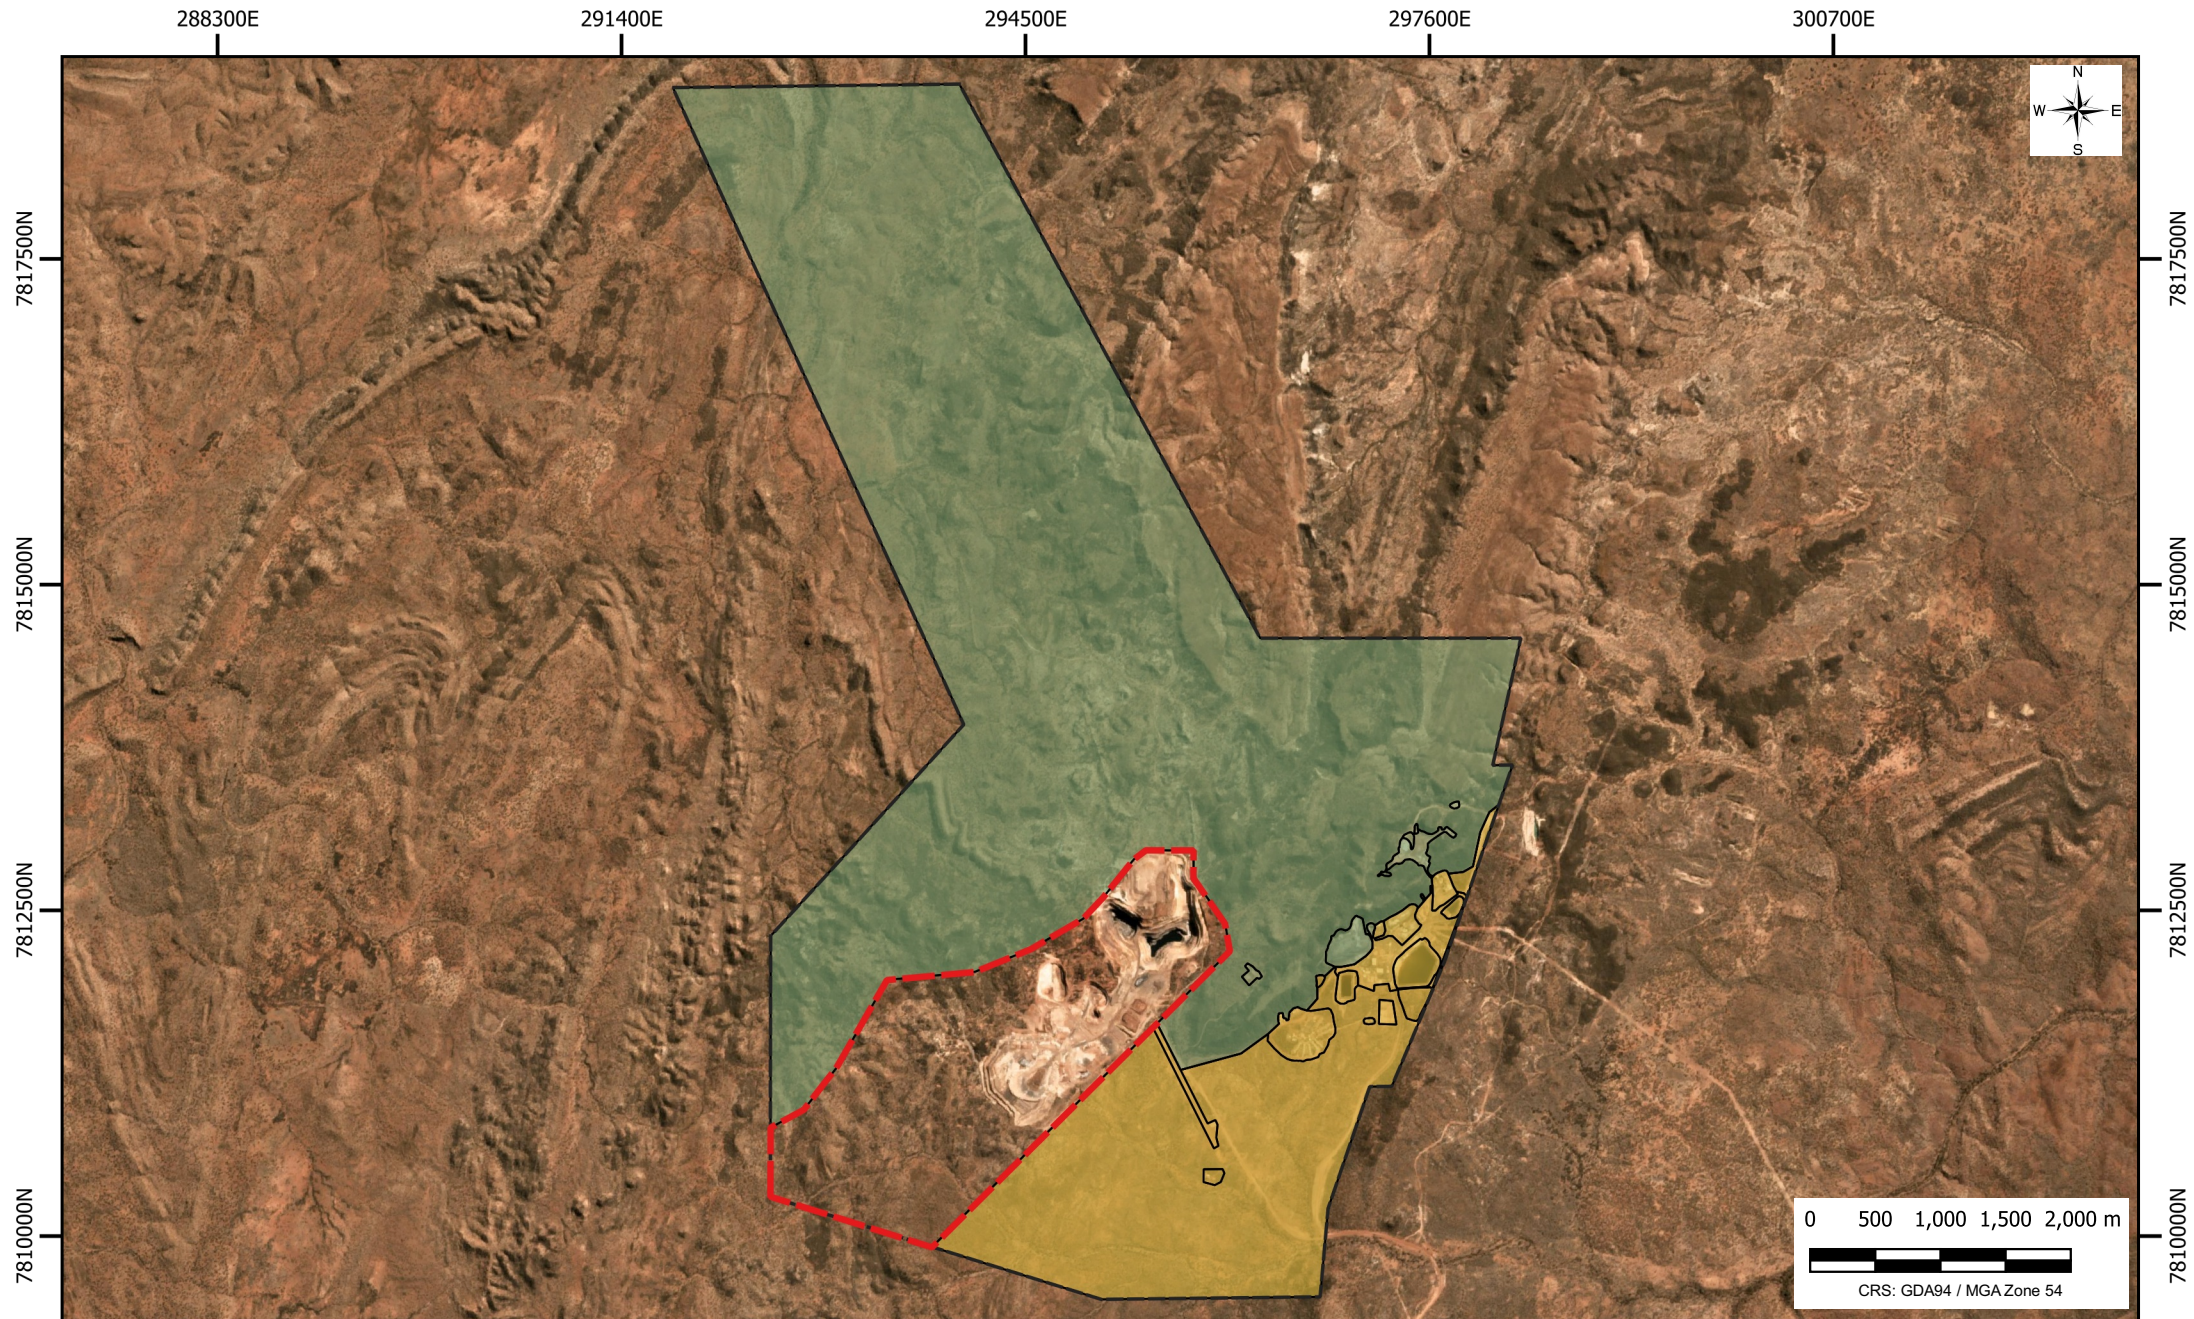
The final site design proposes a PMLU for the entire area of the ML. No NUMAs are proposed for ML5568. The final site design is presented as Figure 21.

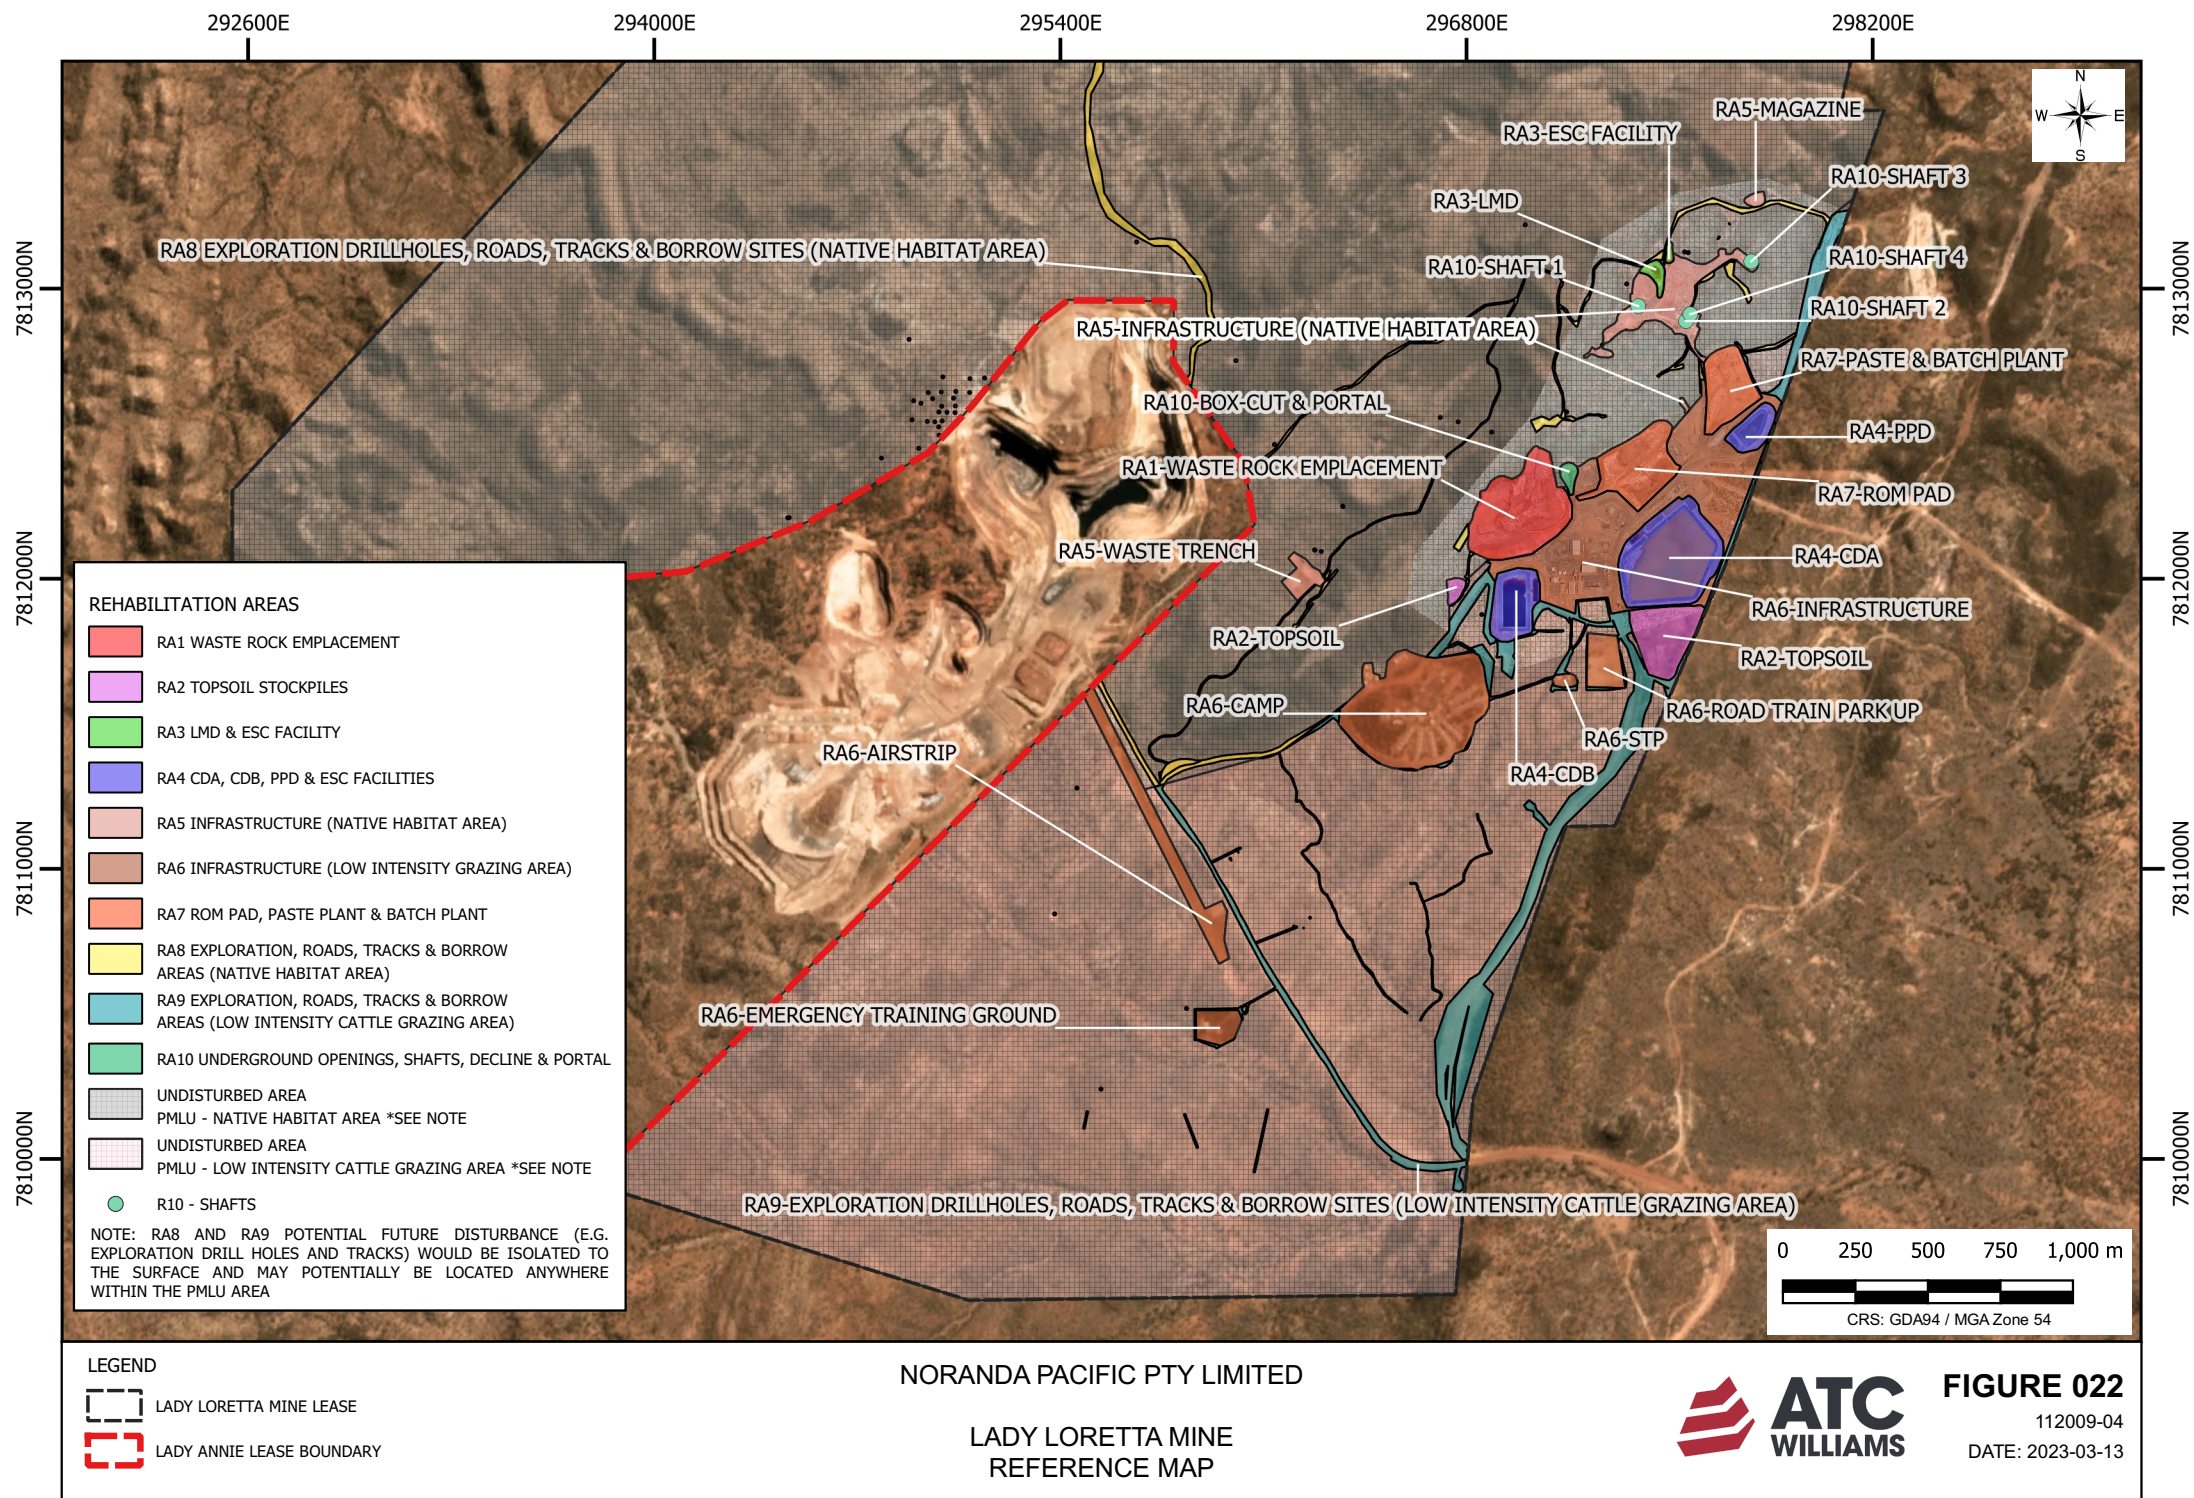
- RA1 Waste Rock Emplacement,
- RA2 Topsoil Stockpiles,
- RA3 LMD and ESC Facility,
- RA4 CDA, CDB, PPD, Sediment Dams and ESC Facilities,
- RA5 Infrastructure (Native Habitat Area),
- RA6 Infrastructure (Low Intensity Grazing Area),
- RA7 ROM Pad, Paste Plant and Batch Plant,
- RA8 Exploration, Roads, Tracks and Borrow Sites (Native Habitat Area),
- RA9 Exploration, Roads, Tracks and Borrow Sites (Low Intensity Cattle Grazing Area), and
- RA10 Underground Openings, Shafts, Decline and Portal.

A map showing the location and extent of the RAs is presented in Figure 22.

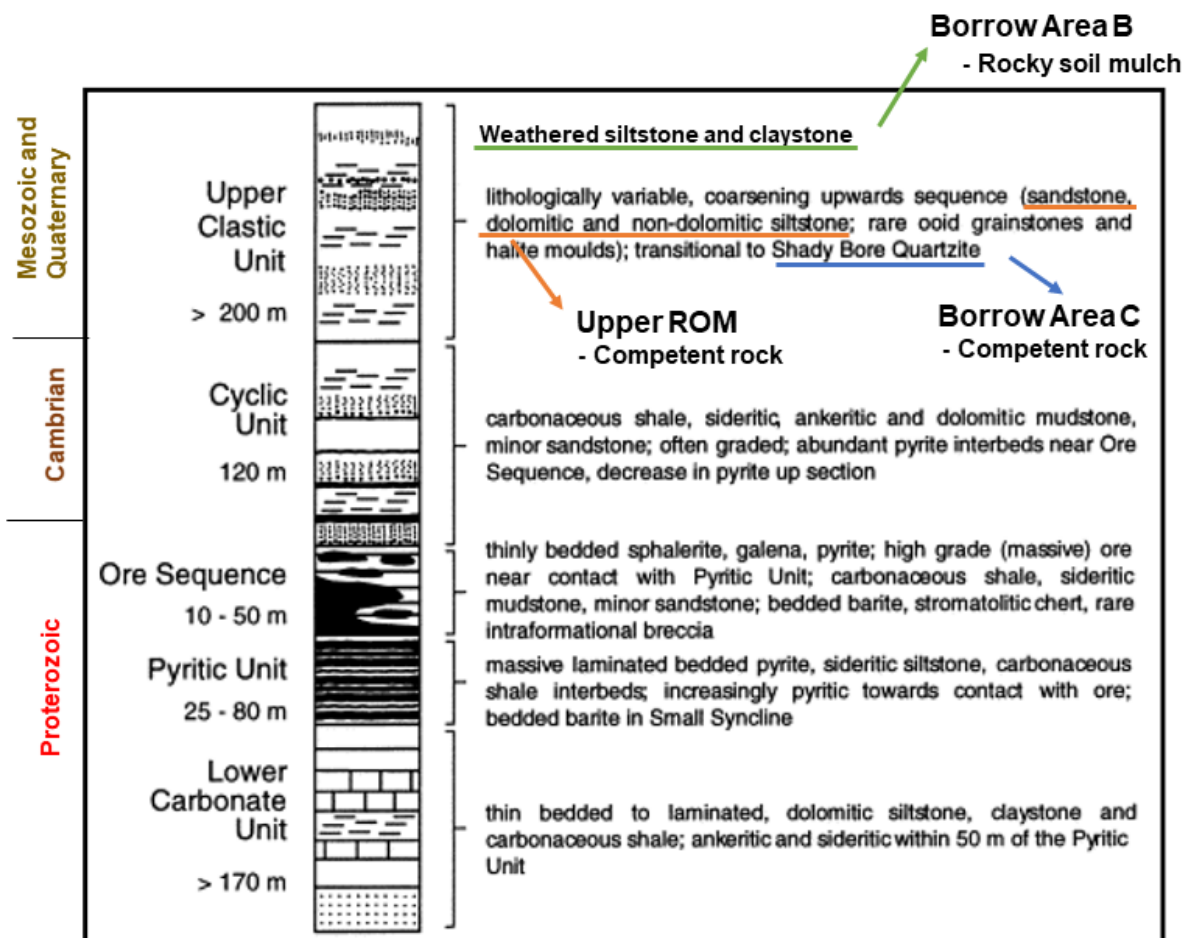
Figure 1-1: Stratigraphic sequence of the Lady Loretta Formation

The stratigraphic sequence of LLM geology is shown in **Figure 1-1** (based on AGE, 2020; Large and McGoldrick, 1998). Mesozoic and Quaternary sedimentary sequences are most likely to be encountered in the borrow pit and rehabilitation materials investigation. These relatively young rocks are thin and somewhat

variable in lithology but widespread. The weathered sandstone and siltstone encountered in Borrow Area A and B is slightly to moderately weathered and will be suitable as a rocky soil mulch. Quartzite in Borrow Area C and dolomitic siltstone and sandstone in the Upper RoM are less weathered and are potentially suitable as competent rock for surface armouring.

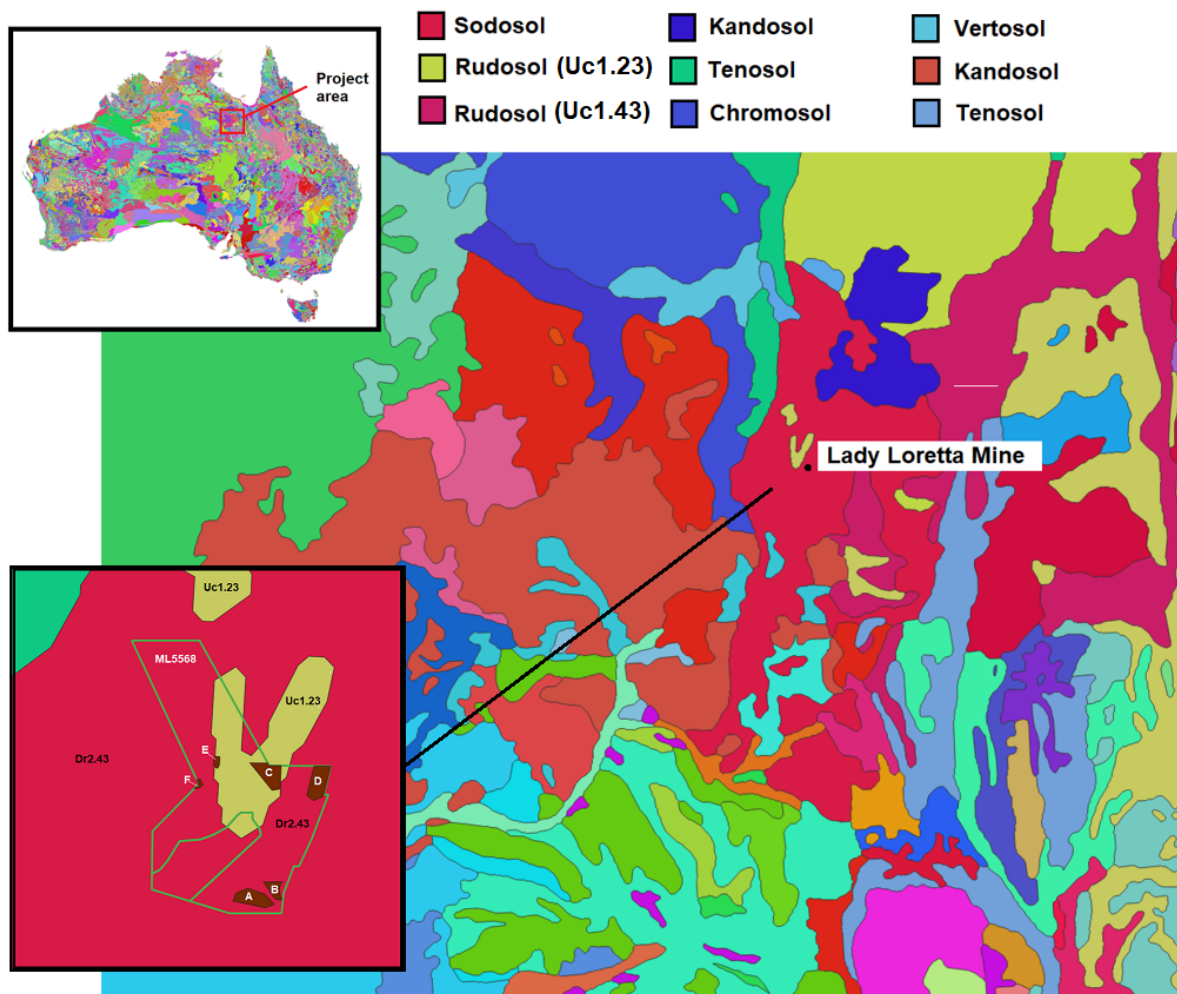
Figure 1-2: Regional soil classifications at LLM

Using the regional Australian Soil Classification, RGS identified two soil types present within ML 5568 (Table 1-2 and Figure 1-2). Rudosols are present in the area shaded in lime green, while the remaining surrounding areas shaded red are sodosols. Both of these soil types are capable of supporting local vegetation communities. Sodosols are present in Borrow Area A and Borrow Area B, while rudosols are present in Borrow Area C. Soil types of D, E, and F are provided for reference (Table 1-2 and Figure 1-2).

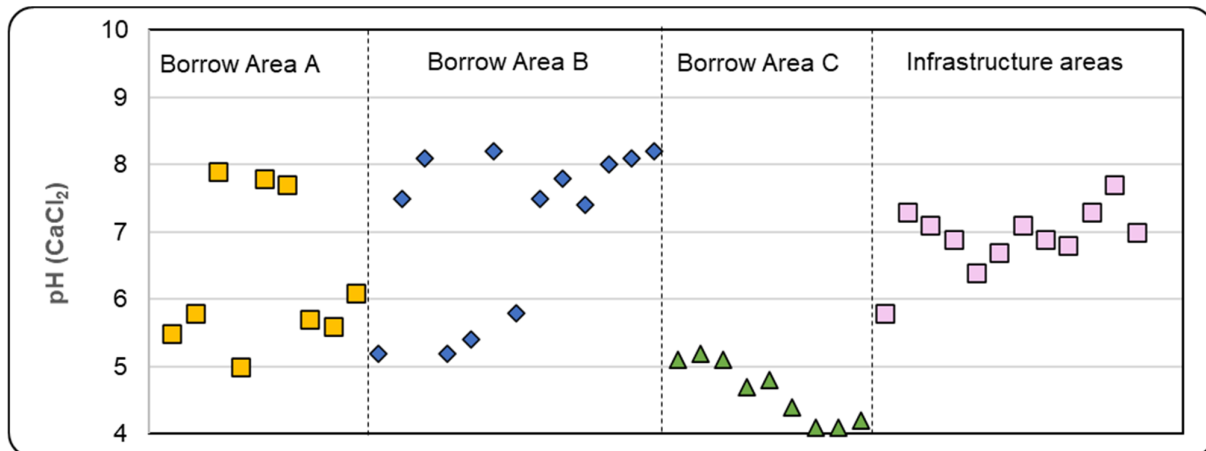
**Figure 3-2: Soil pH (CaCl<sub>2</sub>) for soil samples from borrow areas and infrastructure areas**

Soil pH ( $\text{CaCl}_2$ ) for borrow area samples and drillhole composites from infrastructure areas ( $n=43$ ) was 4.1 to 8.2 with a median pH of 5.7. The 9 soil samples from Borrow Area C had the lowest soil pH values of 4.1 to 5.2, median 4.7 (**Figure 3-2**). The 0.01 M  $\text{CaCl}_2$  pH method provides pH results about 1 pH unit lower than a

water-soluble pH<sub>1:5</sub> test and the results for the borrow areas are typical for soil unimpacted by mining in the ML and can be used as baseline values. The pH<sub>1:5</sub> values for pasture/woodland land use range from pH 5 – 8.5.

The 0.01 M  $\text{CaCl}_2$  pH method provides pH results about 1 pH unit lower than a water-soluble  $\text{pH}_{1:5}$  analytical method and the results for the borrow areas are typical for soil unimpacted by mining on the ML and can be used as baseline values. Soil pH ( $\text{CaCl}_2$ ) for soil samples from Borrow Area V, B, W, T, and I ( $n=47$ ) is 4.7 to 9.1 with a median pH of 8.0 (**Figure 3-2**). Topsoil has a median pH ( $\text{CaCl}_2$ ) of 5.7, which is lower than subsoil (7.5), and saprolite (8.0).

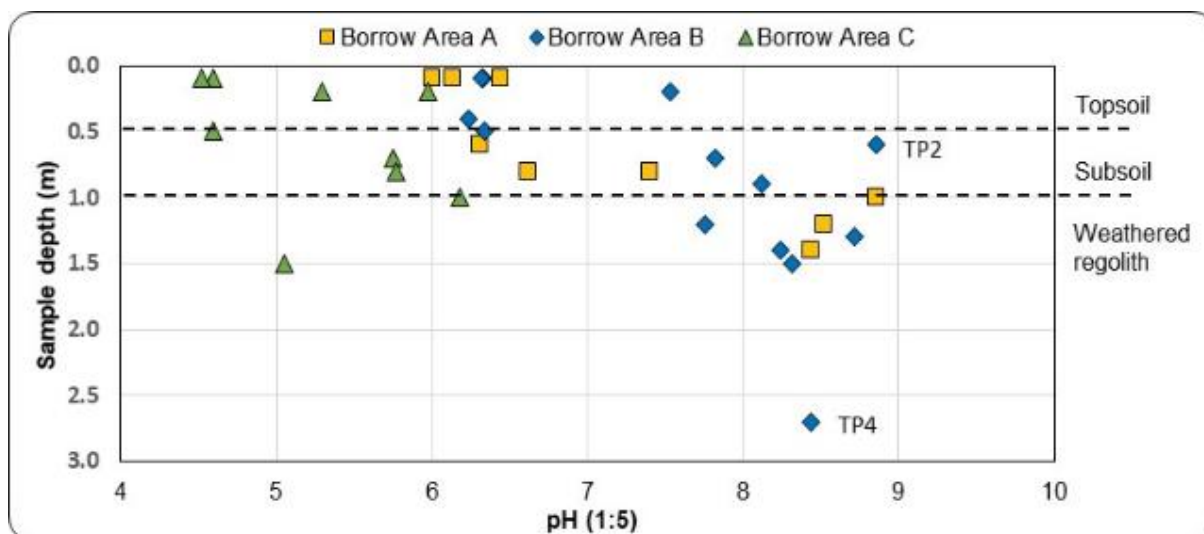
Figure 3-3: pH<sub>1:5</sub> test pit soil samples from borrow areas

The pH<sub>1:5</sub> of all samples (n=31) were 4.4 to 10.1 with a median of 7.7: only five samples were < pH<sub>1:5</sub> 5.5 (**Figure 3-3 to Figure 3-5**). The 5 samples with minor acid were from Borrow Area C. 64% of the samples were mildly alkaline (over pH 7). Lower pH concentrations in surface soil is not due to sulfide oxidation or AMD but occurs naturally as major cations are leached from the soil over time. The pH<sub>1:5</sub> generally increased with depth in undisturbed areas (**Figure 3-3**). pH<sub>1:5</sub> for samples from Borrow Area C is lower than Borrow Area A and B (**Figure 3-3**)

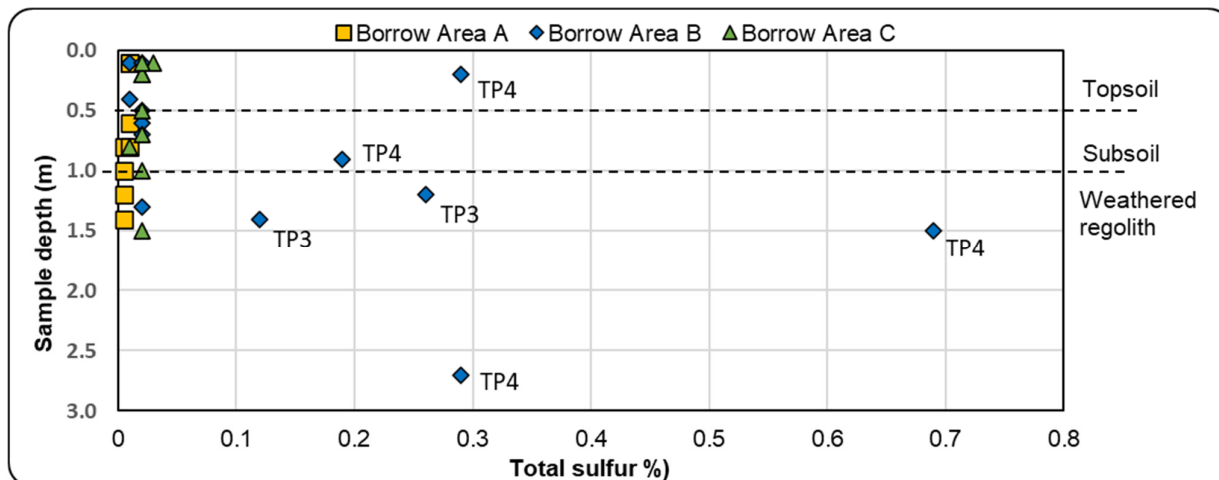
Figure 3-5: Total sulfur for test pit soils from borrow areas

Total sulfur results for test pit samples and drill hole samples in Borrow Area B are in **Figure 3-5** and **Figure 3-6**. **Table 3-9** provides a summary of the geochemical classification criteria used by RGS to classify the acid forming nature of the rehabilitation material samples from LLM.

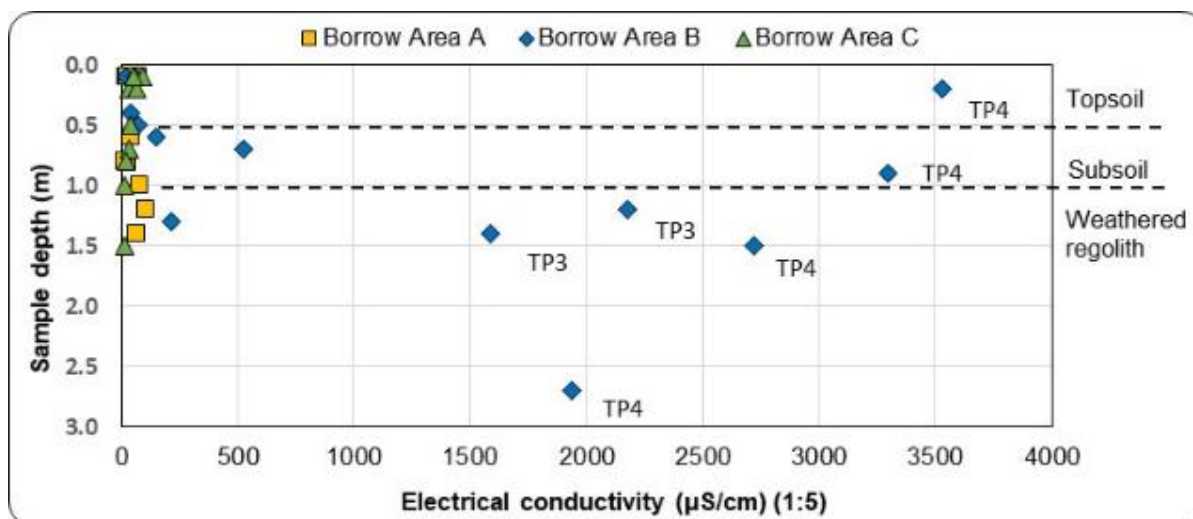
Figure 3-7: EC<sub>1:5</sub> test pit soil samples from borrow areas

EC<sub>1:5</sub> was high in TP 3 and TP 4 from Borrow Area B (**Figure 3-7**). These samples also have high TS and the salinity in these samples are dominated by sulfate, as well as sodium chloride; the source of this could be celestite (SrSO<sub>4</sub>) as strontium is elevated in the water soluble results (RGS, 2020).

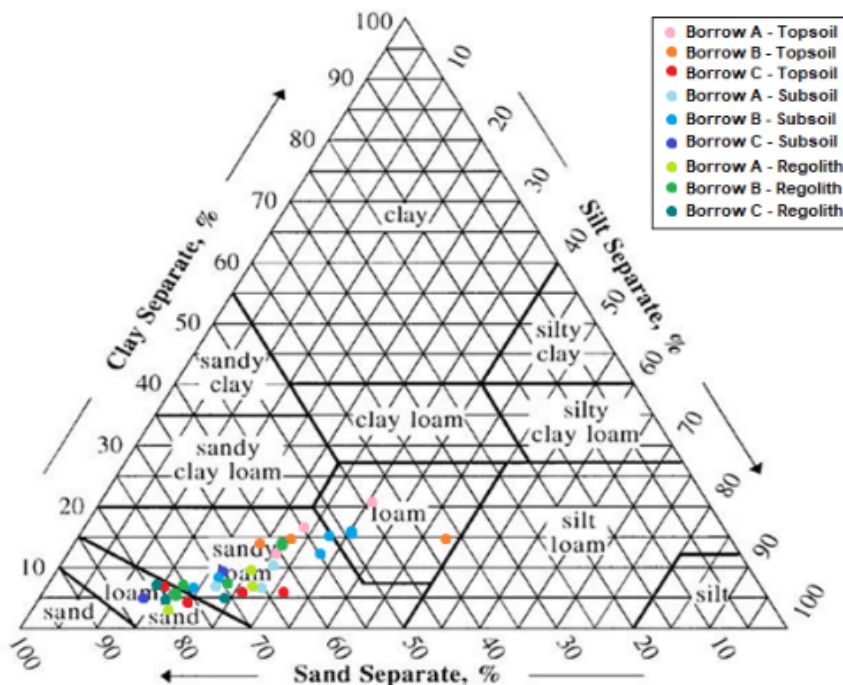
Figure 3-9: Soil texture classification triangle for test pit soils from borrow areas

Using the PSD results and proportions (0 – 100%) of clay ( $< 0.002$  mm PSD), silt ( $> 0.002$  to  $< 0.05$  mm PSD), and sand ( $> 0.05$  to  $< 2$  mm PSD), the soils from the borrow and infrastructure areas have been plotted on soil texture classification triangles (**Figure 3-9** and **Figure 3-10**). The results range from clay to sand and confirm that in test pit samples from borrow areas, fine clay and silt particles are more common in topsoil, while regolith tends to have a higher proportion of sand. Classifications range from loamy sand and sandy loam to loam. By comparison, infrastructure areas have more clay and silt throughout the entire soil profile, inferring a higher degree of weathering. Classifications range from silt loam to clay loam to loam. Excluding gravels, soils from borrow areas are generally 60 – 85% sand, 10 – 20% silt and 5 – 20% clay; whereas soils from infrastructure areas are generally 45 – 60% sand, 30 – 50% silt and 0 – 30% clay.

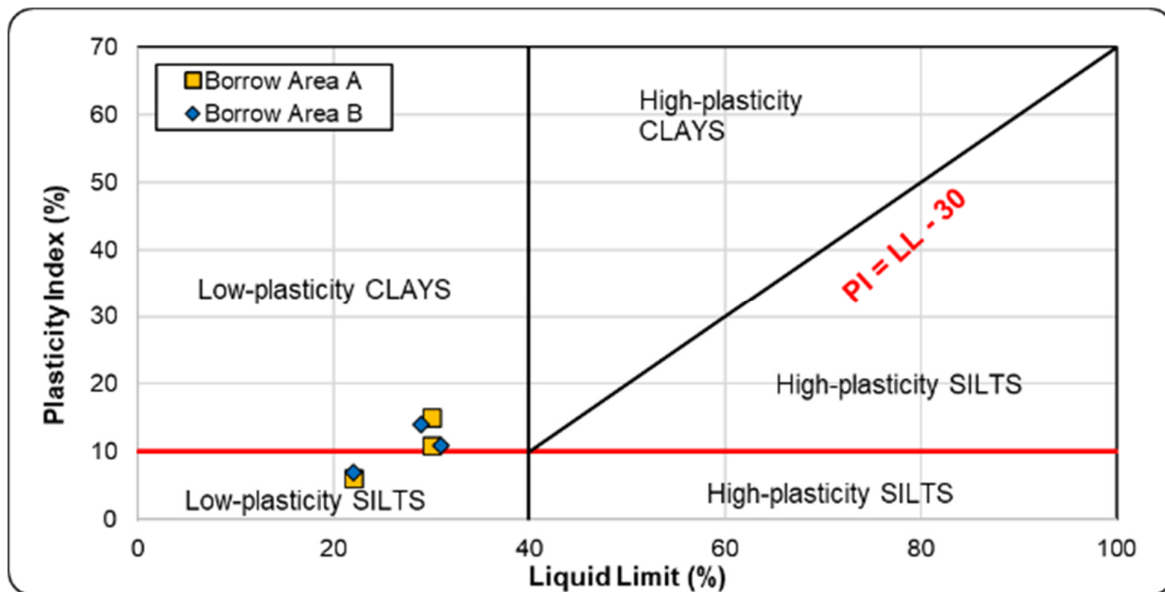
Figure 3-11: AASHTO soil classifications for borrow area soils

Borrow Area A and Borrow Area B soils were tested for Atterberg Limits. Borrow Area C was not tested as the thin soils in the area are gravelly and do not contain much clay, making them unsuitable as a sealing layer. The Atterberg results verify the topsoil, subsoil, and regolith all have low liquid limits and linear shrinkage values. This infers that the soils are low in clay or do not contain shrinking and swelling clay mineral types (**Table 3-15**). Plasticity index (PI) % is the water content at which the soil begins to display plastic properties. It can be non-plastic (0%), slightly plastic (1-6%), medium plastic (7-17%), or highly plastic (18-100%) (Sowers, 1979). Silt, sand, and gravel have very low or no plasticity. The AASHTO soil classifications based on WAQTC (2020) are presented in **Figure 3-11**.

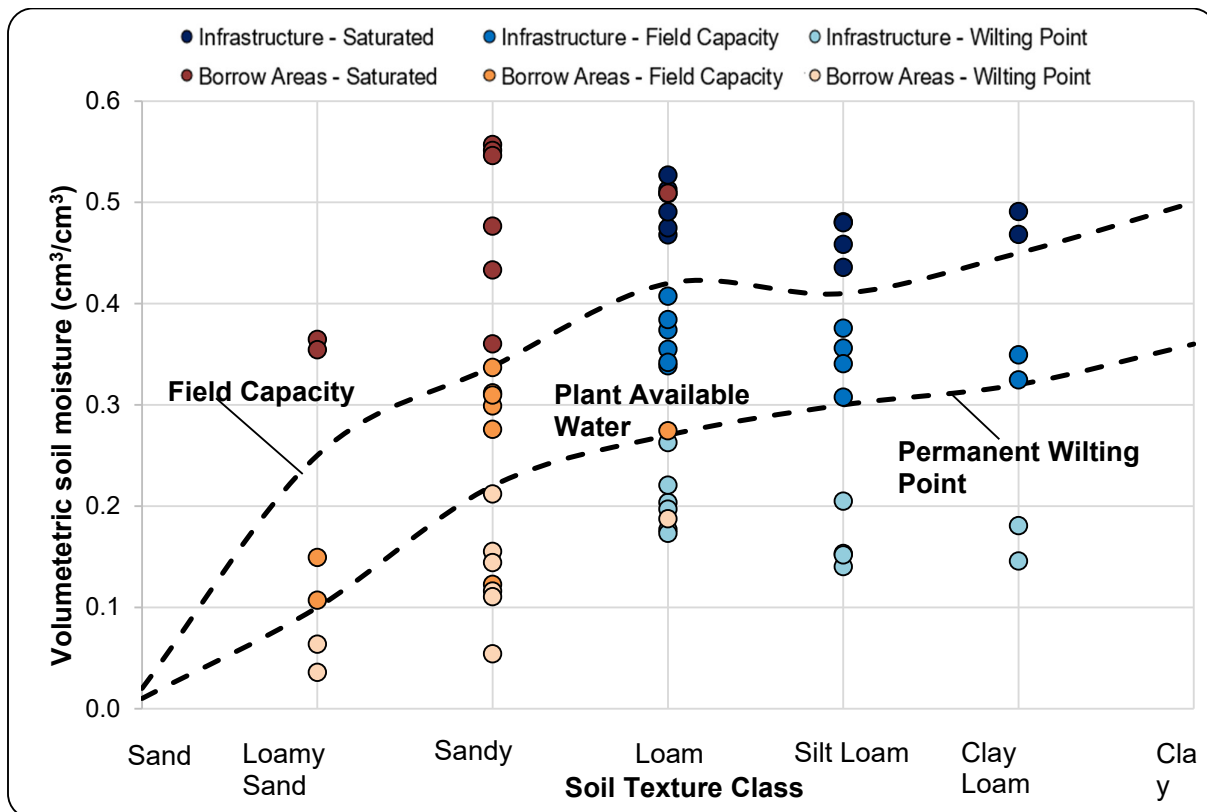
Figure 3-12: Relationship between soil texture class and plant available water

Soil water characteristic curves measure the limits of water storage capacity. The upper limit is called field capacity, and the lower limit is called the permanent wilting point. Between these two limits is the plant available water. After a rainfall event saturates the soil, there will be infiltration due to gravity which is referred to as drainage. During this process, the soil moisture decreases, and the rate at which it decreases is dependent on the soil texture class. In general, soils with higher clay content will retain water for longer. The results in **Figure 3-12** demonstrate that the soils from infrastructure areas have higher water retention properties than soils from Borrow Areas A, B, and C.

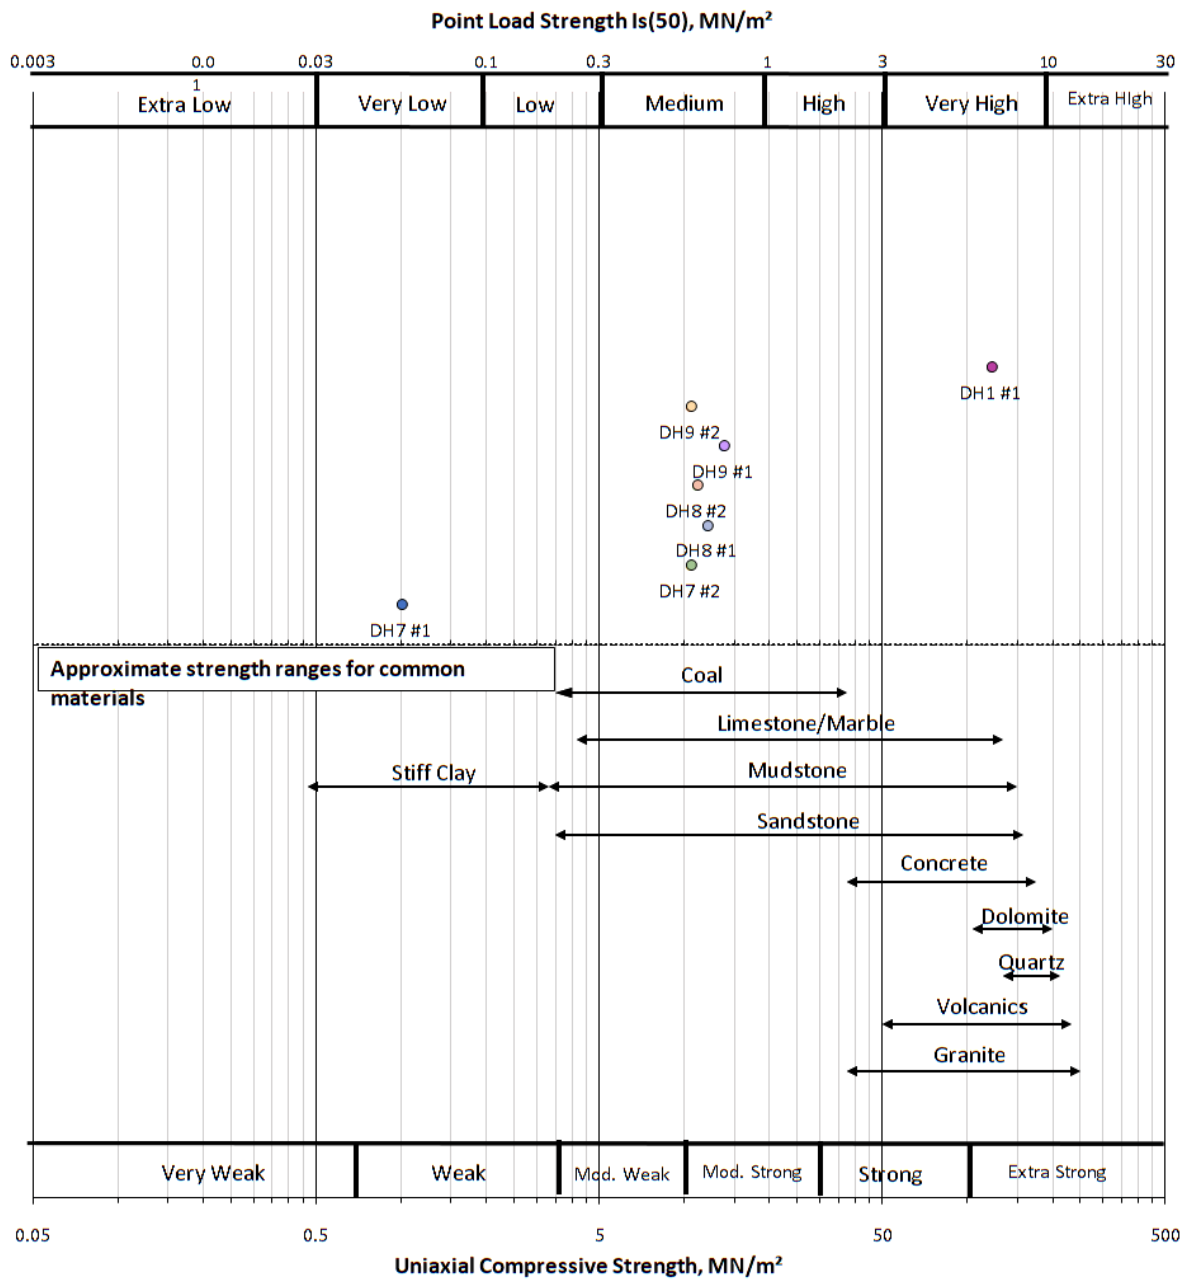
**Figure 3-13: Point load strength of borrow materials compared to standard materials**

The point load strength of fresh rock samples that were diamond drill cored from borrow areas have been analysed (**Table 3-20**). The load strengths ( $I_s$ ) of the materials range from 0.06 to 6.77 MN/m² (or MPa), and are classified as irregular lumps. When a correction factor is applied to standardise the samples to have a 50 mm diameter, the corrected load strengths ( $I_s(50)$ ) range from 0.06 to 7.27 MN/m² (median 0.66 MN/m²). These values have been plotted in **Figure 3-13**, and range from weak to very strong.

- The majority of rock types from Borrow Area B fall within the expected point load strength range for mudstone and sandstone (DH7 #2, DH8, DH9) and have medium  $I_s(50)$  ranging from 0.63 to 0.82 MN/m² (Mpa);
- The exception is extremely weathered claystone rock found at Borrow Area B (DH7 #1), which has  $I_s(50)$  0.06 MN/m² (Mpa), and is weak and equivalent to stiff clay;
- The quartzite from Borrow Area C is very strong, has  $I_s(50)$  of 7.27 MN/m² (Mpa) and equivalent to granite (DH1).

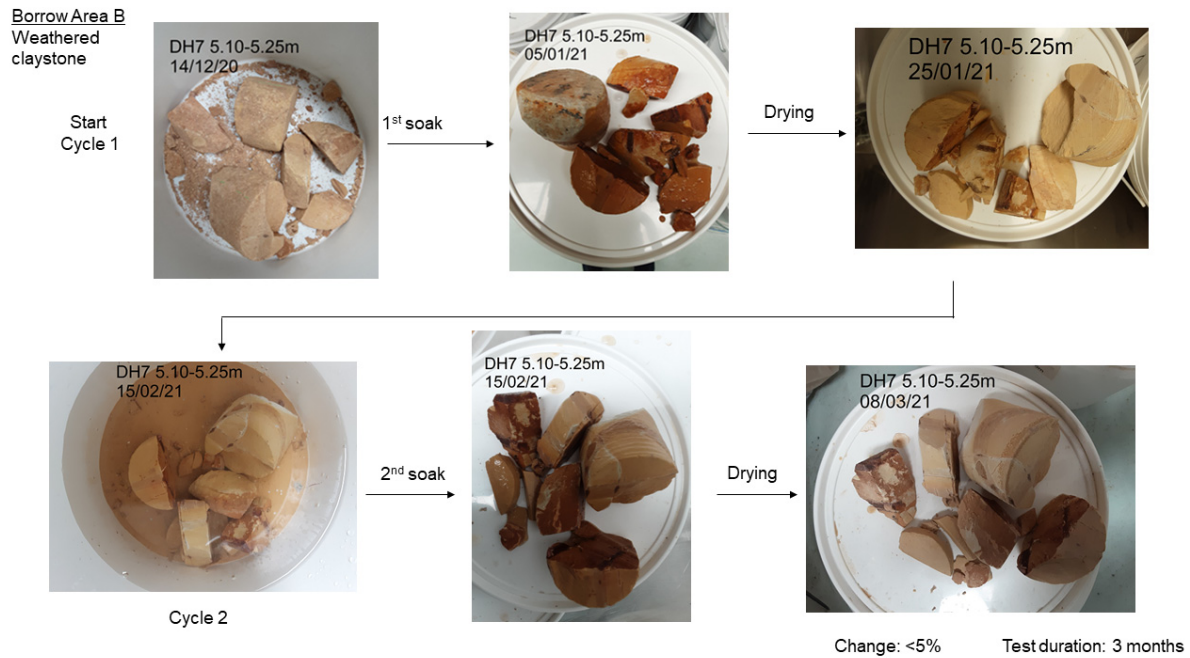
**Figure 3-14: Sodium soundness test at Borrow Area B: DH7 5.10-5.25 m**

Fresh rock from Borrow Area B was subjected to sodium soundness testing at the RGS in-house laboratory (to **Figure 3-19**). The rock samples have been subjected to two complete cycles over a period of 3 months.

- No significant degradation was observed for any of the fresh rock samples over the test period (<5% change).

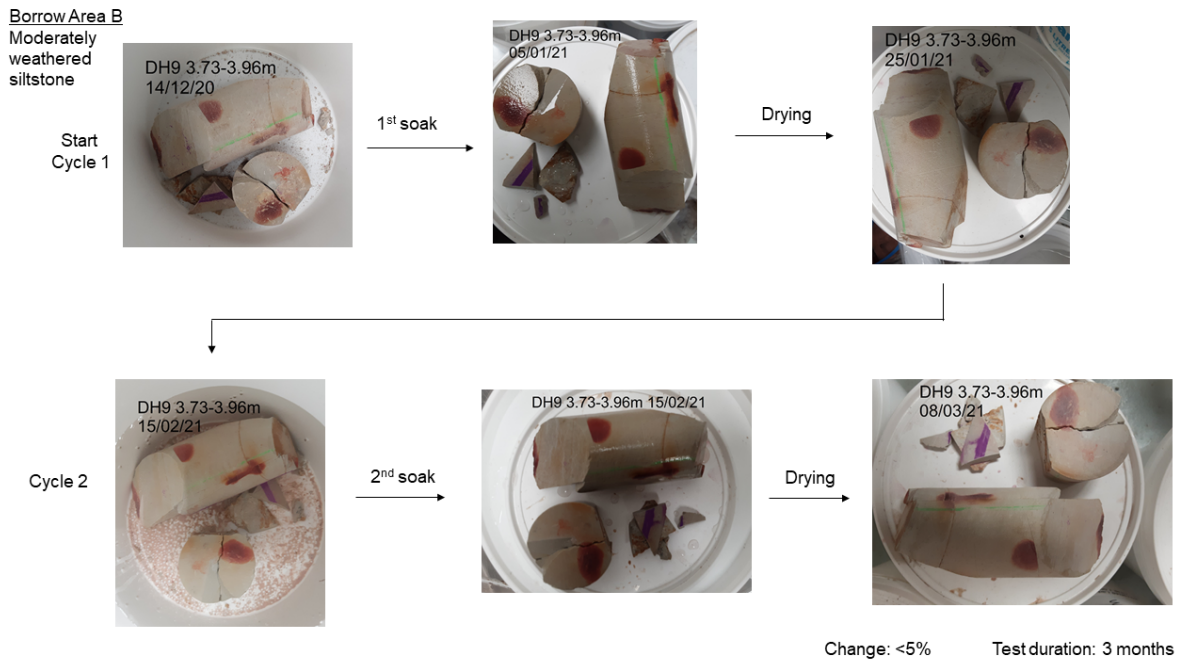
**Figure 3-18: Sodium soundness test at Borrow Area B: DH9 3.73-3.98 m**

Moderately weathered siltstone

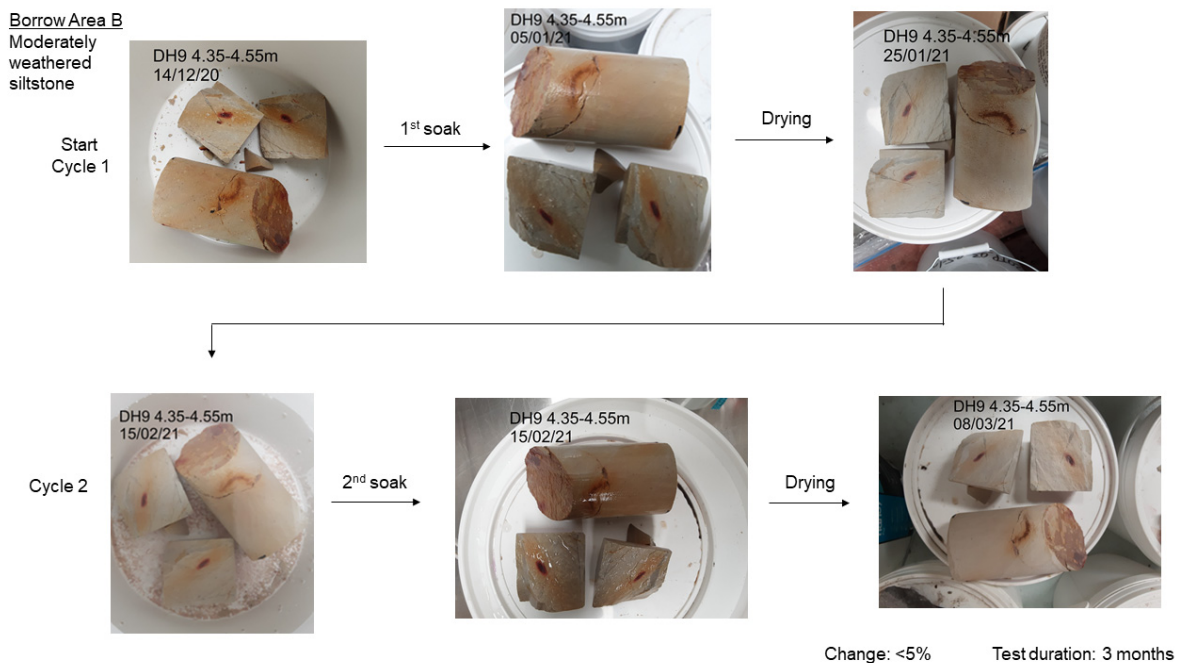
**Figure 3-19: Sodium soundness test at Borrow Area B: DH9 4.35-4.55 m**

Moderately weathered siltstone

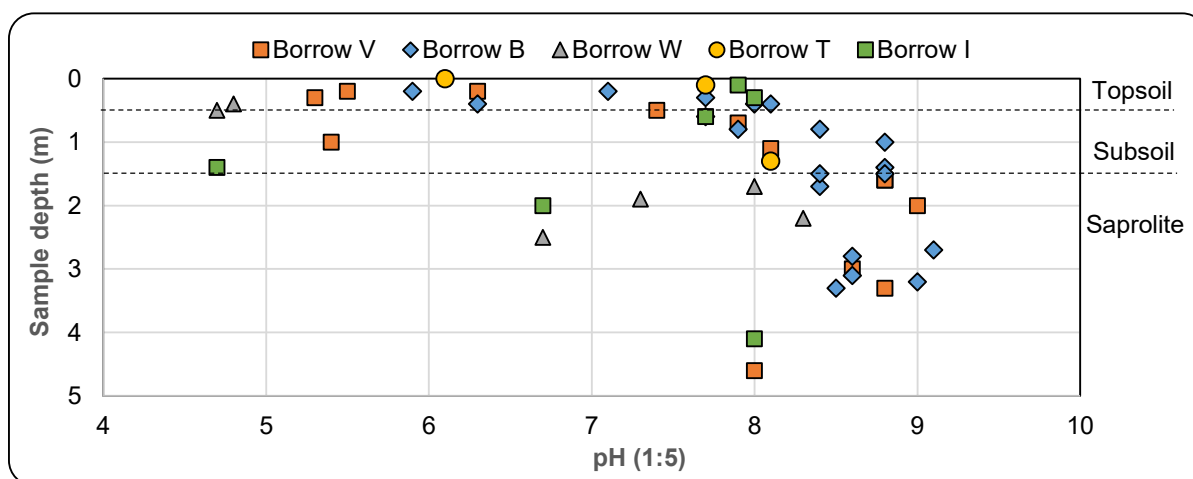
**Figure 3-21: pH<sub>1:5</sub> for borrow area soils and saprolite**

The pH<sub>1:5</sub> of all borrow area samples (n=47) are 4.7 to 9.1 with a median of 8.0: only six samples were ≤ pH<sub>1:5</sub> 5.5 (**Figure 3-21**). The 6 samples with minor acid were from Borrow Areas V, W, and I. Lower pH<sub>1:5</sub> concentrations in surface soil are not due to sulfide oxidation or AMD but occurs naturally due to the leaching of base cations and the presence of Al and Mn. 74% of the samples were mildly alkaline (over pH 7) and the pH<sub>1:5</sub> increased with depth in undisturbed areas.

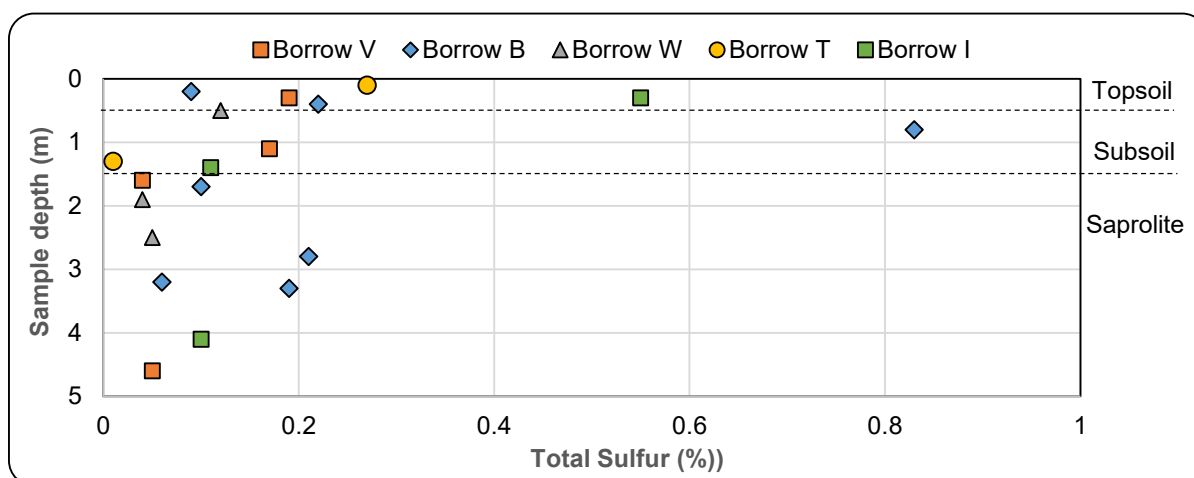
Figure 3-22: Total sulfur for borrow area soils

Total sulfur (TS) results are in **Figure 3-22**. TS and chromium reducible sulfur (CRS) correlations are in **Figure 3-23**, and suggest that in all samples the sulfur content is dominated by sulfate bearing minerals (e.g., barite ( $\text{BaSO}_4$ ), celestine ( $\text{SrSO}_4$ ), gypsum ( $\text{CaSO}_4 \cdot 2\text{H}_2\text{O}$ ), or alunite ( $\text{KAl}_3(\text{SO}_4)_2(\text{OH})_6$ ) rather than sulfide mineralogy. Neutralisation potential ratios (NPR) are in **Figure 3-24** and net acid production potential (NAPP) data is in **Figure 3-25**.

Test pit composite samples from Borrow Area V (n=4) and Borrow Area B (n=7) have two TS groupings. Samples in the higher group (n=6) have 0.17 to 0.83% TS and 0.013 to 0.02% CRS. These samples have low MPA due to the low CRS but have a high potential to leach sulfate that may precipitate as secondary sulfate minerals. This interpretation is based on the water-soluble sulfate concentration after leaching for 16 hours (**Figure 3-28**). Samples in the lower group (n=5) have 0.04 to 0.1% TS. These samples have low TS and are unlikely to produce acid from sulfide oxidation as they are geochemically barren of sulfur and have a median NAPP of -30 kg  $\text{H}_2\text{SO}_4/\text{t}$ .

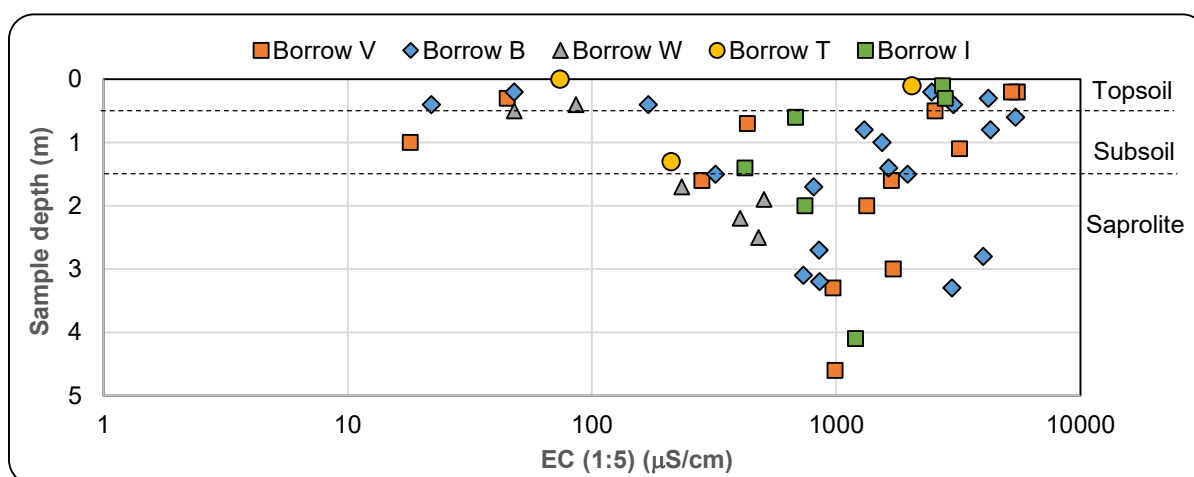
**Figure 3-26: EC<sub>1:5</sub> for borrow area soils**

The EC<sub>1:5</sub>, of the 47 samples is 18 to 5,510 µS/cm with a median of 776 µS/cm: 8 samples have > 3,000 µS/cm, 14 samples have 1,000 to 3,000 µS/cm and 25 samples have < 1,000 µS/cm (**Figure 3-26**).

The 8 samples with high EC<sub>1:5</sub> are all from topsoil and subsoil in Borrow Area V and B. EC<sub>1:5</sub> is 2,000 to 3,000 µS/cm in topsoil from Borrow Area T and I. All of the high EC<sub>1:5</sub> samples also have high TS and the salinity in these samples are dominated by sulfate, with a contribution from sodium chloride. The source of this could be celestine (SrSO<sub>4</sub>) as strontium is elevated in the water soluble results (**Figure 3-28**). Other sulfate bearing minerals in the weathered zone could include gypsum, alunite, or barite.

- All soil samples (n=32) are circumneutral at pH<sub>1:5</sub> 5.3 to alkaline at pH<sub>1:5</sub> 9.1 with a median of pH<sub>1:5</sub> 8.3.
- The EC<sub>1:5</sub>, of the 47 samples is 18 to 5,510  $\mu\text{S}/\text{cm}$  with a median of 776  $\mu\text{S}/\text{cm}$ : 8 samples have > 3,000  $\mu\text{S}/\text{cm}$ , 14 samples have 1,000 to 3,000  $\mu\text{S}/\text{cm}$  and 25 samples have < 1,000  $\mu\text{S}/\text{cm}$  (**Figure 3-26**).
