LADY LORETTA

## **Z-LLM-HSEC-PLN-Progressive Rehabilitation and Closure Plan**

| Project Name | Lady Loretta Mine |
| Document Title | Z-LLM-HSEC-PLN-Progressive Rehabilitation and Closure Plan |

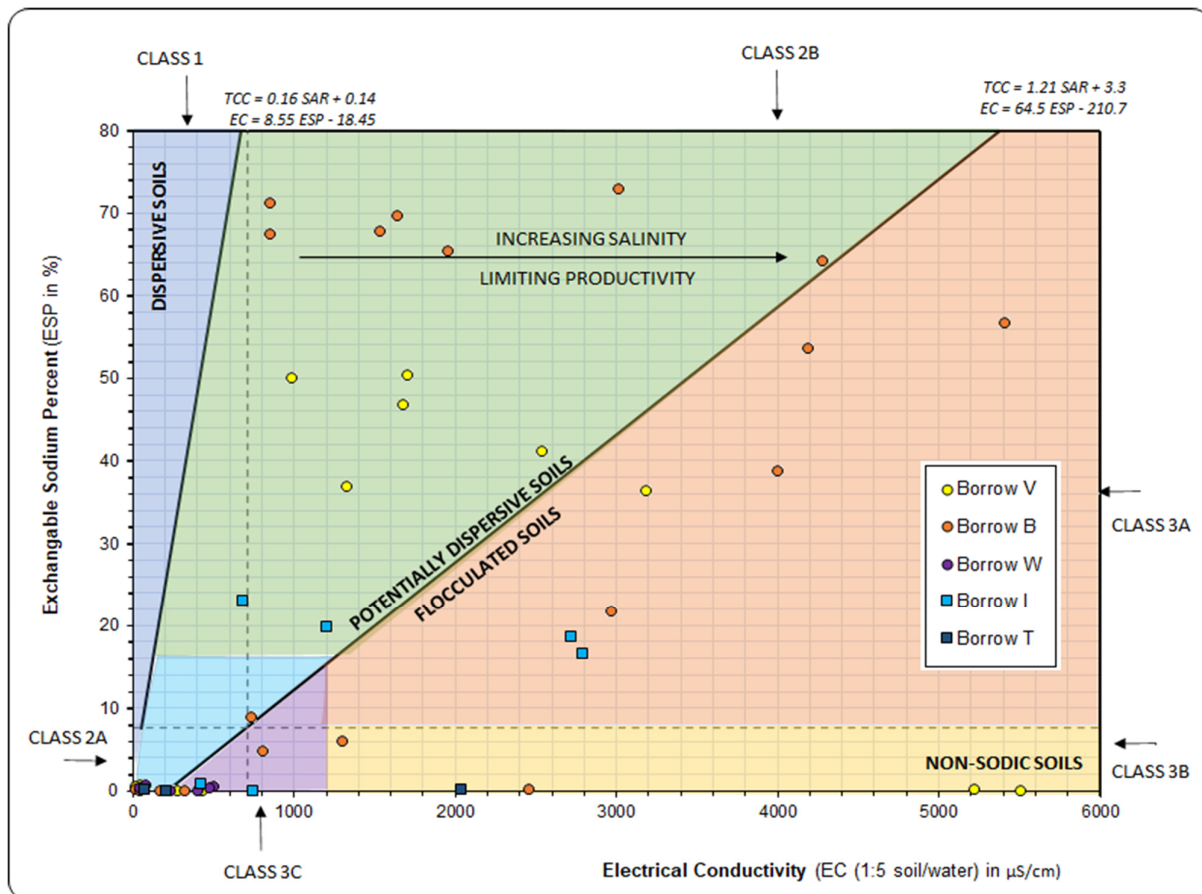
**Figure 3-27: Salinity classification classes for soils from borrow areas**

Soils from Borrow Areas V, B, and I (n=37) classify as Class 2A (n=6 or 16%), Class 3C (n=6 or 16%), Class 3B (n=4 or 11%), Class 2B (potentially dispersive) (n=14 or 38%) or Class 3A (flocculated) (n=7 or 19%). Potentially dispersive soils with greater than 4,000  $\mu S/cm$  have improved stability (Hazelton and Murphy, 2016). Dispersive materials with less than 4,000  $\mu S/cm$  may be suitable as a low permeability layer to replace clay layer materials, which are unavailable at LLM.

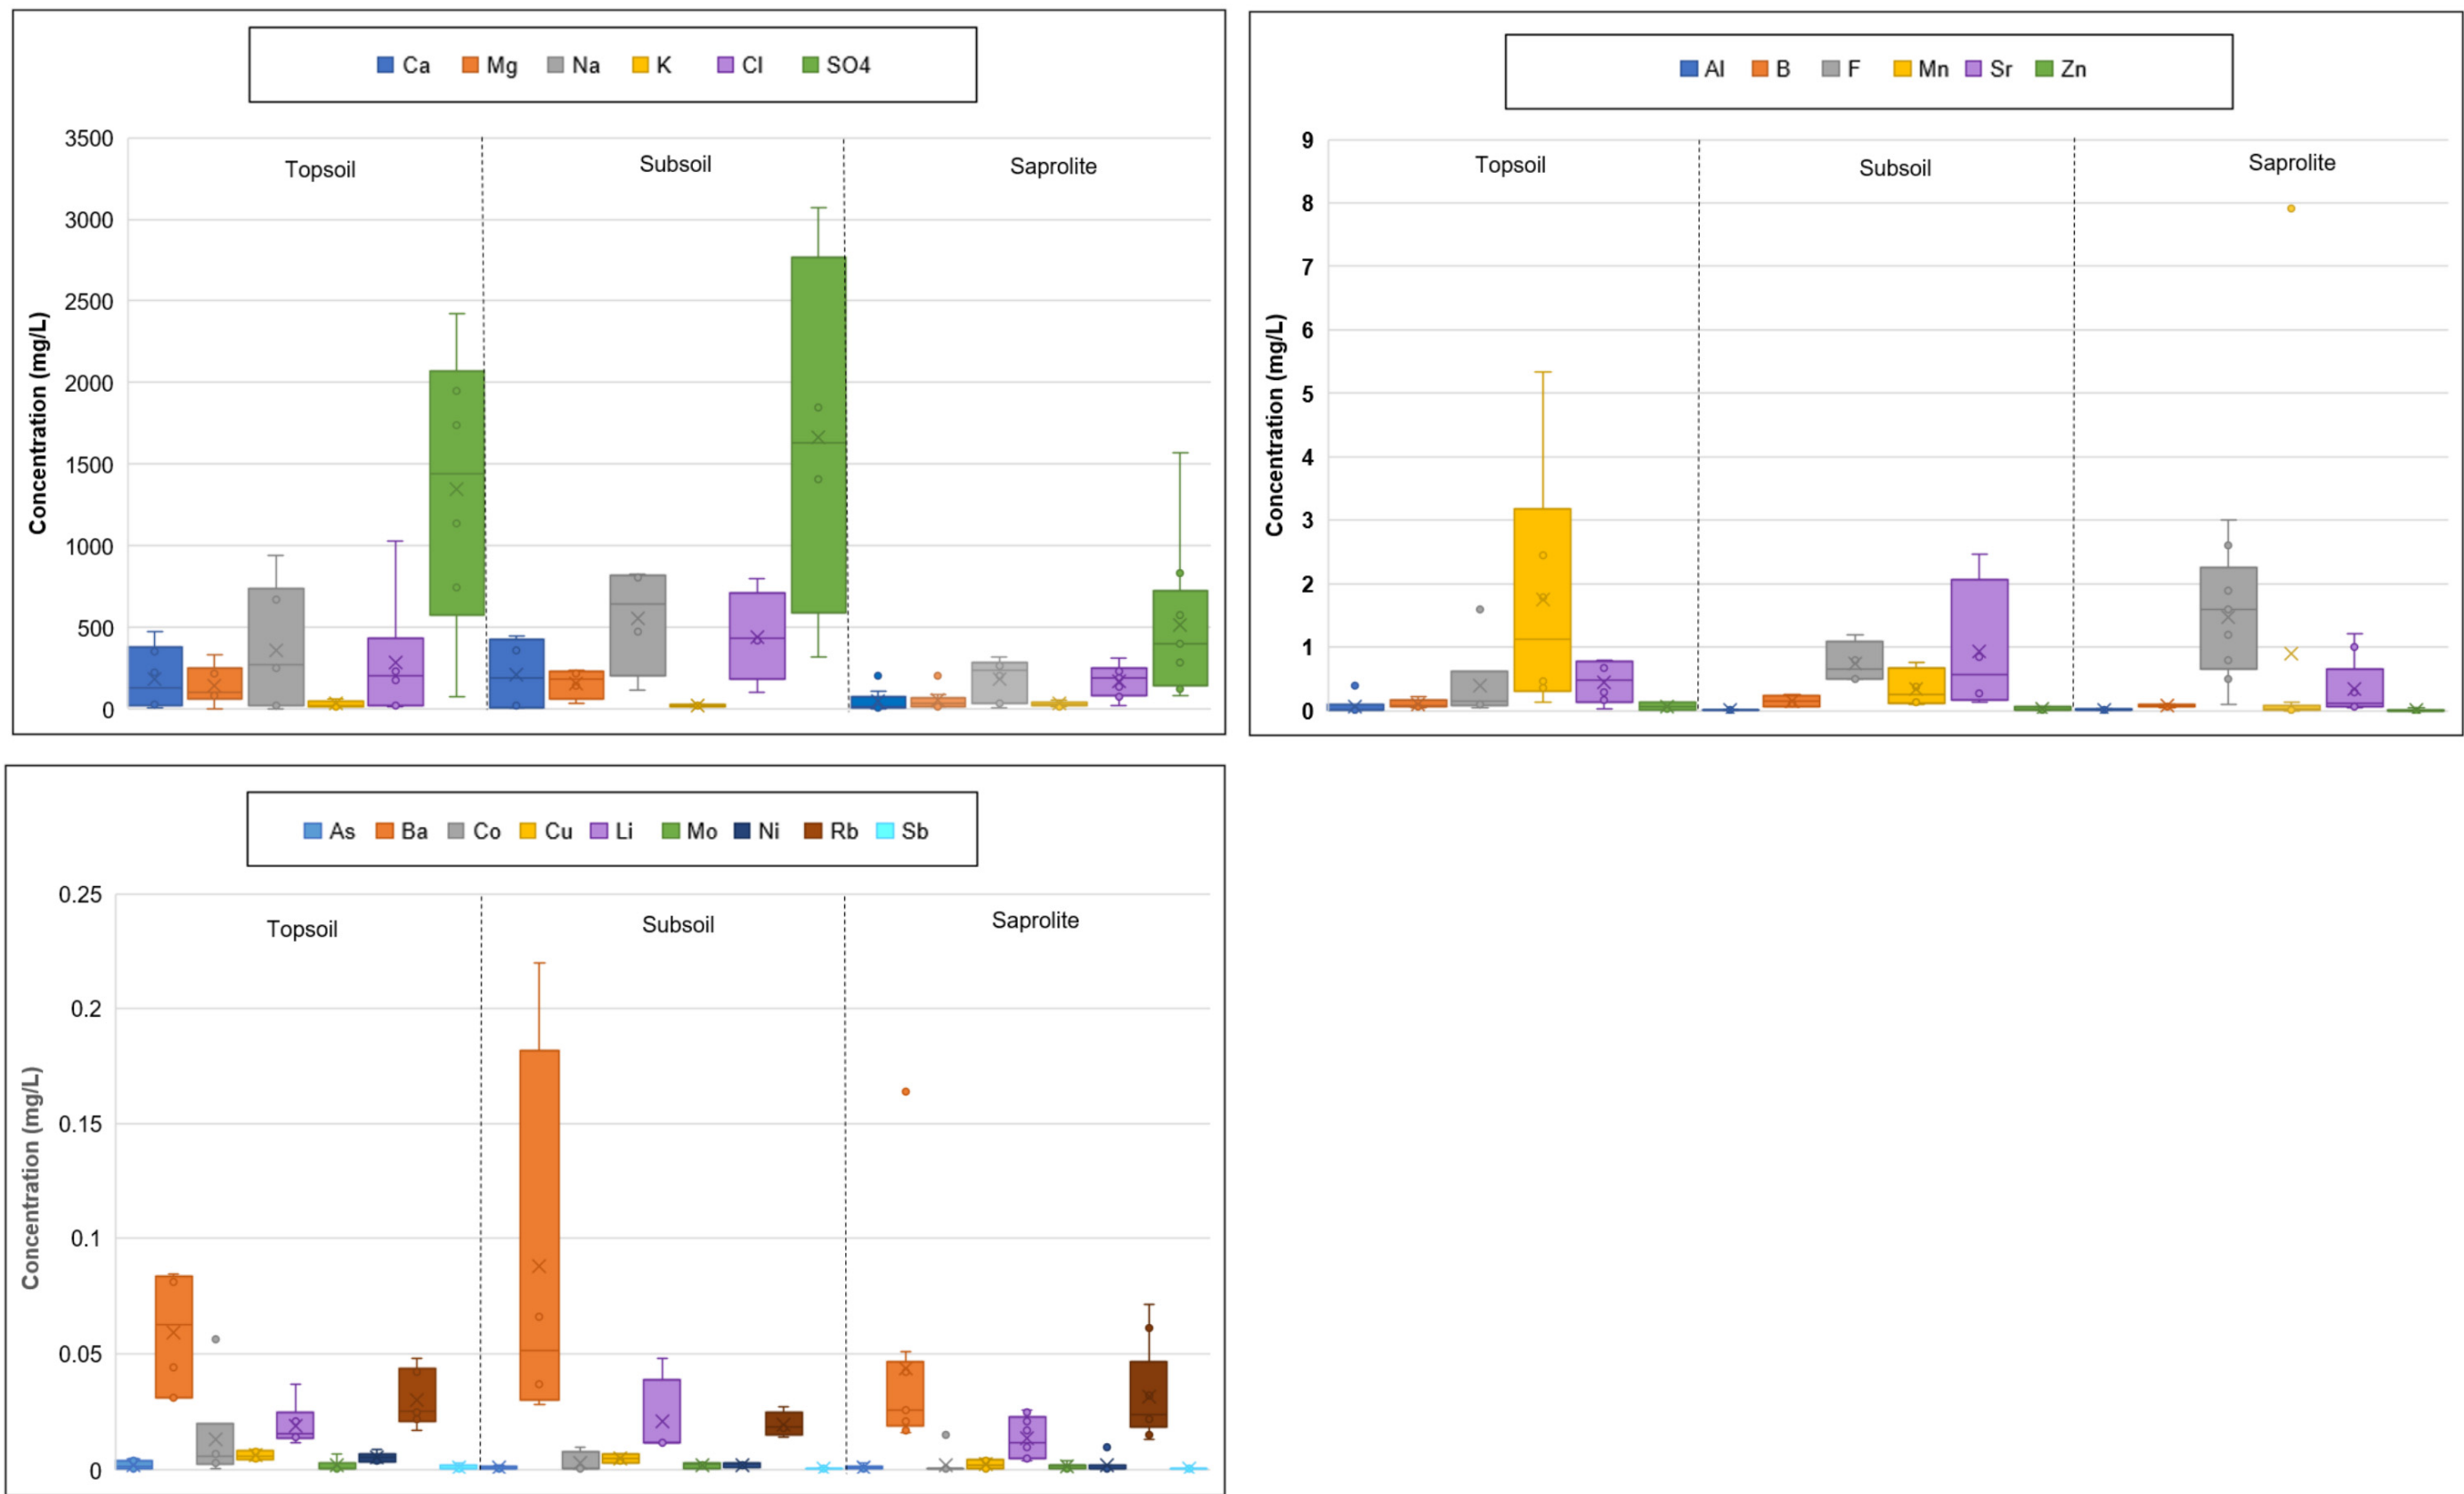
Figure 3-28: 1:3 (16hr) water-soluble multi-element results for rehabilitation materials

The 1:3 – 16-hour water-soluble statistics and selected plots are in **Figure 3-28**. Analysis was undertaken on composite samples from Borrow Areas V, B, W, T, and I. Observations from these measurements are summarised below.

- No acid (pH<sub>1:3</sub>) results below pH 5 were observed in any samples (n=19).
- EC<sub>1:5</sub>, sodium (Na<sup>+</sup>), sulfate (SO<sub>4</sub><sup>2-</sup>), and chloride (Cl<sup>-</sup>) concentrations (i.e., mobile salts) are highest in topsoil and subsoil samples from Borrow Area V, B, T, and I. Materials from Borrow Area W are comparatively low in mobile salts.

- High concentrations of soluble Aluminium (Al) in Borrow Area B observed in the Phase 1 investigation (3 – 4 mg/L) appear to be significantly lower (<0.01 – 0.03 mg/L) in Phase 2 results. Further investigation regarding Al colloidal particles will not be necessary.

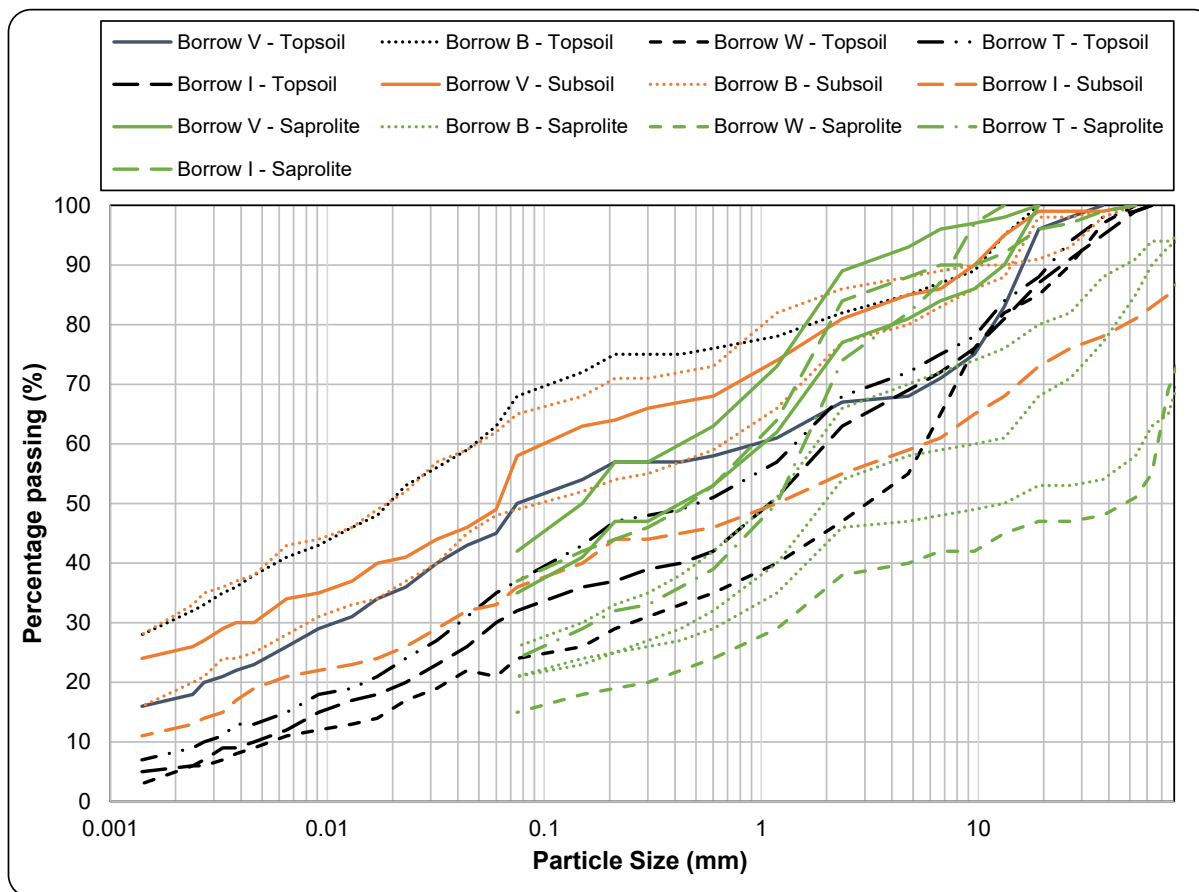
Figure 3-29: PSD results for rehabilitation materials

For the borrow areas, **Figure 3-29** and **Table 3-13** show that the topsoil, subsoil and saprolite of Borrow Areas V and B contain a larger proportion of fine (clay, silt and sand) material compared to Borrow Areas W, T, and I, which have a higher proportion of gravel. In Borrow Areas V and B, subsoil has a higher proportion of clay compared to topsoil. However, Borrow Area V topsoil contains more gravel (33%) than Borrow Area B topsoil (18-23%). Soil and saprolite from Borrow W has 51-62% gravel, and only 0-9% clay, verifying that the geology of the parent materials is different.

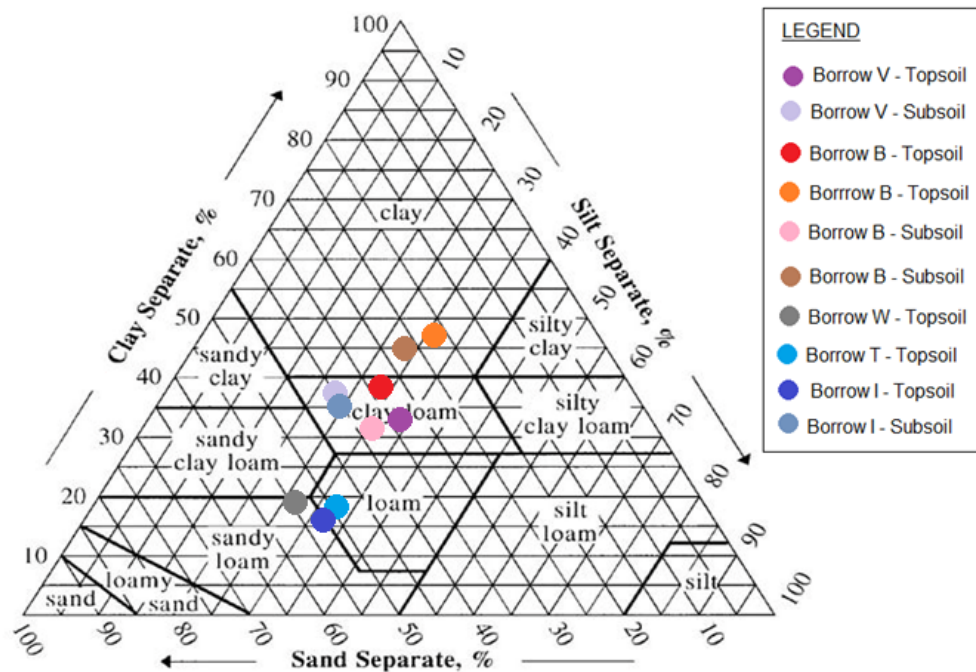
Figure 3-30: Soil texture triangle for borrow area soils

Using the PSD results and only the fine (excluding gravels) proportions (0 – 100%) of clay (< 0.002 mm PSD), silt (> 0.002 to < 0.05 mm PSD), and sand (> 0.05 to < 2 mm PSD), topsoils and subsoils from the borrow areas have been plotted on a soil texture classification triangle (**Figure 3-30**).

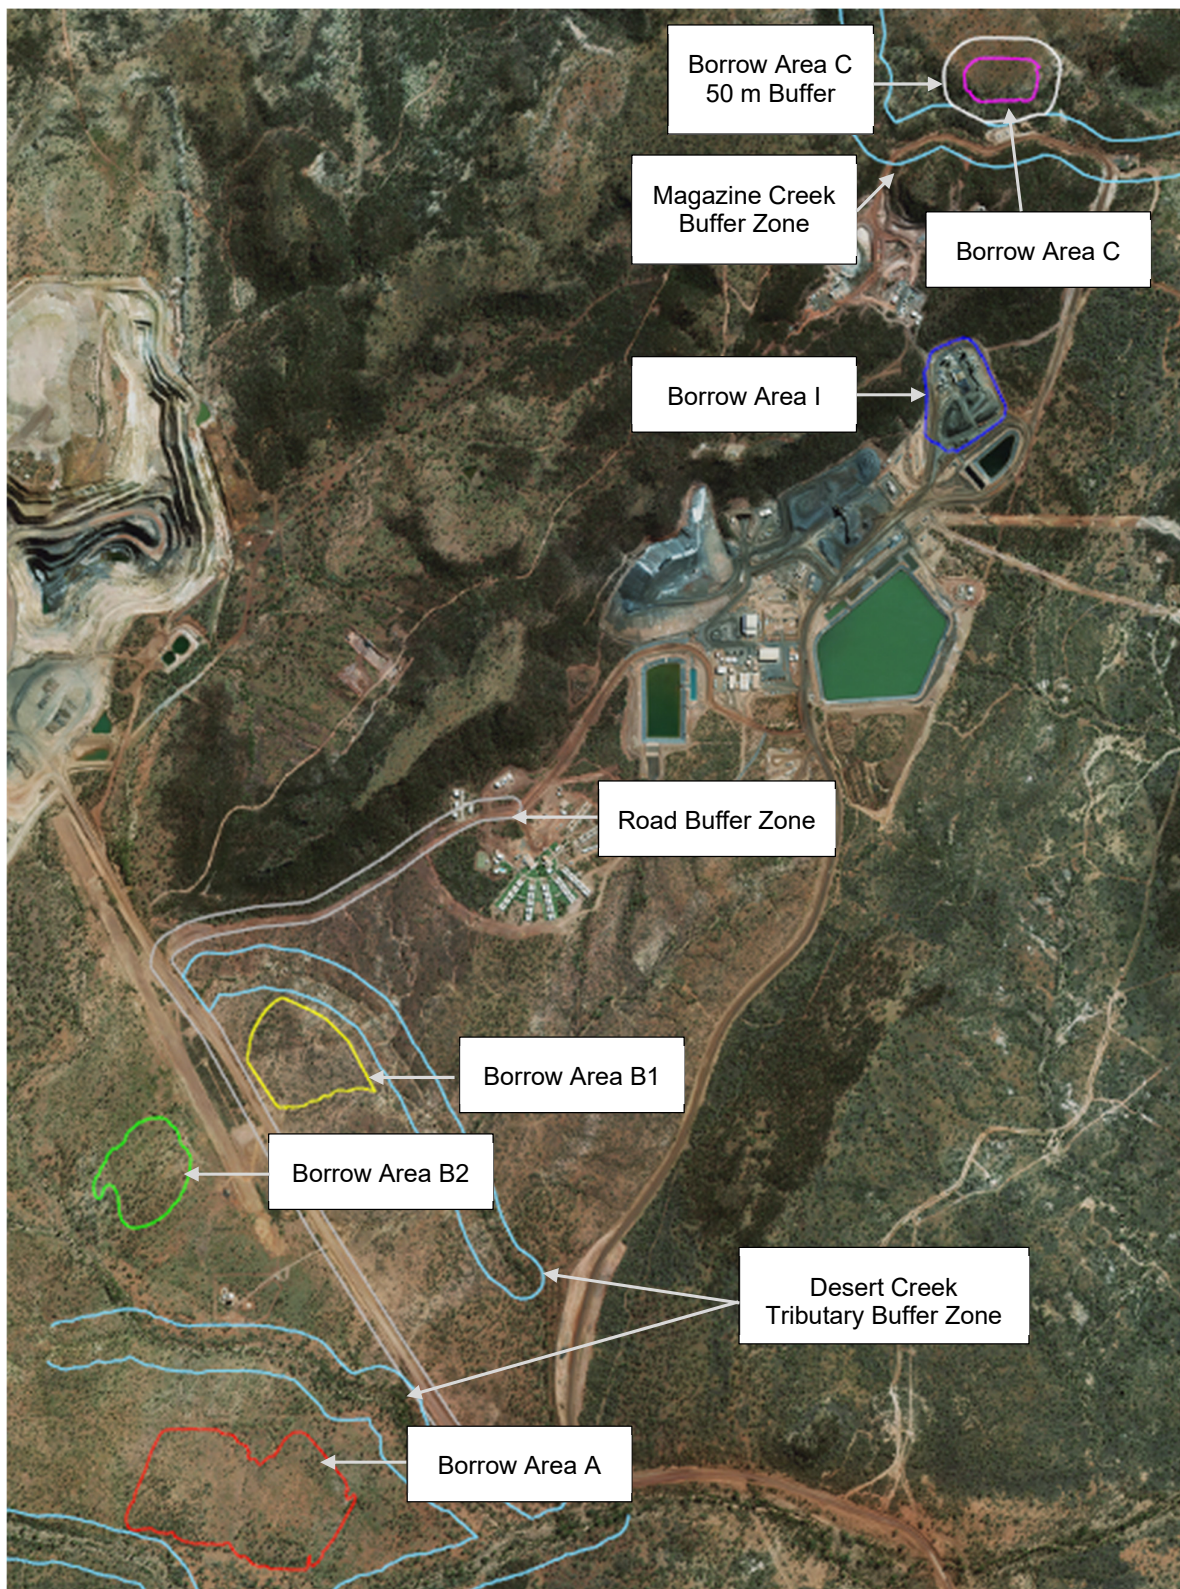
Figure 4-1: Borrow areas and creek and road buffer zones.

The location and extent of Borrow Area B1, B2, A, I and C is illustrated in **Figure 2-1** and **Figure 4-1** and a summary of material types and their suitability for rehabilitation is outlined in **Table 7-1** in **Section 7 Attachment B: Additional figures and results**.

- A buffer zone is required from existing roadways and from the identified Magazine Creek and tributaries to Desert Creek (**Figure 4-1**).
- The magazine has been moved prior to quarrying at Borrow Area C.

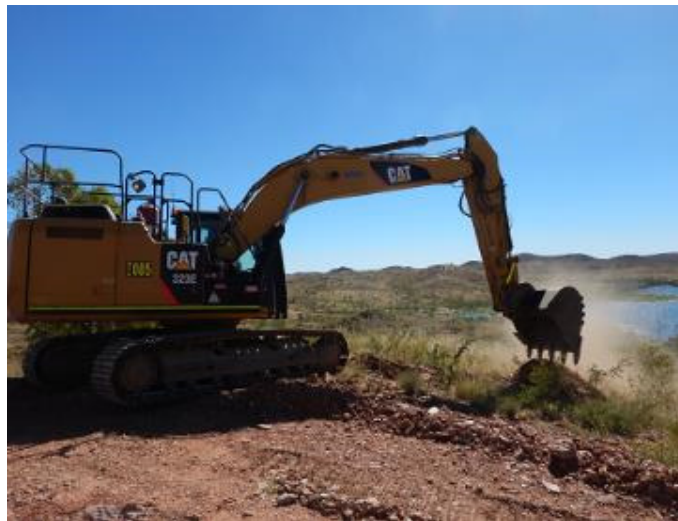
**Figure 7-1: Illustration of a test pit excavation**

1. Ensure access is available (e.g. via track or road) to the proposed test pit location. Generally, it is better to move the test pit location to be convenient, rather than to clear excess vegetation to access the exact spot that has been pinpointed.
2. Preferably, the test pit should be dug on a flat surface, facing away from the sun. This is to ensure that photographs of the test pit walls are not obscured by shadows.
3. Carefully remove any obstructing vegetation. Test pit dimensions will be about 1 m wide x 2 m long x 1-4 m deep. The excavator will also need room to swing the arm and to turn around (**Figure 7-1**)

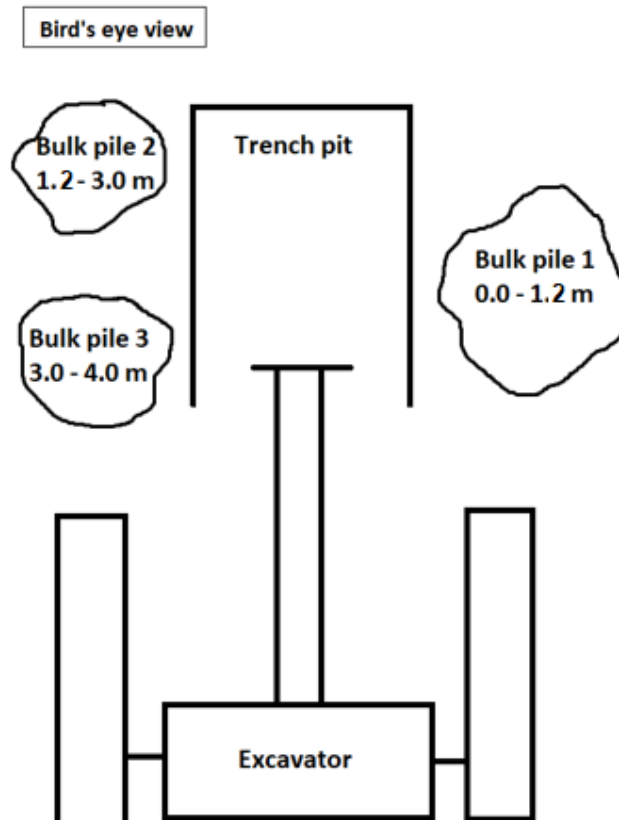
Figure 7-2: Diagram showing placement of excavated material from a test pit

4. Excavate the test pit, placing the regolith materials into a bulk pile on the right side (**Figure 7-2**). Stop excavating at a depth of approximately 1.2 m (or until a hard base is reached). Place the arm on the ground to signal the sampler that it is safe to approach.

9. The material from the deeper excavation should be placed in bulk piles on the left side of the pit (**Figure 7-2**). Where possible, try to separate the piles into different soil materials (e.g. on the basis of colour or texture).

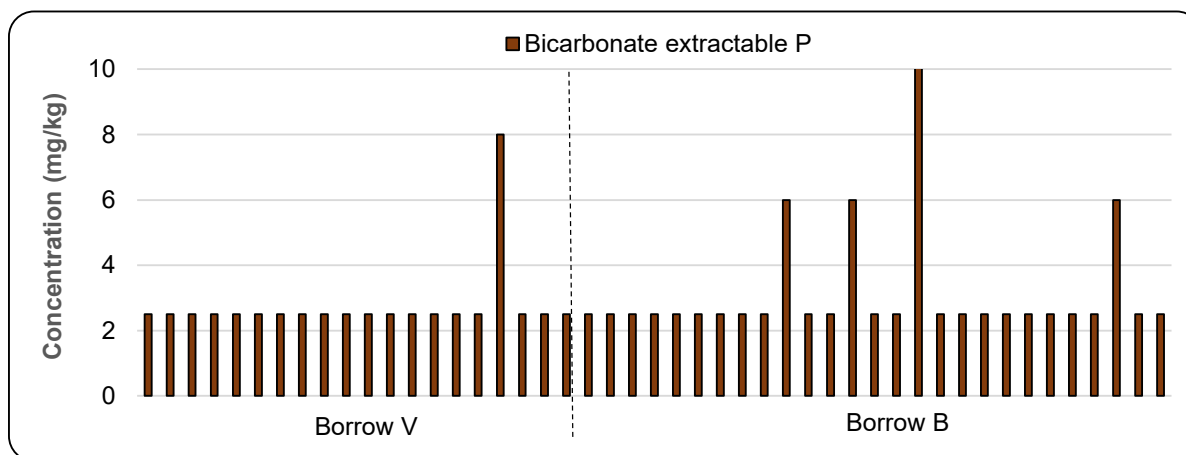
Figure 7-17: Extractable Phosphorus (P) for soils and saprolite from Borrow V and B

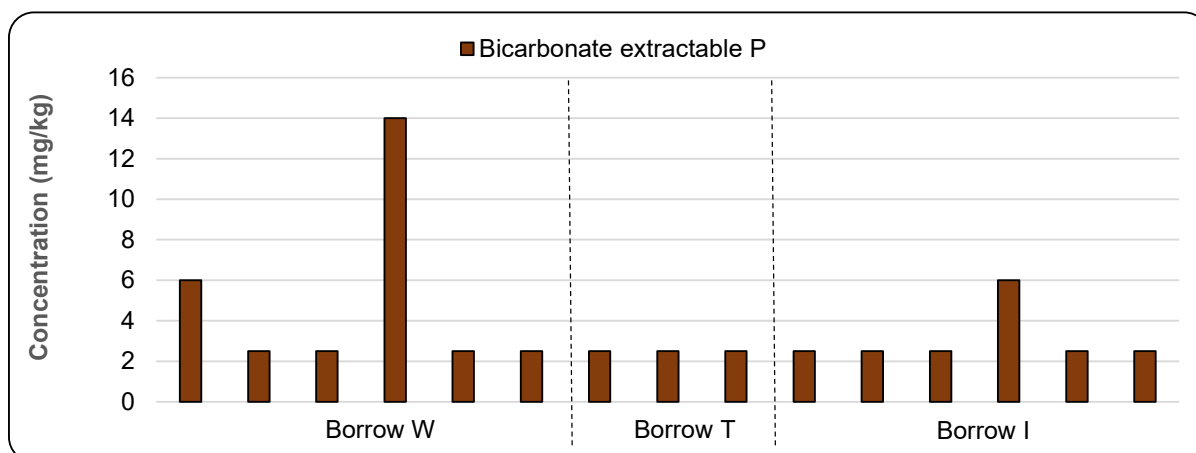
Figure 7-18: Extractable P for soils and saprolite from Borrow W, T, and I

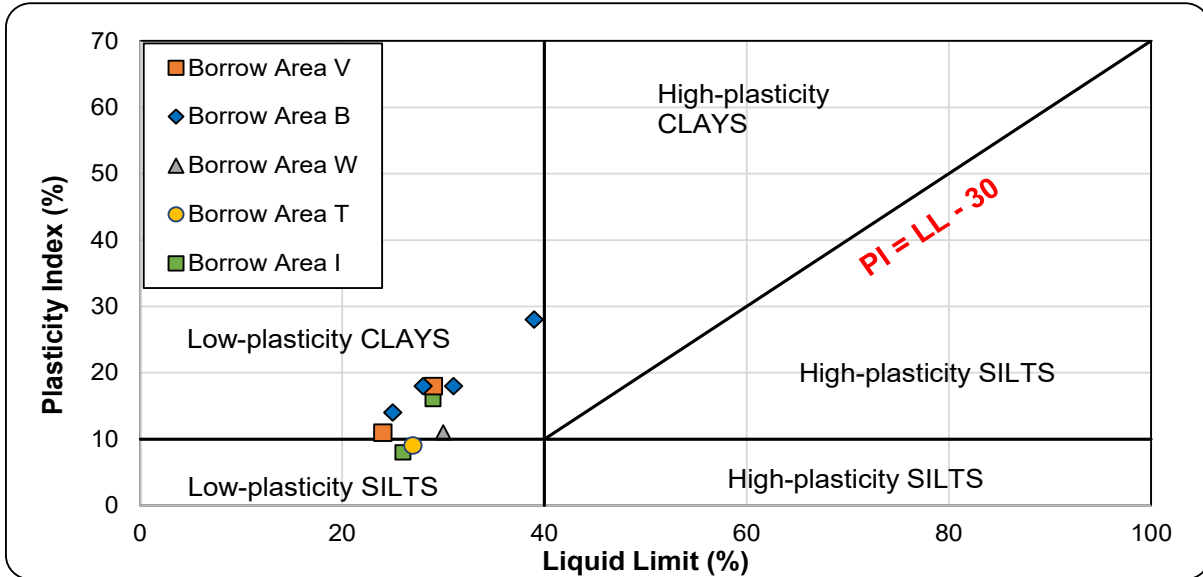
Figure 7-19: AASHTO soil classifications for borrow area soils

The AASHTO soil classifications based on WAQTC (2020) are presented in **Figure 7-19 (Attachment B)**.

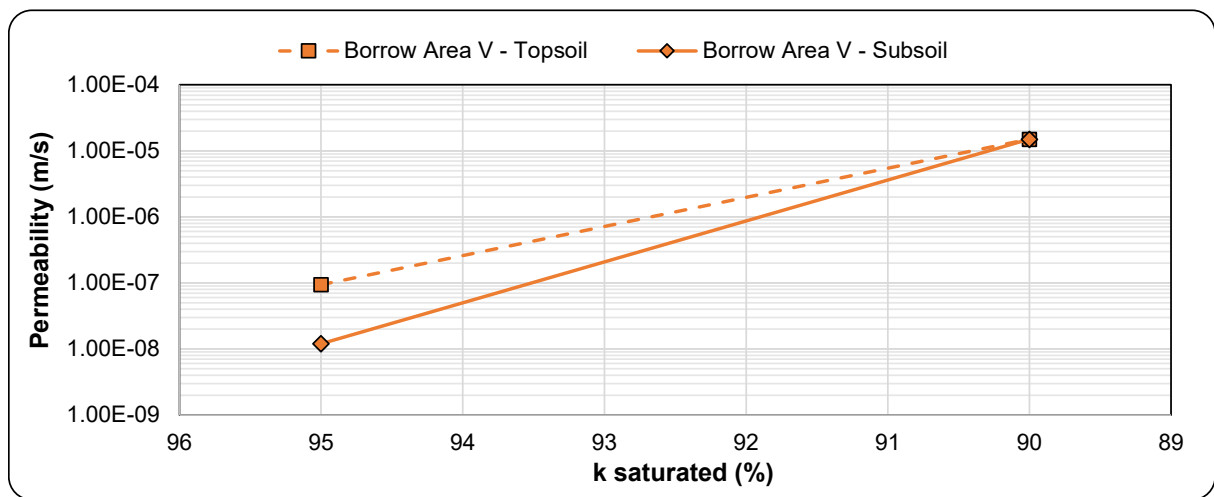
Figure 7-20: Permeability results for Borrow Area V

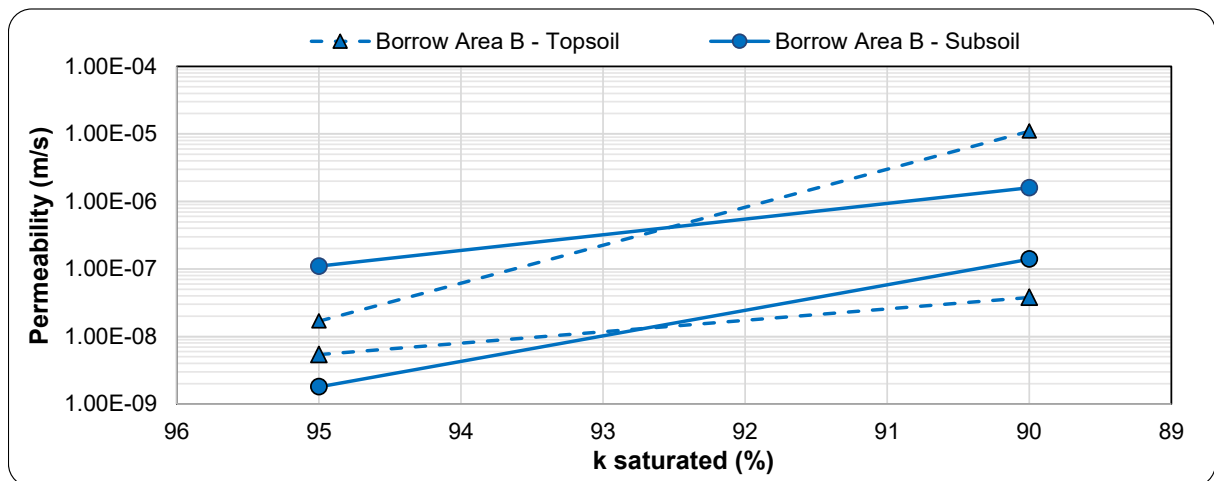
Figure 7-21: Permeability results for Borrow Area B

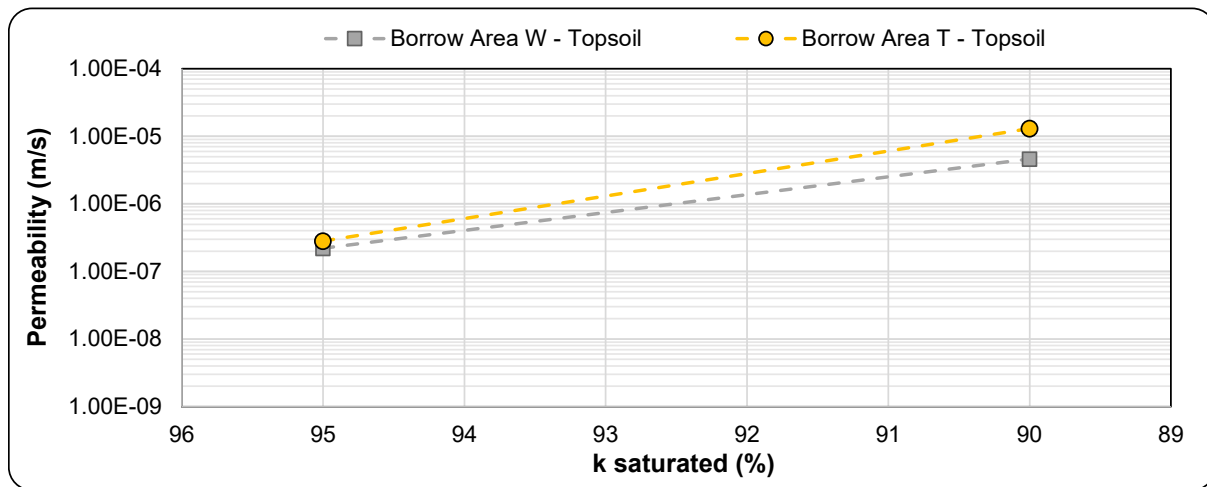
Figure 7-22: Permeability results for Borrow Area W and T

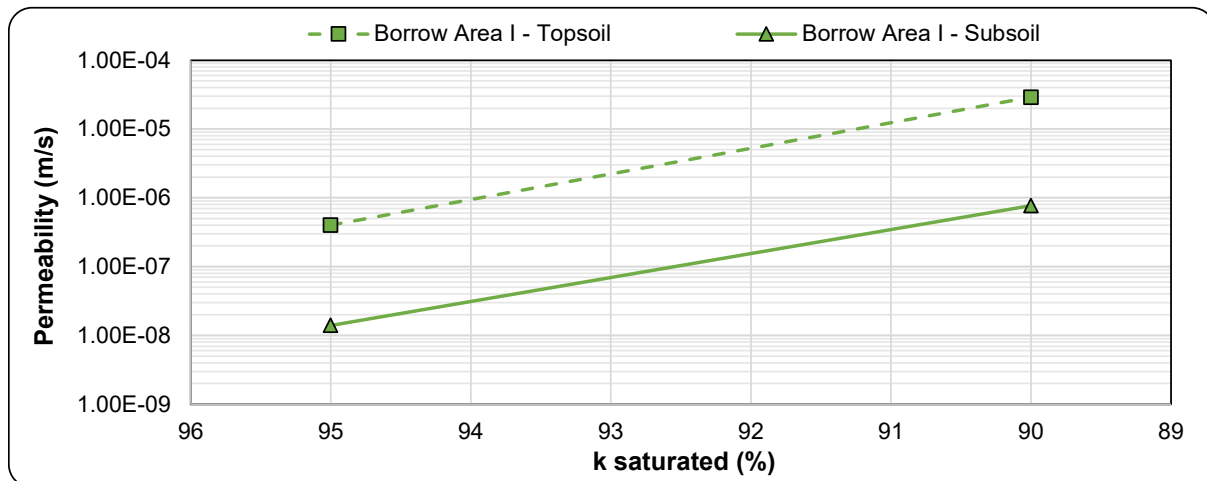
Figure 7-23: Permeability results for Borrow Area I

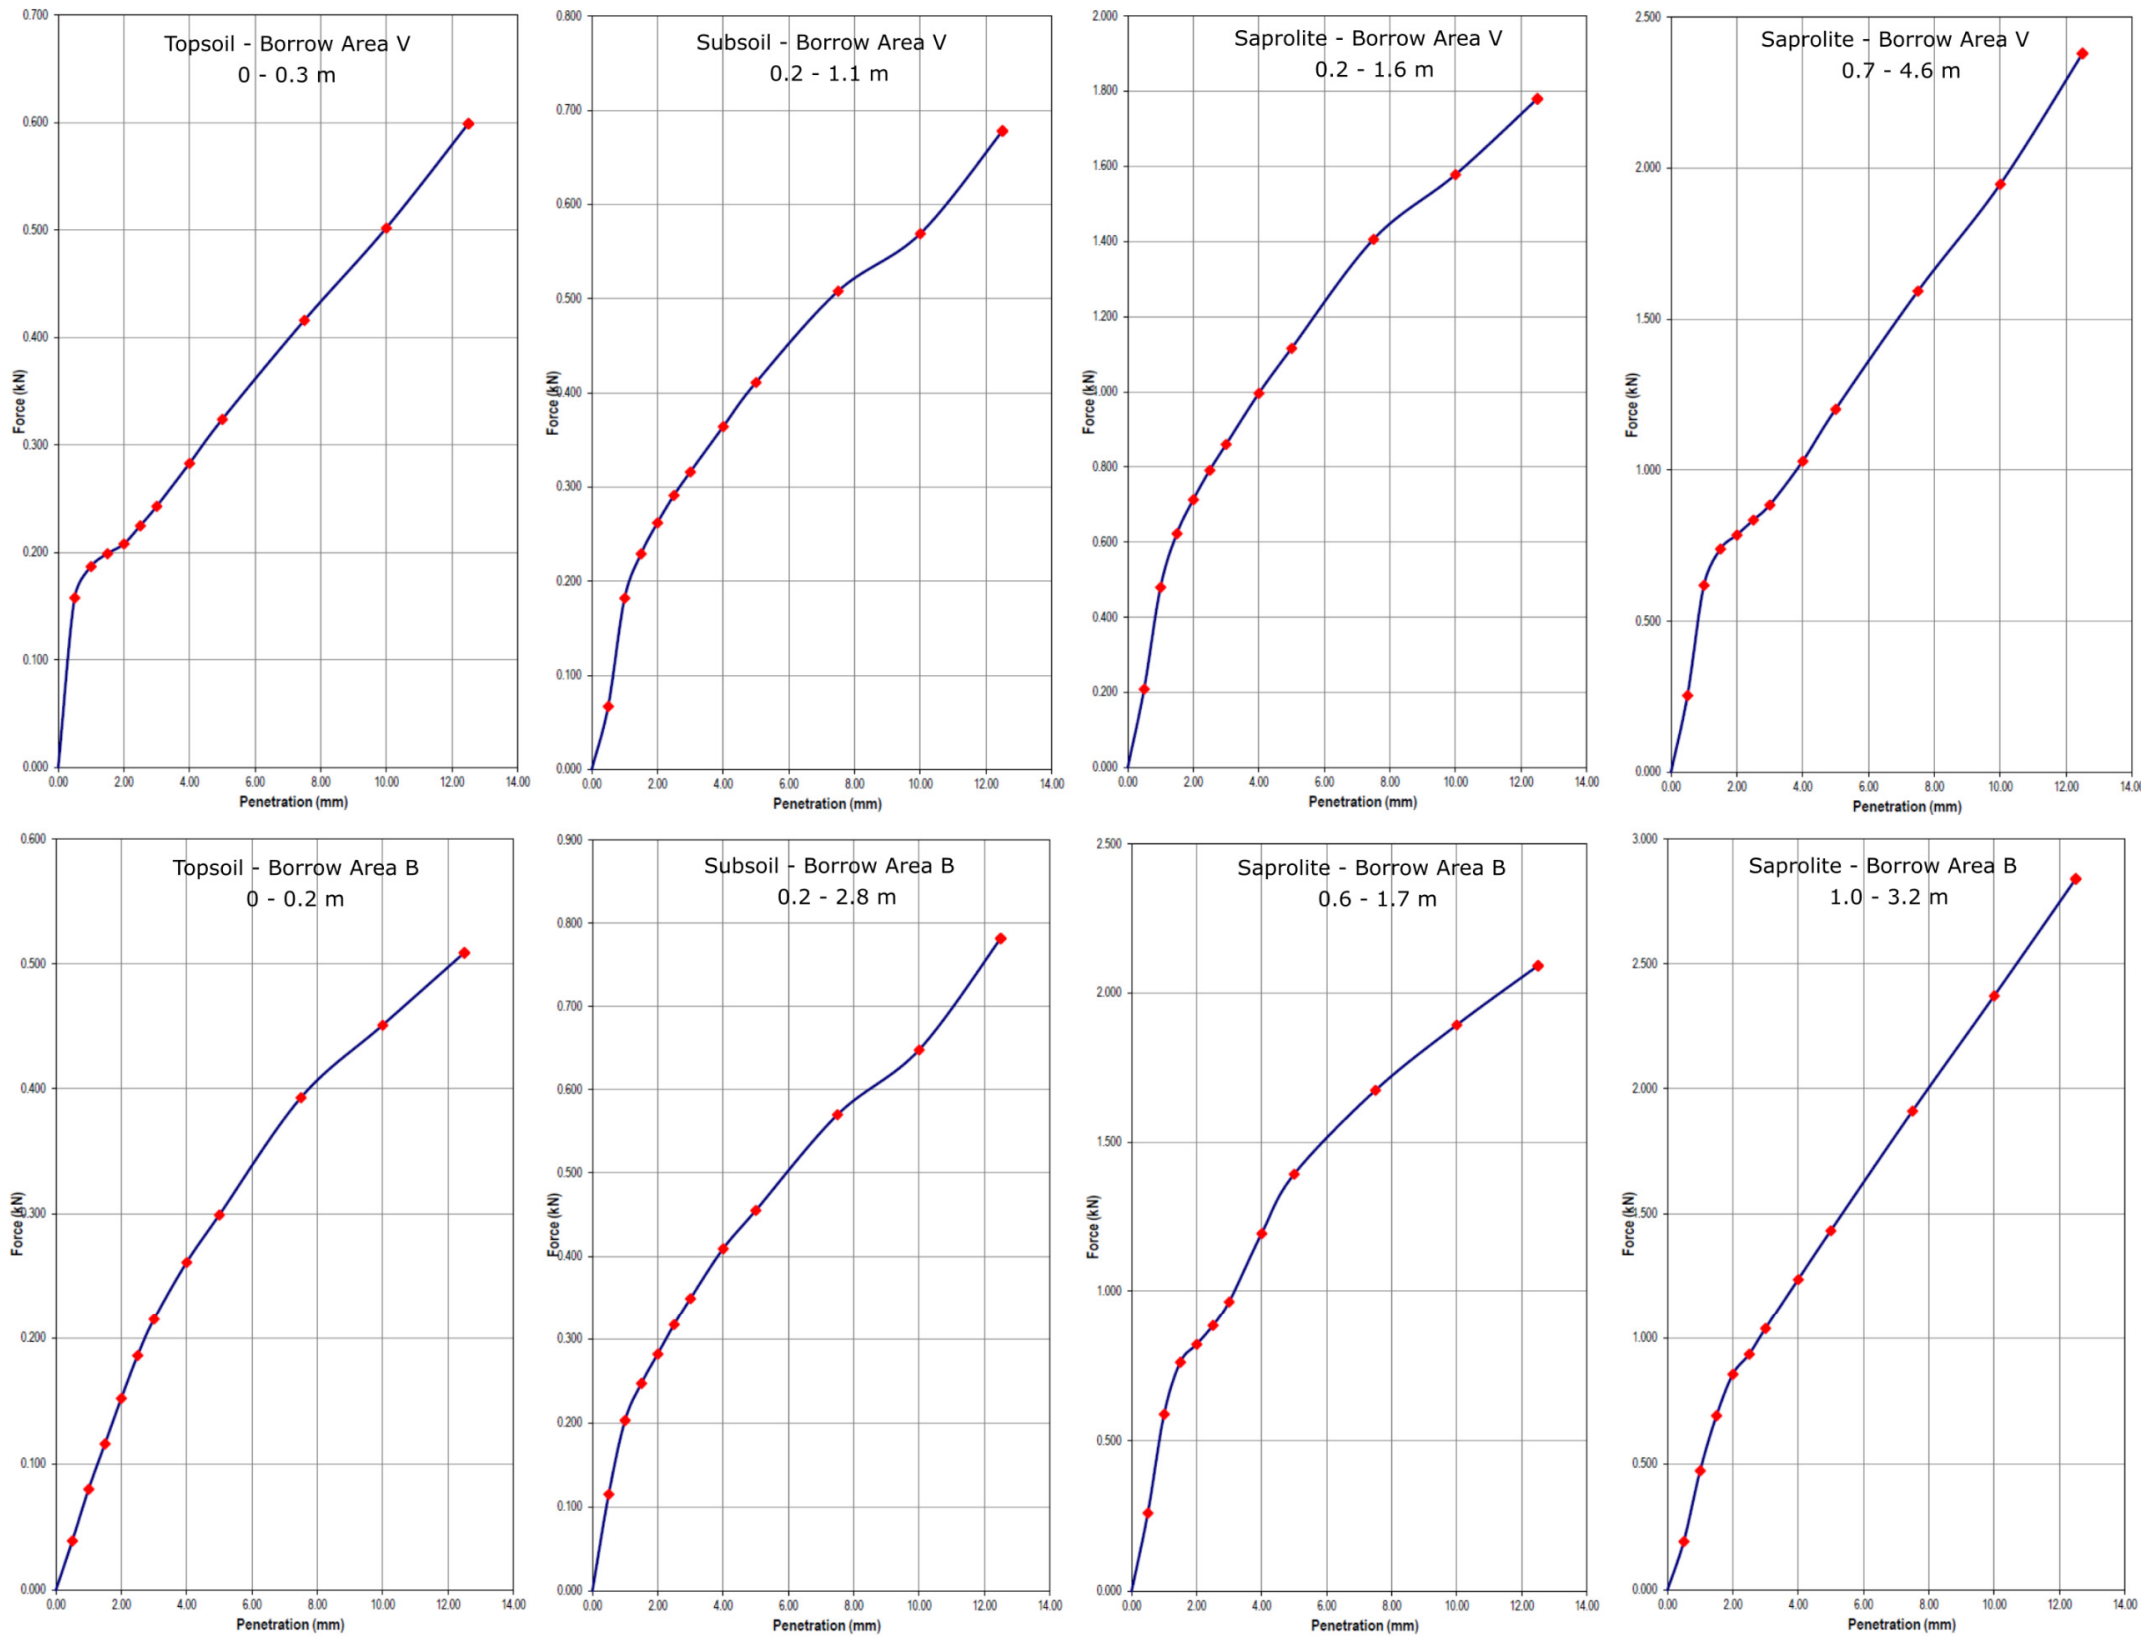
Figure 7-24: California Bearing Ratio (CBR) graphs for Borrow Areas V and B

California Bearing Ratio (CBR) results verify that topsoils and subsoils (CBR 1.5 – 2.5%) in Borrow Areas V and B have lower CBR values compared to saprolite (CBR 6-7%). Saprolite in Borrow Area B compacts to form a slightly harder surface than saprolite from Borrow Area V (**Table 3-18**). Additional graphs are shown in **Figure 7-24 (Attachment B)**.

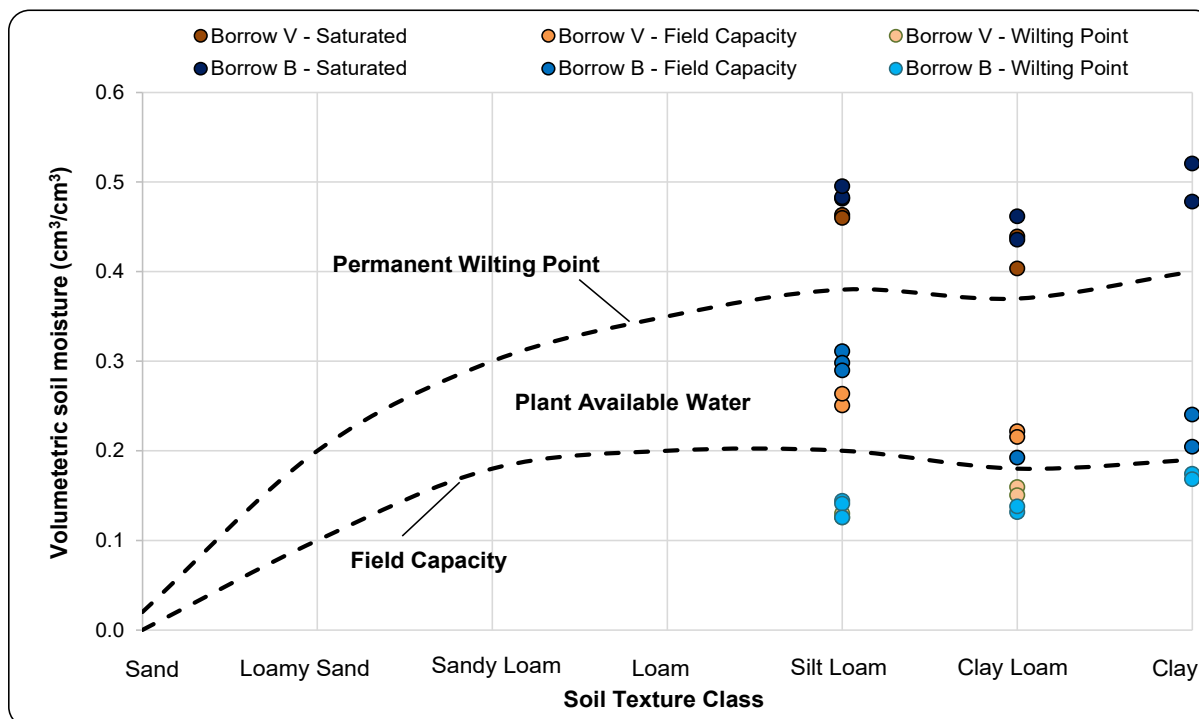
Figure 7-25: Relationship between soil texture class and plant available water for Borrow V and B

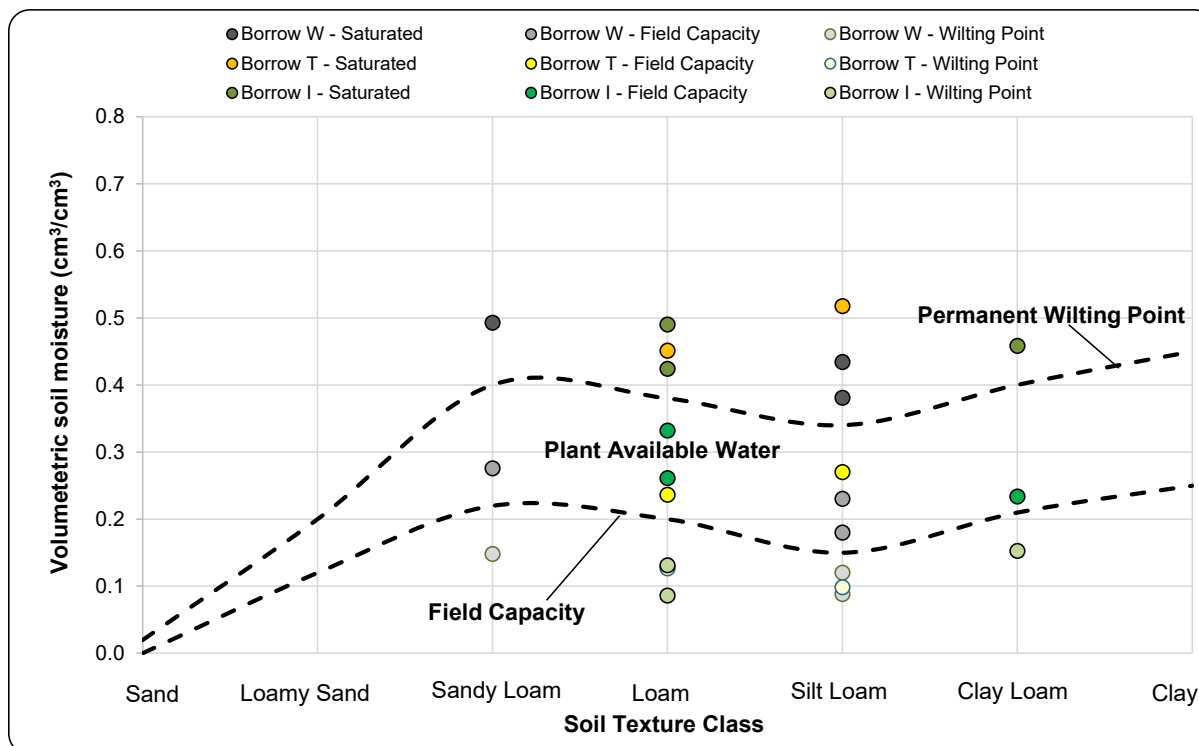
Figure 7-26: Relationship between soil texture class and plant available water for Borrow W, T, and I

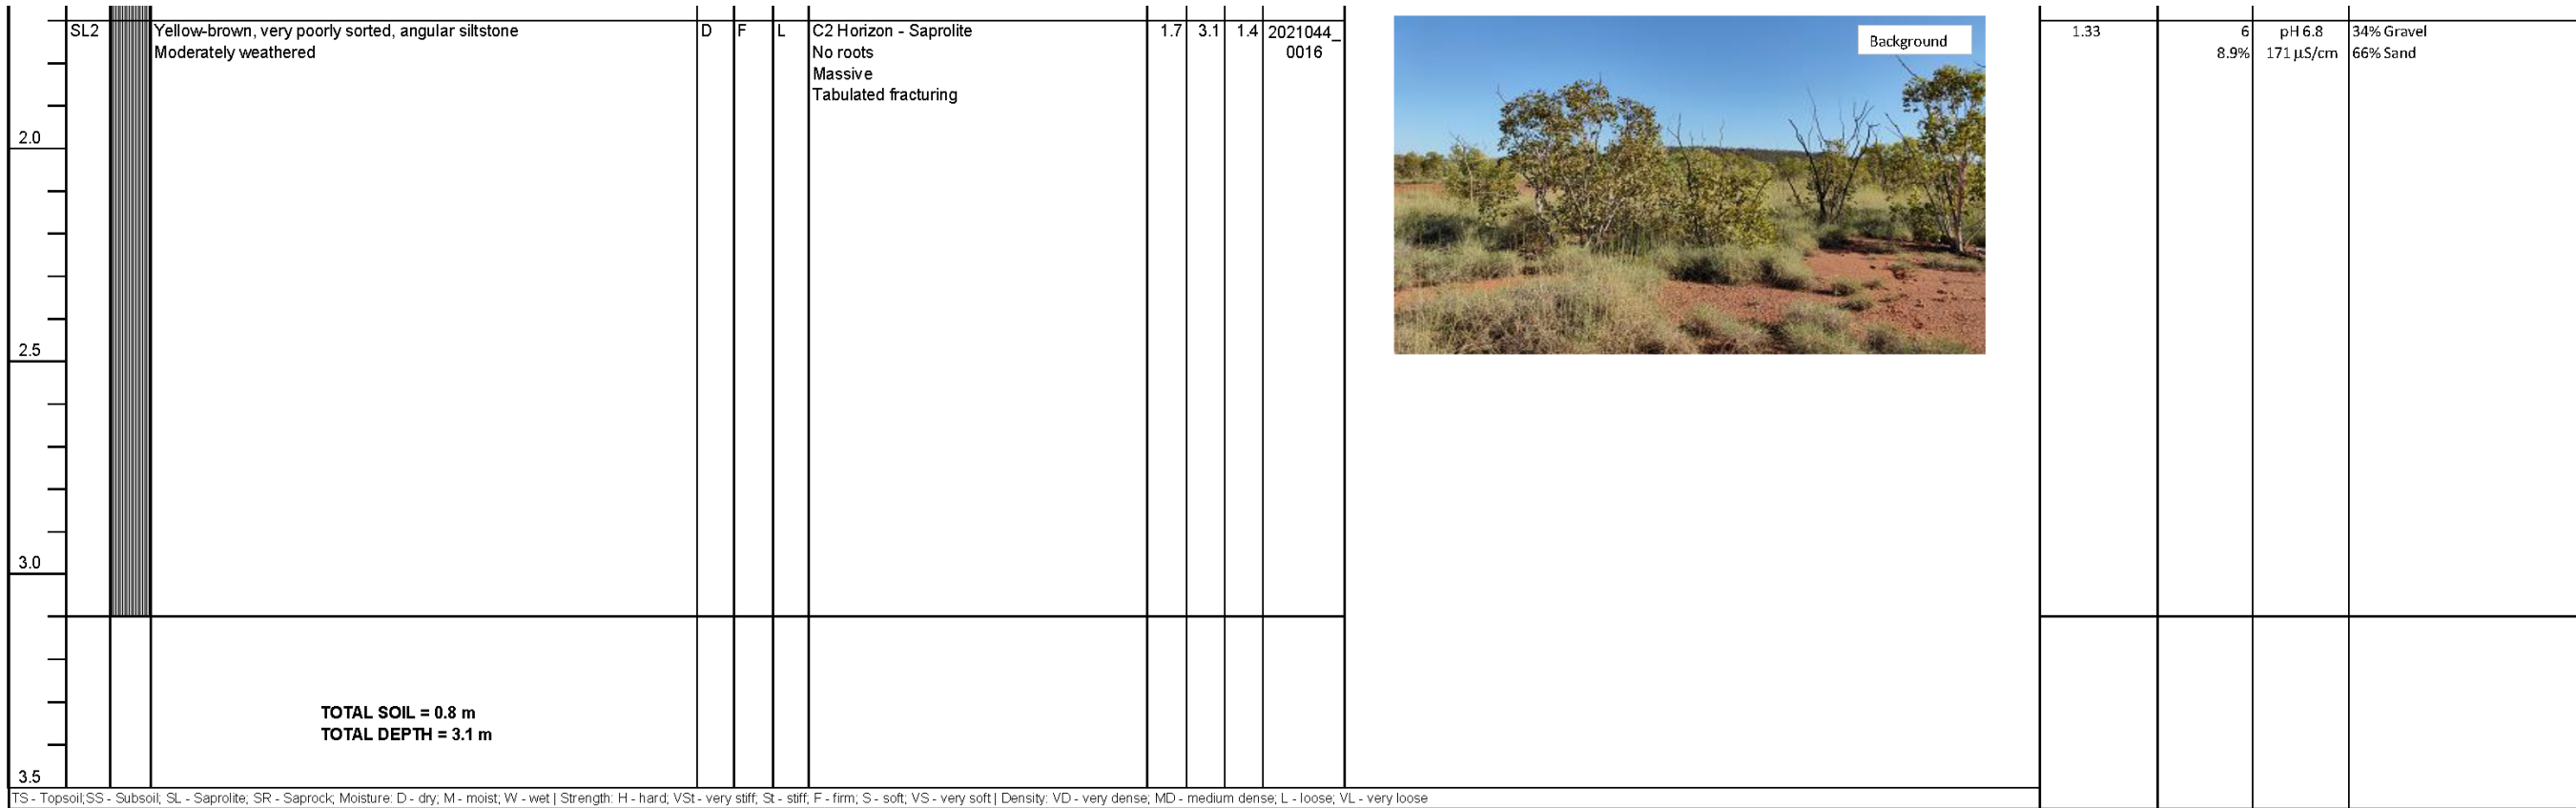
Figure 7-30: Test pit soil log: Test Pit 4 - Borrow Area B
