LADY LORETTA

## **Z-LLM-HSEC-PLN-Progressive Rehabilitation and Closure Plan**

| Project Name | Lady Loretta Mine |
| Document Title | Z-LLM-HSEC-PLN-Progressive Rehabilitation and Closure Plan |

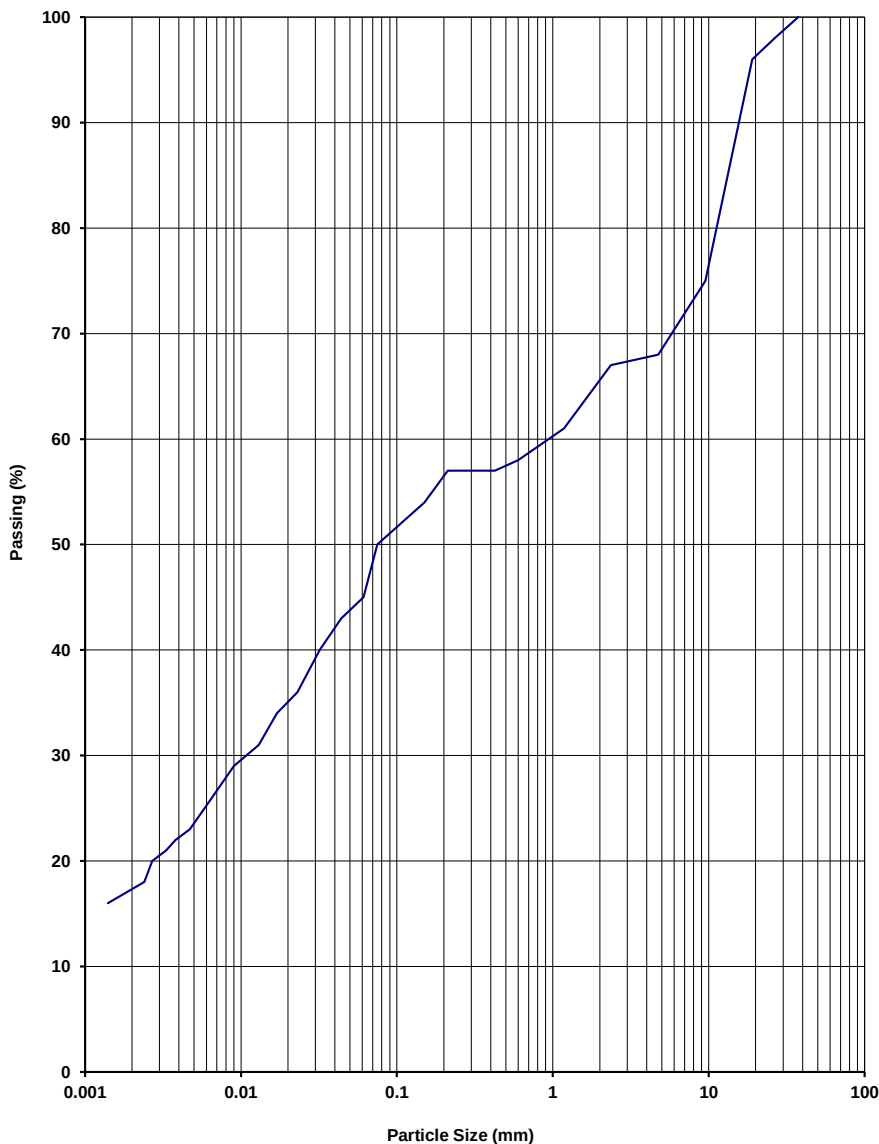
-  
 Moisture Content 9.4%      -2.36mm Soil Particle Density(t/m<sup>3</sup>) 2.59  
 Sample/s supplied by the client

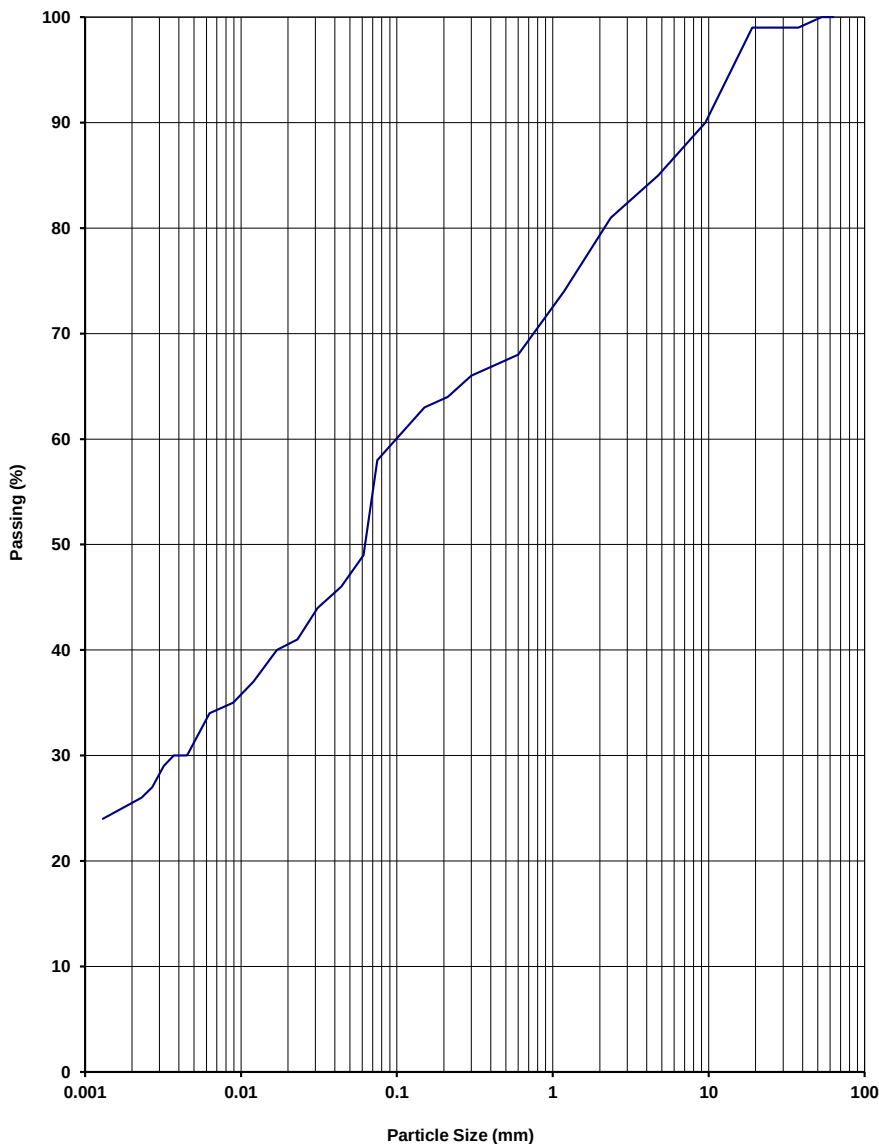
-  
 Moisture Content 9.4%      -2.36mm Soil Particle Density(t/m<sup>3</sup>) 2.64  
 Sample/s supplied by the client

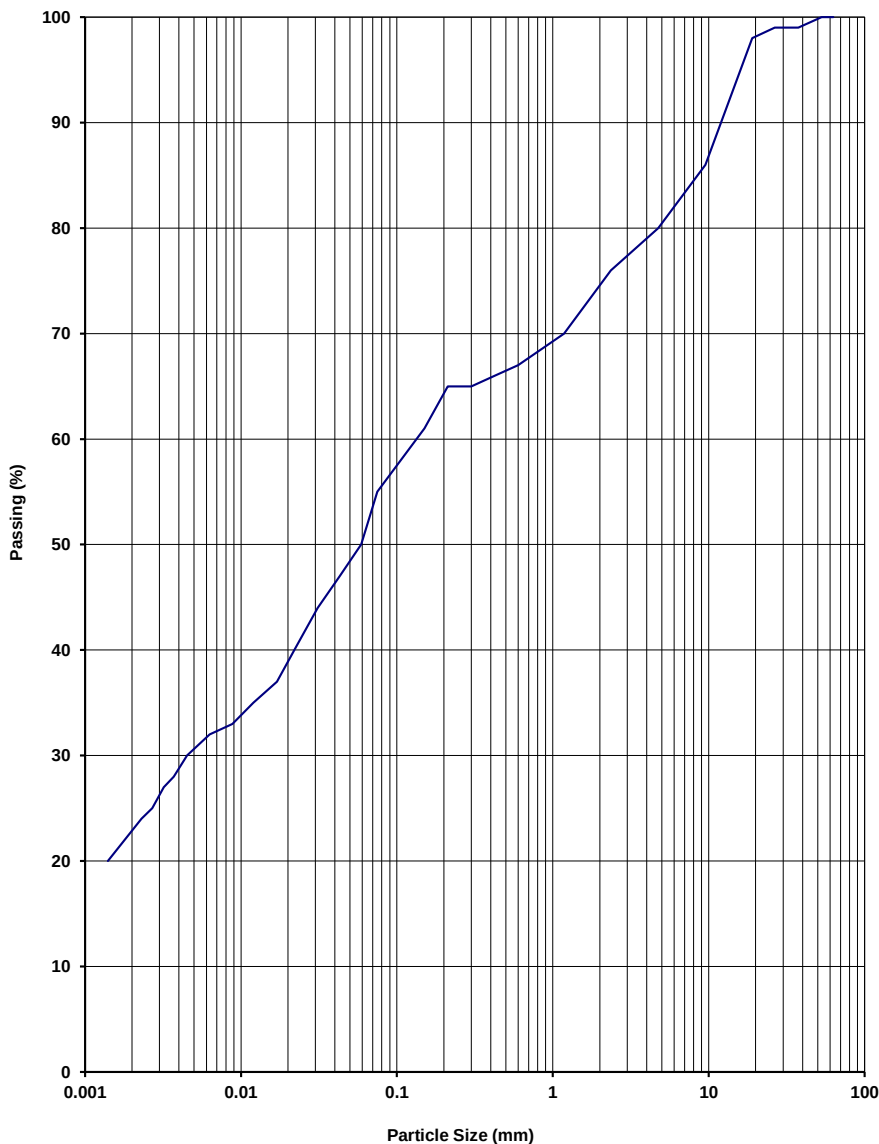
-  
 Moisture Content 11.3%      -2.36mm Soil Particle Density(t/m<sup>3</sup>) 2.64  
 Sample/s supplied by the client

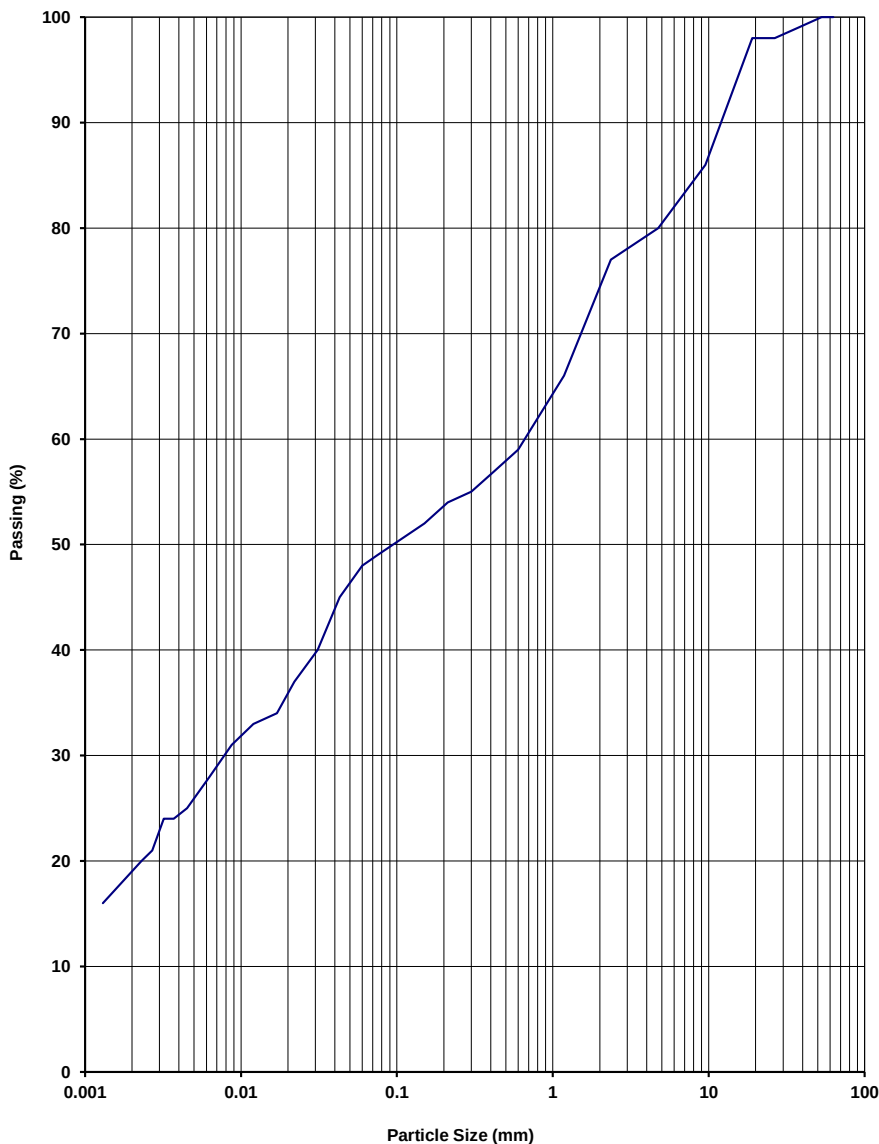
-  
 Moisture Content 8.1%      -2.36mm Soil Particle Density(t/m<sup>3</sup>) 2.67  
 Sample/s supplied by the client

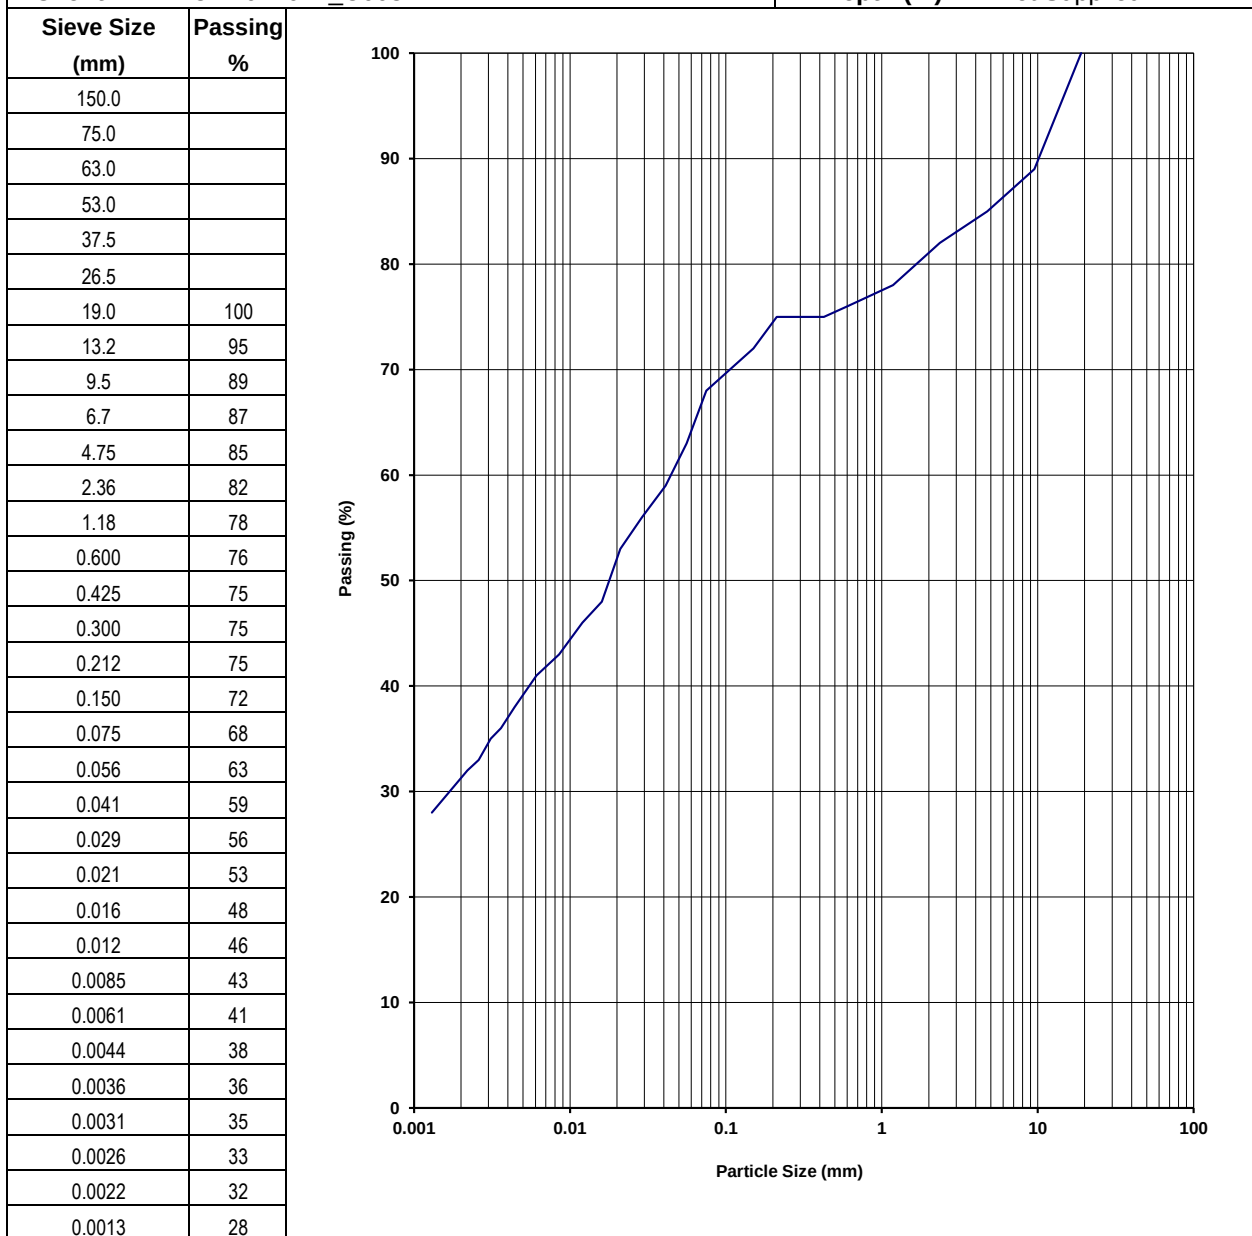
| <b>Client ID</b> | 8 - 2021044_C008 | <b>Depth (m)</b> | Not Supplied |

-  
 Moisture Content 10.7%      -2.36mm Soil Particle Density(t/m<sup>3</sup>) 2.57  
 Sample/s supplied by the client

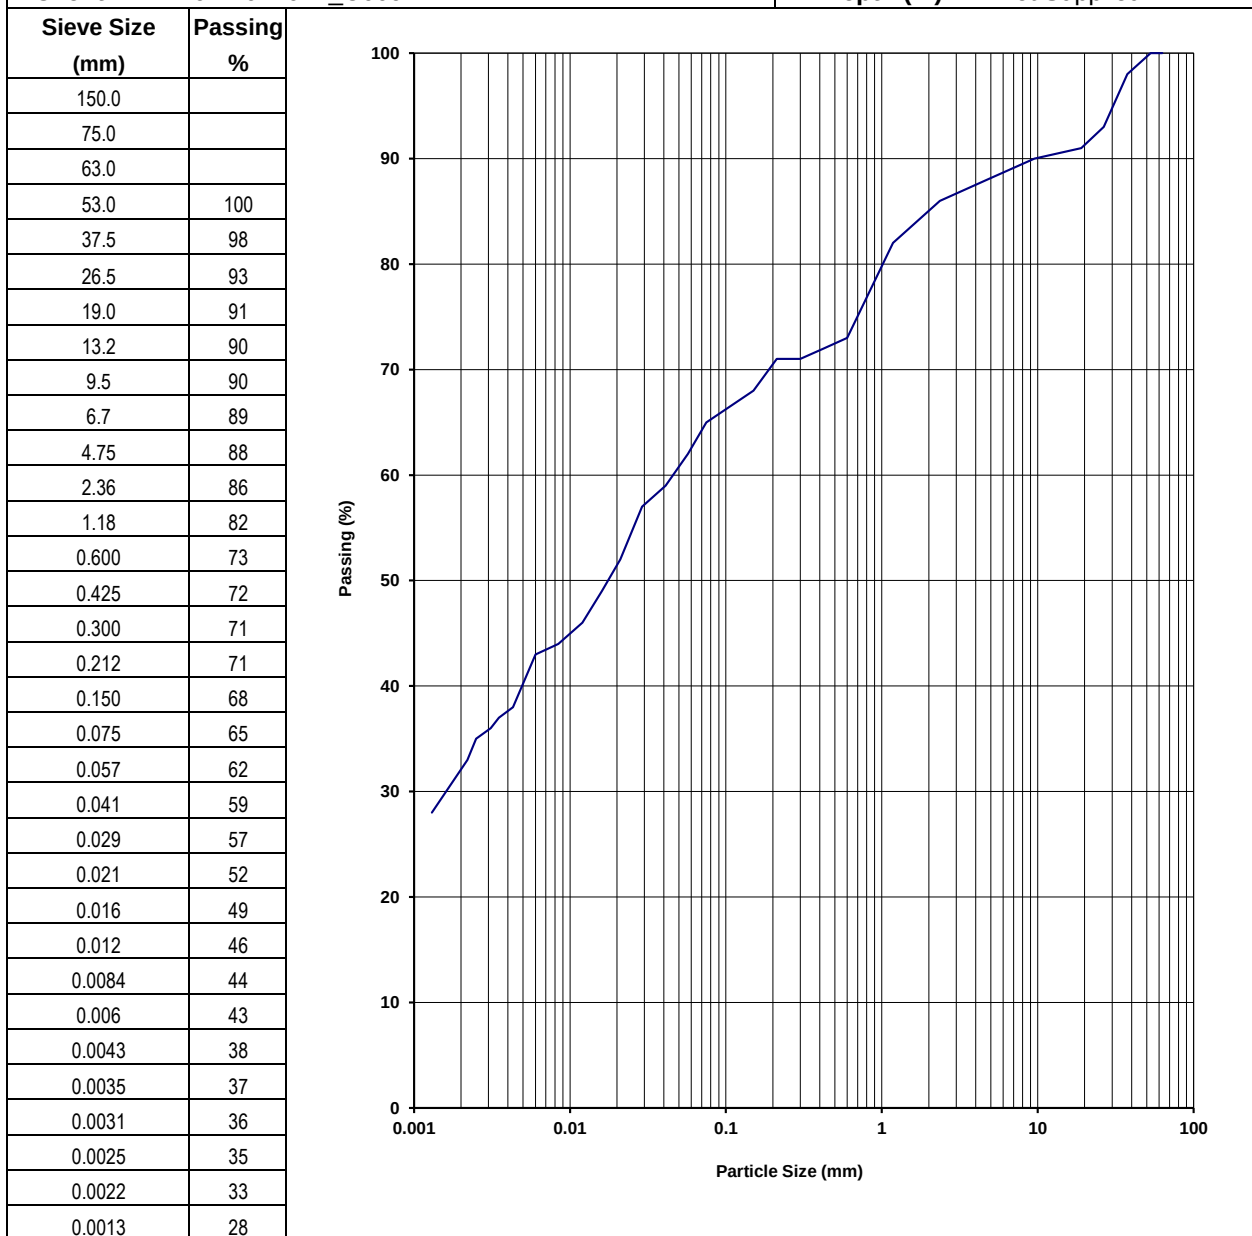
| <b>Client ID</b> | 9 - 2021044_C009 | <b>Depth (m)</b> | Not Supplied |

-  
 Moisture Content 8.3%      -2.36mm Soil Particle Density(t/m<sup>3</sup>) 2.67  
 Sample/s supplied by the client

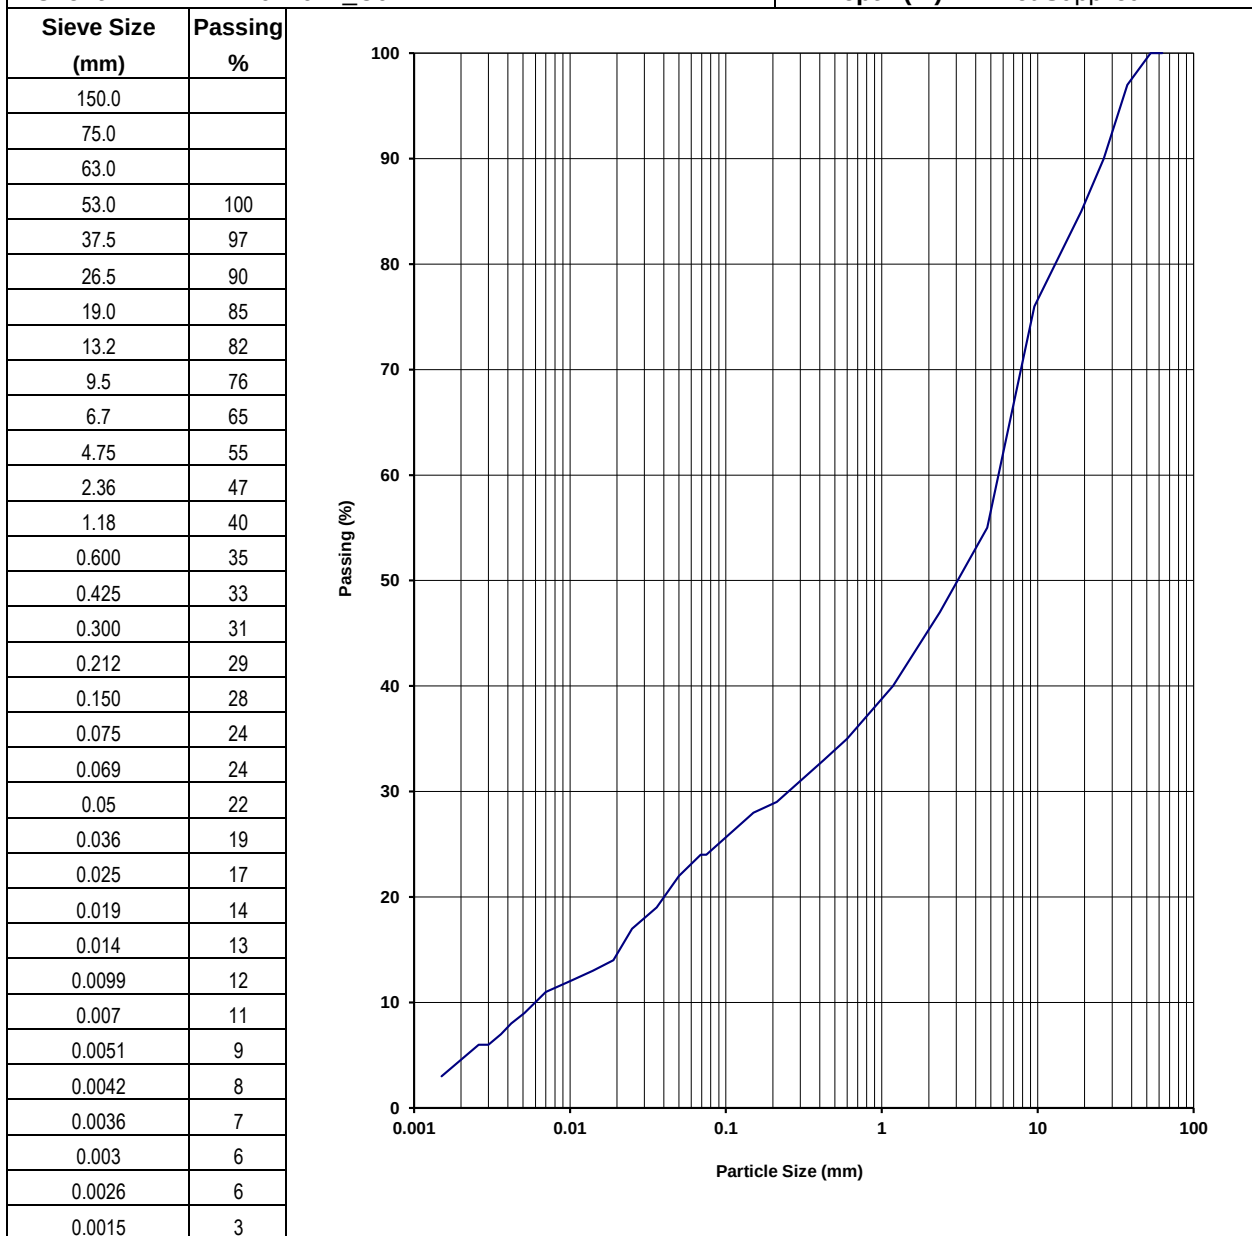
| <b>Client ID</b> | 12 - 2021044_C012 | <b>Depth (m)</b> | Not Supplied |

-  
 Moisture Content 7.4%      -2.36mm Soil Particle Density(t/m<sup>3</sup>) 2.50  
 Sample/s supplied by the client

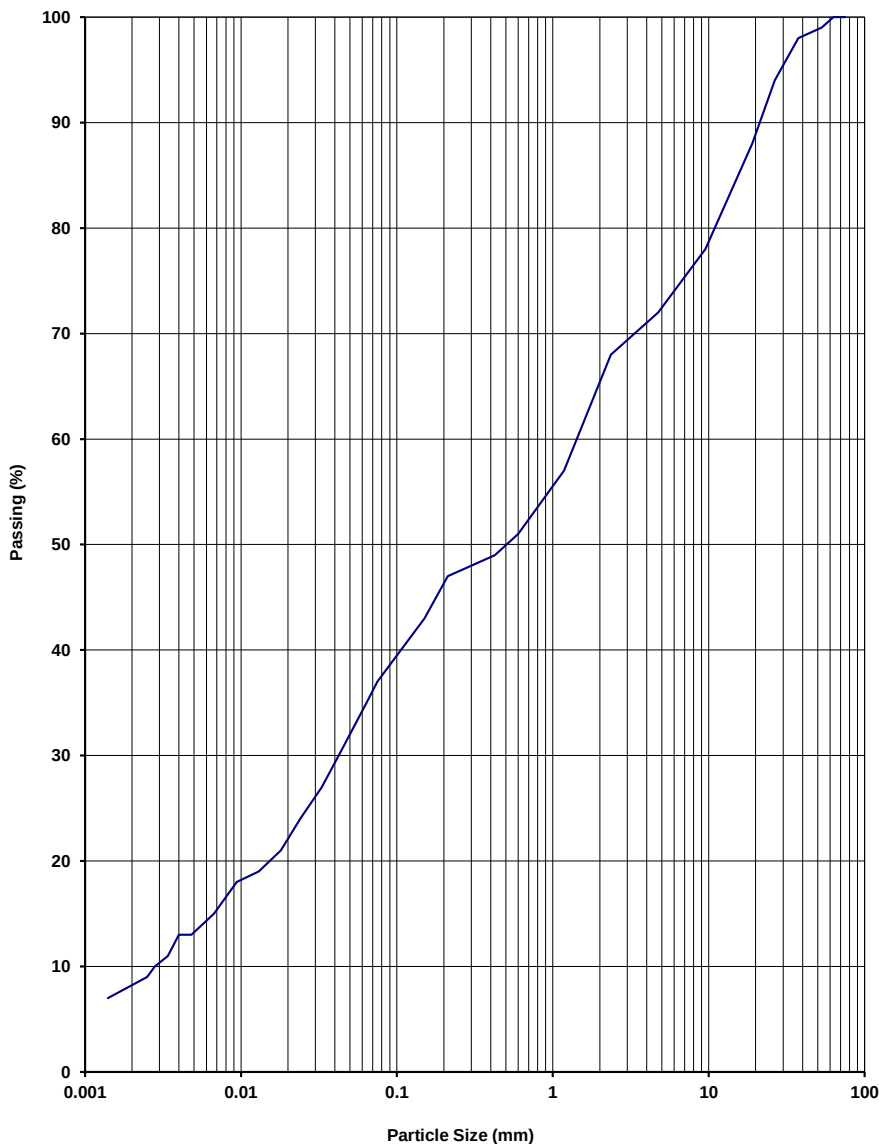
-  
 Moisture Content 5.8%      -2.36mm Soil Particle Density(t/m<sup>3</sup>) 2.60  
 Sample/s supplied by the client

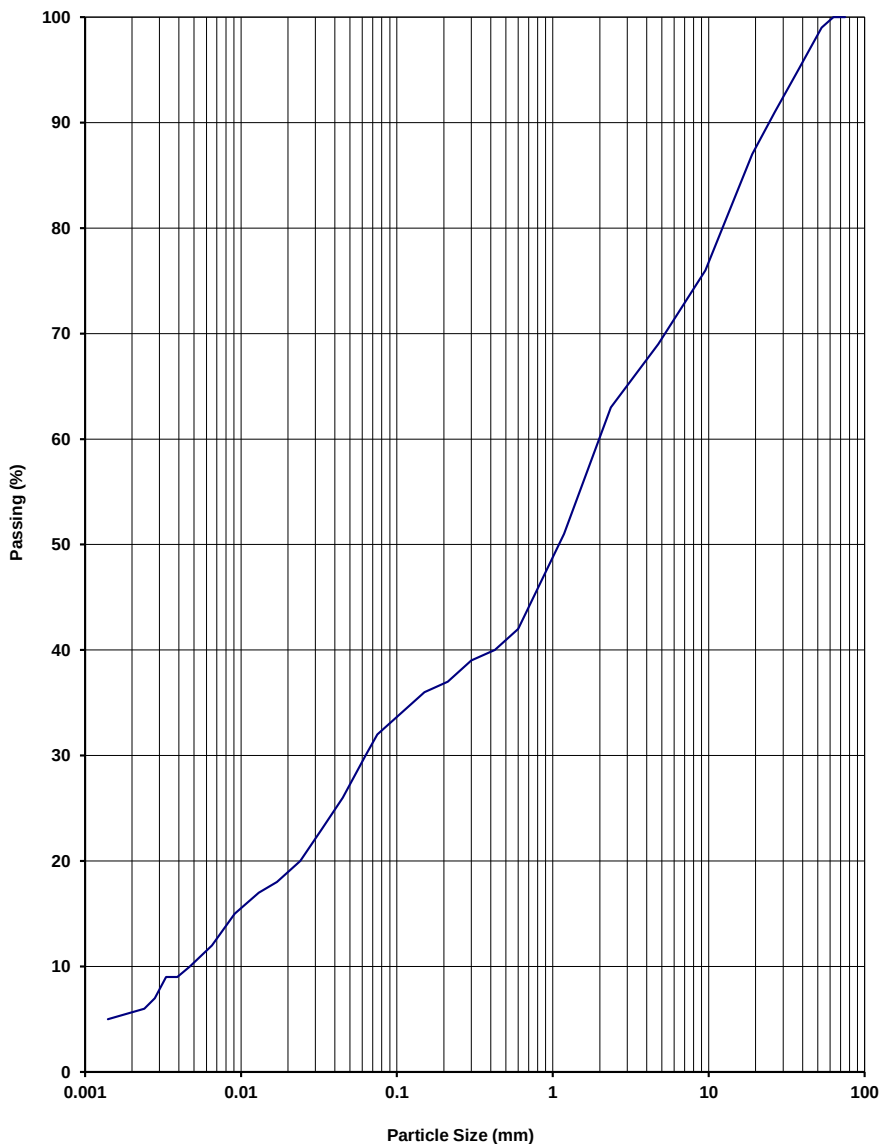
-  
 Moisture Content 5.1%      -2.36mm Soil Particle Density(t/m<sup>3</sup>) 2.70  
 Sample/s supplied by the client

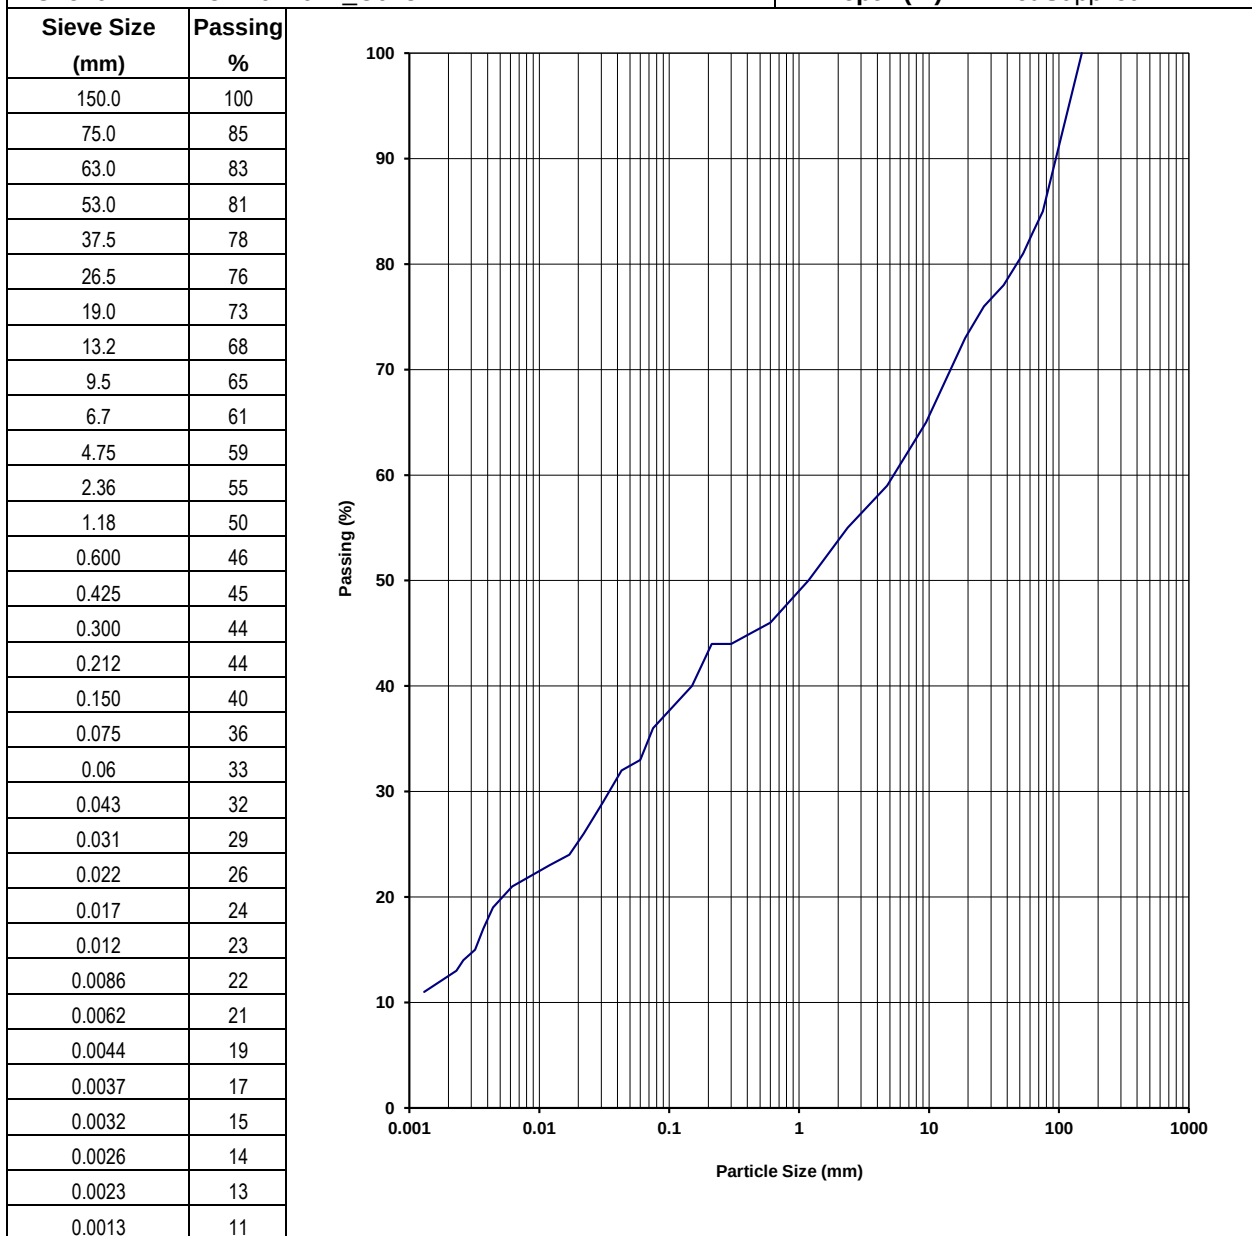
| <b>Client ID</b> | 18 - 2021044_C018 | <b>Depth (m)</b> | Not Supplied |

-  
 Moisture Content 8.3%      -2.36mm Soil Particle Density(t/m<sup>3</sup>) 2.72  
 Sample/s supplied by the client

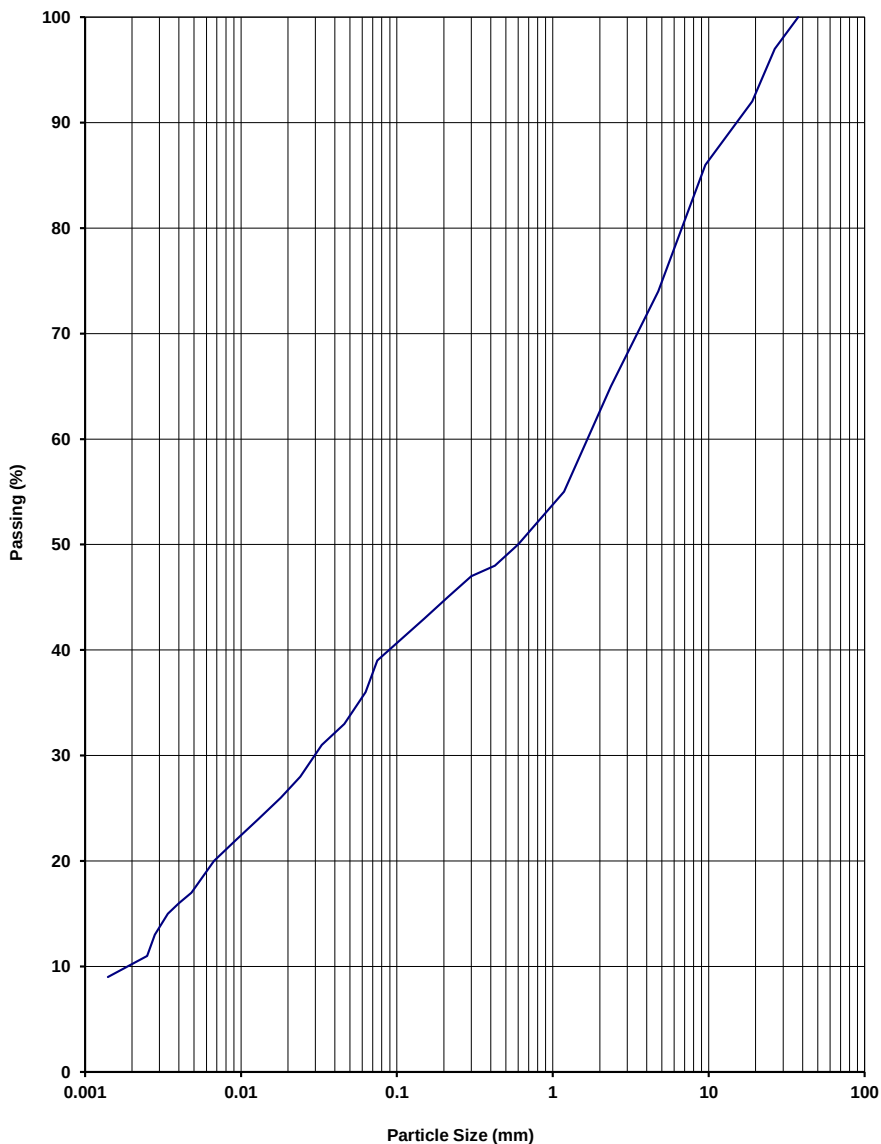
-  
 Moisture Content 6.9%      -2.36mm Soil Particle Density(t/m<sup>3</sup>) 2.54  
 Sample/s supplied by the client

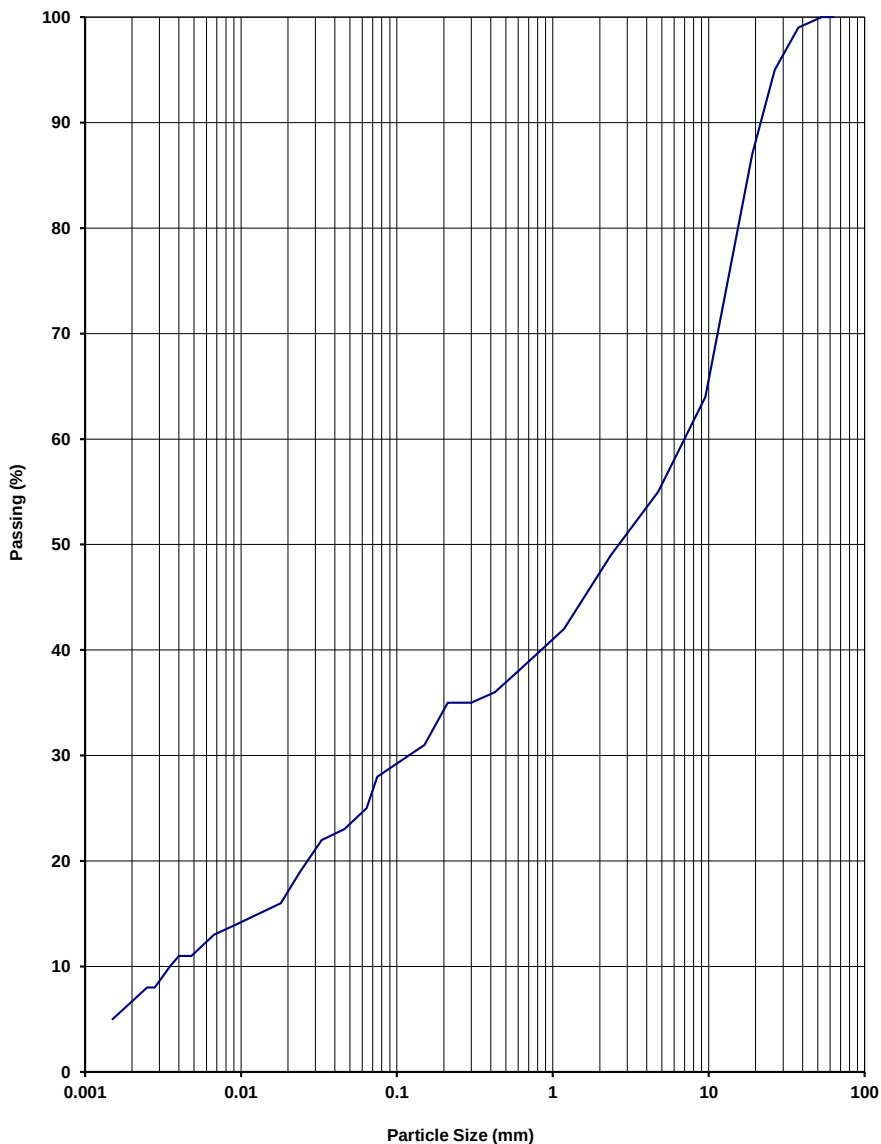
-  
 Moisture Content 5.1%      -2.36mm Soil Particle Density(t/m<sup>3</sup>) 2.55  
 Sample/s supplied by the client

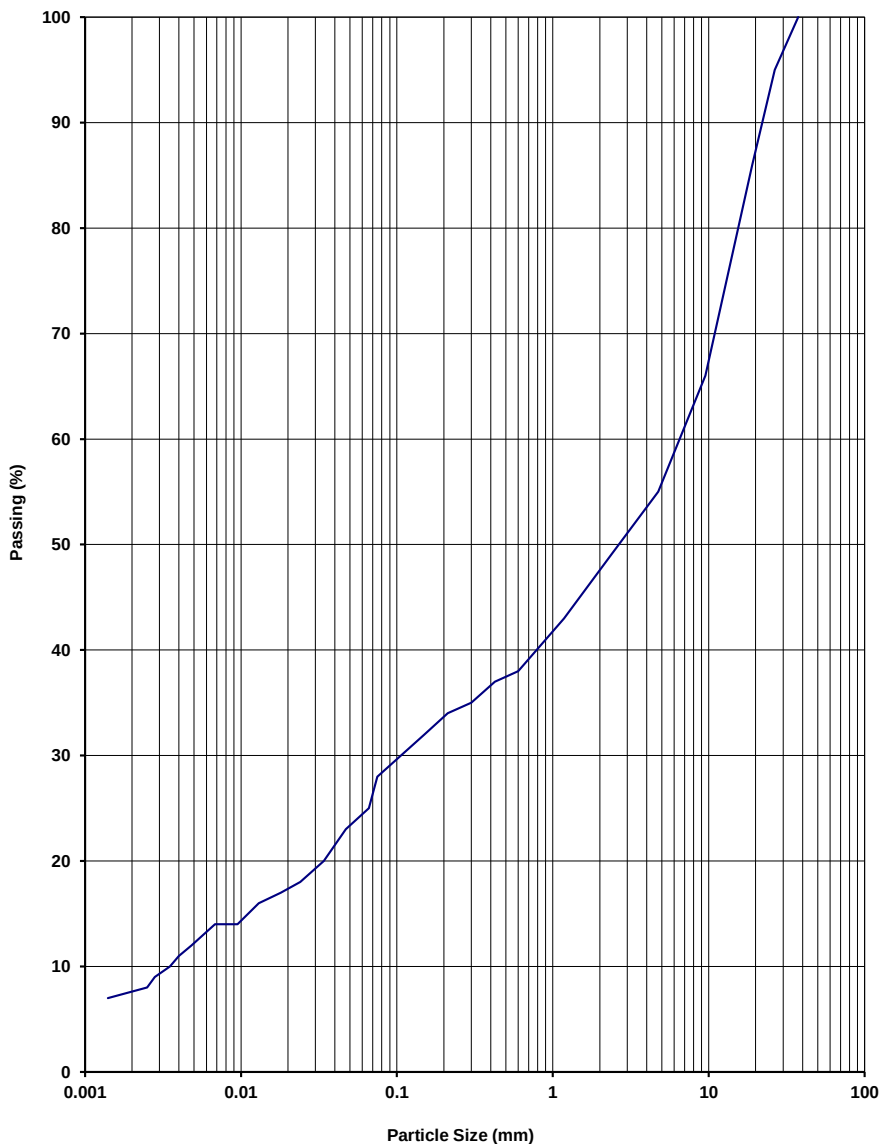
-  
 Moisture Content 6.2%      -2.36mm Soil Particle Density(t/m<sup>3</sup>) 2.56  
 Sample/s supplied by the client

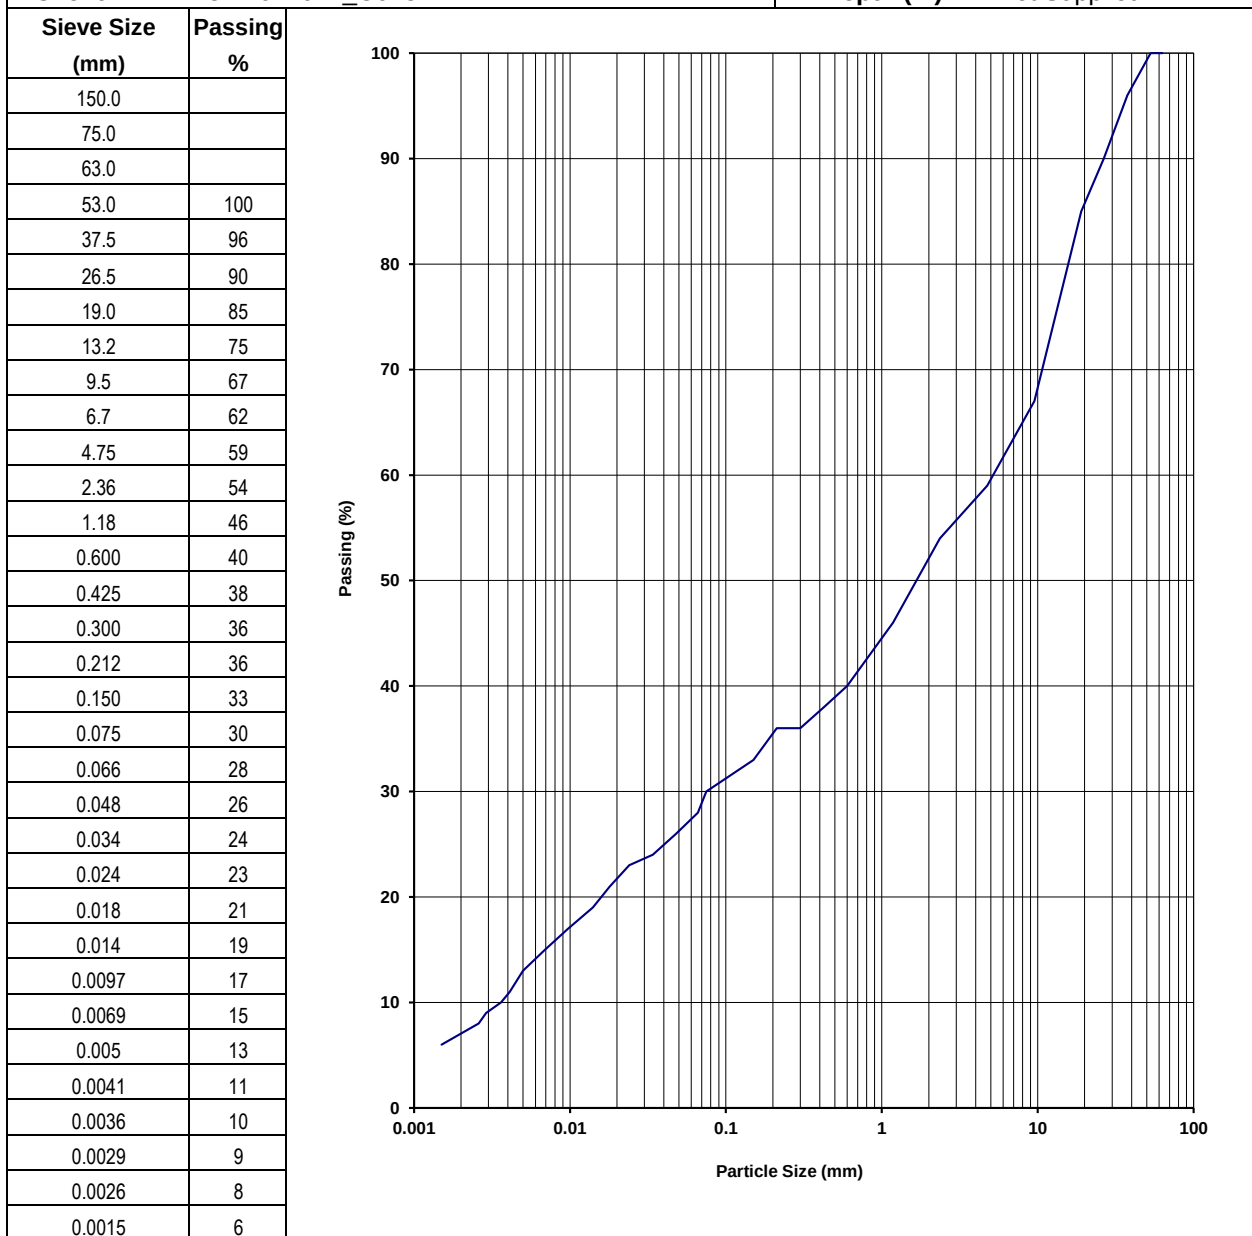
| <b>Client ID</b> | 23 - 2021044_C023 | <b>Depth (m)</b> | Not Supplied |

-  
 Moisture Content 9%      -2.36mm Soil Particle Density(t/m<sup>3</sup>) 2.46  
 Sample/s supplied by the client

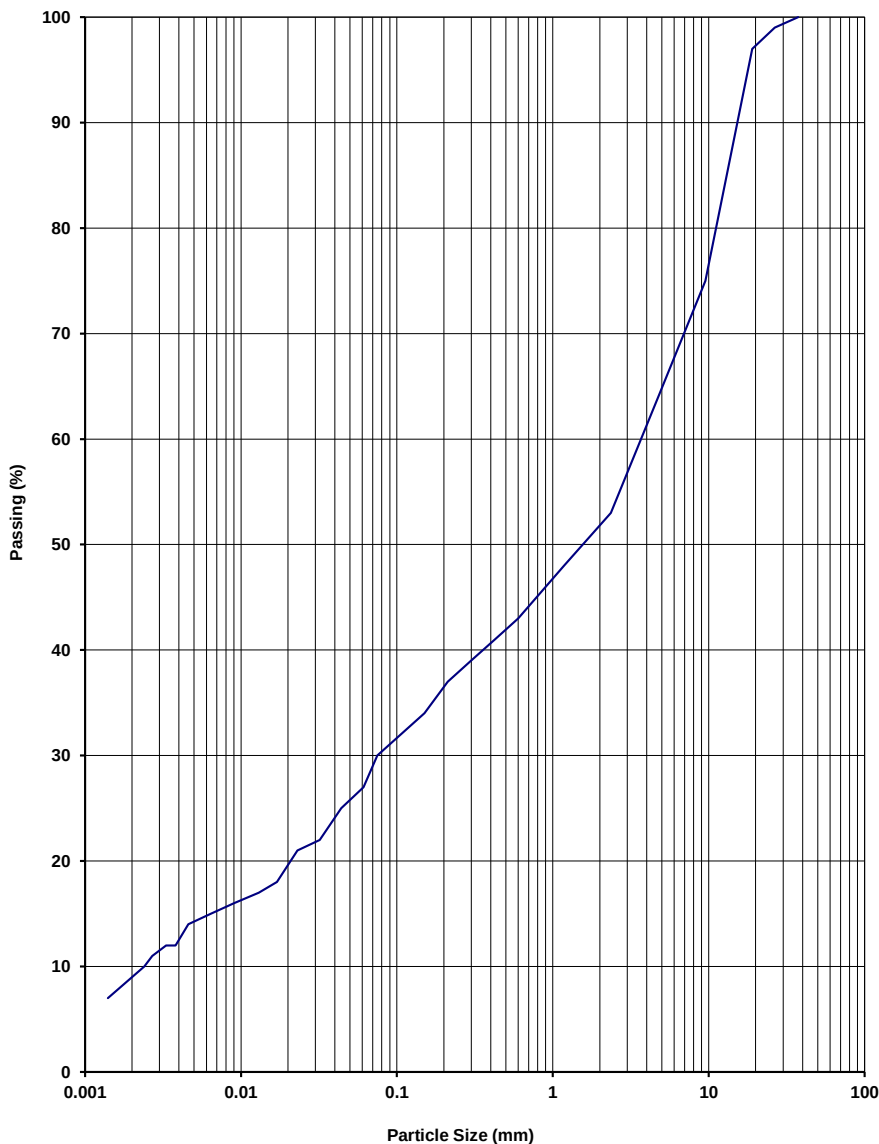
-  
 Moisture Content 9.3%      -2.36mm Soil Particle Density(t/m<sup>3</sup>) 2.67  
 Sample/s supplied by the client

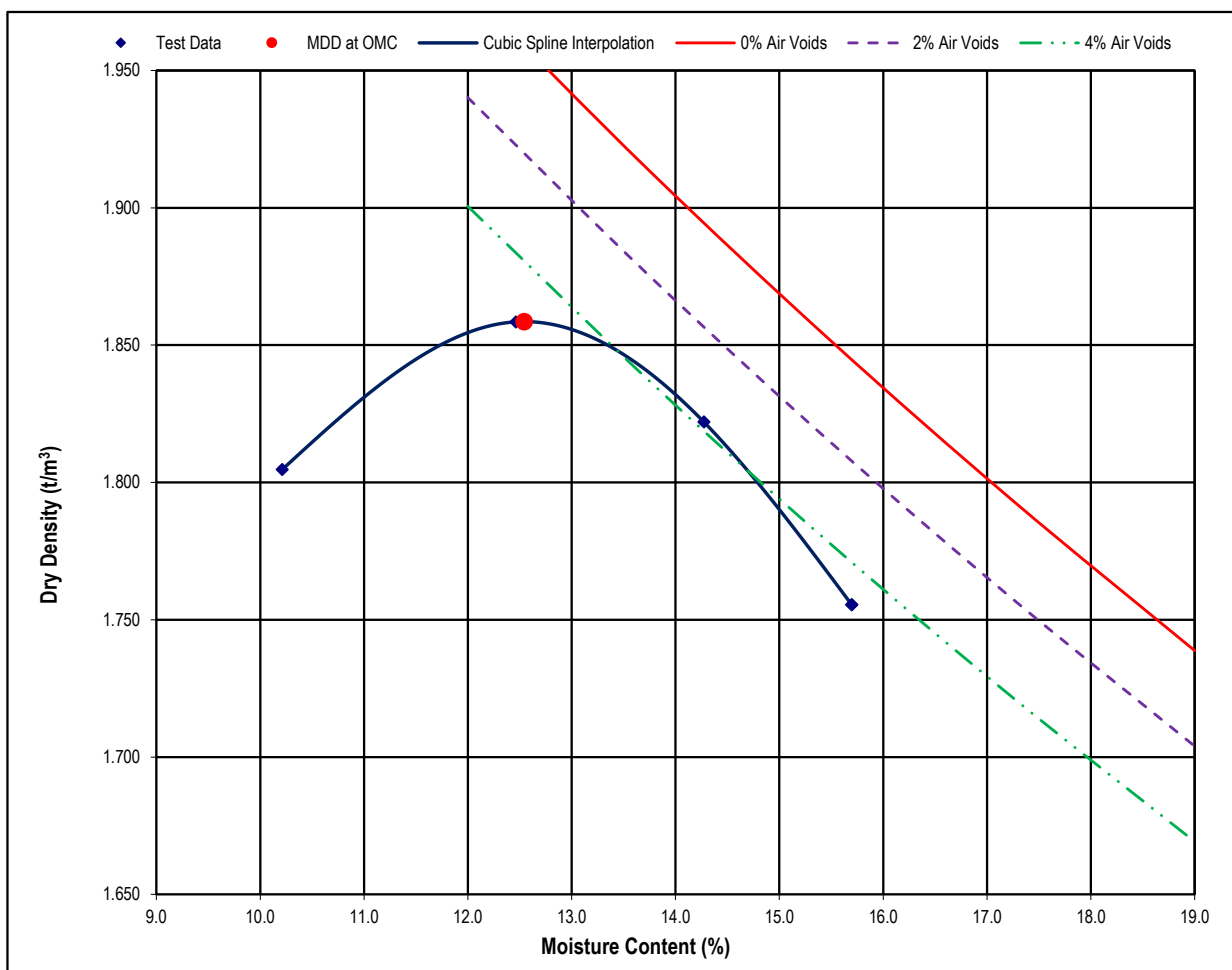
| <b>Client ID</b> | 1 - 2021044_C001 | <b>Depth (m)</b> | Not Supplied |

| <b>Description</b> | Gravelly Clayey SILT - brown | | |

| <b>Maximum Dry Density (t/m³)</b> | 1.86 | <b>Optimum Moisture Content (%)</b> | 12.5 |
| <b>Moisture Content (%)</b> | 9.4 | <b>Percentage of Oversize/Sieve Size (mm)</b> | 4.0 / 19 |

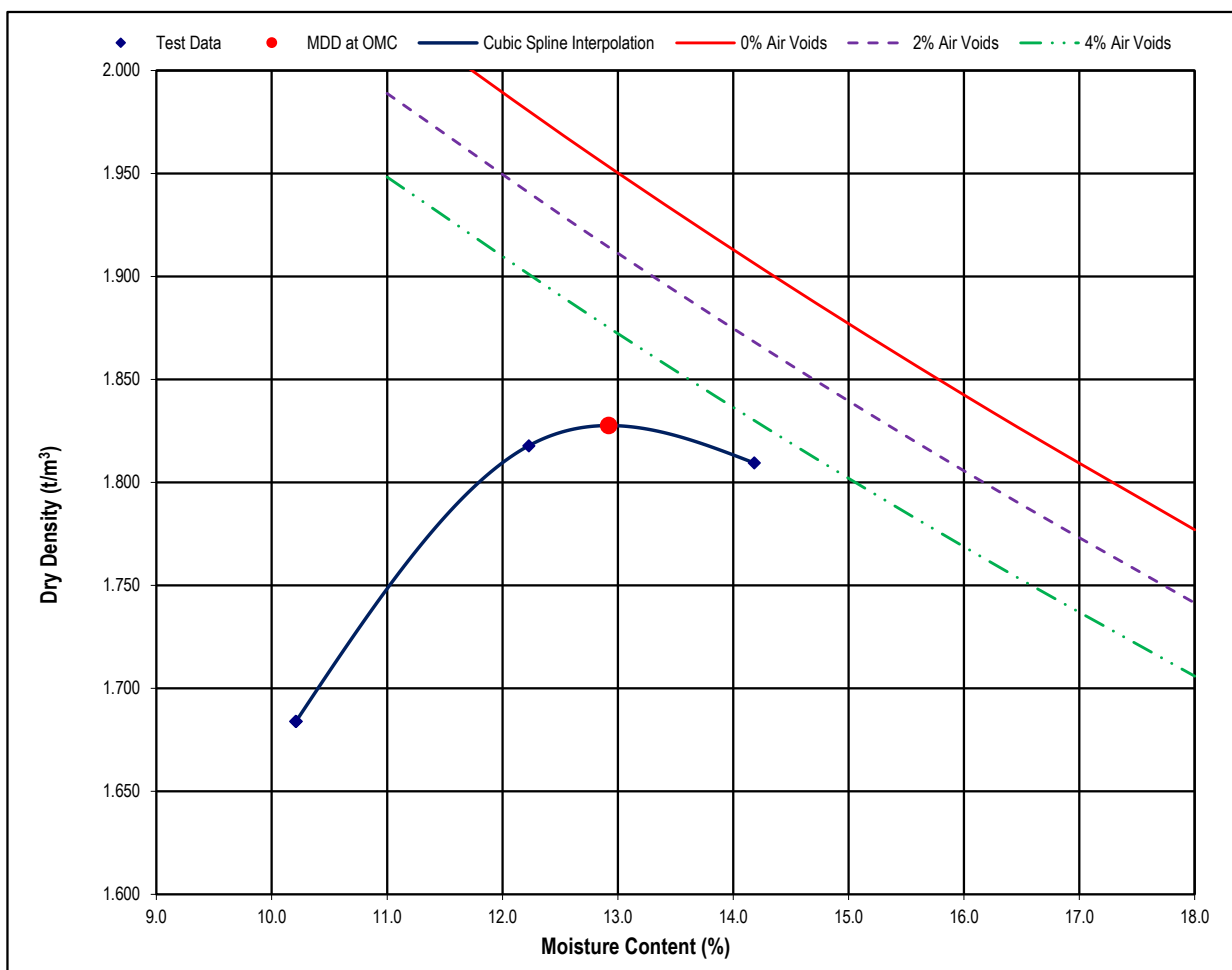
| <b>Client ID</b> | 2 - 2021044_C002 | <b>Depth (m)</b> | Not Supplied |

| <b>Description</b> | Sandy SILT with gravel - brown | | |

| <b>Maximum Dry Density (t/m<sup>3</sup>)</b> | 1.83 | <b>Optimum Moisture Content (%)</b> | 12.9 |
| <b>Moisture Content (%)</b> | 9.4 | <b>Percentage of Oversize/Sieve Size (mm)</b> | 1.0 / 19 |

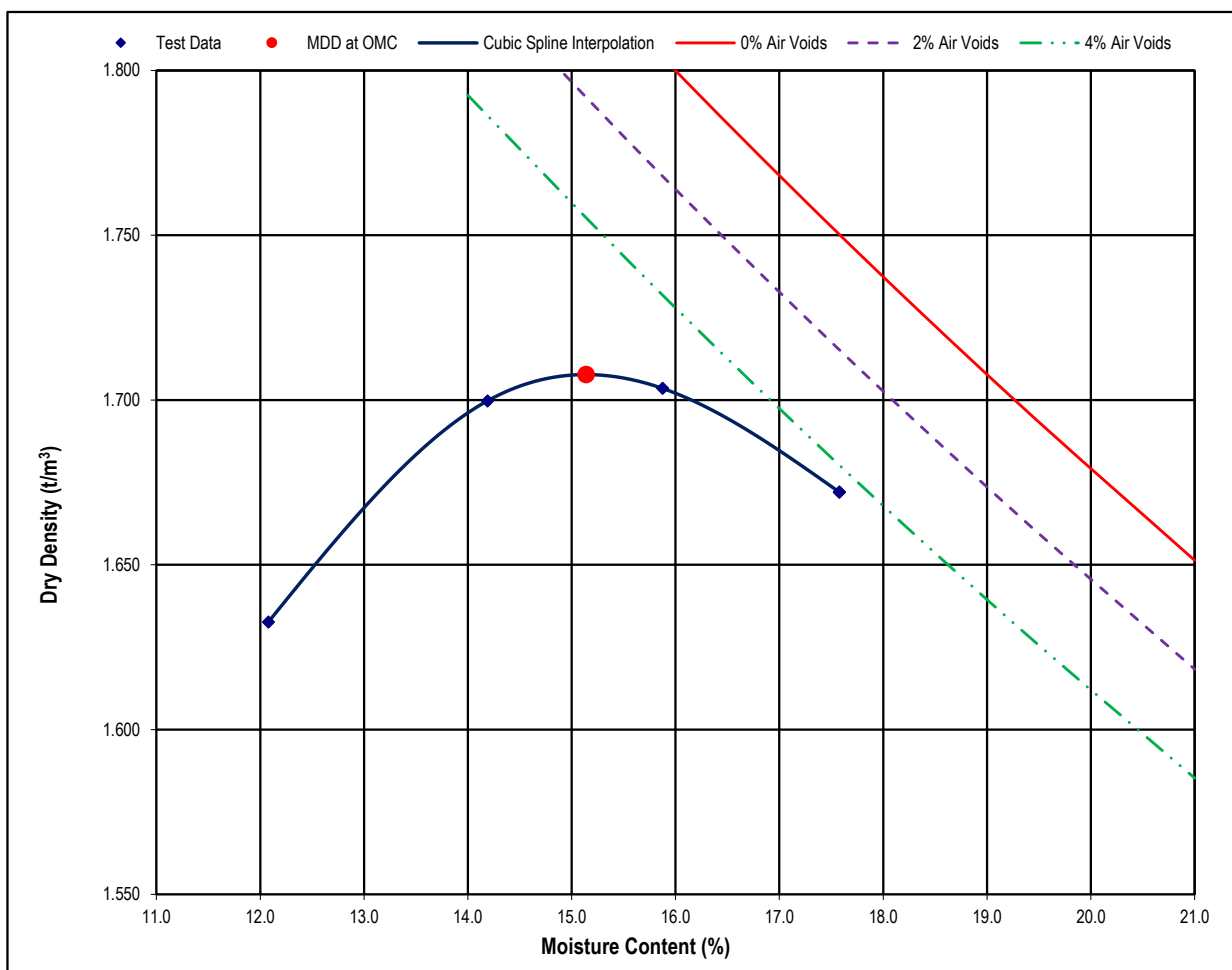
| <b>Client ID</b> | 3 - 2021044_C003 | <b>Depth (m)</b> | Not Supplied |

| <b>Description</b> | Sandy SILT - brown/white | | |

| <b>Maximum Dry Density (t/m<sup>3</sup>)</b> | 1.71 | <b>Optimum Moisture Content (%)</b> | 15.1 |
| <b>Moisture Content (%)</b> | 6.8 | <b>Percentage of Oversize/Sieve Size (mm)</b> | 0 / 19 |
