LADY LORETTA

## **Z-LLM-HSEC-PLN-Progressive Rehabilitation and Closure Plan**

| Project Name | Lady Loretta Mine |
| Document Title | Z-LLM-HSEC-PLN-Progressive Rehabilitation and Closure Plan |

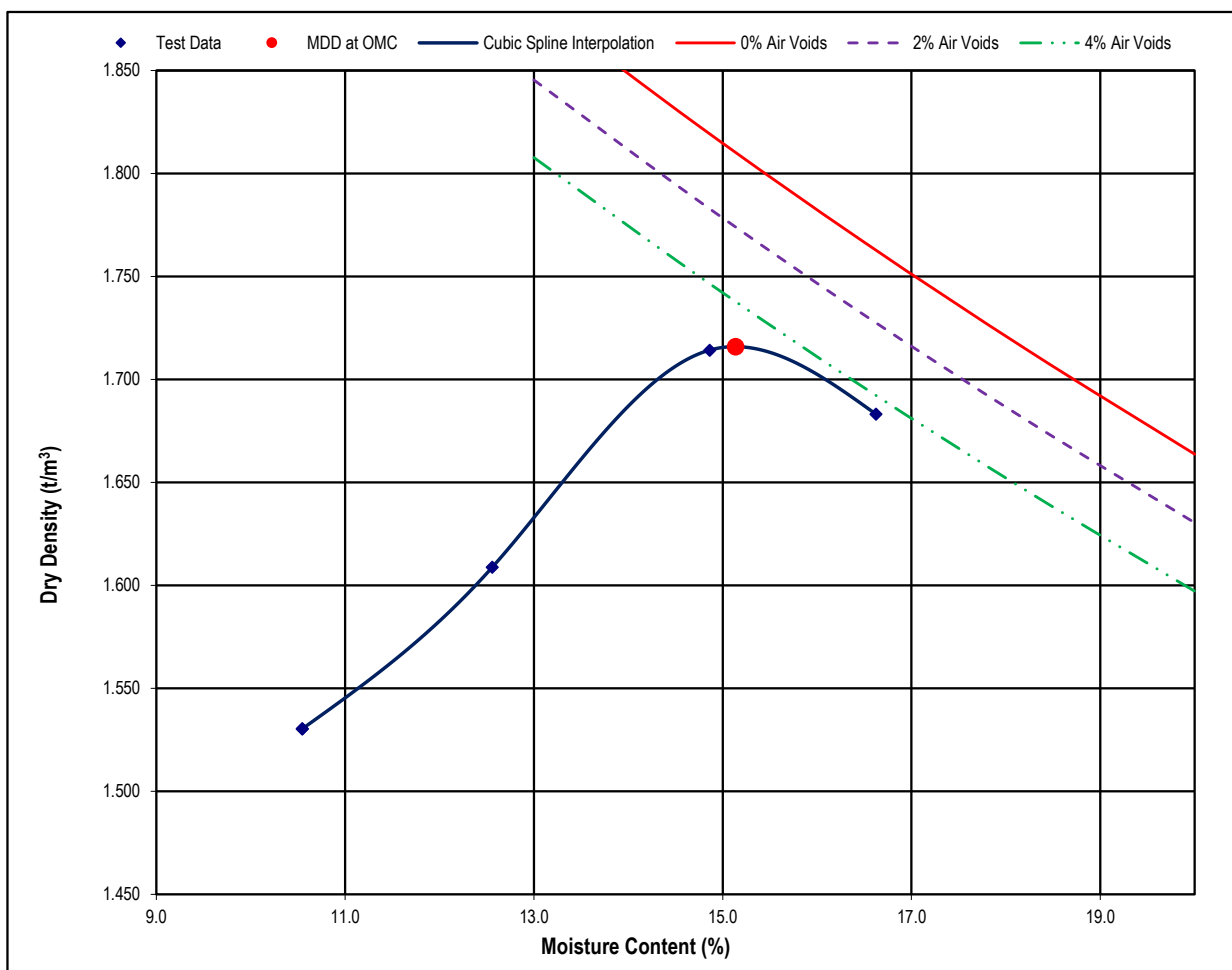
| <b>Client ID</b> | 4 - 2021044_C004 | <b>Depth (m)</b> | Not Supplied |

| <b>Description</b> | Sandy SILT - brown/white | | |

| <b>Maximum Dry Density (t/m³)</b> | 1.72 | <b>Optimum Moisture Content (%)</b> | 15.1 |
| <b>Moisture Content (%)</b> | 6.1 | <b>Percentage of Oversize/Sieve Size (mm)</b> | 0 / 19 |

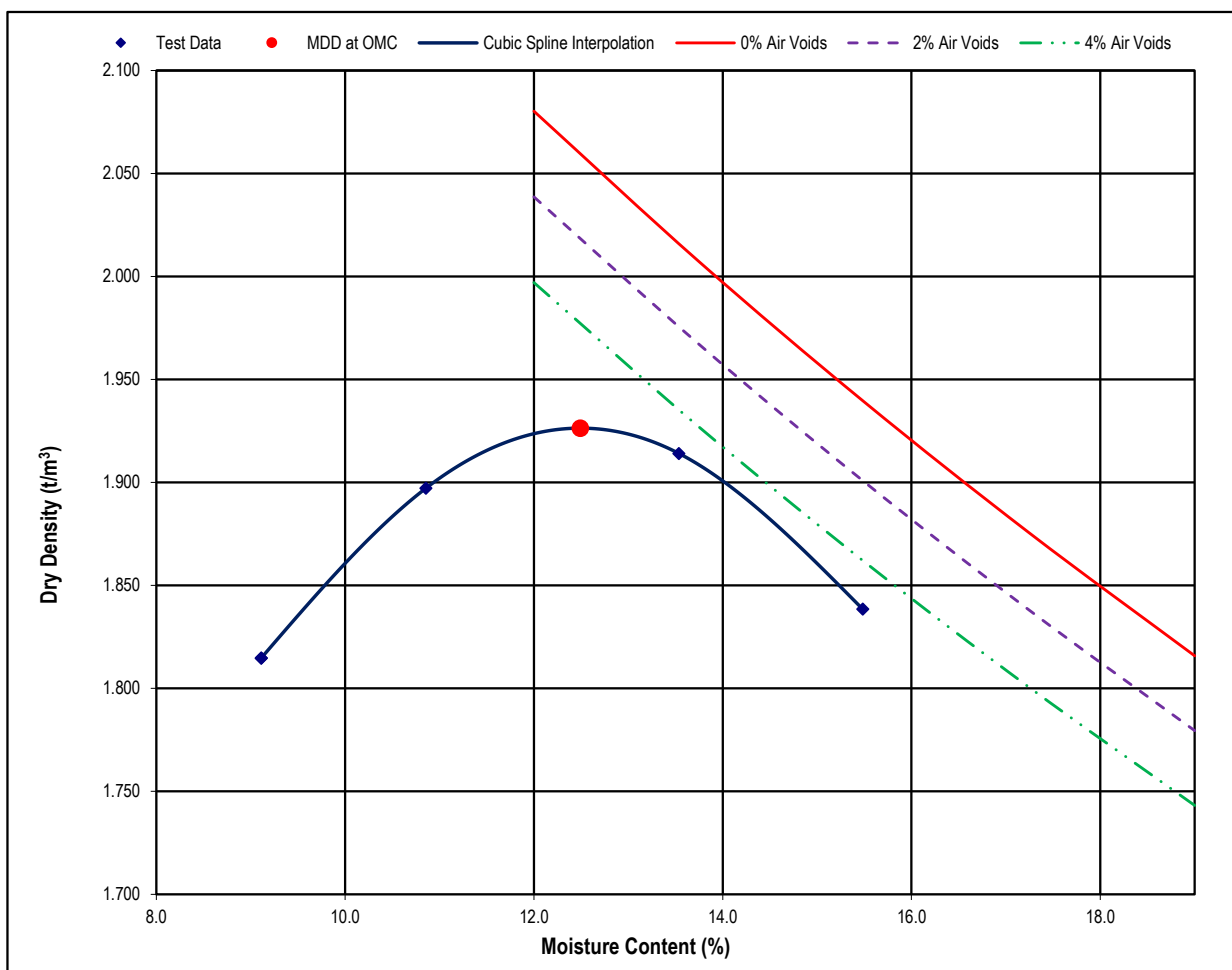
| <b>Client ID</b> | 5 - 2021044_C005 | <b>Depth (m)</b> | Not Supplied |

| <b>Description</b> | Gravelly Sandy CLAY - brown | | |

| <b>Maximum Dry Density (t/m³)</b> | 1.93 | <b>Optimum Moisture Content (%)</b> | 12.5 |
| <b>Moisture Content (%)</b> | 11.3 | <b>Percentage of Oversize/Sieve Size (mm)</b> | 2.0 / 19 |

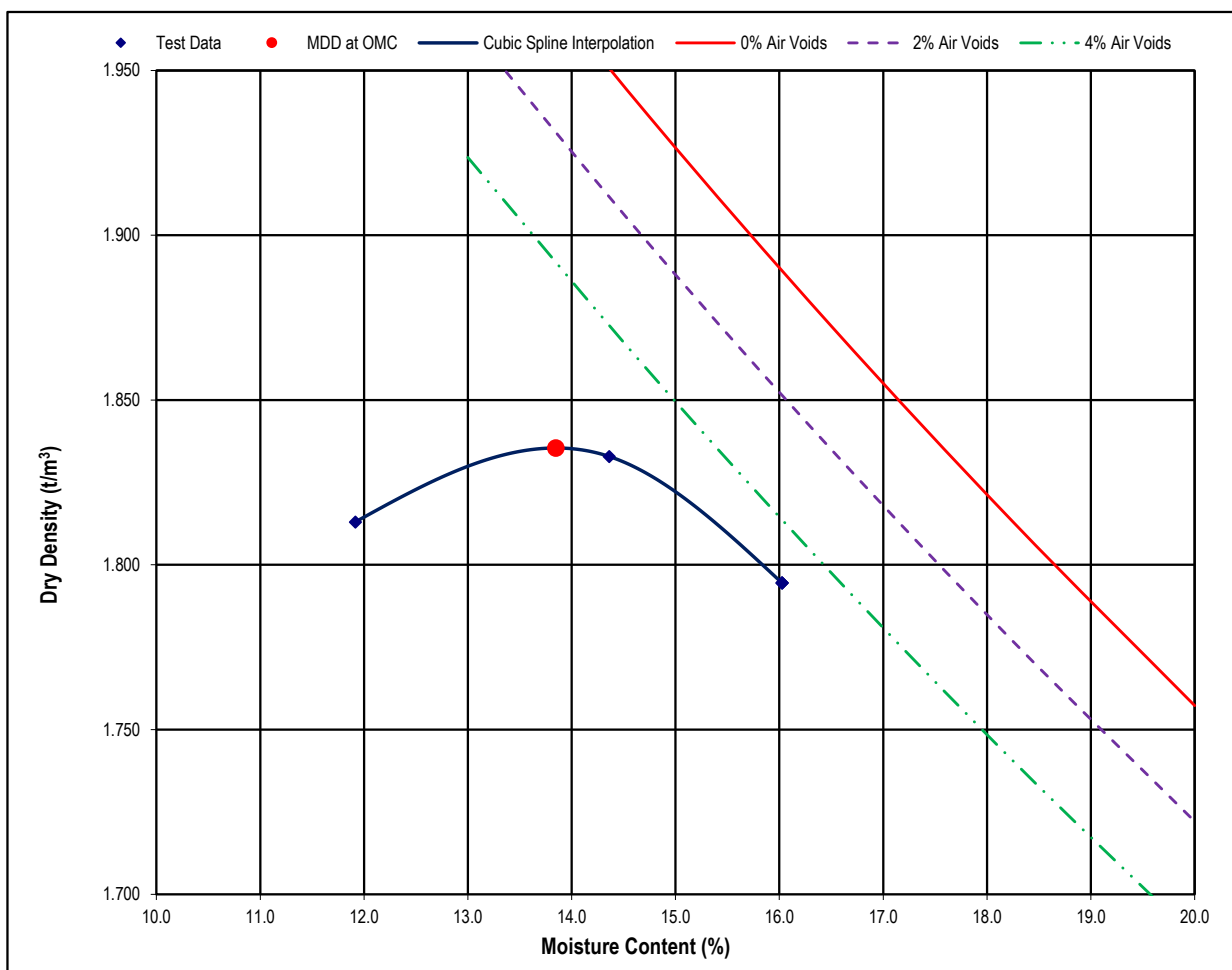
| <b>Client ID</b> | 6 - 2021044_C006 | <b>Depth (m)</b> | Not Supplied |

| <b>Description</b> | Silty CLAY with gravel - brown | | |

| <b>Maximum Dry Density (t/m³)</b> | 1.84 | <b>Optimum Moisture Content (%)</b> | 13.8 |
| <b>Moisture Content (%)</b> | 8.1 | <b>Percentage of Oversize/Sieve Size (mm)</b> | 2.0 / 19 |

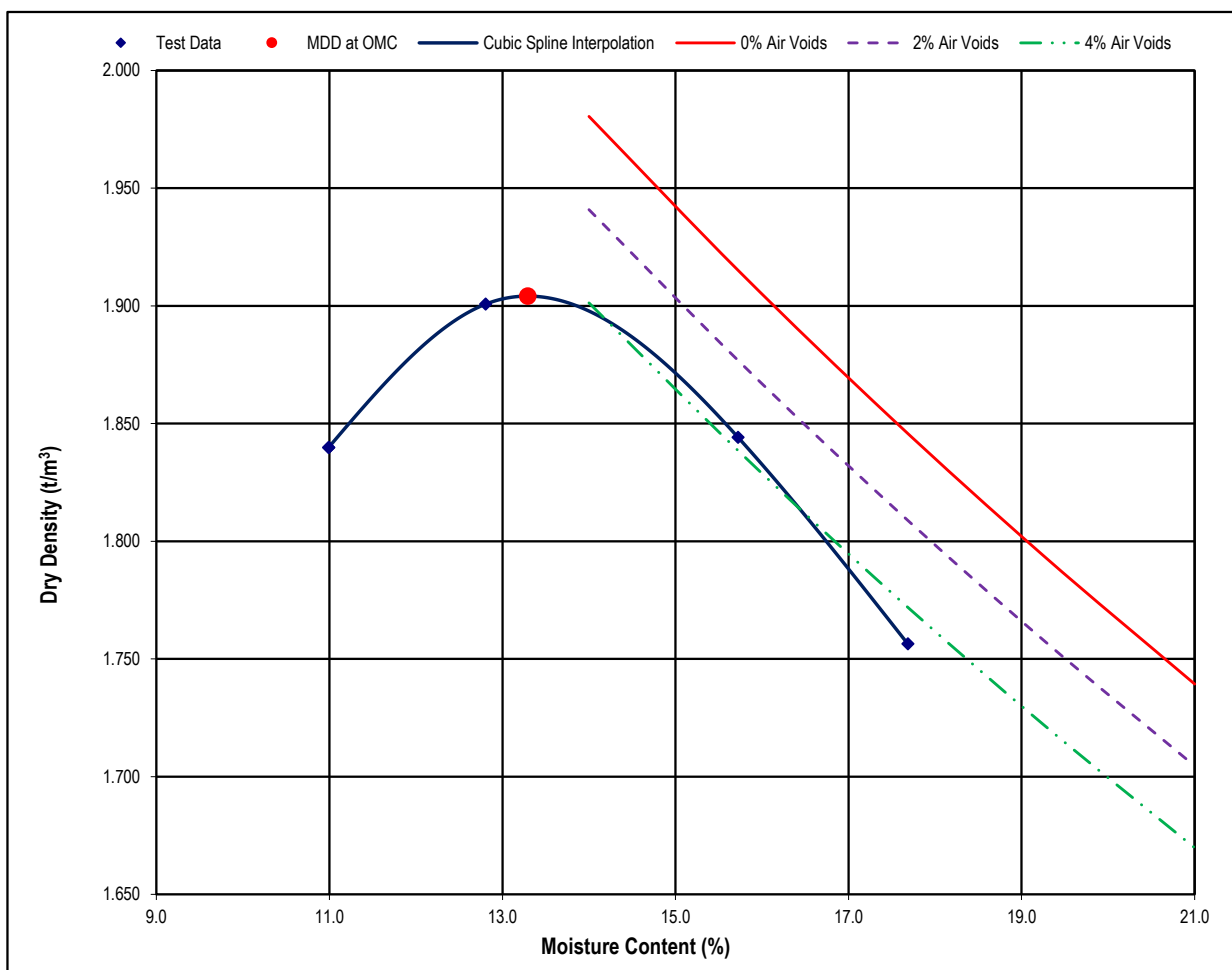
| <b>Client ID</b> | 8 - 2021044_C008 | <b>Depth (m)</b> | Not Supplied |

| <b>Description</b> | Silty CLAY trace gravel - brown | | |

| <b>Maximum Dry Density (t/m<sup>3</sup>)</b> | 1.90 | <b>Optimum Moisture Content (%)</b> | 13.3 |
| <b>Moisture Content (%)</b> | 10.7 | <b>Percentage of Oversize/Sieve Size (mm)</b> | 0 / 19 |

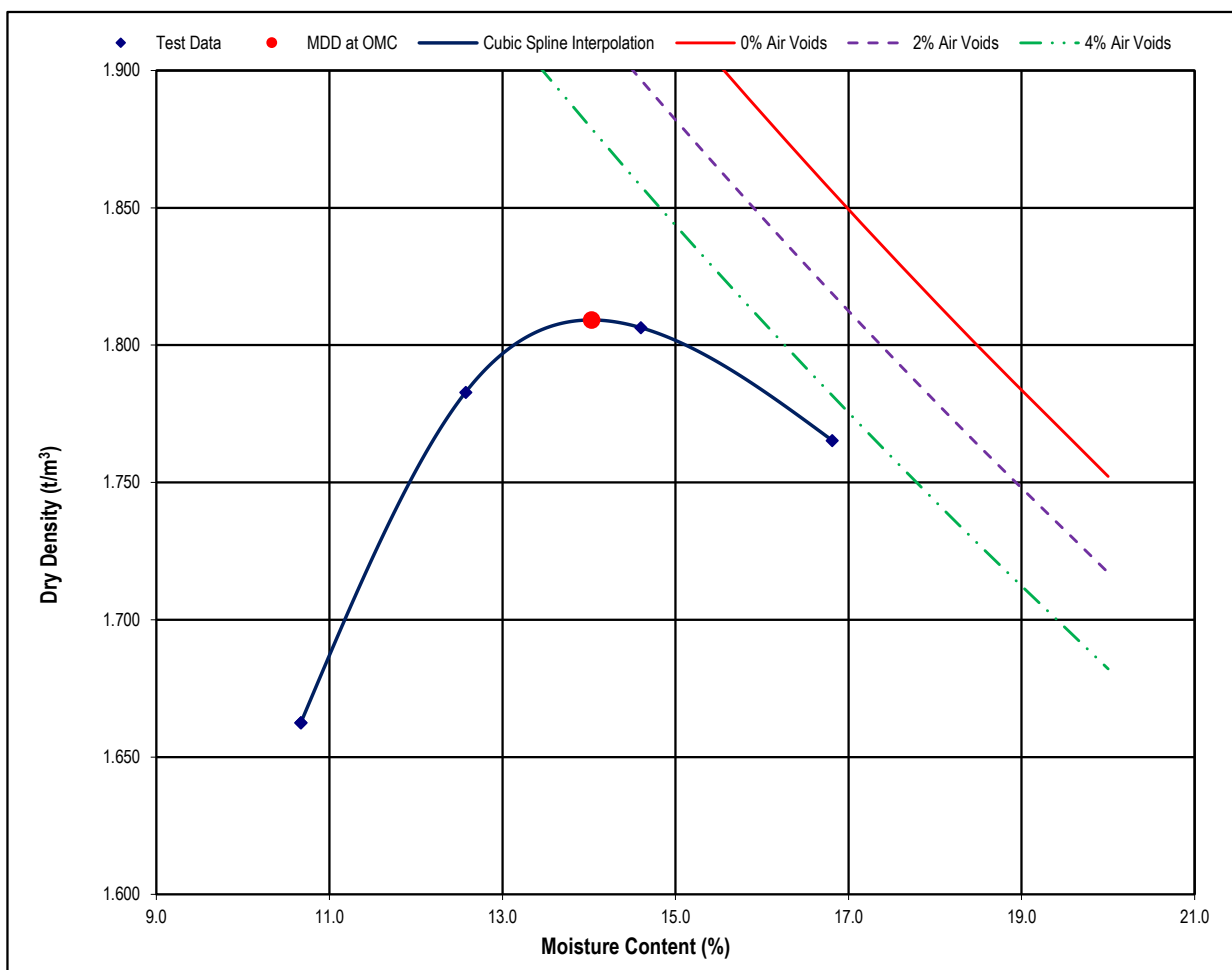
| <b>Client ID</b> | 9 - 2021044_C009 | <b>Depth (m)</b> | Not Supplied |

| <b>Description</b> | Gravelly Silty CLAY - brown | | |

| <b>Maximum Dry Density (t/m<sup>3</sup>)</b> | 1.81 | <b>Optimum Moisture Content (%)</b> | 14.0 |
| <b>Moisture Content (%)</b> | 8.3 | <b>Percentage of Oversize/Sieve Size (mm)</b> | 8.4 / 19 |

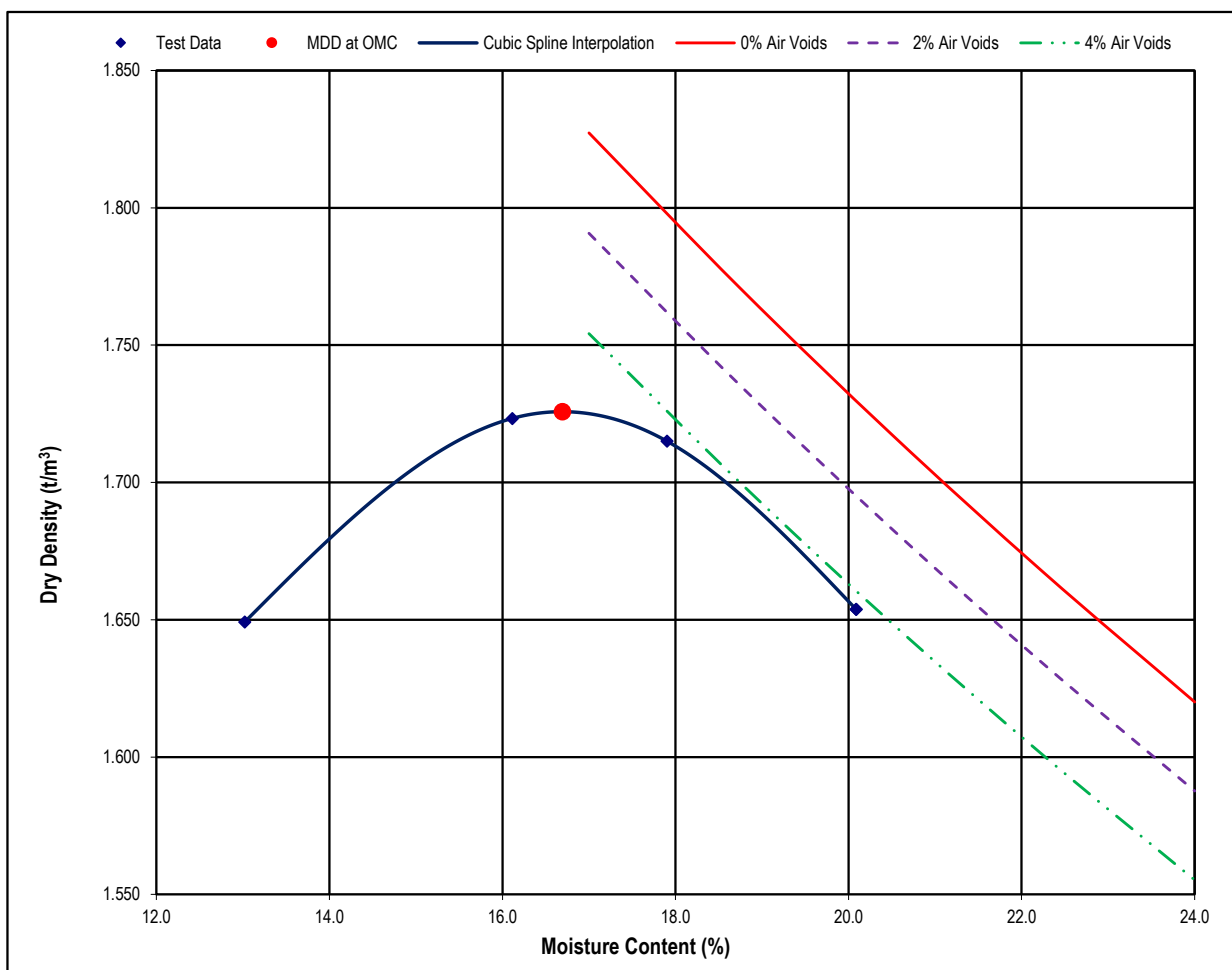
| <b>Client ID</b> | 10 - 2021044_C010 | <b>Depth (m)</b> | Not Supplied |

| <b>Description</b> | SILT trace gravel - pale brown | | |

| <b>Maximum Dry Density (t/m<sup>3</sup>)</b> | 1.73 | <b>Optimum Moisture Content (%)</b> | 16.7 |
| <b>Moisture Content (%)</b> | 4.3 | <b>Percentage of Oversize/Sieve Size (mm)</b> | 31.0 / 19 |

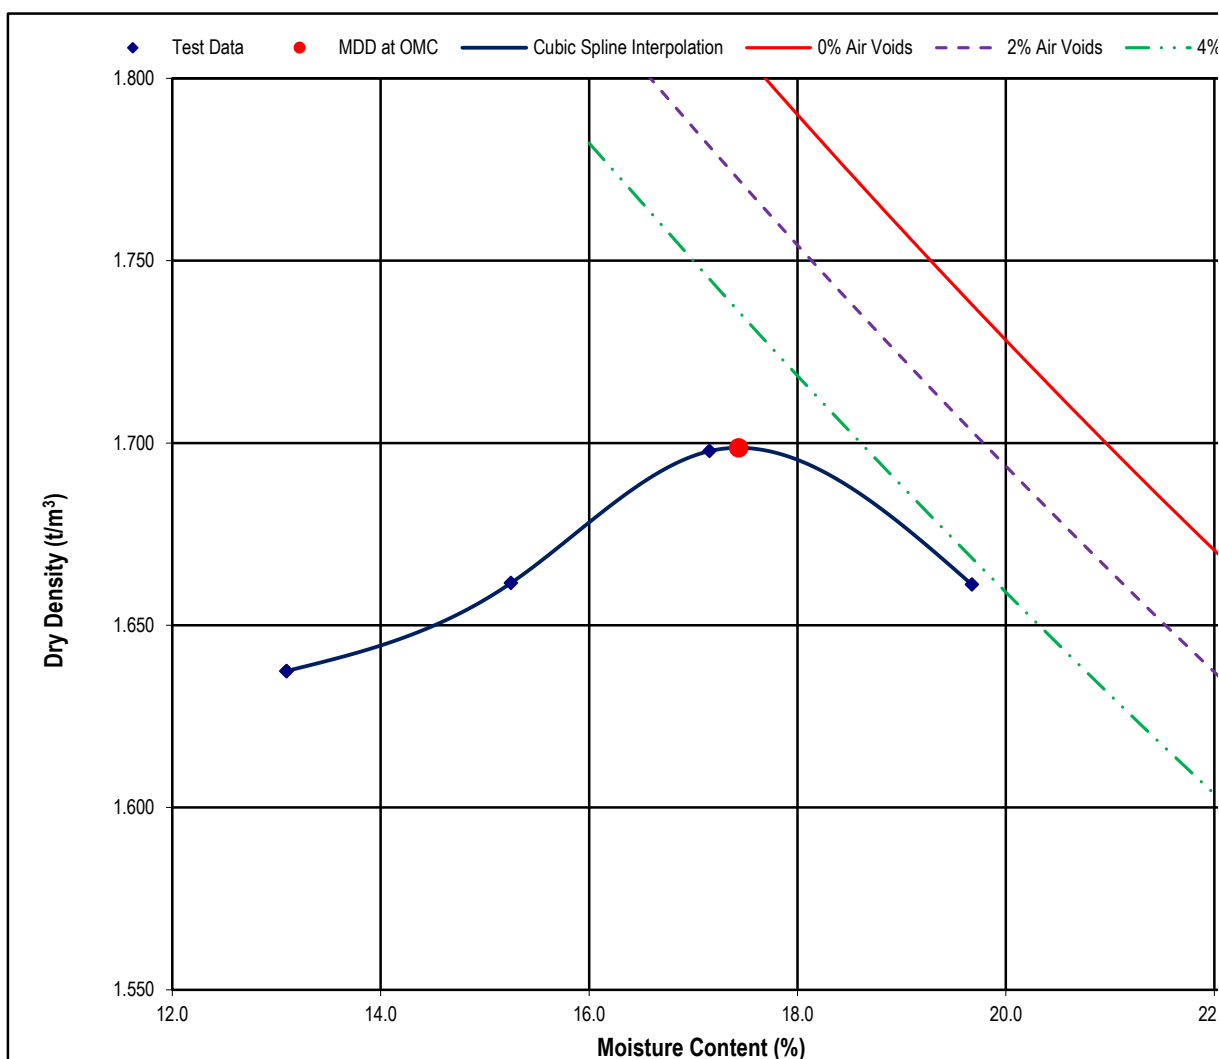
| <b>Client ID</b> | 11 - 2021044_C011 | <b>Report Date</b> |

| <b>Description</b> | SILT with gravel - brown | |

| <b>Maximum Dry Density (t/m³)</b> | 1.70 | <b>Optimum Moisture Content (%)</b> |
| <b>Moisture Content (%)</b> | 5.4 | <b>Percentage of Oversize/Sieve Size (mm)</b> |

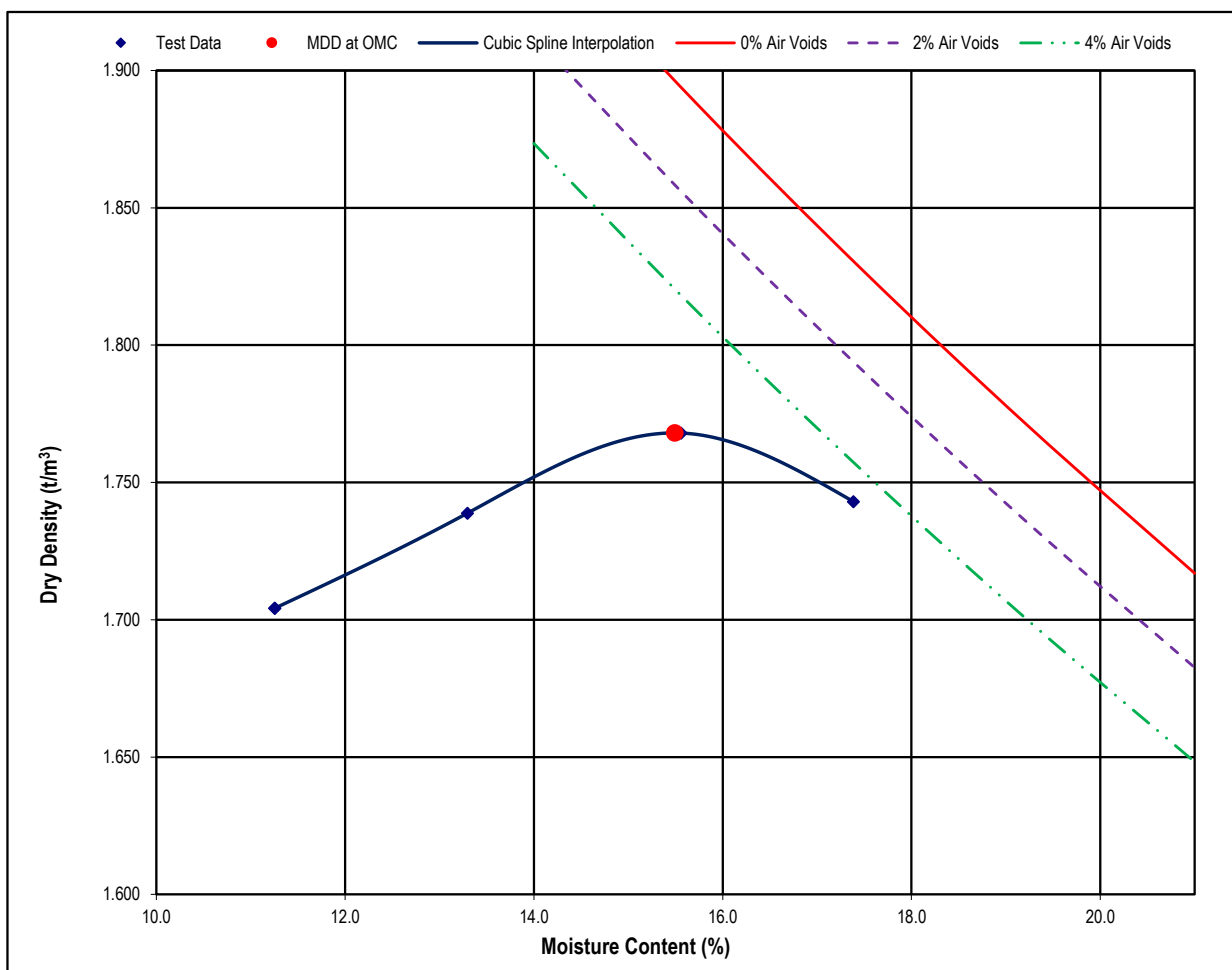
| <b>Client ID</b> | 12 - 2021044_C012 | <b>Depth (m)</b> | Not Supplied |

| <b>Description</b> | Gravelly SILT - brown | | |

| <b>Maximum Dry Density (t/m<sup>3</sup>)</b> | 1.77 | <b>Optimum Moisture Content (%)</b> | 15.5 |
| <b>Moisture Content (%)</b> | 7.4 | <b>Percentage of Oversize/Sieve Size (mm)</b> | 14.0 / 19 |

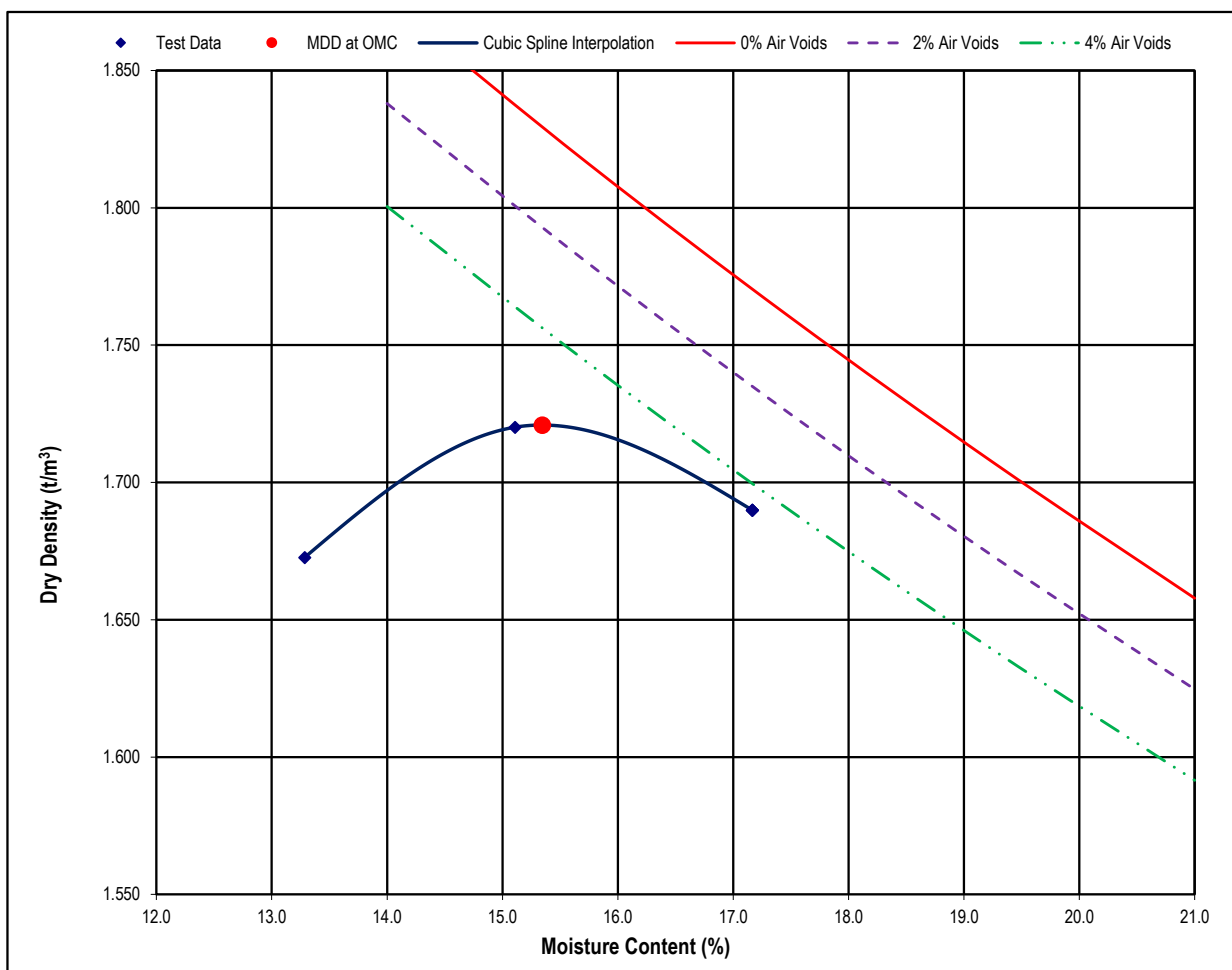
| <b>Client ID</b> | 15 - 2021044_C015 | <b>Depth (m)</b> | Not Supplied |

| <b>Description</b> | Gravelly SILT - brown | | |

| <b>Maximum Dry Density (t/m<sup>3</sup>)</b> | 1.72 | <b>Optimum Moisture Content (%)</b> | 15.3 |
| <b>Moisture Content (%)</b> | 5.8 | <b>Percentage of Oversize/Sieve Size (mm)</b> | 11.0 / 19 |

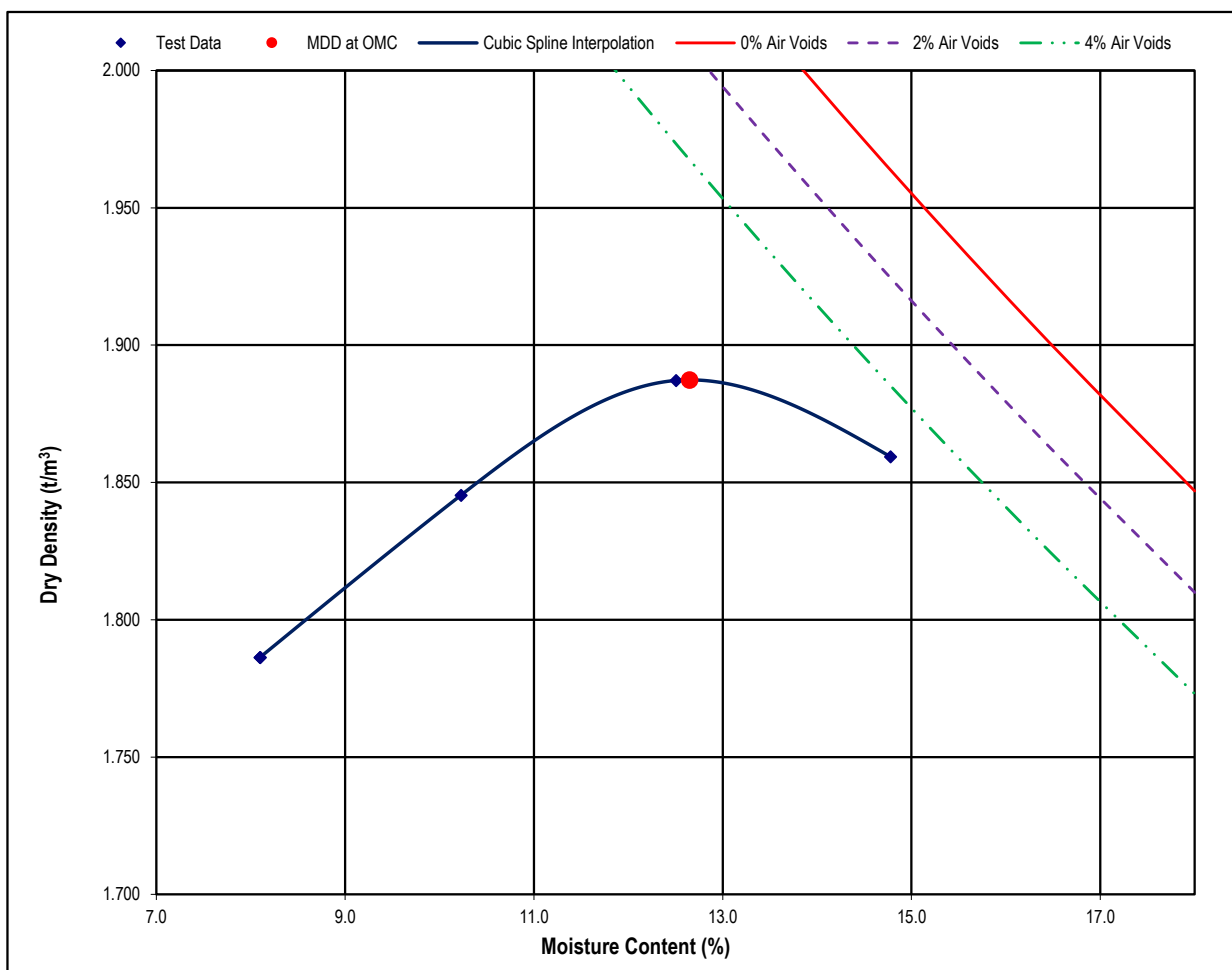
| <b>Client ID</b> | 18 - 2021044_C018 | <b>Depth (m)</b> | Not Supplied |

| <b>Description</b> | Gravelly SILT - brown | | |

| <b>Maximum Dry Density (t/m³)</b> | 1.89 | <b>Optimum Moisture Content (%)</b> | 12.6 |
| <b>Moisture Content (%)</b> | 8.3 | <b>Percentage of Oversize/Sieve Size (mm)</b> | 8.4 / 19 |

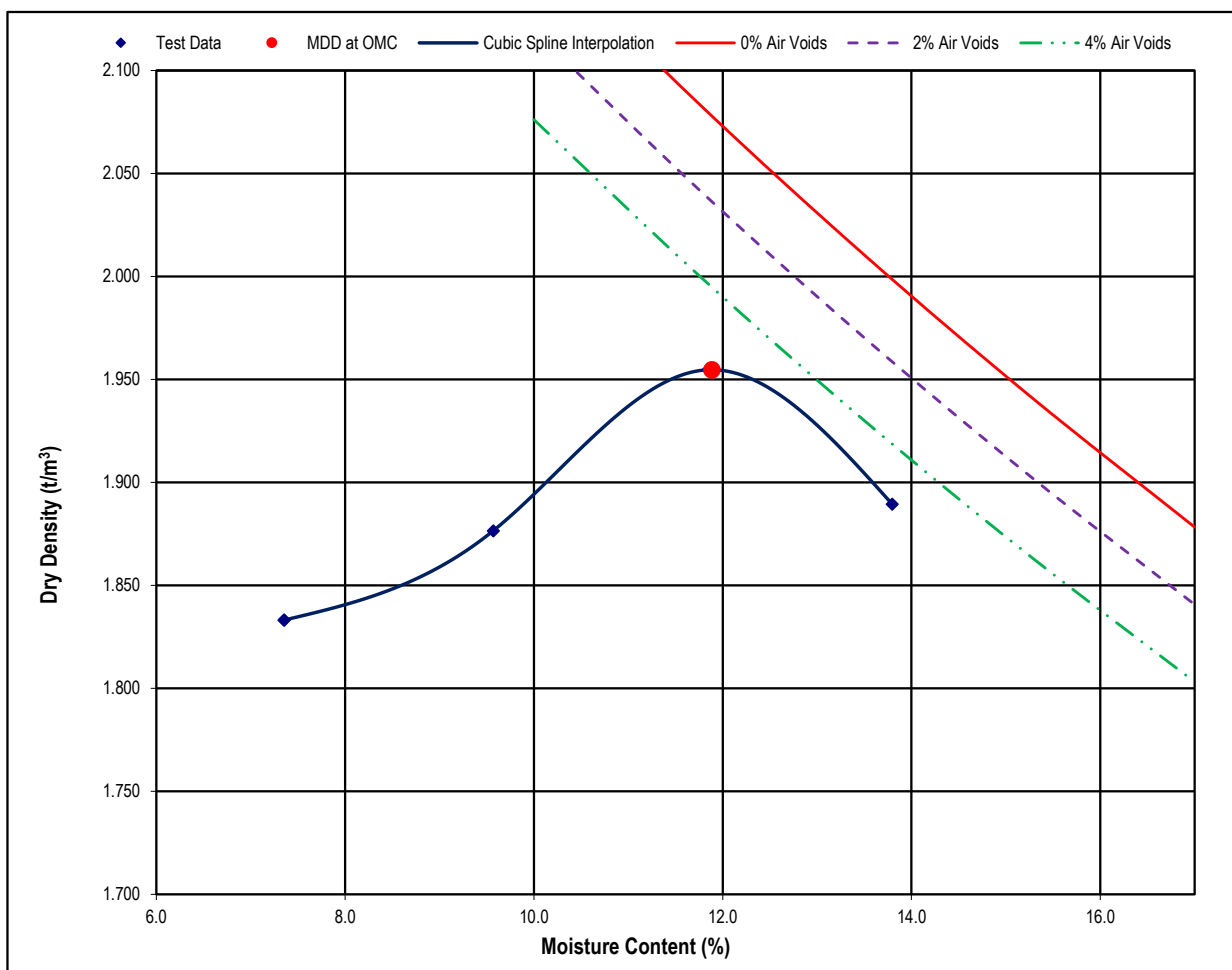
| <b>Client ID</b> | 22 - 2021044_C022 | <b>Depth (m)</b> | Not Supplied |

| <b>Description</b> | Gravelly SILT - brown | | |

| <b>Maximum Dry Density (t/m<sup>3</sup>)</b> | 1.95 | <b>Optimum Moisture Content (%)</b> | 11.9 |
| <b>Moisture Content (%)</b> | 6.2 | <b>Percentage of Oversize/Sieve Size (mm)</b> | 13 / 19 |

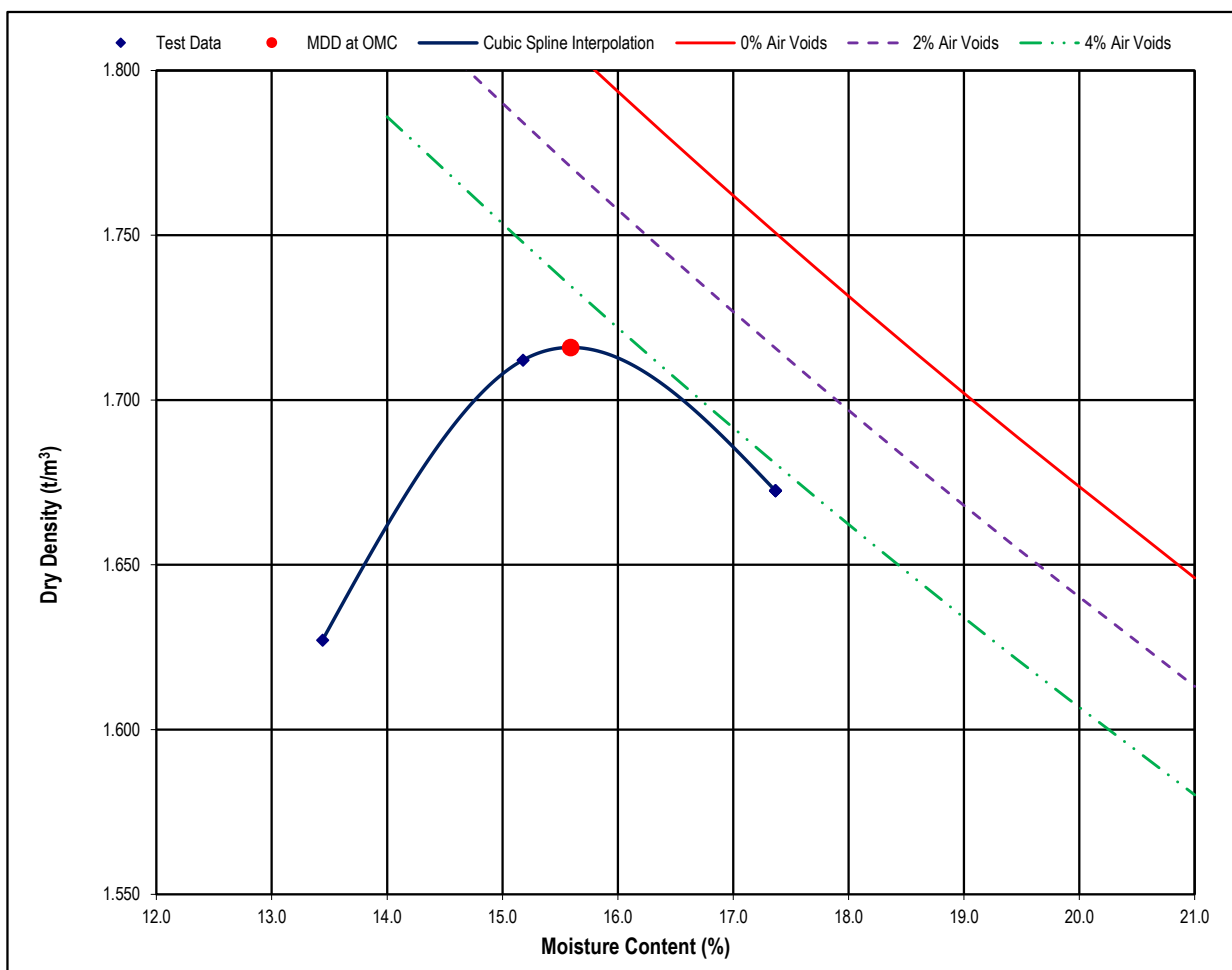
| <b>Client ID</b> | 23 - 2021044_C023 | <b>Depth (m)</b> | Not Supplied |

| <b>Description</b> | Gravelly SILT - brown | | |

| <b>Maximum Dry Density (t/m³)</b> | 1.72 | <b>Optimum Moisture Content (%)</b> | 15.6 |
| <b>Moisture Content (%)</b> | 9.0 | <b>Percentage of Oversize/Sieve Size (mm)</b> | 14 / 19 |

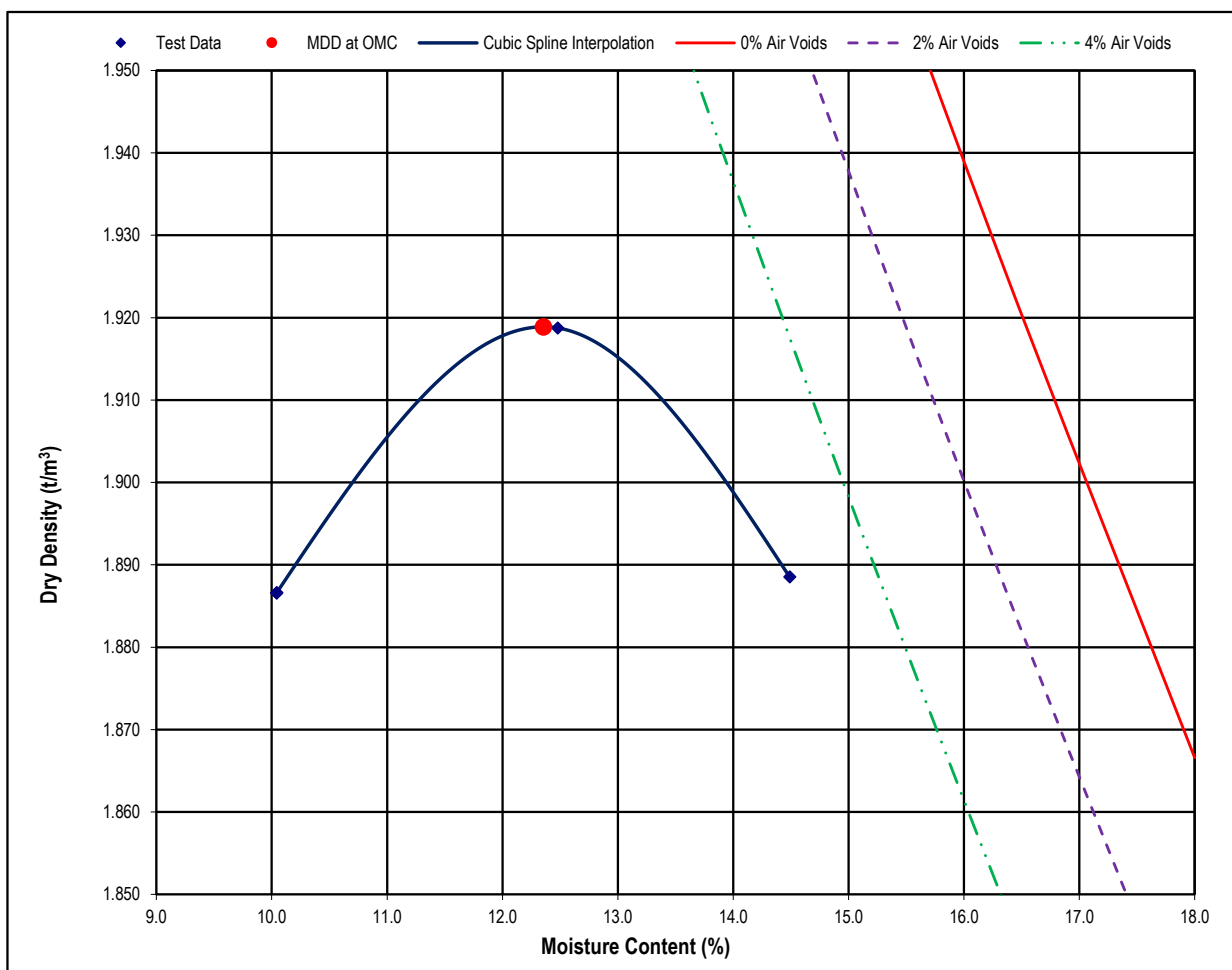
| <b>Client ID</b> | 24 - 2021044_C024 | <b>Depth (m)</b> | Not Supplied |

| <b>Description</b> | SILT with gravel - brown | | |

| <b>Maximum Dry Density (t/m³)</b> | 1.92 | <b>Optimum Moisture Content (%)</b> | 12.4 |
| <b>Moisture Content (%)</b> | 9.3 | <b>Percentage of Oversize/Sieve Size (mm)</b> | 3.0 / 19 |

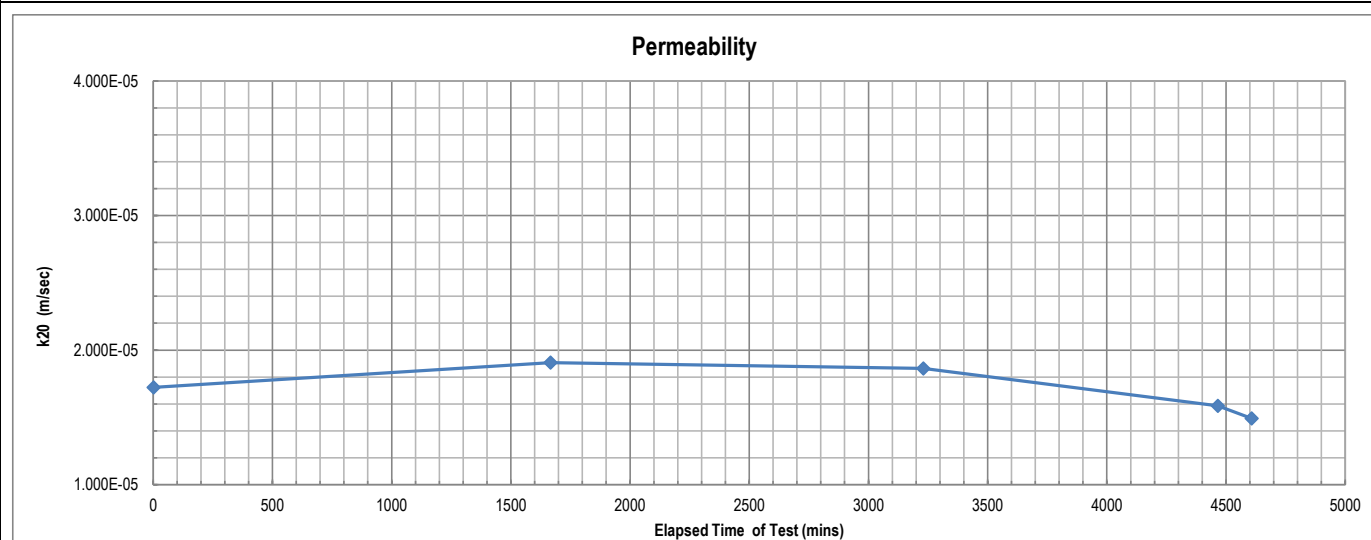
**PERMEABILITY**  $k_{(20)} = 1.5 \times 10^{-05}$  (m/sec)

**Remarks:** The above specimen was remoulded to a target of 90% of Standard Maximum Dry Density and at Optimum Moisture Content.

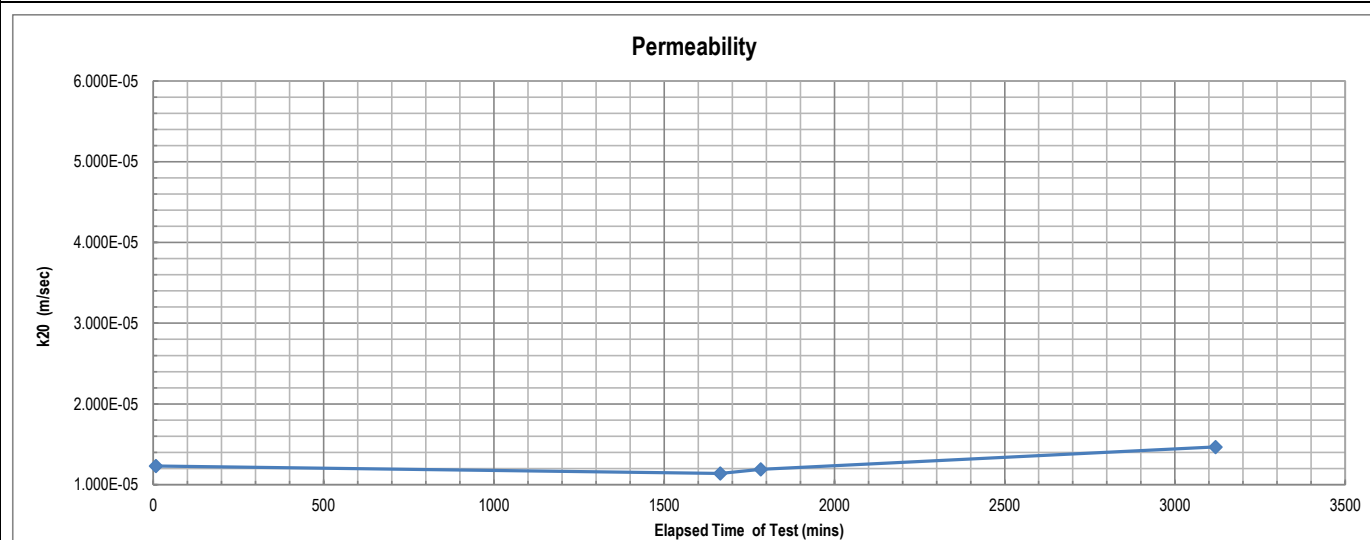
**PERMEABILITY**  $k_{(20)} = 1.5 \times 10^{-05}$  (m/sec)

**Remarks:** The above specimen was remoulded to a target of 90% of Standard Maximum Dry Density and at Optimum Moisture Content.

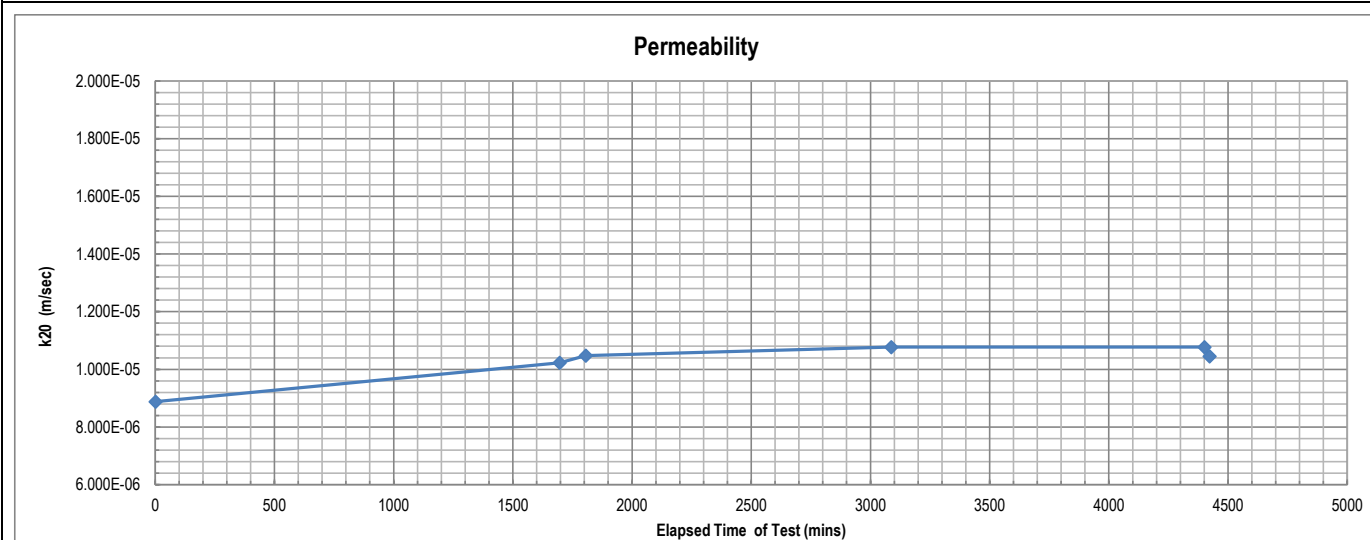
**PERMEABILITY**  $k_{(20)} = 1.1 \times 10^{-05}$  (m/sec)

**Remarks:** The above specimen was remoulded to a target of 90% of Standard Maximum Dry Density and at Optimum Moisture Content.

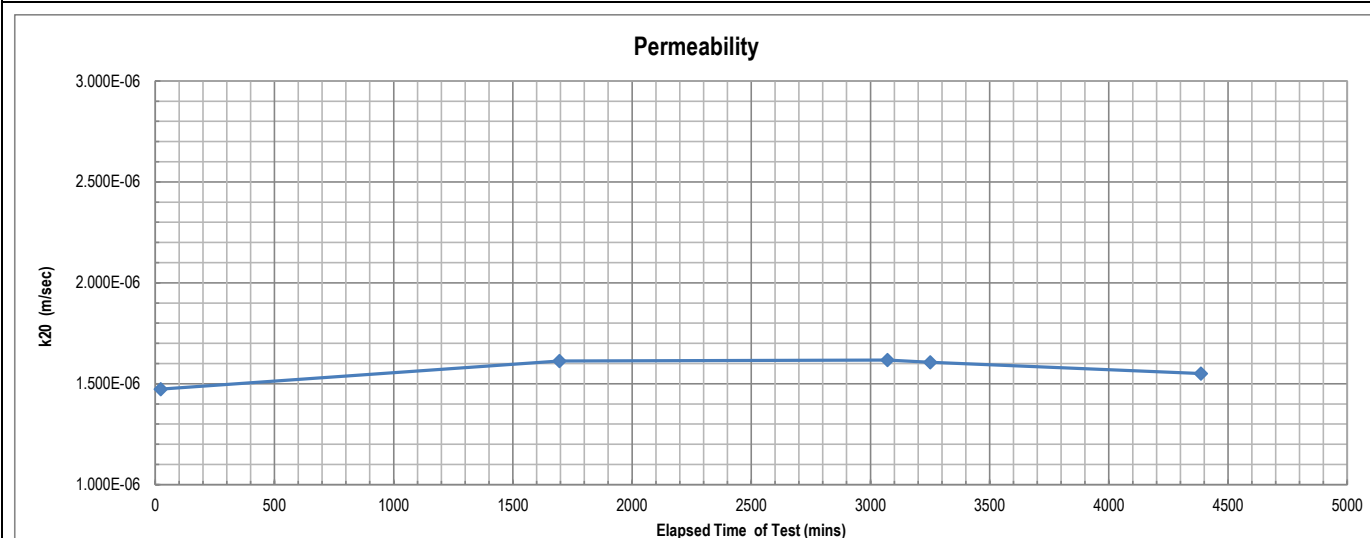
**PERMEABILITY**  $k_{(20)} = 1.6 \times 10^{-06}$  (m/sec)

**Remarks:** The above specimen was remoulded to a target of 90% of Standard Maximum Dry Density and at Optimum Moisture Content.

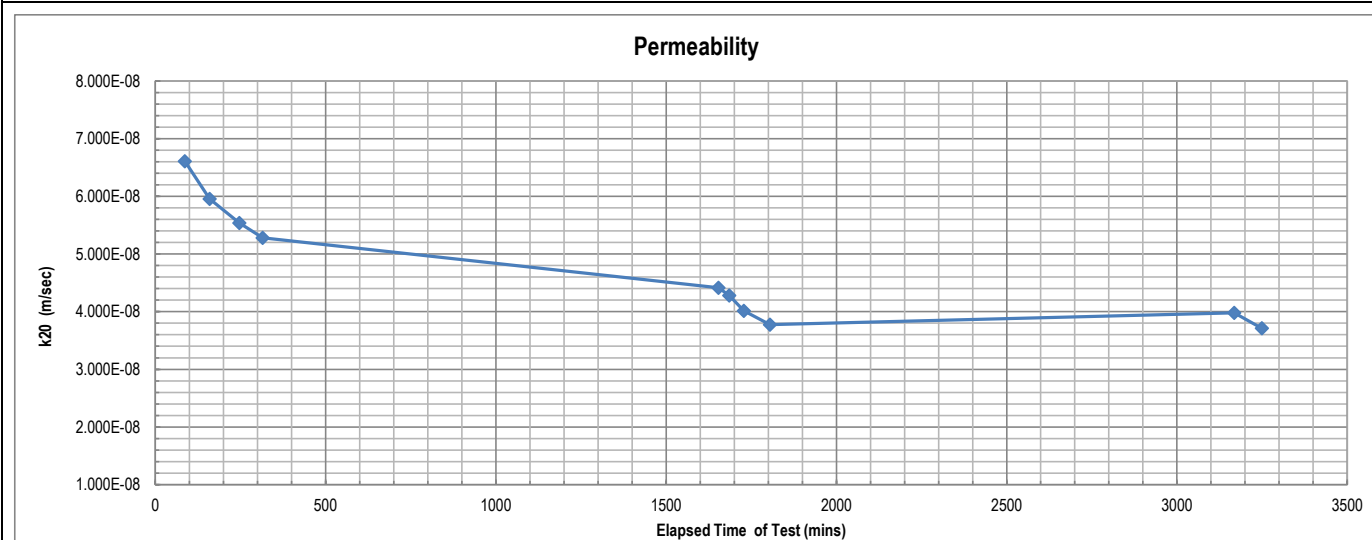
**PERMEABILITY**  $k_{(20)} = 3.8 \times 10^{-08}$  (m/sec)

**Remarks:** The above specimen was remoulded to a target of 90% of Standard Maximum Dry Density and at Optimum Moisture Content.

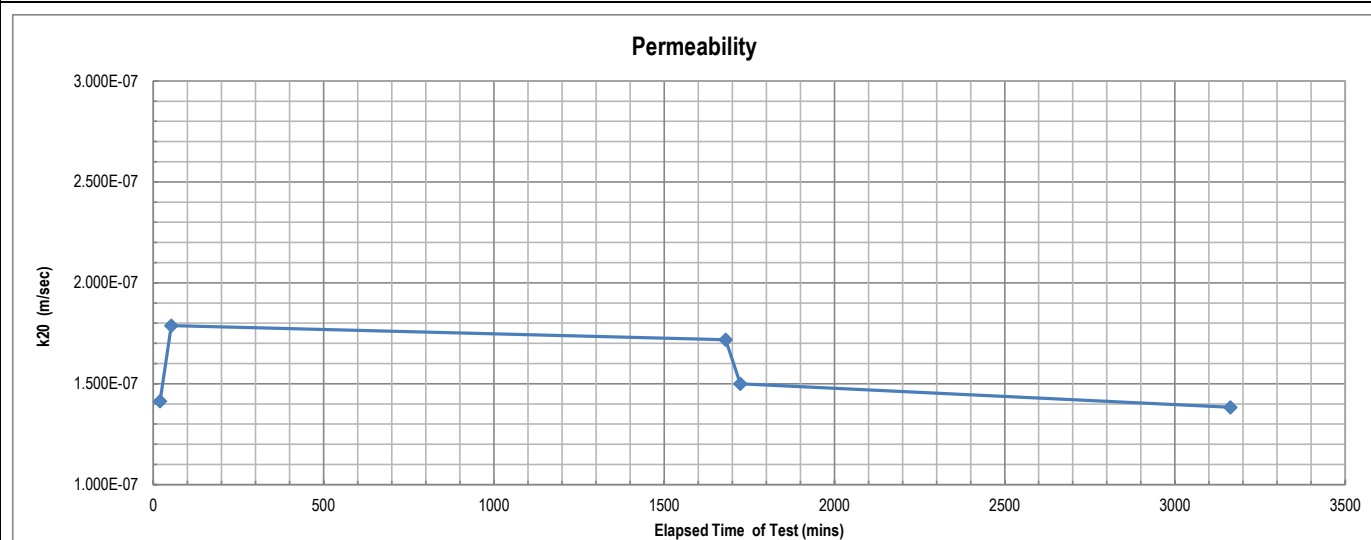
**PERMEABILITY**  $k_{(20)} = 1.4 \times 10^{-07}$  (m/sec)

**Remarks:** The above specimen was remoulded to a target of 90% of Standard Maximum Dry Density and at Optimum Moisture Content.

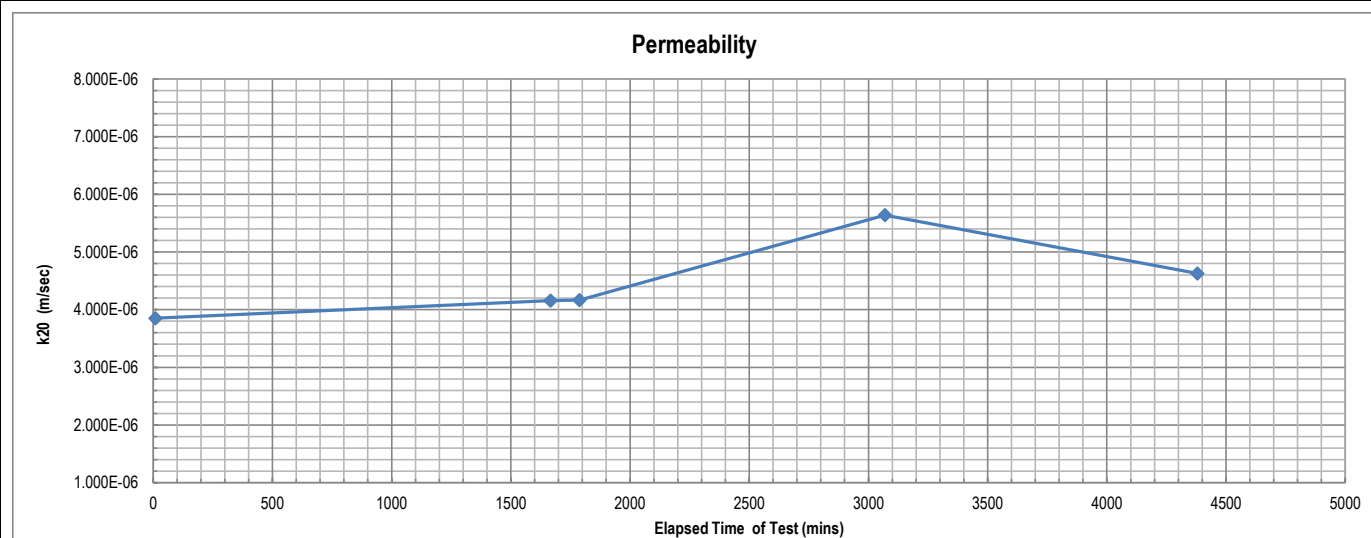
**PERMEABILITY**  $k_{(20)} = 4.6 \times 10^{-06}$  (m/sec)

**Remarks:** The above specimen was remoulded to a target of 90% of Standard Maximum Dry Density and at Optimum Moisture Content.

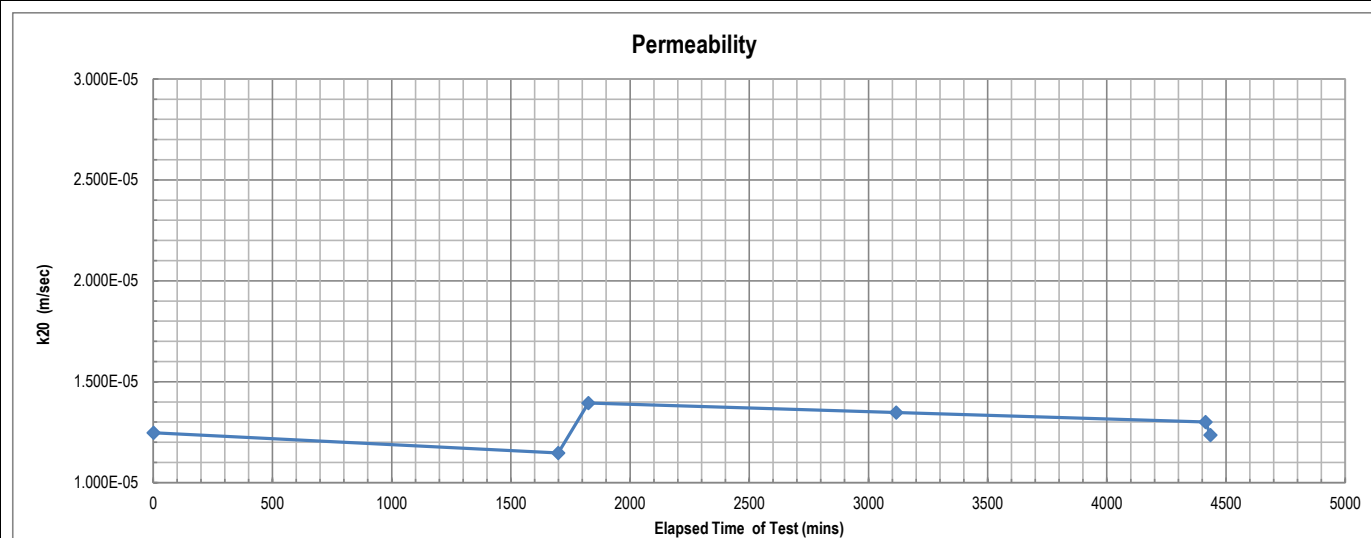
**PERMEABILITY**  $k_{(20)} = 1.3 \times 10^{-05}$  (m/sec)

**Remarks:** The above specimen was remoulded to a target of 90% of Standard Maximum Dry Density and at Optimum Moisture Content.
