LADY LORETTA

## **Z-LLM-HSEC-PLN-Progressive Rehabilitation and Closure Plan**

| Project Name | Lady Loretta Mine |
| Document Title | Z-LLM-HSEC-PLN-Progressive Rehabilitation and Closure Plan |

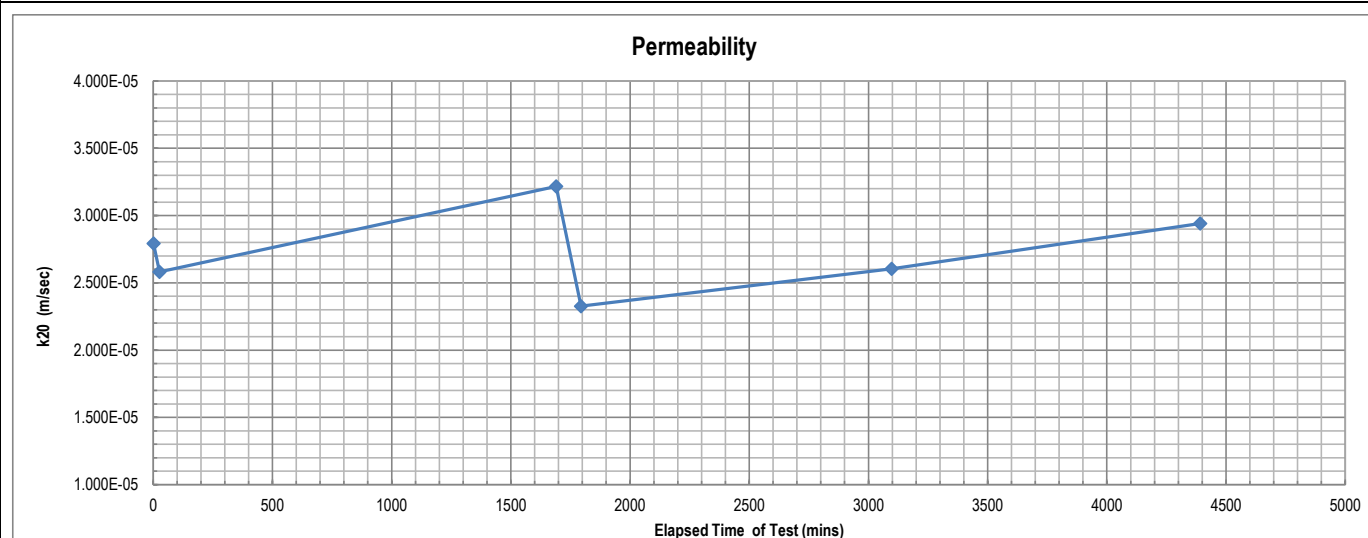
**PERMEABILITY**  $k_{(20)} = 2.9 \times 10^{-05}$  (m/sec)

**Remarks:** The above specimen was remoulded to a target of 90% of Standard Maximum Dry Density and at Optimum Moisture Content.

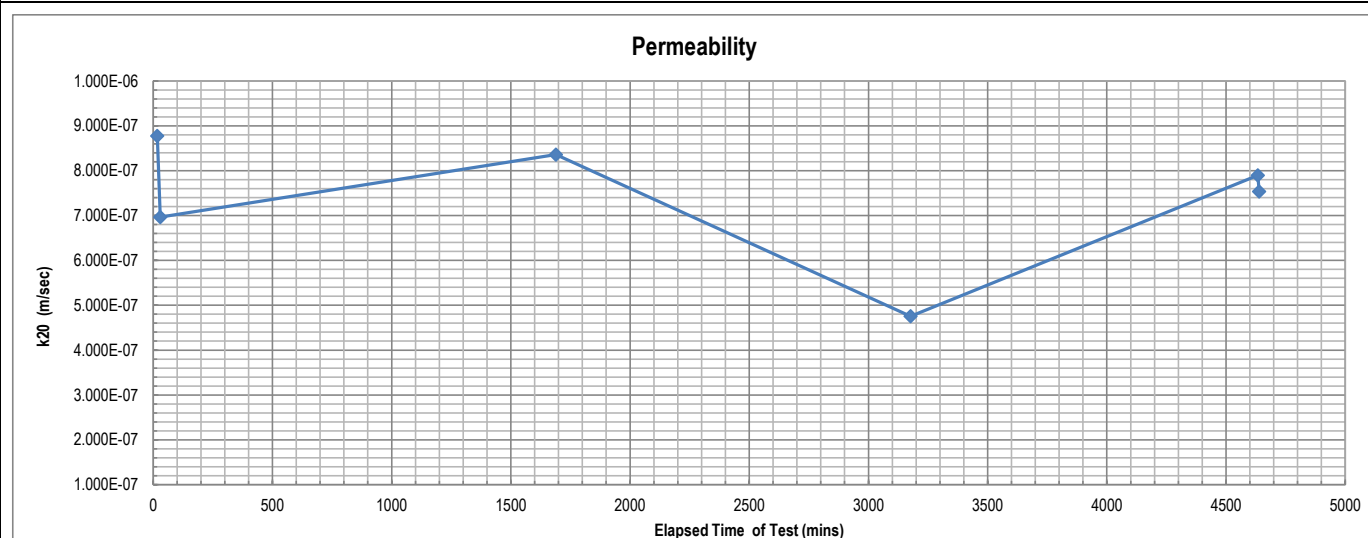
**PERMEABILITY**  $k_{(20)} = 7.7 \times 10^{-07}$  (m/sec)

**Remarks:** The above specimen was remoulded to a target of 90% of Standard Maximum Dry Density and at Optimum Moisture Content.

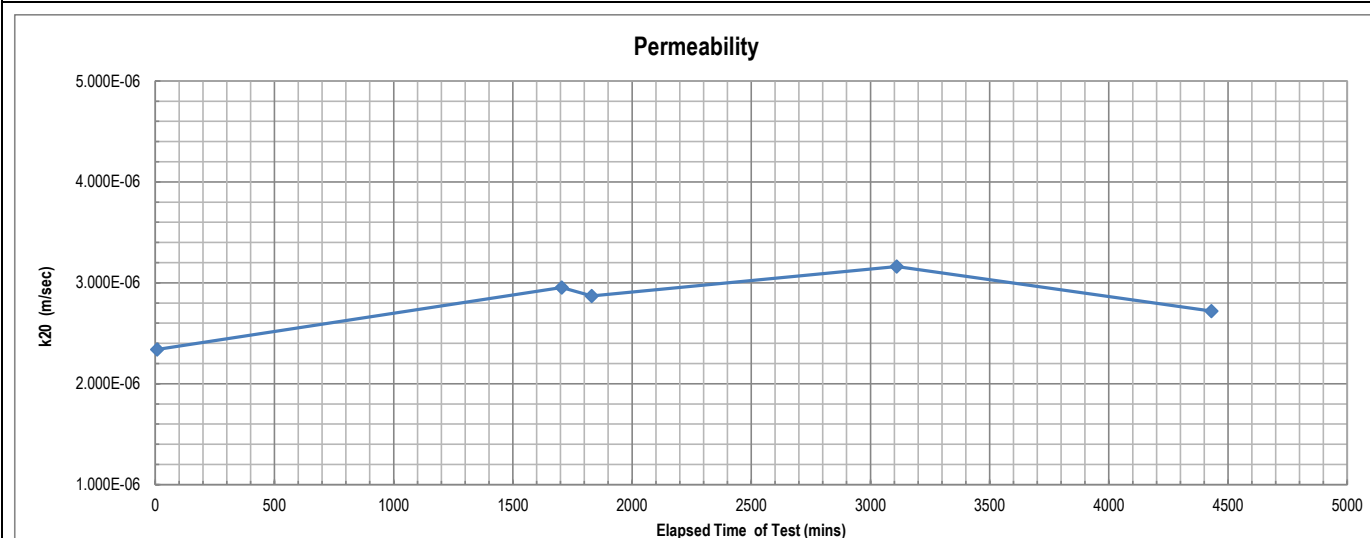
**PERMEABILITY**  $k_{(20)} = 2.7 \times 10^{-06}$  (m/sec)

**Remarks:** The above specimen was remoulded to a target of 90% of Standard Maximum Dry Density and at Optimum Moisture Content.

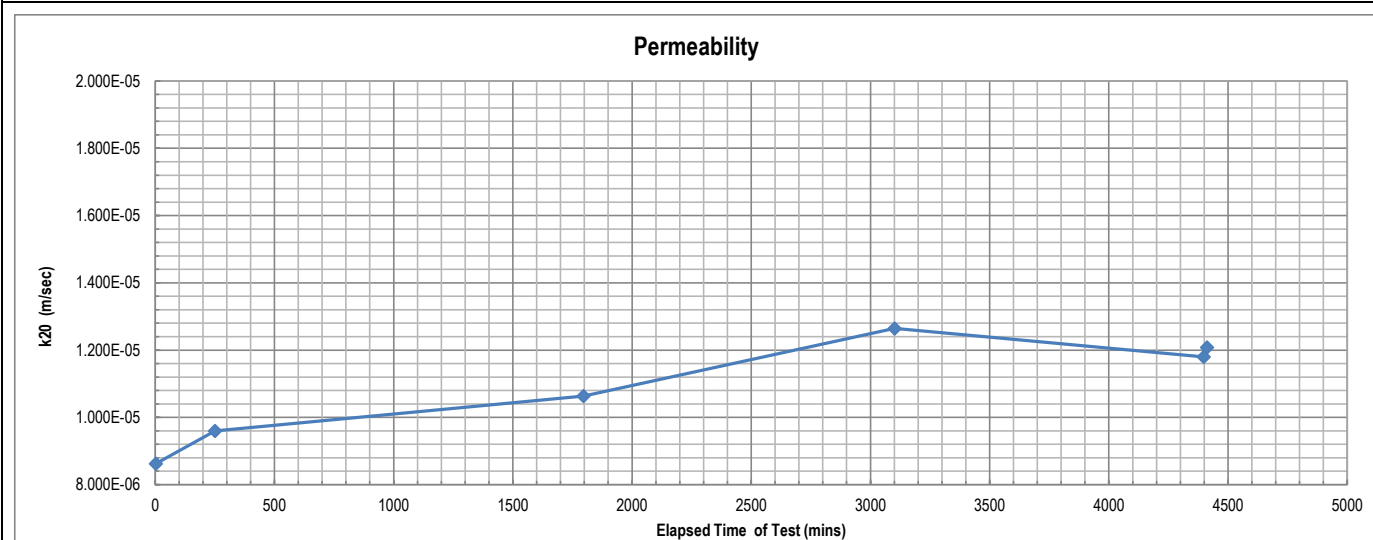
**PERMEABILITY**  $k_{(20)} = 1.2 \times 10^{-05}$  (m/sec)

**Remarks:** The above specimen was remoulded to a target of 90% of Standard Maximum Dry Density and at Optimum Moisture Content.

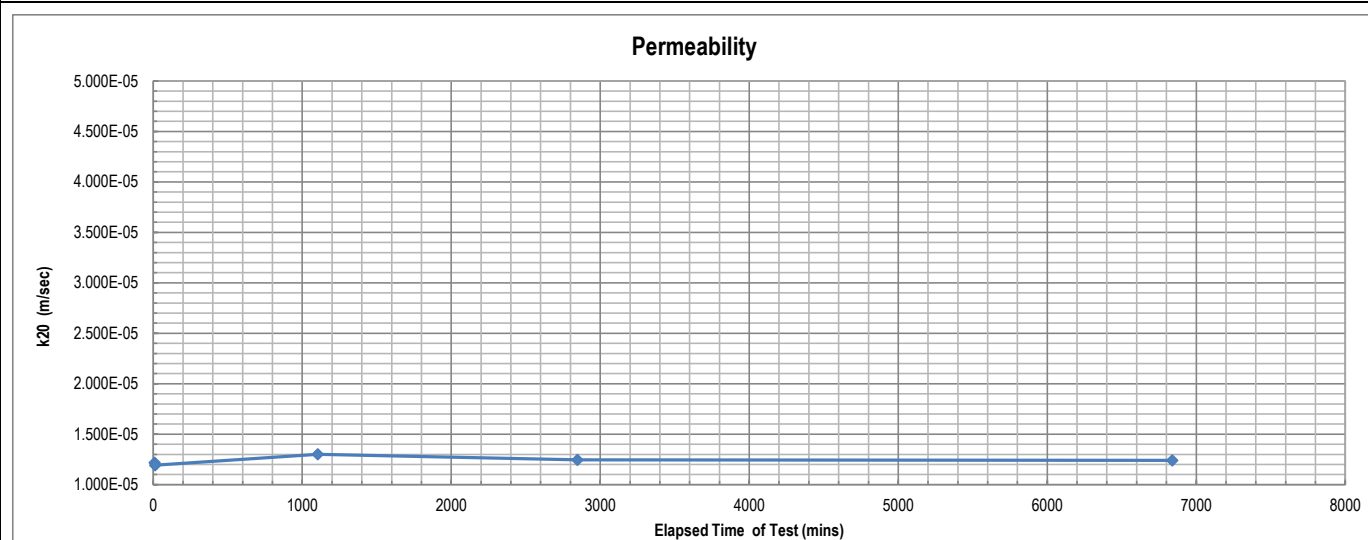
**PERMEABILITY**  $k_{(20)} = 1.2 \times 10^{-05}$  (m/sec)

**Remarks:** The above specimen was remoulded to a target of 90% of Standard Maximum Dry Density and at Optimum Moisture Content.

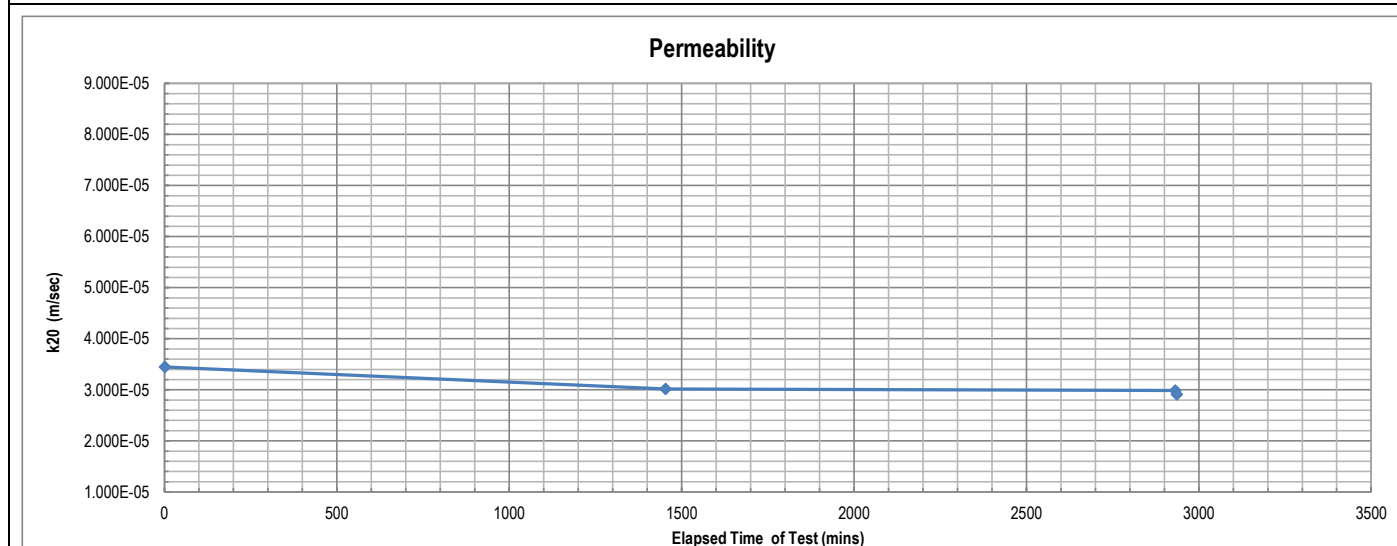
**PERMEABILITY**  $k_{(20)} = 2.9 \times 10^{-05}$  (m/sec)

**Remarks:** The above specimen was remoulded to a target of 90% of Standard Maximum Dry Density and at Optimum Moisture Content.  
This report replaces 21120173-FHPT issued on the 31/1/2022.

Sample/s supplied by client +19mm material crushed and added to sample prior to testing. Page: 1 of 1 REP06301

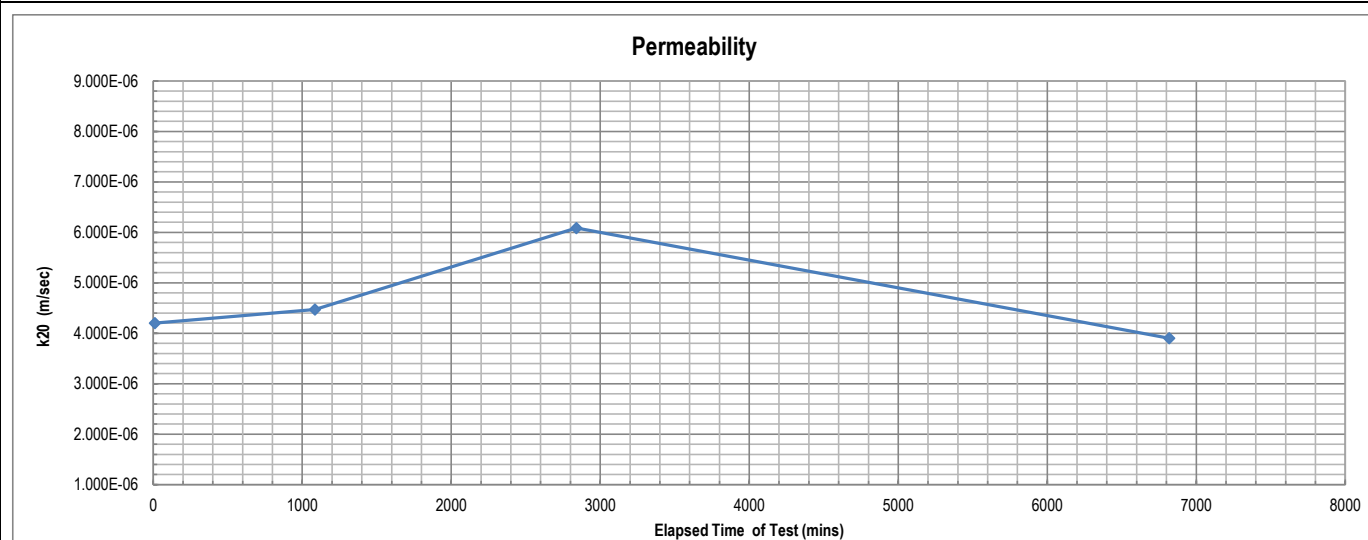
**PERMEABILITY**  $k_{(20)} = 3.9 \times 10^{-06}$  (m/sec)

**Remarks:** The above specimen was remoulded to a target of 90% of Standard Maximum Dry Density and at Optimum Moisture Content.

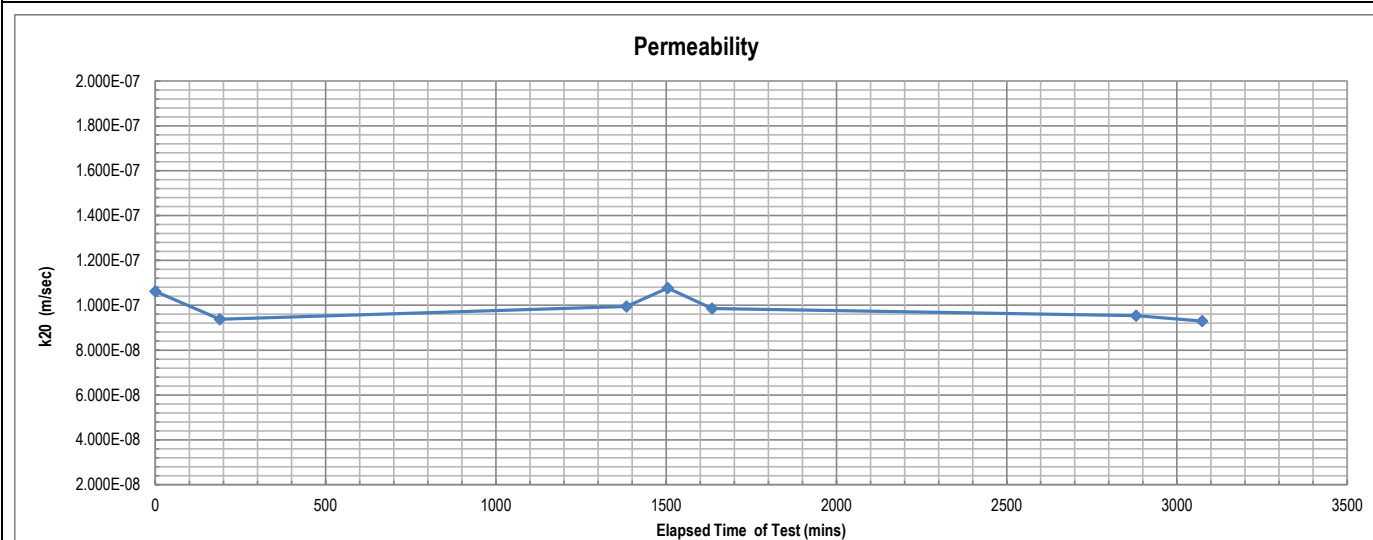
**PERMEABILITY**  $k_{(20)} = 9.4 \times 10^{-08}$  (m/sec)

**Remarks:** The above specimen was remoulded to a target of 95% of Standard Maximum Dry Density and at Optimum Moisture Content.

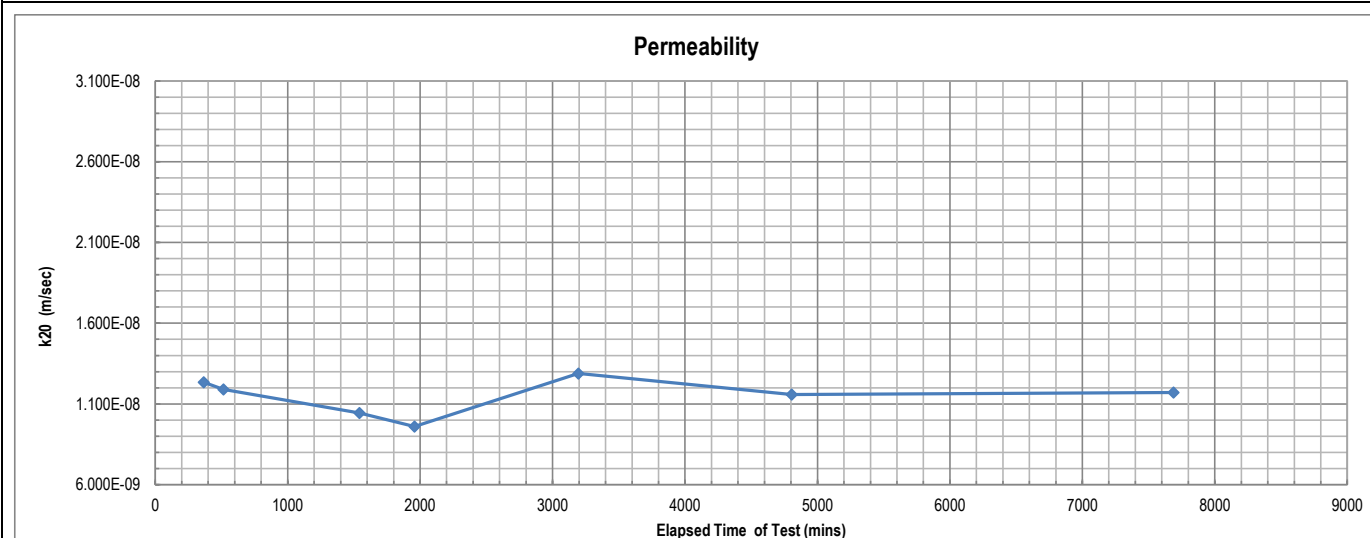
**PERMEABILITY**  $k_{(20)} = 1.2 \times 10^{-08}$  (m/sec)

**Remarks:** The above specimen was remoulded to a target of 95% of Standard Maximum Dry Density and at Optimum Moisture Content.

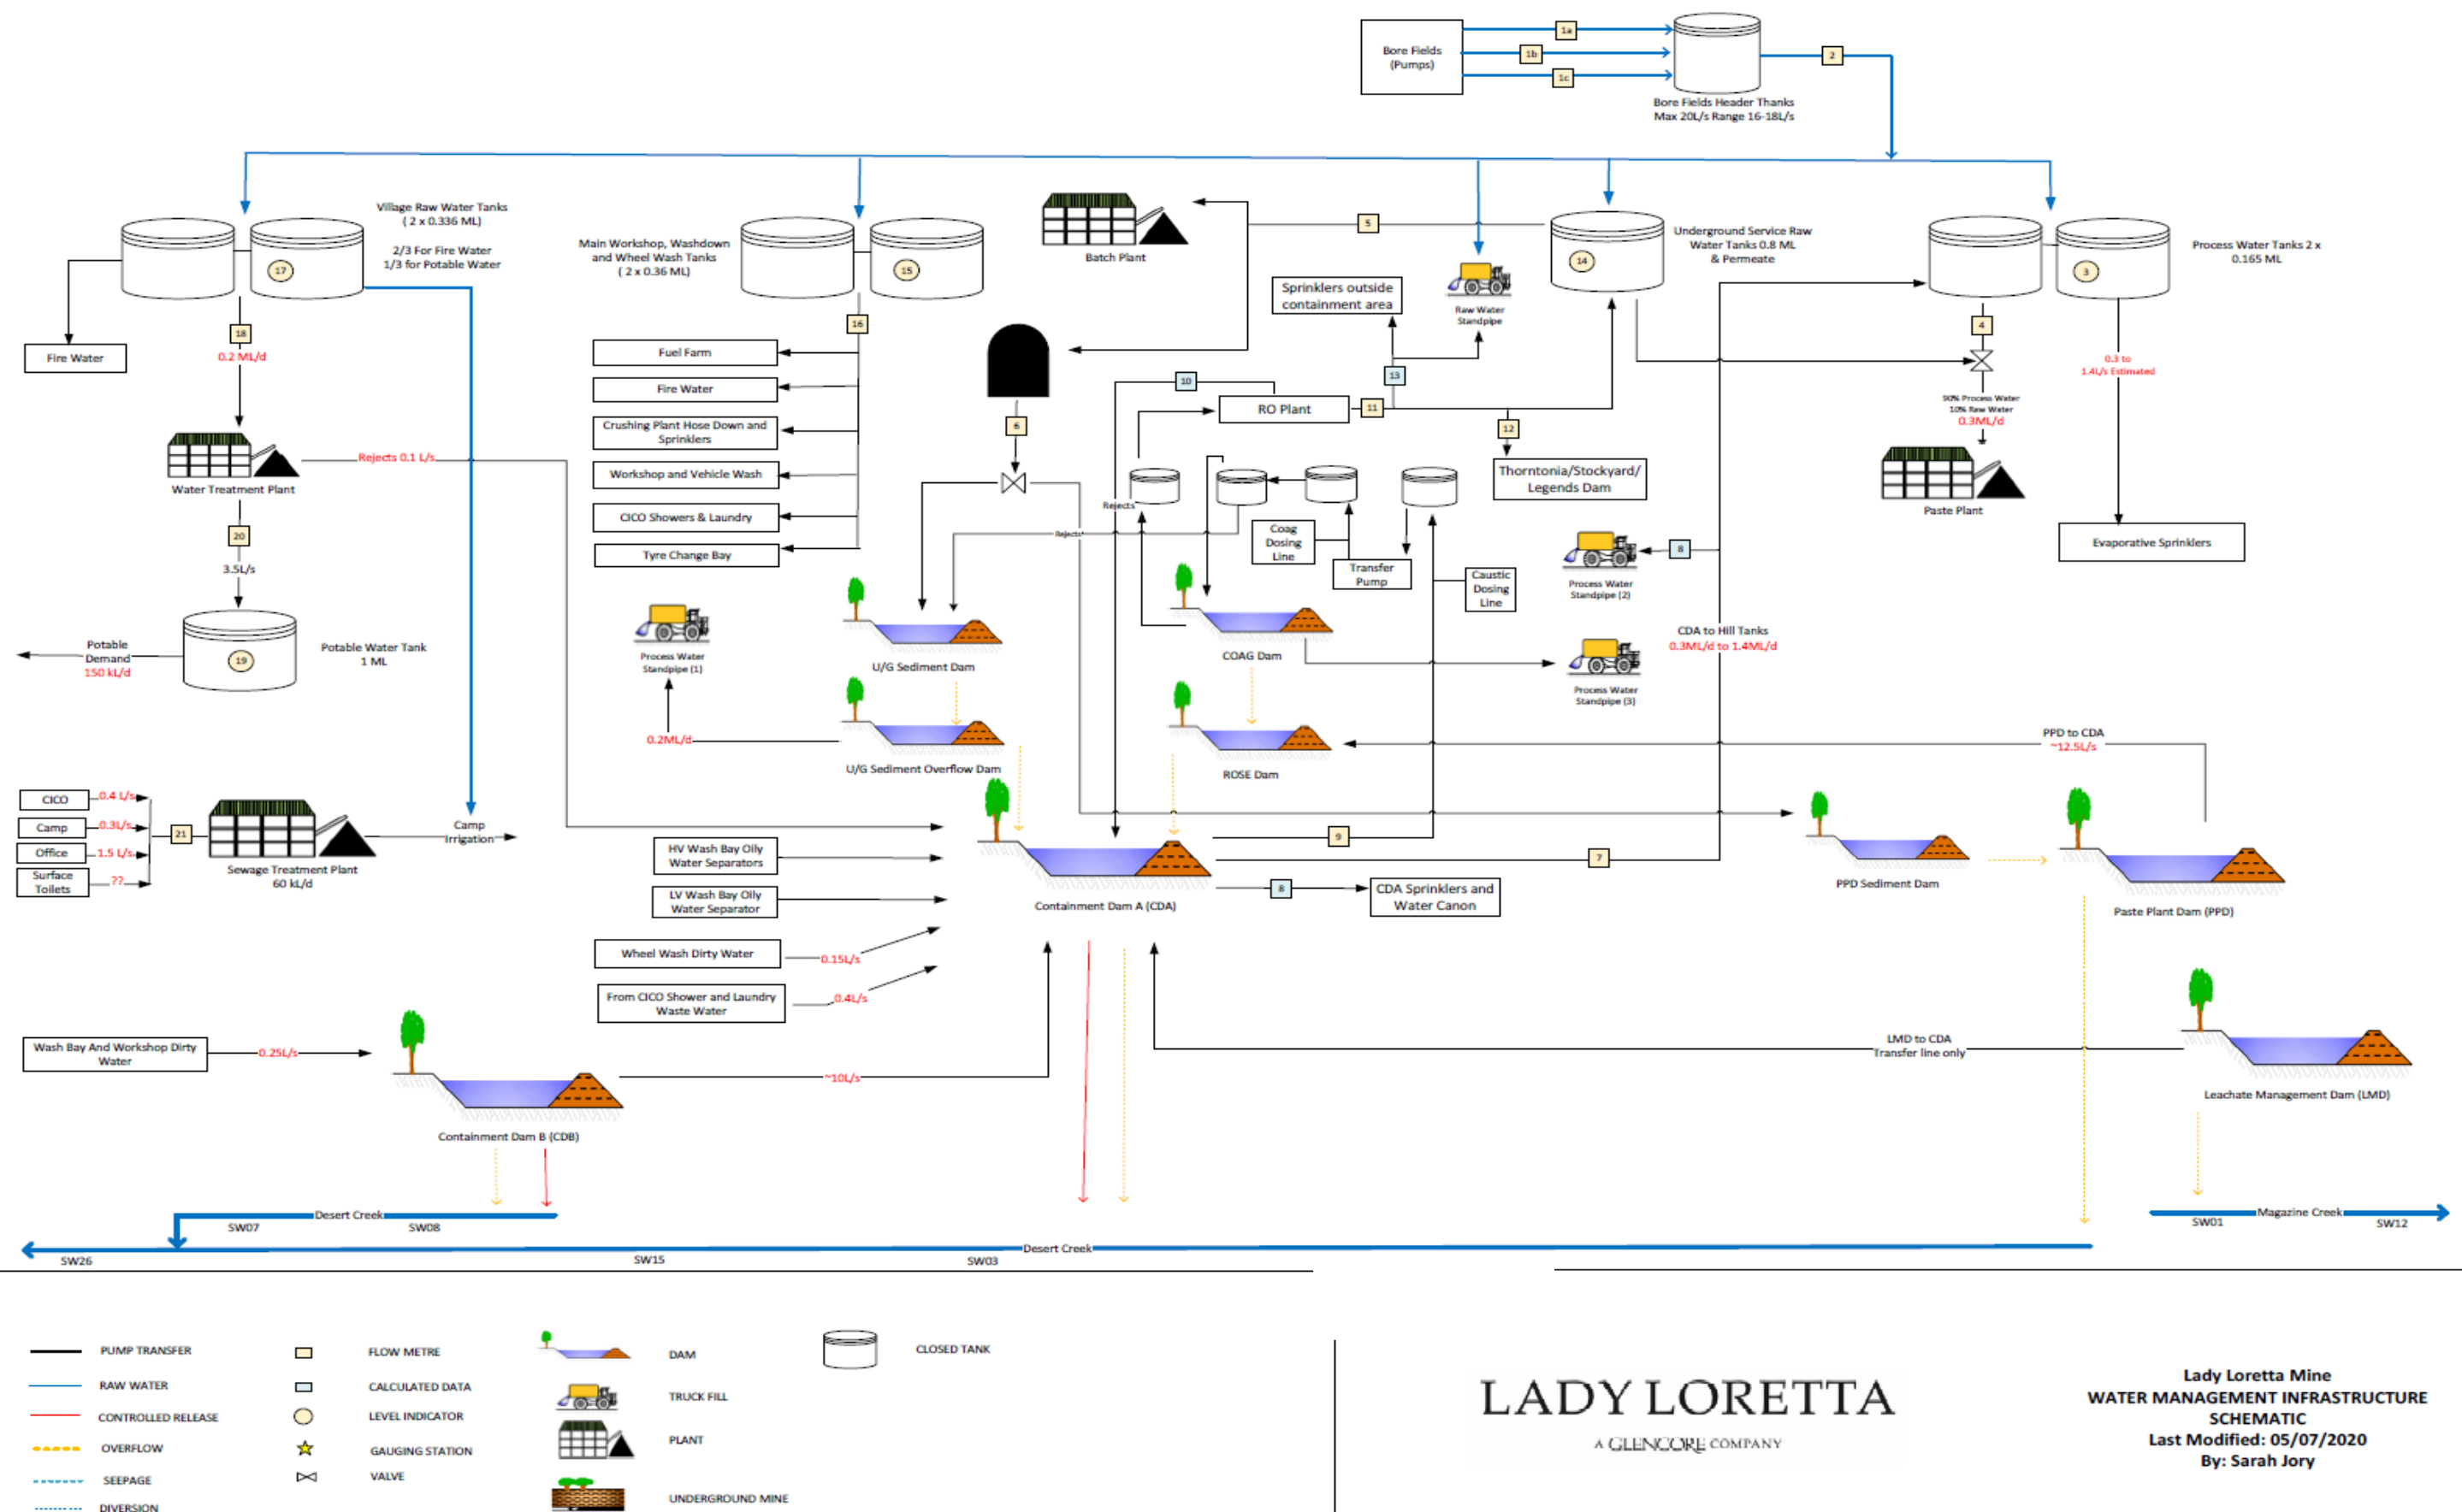
Figure 2.1: LLM Water Balance Model Schematic

The LLM site WBM schematic is shown in Figure 2.1 and represents the site storages, movement of water, demands and inflows. The model consists of the four mine water storages on site representing the site’s water management system, which are shown on Figure 2.2 and listed below.

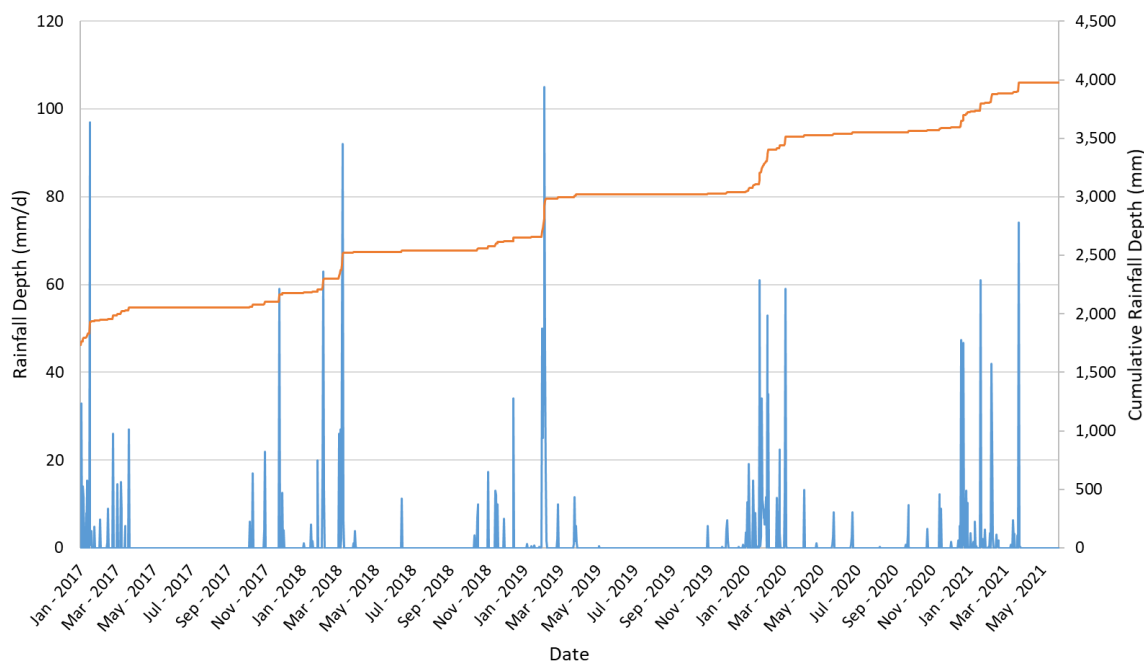
**Figure 2.3: LLM Daily Recorded Rainfall**

Historical daily rainfall data has been sourced from the LLM site rainfall gauge. Rainfall data was available from 1<sup>st</sup> of January 2017 until the 28<sup>th</sup> of May 2021. Figure 2.3 shows the rainfall recorded for this period. It shows distinct wet season periods between November and April each water year (1<sup>st</sup> of July to 30<sup>th</sup> of June each year).

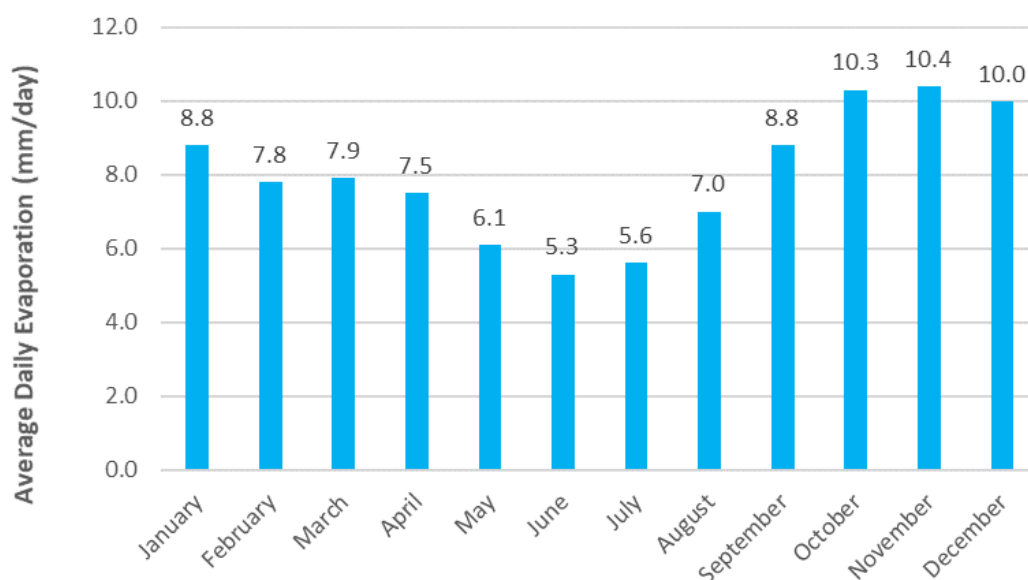
Figure 2.4: Adopted Evaporation Rates

The pan evaporation rates in the model were obtained from the SILO data base (Lat: -190.80°S Long: 139.05°E) and were generated based on interpolative methods using available Bureau of Meteorology (BoM) stations in the region. Due to limited number of stations in the region, long term average values were used in the WBM. Figure 2.4 shows the adopted daily evaporation rates per month. A pan factor of 0.85 was determined appropriate through model calibration (SLR, 2020) and applied to convert pan evaporation to lake evaporation.

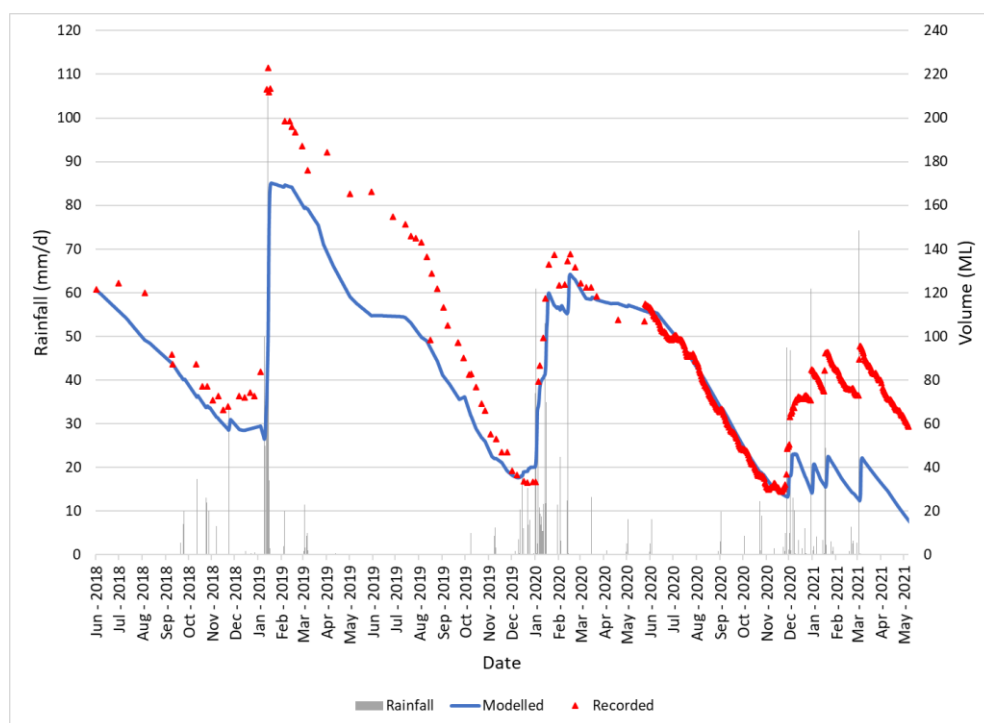
Figure 2.5: Total Site Inventory Calibration Results

The total recorded combined volume for the four storages against the calibration model results from the WBM are shown in Figure 2.5 (Engeny, 2021). The calibration results for this period show the model reproduces the site inventory trend well however there are some inconsistencies in peak volumes as well as rates of reduction. Inconsistencies in the model calibration are a function of the following:

- Runoff parameters.
- Demands applied as a constant historical average rate
- Spatial distribution of rainfall over the sites catchment not captured by the site's rainfall gauge.

Sensitivity analyses of the runoff parameters indicated that adopting parameters producing unrealistically high runoff did not significantly improve the match during the larger rainfall events (January 2019 and December 2020 events) and worsened the match for other parts of the calibration period. Recalibration of AWBM parameters was not undertaken during this calibration effort.

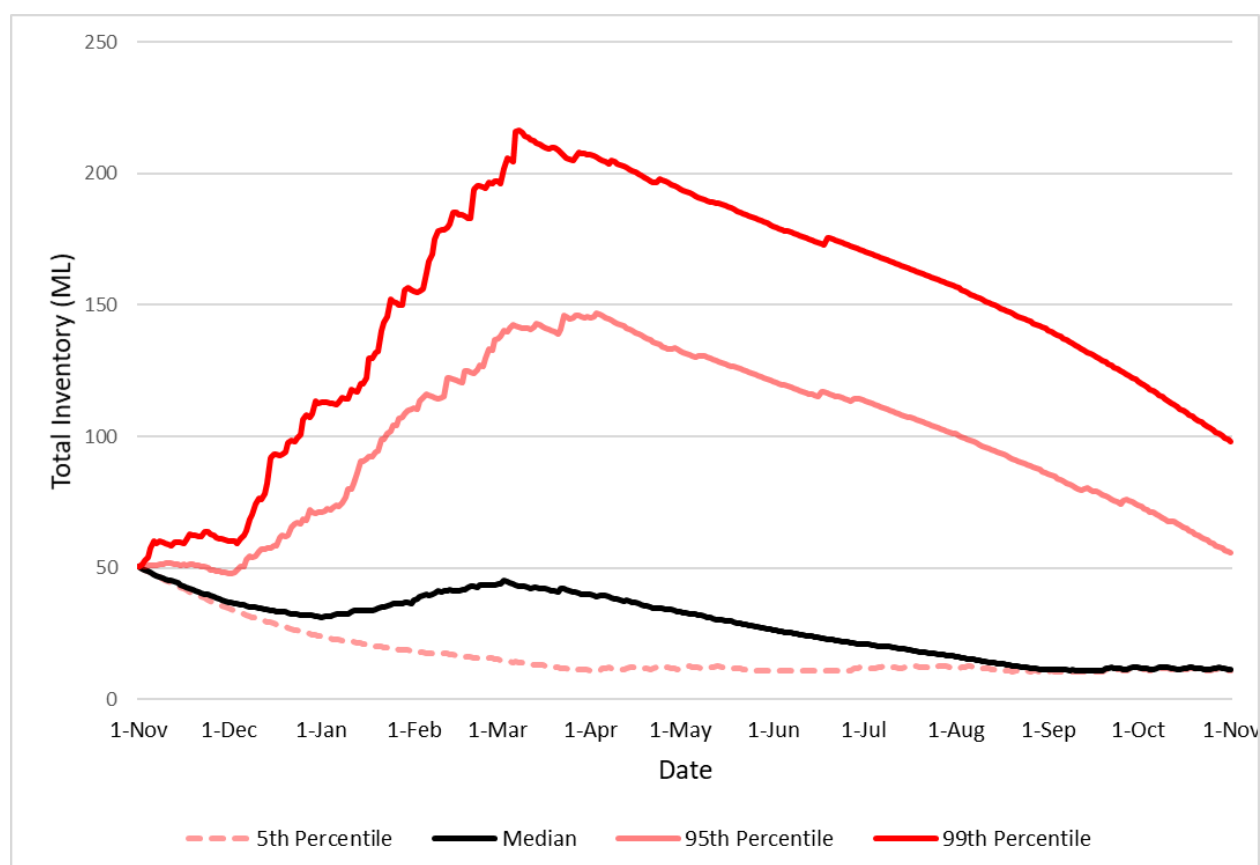
Figure 3.1: Total Site Inventory – Existing System

The containment performance of the water containment storages at LLM are summarised in Table 3.1 and the total site inventory forecast for the assessment is shown in Figure 3.1. The total system initial volume (~50 ML) was adopted as it is representative of the typical volume prior to the start of the wet season, as predicted by model runs and based on historical dam inventories. The results show the dams have a very high containment standard with all dams overflowing 1% of years or less.

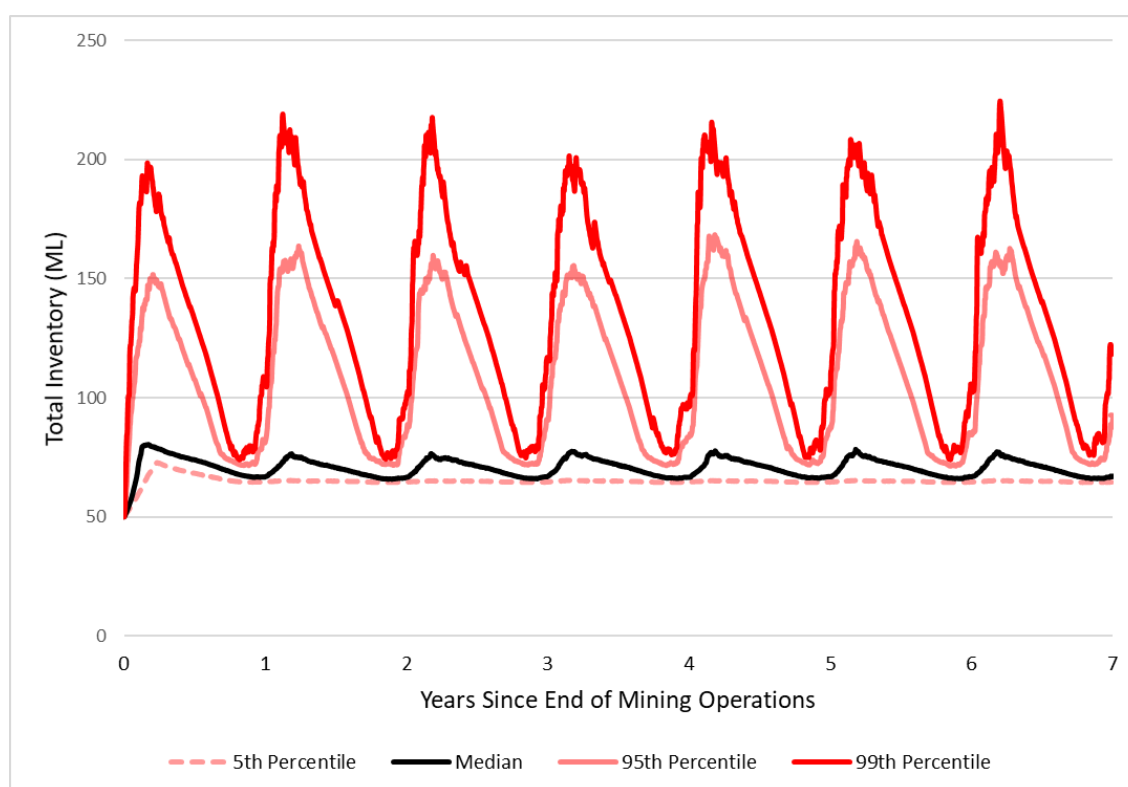
**Figure 4.1: Total Site Inventory – End of Mining Operations**

The containment performance of the water containment storages at LLM are summarised in Table 4.1 and the total site inventory is shown in Figure 4.1. The results show after the end of mining operations all dams are expected to continue to achieve a containment standard better than 1% AEP (overflows is less than 1% of years) besides CDB which has a slightly increased overflow rate due to proposed changes to demands and dam transfer rules compared to the existing operational system. Contingencies are available to slow down underground mine dewatering rates and other approaches such as dam transfers and sending water back underground to reduce the annual overflow frequency below 1% at CDB.

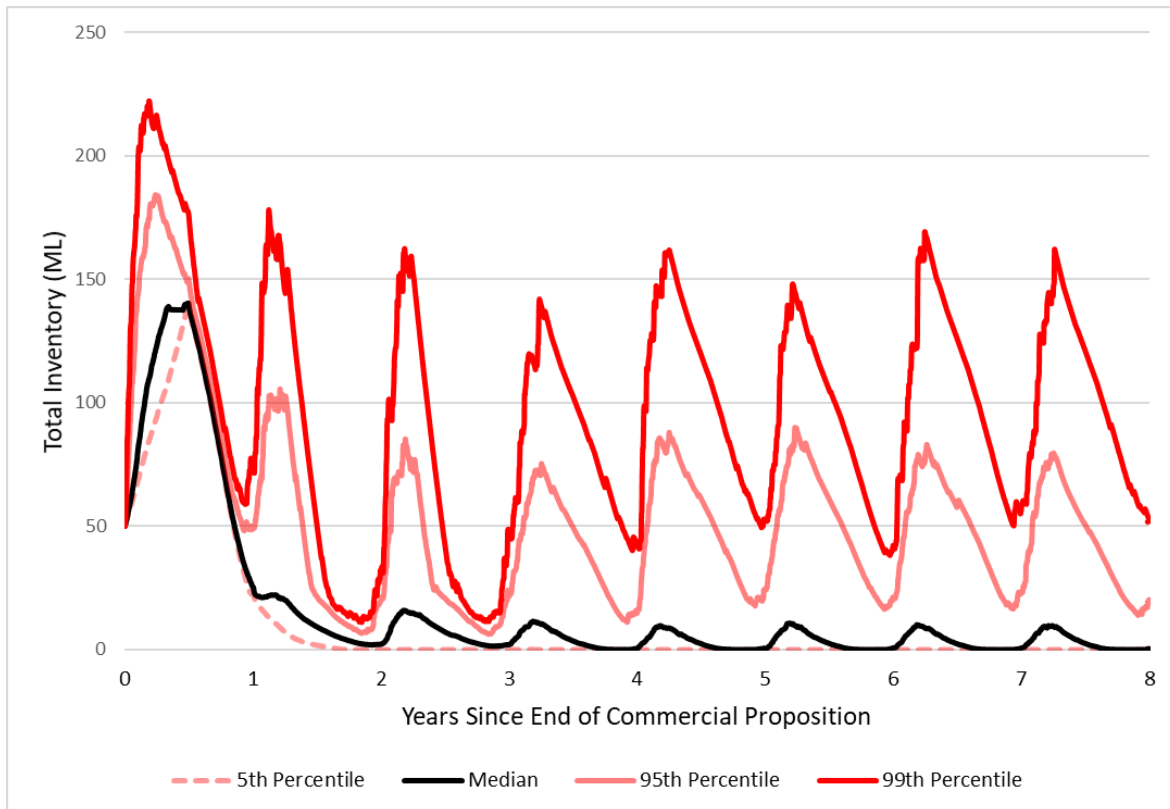
**Figure 4.2: Total Site Inventory – End of Commercial Proposition**

The containment performance of the water containment storages at LLM are summarised in Table 4.3 and the total site inventory is shown in Figure 4.2. The results show after the end of commercial proposition all remaining dams are expected to continue to achieve a containment standard better than 1% AEP (overflows in less than 1% of years).

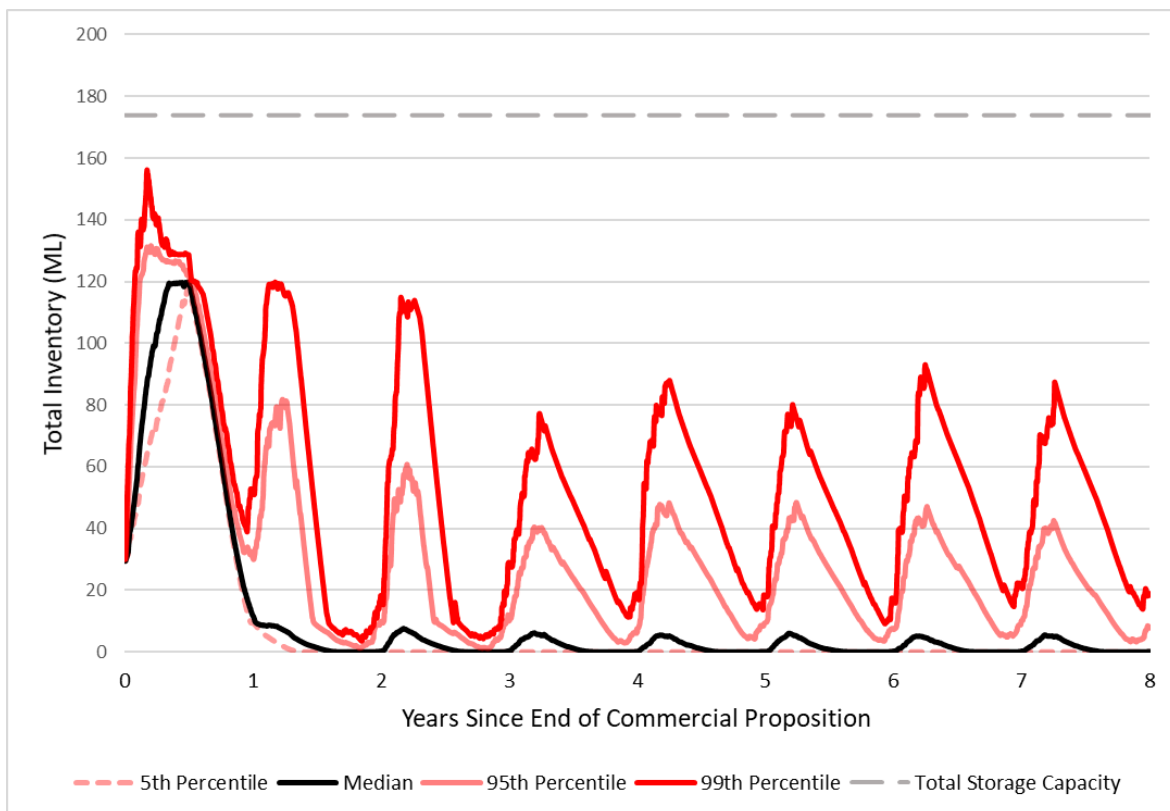
**Figure 4.3: CDA Inventory – End of Commercial Proposition**

- Under all climate scenarios (up to the 99<sup>th</sup> percentile), the total site inventory does not exceed the maximum available storage capacity (259 ML). Figure 4.3 to Figure 4.5 show the modelled inventories against available capacity for individual dams.
- Following the first year, and full dewatering is achieved, the overall trend in storage inventory, including maximum volume, is relatively consistent across each year of the simulation. This indicates that LLM is not expected to accumulate water across the Stage 2 period.
- Once the regulated dams are decommissioned and repurposed as erosion and sediment control facilities, there will likely be between 2 ML (50<sup>th</sup> percentile climate scenario) and 50 ML (99<sup>th</sup> percentile climate scenario) of surface water runoff remaining in the storages.

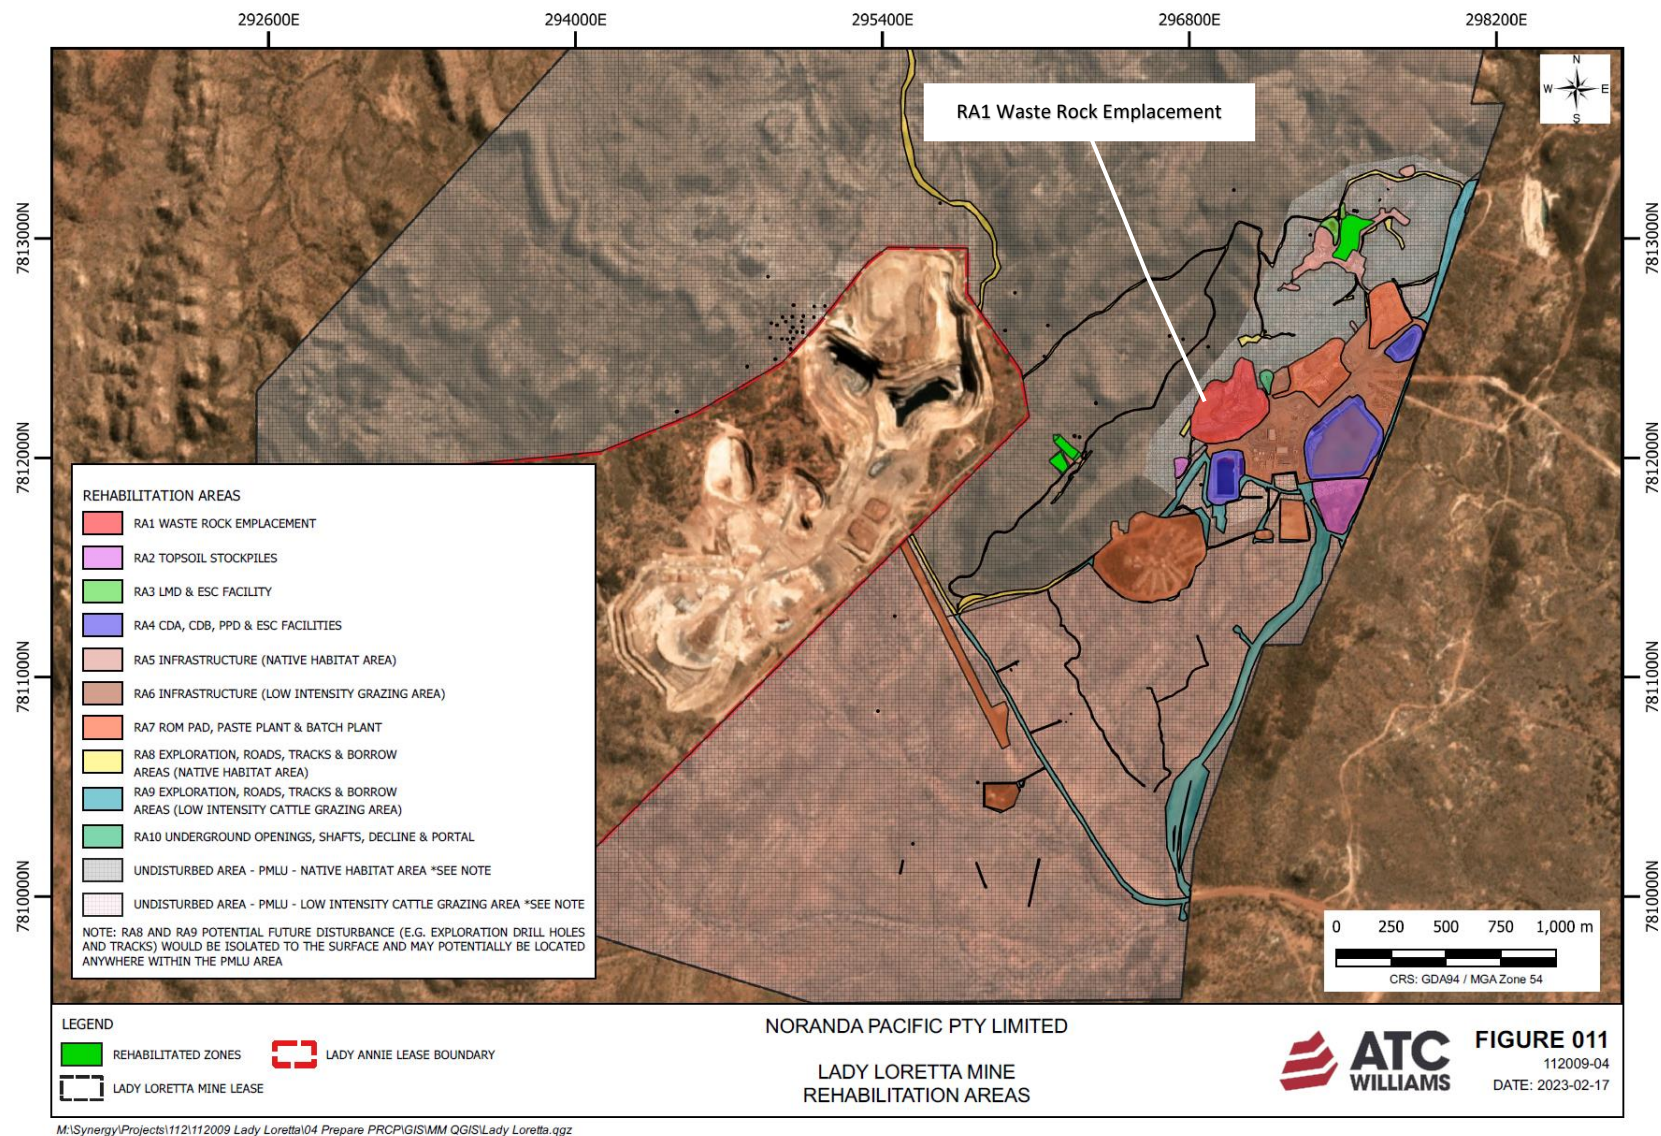
Figure 1: Proposed Rehabilitation Areas, per PRCP (c/o ATC Williams)

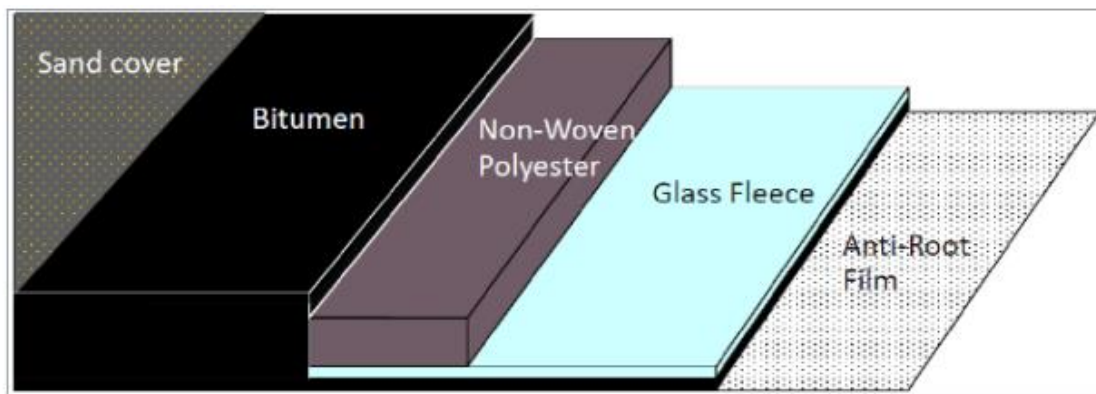
A BGM is a composite material with several constituents to attain the desired overall material properties. They typically consist of non-woven geotextile and glass fleece layers impregnated with and encapsulated in elastomeric bitumen, with a sanded surface on one side for enhanced friction and an anti-root layer on the other. The geotextiles dictate the mechanical properties of the BGM, while the elastomeric bitumen provides waterproofing, chemical resistance and protection from ageing. The glass fleece is used for manufacturing purposes. It ensures stability of the geomembrane during impregnation of the geotextile with hot bitumen.

Figure 2: Diagram of the BGM, (adapted from Appendix H of McArthur River Mine's OMP Supplementary EIS [Glencore 2017])

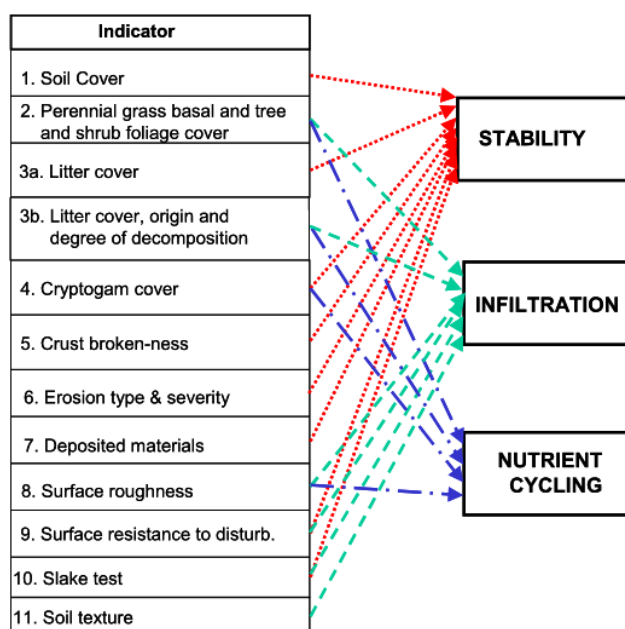
Figure 3: Indicators that make up the stability, infiltration and nutrient cycling scores within the EFA framework (from Tongway and Hindley 2005)

The mid-term milestone of >50% is set that way because some of the indicators that make up the stability score (Figure 3) take many years to develop evidence of presence/absence (such as cryptogam cover, crust broken-ness and deposited materials). Hence, these criteria allow for some time for the site to develop towards final completion.

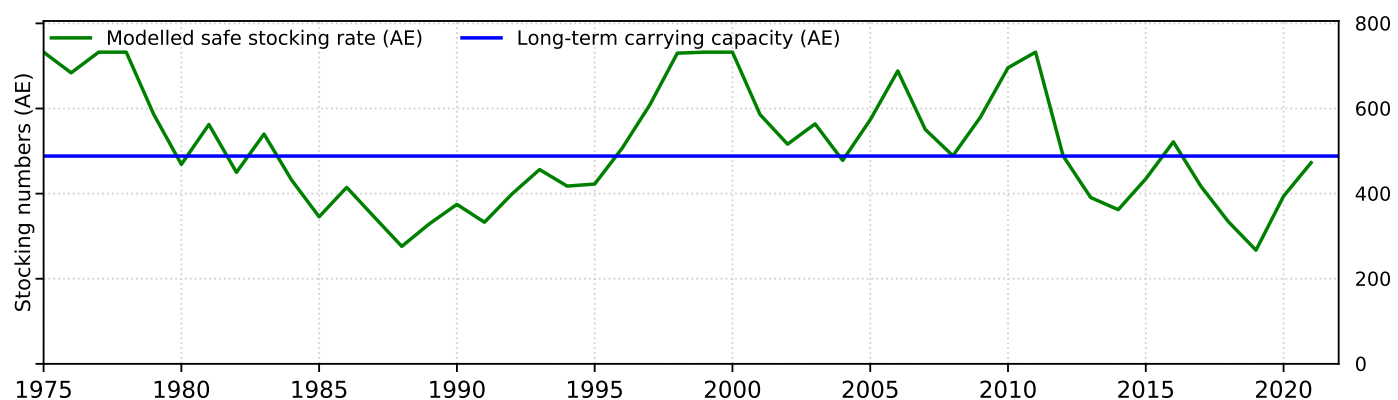
## Modelled safe stocking rate under A condition

The above graph shows the modelled historical annual (Apr-Mar) safe stocking rates for the property. The safe stocking rate calculations are based on a number of factors including: the modelled LTCC; the safe utilisation rate defined for each land type; and a set of rules to increase/decrease the stocking rate in response to changing climate.

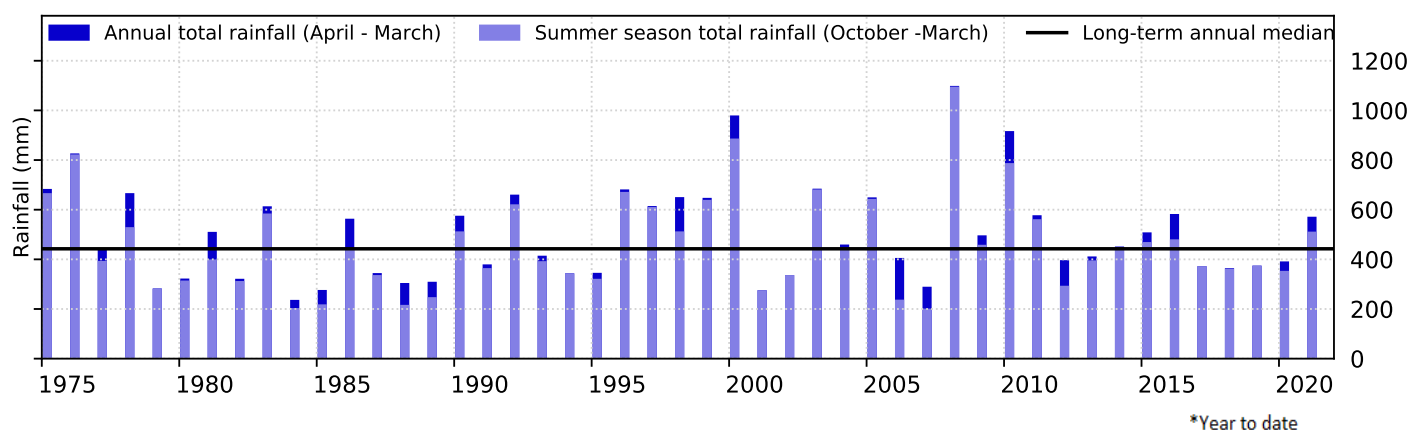
## Historical annual and summer season rainfall

The historical annual and summer season rainfall graph for the requested property is derived from the SILO database (<https://www.longpaddock.qld.gov.au/silo/>). Summer season rainfall is defined as rainfall during October to March. The long-term median rainfall is for a period from 1975 to the current year. The high year to year variability is a normal characteristic of Queensland rainfall.
