LADY LORETTA

## **Z-LLM-HSEC-PLN-Progressive Rehabilitation and Closure Plan**

| Project Name | Lady Loretta Mine |
| Document Title | Z-LLM-HSEC-PLN-Progressive Rehabilitation and Closure Plan |

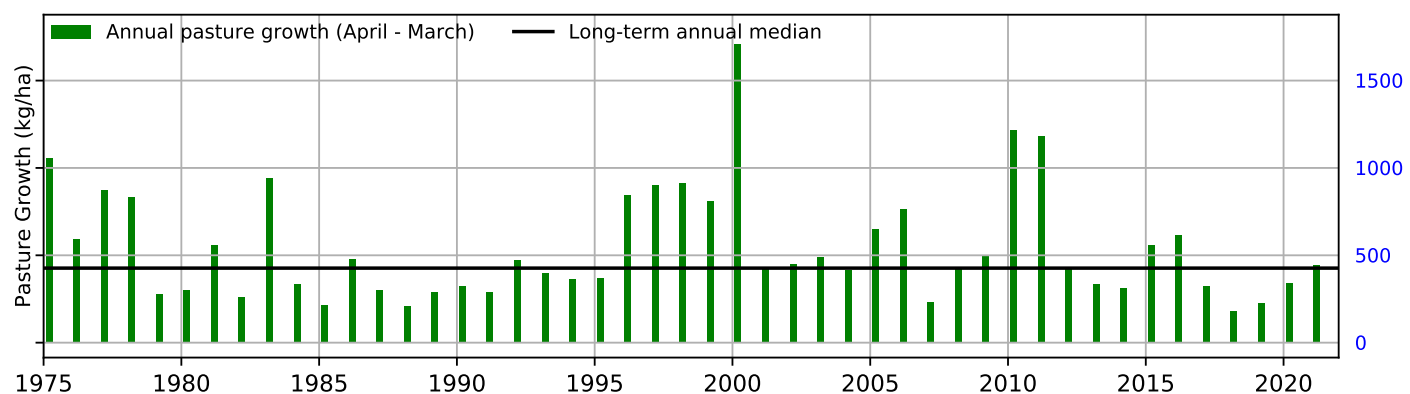
## Historical annual (April - March) pasture growth under A condition (kg/ha)

The historical annual pasture growth (April - March) is an area-weighted average across the property for each land type and foliage projective cover (FPC) level. The long-term median annual pasture growth is for a period from 1975 to the current year. The overall rainfall use efficiency for this property is approximately 1.1 kg DM/ha/mm rainfall.

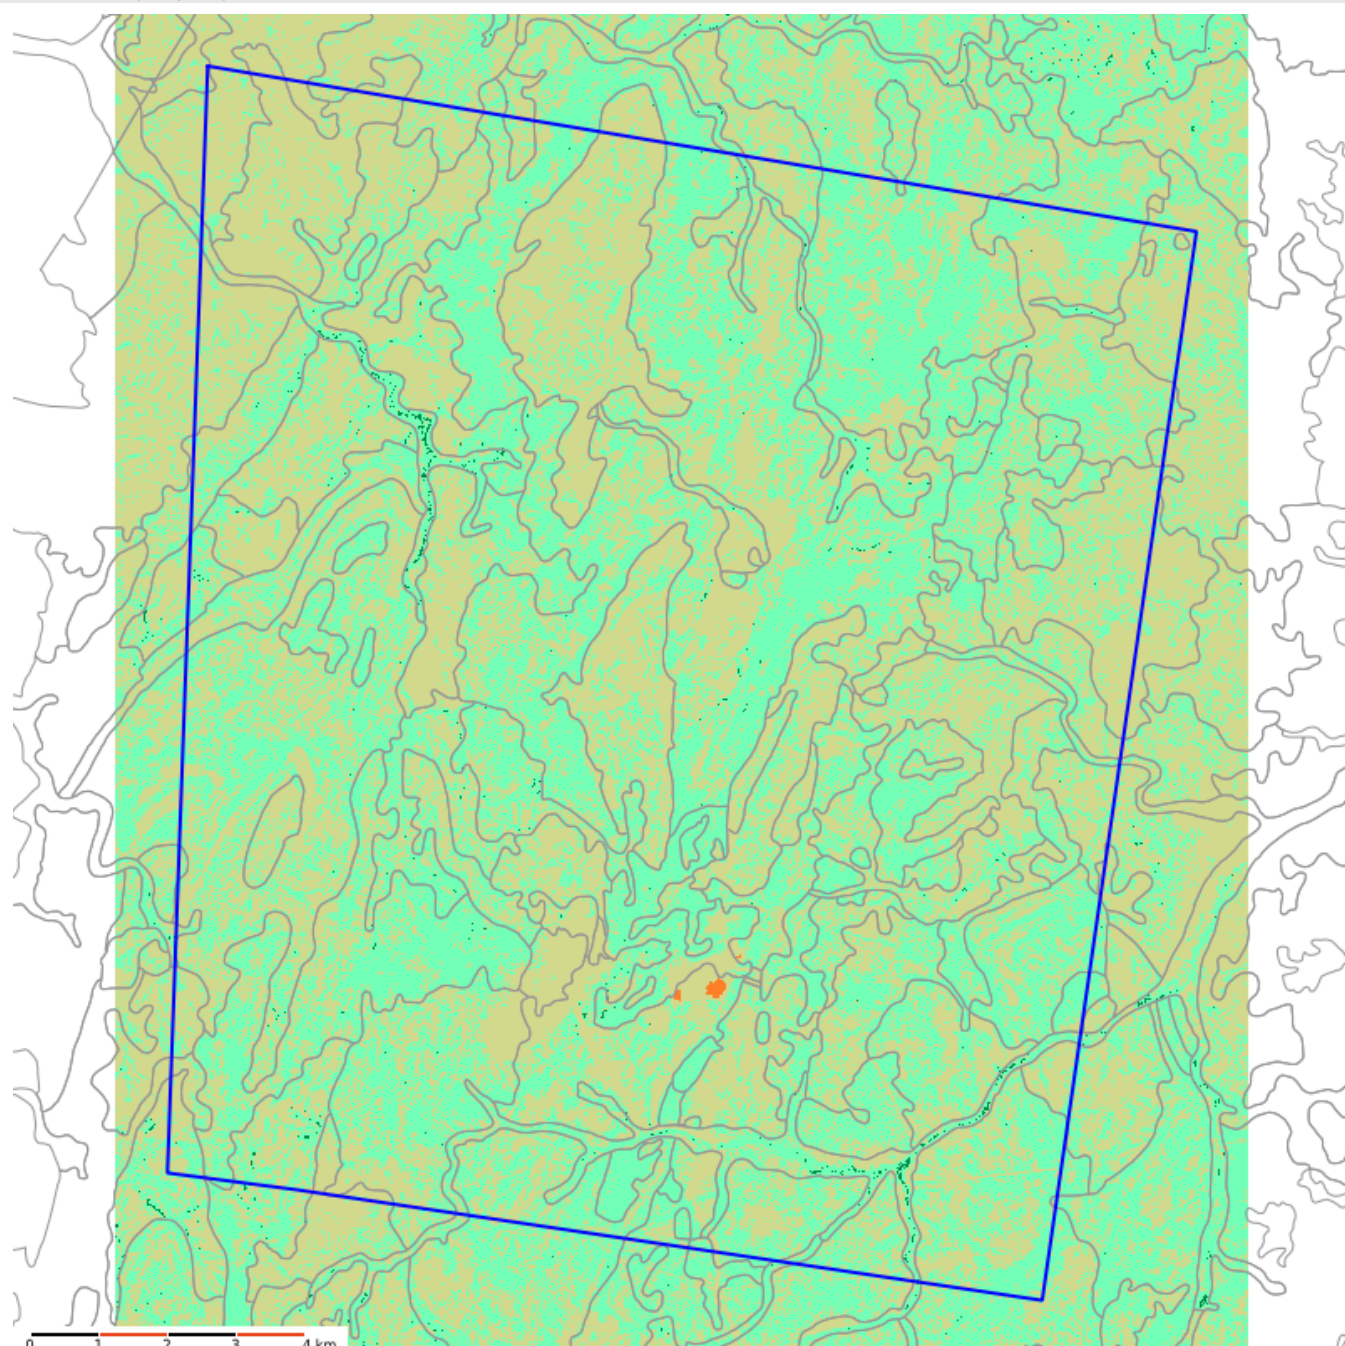
## Estimated foliage projective cover (FPC)

Selected Lot on Plan     
 land type boundaries     
 no data  
 < 15%   
 >= 15% and < 30%   
 >= 30% and < 50%   
 >= 50% and < 70%   
 >= 70%

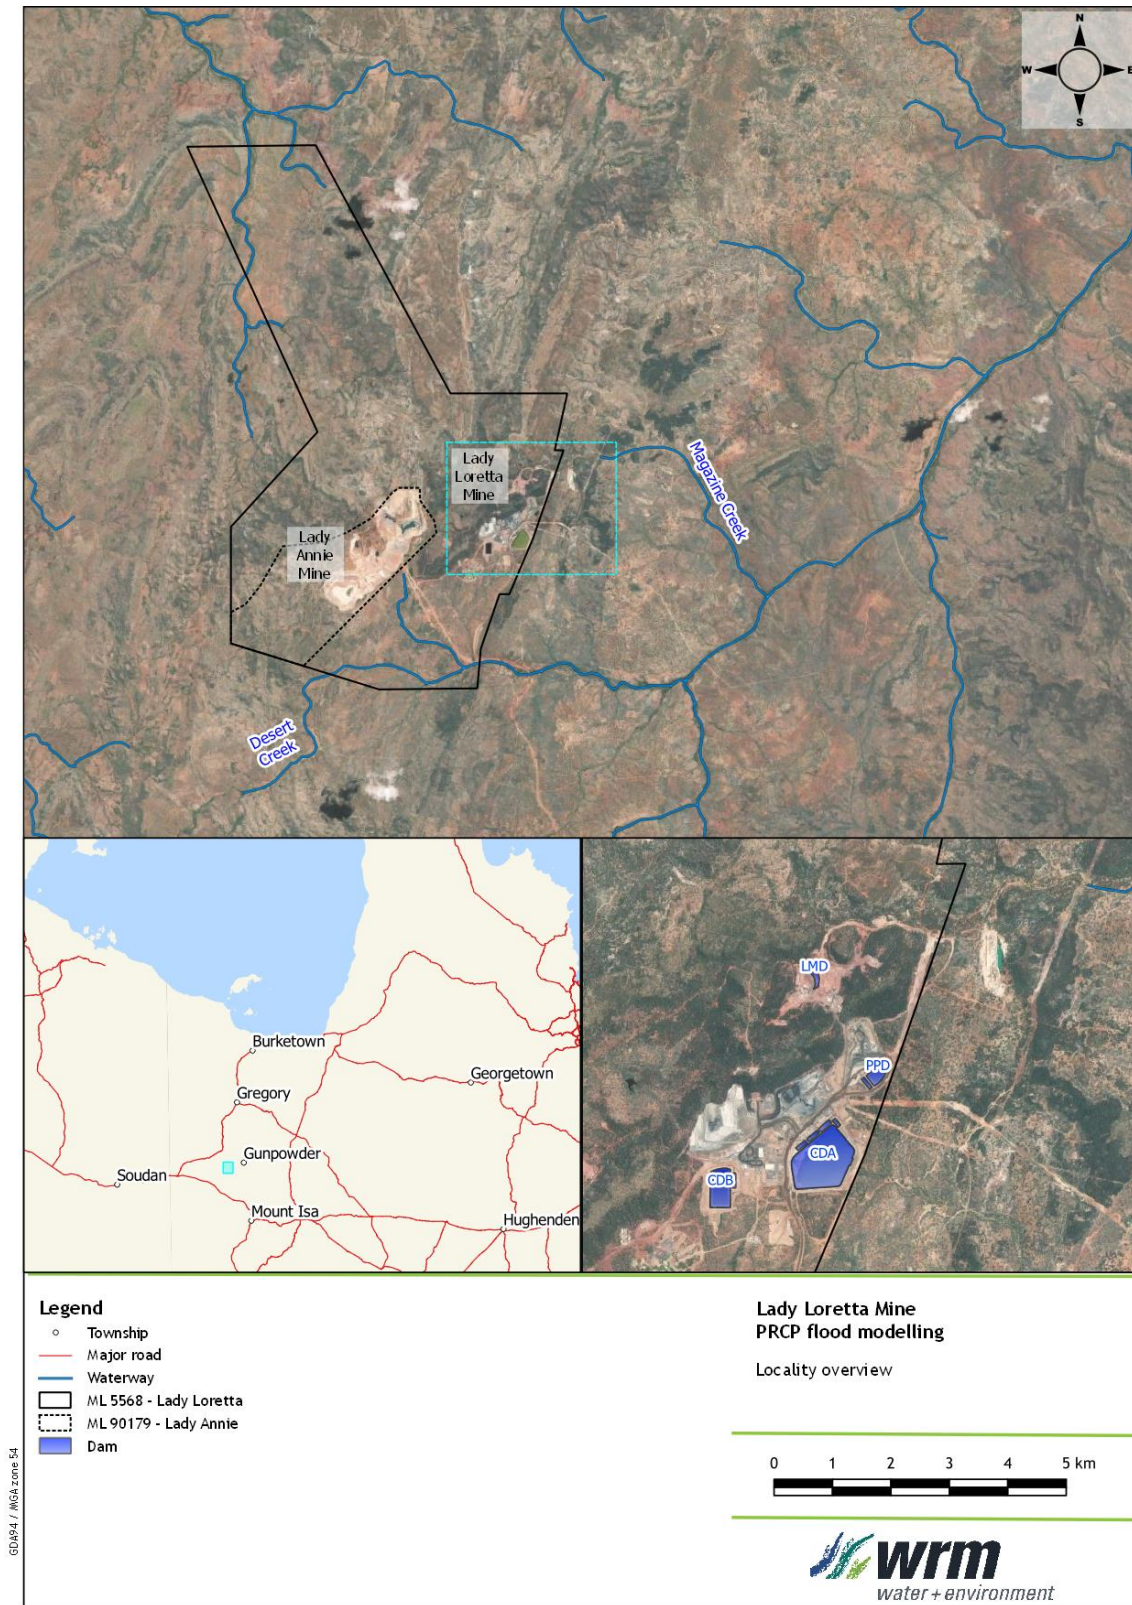
Figure 1.1 - Locality and key drainage features

Glencore Limited (Glencore) is currently preparing the Progressive Rehabilitation and Closure Plan (PRCP) for final landforms associated with the Lady Lorretta Mine (LLM). Figure 1.1 shows the site location and drainage characteristics. Figure 1.2 shows the locations of the PRCP related infrastructure, which includes the rehabilitated waste rock emplacement, rehabilitated dams, and rehabilitated infrastructure areas and associated drainage. The site is proposed to be fully rehabilitated, and no Non-Use Management Areas (NUMAs) such as final voids are proposed.

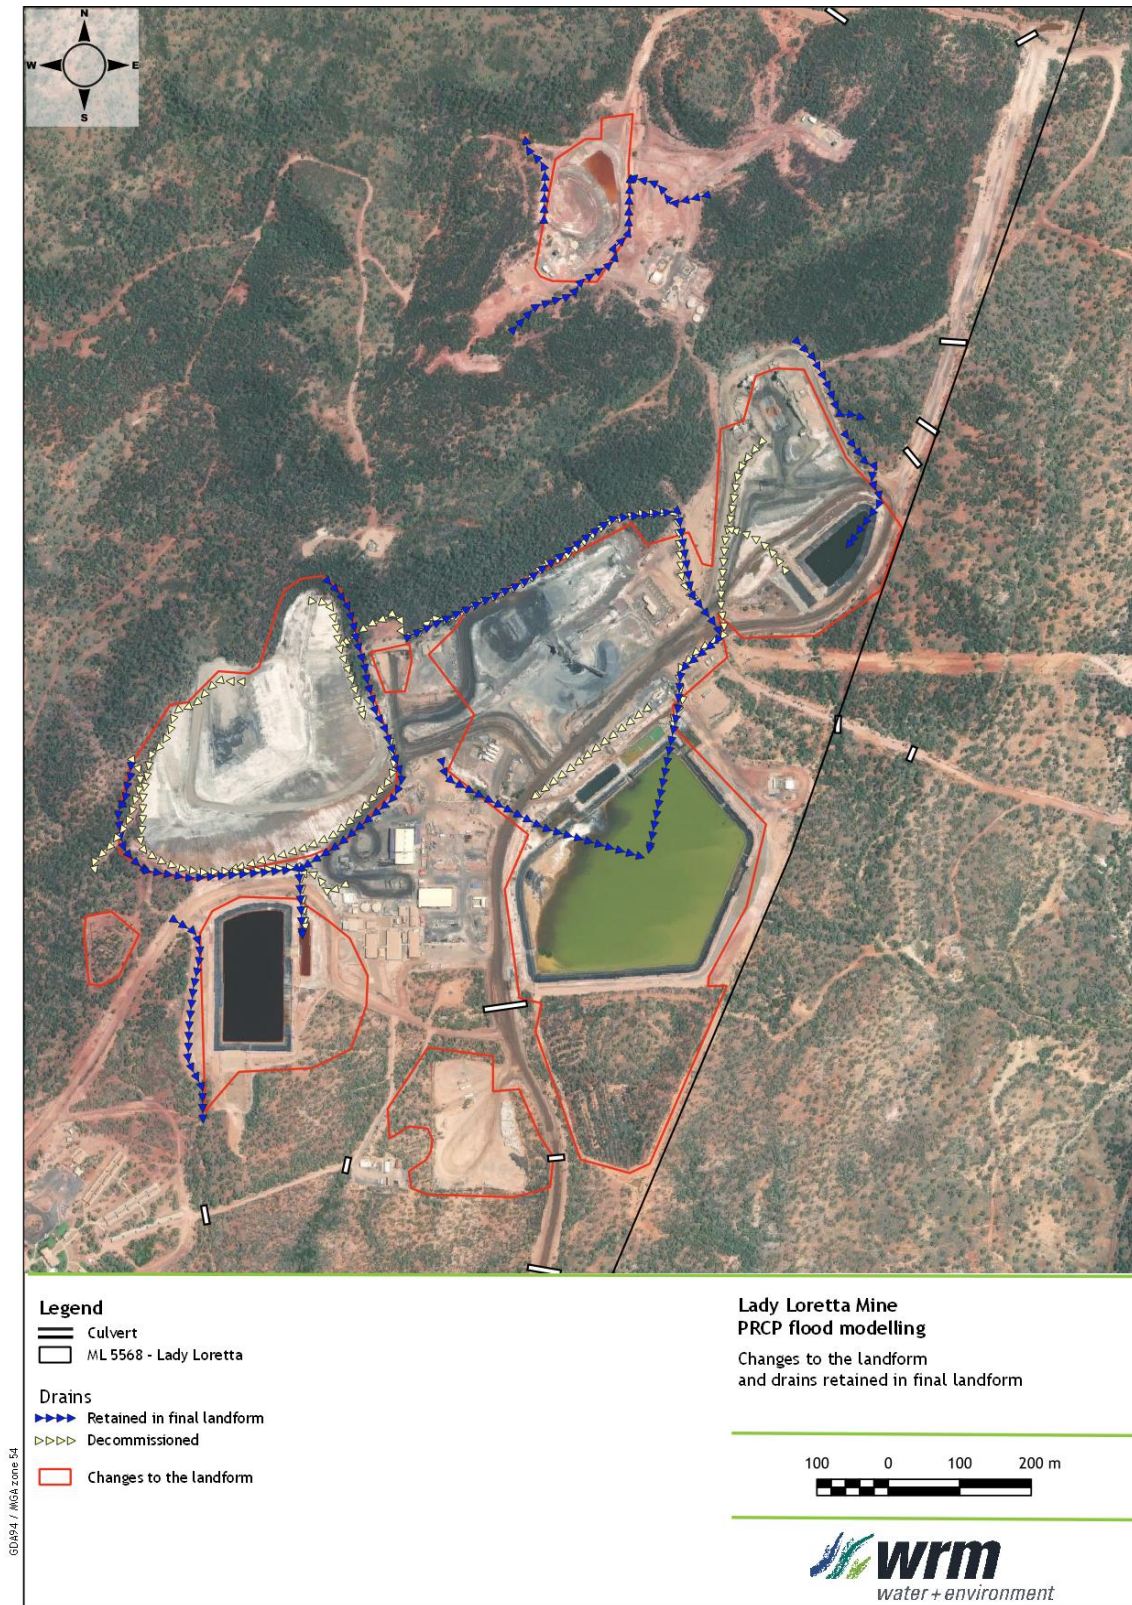
Figure 1.2 - Site overview, proposed changes to the landform and drains

Several drains direct runoff around the mine site, a number of which are proposed to be retained in the final landform (see Figure 1.2).

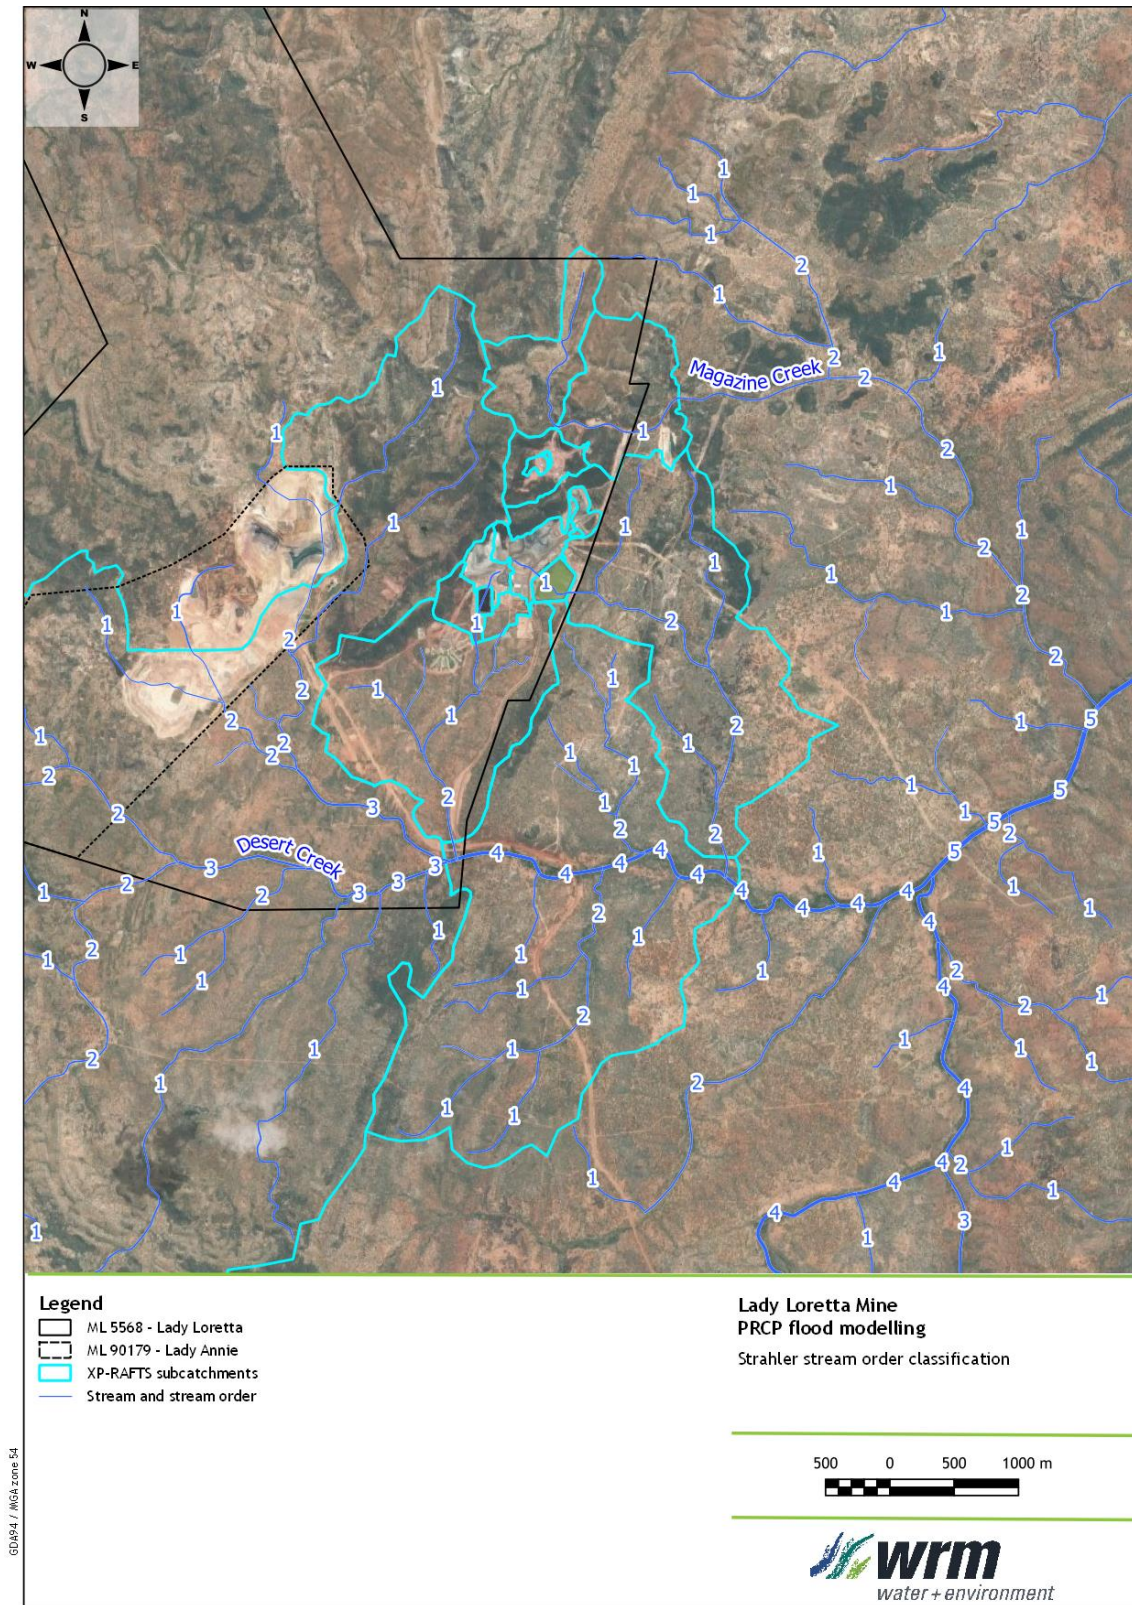
Figure 2.1 - Regional and local catchments and Strahler stream order classification

Figure 2.1 shows the catchments and key drainage features in the vicinity of LLM. The following sections describe the existing catchments and drainage features in the vicinity of the site.

Based on the GeoScience Australia dataset, the upper headwaters of Magazine and Desert Creeks are characterised by steep first and second order watercourses (see Figure 2.1). These upstream catchments have been modified within the Mine site to allow for mining operations.

The Mine site is located at the headwaters of Magazine and Desert creeks. Little external catchment drains to the Mine, with only first order watercourses intersecting the site (see Figure 2.1).

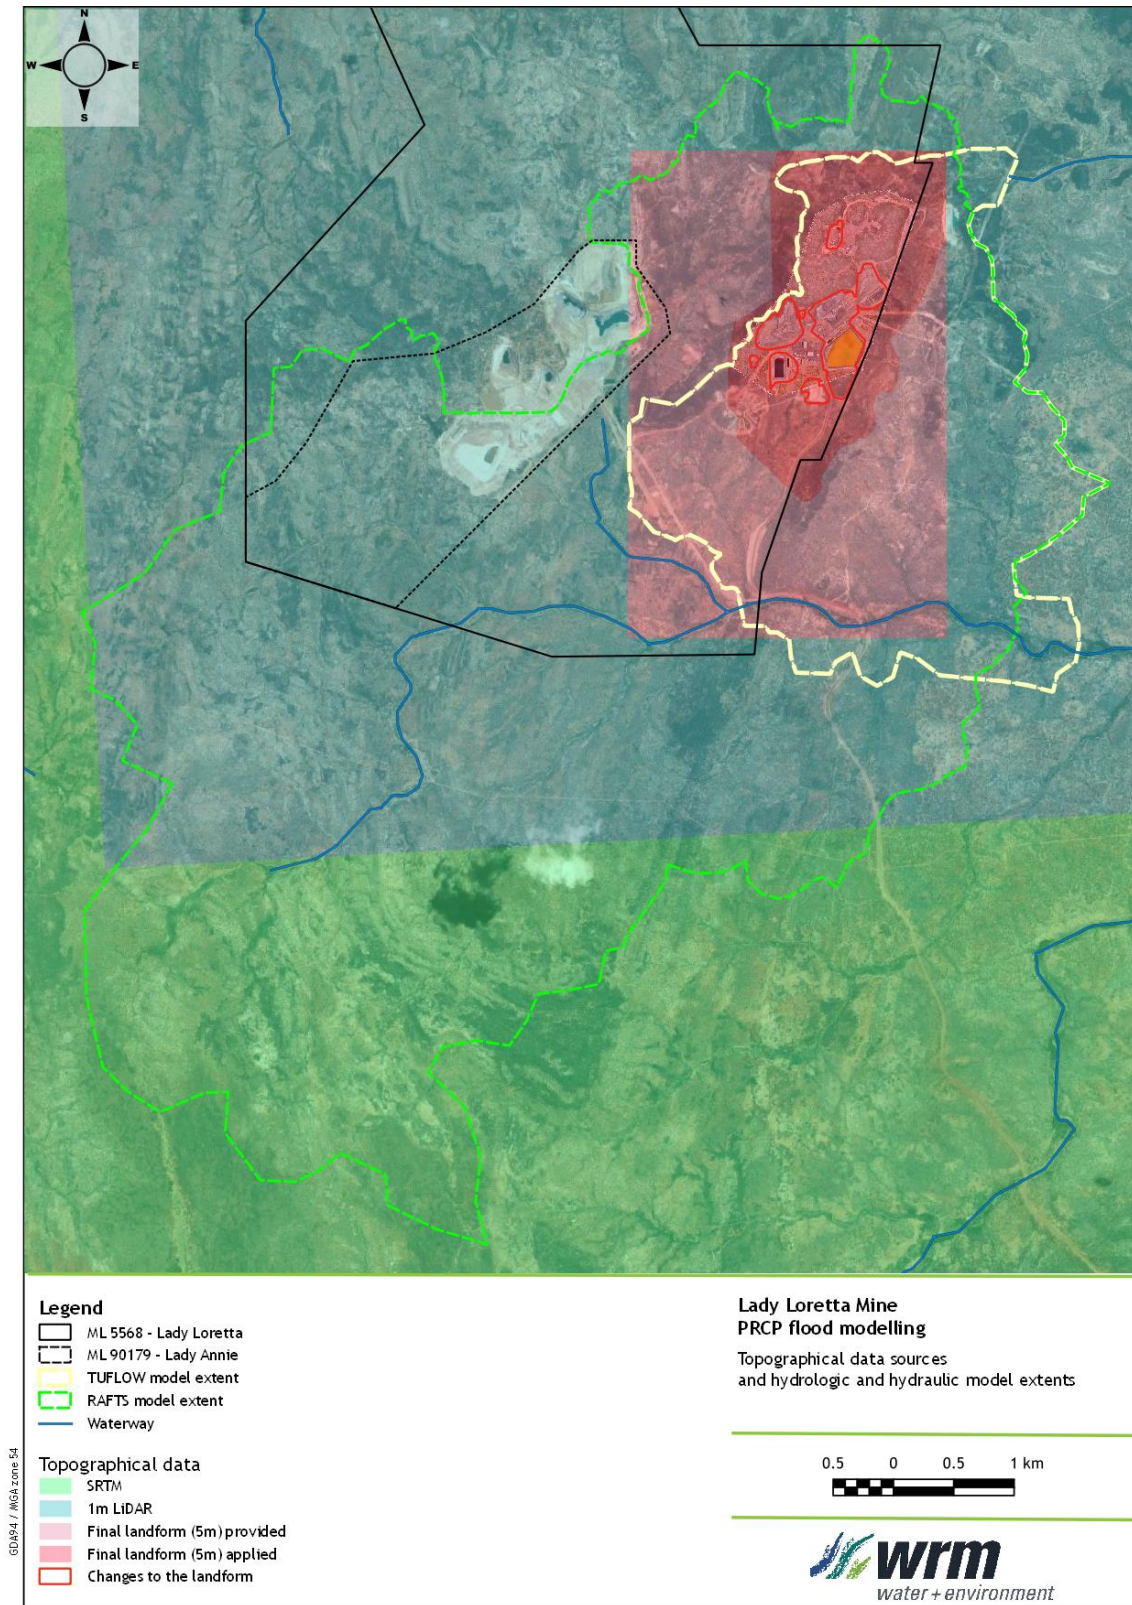
Figure 3.1 - Topographical data availability

Figure 3.1 shows the extents of available topographic data for the study. The topographic data was used to develop a XP-RAFTS hydrologic model (refer to Section 5) and Two-Dimensional Unsteady Flow (TUFLOW) hydraulic model (refer to Section 6) developed for this study. The following topographic data was available for use in this study:

- Light Detection and Ranging (LiDAR) data provided as 199 American Standard Code for Information Interchange (ASCII) tiles merged to a grid with 1 m resolution covering the hydraulic model extent including the existing waste rock emplacement, mine infrastructure area, mine water dams and around the camp and Sewage Treatment Plant (STP) within the LLM mine lease;
- the final landform surface “Post Mining Final Landform.tif”, which had a grid resolution of 5 m, was provided as by ATC Williams on 28 March 2022. It was assumed for the purpose of this assessment the landform surface provided only included permanent features and temporary features were removed; and
- SRTM data for the remaining areas, used to define the hydrologic model where higher resolution data was unavailable.

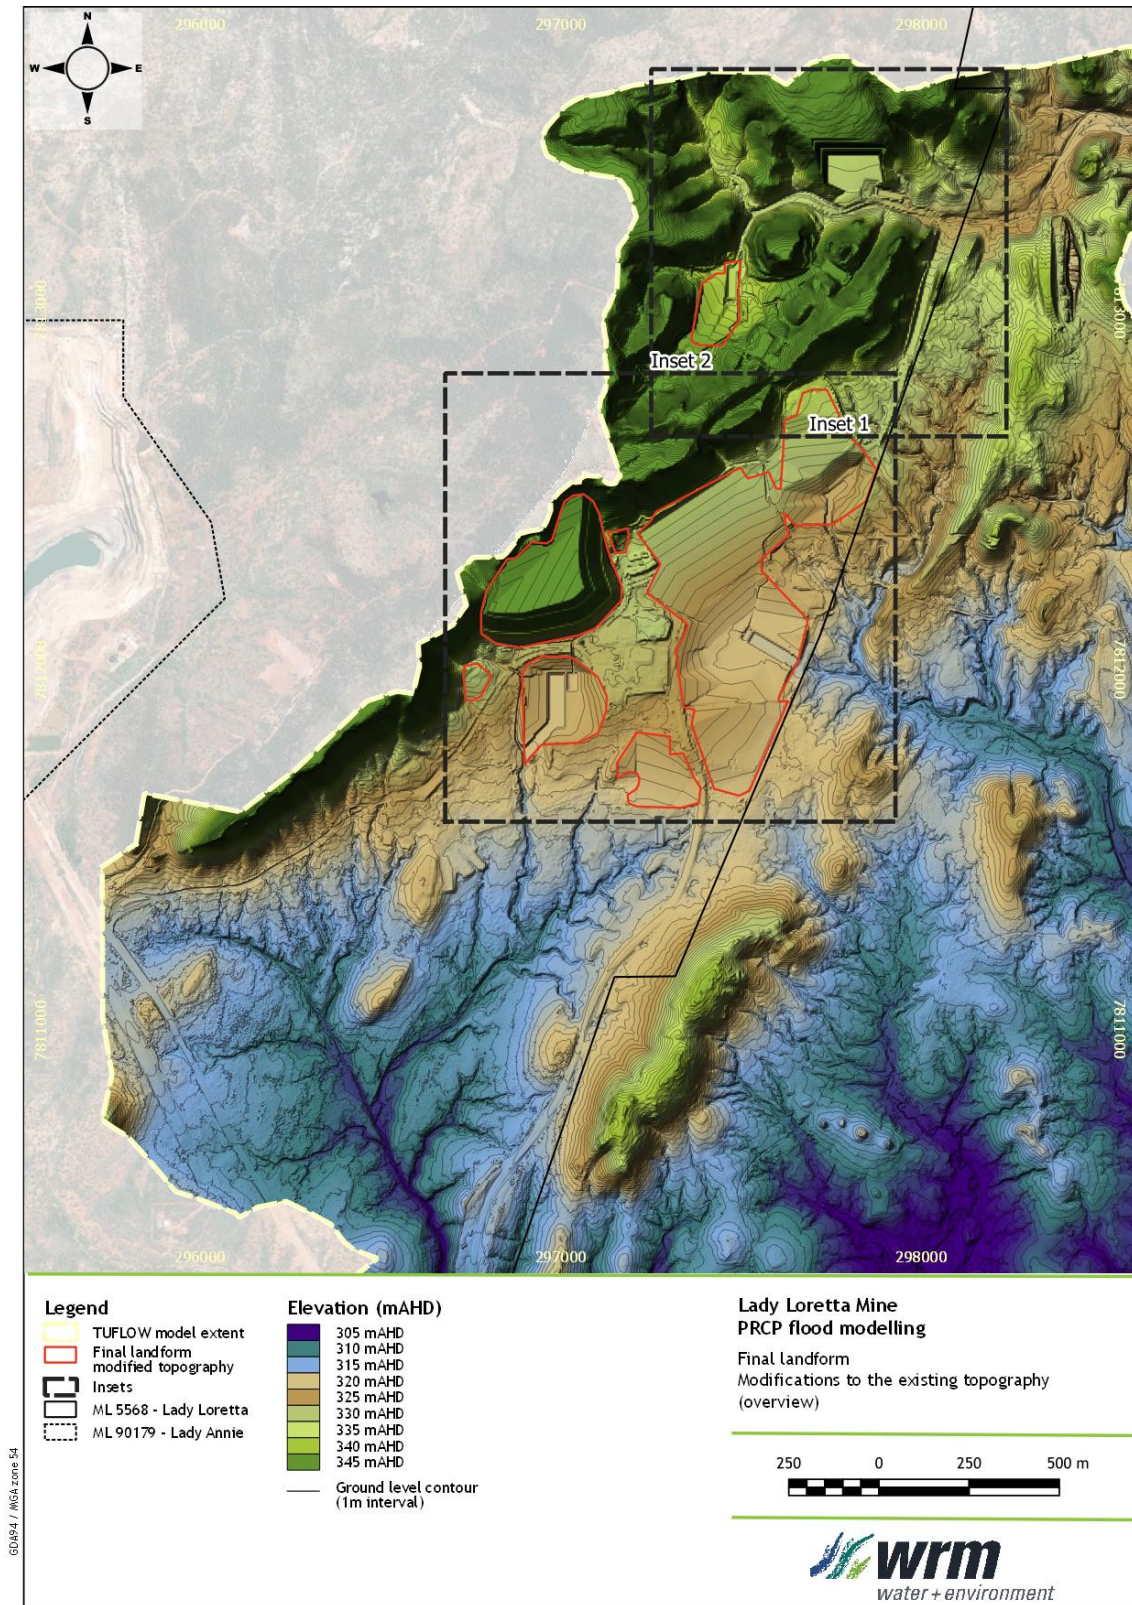
Figure 4.1 - Final landform configuration, overview

The available topographic data described in Section 3 was combined with the post-mining landform data provided by ATC Williams to develop the final landform topography at the LLM site. The final landform topography was used as the basis for hydrologic and hydraulic modelling. Figure 4.1, Figure 4.2 and Figure 4.3 show the modelled final landform configuration for CDA, CDB, PPD, LMD, mine infrastructure area and waste rock emplacement.

The portal box cut, infrastructure areas including the Run of Mine (ROM), Paste Plant area and dams will be regraded where required to be free draining and rehabilitated. It is proposed to retain the rehabilitated waste rock emplacement, haul roads and associated drainage in the final landform, subject to landholder engagement. There are no residual voids associated with the final landform of the LLM site.

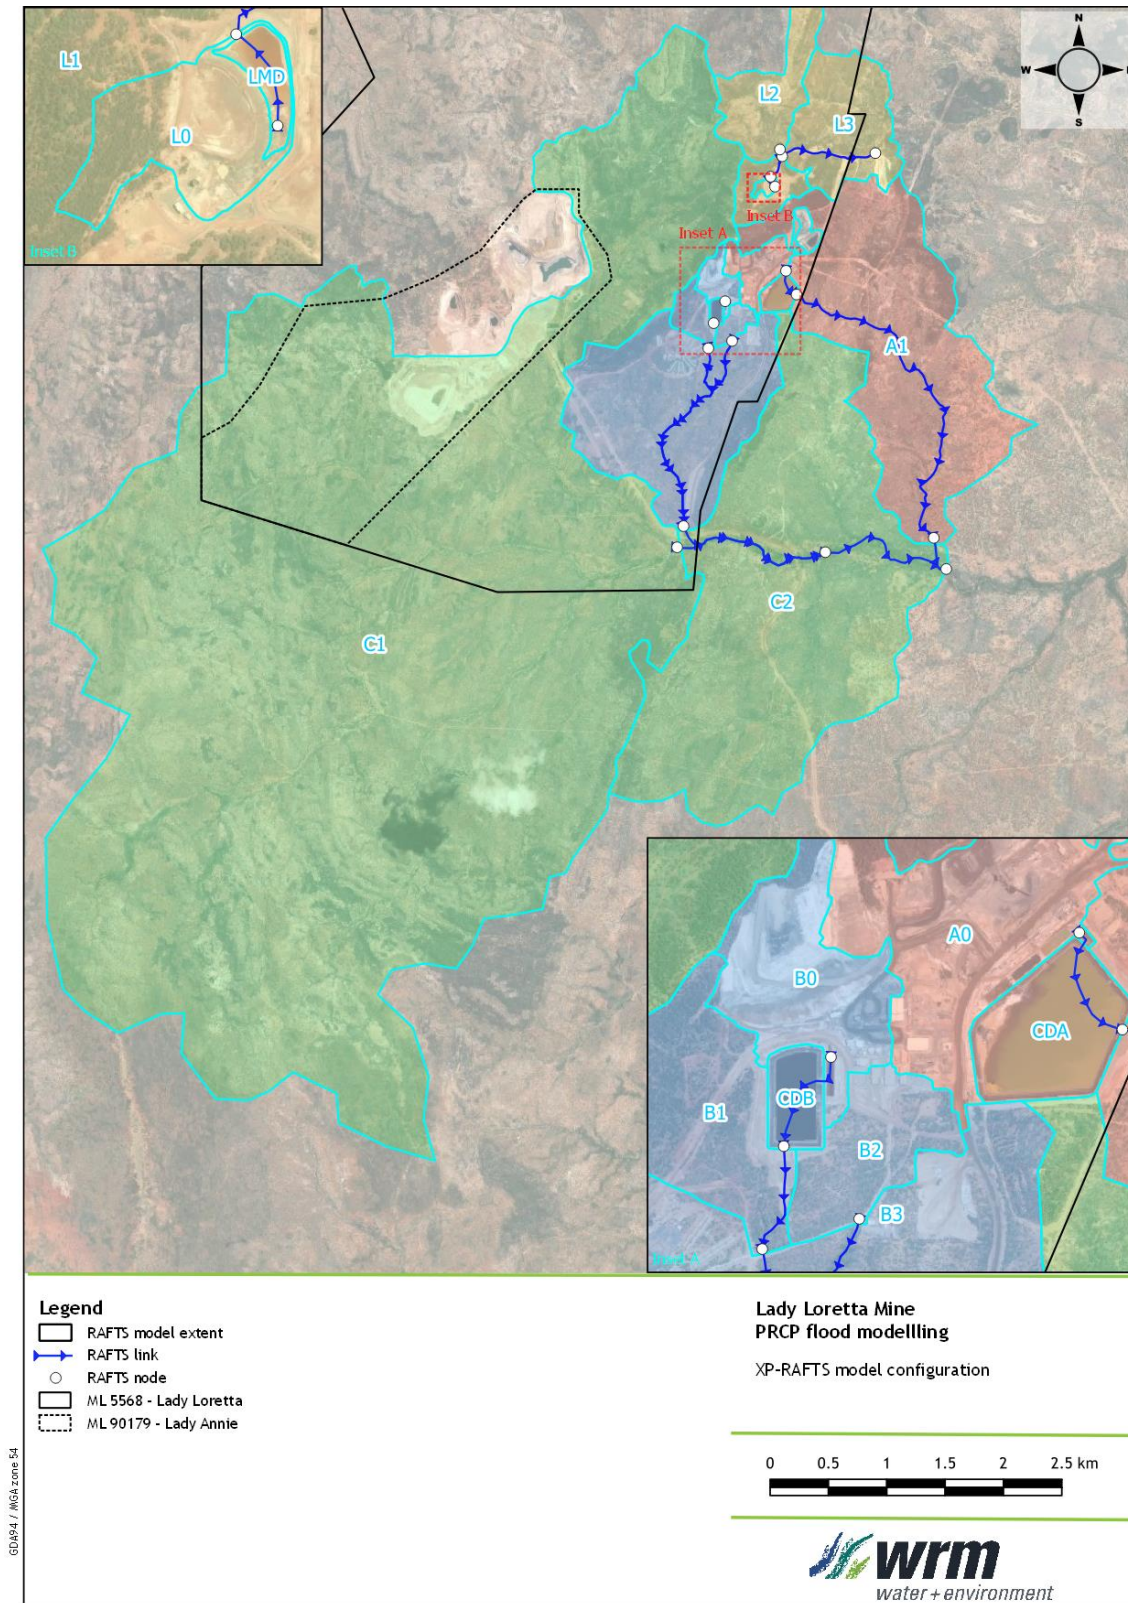
Figure 5.1 - XP-RAFTS hydrologic model configuration

Figure 5.1 shows the Desert Creek hydrologic model configuration. The model covers the entire Desert Creek and Magazine Creek catchments to their common confluence and consists of 15 sub-catchments. Table 5.1 provides a description of each catchment as well as the adopted catchment parameters.

A uniform rainfall depth and temporal pattern were assumed over the entire catchment. Rainfall losses (initial loss /continuing loss) across the catchment were assumed to be uniform.

The XP-RAFTS model was run for the 50% AEP, 1% AEP, 0.1% AEP and PMF flood events for the 10-minute hour to 6 hour storm durations to determine the catchment design hydrographs. Table 5.4 summarises the XP-RAFTS model predicted peak discharges at key locations for each event (refer to Figure 5.1).

The XP-RAFTS design discharges estimated in Section 5.1.7 for Desert Creek (node C1 in Figure 5.1) were validated to design discharges estimated using two methodologies:

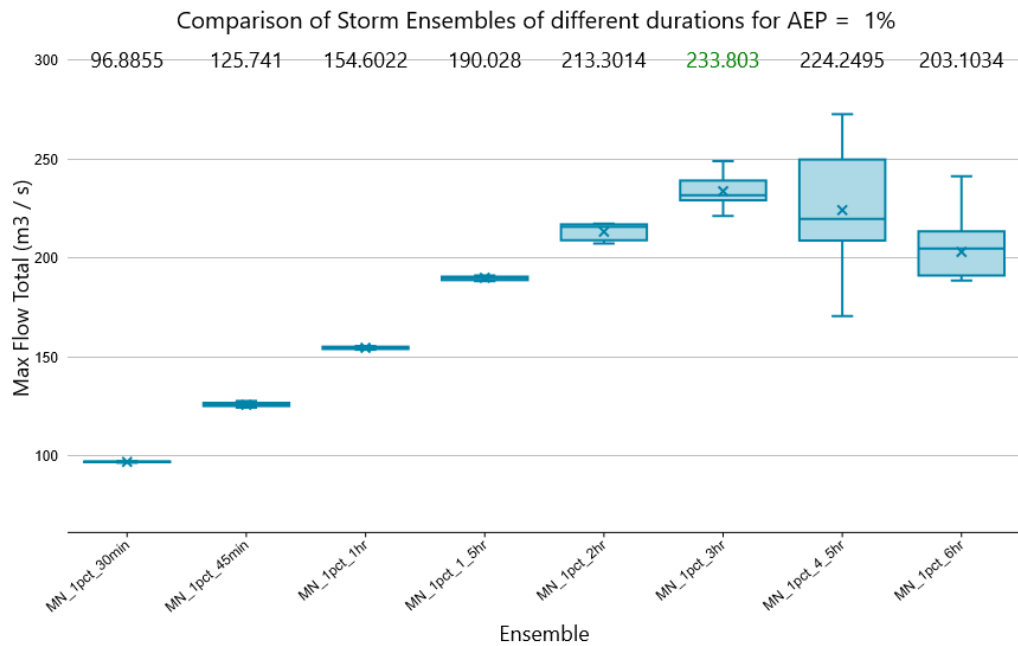
Figure 5.2 - Distribution of 1% AEP design peak discharges at Desert Creek

To illustrate the variation in peak discharges from the ensemble of 10 temporal patterns for each storm duration, Figure 5.2 provides box and whisker plots (box plots) showing the distribution of peak discharges in Desert Creek for the 1% AEP event. For each duration, the rectangle box represents the 25%ile and 75%ile (1<sup>st</sup> and 3<sup>rd</sup> quartile, the interquartile range or IQR) bound of the estimate. The horizontal lines at the top and bottom (whiskers) represent the upper and lower estimates for 1.5 times the IQR. The horizontal line within the box is the median value and the “X” represents the mean value, the value of which is shown above the box plots (critical in green).

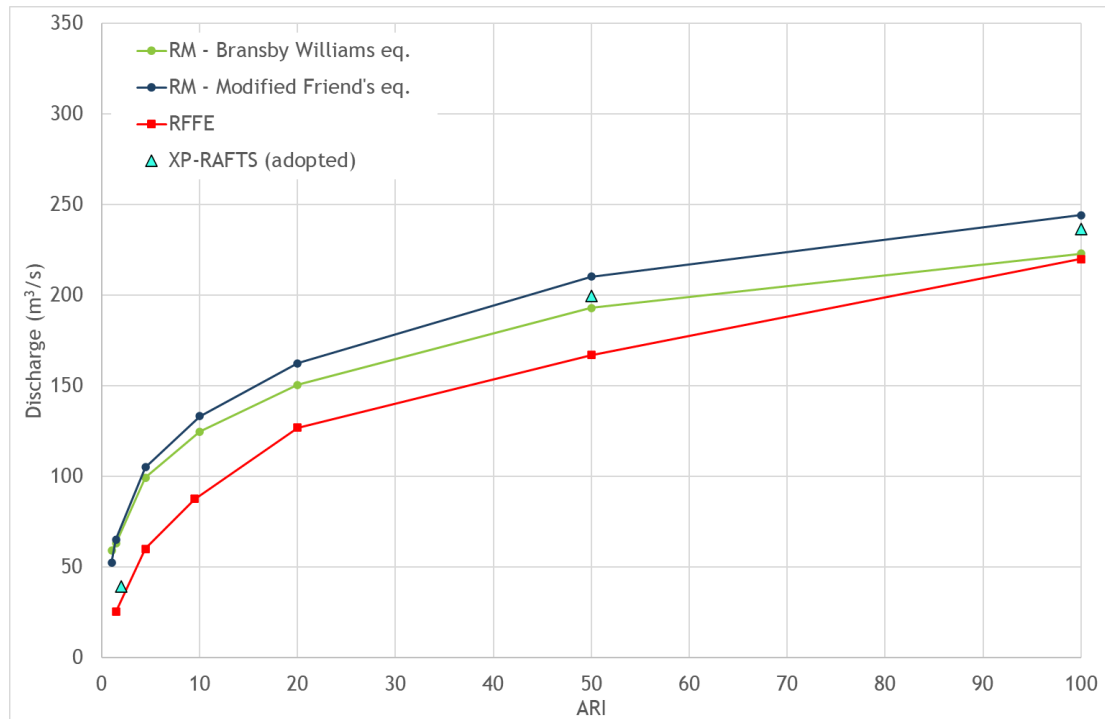
Figure 5.3 - Rational Method and RFFE discharge validation for Desert Creek

As per the ARR (2019) guidelines, the Rational Method is valid only up to and including the 1% AEP event. Validation was carried out for the 50% AEP, 2% AEP and 1% AEP event and additionally confirmed against a RFFE assessment. A summary of the validation assessments undertaken is shown in Table 5.5 and Figure 5.3. A good agreement with the peak discharges predicted by the Rational Method was achieved. Therefore, the adopted model parameters are considered suitable for this assessment.

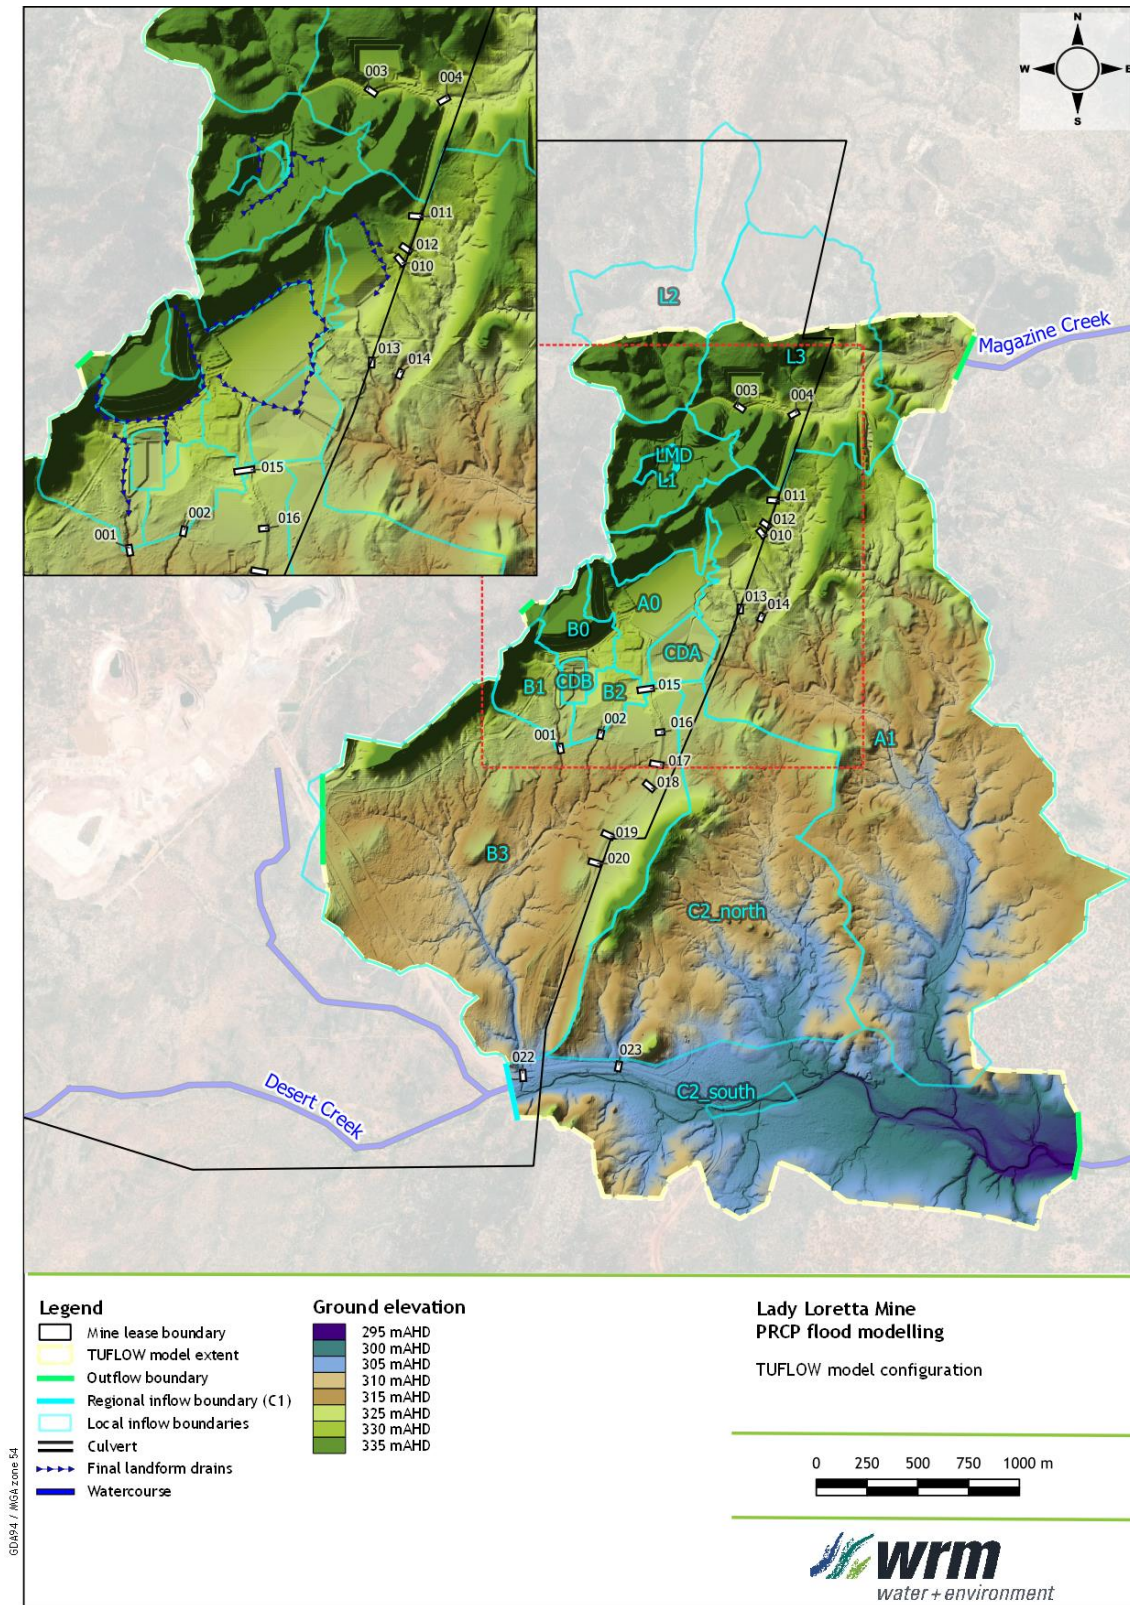
Figure 6.1 - TUFLOW hydraulic model configuration (final landform)

Figure 6.1 shows the spatial extent and configuration of the TUFLOW hydraulic model developed for this study. The model covers an area of 10.93 km<sup>2</sup> and extends:

The discharge hydrographs estimated using XP-RAFTS were applied at 16 inflow locations throughout the model. Figure 6.1 shows the locations of the inflow polygons. The regional inflow boundary for Desert Creek was configured as a 2D boundary condition (BC) at the code boundary to the west. The local model inflow boundaries were configured using 2D surface area (SA) polygons. Inflow hydrographs at these locations were applied equally distributed across all active cells within a given subarea, effectively applying runoff to all areas within the model extent. The model inflow approach was validated by comparing design discharges against those estimated by the hydrologic model. Peak flows were found to be generally similar (less than 5% to 10% difference). These small differences were expected to occur and were considered acceptable when accounting for storage and breakout flows represented in the hydraulic model that were not represented in the hydrologic model.

Figure 6.1 shows the locations of key hydraulic structures included in the TUFLOW model. Details of the hydraulic structures are based on information and photographs provided by LLM personnel and the available topographic information as well as aerial imagery.

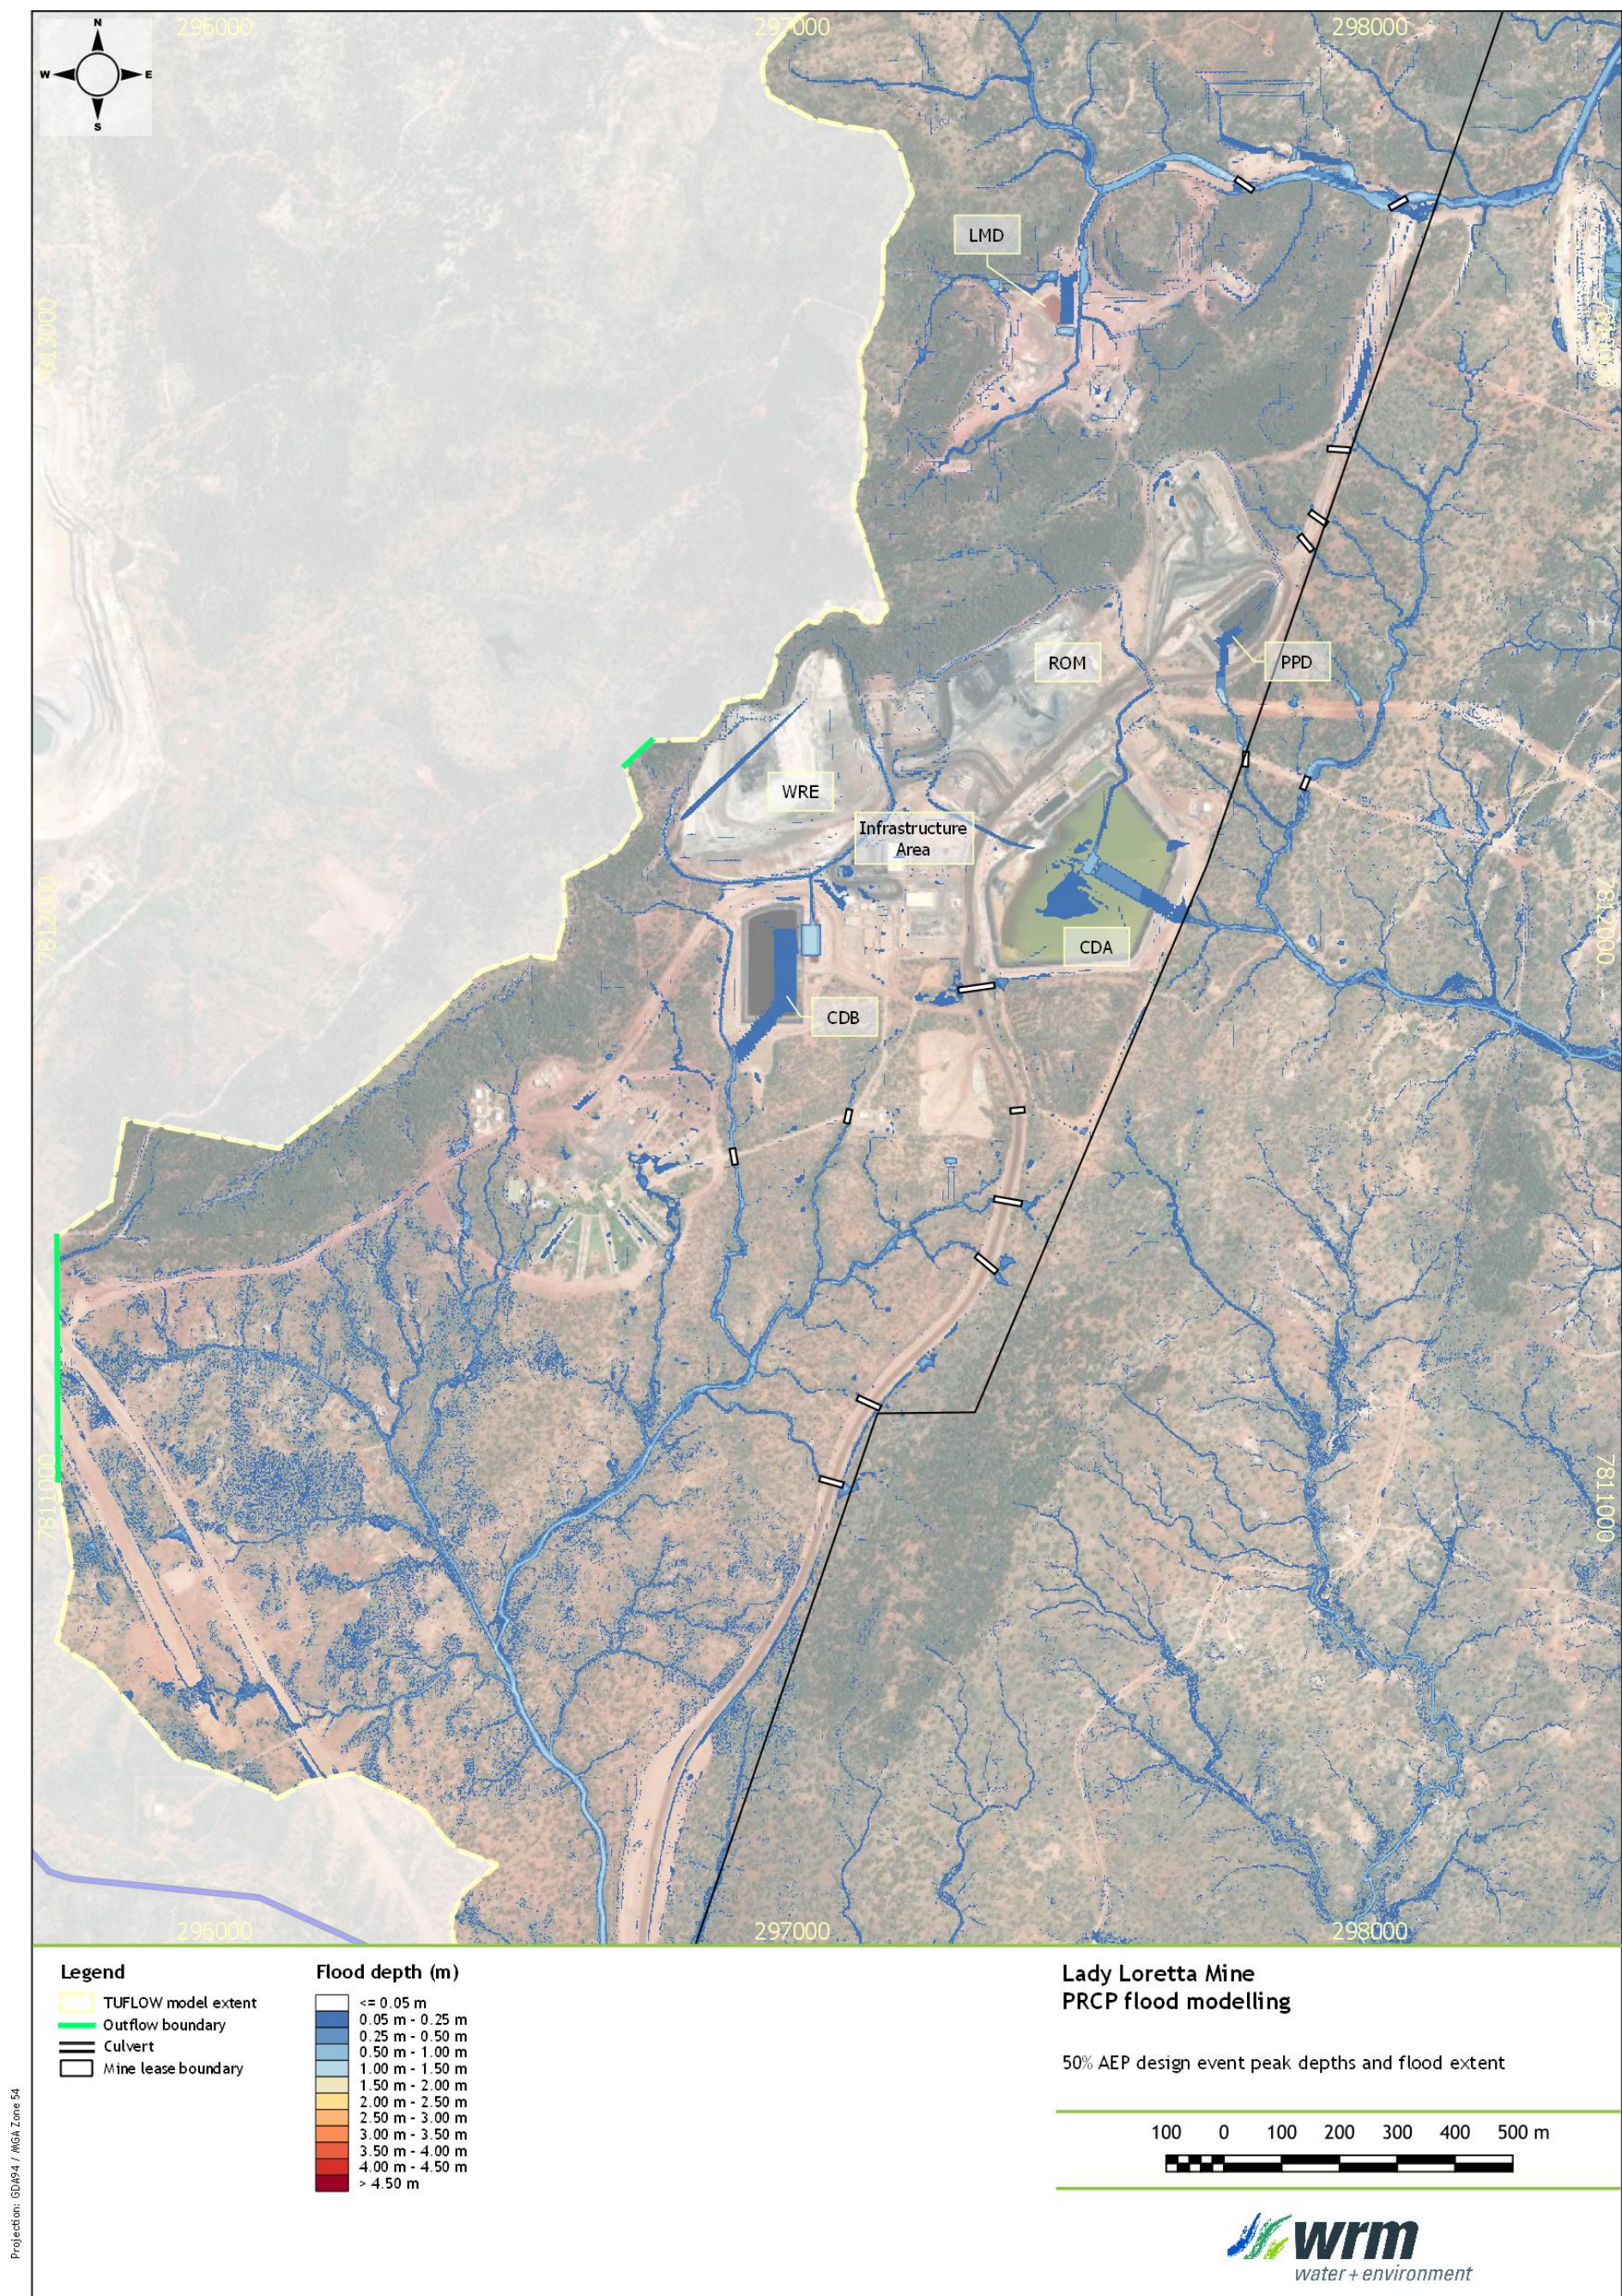
Figure 7.1 - Predicted 50% AEP peak flood depths in the vicinity of the Mine for post-mining conditions

- Peak velocities along the proposed final landform drain east of the Waste Rock Emplacement are up to 2.5 m/s.
  - Peak velocities in the natural drainage line downstream of the LMD landform are up to 2.5 m/s.
