LADY LORETTA

## **Z-LLM-HSEC-PLN-Progressive Rehabilitation and Closure Plan**

| Project Name | Lady Loretta Mine |
| Document Title | Z-LLM-HSEC-PLN-Progressive Rehabilitation and Closure Plan |

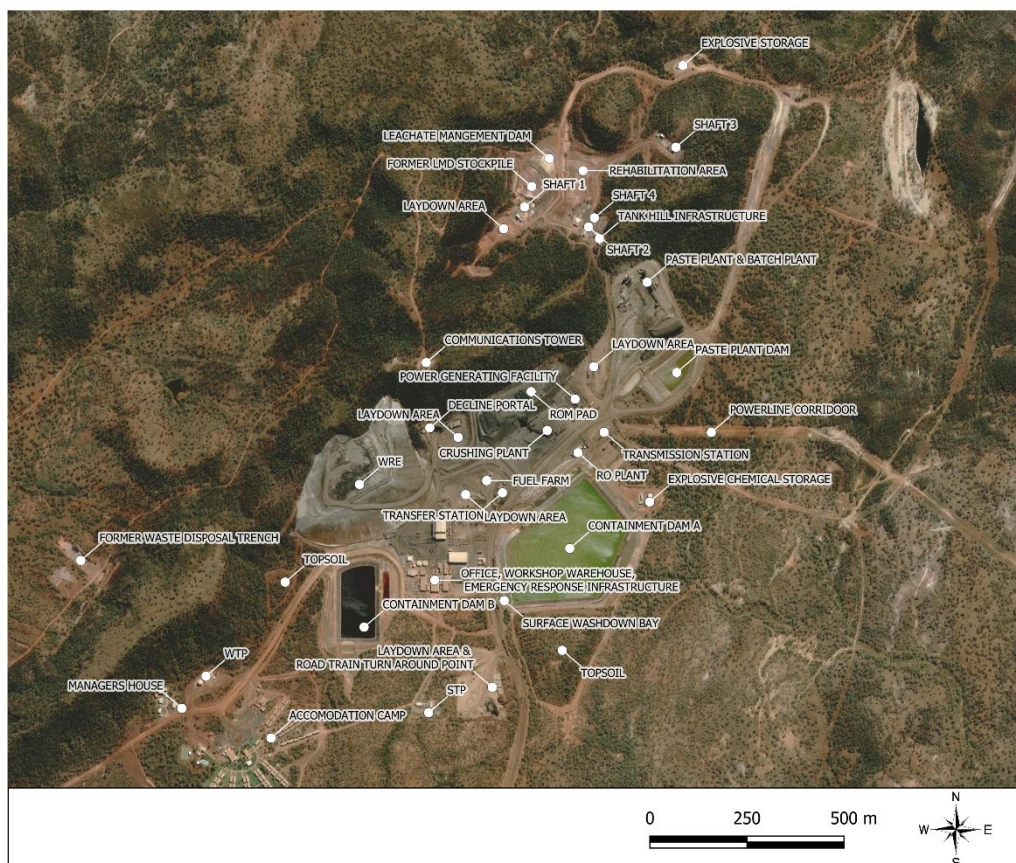
**MAP 1: SITE LAYOUT**

Other waste rock removed during underground excavations and construction is characterised and selectively handled depending on its geochemical and geophysical properties. Non-acid forming (NAF) waste rock removed during the construction of the decline in 2011 was transported to the surface forming construction of the ROM Pad. Non-NAF material is placed in the purposely designed Waste Rock Emplacement (WRE). A second, smaller potential acid-forming (PAF) waste rock stockpile was created during exploration phases between 1986 and 1987 (during the construction of Shaft 1) and stored adjacent to the leachate management dam (LMD). This stockpile has recently been removed and transported to the WRE. The current site layout is shown in **MAP 1**.

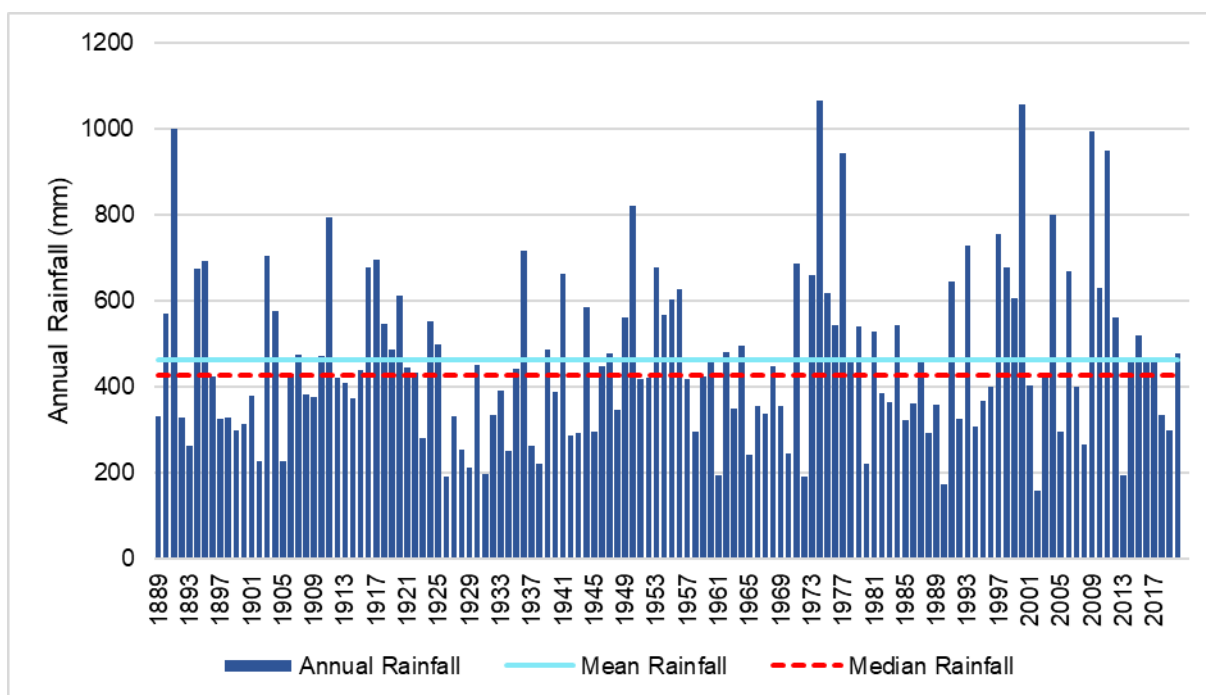
**DIAGRAM 1: TOTAL ANNUAL RAINFALL**

**DIAGRAM 1** shows that annual rainfall is extremely variable, and has historically ranged between 160 mm and 1,070 mm, with the long-term average in the order of 460 mm. **DIAGRAM 2** shows that annual evaporation has ranged between approximately 2,700 mm and 3,500 mm, with average annual evaporation (2,880 mm) exceeding average annual rainfall by a factor of approximately 6.2.

The SILO Data Drill annual rainfall and evaporation totals based on the available historical record (noting that evaporation data is only available from 1968) are presented in **DIAGRAM 1** and **DIAGRAM 2**.

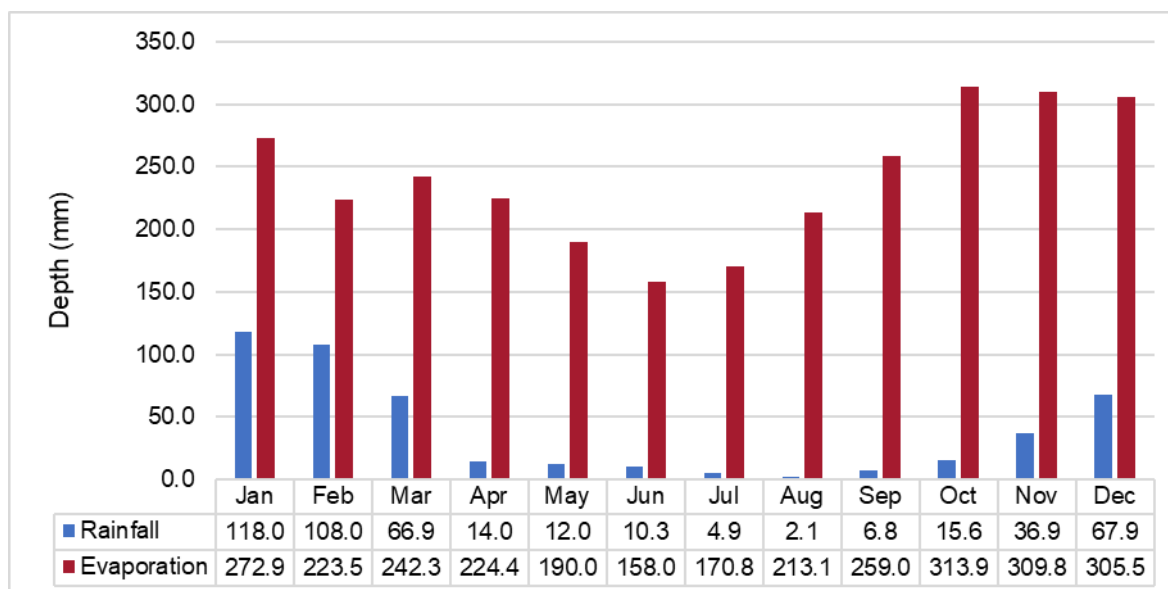
DIAGRAM 3: MONTHLY AVERAGE RAINFALL AND PAN EVAPORATION

**DIAGRAM 3** shows that the site is characterised by marked seasonal rainfall. On average most of the rainfall (85%) occurs between November and March. Average evaporation also significantly exceeds average rainfall for all months of the year.

The SILO Data Drill average monthly rainfall and pan evaporation are presented in **DIAGRAM 3**.

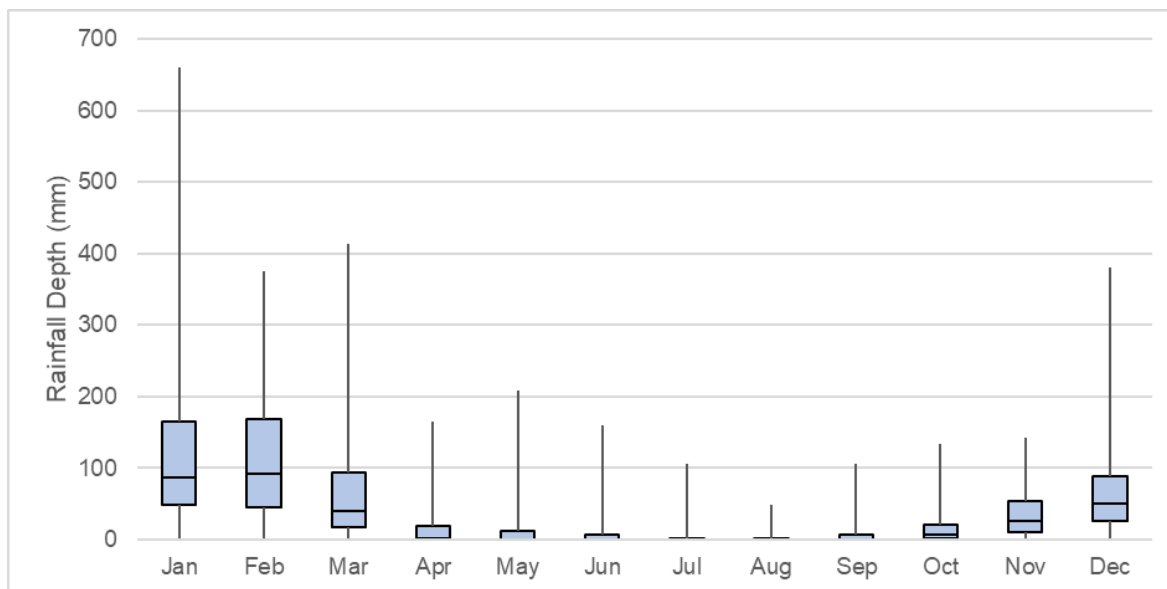
**DIAGRAM 4: RAINFALL STATISTICS (SILO DATA DRILL)**

Rainfall statistics are presented as box and whisker plots in **DIAGRAM 4**. The box and whisker plot depicts the following:

**DIAGRAM 4** shows that monthly rainfall over the wet season months (December to March) is highly variable.

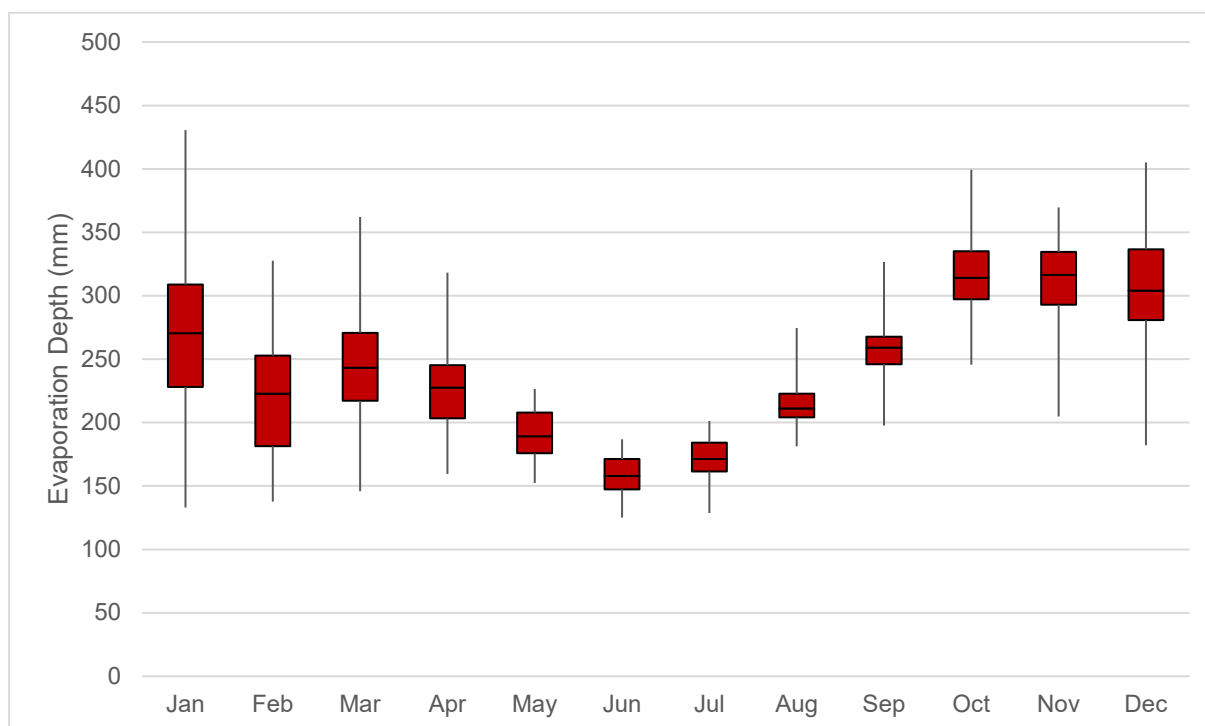
**DIAGRAM 5: EVAPORATION STATISTICS (SILO DATA DRILL)**

**DIAGRAM 5** shows monthly variability in evaporation is similarly pronounced over the wet season month, compared to the winter months.

Evaporation statistics are presented as box and whisker plots in **DIAGRAM 5**.

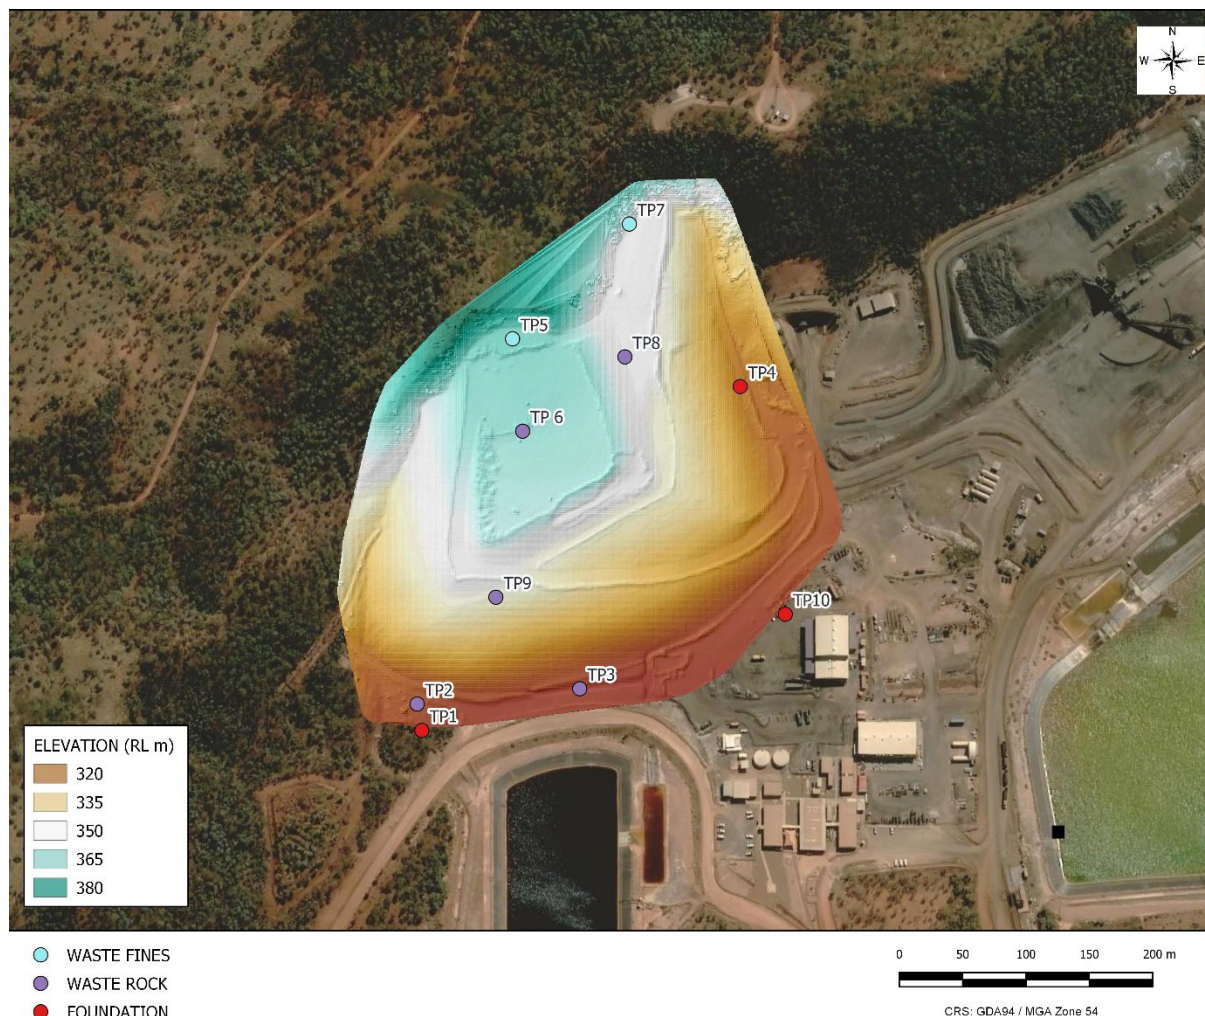
**MAP 3: WRE TEST PITTING LAYOUT**

A summary of soil types encountered during the test pitting at foundation sites is summarised as follows:

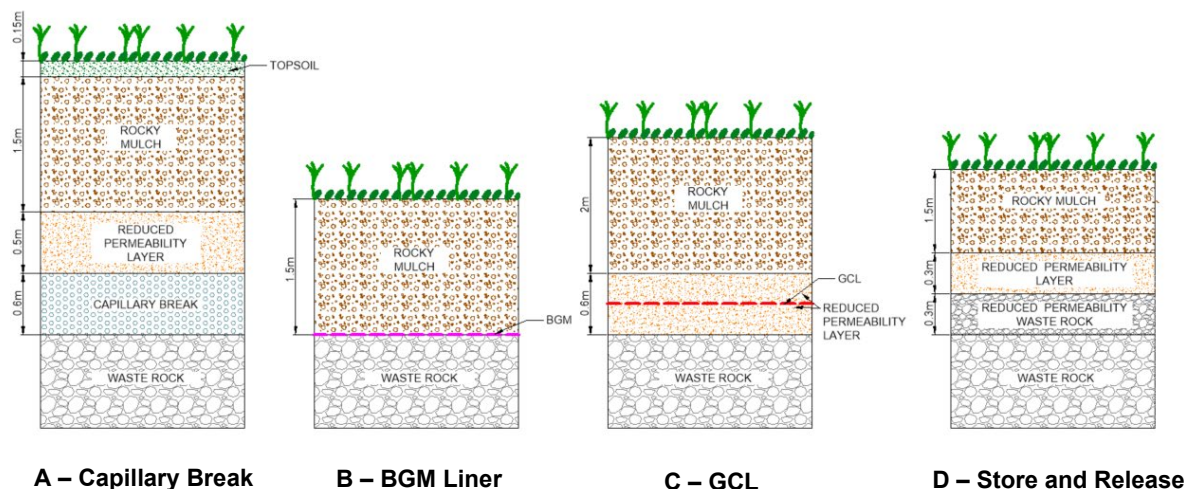
**DIAGRAM 7: COVER SYSTEM OPTIONS**

Typical profiles for each of these cover options are shown in **DIAGRAM 7**. All cover system options were deemed plausible with modelling recommended (as detailed in **Section Error! Reference source not found.**) to assess performance against closure objectives.

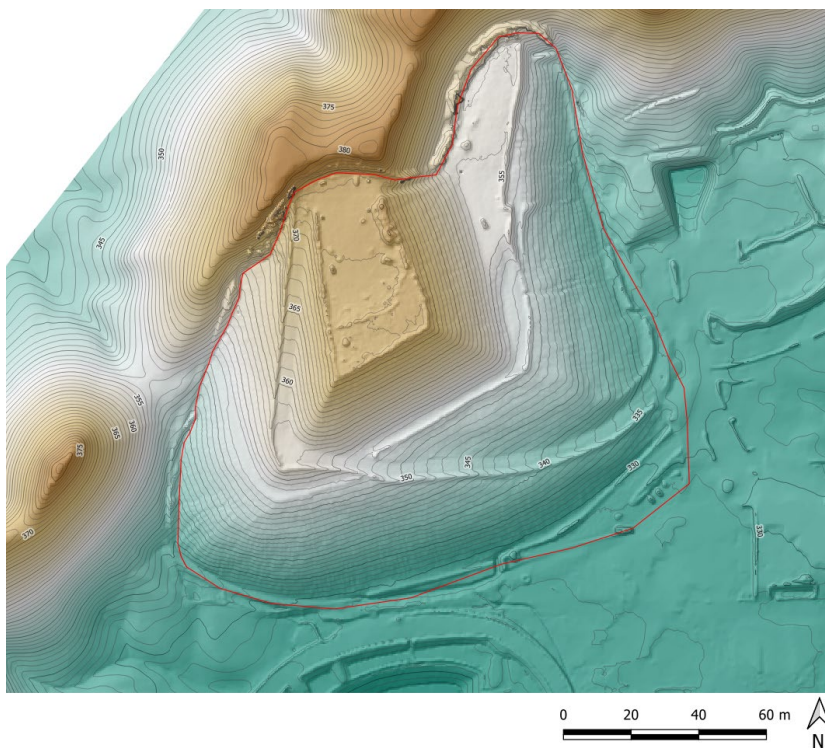
**MAP 4: LANDFORM 1**

Early concepts for each of these landform options are depicted in **MAP 4** to **MAP 6**. It is noted that further development of the preferred option was undertaken as discussed in **Section 3.4.4**.

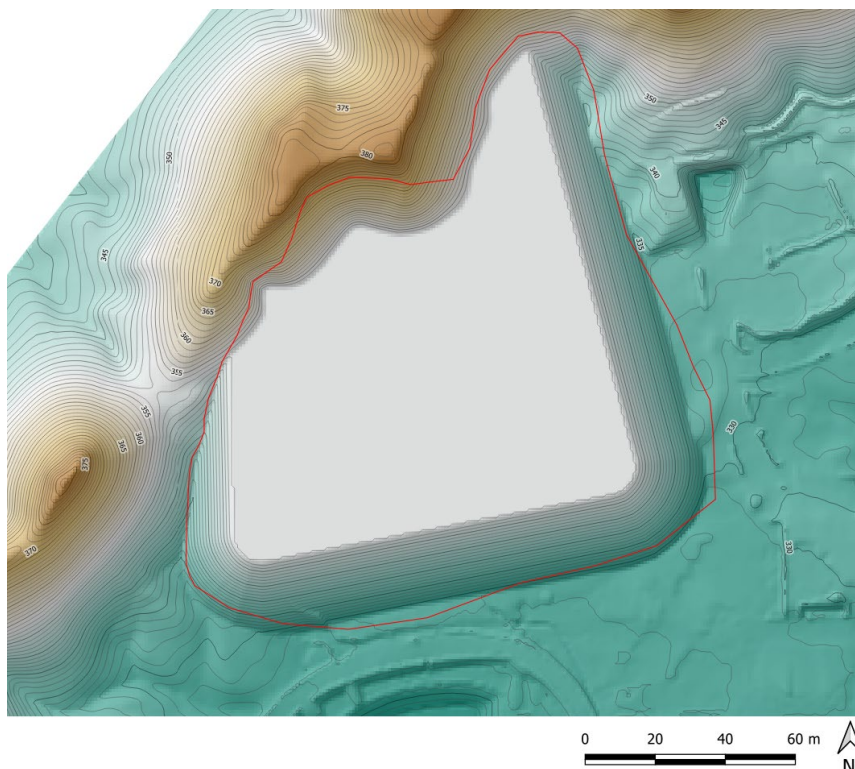
**MAP 5: LANDFORM 2**

Landform 2 was developed with the steepest slopes possible while maintaining constructability and the required factors of safety with respect to geotechnical stability (refer **Section** Error! Reference source not found.). Considerations for Landform 2 were as follows:

- Revegetation of the plateau created for Landform 2 is expected to be more successful than vegetation on slopes (e.g., for the current landform).
- Rock lined, steep batters are comparable conditions to rocky slopes, commonly observed in the surrounding landscape.
- Construction of Landform 2 during operations maximises the storage capacity available for future mine development.

Based on the assessment undertaken, Landform 2 was adopted as the preferred option for further assessment. It is noted that further development of the conceptual landform shown in **MAP 5** was undertaken to meet LOM waste volume requirements.

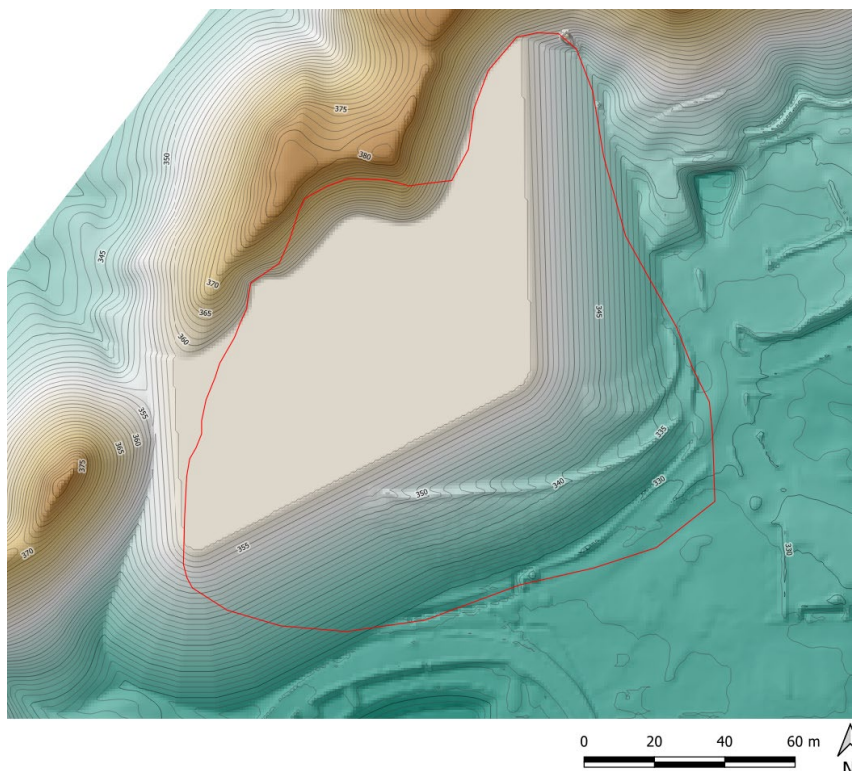
**MAP 6: LANDFORM 3**

Landform 3 was discarded noting the following:

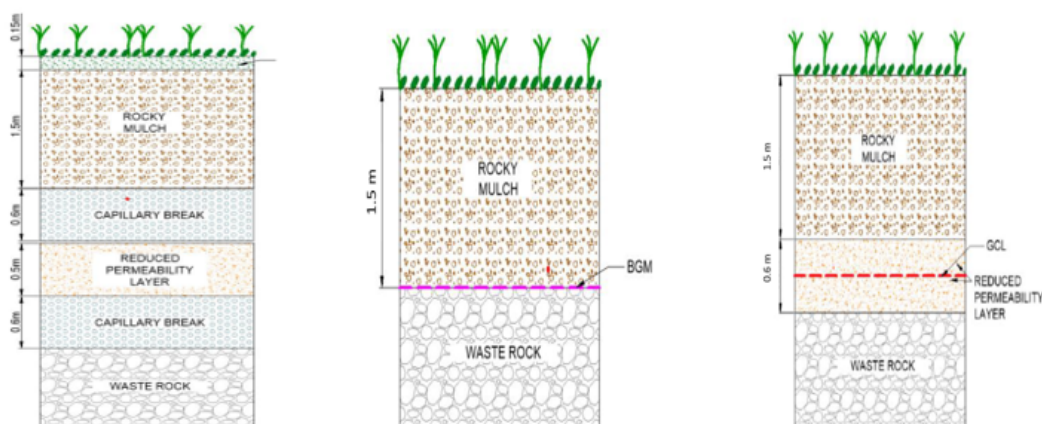
| Cover option A | Cover option B | Cover option C |
|---|---|---|
| <b>Double capillary break (CB)<sup>1</sup></b> | <b>Bituminous geomembrane liner (BGM)</b> | <b>Geosynthetic clay liner (GCL)</b> |
| <ul style="list-style-type: none"> <li>0.1-0.2 m growth media;</li> <li>1.5 m ISL (rocky mulch);</li> <li>0.6 m capillary break;</li> <li>0.5 m RPL (fine oxide); and</li> <li>0.6 m capillary break.</li> </ul> | <ul style="list-style-type: none"> <li>1.5 m ISL (rocky mulch); and</li> <li>0.3 m protective layers above (graded/crush and screen) BGM (ie free issue).</li> </ul> | <ul style="list-style-type: none"> <li>1.5 m ISL (rocky mulch);</li> <li>0.3 m protective layer above GCL (ie RPL fine oxide); and</li> <li>0.3 m protective layer below GCL.</li> </ul> |

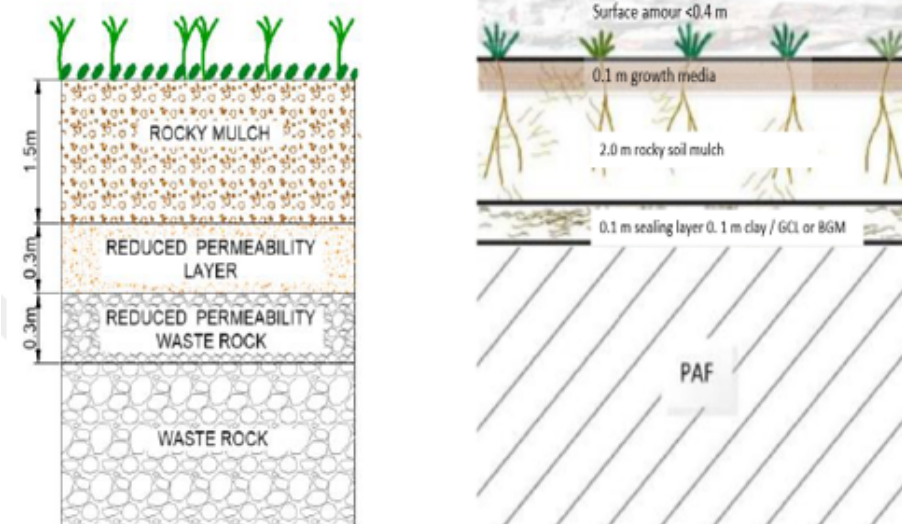
**Hybrid SRC system (hybrid cover system)**

- 0.4 m surface armour;
- 0.1 m growth media;
- 2 m rocky mulch; and
- 0.1 m clay / GCL or BGM.

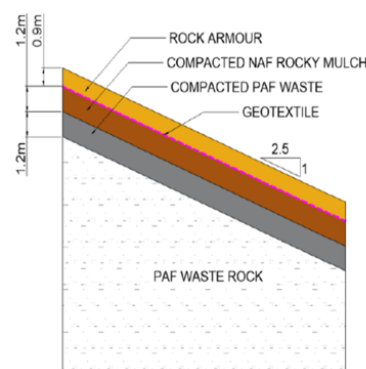
**DIAGRAM 9: MAA BATTER TREATMENT OPTIONS**

| Batter option 1 | Batter option 2 | Batter option 3 | Batter option 4 |
|---|---|---|---|
| <b>BGM (no cover)</b> | <b>BGM crest tip</b> | <b>BGM bottom-up build</b> | <b>NAF rind</b> |
| <ul style="list-style-type: none"> <li>• compacted PAF waste to reduce infiltration; and</li> <li>• BGM liner.</li> </ul> | <ul style="list-style-type: none"> <li>• 1.2 m rocky mulch.</li> </ul> | <ul style="list-style-type: none"> <li>• 1.8 m rocky soil mulch; and</li> <li>• 0.9 m rock armour.</li> </ul> | <ul style="list-style-type: none"> <li>• 1.2m compacted PAF waste (to reduce infiltration);</li> <li>• 1.2 m compacted NAF rocky mulch (graded rocky / gravelly fill to reduce infiltration in the PAF waste);</li> <li>• Geotextile (to reduce erosion of the compacted NAF rocky mulch); and</li> <li>• 0.9 m rock armour (erosion resistance layer of fresh durable rock fill).</li> </ul> |

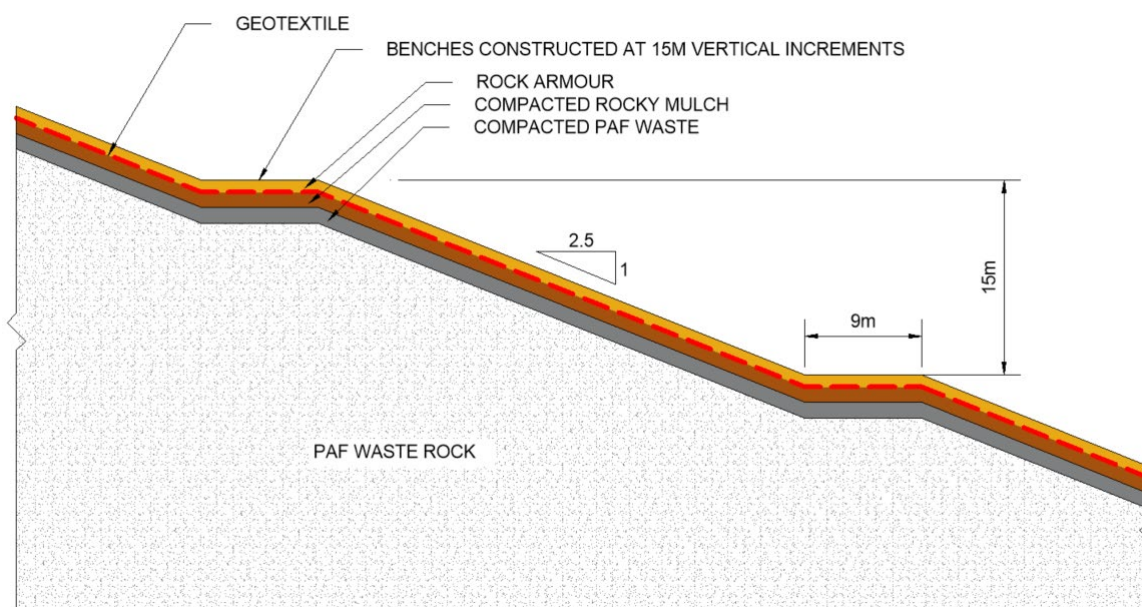
**DIAGRAM 10: NAF RIND**

The adoption of 3 m width for the compacted PAF and Rocky Mulch layers was based on the minimum working width for a compactor (assuming material will be placed in horizontal lifts). Compaction for these layers is critical for limiting infiltration and optimising erosion and geotechnical (slope) stability.

The rockfill thickness is based on achieving two to three layers of D<sub>50</sub> diameter of rock armouring (best practice), as discussed in **Section 8**. The material will need to comprise a well graded material including boulders derived from hard, dense and durable rock of sufficient diameter (anticipated maximum size of 300 to 450 mm) to ensure erosion from surface water runoff does not occur. Smaller particles (anticipated size of 30 to 100 mm) will also be required to provide structural stability and limit infiltration.

Any rainfall infiltrating through the rock armour, has potential to erode fines in the Rocky Mulch layer thereby undercutting the Rock Armour. The geotextile will limit the risk of erosion, by limiting the potential of fines washing out of Rocky Mulch layer underlying the Rock Armour.

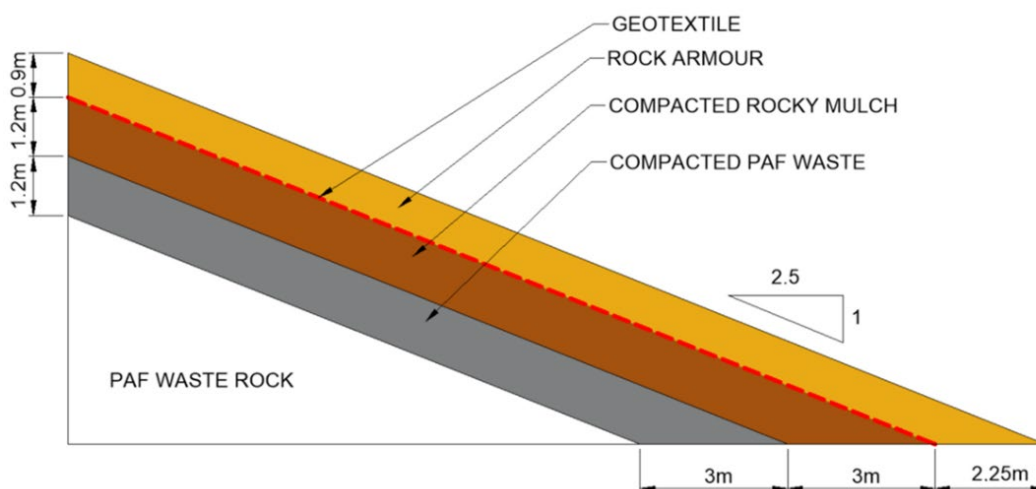
**DIAGRAM 11: NAF RIND PROFILE**

Note: Rock Armour is to extend across the benches. Gravel sheeting may be required for trafficability, however this would be assessed during Detailed Design.

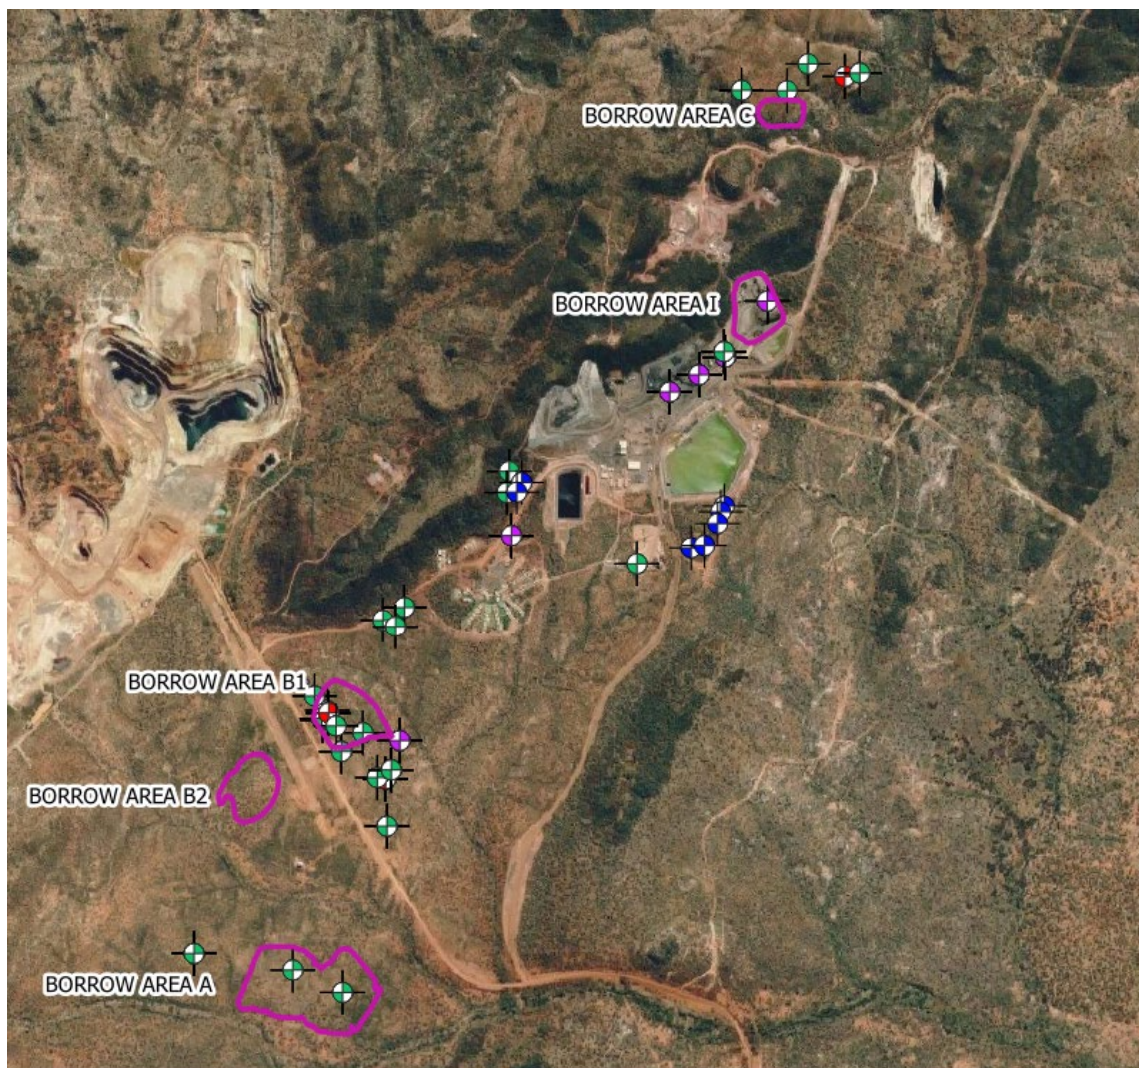
MAP 7: OPTIONAL BORROW AREAS AND INVESTIGATION LOCATIONS

RMSAP Stage 1 & 2 Sample Locations

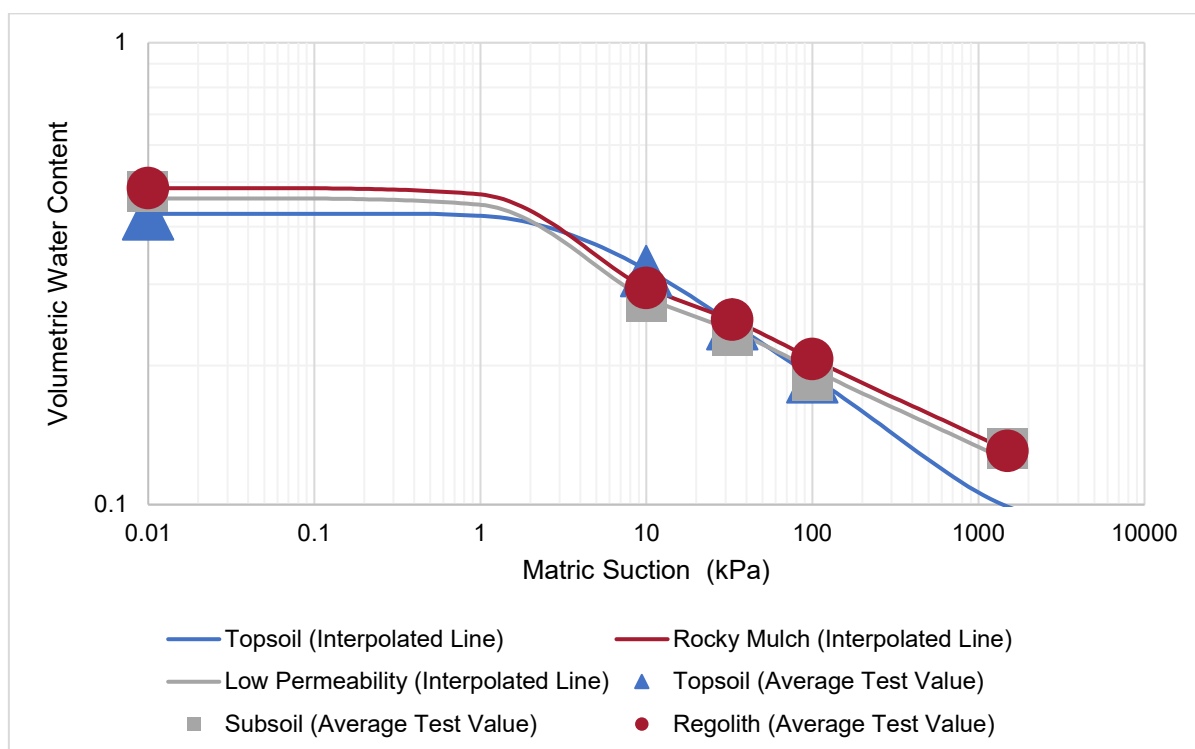
**GRAPH 1: SOIL WATER CHARACTERISTIC CURVES**

The volumetric water content was tested at 0, 10, 33, 100 and 1,500 kpa as plotted in **GRAPH 1** below. For the purposes of modelling, a line was interpolated within the data points, also shown in **GRAPH 1**. With reference to the pressures tested in the soil water characteristic curve, 33 kpa is considered the field capacity, with 1,500kpa being the permanent wilting point. The amount of water available to plants is the difference between the field capacity and the wilting point.

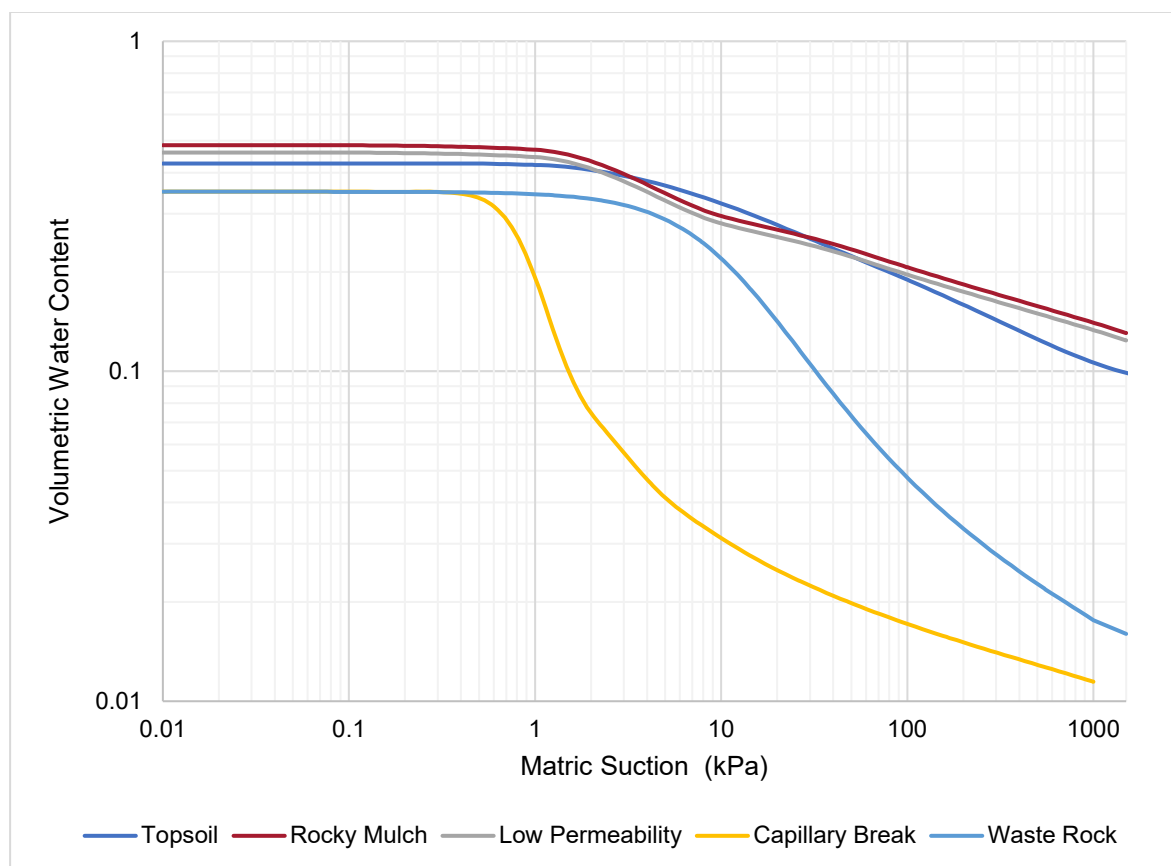
## GRAPH 2: SOIL WATER CHARACTERISTIC CURVES

Generated soil water characteristics curves and permeability curves are depicted in **GRAPH 2** and **GRAPH 3** respectively.

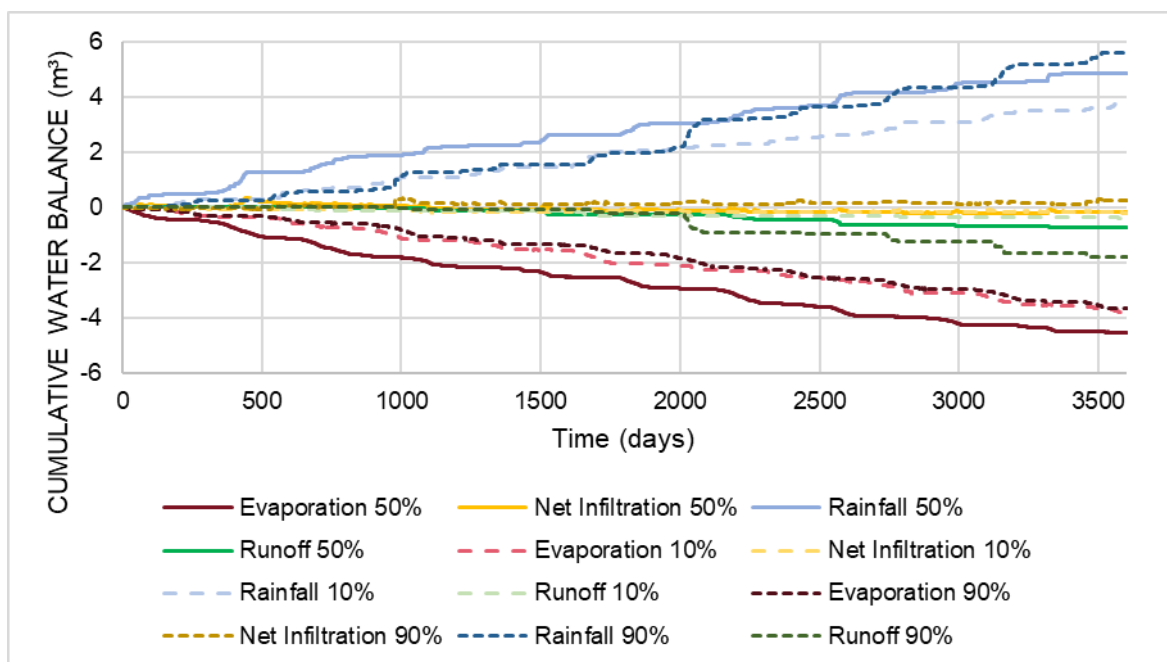
**GRAPH 4: CAPILLARY BREAK: WATER BALANCE**

Model results indicate zero flux through the base of the cover system into the waste rock, similarly no upward flux is measured.

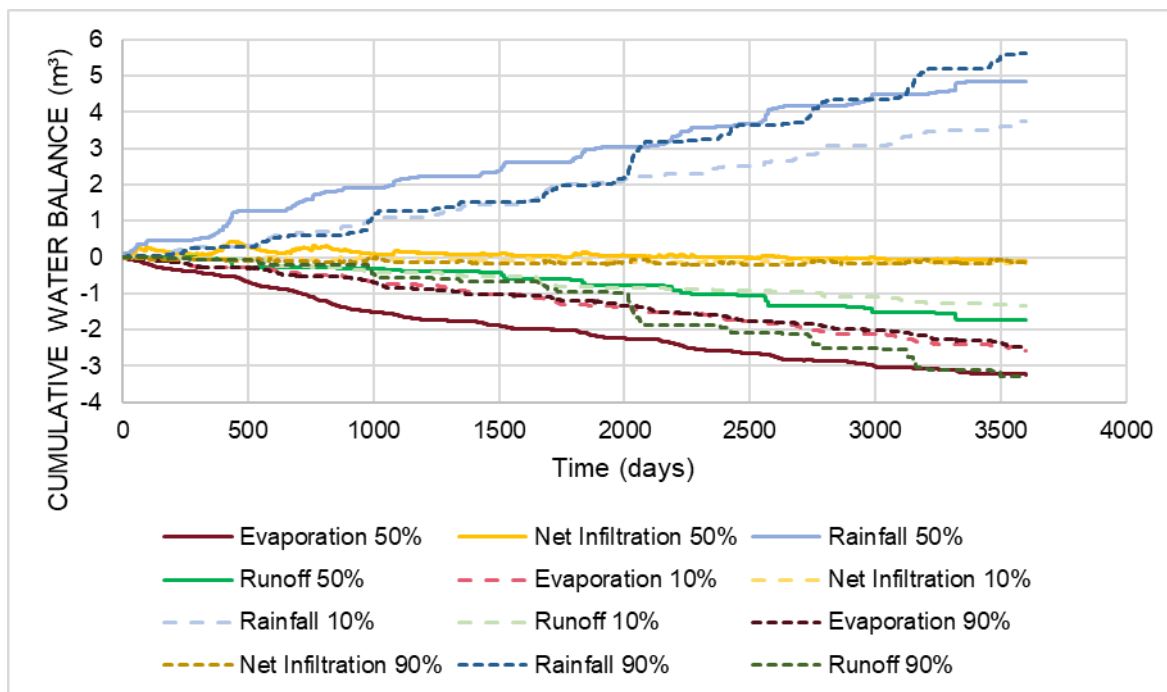
GRAPH 7: BGM: WATER BALANCE

Model results (refer **TABLE 12**) indicate approximately 35.9% and 35.6% of the rainfall reports as runoff for the dry and average rainfall conditions respectively. The runoff rate for the wet conditions is significantly higher at around 58%, with more frequent, higher intensity rainfall events producing more runoff than is generated for model scenarios with lower rainfall. The net infiltration for all scenarios is less than zero, meaning all rainfall infiltration is lost through evaporation rather than seeping through the model profile. The evaporative losses as a percentage of total rainfall are high for the dry and average scenarios (around 69 and 66% respectively), with a lower percentage for the wet scenario (44%). It is noted that the total evaporation depth for each scenario is similar, with the difference in percentage due to the higher rainfall depth of the wet scenario.

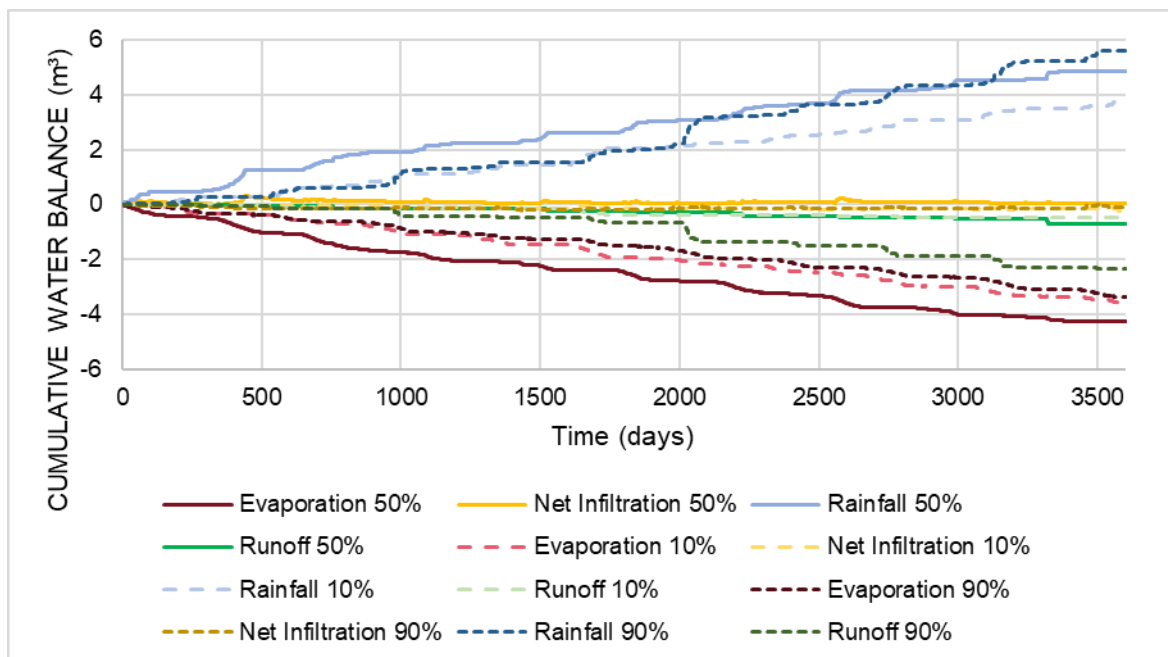
**GRAPH 10: STORE AND RELEASE 1.5M: WATER BALANCE**

Model results (refer **TABLE 13**) indicate some 12% and 14% of the rainfall reports as runoff for the dry and average rainfall conditions respectively. The runoff rate for the wet conditions is significantly higher at around 40%, with more frequent, higher intensity rainfall events producing more runoff than is generated for model scenarios with lower rainfall. The net infiltration for all scenarios is low meaning the majority of all rainfall infiltration is lost through evaporation rather than seeping through the model profile. The evaporative losses as a percentage of total rainfall are high for the dry and average scenarios (around 80%), with a lower percentage for the wet scenario. It is noted that the total evaporation depth for each scenario is similar, with the difference in percentage due to the higher rainfall depth of the wet scenario.

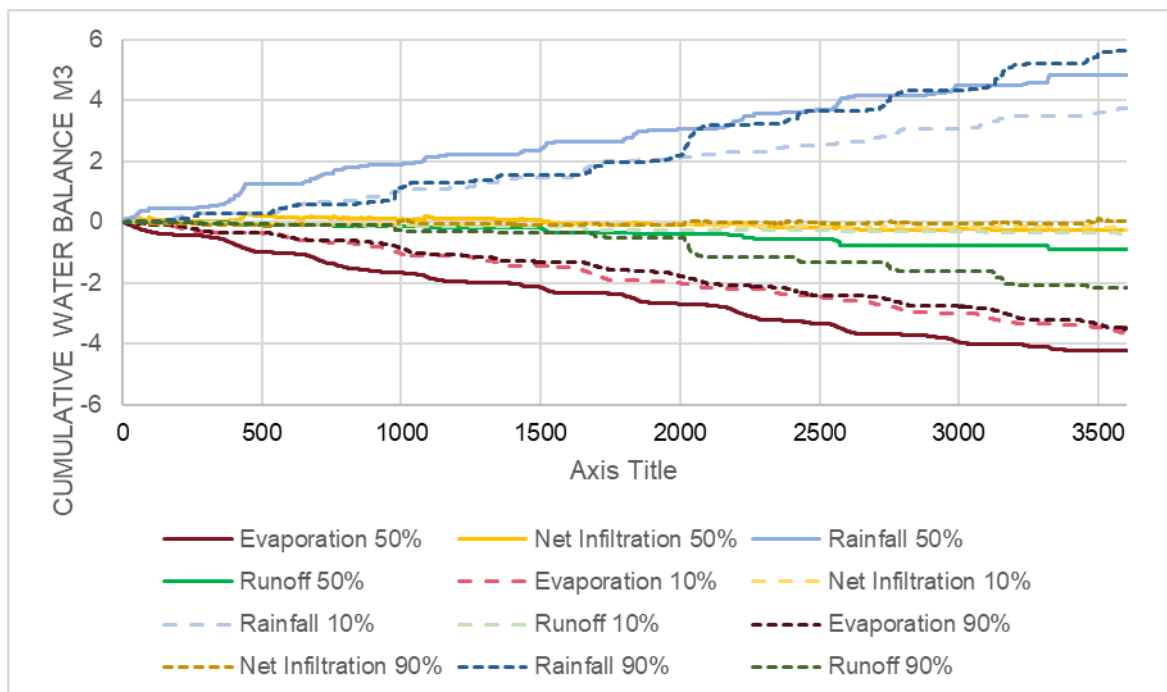
**GRAPH 13: STORE AND RELEASE 2M: WATER BALANCE**

Model results (refer **TABLE 14**) indicate approximately 9% and 17% of the rainfall reports as runoff for the dry and average rainfall conditions respectively. The runoff rate for the wet conditions is significantly higher at around 38%, with more frequent, higher intensity rainfall events producing more runoff than is generated for model scenarios with lower rainfall. The net infiltration is minimal for all scenarios meaning the majority of all rainfall infiltration is lost through evaporation rather than seeping through the model profile. The evaporative losses as a percentage of total rainfall are high for the dry and average scenarios (around 85% to 78%), with a lower percentage for the wet scenario (62%). It is noted that the total evaporation depth for each scenario is similar, with the difference in percentage due to the higher rainfall depth of the wet scenario.

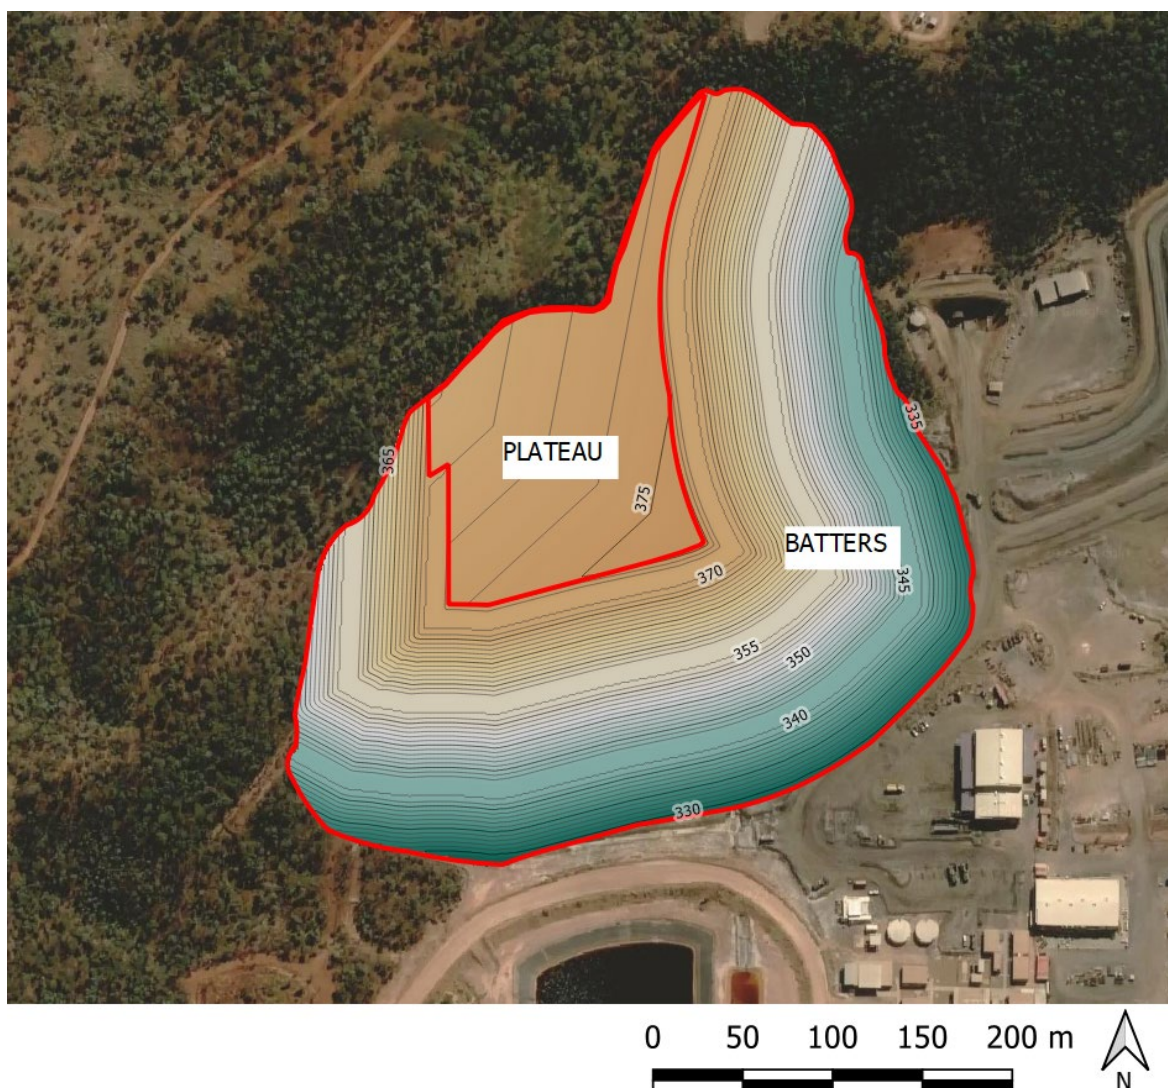
**MAP 8: PLATEAU AND BATTER AREAS**

A schedule of quantities is provided in **TABLE 16** based on the adopted final conceptual landform configuration shown in **MAP 8**.

Plateau Area: 1.7 ha

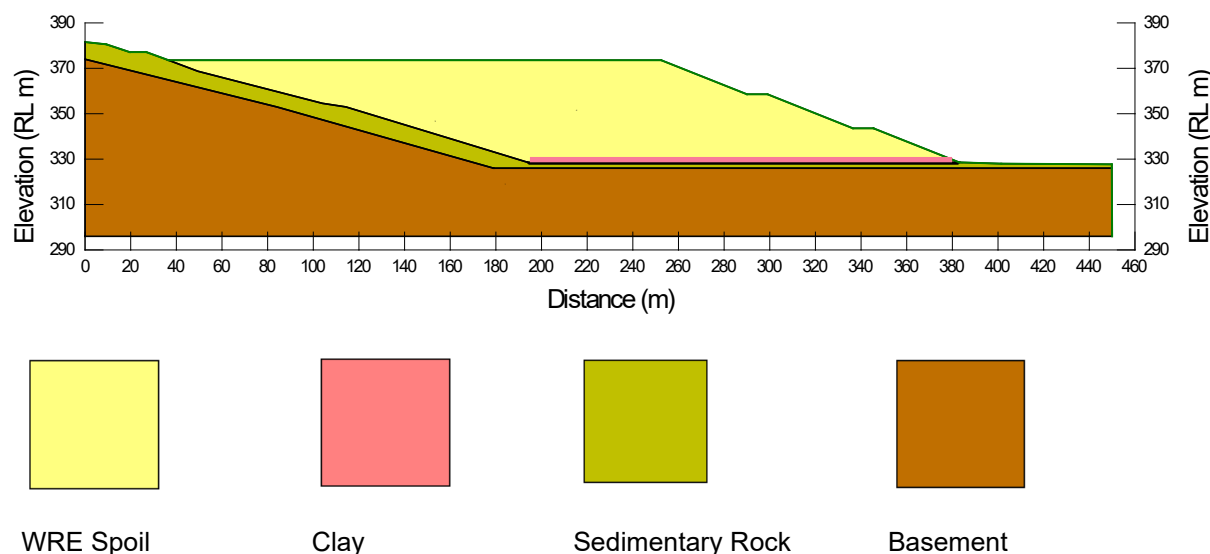
**DIAGRAM 12: WRE CONFIGURATION**

The Geometric configuration for modelling is as shown in **DIAGRAM 12**.

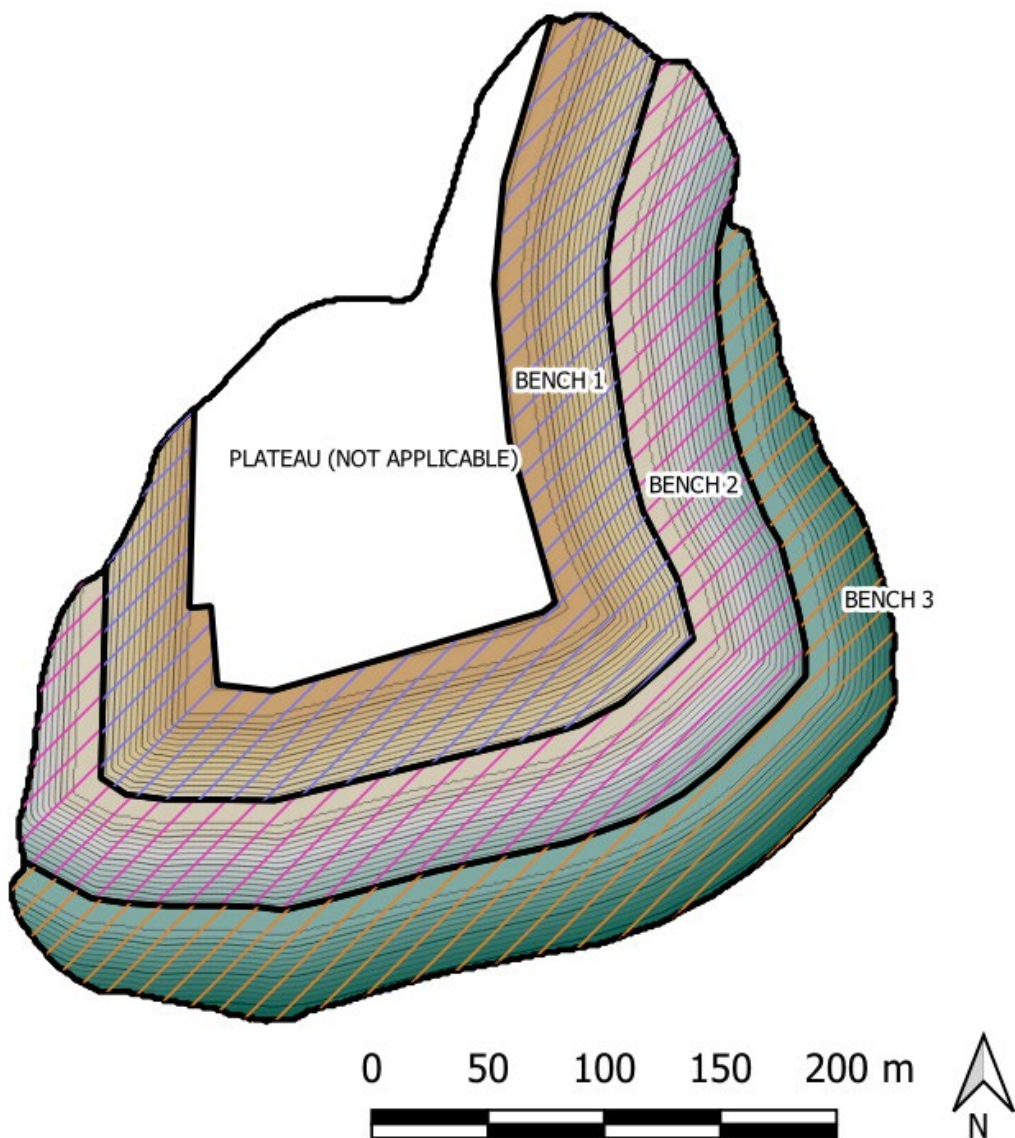
**MAP 10: BATTER AREAS**

The exact extents for the rock armouring would be determined during detailed design. This would include consideration around rock aprons at the toe, trafficability of the benches, number of layers and grading envelope to achieve interlocking and fill voids in between D50 rock. These aspects would be confirmed during detailed design.
