LADY LORETTA

## **Z-LLM-HSEC-PLN-Progressive Rehabilitation and Closure Plan**

| Project Name | Lady Loretta Mine |
| Document Title | Z-LLM-HSEC-PLN-Progressive Rehabilitation and Closure Plan |

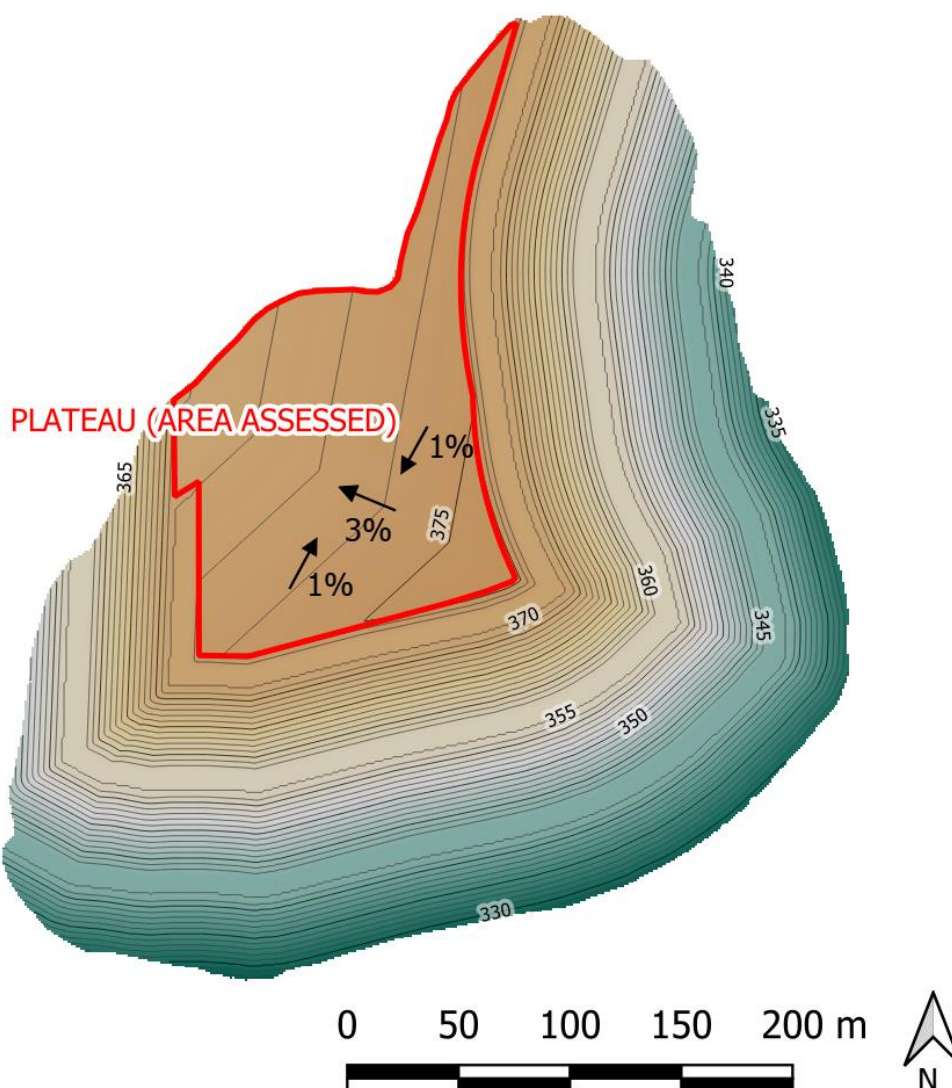
Figure 1: Landform Geometry

The purpose of WEPP modelling is to estimate the soils loss, based on site climate, soil characteristics, expected vegetation conditions and catchment geometry.

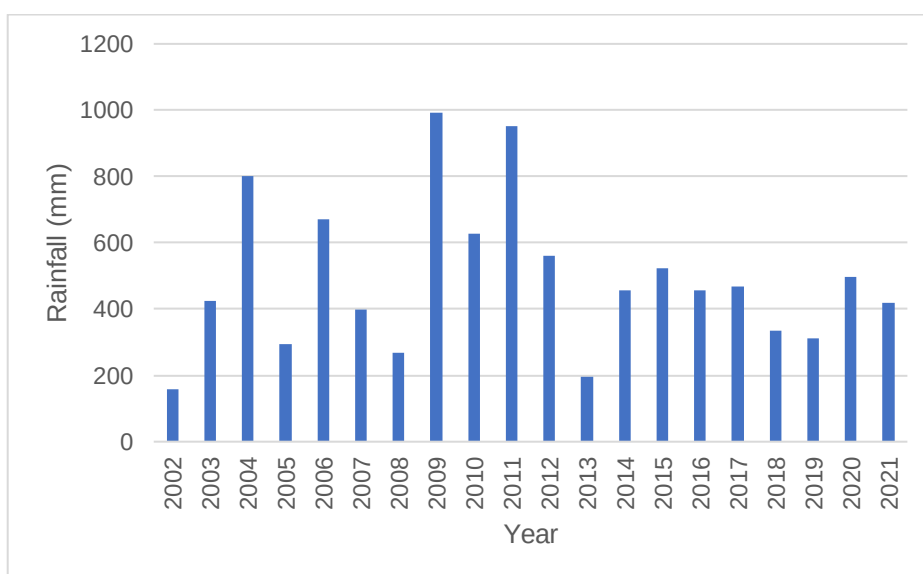
**Figure 2: Annual Rainfall**

Twenty years of SILO data for Mt Isa, from the years 2002 to 2021, was used in the simulation. The annual rainfall for the years 2002 to 2021 are shown in **Figure 19**. The modelled period includes years of low rainfall (2002, 160mm) and high rainfall (2009, 992mm),

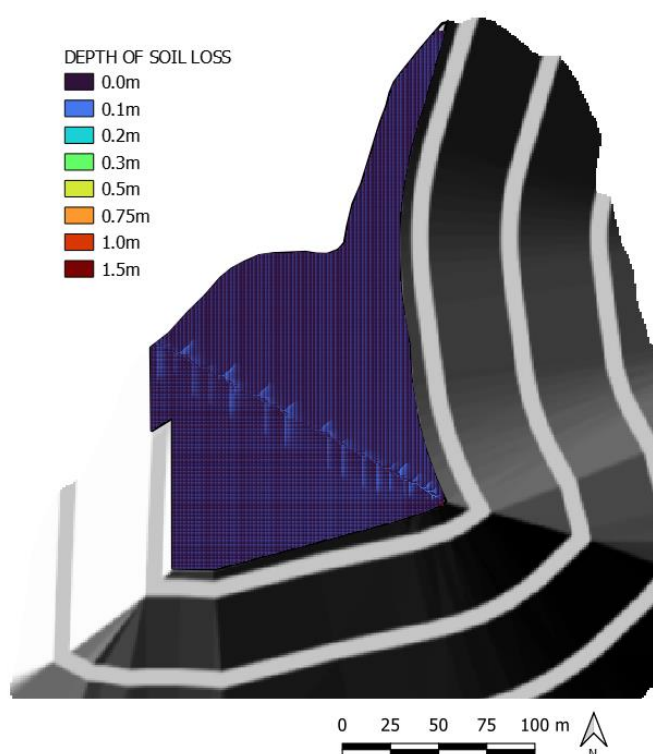
**Figure 3: WRE PLATEAU – 100Y EROSION**

Model results indicate expected rates of erosion are unlikely to impact the performance of the cover system. Based on the modelling outcomes, the thickness of the proposed cover system in addition to the proposed geometry is suitable for closure. It is further noted that the SIBERIA model assumes a uniform surface and does not account for surface texture, created at closure. Creating a loose, hummocky surface is critical to minimising surface runoff and erosion.

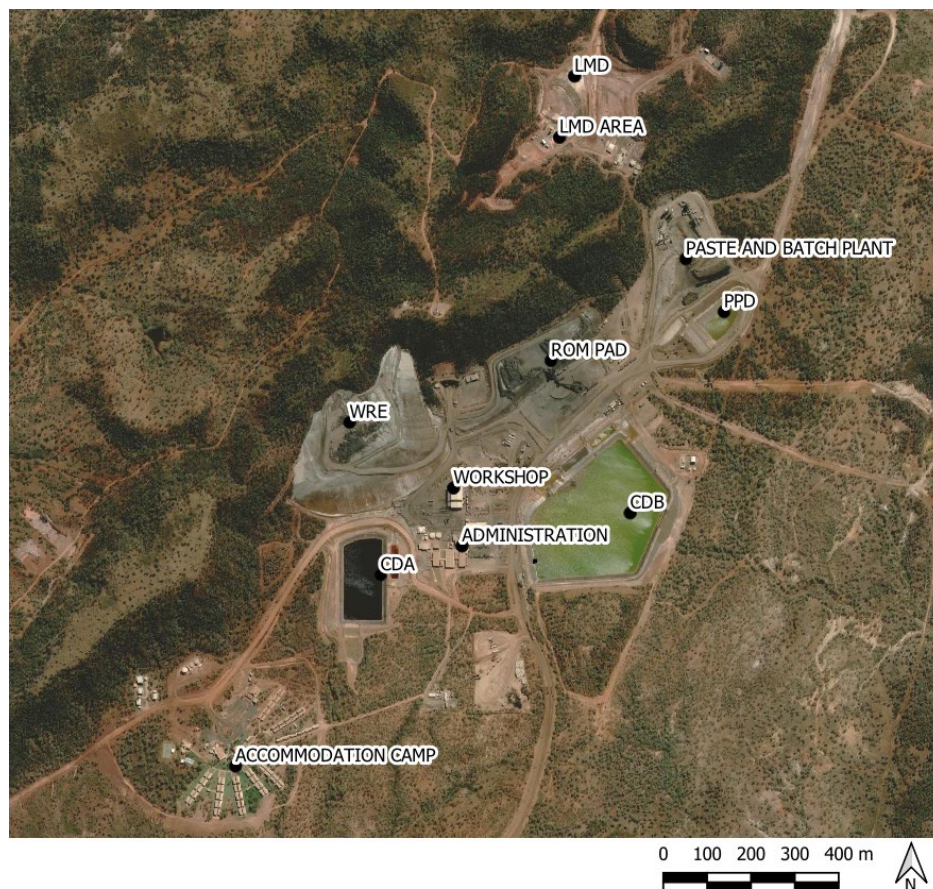
**DIAGRAM 1: SITE LAYOUT**

The general site layout is shown in **DIAGRAM 1**.

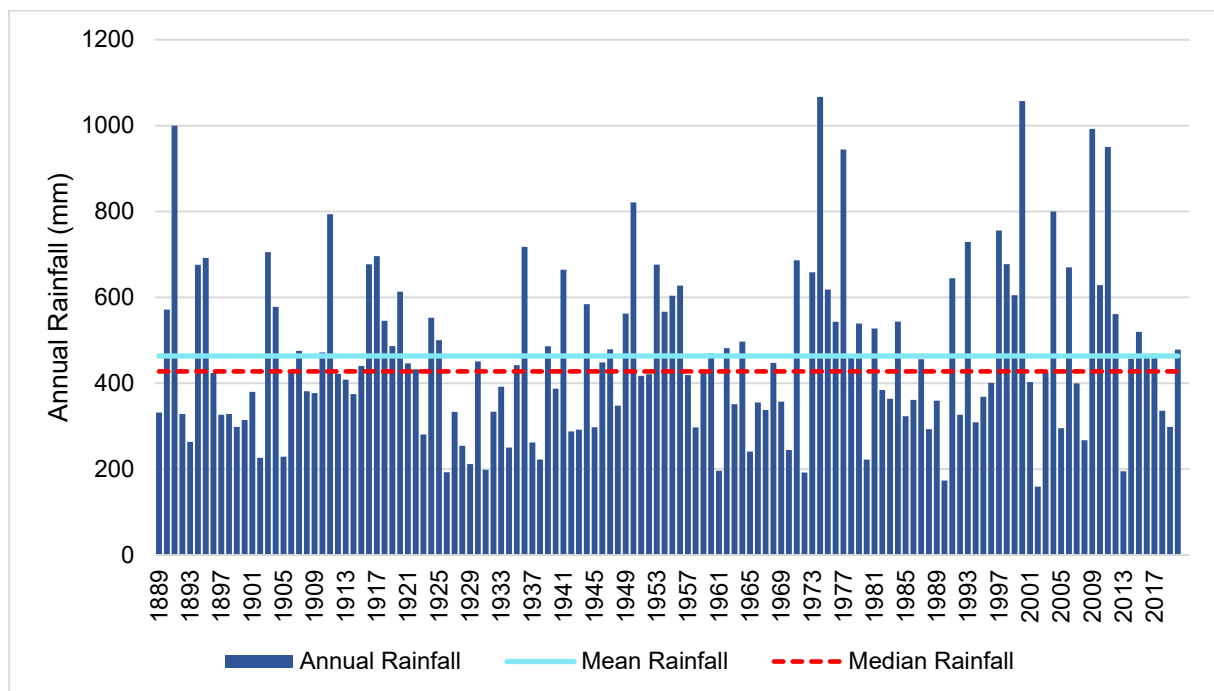
**DIAGRAM 3: ANNUAL RAINFALL TOTALS (SILO DATA DRILL)**

The average annual evaporation (2,880 mm) exceeds mean annual rainfall by a factor of 6.2 and on average is greater than rainfall for all months of the year (**DIAGRAM 3**). In general, based on precipitation and evaporation data presented in this section, the regional climate is water deficient, which is typical of a semi-arid environment.

Twenty years of SILO data for Mt Isa, from the years 2002 to 2021, was used in the simulation. The annual rainfall for the years 2002 to 2021 are shown in **DIAGRAM 18**. The modelled period includes years of low rainfall (2002, 160mm) and high rainfall (2009, 992mm), compared to a mean annual rainfall of 464mm (refer **DIAGRAM 3**).

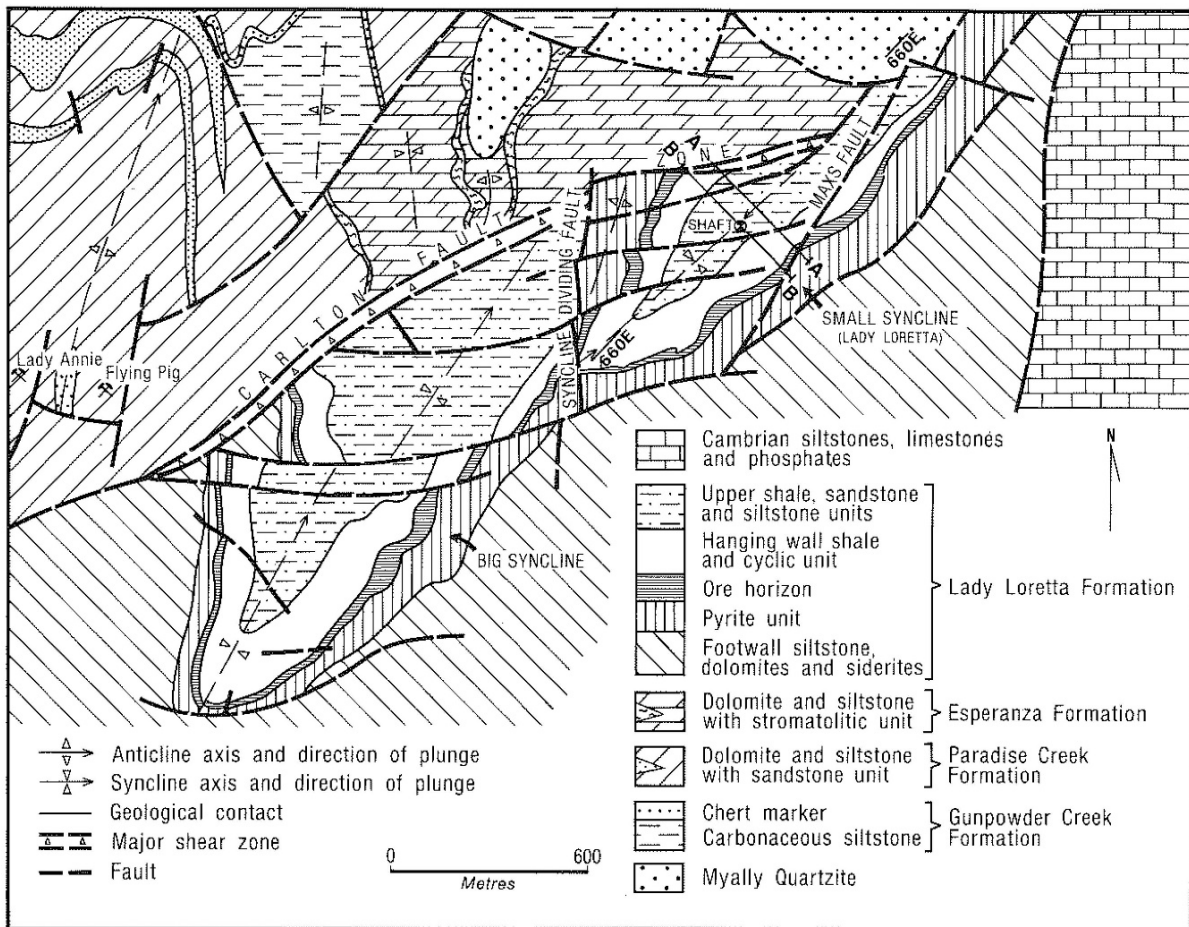
**DIAGRAM 7: REGIONAL GEOLOGICAL MAP (HANCOCK AND PURVIS, 1990)**

The deposit is hosted within the Palaeoproterozoic Lady Loretta formation, which is the uppermost outcropping unit of the McNamara Group (Valenta, 2018) within the keel of the Small Syncline, a tight north-east trending fold. The Small Syncline as well as the Big Syncline are heavily faulted with a series of north-east and south trending faults. Local geology is shown in **DIAGRAM 7**.

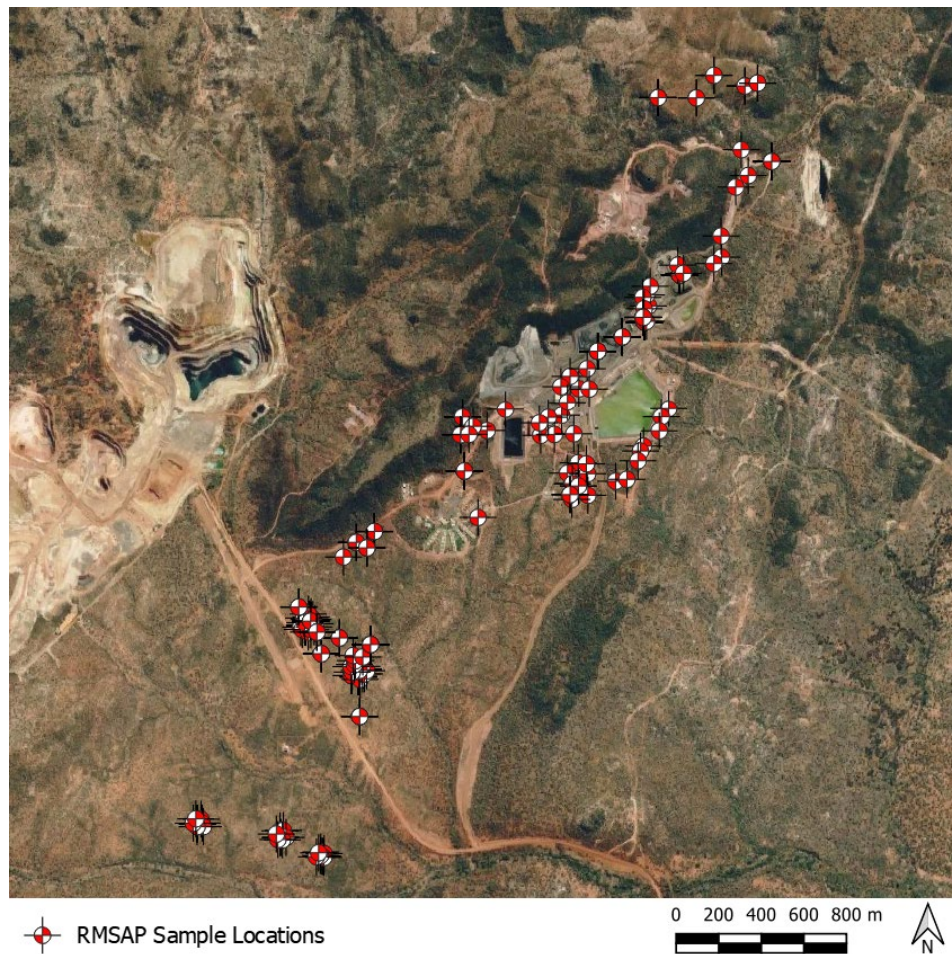
**DIAGRAM 8: SAMPLE LOCATIONS**

Soils relevant to erosion modelling generally comprise the topsoil and subsoil unit. A summary of laboratory test results, which are relevant to WEPP modelling as outlined in RGS (2022) is provided below. The location of test samples is shown in **DIAGRAM 8**.

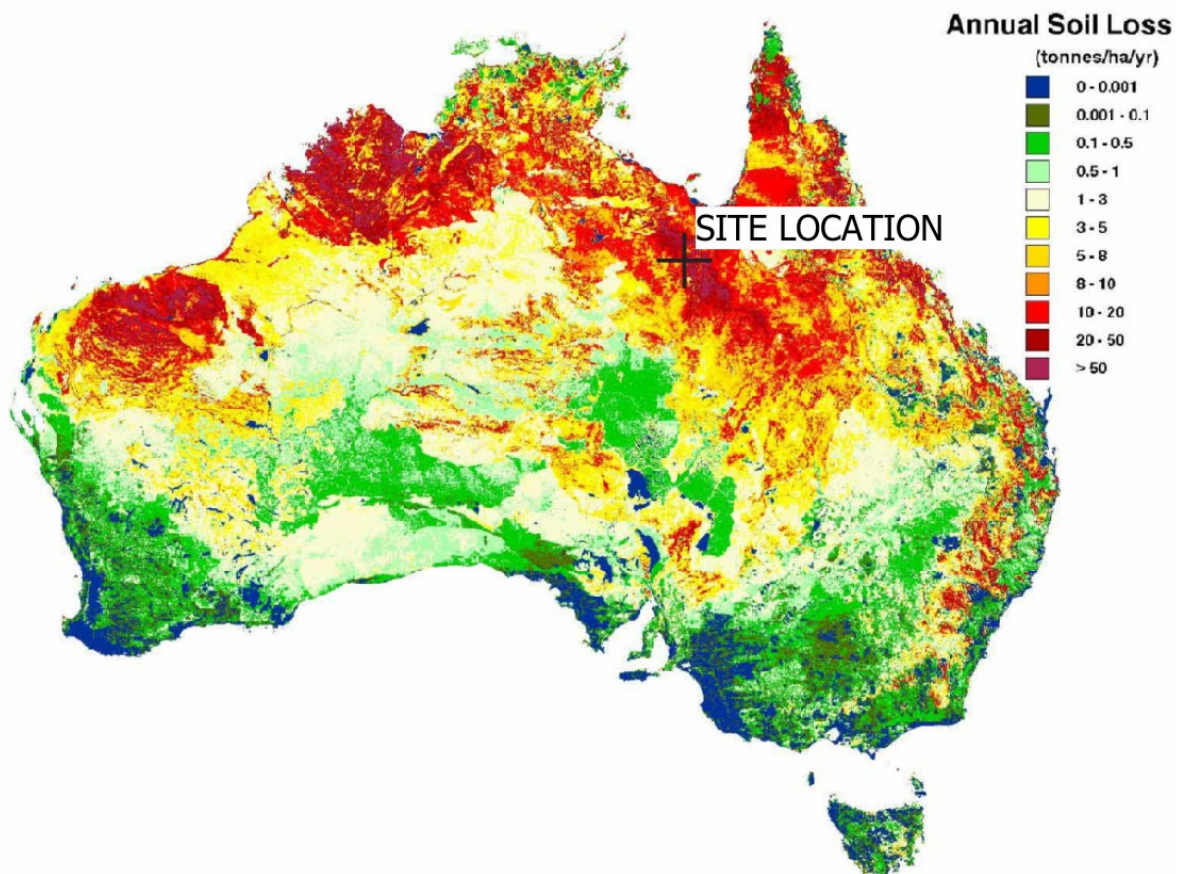
**DIAGRAM 10: AUSTRALIAN SOIL LOSS RATES**

It is important to note that the presented values are annual averages that are considered over the long-term and that measured erosion rates in any one year will vary due to temporal climatic conditions.

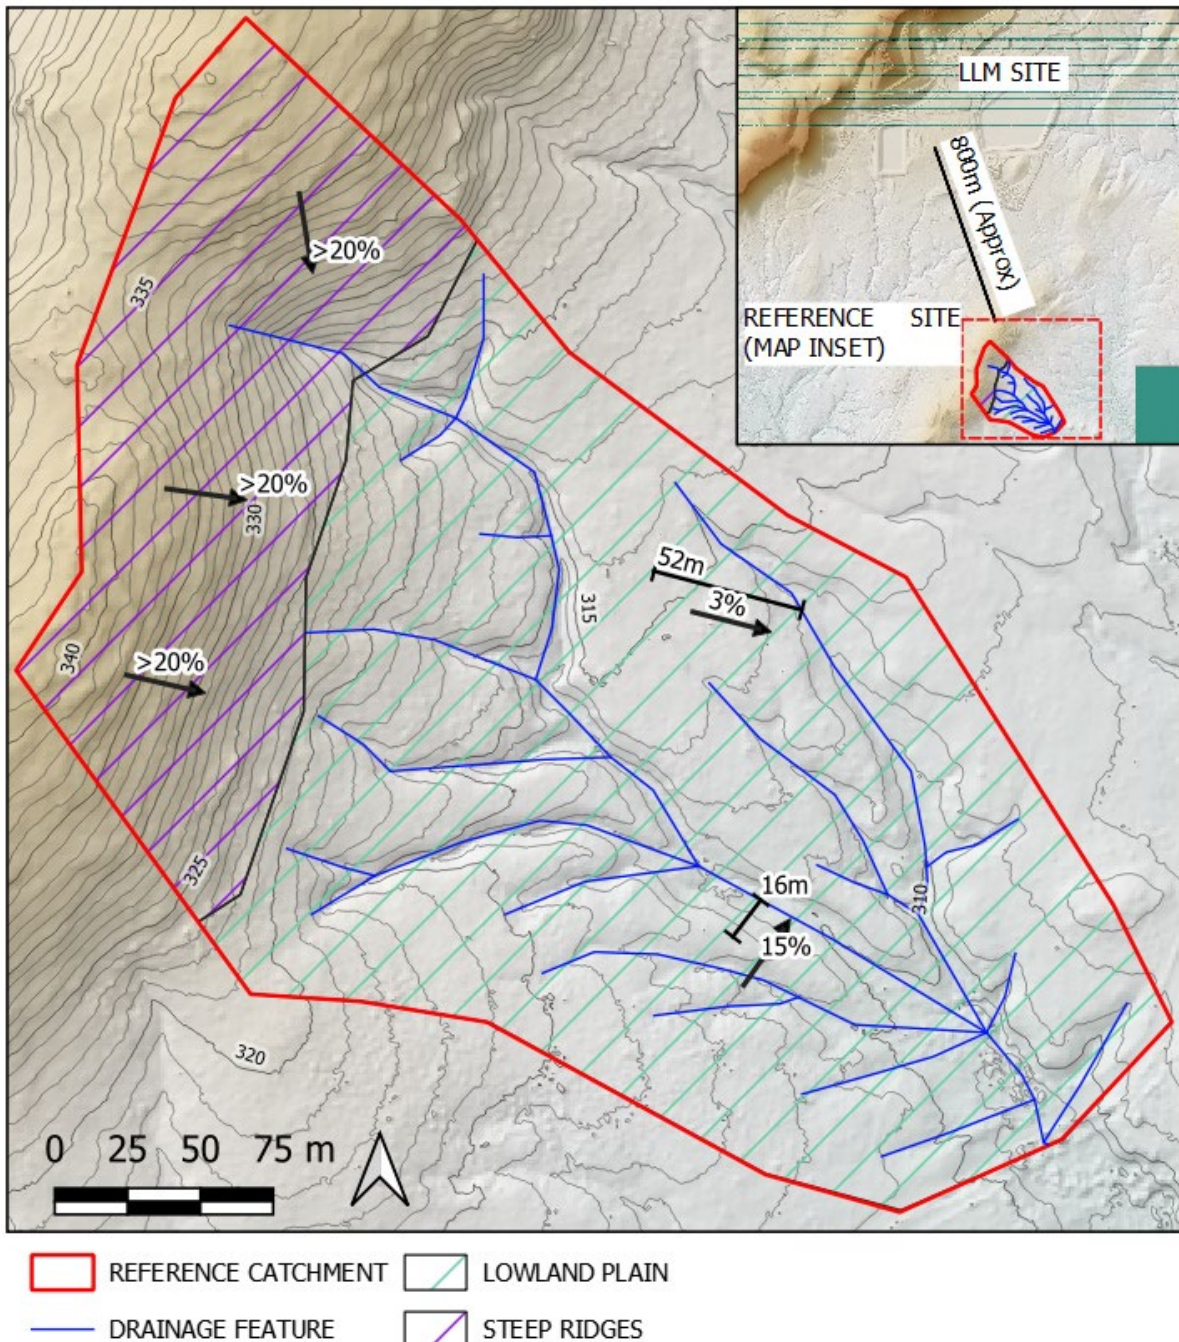
**DIAGRAM 11: REFERENCE SITE**

To characterise the local natural topography and drainage conditions, an example landform similar in scale to the LLM rehabilitation areas has been mapped. The chosen landform appears to be generally undisturbed by mining or other human activities. The landform is located approximately 800m south east of the site and includes both steep ridges and lowland plains as shown in **DIAGRAM 11**.

**DIAGRAM 11** above shows steep batters only form drainage paths to convey flows from upstream contributing catchments. Whilst within the lowland plain areas, drainage paths are formed with a separation distance of 20m where surface slopes are steep and a separation distance of 50m or more where surface slopes are flat.

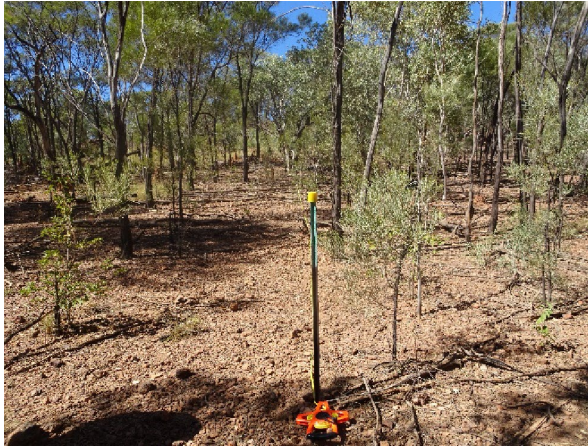
**DIAGRAM 12: NATIVE HABITAT/STEEP BATTERS**

Similar to **Section 2.5.2**, the target vegetative cover is to mimic two vegetation types defined in **Section 2.4**, with snappy gum woodland on lowland plains and open woodland to open-forest of *acacia shirleyi* on steep ridges. An example photo of both the low land plains and steep batters are shown in **DIAGRAM 12** and **DIAGRAM 13**.

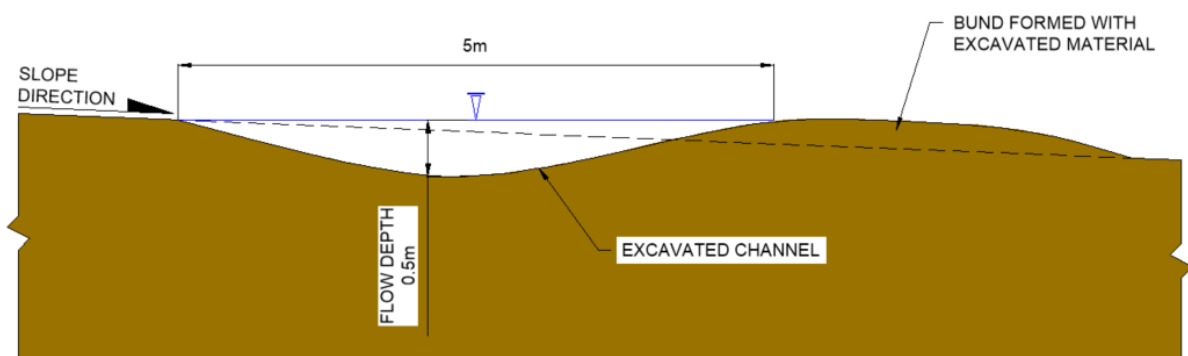
**DIAGRAM 16: CONTOUR FURROW TYPICAL DETAIL**

The proposed final landform comprises long, unbroken overland flow paths, drainage features are therefore required to reduce the overland flow paths. This will be achieved through the construction of contour furrows. Contour furrows are proposed to reduce the overland flow path length of rehabilitated

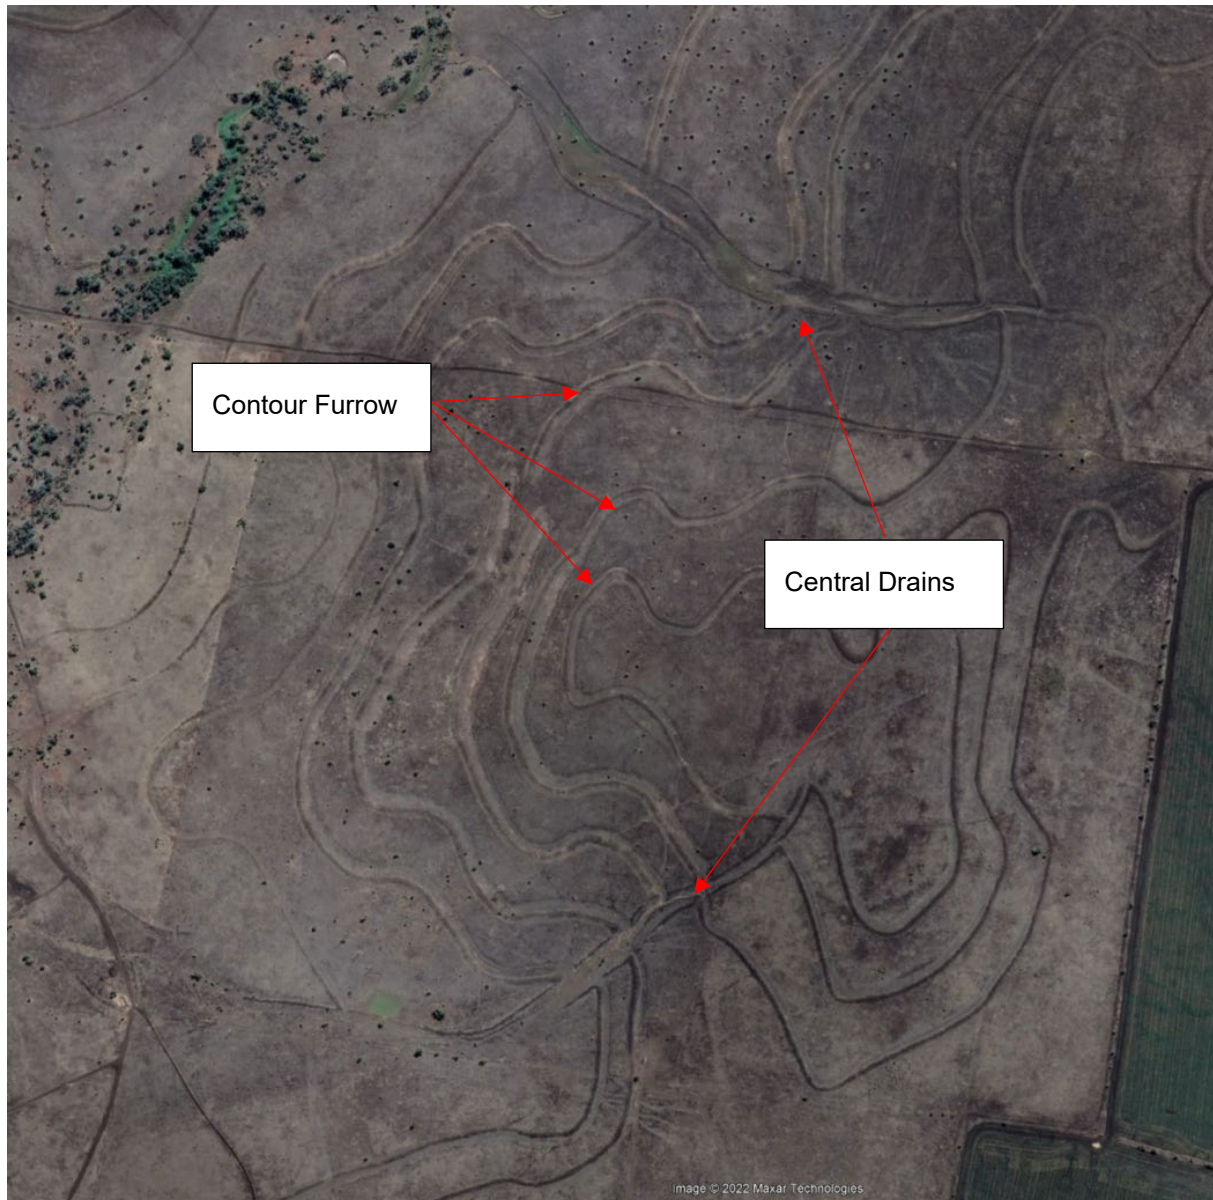
**DIAGRAM 17: CONTOUR FURROW EXAMPLE LAYOUT**

**DIAGRAM 17** shows an example catchment utilising furrows. The proposed furrow spacings presented in **Section 3** (and WEPP modelling) adopts a similar methodology for erosion control.

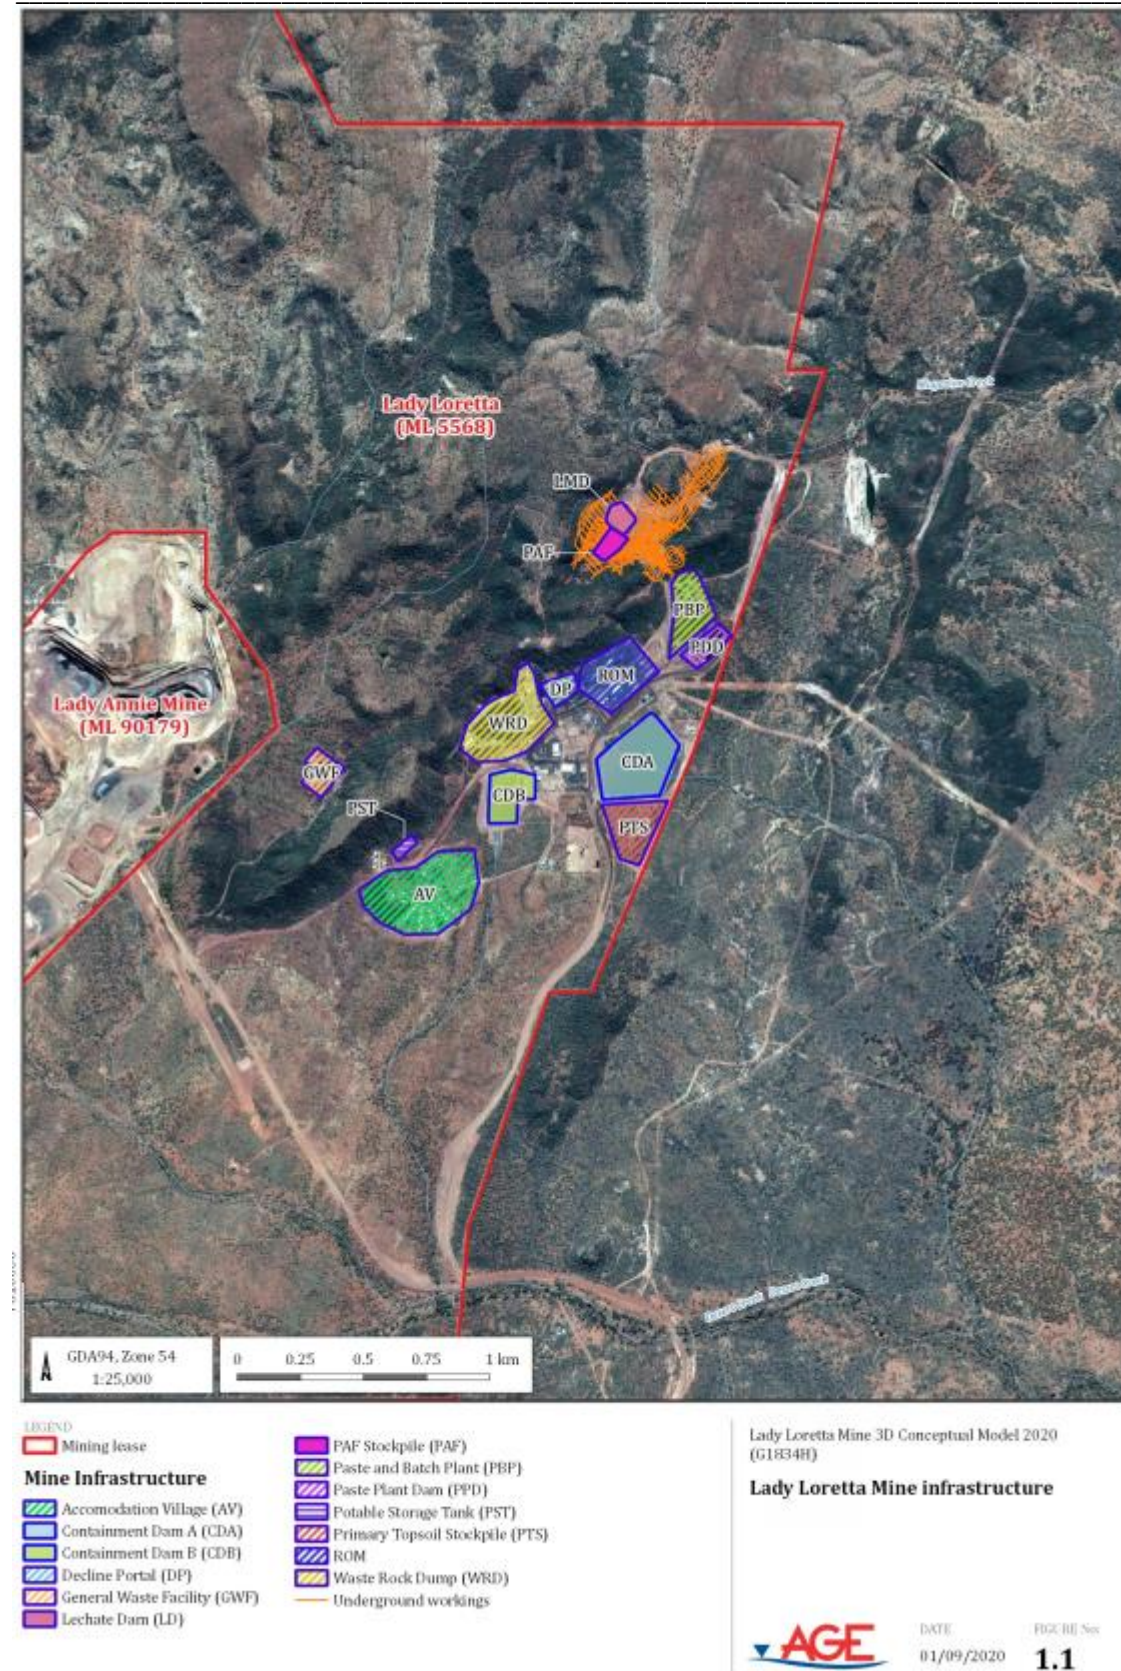
Lady Loretta Mine is an underground zinc, lead, silver mine with legacy workings. The deposit was discovered in 1969, and in 1987–1988 the first shaft was developed by Pancontinental Mining Ltd in the area near the current underground mine. Glencore Zinc Australia has owned the mine since 2012, when it merged with Xstrata Plc (previous owner). Underground operations at Lady Loretta commenced in 2013 and paused in 2015 in response to global zinc prices. Mining re-commenced in 2018 and is scheduled to reach end of LOM (life of Mine) in 2025. The modern Decline (initiated in 2013) is 500 m deep and is hosted within a Dolomite Unit of the Lady Loretta Formation. The main mineral resource is hosted in the ore sequence of the Lady Loretta Formation, which stratigraphically overlies this dolomite. Stopping is conducted into the ore bearing unit from the main Decline. On-site infrastructure includes several water storages (Catchment Dam A–CDA; Catchment Dam B–CDB; Paste Plant Dam (PPD); Leachate Management Dam–(LMD), legacy (potentially acid forming [PAF]) and modern waste rock dumps (WRD), a paste production plant, and a run of mine (ROM) area (Figure 1, AGE, 2020).

Figure 1 - Mine Surface Infrastructure.

During active mining, the underground mine workings are backfilled in stages using paste produced from tailings in the paste production plant, and/or rockfill. Water for the paste production is held in the PPD (Figure 1, AGE, 2020). To ensure stability of the underground mine, the maximum allowable void volume (represented as a mass) at any one time is 150,000 tons. So that the void volume does not exceed the allowable limit, stoping and paste-filling occur concurrently, and they can overlap in different areas.

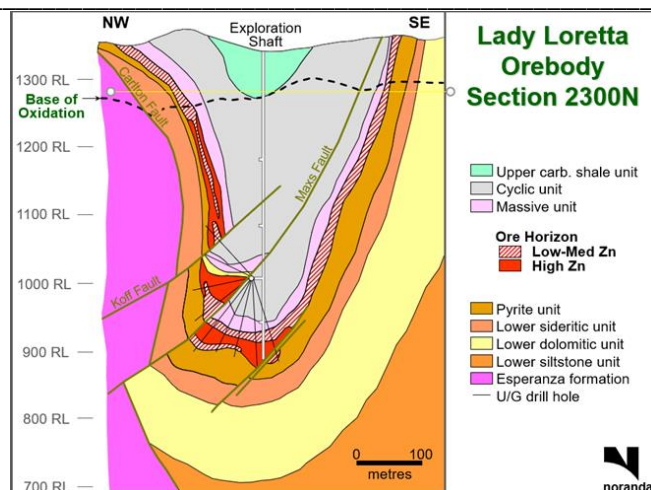
Figure 2 from Brummer (2006) is a lithological cross section through 2300N (mine grid). This figure shows the major identified fault structures, which are locally known as the Carlton, Max's, and Koff's Faults.

Figure 2- Lithological Section through 2300 N (Brunner, 2006)

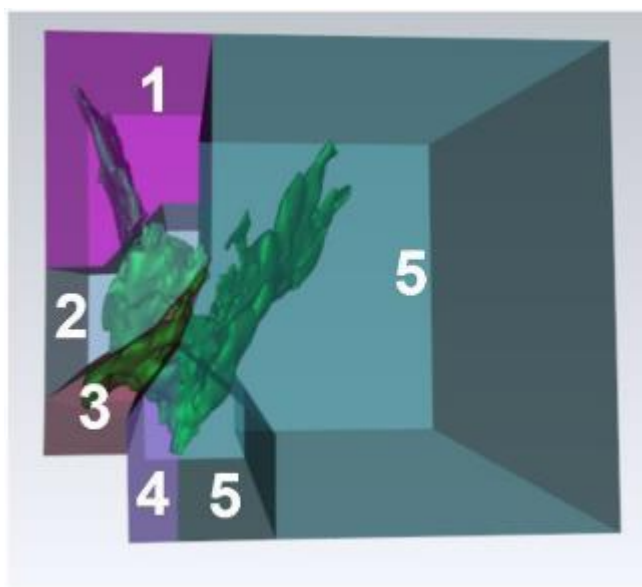
The structural domaining at LLM reflects a global view of the discontinuity regime in the underground mine. MineGeoTech (2018) conducted a structural review using historical and newly collected data and compiled five structural domains. This data includes geotechnical logging from drilled cores, geology sirovision database and underground face and wall mapping to produce these structural domains (Figure 3). These five geotechnical domains identified at Lady Loretta are:

- Domain 1: Western Limb
- Domain 2: Western Limb between Max and Koff's faults
- Domain 3: Western Limb below Max's Faults
- Domain 4: Western Side of the Keel, and
- Domain 5: The Eastern Keel and Eastern Limb

**Figure 3- Lady Loretta Structural Domains**

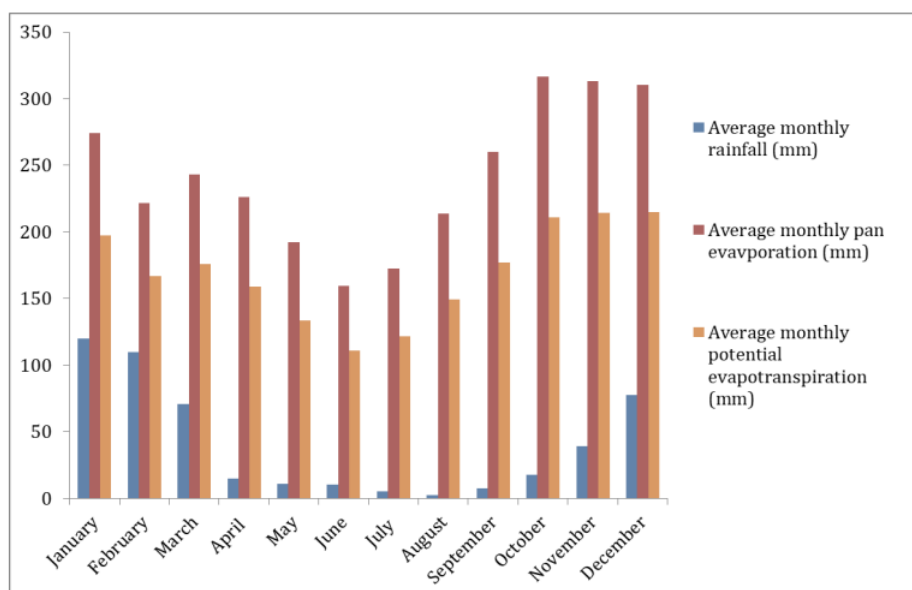
Annual rainfall in the area is highly variable. The average total annual rainfall, evaporation, and potential evapotranspiration derived from Silo Data Drill records (1889–2017) are shown in Figure 4 (AGE, 2020).

**Figure 4 - Long term average climate data**

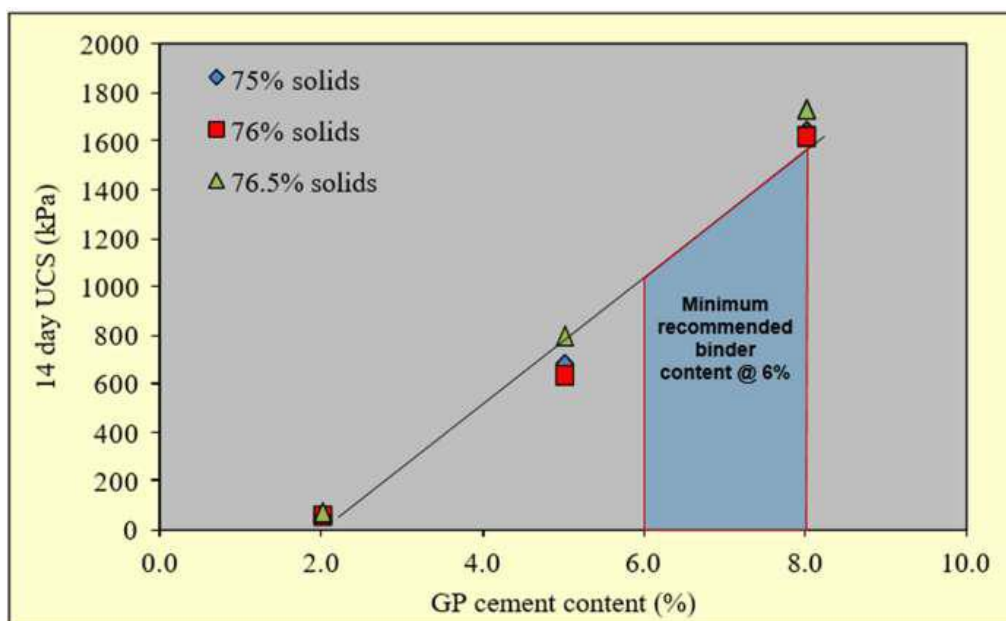
Lady Loretta uses GP cement as the binder to their paste. The paste strength is sensitive to GP cement content and Figure 5 illustrates the relationship at 14 days hydration. The strength to GP cement content relationship is consistent also with 7 and 28 days hydration. The graph in Figure 5 indicates:

- The paste strength has a lineal relationship to binder content such that a 1% change in GP% corresponds to a strength increase of approximately 200-300 kPa.
- Paste batched with 2% binder generates no tangible strength.
- Due to variability in the imported tailings (and resulting solids%), 4% GP cement content generally produces paste with lower than the required design strength for vertical exposures. 4% GP cement content has historically caused large overbreak.

**Figure 5- Curing time and GP cement content relation**

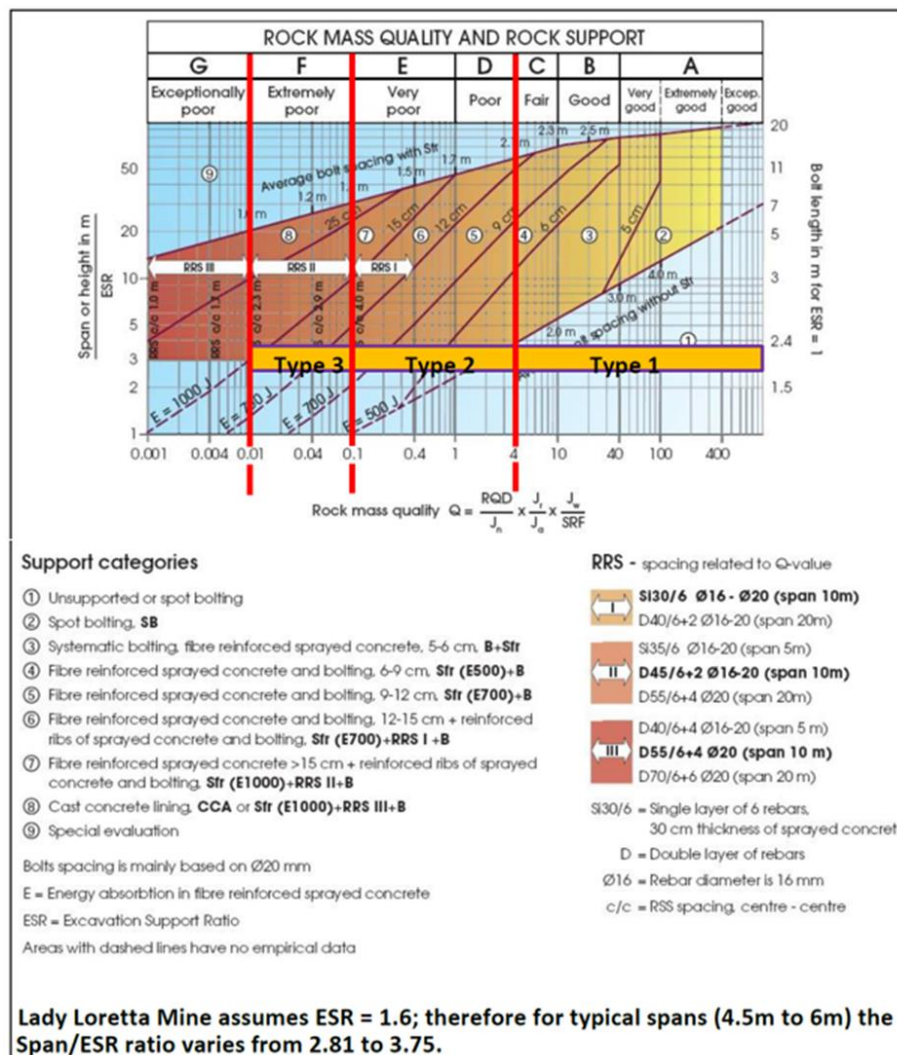
Figure 6 (extracted from the LLM GCMP) illustrates the use of Barton (1974) empirical Ground Support Design Chart. The graph plots each geotechnical domain boundary against the range of excavation profiles typically used at Lady Loretta.

Figure 6- Lady Loretta Modified Barton Q-Method Handbook (2013) Ground Support Design Chart

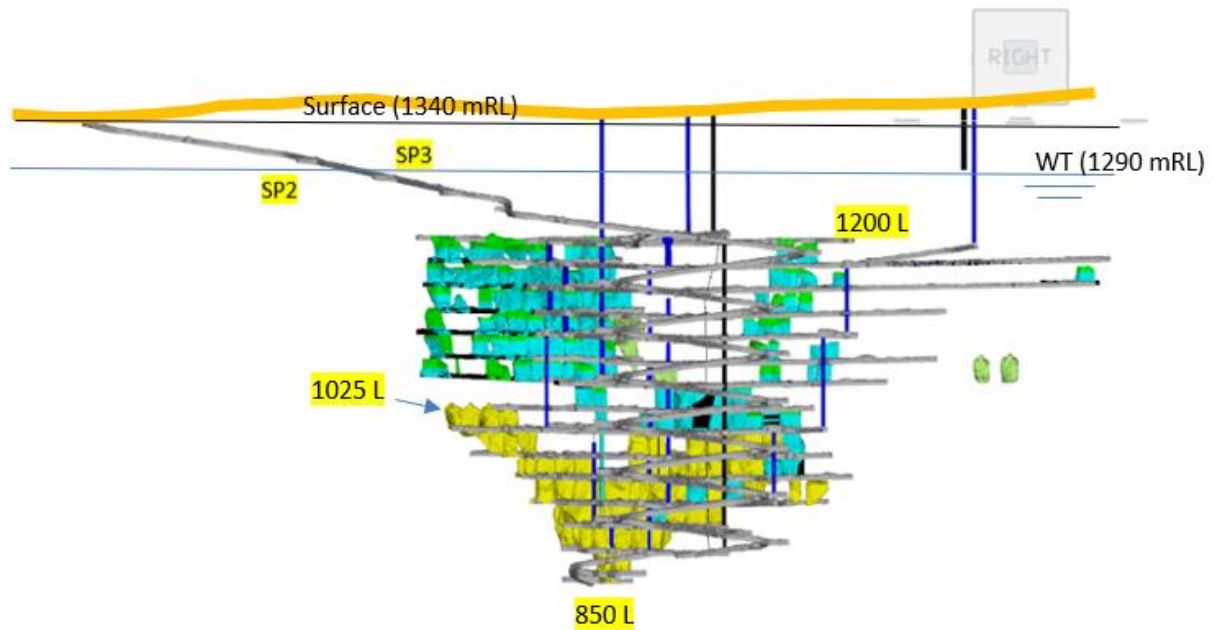
After mine closure, the main dewatering pumps located at the bottom at 875 level will be decommissioned. Water inflow will fill the mine until the pre-mining water table level is reached at approximately 1290 mRL. The average surface level is around 1340 mRL. The highest level of the mine (the 1200 Level) and base of the crown pillar is located at 1215 mRL. Given the pre-mining water table, all mined stopes and developed levels are expected to eventually be under water. The water table at 1290 mRL after recharging will be located approximately in between stockpiles SP2 and SP3 in the Decline (Figure 7).

**Figure 7- View from East showing location of SP2 and SP3 along the Decline. Pre-mining water table (WT), topographic surface and some levels shown for reference.**

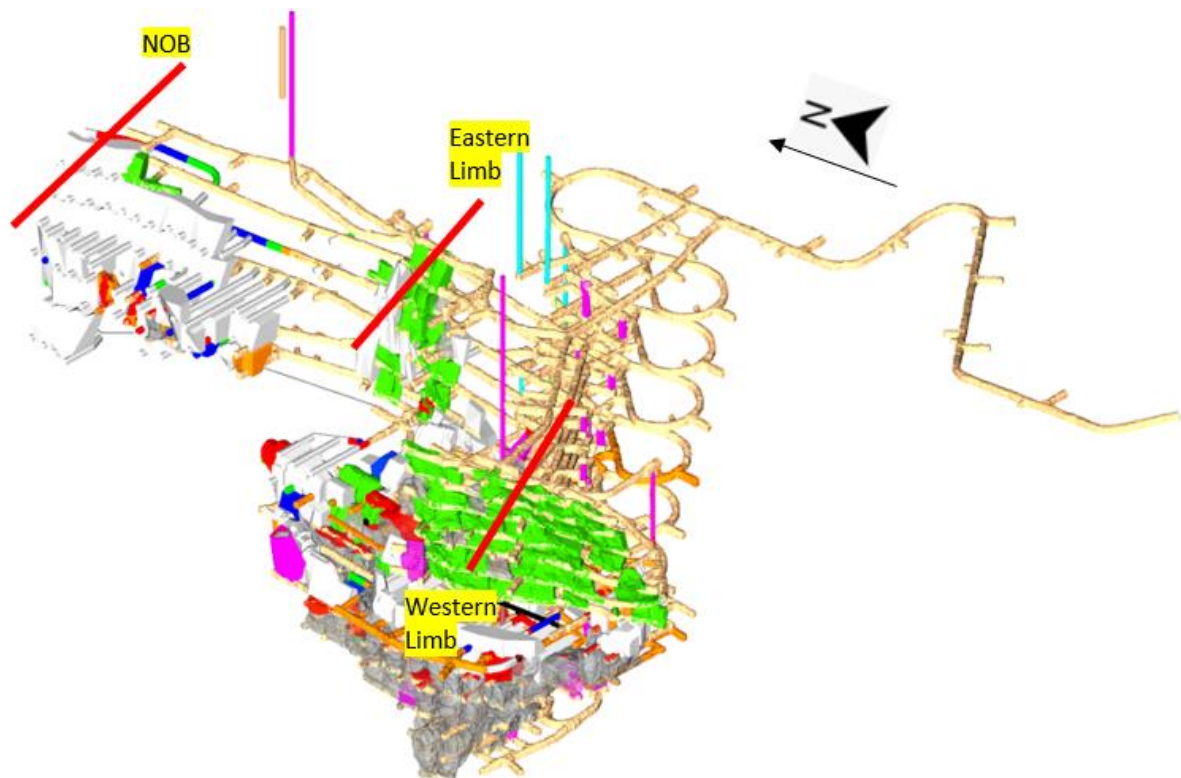
The sections for the empirical and 2D analysis are illustrated as red lines in Figure 8. They are the three crown pillars for the underground mine. At the time of writing this report, the North Ore Body (NOB) crown pillar stopes had not been extracted.

Figure 8- Underground location of the three crown pillars analysed. Red lines are representative sections.

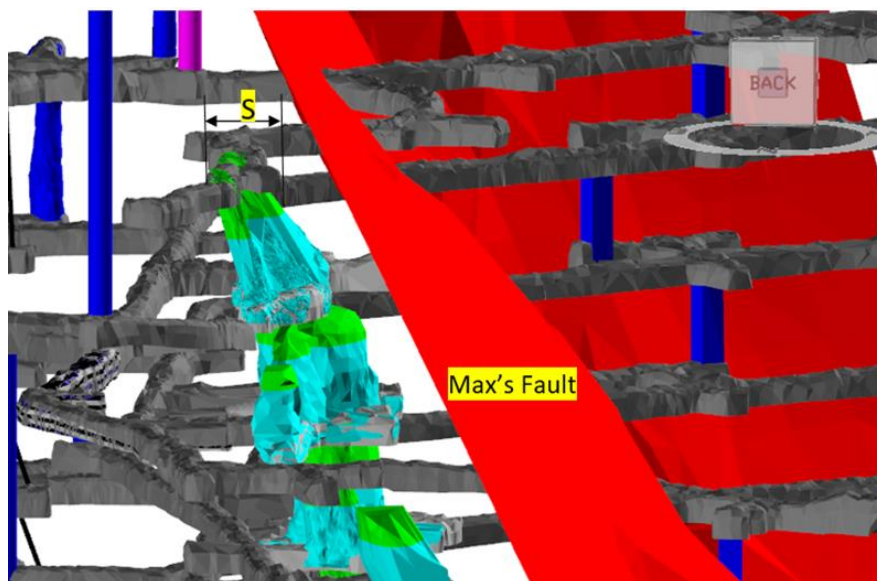
Figure 9 and Figure 10 show the Eastern Limb and Western Limb, respectively. The Eastern Limb has two combined stopes as part of the crown pillar at this region. The Western Limb has five combined stopes.

**Figure 9- Eastern Limb with crown at 1200 level and Max's Fault. S = crown pillar span.**

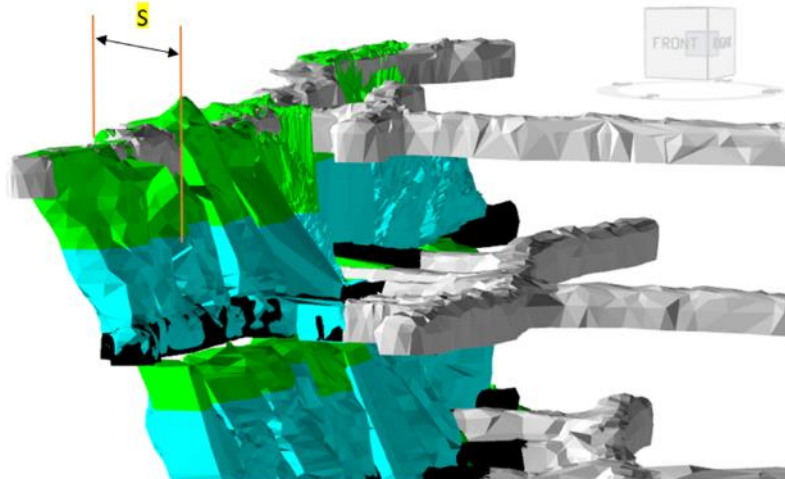
Figure 10- Western Limb and 5 longitudinal stopes mined (1175 to 1200 level). S = crown pillar span.

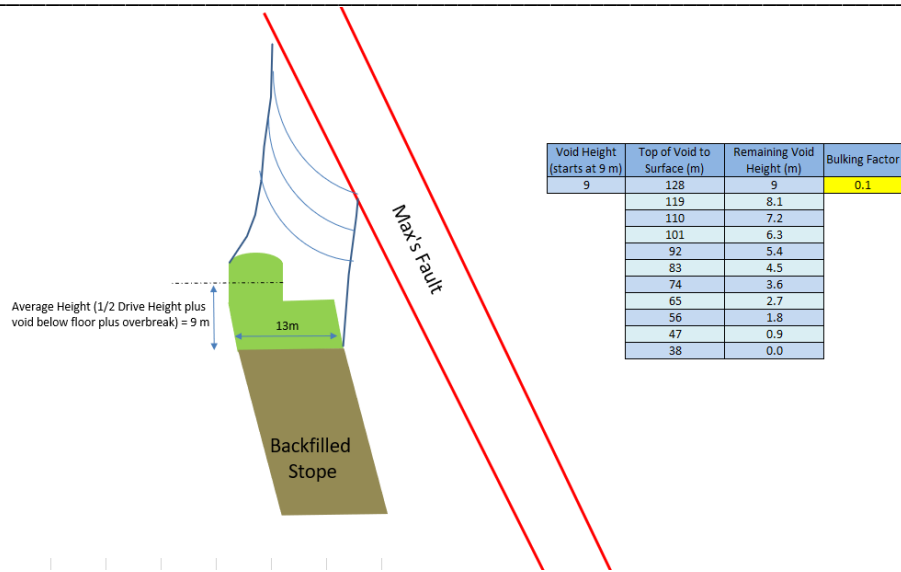
Due to Max's Fault proximity to the Eastern limb crown pillar, poor rock mass characteristics is expected. This fault, presenting a 5-10m thick zone mapped underground, will unravel, and occupy the void between the top of the back fill and the crown of the stopes. As shown in Figure 13, using Equation 3 and a bulking factor representative of poor ground of 10% ( $B = 0.1$ ), the void chocking occurs  $D = 38$  m below the 1340 mRL surface level.

**Figure 13- Schematic concept of void with filling by material from unravelling Max's Fault and chocking stage at 38 m below surface at the Eastern Limb. Starting point at 128 m below surface (base of crown pillar)**

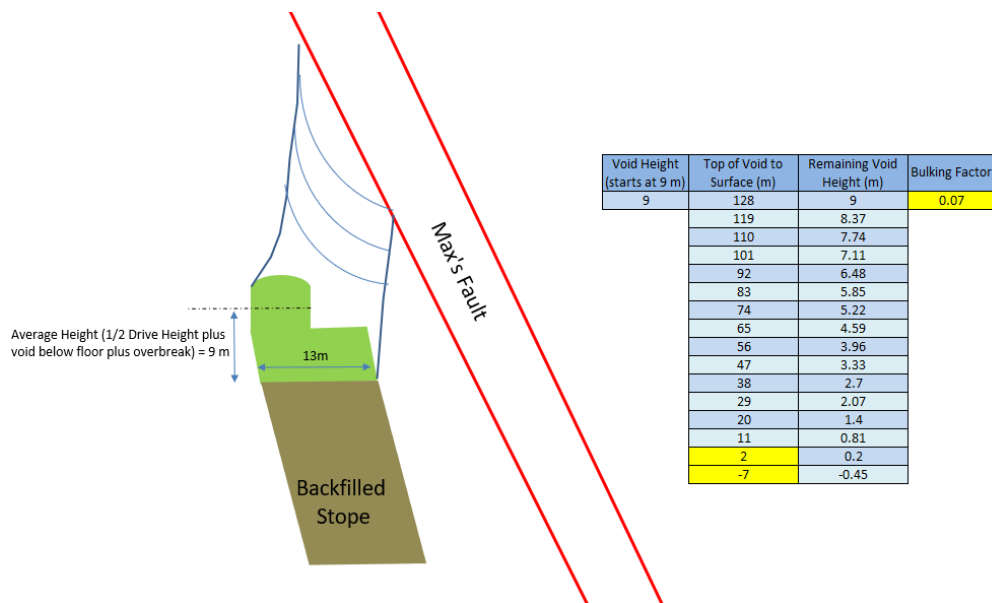
Using Equation 4, the critical bulking factor is around 7% such that the upward failure reaches the surface at the Eastern Limb (Figure 14). Such bulking factor is very unlikely. Based on the BGS (2015) soil classification, 7% is only achieved by very soft to soft clay or silt, this material is not recorded in LLM boreholes.

**Figure 14- Schematic concept of void with filling by material from unravelling Max's Fault and chocking stage at surface at the Eastern Limb. A bulking factor of 7% applied.**

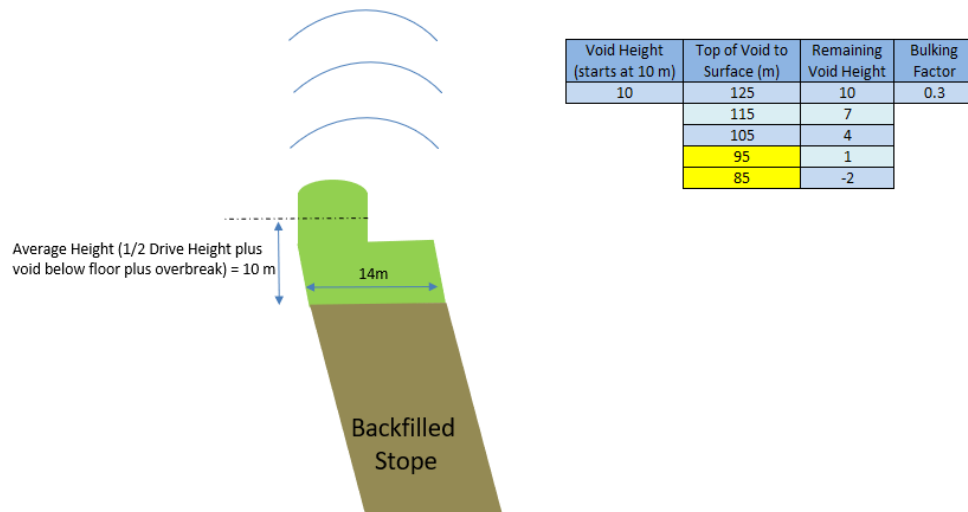
The Western Limb is not proximal to major structures. In contrast to the Eastern Limb, it can be assumed that the rock mass is better (not faulted), therefore a 30% bulking factor has been applied in Equation 3. The stopes are not tight filled; hence a span of 14 m and average void height of 10 m is used. Figure 15 shows void choking

occurs at 92 m from surface. Since this failure zone has choked beneath the base of oxidation, the use of 30% bulking factor for the entire column is appropriate.

**Figure 15- Schematic concept of void with filling by material from unravelling rock mass and chocking stage at 92 m below surface at the Western Limb. Starting point at 125 m below surface (base of crown pillar)**
