LADY LORETTA

## **Z-LLM-HSEC-PLN-Progressive Rehabilitation and Closure Plan**

| Project Name | Lady Loretta Mine |
| Document Title | Z-LLM-HSEC-PLN-Progressive Rehabilitation and Closure Plan |

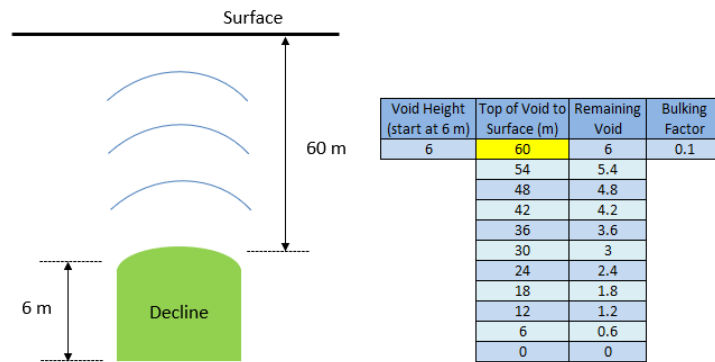
Based on the report 'Lady Loretta Geotechnical Factual Report Proposed Decline and Shaft' (Mining One, 2012) the extremely weathered to highly weathered material is on average 40 m below surface. For this type of rock mass, it is plausible that a bulking factor of 10% ( $B = 0.1$ ) is applied in the analyses. Using Equation 5, it was found that where the Decline is less than 60 m deep from surface, any upward failure will reach the surface before it bulks out and self supports (Figure 16). A plot has been produced in Figure 17, which graphs likely subsidence depth according to origin of failure. Figure 17 shows an upward failure that starts at 50 m from surface (Decline backs at 50 m bgl) will produce 1 metre of subsidence at surface level. For the backs at the portal entrance ('P' in Figure 17) located around 10 m bgl, a subsidence (S) of 5 m is expected.

Figure 16-Schematic concept of void with filling by material from unravelling rock mass and chocking stage at surface for the Decline. Starting point at 60 m below surface.

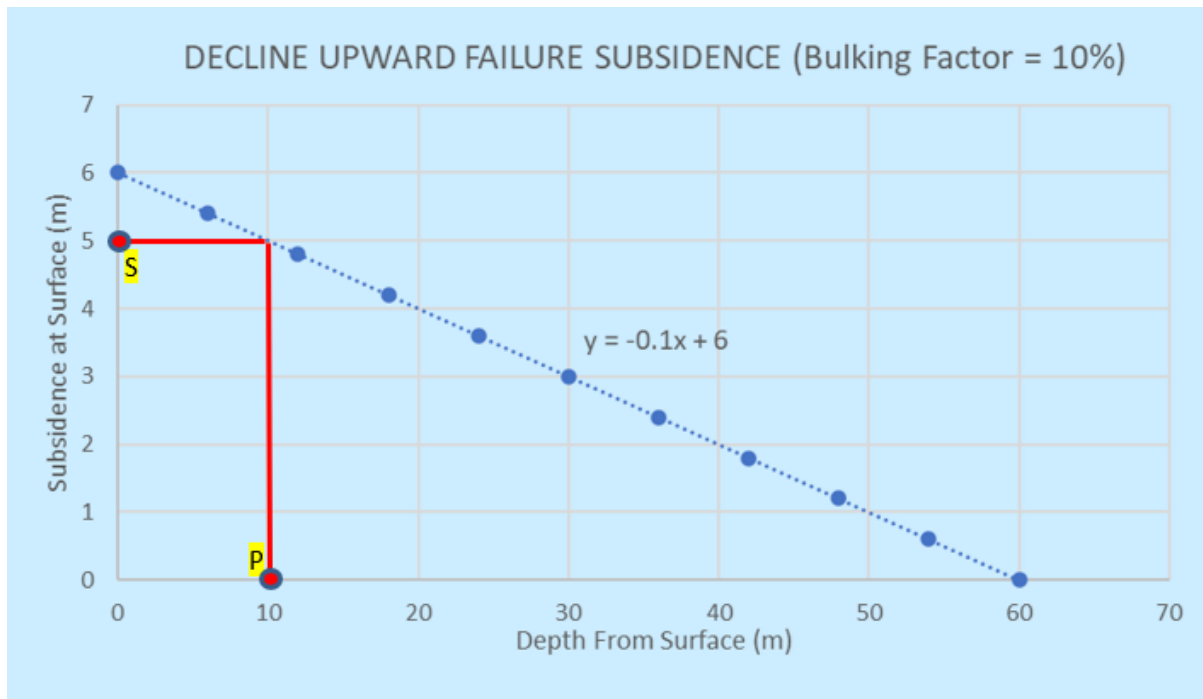
Figure 17- Subsidence metres at surface in relation to the depth from surface of the Decline. Portal backs (P) and expected subsidence (S) expected.

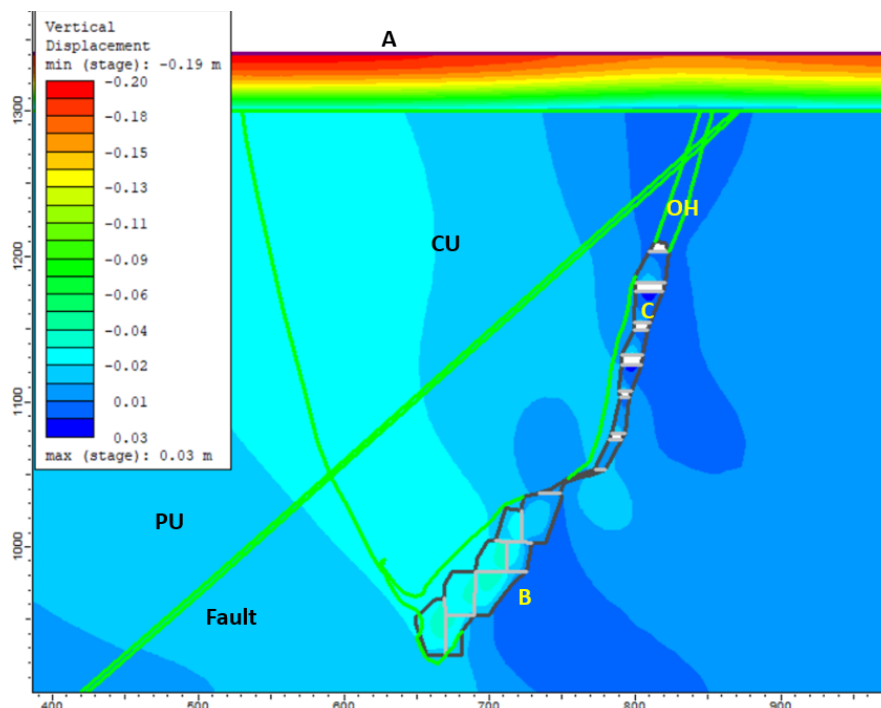
The 2D analysis results from RS2® are presented in Figure 18 to Figure 23. Negative values indicate settlement and positive values indicate raising/swelling relative to the pre-mining levels. For a more comprehensive visualization of the results, refer to the electronic models provided in Interpret RS2® for each of the three sections.

**Figure 18- Eastern Limb – Final stage of mining with last stope backfilled (Dry conditions); 20 cm subsidence on surface (A), 2 cm raising at (B) and 3 cm of raising at the top of paste in (C)**

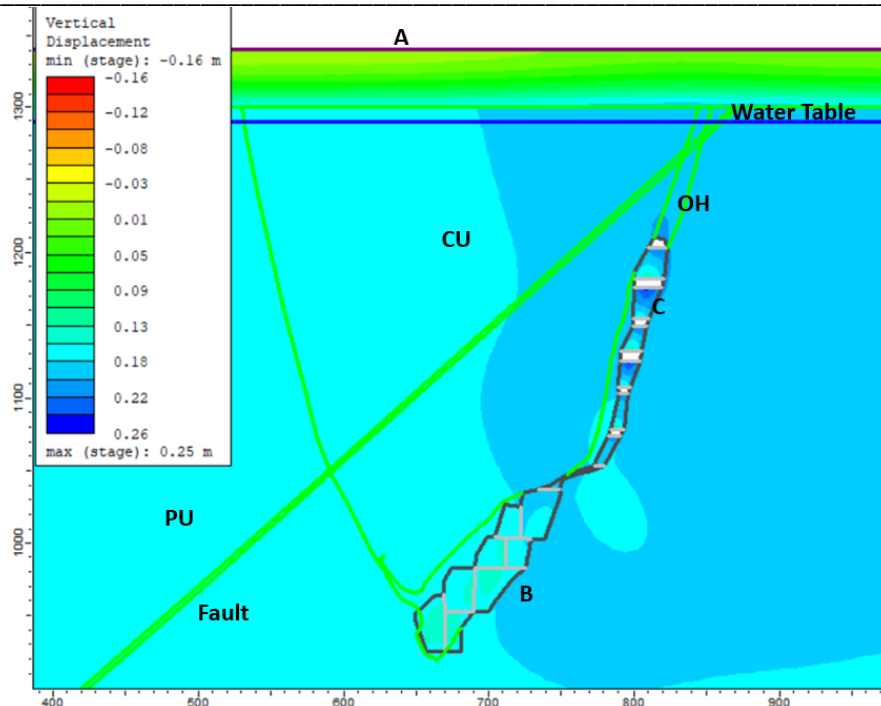
Figure 19- Eastern Limb – End of mining and water recharge completed (Flooded); 2 cm subsidence on surface (A), 18 cm raising at (B) and 24 cm raising on top of paste in 1150 L stope (C)

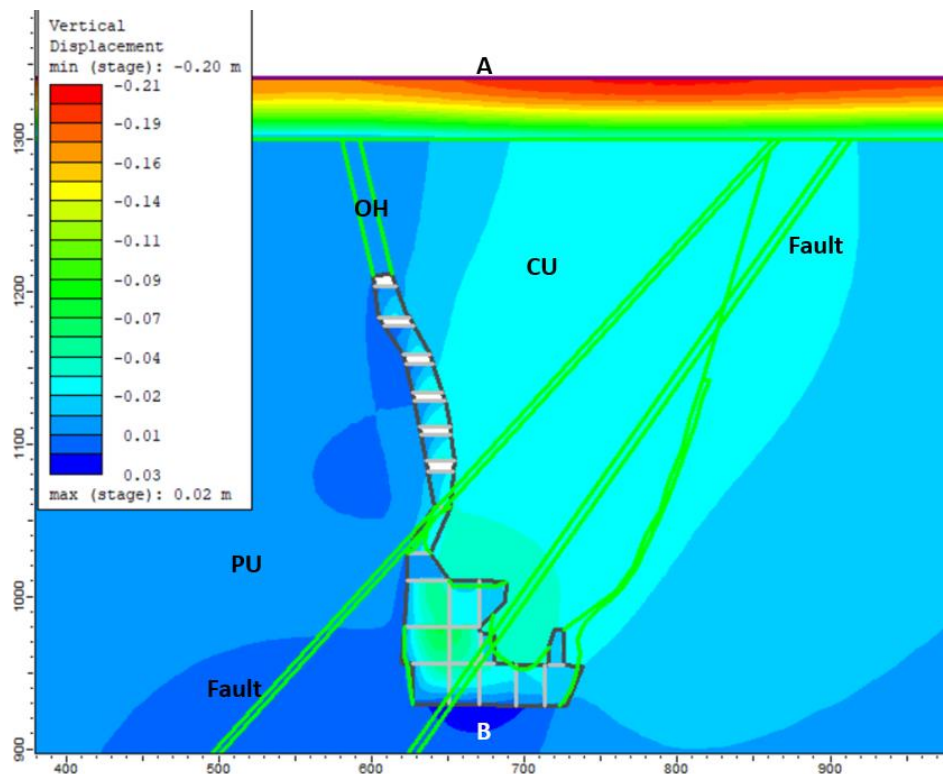
Figure 20 - Western Limb – Final stage of mining with last stope backfilled (Dry conditions); 20 cm subsidence on surface (A) and 2.4 cm raising at the base of excavation (B)

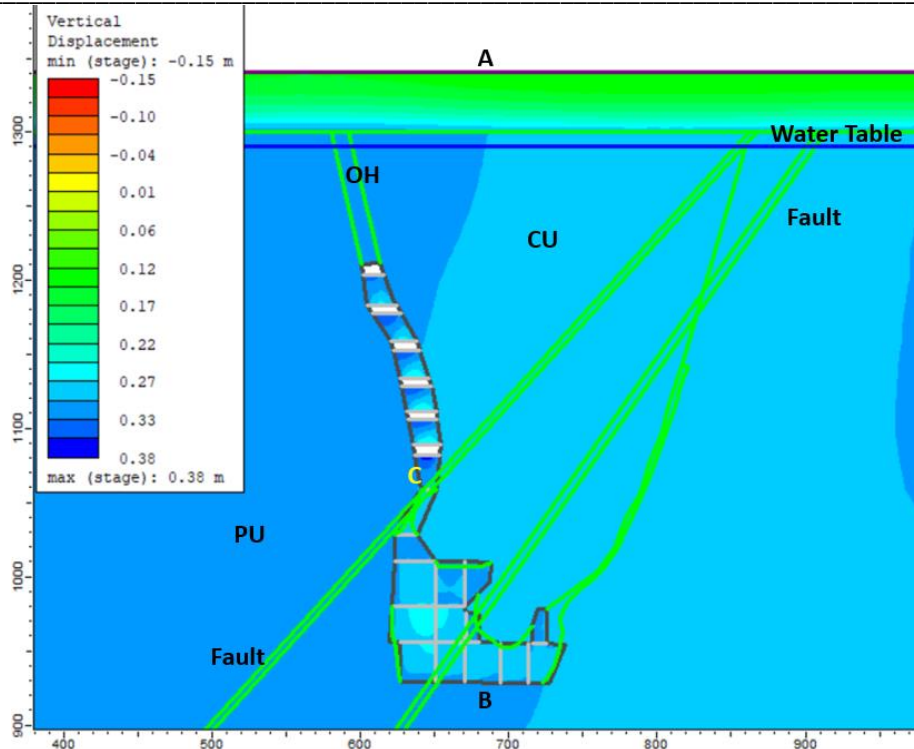
Figure 21- Western Limb – End of mining and water recharge completed (Flooded); 12 cm raising on surface (A), 33 cm raising at the base of excavation (B) and 37 cm raising on top of paste in 1050 L stope (C).

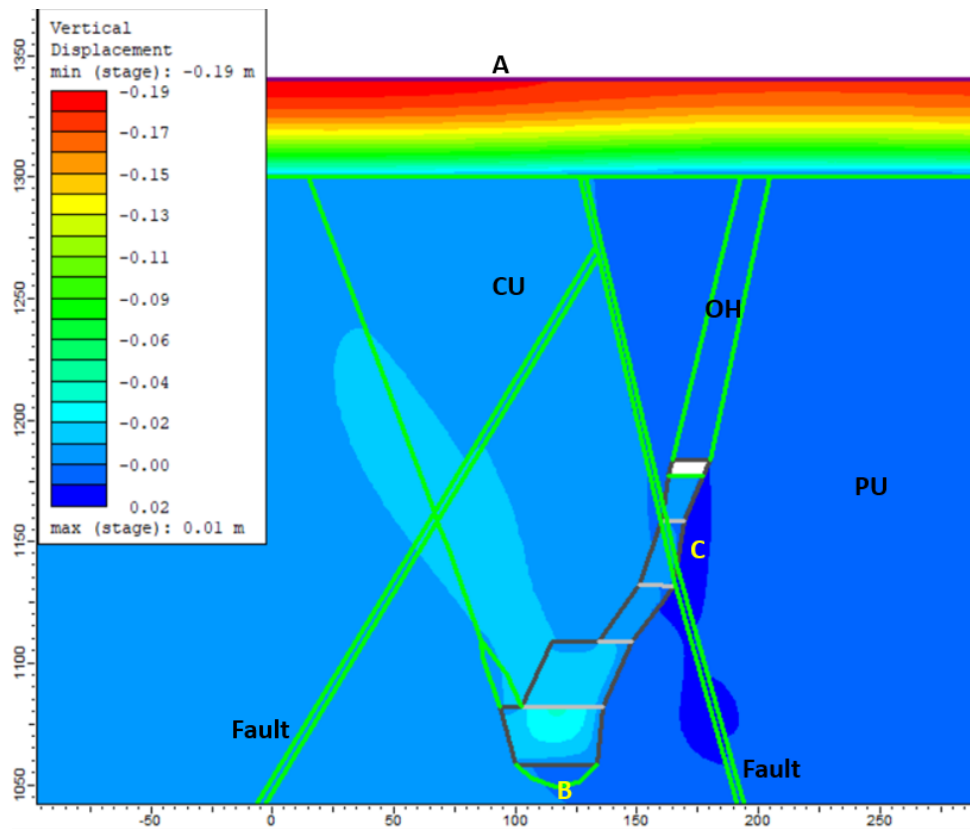
Figure 22 - NOB – Final stage of mining with last stope backfilled (Dry conditions); 19 cm subsidence on surface (A), < 1 cm subsidence at the base of excavation (B) and 1.4 cm raising (C).

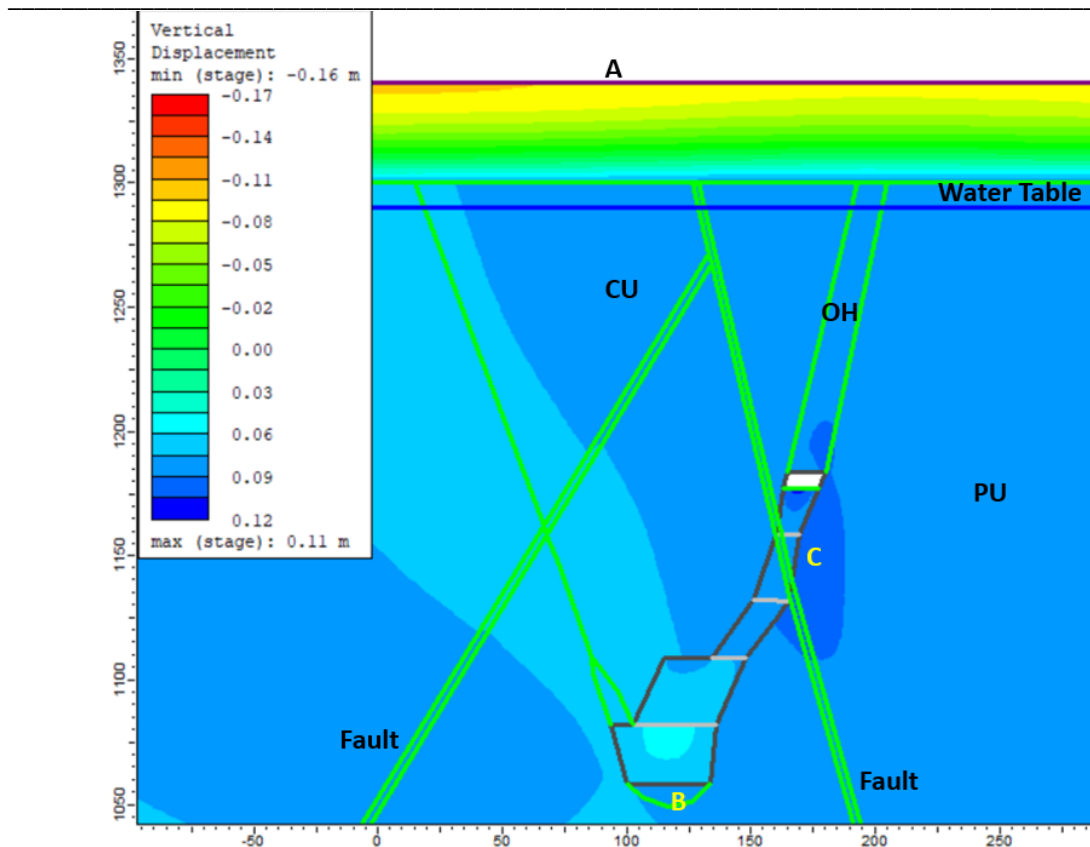
**Figure 23 - NOB – End of mining and water recharge completed (Piezo line added); 10 cm subsidence on surface (A), 8 cm raising at the base of excavation (B) and 10 cm raising at (C).**

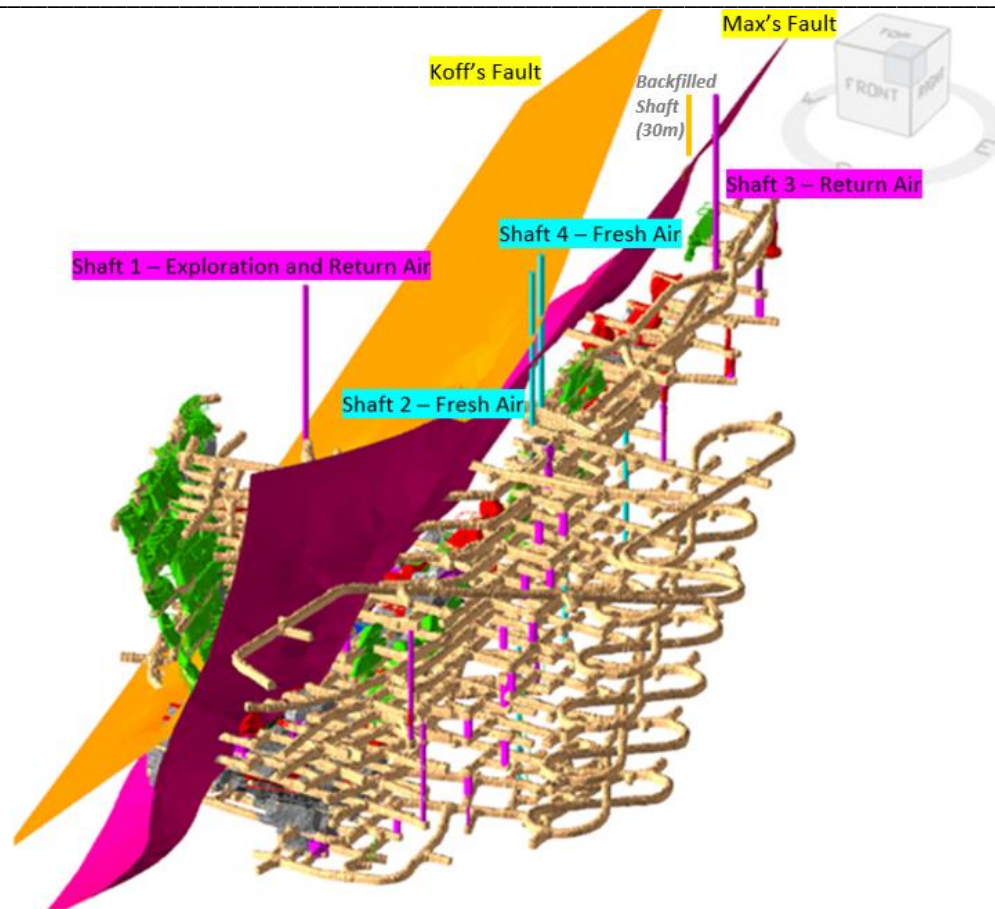
There are four open shafts at LLM that require assessment, two fresh air rises (FAR) and two return air rises (RAR), one of which is also an exploration shaft. There is one additional historical (RAR) shaft, which during excavation collapsed at 30m deep. It was subsequently backfilled and another RAR location developed. Shaft locations are depicted in Figure 24.

**Figure 24- Location of shafts to development and faults. LLGRD8 cored hole at location of Shaft 2 – Fresh Air.**

Conditions found in LLGRD8 can be confidently extrapolated to all other shafts. Section 6.3 of the LLM GCMF domains ground according to RQD values and classifies 52% of diamond drill core as 'Very Poor' to 'Fair' and 8.7% as 'Extremely Poor'. This proportion of poor ground is likely to be even higher closer to surface due to weathering. Additionally, two major faults, Max's and Koff's Fault intersect the Shaft with collars on surface (Figure 24). Both are filled with gouge and broken rock which will worsen stability.

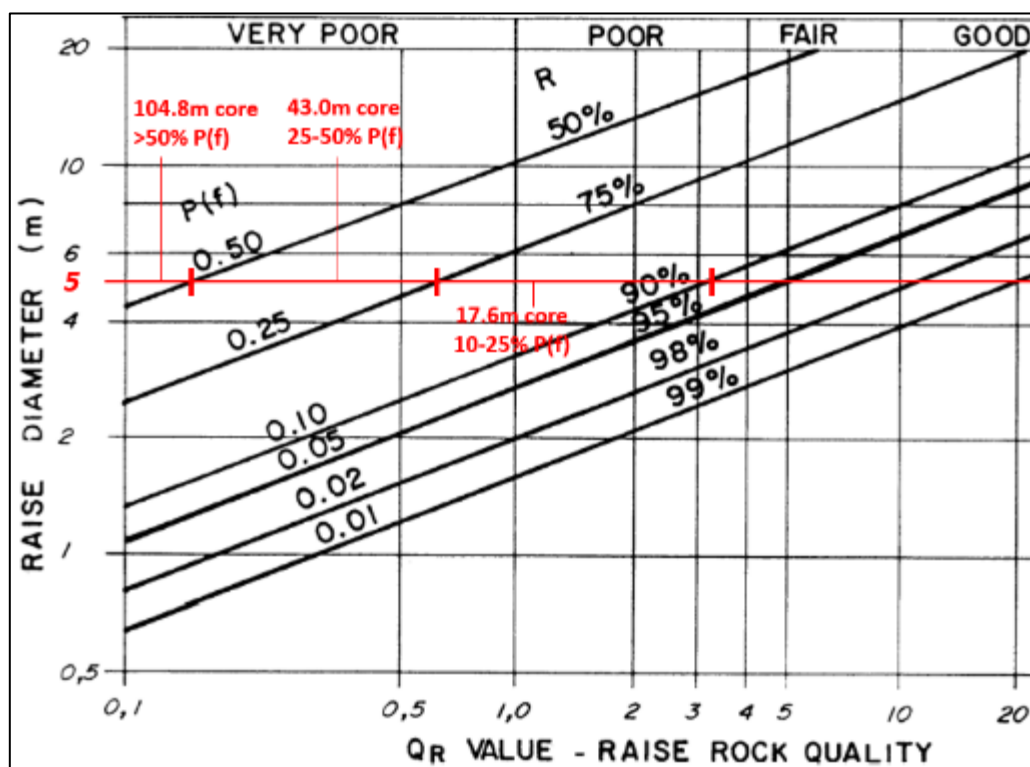
- The completely oxidised upper section from 0 to 43.9m has a PoF >50%,
- The fault intercept section from 113.6 to 132.8m has a PoF >50%,
- Much of the rest of the hole also has a PoF >50%, with only an accumulated 43m having a PoF 25-50% and accumulated 17.6m with a PoF 10-25%.

Figure 25- McCracken-Stacey (1989) Probability of Failure Chart with 5m Shaft diameter and QR results of LLGRD8 superimposed

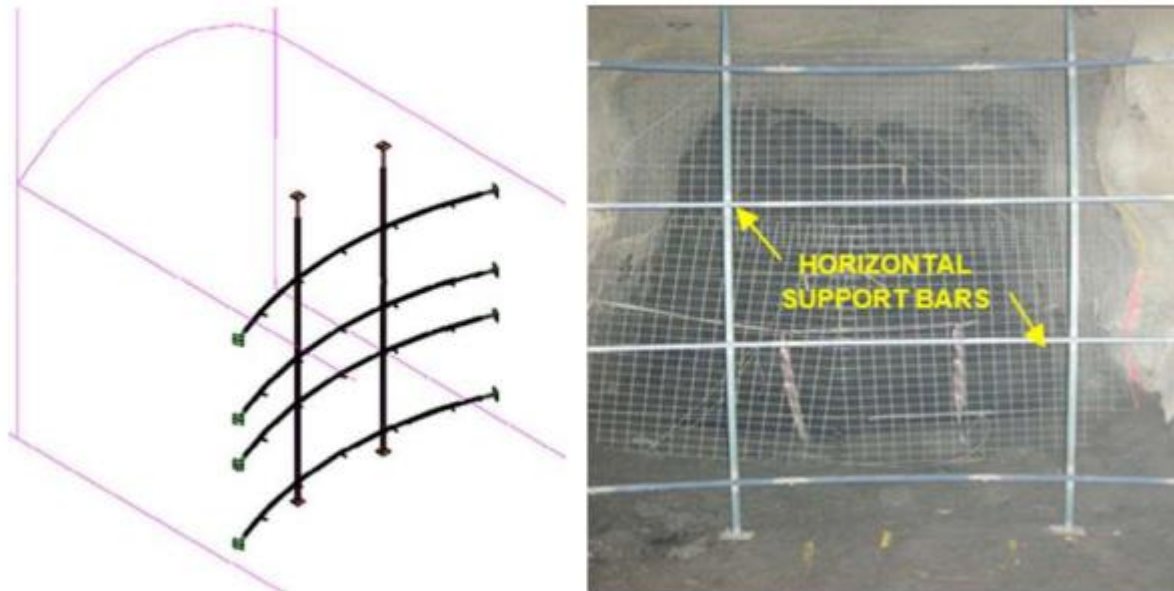
A Bulkhead will be applied for containing in place the waste backfill of the Decline. The bulkhead constructed will use the same specifications as the paste walls (bulkheads) currently utilised for production back filling, which are deemed suitable (Figure 26).

The bulkhead must be constructed with a minimum fibrecrete thickness of 400mm. Fibrecrete must possess a UCS more than 15 MPA at the commencement of backfilling.

The Bulkhead needs to be free draining. This should be achieved by installing 100mm poly pipe through the bulkhead to drain potential water accumulation, reducing pressure against the structure. Poly drains should be installed at regular intervals across the entire bulkhead area, noting that lower drains will silt up quickly.

**Figure 26- Clune Wall Kit Frame**

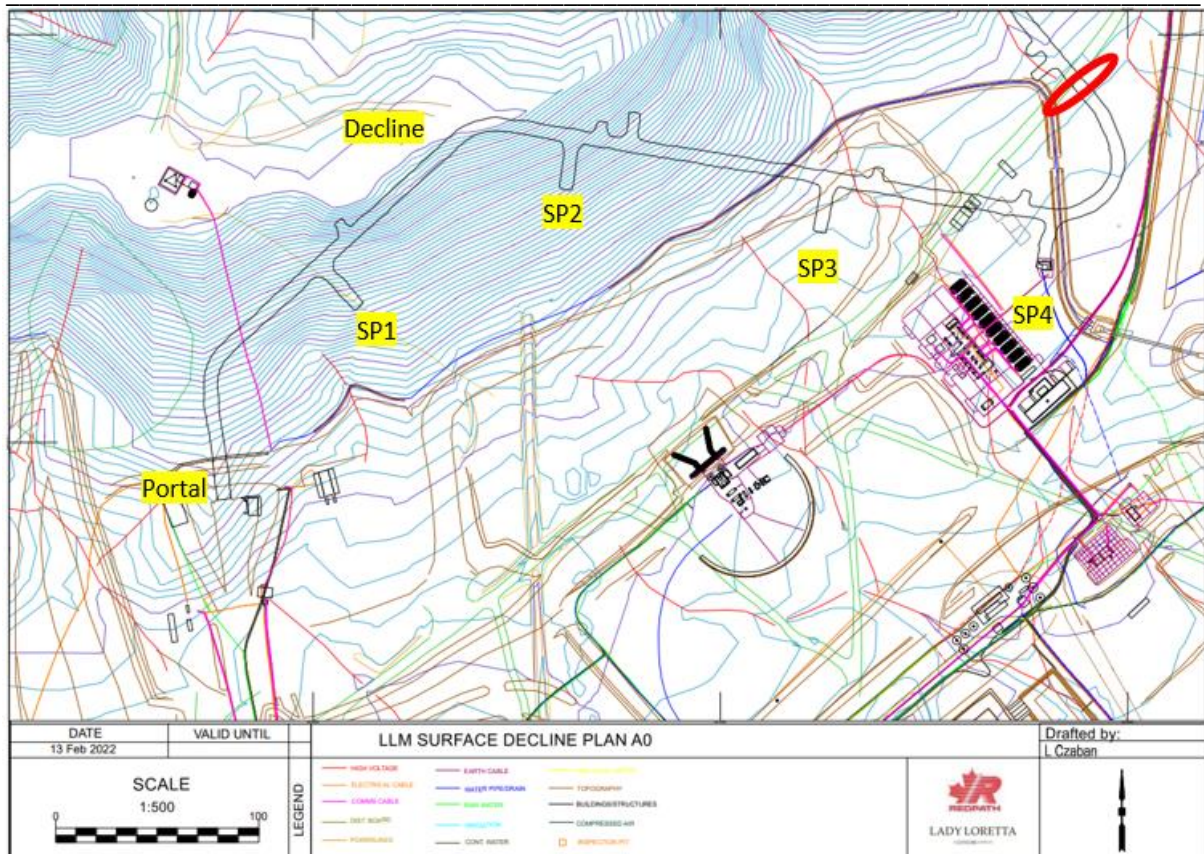
As highlighted in Section 4.3.3., where the Decline is less than 60 m deep from surface, any upward failure will reach the surface before it bulks out and self supports. Considering a Decline gradient of 1: 7 and applying a 10% safety factor, the chainage to commence backfilling is 460 m from the portal as shown in Figure 27. The 10% safety factor covers eventual loss of durability in the bulkhead and collapse. Backfilling must also include stockpiles SP1 to SP4 and any crosscut in between. A “rolling bund” retreat method of placement is recommended, and this will provide the highest level of fill possible. Tight filing will be difficult to achieve, the best effort to reduce the void is required, but not essential.

A bulkhead must be installed at chainage 460 m to hold in place the waste at the start of the backfilling process. When the backfilling process is finished, a sealing bulkhead must be erected at the portal entrance. The box cut then requires backfilling to 3 m above portal backs. The material used to backfill the box cut must be geochemically benign and suitable for plant growth.

Figure 27 – Decline location on the topographic contour map showing where the backfilling towards the portal should start (Chainage 460 m in RED).

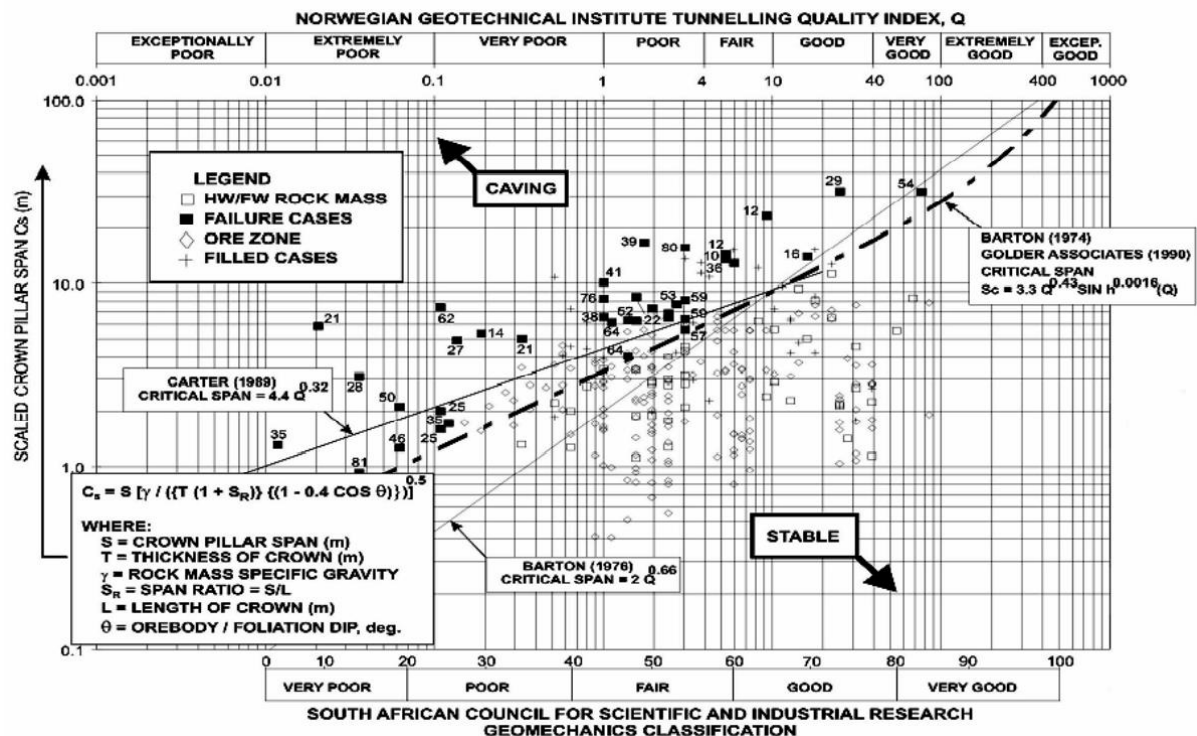
In the same manner as the Q-chart, this scaling expression, CS, is plotted on the y-axis against rock quality on the x-axis. The plot shows the original chart published in 1990, with each of the case records identified as to whether the case was an open stop, or backfilled, and whether stable or not.

The Original Scaled Span Chart, showing stable and failed case records plotted as Scaled Spans versus Rock Quality

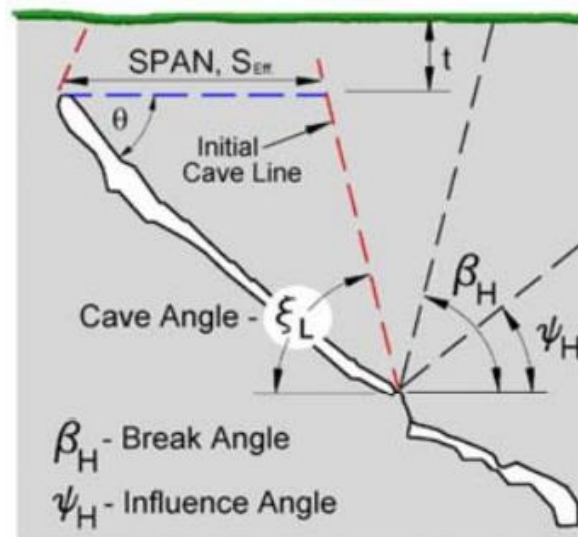
In the revision to the basic relationships published in 2002, the controlling “span” at crown level was therefore redefined to take into account the equivalent “effective” span,  $S_{EFF}$  of the hangingwall projection up to the elevation of the stope crown, as shown in the right diagram, with the extent determined from the cave line,  $\xi_L$  with the failure geometry, that might develop post-collapse of the crown and hangingwall estimated by drawing break lines up from the base of the stope.

## Concept of effective span for shallow dipping stopes based on zone of influence and cave and break angles

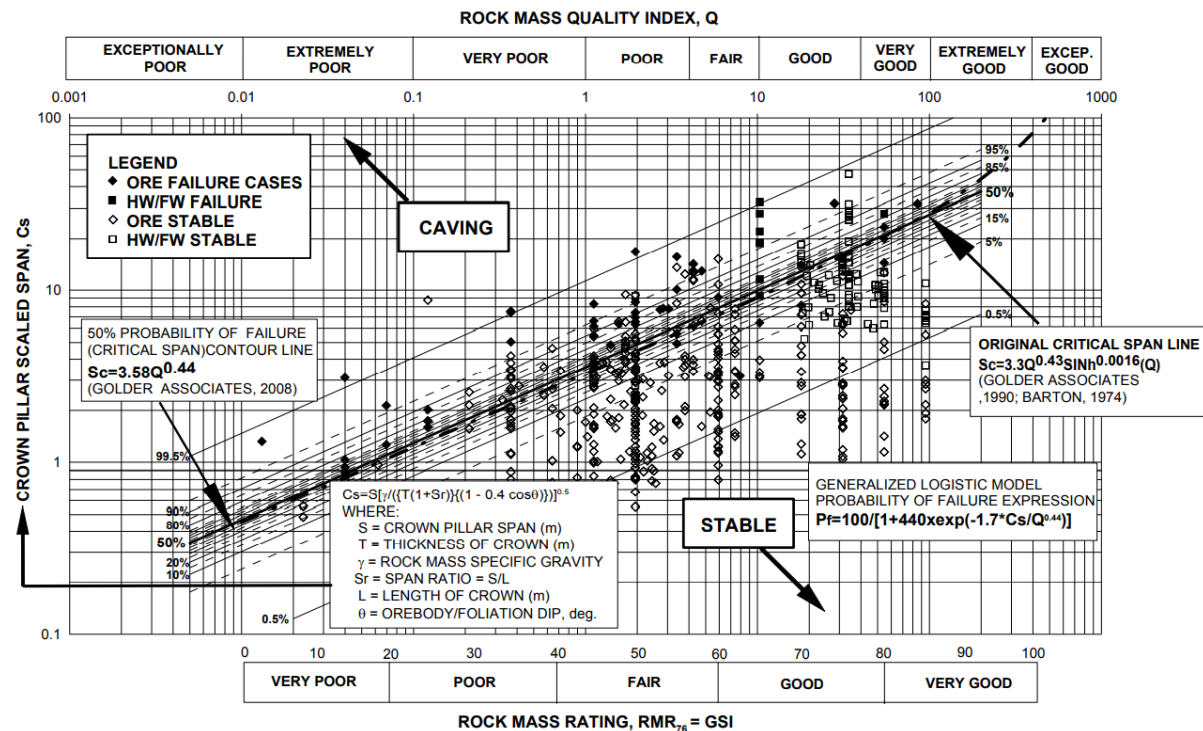
### Updated scaled span chart with probability of failure contour intervals

In its most basic form, the Scaled Span method can be applied deterministically to assess failure risk by simply comparing the Scaled Span (CS) reflecting the mined geometry, to the Critical Span (SC), reflecting the rock mass quality and calculating an approximate Factor of Safety,  $F_c \approx SC/CS$ . If this is done and the Scaled Span, CS exceeds the Critical Span, SC, as defined by the assumed rock quality, unless the stope had been sufficiently supported, or fill approaches had been used in mining; for any opening with  $F_c$  less than 1.0 the likelihood of failure would be predicted to be high.

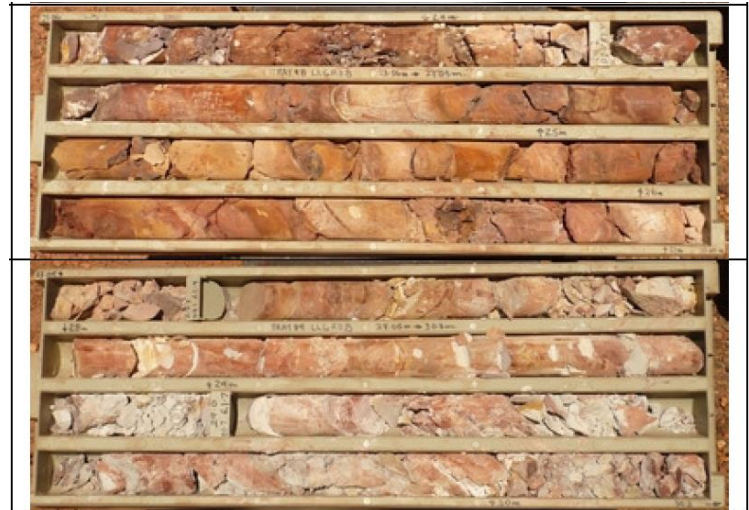
Trays 8 and 9 of LLGRD8: 23.6 – 30.3m.  
Extremely Weathered material that has been  
classified as “Extremely Poor”.  
Includes “Exceptionally Poor” classified  
ground Koff’s Fault intercept (114.5-117.5m)

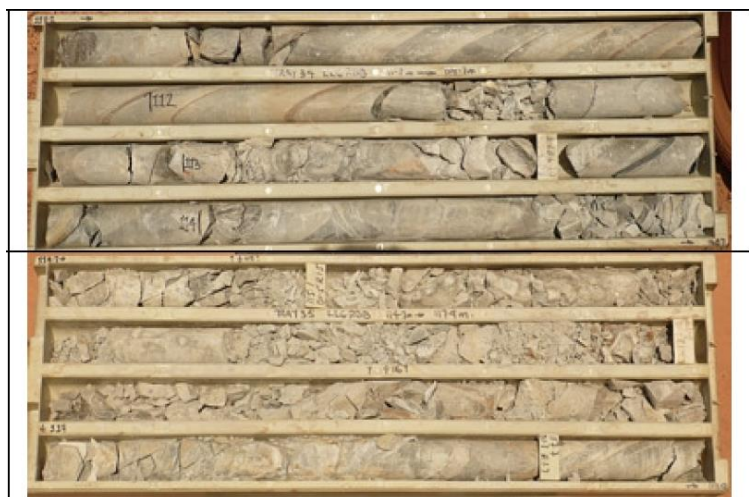
Trays 34 and 35 of LLGRD8: 111.2 – 117.9m.  
Includes “Exceptionally Poor” classified  
ground at the Koff’s Fault intercept (114.5-  
117.5m)

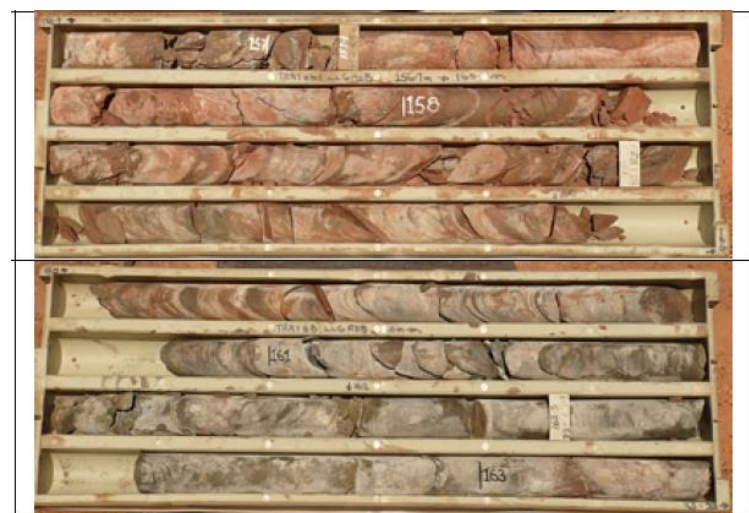
Trays 47 and 48 of LLGRD8: 156.7 – 163.3m.  
Moderately Weathered Rock classified as  
“Very Poor”

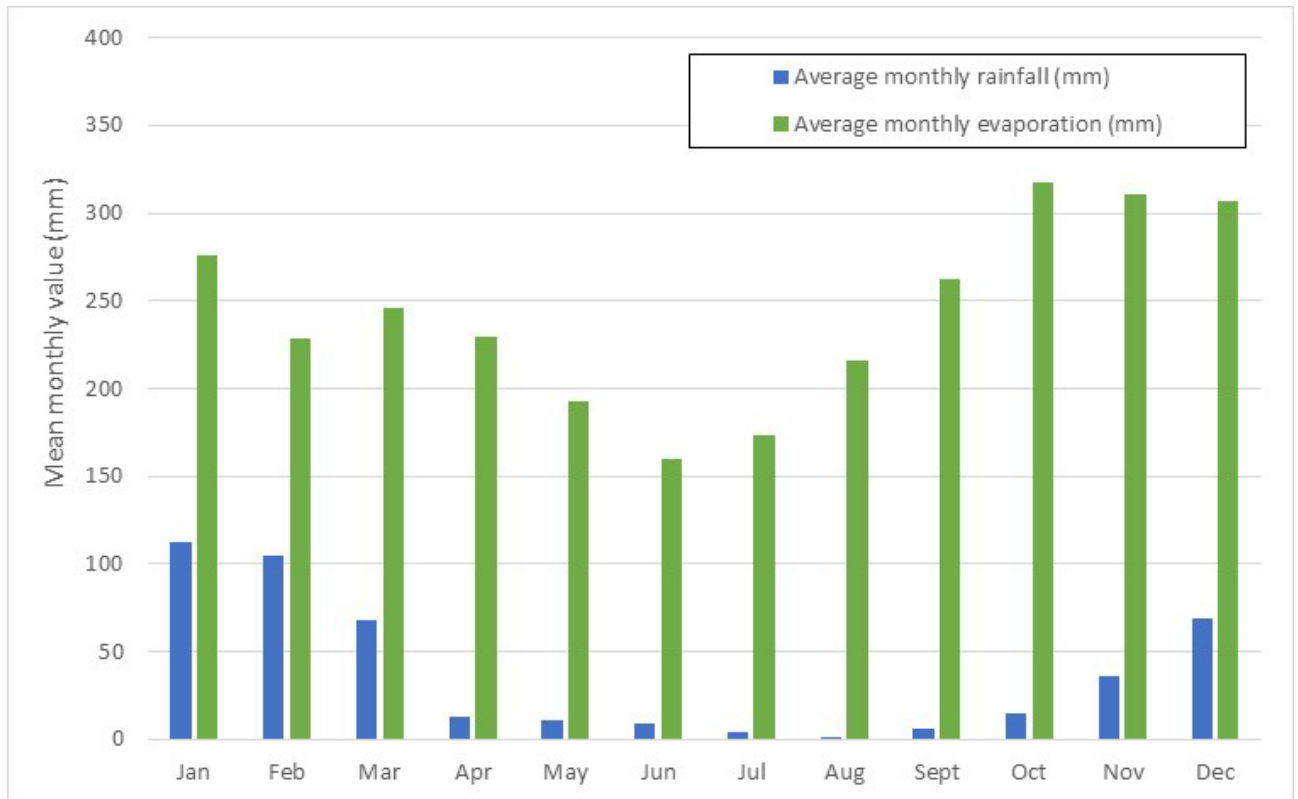
The climate at LLM is dominated by high temperatures, with a regional annual evaporation of 2954 mm/year and an annual rainfall of 414 mm/year. Rainfall is highly variable year on year with long term minimum and maximum rainfall varying between 116 and 1224 mm, respectively. Annual rainfall is concentrated in a distinct wet season from October through to March, with the highest average monthly total occurring in the months November to March (Figure 2-1). On average, monthly rainfall is always exceeded by evaporation.

**Figure 2-1 Average Monthly Rainfall and Evaporation**

The rainfall rate is based on the Camooweal Township weather station (37010; Figure 2-1 and Figure 2-2) and was set to be time-varying but spatially uniform in the LLM2021 model. The rainfall-to-recharge ratio represents the portion of rainfall that becomes recharge and was estimated through model calibration. The ratios were initially zoned based on surface geology (Figure 5-5), with further spatial heterogeneity added through the use of pilot point calibration.

The potential ET rate refers to the groundwater ET rate that would occur if the water table was at the land surface. In the LLM2021 model, the potential ET rate is based on the Camooweal Township weather station (37010; Figure 2-1) from the SILO database. Pan evaporation is considered too high to be used as the potential ET rate as it assumes unlimited water availability. Instead, the potential ET rate is based on the FAO56 estimates (Allen et al., 1998), which is the reference ET rate that takes temperature, relative humidity, wind speed and solar radiation into account. The potential ET rate for the LLM2021 model is time-varying but spatially uniform.

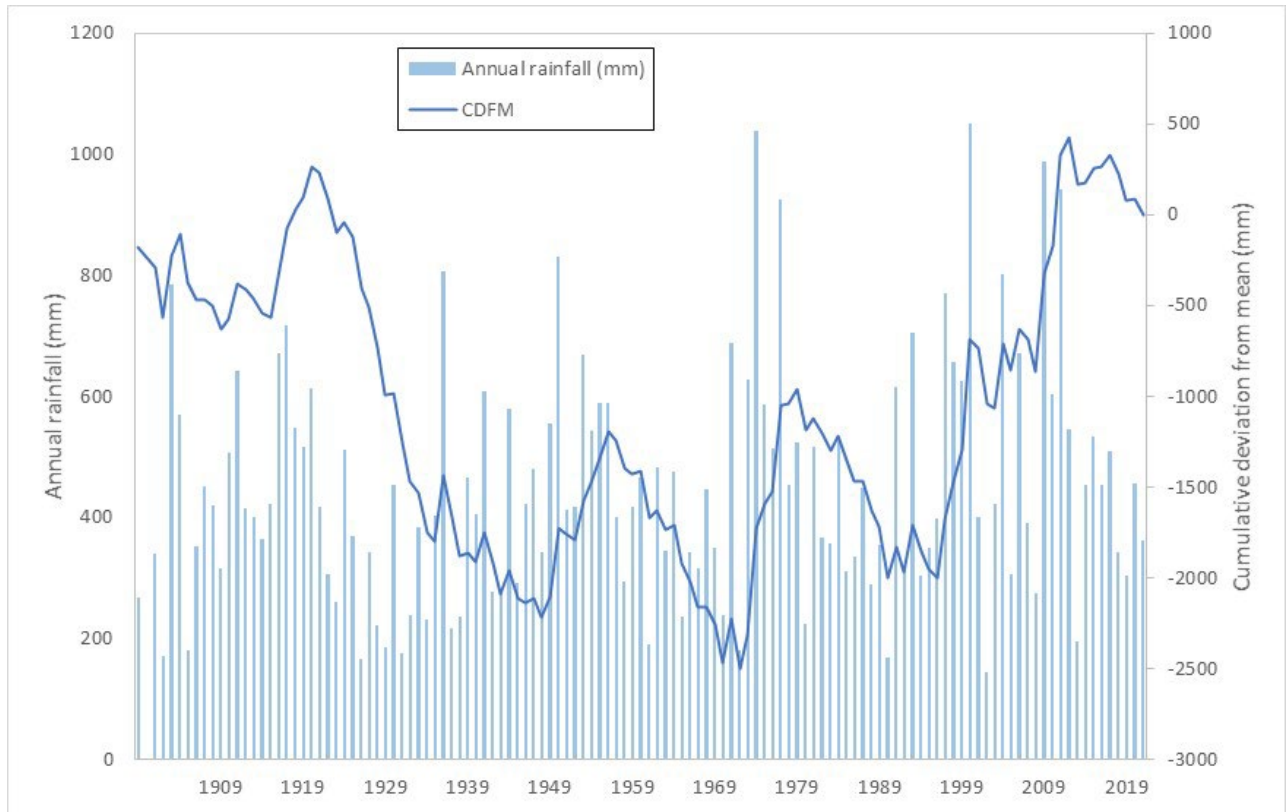
Long term rainfall monthly cumulative deviation from the mean (CDFM) is shown in Figure 2-2, based on the rainfall data obtained from the Australian climate SILO database. Periods of below average rainfall are represented as downward trending slopes, and above average rainfall as upward trending slopes. The data show decadal long periods of below average rainfall and, typically, shorter periods of above average rainfall.

**Figure 2-2 Long term Rainfall and CDFM**

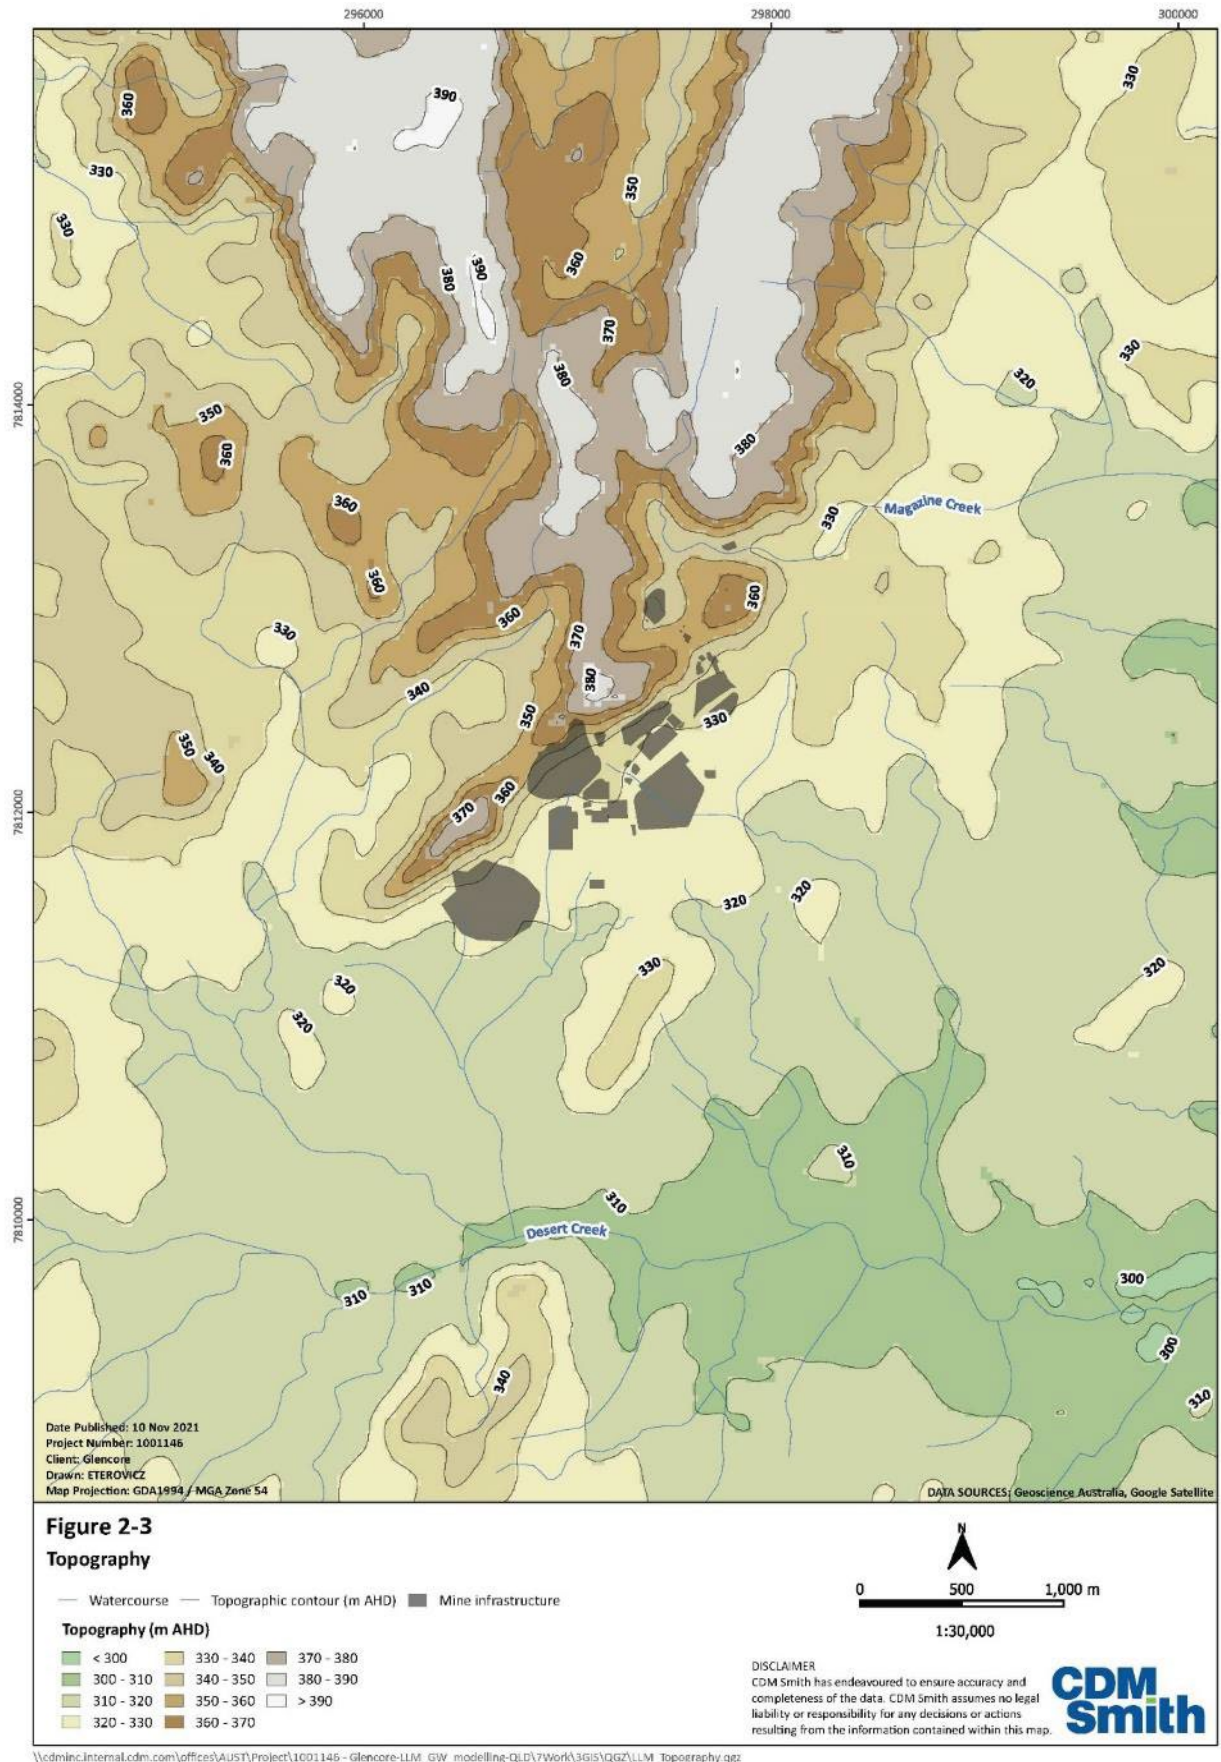
The topography in the study area ranges from approximately 300 to 390 m Australian Height Datum (AHD). The topography is characterised by higher elevation to the north of the LLM site and lower elevation to the south as shown in Figure 2-3. The major topographical feature associated with LLM is a north-east to south-west orientated ridgeline rising to 385 m AHD. The majority of LLM operations are located on the eastern flank of the ridgeline.

**Figure 2-3 Site and Surrounds Topography**

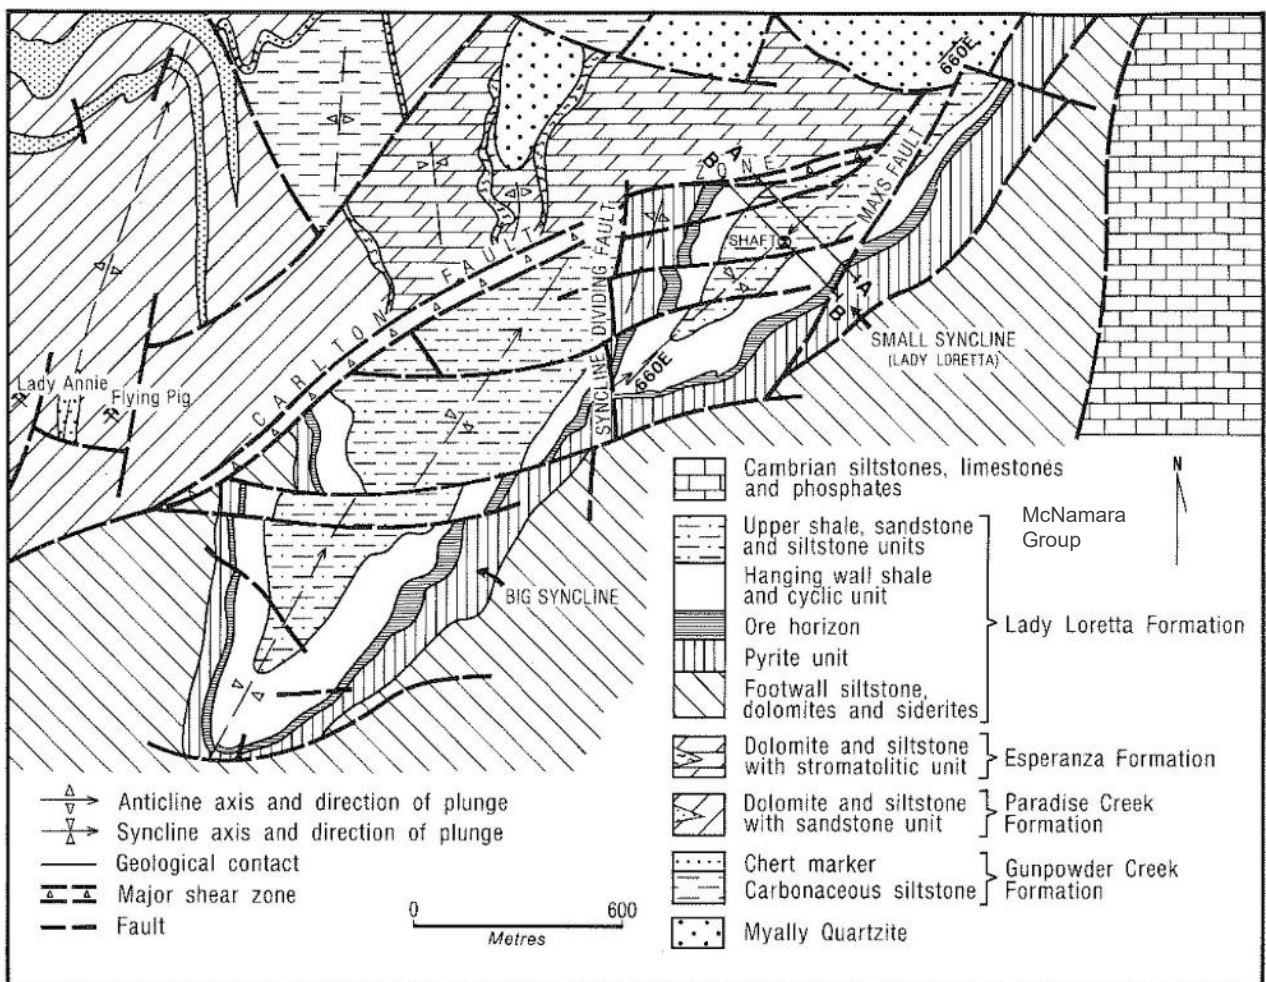
The LLM is located in the Western Fold Belt of the Mount Isa Inlier. The deposit is hosted within the Paleoproterozoic Lady Loretta Formation (Figure 2-4), which forms the uppermost outcropping unit of the McNamara Group (Valenta, 2018). The area is structurally complex and the Lady Loretta deposit is hosted in the keel of the Small Syncline, a tight north-east trending fold truncated by steep to moderately north-west dipping faults called the Koff and Max's Faults, as shown in Figure 2-5.

**Figure 2-4 Plan View Geological Map of the Lady Loretta Deposit and Stratigraphic Column for the Lady Loretta Region (Hancock and Purvis, 1990).**

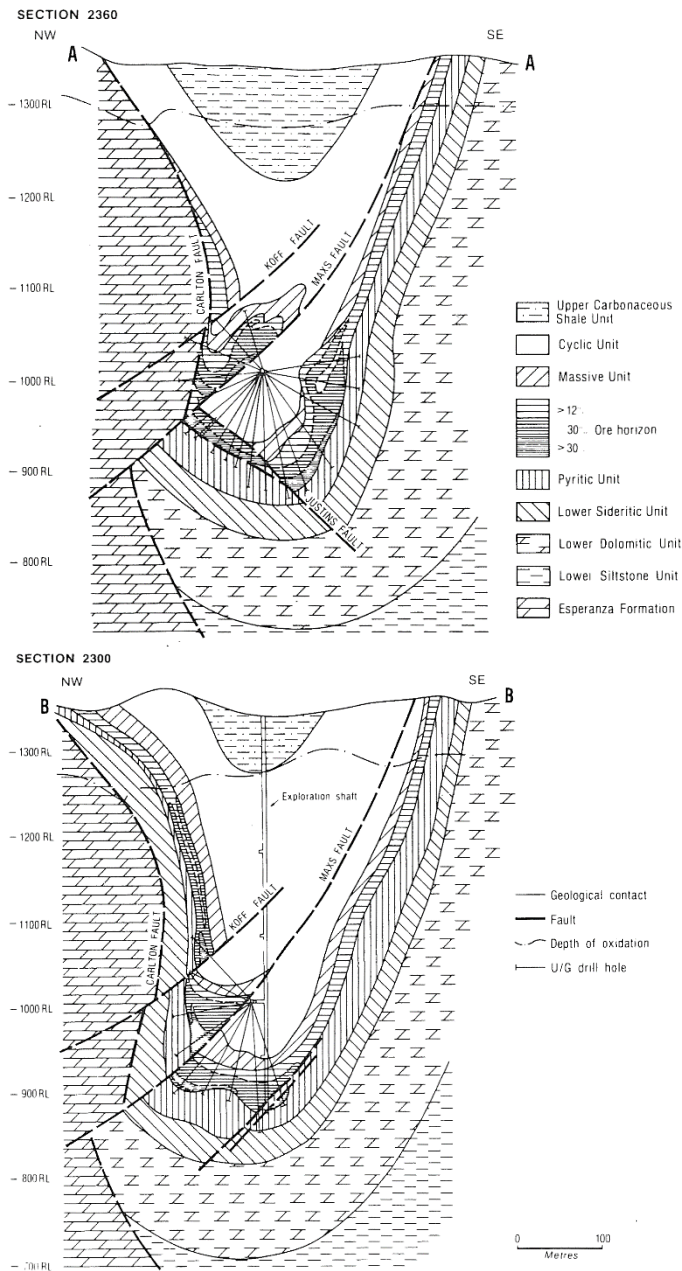
**Figure 2-5 Lady Loretta Cross Sections A-A' and B-B' (Hancock and Purvis, 1990)**
