LADY LORETTA

## **Z-LLM-HSEC-PLN-Progressive Rehabilitation and Closure Plan**

| Project Name | Lady Loretta Mine |
| Document Title | Z-LLM-HSEC-PLN-Progressive Rehabilitation and Closure Plan |

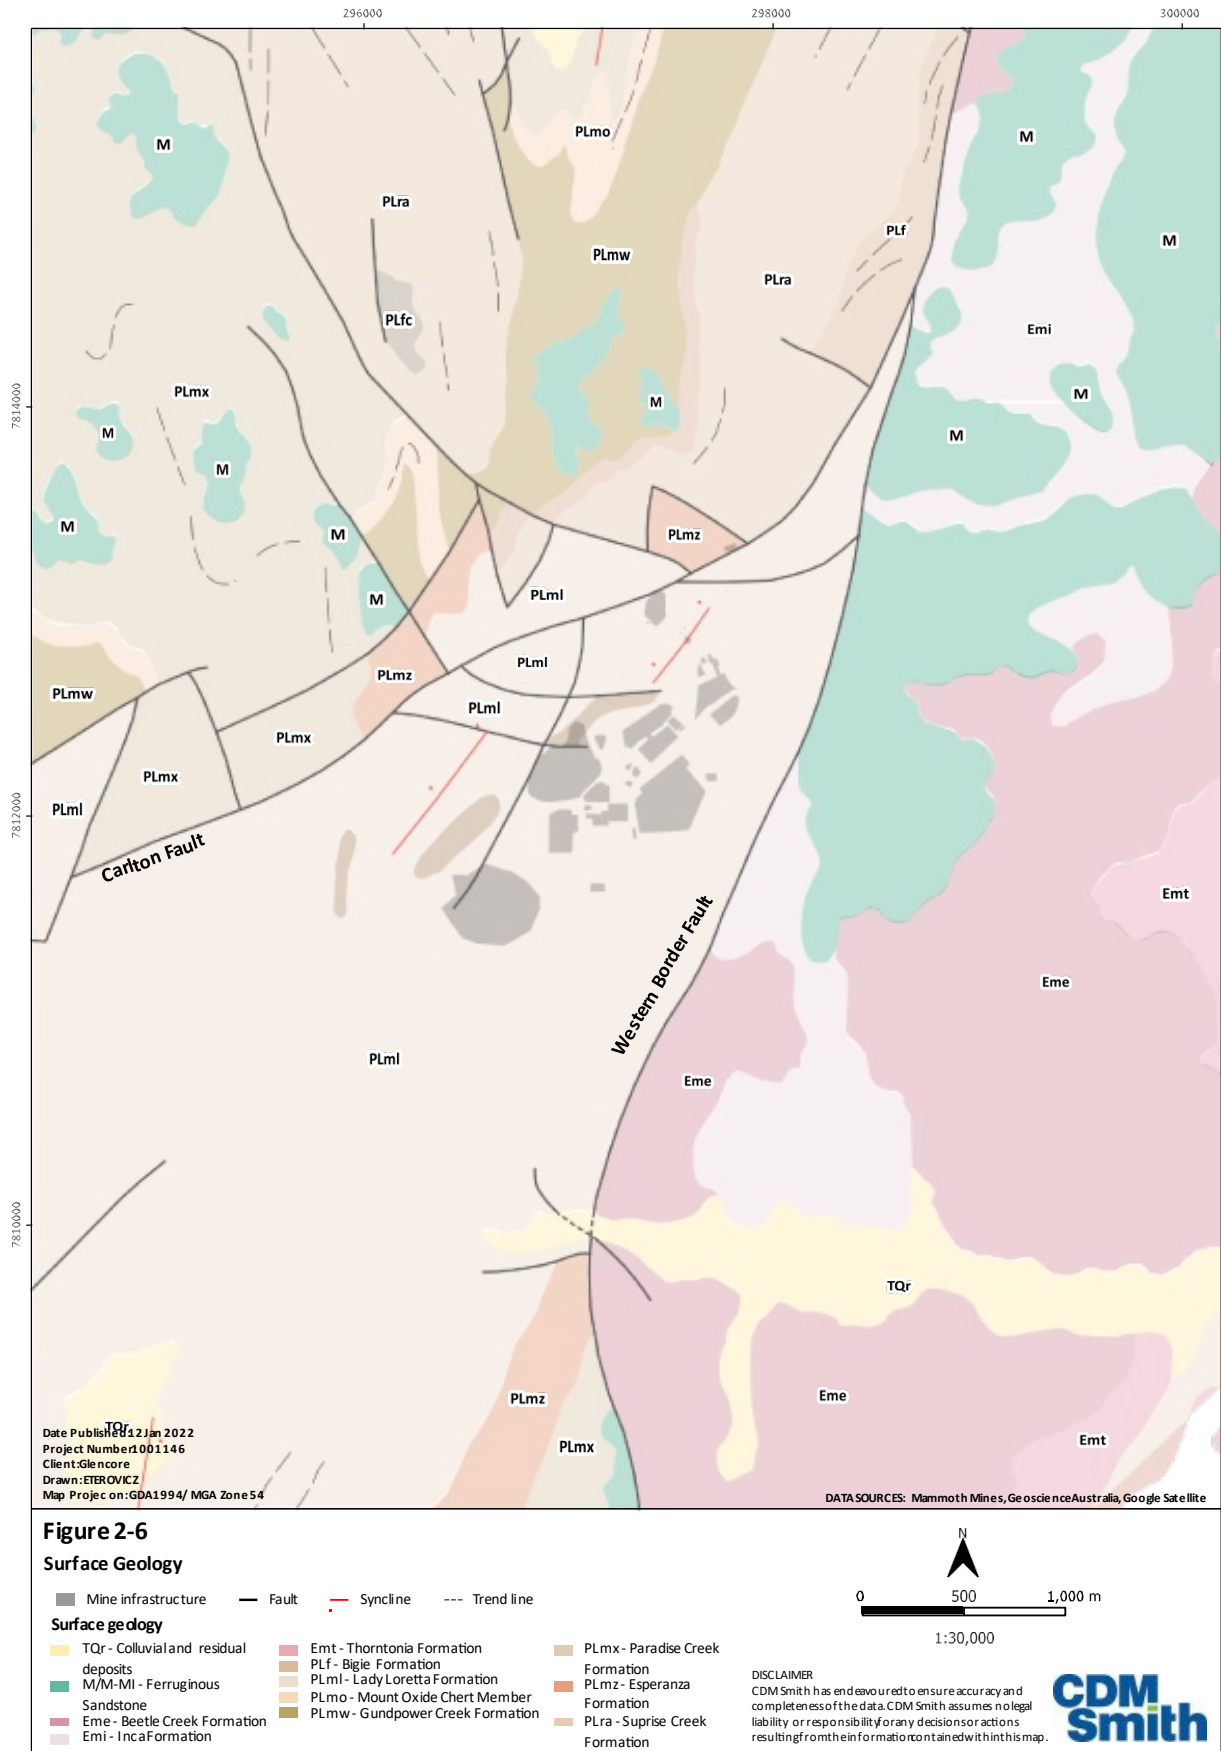
The surface geology is shown in Figure 2-6 and the lithology summary description is presented in Table 2-1. The ore sequence is truncated to the north-west by the north-east trending Carlton Fault zone, which juxtaposes older basin units to the north against the Lady Loretta Formation to the south (Mark, 1998). The Carlton Fault swings into convergence with the north to north-east trending Western Border Fault, which truncates Cambrian and Mesozoic cover rocks east of LLM. The Western Border Fault divides the LLM sulphide ore bearing zone from the less deformed Cambrian strata to the east, while the Carlton Fault separates the Lady Loretta Formation from the Paradise Creek Formation to the west.

**Figure 2-6 Site and Surrounds Surface Geology**

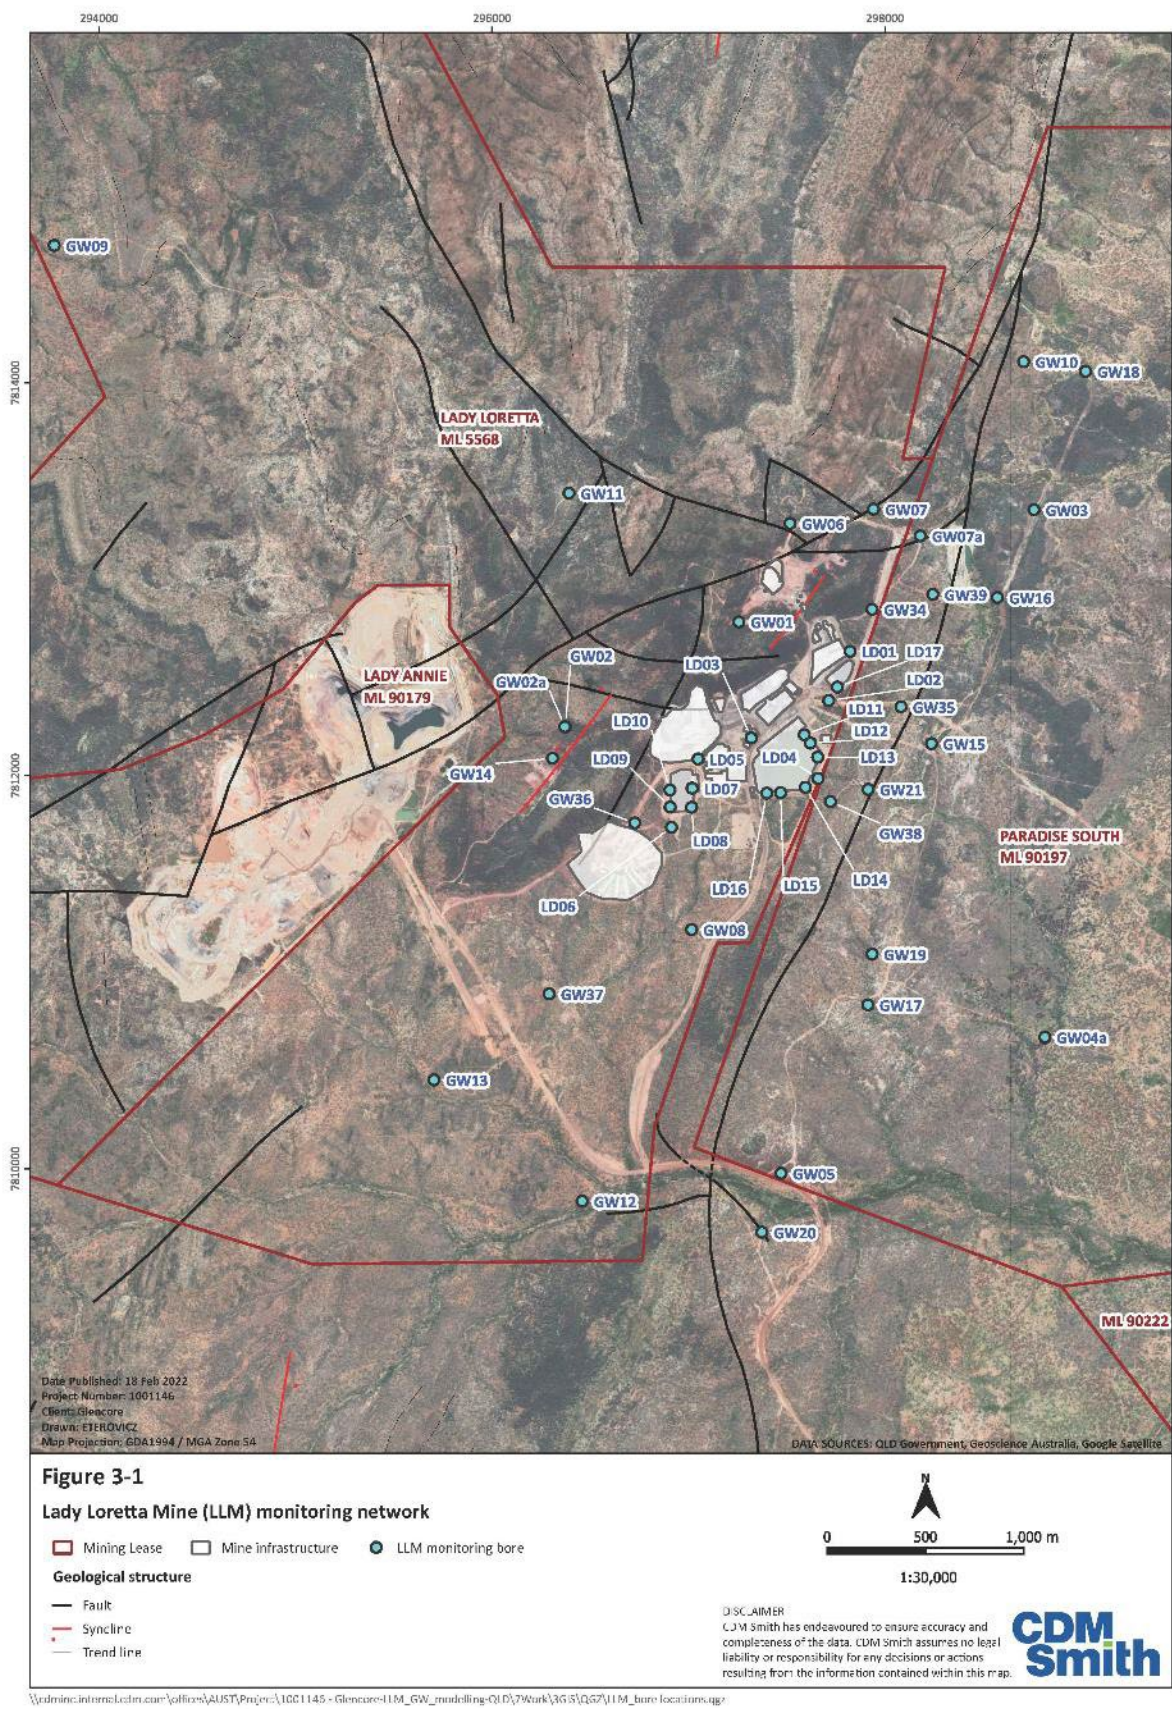
Figure 3-1 Lady Loretta Mine Monitoring Network

The groundwater monitoring network is summarised in Table 3-1 and locations are shown in Figure 3-1. The network consists of 35 groundwater (GW) monitoring bores and 17 Leak detection (LD) sites. The LD sites are typically dry.

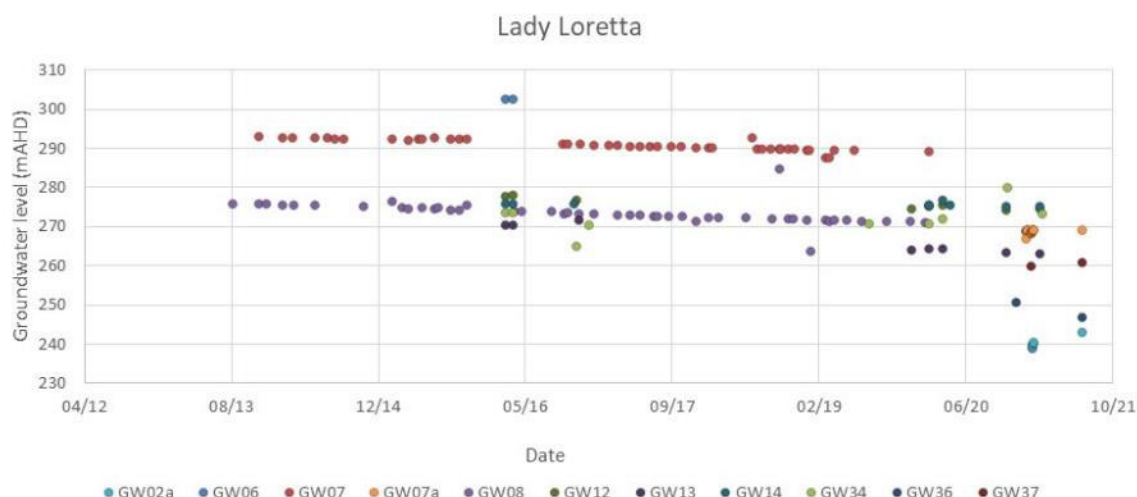
Groundwater head data is available for the Lady Loretta Block bores from August 2013 to July 2021. The groundwater head elevations typically show a declining trend (Figure 3-2). The groundwater monitoring data shows there are variable drawdown rates within the bores over the monitoring period. The highest decline rate is recorded at bore GW13 at 1.5 m/year and GW7, GW8 and GW12 at approximately 0.6 m/year. The lowest decline rate is recorded at bore GW14 at approximately 0.1 m/year and minimal change at GW34 at approximately 0.07 m/year.

Higher elevation areas in the north have higher hydraulic heads for example GW6 and GW7 while lower elevation areas typically have lower hydraulic heads; for example GW8, GW12 and GW13, indicating the natural (pre-mine) groundwater flow direction is inferred as south towards Desert Creek consistent with ephemeral drainage lines and topography. However, the pre-mine groundwater flow field has been altered due to mine dewatering, and flow direction is now generally towards the LLM underground workings. Considering the reported GW14 groundwater heads, which is located between the LLM and the Lady Annie mine pit, there does not appear to be significant dewatering interference between the two mines.

**Figure 3-2 Lady Loretta Block Groundwater Heads**

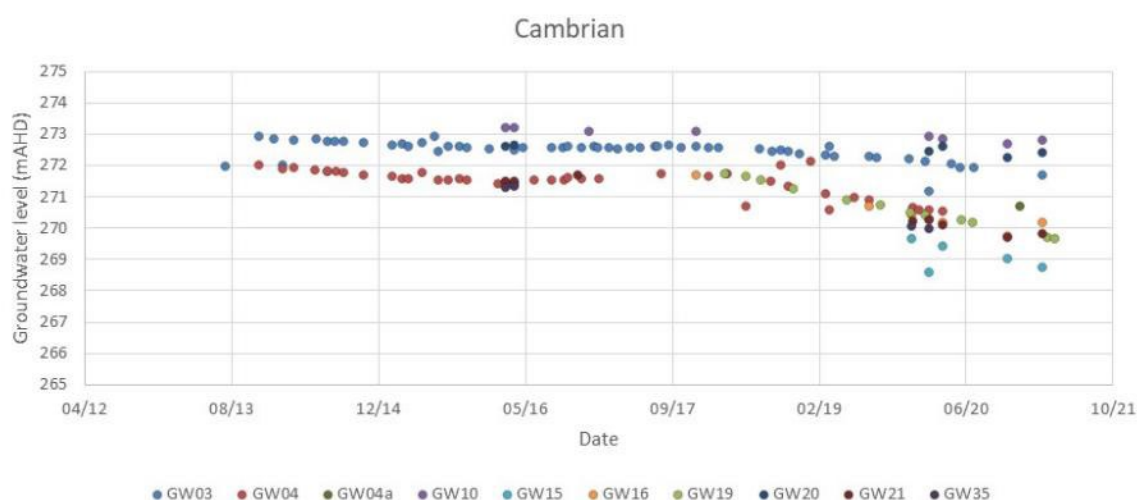
Groundwater head data is available for the Cambrian Block bores from July 2013 to March 2021 (Figure 3-3). All the groundwater monitoring bores show a declining groundwater level trend over the monitoring period. The groundwater heads are approximately 269 to 273 mAHD, with the lowest at GW15 at approximately 268.5 mAHD (possibly in response to pumping from GW15). There are no obvious seasonal recharge responses to annual rainfall evident in the groundwater heads and there is a visible rate of groundwater decline since 2018, despite an increasing slope in CDFM data for the same period.

**Figure 3-3 Cambrian Block Groundwater Heads**

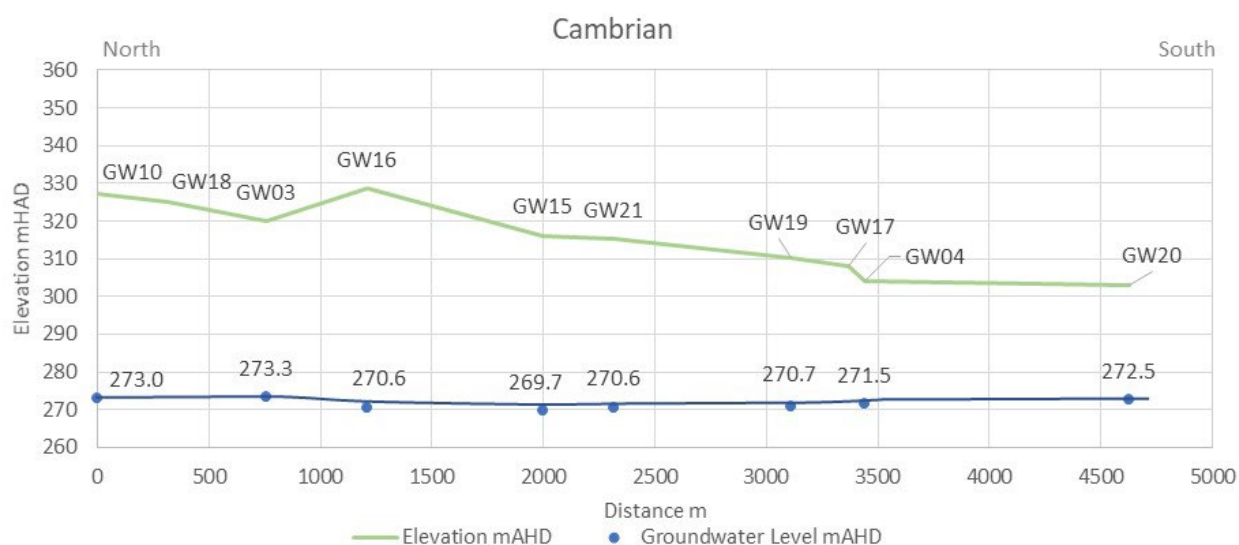
Table 3-6 shows groundwater head statistics and Figure 3-4 shows the average groundwater head over the monitoring period. Groundwater head decline is greatest at monitoring bore GW15. The groundwater heads show a drawdown and flow direction towards the monitoring bore GW15 from the north and south. The groundwater decline is likely to be attributed in part to the LAE borefield. Whilst there is little west to east spread of water head datapoints, the available initial/earliest data suggests the natural (pre-mine) groundwater flow direction inferred as east, consistent with ephemeral drainage lines and topography.

**Figure 3-4 Cambrian Block Average Groundwater Heads**

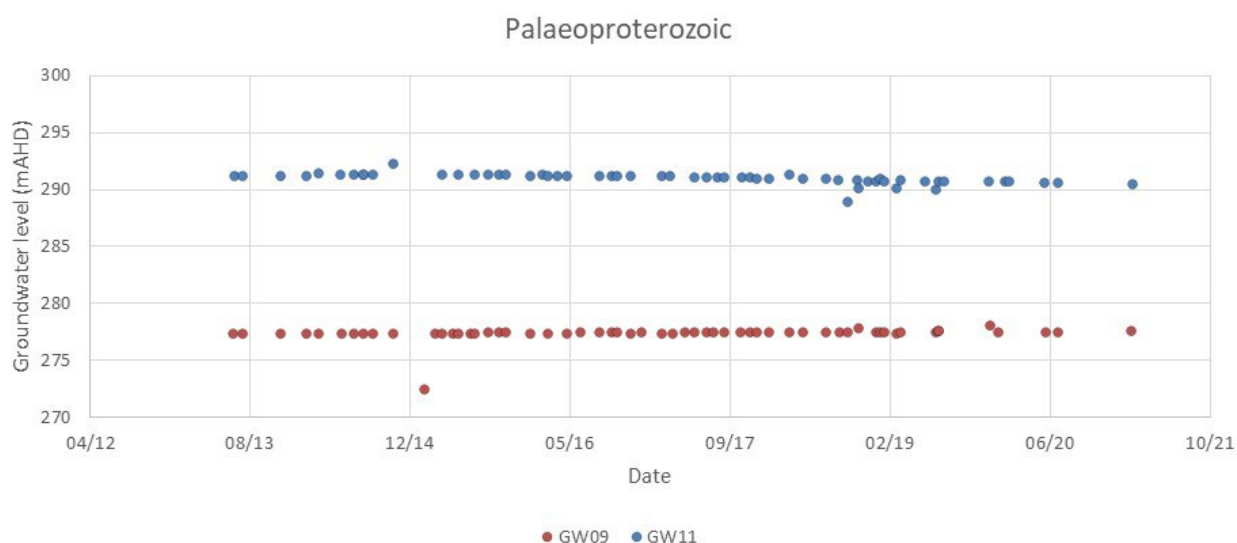
There are two groundwater monitoring bores located in the Paleoproterozoic Block west of LLM and the Carlton Fault (Figure 3-5). The groundwater level measurements over the monitoring period are relatively consistent and show minor change since 2013 despite a variable slope in CDFM data for the same period and no evident recharge response to rainfall. Bore GW11 is located greater than 1 kilometre from LLM and GW09 greater than 4 kilometres. The natural (pre-mine) groundwater flow direction is inferred as west based on the topography and groundwater head data for bores GW09 and GW11.

**Figure 3-5 Palaeoproterozoic Block Groundwater Heads**

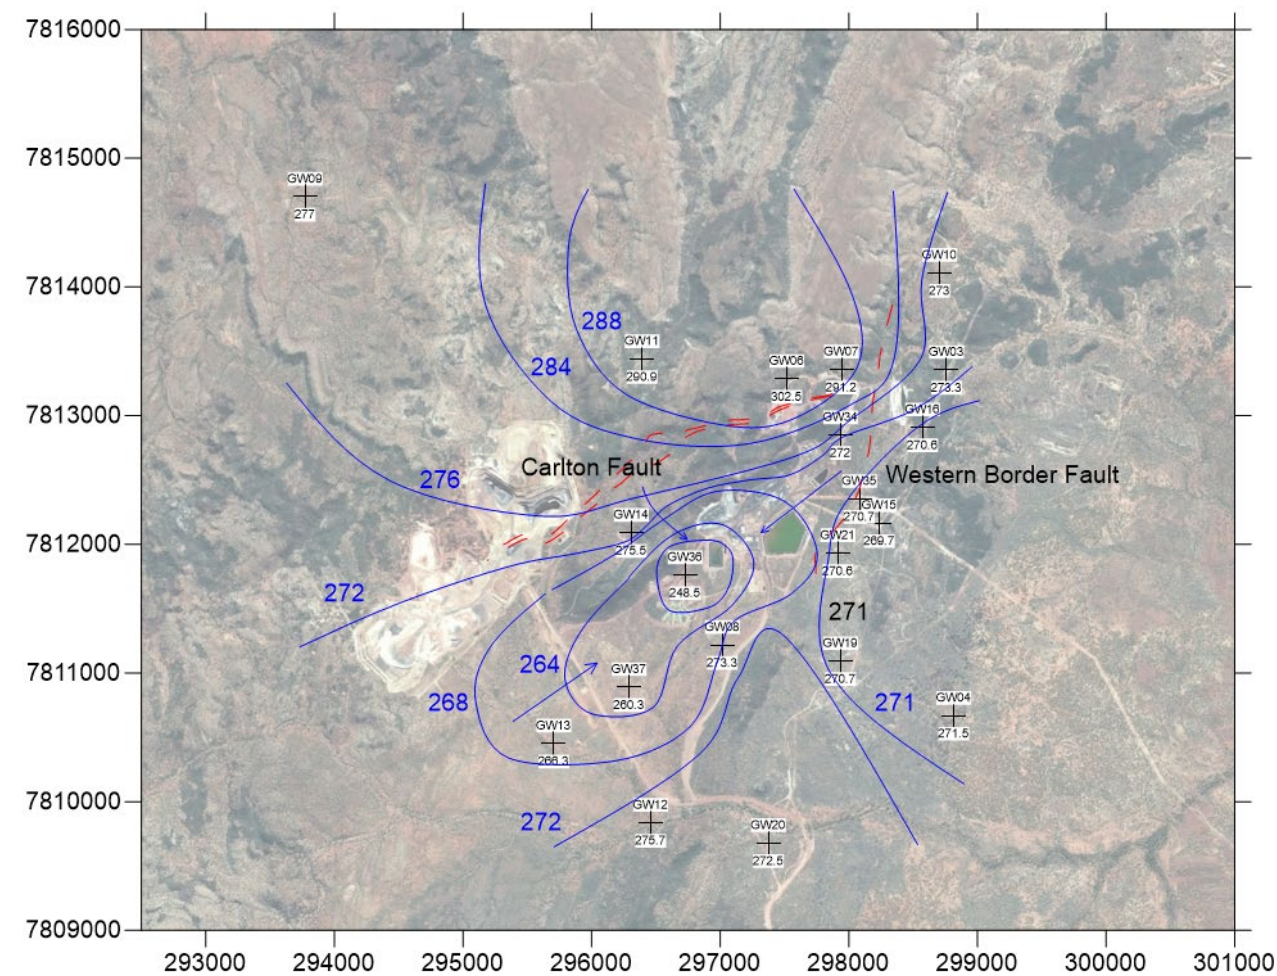
Carlton and Western Border Faults are expected to exert a major control on groundwater flow fields, with groundwater contours also influenced by drawdowns that develop in response to mine dewatering and borefield production. Because of these influences it is not possible to clearly attribute groundwater contours to specific fault controls, so a quantification of the specific influence of faults cannot be made at this time. However, there is a hydraulic gradient towards the LAE borefield and to the LLM site. Overall, on the Lady Loretta Block there is evidence of localised groundwater flow towards LLM due to dewatering within the underground mine workings, a cone of depression has developed, drawing groundwater toward the central part of the site operations. The cone of depression extends south to south-west along the axis of the syncline, toward bore GW13 and there is minimal depressurisation evident in the west around GW14. This contour assessment is considered further as part of the reconceptualisation presented in Section 4.

Figure 3-6 Average Observed Groundwater Levels and Contours (mapped fault locations cannot be assumed to be exact or precise)

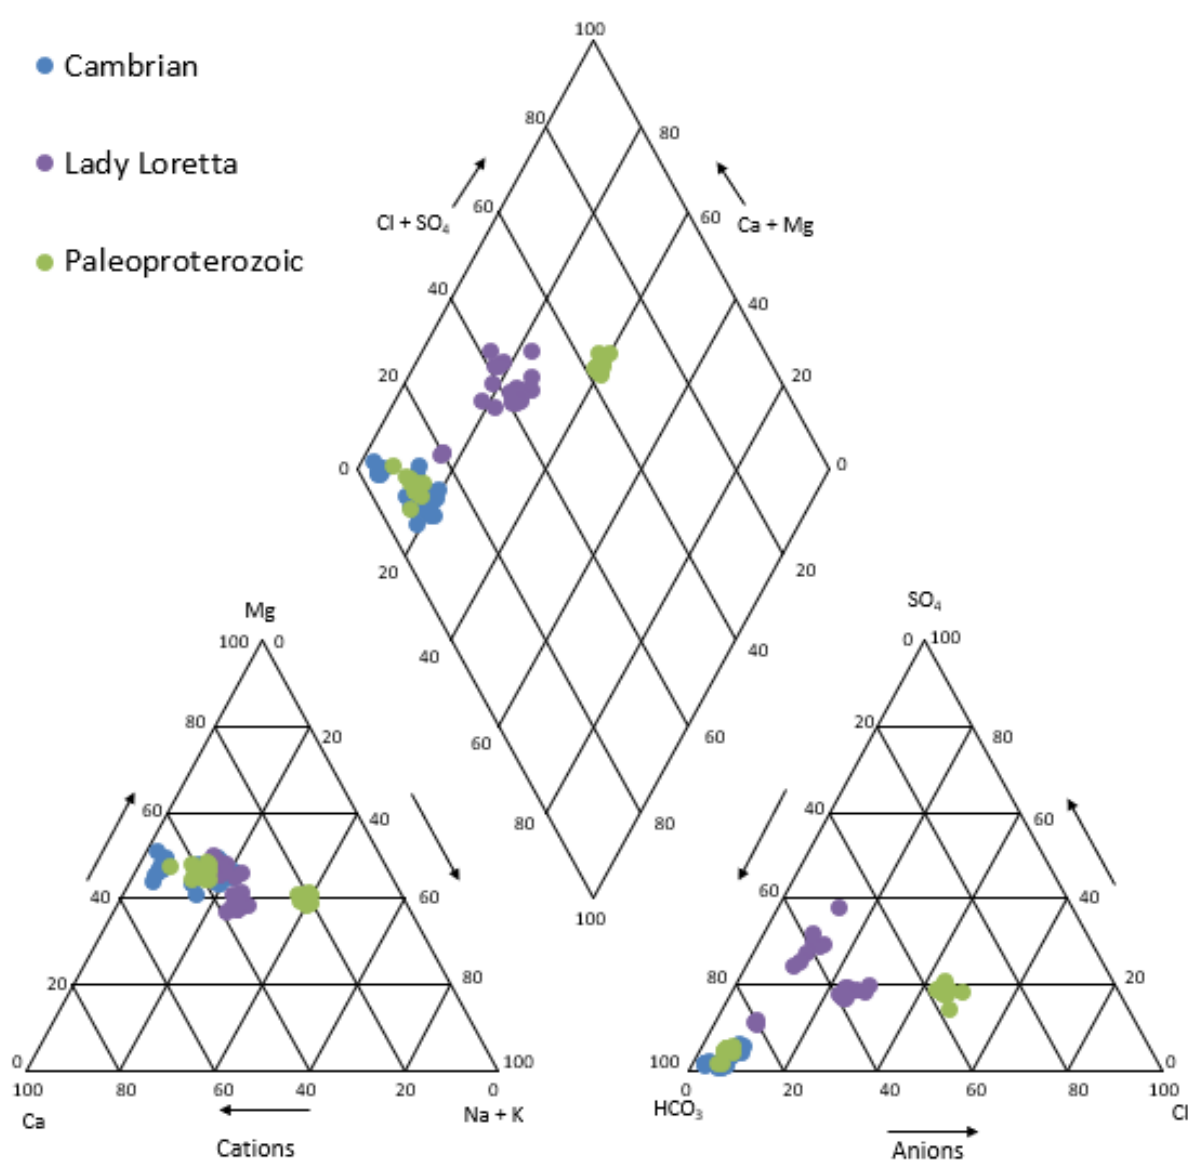
Proportional abundances of major cations and anions are shown on the piper diagram Figure 3-7 for monitoring bores across the site. Piper Plots explain the classification type of water facies on the basis of its interaction with rock and soil minerals. The diamond plot at the centre is a blend of two trilinear plots on the two sides of the diamond. Different quadrants of the diamond show the different type of water on the basis of ion concentration dominance.

Based on the Piper Plot all formations have calcium-bicarbonate dominated groundwater except for the Paleoproterozoic Block, which has calcium-chloride dominated groundwater in some locations. The Paleoproterozoic Block bores located furthest from the LLM to the north-west indicates calcium as the dominant cation and chloride as the dominant anion. Groundwater with calcium as the dominant cation and bicarbonate the dominant anion is typically consistent across the site.

Figure 3-7 Piper Diagram for all Selected Groundwater Samples

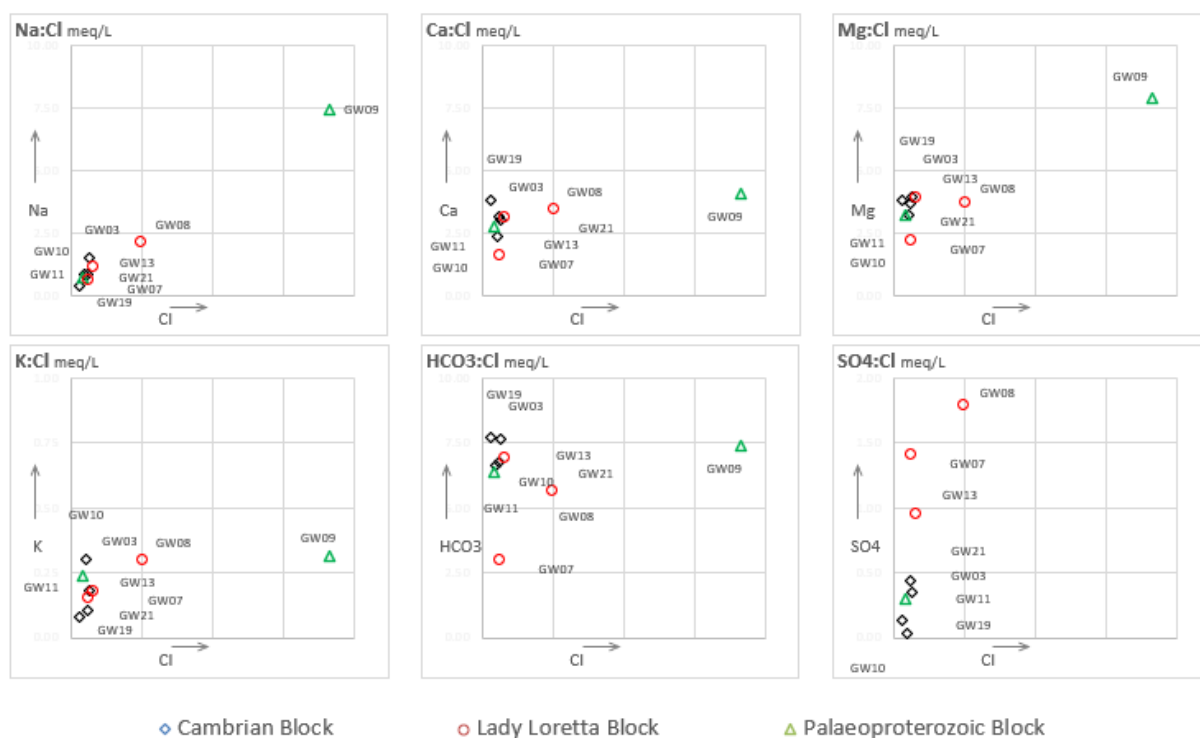
The cations versus chloride proportional abundances are shown in Figure 3-8 for monitoring bores across the site. Based on Figure 3-8 the cations versus chloride plots indicate that groundwaters are similar. All formations have calcium -bicarbonate dominated groundwater except for monitoring bore GW09, which has calcium-chloride dominated groundwater. GW09 located furthest from the LLM to the north-west shows calcium as the dominant cation and chloride as the dominant anion.

**Figure 3-8 Major Ion and Chloride Ratio Plots for Selected Groundwater Samples**

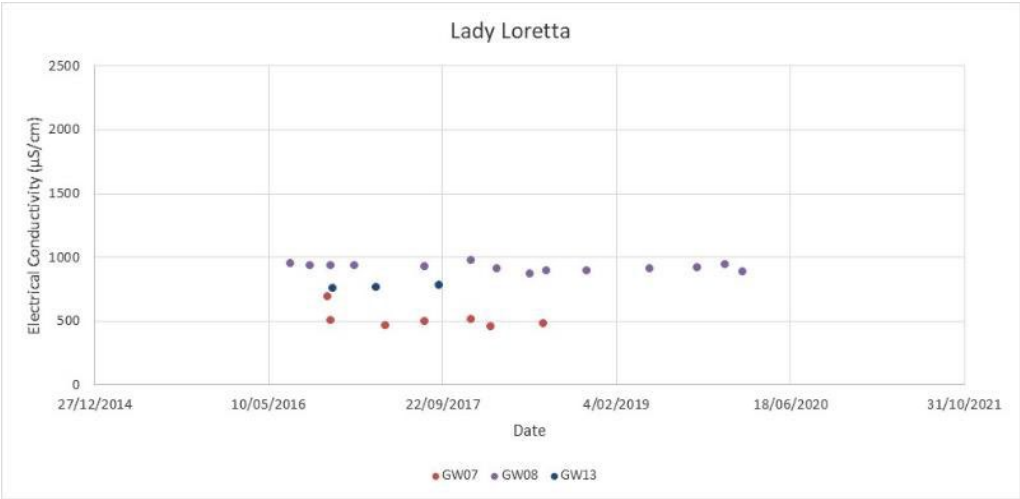
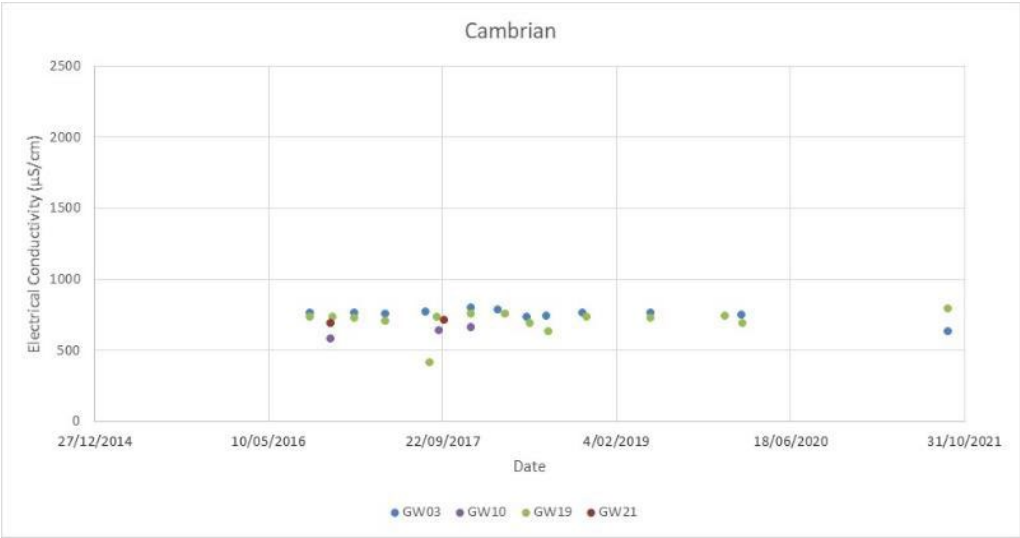
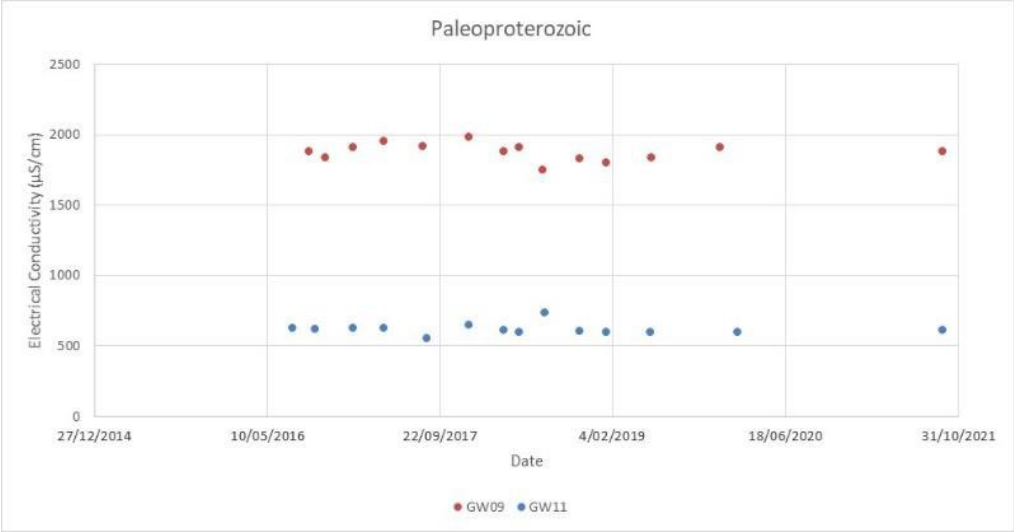
Figure 3-9 to Figure 3-11 show electric conductivity (EC) for monitoring bores across the site. The groundwater samples indicate EC values of less than 1000  $\mu\text{S}/\text{cm}$ , with the exception of GW09 which reports an EC of almost 2000  $\mu\text{S}/\text{cm}$ . Notably, the bores located on the eastern and western side of the Carlton Fault and Western Border Fault show comparable EC values.

Figure 3-9 Lady Loretta Block EC

Figure 3-10 Cambrian Block EC

Figure 3-11 Paleoproterozoic Block EC

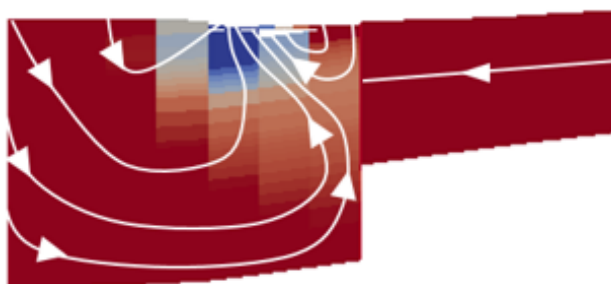
The AGE 2020 concept of barrier to flow is shown below where there is nearly no flow across faults (Figure 4-1).

**Figure 4-1 Cross Section of Barrier Fault Flow Lines (McCallum et al., 2018)**

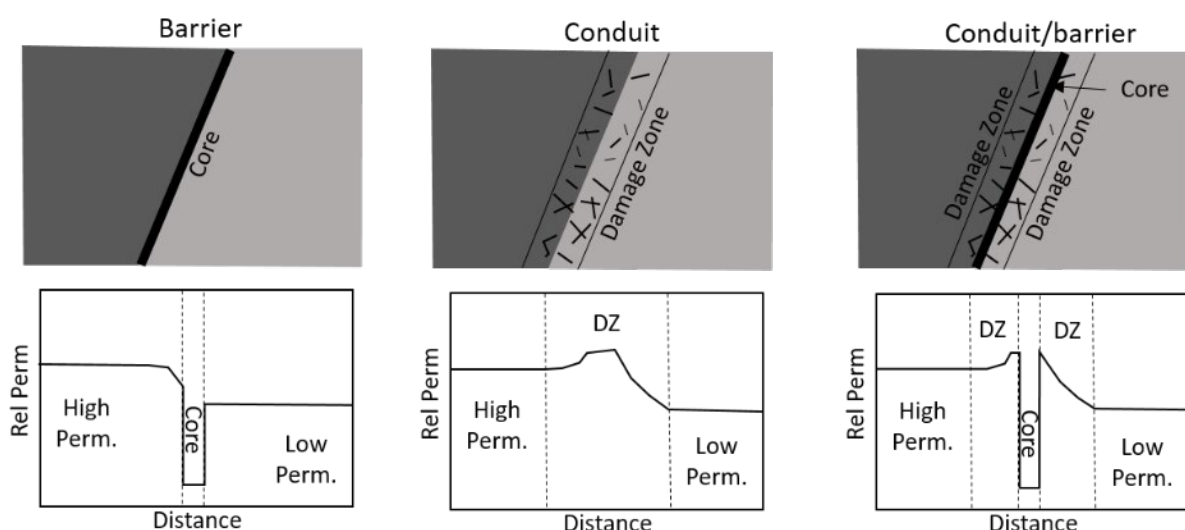
Faults can broadly exhibit three behaviours in a fluid flow context these behaviours are (Figure 4-2):

- A barrier to both along and across fault flow.
- A conduit to both along and across fault flow.
- A conduit to along fault flow and a barrier to across fault flow.

**Figure 4-2 Three Conceptual Models of how Fault Zones Impact Fluid Flow Properties (McCallum et al., 2018)**

Ideally, to represent the faults within the context of the conceptual conduit-barrier system, details of the physical characteristics of the fault zones need to be represented. This includes the widths and permeabilities of the fault core and the damage zone (McCallum et al., 2018). There are insufficient site data or information to inform fault permeabilities and determine the fault behaviour to groundwater flow. Ideally, a site field and data collection program (possibly including groundwater isotopic studies) would inform the fault behaviour and this information would inform the regional numerical model.

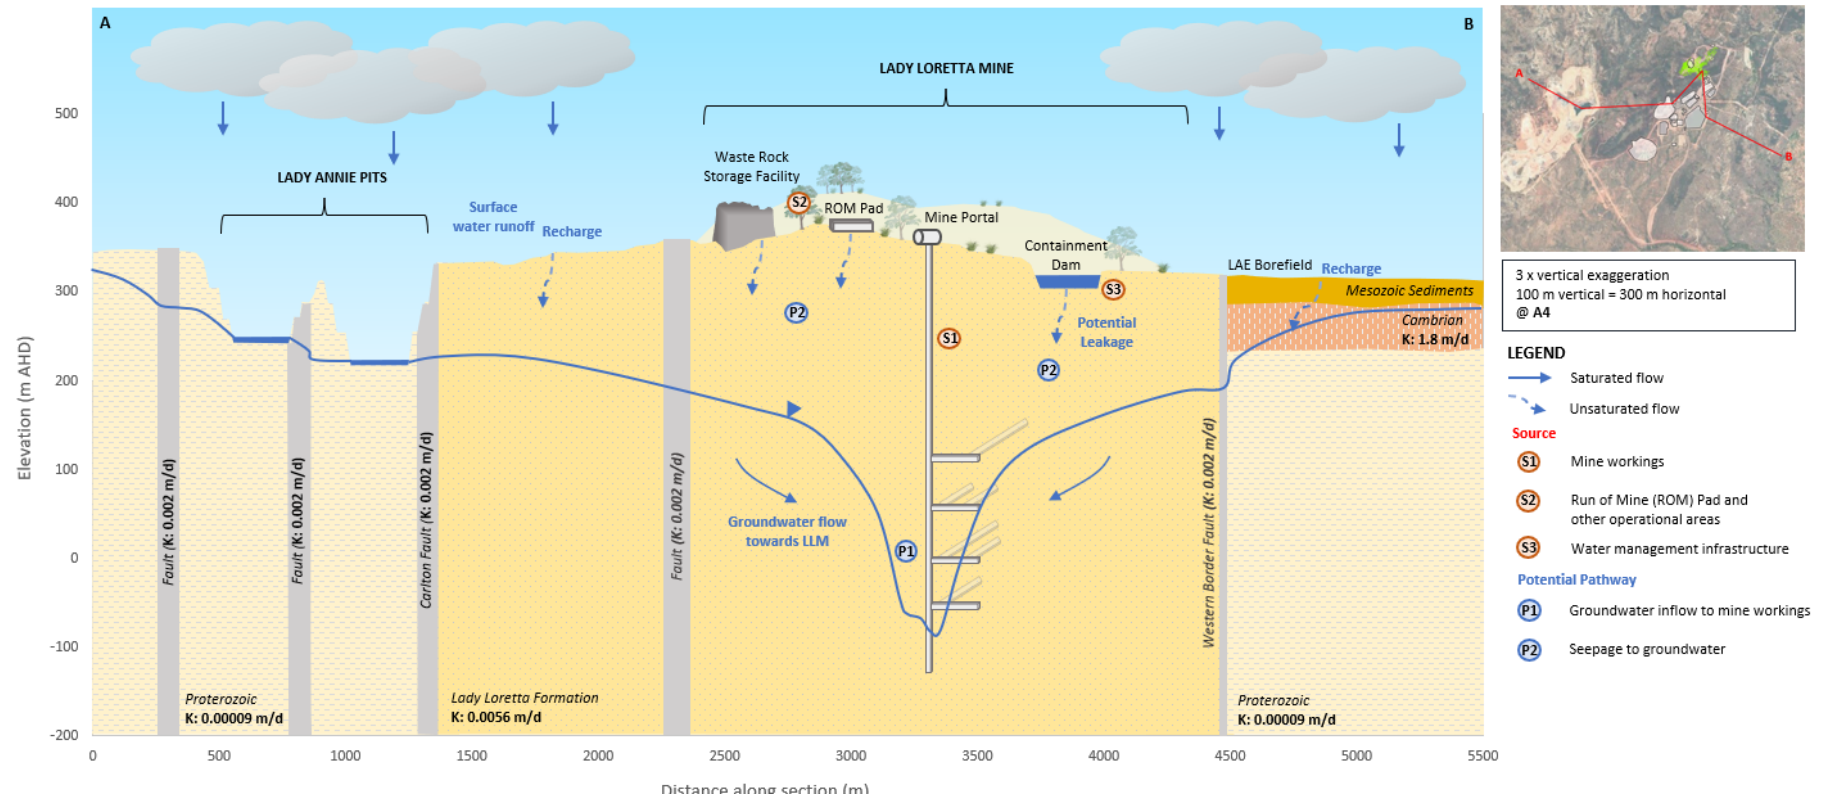
A simplified revised conceptual cross section is shown in Figure 4-3 based on the available hydrogeological information and assessment works completed above.

Figure 4-3 Conceptual Hydrogeological Model Schematic – Operating Mine

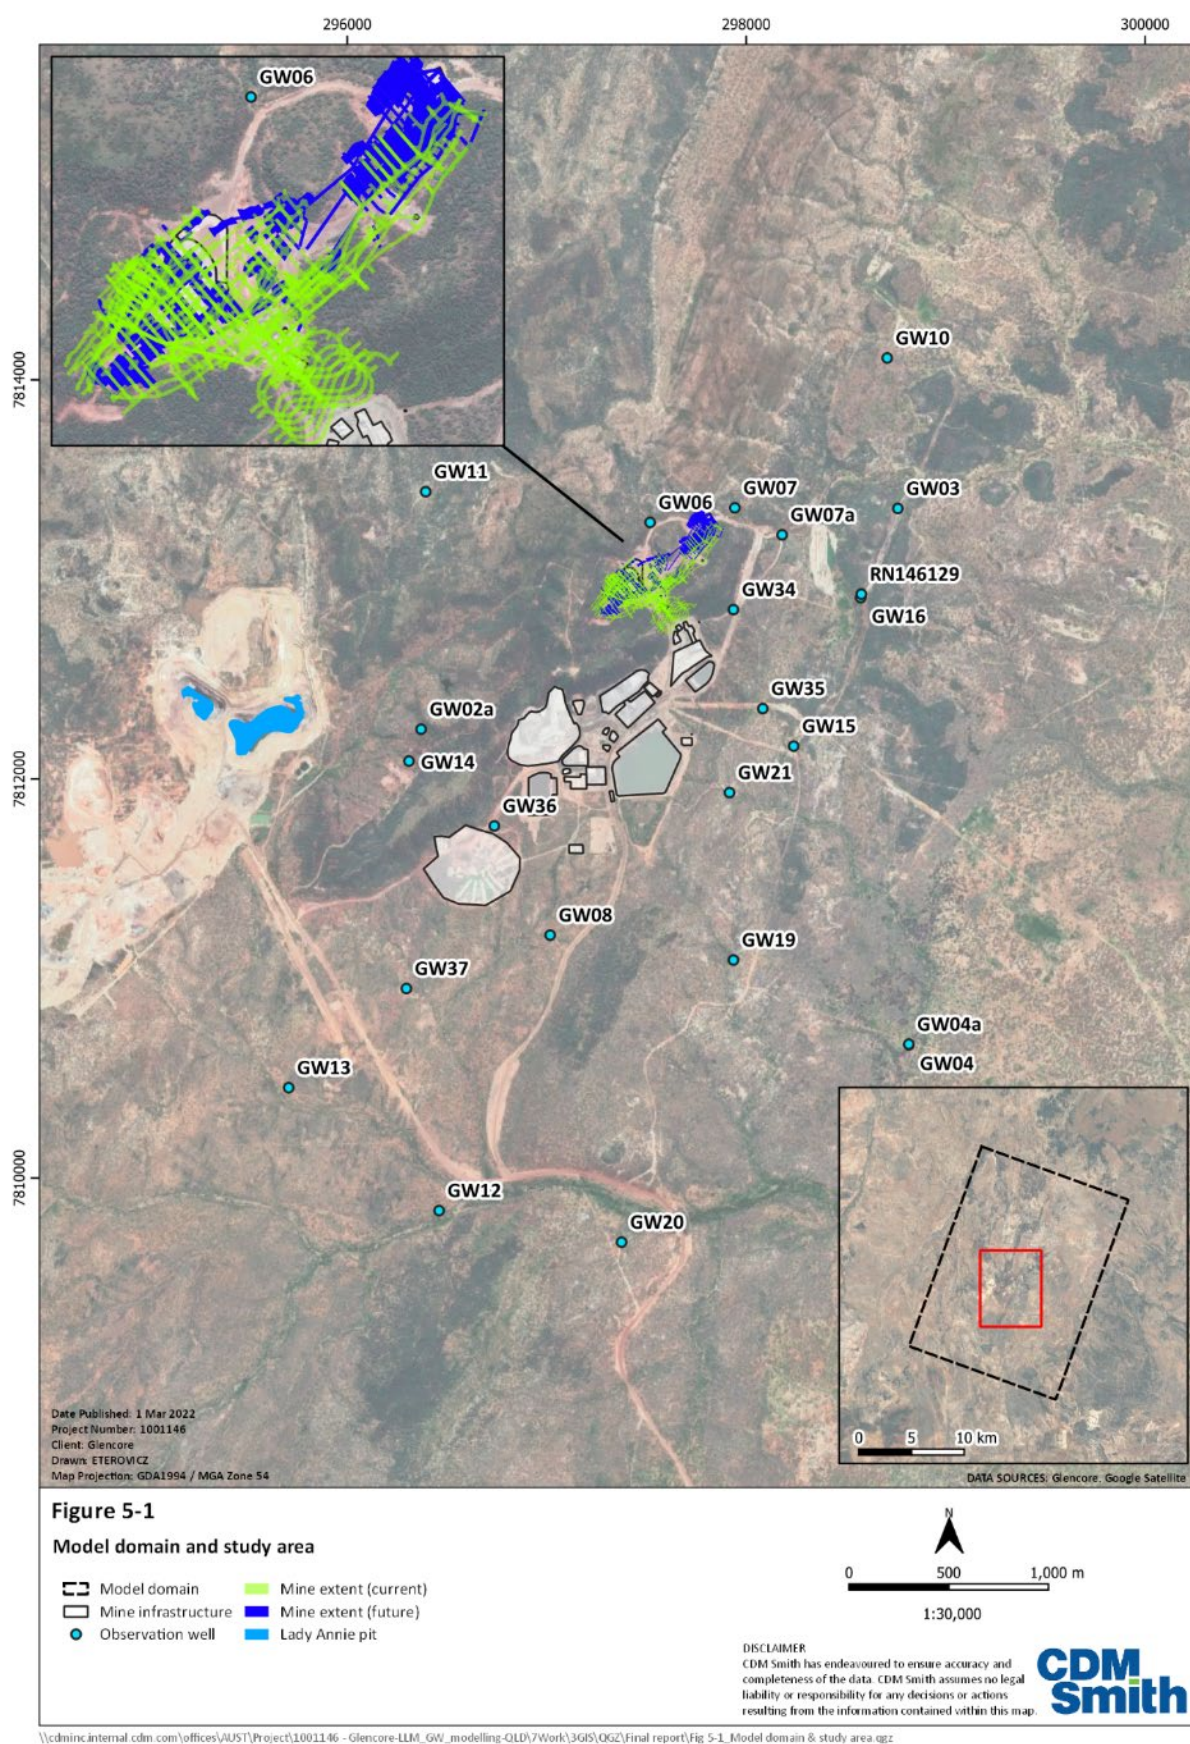
The LLM2021 model domain (Figure 5-1) and grid (Figure 5-2) are consistent with the original model (AGE, 2015). The model domain was discretised into rectangular cells comprising 661 rows and 297 columns. There are 196,317 cells in each layer with the cell dimension varying from 10 x 10 m covering the LLM site and LAE borefield to 100 x 100 m outside the area of interest. The model grid was rotated from north 20 degrees to the east to align the cells parallel to the LAE borefield that is consistent with the principal groundwater flow direction.

**Figure 5-1 Model Domain and Study Area**

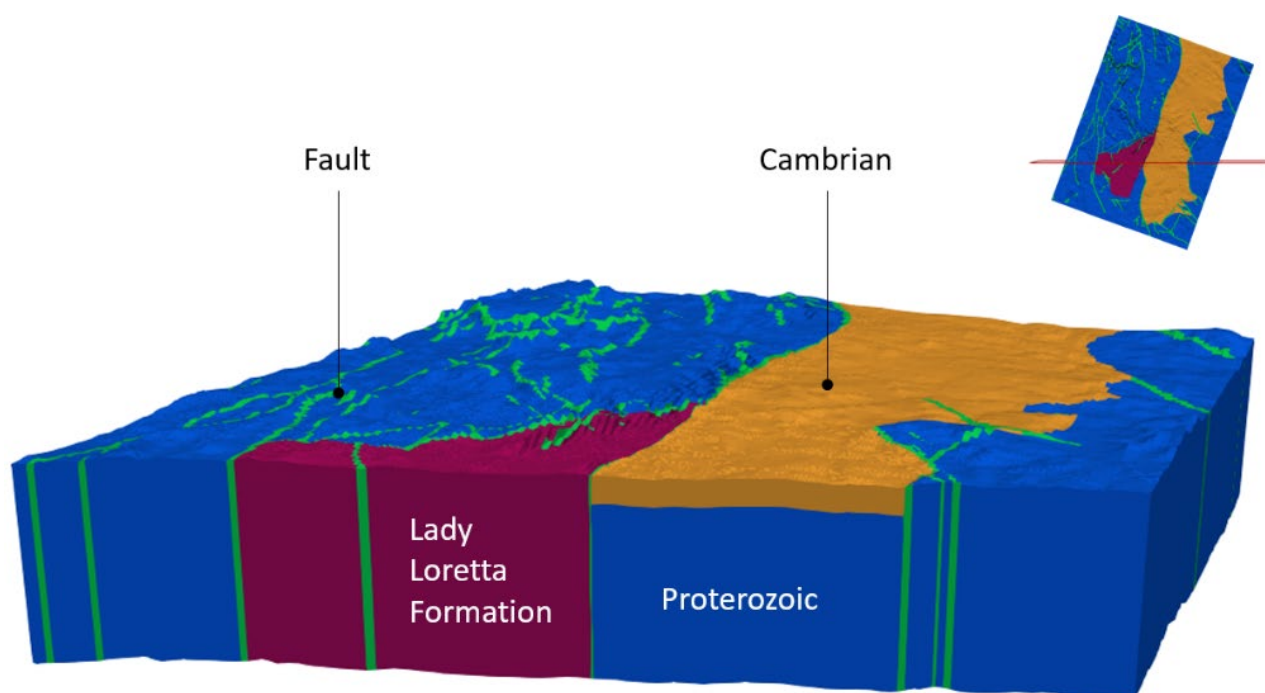
Figure 5-3 and Table 5-1 show the model layer setup with two key differences compared to the original model (AGE, 2015):

- The original model (AGE, 2015) contains a hydraulic parameter zone in the top layer to represent the Cambrian block to the west of Western Fault. However, our hydrogeological conceptualisation review shows that there is no Cambrian block to the west of Western Fault. Therefore, this zone was changed to represent the Lady Loretta Formation in the LLM2021 model and extended to all layers.
- Based on our hydrogeological conceptualisation review, the thickness of model layer 1 was increased from 50 m in the original model (AGE, 2015) to 80 m in the LLM2021 model. This is to account for the nominal thickness of 50 m for the Cambrian block and 30 m for the overlying surficial sediments. The thicknesses of other model layers were also adjusted as shown in Table 5-1.

Figure 5-3 Model Cross-section

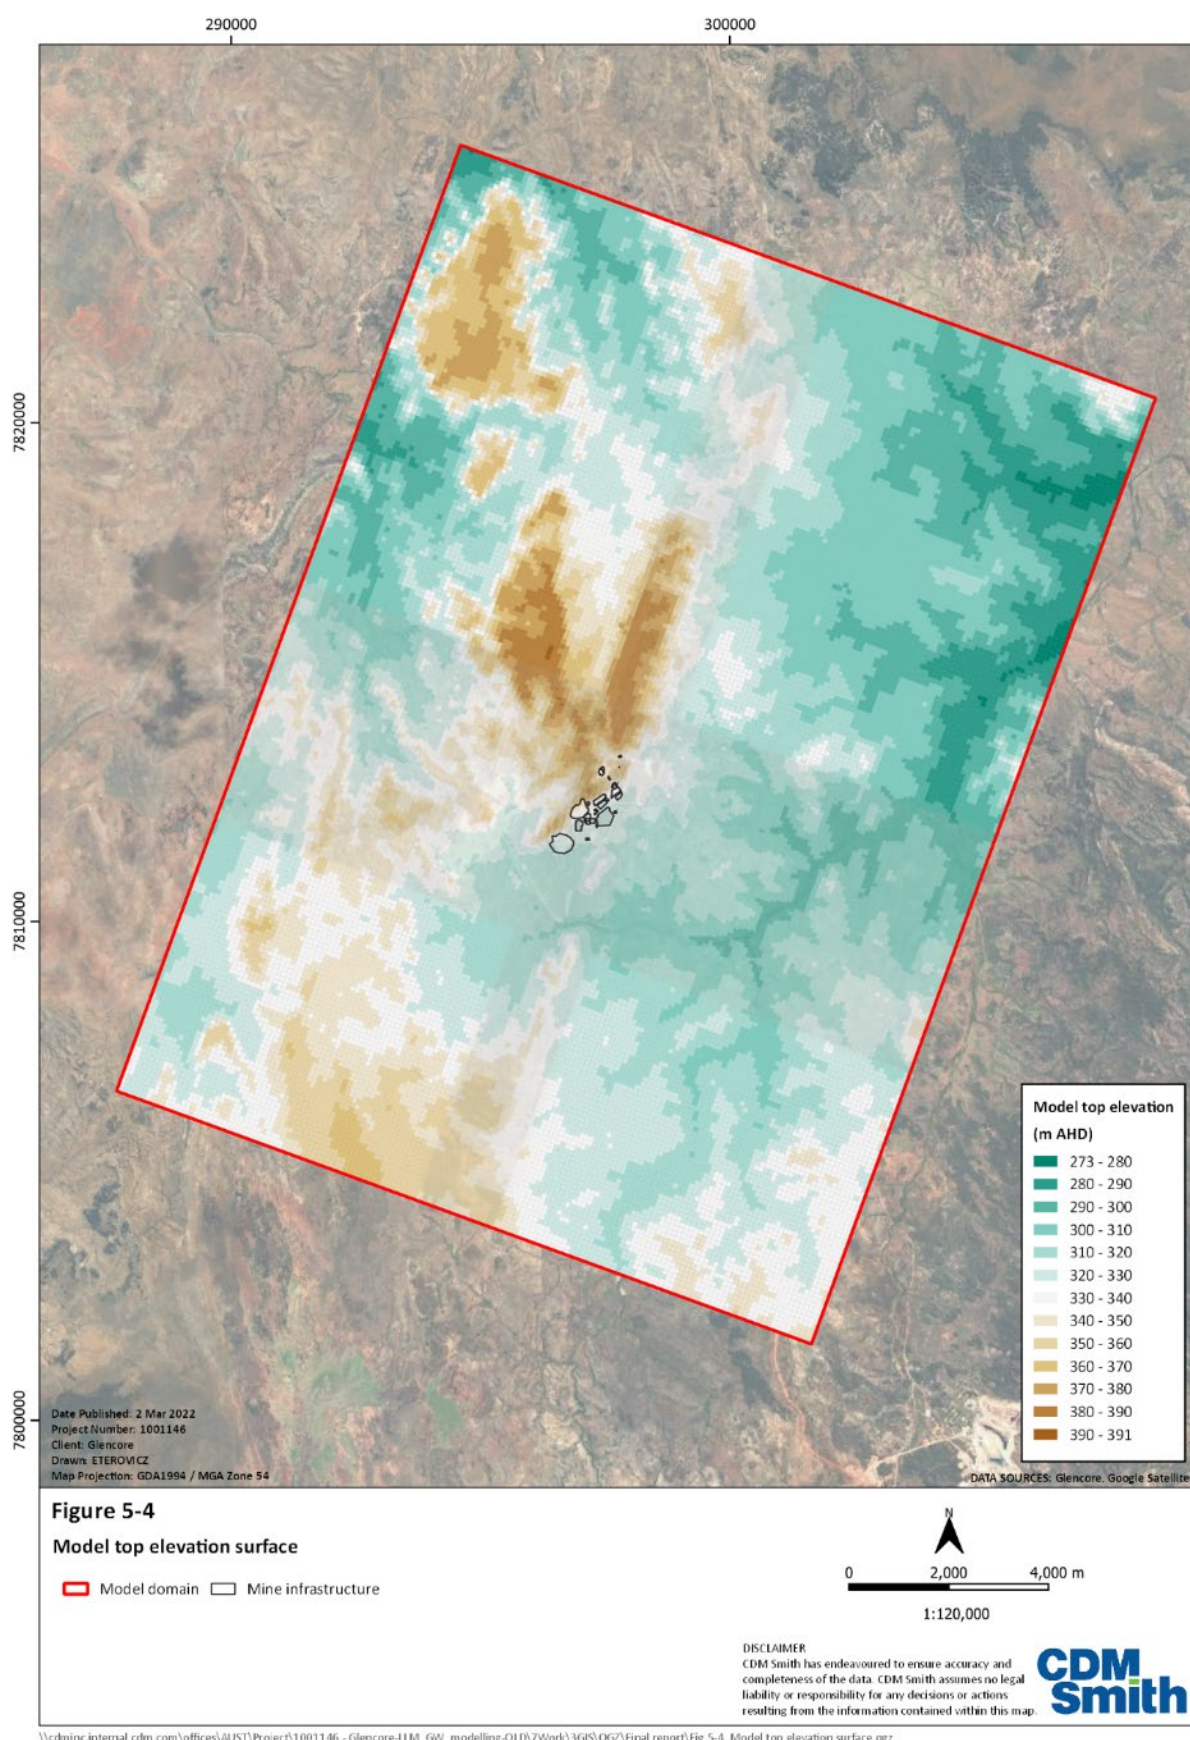
The top elevation surface (Figure 5-4) represents the land surface, and is consistent between the LLM2021 model and the original model (AGE, 2015). While not documented in AGE (2015), this elevation surface is believed to be sourced from the ELVIS database with a spatial resolution of 30 x 30 m. Following the original model (AGE, 2015), a constant thickness approach was adopted for the LLM2021 model due to the lack of data for finer parameterisation.

**Figure 5-4 Model Top Elevation Surface**

Extinction depth defines the depth threshold below which no groundwater ET occurs. The extinction depth for the LLM2021 model was set to the conventional value of 2 m and remains spatially and temporally constant. Within the model domain, most groundwater ET is expected to occur in low-lying areas (Figure 5-4) where the water table is generally shallower.
