LADY LORETTA

## **Z-LLM-HSEC-PLN-Progressive Rehabilitation and Closure Plan**

| Project Name | Lady Loretta Mine |
| Document Title | Z-LLM-HSEC-PLN-Progressive Rehabilitation and Closure Plan |

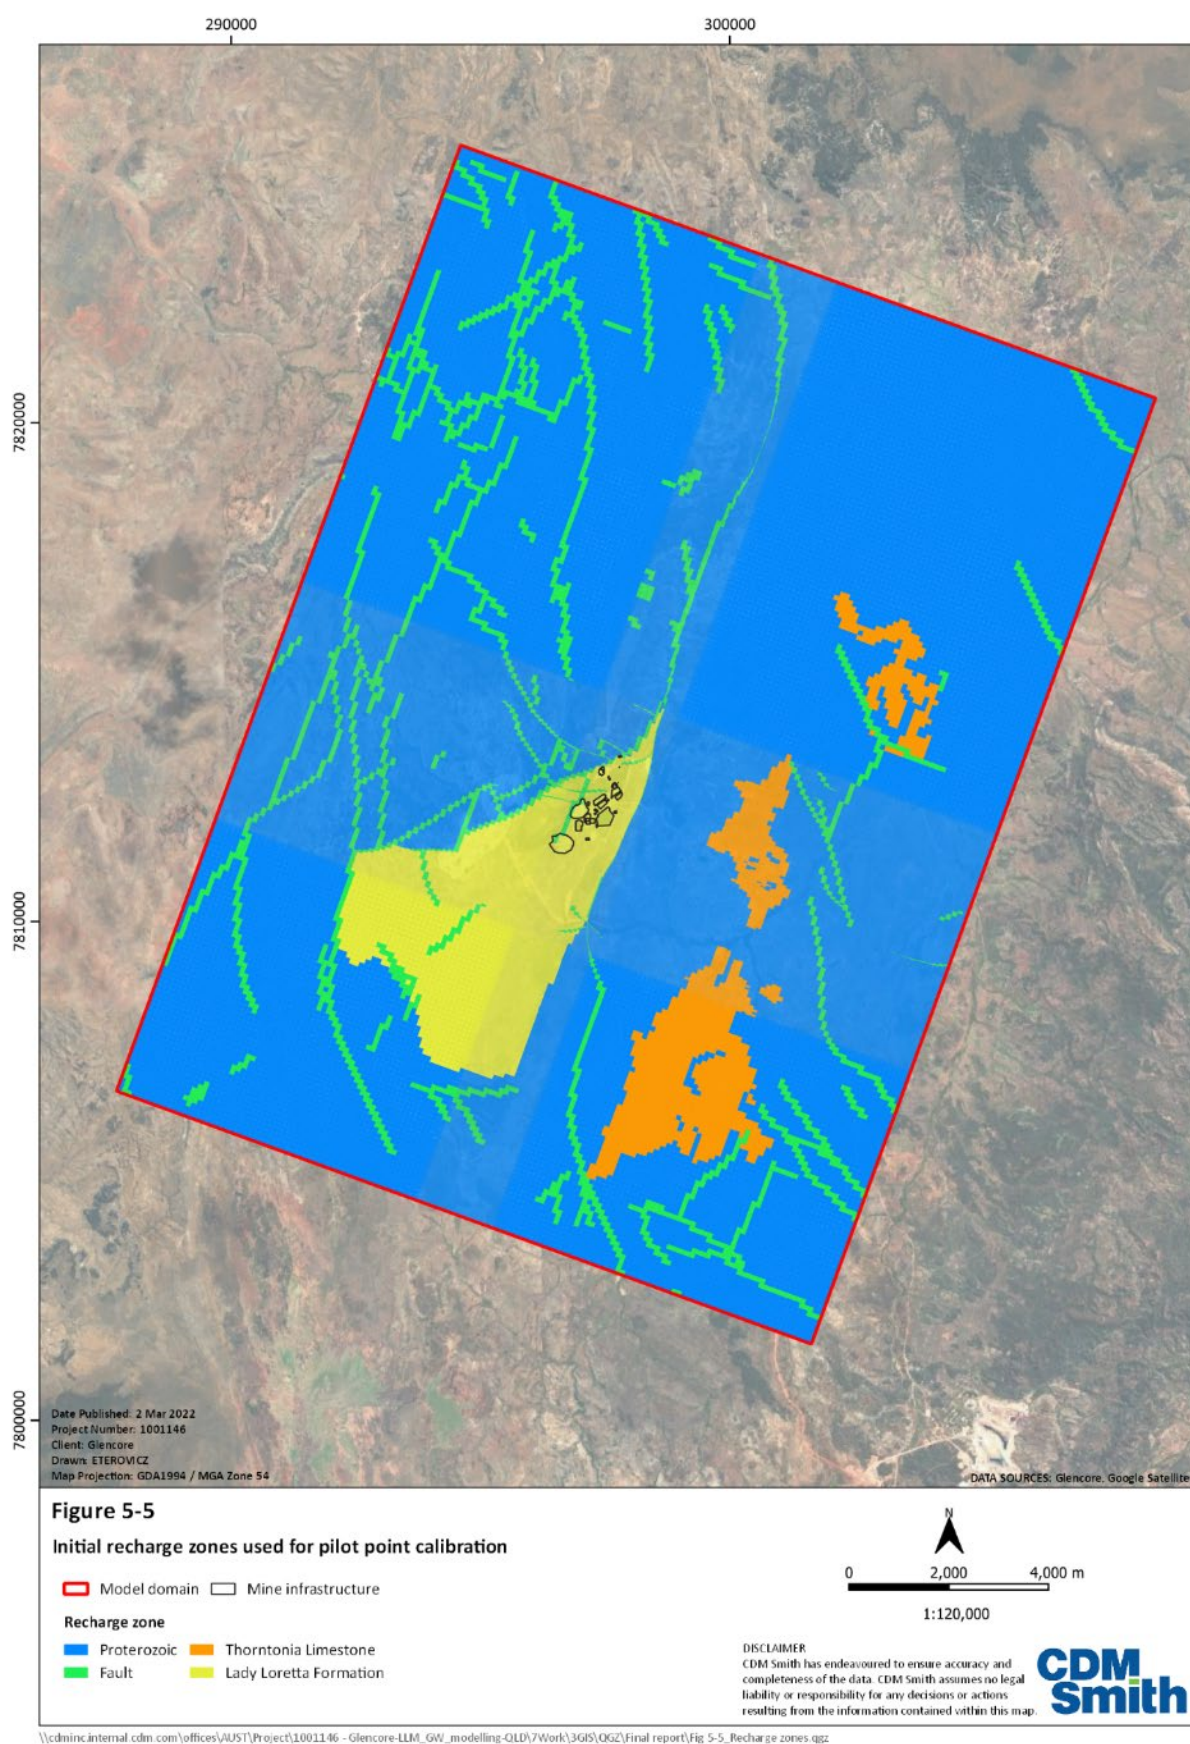
The rainfall rate is based on the Camooweal Township weather station (37010; Figure 2-1 and Figure 2-2) and was set to be time-varying but spatially uniform in the LLM2021 model. The rainfall-to-recharge ratio represents the portion of rainfall that becomes recharge and was estimated through model calibration. The ratios were initially zoned based on surface geology (Figure 5-5), with further spatial heterogeneity added through the use of pilot point calibration.

**Figure 5-5 Initial Recharge Zones Used for Pilot Point Calibration**

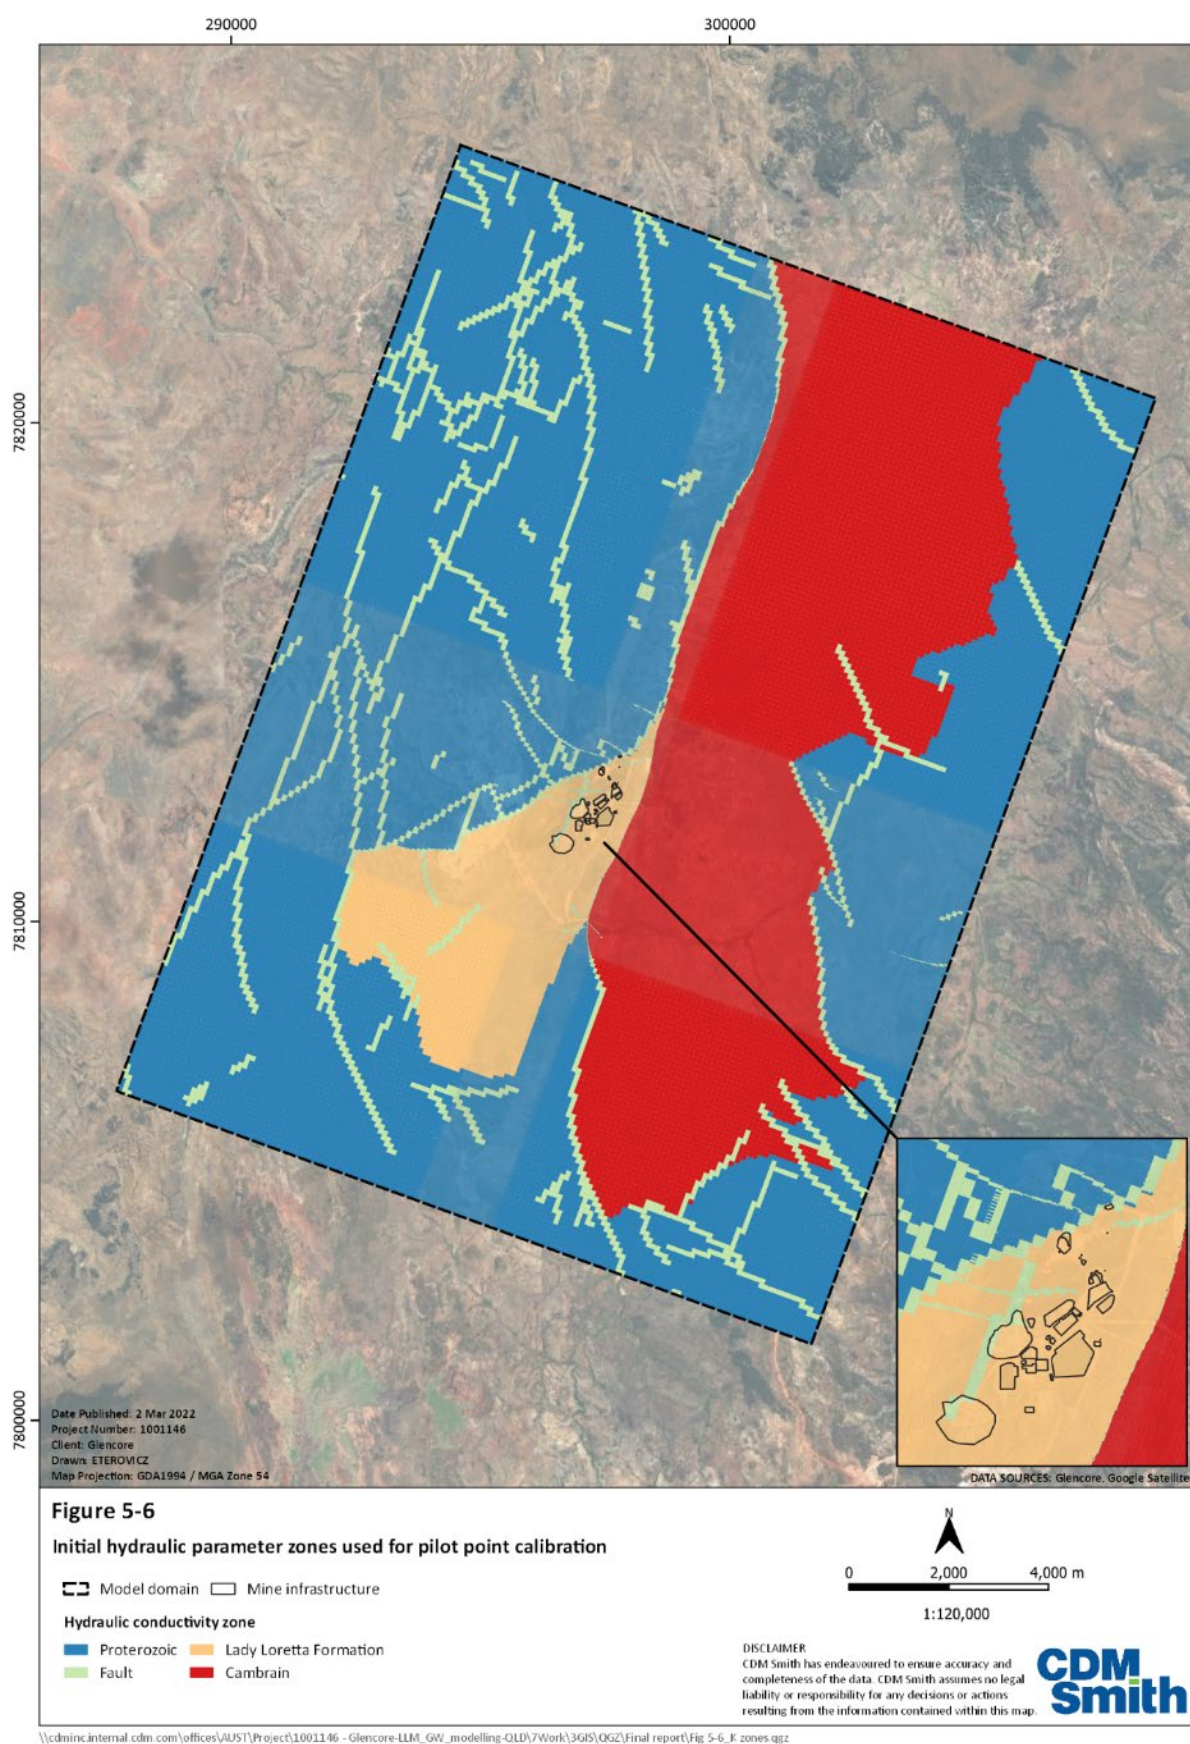
Figure 5-6 Initial Hydraulic Property Zones Used for Pilot Point Calibration

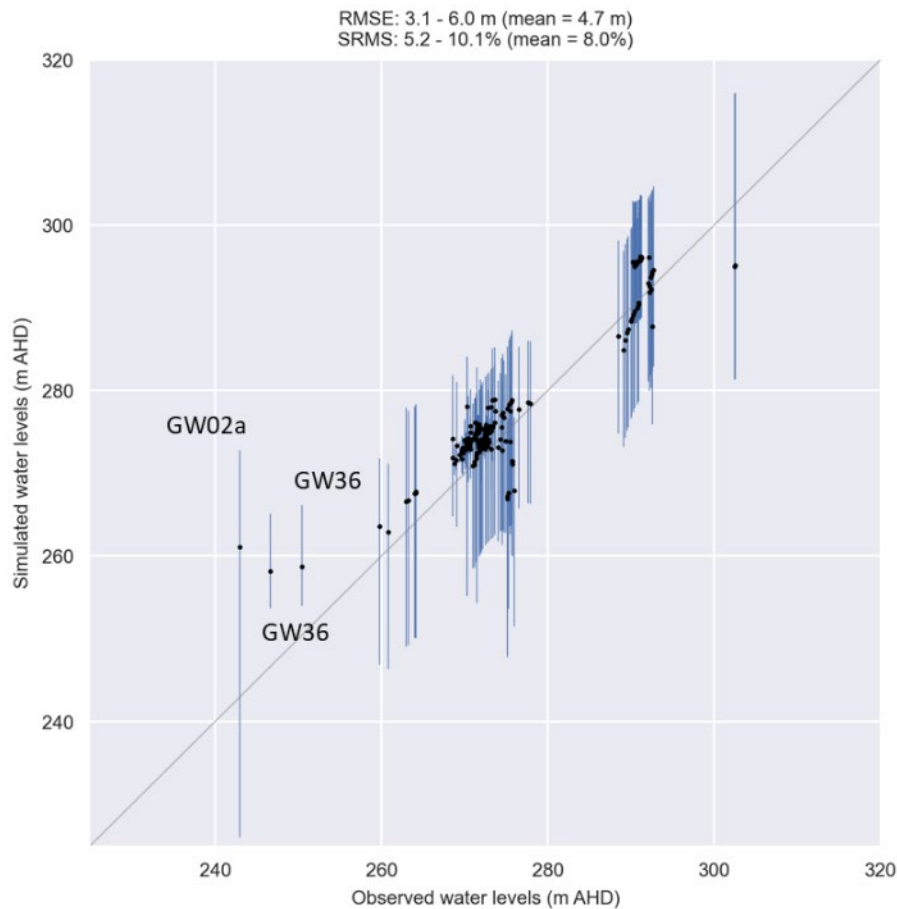
**Figure 5-7 Comparison of Observed and Simulated Water Levels**

A scatter plot comparing the observed and simulated groundwater levels is shown in Figure 5-7. The black data points represent the mean while the blue error bars represent the range of simulated groundwater levels from the 100 calibrated model realisations. The blue error bars indicate the uncertainty associated with the simulated groundwater levels, which varies between observations. The diagonal 1:1 reference line represents the ideal situation where the simulated groundwater levels fit the observations perfectly. Data points that are closer to the 1:1 reference line indicate a better calibration performance, and vice versa.

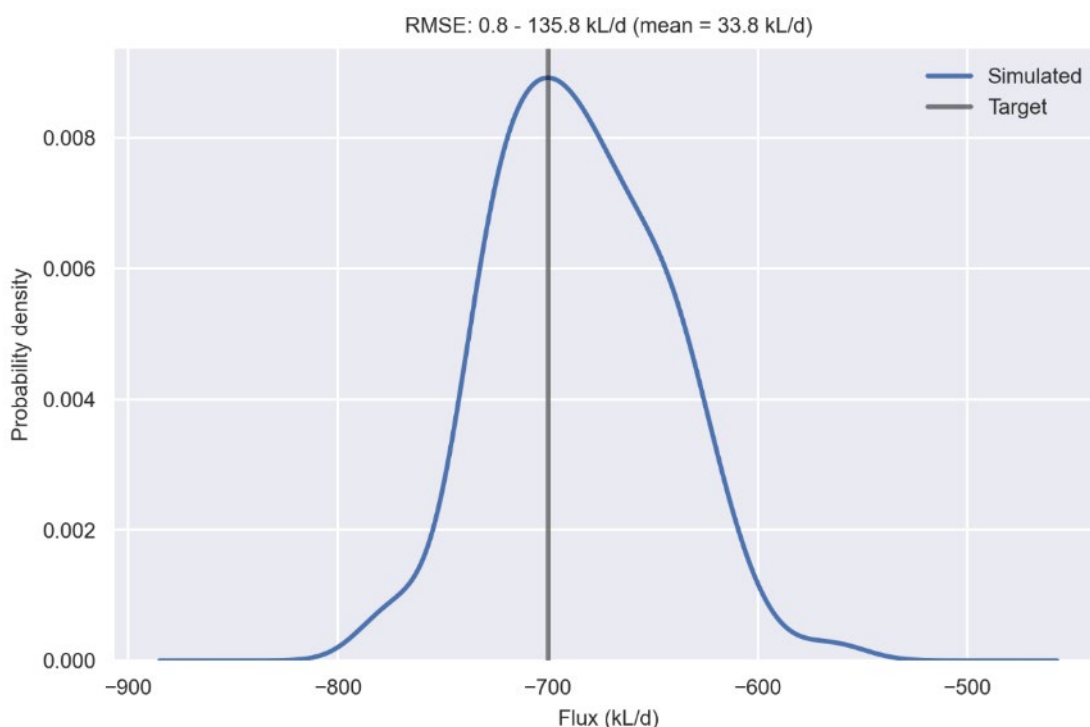
Figure 5-8 shows the probability distribution of simulated groundwater flux to the mine during the care and maintenance period from the 100 calibrated model realisations. The probability distribution resembles a normal distribution with the peak (i.e. the most likely value) at the flux target of 700 kL/d, suggesting an acceptable calibration performance. The probability distribution also provides insights into the uncertainty associated with the flux estimate, where more than 95% of the realisations lie between 600 and 800 kL/d. The RMSE is relatively small and ranges between 0.8 and 135.8 kL/d with a mean of 33.8 kL/d. It should be acknowledged that the mine is represented in a simplified manner in the model (Section 5.2.4.5), and therefore there is uncertainty associated with the mine flux calibration from a conceptual point of view.

**Figure 5-8** Probability Distribution of Simulated Flux to the Mine During the Care and Maintenance Period

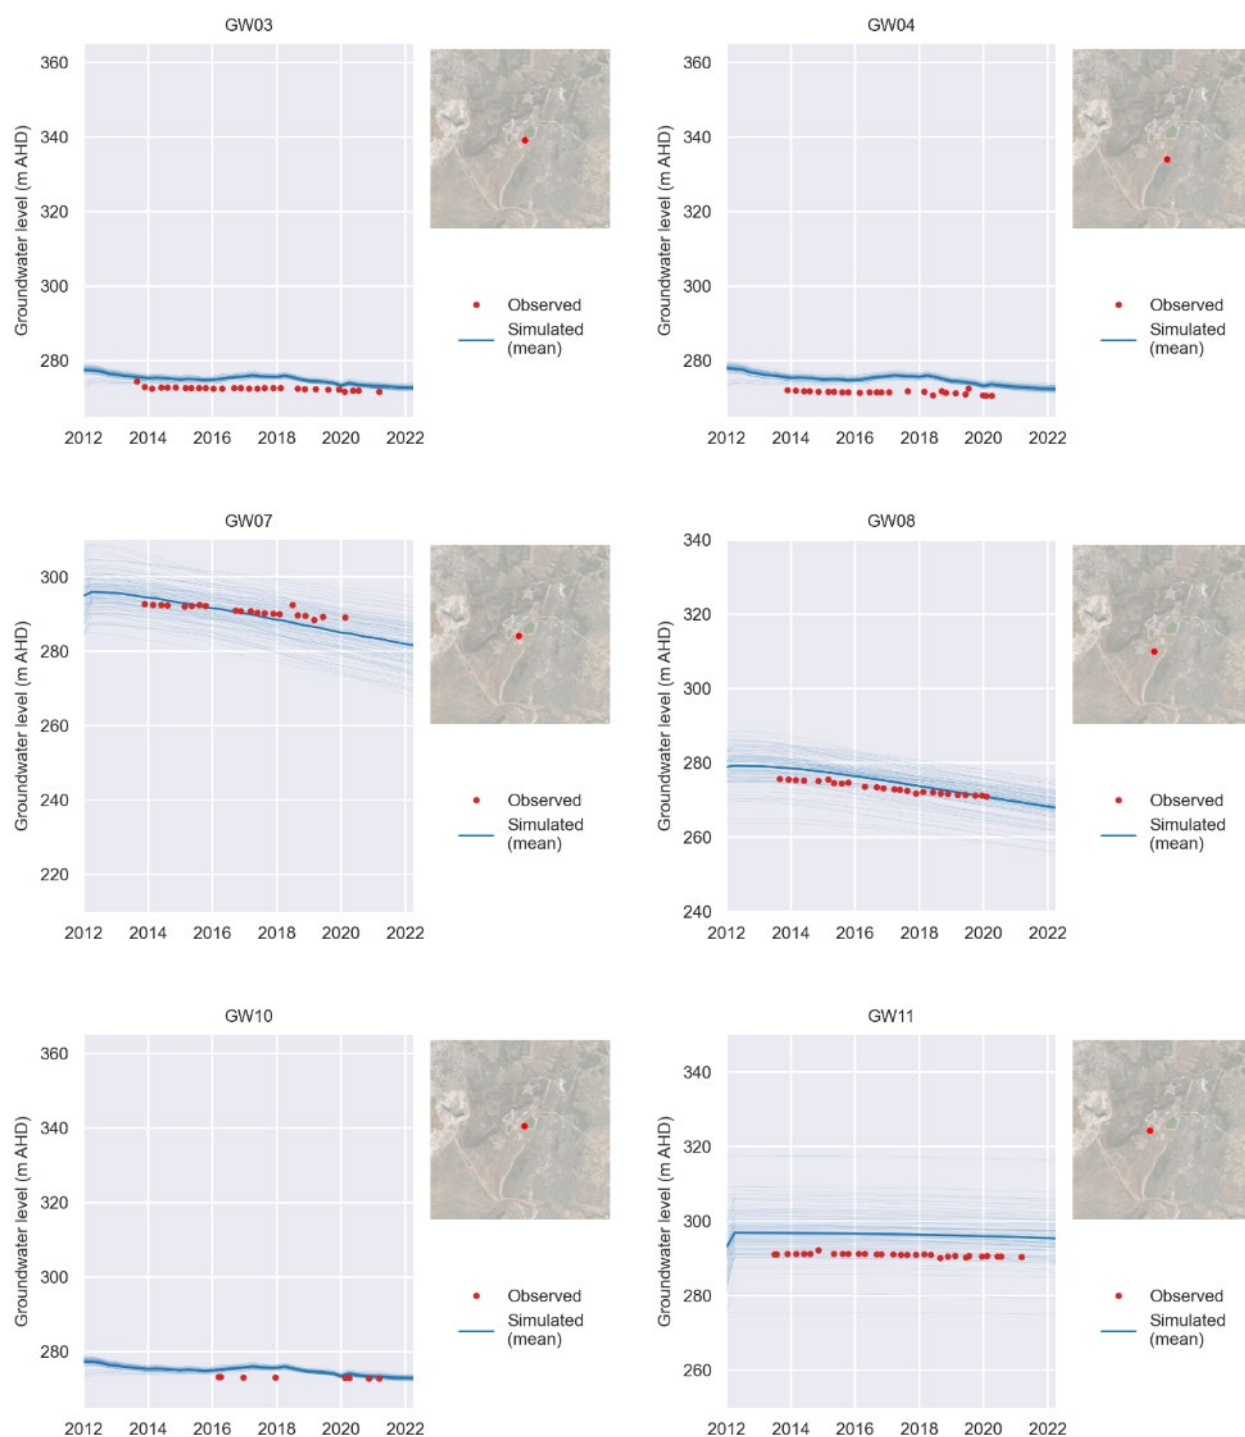
A subset of observed hydrographs is compared with the modelled water levels in Figure 5-9 and Figure 5-10. These hydrographs were selected based on their length of historical records and spatial location. The full set of hydrographs are provided in Appendix B. In general, Figure 5-9 and Figure 5-10 show a reasonable match between the observed and simulated water levels. Some discrepancies can be attributed to the fact that the historical mine extent and elevations are assumed to be constant throughout the calibration period due to the lack of data for finer parameterisation.

Figure 5-9 Hydrograph Comparisons (Set 1)

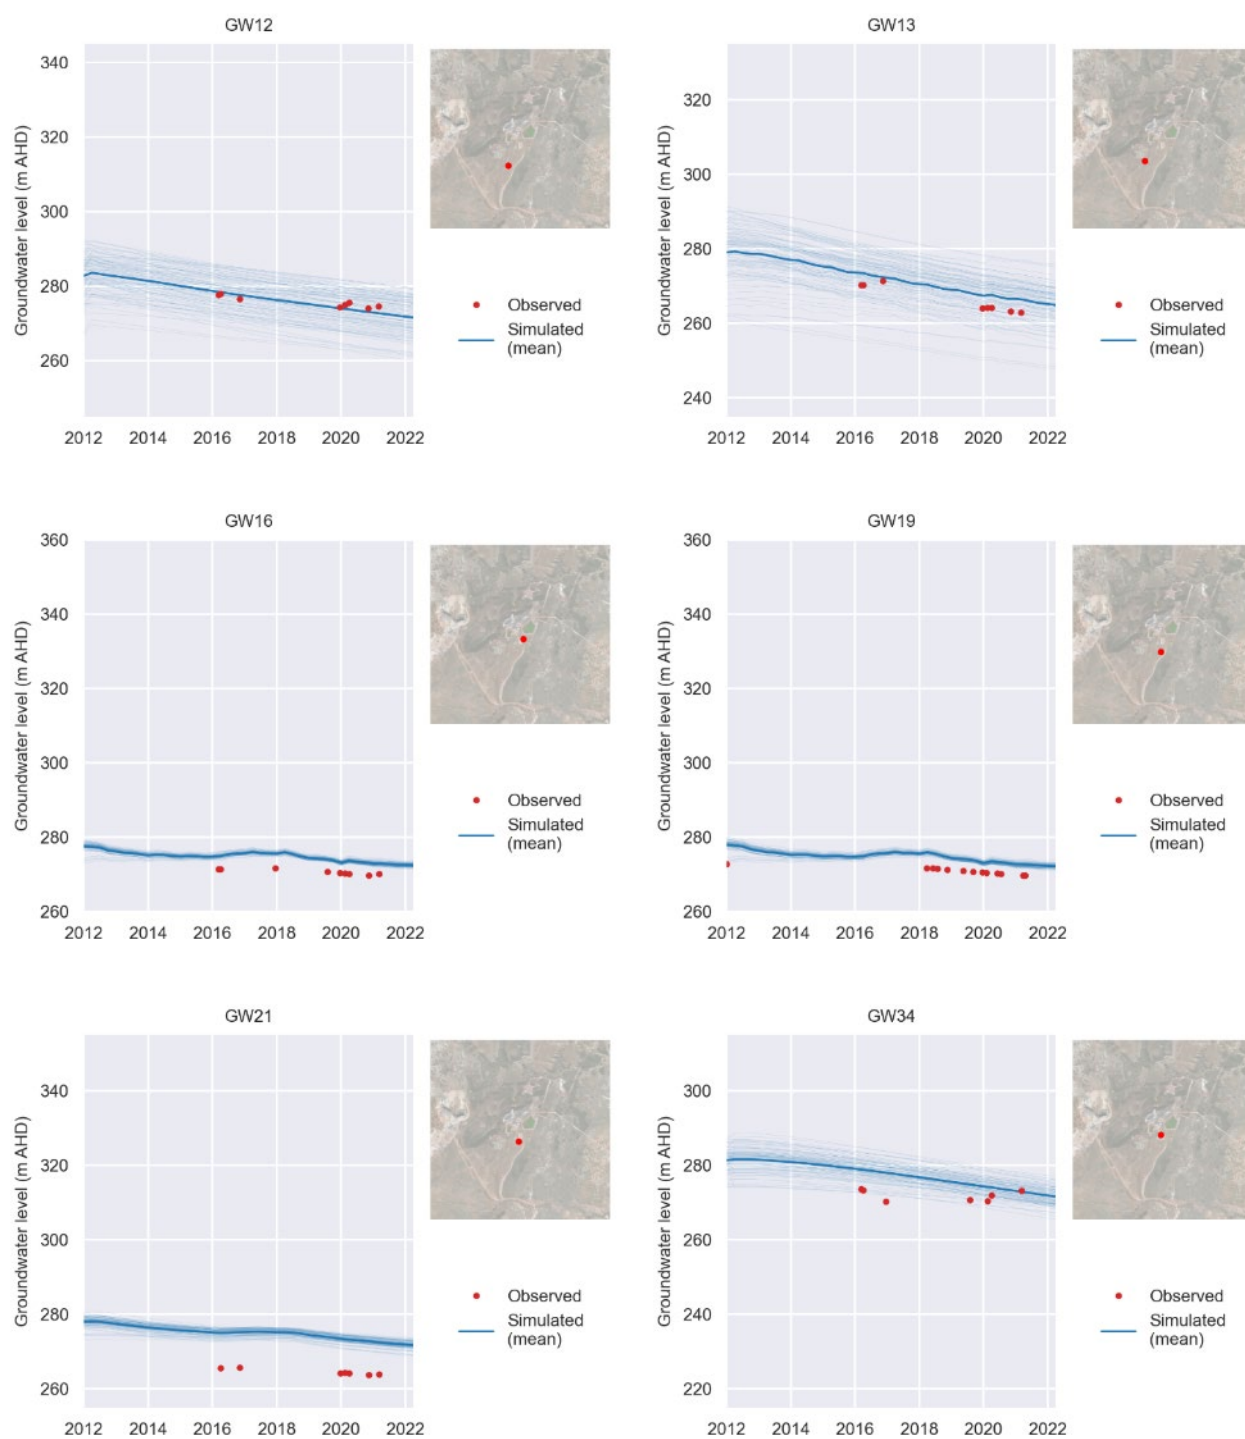
Figure 5-10 Hydrograph Comparisons (Set 2)

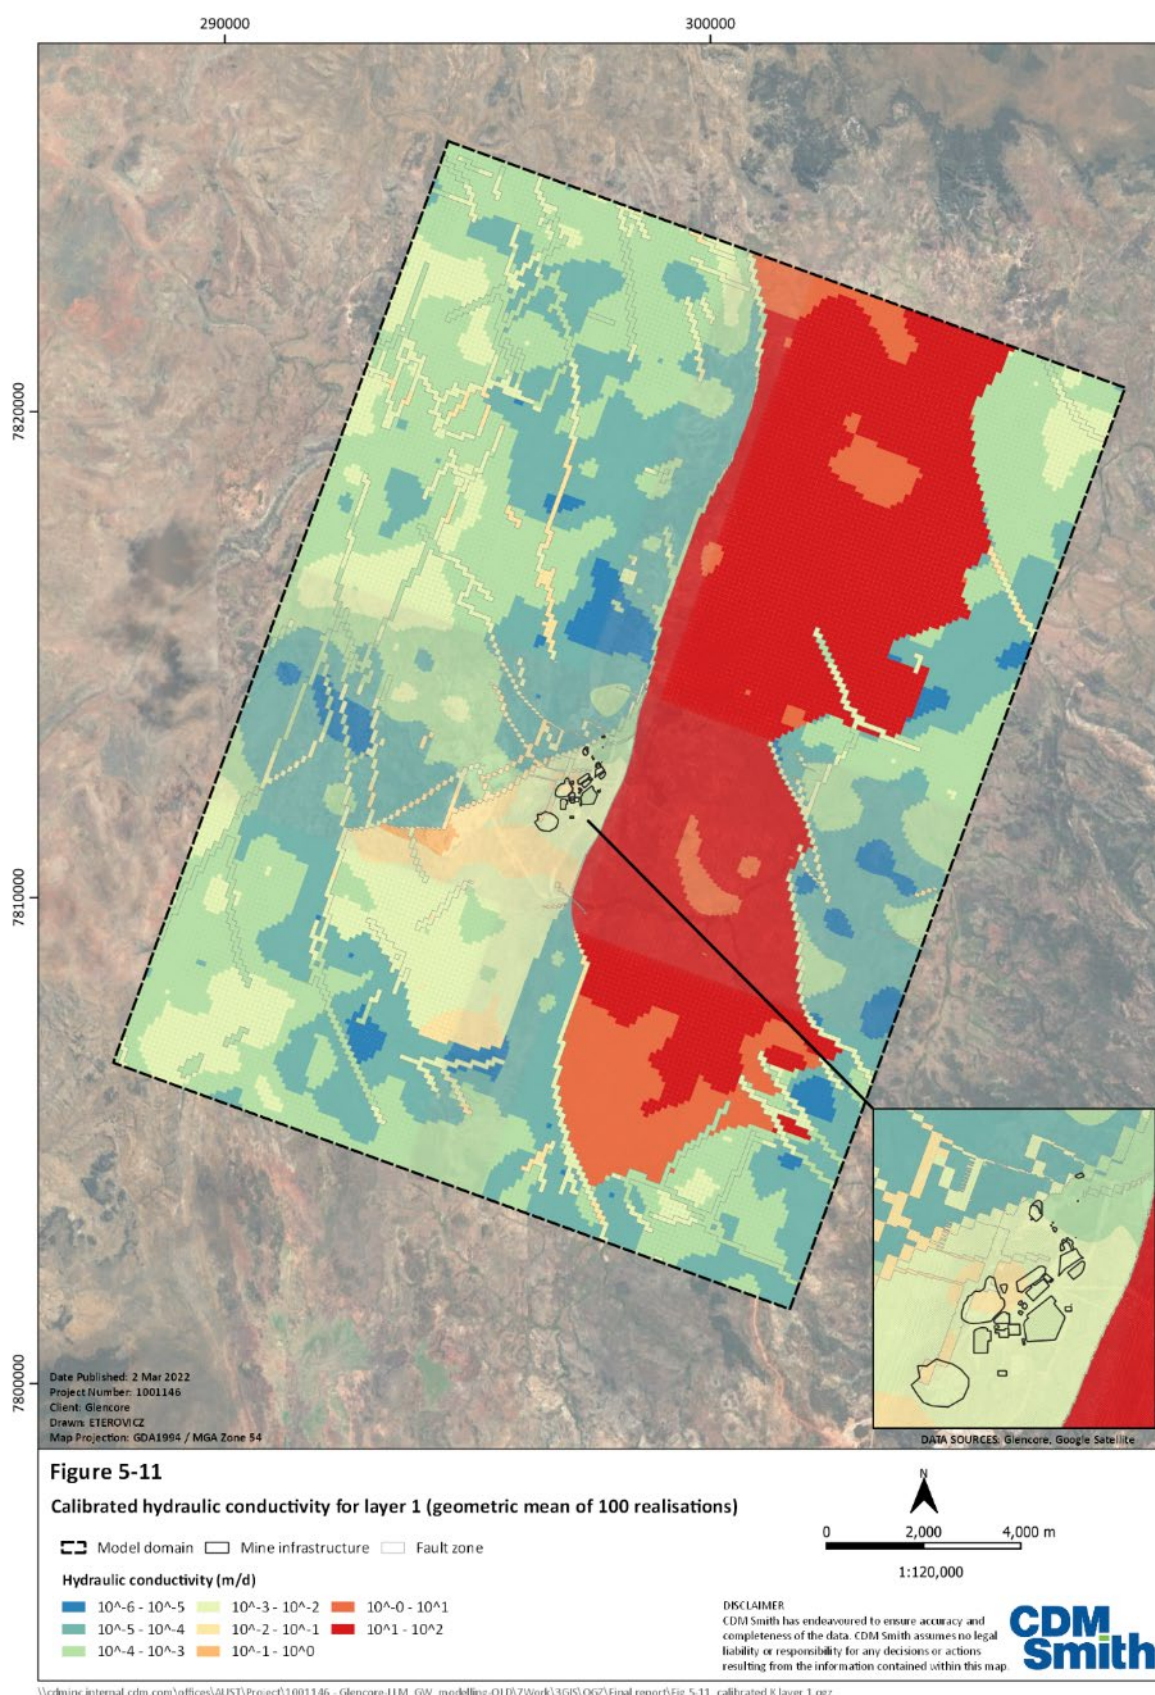
**Figure 5-11 Calibrated Hydraulic Conductivity for Layer 1 (Geometric mean of 100 realisations)**

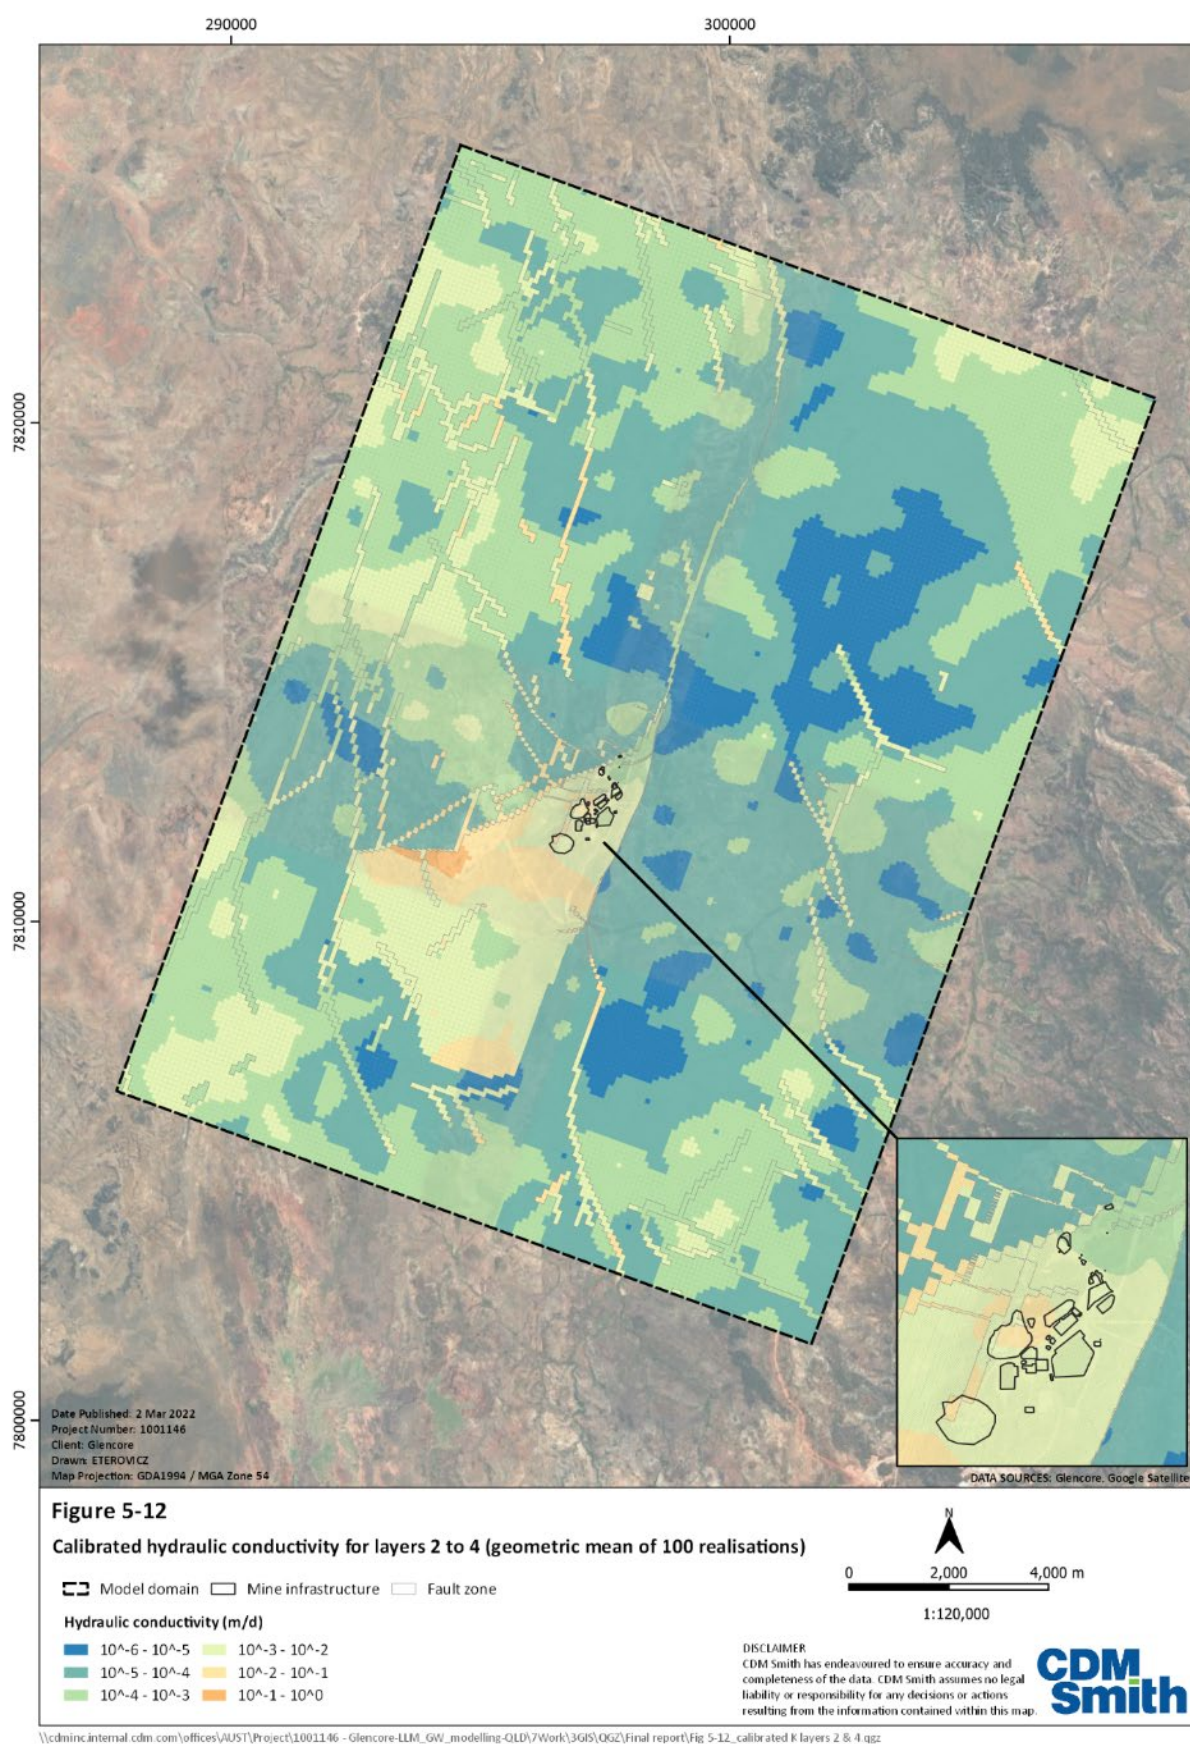
**Figure 5-12 Calibrated Hydraulic Conductivity for Layers 2 to 4 (Geometric mean of 100 realisations)**

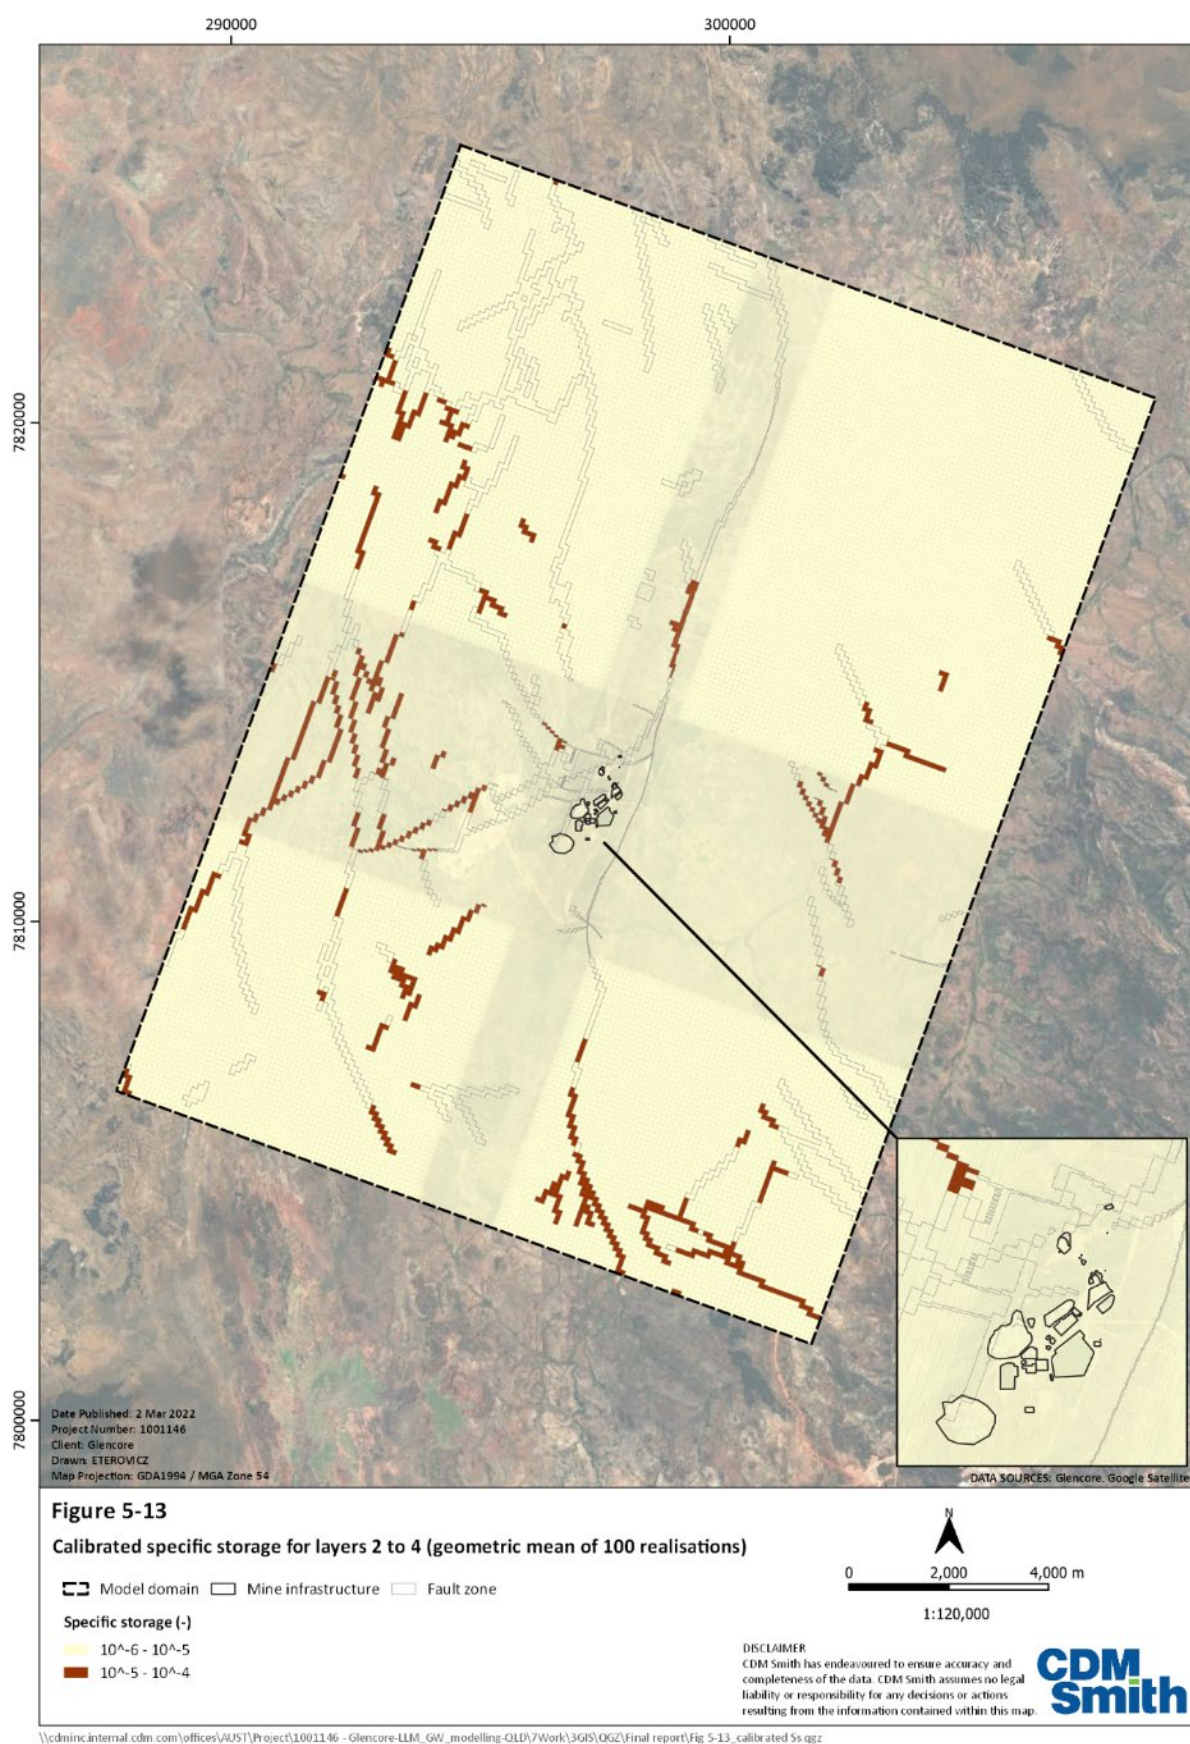
**Figure 5-13 Calibrated Specific Storage for Layers 2 to 4 (Geometric mean of 100 realisations)**

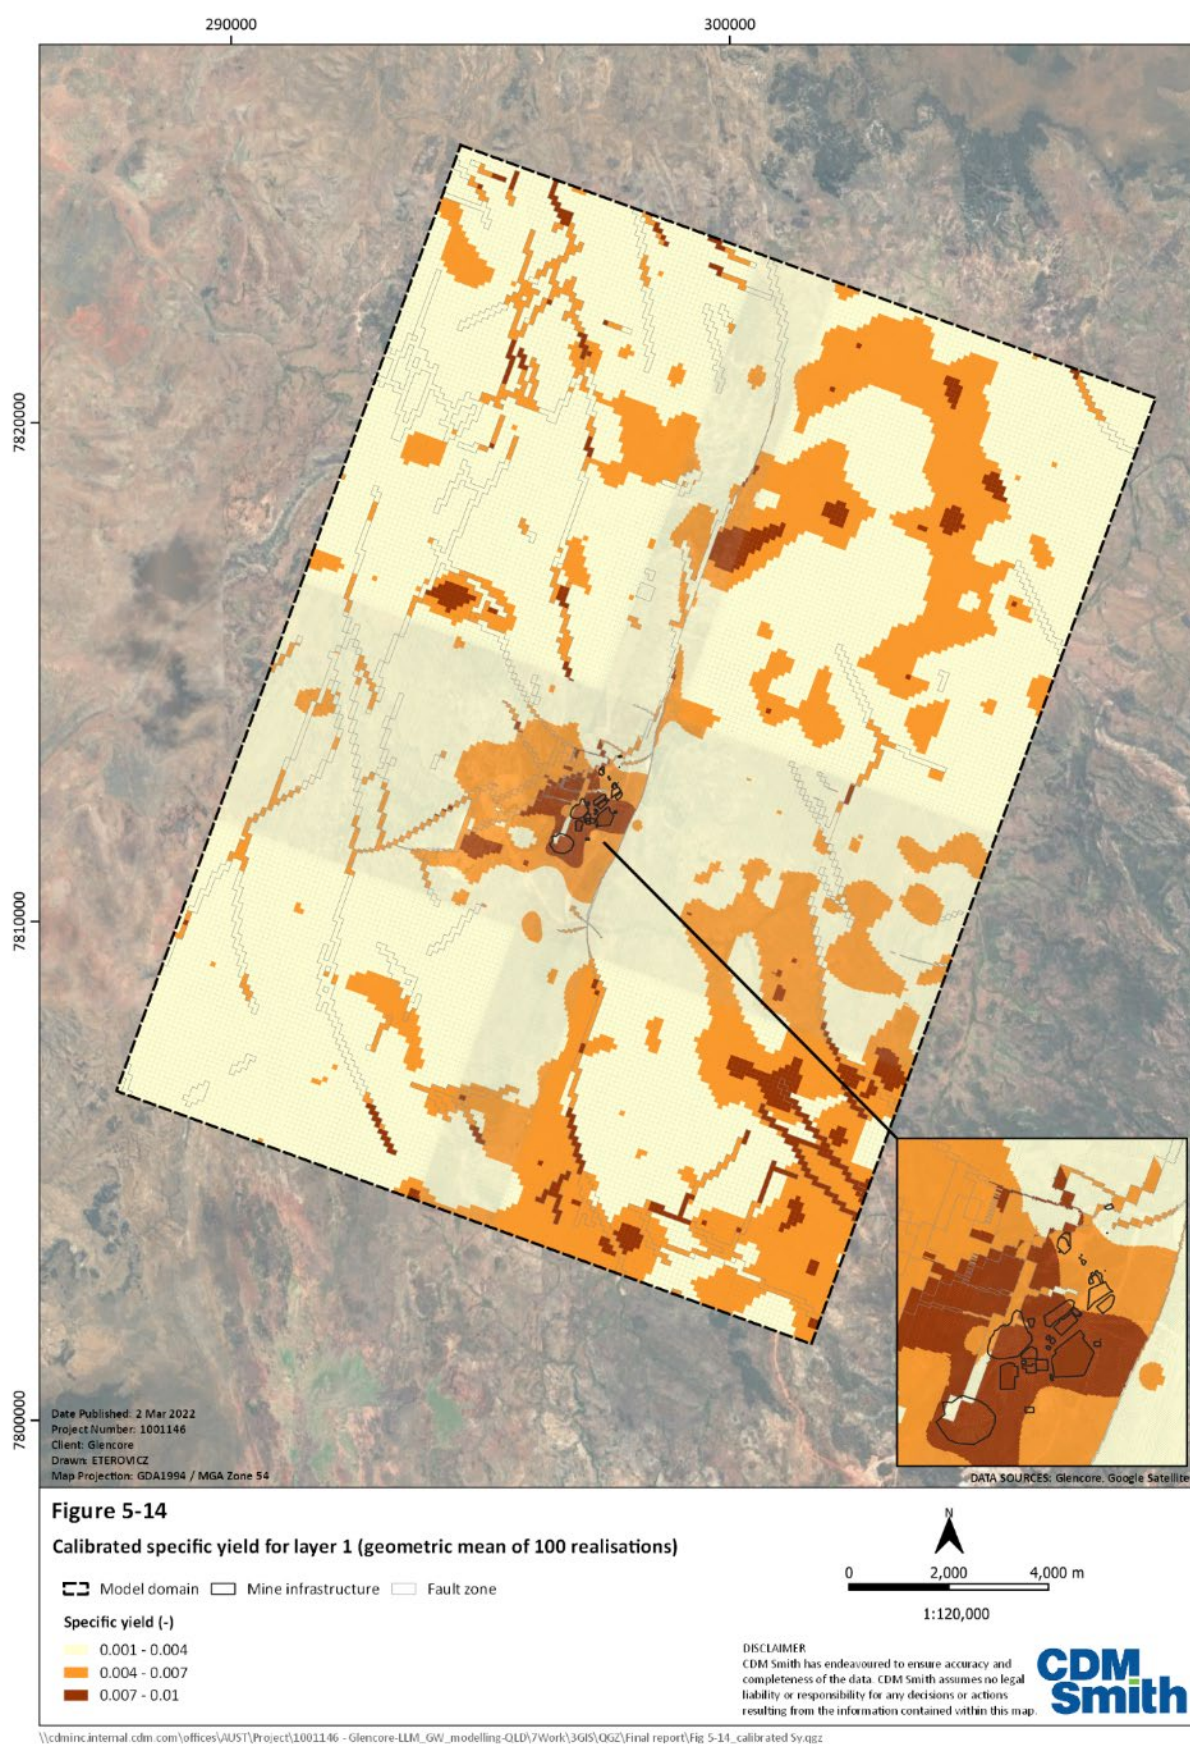
**Figure 5-14 Calibrated Specific Yield for Layer 1 (Geometric mean of 100 realisations)**

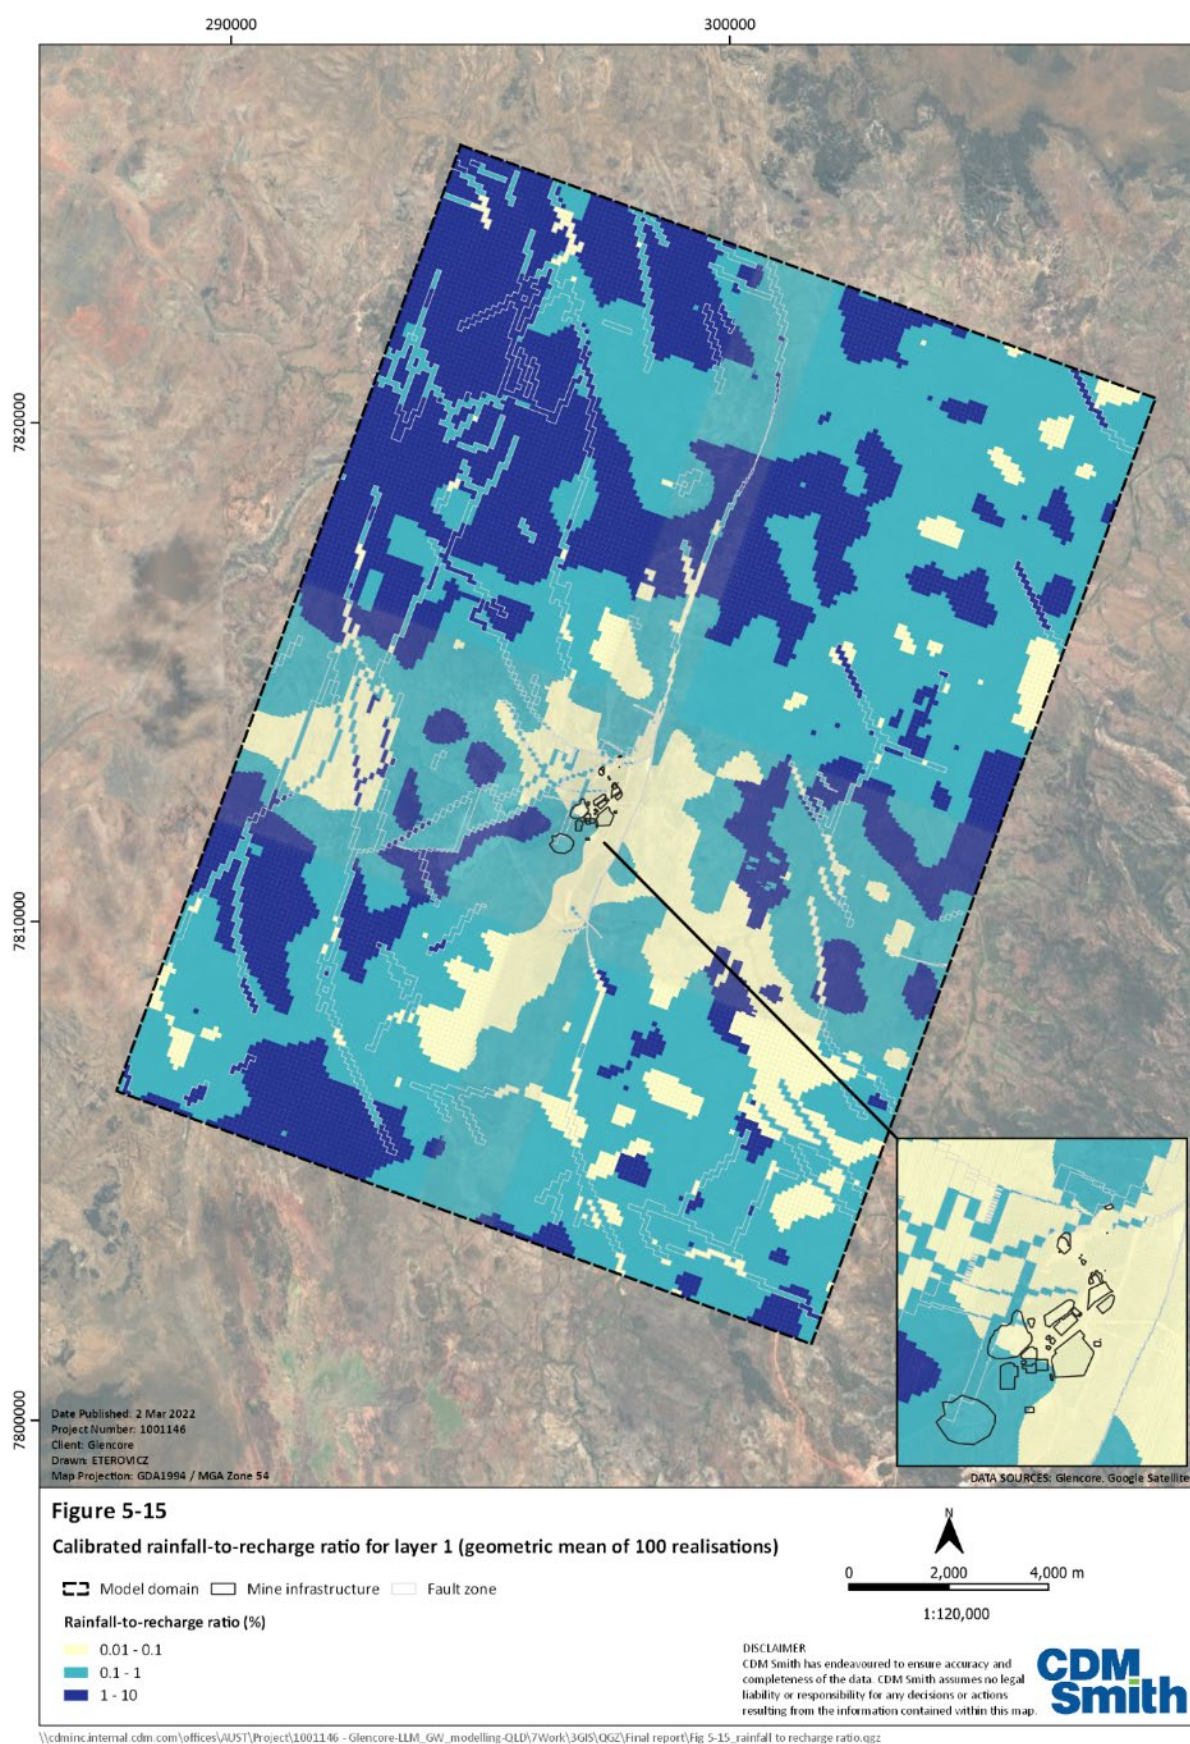
**Figure 5-15 Calibrated Rainfall-to-Recharge Ratio for Layer 1 (Geometric mean of 100 realisations)**

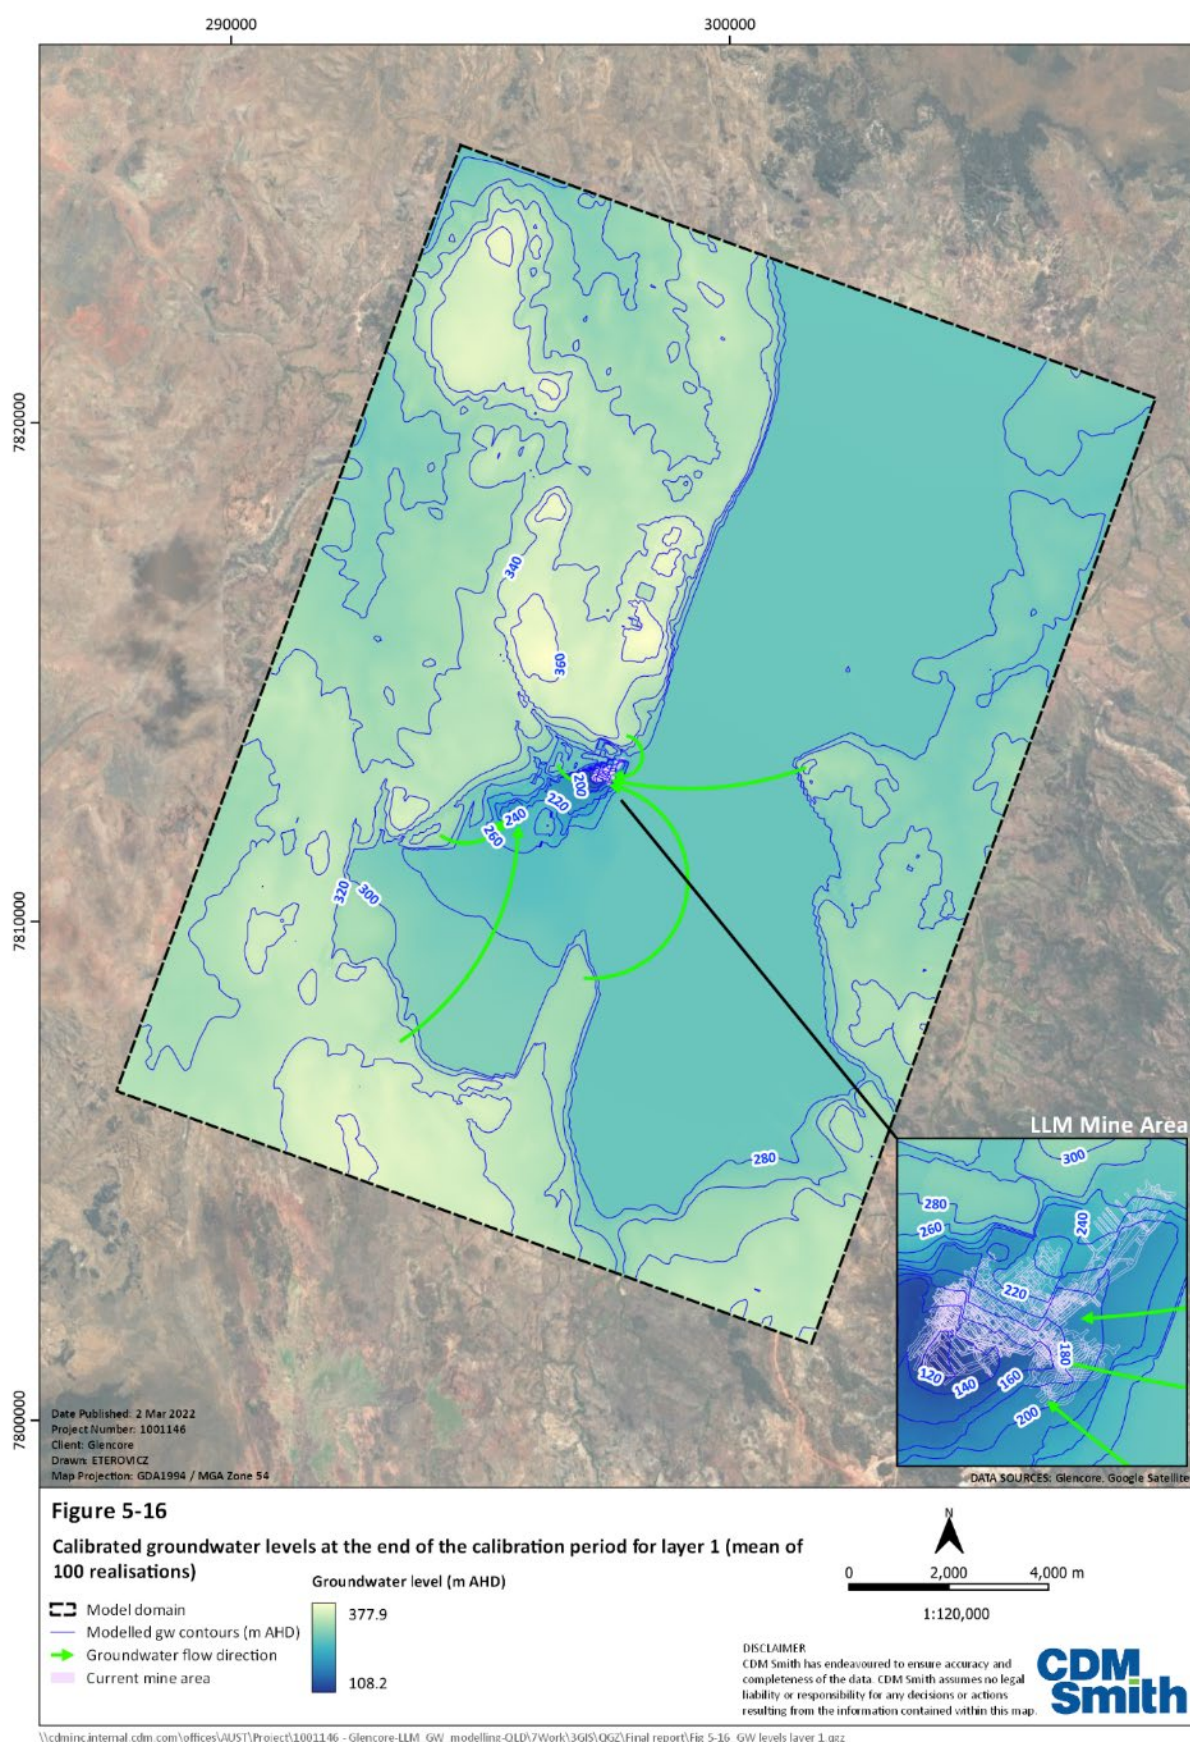
The calibrated groundwater levels (mean of 100 realisations) at the end of calibration period for layers 1 and 4 are shown in Figure 5-16 and Figure 5-17 respectively.

**Figure 5-16 Calibrated Groundwater Levels at the end of Calibration Period for Layer 1 (Mean of 100 realisations)**
