LADY LORETTA

## **Z-LLM-HSEC-PLN-Progressive Rehabilitation and Closure Plan**

| Project Name | Lady Loretta Mine |
| Document Title | Z-LLM-HSEC-PLN-Progressive Rehabilitation and Closure Plan |

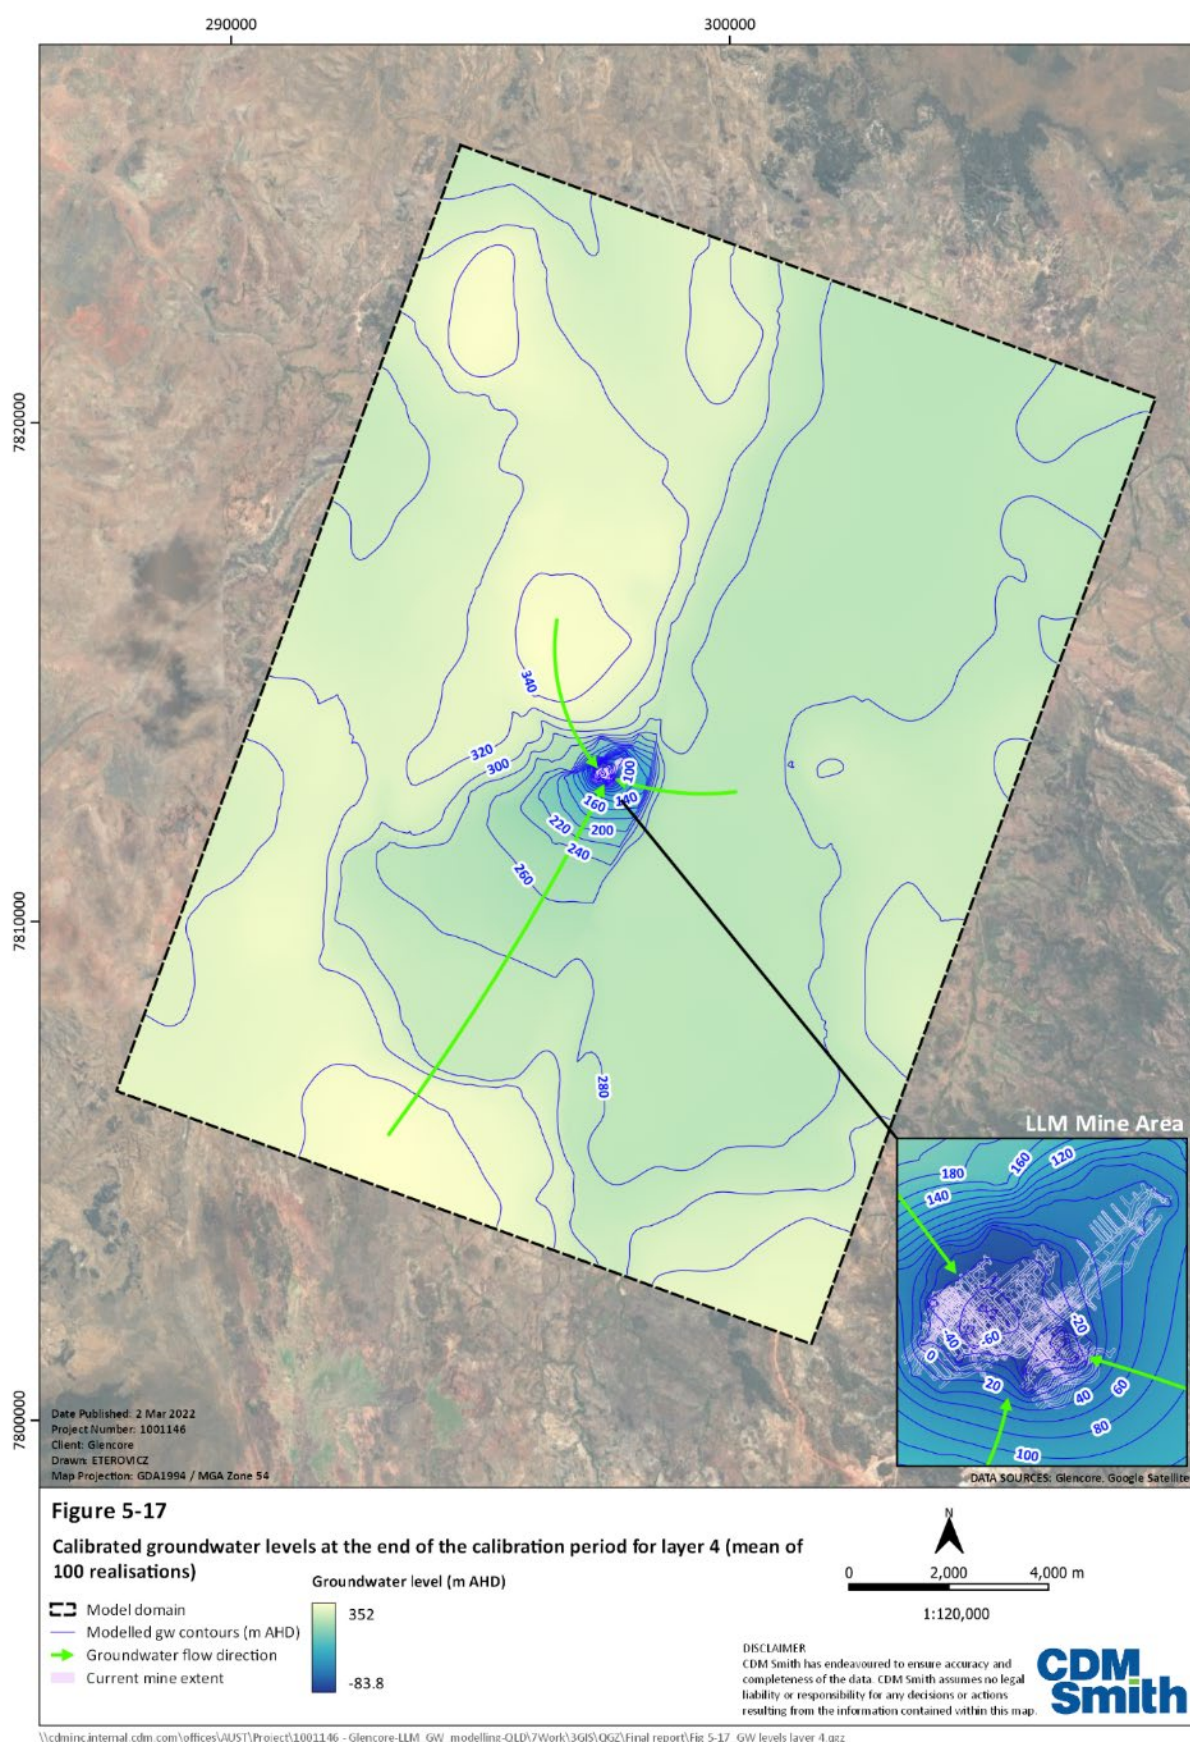
The calibrated groundwater levels (mean of 100 realisations) at the end of calibration period for layers 1 and 4 are shown in Figure 5-16 and Figure 5-17 respectively.

**Figure 5-17 Calibrated Groundwater Levels at the end of Calibration Period for Layer 4 (Mean of 100 realisations)**

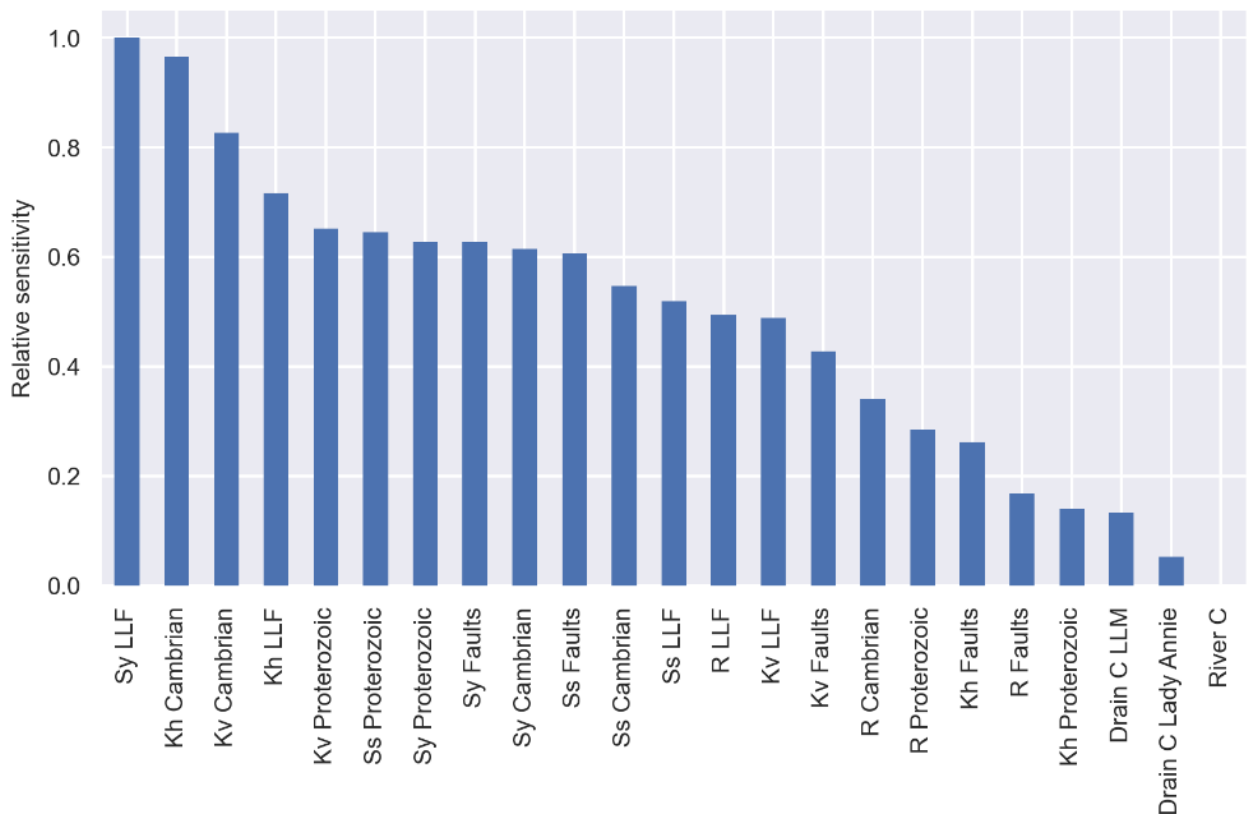
The min-max normalised parameter sensitivities are shown in Figure 5-18. The specific yield of Lady Loretta Formation (LLF) was found to be the most sensitive, possibly due to its control on the LLF response to the LLM underground workings and the inclusion of a flux calibration target. The hydraulic conductivity of Cambrian and LLF were also found to be sensitive, which is expected as these formations host the majority of groundwater level observation wells.

Kh = Horizontal hydraulic conductivity, Kv = Vertical anisotropy of hydraulic conductivity, Ss = specific storage, Sy = specific yield, R = rainfall-to-recharge ratio, C = Conductance, LLF = Lady Loretta Formation

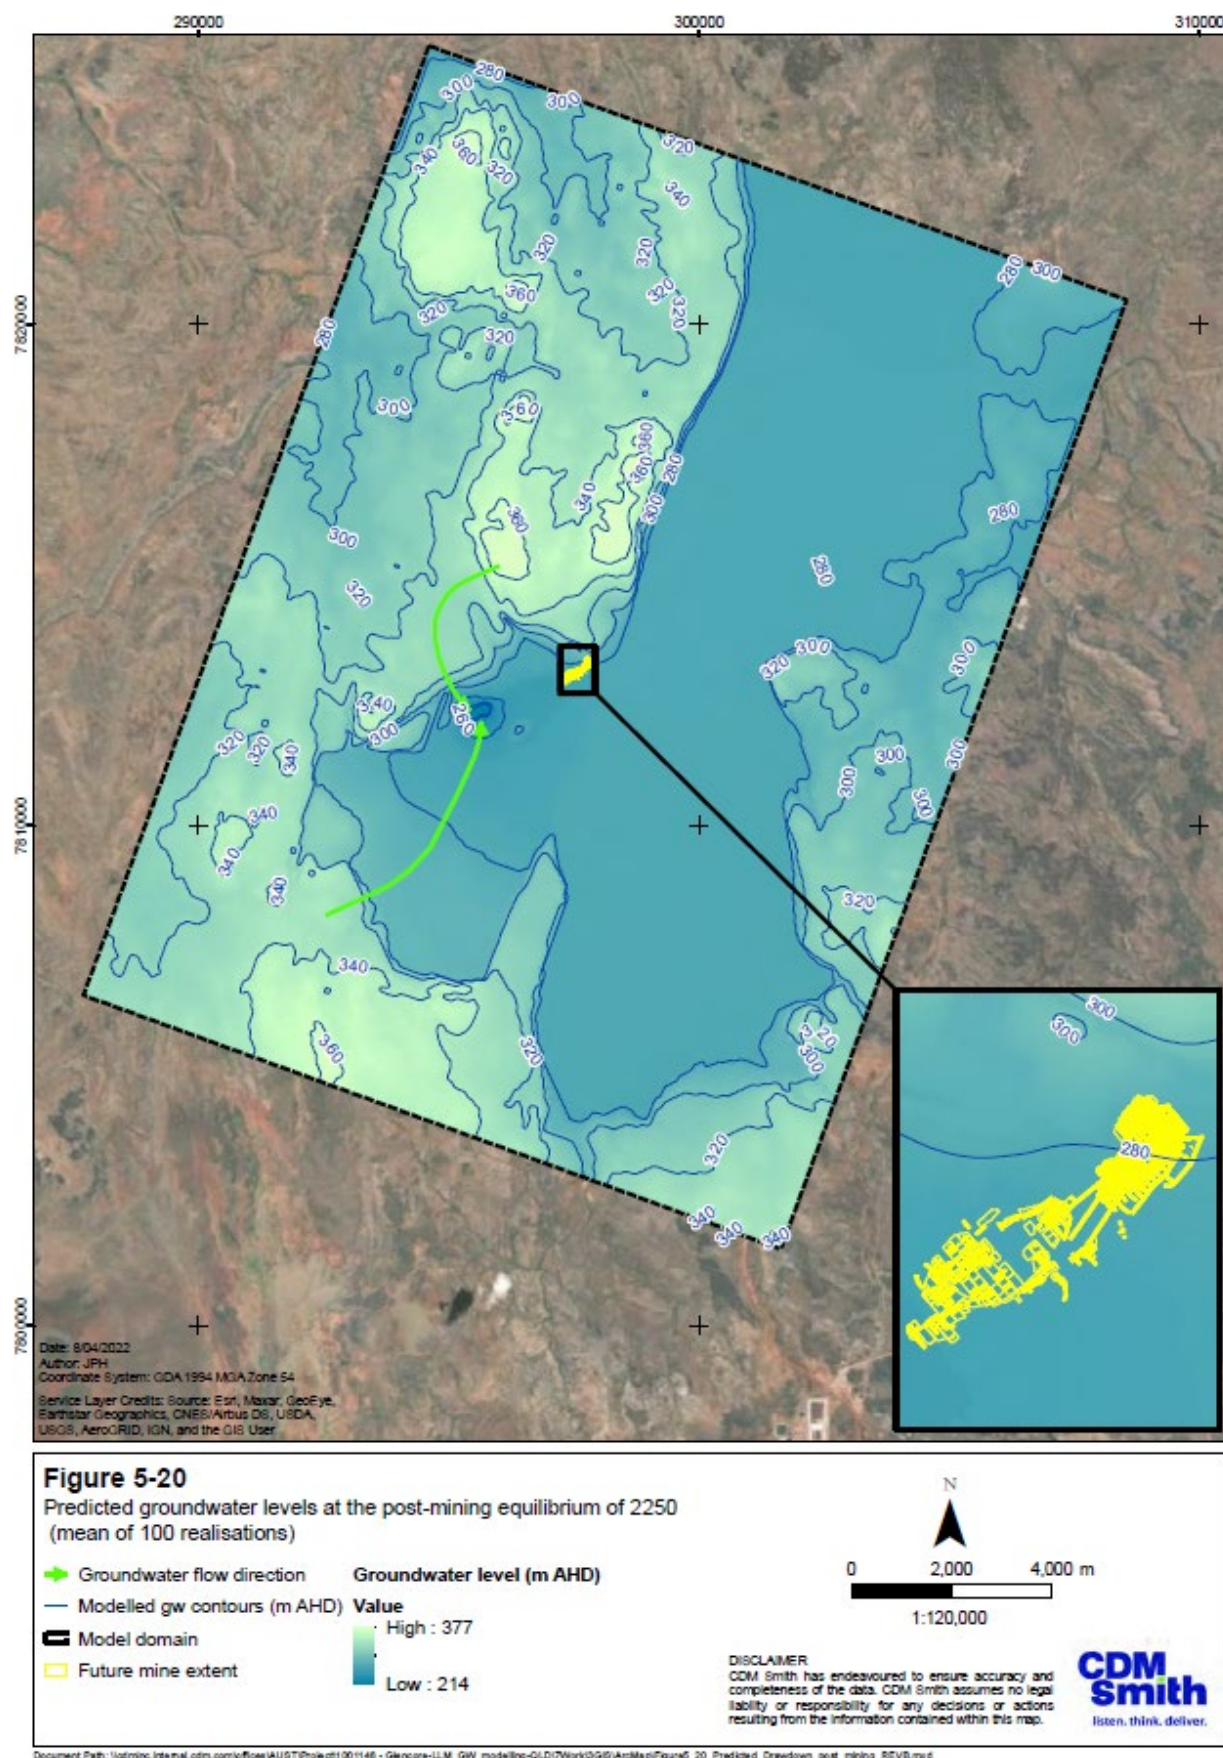
Figure 5-20 Predicted Groundwater Flow Fields at the Post-mining Equilibrium of 2250 (Mean of 100 realisations)

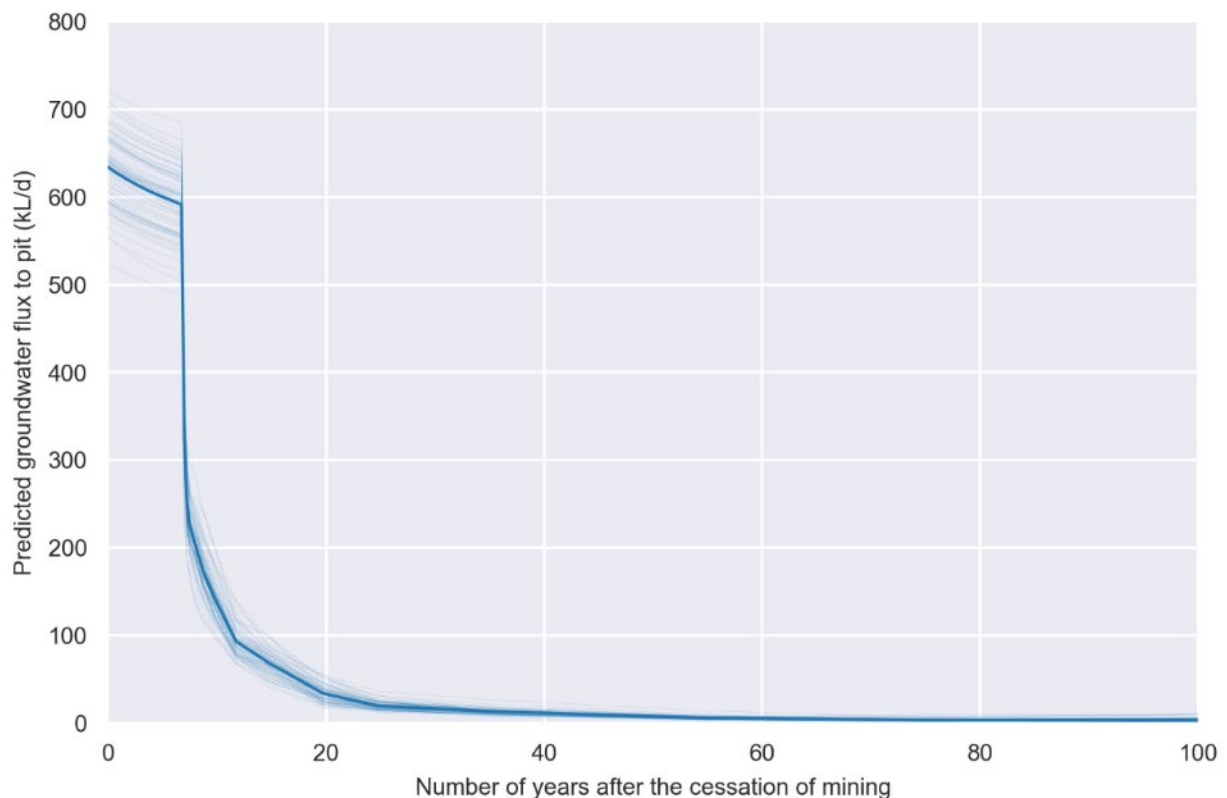
Groundwater fluxes to the underground mine workings over time predicted by the 100 calibrated realisations are shown in Figure 5-21. The semi-transparent lines represent the realisations individually and are an indicator of predictive uncertainty, while the solid line represents the mean of the realisations. The time axis is based on the number of years elapsed since the cessation of mining (Dec 2025).

The modelled flux is predicted to be approximately 630 kL/d at the cessation of mining, reducing over time as dewatering continues. As mine dewatering ceases to operate, groundwater inflow to the mine decreases rapidly as the heads in the backfilled mine voids rises. The modelled flux becomes stabilised at approximately 5 kL/d 50 to 60 years after the cessation of mining. A detail breakdown of modelled flux is shown in Table 5-6.

**Figure 5-21 Predicted Groundwater Flux to the Underground Workings Over Time**

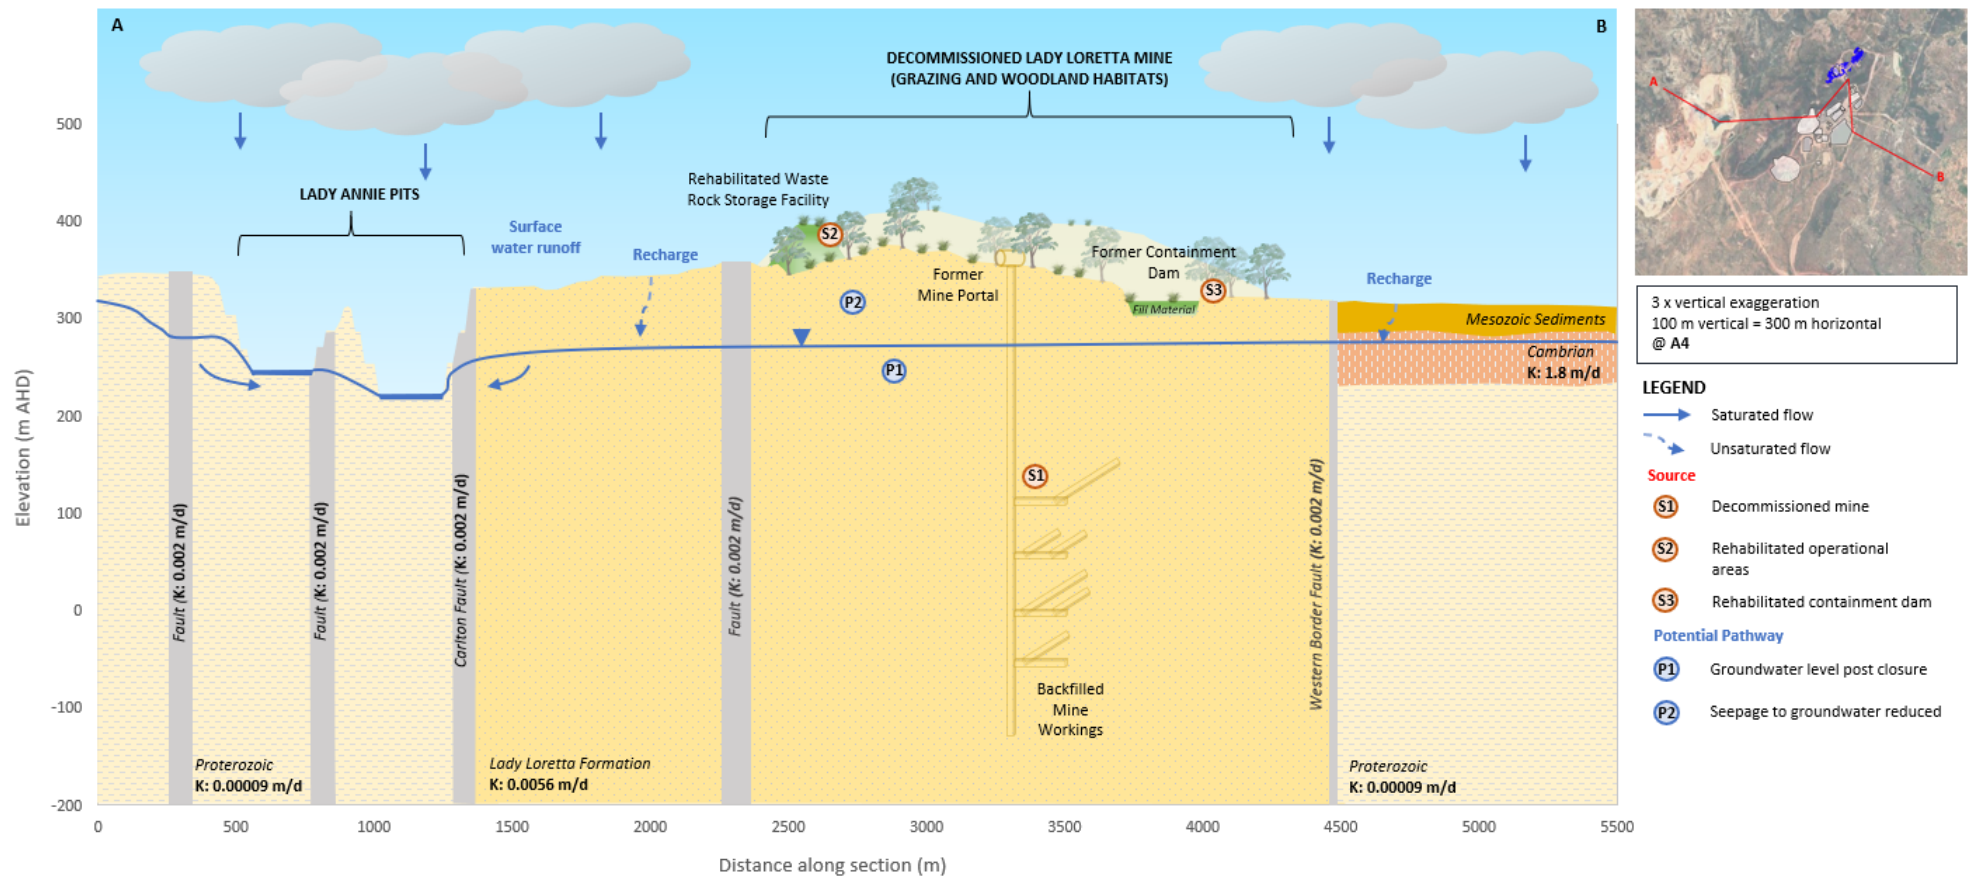
A post closure conceptual model is shown in Figure 5-22 based on the available hydrogeological information and the numerical model results for post closure. Key features being:

Figure 5-22 Conceptual Model – Post Closure

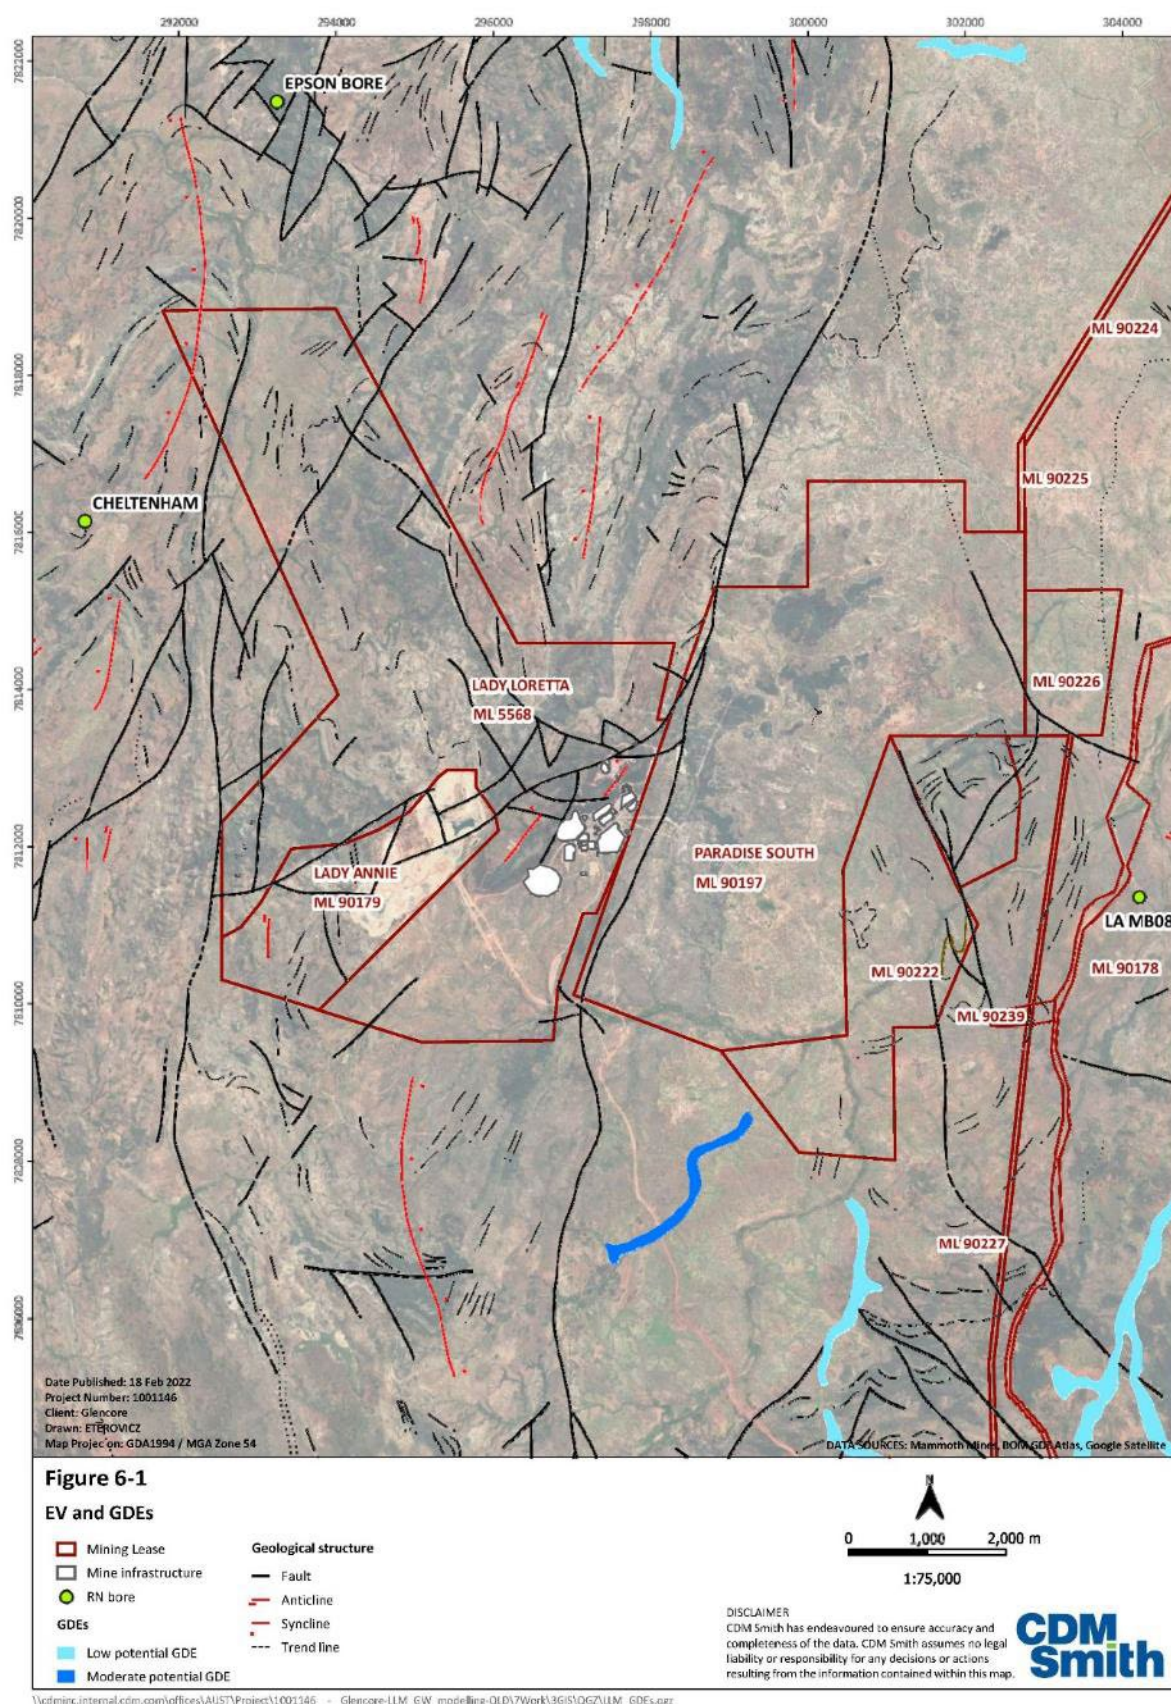
Figure 6-1 Environmental Values and Potential Groundwater Dependent Ecosystems

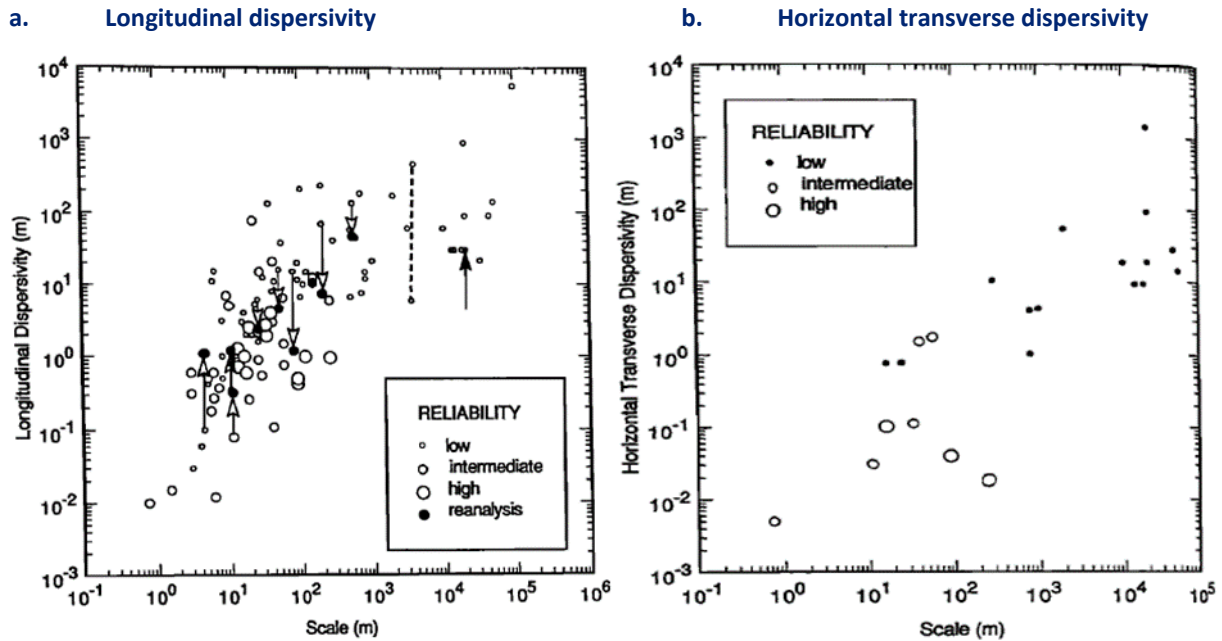
Figure 7-1 Field-scale Dispersivity Values (after: Gelhar et al. 1992)

Larger values of dispersivity can also be regarded as conservative as they tend to enhance the size of the contamination plume. For the simulation a longitudinal dispersivity of 100 m and transverse and vertical dispersivity of 10 m was chosen. The effect of variation of dispersivity on the transport predictions is considered in the sensitivity analysis.

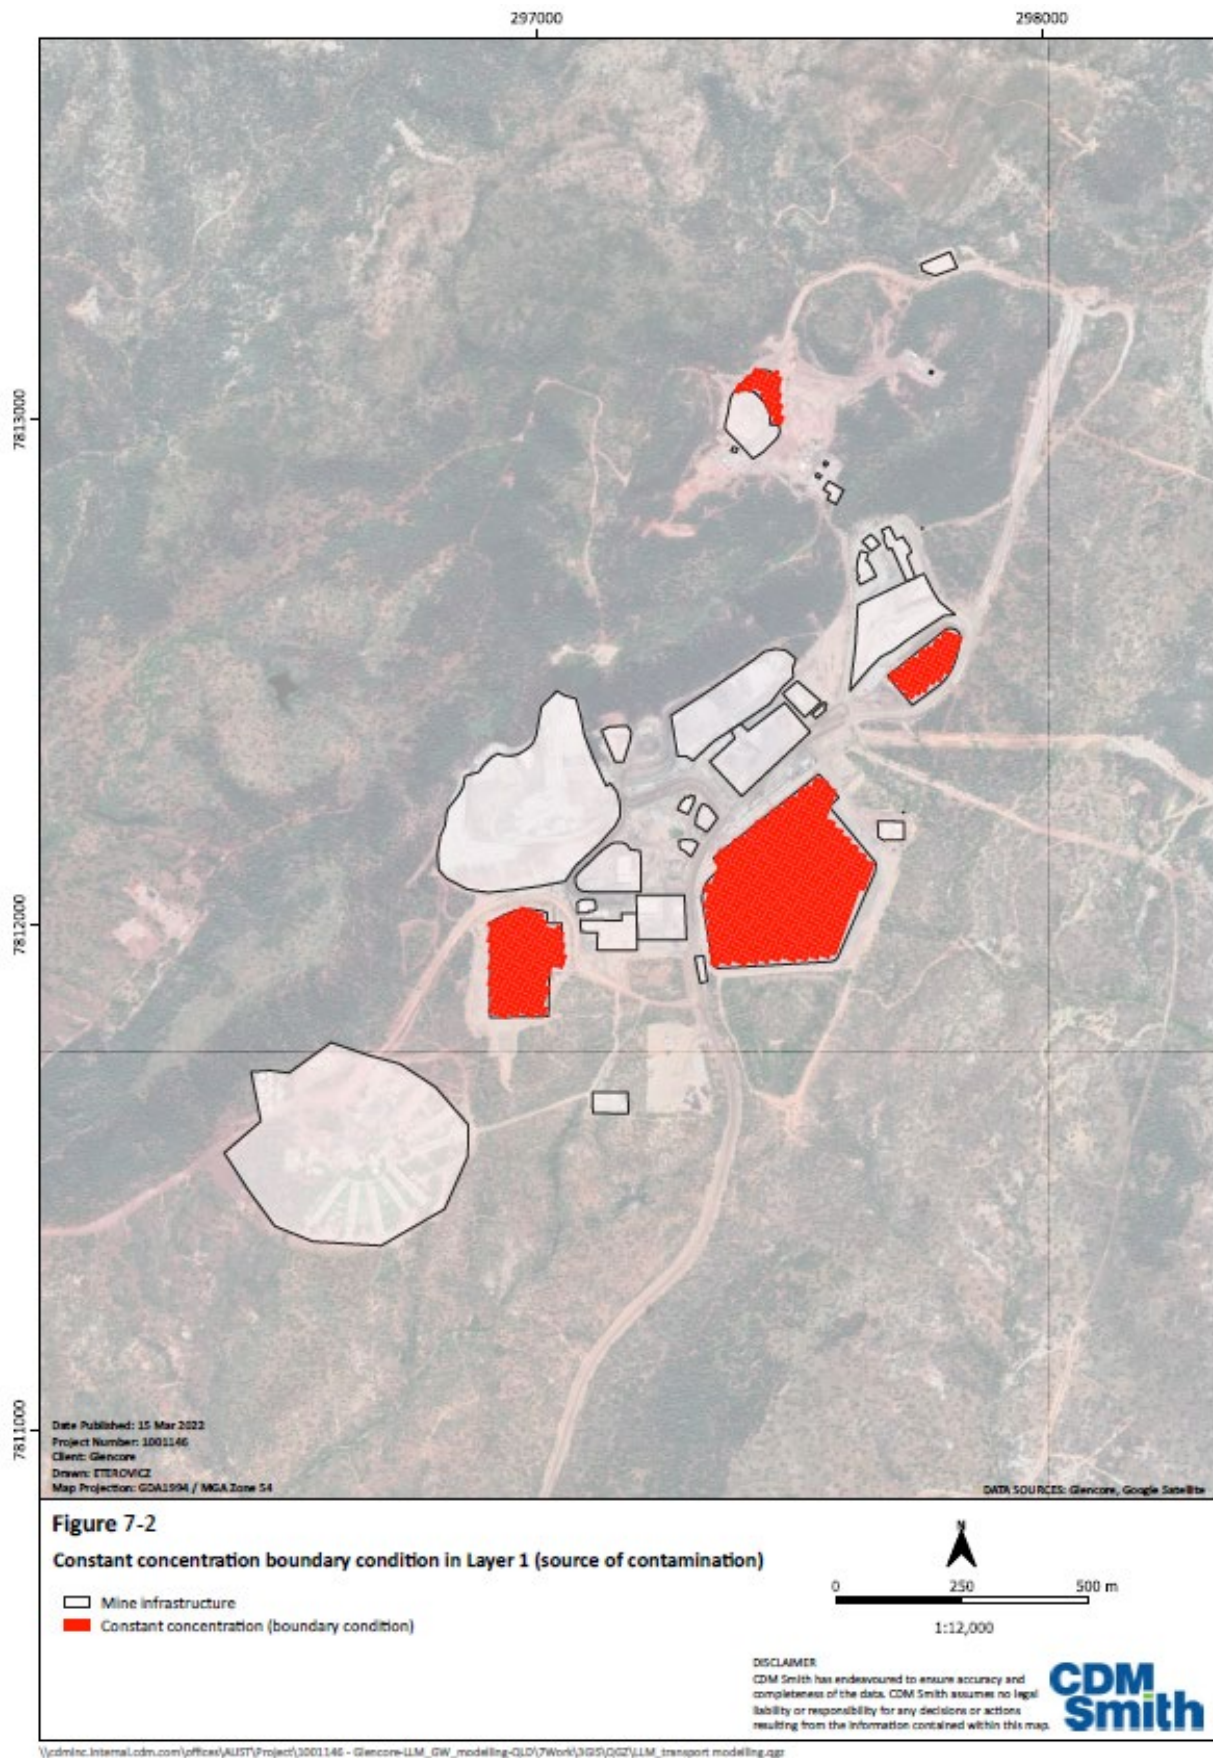
The constant concentration BC representing the source of contamination associated with the underground workings is defined at all the nodes that are representing the underground mine across layer 2 to 5. For the backfilling of the mine workings, the source of contamination is also assumed constant in time for the duration of the whole simulation. It is conservative as it assumes no exhaustion of the contamination potency of the backfill materials or exposed rock.

**Figure 7-2 Constant Concentration BC in Layer 1 (source of contamination)**

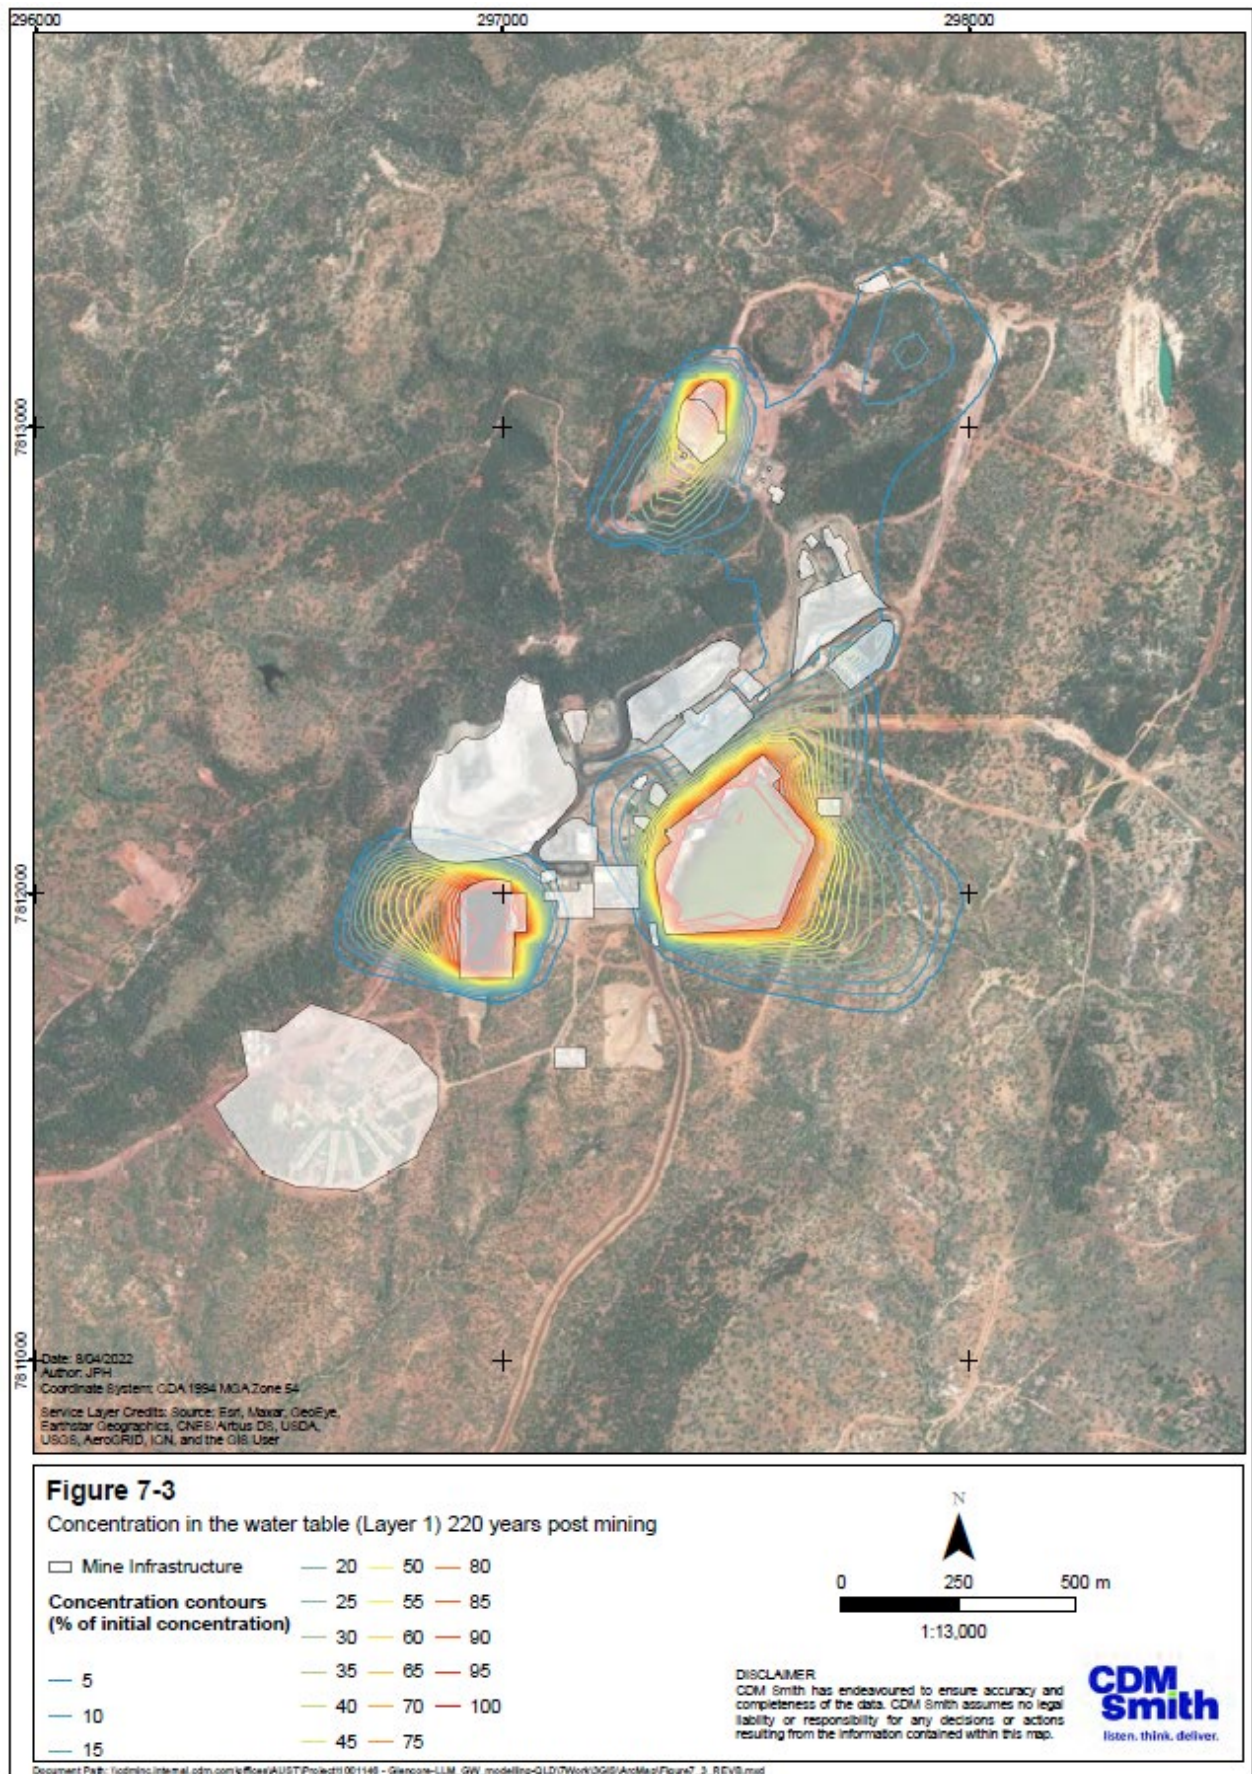
At 220 years post-mining, the concentration of any contaminant 300 m away from the sources is predicted to be less than 10% of the source concentration (Figure 7-3). For the mine workings, after 220 years, no contamination higher than 10% of the source concentration is predicted beyond 500 m of the mine.

**Figure 7-3 Predicted Concentration in the Water Table (Layer 1) - 220 years post-mining**

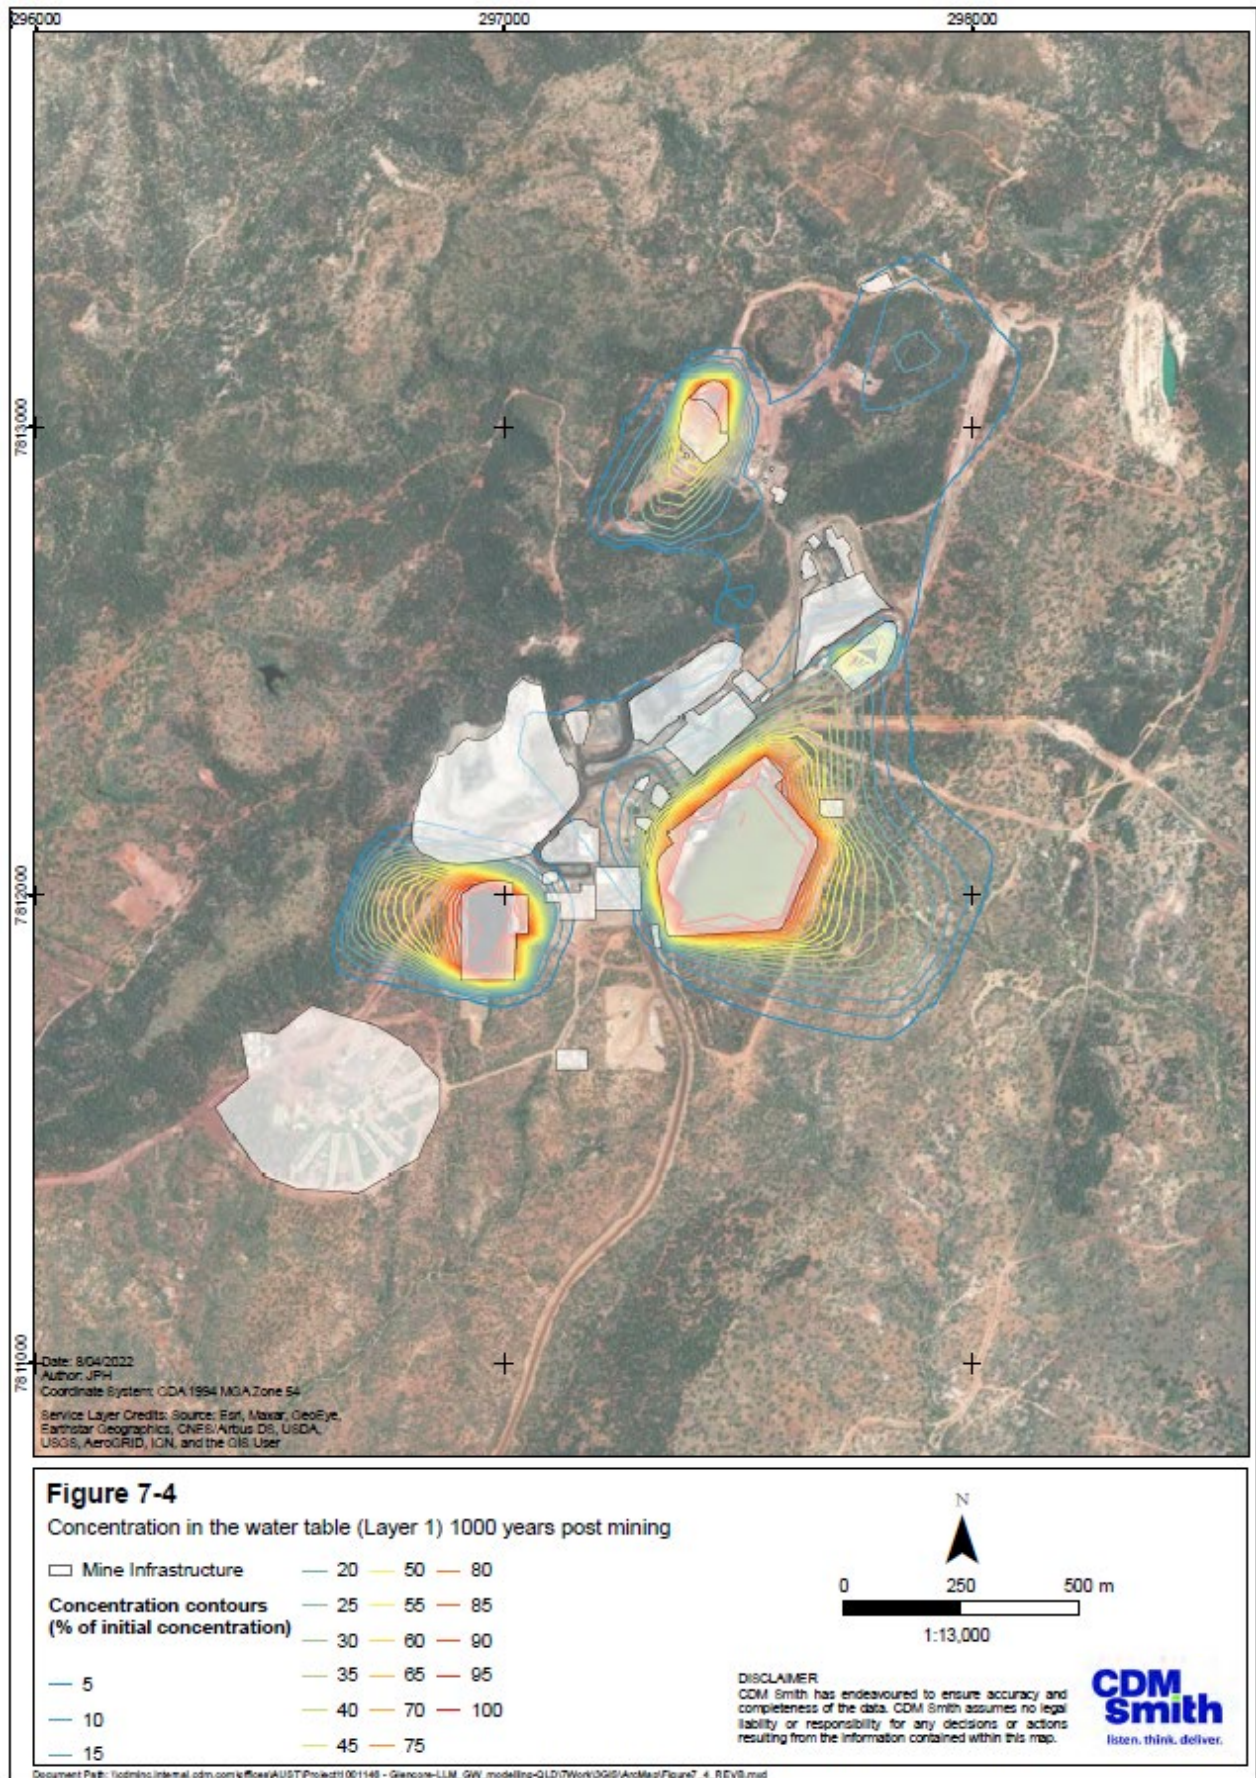
At approximately 1,000 years post-mining, the 10% of source concentration limit is predicted to move around 20 m further from the source (Figure 7-4 to Figure 7-6) reflecting of the limited displacement within the aquifer once pre-mining condition have been re-established, which occurs approximately 200 years post-mining.

**Figure 7-4 Predicted Concentration in the Water Table (Layer 1) - 1000 years post-mining**

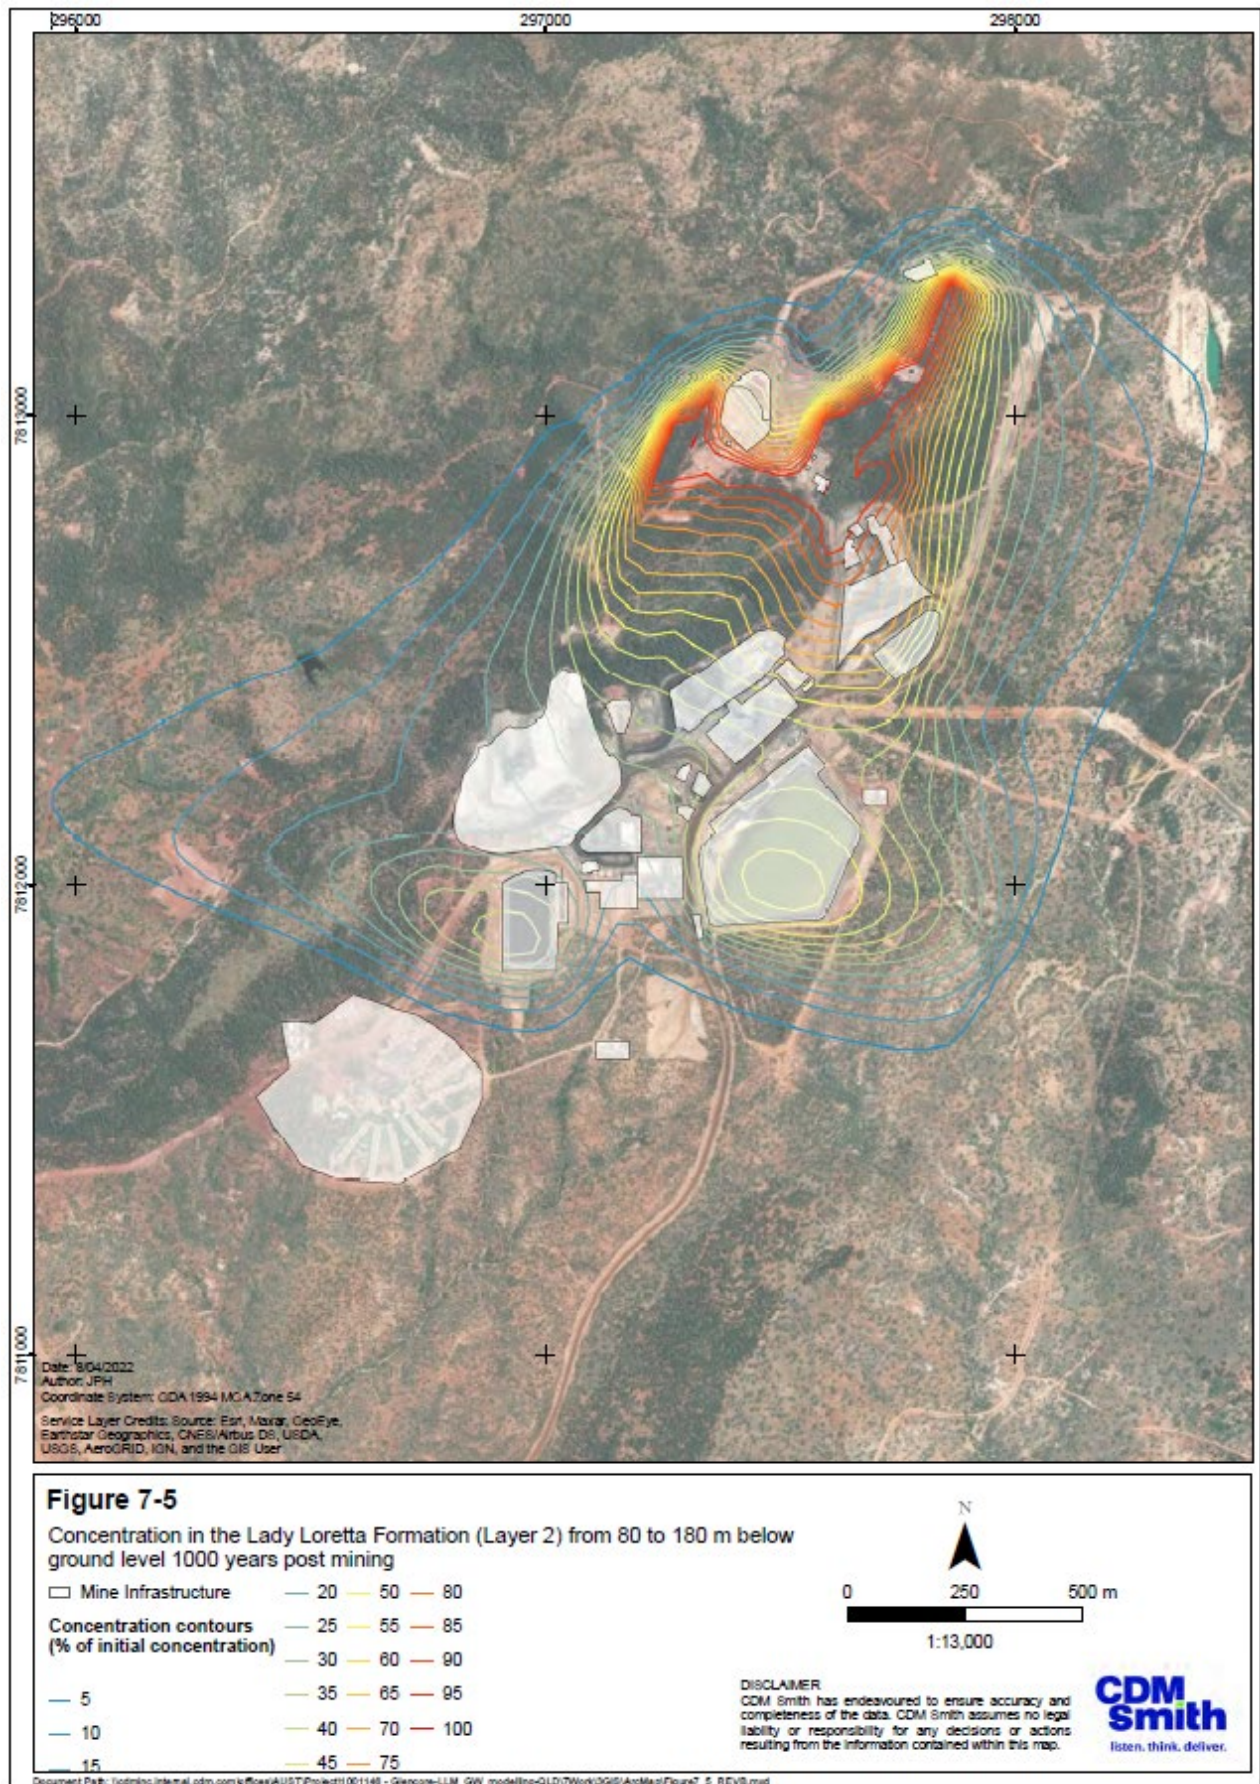
**Figure 7-5** Concentration in the Lady Loretta Formation Between 80 to 180m Beneath Ground Level (layer 2)

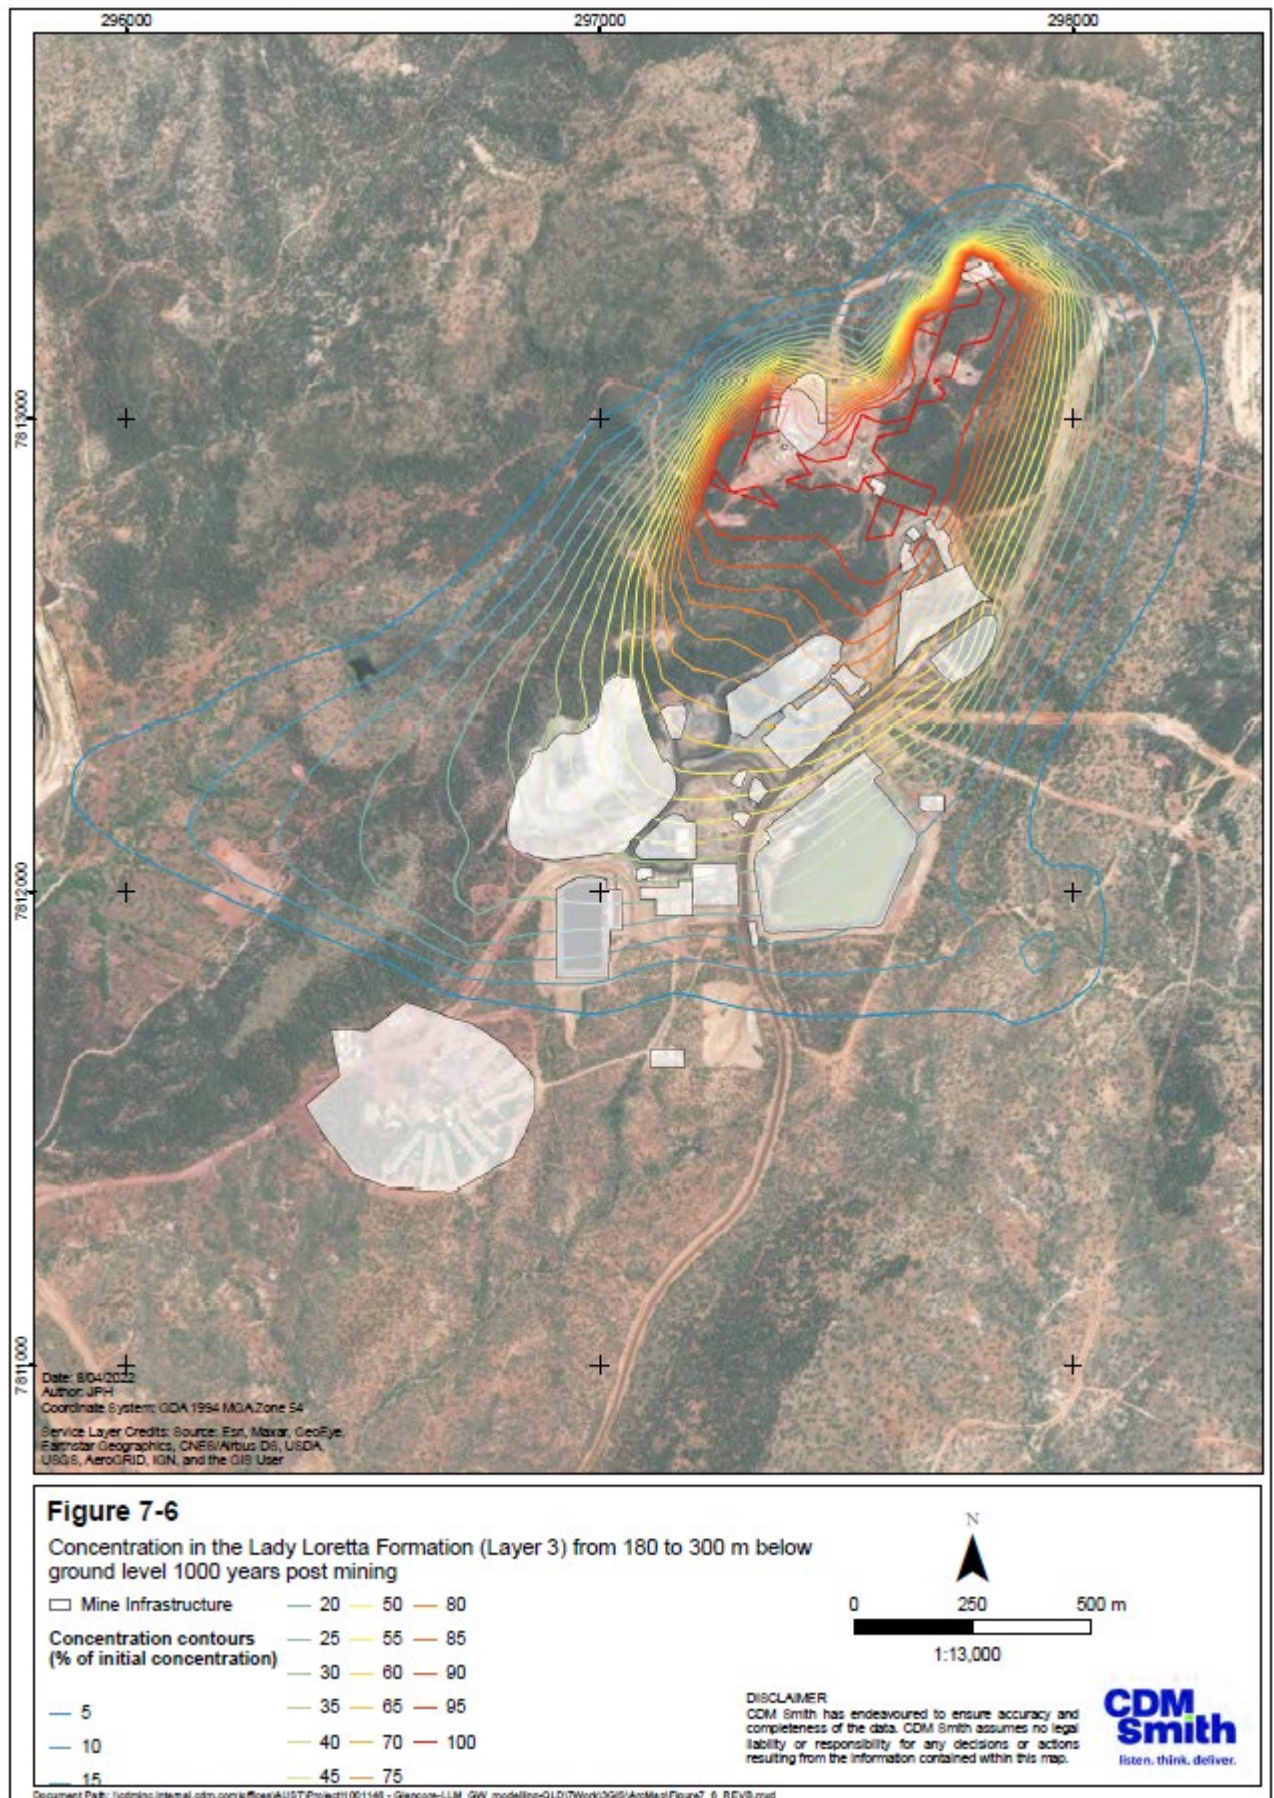
**Figure 7-6** Concentration in the Lady Loretta Formation Between 180 to 300m Beneath Ground Level (layer 3)
