LADY LORETTA

## **Z-LLM-HSEC-PLN-Progressive Rehabilitation and Closure Plan**

| Project Name | Lady Loretta Mine |
| Document Title | Z-LLM-HSEC-PLN-Progressive Rehabilitation and Closure Plan |

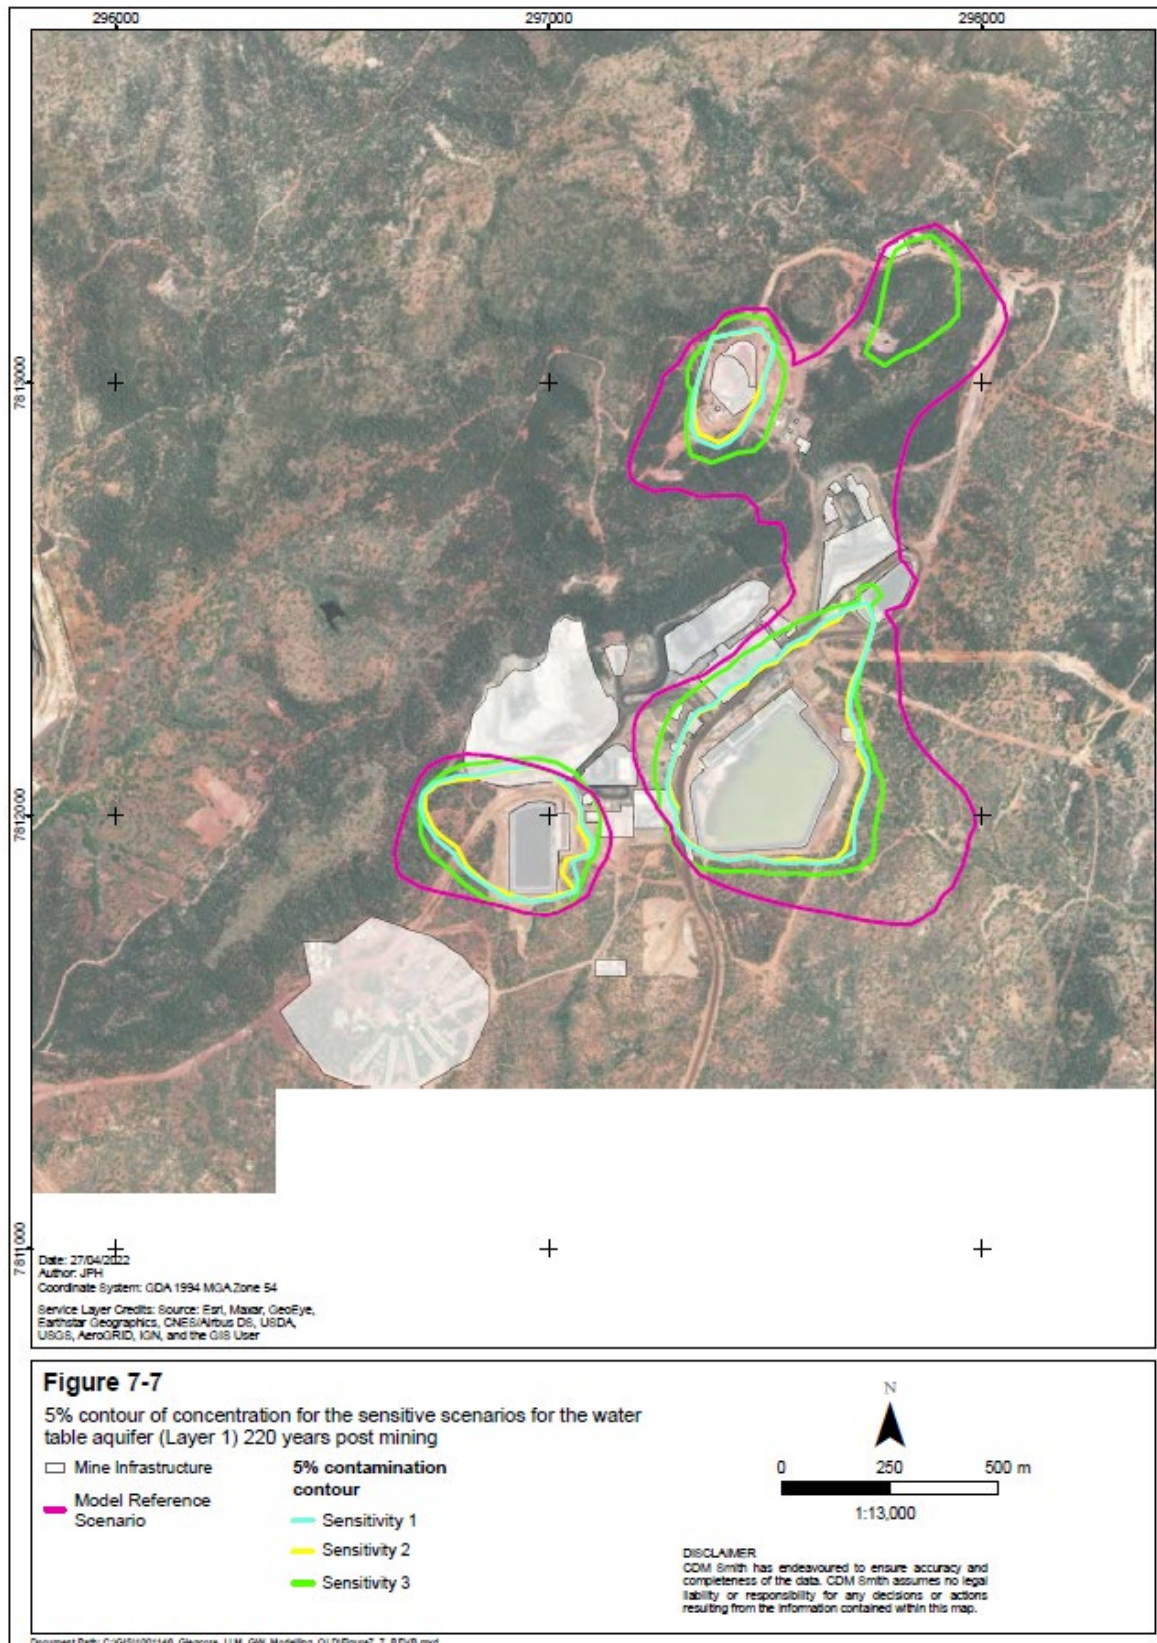
Three sensitivity scenarios were designed and the method of varying parameters for the sensitivity analysis is summarised in Table 7-6. As the adopted dispersivity parameters are conservative, the sensitivity run explores the influence of lower dispersivity parameters (Sensitivity scenario 1) and no dispersivity (sensitivity scenario 2). The reference scenario assumed that the transport of contaminant uses the same pore spaces than flow, and the sensitivity scenario 3 explores the influence of lesser pore space for contaminant movement than for water flow. Results of the sensitivity analysis are illustrated in Figure 7-7. The analysis shows that a reduced dispersivity parameter considerably reduces plume propagation. No sensitivity scenario with a higher value of dispersivity was selected because the reference model scenario adopted a conservative value of dispersivity (overestimated). Sensitivity 3 scenario also shows a reduced plume propagation than the reference scenario.

**Figure 7-7** 5% contour of contamination for the sensitive scenarios for the water table aquifer (Layer 1) (under conservative modelling assumptions)

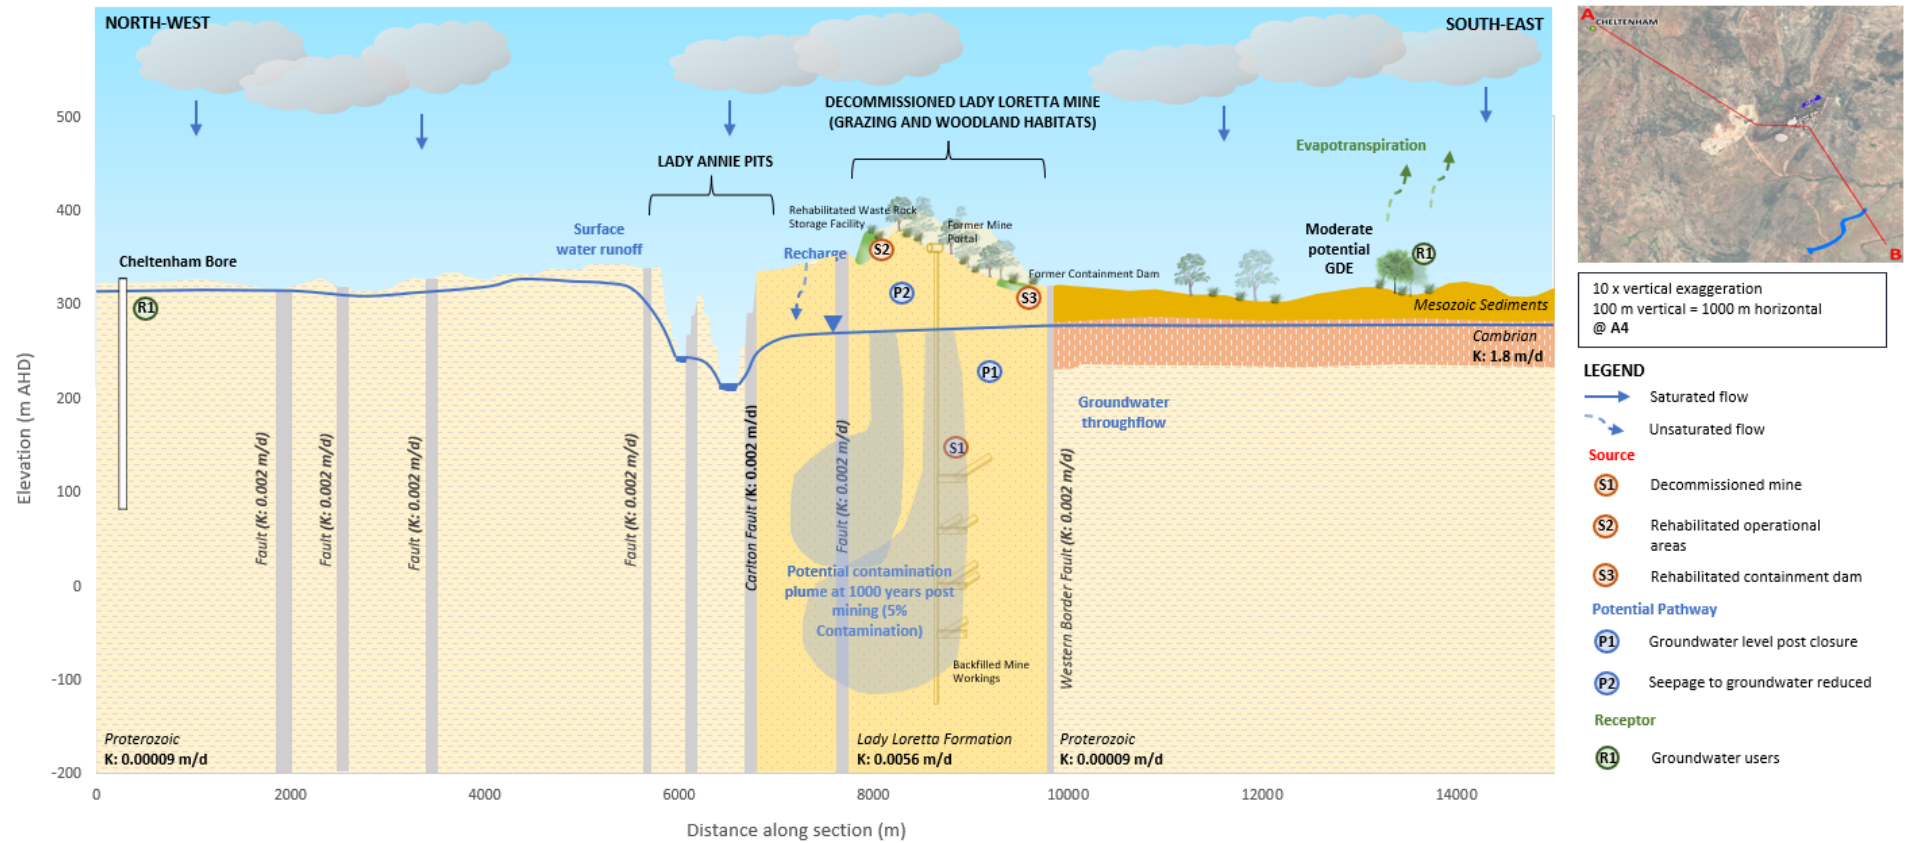
In summary, given the current understanding of groundwater flow, containment dam management, EVs (potential GDEs) and absence of nearby groundwater users, there is a low risk of potential impact. A conceptual cross section summarising these findings is shown in Figure 8-1 based on the available hydrogeological information, numerical model results and solute transport model results to illustrate the groundwater situation as it is currently understood.

Figure 8-1 Conceptual Model – Post Closure showing Solute Transport Model Results and Receptors

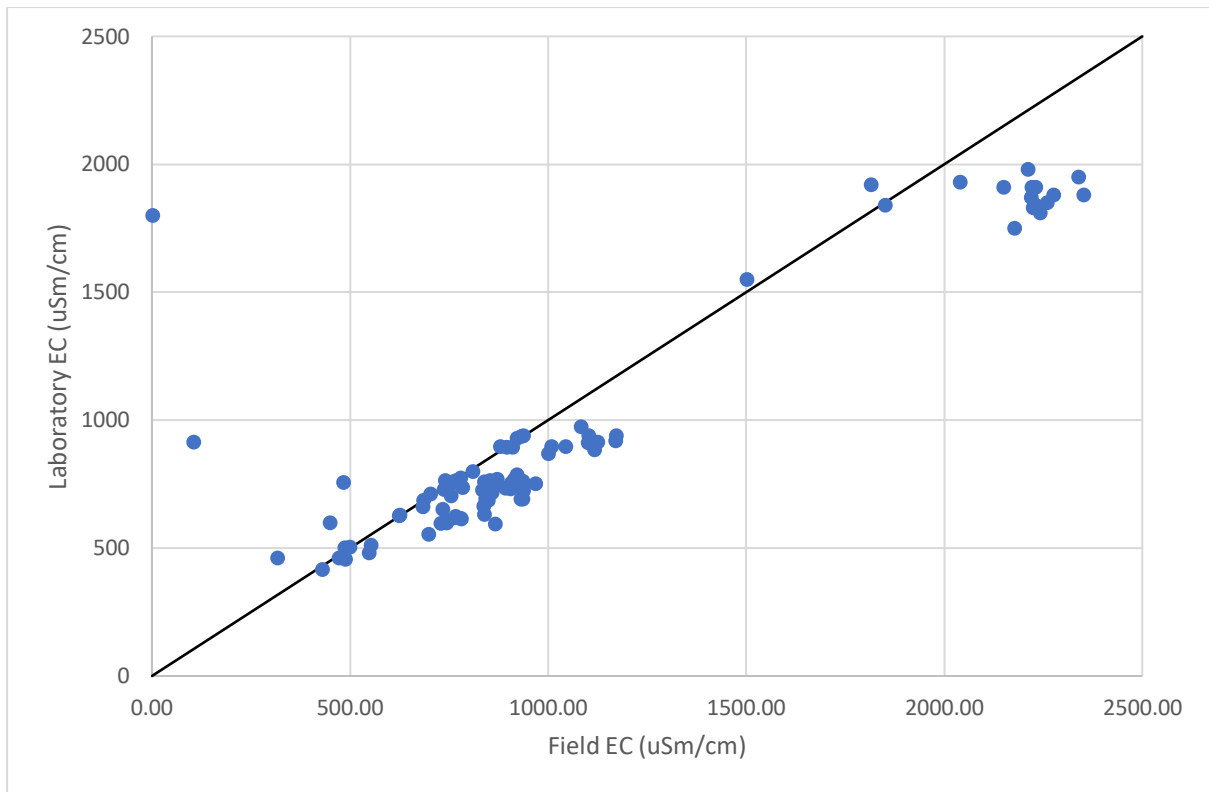
A number of samples have both field and laboratory measurements of electrical conductivity. These are plotted in Figure 1. The data shows a good correlation, but it does not have a slope of 1, indicating that field EC is higher than the laboratory measurement at higher EC values. This discrepancy may reflect field meter calibration issues which may need to be followed up with field staff prior to any future sampling.

Figure 1: Field Electrical Conductivity versus Laboratory Electrical Conductivity (in  $\mu\text{Sm}/\text{cm}$ )

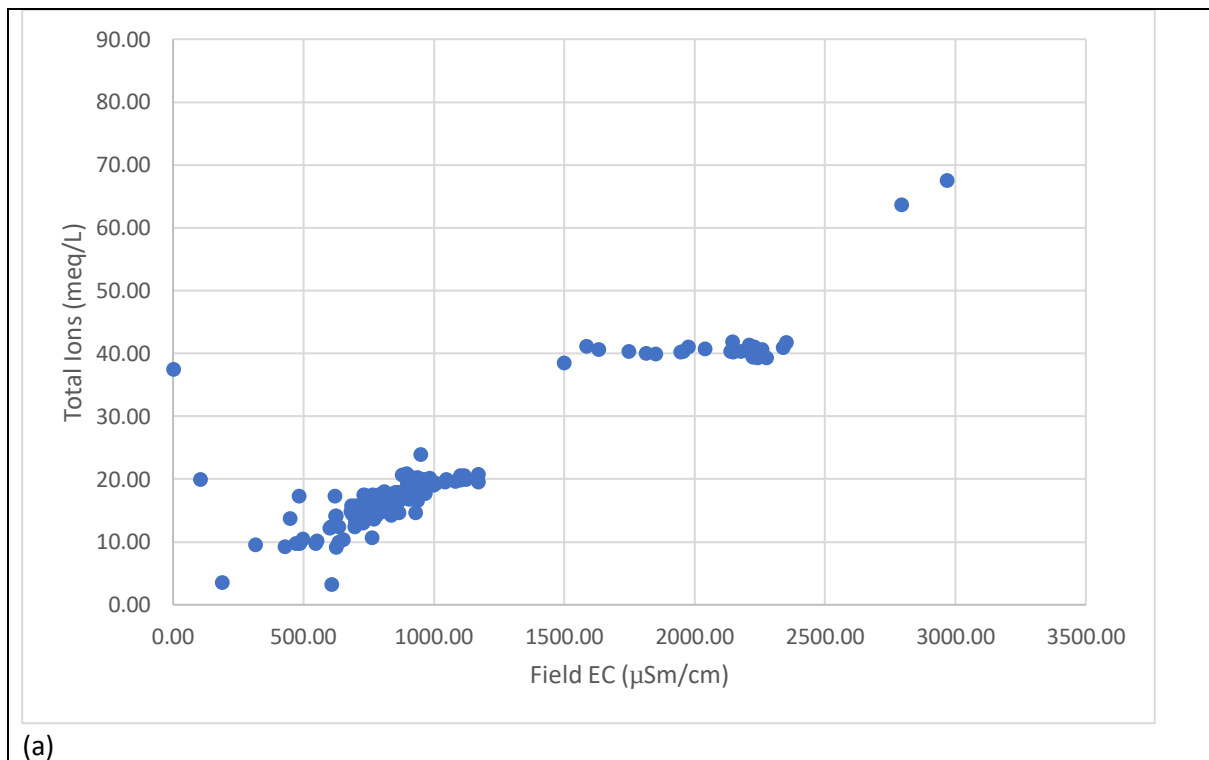
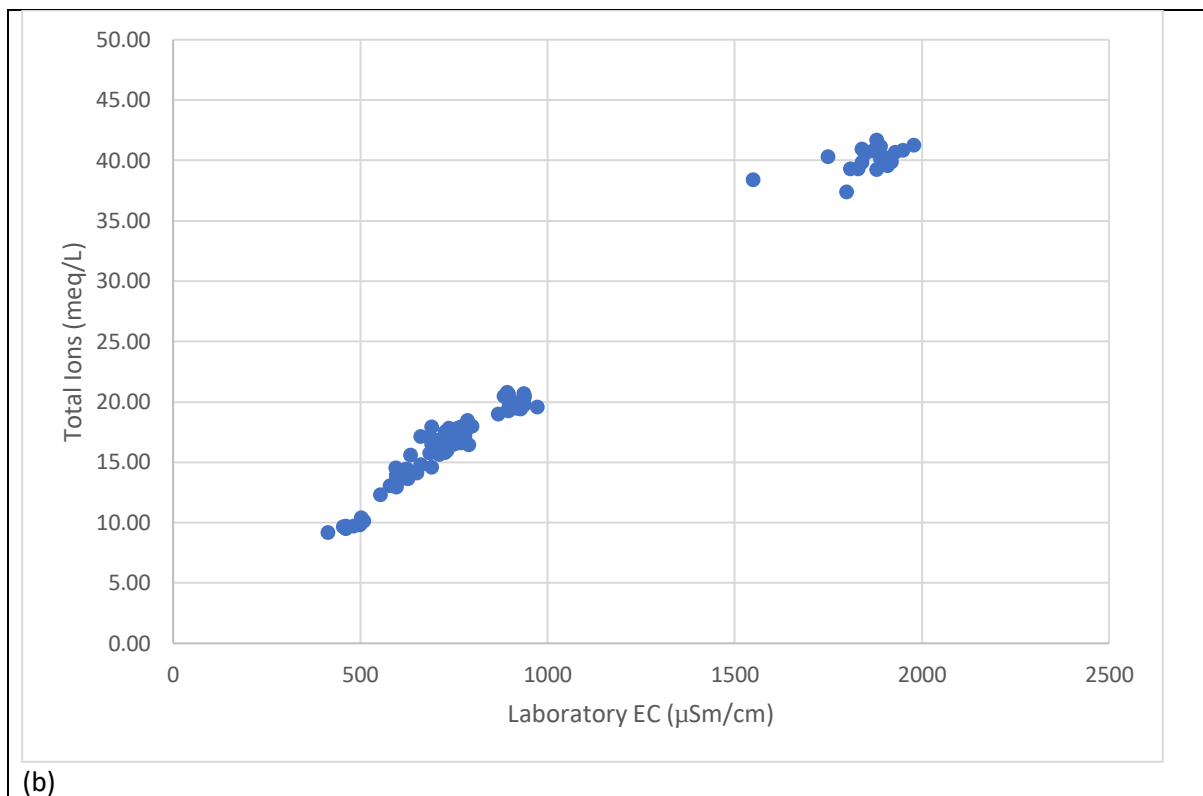
Figure 2: Electrical Conductivity versus Total Ions (a) Field EC vs Total Ions, and (b) Laboratory EC vs Total Ions

Total Ions, calculated as the sum of the major ions as milliequivalents per Litre (meq/L), were plotted against both laboratory and field EC measurements (Figure 2a and b). The plot of laboratory EC vs Total Ions (b) shows a good correlation, but the Field EC plot (a) shows a number of areas of poor correlation. This suggests that the field EC measurement may not be correct, and this could be a function of instrument error (calibration, etc). The almost linear correlation in Figure 2 (b) provides confidence that Total Ions can be used as a surrogate for TDS (or total salinity).

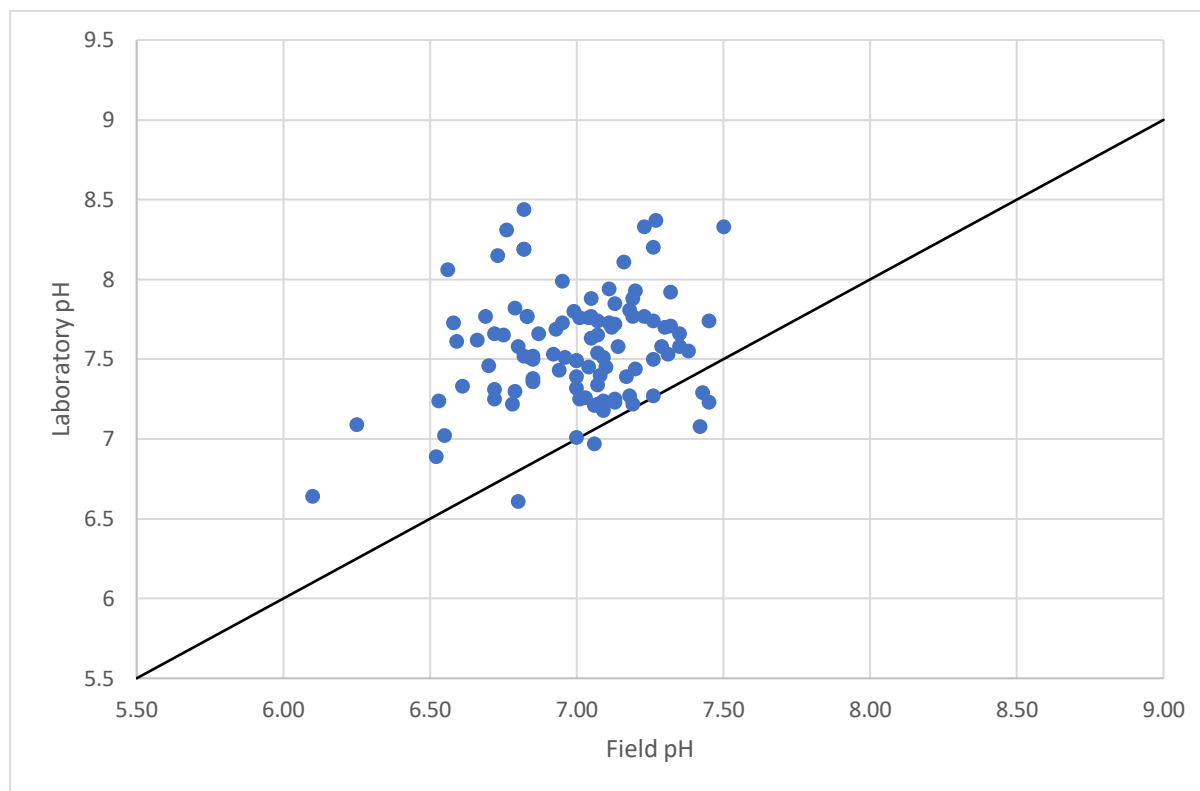
outcome from this lack of correlation is that the results of any assessment of pH driven chemical reactions would be uncertain, and as such, are not undertaken.

Figure 3: Field pH versus laboratory pH (1:1 line shown)

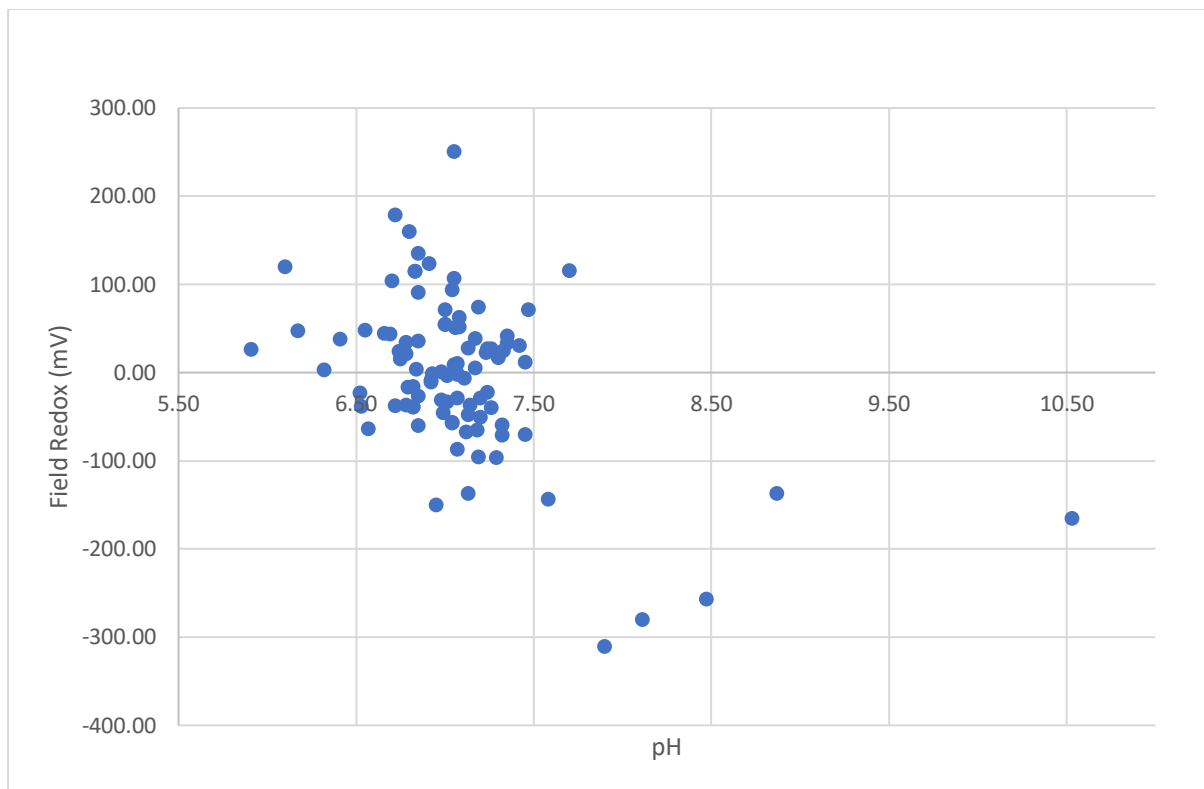
Redox and pH measured in the field were plotted to describe the likely Eh/pH relationships. The plot (Figure 4) shows that the measured values lie in a generally tight grouping showing neutral to slightly acid pH and oxidised to slightly reduced redox potential.

The lowest redox potential values are all from bore GW08. These values might indicate that the waters in GW08 are reduced and that dissolved sulfur might be speciated into  $\text{H}_2\text{S}$  or  $\text{HS}^-$ . Field observations recorded at the time the sample was taken note a strong sulfur smell. Thus, depending on the laboratory analytical methods used to measure sulfur, and the chemical evolution of the sample in the bottle during transit, the reported sulphate concentrations may be a minimum only.

Figure 4: Field pH versus Field Redox

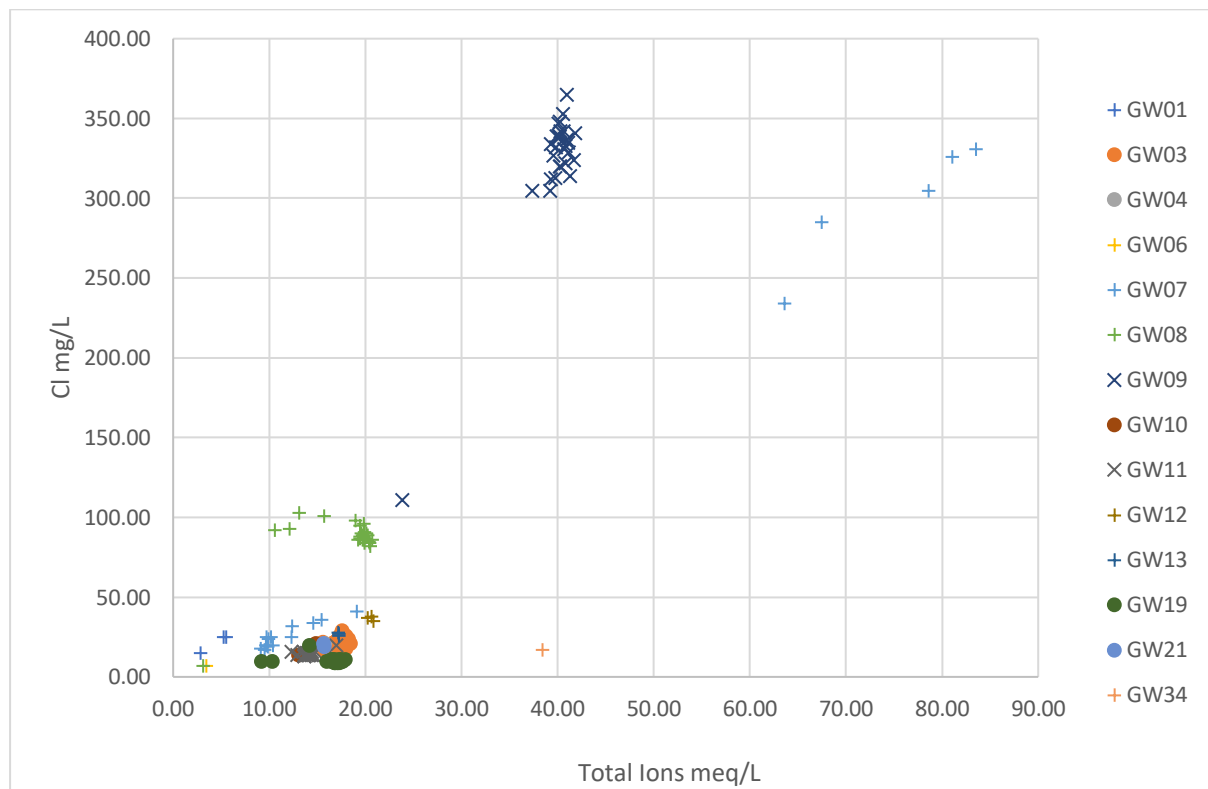
Figure 5: Chloride versus Total Ions. (+ - Lady Loretta Block, o - Cambrian Block, x - Paleoproterozoic Block)

The distribution of Chloride in groundwater in the LLM area is generally simple at the broad scale, but can be complex at the local scale (Figure 5). Generally, groundwater in the Cambrian and Lady Loretta Blocks have low overall Chloride concentrations, whereas the limited data for groundwater in the Paleoproterozoic Block indicate higher levels of Chloride (except for groundwater sampled at bore GW07 – which is discussed in detail below). This distribution tends to suggest that infiltrating water undergoes little concentration due to evapotranspiration in the LL and Cambrian Blocks, when compared to the Paleoproterozoic Block.

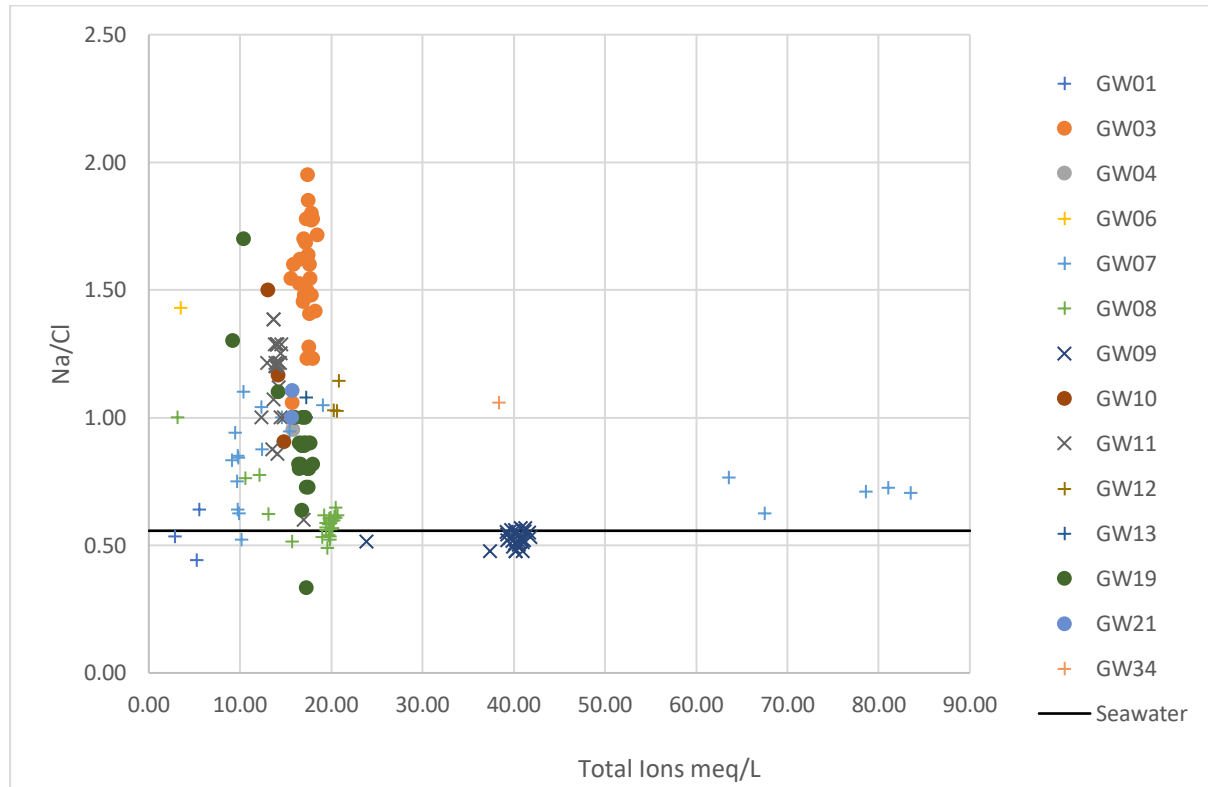
Figure 6: Na/Cl weight ratio vs Total Ions (+ - Lady Loretta Block, o – Cambrian Block, x – Paleoproterozoic Block)

If all the Chloride concentration in groundwater is from oceanic aerosols from rainfall, then one might expect that the Na/Cl weight ratio may reflect seawater values, assuming that Sodium behaves conservatively. Figure 6 shows the Na/Cl ratio for groundwaters plotted against Total Ions. The seawater ratio is also shown. Note that groundwater from bore GW09 falls on the seawater ratio line and indicates that at least the sodium and chloride conform with a simple diffuse recharge from oceanic salt sources. Some of the samples of groundwater from GW07 lie on the same ratio. However, most sampled groundwater shows a trend of increasing Na/Cl ratio for a given Total Ion value. This may indicate that sodium is preferentially added to the groundwater during recharge,

probably due to ion exchange process in the shallow soil/regolith. Note that there is no trend with increasing Total Ion value. The flow system, as it can be deduced, does not support increasing Cl values down the flow path. Thus, the data in Figure 6 show that this ratio is inherited probably shortly after recharge, and is then maintained within that part of the aquifer compartment. This further supports a conceptualisation of the aquifer within the blocks being compartmentalised in specific areas, with little interchange between compartments.

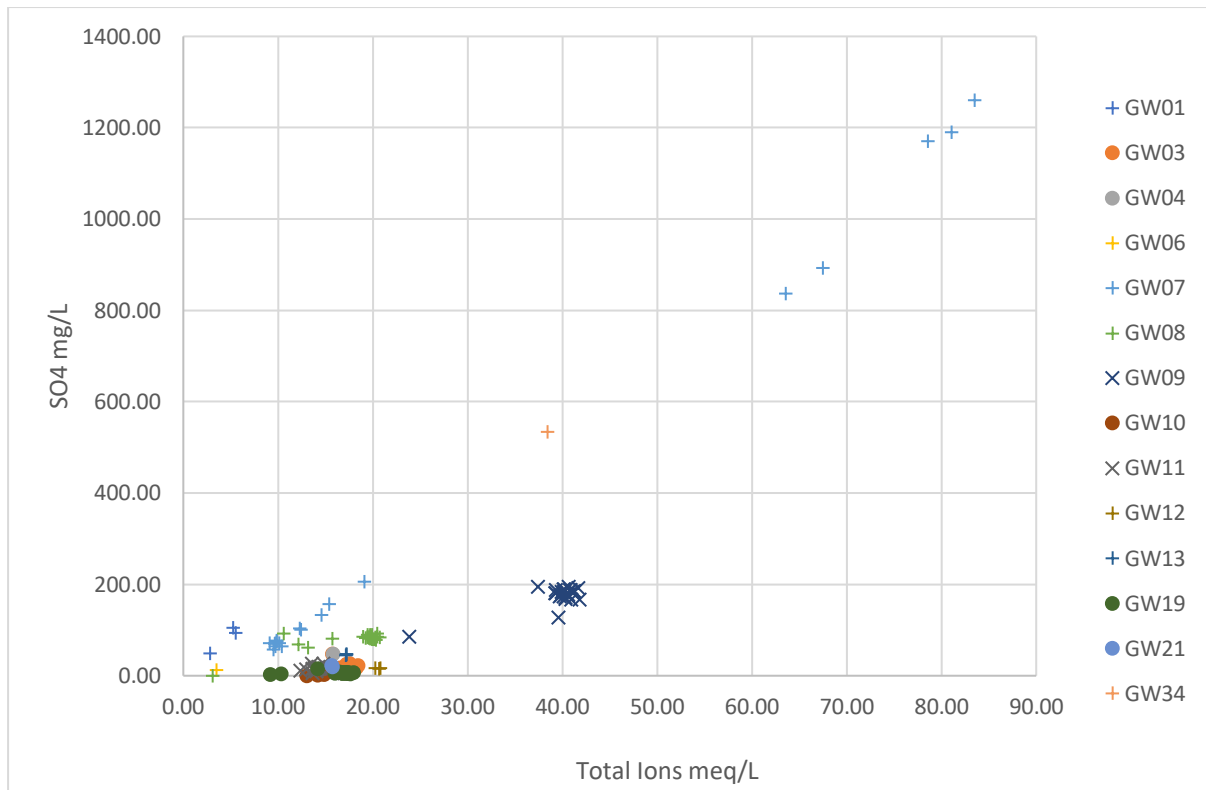
Figure 7: Sulphate versus Total Ions (+ - Lady Loretta Block, o – Cambrian Block, x – Paleoproterozoic Block)

Sulphate plotted against Total Ions (Figure 7) shows that:

These findings are consistent with the understanding of the distribution of sulphidic mineralisation within the bedrock, and indicate that sulfur is being contributed to the groundwater from mineral dissolution (or oxidation) processes. These oxidation processes are consistent with the measured redox potential (as discussed above).

The low sulphate content of groundwater within the Cambrian Block also indicates that the rocks are dominated by carbonates/dolomites, and not by gypsum.

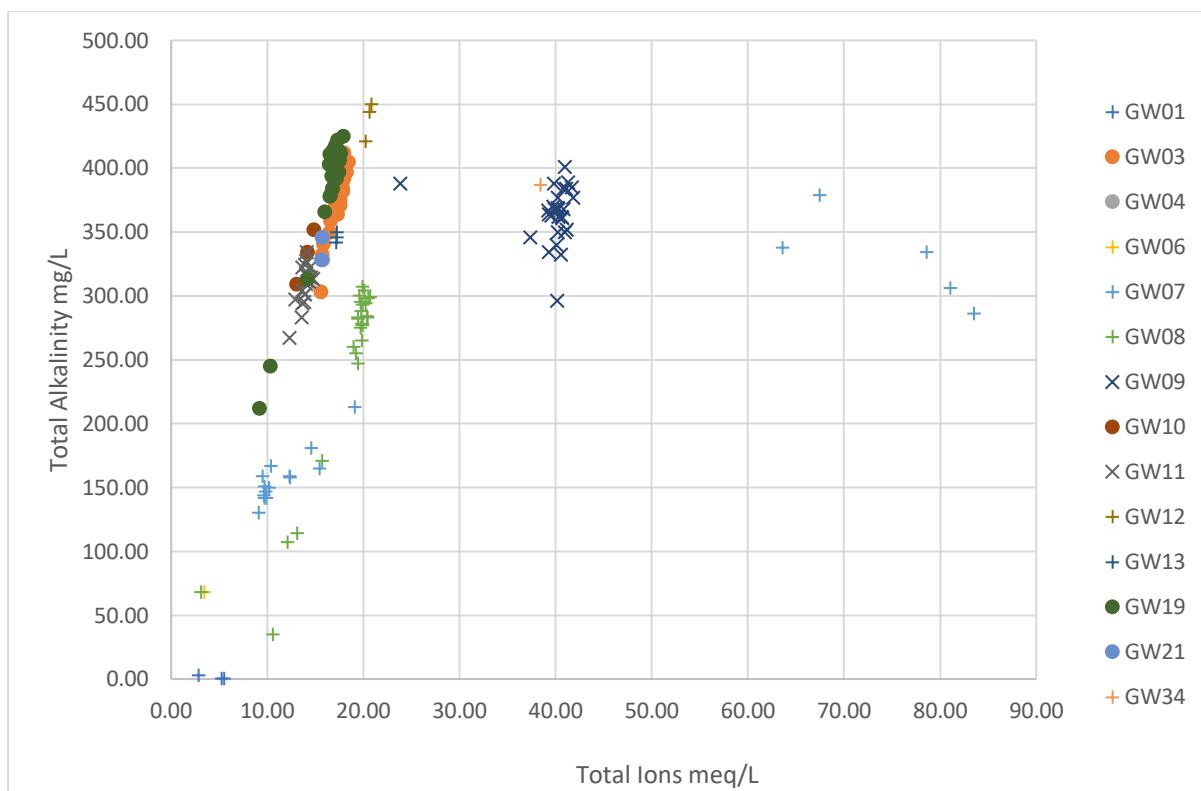
Figure 8: Total Alkalinity versus Total Ions (+ - Lady Loretta Block, o – Cambrian Block, x – Paleoproterozoic Block)

Total Alkalinity is reasonably constant across the different Block groundwaters, with values generally between 300 and 450 mg/L (Figure 8), though the proportion of Total Ions varies, with the Cambrian Block groundwaters having a larger proportion of Total Alkalinity when compared to groundwater sampled from bore GW07 in particular.

Groundwater from bore GW11 (located in the Proterozoic block), GW12 and GW13 (located in the Lady Loretta block) have the same Total Alkalinity and Total Ion values as groundwater from the Cambrian Block. The piezometry of the site precludes any movement of groundwater from the Cambrian Block to the site of GW11, but there may be some limestone layers present at that site. Movement of groundwater may be occurring from the Cambrian Block to the site of GW12 and GW13, but more detailed piezometry would be required to confirm this. It is also possible that there are carbonate layers present in these bores.

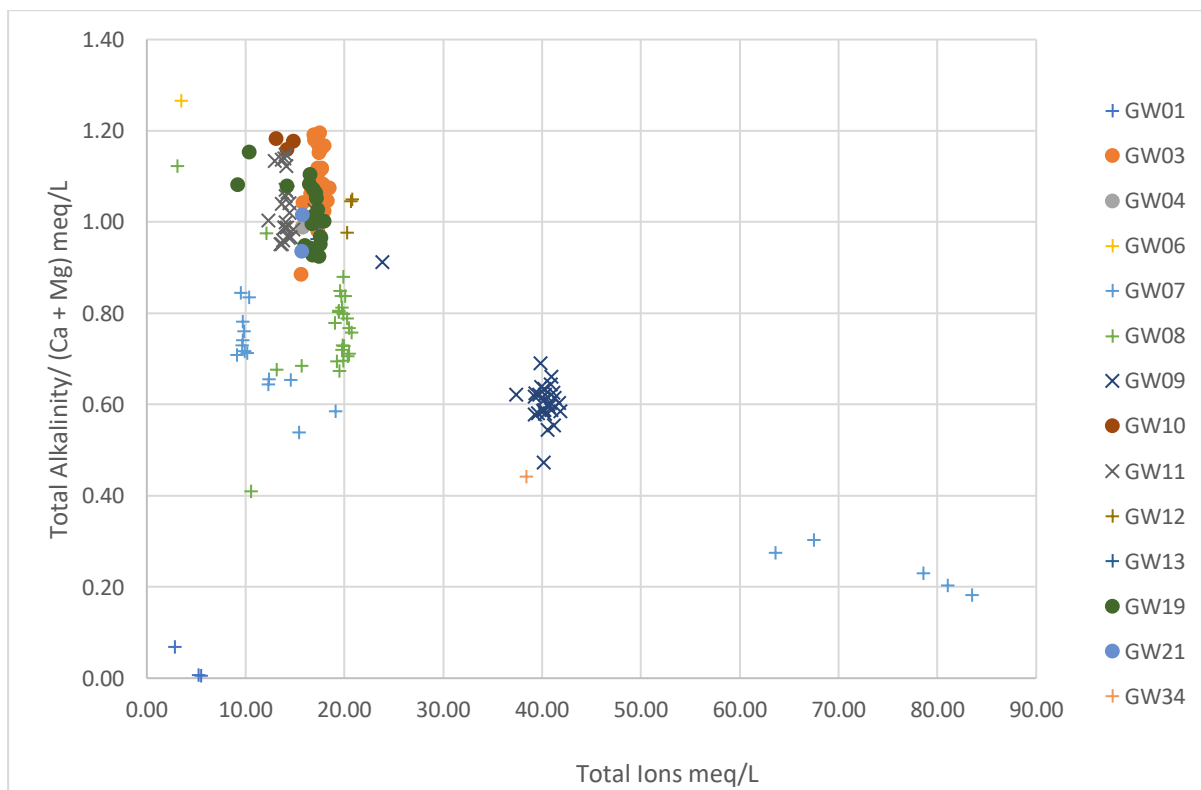
Figure 9: Molar ratio of Total Alkalinity/Ca plus Mg versus Total Ions (meq/L) (+ - Lady Loretta Block, o – Cambrian Block, x – Paleoproterozoic Block)

To further understand the geochemistry of the Cambrian Block groundwater, the molar ratio of Total Alkalinity to Calcium plus Magnesium was plotted against Total Ions (Figure 9).

If dolomitic dissolution were the primary driver on the Total Alkalinity and, Calcium and Magnesium system, then one might expect that the ratio of those constituents would be unity. Figure 9 shows that the ratio for the Cambrian Block groundwater is close to one in all cases.

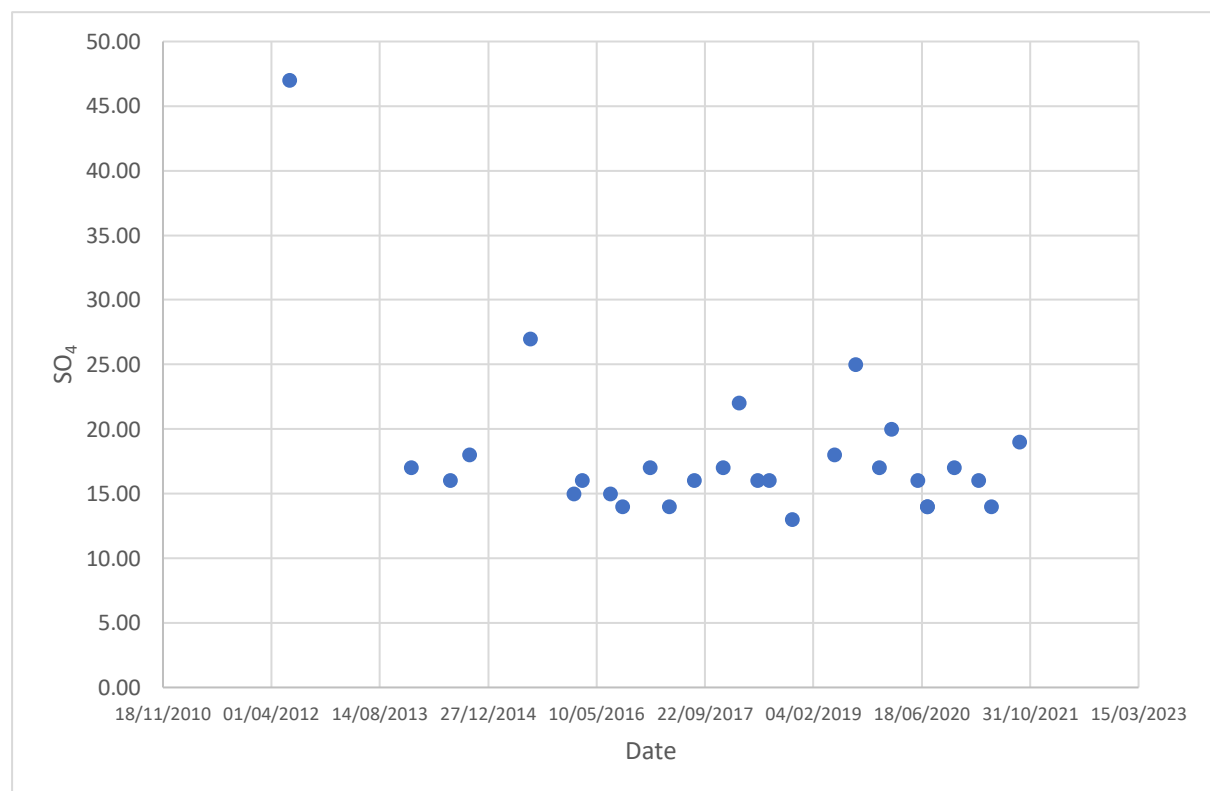
Figure 10: Sulfate concentration over time for GW03

Figure 10 and Figure 11 show temporal changes in SO<sub>4</sub> and the ratio TA/(CA + Mg) respectively. The trends with time are reasonably stable and indicate that as groundwater extraction from the borefield locally increases hydraulic gradients, the water chemistry is uniform. There appear to be no major water chemical reactions taking place at the temporal scale of the data.

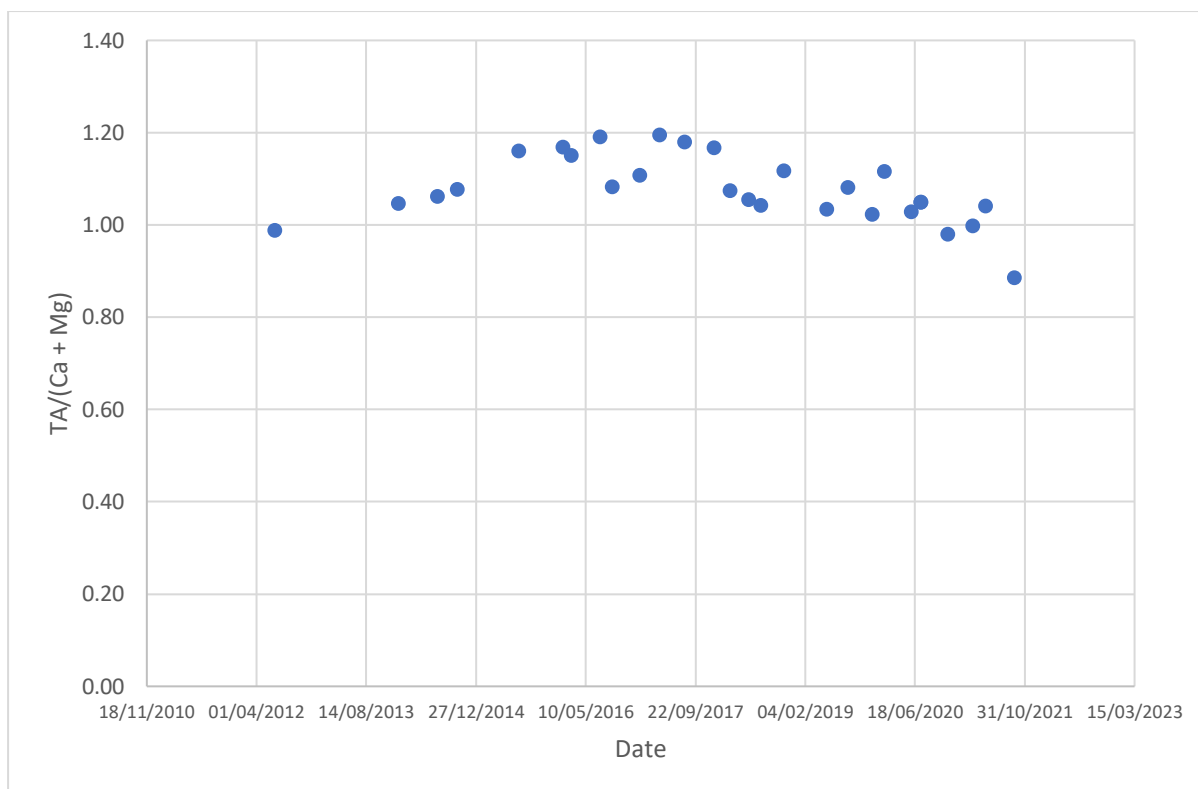
Figure 11: Molar ratio of Total Alkalinity/(Ca plus Mg) versus time for bore GW03

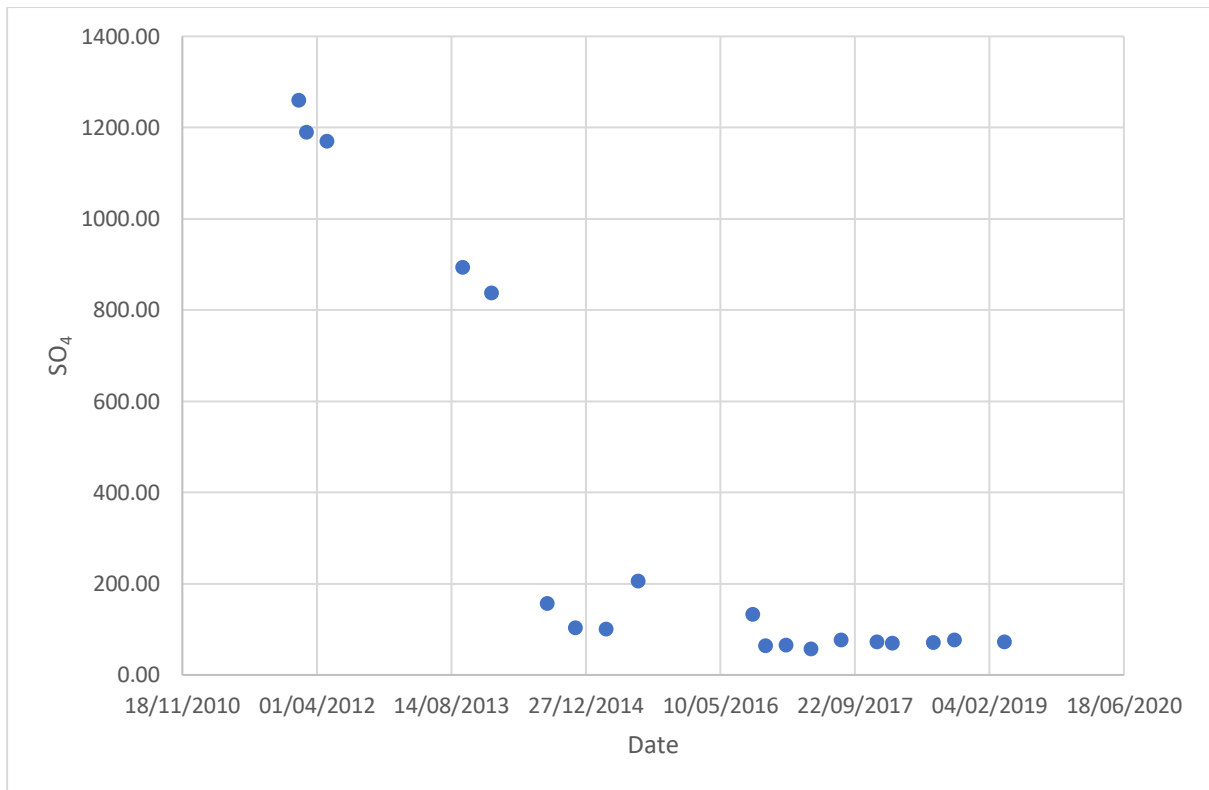
Figure 12: Sulfate concentration over time for GW07

Changes in water chemistry for GW07 show that as the mine dewatering proceeds, there is a rapid decrease in SO<sub>4</sub> concentrations, and a correlated increase in the ratio of TA/(Ca + Mg) (Figure 12 and Figure 13). In mid-2016 the two plots reach a dynamic equilibrium. The sulfate decrease is probably

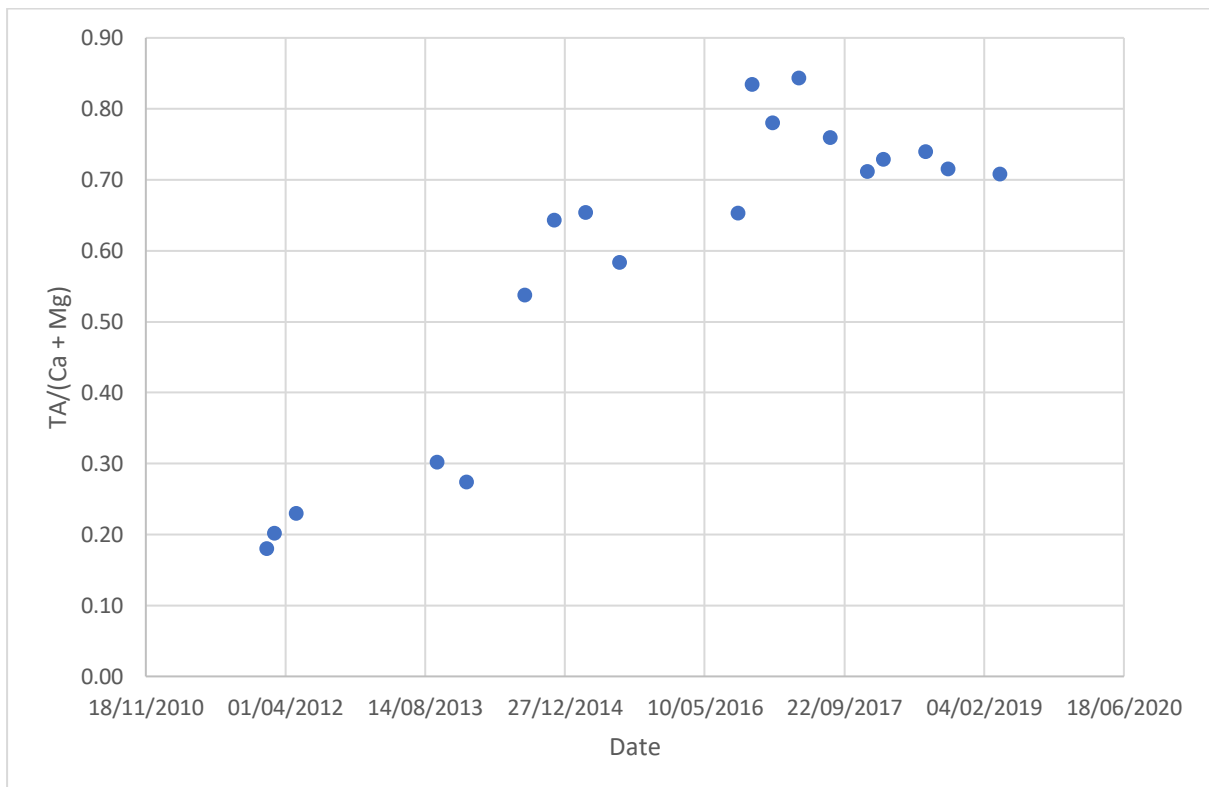
Figure 13: Molar ratio of Total Alkalinity/(Ca plus Mg) versus time for bore GW07

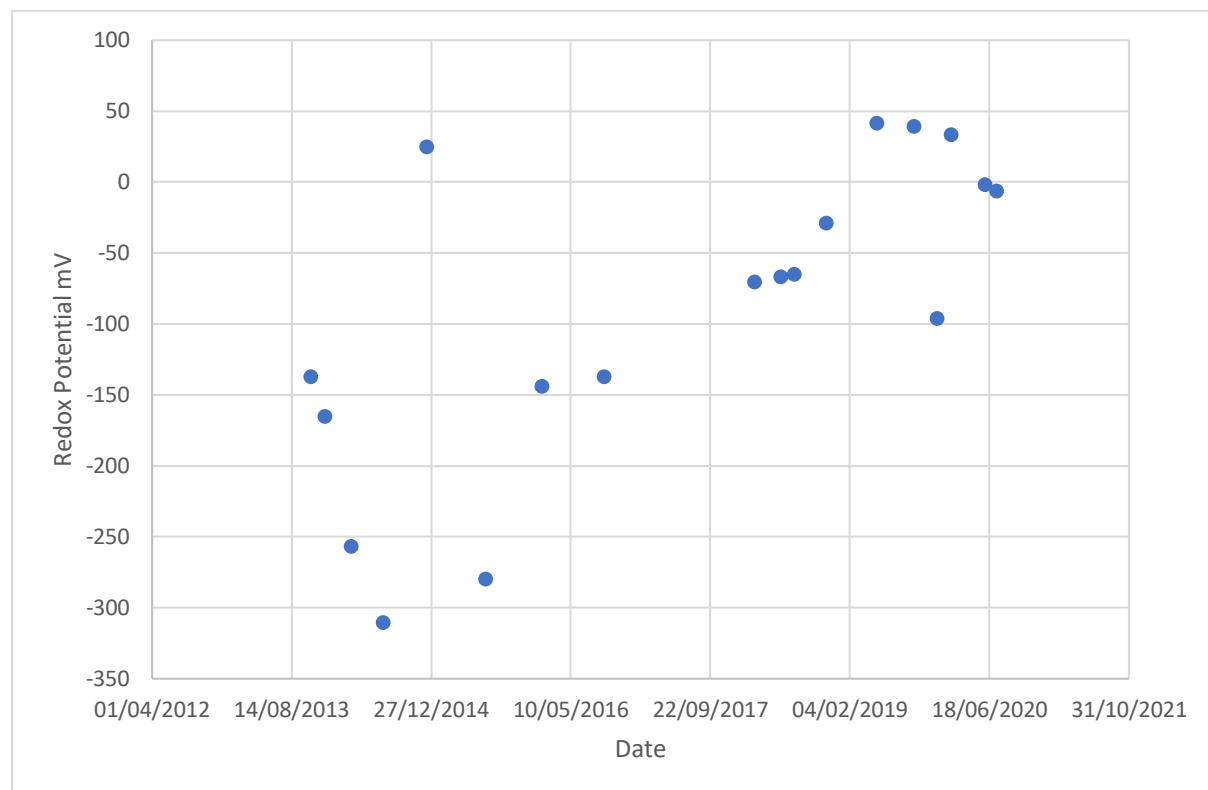
Figure 14: Redox potential variability over time for GW08

Bore GW08 samples groundwater from the Lady Loretta Block and lies to the south east of the Lady Loretta mine.

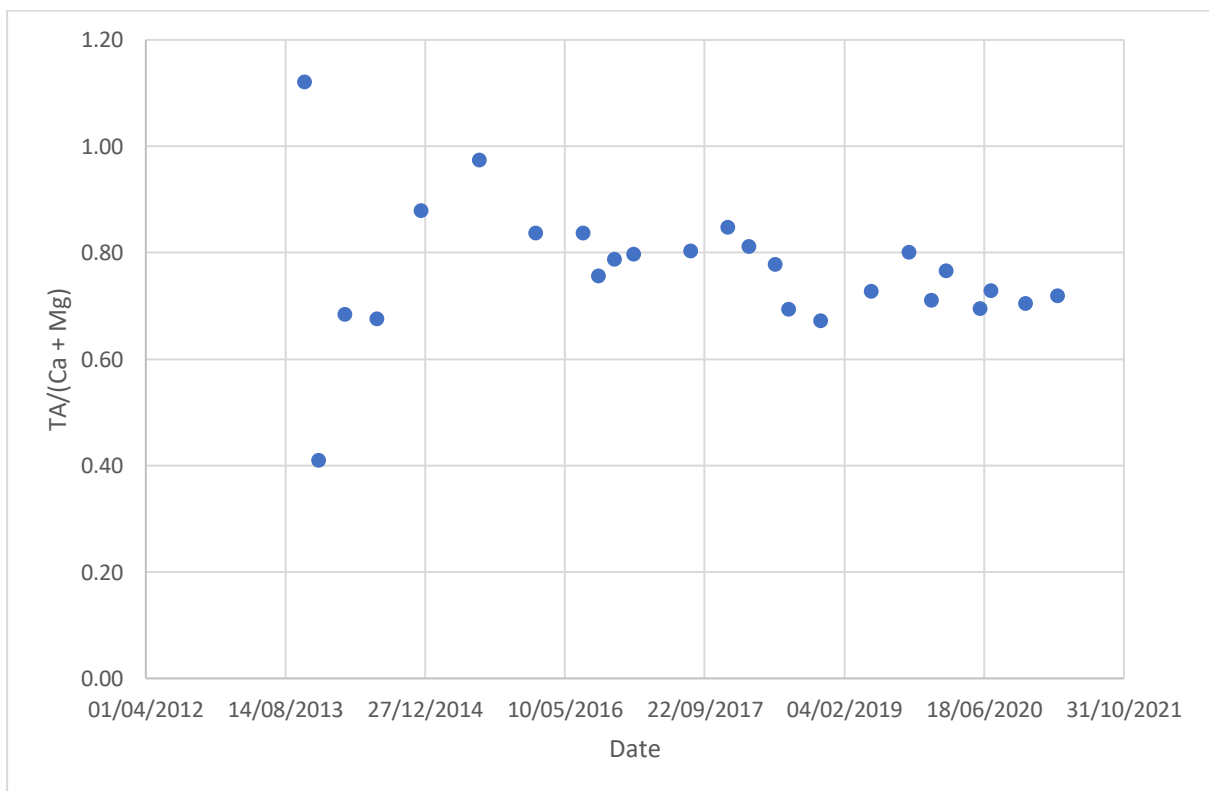
Figure 16: Molar ratio of Total Alkalinity/(Ca plus Mg) versus time for bore GW08

The molar ratio of TA/(Ca + Mg) decreases over time (Figure 16), also indicating that silicate dissolution processes are most likely dominant, but the early data may indicate that there are carbonate rocks within the vicinity of the bore.

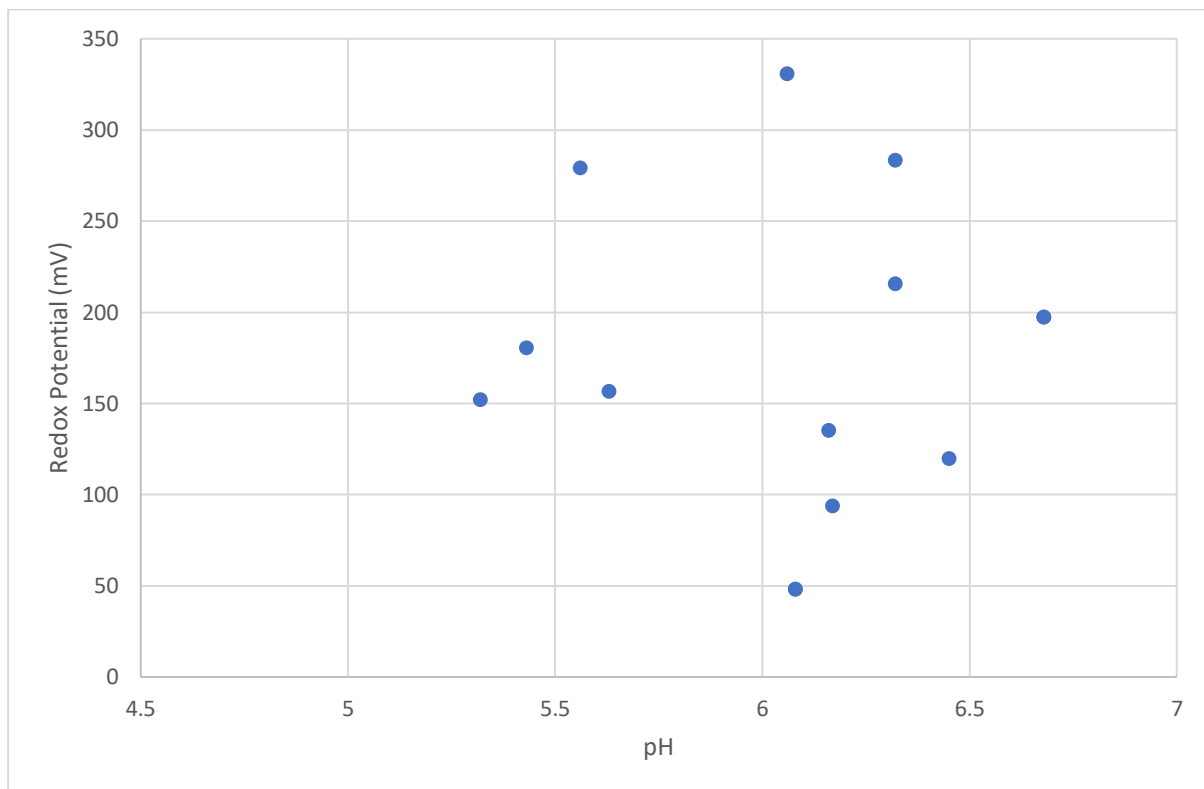
Figure 17: pH versus Redox Potential of Underground Leakage samples

The pH – Redox potential field (Figure 17) shows that the leakage water is slightly acid and oxidised. The oxidation state is similar to the regional samples (Figure 4), however, the pH is lower by about one pH unit. This is consistent with the level of sulphidic content of the mine sequence of rocks, and indicates its acid forming potential.
