LADY LORETTA

## **Z-LLM-HSEC-PLN-Progressive Rehabilitation and Closure Plan**

| Project Name | Lady Loretta Mine |
| Document Title | Z-LLM-HSEC-PLN-Progressive Rehabilitation and Closure Plan |

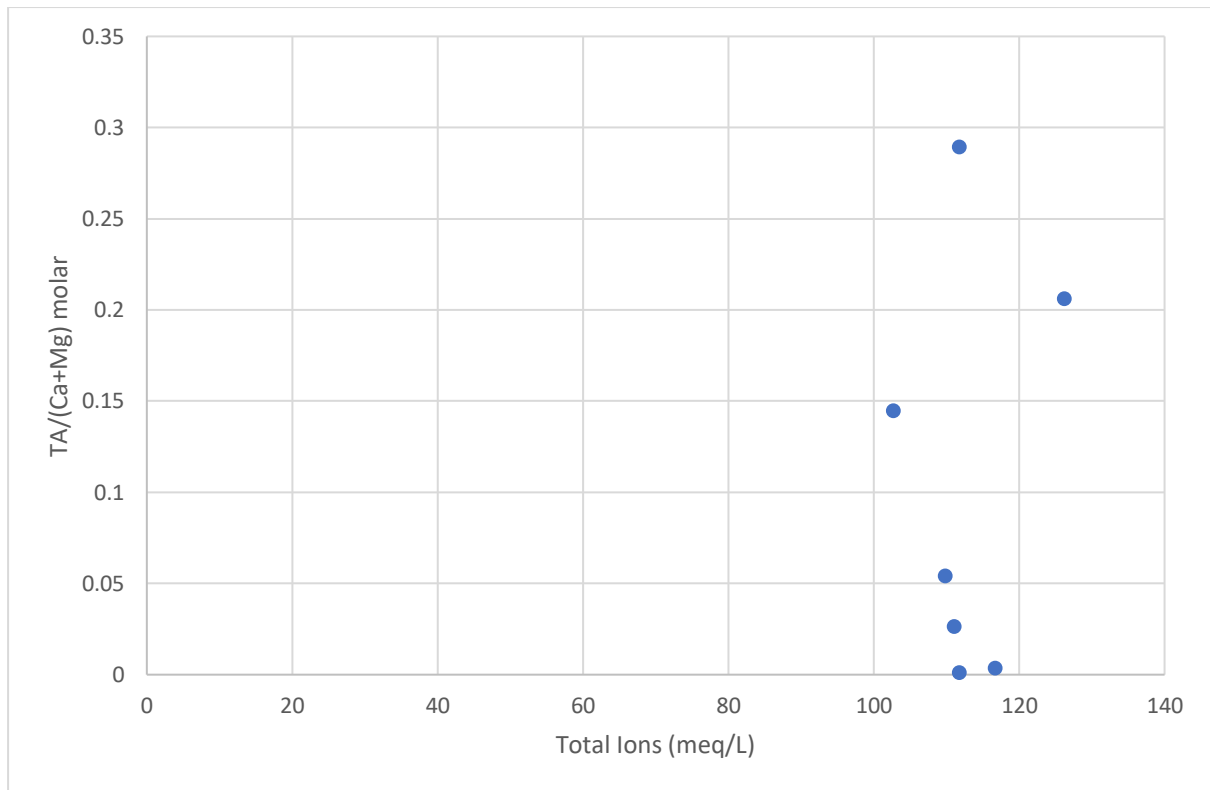
Figure 19: Molar ratio of Total Alkalinity/(Ca plus Mg) versus Total Ions (meq/L) for Underground Leakage samples

The molar ratios of Total Alkalinity to Calcium plus Magnesium ( ) for underground leakage samples are small compared with all other samples and indicates that carbonate dissolution is not a controlling dissolution process close to the mine workings. Concentration of both divalent cations (Calcium and Magnesium) is high when compared to Total Alkalinity. It is unknown at this time what process is responsible for these values.

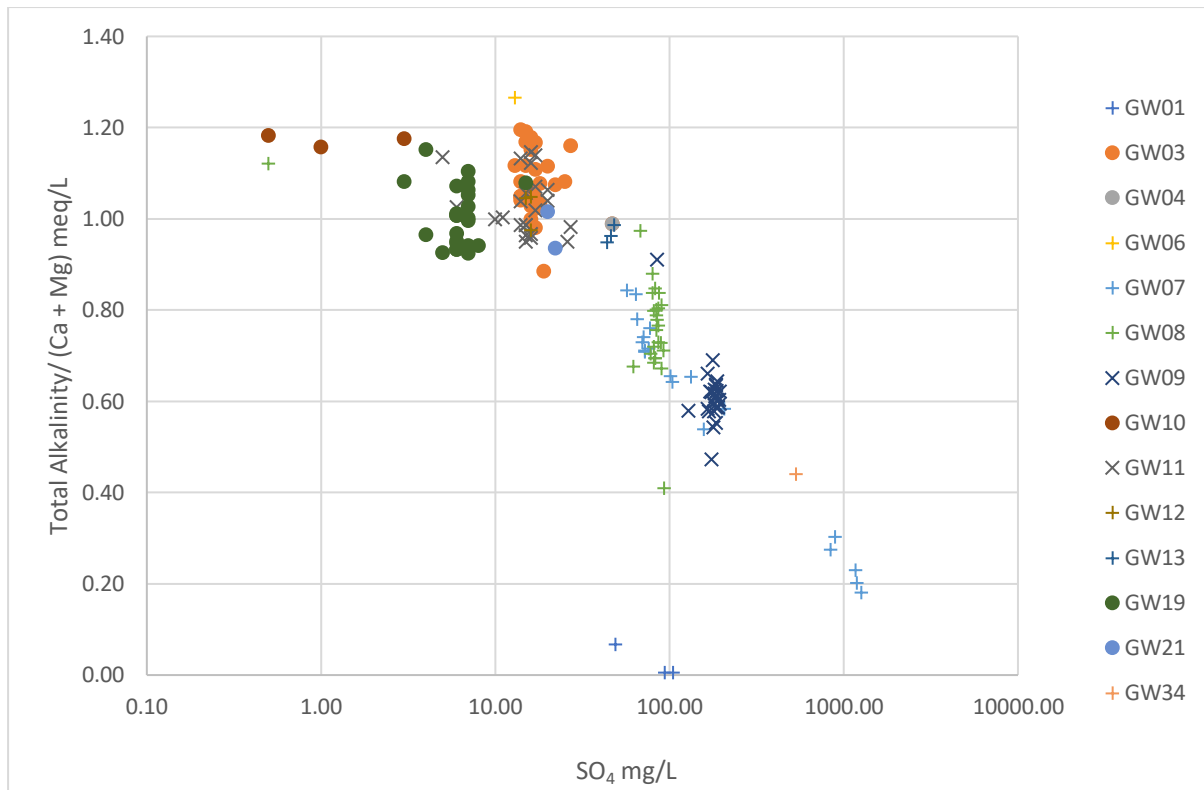
Figure 20: Molar ratio of Total Alkalinity/Ca plus Mg versus Sulphate (mg/L) (+ - Lady Loretta Block, o – Cambrian Block, x – Paleoproterozoic Block) Note the logarithmic scale on the X-axis.

In an effort to further differentiate the groundwaters between Blocks, the molar ratio of Total Alkalinity to Calcium plus Magnesium was plotted against Sulphate (mg/L) (see Figure 20). The plot shows that groundwater from the Cambrian Block has a TA/(Ca+Mg) ratio of around 1, and low Sulphate, whereas groundwater from the Lady Loretta Block has a TA/(Ca+Mg) ratio approaching but never reaching 1, and increasing concentration of Sulphate. Groundwater from GW09 is consistent with the Lady Loretta character, but groundwater from GW11 is consistent with groundwater from the Cambrian Block. Groundwater from bores GW12 and GW13 show a transitional character between the two Blocks.

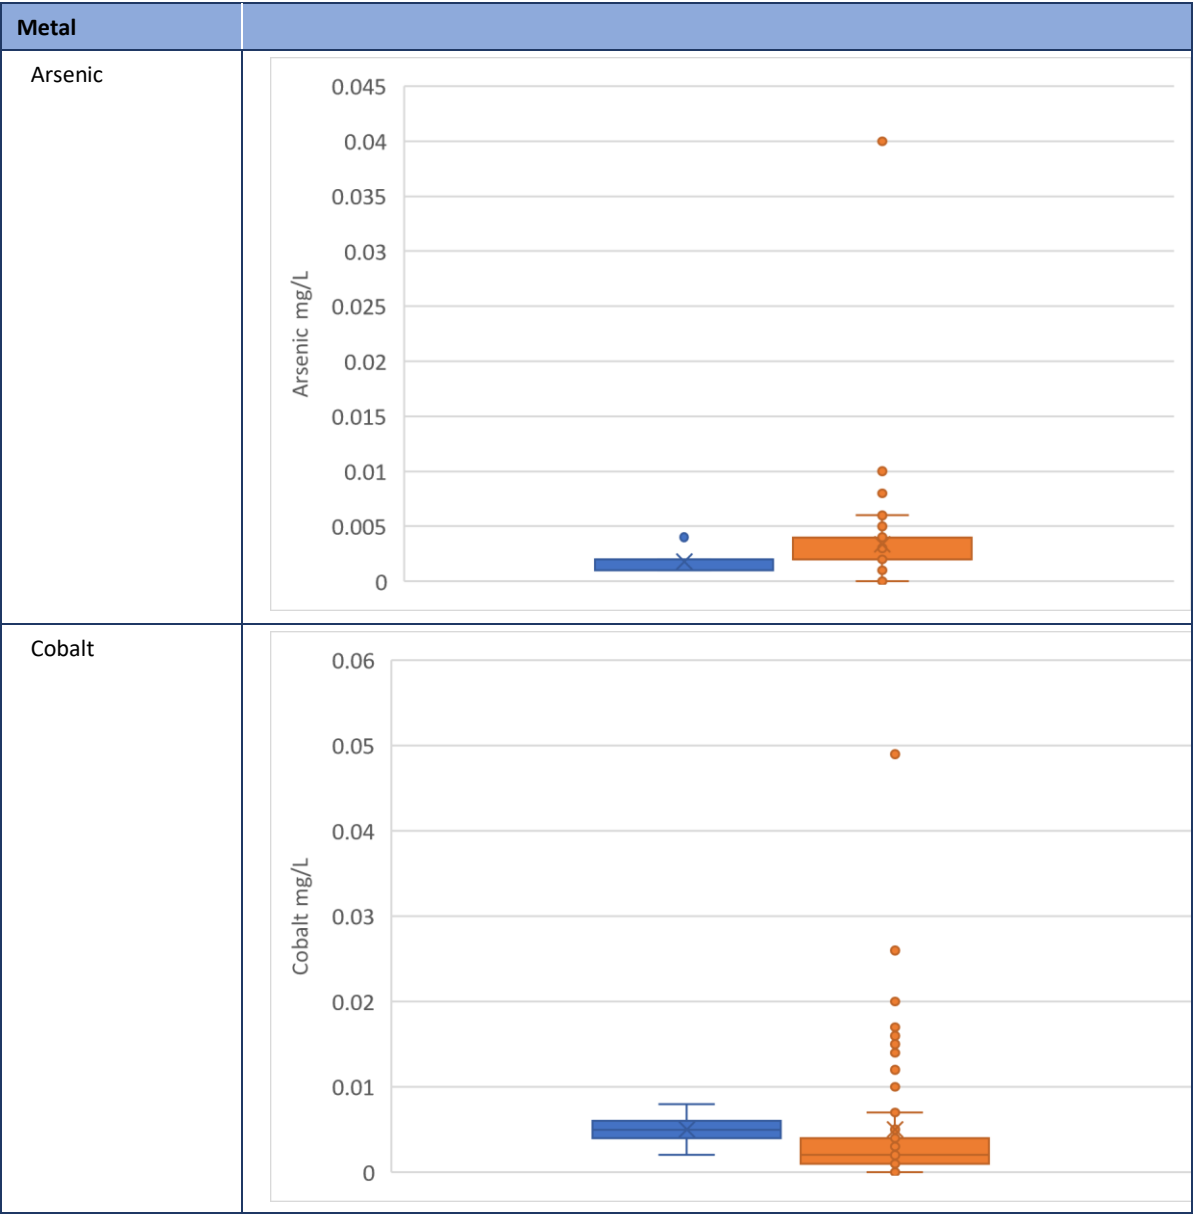
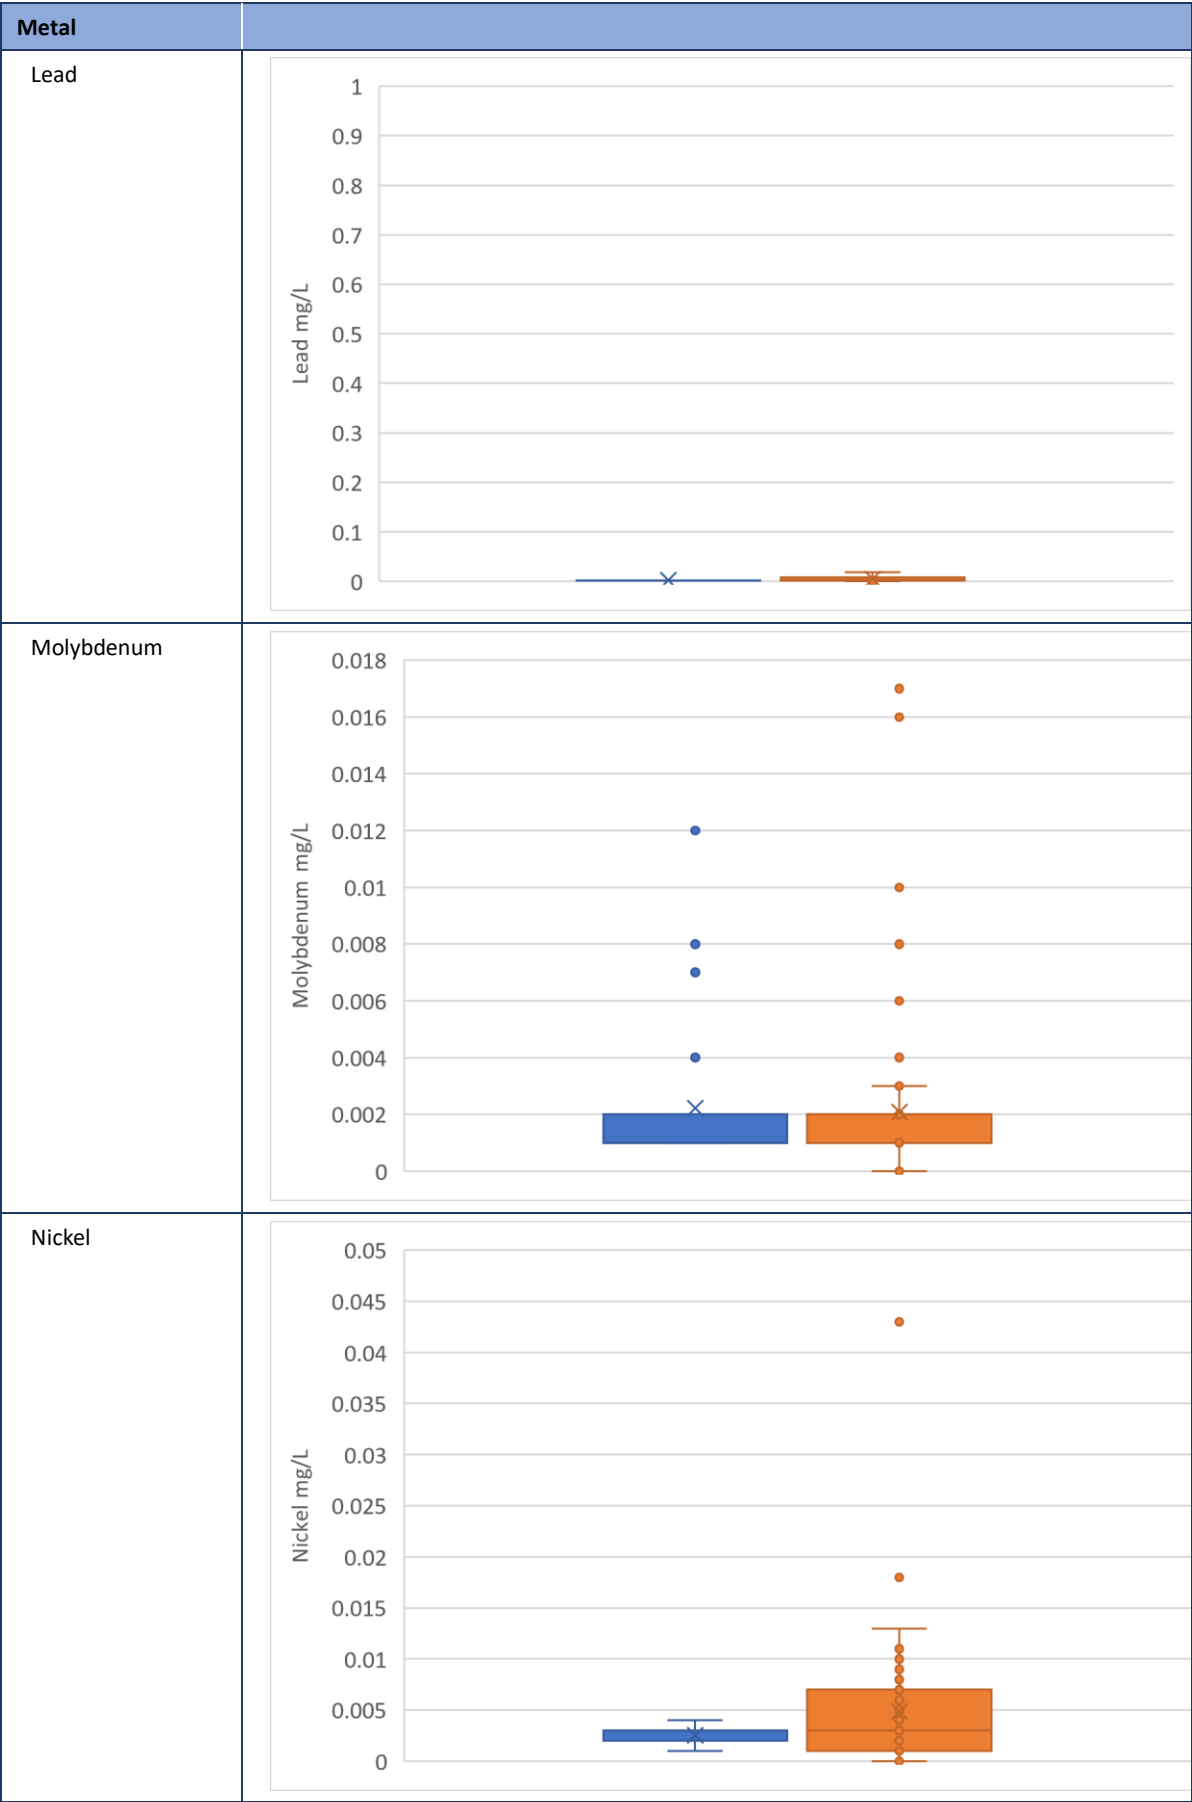
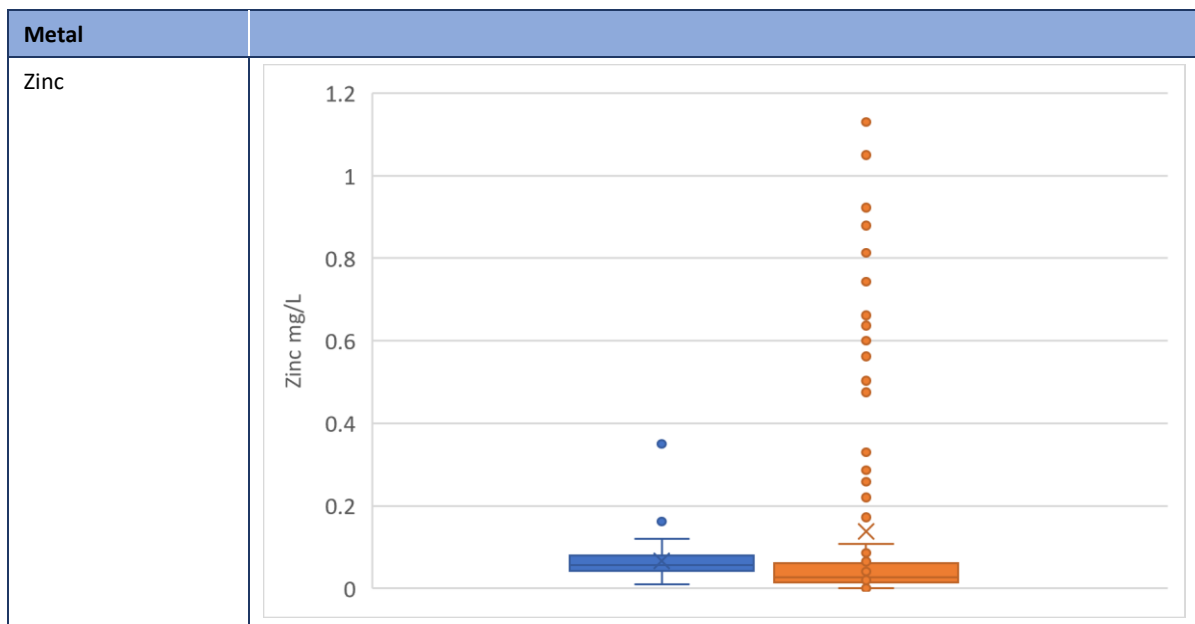
Table 3: Box and Whisker plots for selected dissolved metals for Cambrian Block (blue) and Lady Loretta plus Paleoproterozoic Blocks (orange)

The difference between groundwater sampled from the Cambrian Block and the other two Blocks (Paleoproterozoic and Lady Loretta) is further explored by considering box and whisker plots of dissolved Arsenic, Cobalt, Lead, Molybdenum, Nickel and Zinc (the main elements that have substantial detectable concentrations; Lead has been included as it is a potential CoC; see Table 3).

The plots show that the inter-quartile range (the width of the Box) is similar between the Cambrian and other Blocks. The median values are generally the same, but the means are different. The main difference though is that groundwater samples from the Lady Loretta and Paleoproterozoic Blocks have metal concentrations more likely to be outliers than for the Cambrian Block. That is, the concentration distribution is more likely to be uniform for the Cambrian Block, whereas, a number of samples provide concentrations that are more than the interquartile distance above the mean. This is particularly pronounced for Zinc.

Lead shows very low concentrations for all sampled groundwater.

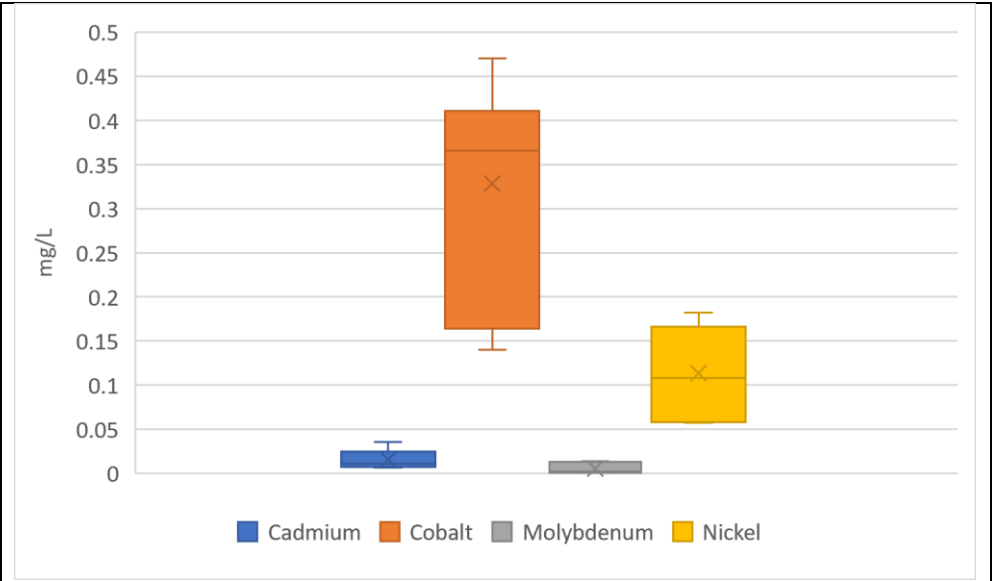
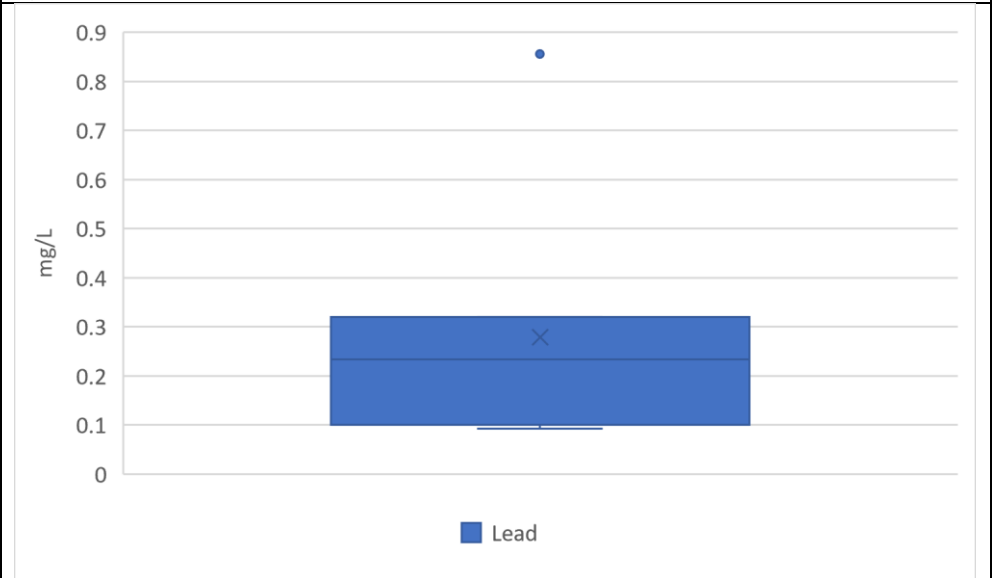
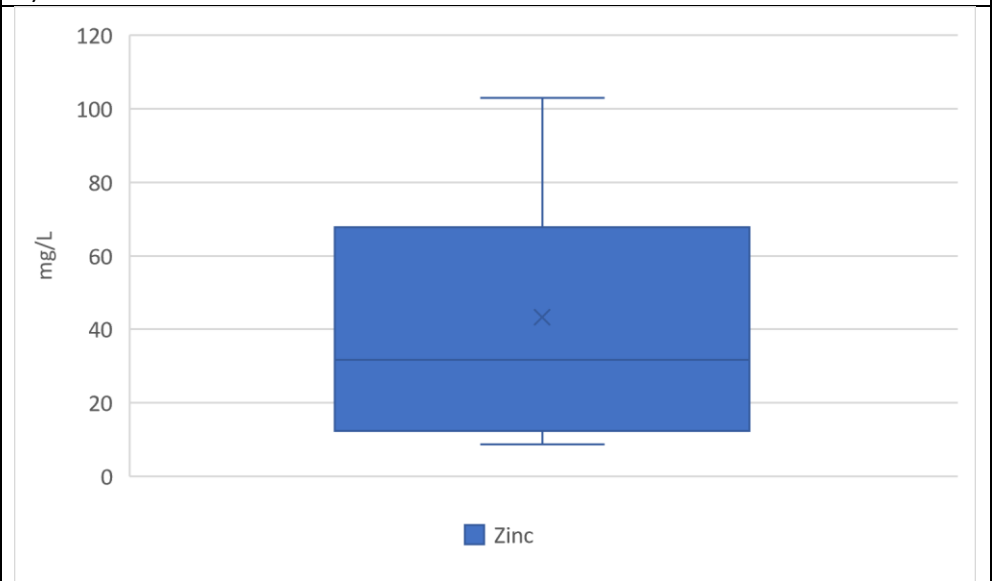
*Figure 21: Box and Whisker Plots for dissolved Metals analysed in Underground Mine Seepage*

Some data (seven samples) is available for groundwater that has egressed into the mine over a seven-month period in late 2019 to early 2020. The metals content of the groundwater is slightly different to that of groundwater from the broader study area. Arsenic, Chromium, Copper and Mercury levels are either very close to or below detection for all samples. Cadmium, Cobalt, Lead, Molybdenum, Nickel and Zinc are above detection limits (Figure 21a, b and c).
