**Geotechnical Investigation  
Residential Subdivision**  
Whitwood Road, Ebbw Vale

Prepared for  
**Chum Street Land Evolution Pty Ltd**  
**Project No. 022-135A**  
15 November 2022

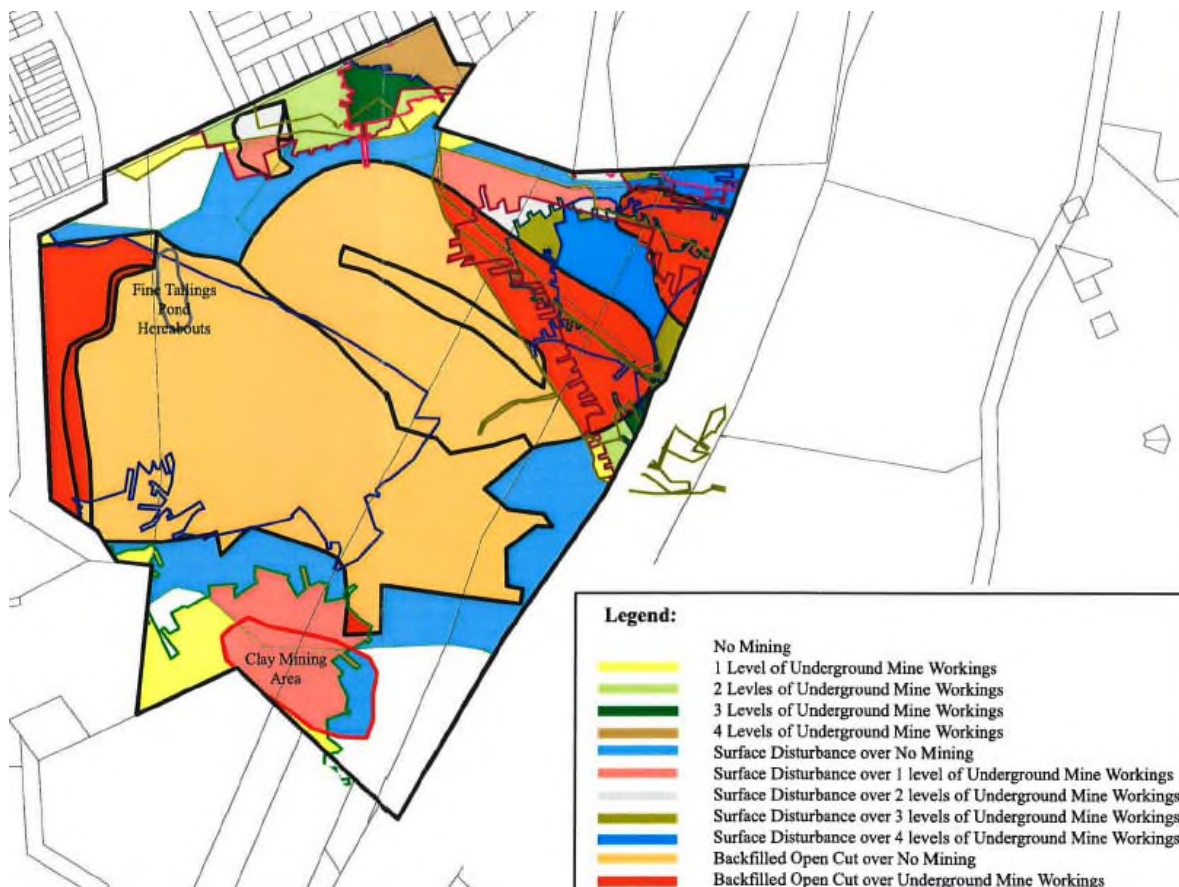
Figure 1: Excerpt from Plan 7 taken from the Moreton Geotechnical Services report

The underground mining was carried out in various seams over a large portion of the site and details are given in the Moreton Geotechnical Services report. The Moreton Geotechnical Services report also notes that past open cut mining activity removed the previous underground mine workings over a significant portion of the site. Figure 1 has been excerpted from *Plan 7* attached to the report and it summarises areas of previous underground mining within the site area, generally around the perimeter of the site.

The reported results from the Moreton Geotechnical Services report have been used in the current assessment of potential impact of past mining activities on the site. It should be noted, however, that the data within the report on the possible location of the various mined coal seams is incomplete.

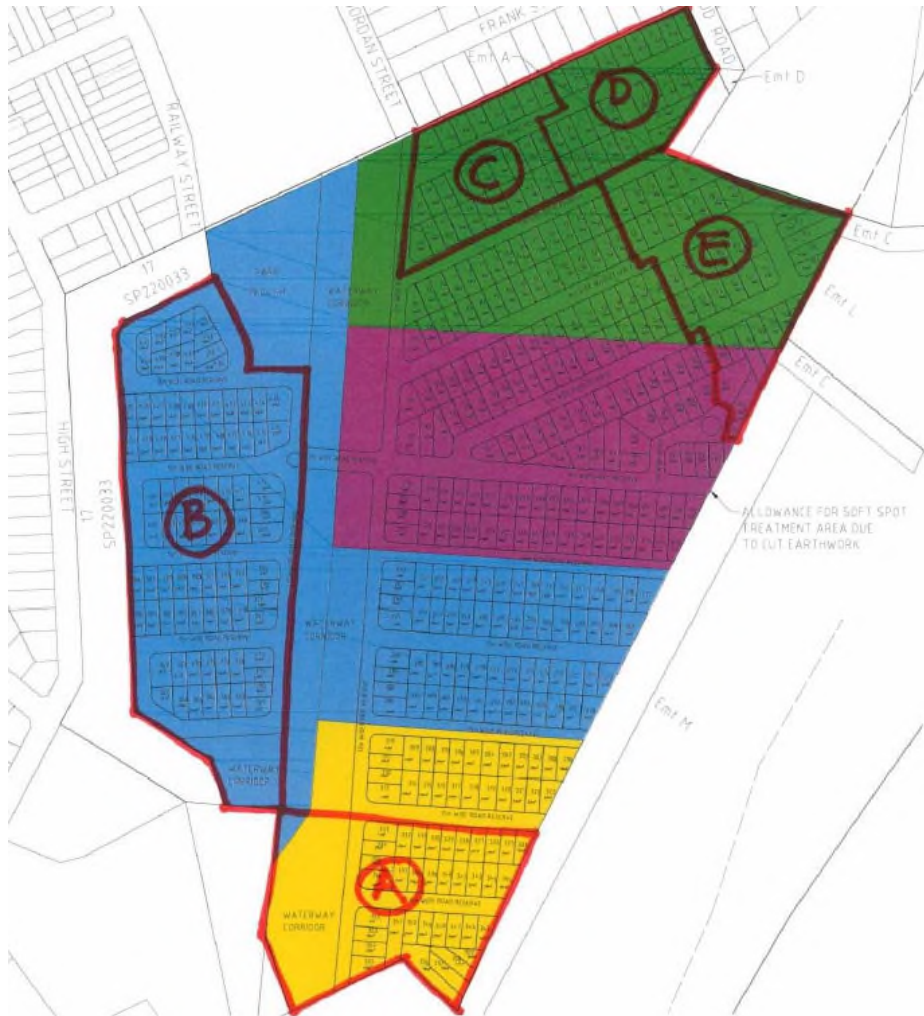
Figure 4: Underground mine workings areas from Moreton Geotechnical Services report

| E | Backfilled open cut and surface disturbance over two levels of underground mine workings in the Four Foot Top Seam and the Four Foot Seam |

It should be recognised that the methodology adopted has some limitations. Firstly, full details of the mining carried out are not and presumably, because the works were carried out between the 1870's and the 1960's, no detailed ground surface observation was normally required and there are therefore no specific field data available to calibrate the currently available subsidence estimation methods. Secondly, the currently used empirical methods mostly deal with the instantaneous response of the ground subsidence observed during the mining operation, rather than 'longer term' subsidence. Published field data sometimes include a delayed response, generally in the order of days and months (but not decades) and very few field data are available for subsidence several decades after the end of mining operations.
