**Geotechnical Assessment**

**Residential Subdivision**

Whitwood Road, Ebbw Vale

**Project No. 022-135A**

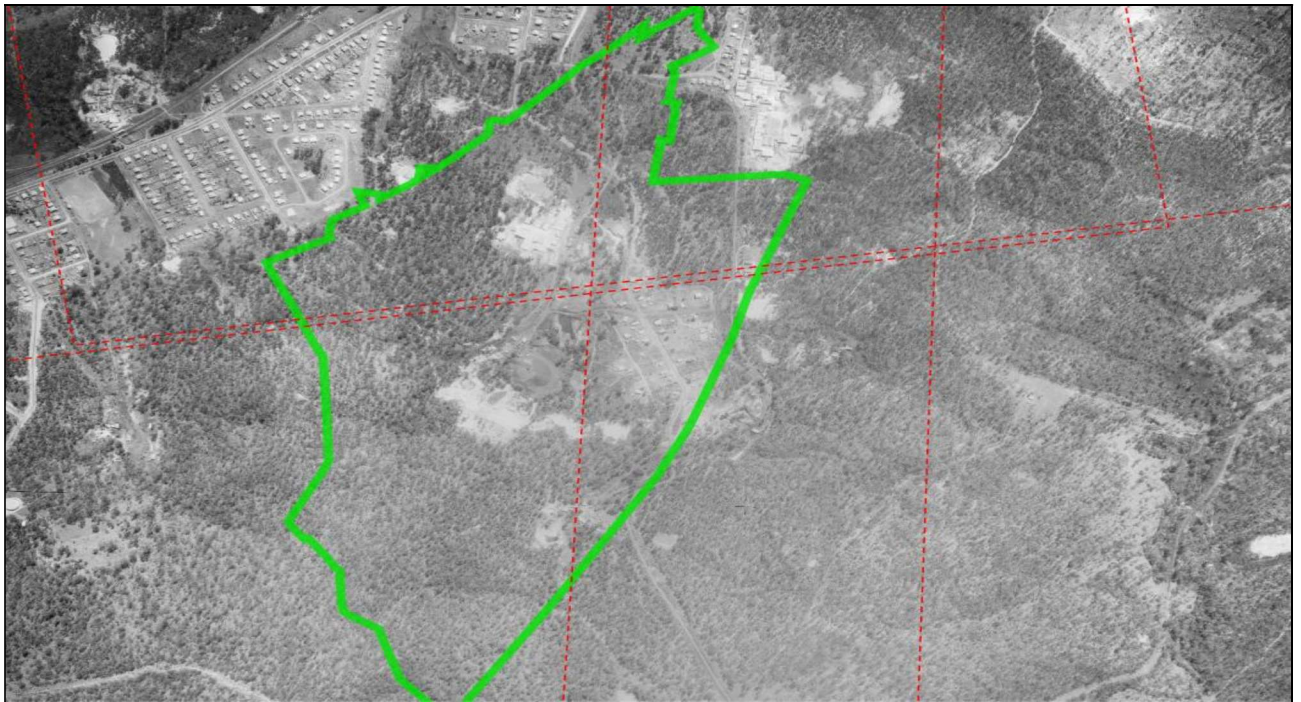
*Photograph 1: Historical aerial photo from 9 September 1960*

A review of historical aerial photographs of the site has indicated that the site showed no evidence of major excavations at the site prior to 1960, and the site was generally undeveloped at the time (refer Photograph 1). In December 1972 (refer Photograph 2) large scale open cut excavations are evident, and the site appears to have been substantially backfilled by February 1986 (refer Photograph 3).

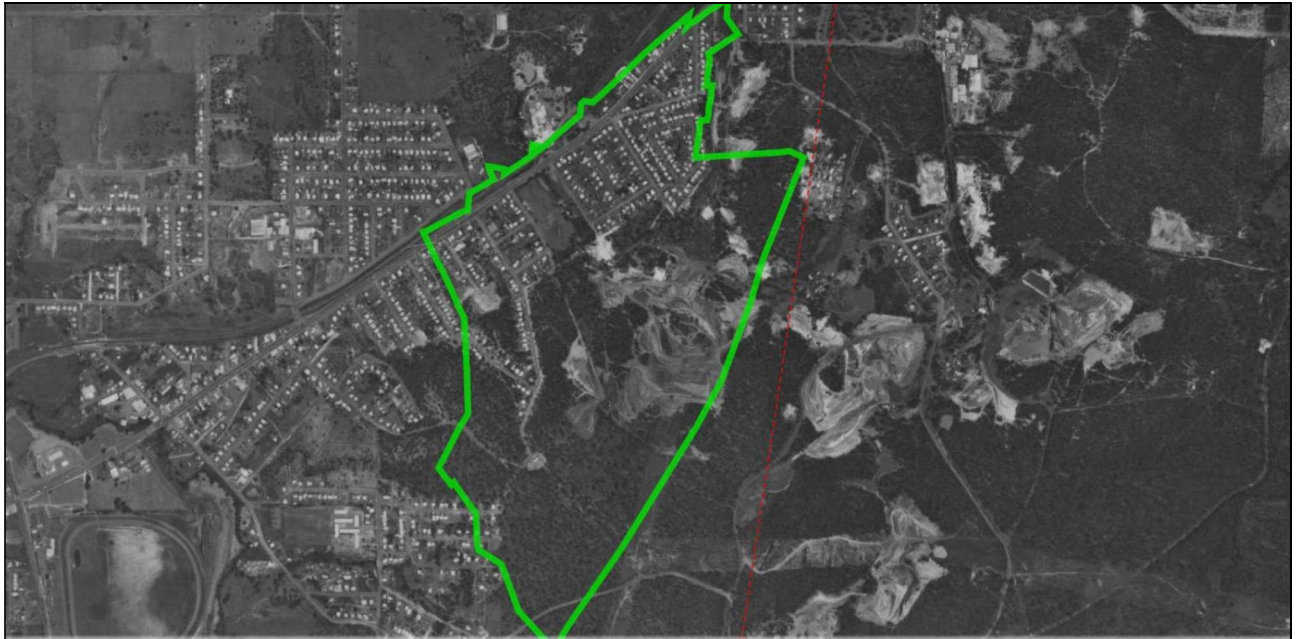
*Photograph 2: Historical aerial photo from 1 December 1972*

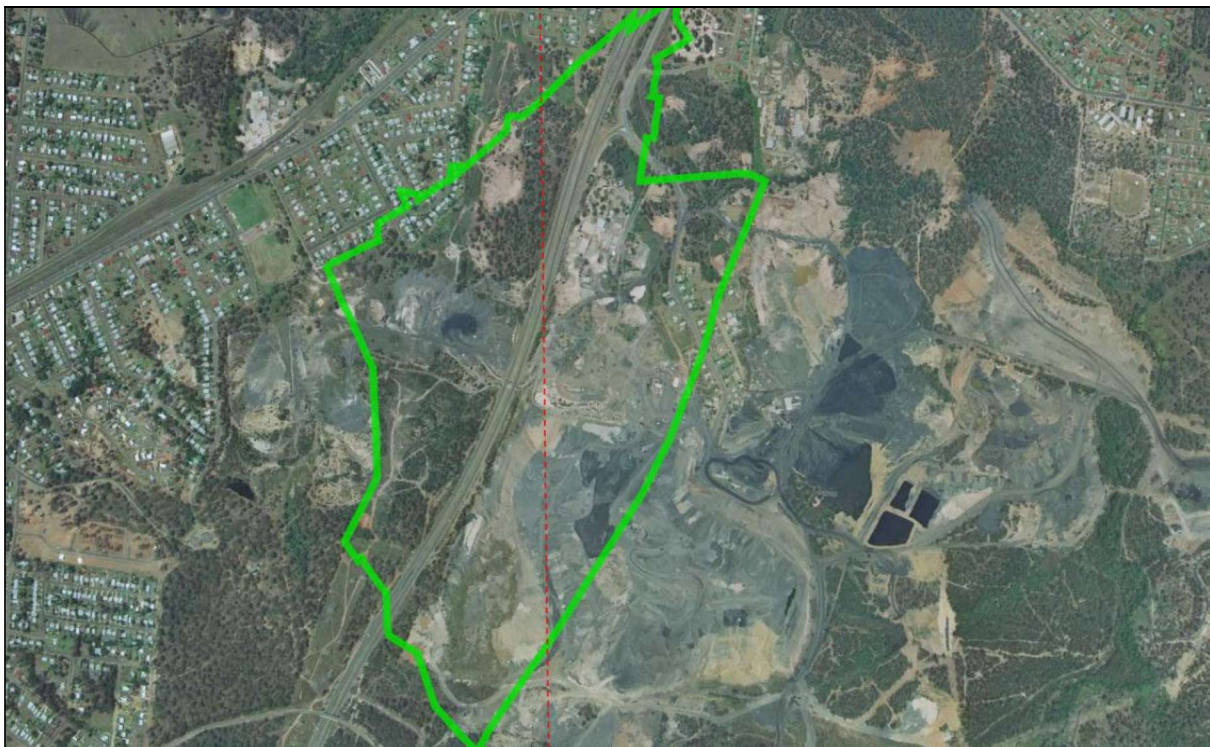
*Photograph 3: Historical aerial photo from 21 February 1986*

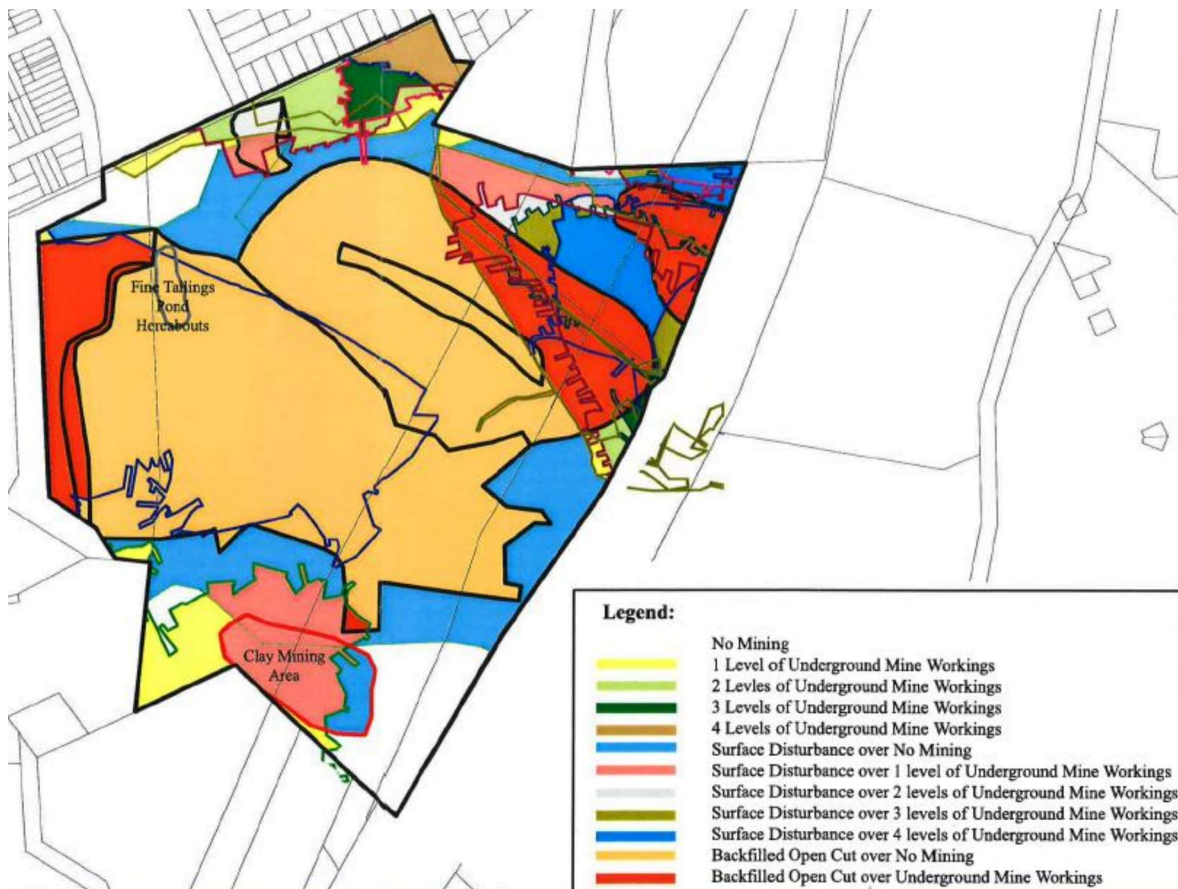
Figure 1: Excerpt from Plan 7 taken from the Moreton Geotechnical Services report

The underground mining was carried out in various seams over a large portion of the site and details are given in the Moreton Geotechnical Services report. The Moreton Geotechnical Services report also notes that past open cut mining activity removed the previous underground mine workings over a significant portion of the site. Figure 1 has been excerpted from *Plan 7* attached to the report and it summarises areas of previous underground mining within the site area, generally around the perimeter of the site.

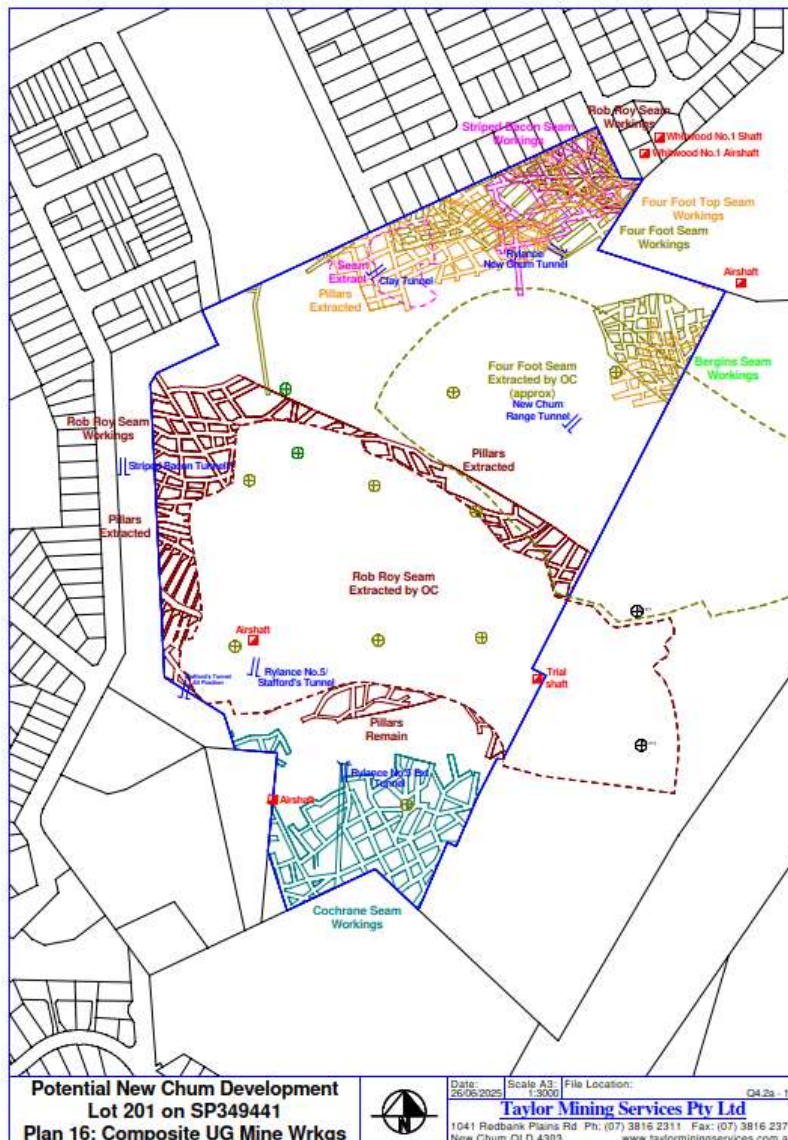
Figure 2: Excerpt from Plan 16 taken from Taylor Mining Services

The TMS report includes details of the historic mining and backfilling activities at the site. Plan 16 from the TMS report (reproduced below as Figure 2) shows a composite view of the remnant underground mine workings and Plan 18 (reproduced below as Figure 3) shows mine constraint zones proposed by TMS.

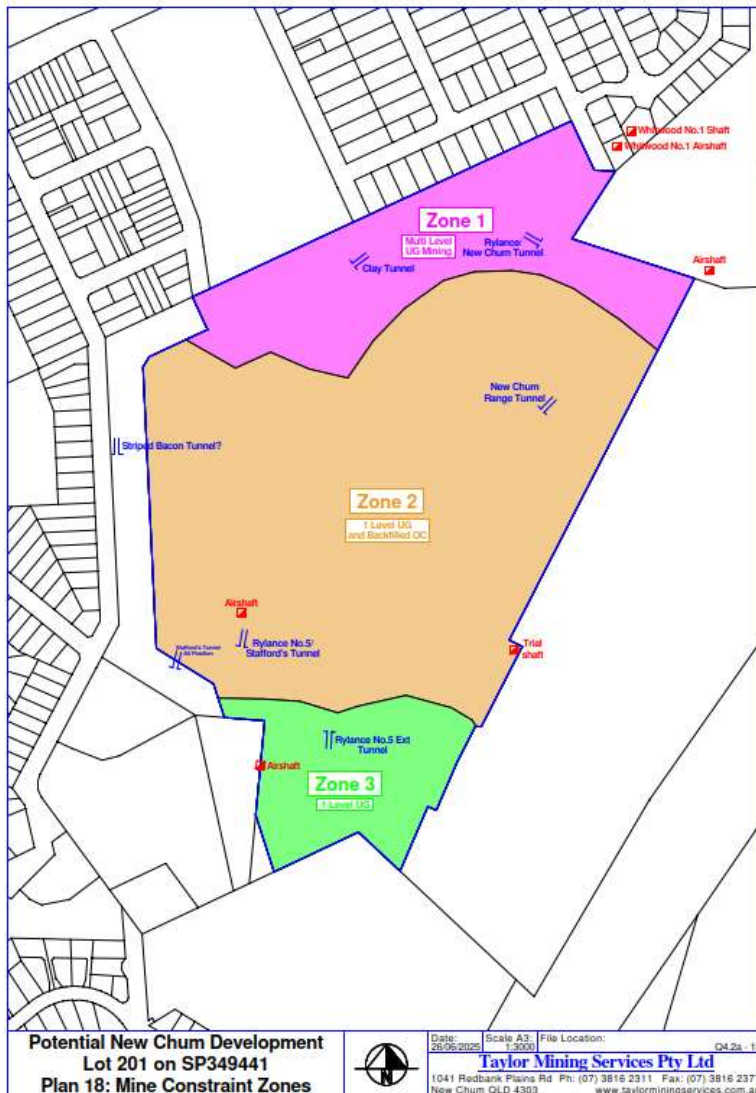
Figure 3: Excerpt from Plan 18 taken from the Taylor Mining Services report

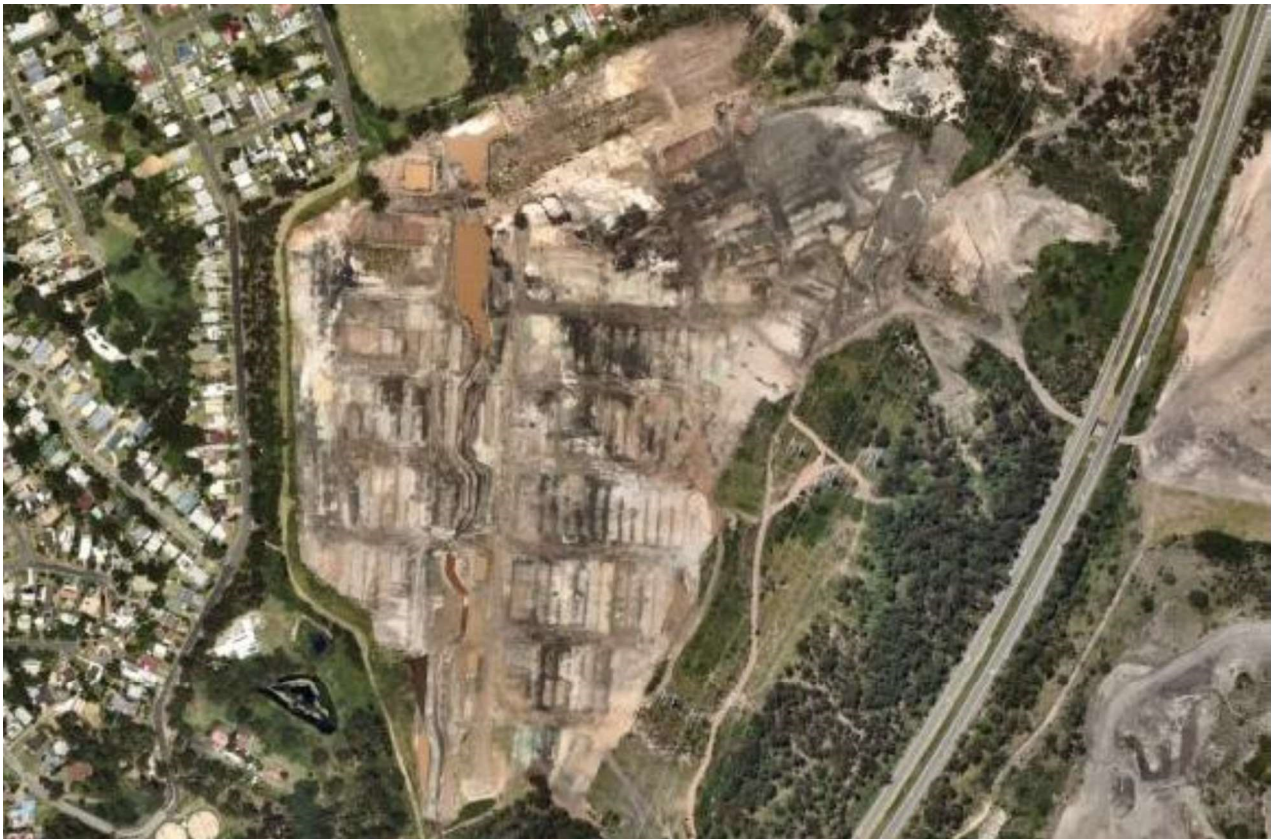
Since Butler Partners geotechnical investigation in November 2022, bulk earthworks drawings were prepared for the site by Bespoke Engineering Solutions Pty Ltd and subsequent bulk earthworks operations have been carried out at the site. An aerial view of the site showing the extents of the site clearing and cut and fill earthworks is given in Photograph 6.

*Photograph 6: Aerial view of the site looking (Nearmap – December 2024)*

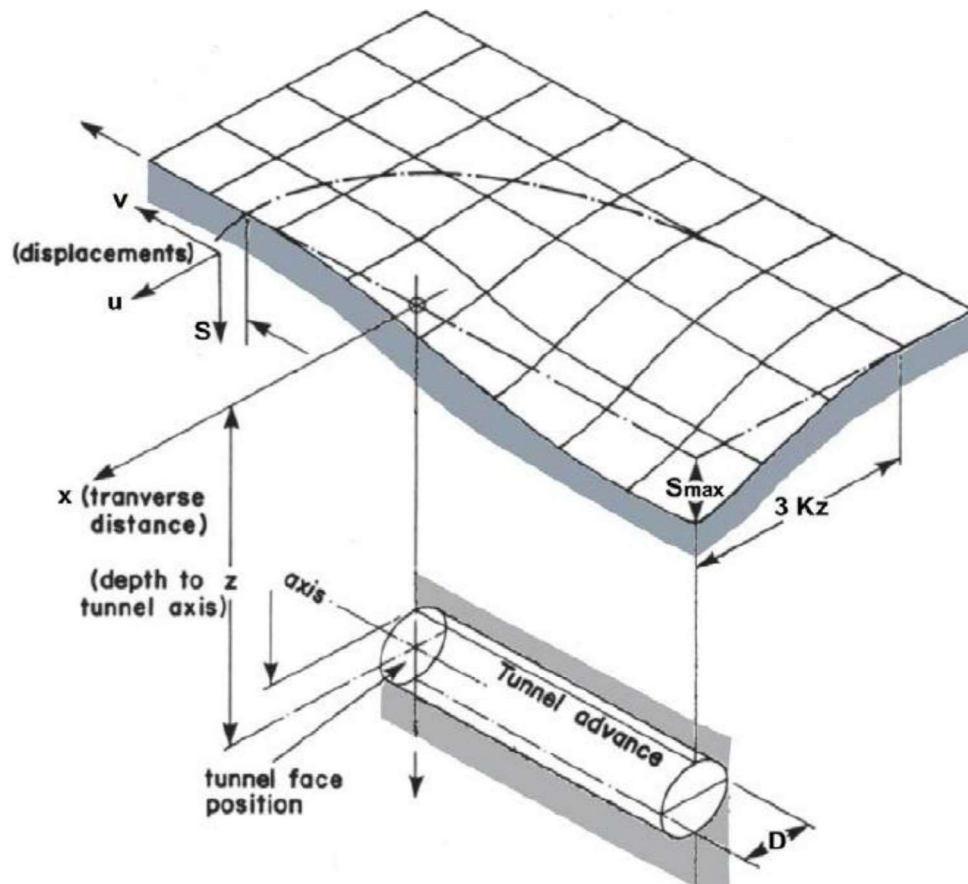
Figure 4 shows the general case of an advancing tunnel with its axis at depth below ground level. Collapse of the tunnel results in ground settlements with a settlement trough developing above and ahead of the tunnel.

Figure 4: Settlement trough above a tunnel (Attewell et al, 1986)

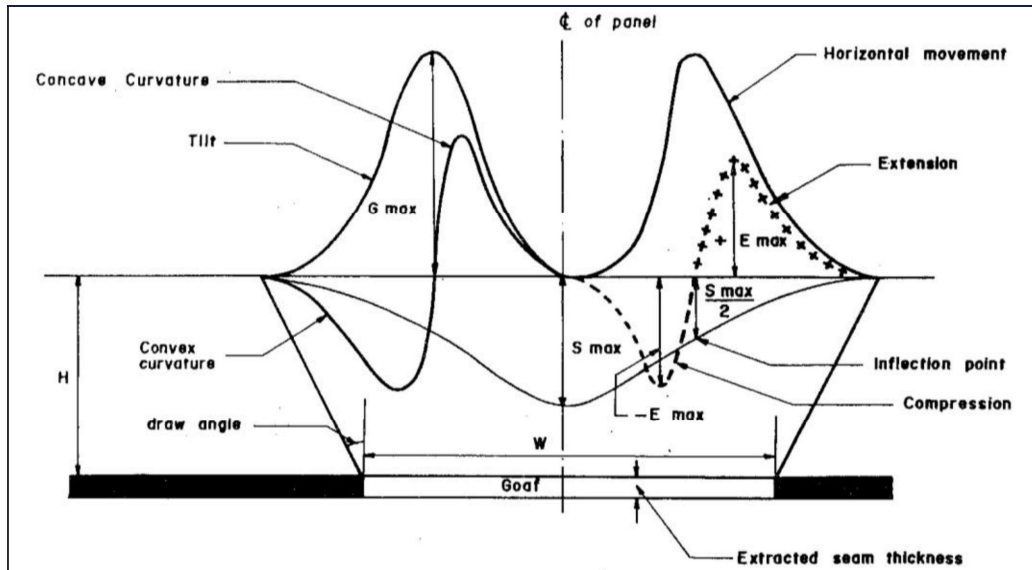
The subsidence parameters significant to the estimation of potential structural damage to overlying residences, include the vertical displacement, tilt, horizontal ground strain and curvature of the ground surface. Their relationship for a single longwall panel is shown in Figure 5.

Figure 5: Relationship between different subsidence parameters (Waddington 2009)

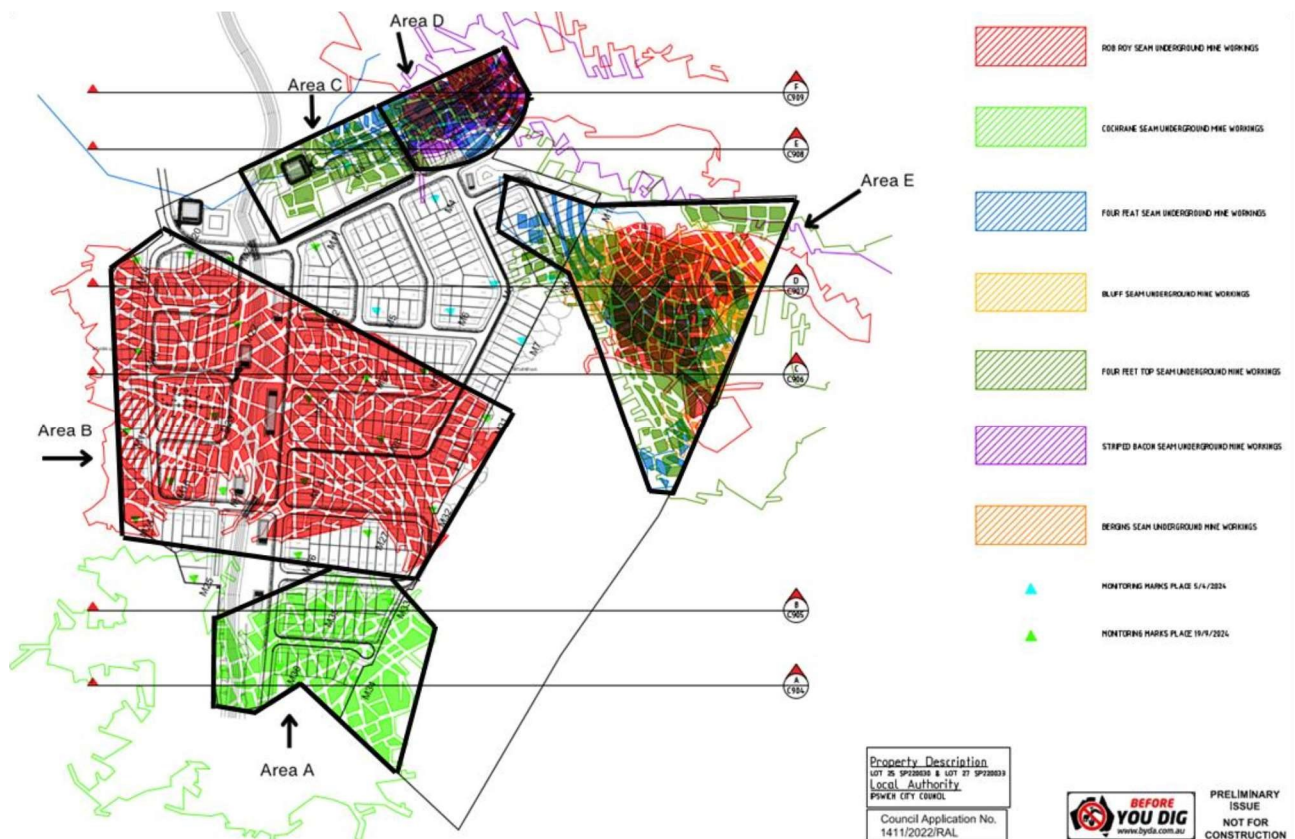
Figure 6: Underground mine workings areas from Bespoke Engineering drawings

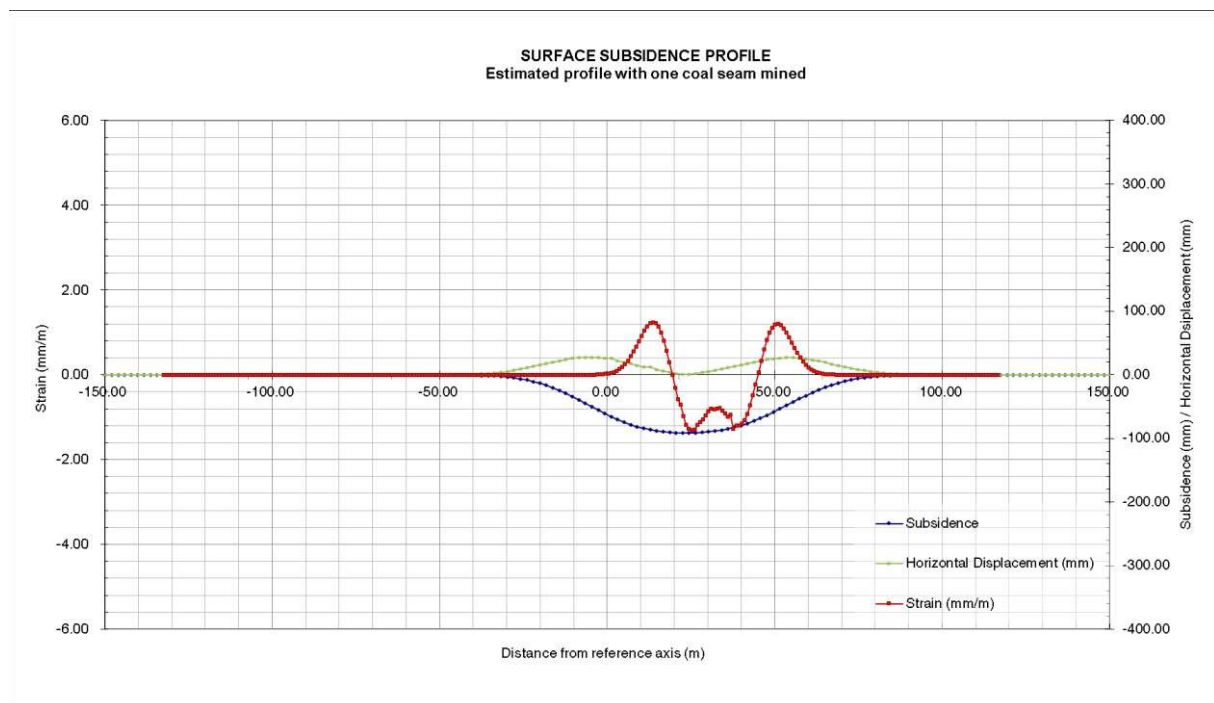
*Figure 7: Subsidence profile for continued collapse of a single level of workings with 20m cover*

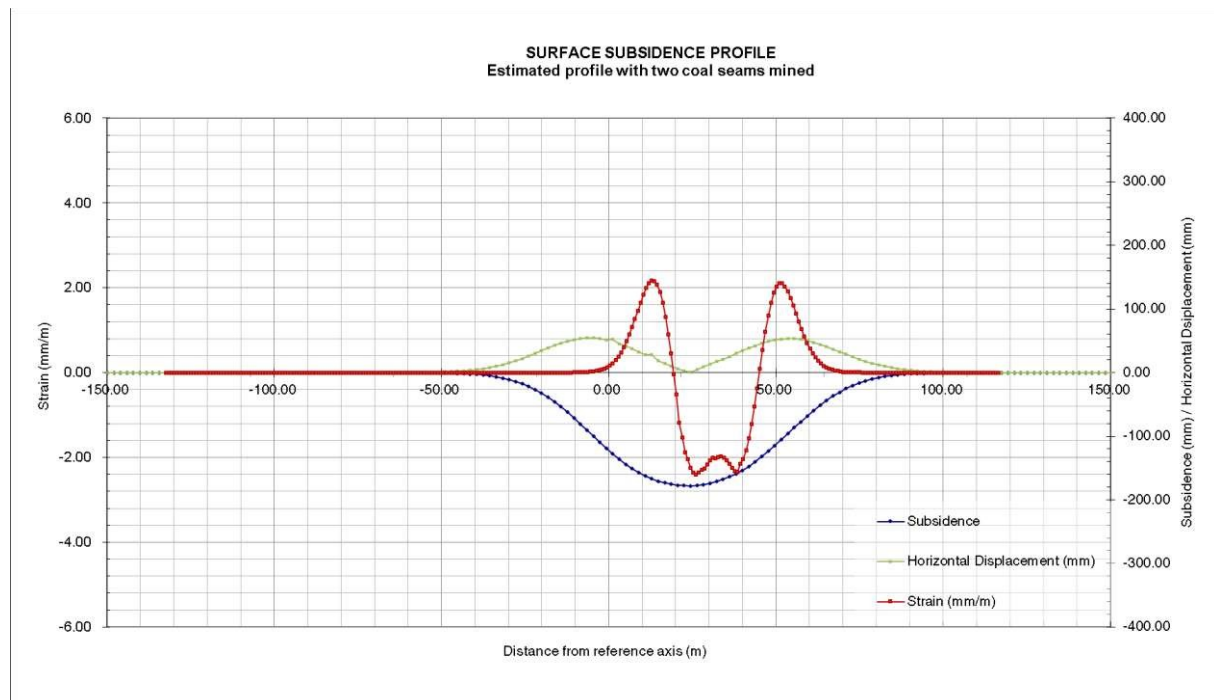
Figure 8: Subsidence profile for continued collapse of two levels of workings with 20m cover

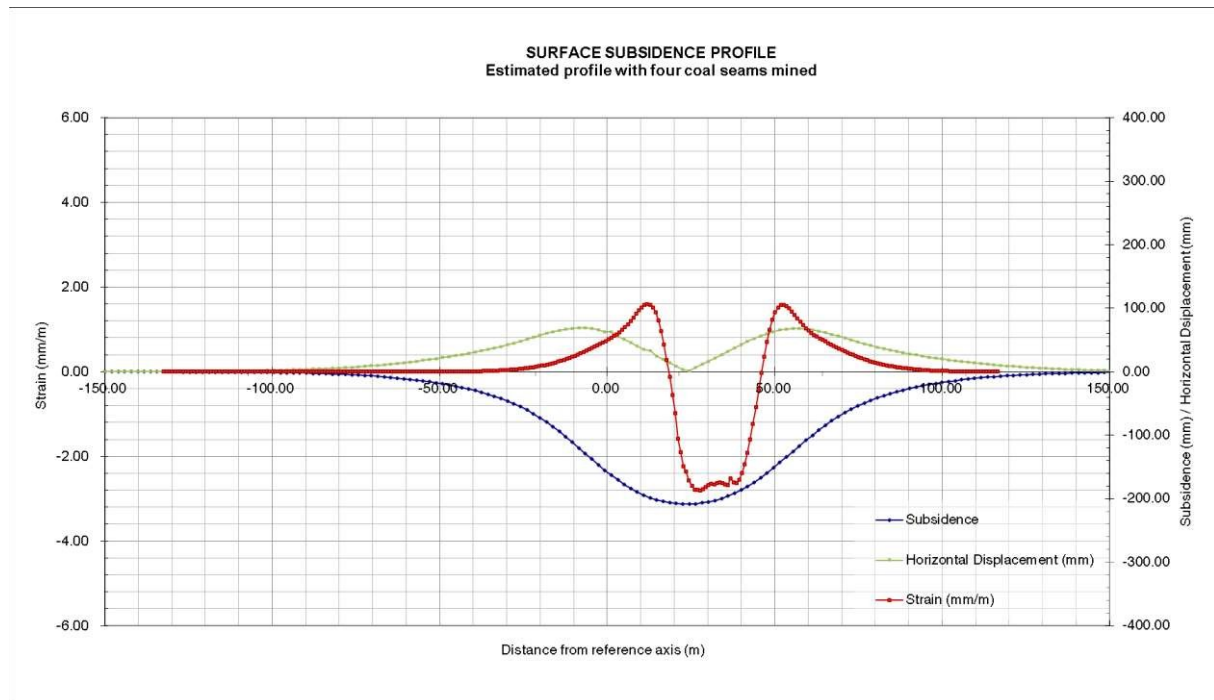
Figure 9: Subsidence profile for continued collapse of four levels of workings with 20m cover

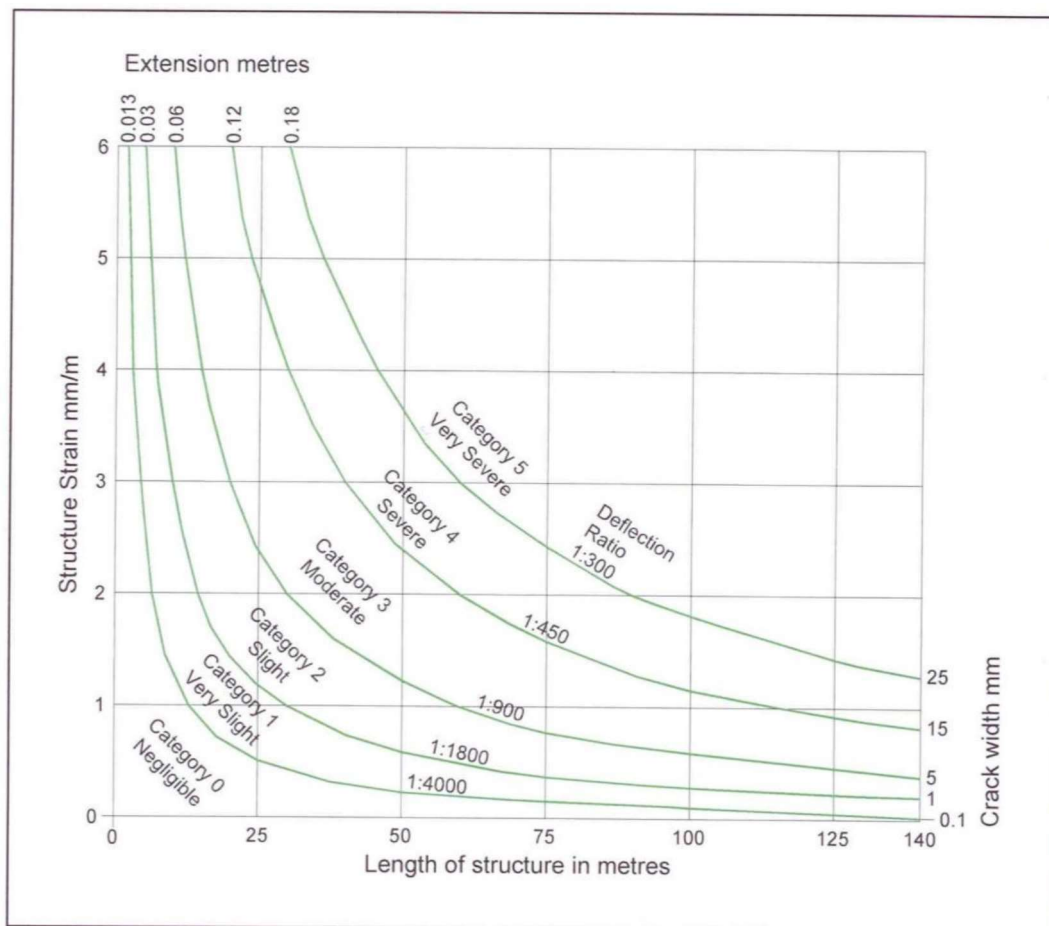
The National Coal Board of the United Kingdom has published a method (reproduced in Figure 10) to assess the potential impacts of mining on structures and this method relates the level of ground strain and the length of the building to the potential level of damage. The damage categories noted in Figure 10 are those described in Table 5.

Figure 10: Damage classification based on horizontal ground strain and building length for two storey brick structures

It is important to note that not all of the calculated ground surface strains will be transferred to the structure. Where flat slabs are adopted and are cast over bedding sand and a damp proof membrane, then significantly less ground strain will be transferred to the structure compared to a structure founded on a series of parallel strip footings running perpendicular to the predicted ground strain direction. Past experience in the NSW coalfields (Waddington 2009) has suggested that possibly as little as 25% of the ground strain gets transferred to the structure for a typical slab on ground construction.

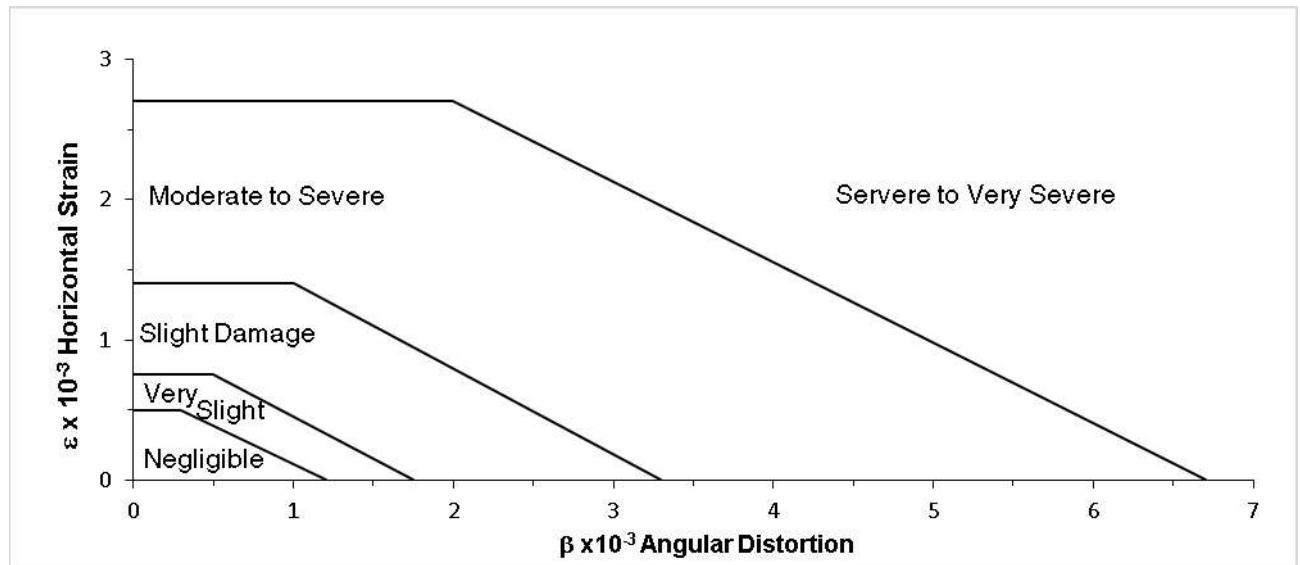
As well as the tensile and compressive ground strains, the subsidence profile includes an angular distortion and typical damage criteria based on the combination of angular distortion and tensile strain that needs to be considered in structural design. As a guide to the performance of structures under the combined effects of angular distortion and ground strain, for masonry load bearing wall structures on a conventional foundation that is undermined, the damage categories presented in Figure 11 could be adopted.

Figure 11: Damage Criteria for Masonry Bearing Wall Structures

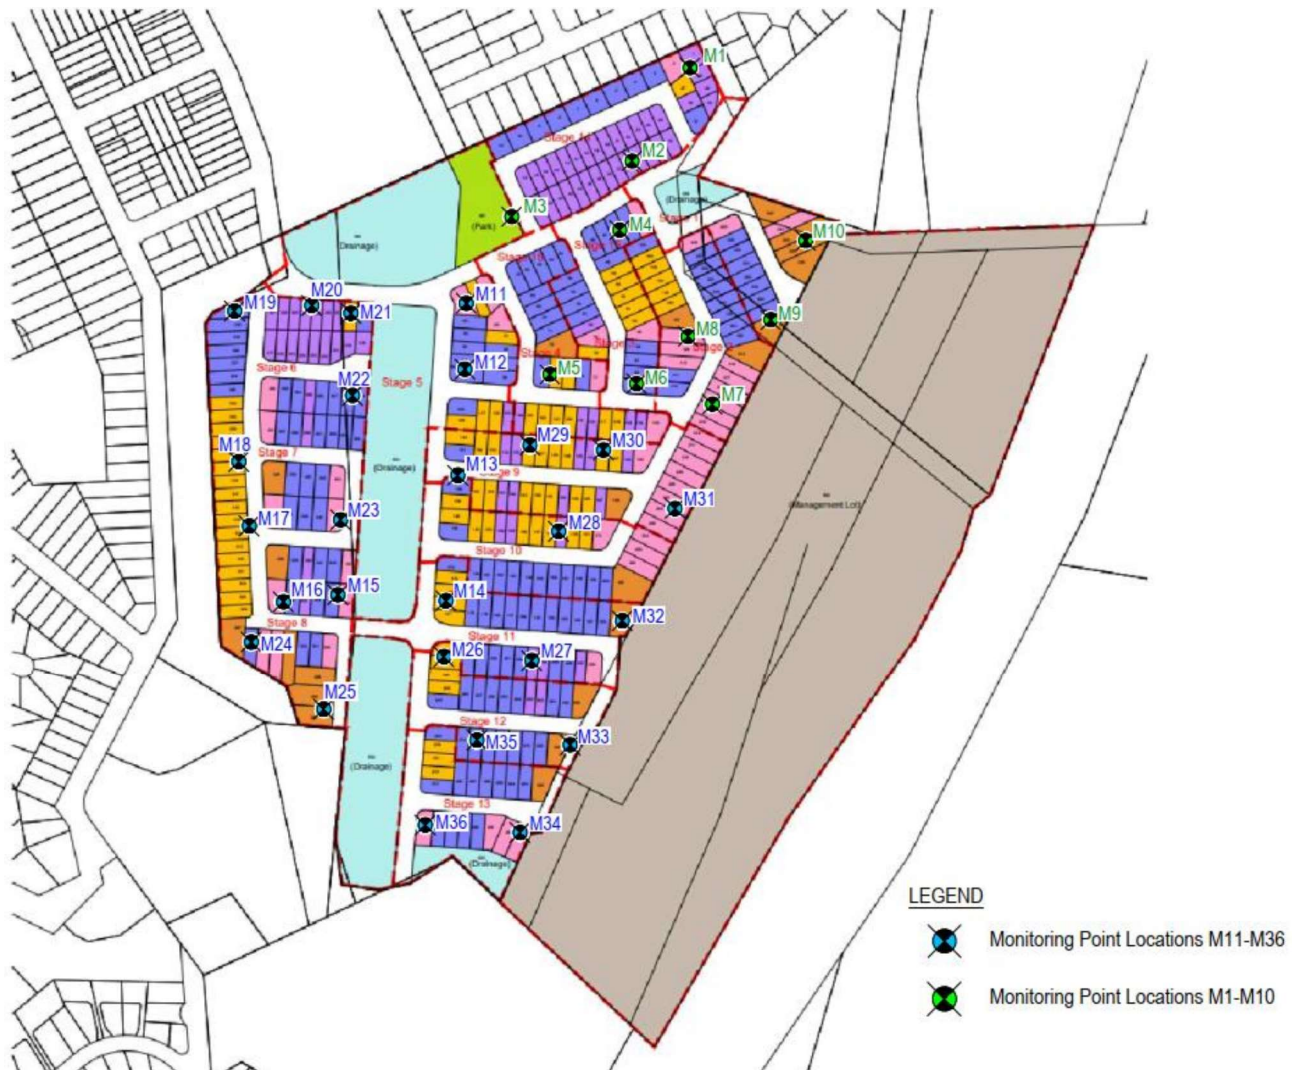
In order to confirm reduced settlement occurrence following site earthworks, consulting surveyors Bennett and Bennett Pty Ltd (Bennett & Bennett) and Gold Coast Surveys Pty Ltd (GCS) have carried out settlement monitoring at the locations indicted in Figure 12.

Figure 12: Monitoring point locations

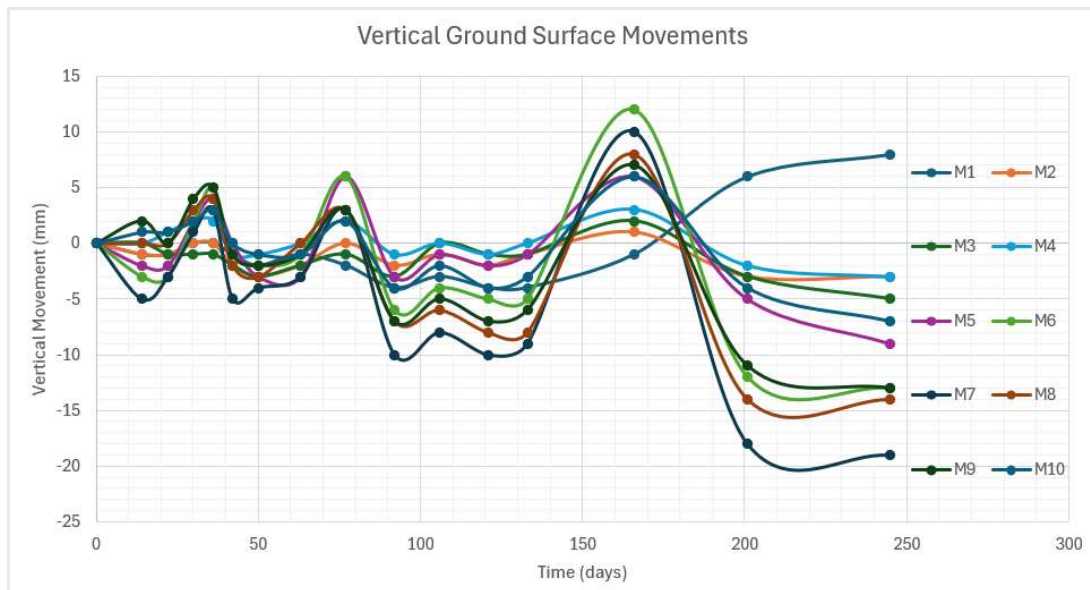
Figure 13: Blue Monitoring Points M1 to M10 – vertical movements over the monitoring period

Settlement results for monitoring points M1 to M10 appear to indicate that the vertical movements that have occurred at the monitoring locations, whether they are in areas of cut or areas of fill, are indicating areas of upwards and downwards movement with oscillations in both directions evident at the majority of the locations. These results appear to be indicating that ground surface movements at the monitoring locations are being governed by reactive soil movements. That is they are swelling and moving upwards when wet and shrinking and moving downwards when dry.

The upwards movement that was recorded for several of the monitoring points on 4 November 2024 (day 166) seems to be against trend for several of the monitoring points. It therefore seems reasonable to conclude that the vertical ground surface movements are a results of reactive ground surface movements and that there has not been underlying significant settlements occurring over the monitoring period.

For each of the groups of settlement monitoring points, a plot of vertical deflection against time is given in Figure 13 and Figure 14.

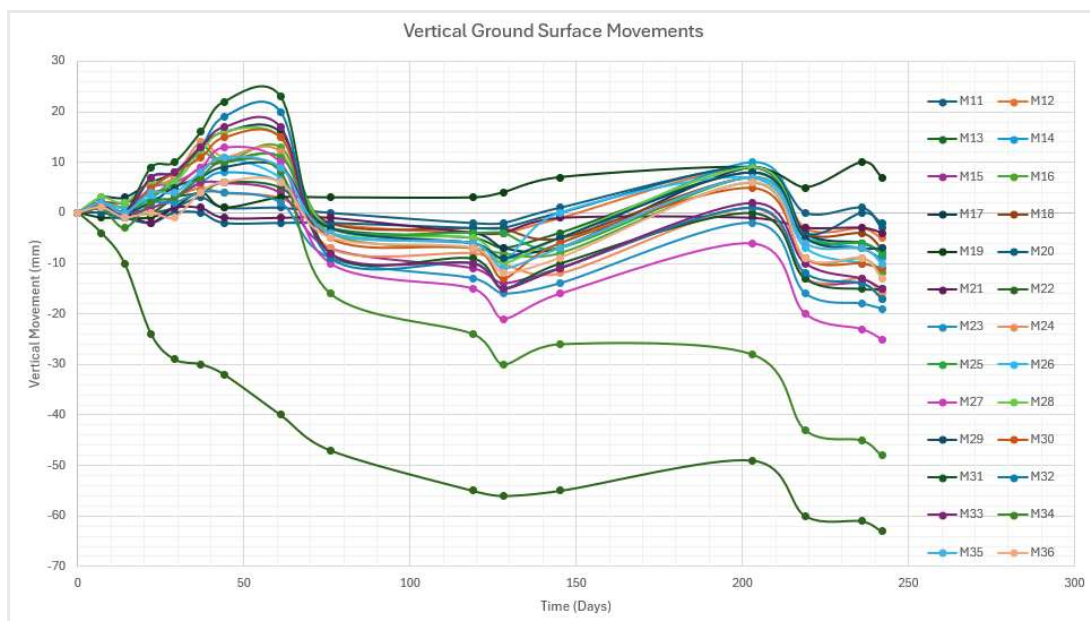
Figure 14: Monitoring Points 11 to 36 – vertical movements over the monitoring period

There appears to be a reversal in the data on two occasions with upwards movement being recorded. For example, at day 203 most locations recorded a reading of at least 5mm to 8mm against the gradual settlement trend measured in the prior three measurements. These readings are potentially due to reactive soil behaviour, as Ebbw Vale was subject to approximately 343mm of rain in the period immediately before day 203 (i.e. throughout March 2025). The ground has returned to a trend of gradual settlement between the measurements taken on day 219 and day 242 of monitoring.

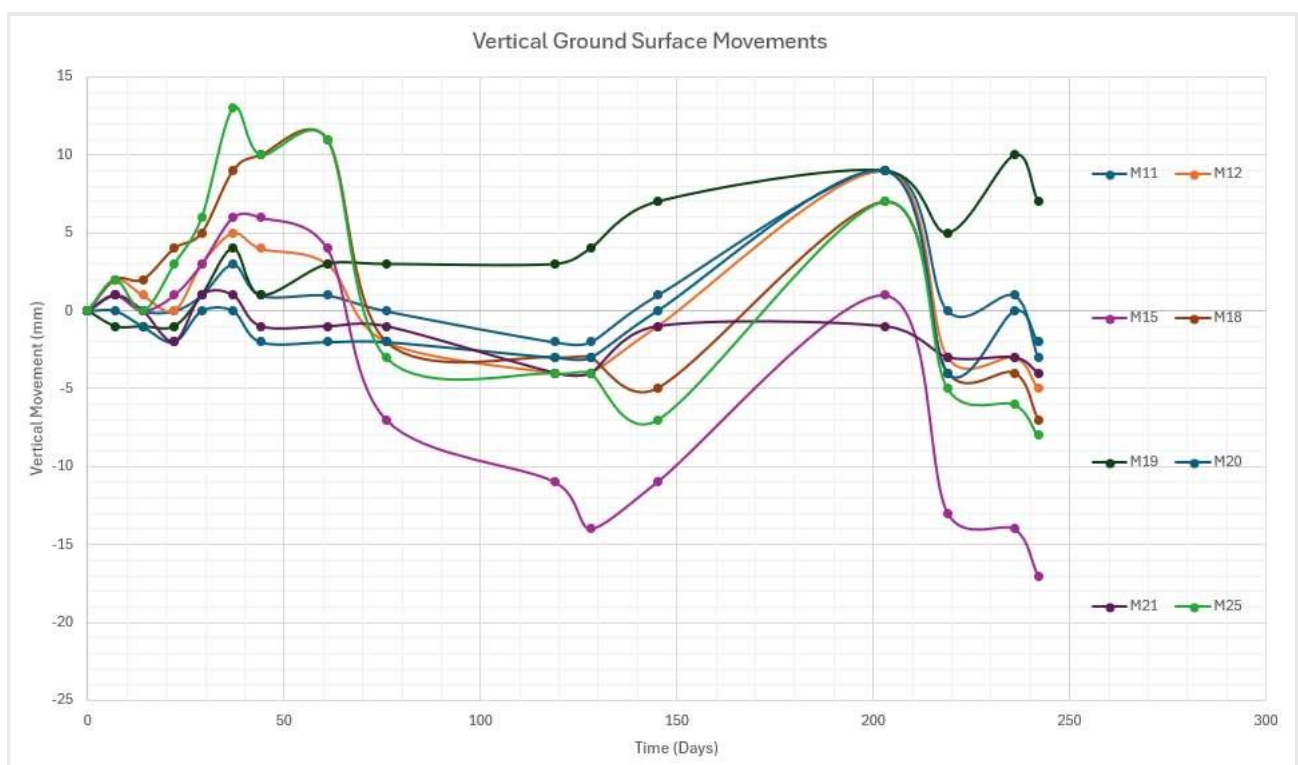
Also, for the monitoring points M11 to M36 there appeared to be groups of monitoring points that appear to be showing some different behaviours. Figure 15 shows a group of monitoring points that appear to show reactive soil behaviour with little indication of significant settlement magnitude.

Figure 15: Monitoring Points 11 to 36 – possibly reactive soil dominated vertical movements

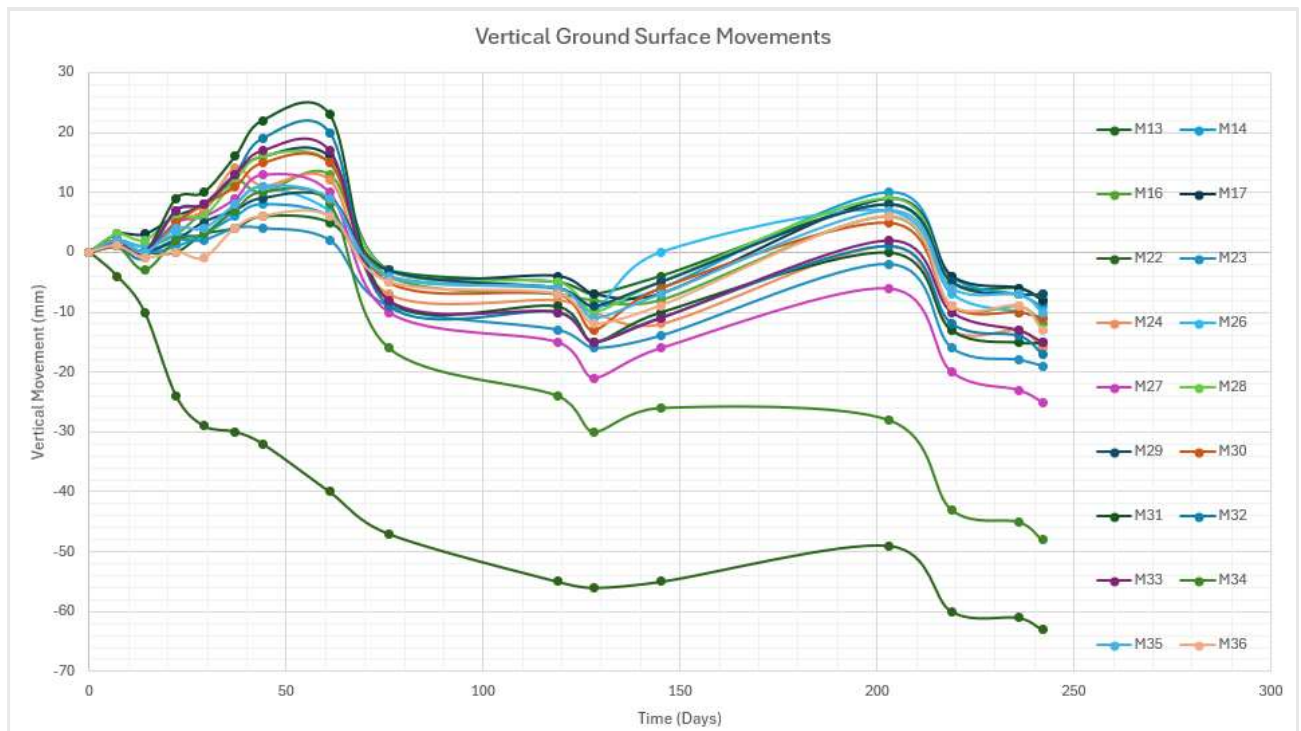
Figure 16 shows a group of monitoring points that have all trended downwards more consistently. Of the settlement monitoring points shown in Figure 16, monitoring points M22, M23, M27 and M33 appear to be indicating an ongoing downwards trend that is most prominent in monitoring points M22 (total downwards movement of 63mm) and M33 (total downwards movement of 48mm) with M22 showing a uniformly downwards movement trend. The other monitoring points in the group are all indicating change in vertical movement since 10 December 2024 of less than 25mm.

Figure 16: Monitoring Points 13 to 36 – monitoring points possibly showing settlement

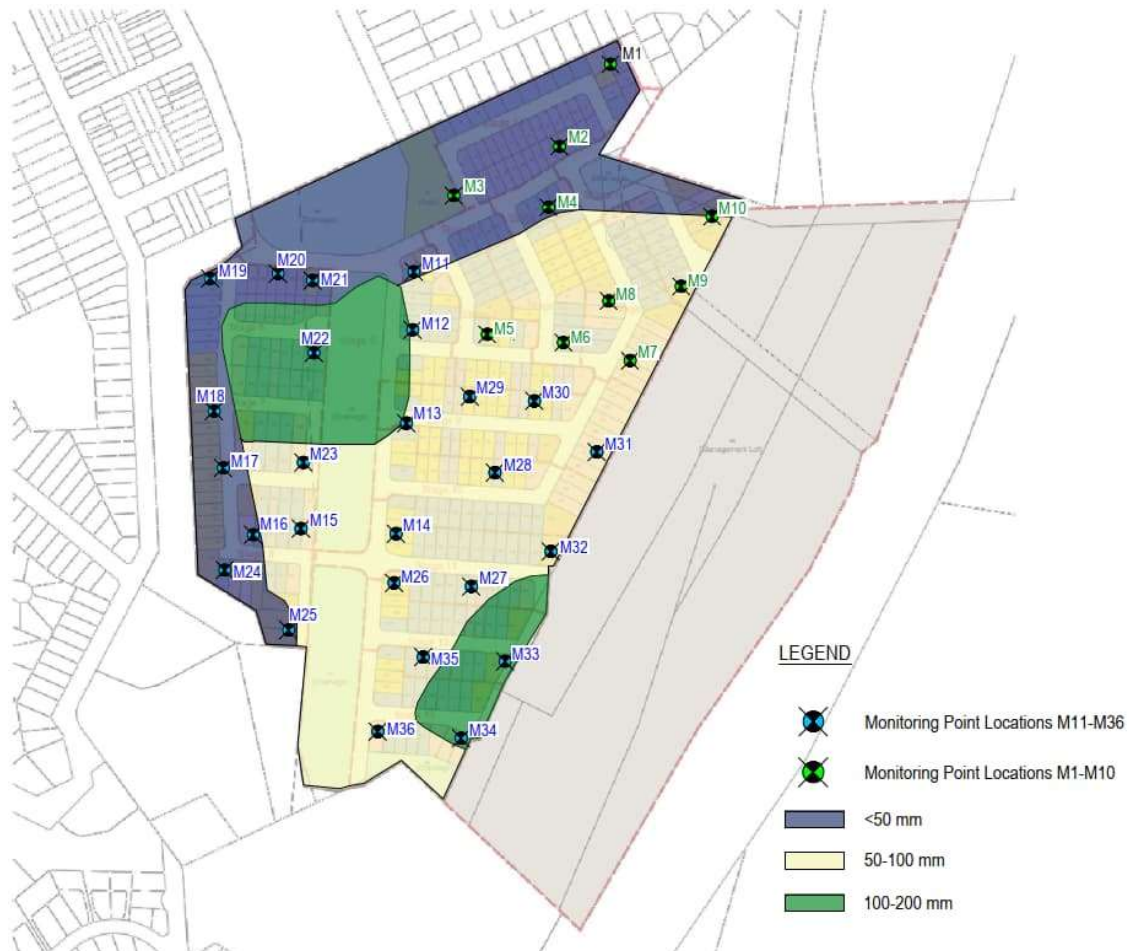
There are, however, some monitoring points that are indicating that settlement is occurring in areas of the site, most notably at monitoring point M22 where 63mm of settlement has occurred in an area where approximately 5m of new controlled fill has been placed over an area of deep, pre-existing uncontrolled fill. Based on the data available, it is estimated that the approximate order of magnitude of future settlement that could occur at this location over a 50 year design life could be 100mm to 200mm. A broadly similar order of magnitude of future site settlement is considered possible at monitoring point M33 where 48mm of downwards movement has occurred under approximately 10m depth of new controlled fill. Figure 17 shows an estimate of the possible distribution of future settlement at the site based on the monitoring results only.

Figure 17: Estimated future settlement zones

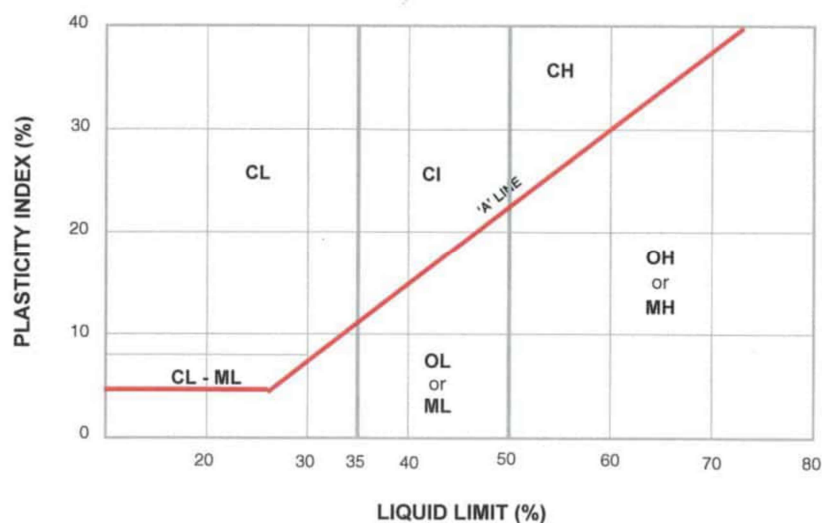
#### PLASTICITY CHART FOR CLASSIFICATION OF FINE GRAINED SOILS

(Reference: Australian Standard AS1726-1993 Geotechnical site investigations)
