# REPORT

## Environmental Studies Report for Vance Mining Lease (ML1108), North Stradbroke Island, Queensland

**Unimin Australia Limited**

15 October 2007

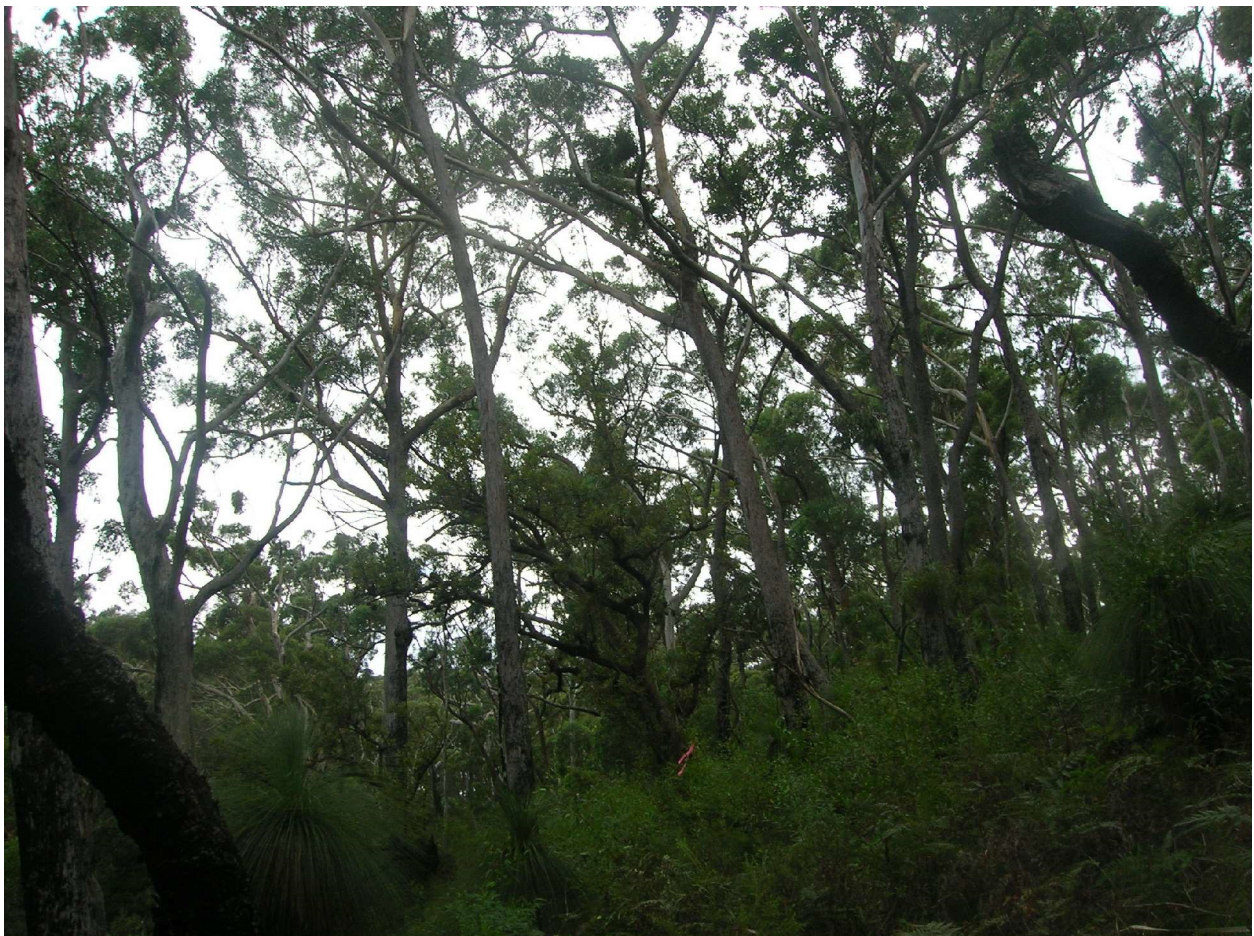
*Plate B.1: Example of mixed tall Eucalypt forest at Reference Site 1 (08/03/06)*

The community was generally found to be co-dominated dominated in the canopy by *Eucalyptus Pilularis* (needle bark) and *E. racemosa* to a height of 25m. *Corymbia gummifera* (red bloodwood) was usually present, however floristic variation was evident across the lease with *E. Pilularis*, *E. racemosa* and *C. gummifera* all exhibiting dominance in the canopy at various locations. Disturbance was minimal at this site, with some fire disturbance evident within the past 2-5 years. Detailed structural and floristic data for this site is presented below.

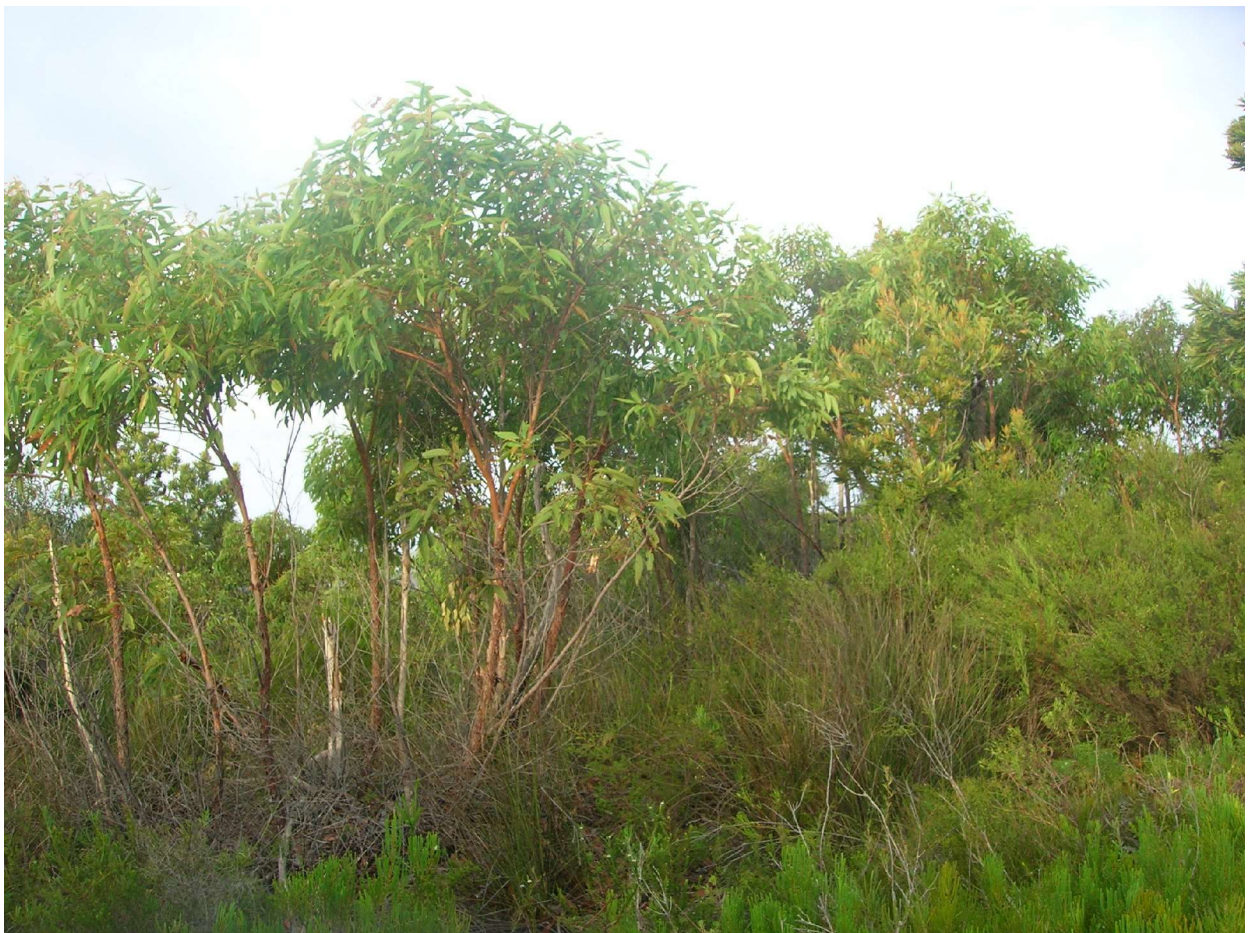
*Plate B.2: Example of Mallee woodland community at Reference Site 2 (08/03/06)*

The regional ecosystem most analogous to this community is RE 11.2.10 Mallee *Eucalyptus* spp. low woodland on Quaternary dunes and sand plains. This community is found on most landforms of the lease including the Cooroon Cooroonpah Creek drainage line, lower and upper slopes and elevated high dunes. This community is primarily dominated by mallee form of *Eucalyptus planchoniana* (needle bark) with *Banksia aemula* (wallum banksia), however was also found to be dominated by the mallee form of *Eucalyptus racemosa* (scribbly gum) in more exposed areas close to the ridge lines on elevated dunes. Detailed structural and floristic data for this site is presented below.

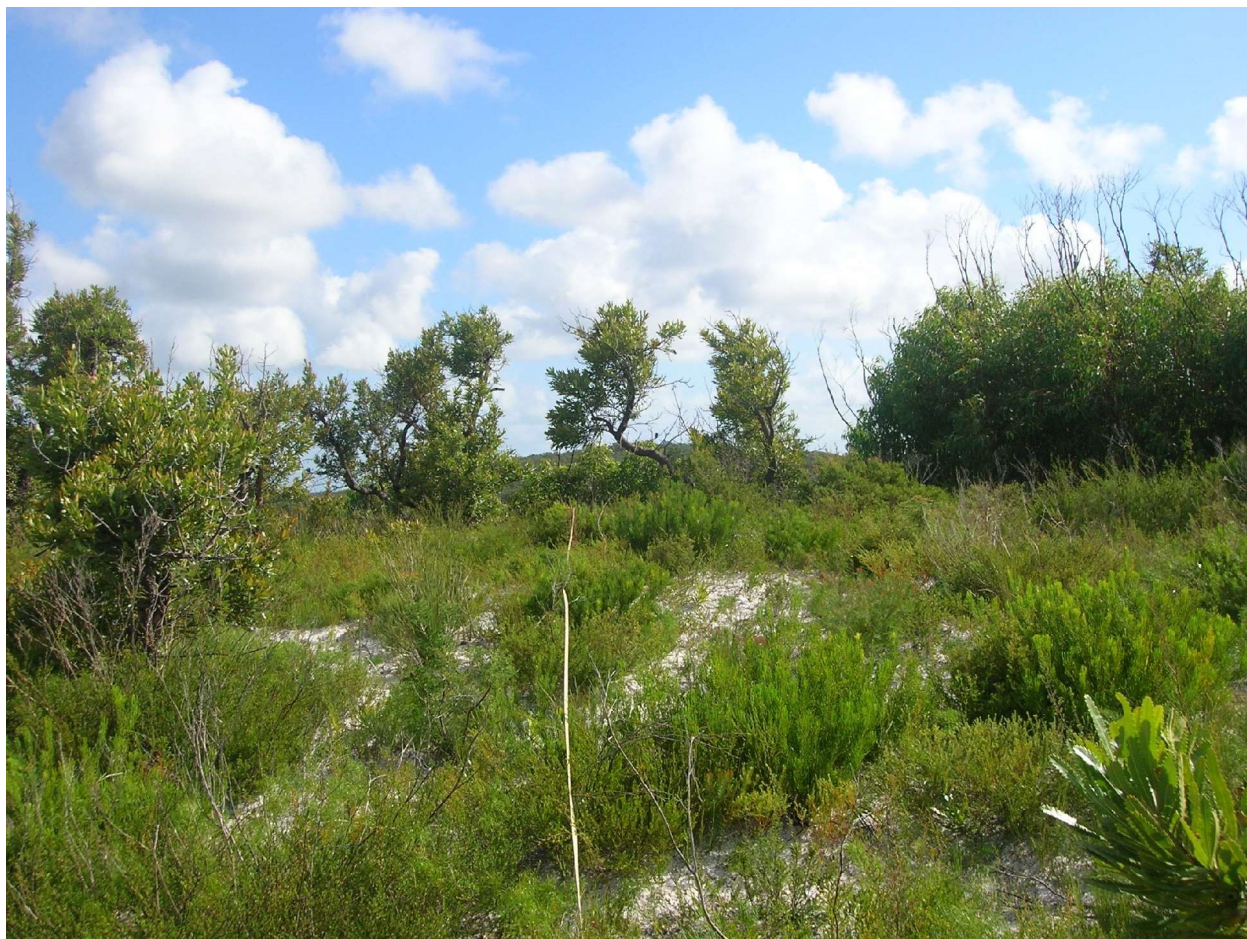
*Figure B.3: Example of Dry heath vegetation at Primary Transect 3 (09/03/06)*

Reference Site P3 is located at the east of the site in a relatively small extent (approximately 0.34 ha) of low open dry heathland. The transect is located approximately 200 m down slope, to the south west of the Mount Bippo Penbean wheel drive vehicle access track (Figure 2).

The regional ecosystem most analogous to this community is RE 11.2.10 Mallee *Eucalyptus spp.* low woodland on Quaternary dunes and sand plains. As well as being present at Transect P3, extents of this community are present in exposed ridge areas on the high dunes to the west of the site. This community is dominated by a number of Myrtaceous and Fabaceae heath species. However *Banksia aemula* (wallum banksia) is growing around the edges and as isolated scattered examples throughout the heath community. Detailed structural and floristic data for this site is presented below.

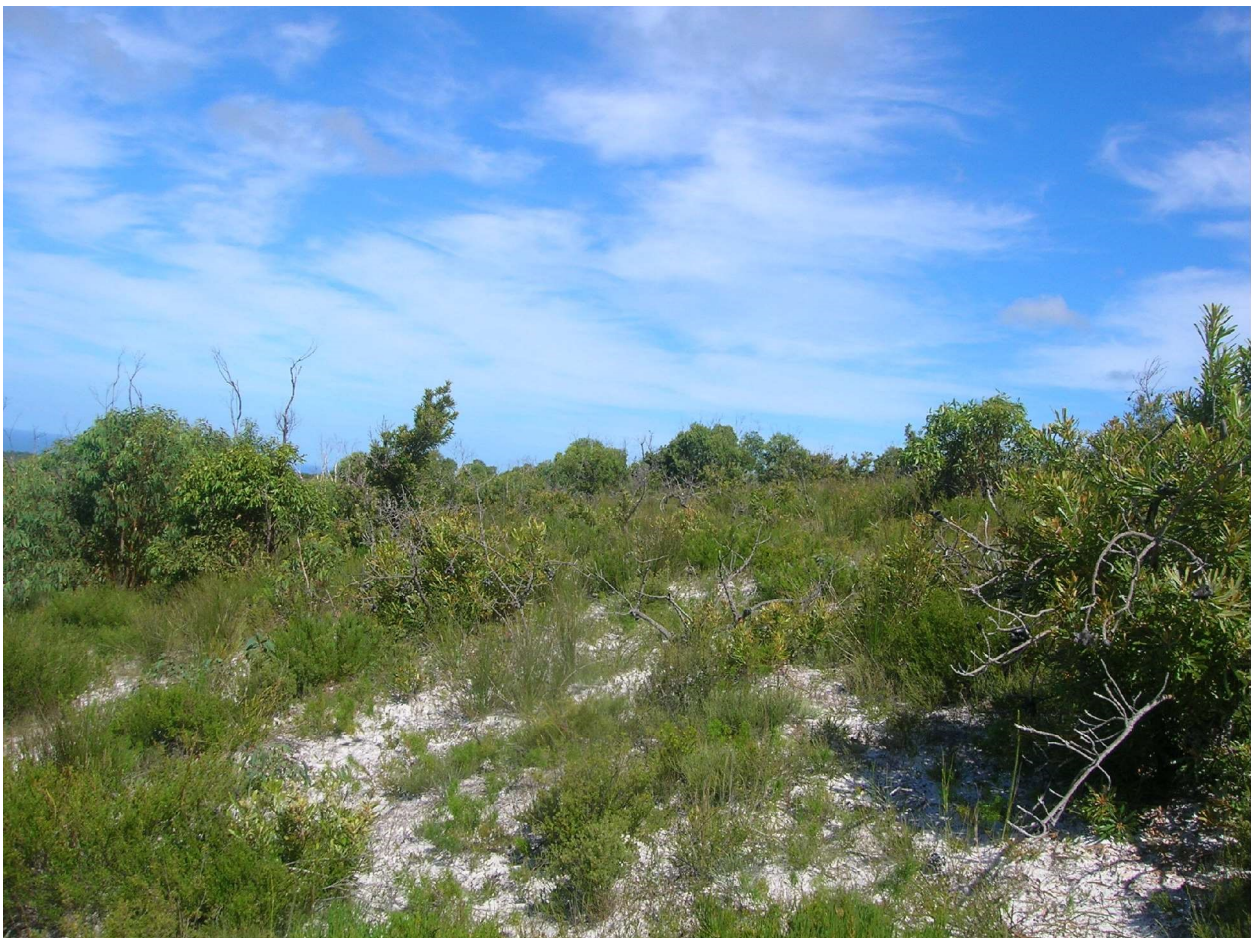
*Figure B.4: Example of Dry heath vegetation at Primary Transect 4 (11/03/06)*

Reference Site P4 is located on an exposed ridge line on elevated dunes (at approximately 180 m elevation) near the centre of ML 1108. The community here is a relatively small extent (approximately 0.54 ha) of low open dry heathland. The transect is located adjacent to the main four-wheel drive access track in this part of the lease (Figure 2).

The regional ecosystem most analogous to this community is RE 11.2.10 Mallee *Eucalyptus* spp. low woodland on Quaternary dunes and sand plains. As well as being present at Transect P3 and P4, extents of this community are present in exposed ridge areas on the high dunes to the west of the site. This community is dominated by a number of Myrtaceous and Fabaceae heath species. However *Banksia aemula* (wallum banksia) is growing around the edges and as isolated scattered examples throughout the heath community. Detailed structural and floristic data for this site is presented below

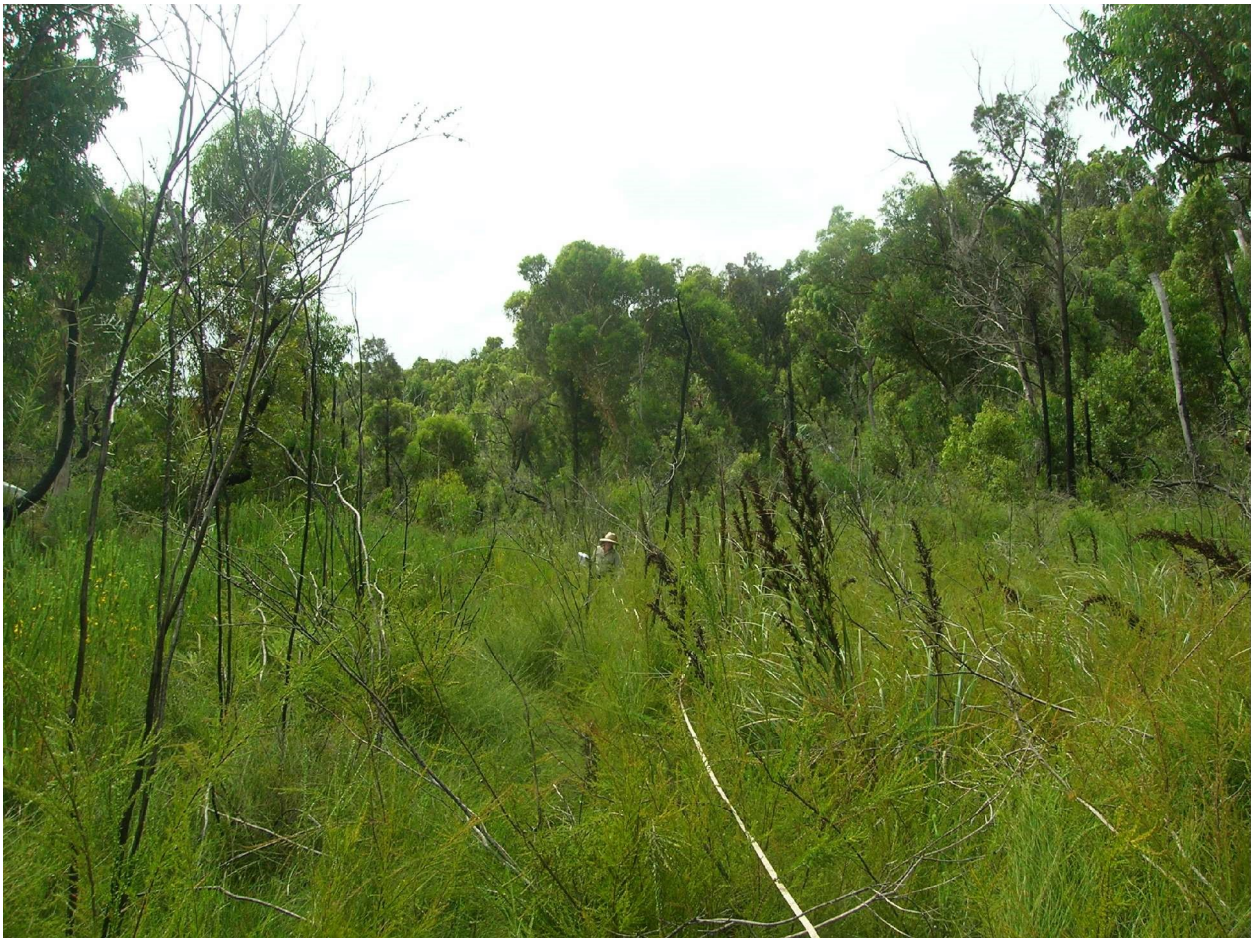
*Figure B.5: Example of Closed wet heath vegetation at Primary Transect 5 (11/03/06)*

The extent of Closed wet heath on the lease was restricted to the ephemeral drainage line of Cooroon Cooroonpah Creek covering an area of approximately 3 ha (Figure 2). This community was dominated by *Leptospermum liversidgei* (lemon-scented tea tree) with *Empodisma minor* (spreading rope rush) and *Baumea muelleri* (flat twigrush) also in common abundance. The regional ecosystem most analogous to this community is RE 11.2.13 Low open dry heath on Quaternary dunes and sand plains. Detailed structural and floristic data for this site is presented below

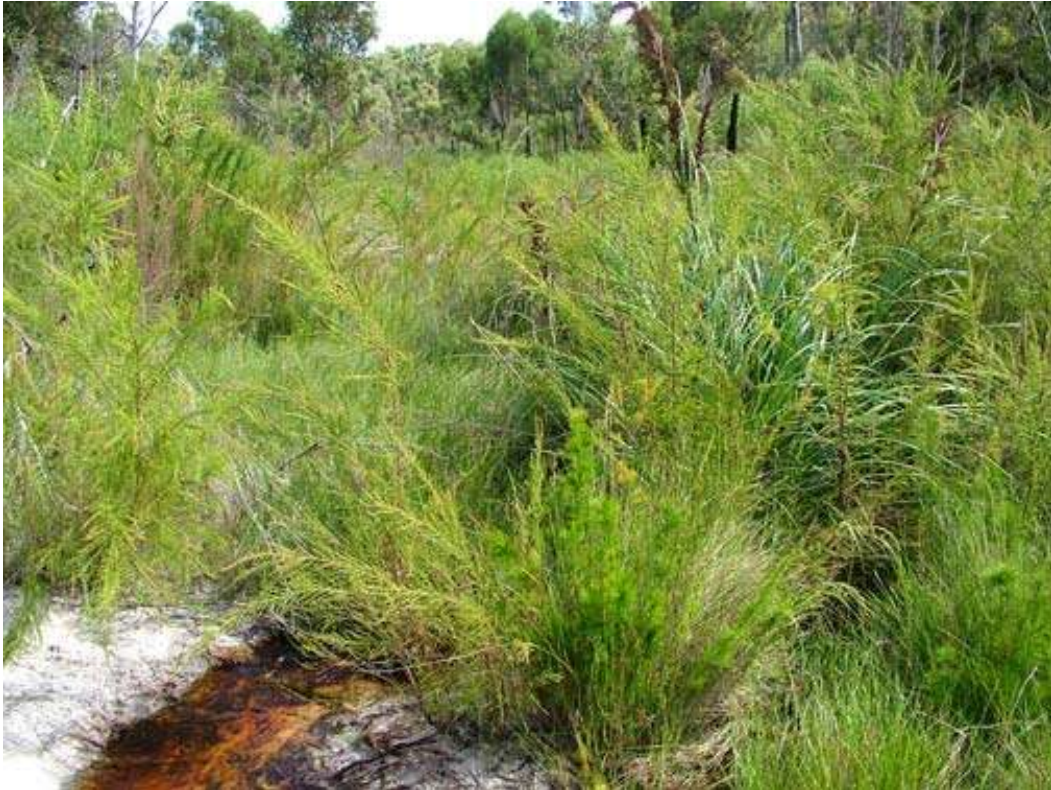
Plate 1: Site 1 Closed wet heath Cooroon Cooroonpah Creek

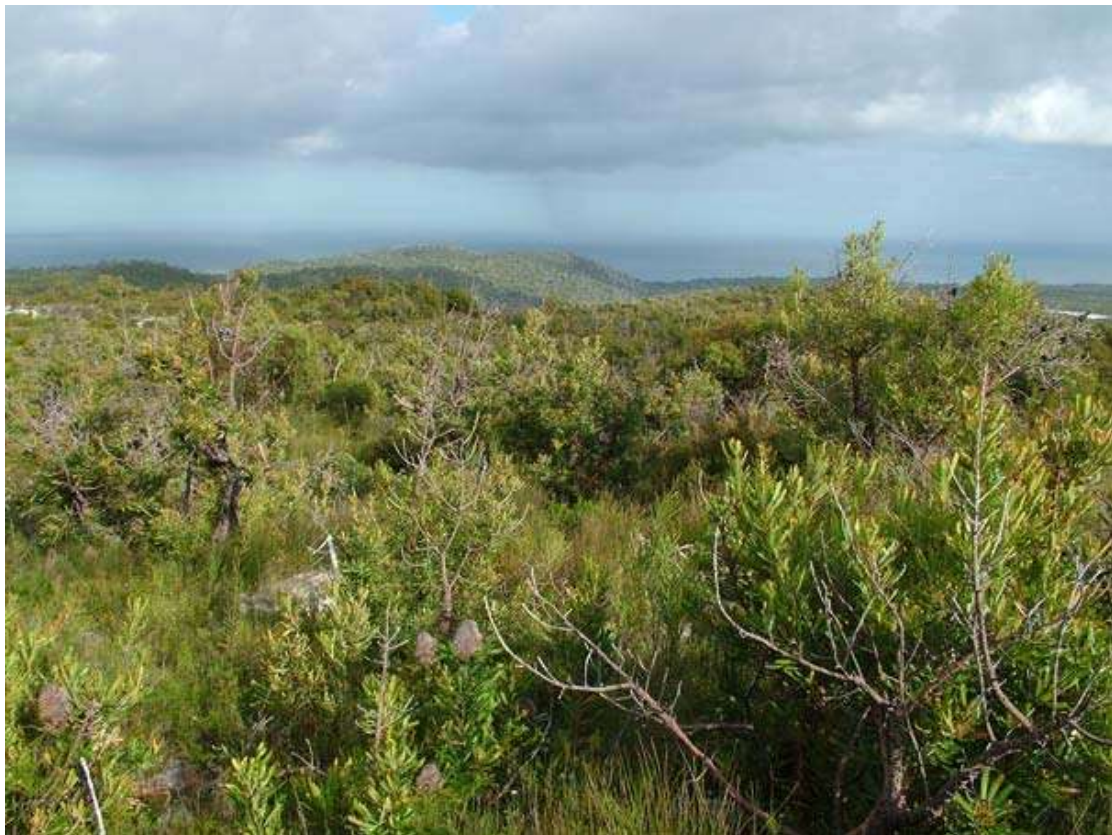
Plate 6: Site 6 Open or dry heath with stunted *Banksia aemula* on upland dunes

| Site No | Location | Dominant Canopy Species | Broad Habitat/Land Unit | Vegetation Type (URS 2006) |
|---|---|---|---|---|
| 6 | Central component of the study area. | Open or dry heath, stunted Banksia aemula and E. racemosa. | Open or dry heath (Plate 6). Occurs on Quaternary coastal dunes. Undulating to low rounded hilly upland dune areas. | 1a |

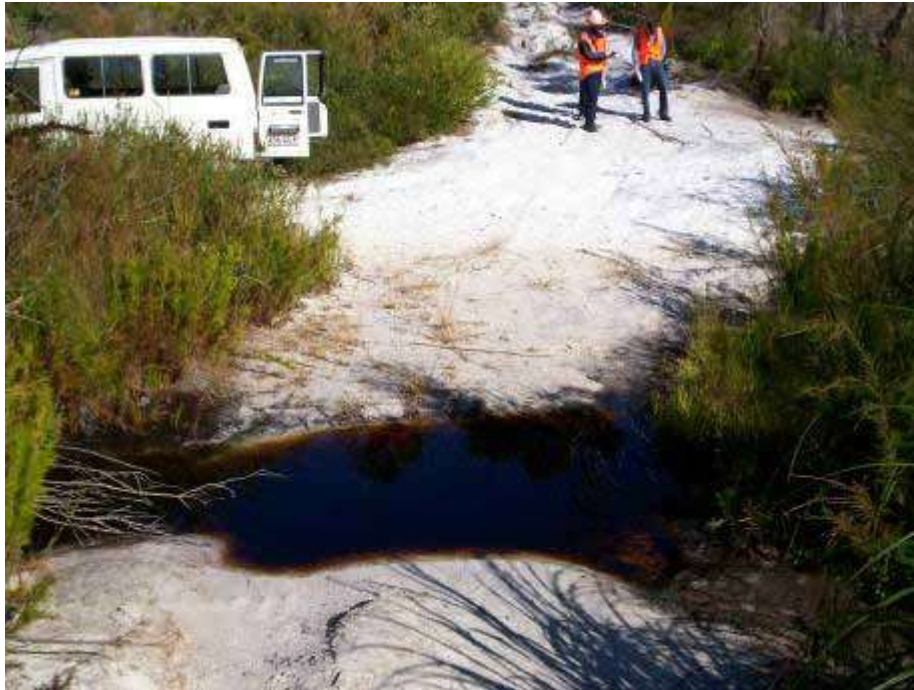
**Plate 3-2** Cooroon Cooroonpah Creek Site 2 with stagnate water present

This site is located at an upstream crossroads between 4WD tracks approximately 2.5 km upstream of Site 1 and adjacent to where groundwater boreholes 2D and 2S are installed. The approximate coordinates of this location are E546172; N6959080 (MGA Zone 56, GDA 94). The location of Site 2 is shown on Figure 2, Appendix A. Water has been intermittently identified at the site. Photos presented below show the creek at the maximum extent observed during site inspections after a period of prolonged wet weather.

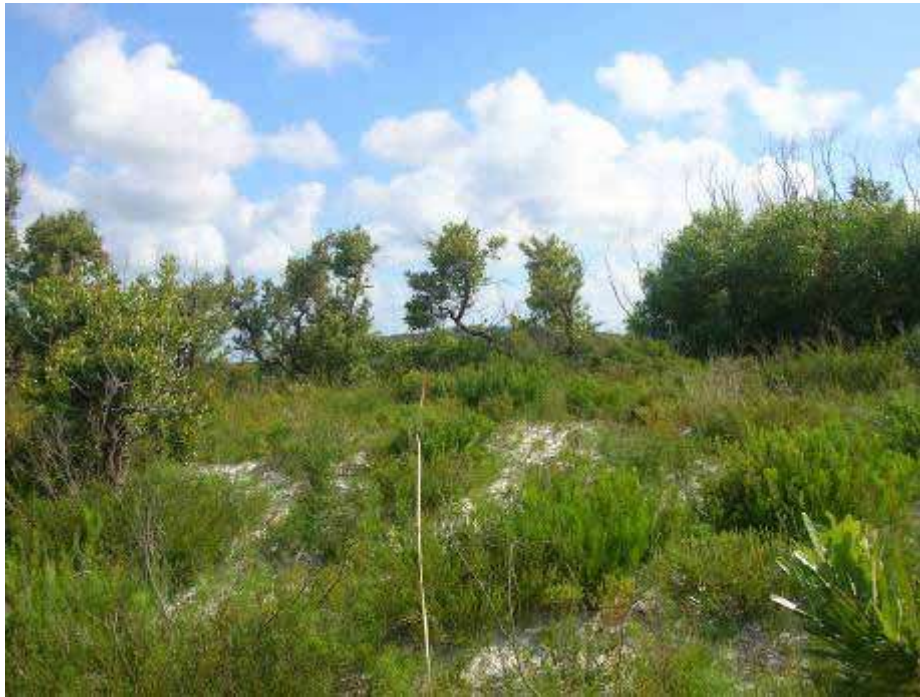
**Plate 3-4 Vegetation at higher elevations in the catchment**

The upland areas of Cooroon Cooroonpah Creek catchment are densely vegetated. The substrate across the entire site is sand and no surface water features have been observed during any of the site inspections. There does not appear to be any localised rills or gullies caused from overland flow on the upstream areas. The sand appears to be dry, poorly graded material with few fines.

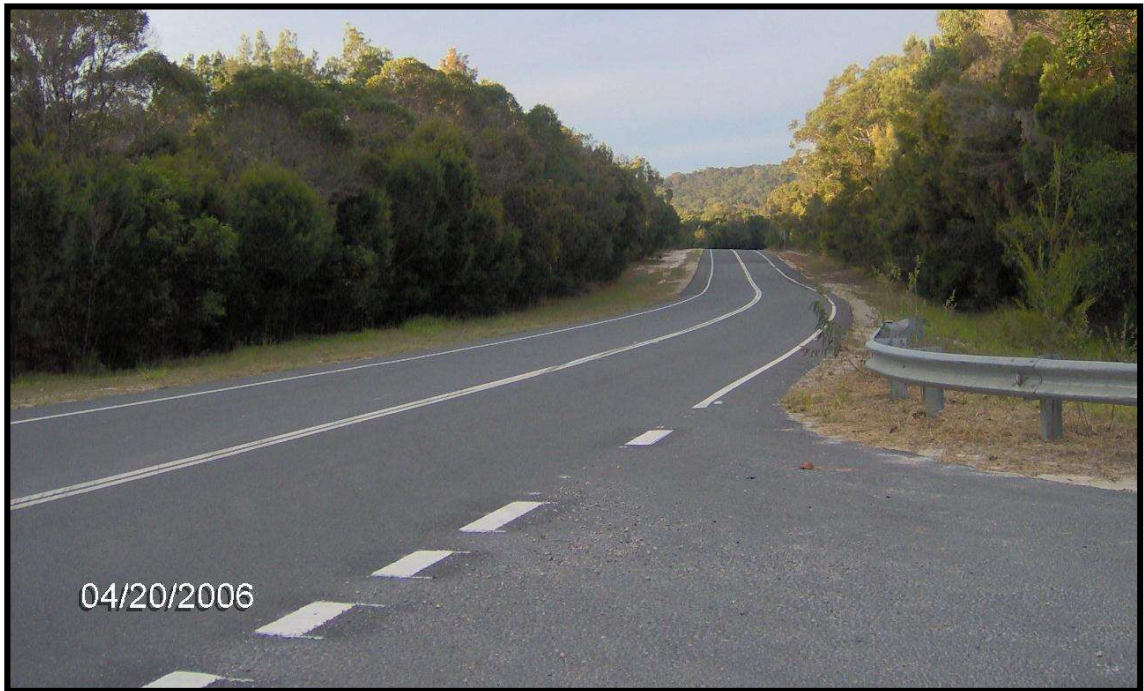
**Figure 5.1 – Sight lines from UAL Access - north**

The existing access to the UAL mining operations allows excellent sight distances to approaching vehicles, well in excess of the 140 m required for the 70 km/hr speed limit operating on East Coast Road. These sight distances are illustrated in **Figures 5.1 and 5.2.**

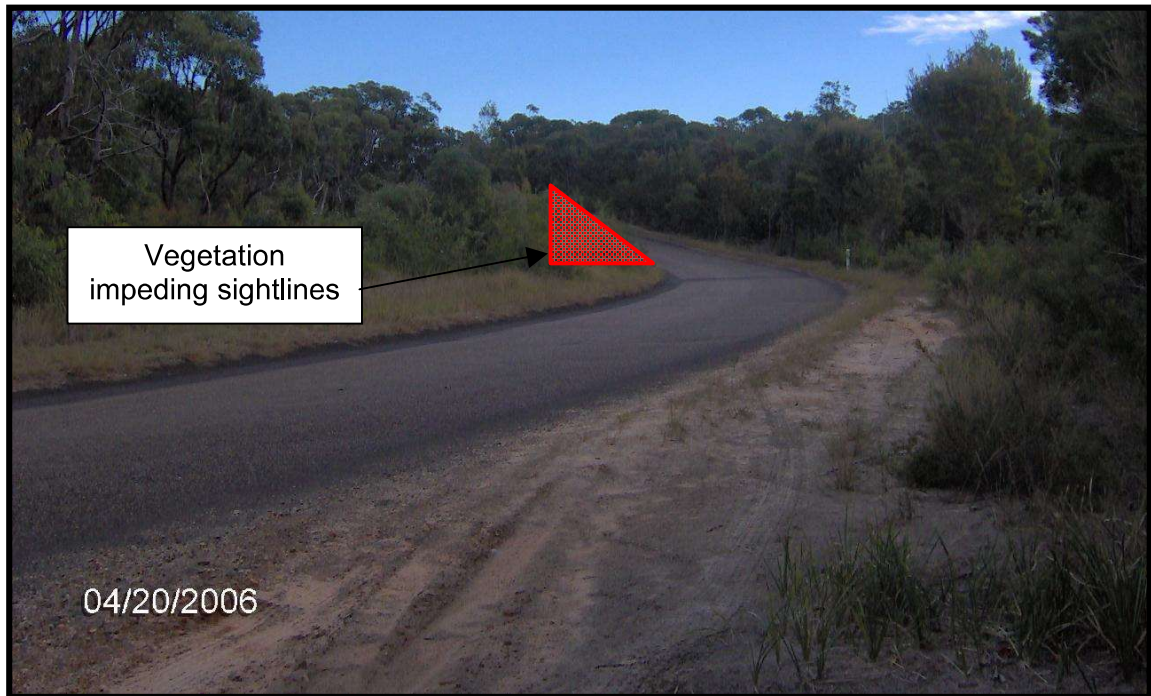
**Figure 5.3 – Sight lines from Vance Lease - west**

The sight lines are impeded by low growing vegetation on the southern side of the road, as shown in Figures 5.3 and 5.4. If this vegetation were to be removed, appropriate sightlines from the access point may be achieved.

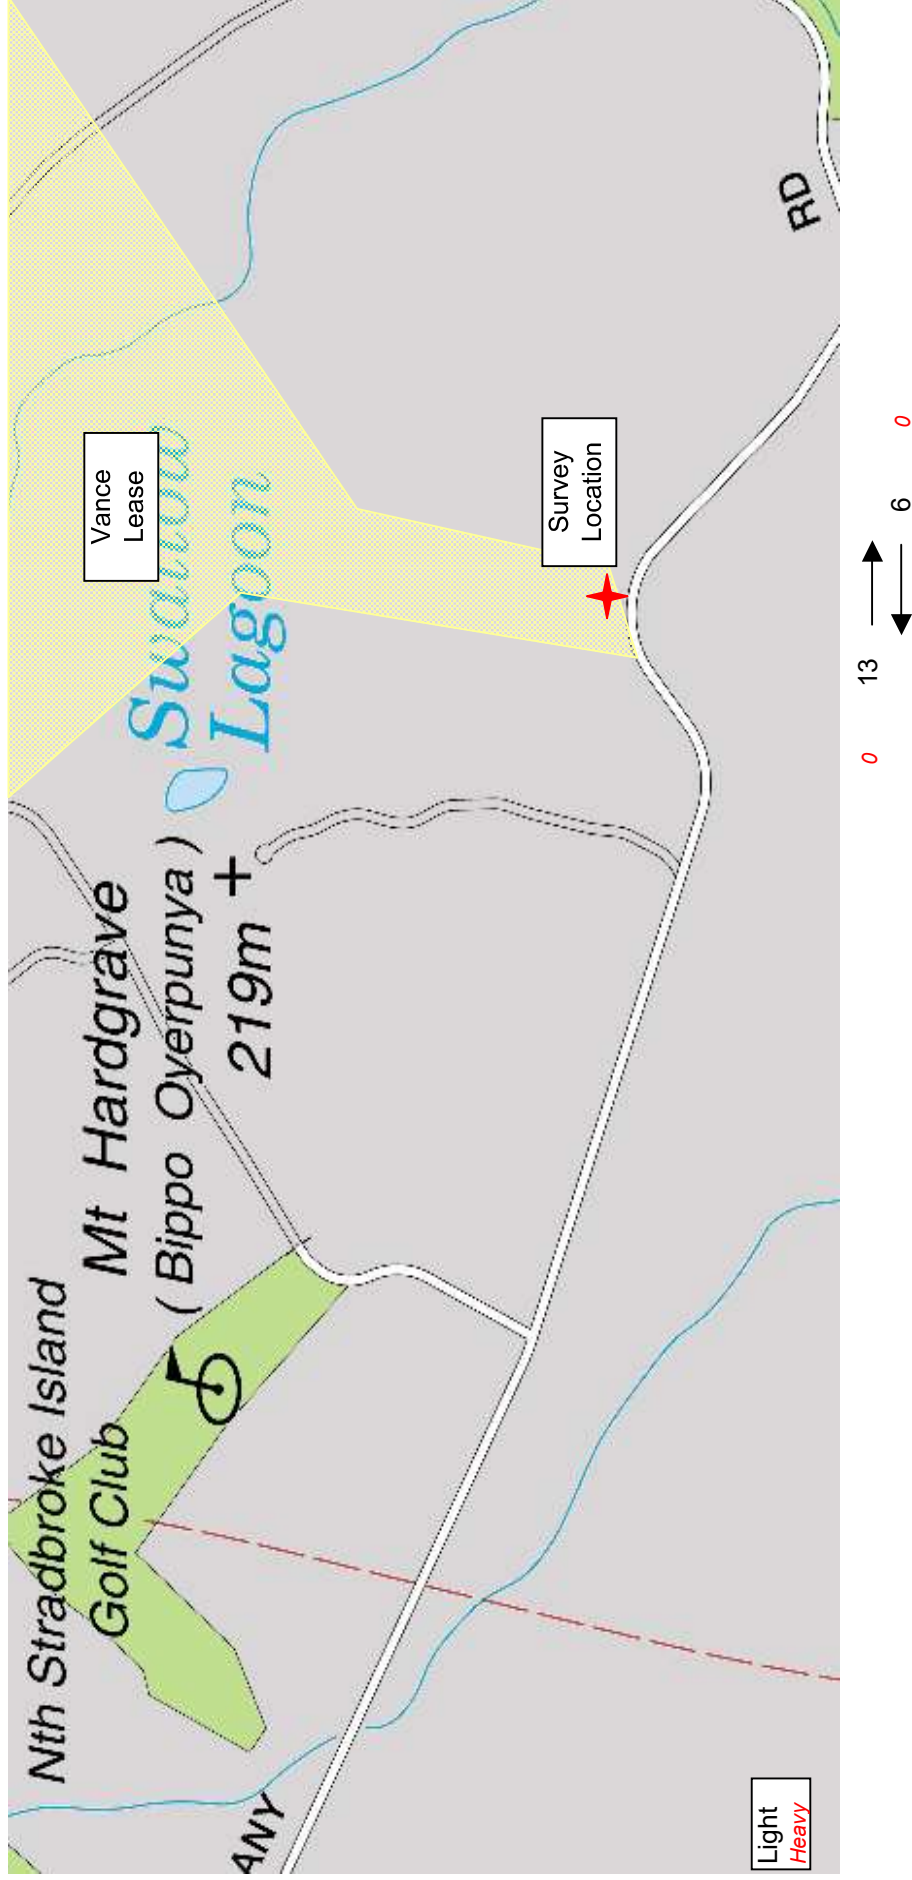
## Figure B6

Forecast Traffic Demands 2016  
Evening Peak Period
