# Progressive Rehabilitation and Closure Plan

**Title of the Project:** Mt Garnet Dalcouth Project

**Document ID Number:** MGT-006 PRCP

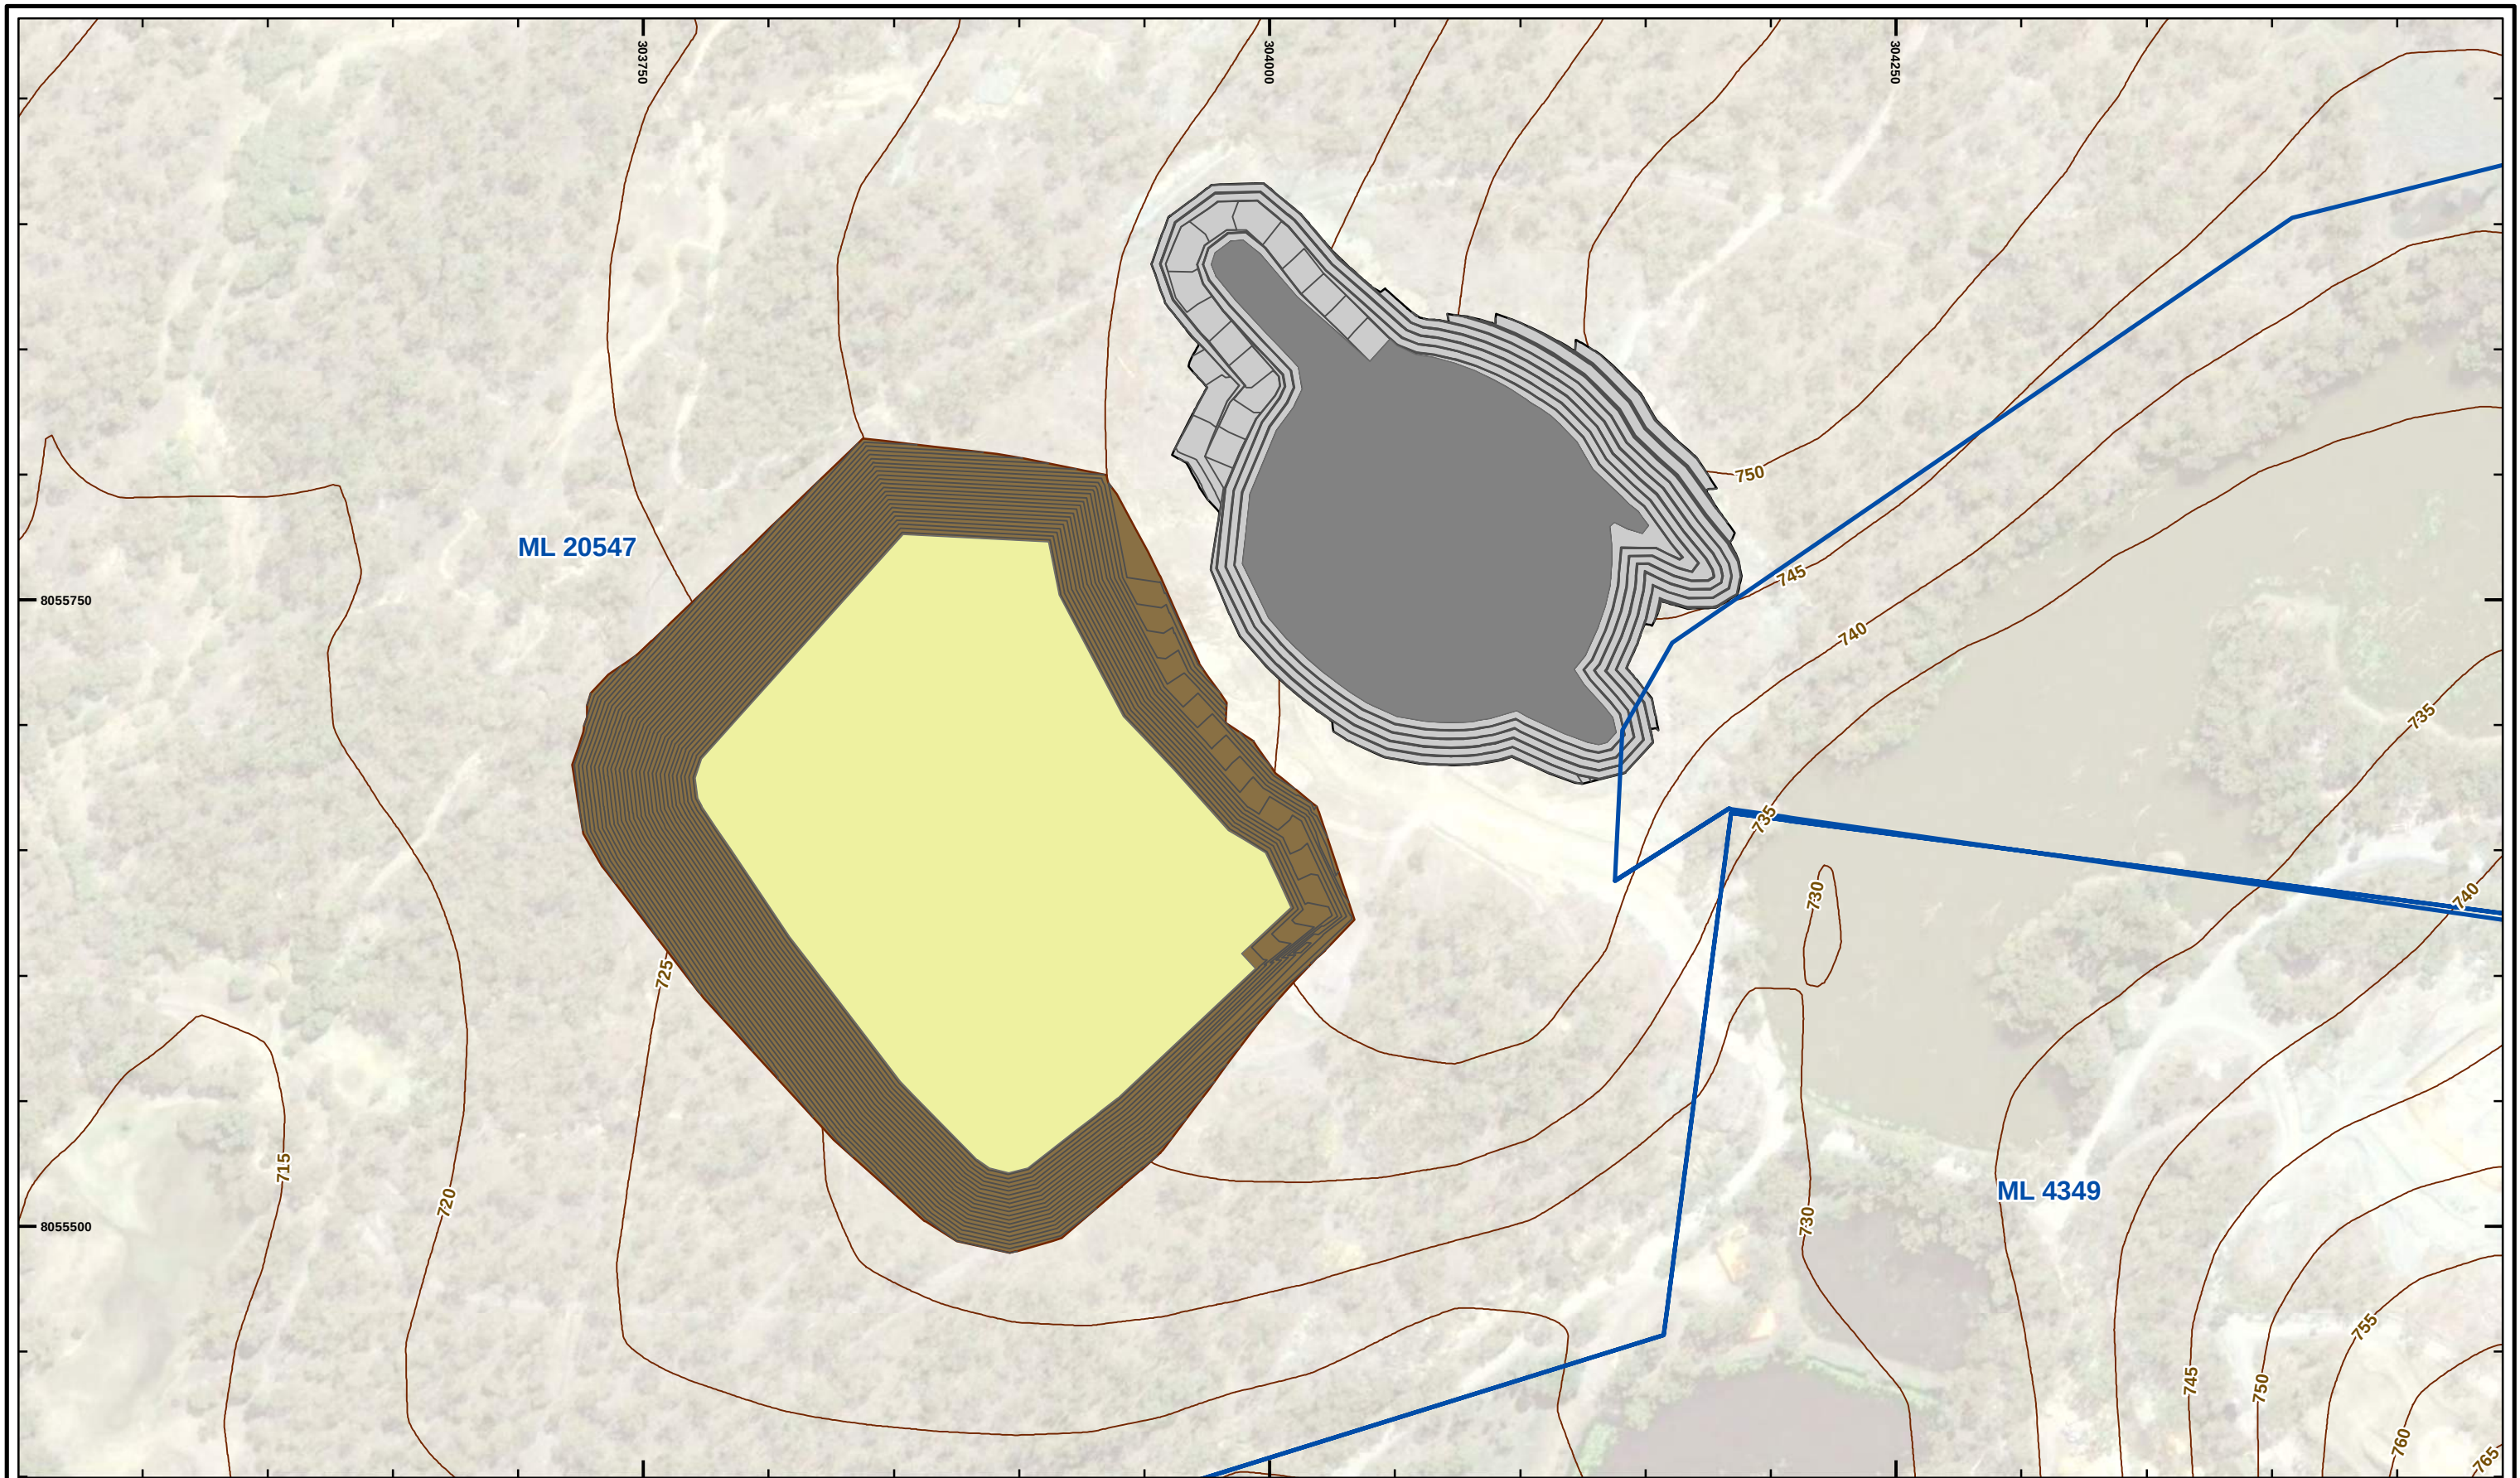
| | <b>Figure 21 - Dalcouth Pit and Dump Stage 2</b> | Mining Lease Boundary<br> Dalcouth Pit<br> Dalcouth Pit Floor - 715m<br> Dalcouth Dump<br> Dalcouth Dump Top - 747.5m | Contour (5m) |

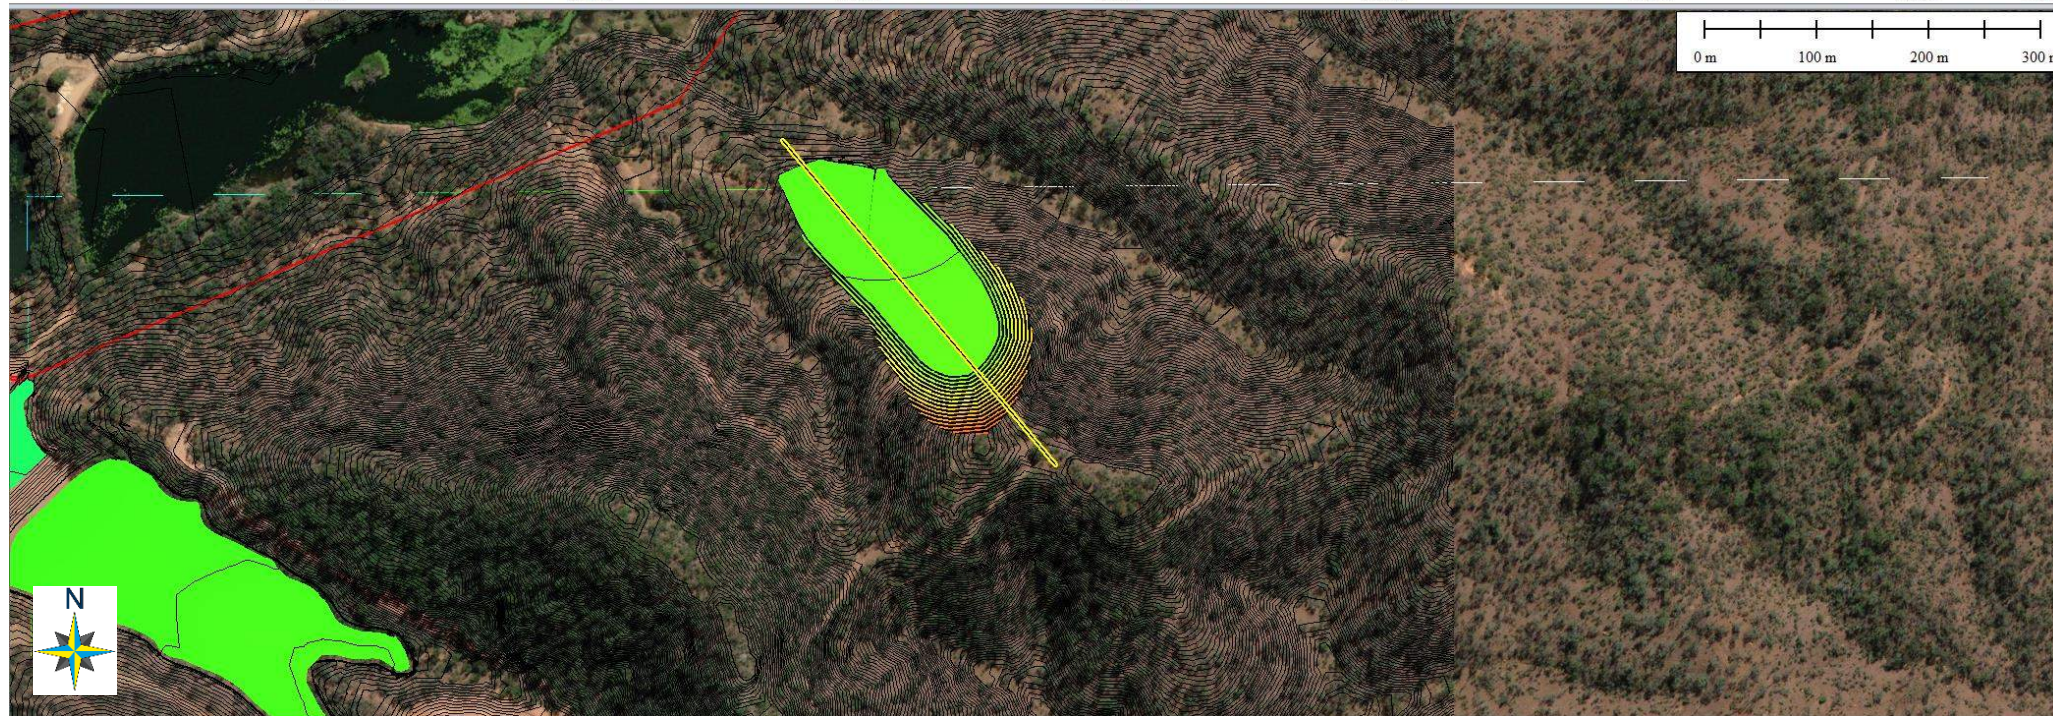
Figure 28 – Final Landform Design Proposed TSF
