# TRANSITIONAL PROGRESSIVE REHABILITATION AND CLOSURE PLAN

## YANDAN GOLD PROJECT

PREPARED FOR  
STRAITS GOLD PTY LTD

28 MARCH 2022

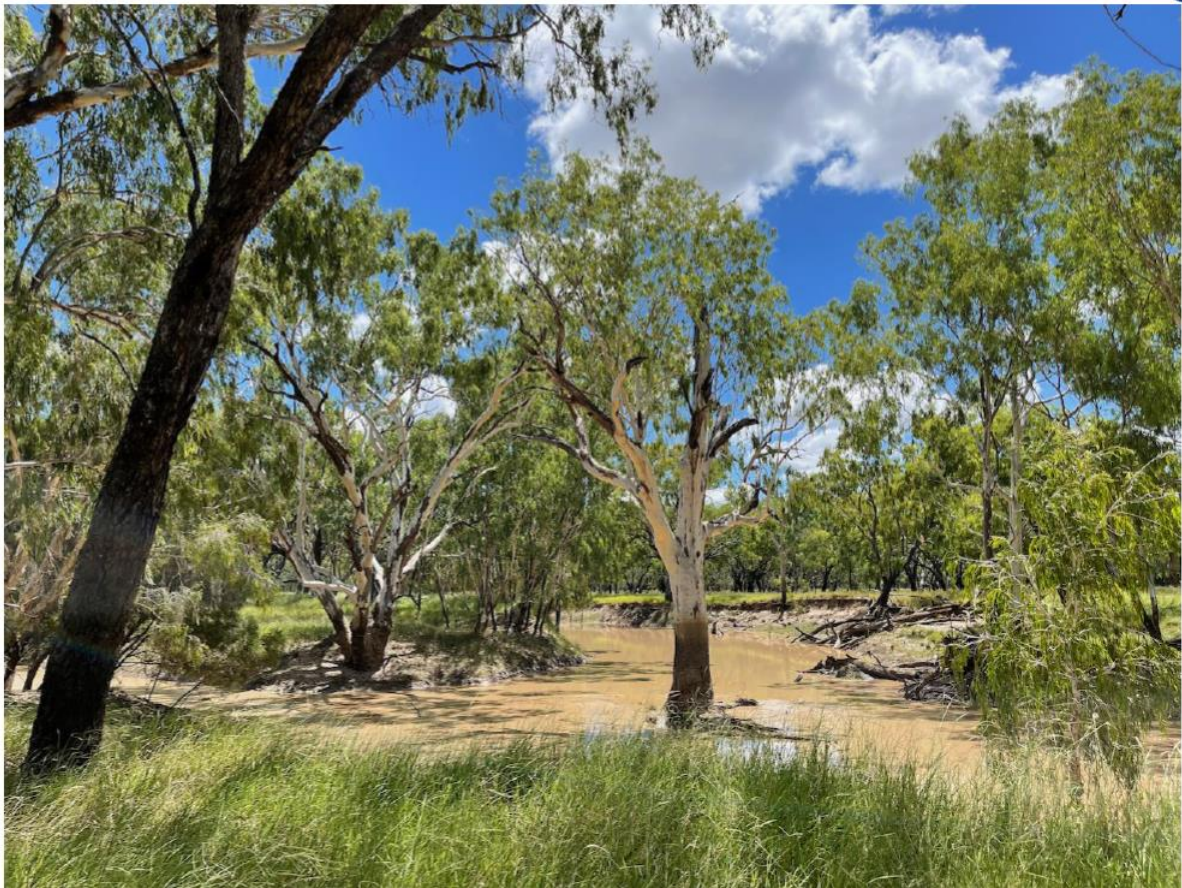
*Figure 16: View of Suttor River near release point of Main Pit (SBE 2022)*

Connectivity with the Suttor River and Yandan Creek has continued to maintain this water cover. Two spillways have been installed on the north-west and south-east walls of the pit to enable recharge as well as discharge (Figure 16). Releases from Main Pit are limited to when flows are sufficient, where the pit water level exceeds 169 mAHD (SBE 2022). The most recent discharge event from the pit occurred in April 2017. Water quality monitoring completed during this event did not identify any contaminant issues in the receiving environment.

Direct connectivity between Main Pit waters and the Suttor River is established if the Suttor River reaches a sufficient height (SBE 2022), with two spillways permitting inflows and outflows with the Suttor River as part of the ‘flushing pit’ design. River inflows to Main Pit are established when the height of the Suttor River reaches 3.8 m, or when flow elevation is established at 169.05 mAHD at Yandan (SBE 2022).

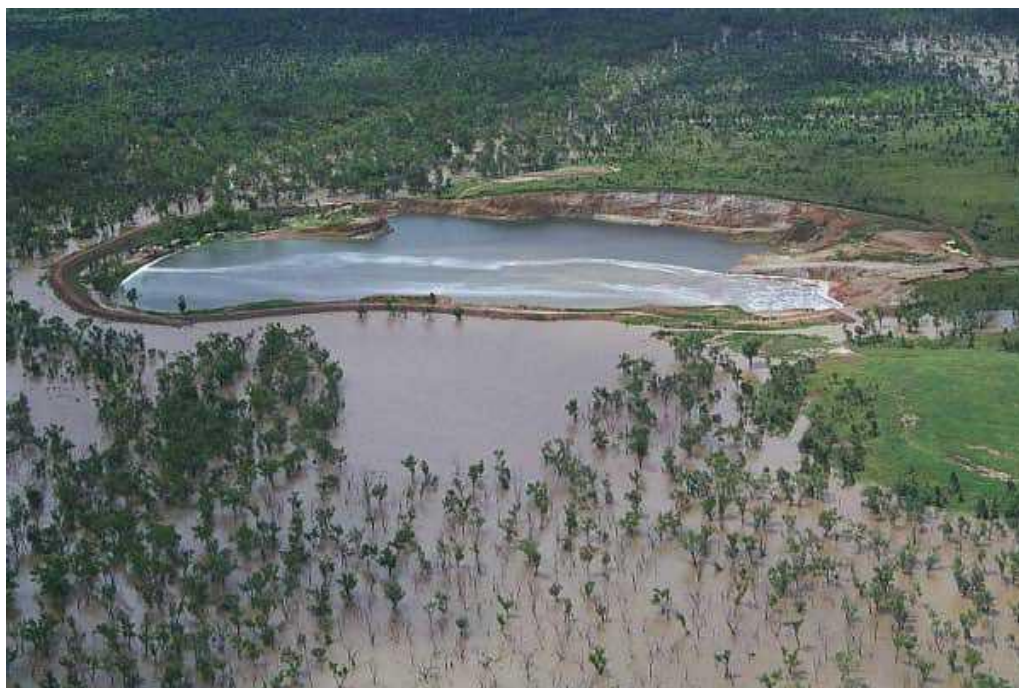
Figure 31: Main Pit inflows during flooding of the Suttor River in February 2000

River height records for the Project are inferred from the St Ann’s gauging station, located downstream from the Project on the Suttor River. Based on a river height records, connectivity between Main Pit and the Suttor River has occurred six times since the establishment of the flushing pit design (i.e. in 2001, 2003, 2004, 2007 and 2011) (SBE 2022).

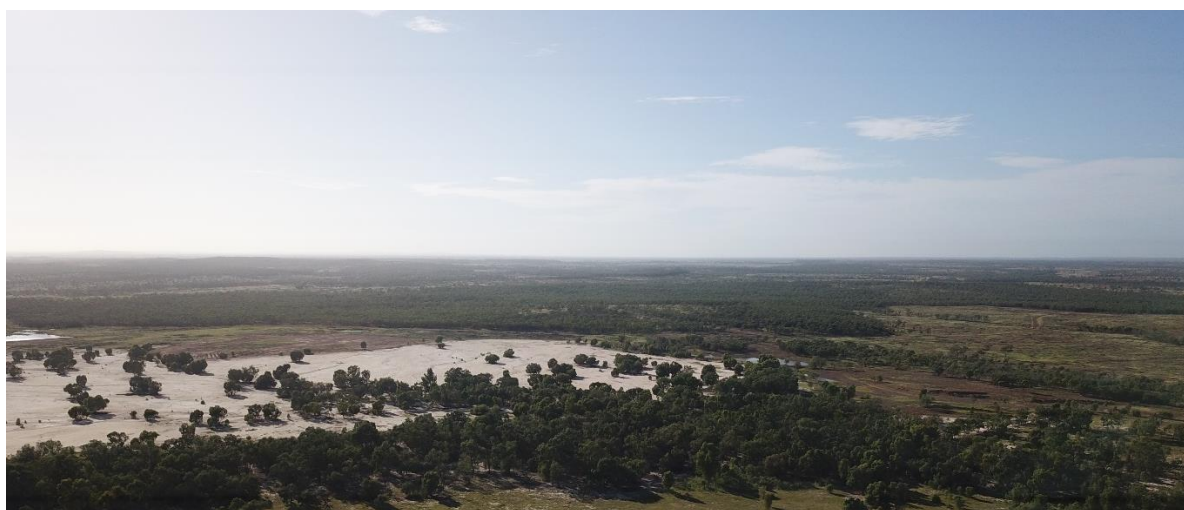
Figure 34: Established vegetation in the drainage channels of Cell B

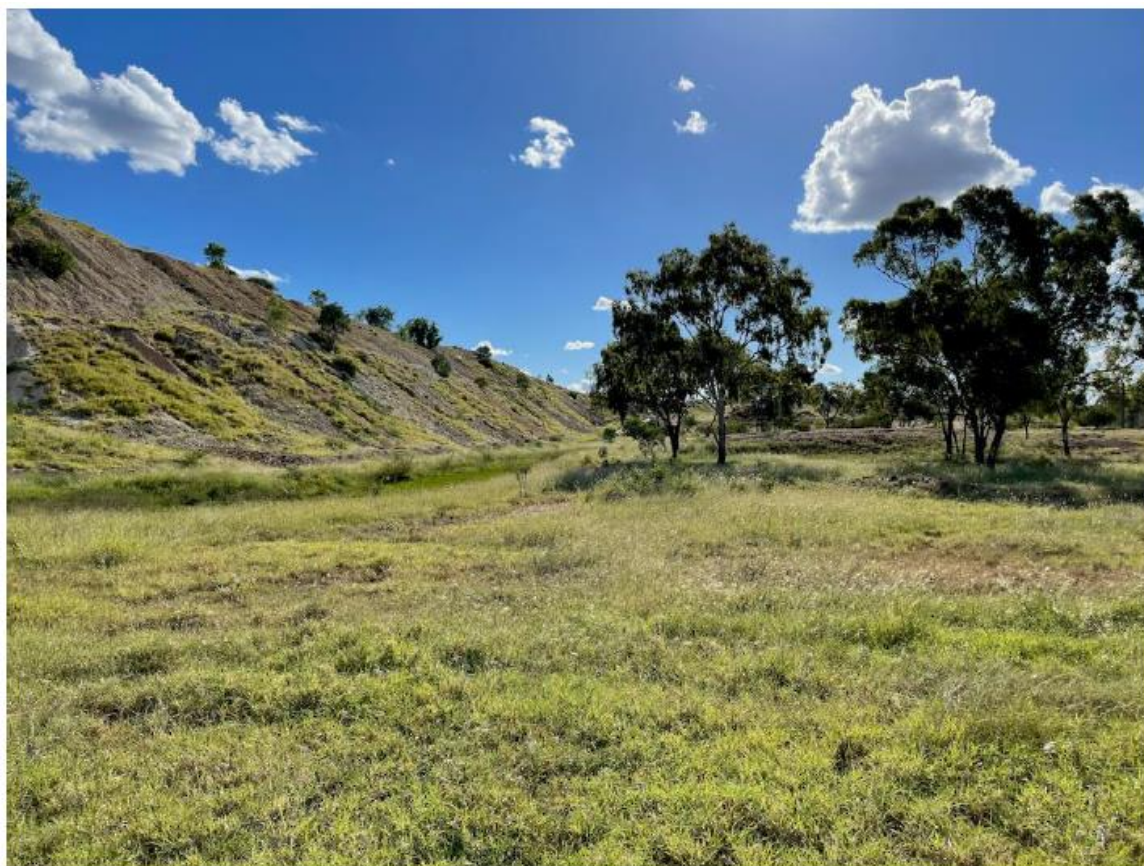
Figure 50: View of Heap Leach Pad (SBE 2022)

The legacy Heap Leach Pad is constructed at the top of a hill and above the 1% AEP flood levels to direct water flow downgradient (SBE 2022)(Figure 50). During construction and operation, the leaching process involved the application of lime within the facility, and cyanide to liberate the fine gold. The process of leaching works on the principal of infiltration of the landform, spraying a low cyanide concentration water across the facility, which percolates through the ore to be captured as leachate by the HDPE liner for subsequent processing and gold recovery.

The rehabilitation approach for the Heap Leach Pad includes landform development (principally focusing on slope reduction and stabilisation) and installation of a store-and-release cover system. In regard to water management considerations, the leach ponds will be fully rehabilitated and integrated into the final landform. Additional groundwater monitoring bores downgradient of existing monitoring bores 'HL1' and 'HL3' will be installed to provide for closure monitoring.

As identified through the flood assessment (Section 3.5.9) in the extremely rare scenario of a PMF event there is potential for 0–1 m of floodwaters through part of the Heap Leach Pad domain. Given the relatively low flood levels predicted in this scenario, it is anticipated that flood water velocities would be sufficiently low to not warrant additional protection to the base of the Heap Leach Pad.

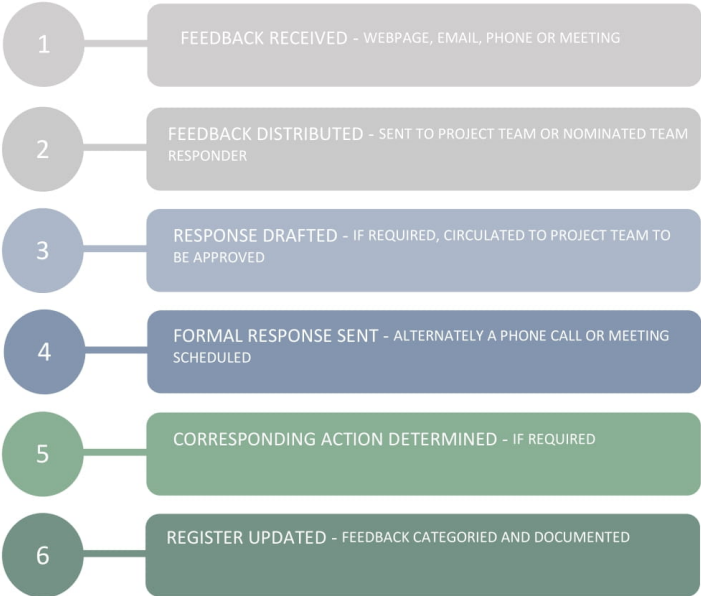
Figure 3: Feedback protocol

The feedback protocol to ensure a timely response to stakeholders and achieve feedback handling efficiency is outlined below (Figure 3).

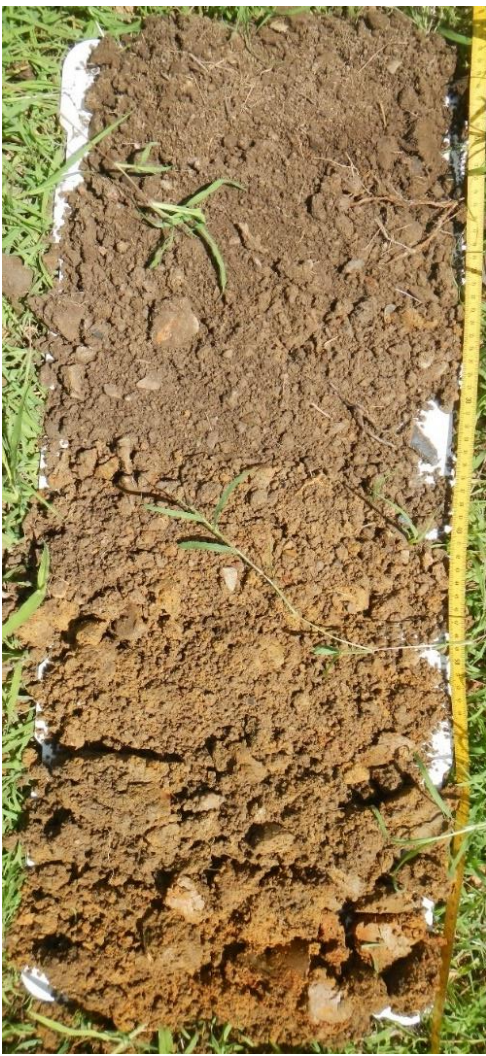
Table 28: Soil profile characteristics of Clayey SMU

| Depth (m) | Horizon | Field pH | Field Colour | Field Texture | Structure | Soil profile |
|---|---|---|---|---|---|---|
| 0–0.05 | A1 | 6 | 2.5Y 3/2<br>Very Dark Greyish Brown | Clay Loam | < 0.2 mm, Single grain, Weak, Angular blocky | |
| 0.05–0.2 | B21 | 6.5 | 2.5Y 4/2<br>Dark Greyish Brown | Silty Clay Loam | < 0.2 mm, Single grain, Weak, Angular blocky | |
| 0.2–0.4 | B22 | 6.5 | 2.5Y 4/2<br>Dark Greyish Brown | Light Clay | < 0.2 mm, Single grain, Weak, Subangular blocky | |

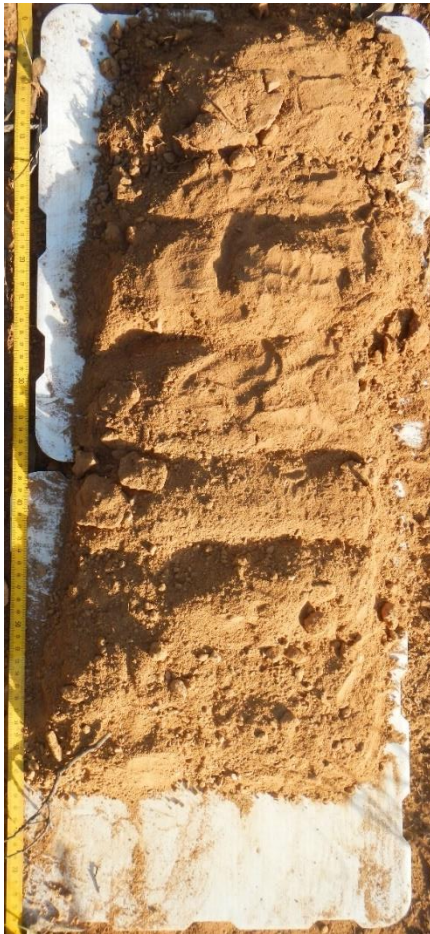
Table 32: Soil profile characteristics of Sandy SMU

| Depth (m) | Horizons | Field pH | Field Colour | Field Texture | Structure | Soil profile |
|---|---|---|---|---|---|---|
| 0–0.65 | B2 | 6.5 | 7.5YR 6/6<br>Reddish Yellow | Clay Loam | <2 mm<br>Single Grain,<br>Weak,<br>Granular | |

The pH of the Sandy SMU is moderately acidic throughout the profile with pH values increasing with depth; but remaining within a suitable range for plant growth. The profile is non-saline and non-sodic, indicated by low EC<sub>SAT</sub> and ESP values. Chloride values are also very low and not expected to impact the osmotic capacity of plants.

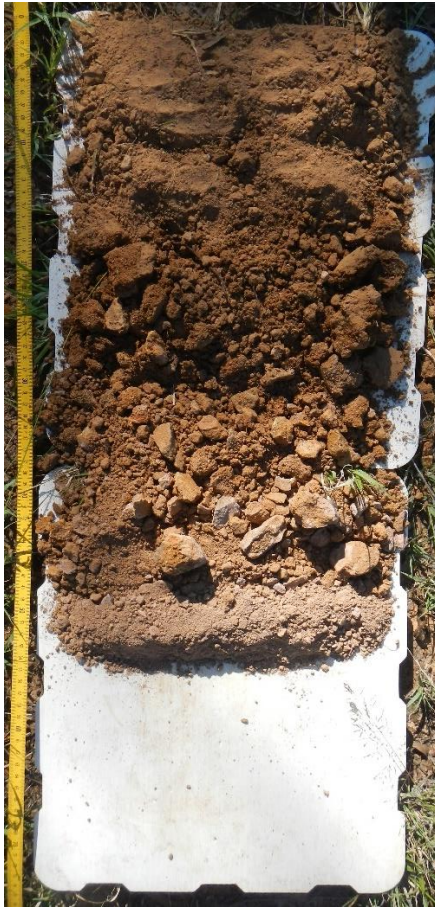
Table 36: Soil profile characteristics of Shallow SMU

| Depth (m) | Horizons | Field pH | Field Colour | Field Texture | Structure | Soil profile |
|---|---|---|---|---|---|---|
| 0–0.2 | B21 | 7 | 5YR 5/4 Reddish Brown | Loam | < 2mm, Single Grain, Weak, Granular | |
| 0.2–0.3 | B22 | 8 ½ | 5YR 4/6 Yellowish Red | Light Clay | 5–10 mm, Massive, Moderate, Subangular Blocky | |
| 0.3–0.55 | C | 9 | 5YR 6/3 Light Reddish Brown | Light Clay | < 2 mm, Single Grain, Weak, Granular | |

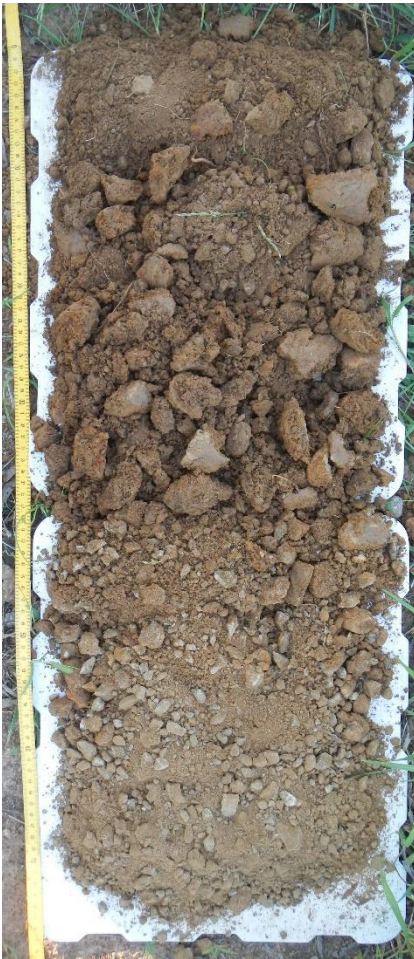
Table 38: Soil profile characteristics of Silty SMU

| Depth (m) | Horizons | Field pH | Field Colour | Field Texture | Structure | Soil profile |
|---|---|---|---|---|---|---|
| 0–0.2 | B21 | 6.5 | 10YR 5/8 Yellowish Brown | Clay Loam | < 2mm, Single Grain, Weak, Granular | |
| 0.2–0.4 | B22 | 7 | 10YR 3/4 Dark Yellowish Brown | Silty Clay Loam | 5–10 mm, Massive, Moderate, Polyhedral | |
| 0.4–0.7 | B23 | 7.5 | 10YR 5/6 Yellowish Brown | Silty Loam | < 2mm, Single Grain, Weak, Granular | |

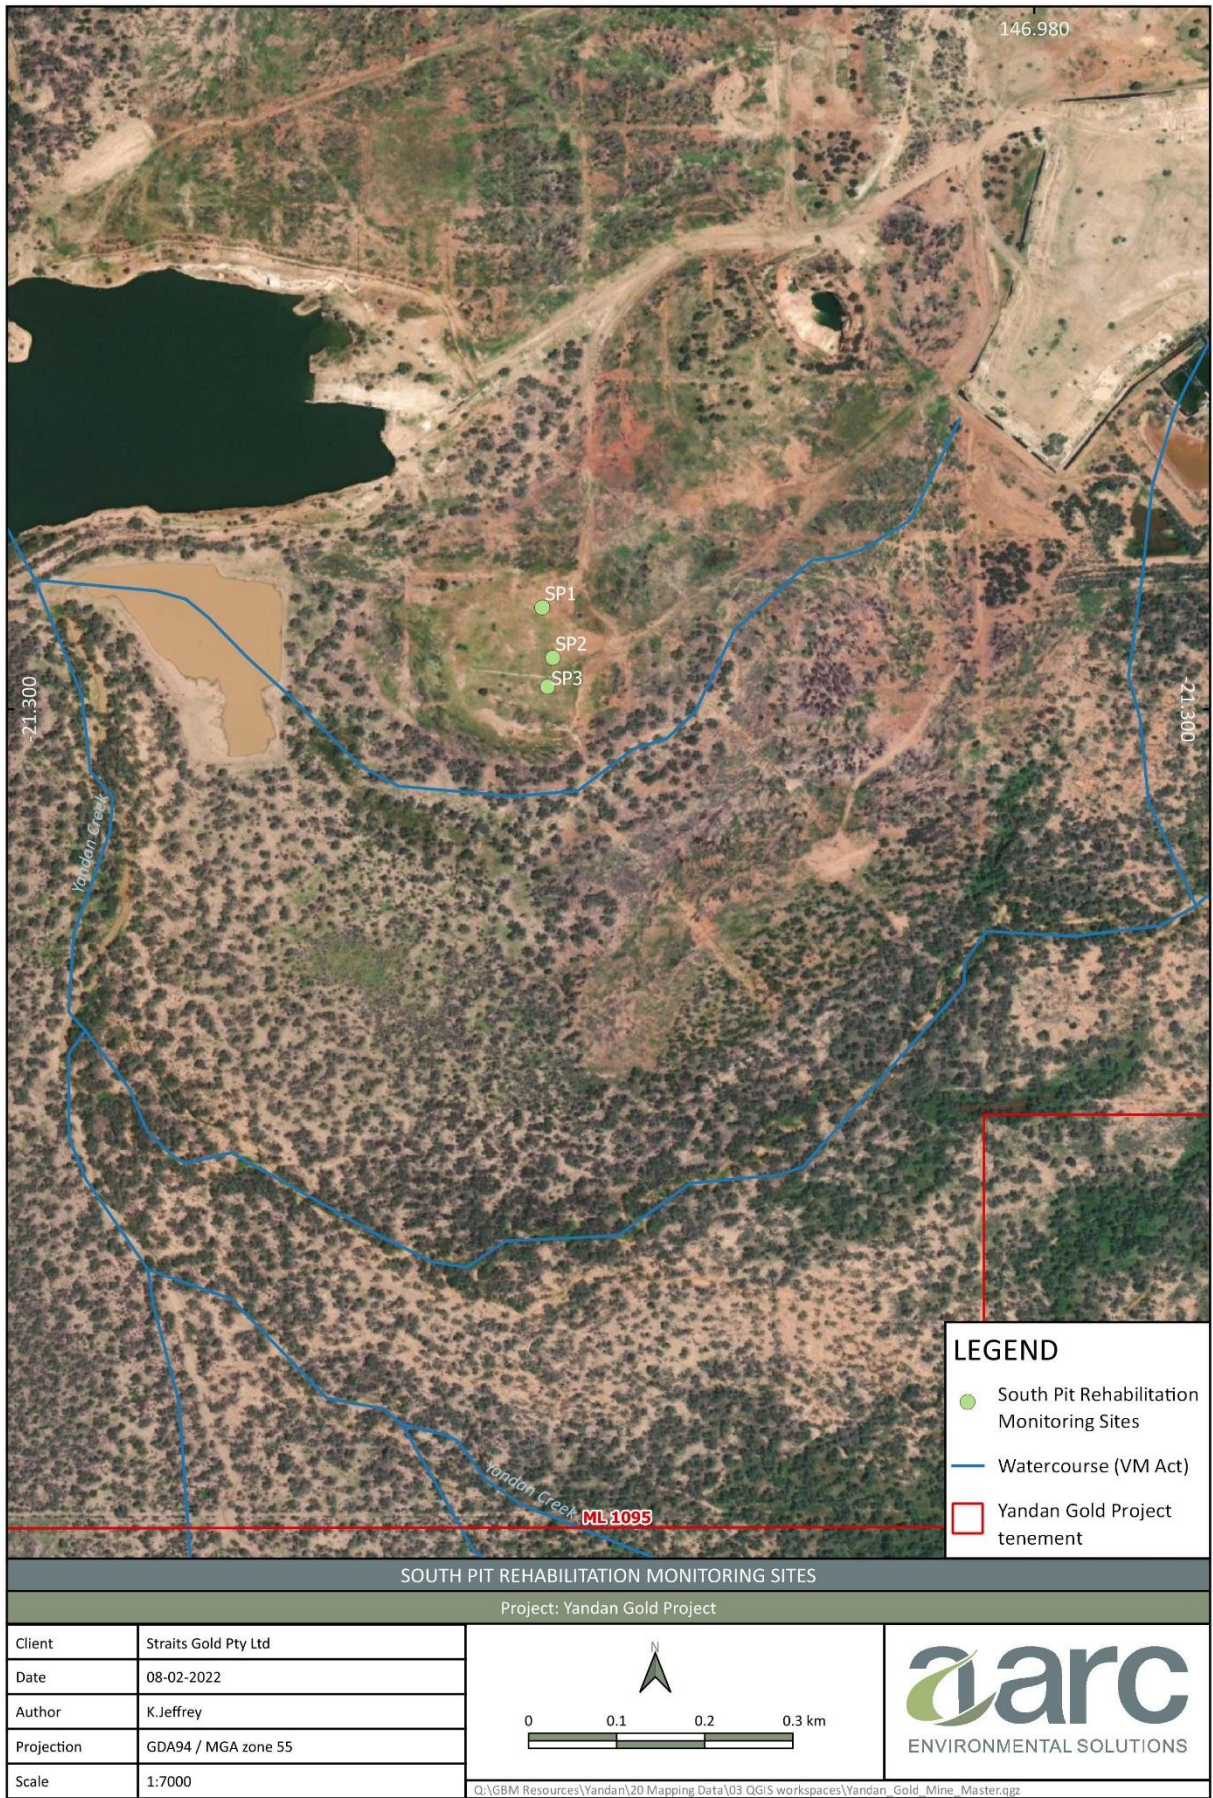
Figure 3: Monitoring transects in the rehabilitated South Pit area

- vegetation monitoring at established monitoring transects using standard methods adapted from the Queensland Herbarium survey technique titled *Methodology for Surveying and Mapping of Regional Ecosystems and Vegetation Communities in Queensland* (Version 5.1) (Neldner *et al.* 2020), and the *Method for the Establishment and Survey of Reference Sites for BioCondition* (Eyre *et al.* 2017);
- photographic monitoring from permanent photo points within the rehabilitated areas; and
- erosion monitoring including feature type, rill number and depths.

Monitoring data for the rehabilitated South Pit area was available for the 2017–2021 period.

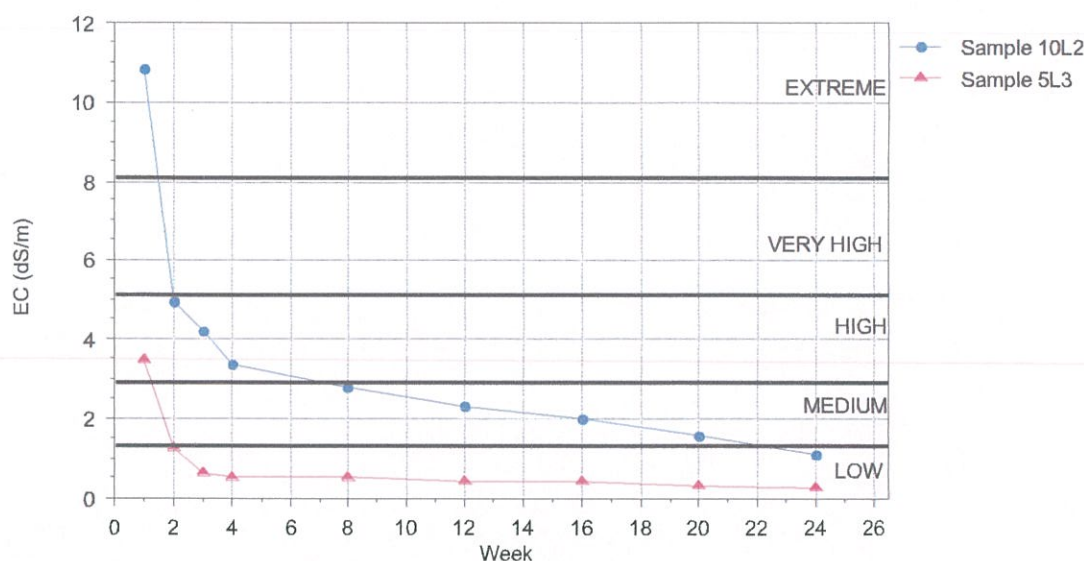
electrical conductivity (EC) of the leachates over time and shows the rapid depletion of EC caused by flushing of readily soluble salts from these materials. Using irrigation water criteria<sup>3</sup> leachates from these material initially had a high to extreme rating and after 2 weeks for sample 5L3 and 24 weeks for sample 10L2 the rating dropped to low.

Figure 4: Line plot showing the electrical conductivity (EC) of column leachates through time. Irrigation water salinity ratings are also shown (Ref. ANZECC 2000).

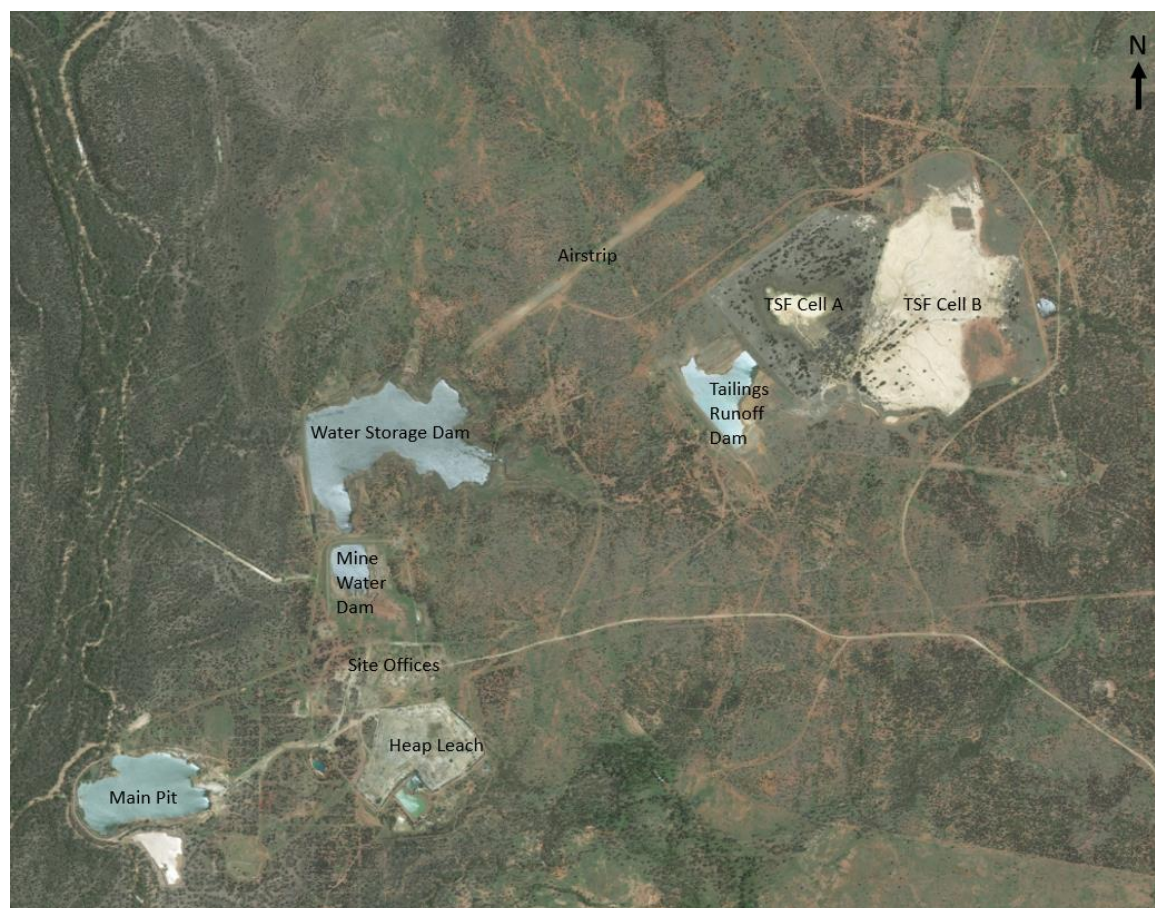
- Tailings impacts are characterised by low-risk saline drainage and not acid rock processes (either pH or sulphate). Sulphate may be elevated; however, levels have been stable for some time which indicates that the production of sulphate has reduced (Figure 47).

A total of three pits, Main Pit, South Hill Pit and East Hill Pit, were mined and other site facilities were constructed to support mining operations including a heap leach, a carbon-in-leach processing plant and a two-cell Tailings Storage Facility (TSF) (GHD Pty Ltd, 2008). The site has been under a period of care and maintenance since its closure in 1998 (Straits Gold, 2013). Figure 2.1 shows a satellite image of the main facilities / landforms within Yandan.

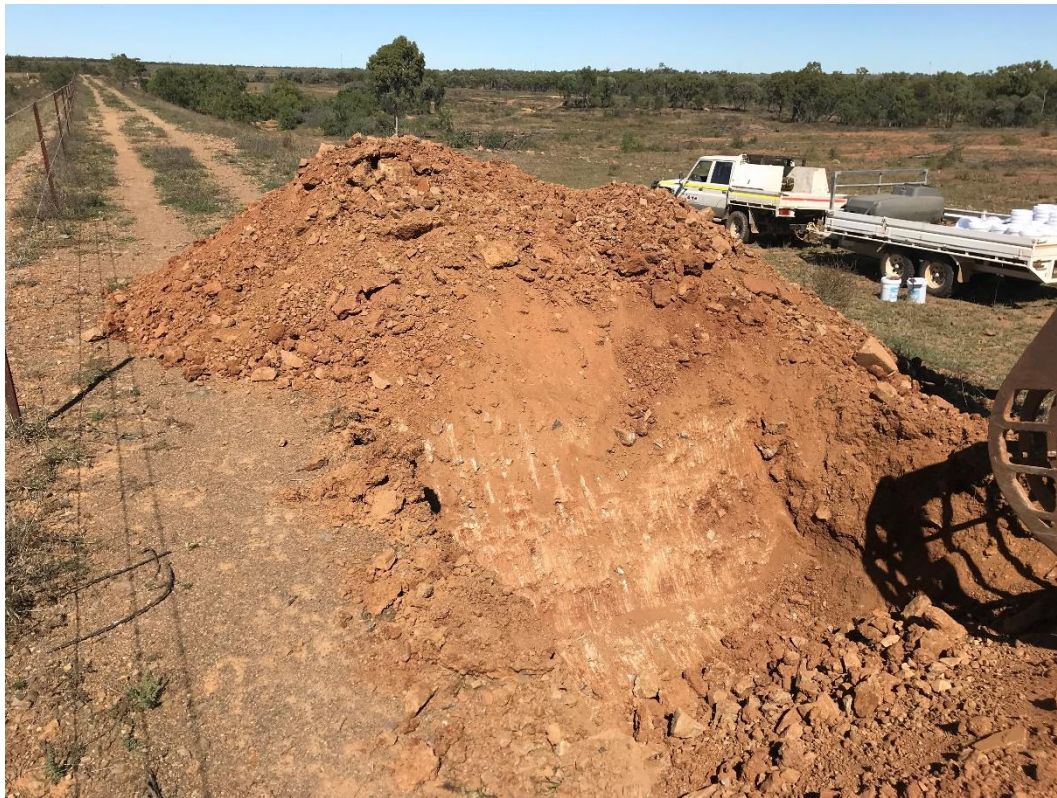
Figure 3.1: Test Pit #13, tailings water dam embankment (clay core)

Stratigraphic logs of each test pit are provided as Appendix B, each detailing the soil profile at each location, samples collected, presence of organic material / roots in the soil, results of the paste pH/EC testing and a photograph of the test pit. Select photographs showing each different material sampling type are included herein for reference (Figure 3.1 to Figure 3.10).

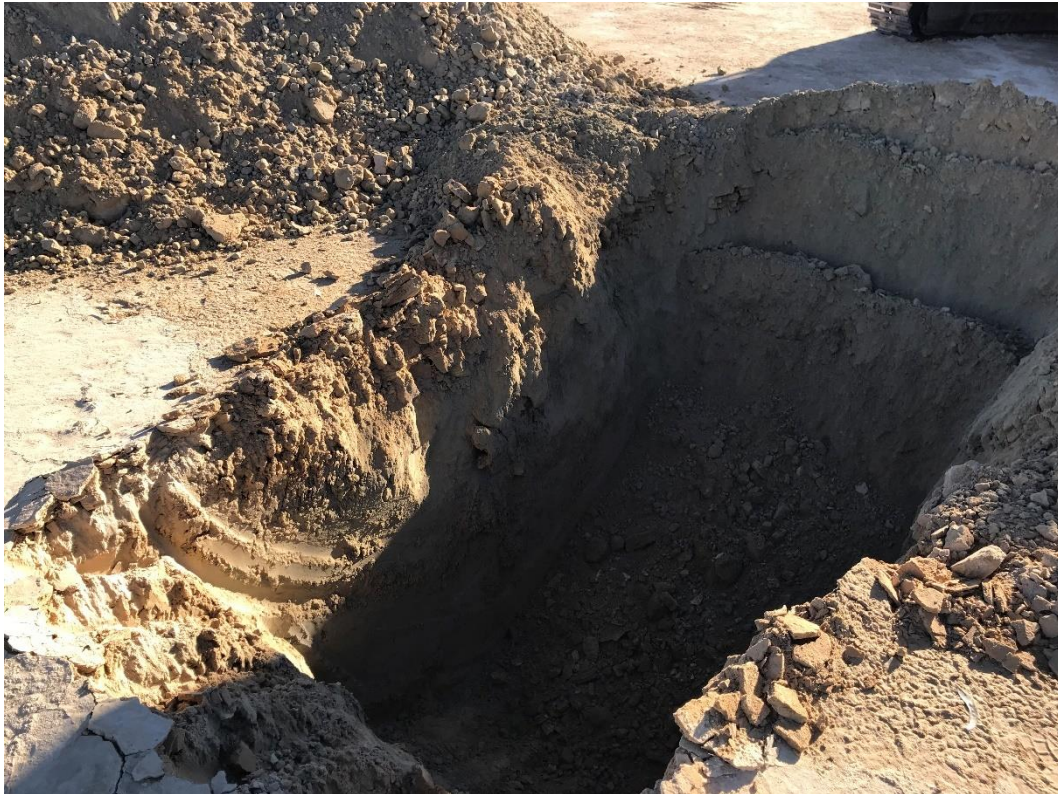
Figure 3.2: Test Pit #23, Tailings.

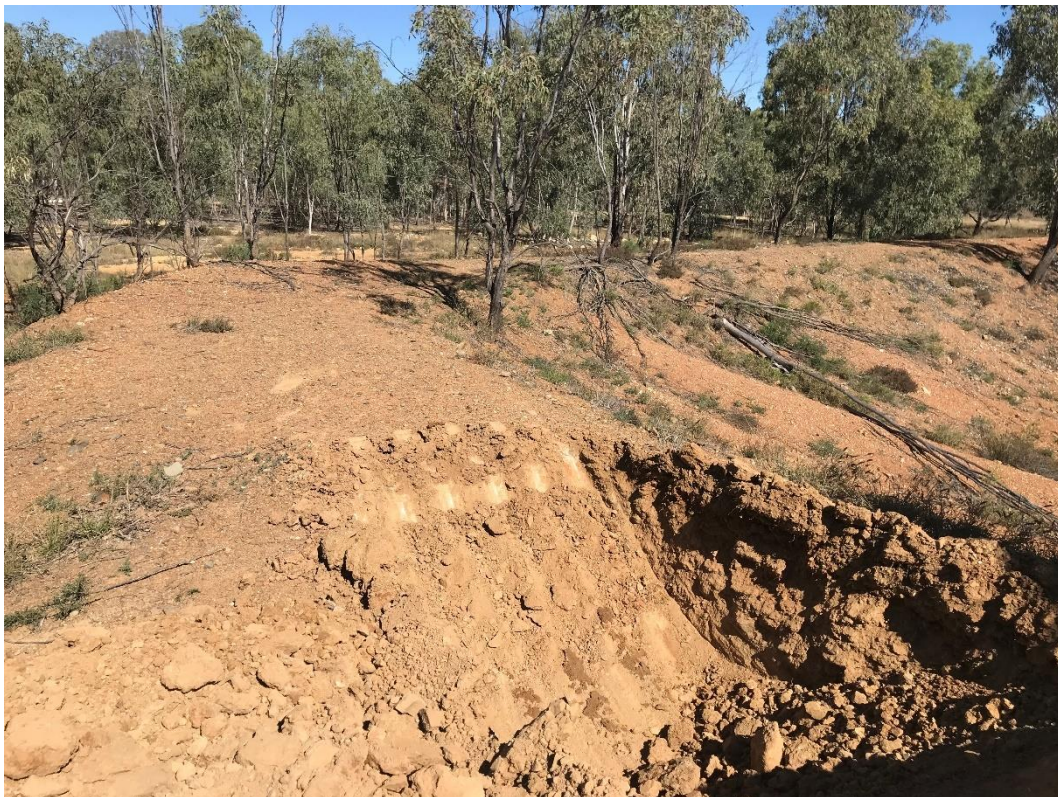
Figure 3.3: Test Pit #5, HL Pond Embankment

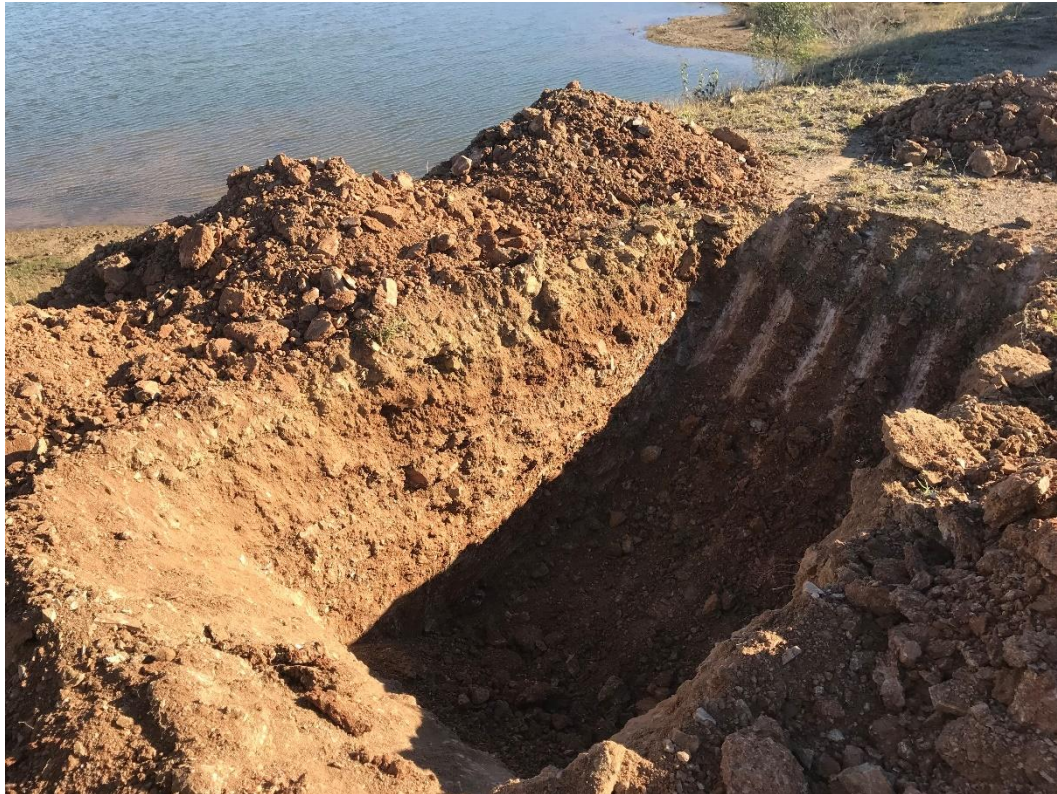
Figure 3.4: Test Pit #7, MWD Embankment (Clay Core)

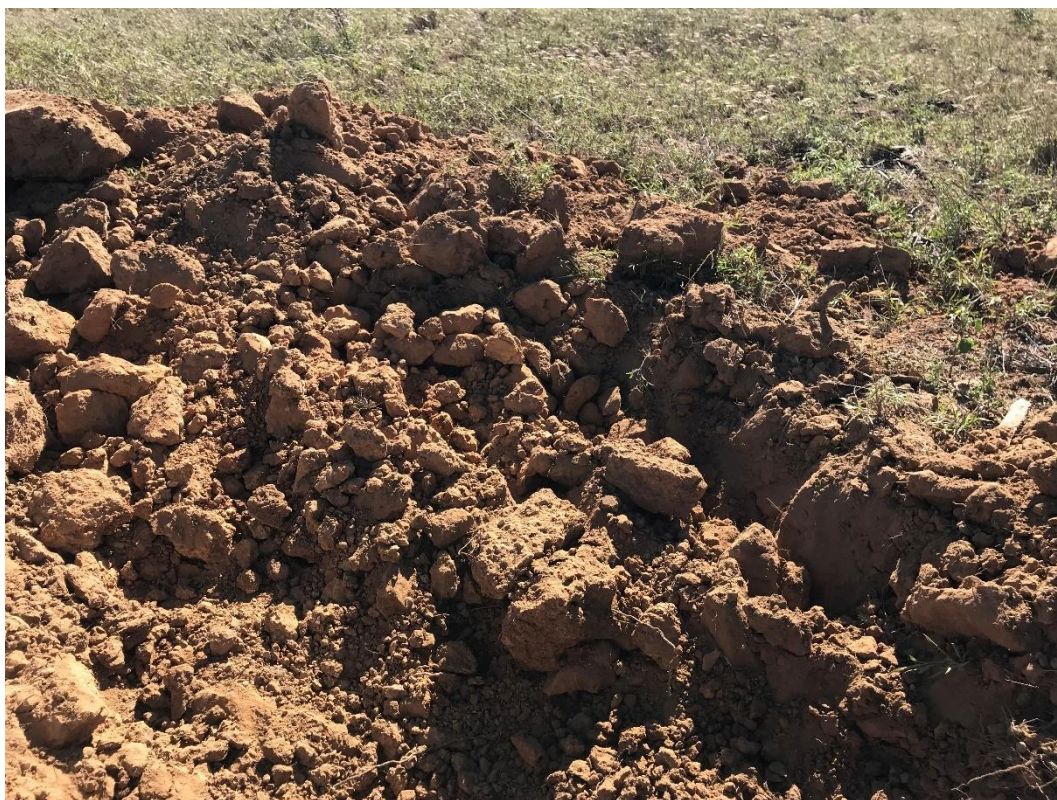
Figure 3.5: Test Pit 1, off-site clay borrow material.

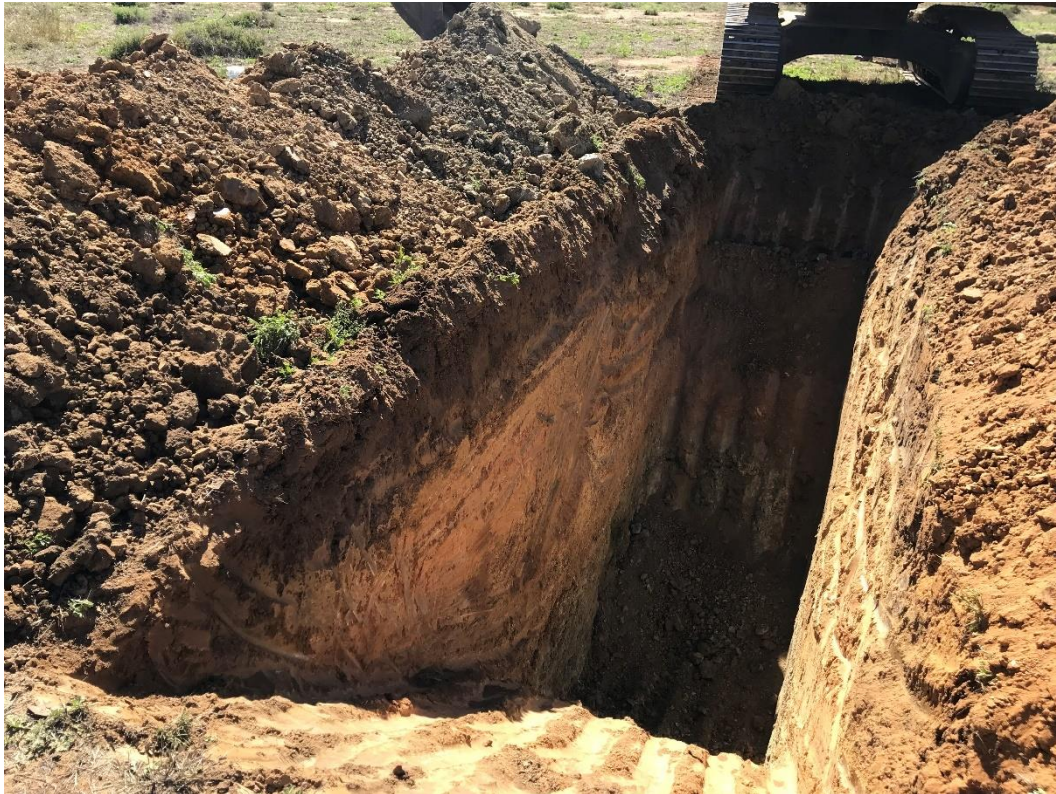
Figure 3.6: Test Pit #11, on-site clay borrow material.

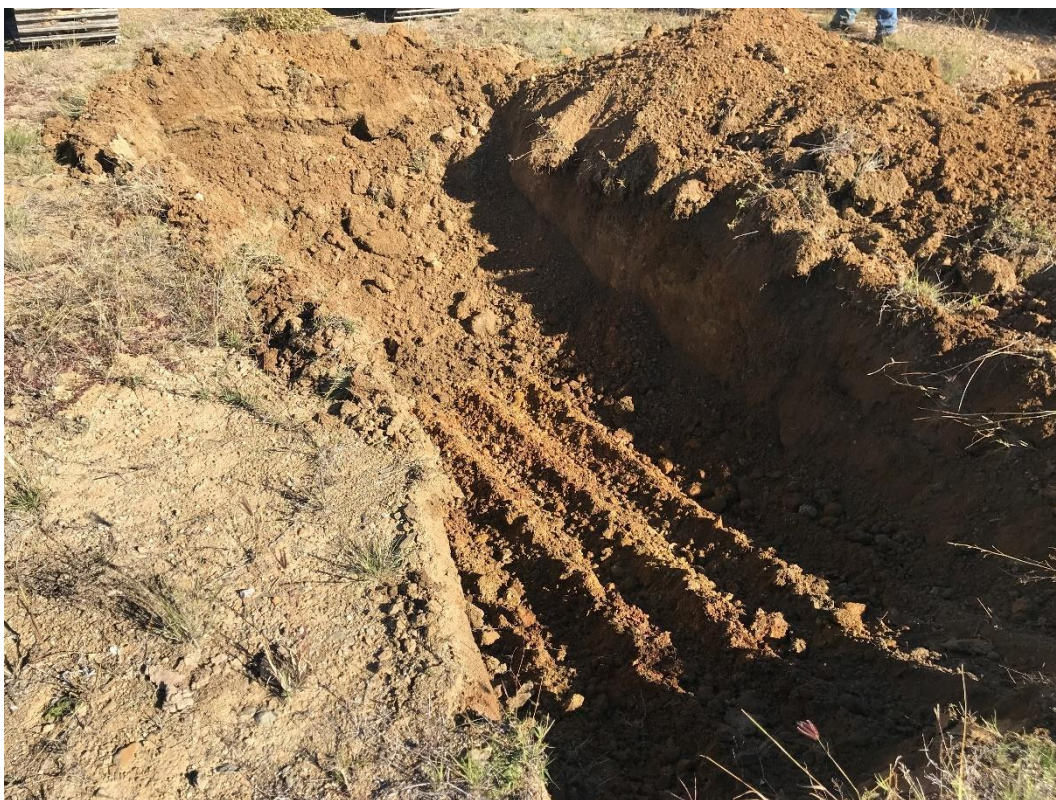
Figure 3.7: Test Pit #18, Topsoil.

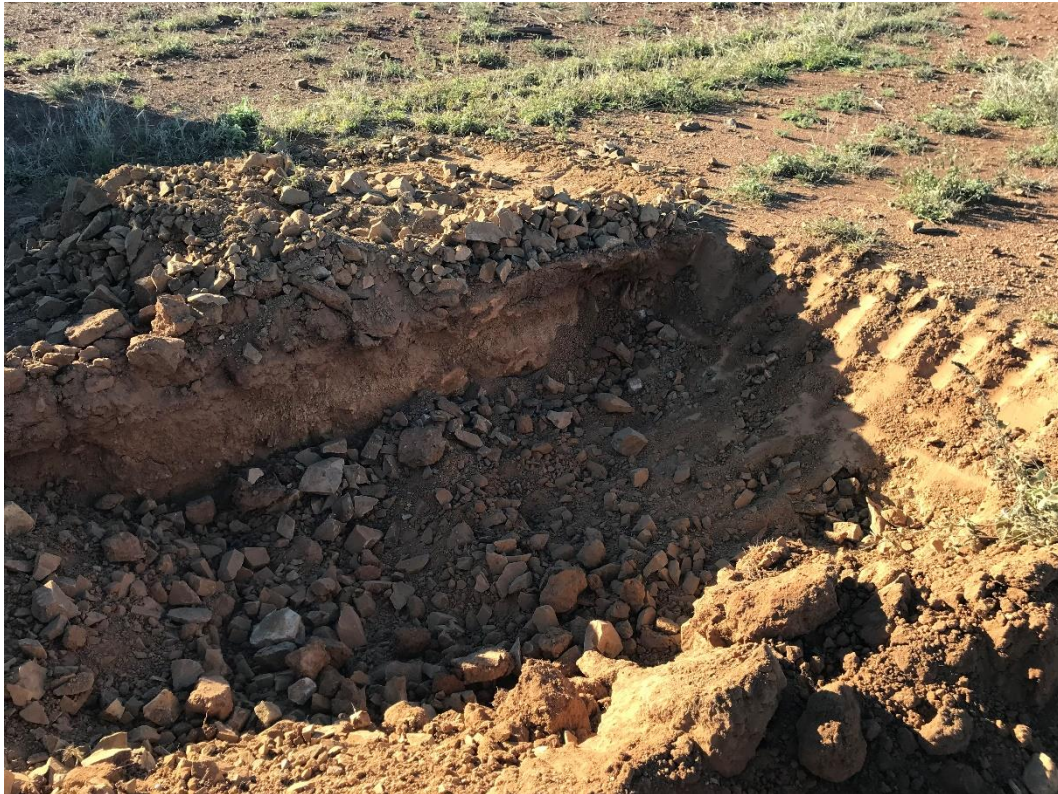
Figure 3.8: Test Pit #20, gravel borrow source.

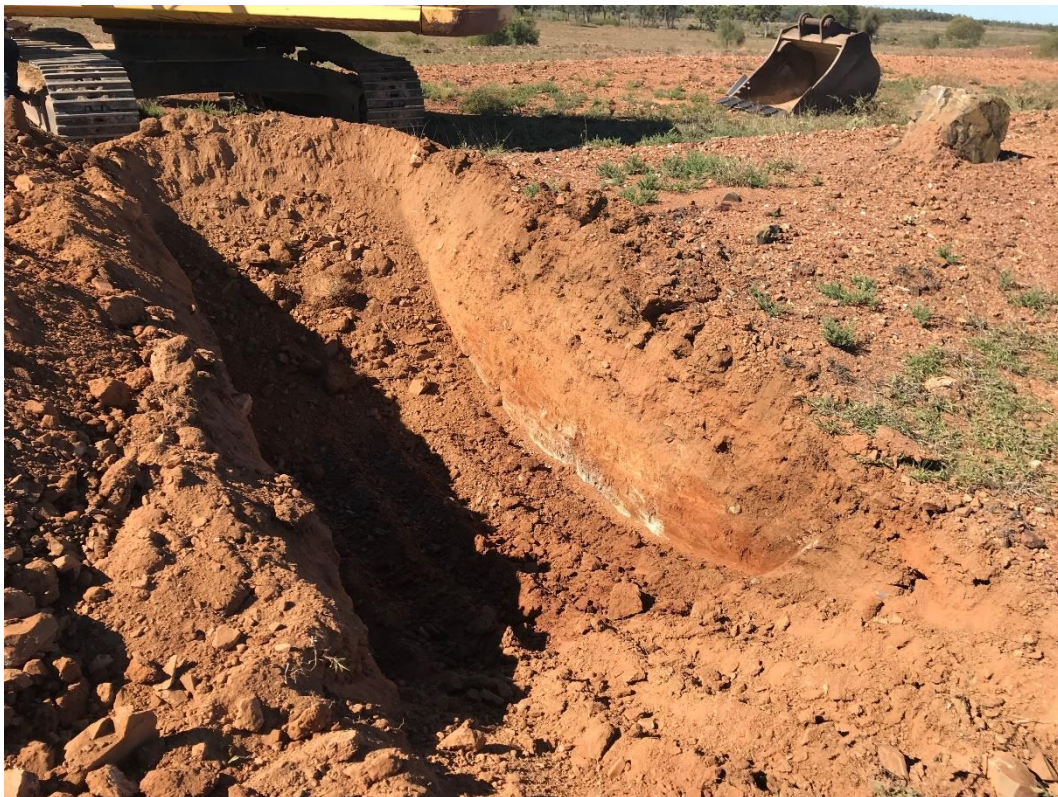
Figure 3.9: Test Pit #15, gravel and topsoil borrow source.

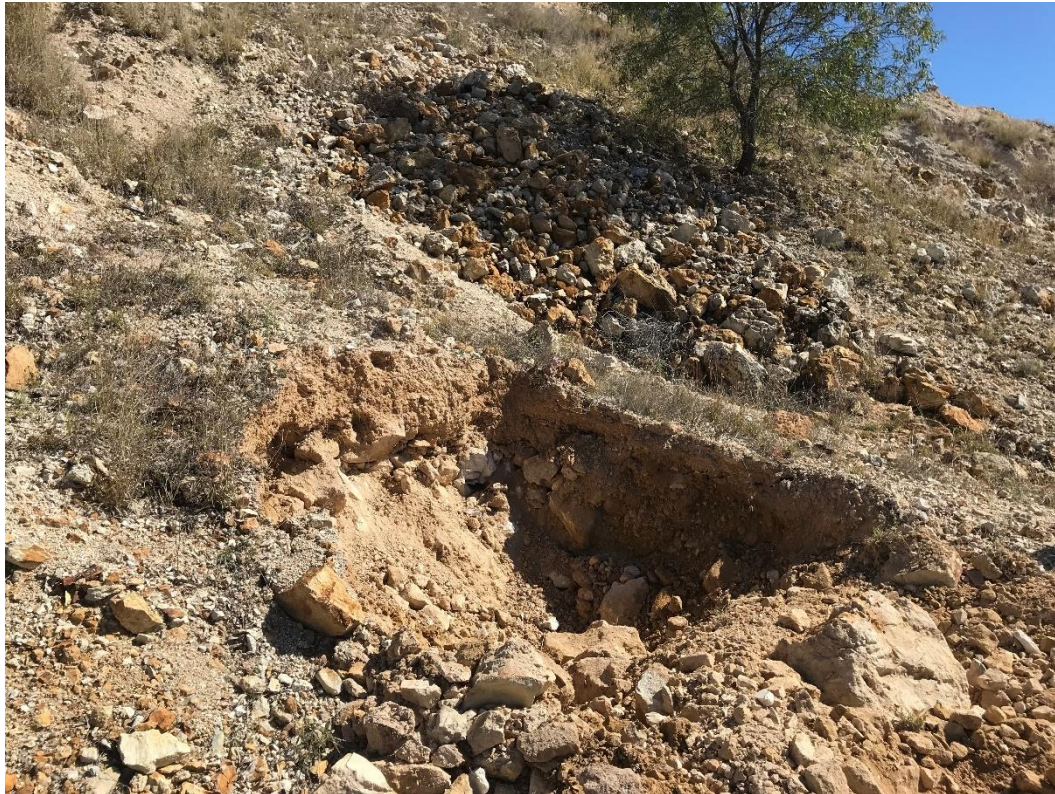
Figure 3.10: Test Pit #4, Heap Leach Pad.

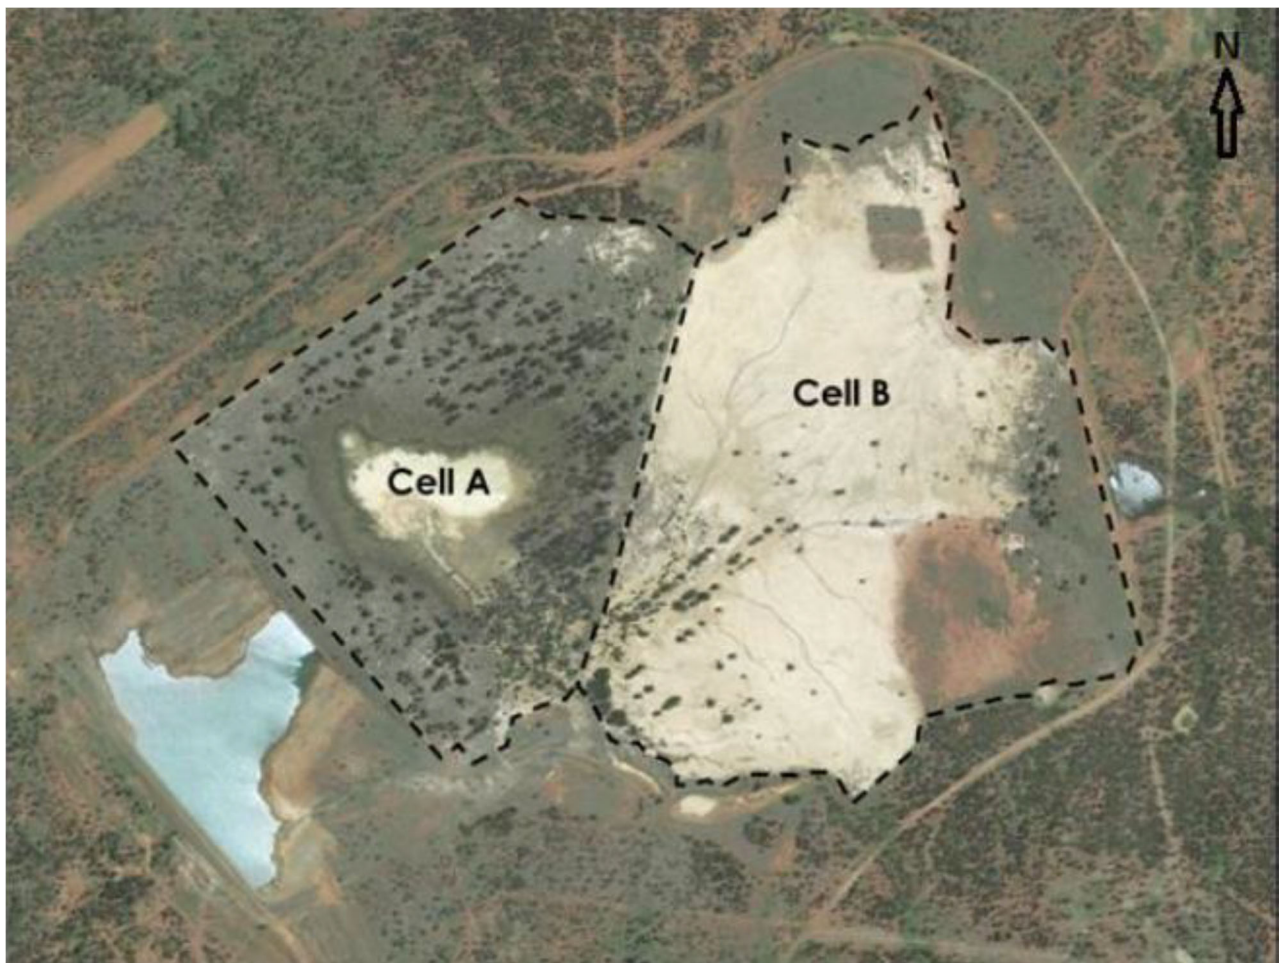
**Figure 1: Yandan TSF** (Source: Williams, 2021)

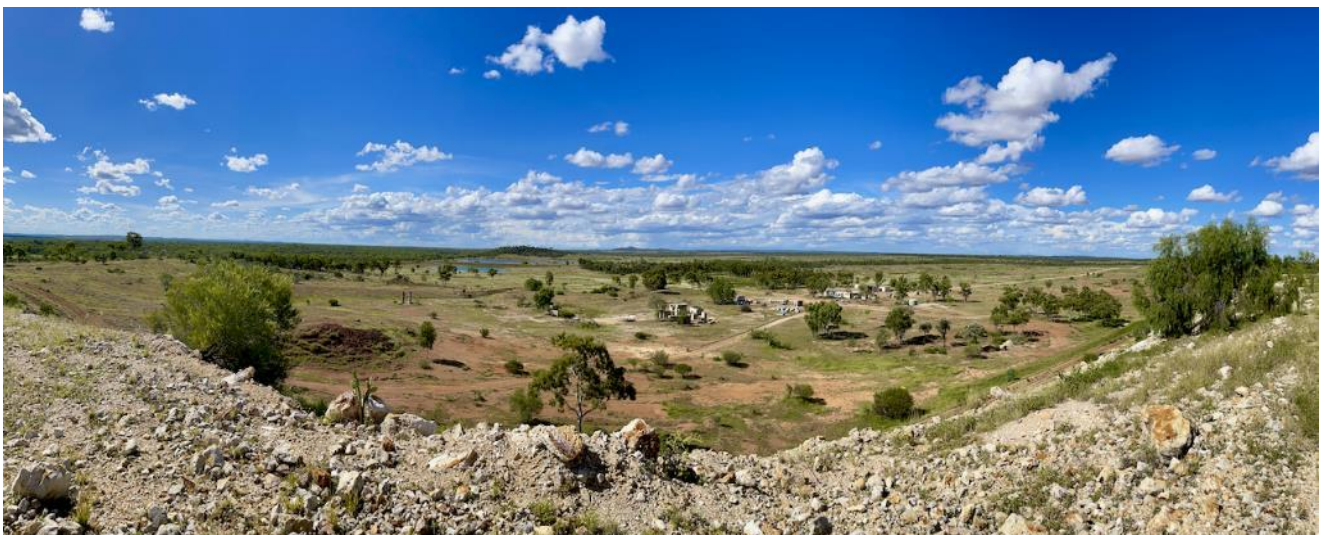
Yandan site is a gently undulating site, rising from adjacent to the Suttor River at around 168mAHD to 191mAHD at the tailings area in the east over 3 kilometers (Figure 3). There are three (3) small hills on the site, rising generally 5-10m, but up to 30m from the broad depression where the Suttor River flows. The highest elevation on the site is 212mAHD as the top of the heap leach pad. Mount Coolon township lays at ~230mAHD.

*Figure 3 - View north over Yandan project site from top of heap leach pad*

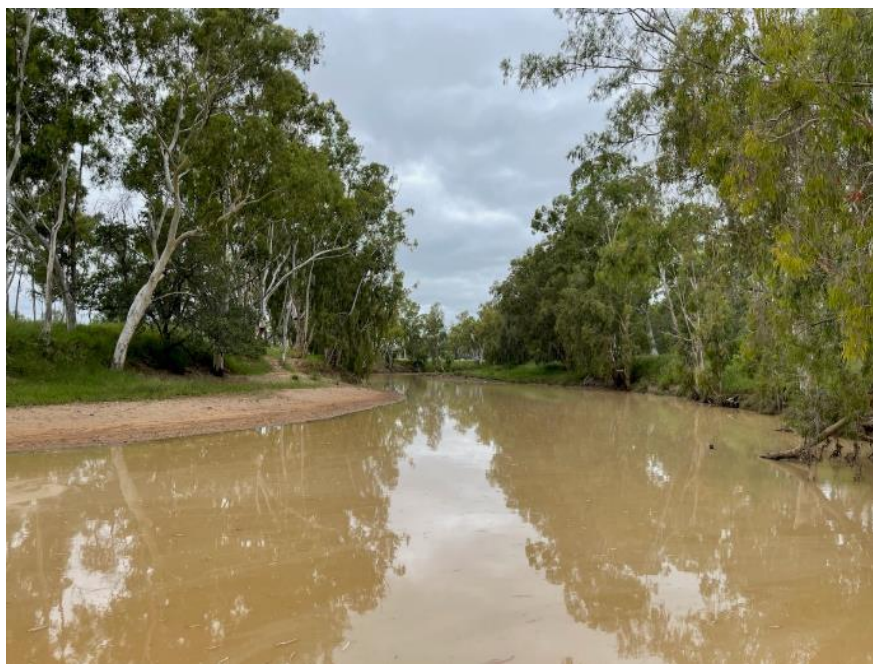
*Figure 5 -Suttor River approximately 50km upstream of Yandan*
