# TRANSITIONAL PROGRESSIVE REHABILITATION AND CLOSURE PLAN

## YANDAN GOLD PROJECT

PREPARED FOR  
STRAITS GOLD PTY LTD

28 MARCH 2022

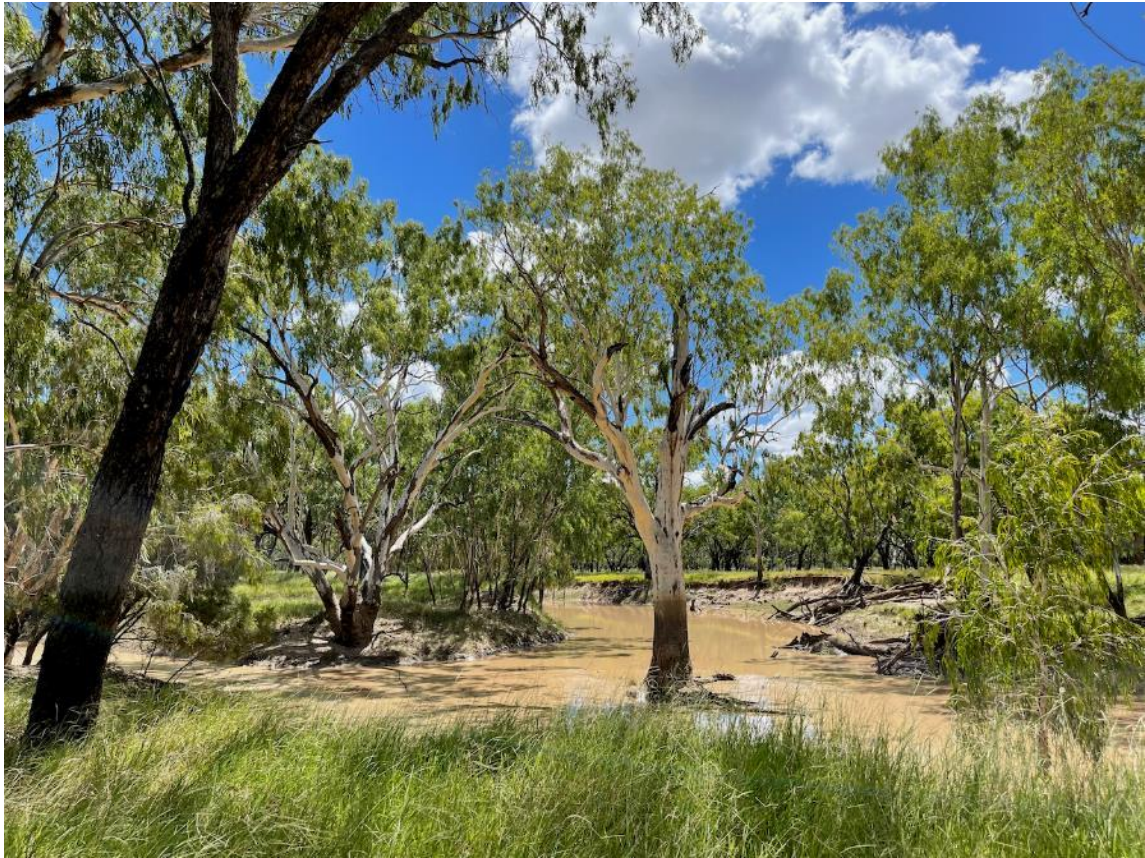
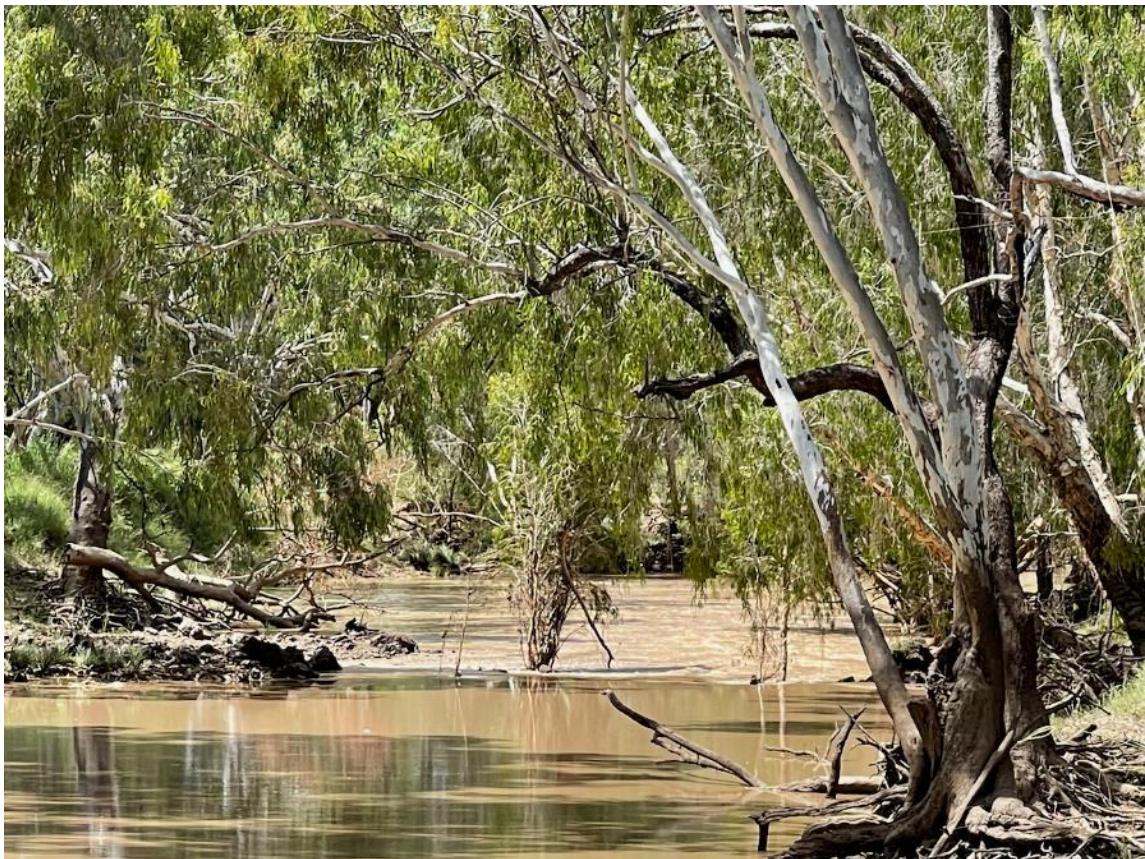
*Figure 11 - View of Suttor River near discharge zone of Main Pit*

The Suttor River runs along the western extent, flowing north towards Burdekin Dam 50km to the north. The Suttor River runs close to the periphery of Main Pit, & Main pit has two spillways which enable hydraulic connections between the pit lake & river flow from the Suttor or Yandan Creek when water level exceeds 169mAHD. Yandan Creek enters the project area from the south & is diverted around Main Pit before joining the Suttor River. Conditions are generally dry, with drainage lines only flowing after rainfall.

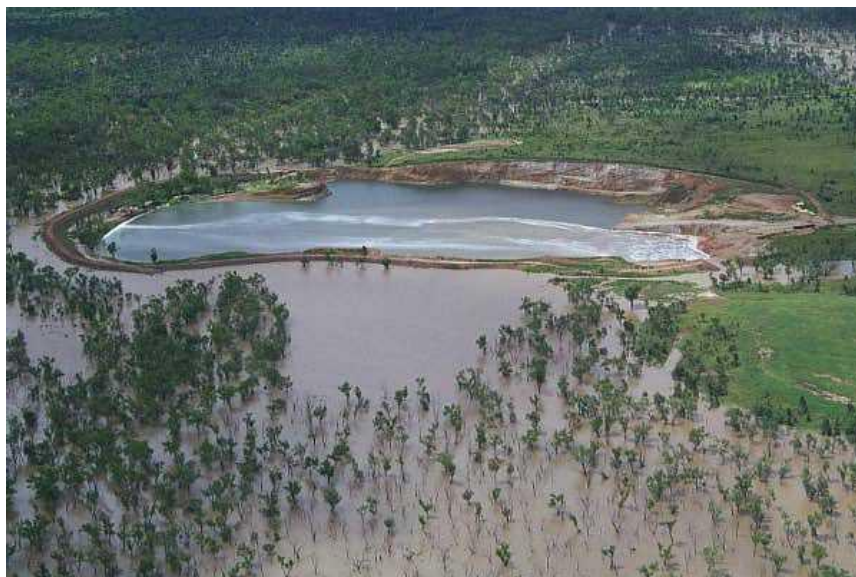
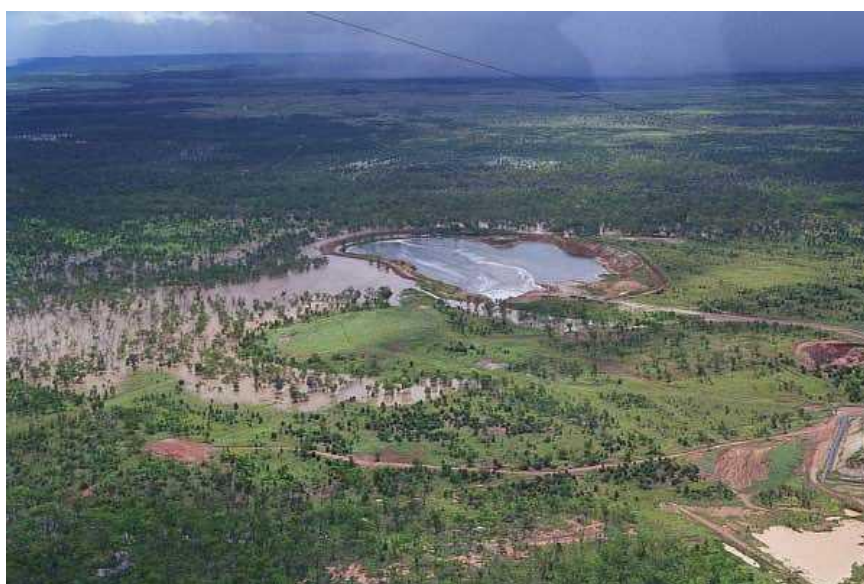
Figure 24 - View of Main pit during flood in 2020

Conversion of river height where hydraulic connection from the river to the pit matches 3.8m depth at the gauge to a flow rate of 500m<sup>3</sup>/s at St Anns. The equivalent flow rate averages around 10% AEP, or once in every 10 years, but with variable rainfall & flow over the record, varies from 5% AEP to up 25% AEP.

Based on AECOM (2020) records, the pit & river have connected (either through inflow or releases) 6 times since installed (2000, 2001, 2003, 2004, 2007, 2011) over 22 years, which would support an AEP based on past climate of 25%. A view of Main Pit & Suttor River in flood from 2000.

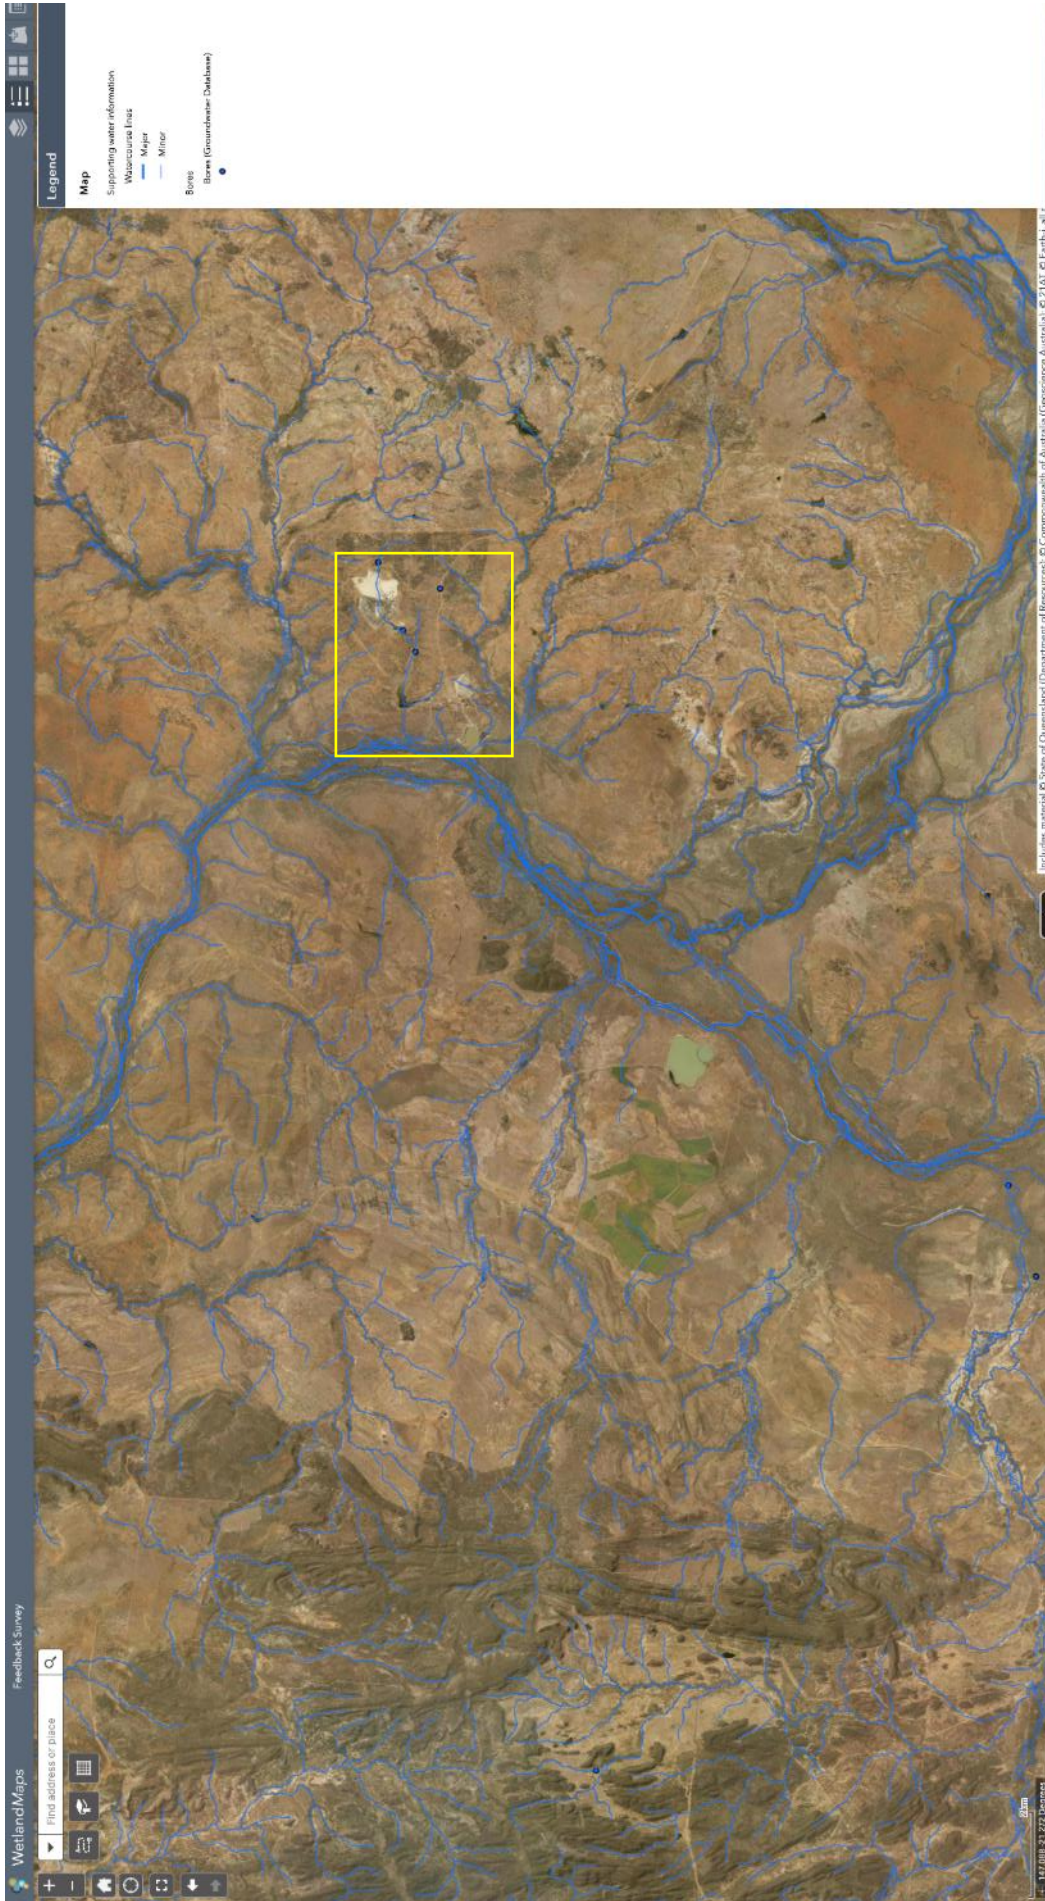
Figure 34 - State registered well locations & nearby water users

Groundwater is not well developed in the area, with state registered showing only a few bores within Yandan for the region (Figure 34). An upstream neighbour appears to be running a very large irrigation operation, with a significant dam storage & cultivated field.

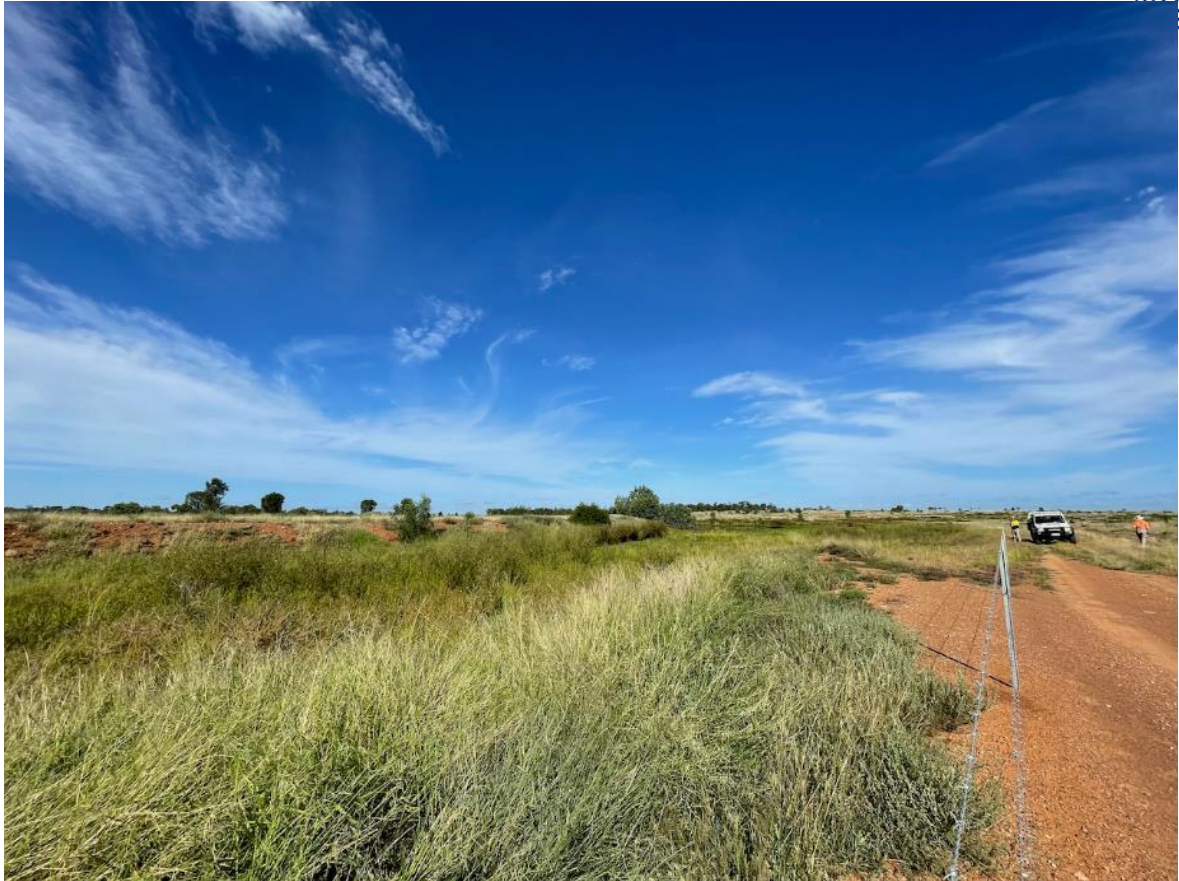
*Figure 40 - View of low relief tailings landform at top of catchment*

Yandan tailings is stored in a broad & low relief 115ha landform (Figure 39) which begins as a low 1-3m embankment from the top of catchment & wraps over the landscape in a platform to a 12m earthen embankment downstream (Figure 40 & Figure 41). The landform sits above maximum flooding elevations of current PMF & consists of two cells: Cell A & Cell B.

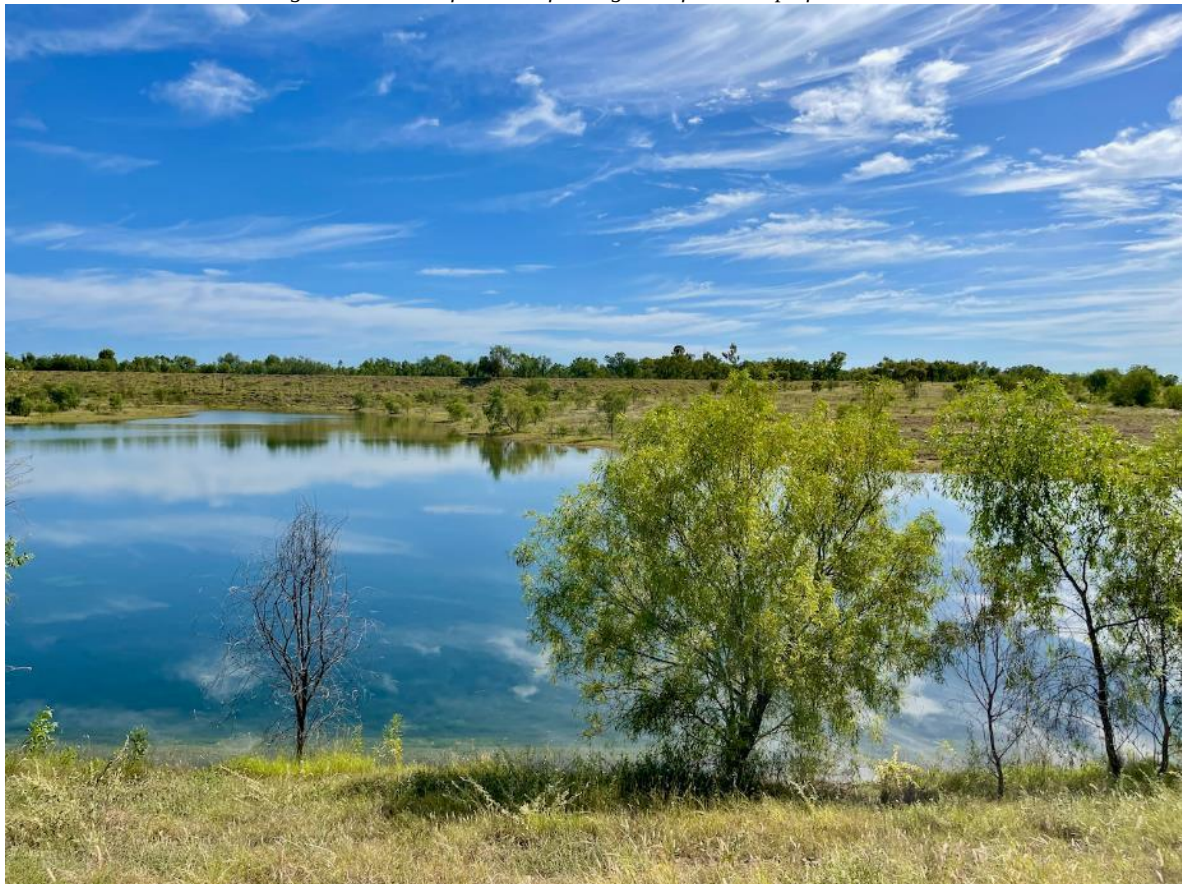
*Figure 41 - View from downstream of facility looking at downstream embankment from containment dam*

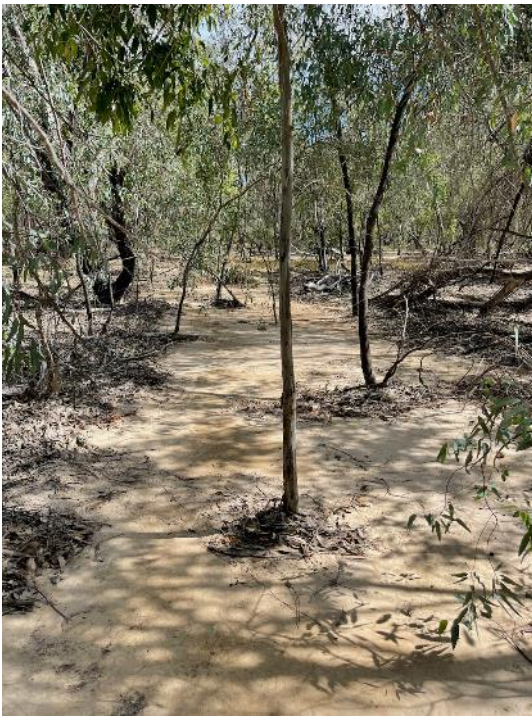
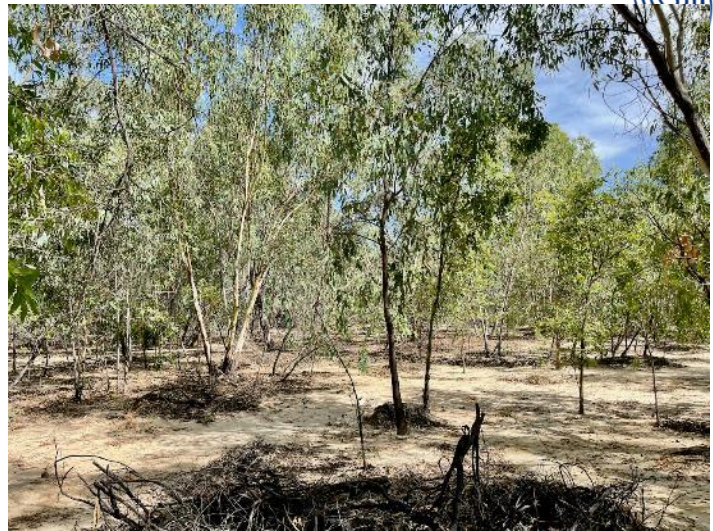
*Figure 42 - Views of surface of Cell A (rehabilitated)*

Cell A is classed as rehabilitated (Figure 42) & Cell B is yet to be rehabilitated (Figure 43). The surface of the facility is very low gradient (flat): rainfall flows across the surface of Cell B to a broad depression area in Cell A where it ponds & likely seeps into the tailings storage below (Figure 44). When Cell A when pond capacity is exceeded, excess water flows over the spillway on the south side when the pond fills. Spillway flow is directly contained by the tailings return dam (containment dam).

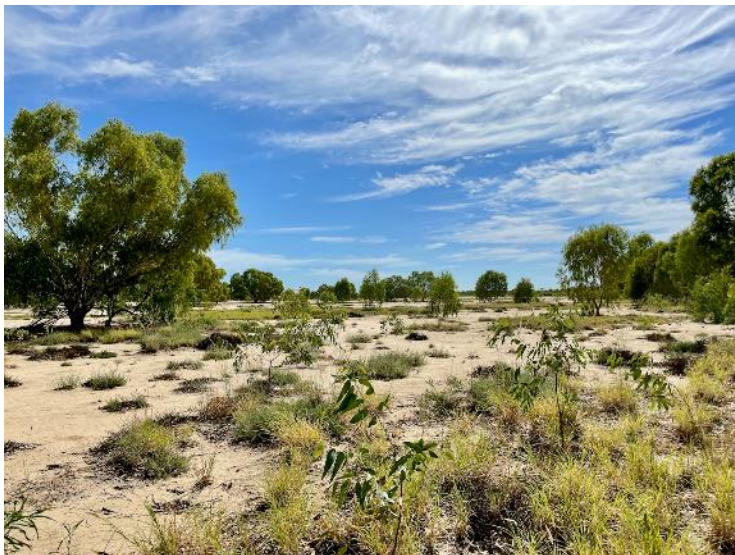
*Figure 43 - Views of surface of Cell B tailings*

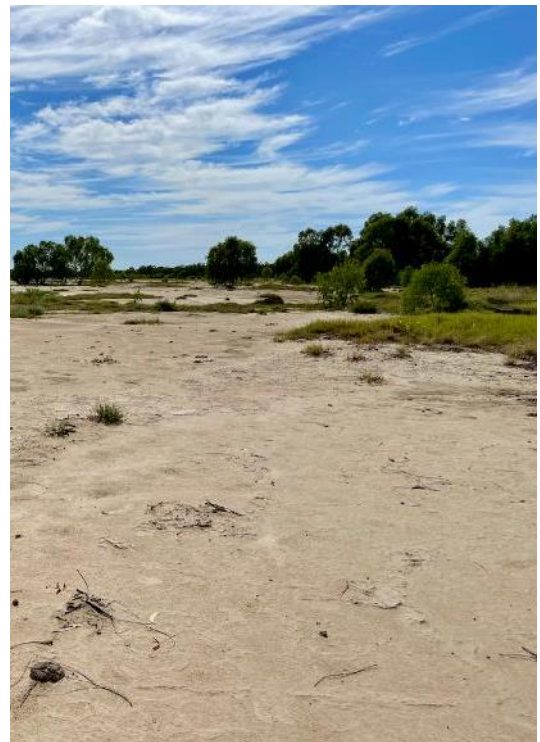
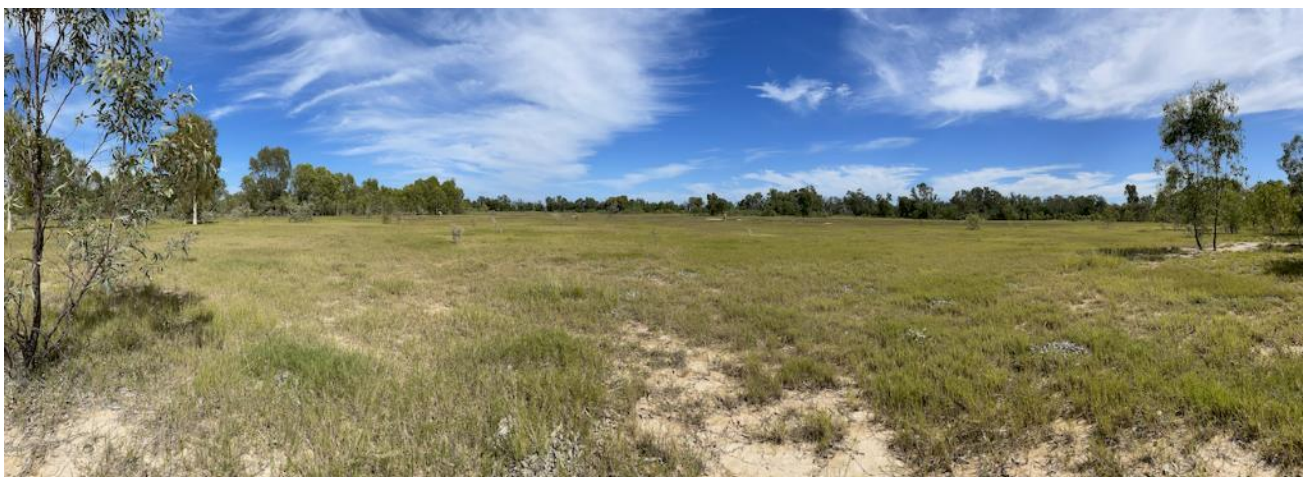
*Figure 44 - View of broad depression & ponding area on Cell A*

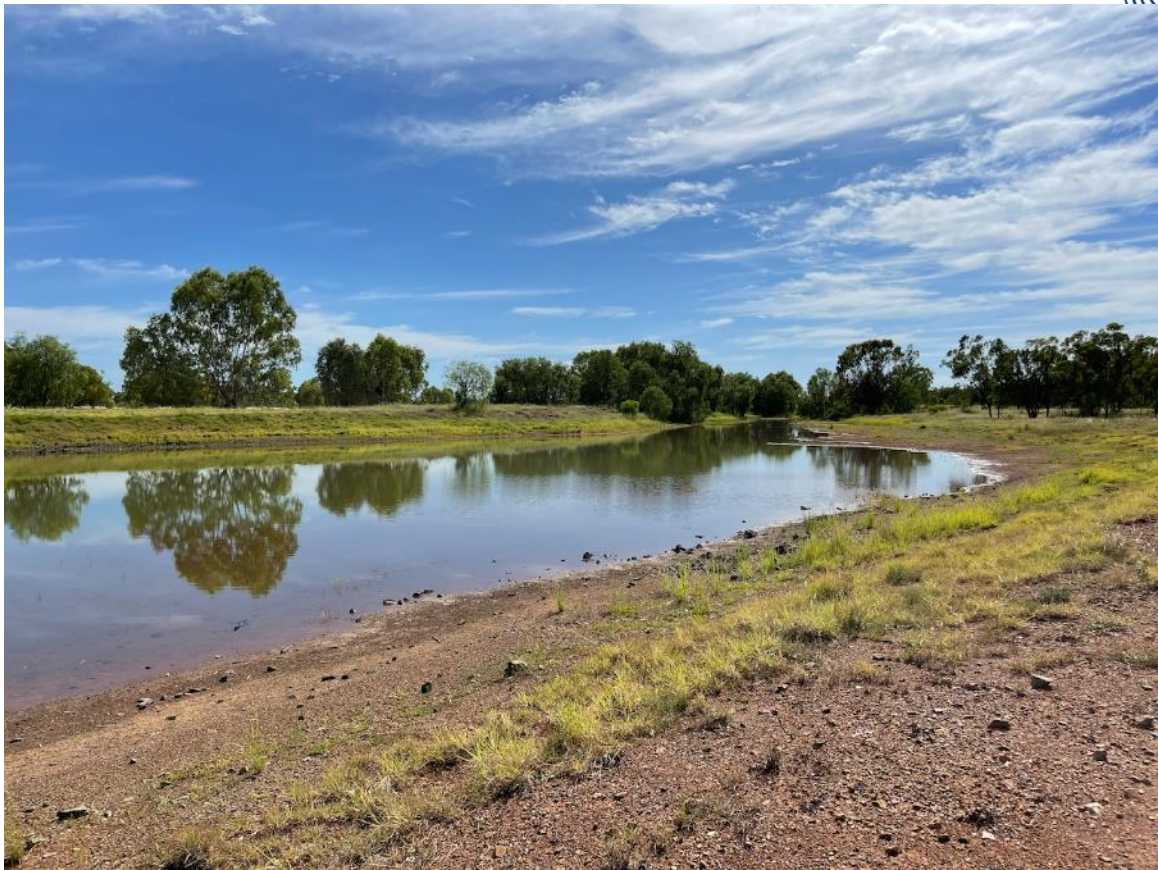
*Figure 45 - South borrow pit ponding against embankment (TD Cell B)*

Around the perimeter of the landform, there are several borrow pits directly adjacent to tailings embankment, presumably for use of material in construction (Figure 45 & Figure 46). With rainfall, these borrow pits are acting as places for additional ponding & actively store water given the low relative level to tailings & ground surface: it is likely the ponds are a mix of tailings seepage water & rainfall. On the eastern side, the landform is not quite at the top of catchment & has a small drainage line above which has a retaining structure as a dam wall with an access road, & a storage lays beneath (TDP).

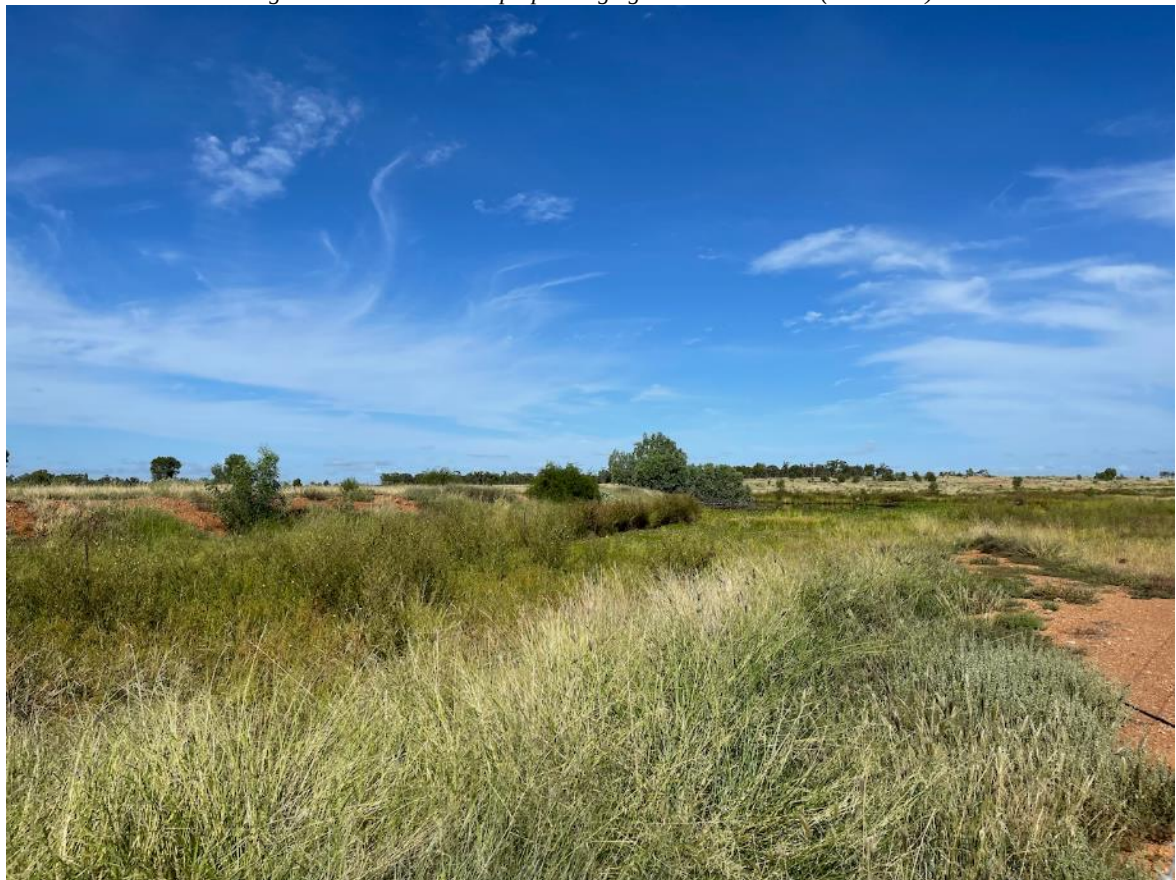
*Figure 46 - North borrow pit ponding against embankment (TD5)*

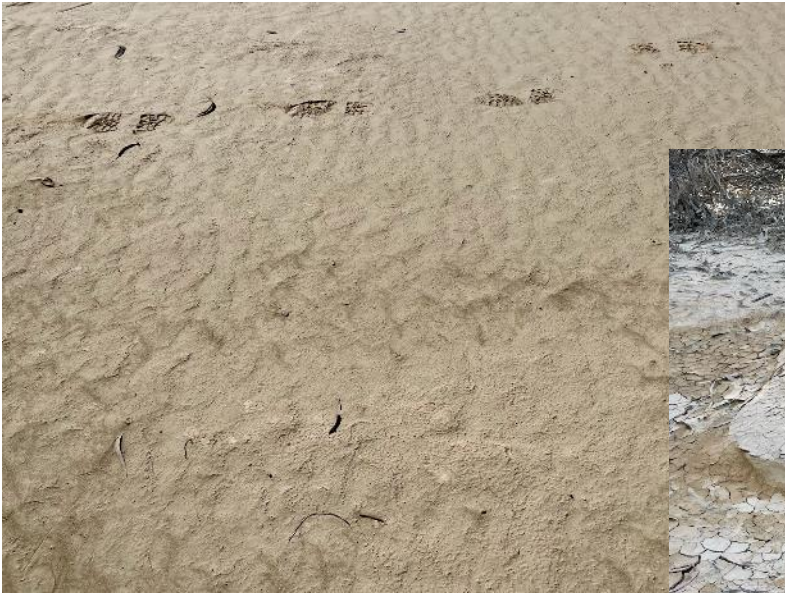
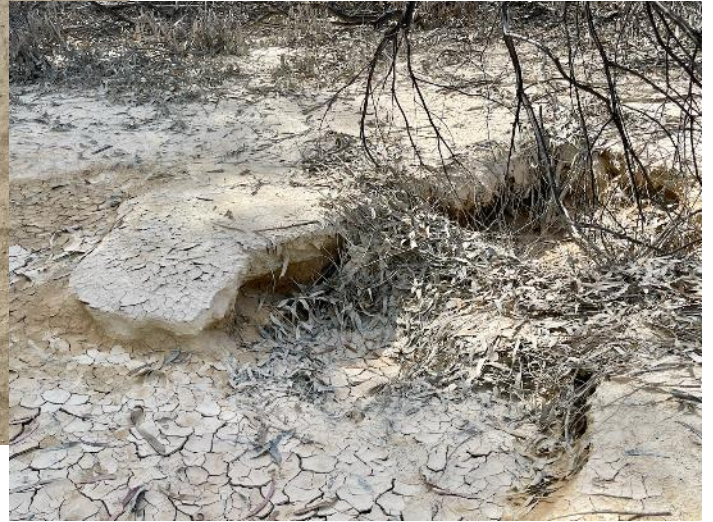
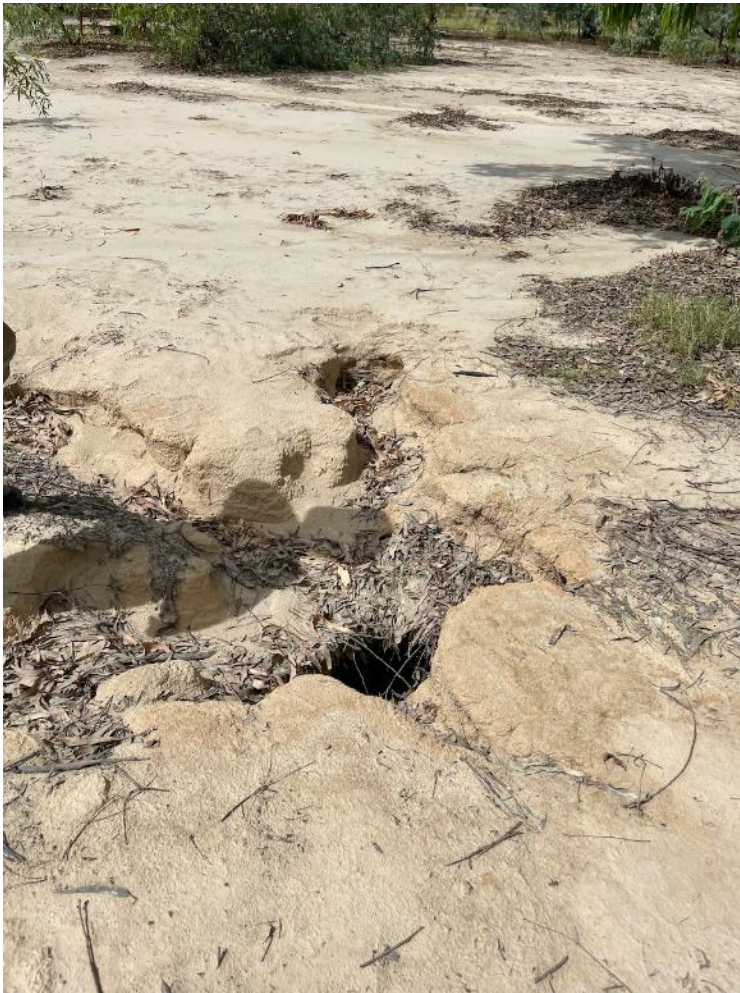
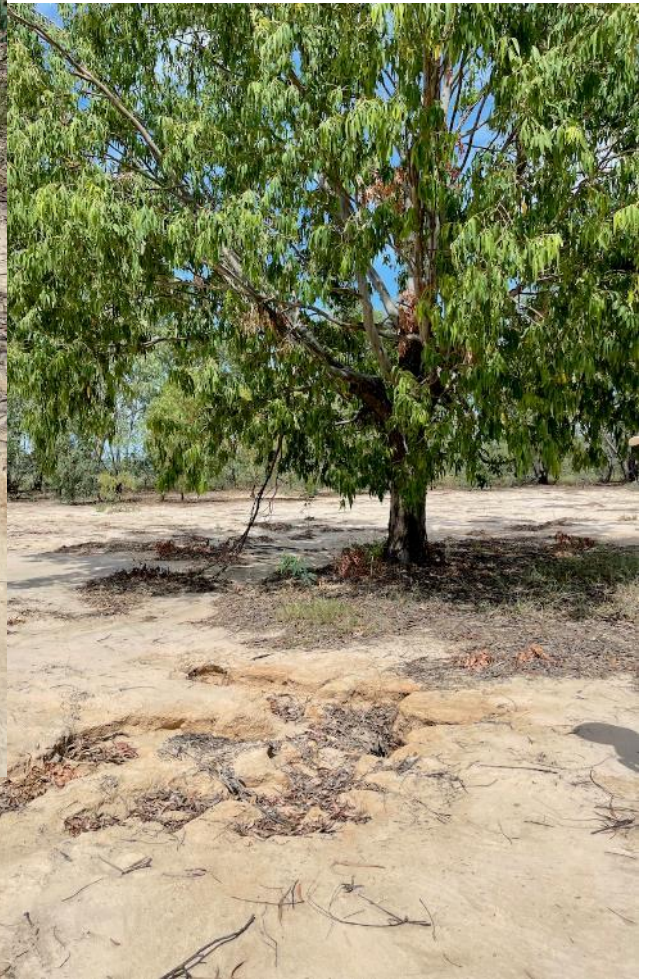
*Figure 47 - Views of differential settling & internal erosion visible on the tailings surface*

Inspection of the tailings surface identified several areas of internal erosion & small voids observed into the tailings (Figure 47), likely associated with either differential settling & increased flow with the lack of drainage, taking advantage of decomposed tree roots which when removed leave a preferential pathway for water flow. Ripple marks from over-surface flow from rainfall is also present.

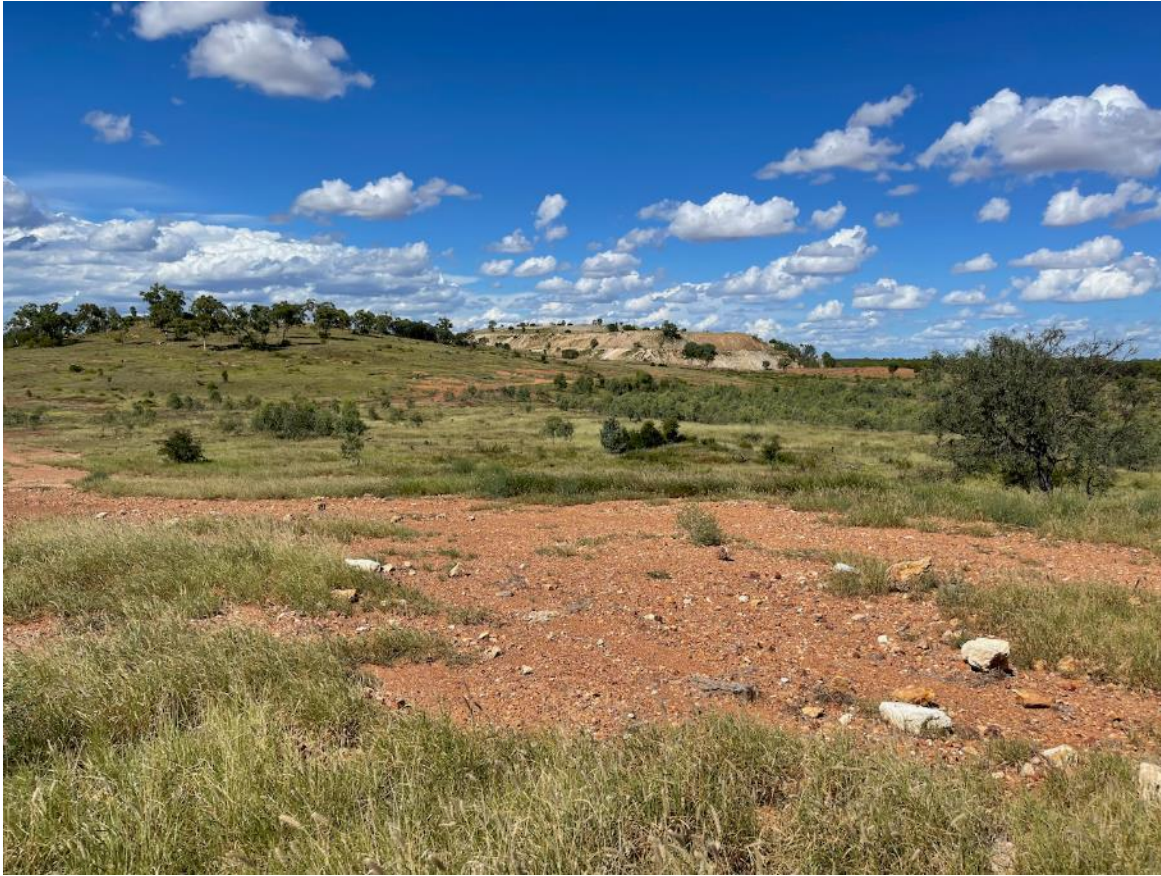
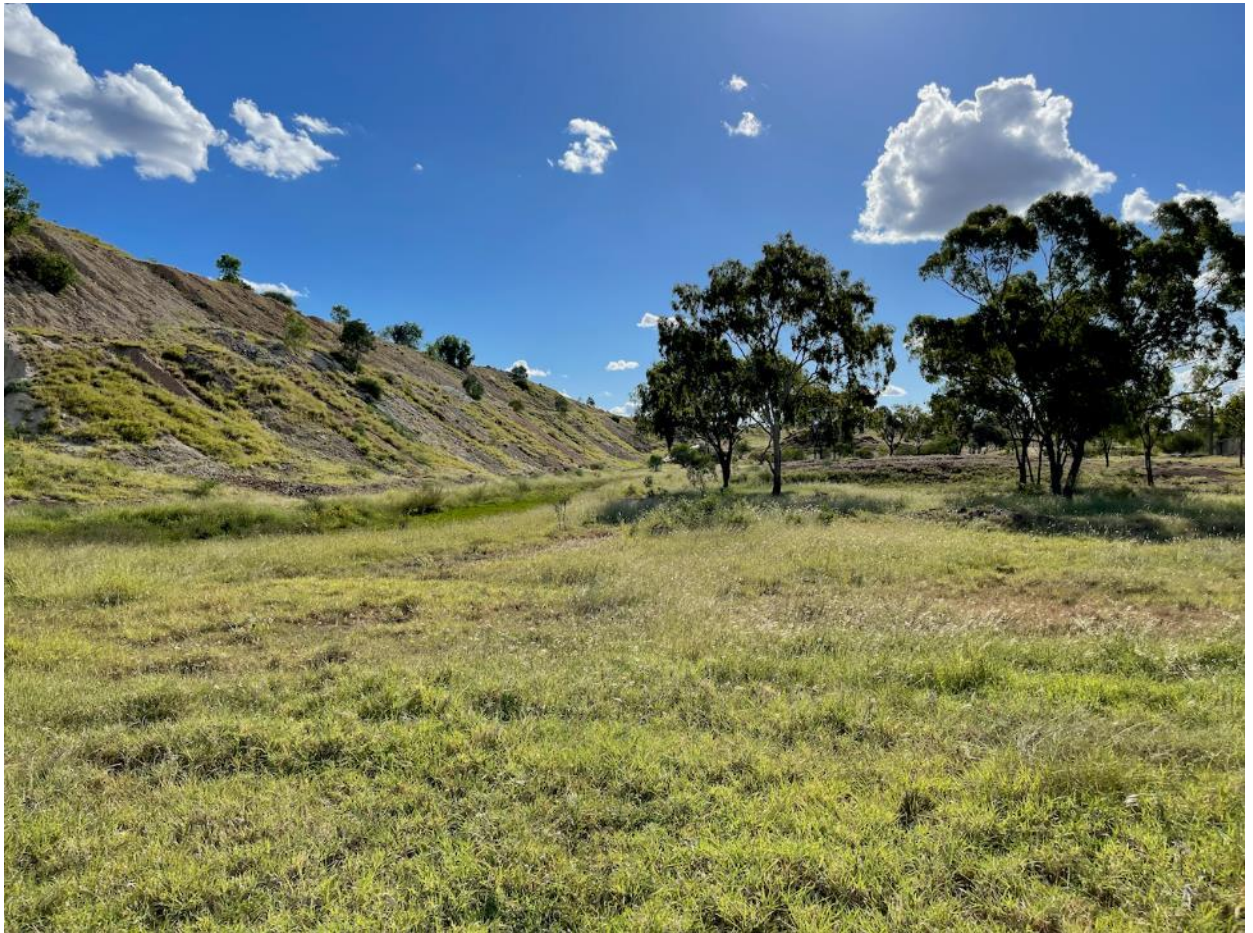
*Figure 54 - View of heap leach pad (distance & nearby wall)*

The legacy Yandan heap leach is a 25m high, 17.4 hectare landform, constructed at the top of a small hill upgradient from Main pit (Figure 53 & Figure 54). Construction at the top of the hill & to the south side enabled the heap leach to remain above the 1% AEP flood levels & to direct water flow downgradient towards containment ponds. At 212mAHD, the top of the heap leach landform is the highest point across the site. During operation, the leaching process involved application of lime within the facility, & cyanide to liberate the fine gold. The process of leaching is based on infiltration through a landform: spraying a low cyanide concentration water across the leach pad, which percolates through the landform & is captured as a leachate for processing & gold recovery.

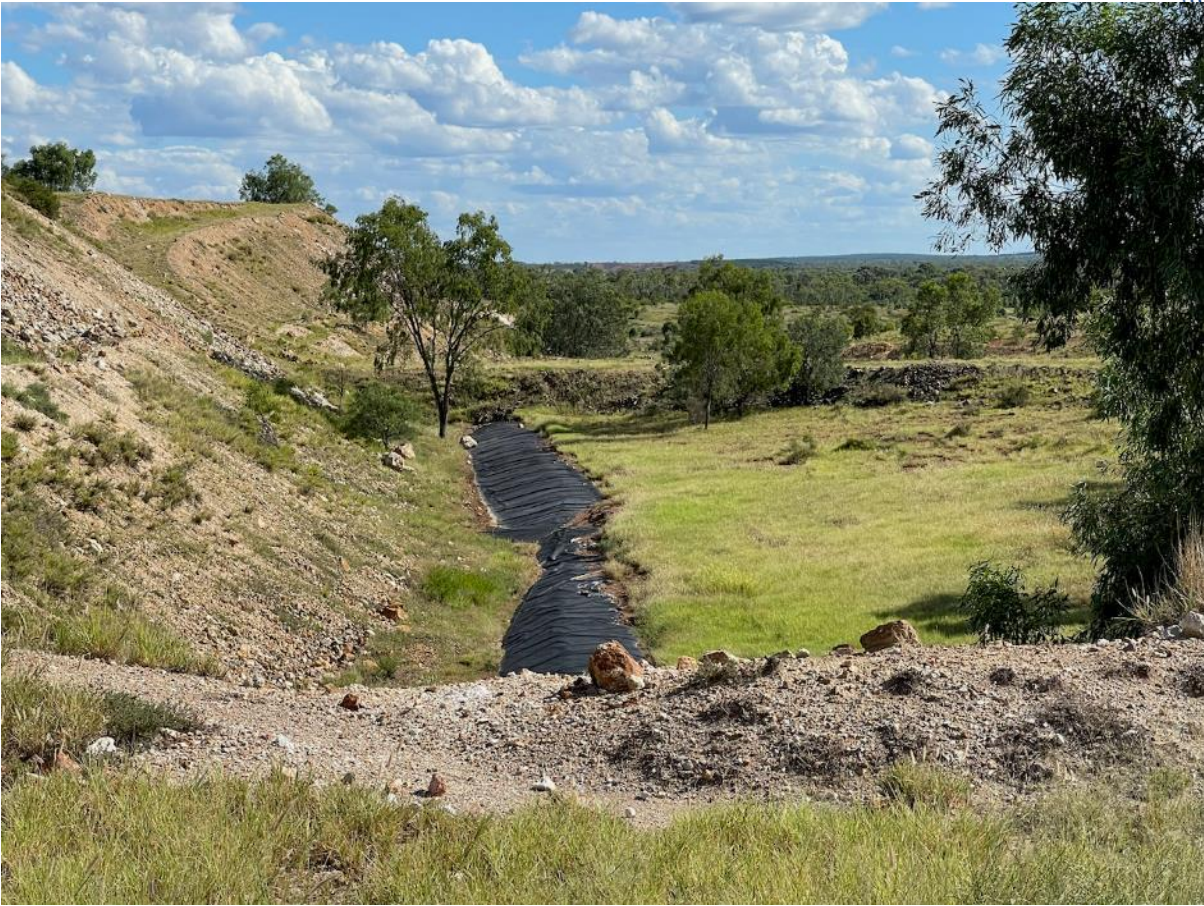
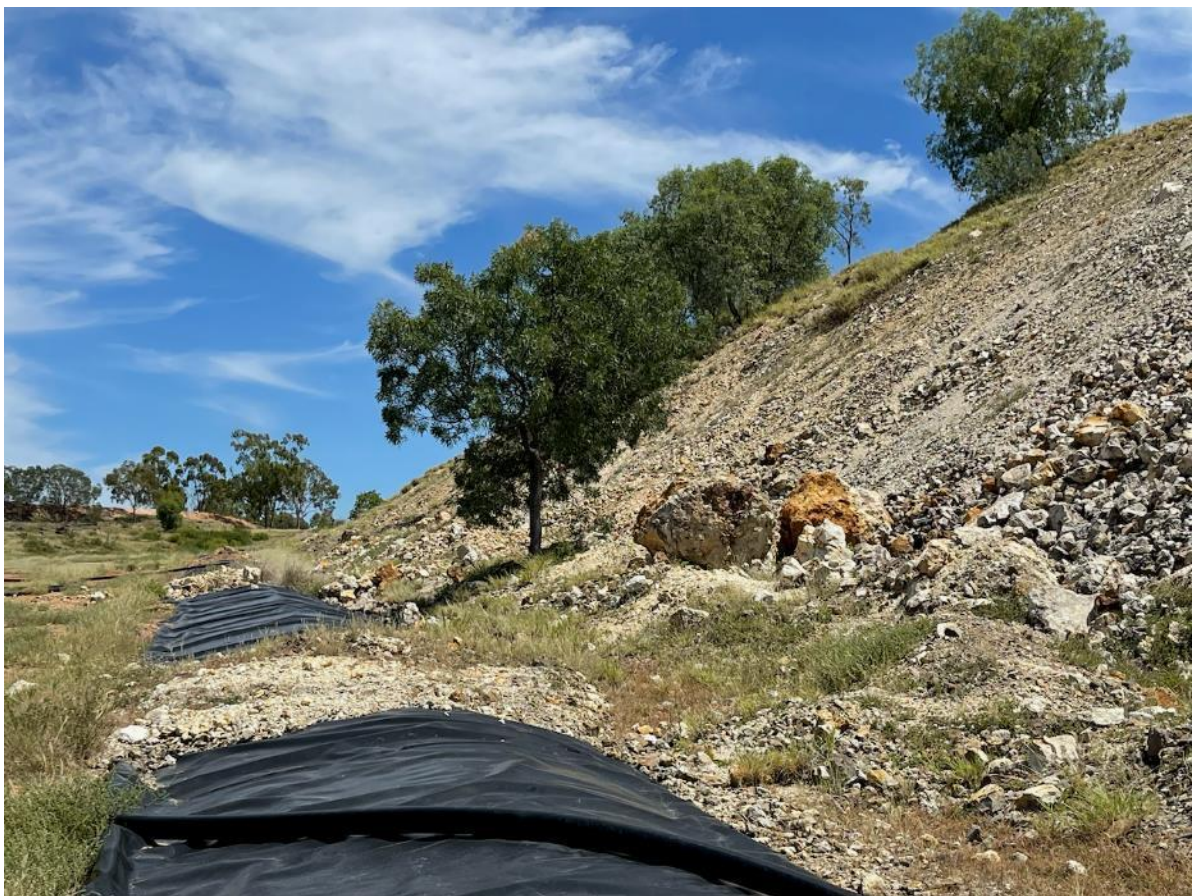
*Figure 55 - Views of leach pad drainage with some erosion & minor wall slumping*

The heap leach drains from north to south, & consists of the constructed landform of low grade oxide rock, a perimeter capture drain (Figure 55), a remnant leach collection pond area, and stormwater capture dam (Figure 56). A bund wall lays further to the south as secondary protection from overland flow. Groundwater monitored by six (6) shallow monitoring wells around the perimeter & near to the leach ponds, plus a downgradient well, HL3. The site is likely to lay on geology of volcanics & siltstone.

Inspection of the heap leach landform & surrounding infrastructure indicated a broadly sound structure: degradation of the perimeter drain through sediment fill has occurred in multiple locations & would not function well as a containment drain. The lining of the leach pond is also ripped & would no longer be acting as containment (Figure 56). HL1 close to the embankment of the leach pond & is likely in connection with the water storage.

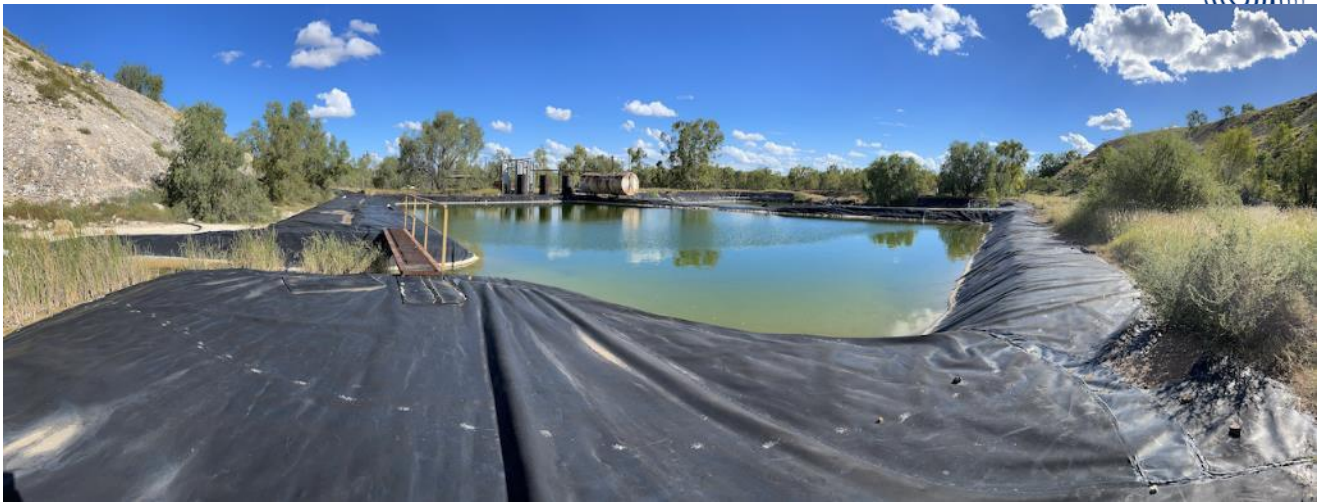
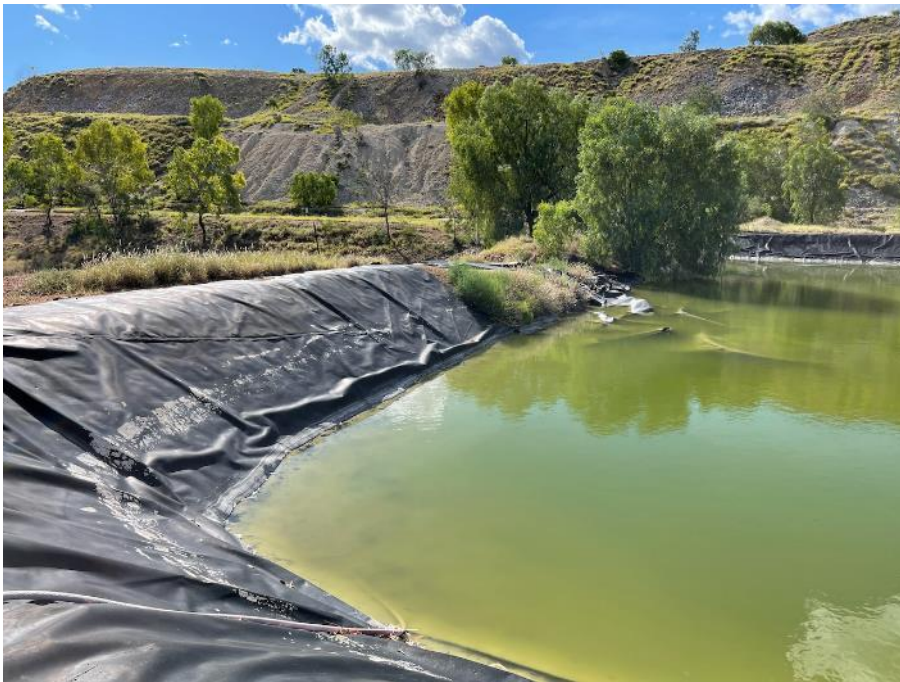
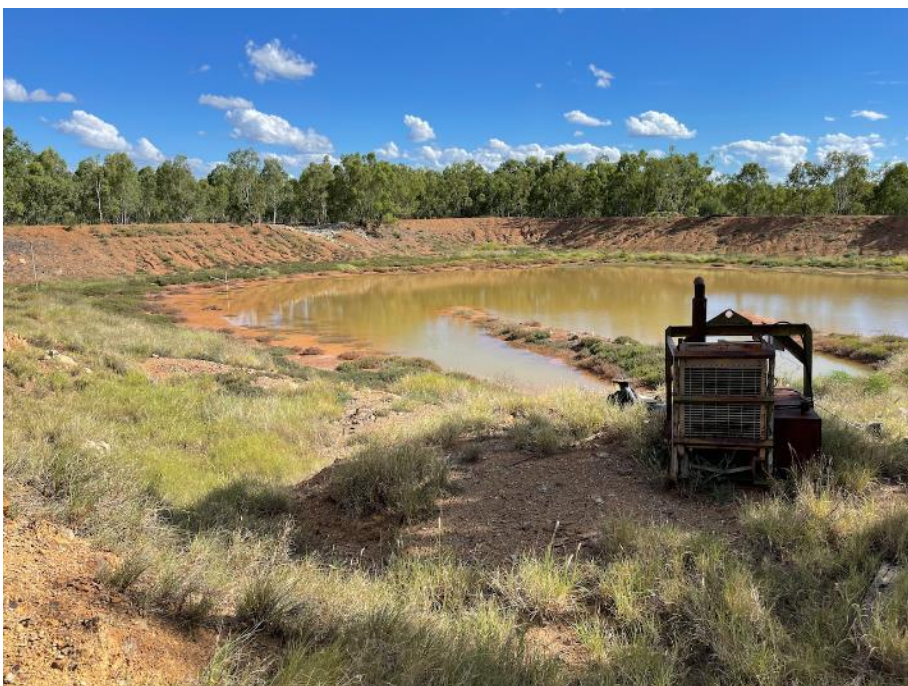
*Figure 56 - View of leach ponds & stormwater*
