# TRANSITIONAL PROGRESSIVE REHABILITATION AND CLOSURE PLAN

## YANDAN GOLD PROJECT

PREPARED FOR  
STRAITS GOLD PTY LTD

28 MARCH 2022

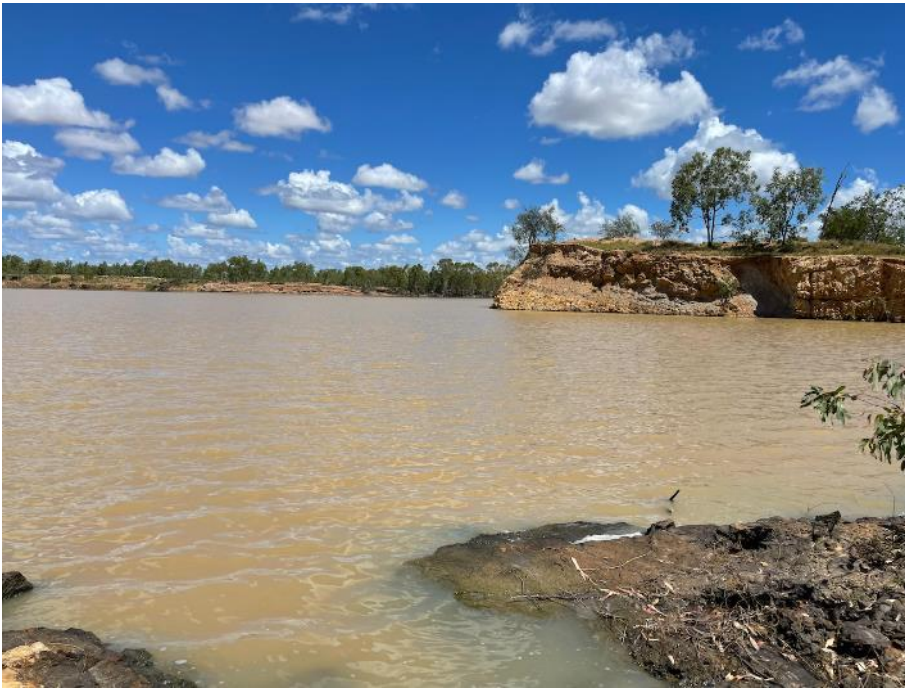
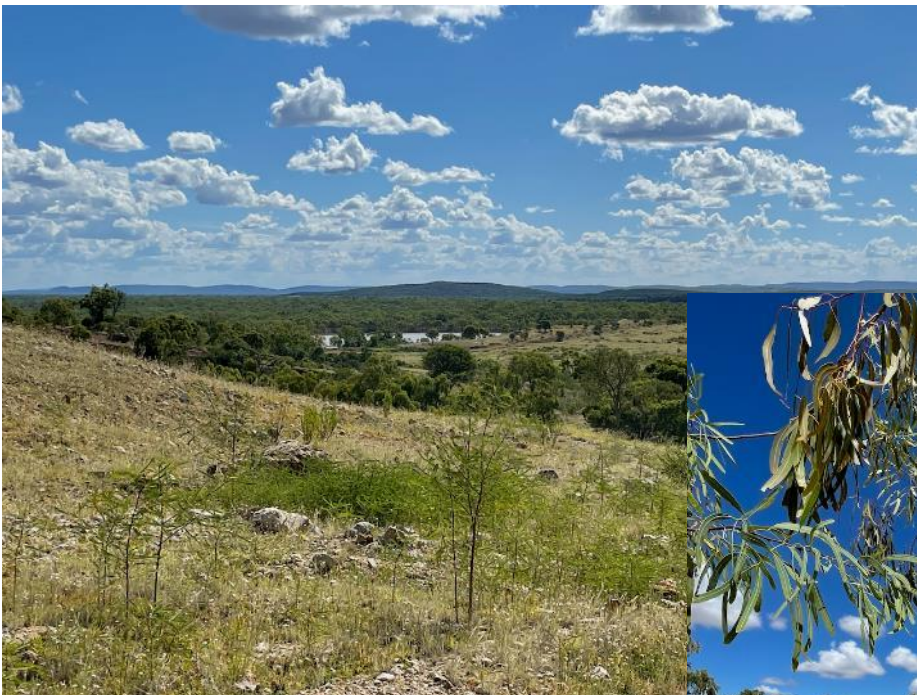
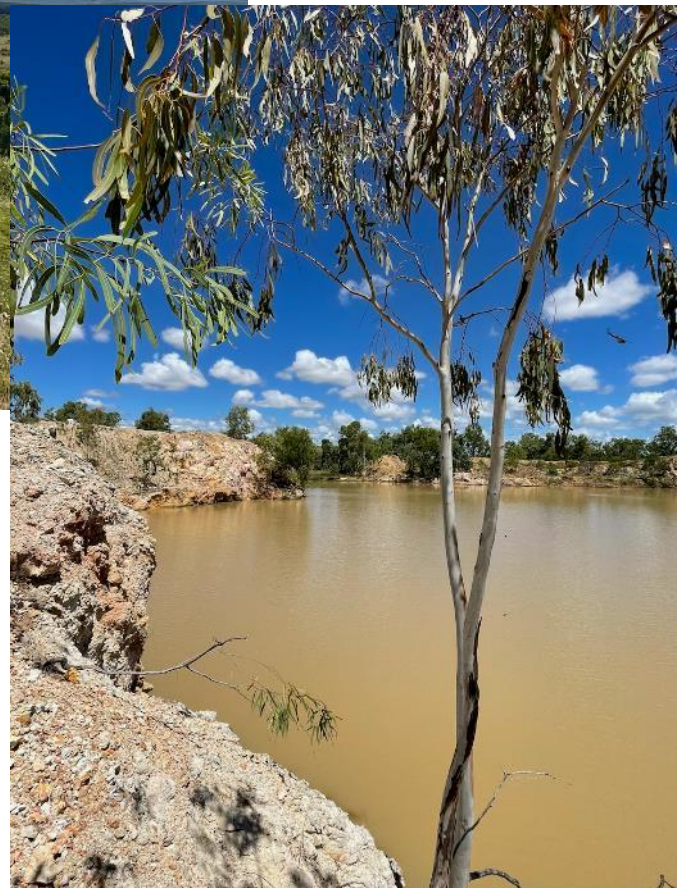
*Figure 61 - Views of Main Pit*

Main pit is a 22ha historical mine void formed during open pit mining which has operated since 1999 as a water cover legacy landform (Figure 60, Figure 61). To be successful, water cover requires water levels to always remain above 160mAHD to cover waste rock placed into the pit base at closure to avoid oxygen exposure & potential acid rock drainage. At full capacity, the pit is estimated to hold up to 6.8 gigalitres of water based on historical mine shells. Based on historical studies of dewatering (Forbes 1988), there is strong potential for groundwater connection to Main Pit with an estimated demand of 5,000m<sup>3</sup>/d to maintain dry operations within the pit. It not clear if this is sourced from a fault or from a porous boiling zone unit. Notably the pit is defined as being hydraulically separate to the alluvial aquifer of the Suttor River.

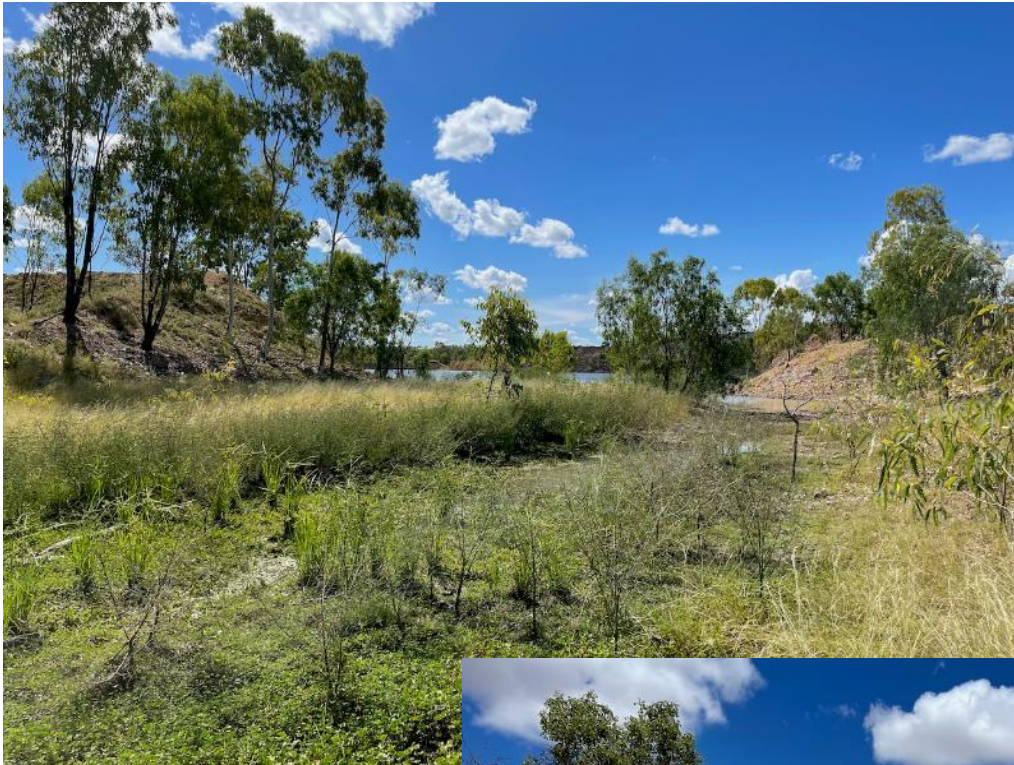
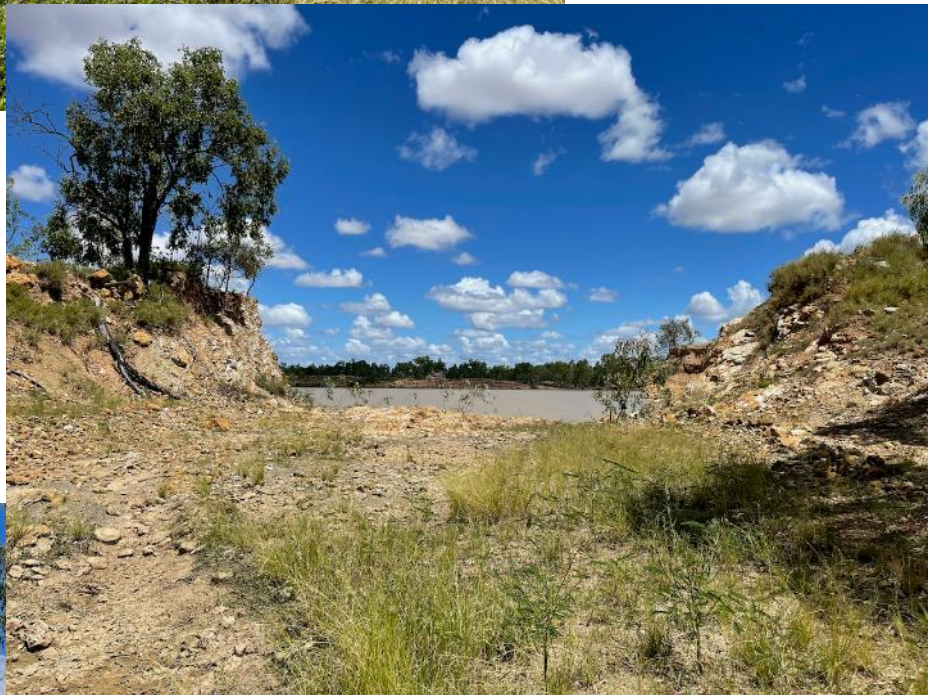
*Figure 62 - Views of spillways at south east & north west ends of Main pit*

The pit is located close to the Suttor river & lays within the flood plain: when river levels or pit water level reach 169mAHD, the pit & river connect & flow in/out via excavated spillways (Figure 62) on the north west & the south east of the pit (@ 169mAHD). Design of the pit void & spillways was extensively developed throughout 1999-2000 for hydraulic design, positioning/height of the spillways & achieving water cover: R&D Environmental 1999; Chapman & Dwyer 1999; SRK Consulting 1999a; SRK Consulting 1999b & HLA EnviroSciences 2001. There are two ways for water to enter the pit (via surface flow): from the Suttor River when at level >169mAHD, or from Yandan Creek (south) where the borrow pit constructed to the south fills & flows to the pit.

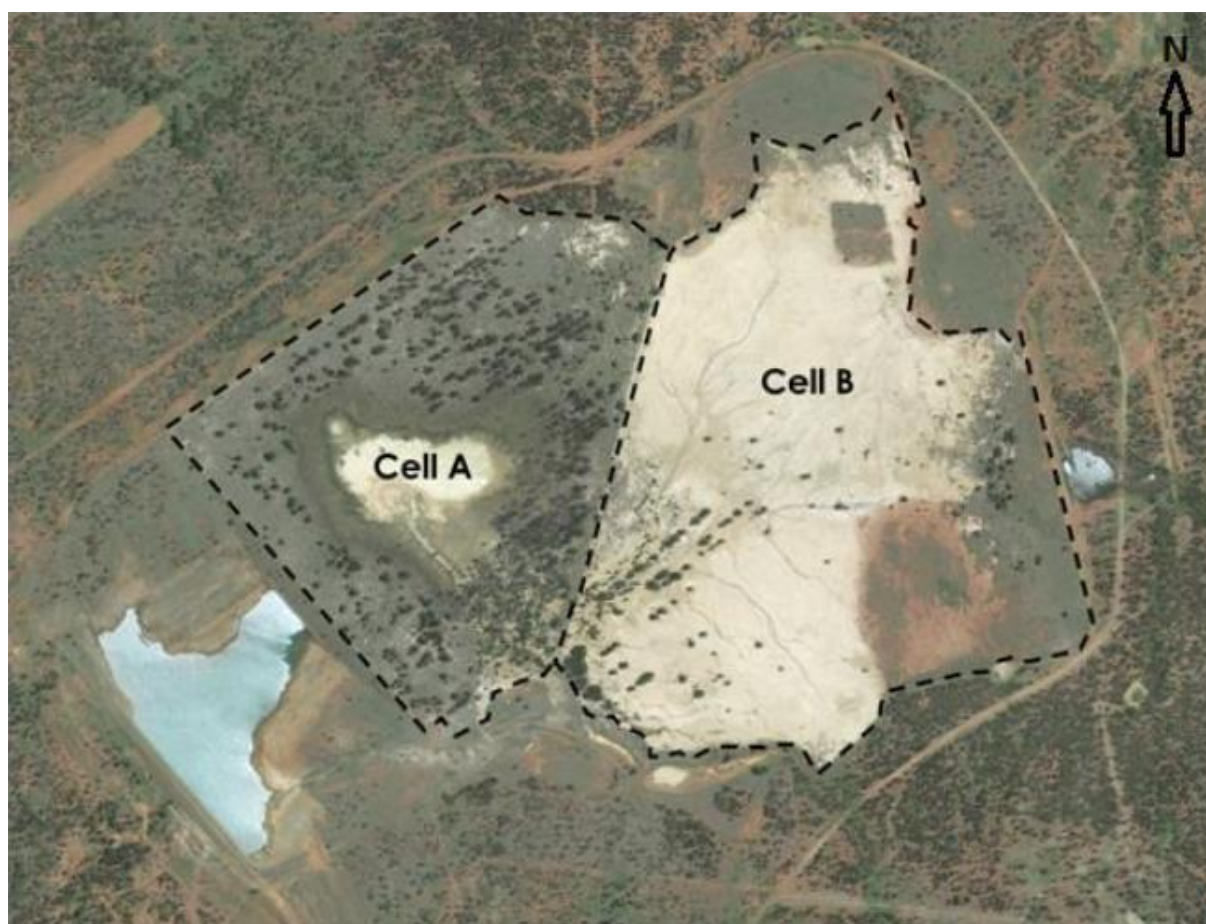
**Figure 1** Revegetated TSF Cell A and largely unvegetated Cell B

The Yandan TSF comprises two cells. Cell A was revegetated directly on tailings and was considered in Straits Gold's Rehabilitation Review in 2013 to have been largely effective in terms of revegetation and surface drainage, apart from limited central ponding and lack of revegetation (see Figure 1, Figure 2.2 in the O'Kane Report). ***No comment is offered in the O'Kane Report, although the bare patch in the middle of Cell A may be related to consolidation of the tailings producing a low spot prone to ponding. Salinity at this location is most likely related to evaporative concentration rather than to uptake from the tailings.***
