## YANDAN GOLD MINE POST MINE LAND USE PLAN

PREPARED FOR  
**STRAITS GOLD PTY LTD**

AUGUST 2018

# YANDAN GOLD PROJECT 2023 REHABILITATION MONITORING REPORT

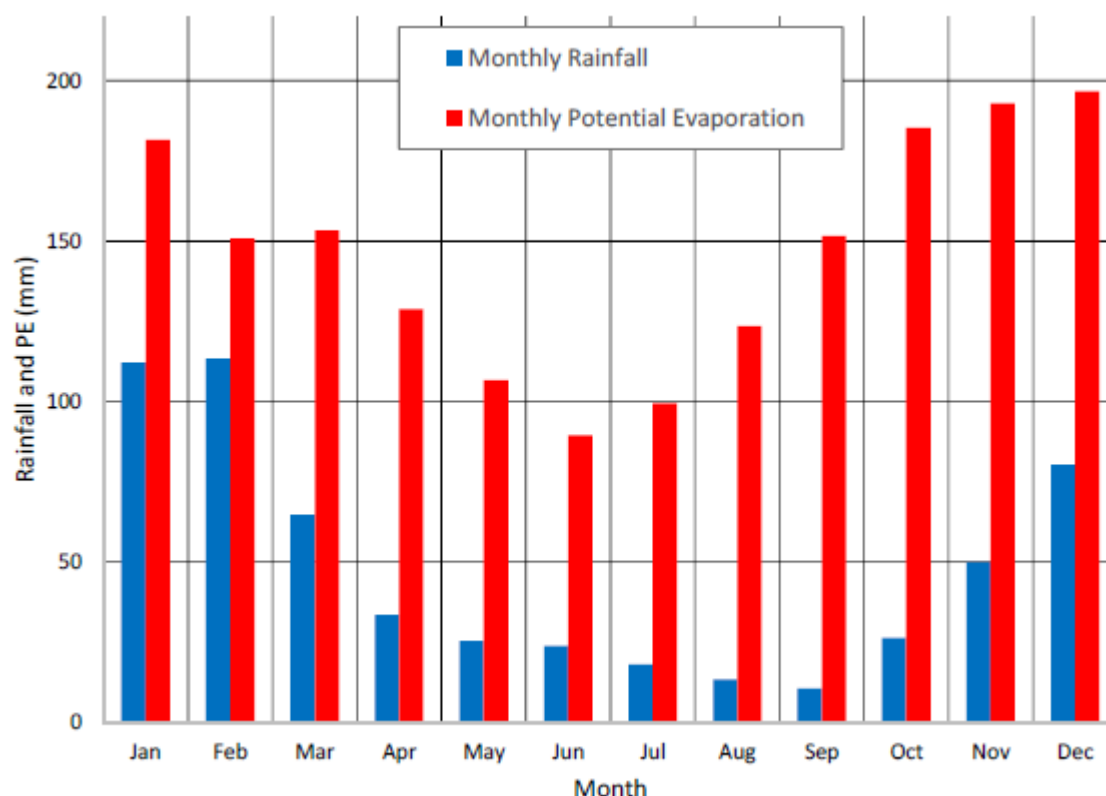
**Figure 3 Yandan Site Average Monthly Rainfall and Potential Evaporation (1913 – 2014)**

The Yandan Gold Mine semi-arid tropical climate is characterised by a hot wet season and mild dry season, highly variable rainfall, high evaporation rates and low humidity. A Silo Data Drill was obtained from the Queensland government for climate data specific to the Yandan mine site. A preliminary assessment of the obtained data was performed, with the main elements presented below. For the purposes of the initial proposal, O’Kane used data dating back to 1913. Monthly averages for precipitation and potential evaporation are presented in Figure 3.

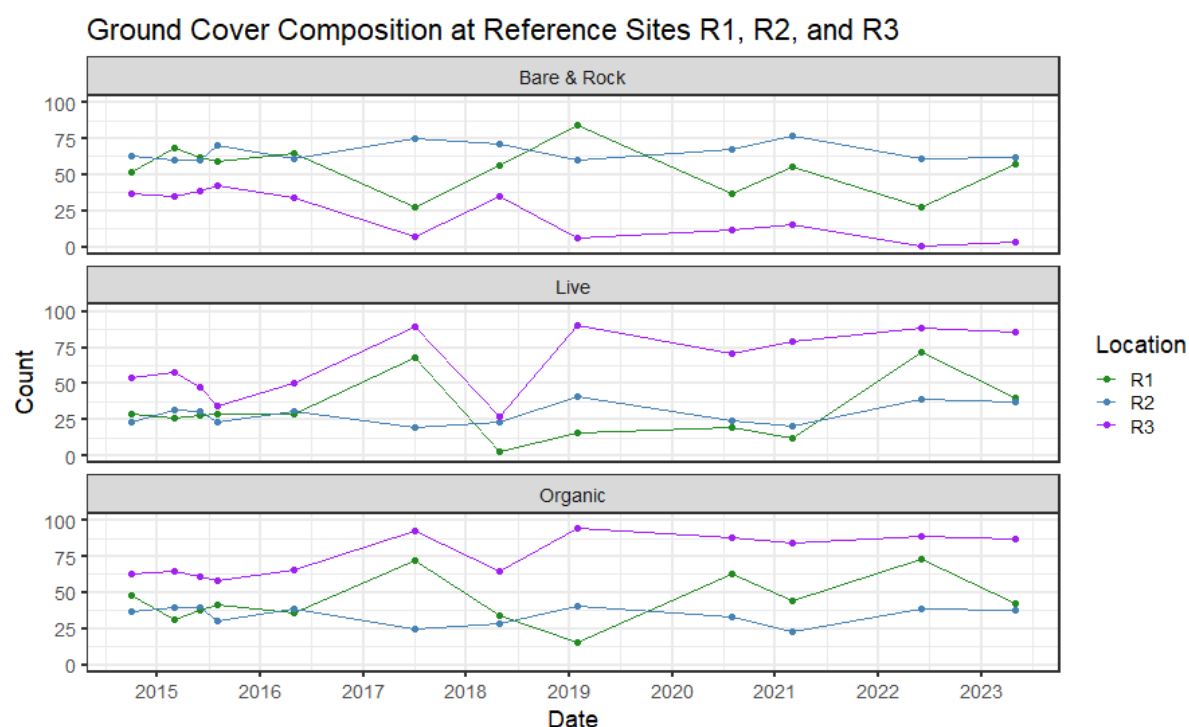
Figure 4-2: Mean ground cover at the reference sites (2015 – 2023)

The changes in bare ground have resulted from the changes to the other variables; increases in live cover and organic litter will inherently decrease the available bare ground in the site.

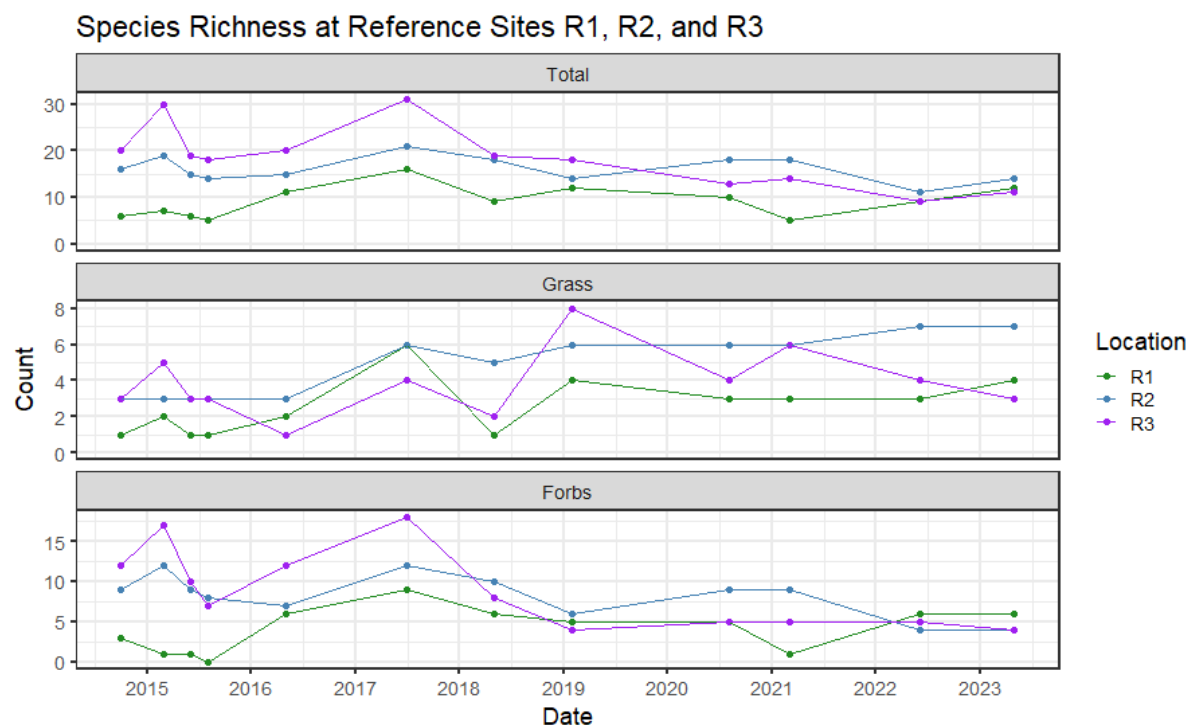
Figure 4-3: Species richness across Reference sites

Total species richness remained in the central range of recorded values (1-31) in 2023 (R1 with 12 species, R2 with 14 species, R3 with 11 species). There were no long-term trends apparent in the species richness observed at the reference sites. The total species richness values were consistent with a sustainably managed low intensity grazing land use.

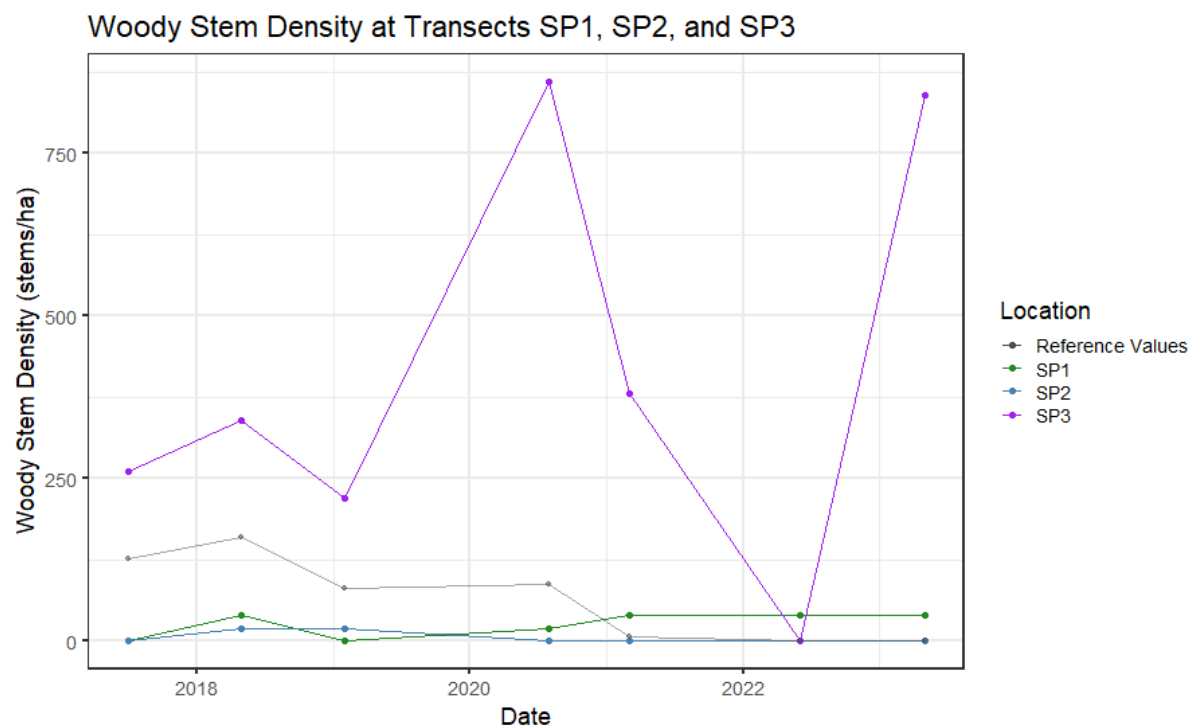
Figure 4-8: Mean woody stem density at South Pit

Woody stem density at the South Pit sites during the 2023 RMP averaged 293.3 stems/ha. An uplift in woody stem density has been seen since the 2020 RMP, which has also been observed at the reference sites to a lesser degree (Figure 4-8).

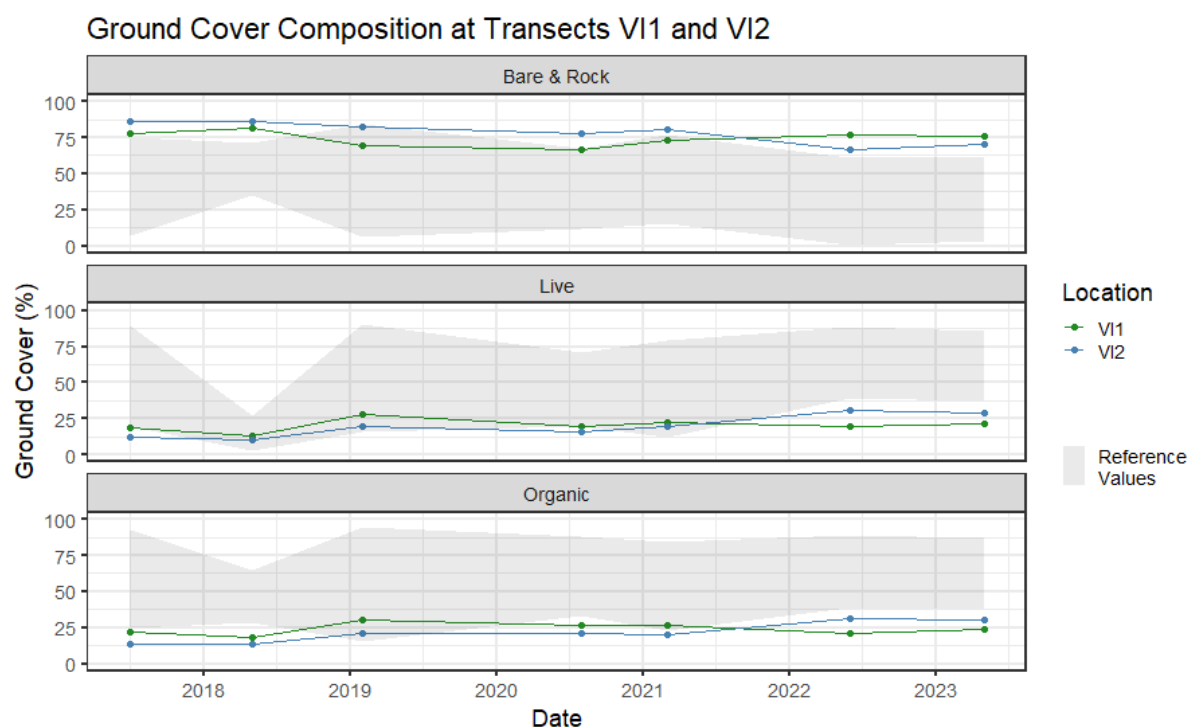
Figure 4-16: Ground cover proportional to reference site mean for village infrastructure sites

The village infrastructure rehabilitation area has retained a consistently higher proportion of bare ground and rock since monitoring commenced. The proportion of bare ground and rock cover in monitoring sites exceeded mean reference cover in 2023 (VI1 76%, VI2 70.1%, Reference 41%) (Figure 4-16: top graph). Increased bare ground and rock cover fraction coincided with slight decreases in live cover and total organic cover fractions (Figure 4-16: middle graph). Live cover and total organic fraction appear stable at approximately 50% of the reference site mean since 2017.

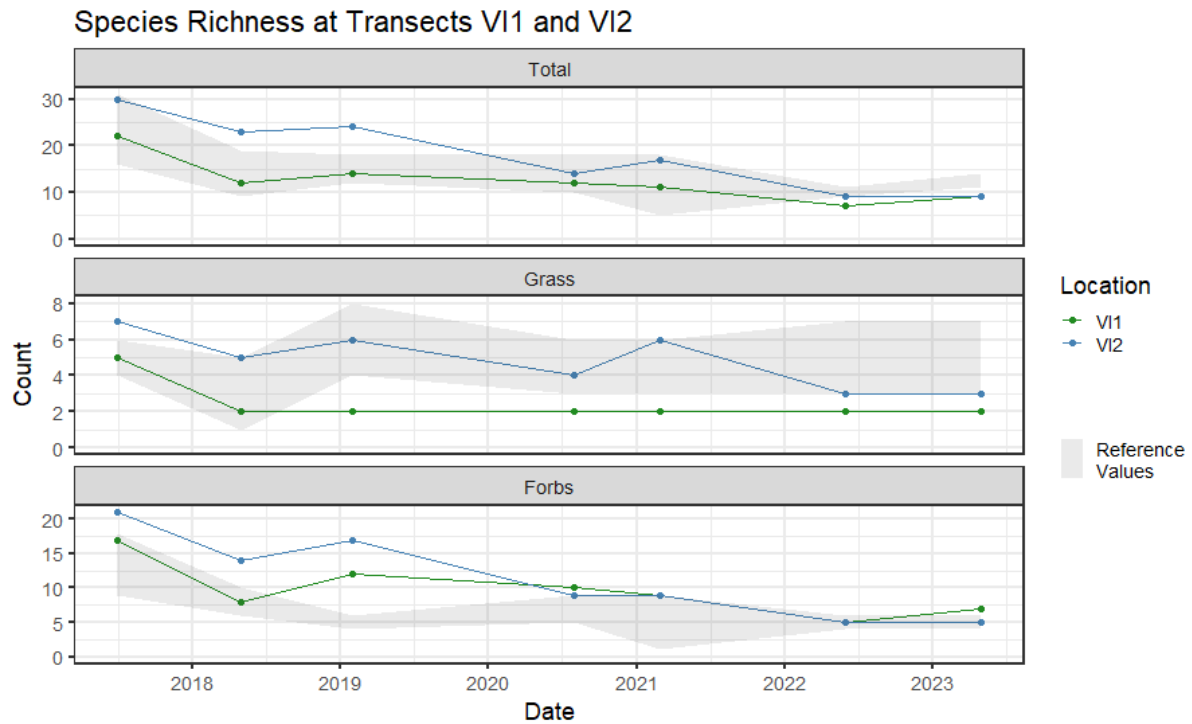
Figure 4-17: Species richness at village infrastructure monitoring sites

In terms of functional composition, the village infrastructure sites contain a relatively diverse forb assemblage, generally exceeding the forb richness seen at reference sites. During the 2023 RMP, an average of 6 forbs and non-grasses were observed at the village infrastructure sites. Grasses were much less speciose, with only two exotic pasture grasses (2 species – VI1 and VI2), and one non-pasture grasses (one species – VI2) observed. Only one tree and shrub species was recorded.

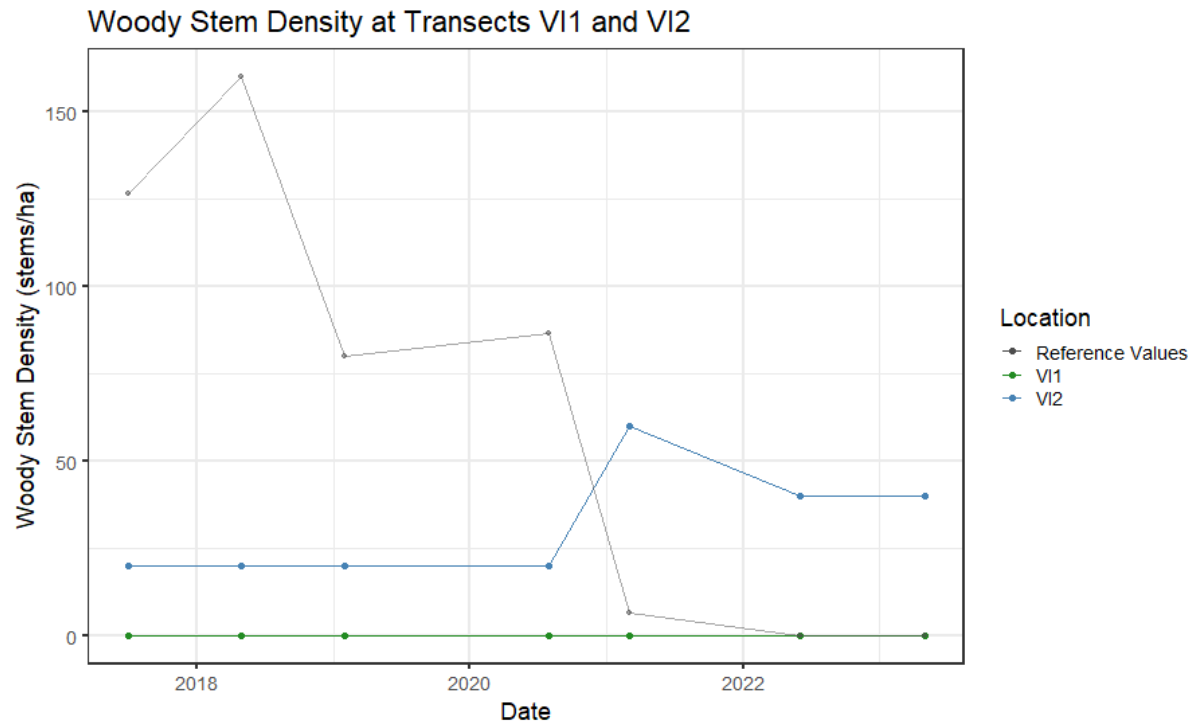
Figure 4-18: Mean woody stem density at village infrastructure monitoring sites

Woody stem density at the village infrastructure sites during the 2023 RMP averaged 20 stems/ha, remaining thereabouts consistent with the trend observed since 2020 (Figure 4-18).

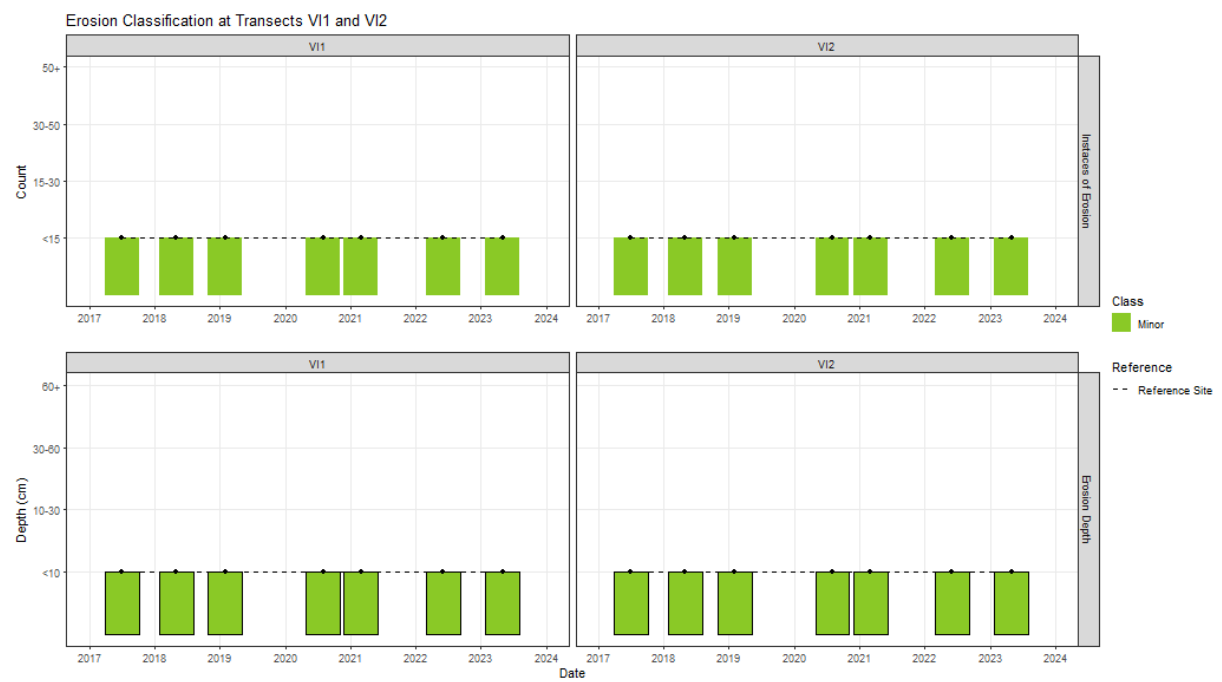
Figure 4-20: Erosion characteristics for VI sites

These results are consistent with previous monitoring events, with no deterioration in erosion recorded since the 2017 survey. The minor erosion recorded at the VI sites is comparable with the minor erosion recorded at the reference sites.

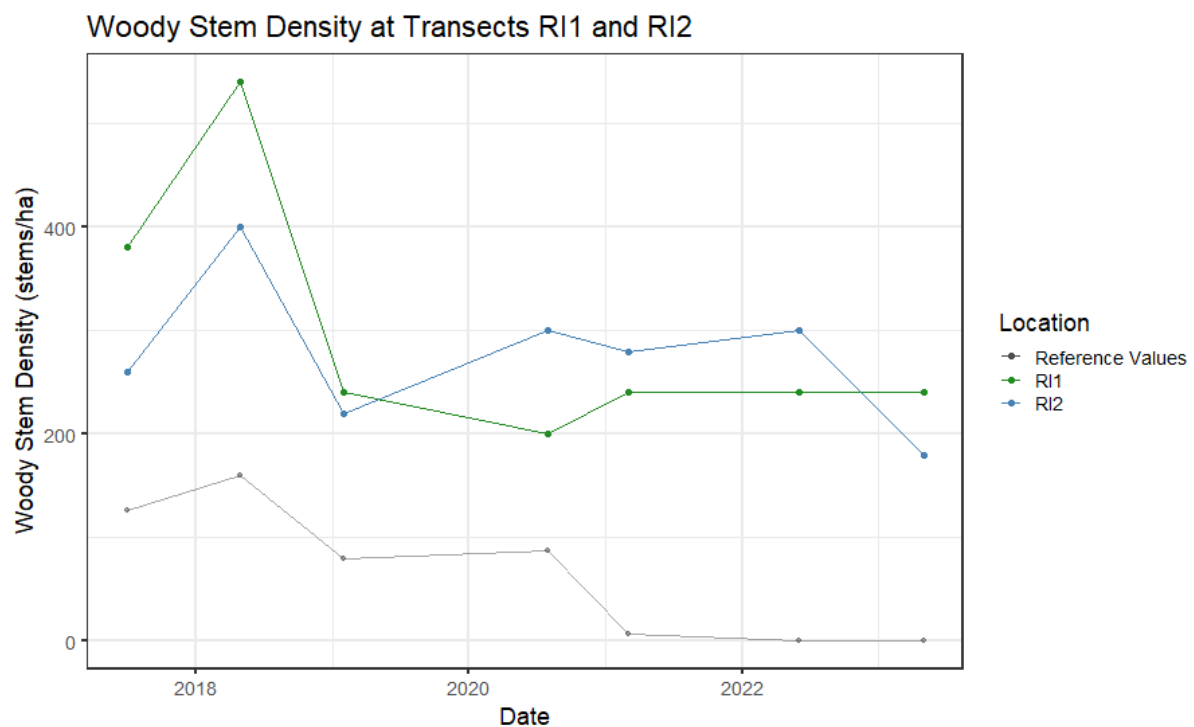
Figure 4-23: Mean woody stem density at Rehabilitated Infrastructure

Woody stem density at the rehabilitated infrastructure sites averaged 210 stems/ha during the 2023 RMP event. Woody stem density remained stable at the RI1 transect during the 2023 RMP event, however a reduction was observed at the RI2 transect (Figure 4-23).

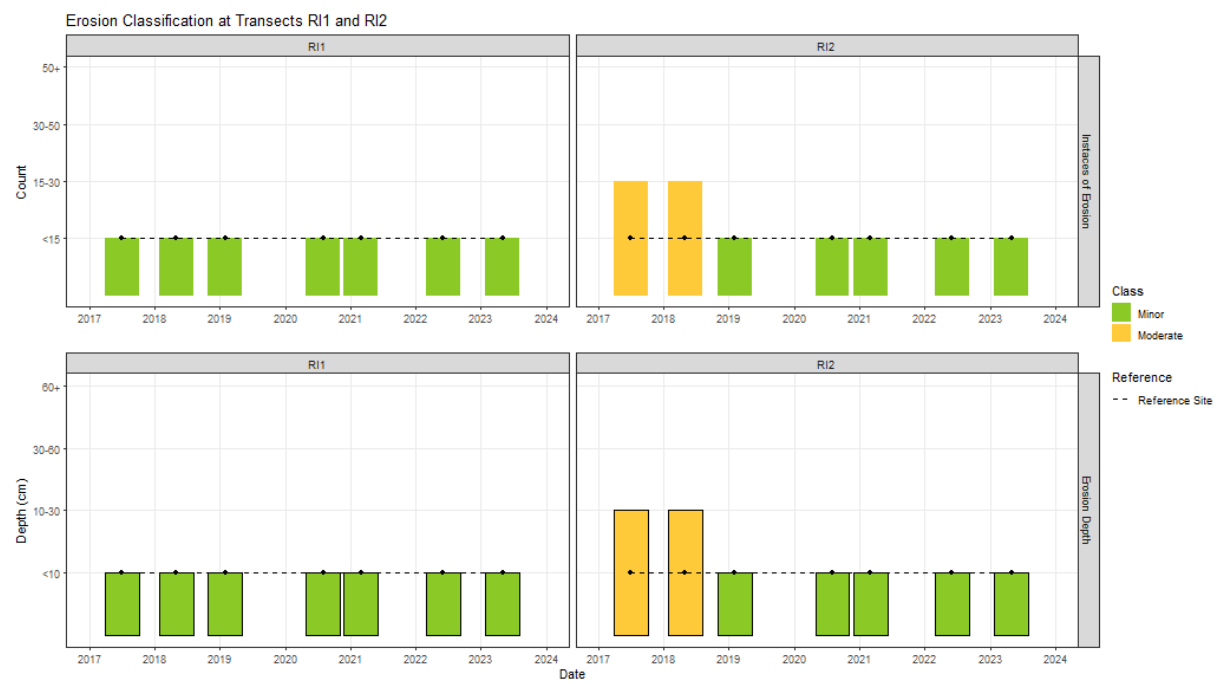
Figure 4-25: Erosion characteristics at RI sites

These results are consistent with previous monitoring events, with no further deterioration in erosion recorded since the 2019 survey. The minor erosion recorded at the monitoring sites is comparable with the minor erosion recorded at the reference sites. Both sites consistently observed 0 – 15 cm rills with low levels of erosion in for form of small rills and short depths.

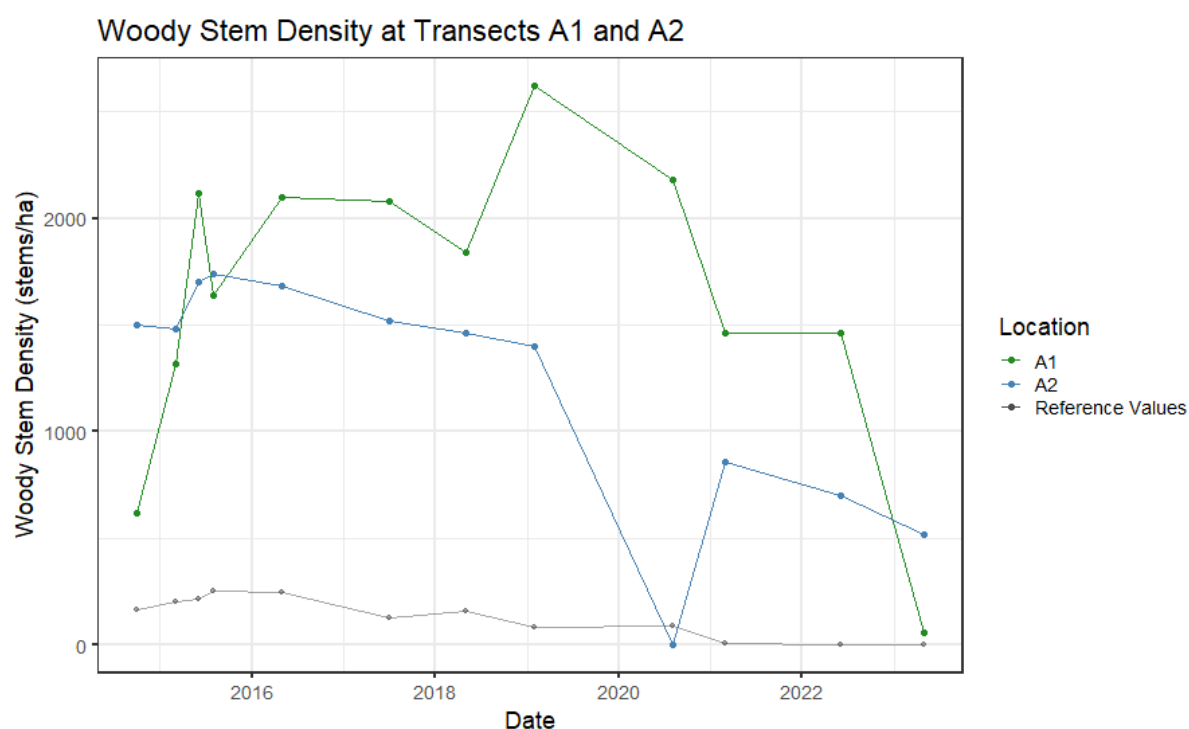
Figure 4-28: Mean woody stem density at Cell A monitoring sites

Long term monitoring of woody vegetation at the TSF Cell A sites has consistently recorded significantly denser woody vegetation than the reference sites. Over recent years (2021 -2023), the significantly higher density of woody vegetation on the rehabilitated TSF Cell A has contrasted with near non-existent woody vegetation at the reference sites, following the decline of woody vegetation at the reference sites from around 2016-2017. The higher density of woody vegetation is expected given the rehabilitation methodology of directly planting a variety of woody species into the surface of the facility during rehabilitation, approximately 23 years ago.

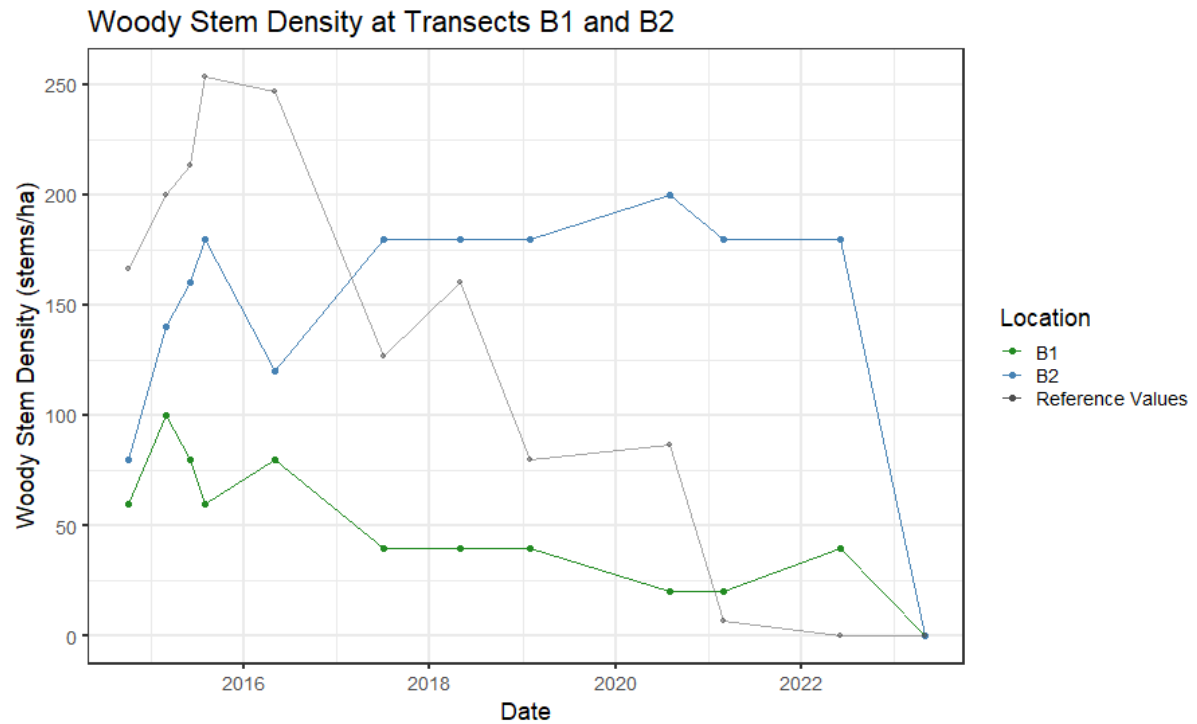
Figure 4-33: Mean woody stem density at Cell B thin cover trial sites

Woody stem density at the thin cover trial sites is comparable with reference conditions, being negligible at both during the 2023 RMP event (Figure 4-38).

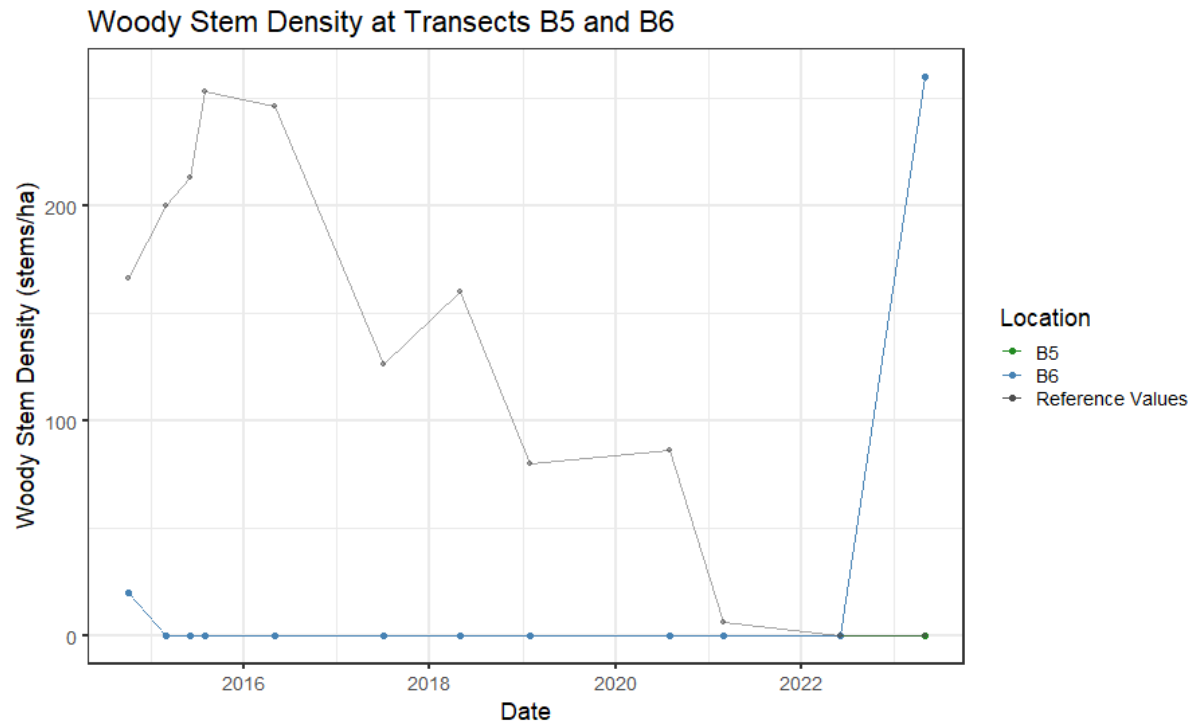
Figure 4-43: Mean woody stem density at the gravelly topsoil plots (B5 and B6)

Woody stem density at the gravelly topsoil cover trials averaged 130 stems/ha in 2023 (Figure 4-43). Woody stemmed flora has not previously been observed at site B6, although some small scattered shrubs were observed during the 2023 RMP.

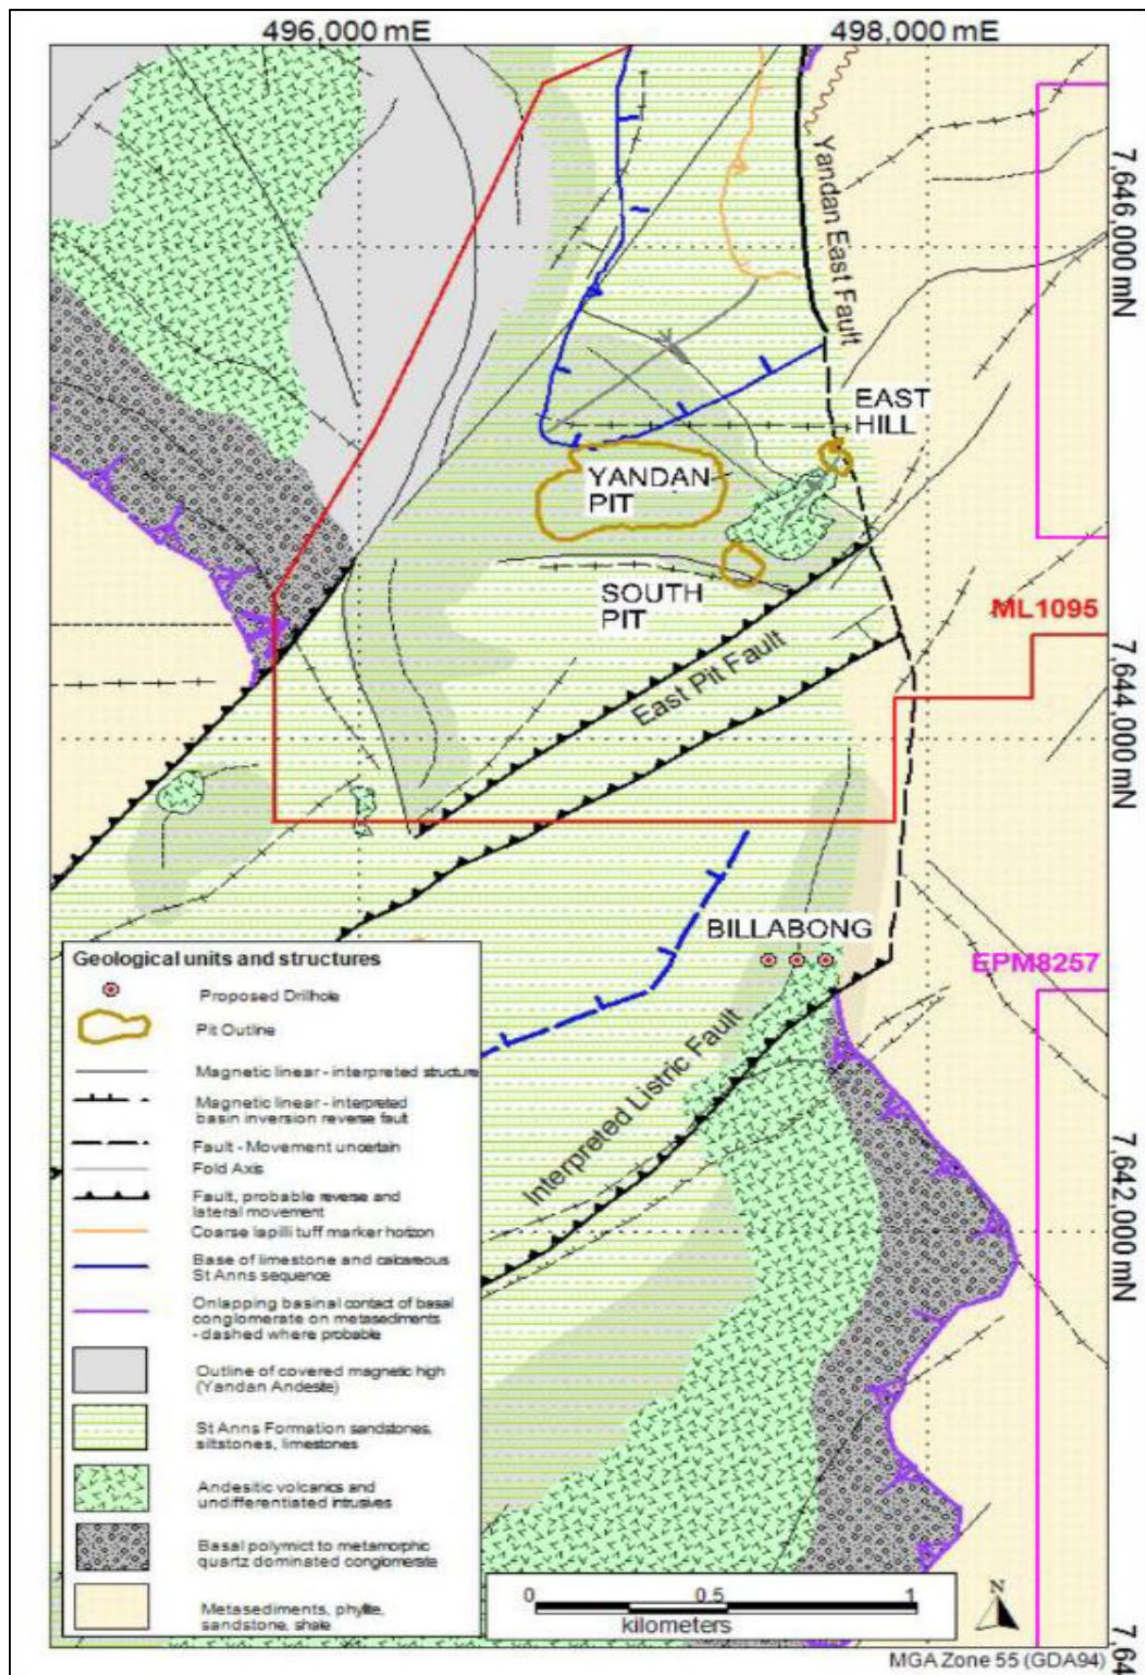
**Figure 4-1: Yandan Regional Geology (after GBM 2022)**

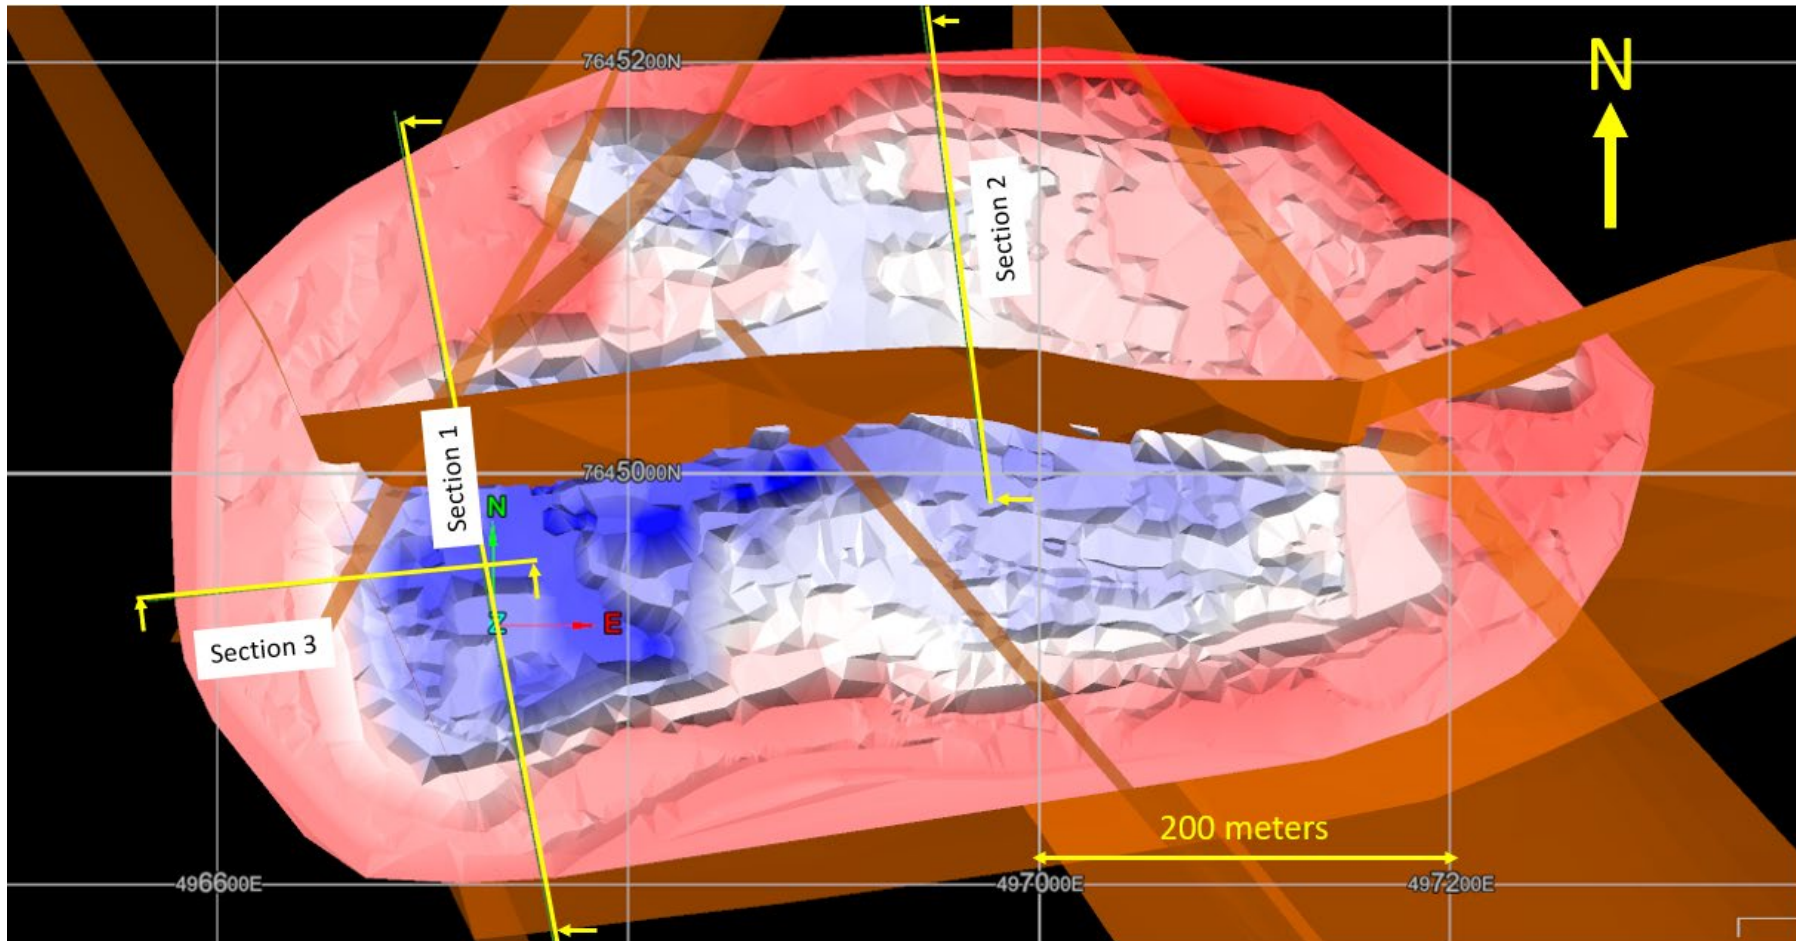
**Figure 7-1: Yandan Main Pit – Representative Sections**

- In pit void completely inundated to spillway height;
- Assumed weathered horizon tested for circular failure where applicable; and
- Global slope failure (crest to toe) using non-circular methods.

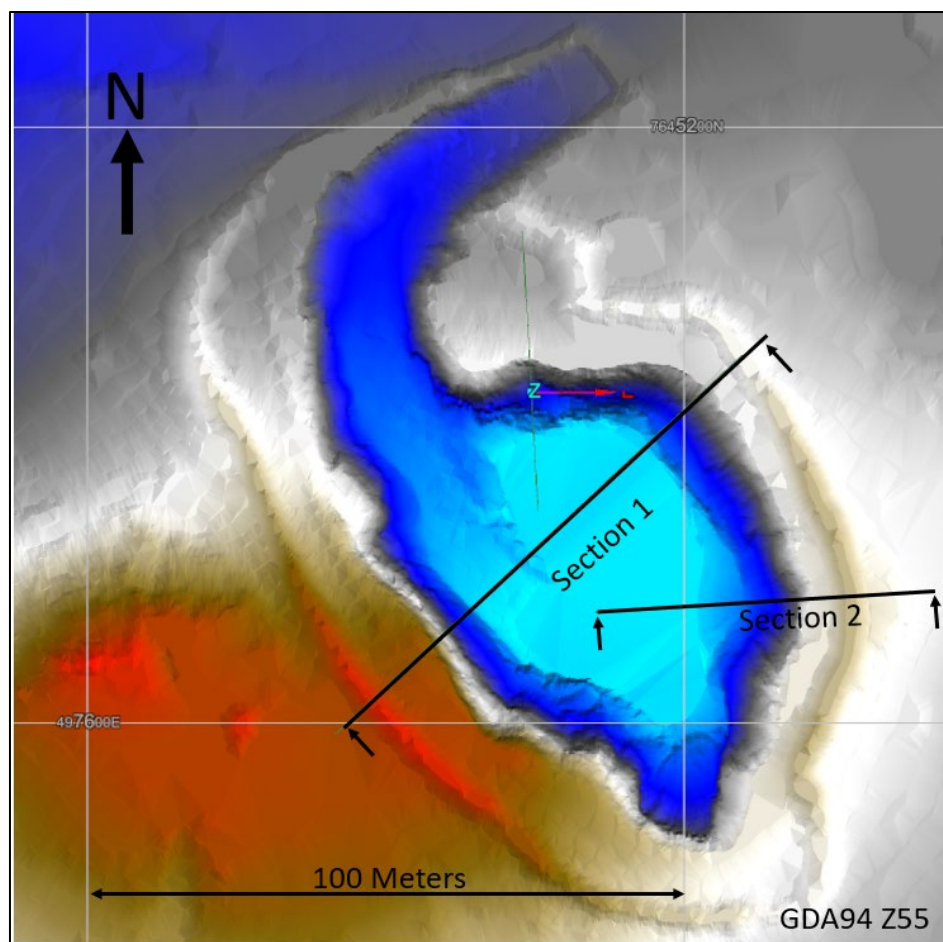
**Figure 7-8: East Hill Pit – Representative Sections**

- Weathered horizon Circular failure; and
- Global non-circular slope failure (crest to toe).

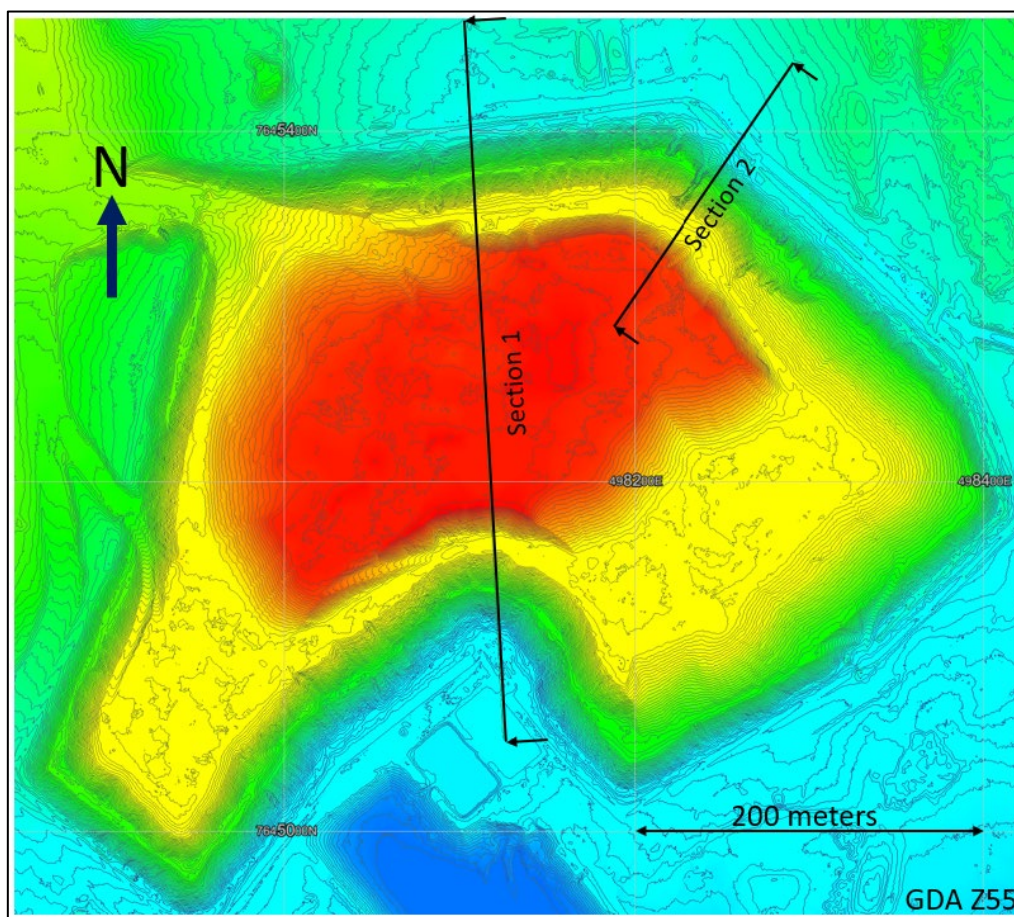
**Figure 7-11: HLF Representative Section Locations**

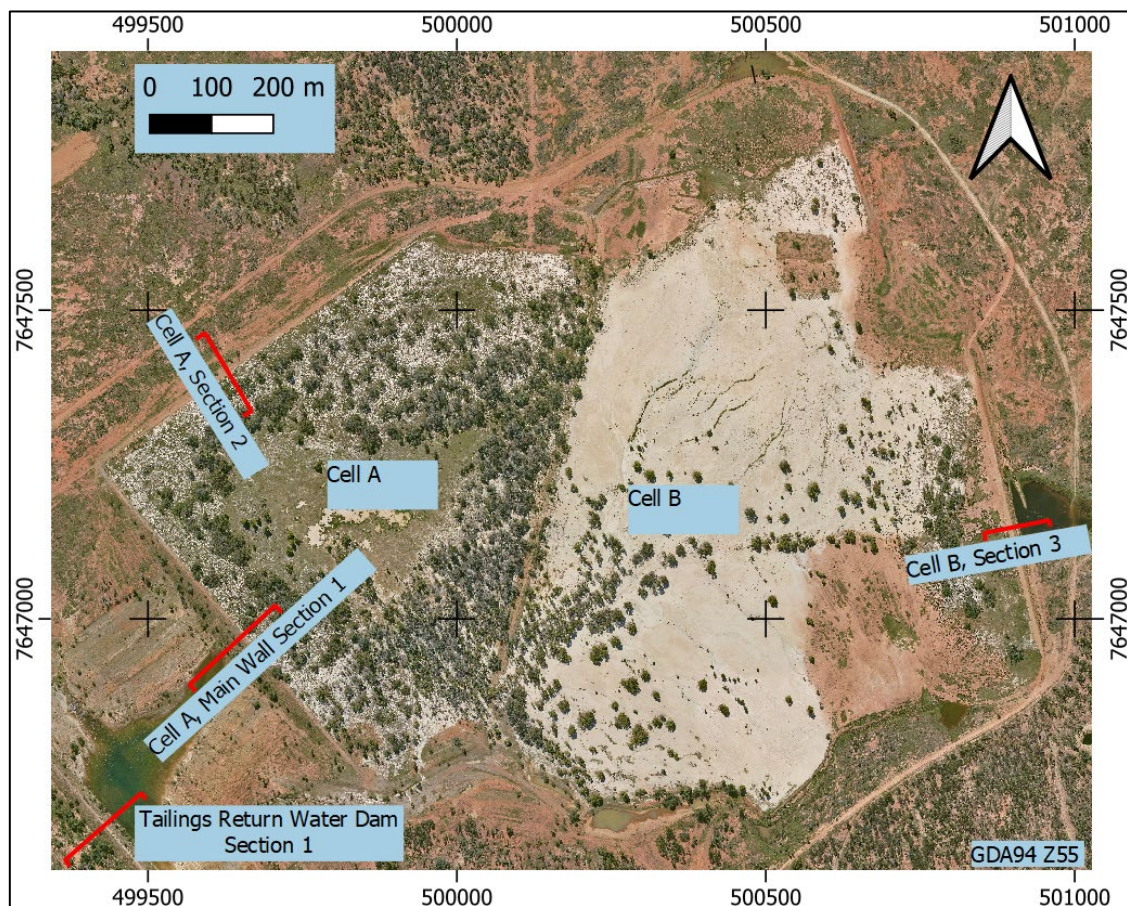
**Figure 7-14: Tailings Storage Facility Sections Plan**

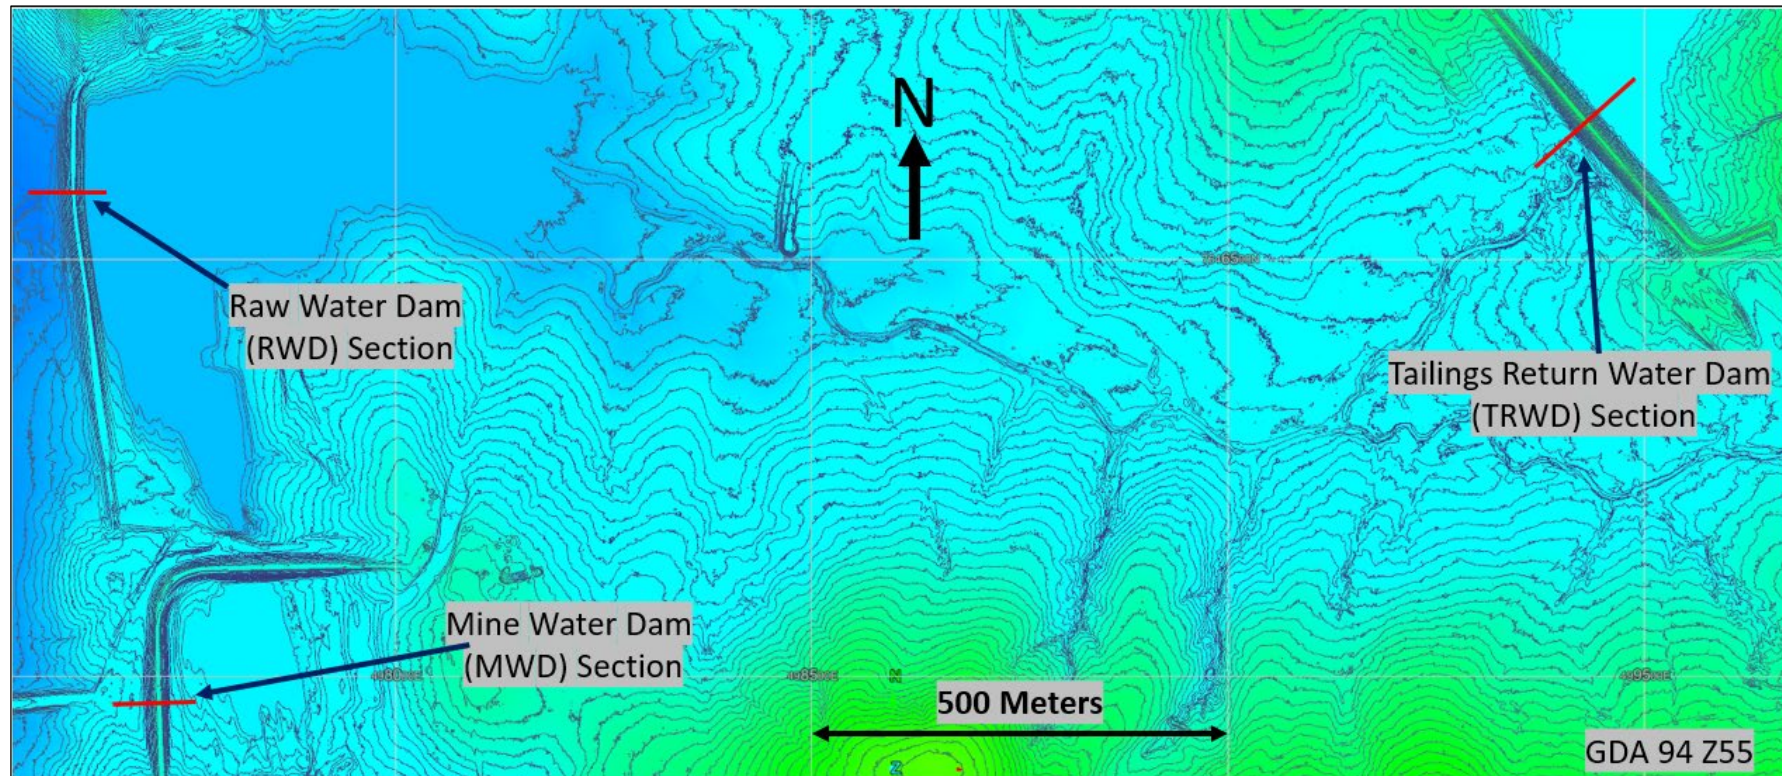
**Figure 7-18: Multiple Water Storage Facility Section Locations Plan**

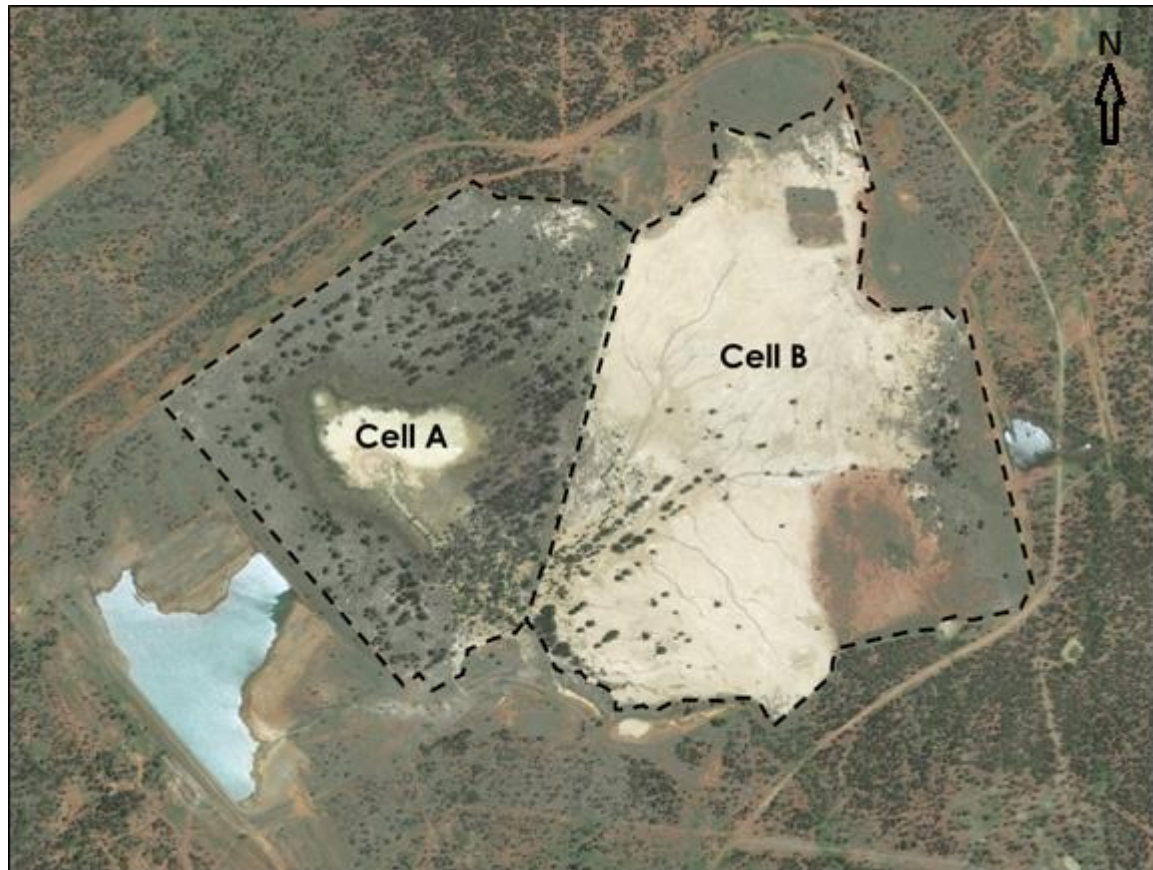
Figure 2.2: Cell A and Cell B approximate location for TSF cover system design.

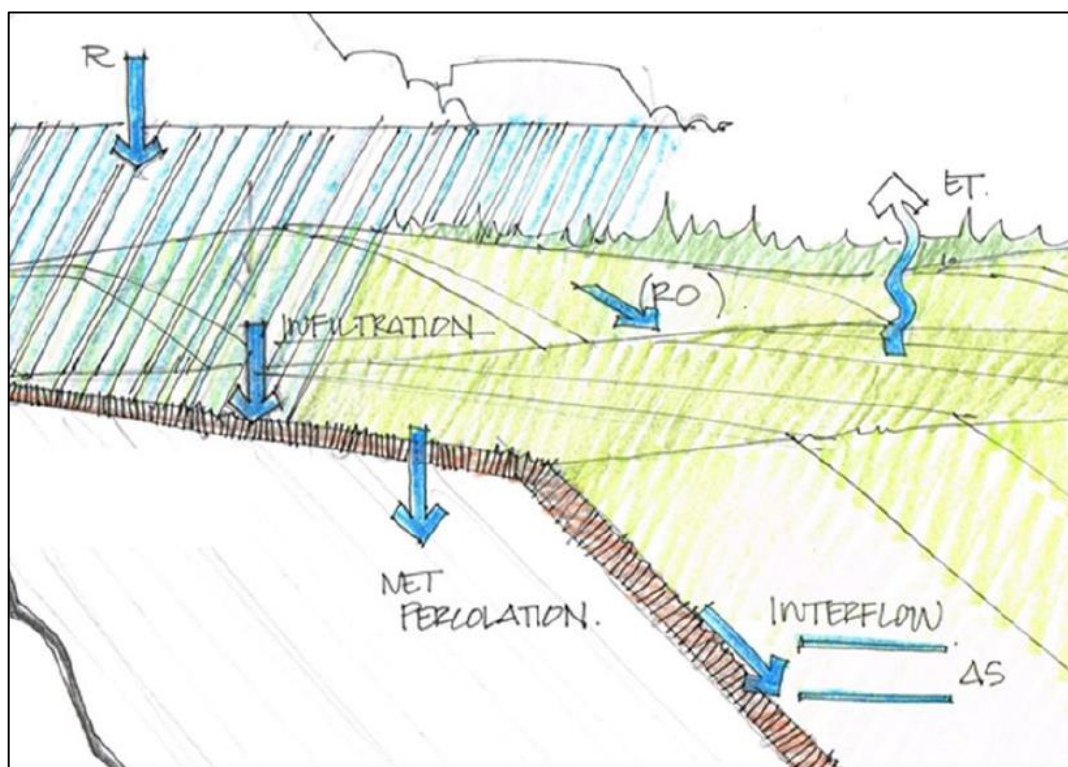
Figure 2.3: Schematic of hydrologic processes that influence performance of cover systems.

The term net percolation (NP) is used throughout this report and is defined as presented in Figure 2.3. Rainfall (R) will either be intercepted by vegetation, runoff (RO), or infiltrate into the surface. A portion of the water that infiltrates will be stored in the active zone ( $\Delta S$ ) and subsequently exfiltrate back to the surface and evaporate (E) or be removed by transpiration (ET). Infiltration can also move laterally downslope within and below the active zone (referred to as interflow). A percentage of the infiltrating water will migrate beyond the active zone as a result of gravity overcoming the influence of atmospheric forces (i.e. evaporation) and result in NP to the underlying material.
