## YANDAN GOLD MINE POST MINE LAND USE PLAN

PREPARED FOR  
**STRAITS GOLD PTY LTD**

AUGUST 2018

# YANDAN GOLD PROJECT 2023 REHABILITATION MONITORING REPORT

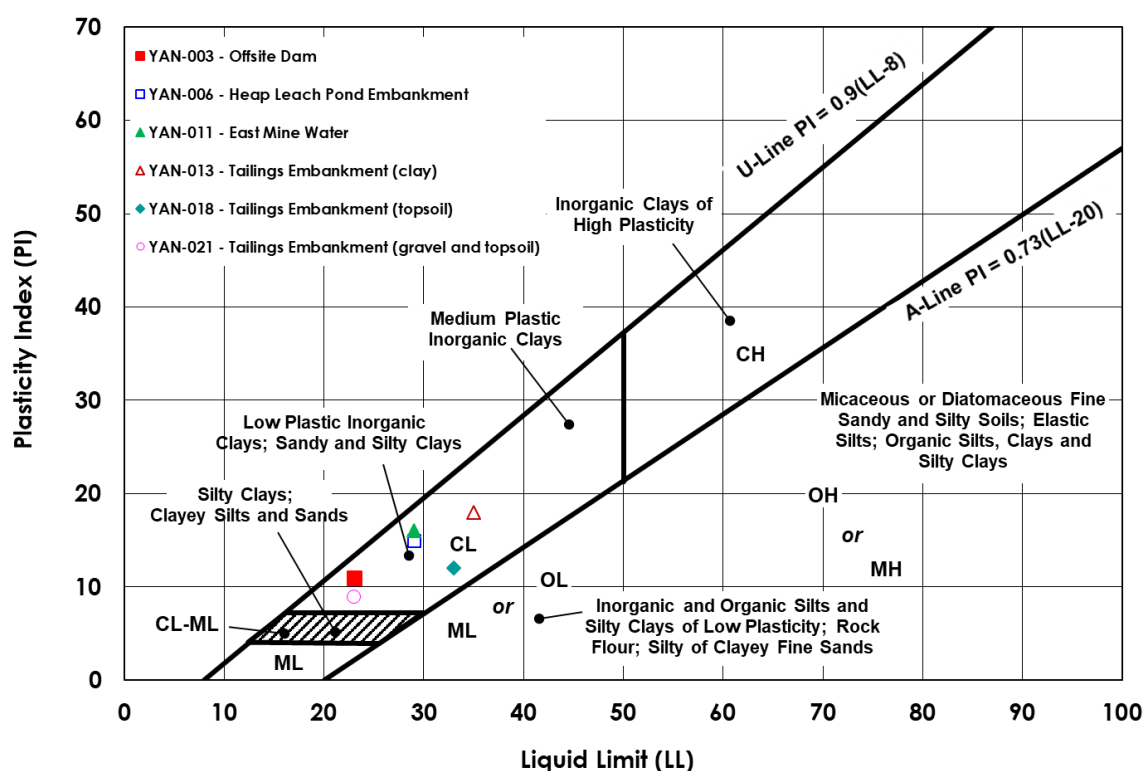
Figure 3.14: Atterberg limit results for fine-grained material tested as potential clay source.

The characteristics of various fine-textured materials, such as clay content and mineralogy, can be determined through the relationship between the LL and PI. The plot of LL-PI can be used to identify clay mineralogy of a sample. Montmorillonites are highly active clay minerals and plot above the A-line near the U-line. Illites plot directly above the A-Line and are less active than Montmorillonites, and Kaolinites plot below the A-Line and are relatively inactive. Active clay minerals provide additional water storage capacity as a bound water volume. Figure 3.14 shows that the Yandan samples plot above the A-Line and below the U-Line with low plastic and inorganic clays (CL), indicating moderately active clays containing predominately illites and montmorillonites.

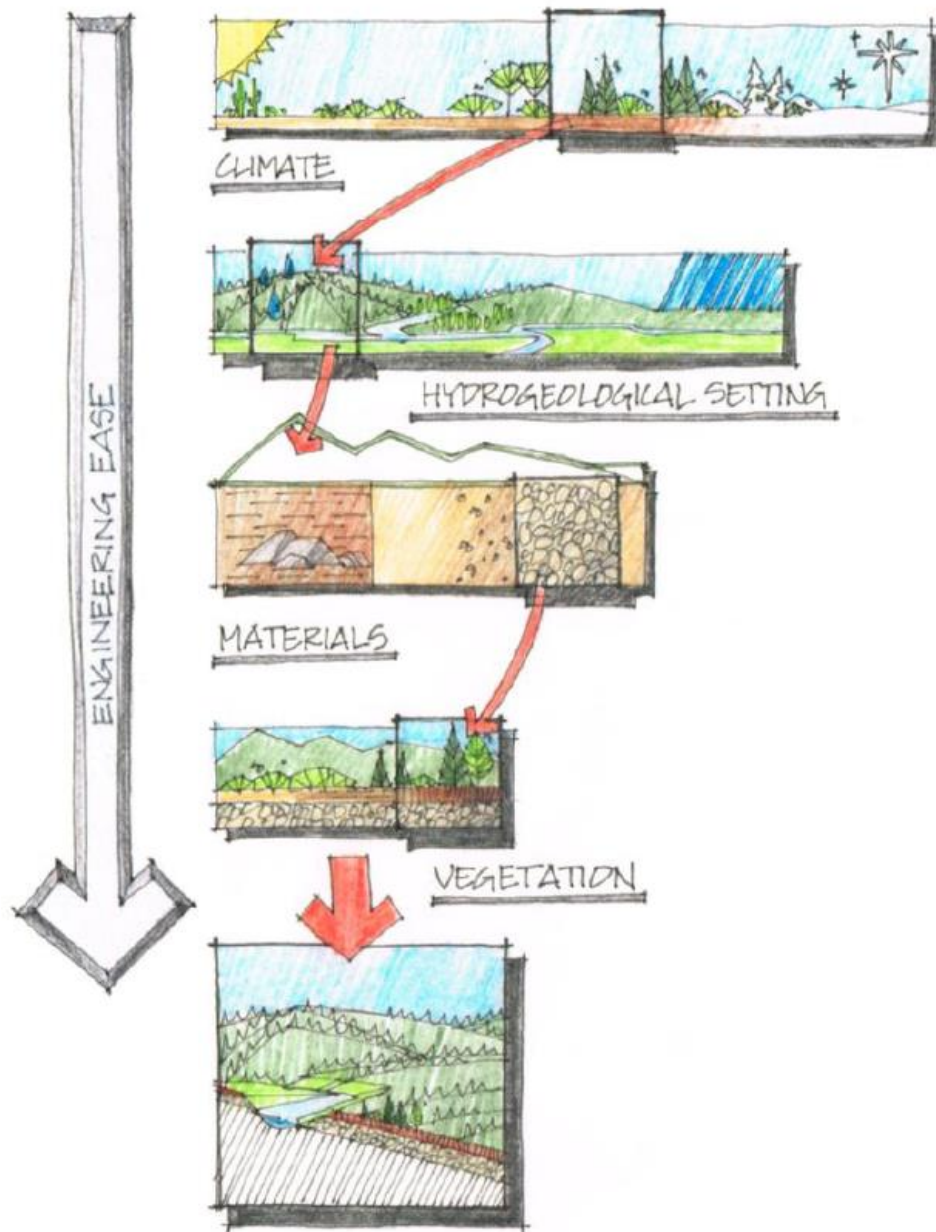
Figure 4.1: Cover system design framework displaying four filters.

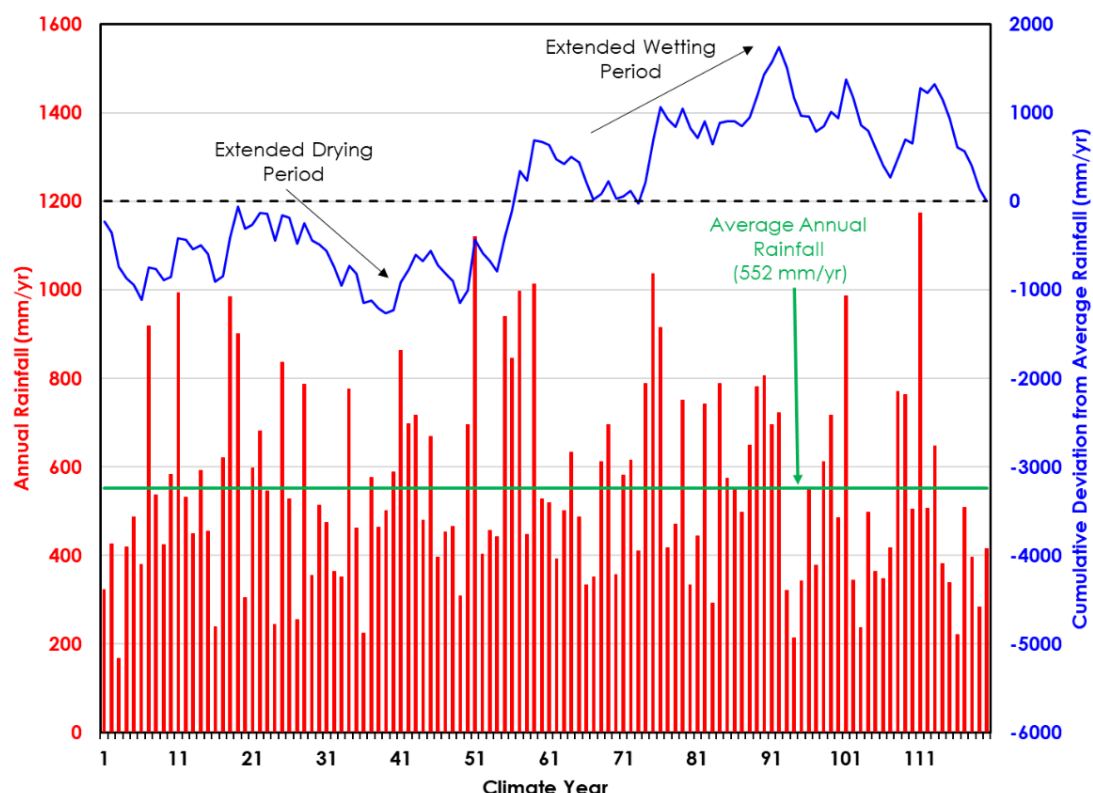
Figure 4.2: Annual rainfall and cumulative deviation from average rainfall for Yandan.

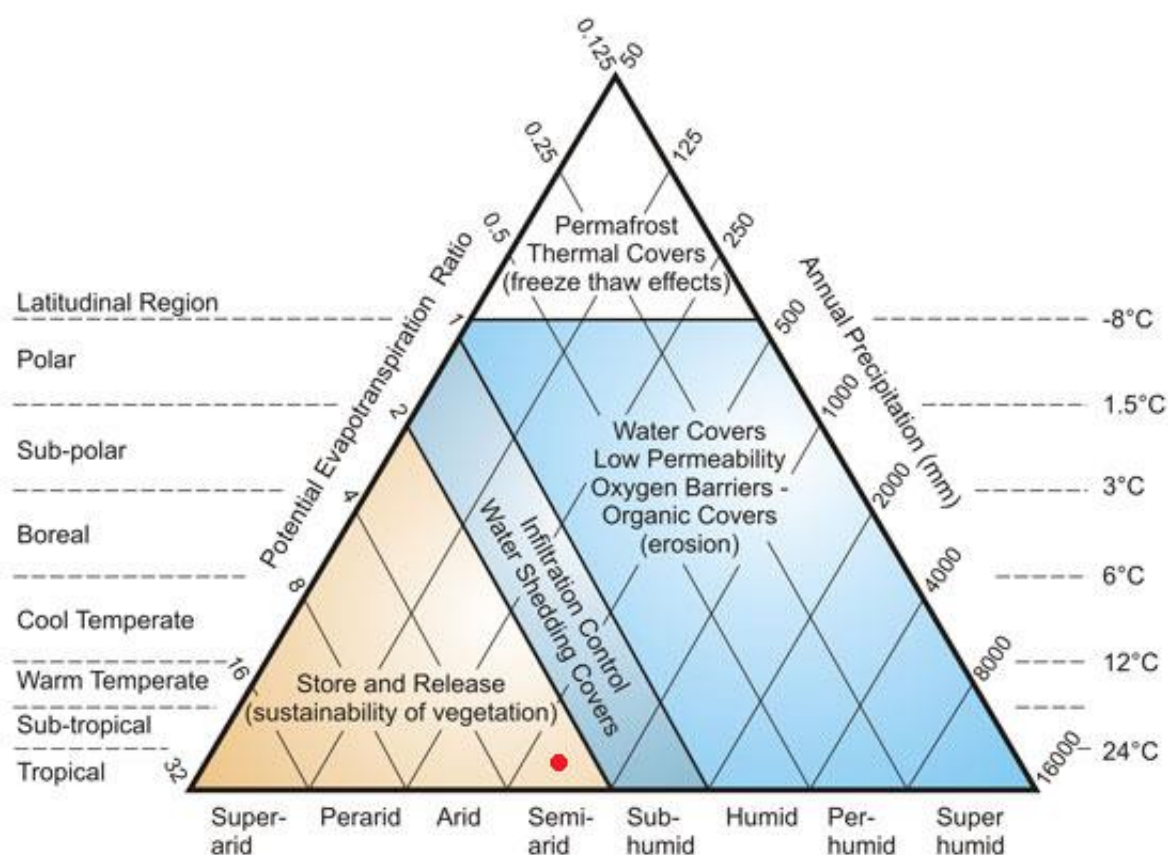
Figure 4.3: Cover systems and climate types. Red dot indicates approximate performance for Yandan.

For these reasons the three alternative cover system designs all include a barrier layer.

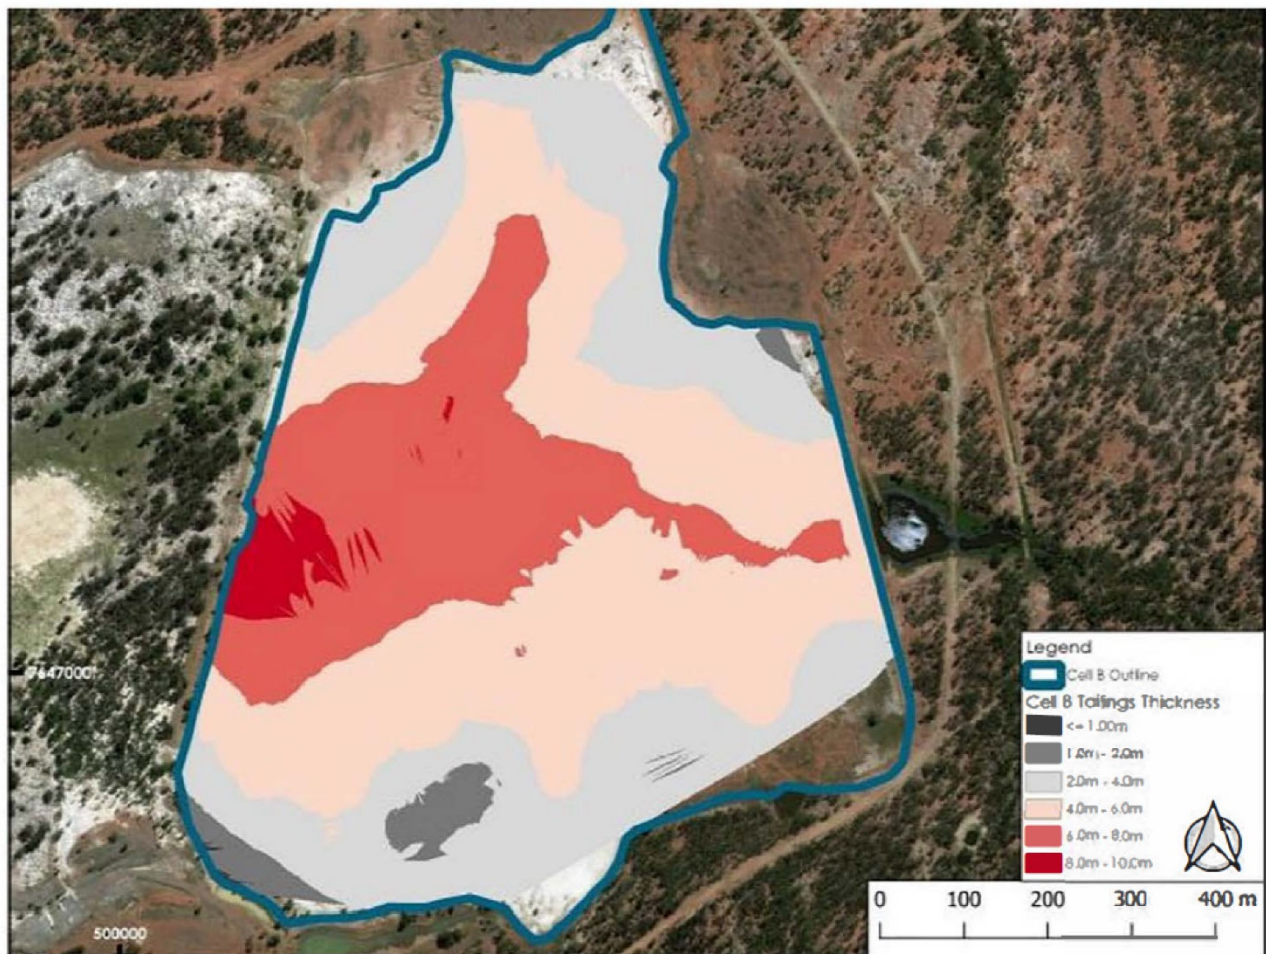
Figure 3: Depth of Tailings within TSF Cell B (Source: AARC, 2021)

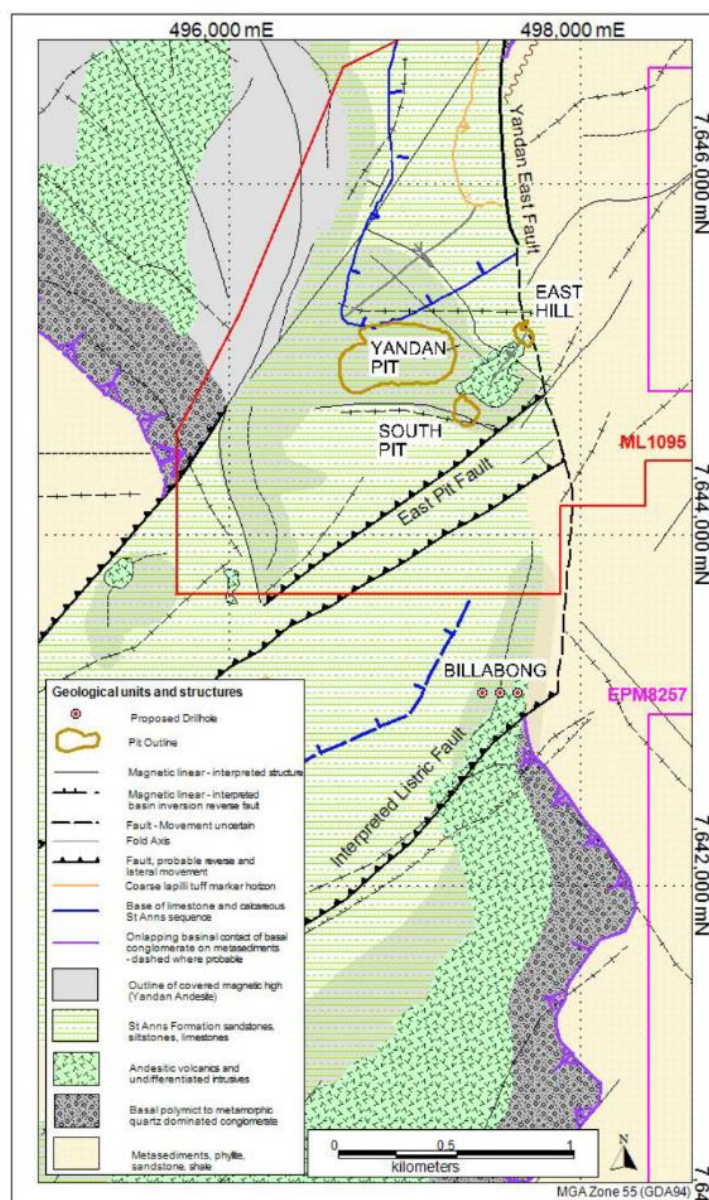
Figure 14 - Geology of Yandan site

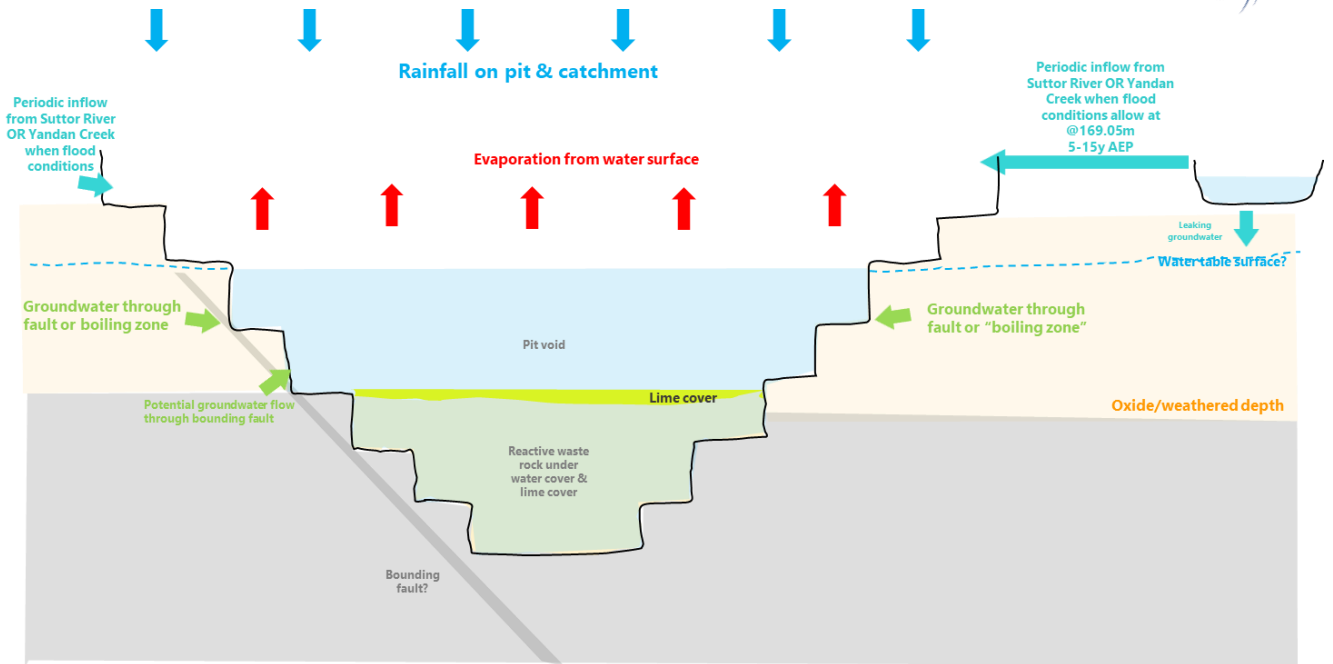
Figure 75 - Conceptual model for Main pit lake

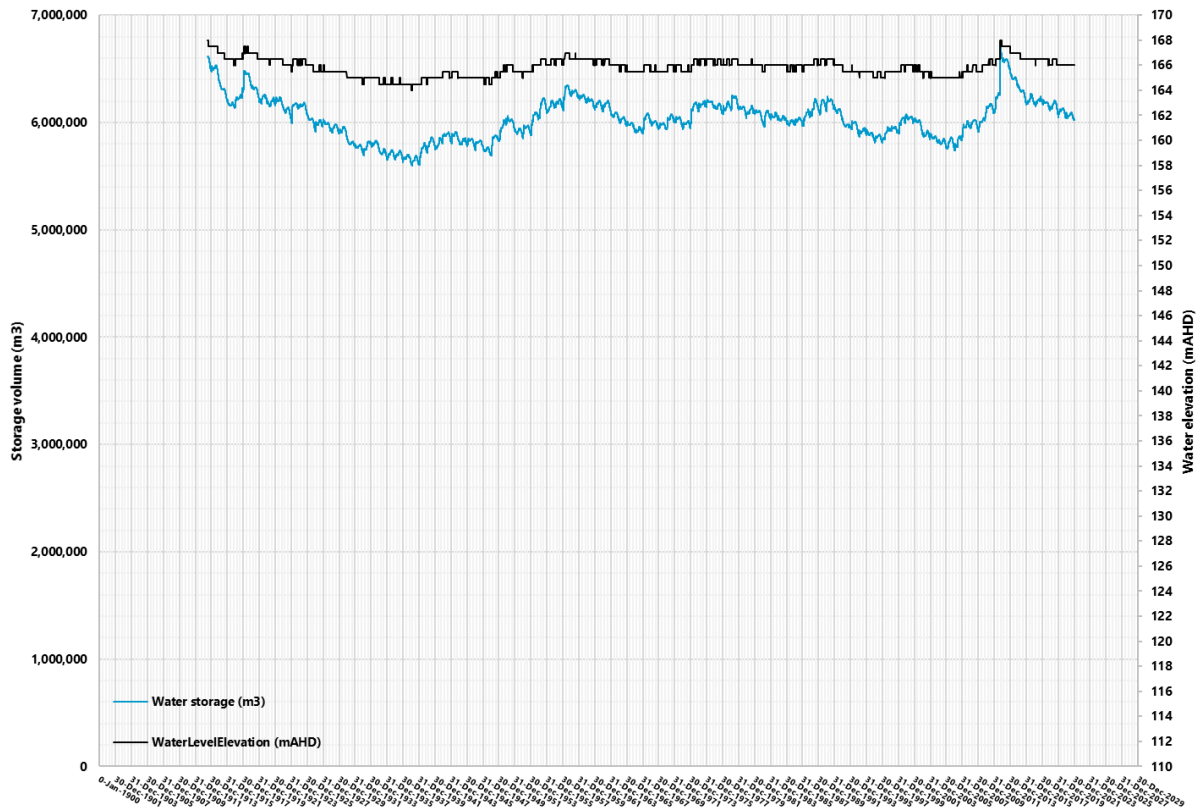
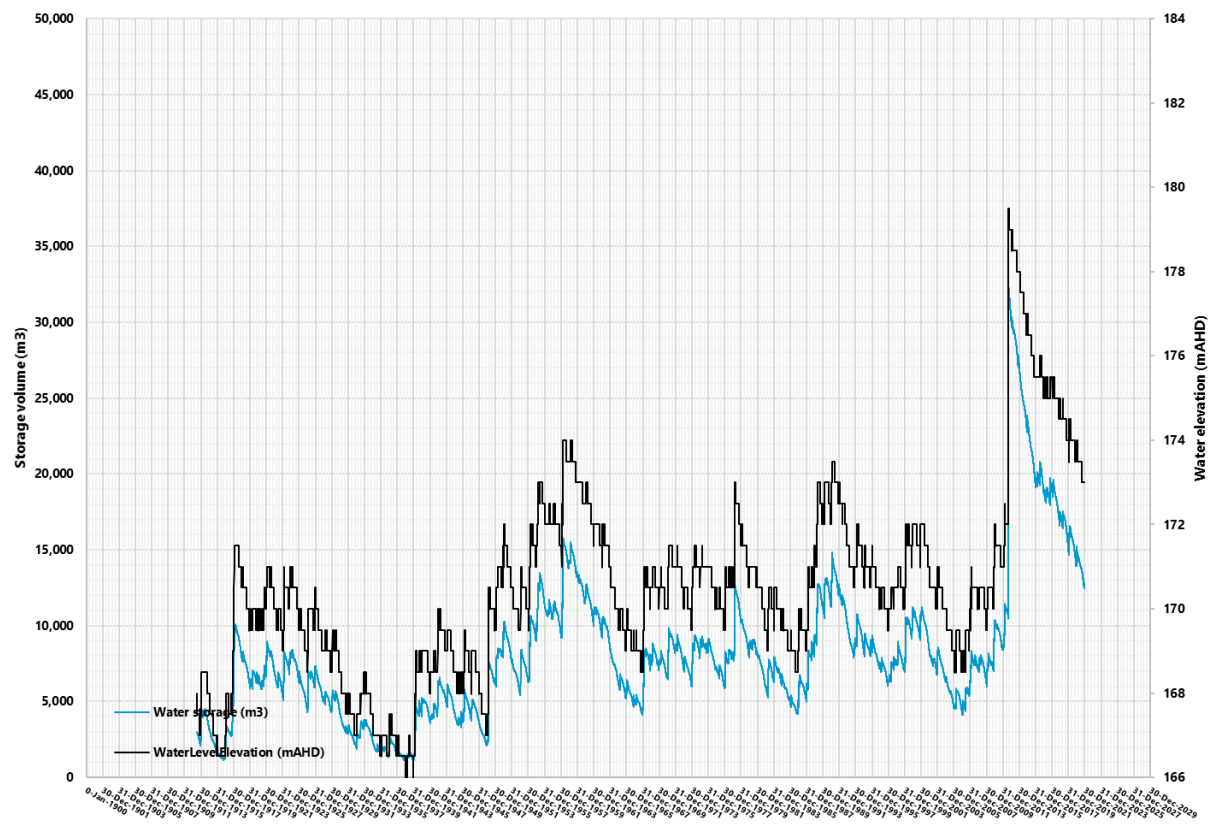
East Hill pit base case void model as per conditions 1913-2021 - PMF

Figure 79 - View of PMF event into Main & East Hill pit: standard (top), increased runoff rates(bottom)

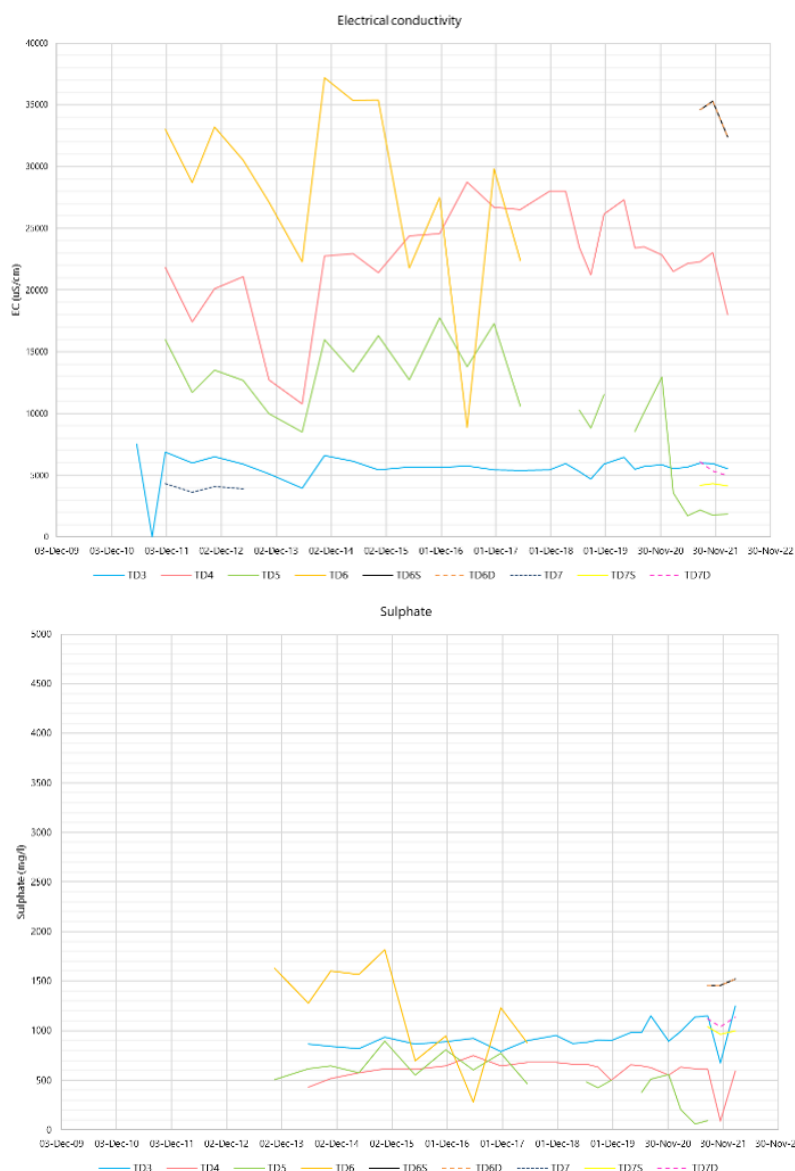
Figure 10 - Bore water quality for tailings area

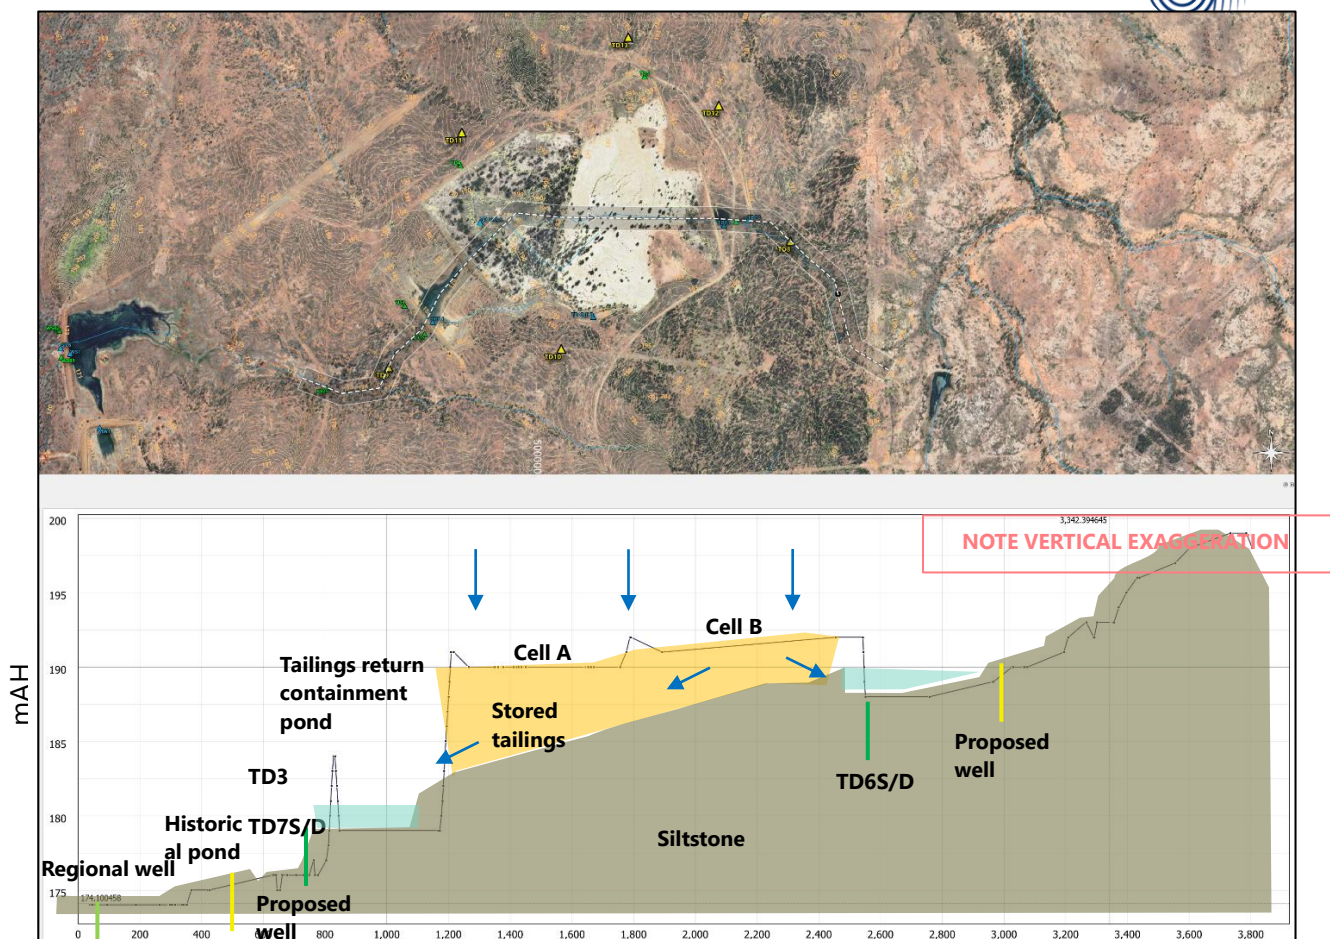
Figure 16 - East-West section through TSF and landscape

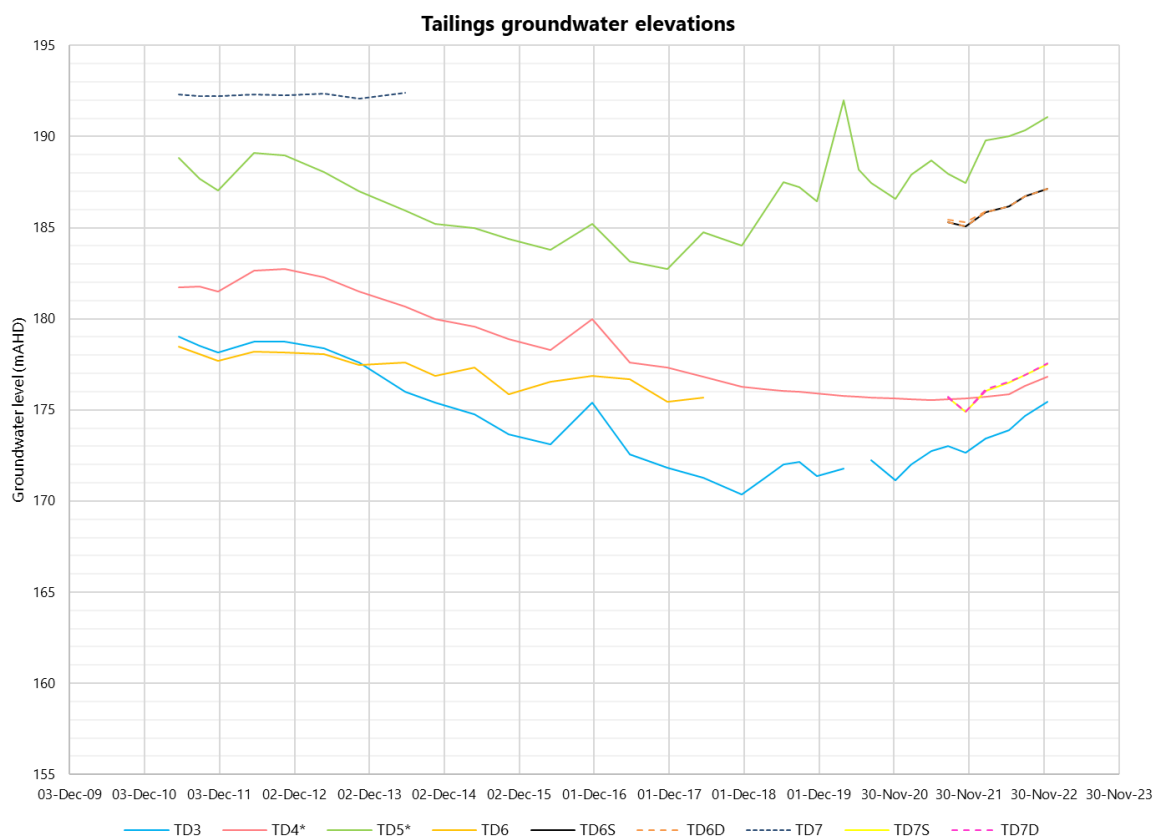
*Figure 25 - Tailings groundwater relative levels*

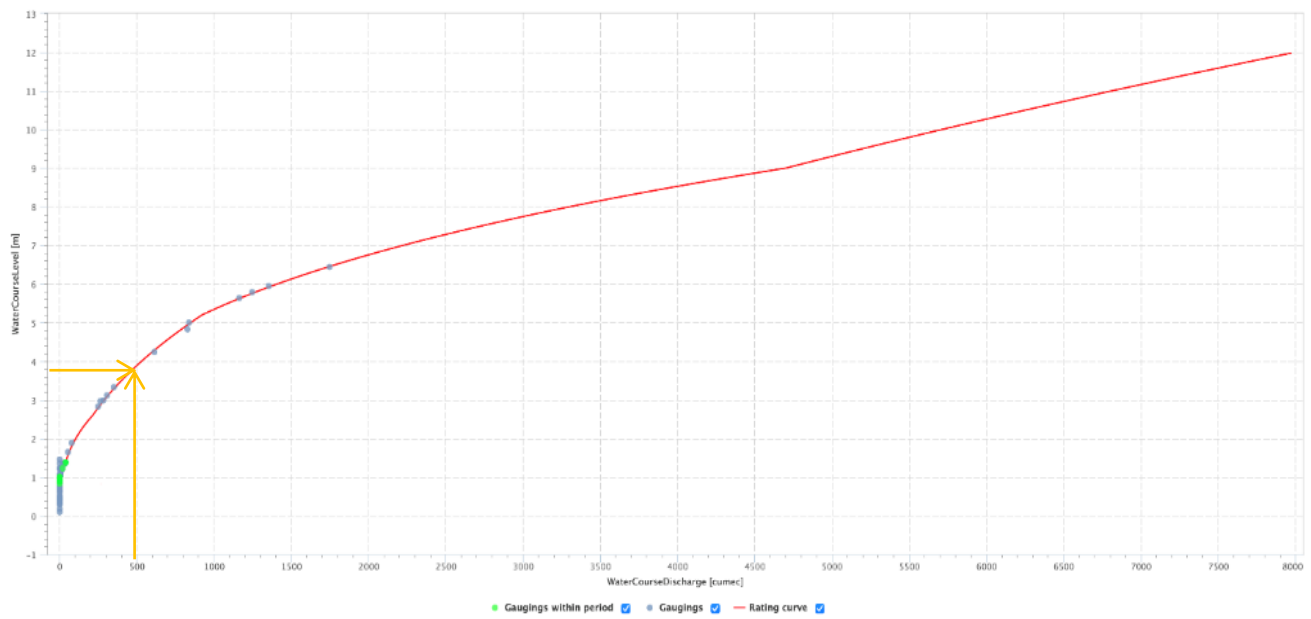
Figure 22 - River gauging curve for St Anns converting river height to flow (BOM 2024)

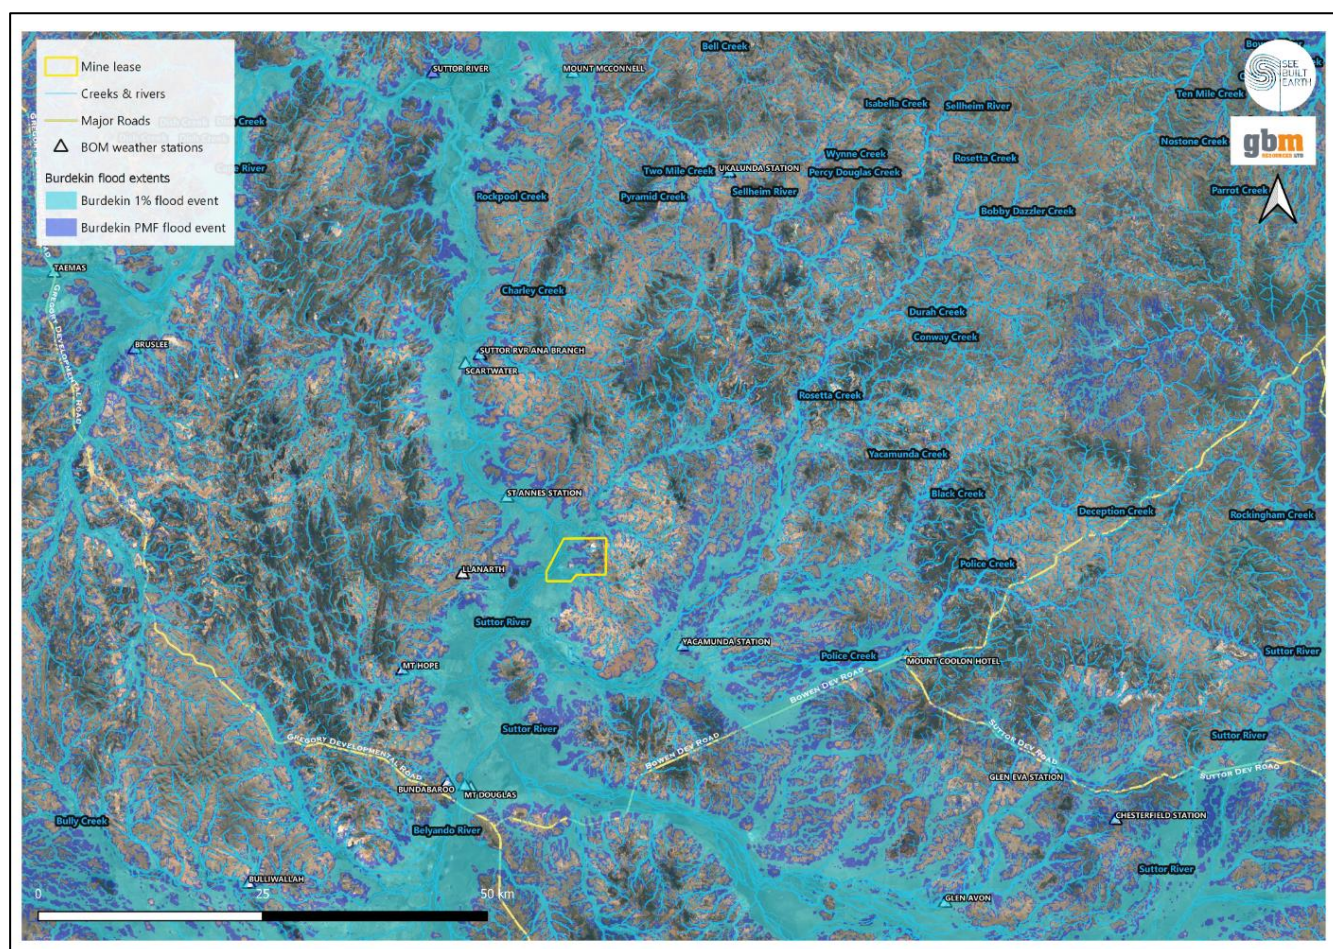
Figure 14 – Mid-reach Suttor River and tributaries flooding profiles – 1% AEP & PMF events

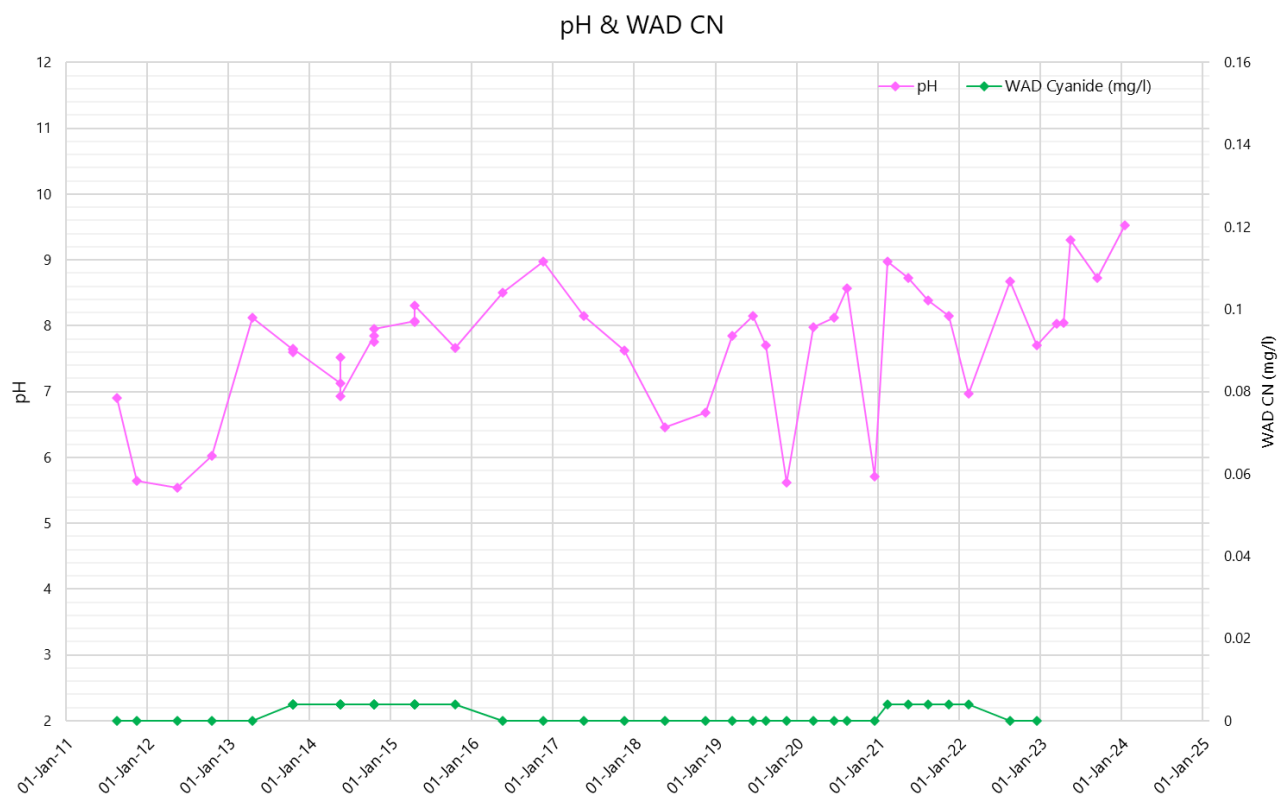
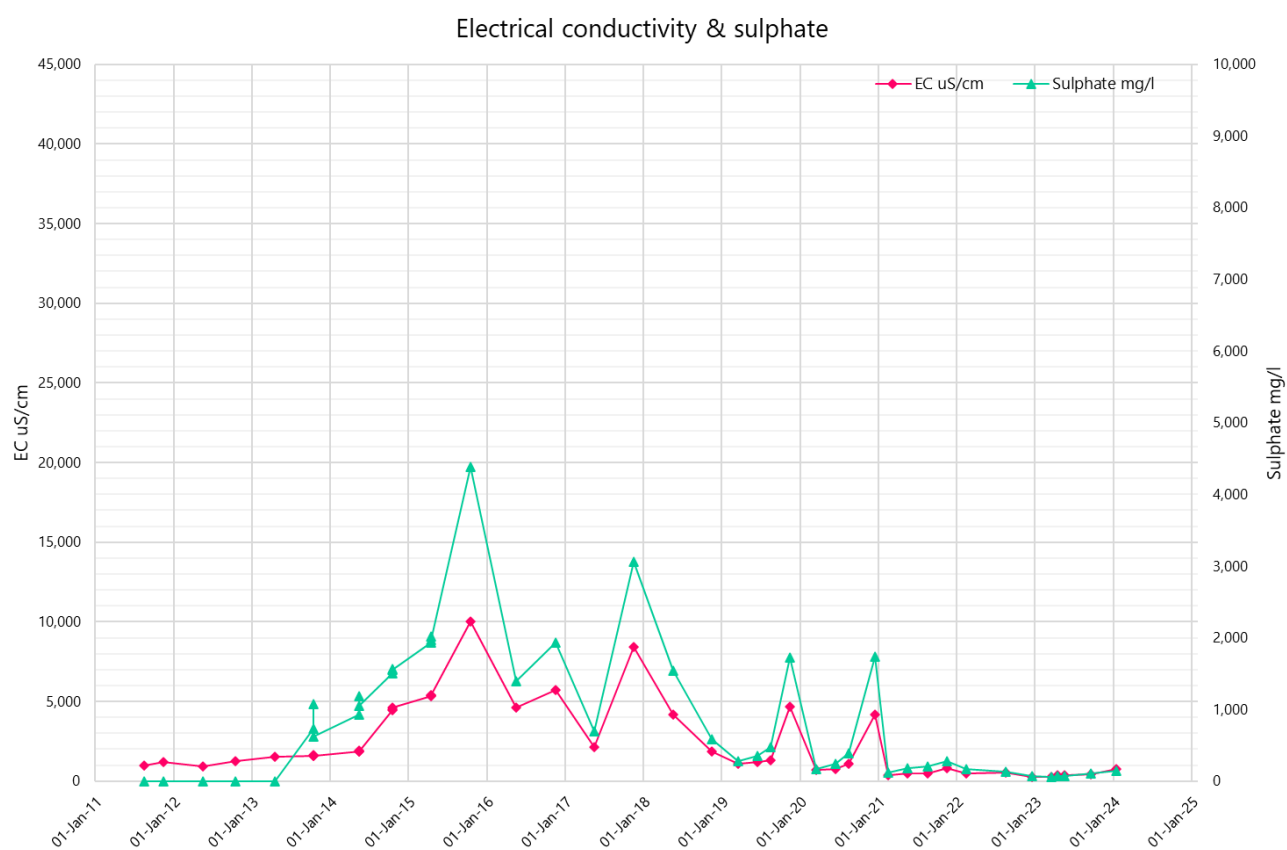
Figure 5 - Tailings containment storage pH, WAD CN, EC and SO4 concentrations

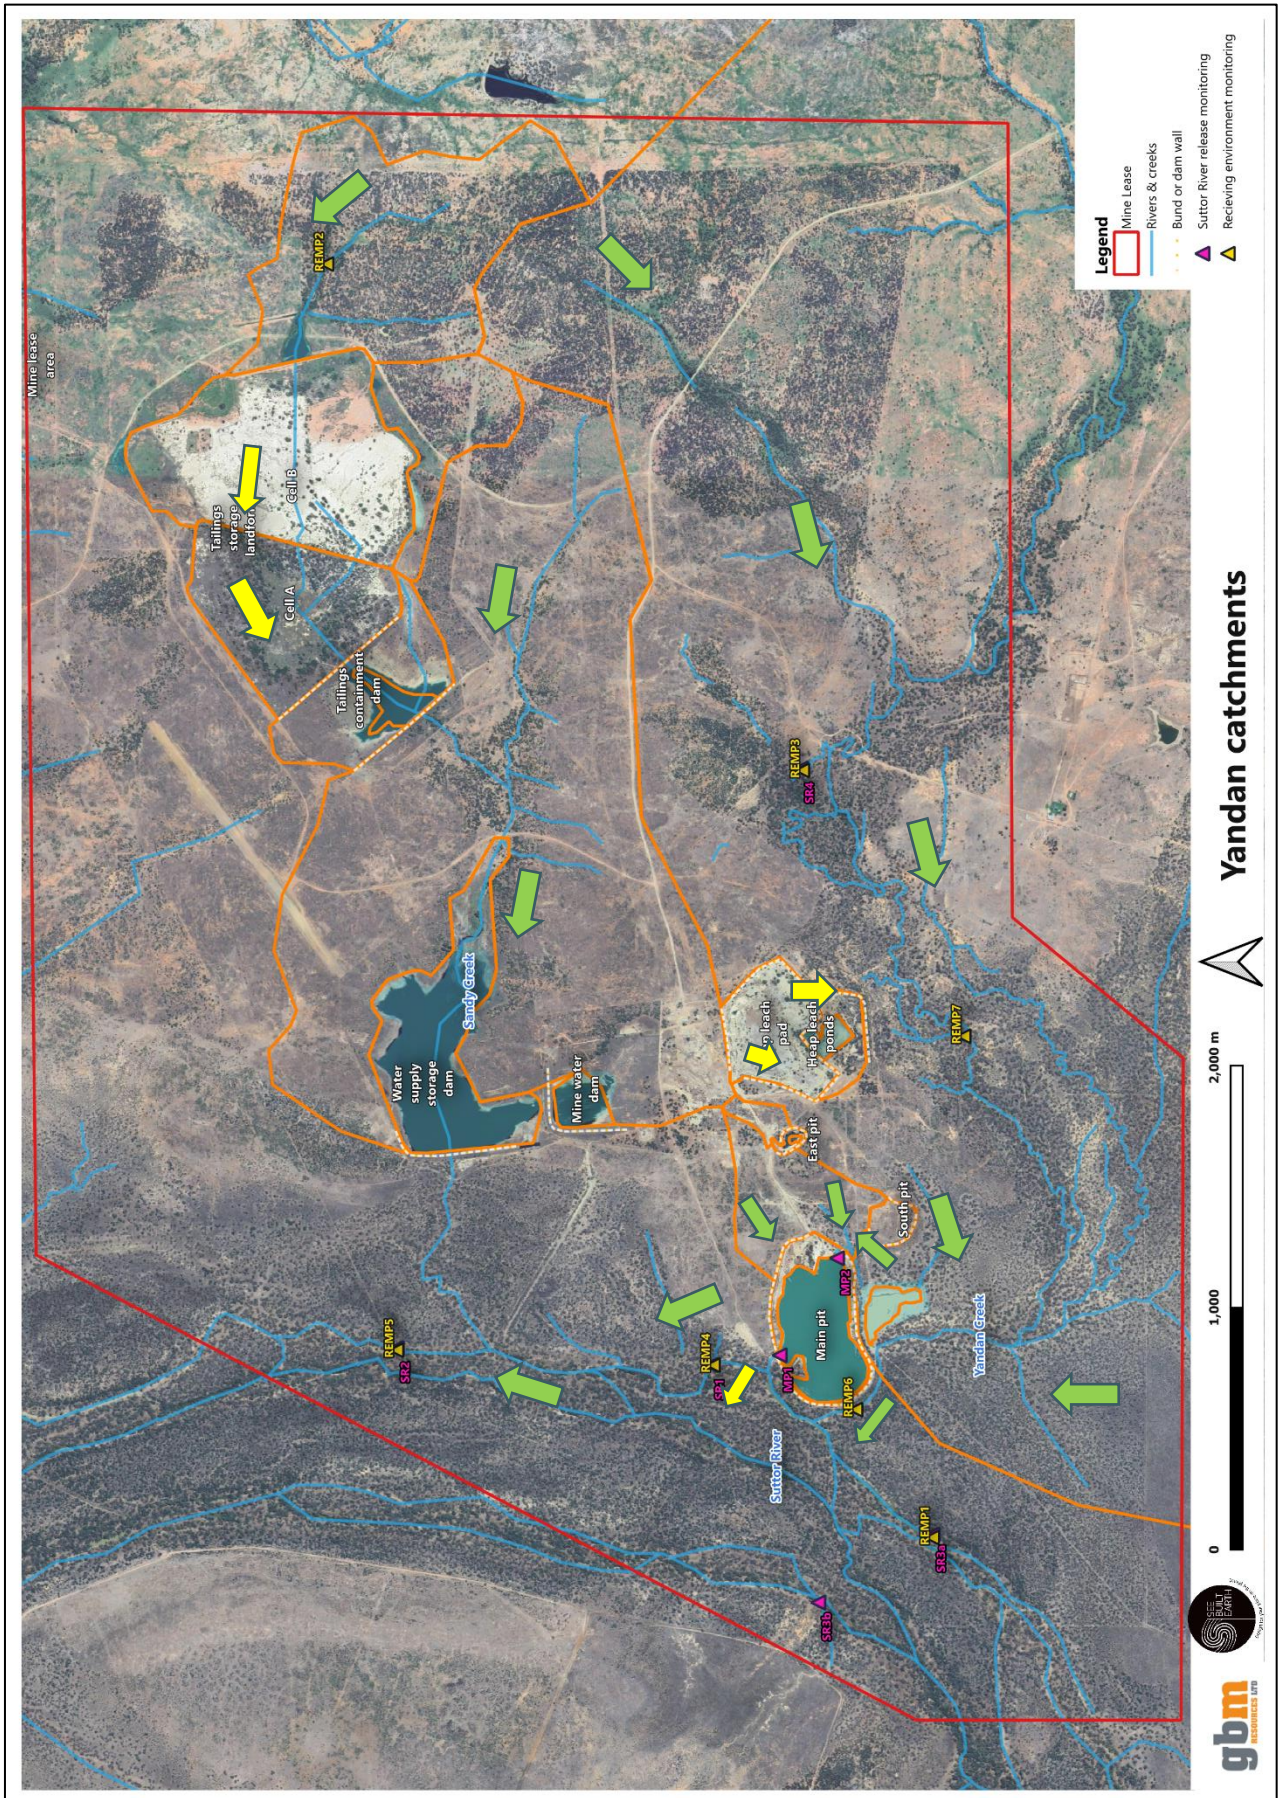
Figure 11 – Surface water framework of Yandan site with catchments & drainage directions

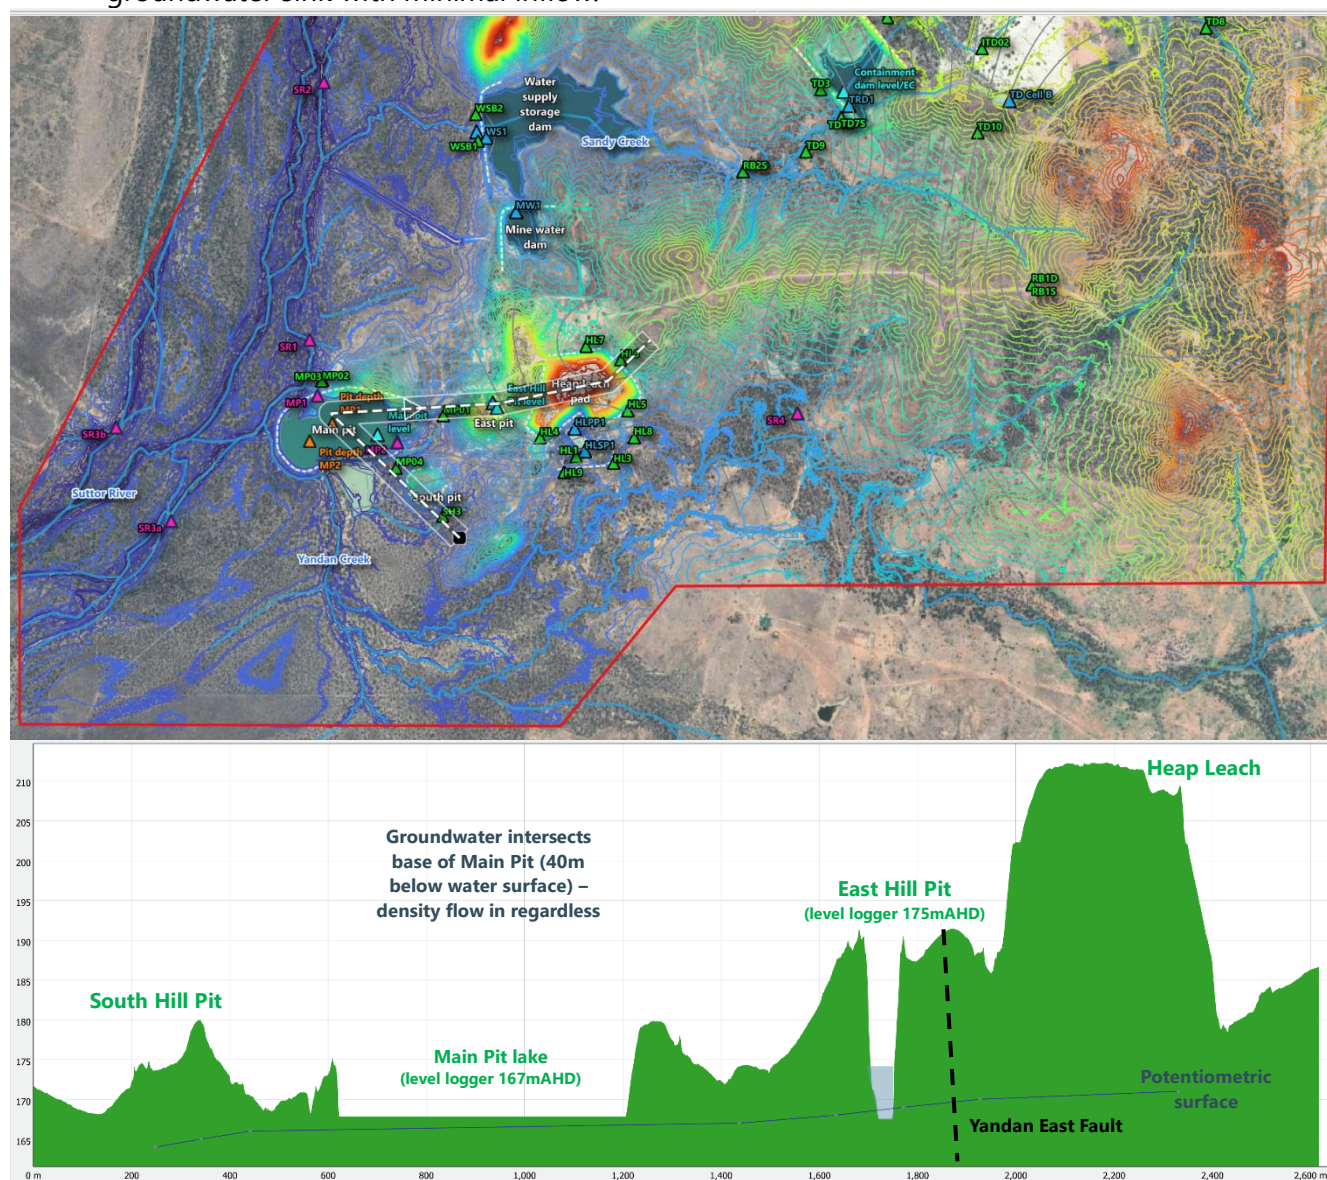
Figure 25 - Profile and groundwater-surface with inferred geology – Mineralised domain

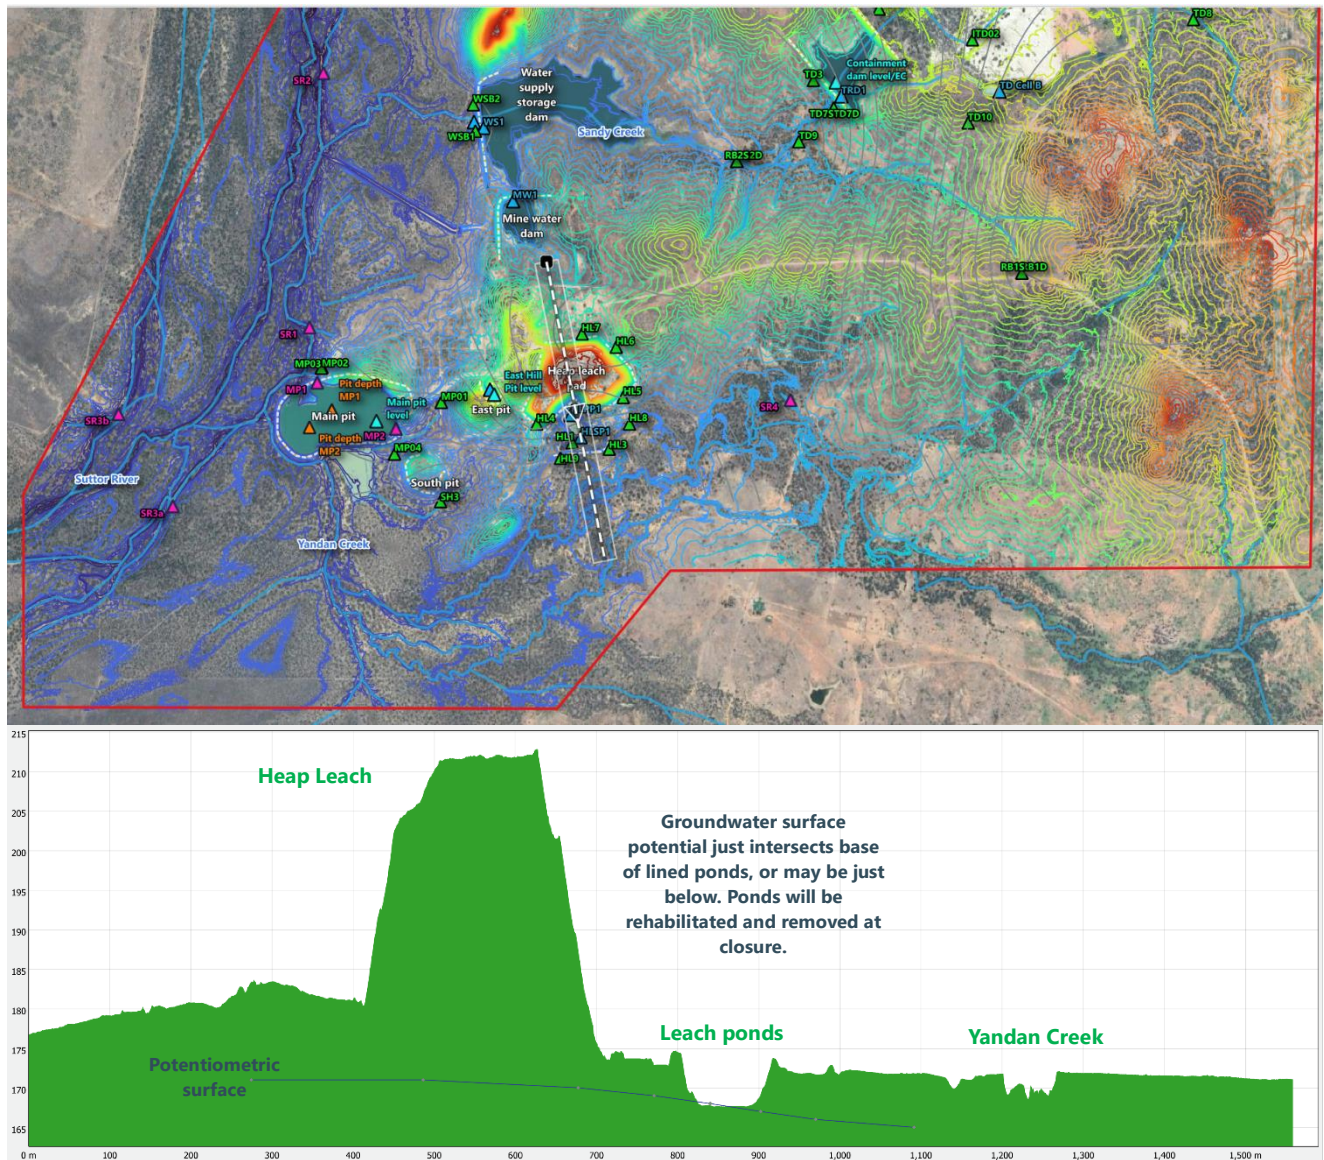
Figure 27 - Profile and groundwater surface with inferred geology - Heap Leach domain

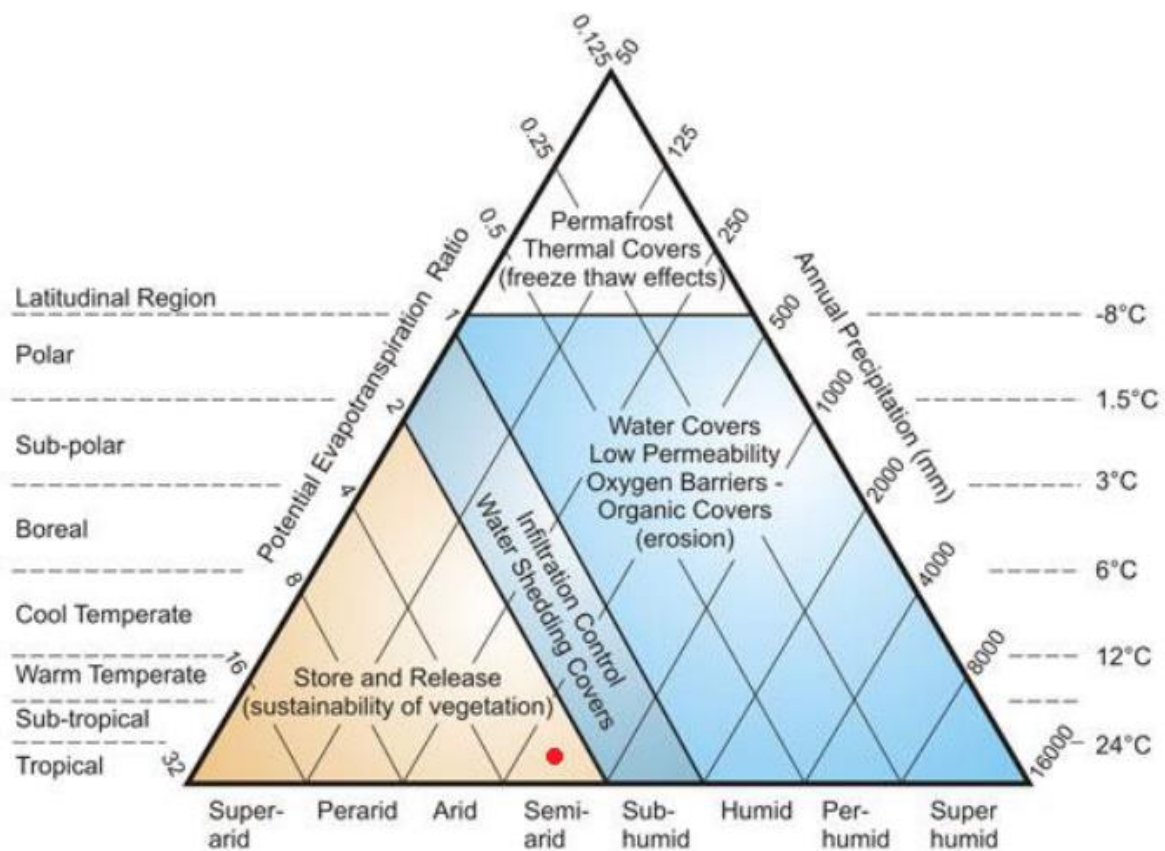
**Figure 4** Recommended cover system for Yandan TSF Cell B (indicated by red dot)
