## YANDAN GOLD MINE POST MINE LAND USE PLAN

PREPARED FOR  
**STRAITS GOLD PTY LTD**

AUGUST 2018

# YANDAN GOLD PROJECT 2023 REHABILITATION MONITORING REPORT

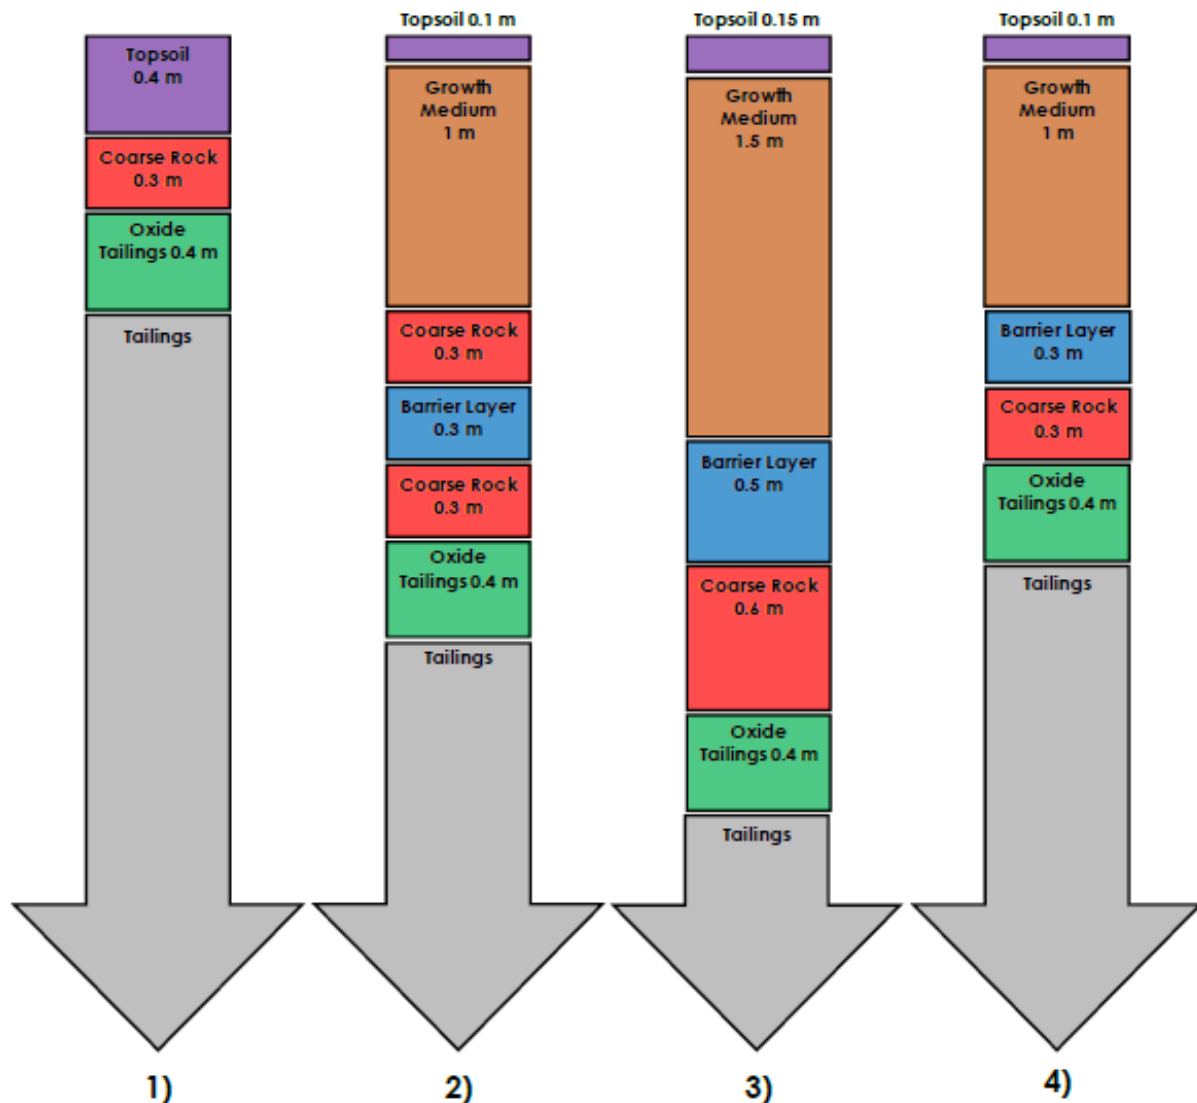
**Figure 5** Four cover system designs considered by O’Kane
